NATIONAL AERONAUTICS AND SPACE ADMINISTRATION
MANNED SPACECRAFT CENTER
HOUSTON, TEXAS 77058

IN REPLY REFER TO: 69-FC56-11

MEMORANDUM TO: Apollo 12 Flight Director
FROM : Guidance Officers
SUBJECT : Apollo 12 Postflight Report

DSKY DISPLAY ANOMALY

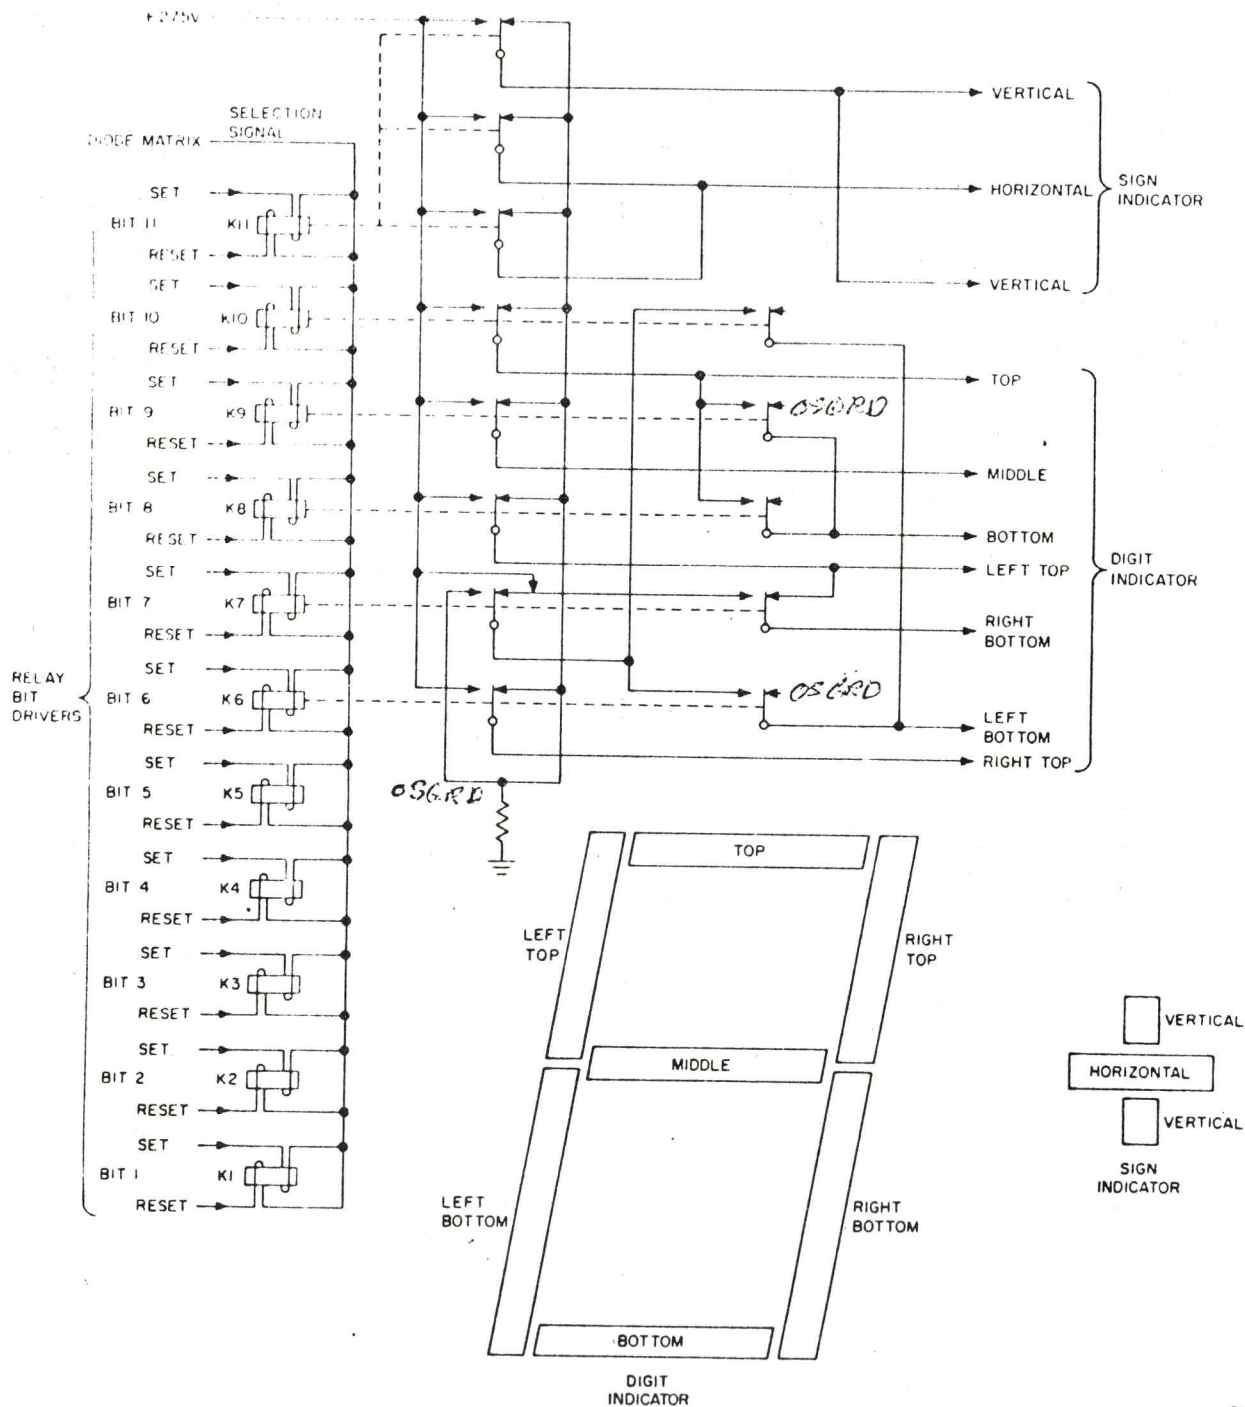
Figure 4-136. Relay Matrix, Simplified Schematic Diagram

Approximately 1.5 hours before liftoff, the crew reported the intermittent appearance of all 8's on the main DSKY numeric display. The reported condition was not observed on telemetry.

The cause of the anomaly is not known at this time, however, one mechanism which could cause the reported symptoms has been encountered previously in the block II DSKY. The electroluminescent segments which make up the displayed characters are controlled by a relay matrix as illustrated in the attached figure. The relays have a small (approximately 0.003 inch) clearance between the contacts, and despite extensive screening, have a history of contamination causing shorts in this area. Because the segments are capacitive, they must be discharged positively to avoid residual glow when turned off. As indicated on the figure the discharge path for all segments is through a common resistor. If, with the relays in the off position as shown, a short occurs across the contacts of any one of the relays, the operating voltage will be applied to all segments through the common discharge path and 8's will appear in all locations.

A failure of this type will affect only the display function of the DSKY involved. All data entry and control functions and the display function of the redundant DSKY (in the CM) will remain operational.
