STS-124 SPACE SHUTTLE MISSION REPORT

February 2009

**National Aeronautics and
Space Administration**

**Lyndon B. Johnson Space Center
Houston, Texas**

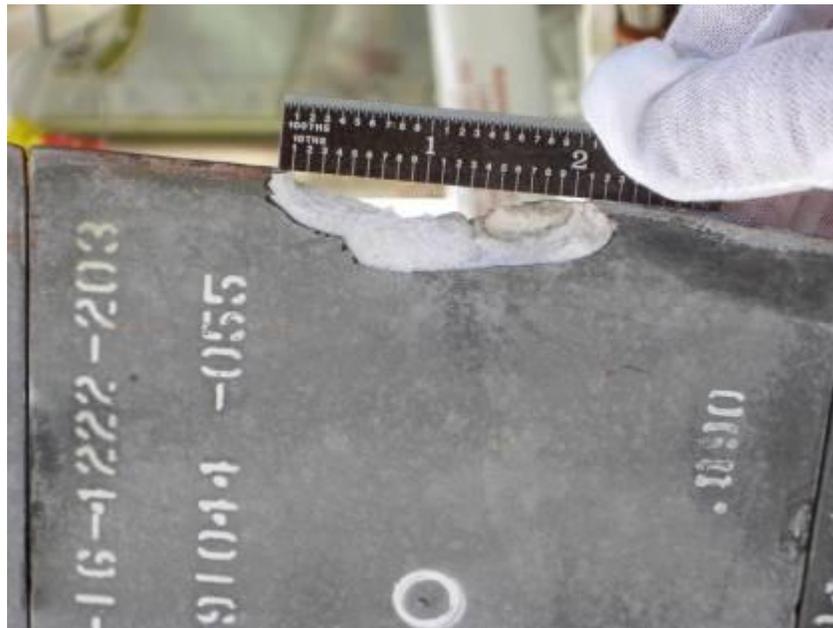
Photograph of Tile Damage

All Nose Landing Gear Door (NLGD) thermal barriers exhibited typical fraying. The NLGD tile damage on the V070-391044-055 tile (photograph below) was measured to be 2.3-in. by .6-in. by 0.5 in. The tile was also cracked adjacent to damage approximately 2-in., noted on sidewall. No charring noted on adjacent thermal barrier
