LOWER MORGAN CREEK GROUP

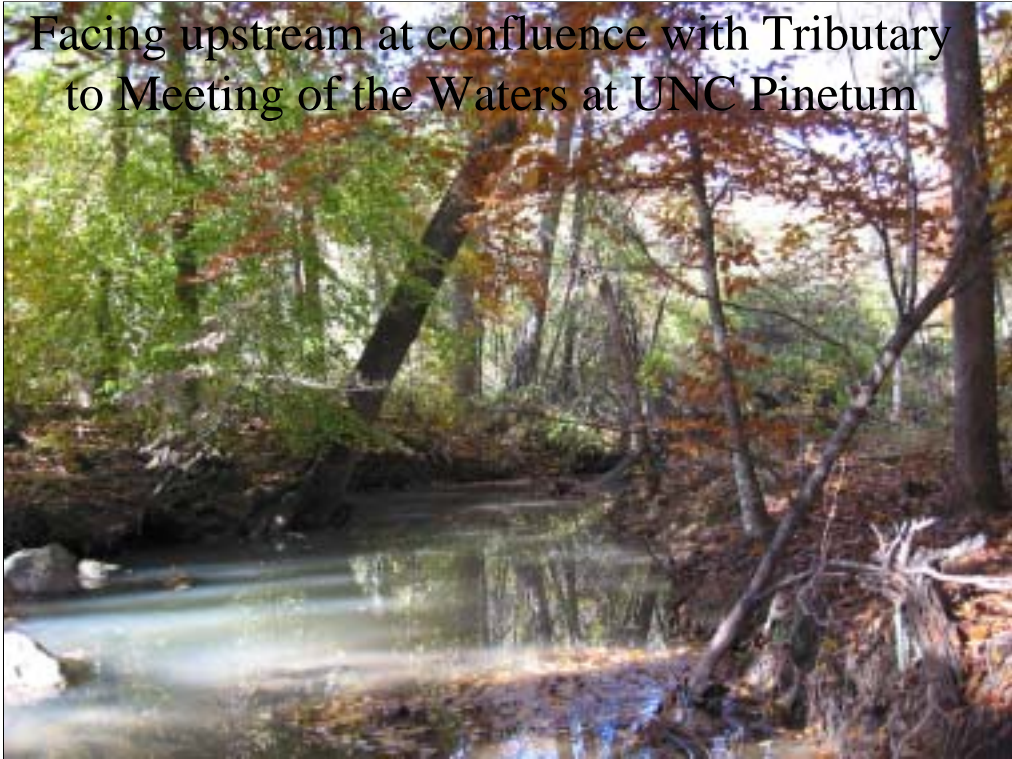
Confluence of Unnamed Tributary and Meeting of the Waters at UNC Pinetum

Obvious gray discoloration of water

Source was investigated by Sharon Myer and her staff and found to be a illicit discharge from a laundry facility at UNC Hospital

Measures under way to correct problem

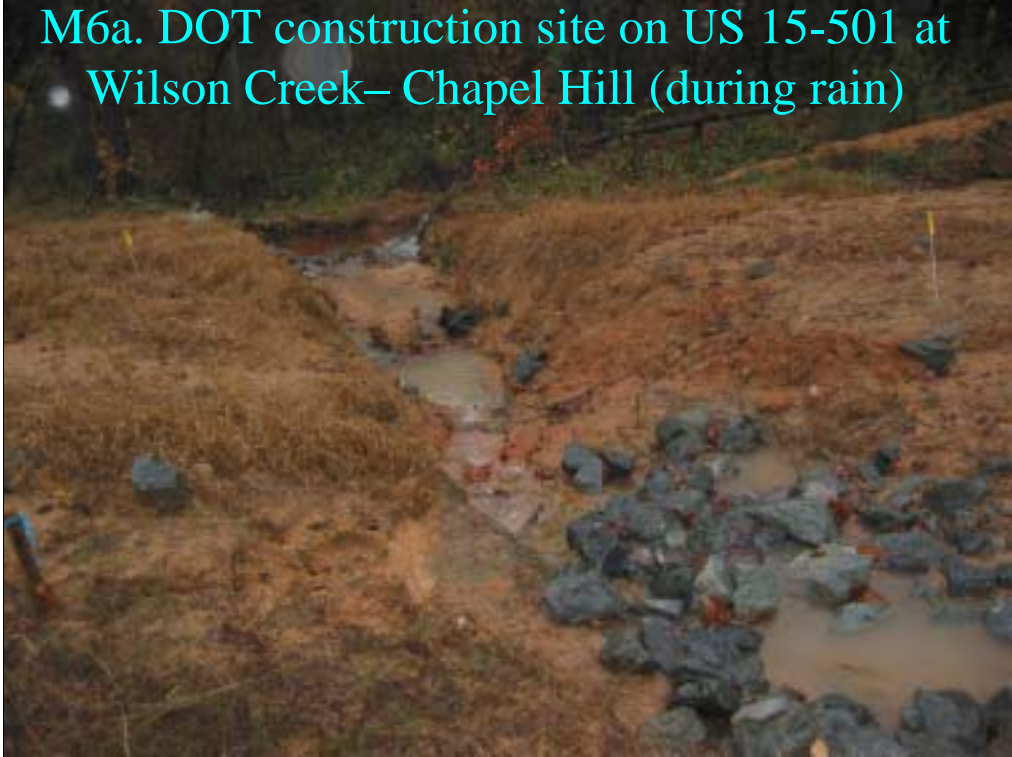
Wilson Creek at US 15-501

Poor stormwater control at DOT construction site

Obvious erosion of topsoil

Visible turbidity in runoff

Source of sediment deposition to Wilson Creek

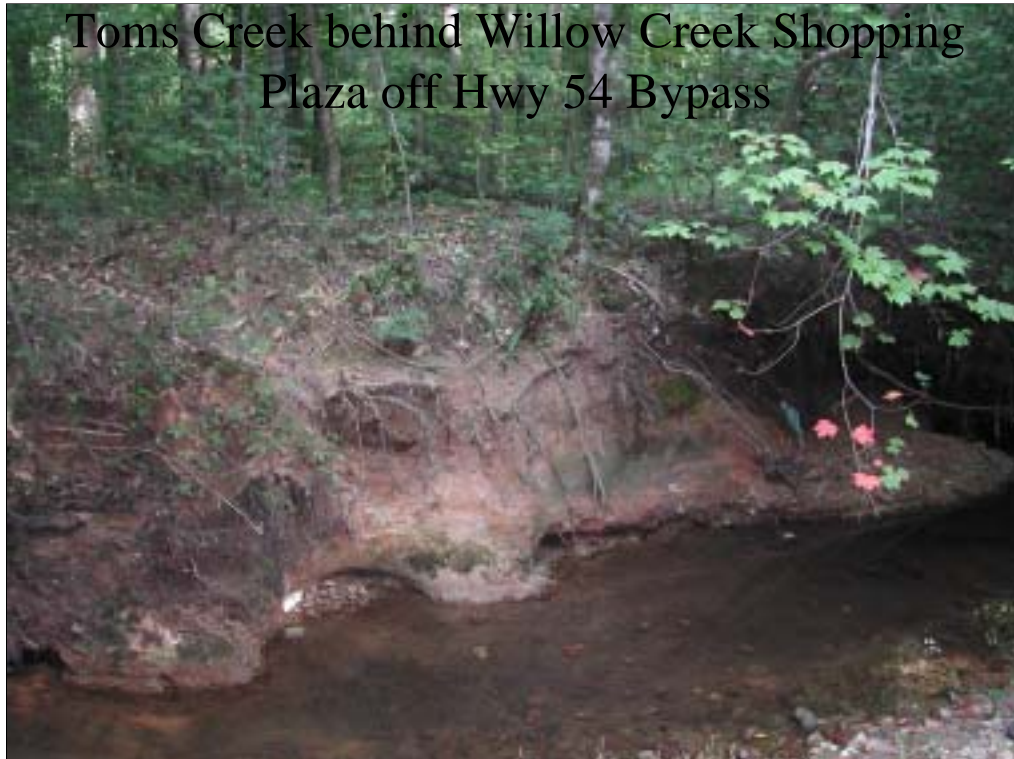
Toms Creek behind Willow Creek Shopping Plaza off Hwy 54 Bypass

Significant bank erosion

Exposed roots indicate that bank erosion may be ongoing

High bank indicates stream may be incised at this location

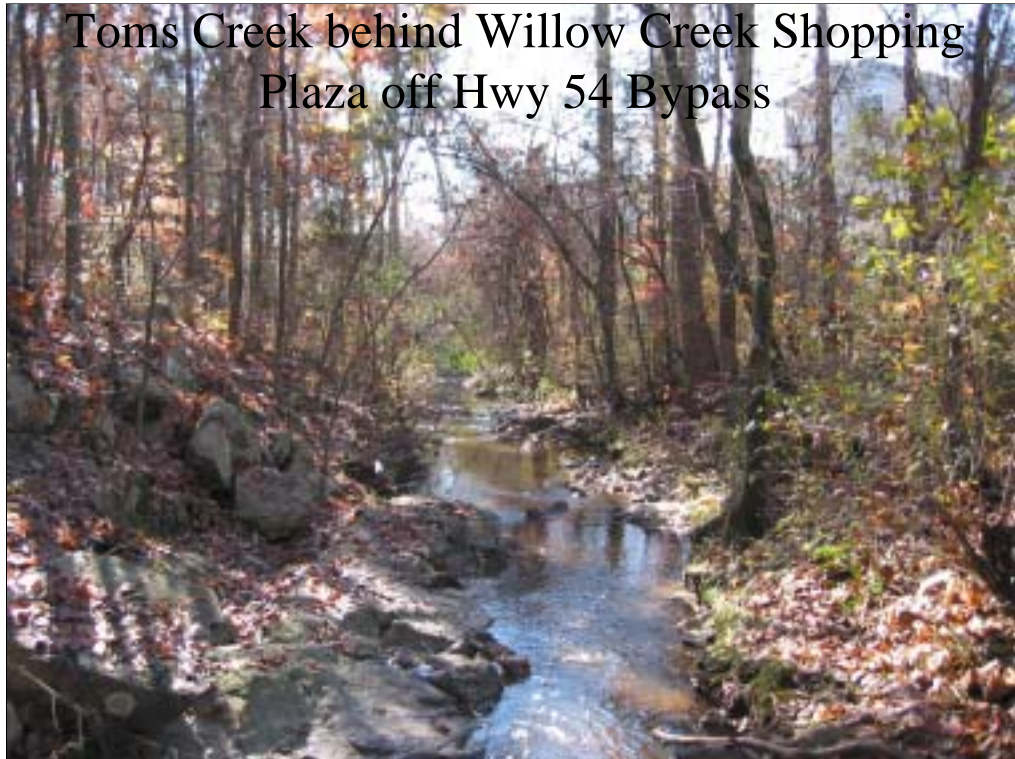
Toms Creek behind Willow Creek Shopping Plaza off Hwy 54 Bypass

Bedrock substrate maintains grade control which has prevented stream from incising

Right bank low – flood plain readily accessible during storm flow events

Riparian buffers intact

Some sections are good example of step-pool stream type

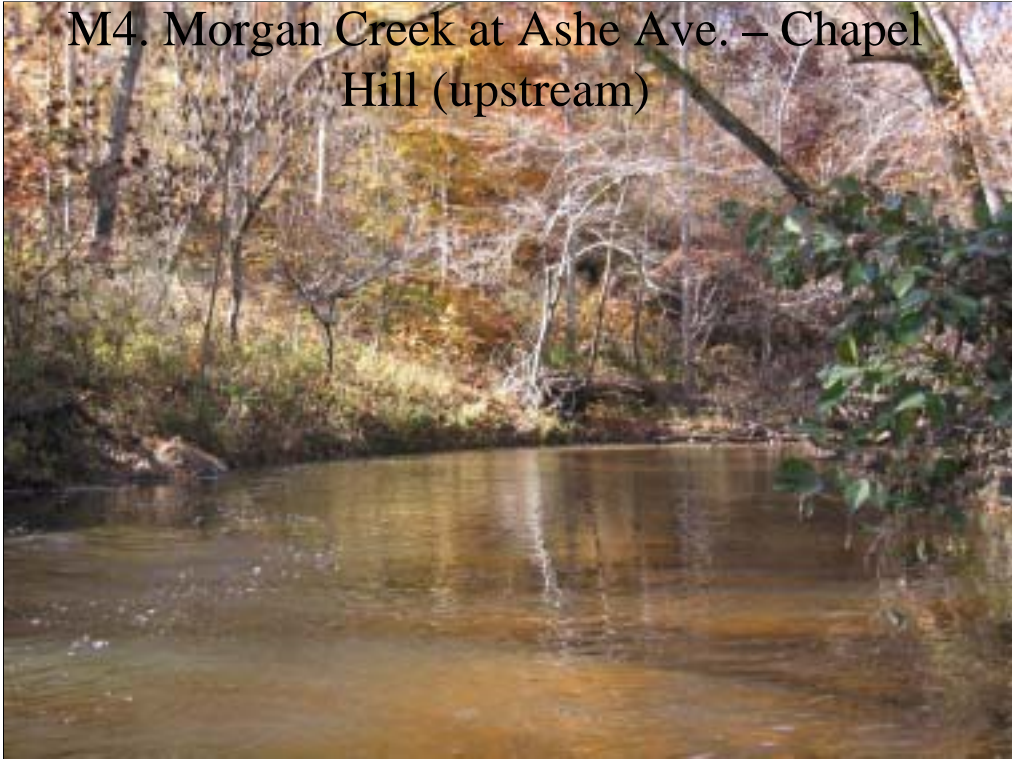
Morgan Creek at Ashe Ave. – Chapel Hill

Buffers intact – alluvial valley heavily forested through this section (despite surrounding suburban community)

Floodplain immediately accessible off right bank (not visible in photo)

Photo taken in meander bend indicative of good stream pattern in this area

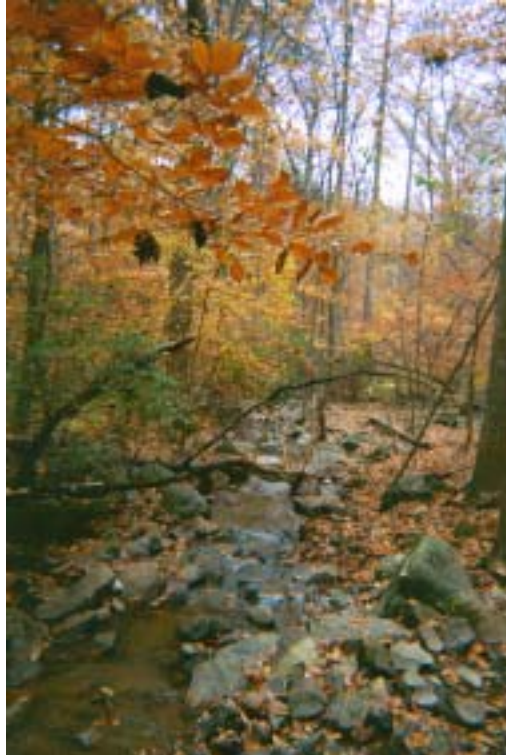
Meeting of the Waters in UNC Pinetum

Rocky substrate helps maintain grade control in this section, which has prevented stream from incising

Banks low – flood plain readily accessible during storm flow events

Preservation of Pinetum insures that riparian buffers remain intact

Some sections are good example of step-pool stream type (including the section in the photo)

Highly valuable open space/habitat near urban center

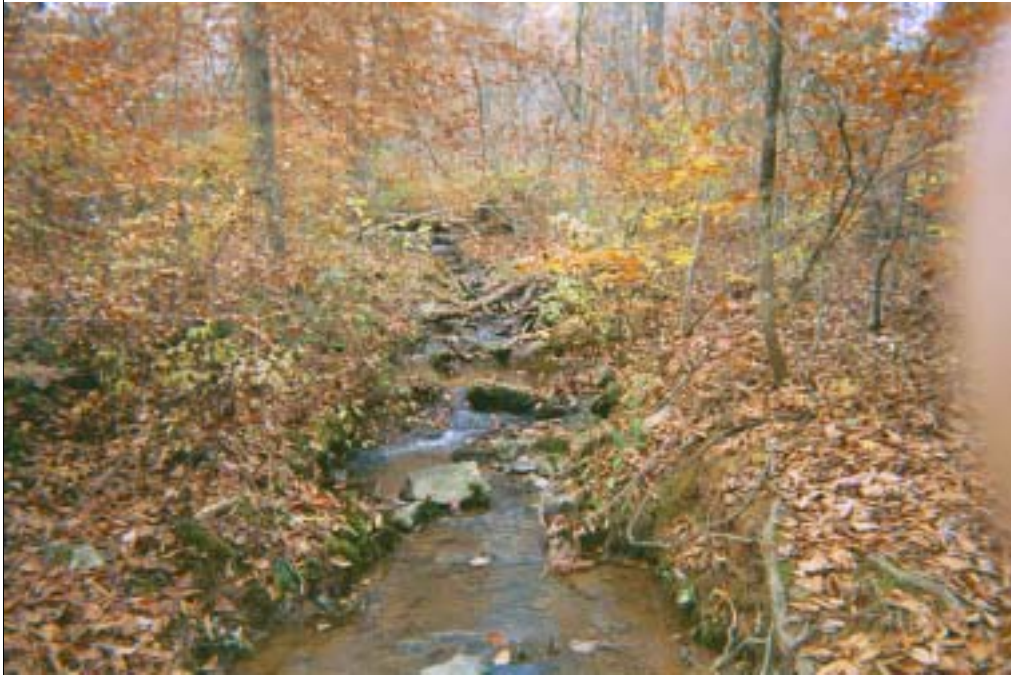
Tributary to Bolin Creek at edge of Adams Property

Relatively Intact; Edge of Adam's Property

Floodplain appears readily accessible – stream not incised

Riparian buffer intact and extensive

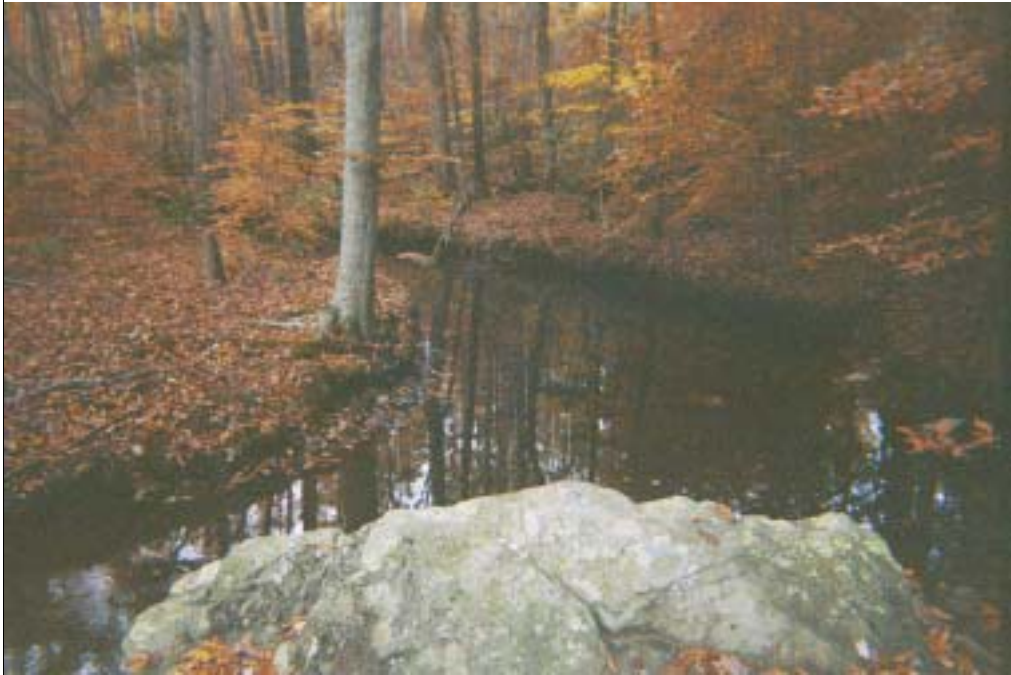
Bolin Creek at Claymore Rd.

Undisturbed Reach

Floodplain appears accessible – stream not likely to be incised

Riparian buffer intact and extensive

Extensive mid-age to mature hardwood forest in riparian zone – good habitat

Photo taken in meander bend indicative of good stream pattern in this area

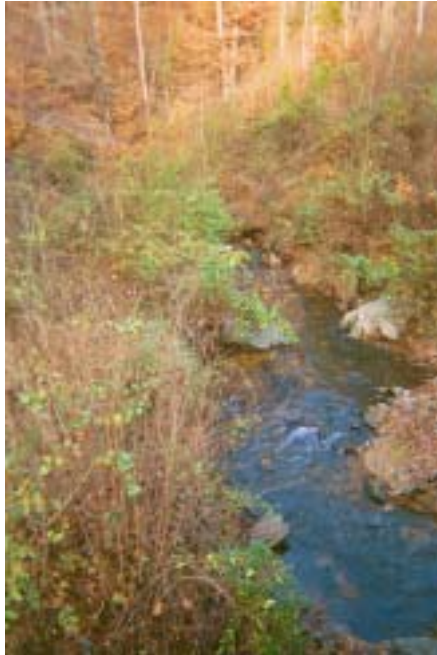
Phils Creek at Greensboro Road (not actually in Little/Bolin Creek watershed)

Floodplain appears accessible – stream not likely to be incised

Meander bend in photo indicative of good stream pattern in this area

Riparian buffer intact and extensive (not clearly visible in photo).

Extensive portions of alluvial valley covered with mature hardwood forest in this area

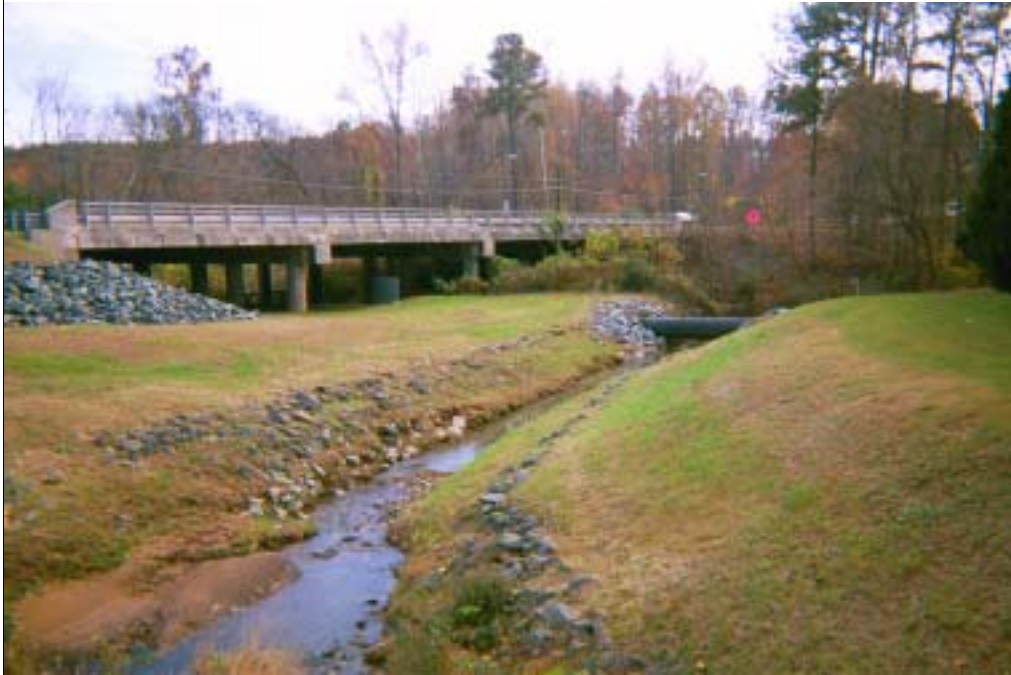
Tributary to Morgan Creek at Smith Level Road (not actually in Little/Bolin Creek watershed)

Tributary to Morgan Creek; Alluvial Deposits

Stream segment straightened

Riparian vegetation removed

Sediment deposits in stream bed

Stream banks artificially hardened

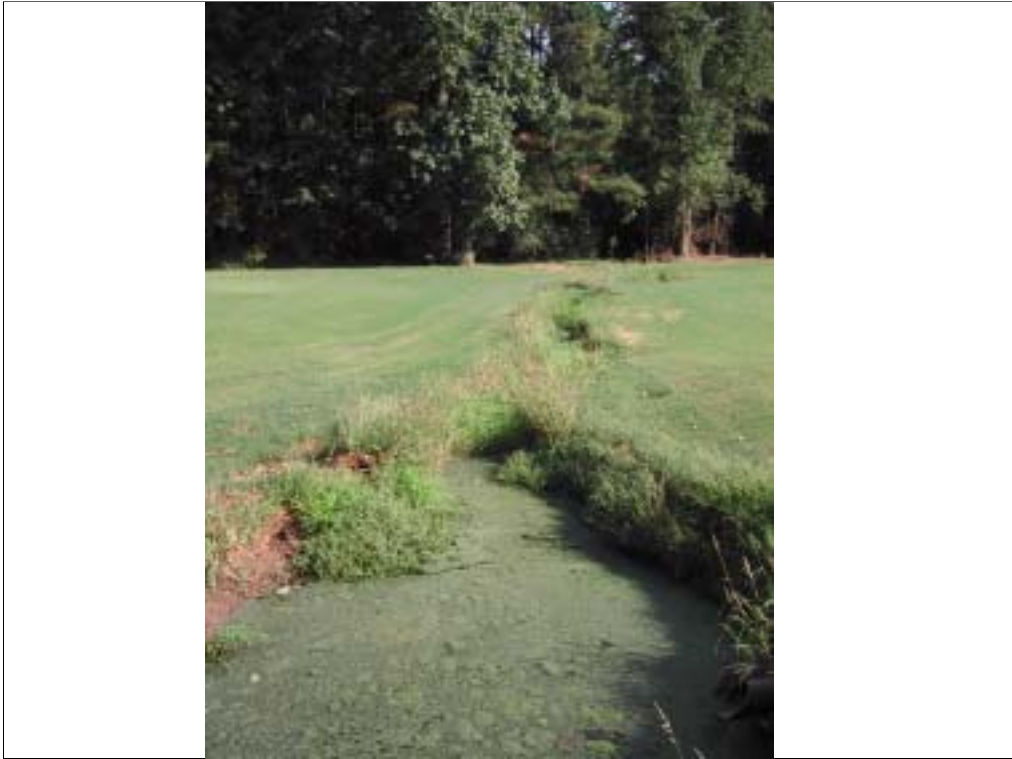
Tributary to Little Creek at Chapel Hill Golf Course

Riparian vegetation removed and regularly disturbed (mowed)

Algae and/or aquatic macrophyte growth in still section indicates strong potential for nutrient over-enrichment

Banks eroded (not shown in photo)

Stream likely to be incised in some sections

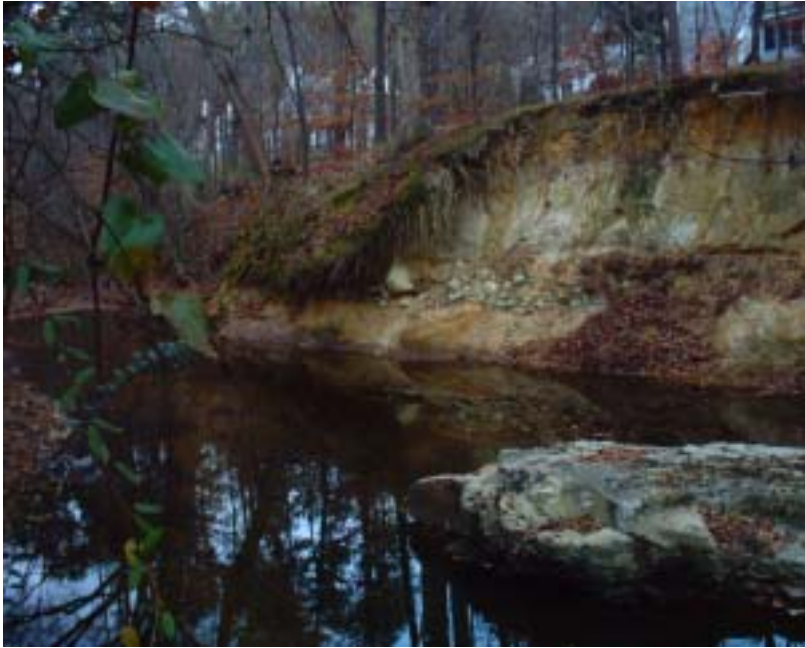
Bolin Creek at Bollingwood

Severe erosion of steep of very high, steep embankment below residential structures with very narrow buffer.

Severe bank erosion – prime example of slope failure

High steep bank – stream may be incised in this area

Narrow riparian buffer – encroachment by structures

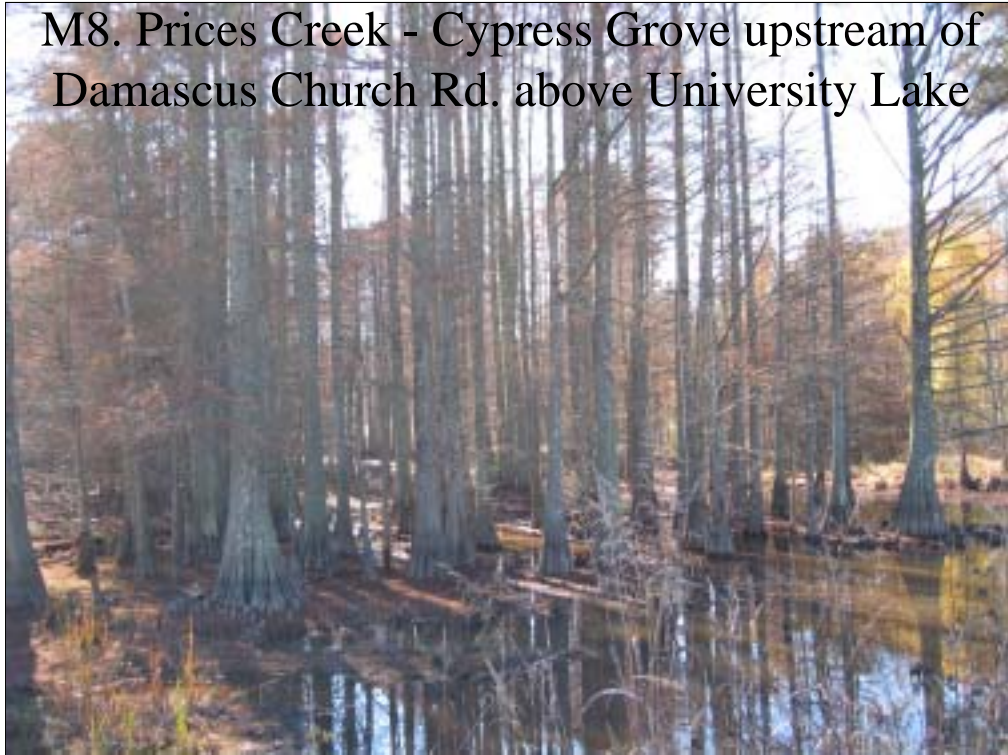
Prices Creek at Damascus Church Rd. – upstream of University Lake

Broad and easily accessible flood plain

Mid-age cypress grove – unique ecological community and habitat

*It was noted in the meeting that this is technically an invasion of a non-native species.

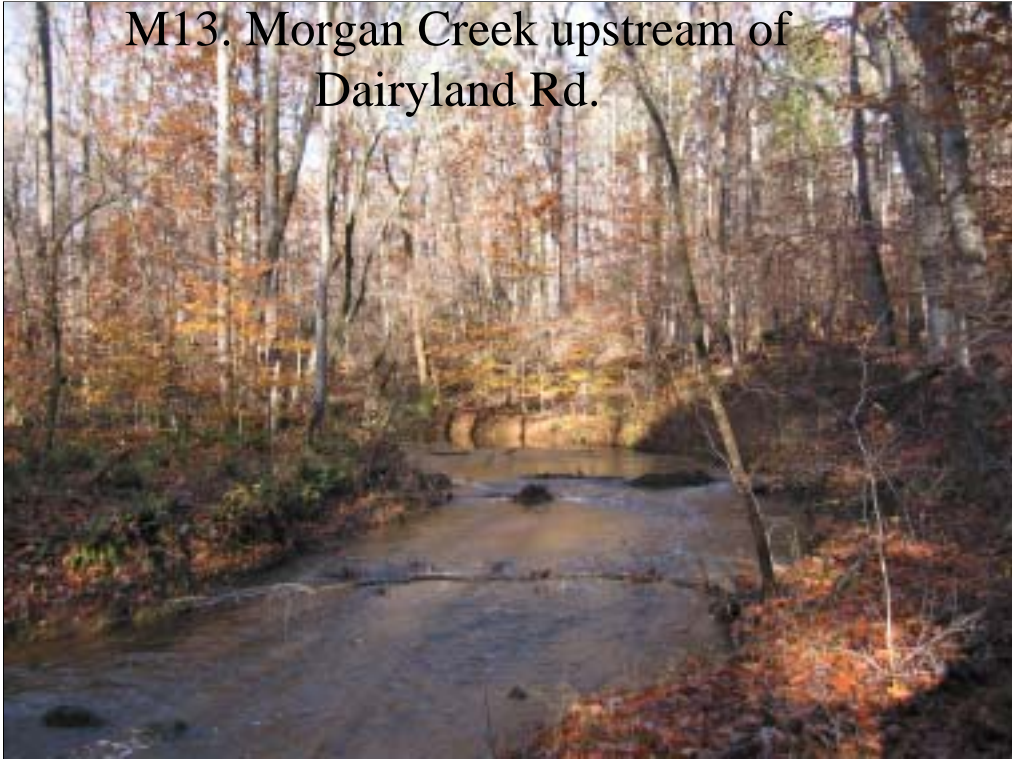
Morgan Creek upstream of Dairyland Rd.

Floodplain appears accessible – stream only slightly incised, if at all

Rocky substrate helps maintain stream grade

Meander bend in photo indicative of good stream pattern in this area

Riparian buffer intact and extensive

Extensive portions of alluvial valley covered with mature hardwood forest in this area

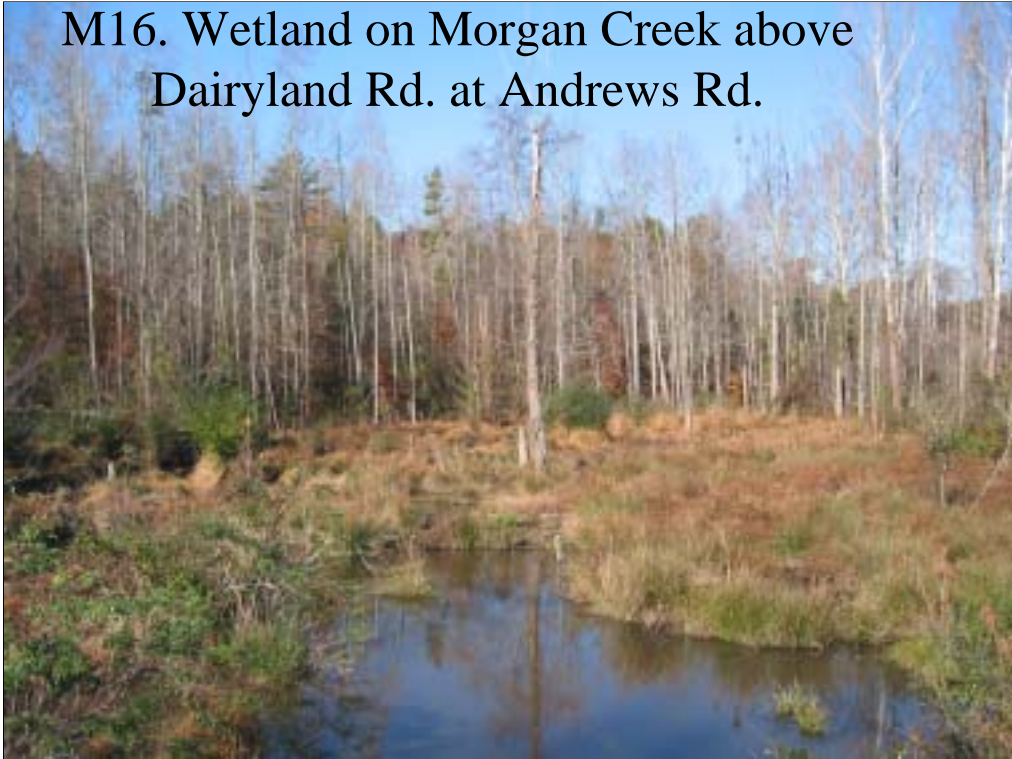
Wetland on Morgan Creek at Andrews Rd.

Extensive riparian wetland formed by beaver impoundment

Good for flood control and pollutant removal

Prime habitat

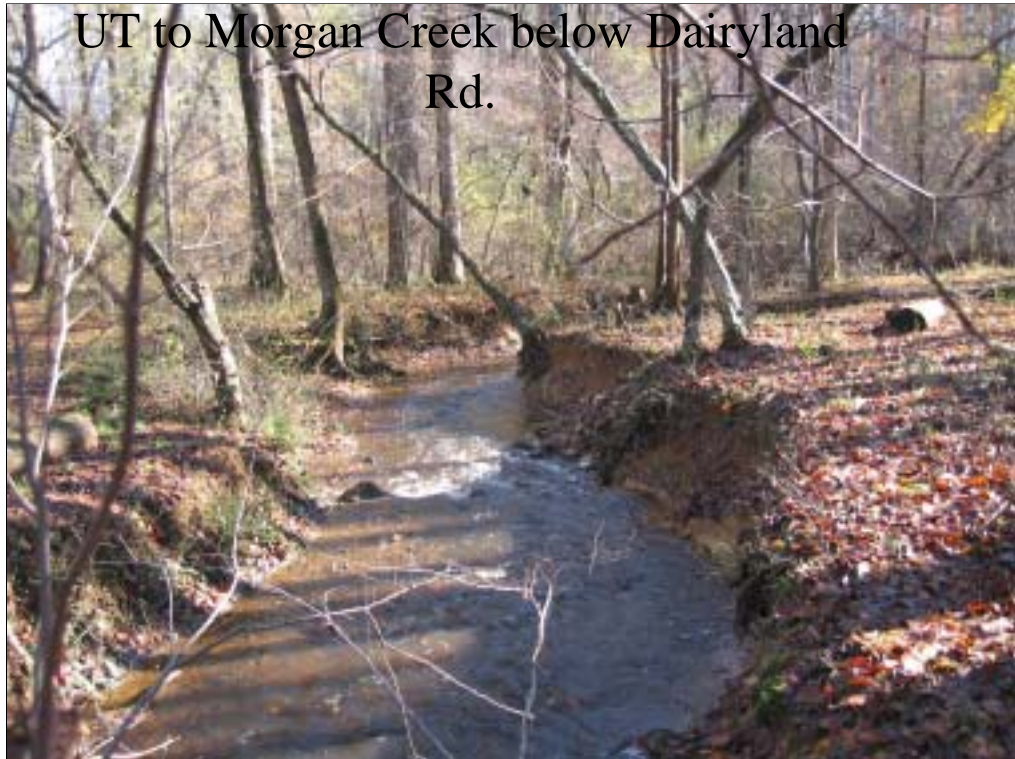
Unnamed tributary to Morgan Creek below Dairyland Rd.

Banks high and near vertical, with obvious areas of ongoing erosion

Stream significantly incised – floodplain not accessible

Trees falling into stream indicate erosion is ongoing

Undisturbed forest cover in floodplain indicates that source of hydromodification may be coming from upstream areas (possibly Lemola Dairy)

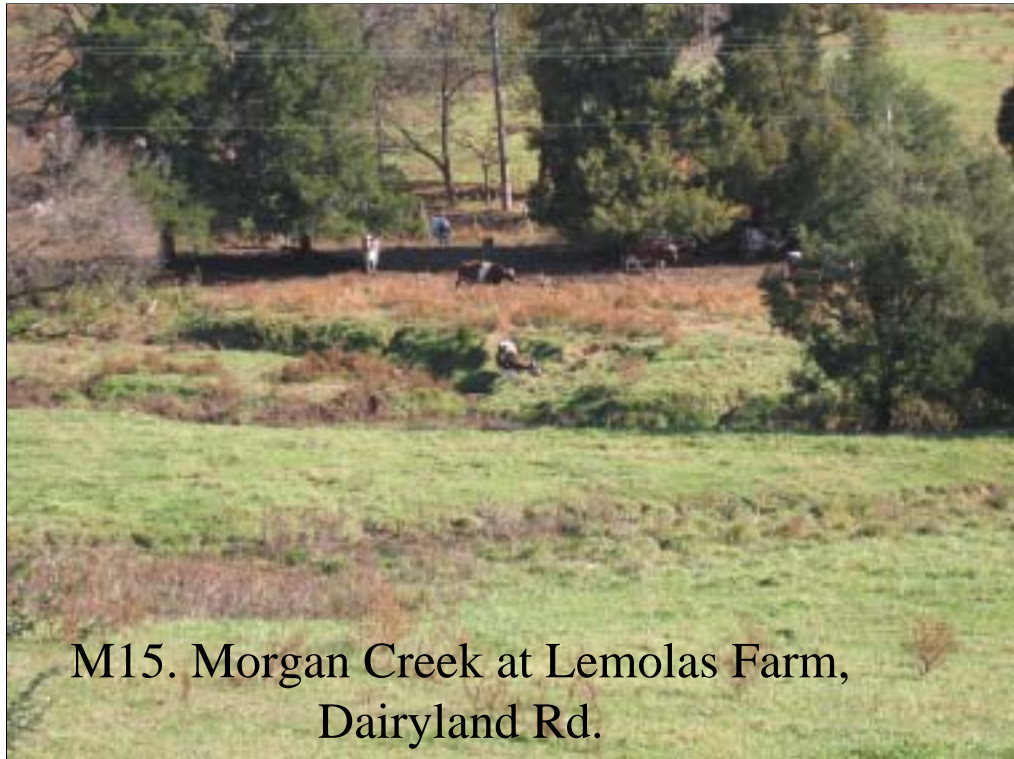
Morgan Creek along Dairyland Rd.

Riparian vegetation removed and disturbance ongoing

Cattle allowed in stream exacerbating active bank erosion

Stream likely to be incised throughout this section

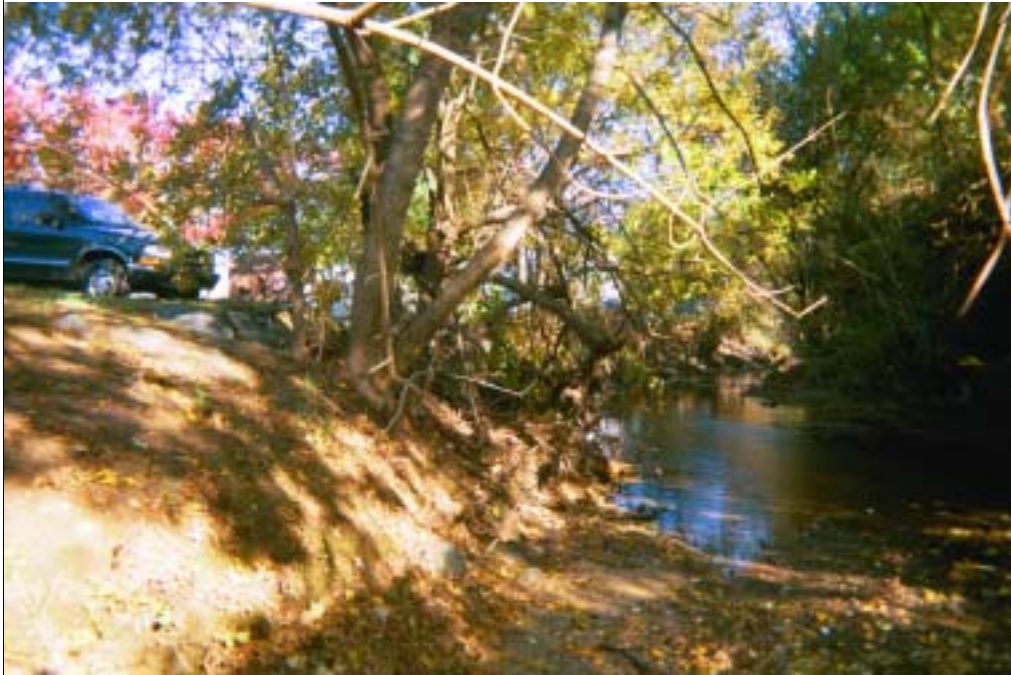
Bolin Creek along Estes Dr./University Mall (not actually in Upper Morgan Creek watershed)

Office Parking Adjacent to Creek

Stream likely to have been channelized in the past

Stream incised throughout this section – floodplain inaccessible

Riparian buffer removed with extensive impervious surfaces immediately adjacent to stream
