DESTROYER REPORT

GUNFIRE, BOMB AND KAMIKAZE DAMAGE
INCLUDING LOSSES IN ACTION

17 OCTOBER, 1941 TO 15 AUGUST, 1945

WAR DAMAGE REPORT No. 51

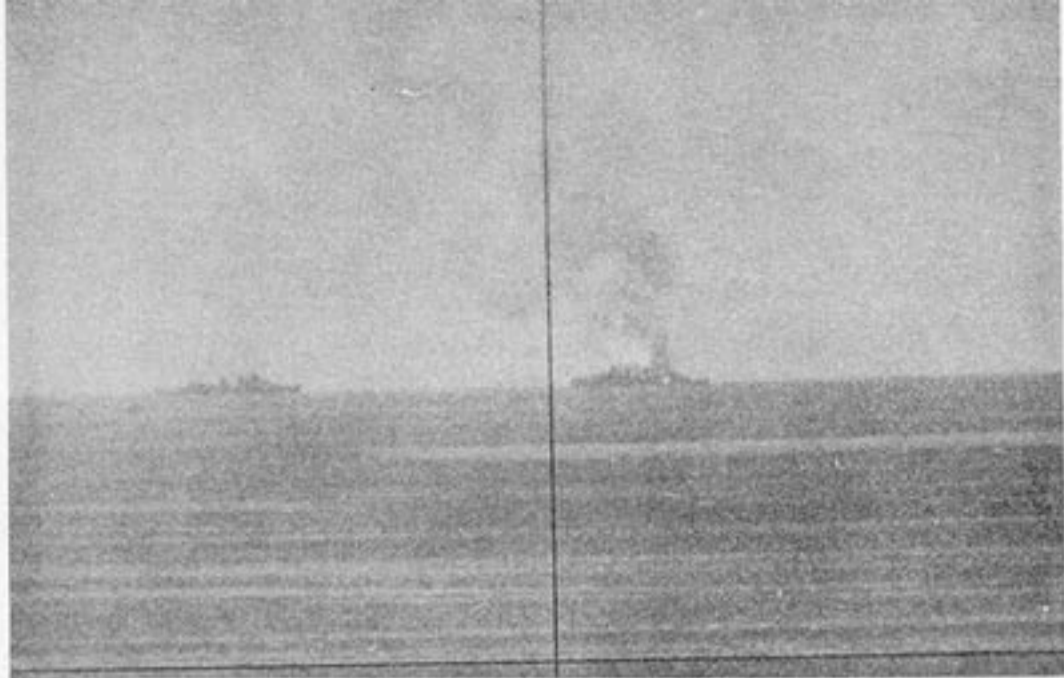
Photo 11-1: ABNER READ (DD526). View taken shortly after Kamikaze hit causing blaze in way of No. 3 upper handling room. Ship standing by is CLAXTON.

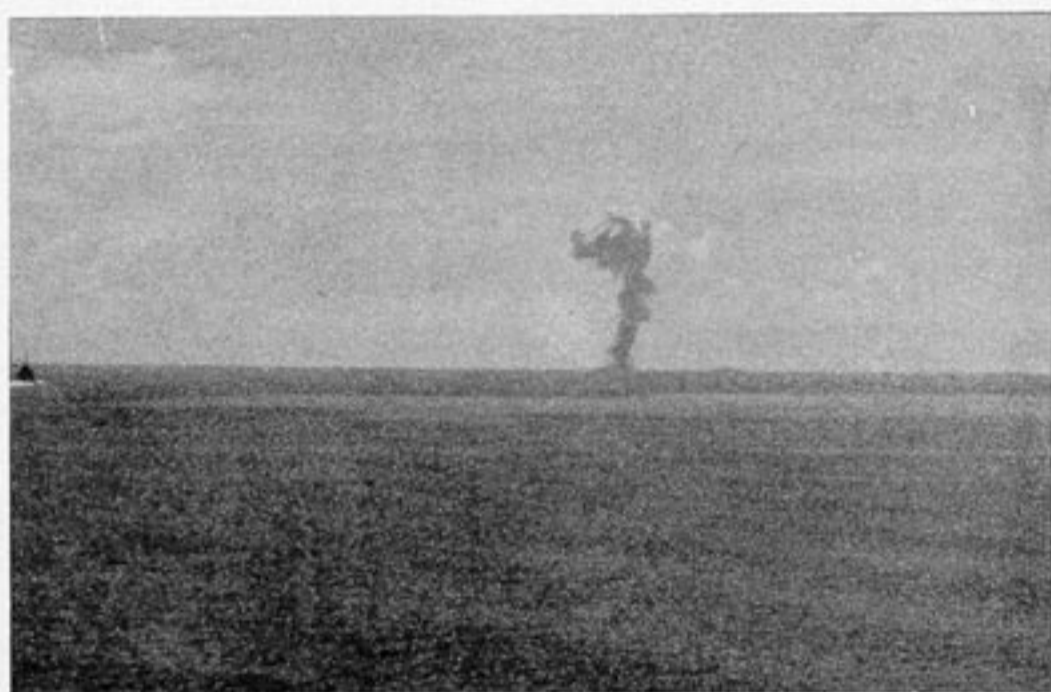
Photo 11-2: ABNER READ (DD526). Column of smoke rising following handling room explosion about ten minutes after Kamikaze crash.

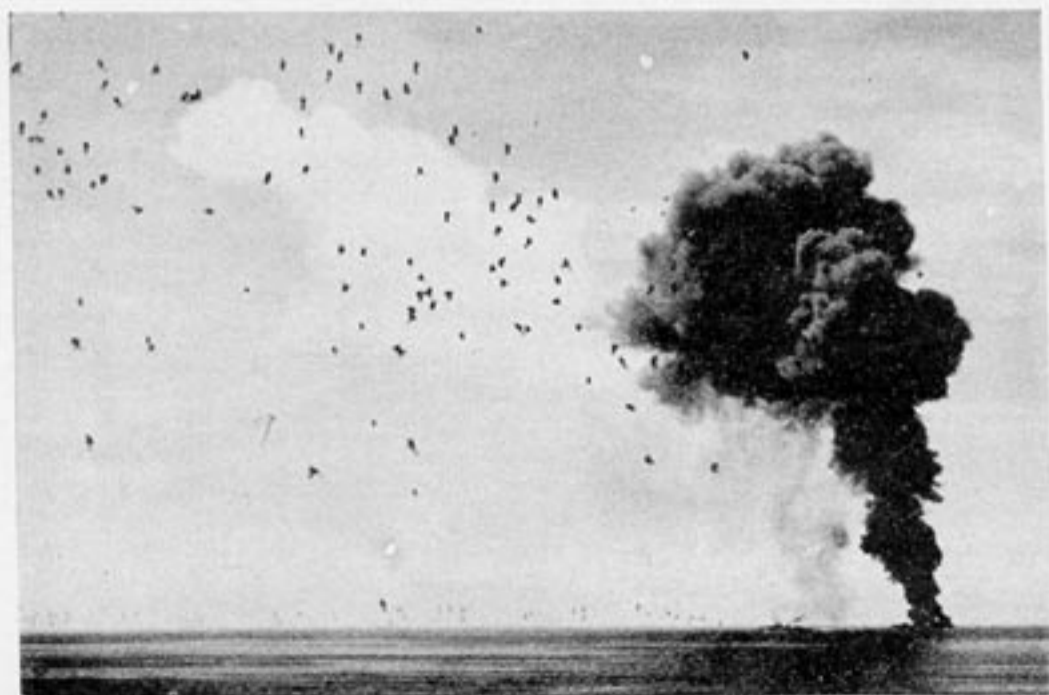
Photo 11-3: ABNER READ (DD526). View shortly before ship sank. Black smoke is probably due to oil fire which continued to burn long after ship disappeared. Anti-aircraft puffs are from gunfire directed at third Kamikaze, shot down about 25 minutes after ABNER READ was hit.

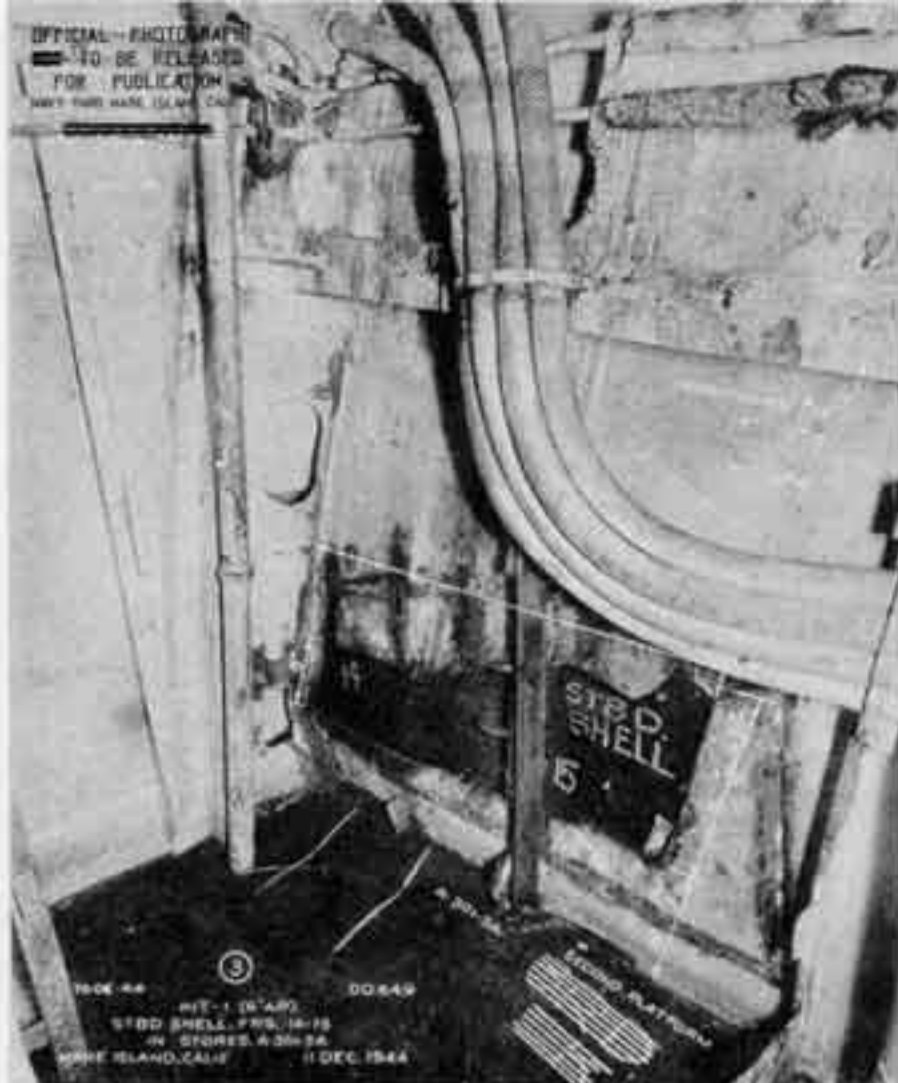
Photo 5-1: A.W. GRANT (DD649) - Hit #1. Temporary patch at entrance hole at frame 15, starboard, in A-301-3A. The entering projectile was apparently a ricochet and did not detonate.

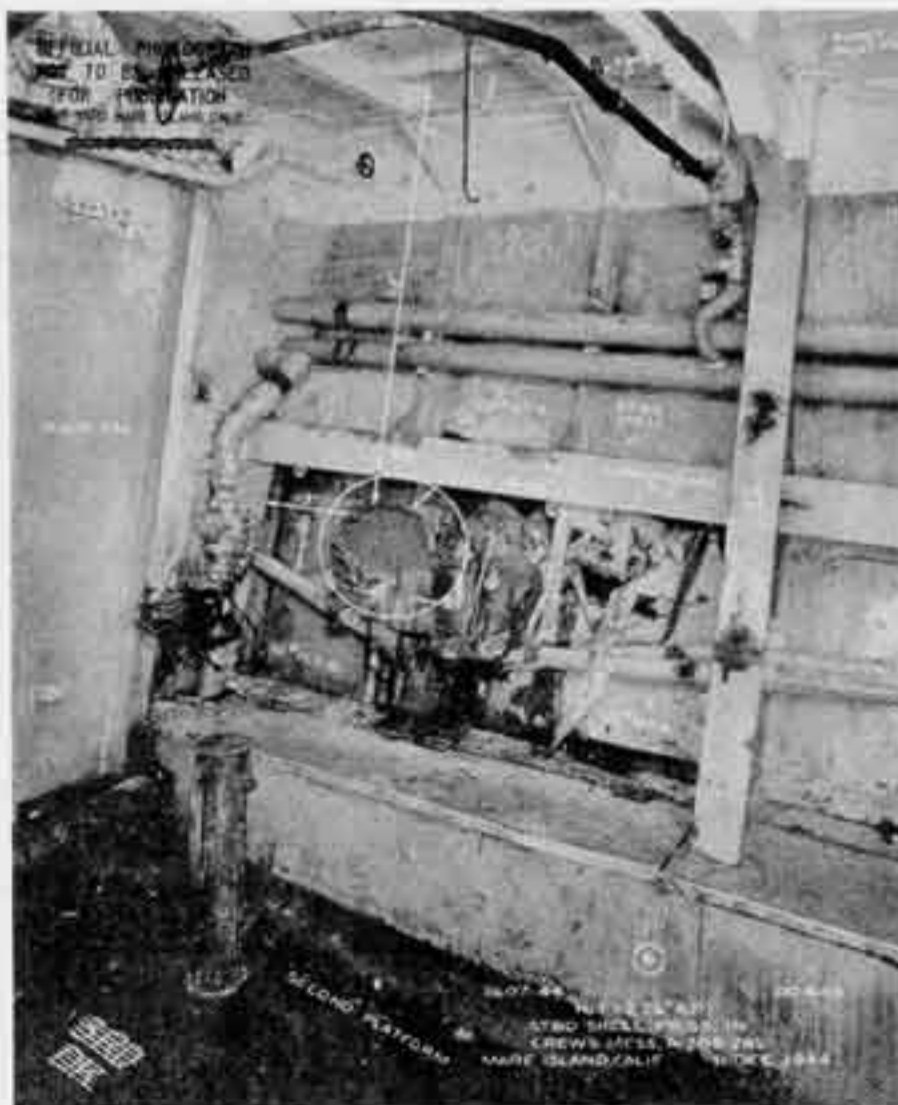
Photo 5-2: A.W. GRANT (DD649) - Hit #2. Welded patch over hole in shell at frame 55, looking forward and to starboard in compartment A-305-2A.

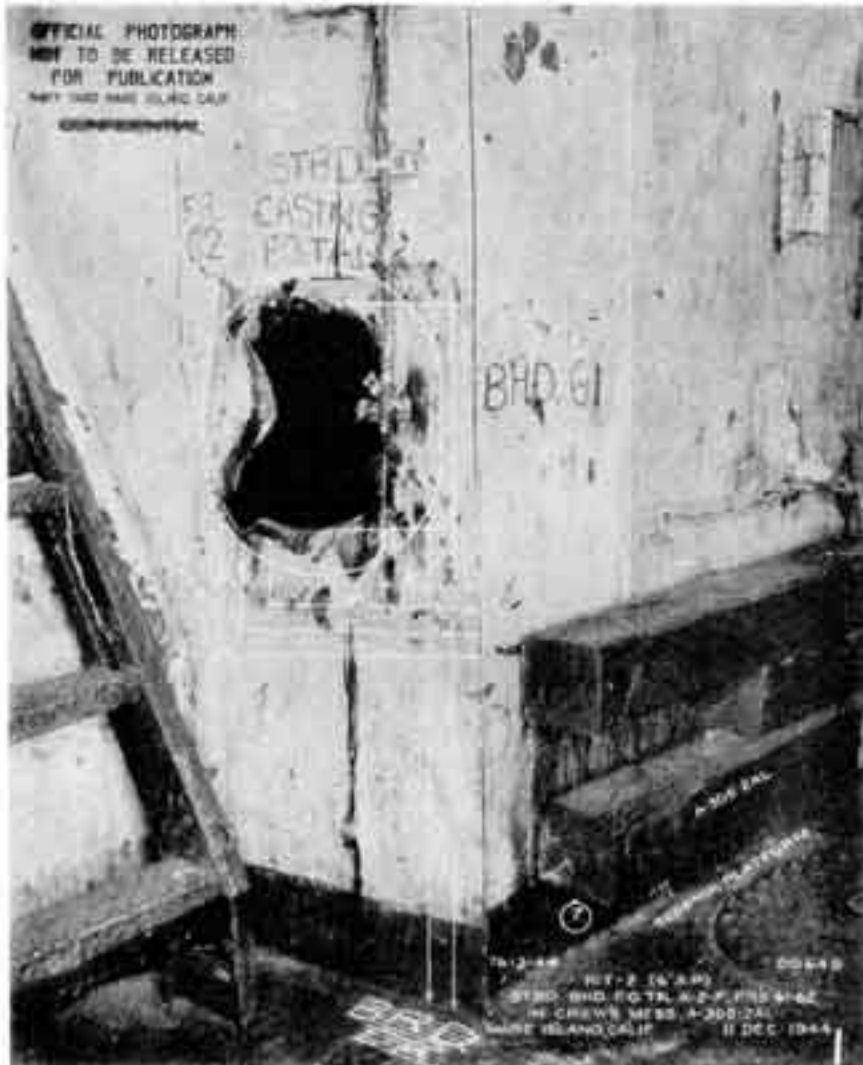
Photo 5-3: A.W. GRANT (DD649) - Hit #2. View looking aft at hole in forward starboard corner of A-2-F caused by 6-inch AP dud which passed through A-305-2AL. Shown looking aft on second platform.

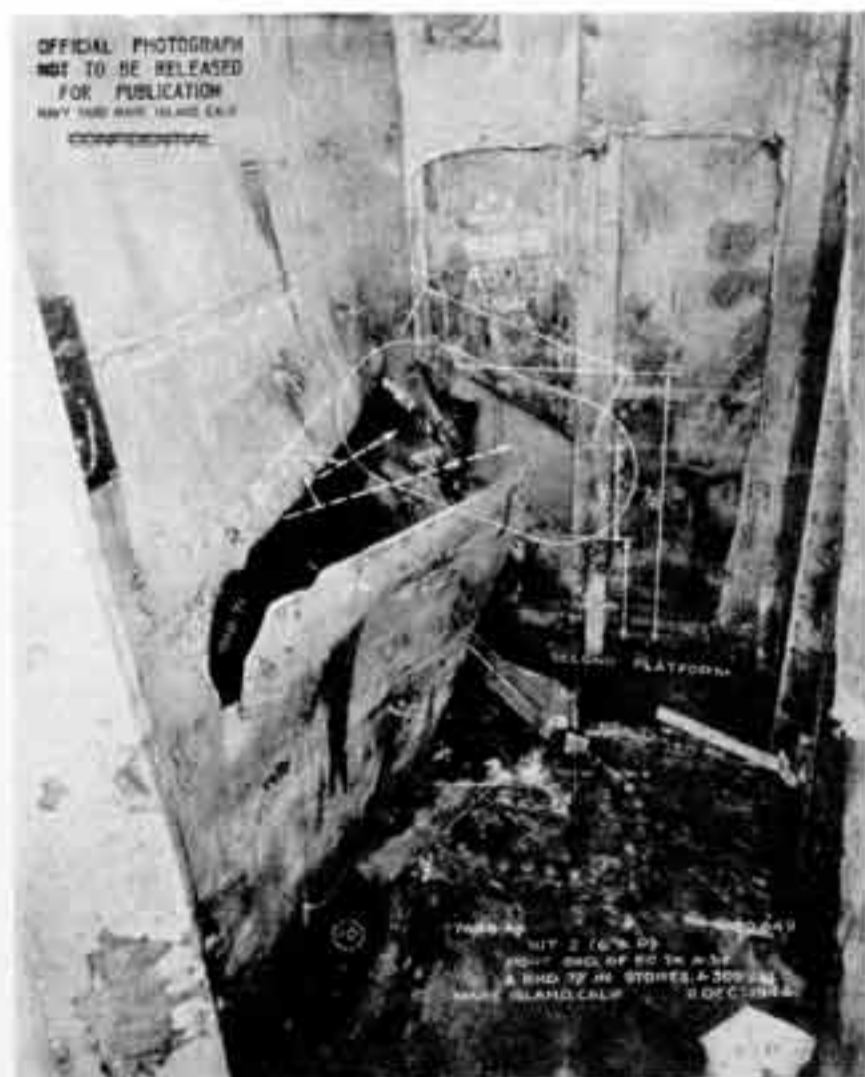
Photo 5-4: A.W. GRANT (DD649) - Hit #2. Hole in after port corner of A-3-F caused by 6-inch AP dud as it entered the forward fireroom. The projectile apparently broke into several large fragments before it emerged from A-3-F.

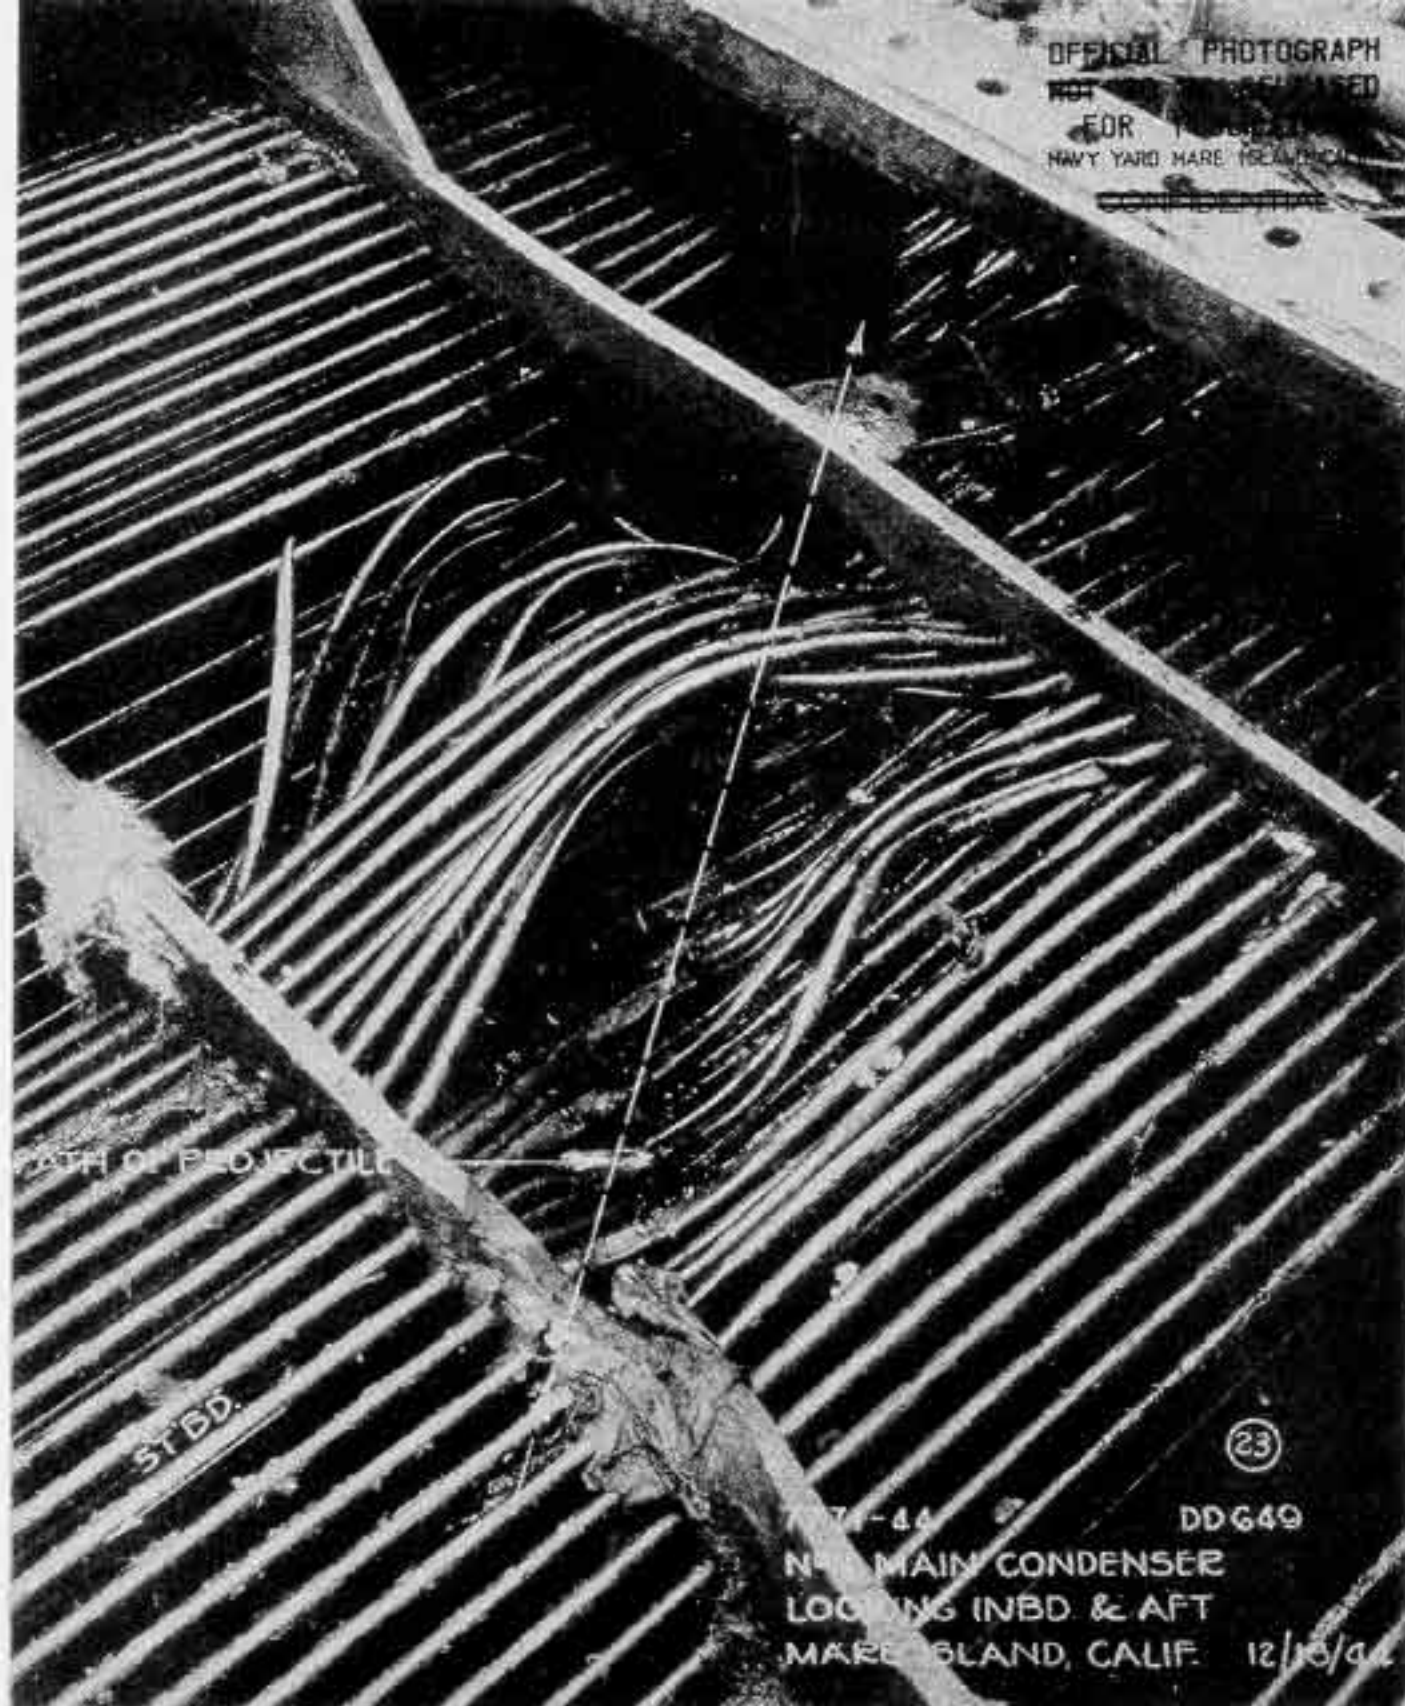
Photo 5-5: A. W. GRANT (DD649) - Hit #3. Damage to forward main condenser caused by dud 6-inch AP projectile which entered the tube nest after passing through the skirt of the L.P. turbine and fracturing the lower casing.

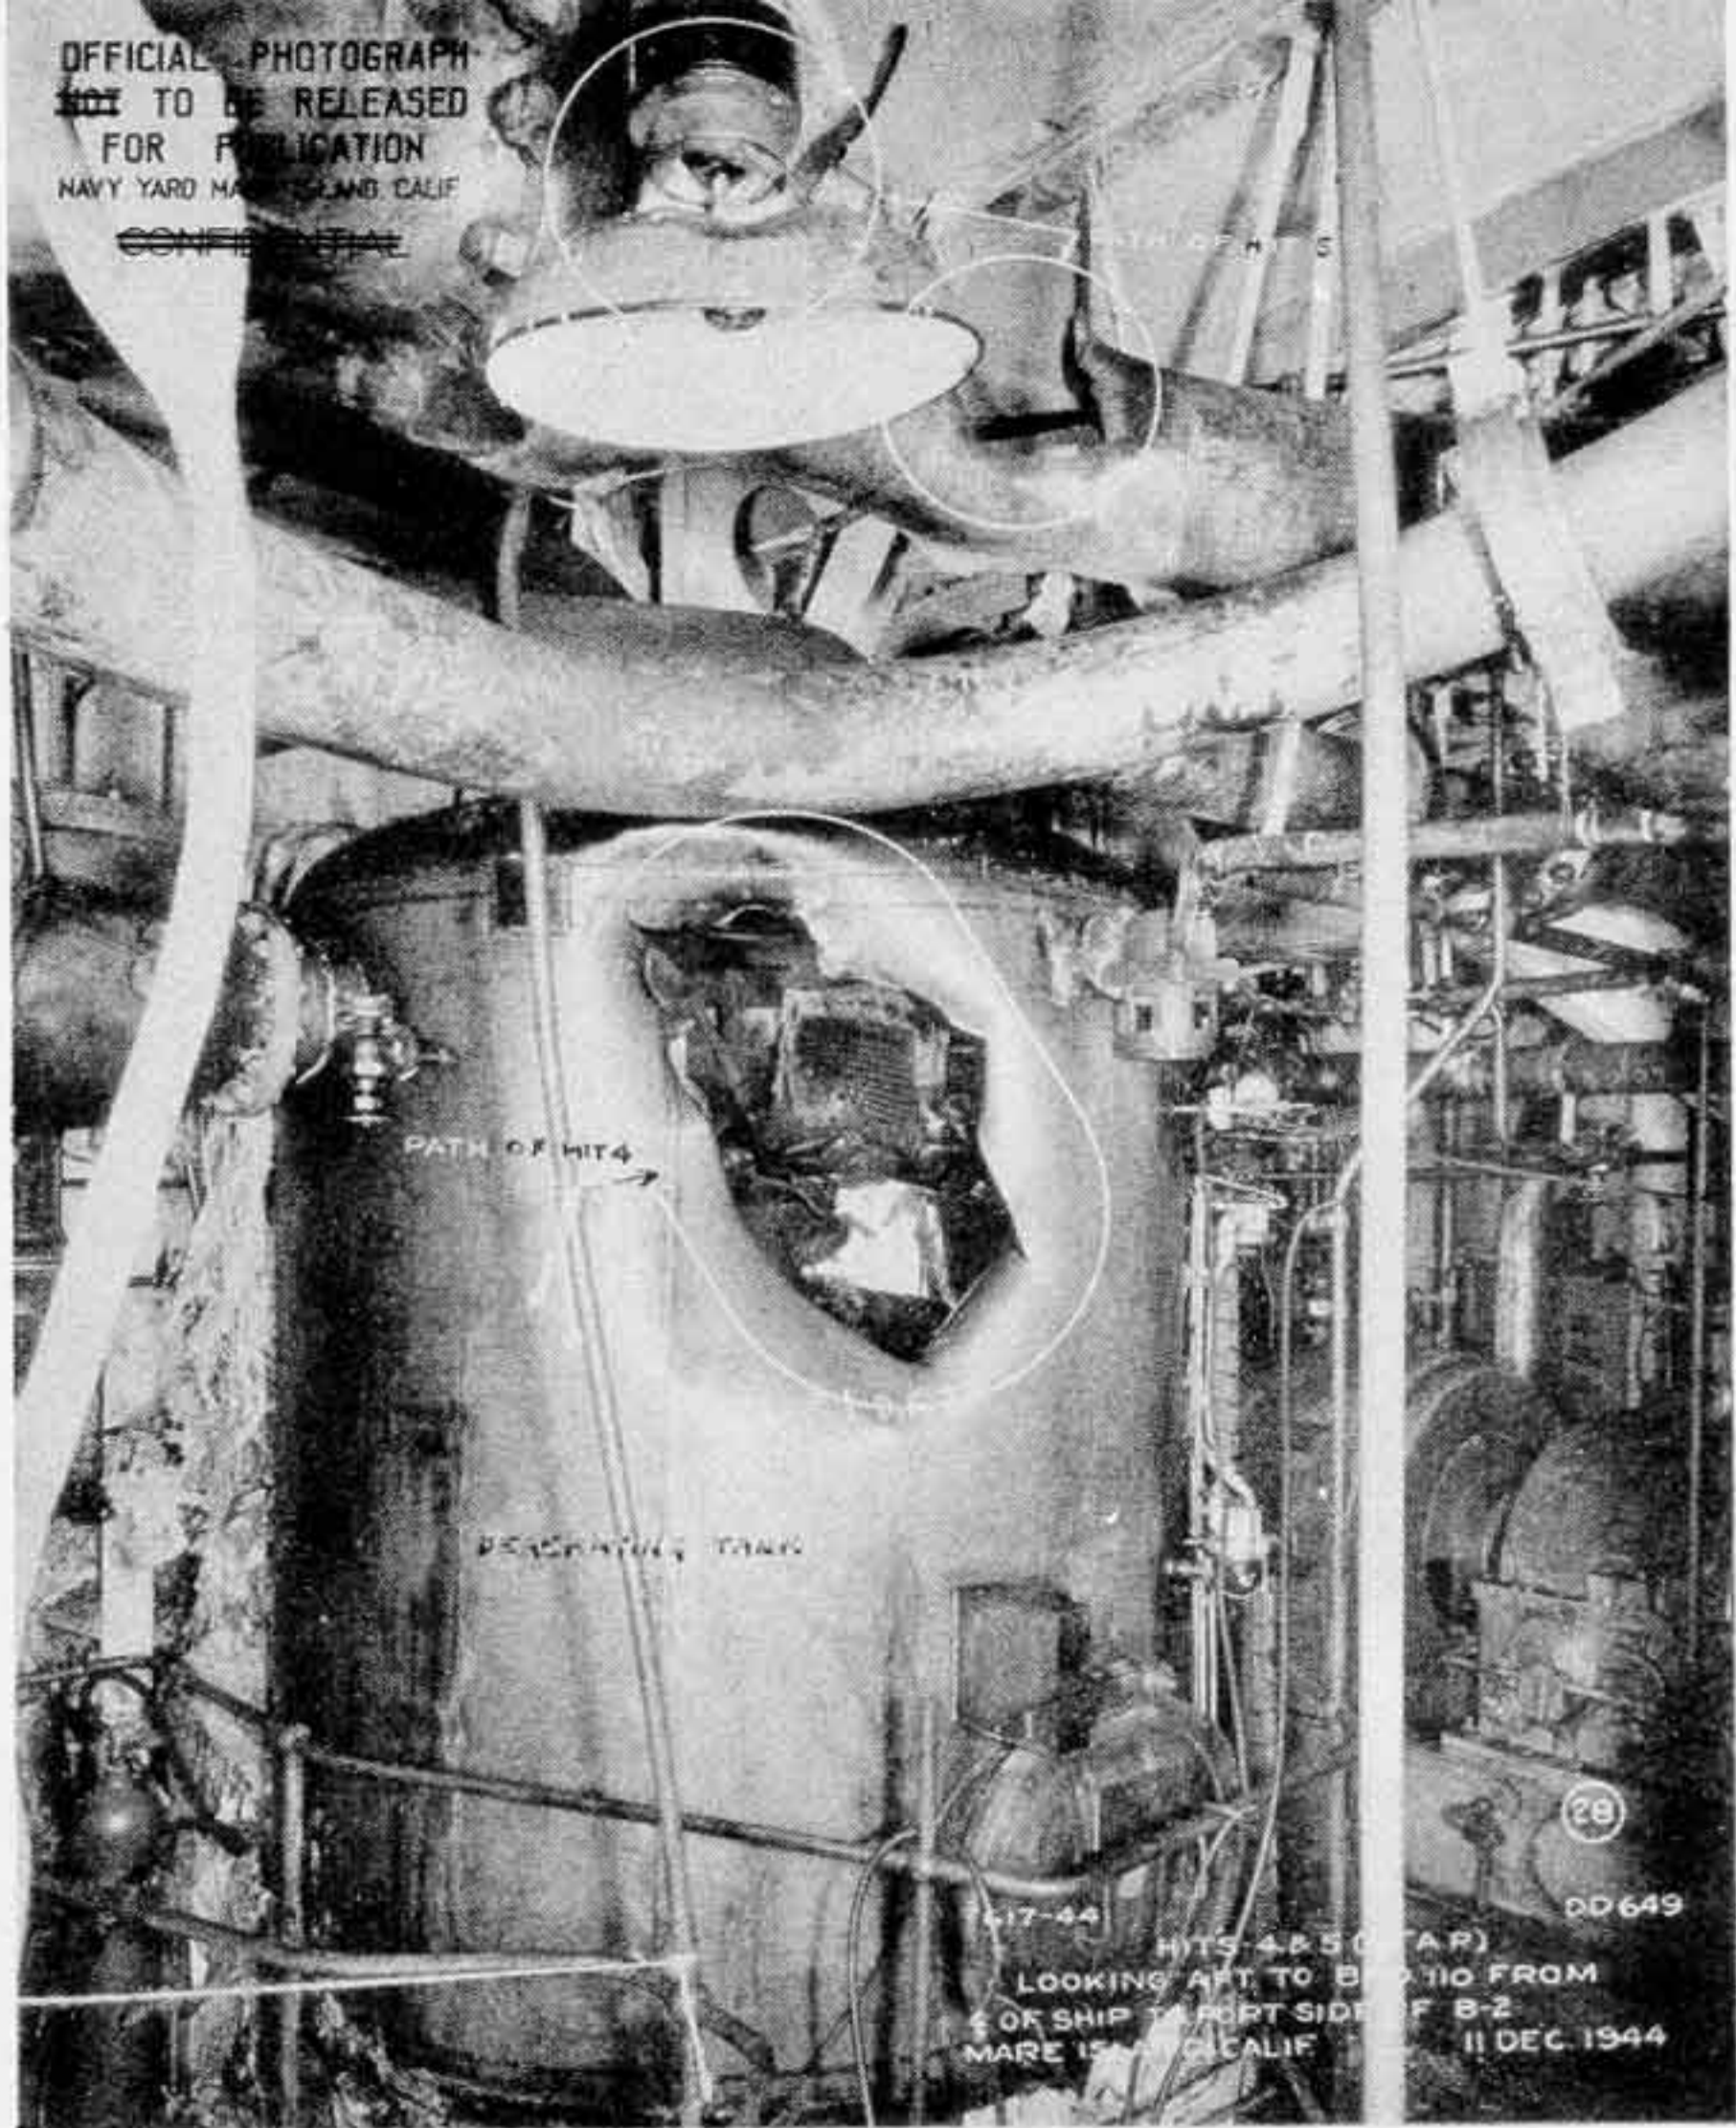
Photo 5-7: A.W. GRANT (DD649) - Hits 4 and 5. Looking aft and to port at deaerating tank and main steam line in forward engine room.

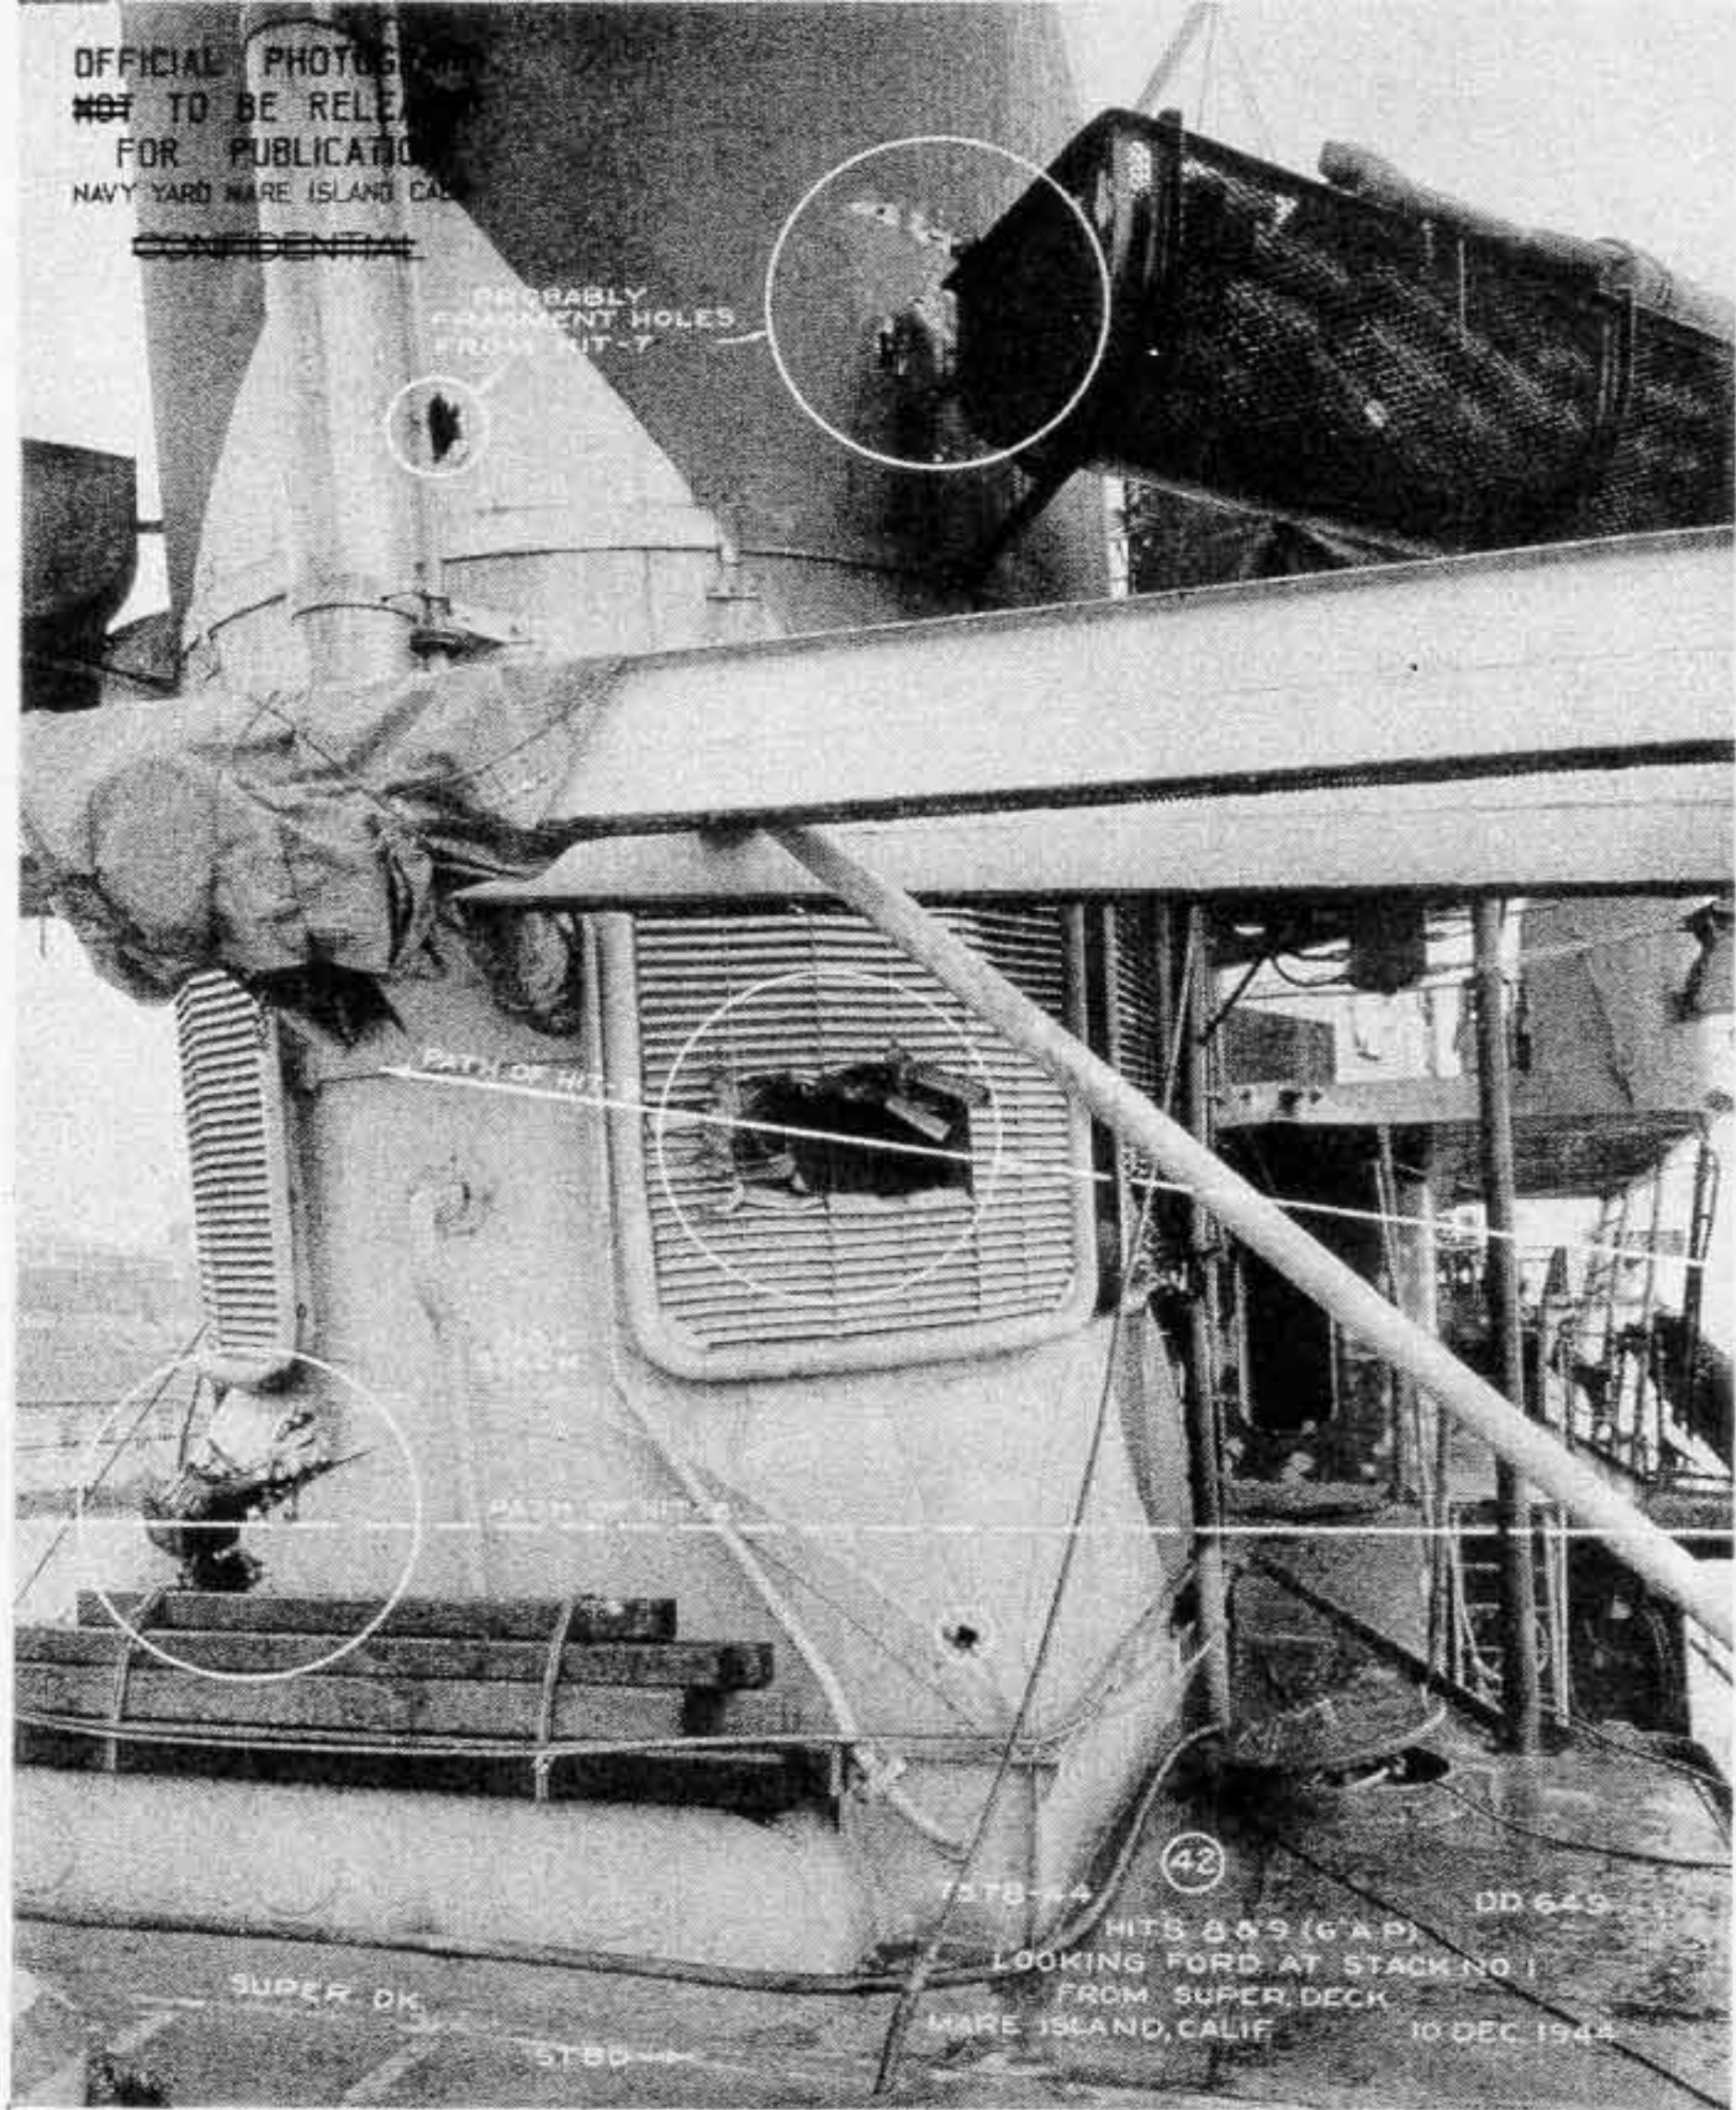
Photo 5-9: A.W. GRANT (DD649) - Hits 8 and 9. Stack damage caused by 6-inch projectiles.

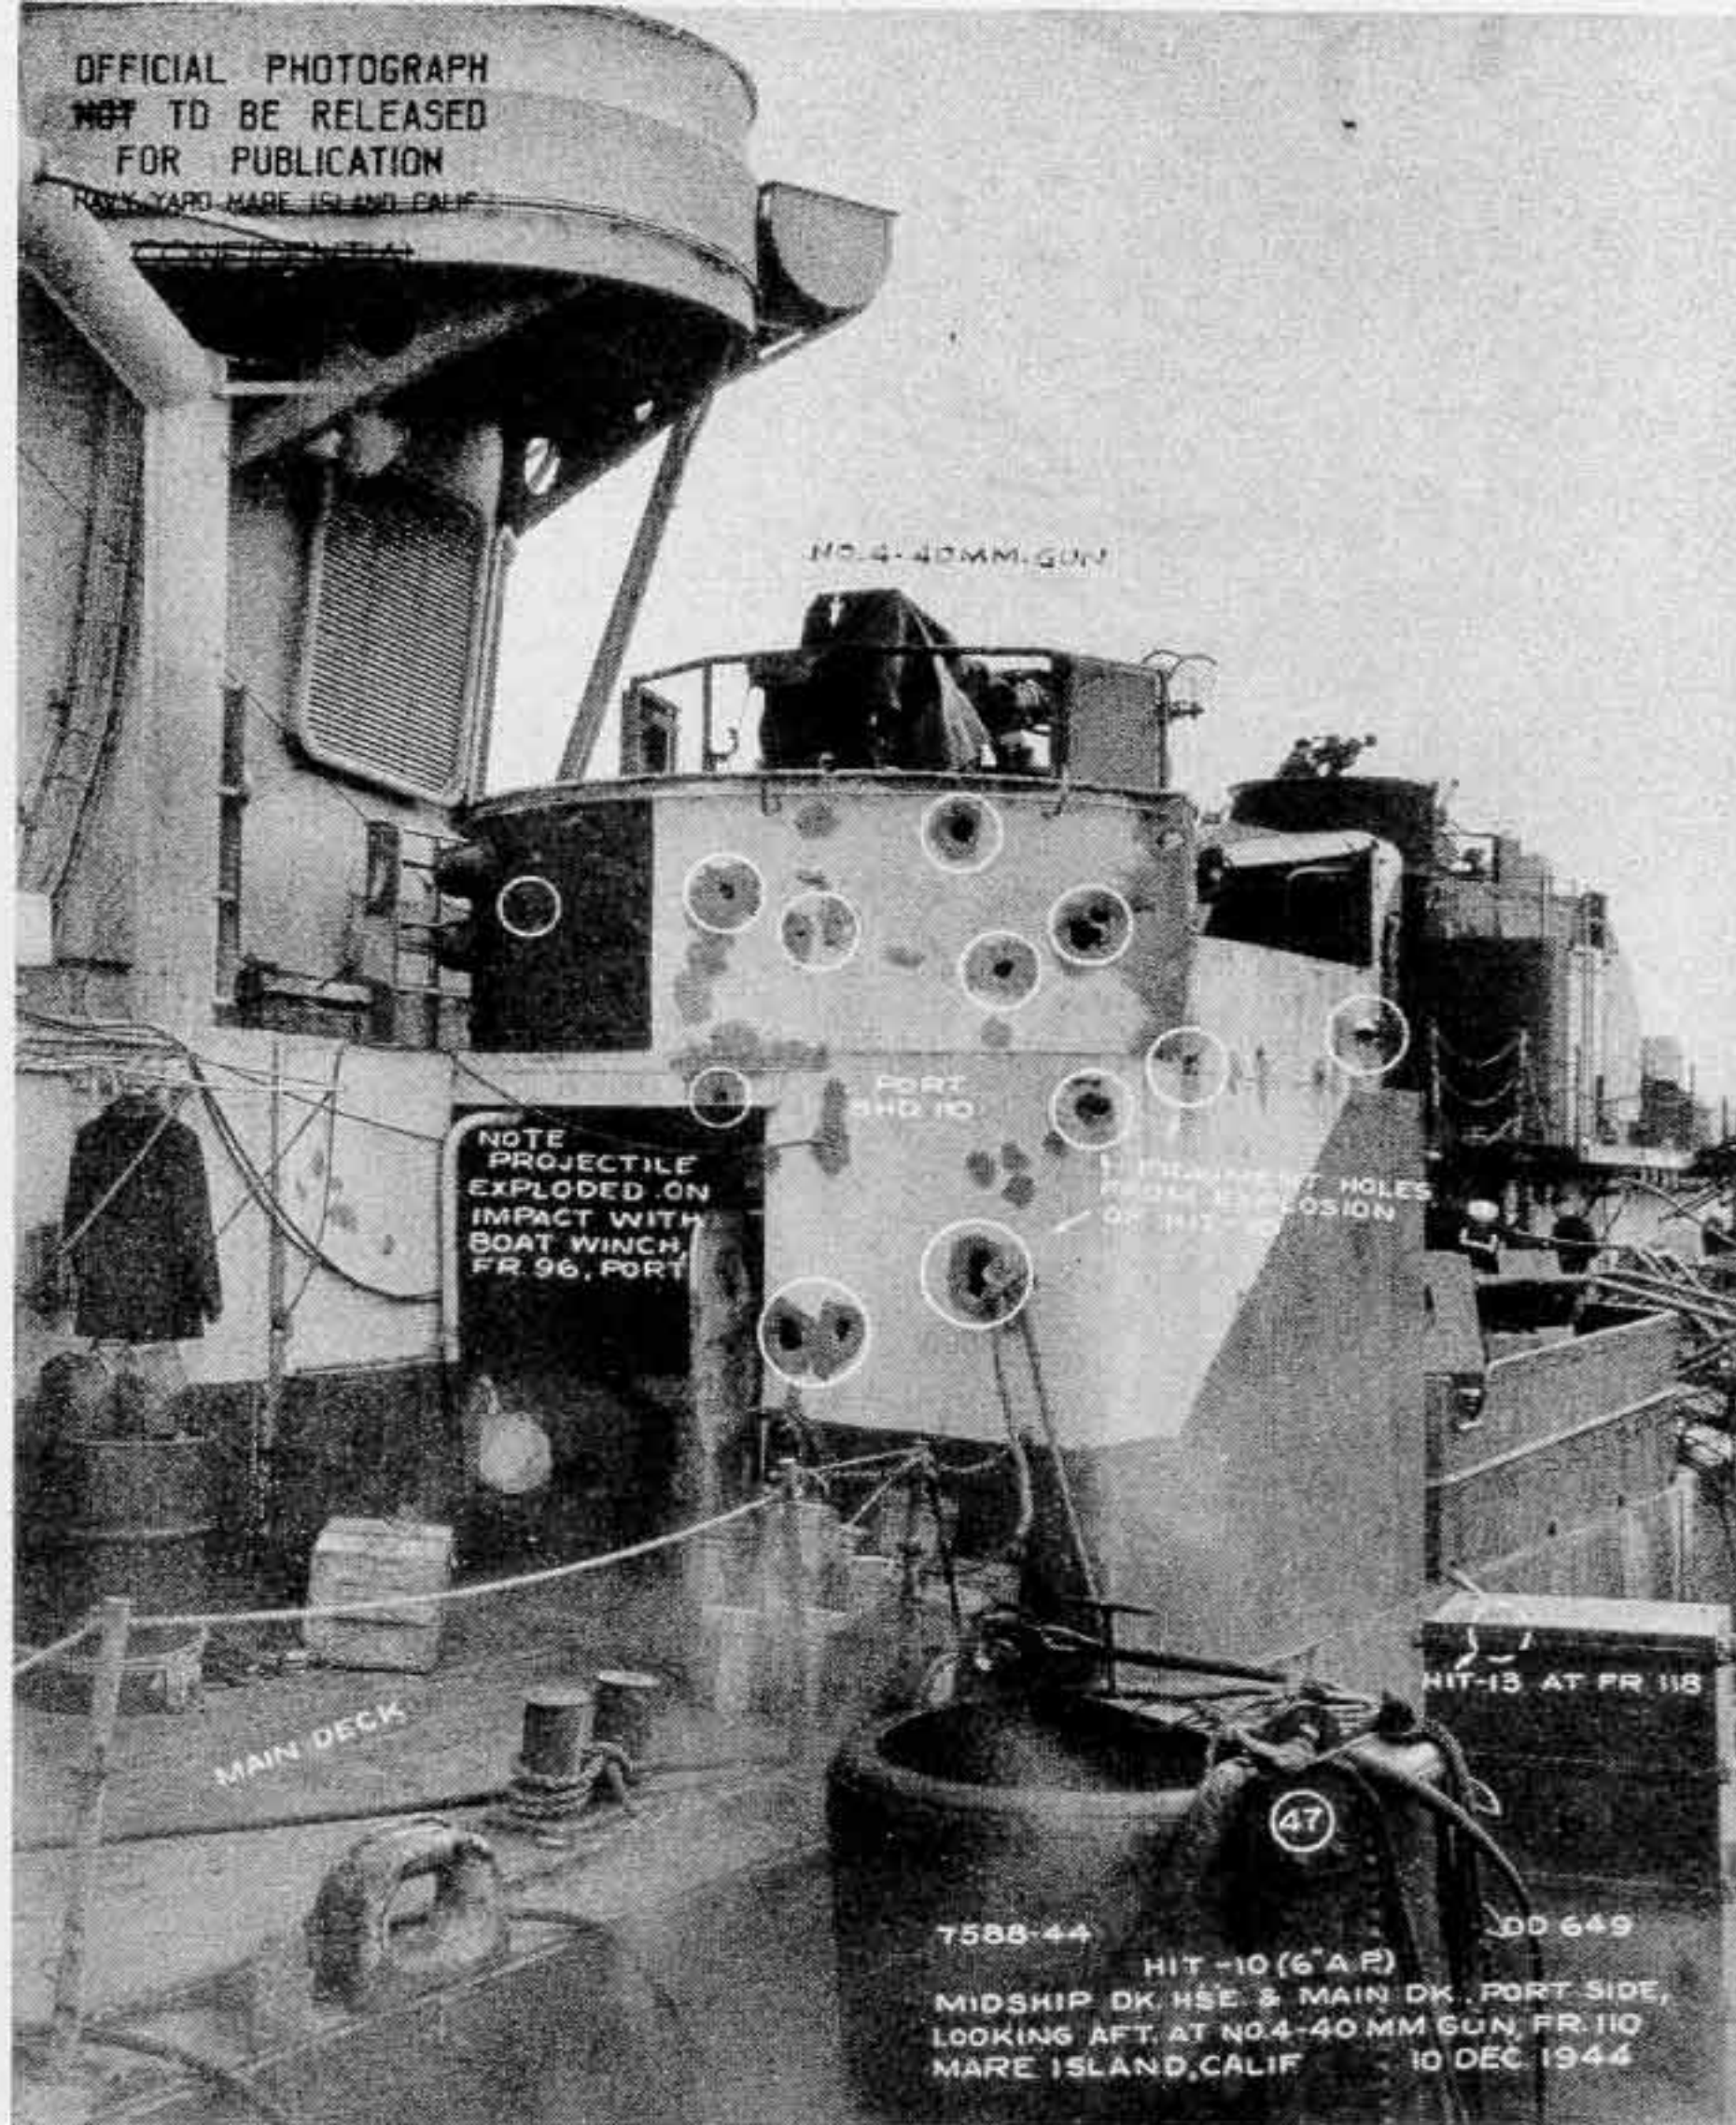
Photo 5-10: A.W. GRANT (DD649) - Hit #10. Fragment damage caused by 6-inch projectile which detonated on striking the boat winch at frame 96, port side.

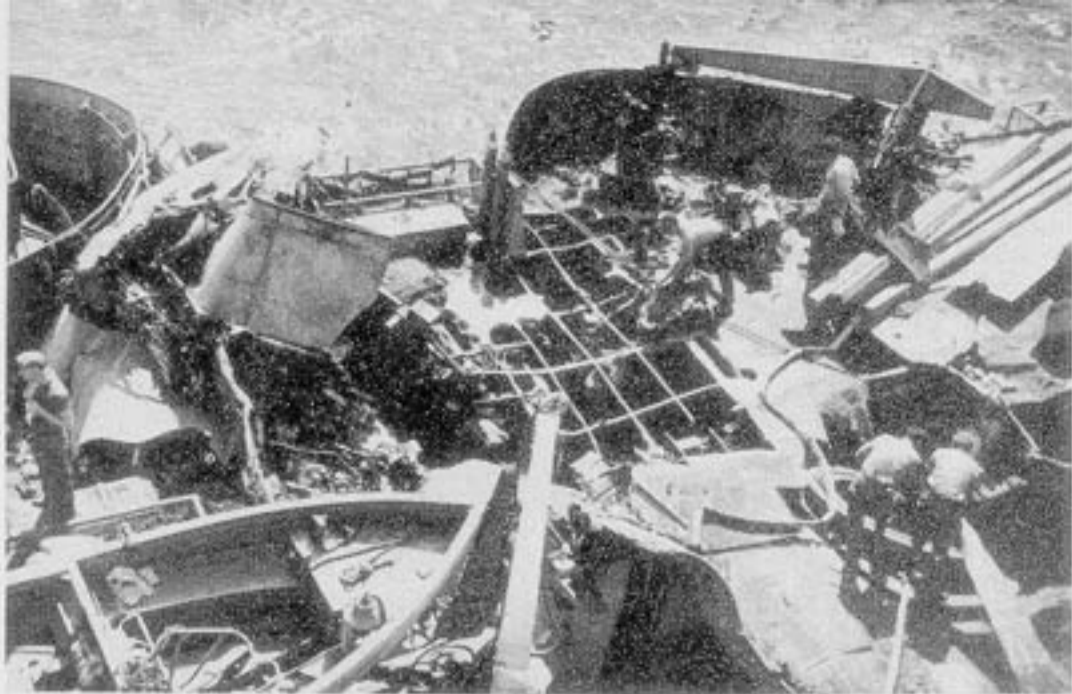
Photo 12-1: HUGH W. HADLEY (DD774). View of midship deckhouse, frames 130 to 150, in way of third Kamikaze crash and ensuing fire. Plane hit at base of director tower, left center, bomb at 40mm mount No.4, lower right.

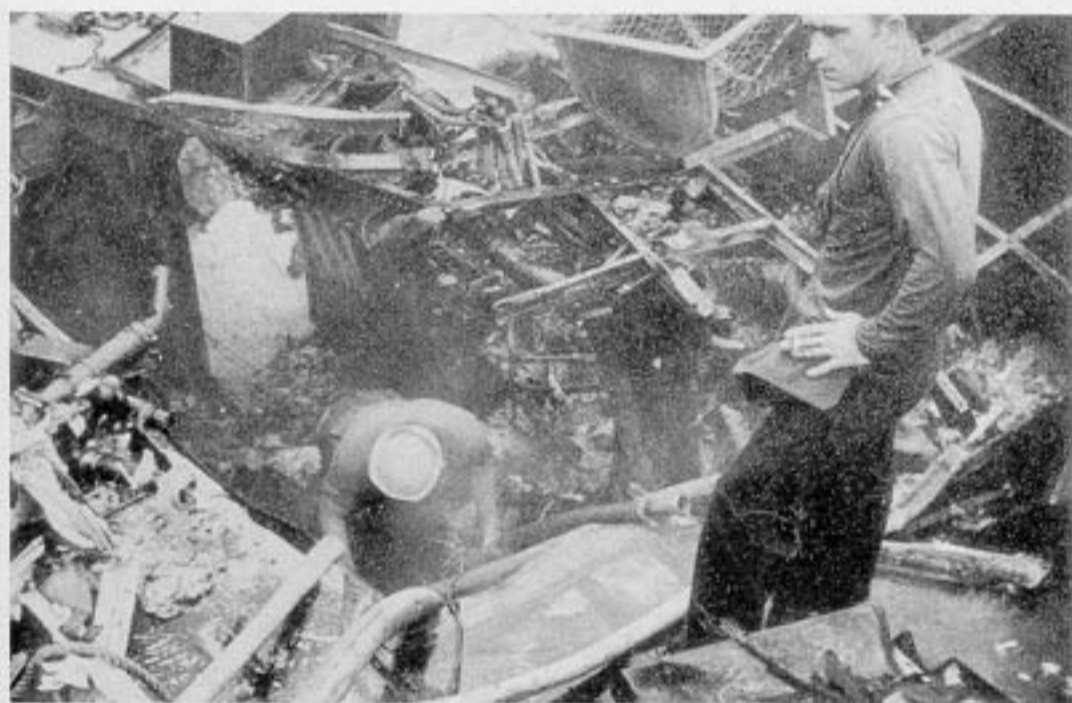
Photo 12-2: HUGH W. HADLEY (DD774). Close-up view of deckhouse top at frame 140 in way of plane crash and fire, looking down into officers' quarters aft.

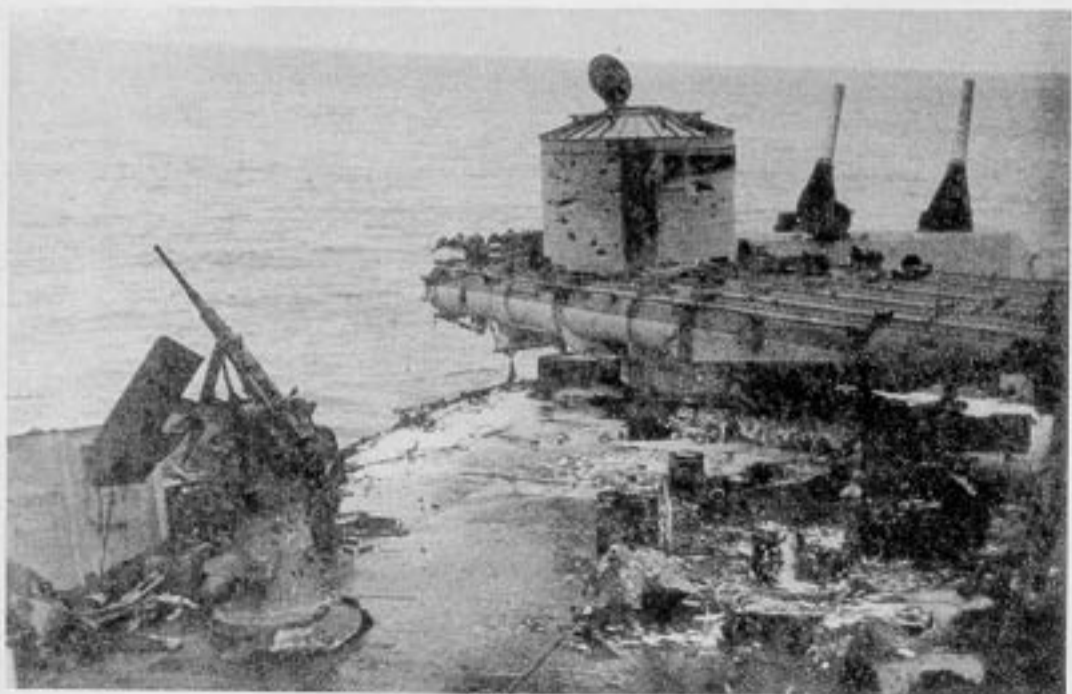
Photo 12-3: HUGH W. HADLEY (DD774). After torpedo mount, frame 163, showing fragment damage. Foam used in fighting fire is in foreground.
