DESTROYER REPORT

GUNFIRE, BOMB AND KAMIKAZE DAMAGE
INCLUDING LOSSES IN ACTION

17 OCTOBER, 1941 TO 15 AUGUST, 1945

WAR DAMAGE REPORT No. 51

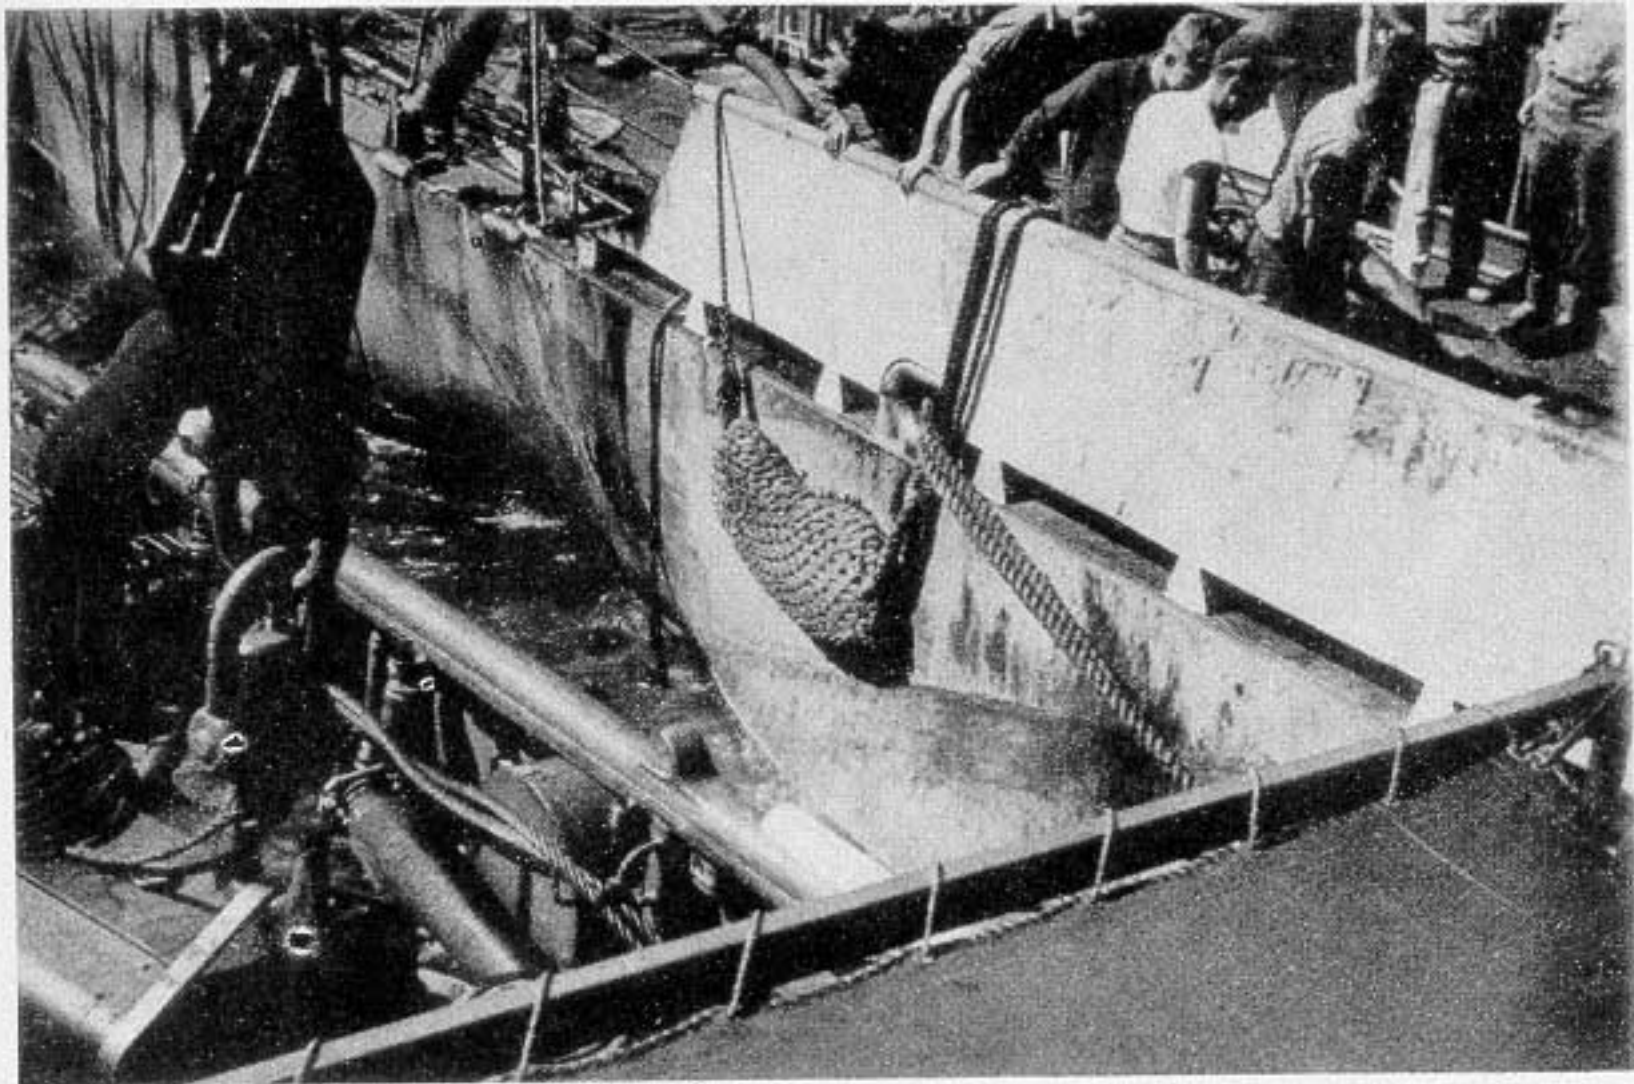
Photo 12-4: HUGH W. HADLEY (DD'774). Starboard side looking aft at frame 105 from fantail of salvage tug during diving operations.

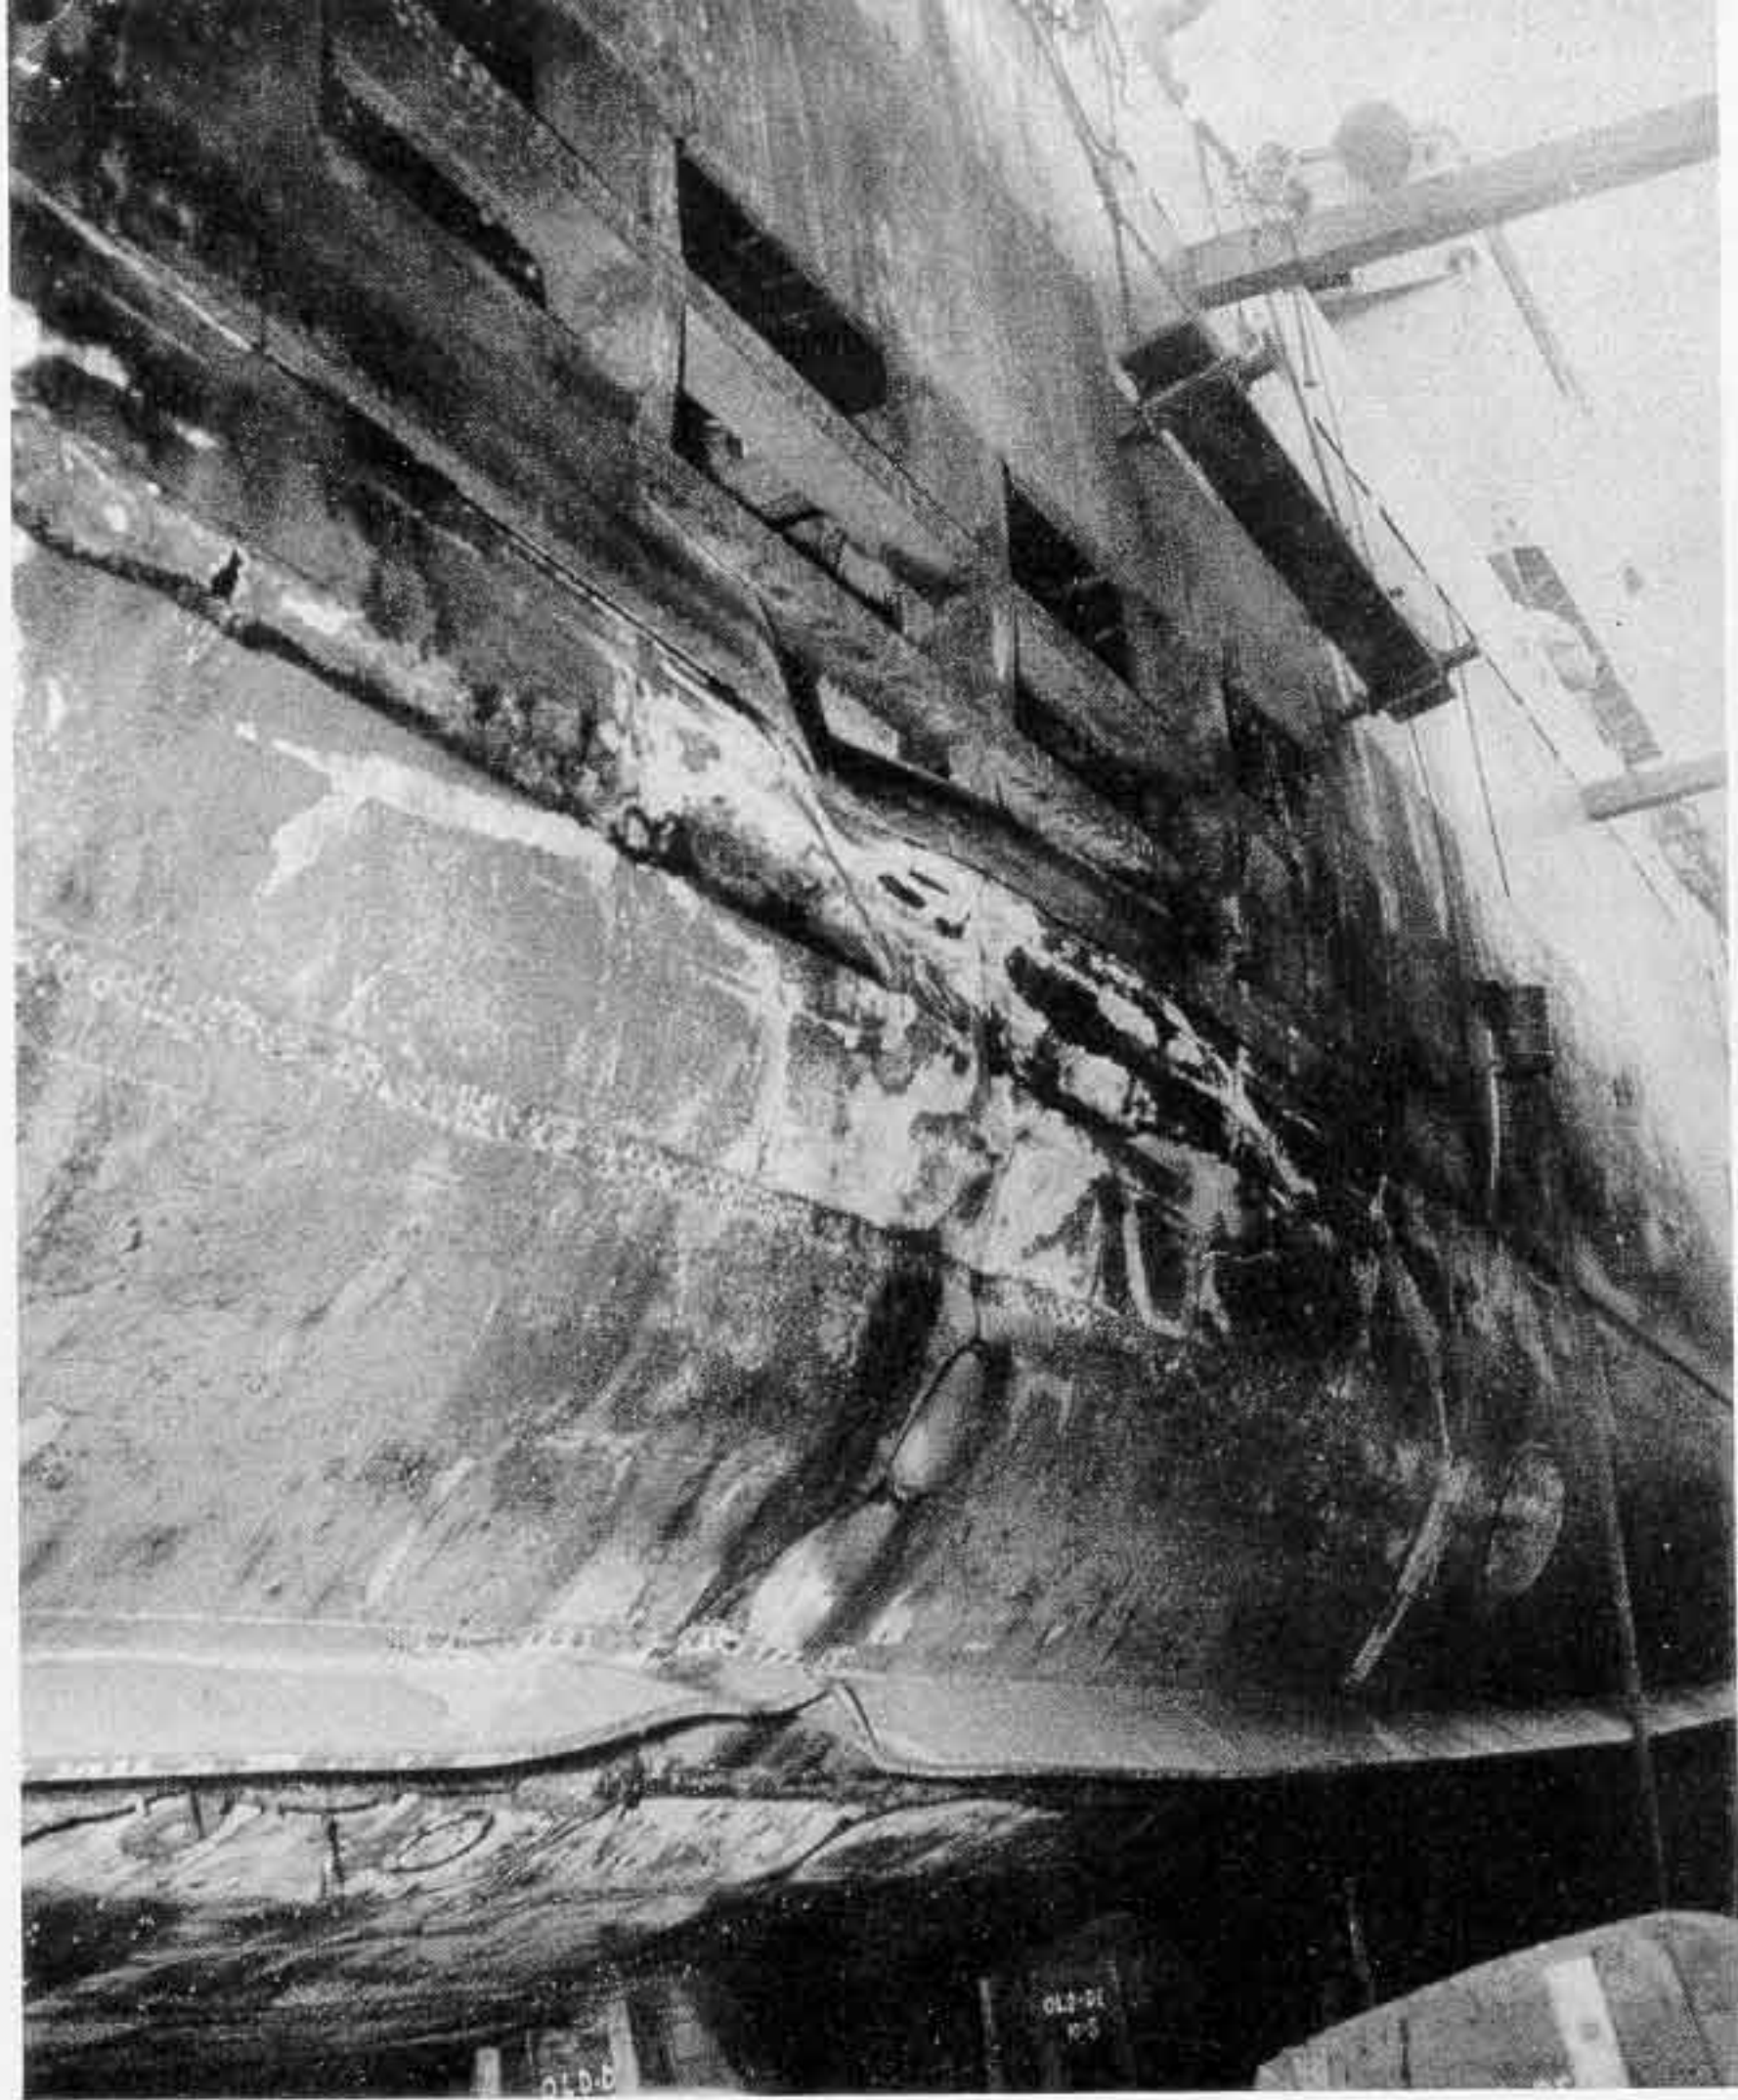
Photo 12-5: HUGH W. HADLEY (DD 774). Starboard side looking forward from frame 115 in dock at Kerama Retto. Partial structural repairs have been completed in way of the hole made by the second Kamikaze.

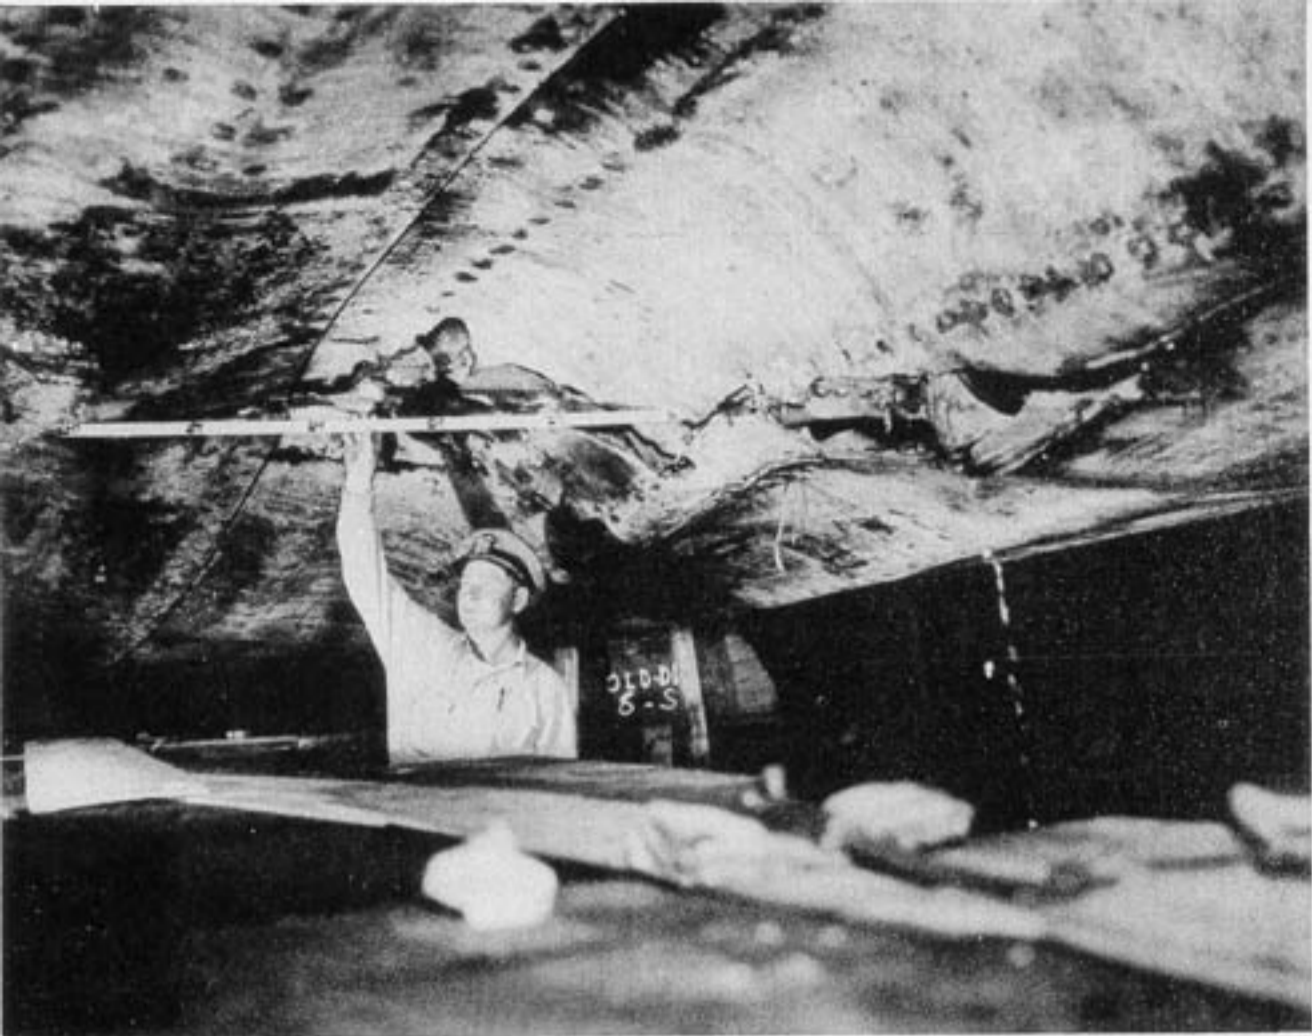
Photo 12-6: HUGH W. HADLEY (DD774). Ruptured keel and garboard plating about frame 115 looking aft and to port from keel blocks in ARD28.

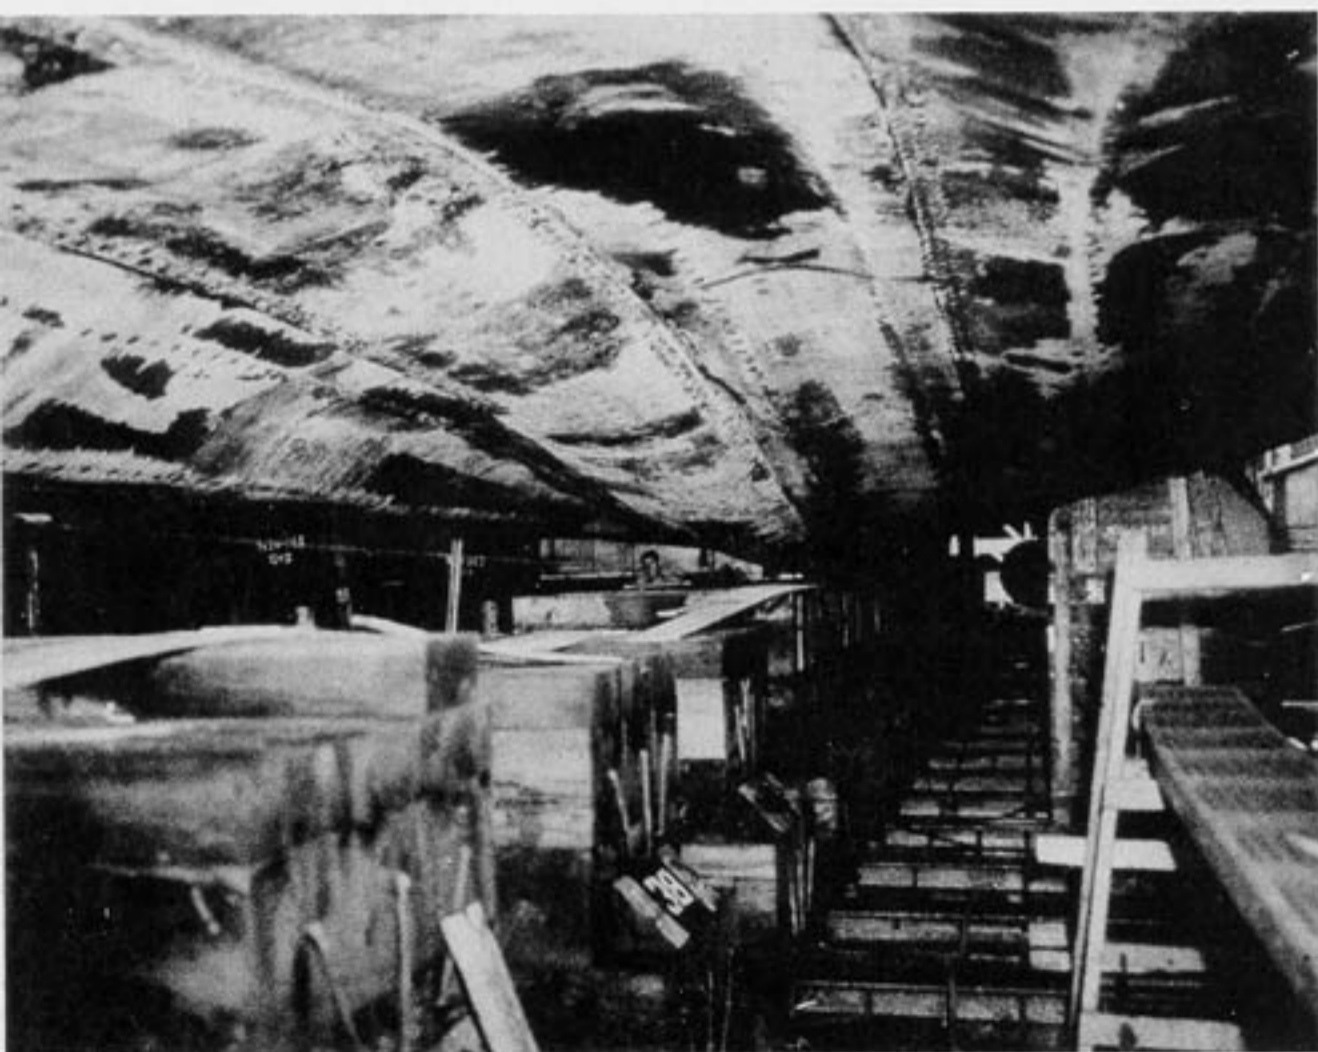
Photo 12-7: HUGH W. HADLEY (DD774). View aft along keel blocks abaft frame 115. Note extent of hogging.

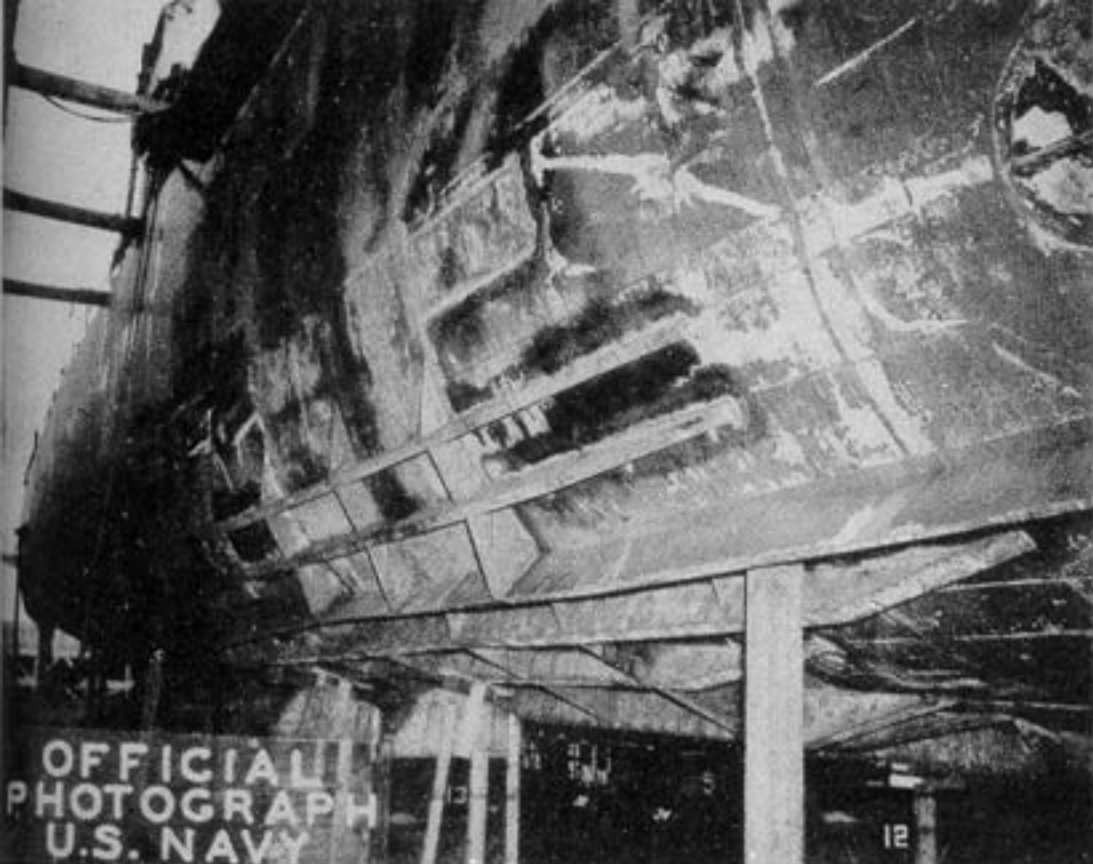
Photo 12-8:
HUGH W. HADLEY
(DD774).
Starboard side from
about frame 90 aft
showing temporary
repairs installed in
ARD28 by ZANIAH
personnel. Note
depth and length of
external longitudi-
nals.

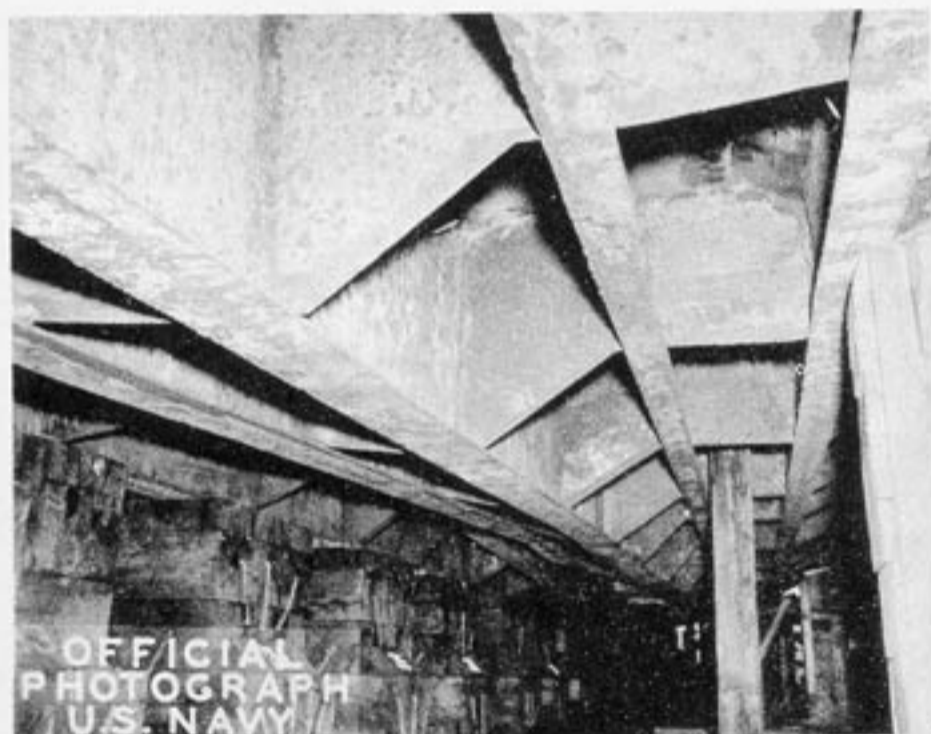
Photo 12-9:
HUGH W. HADLEY
(DD774).
Port bottom shell
looking aft following
temporary repairs
in ARD28.

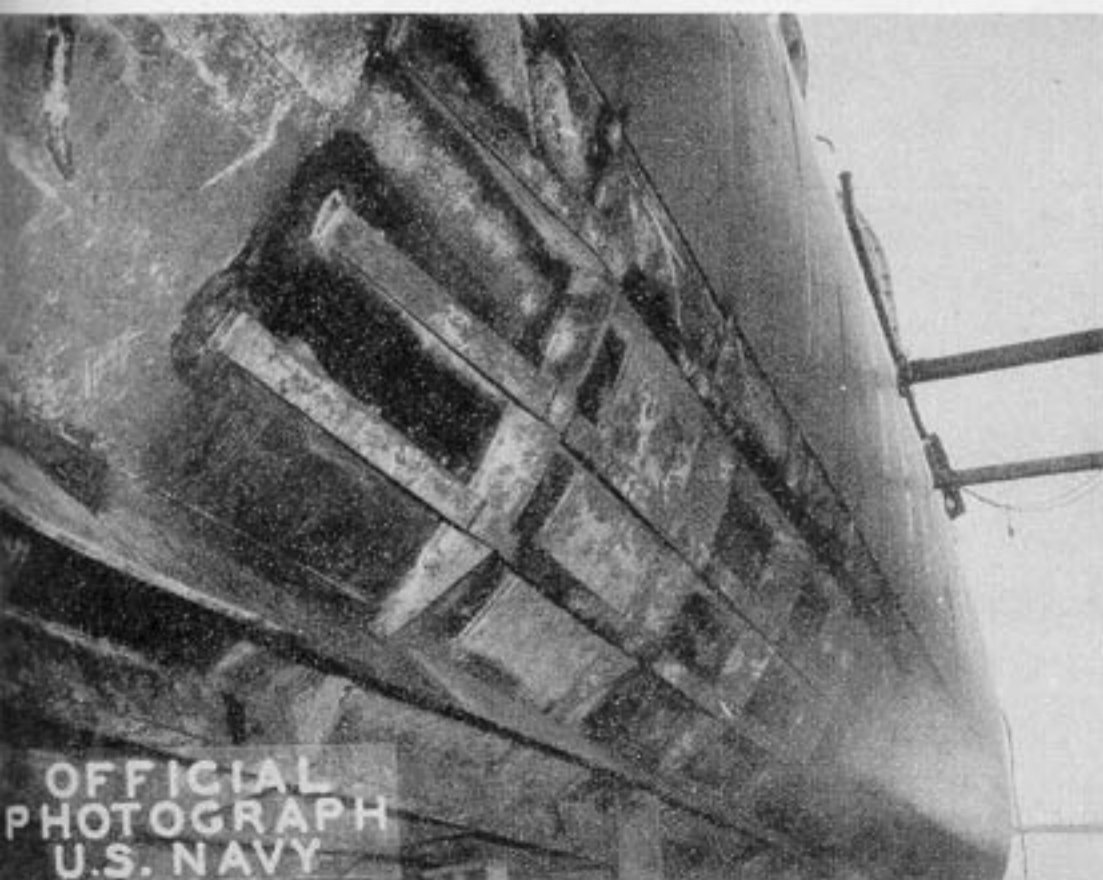
Photo 12-10
HUGH W. HADLEY
(DD774).
Port side looking
aft following repairs
in ARD28.

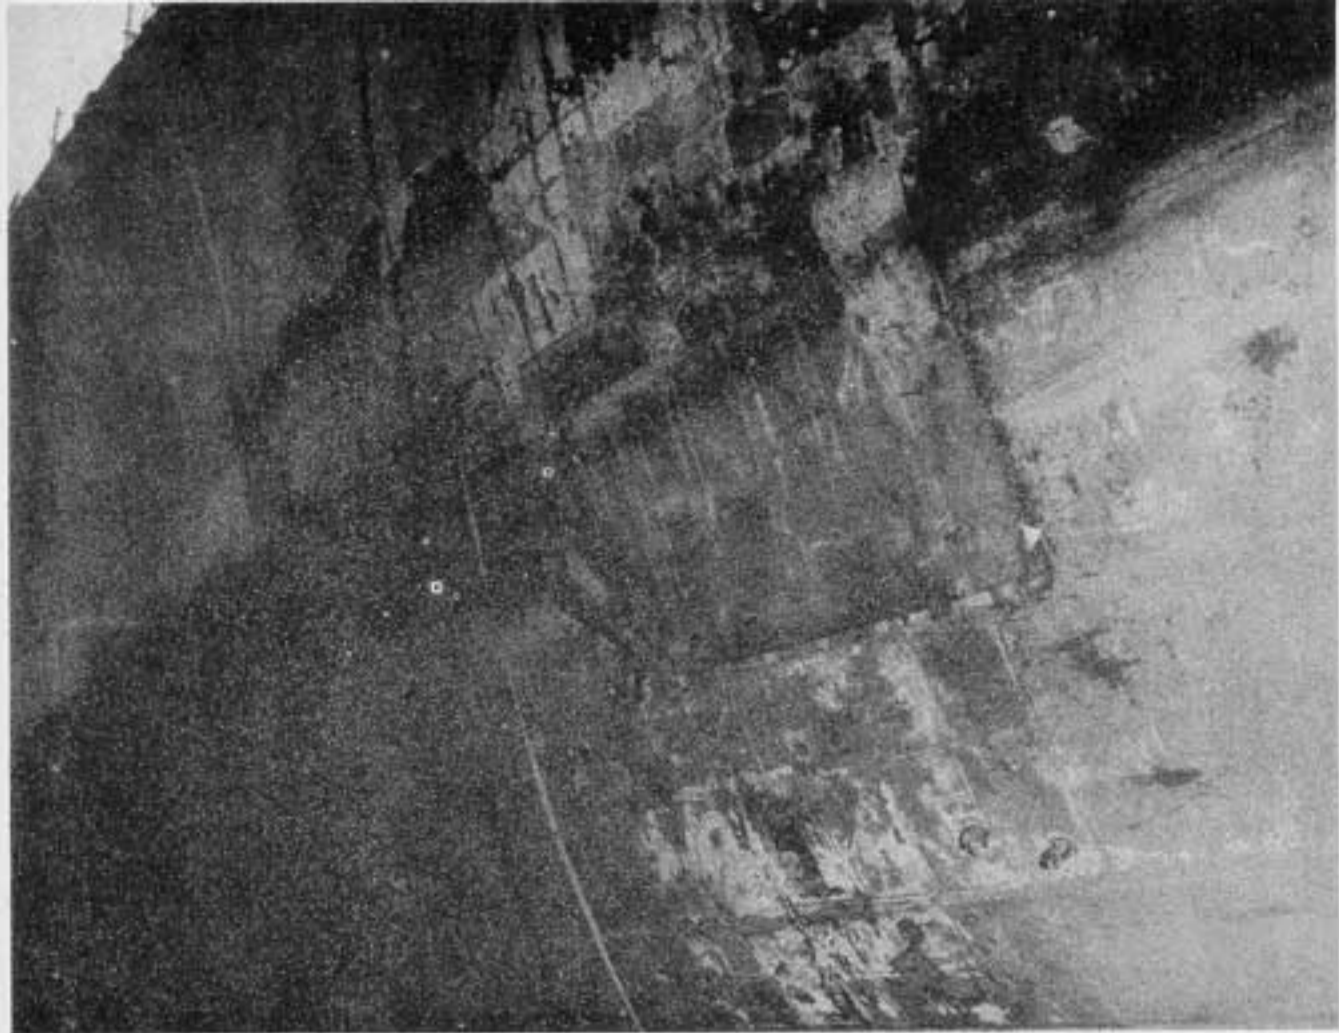
Photo 10-1: KILLEN (DD593). View of bow in ABSD2 at Manus, from port side looking slightly forward, showing patches and plugs installed by salvage personnel at Leyte.

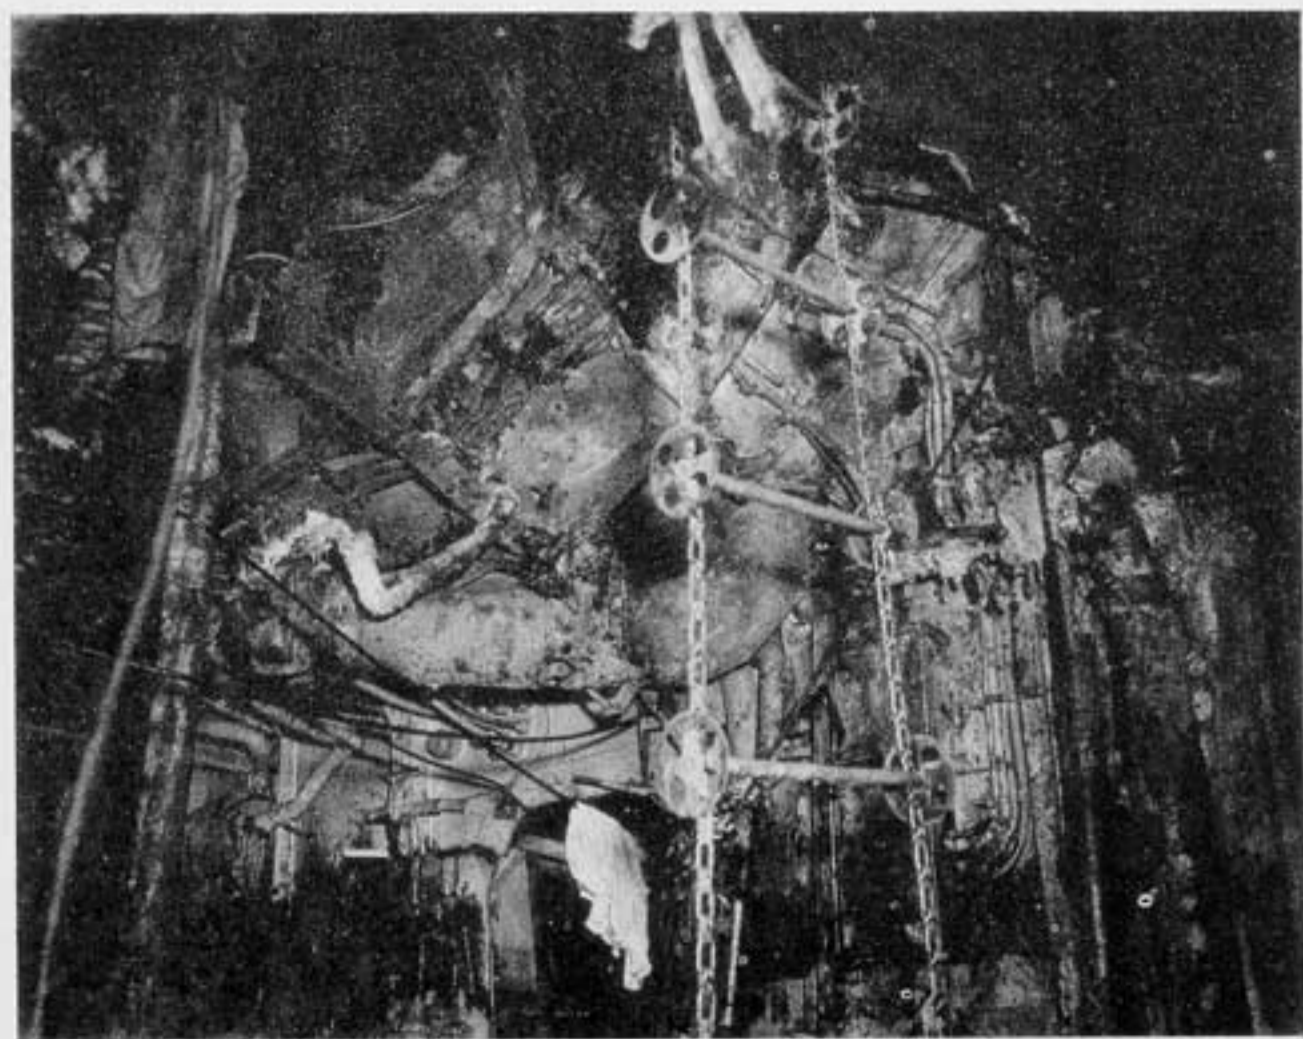
Photo 10-2: KILLEN (DD593). Compartment A-303-L looking aft and to starboard. Note upward distortion of first platform deck and splitting of door frame 3-42-1.

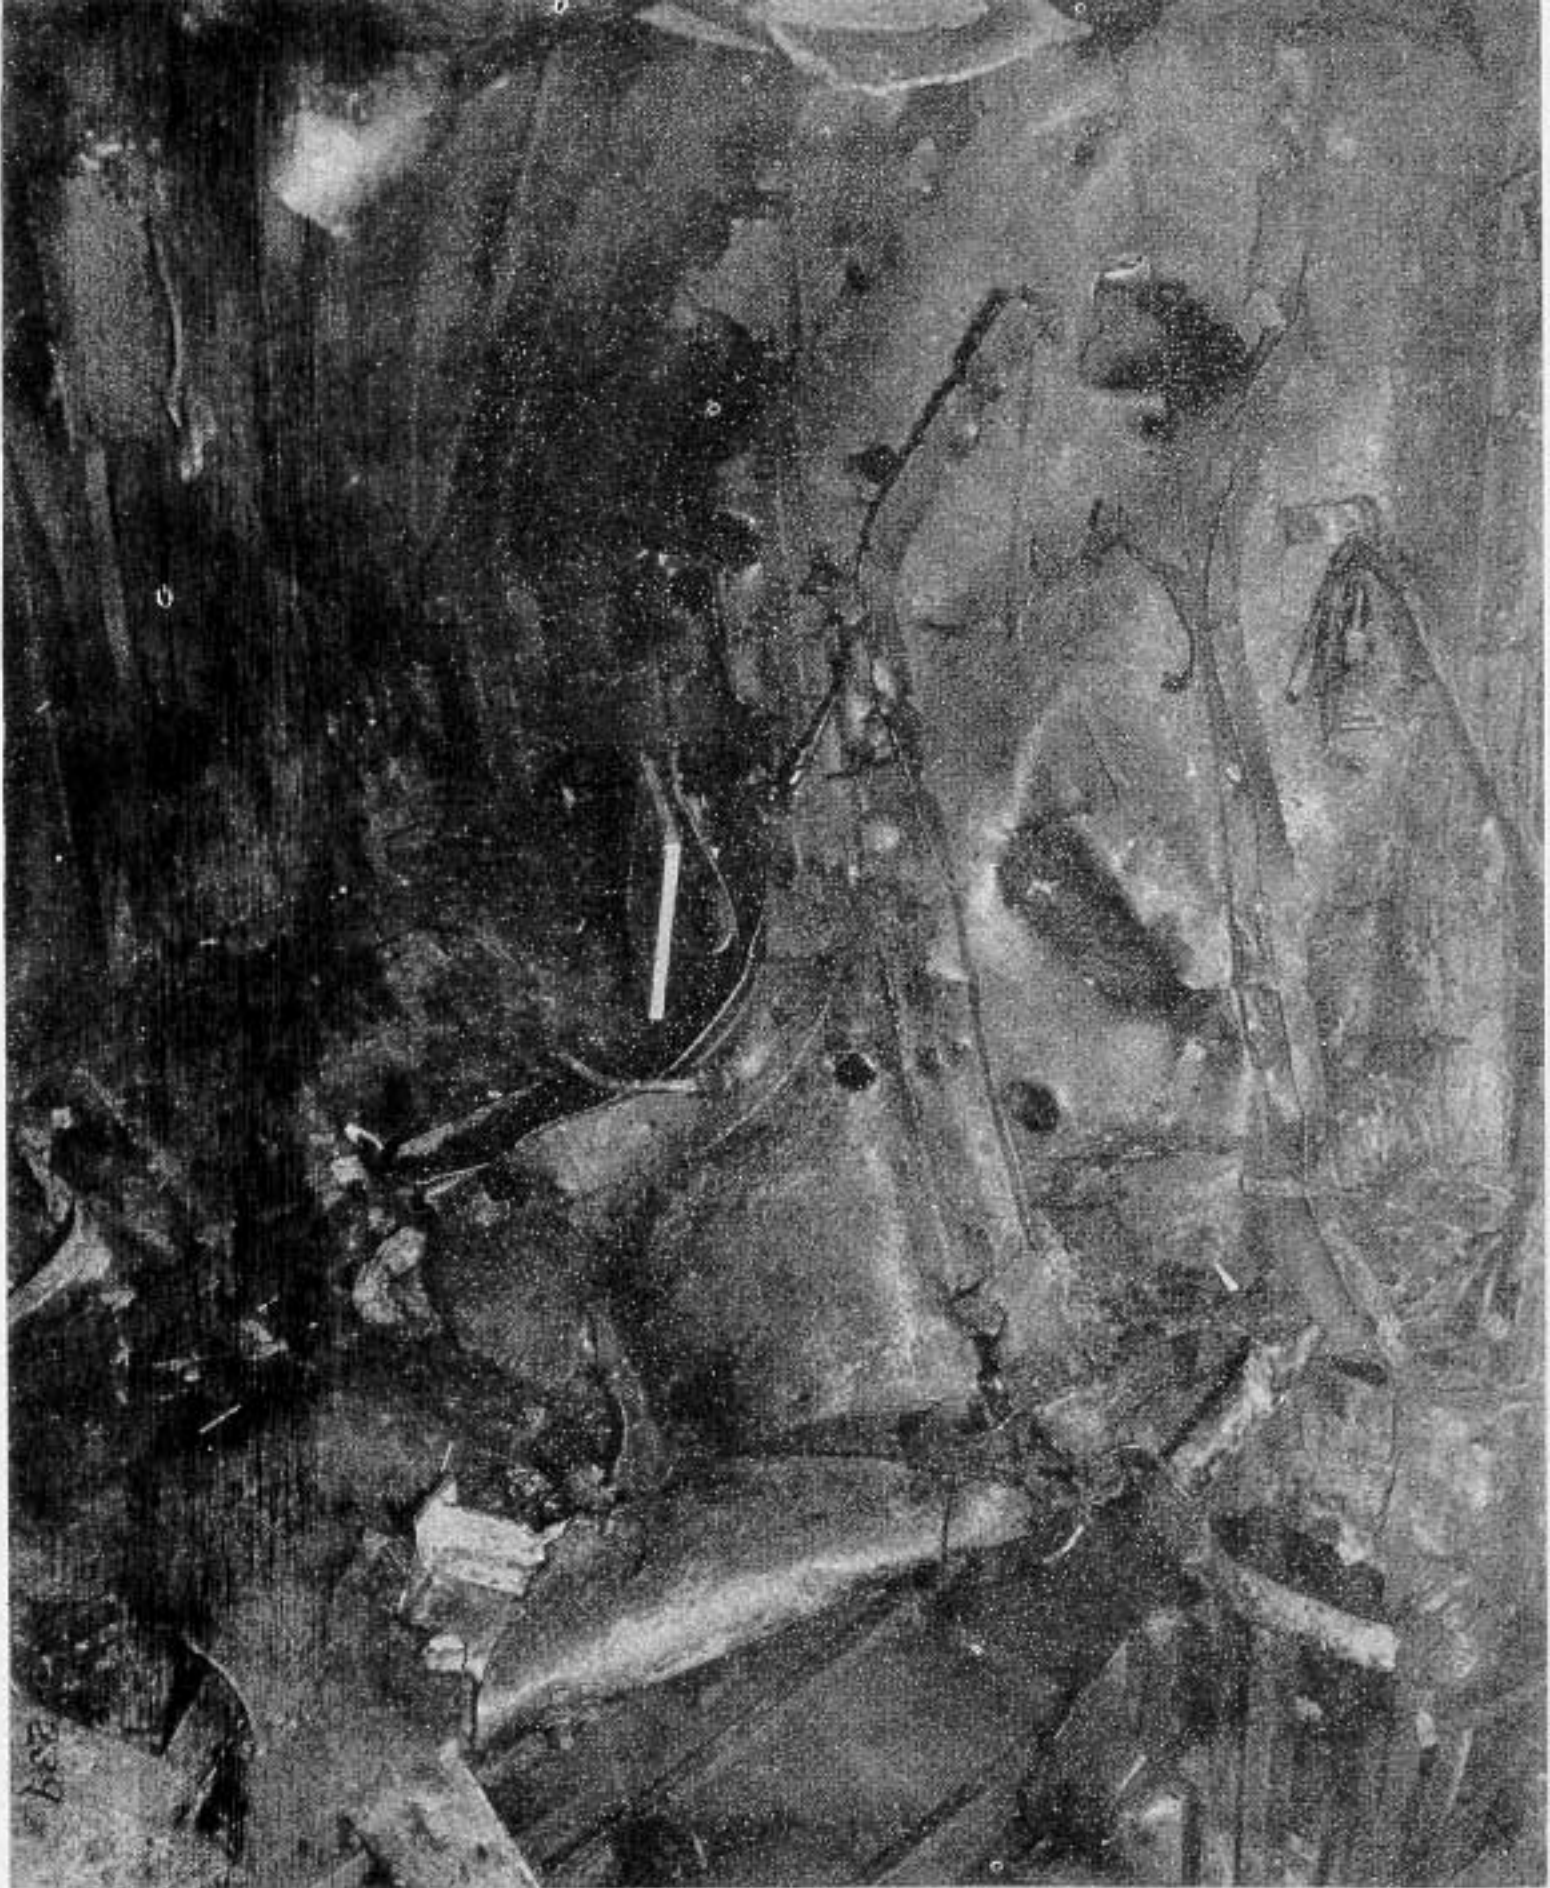
Photo 10-3:
KILLEN (DD593).
Looking forward and to
starboard from the
approximate point that
the bomb detonated.
Note powder can stowage
racks in A-408-M.
Demolished door is
4-38. Through the hole
in the deck the 40mm
magazine A-505-M can
be seen.

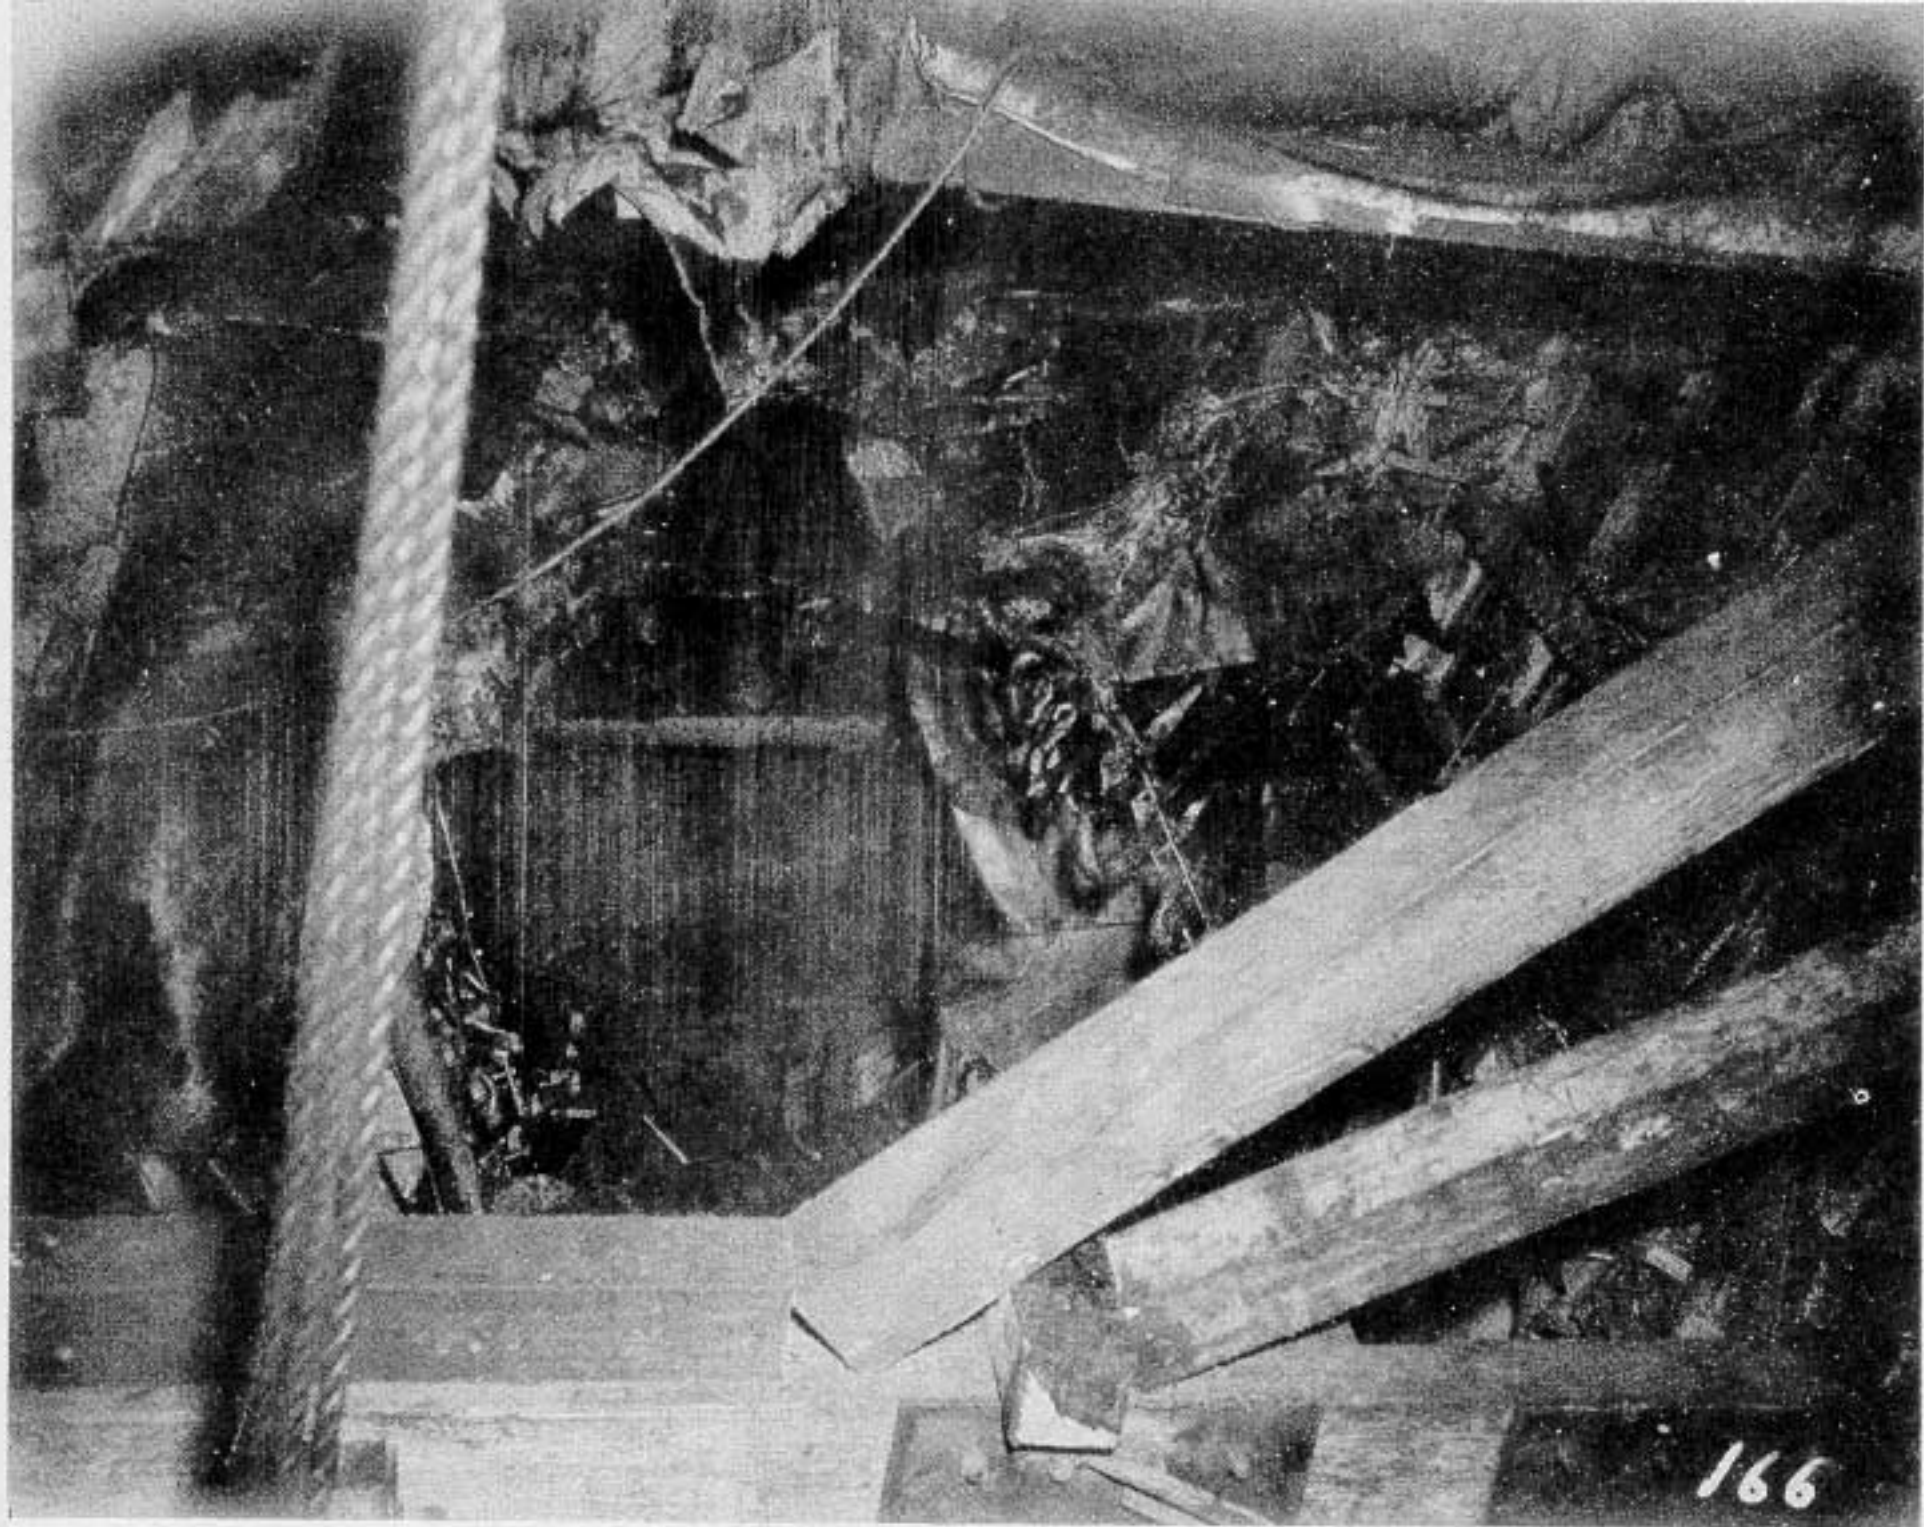
Photo 10-4: KILLEN (DD593). Damage to refrigerated spaces below second platform looking down and aft from frame 34 at second platform. The shoring in the foreground supported the temporary shell patch shown in Photo 10-1.

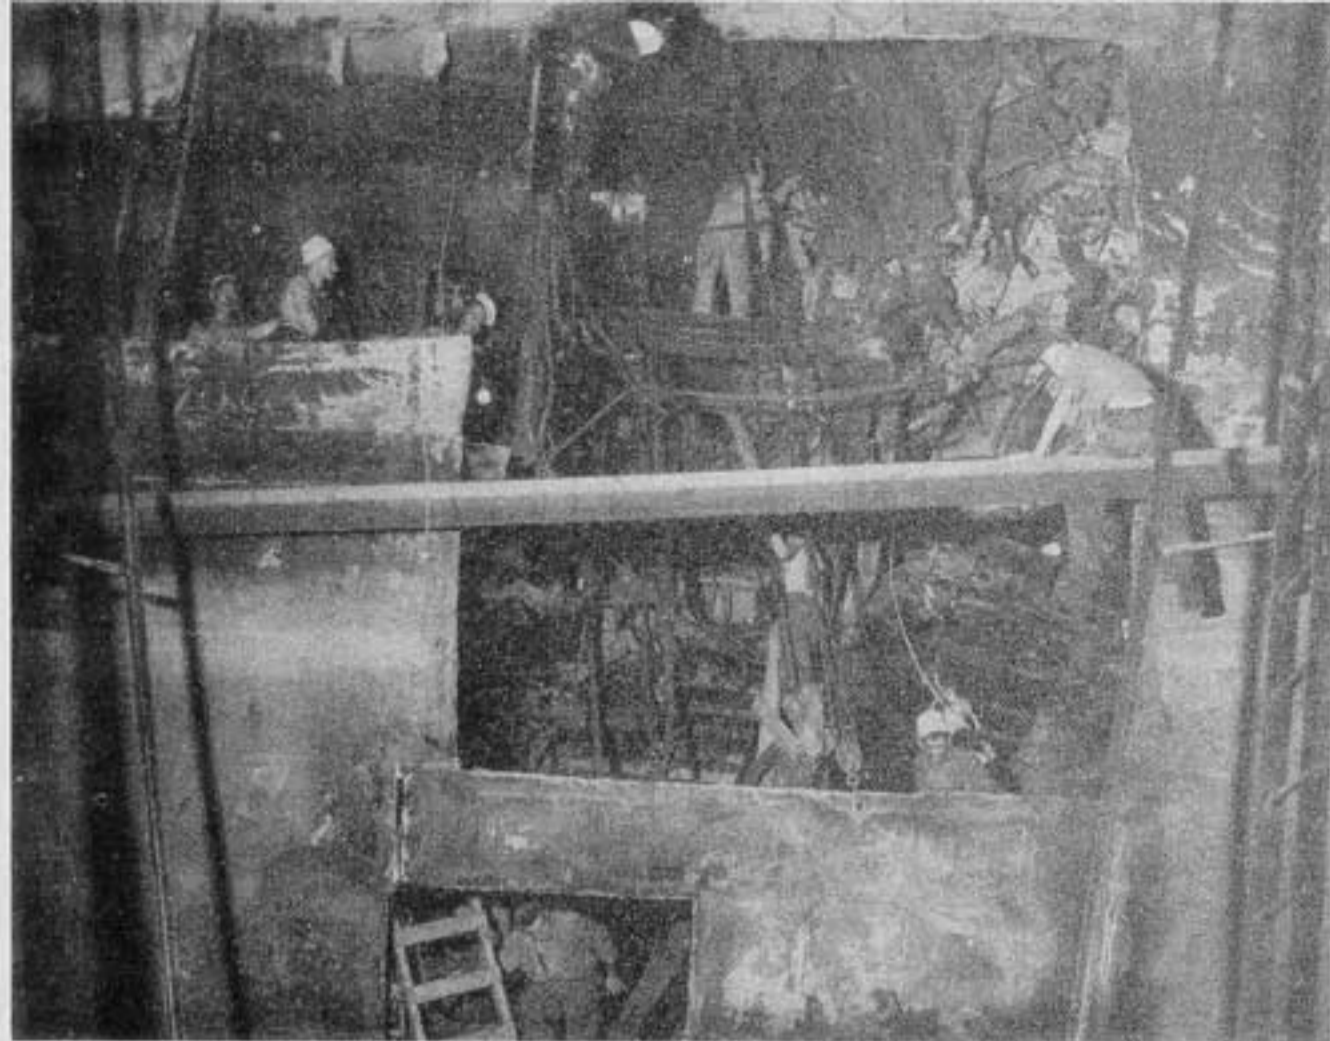
Photo 10-5: KILLEN (DD593). Looking up into damaged area from dock floor in ABSD2 after damaged shell plating was cut away, port side.

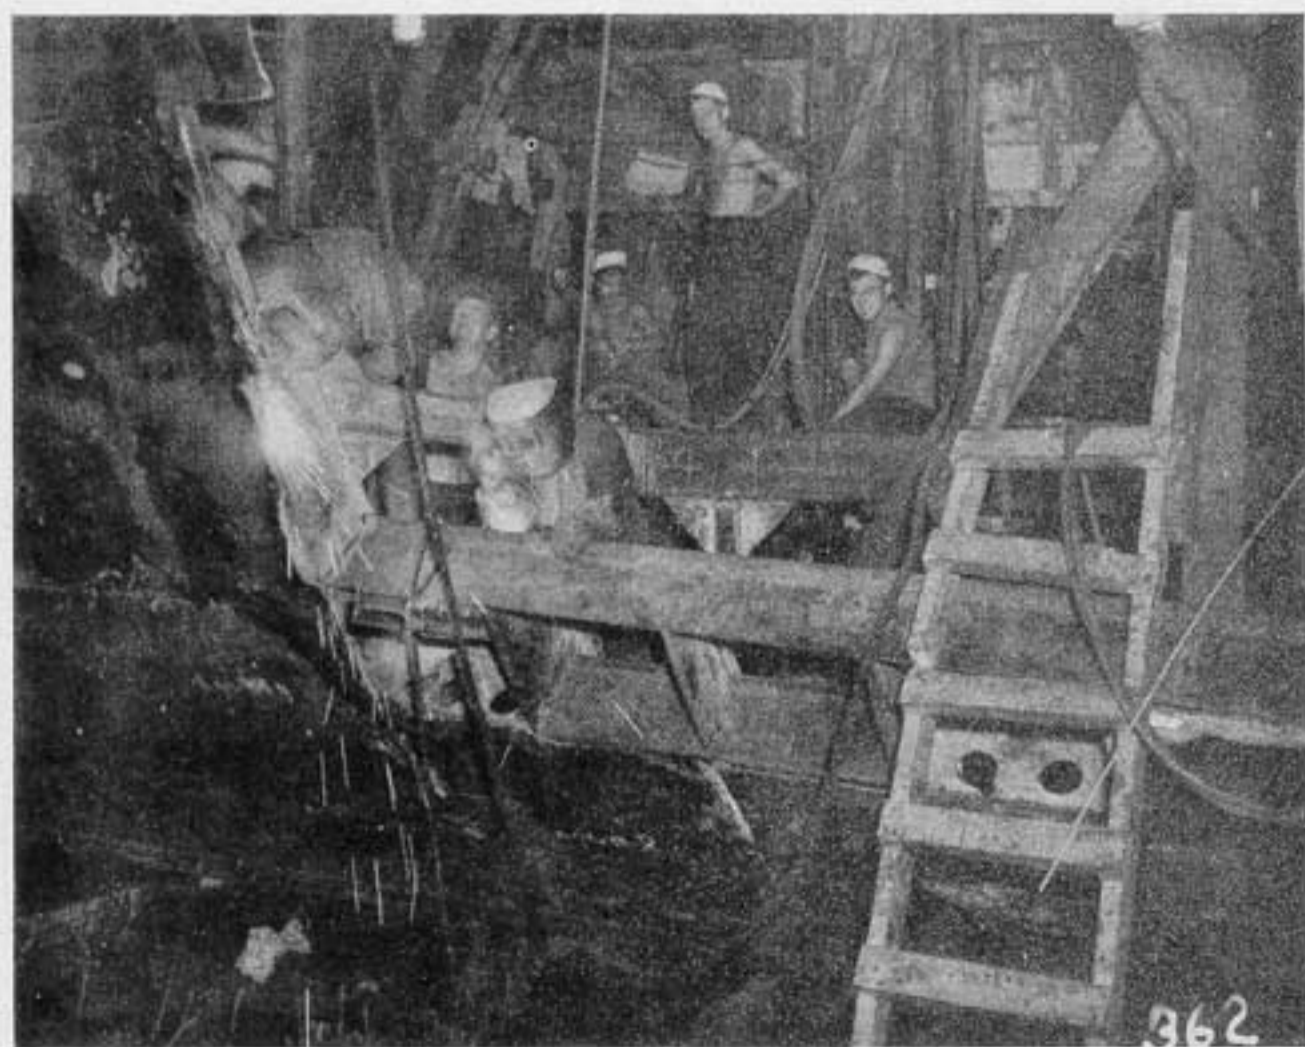
Photo 10-6: KILLEN (DD593). Longitudinals in way of damaged shell being restored by PIEDMONT (AD17) personnel.
