DESTROYER REPORT

GUNFIRE, BOMB AND KAMIKAZE DAMAGE
INCLUDING LOSSES IN ACTION

17 OCTOBER, 1941 TO 15 AUGUST, 1945

WAR DAMAGE REPORT No. 51

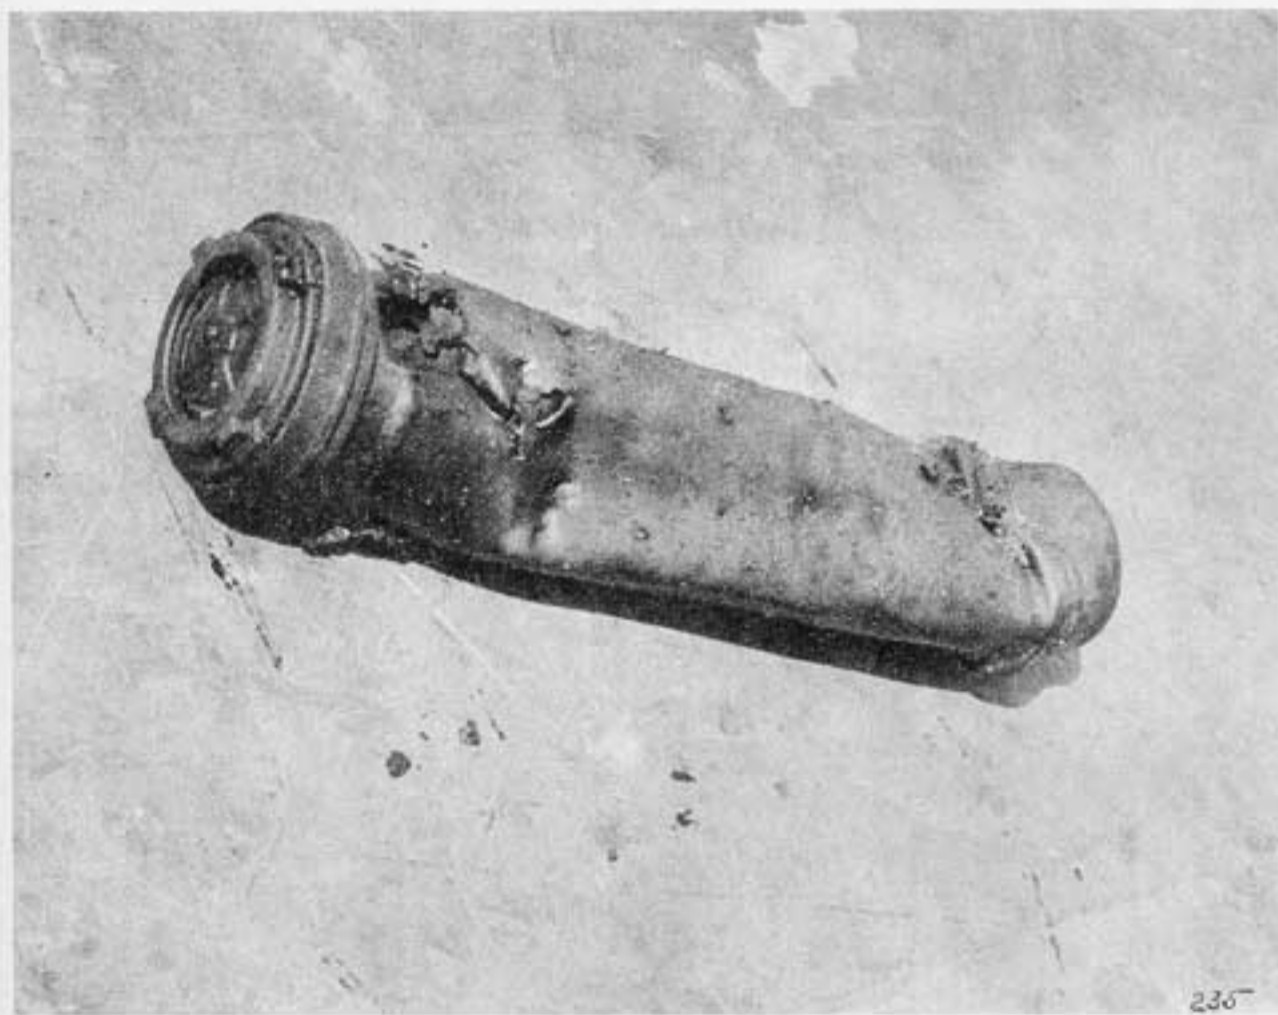
Photo 10-8: KILLEN (DD597). A typical burned-out powder cartridge can recovered from A-408-M. It has been crushed by blast, punctured by fragments, and powder inside burned out. Some unburned powder grains cling to the exterior surface.

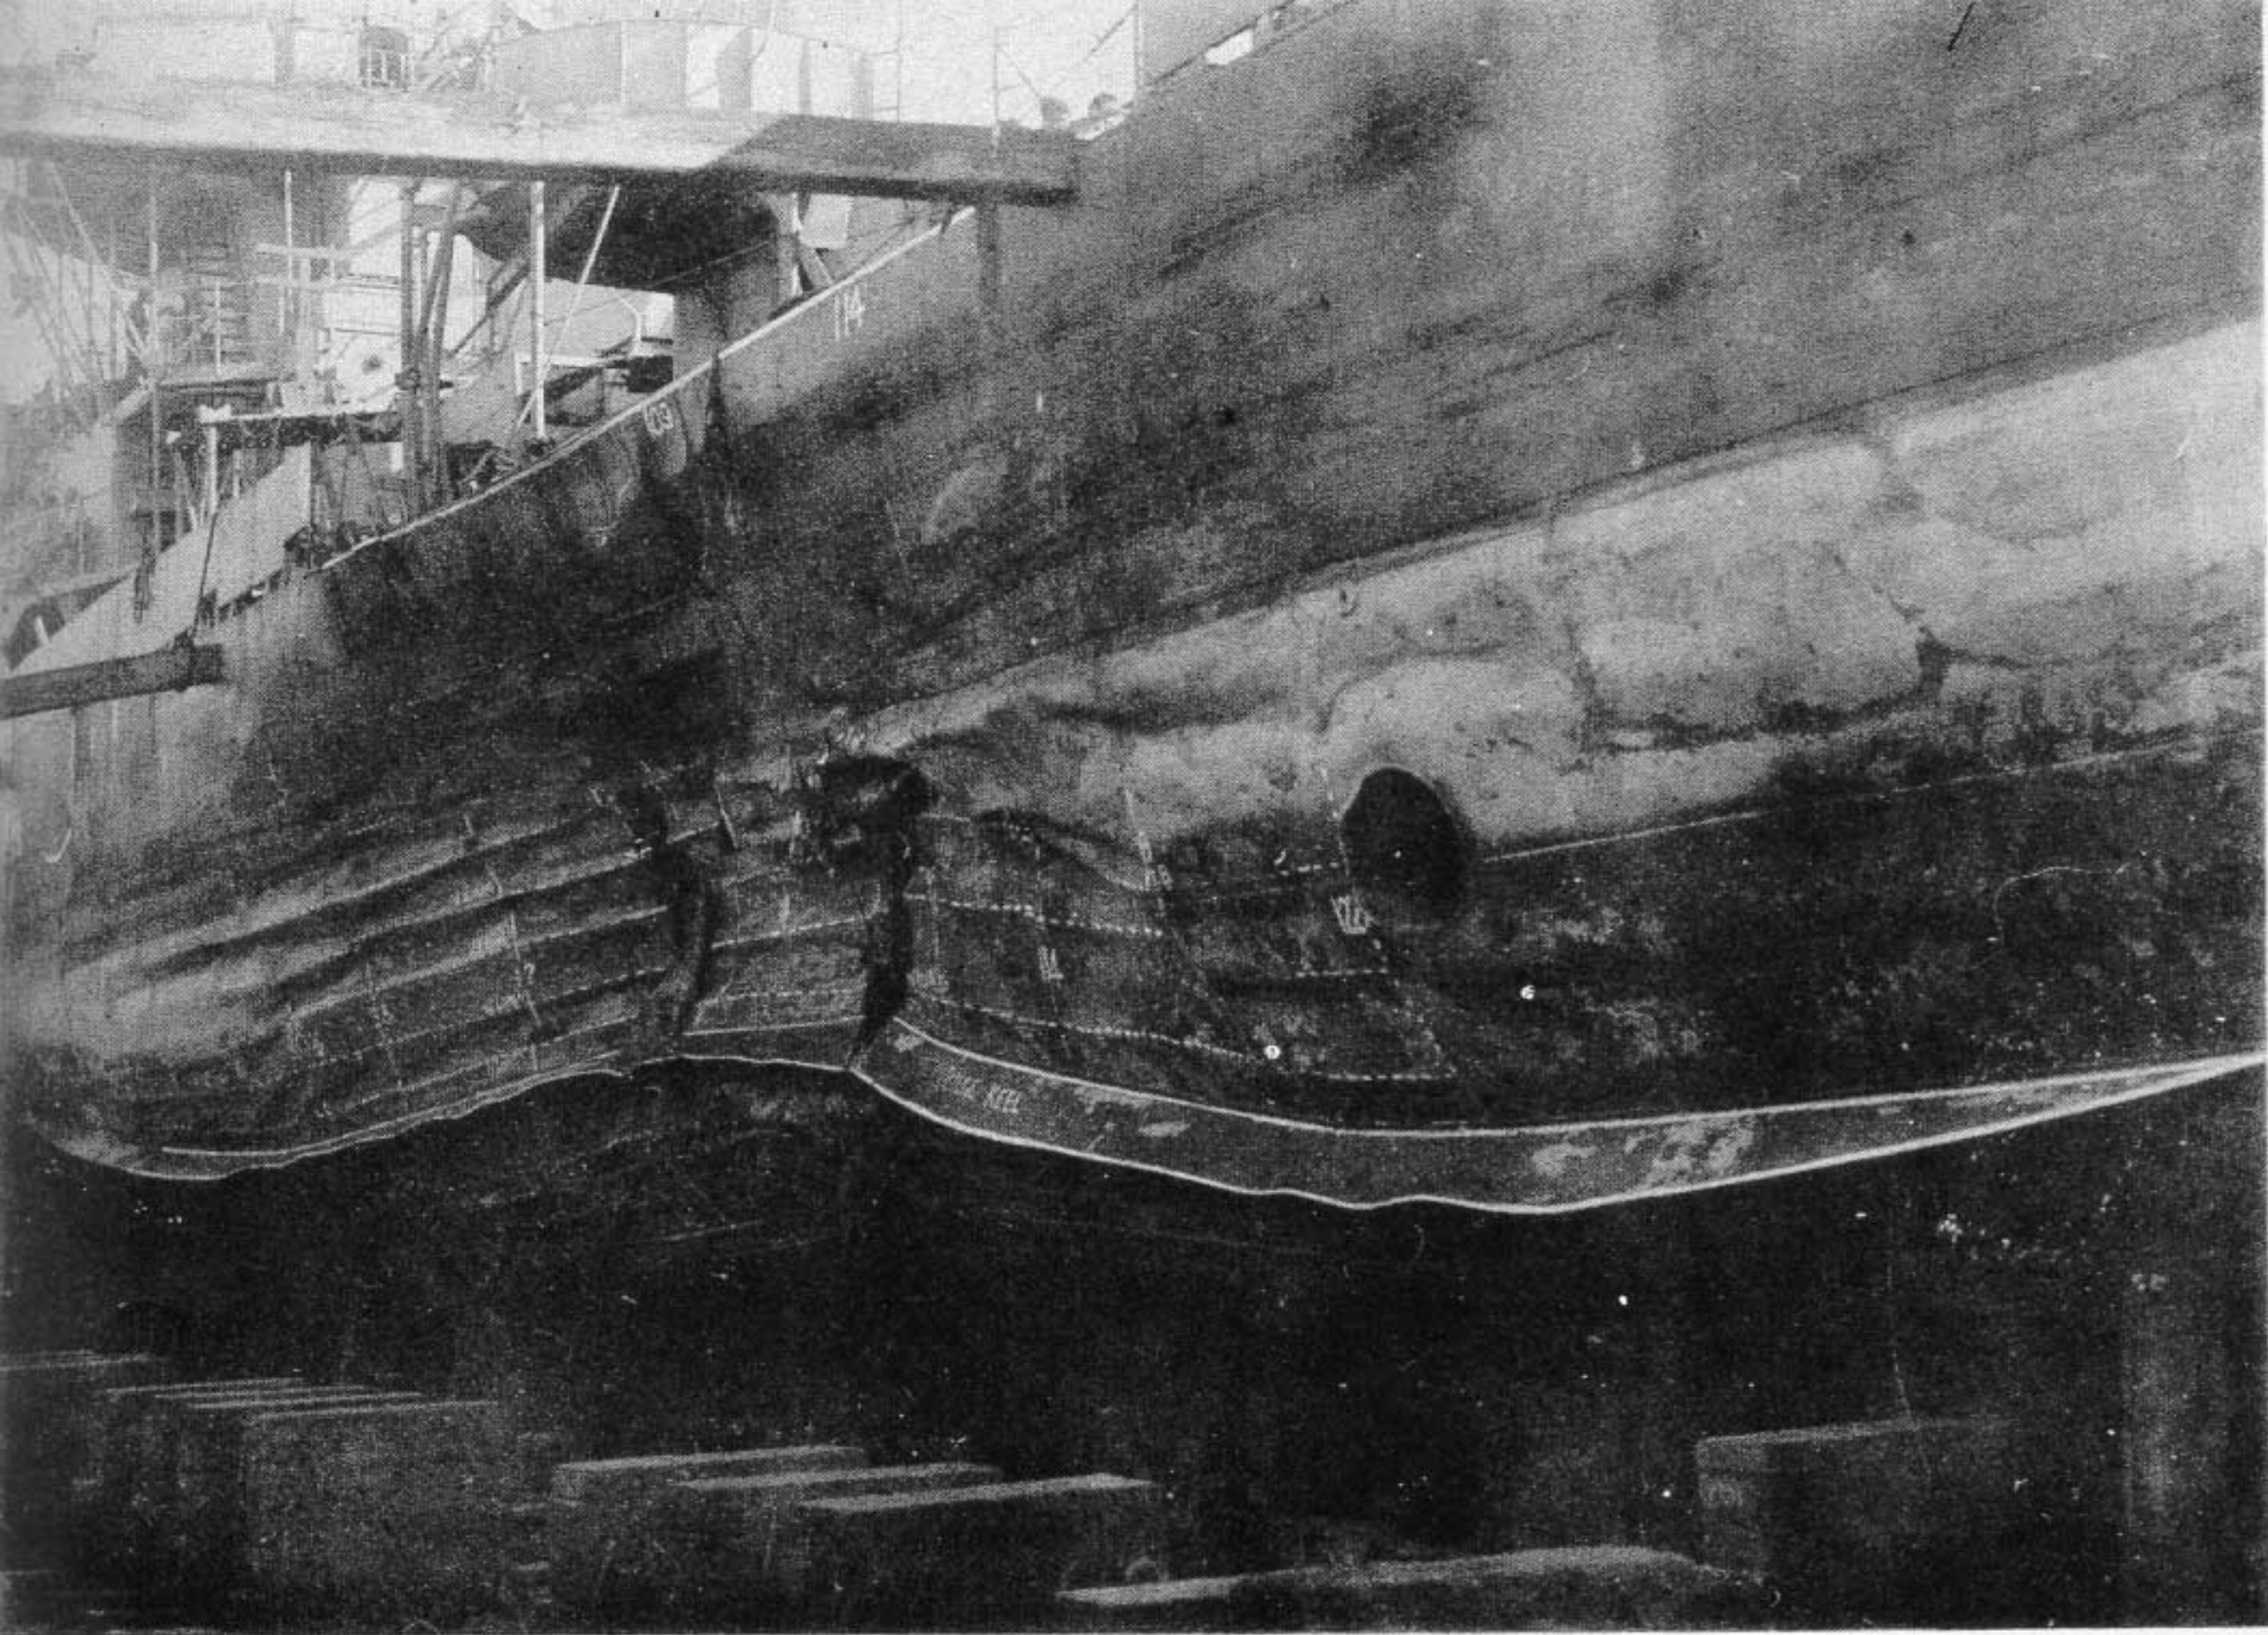
Photo 7-1: MAYRANT (DD402). Looking forward at damage to port side.

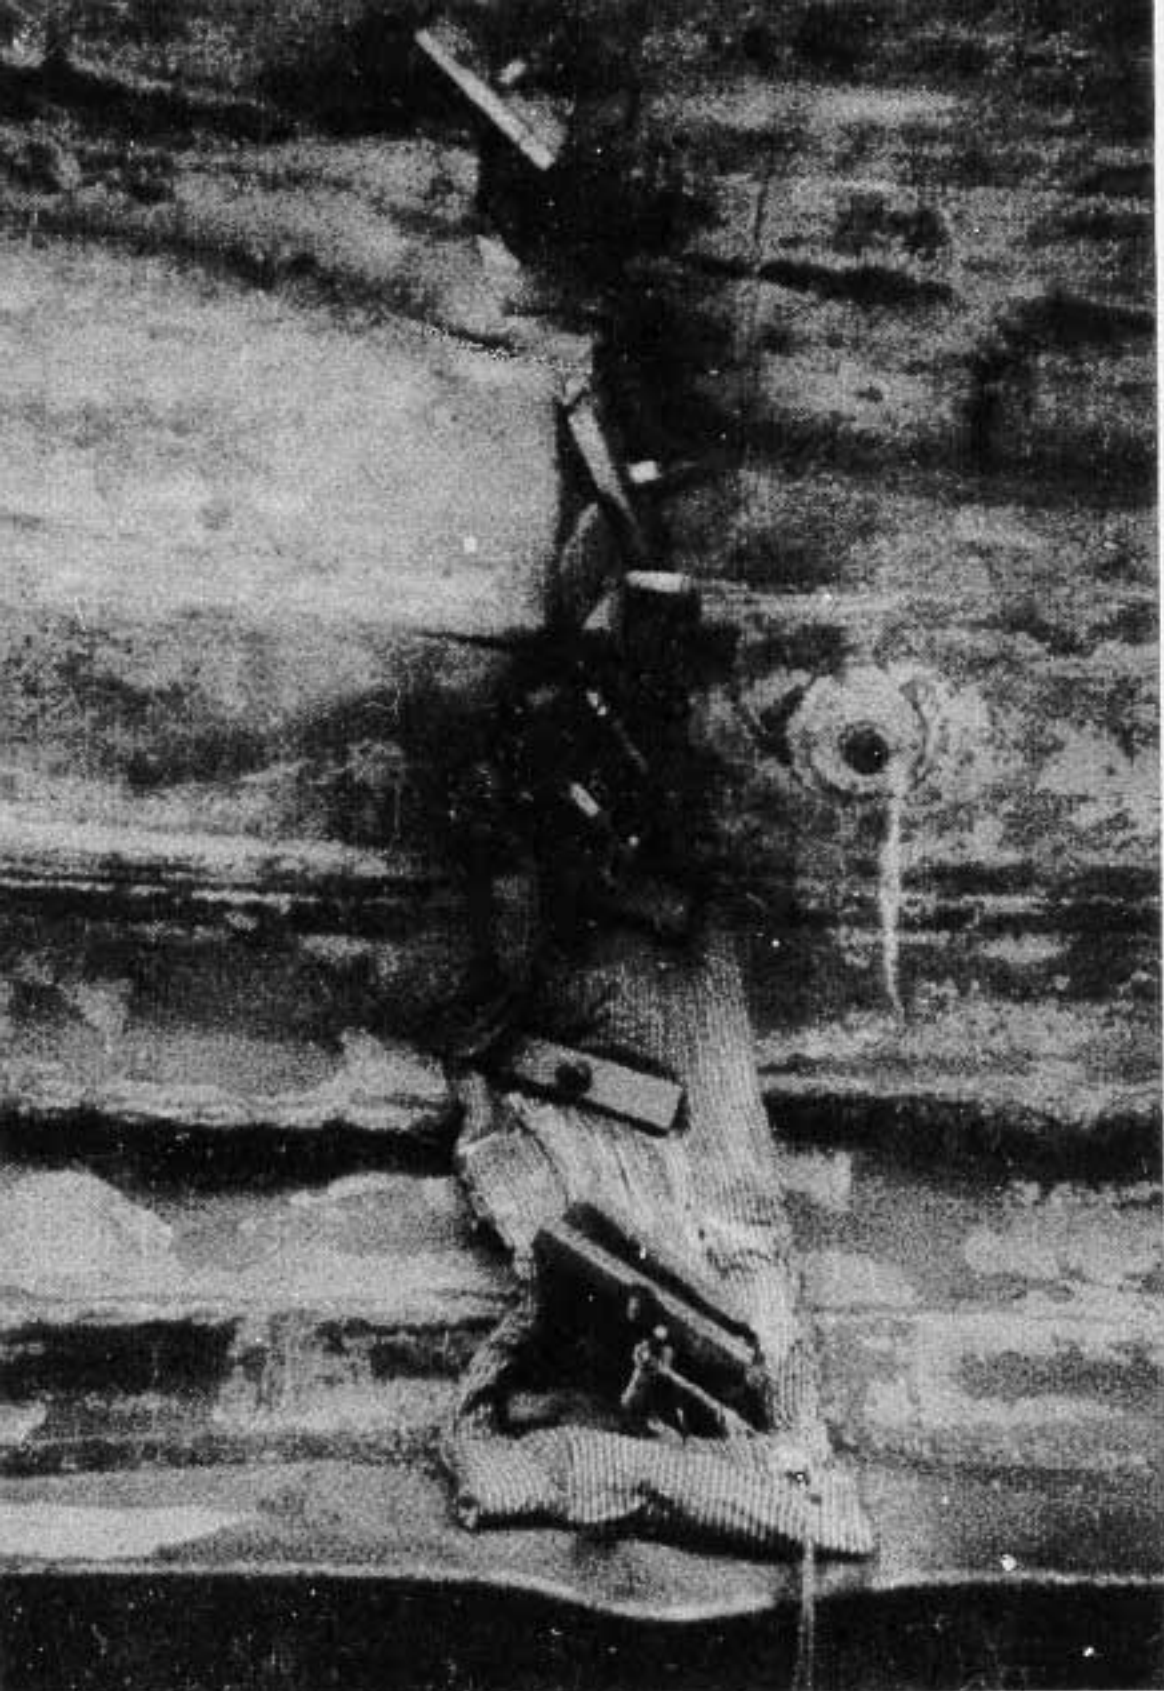
Photo 7-2:
MAYRANT (DD402)
Temporary patches
installed by divers
over tears in shell,
frame 101, port side.

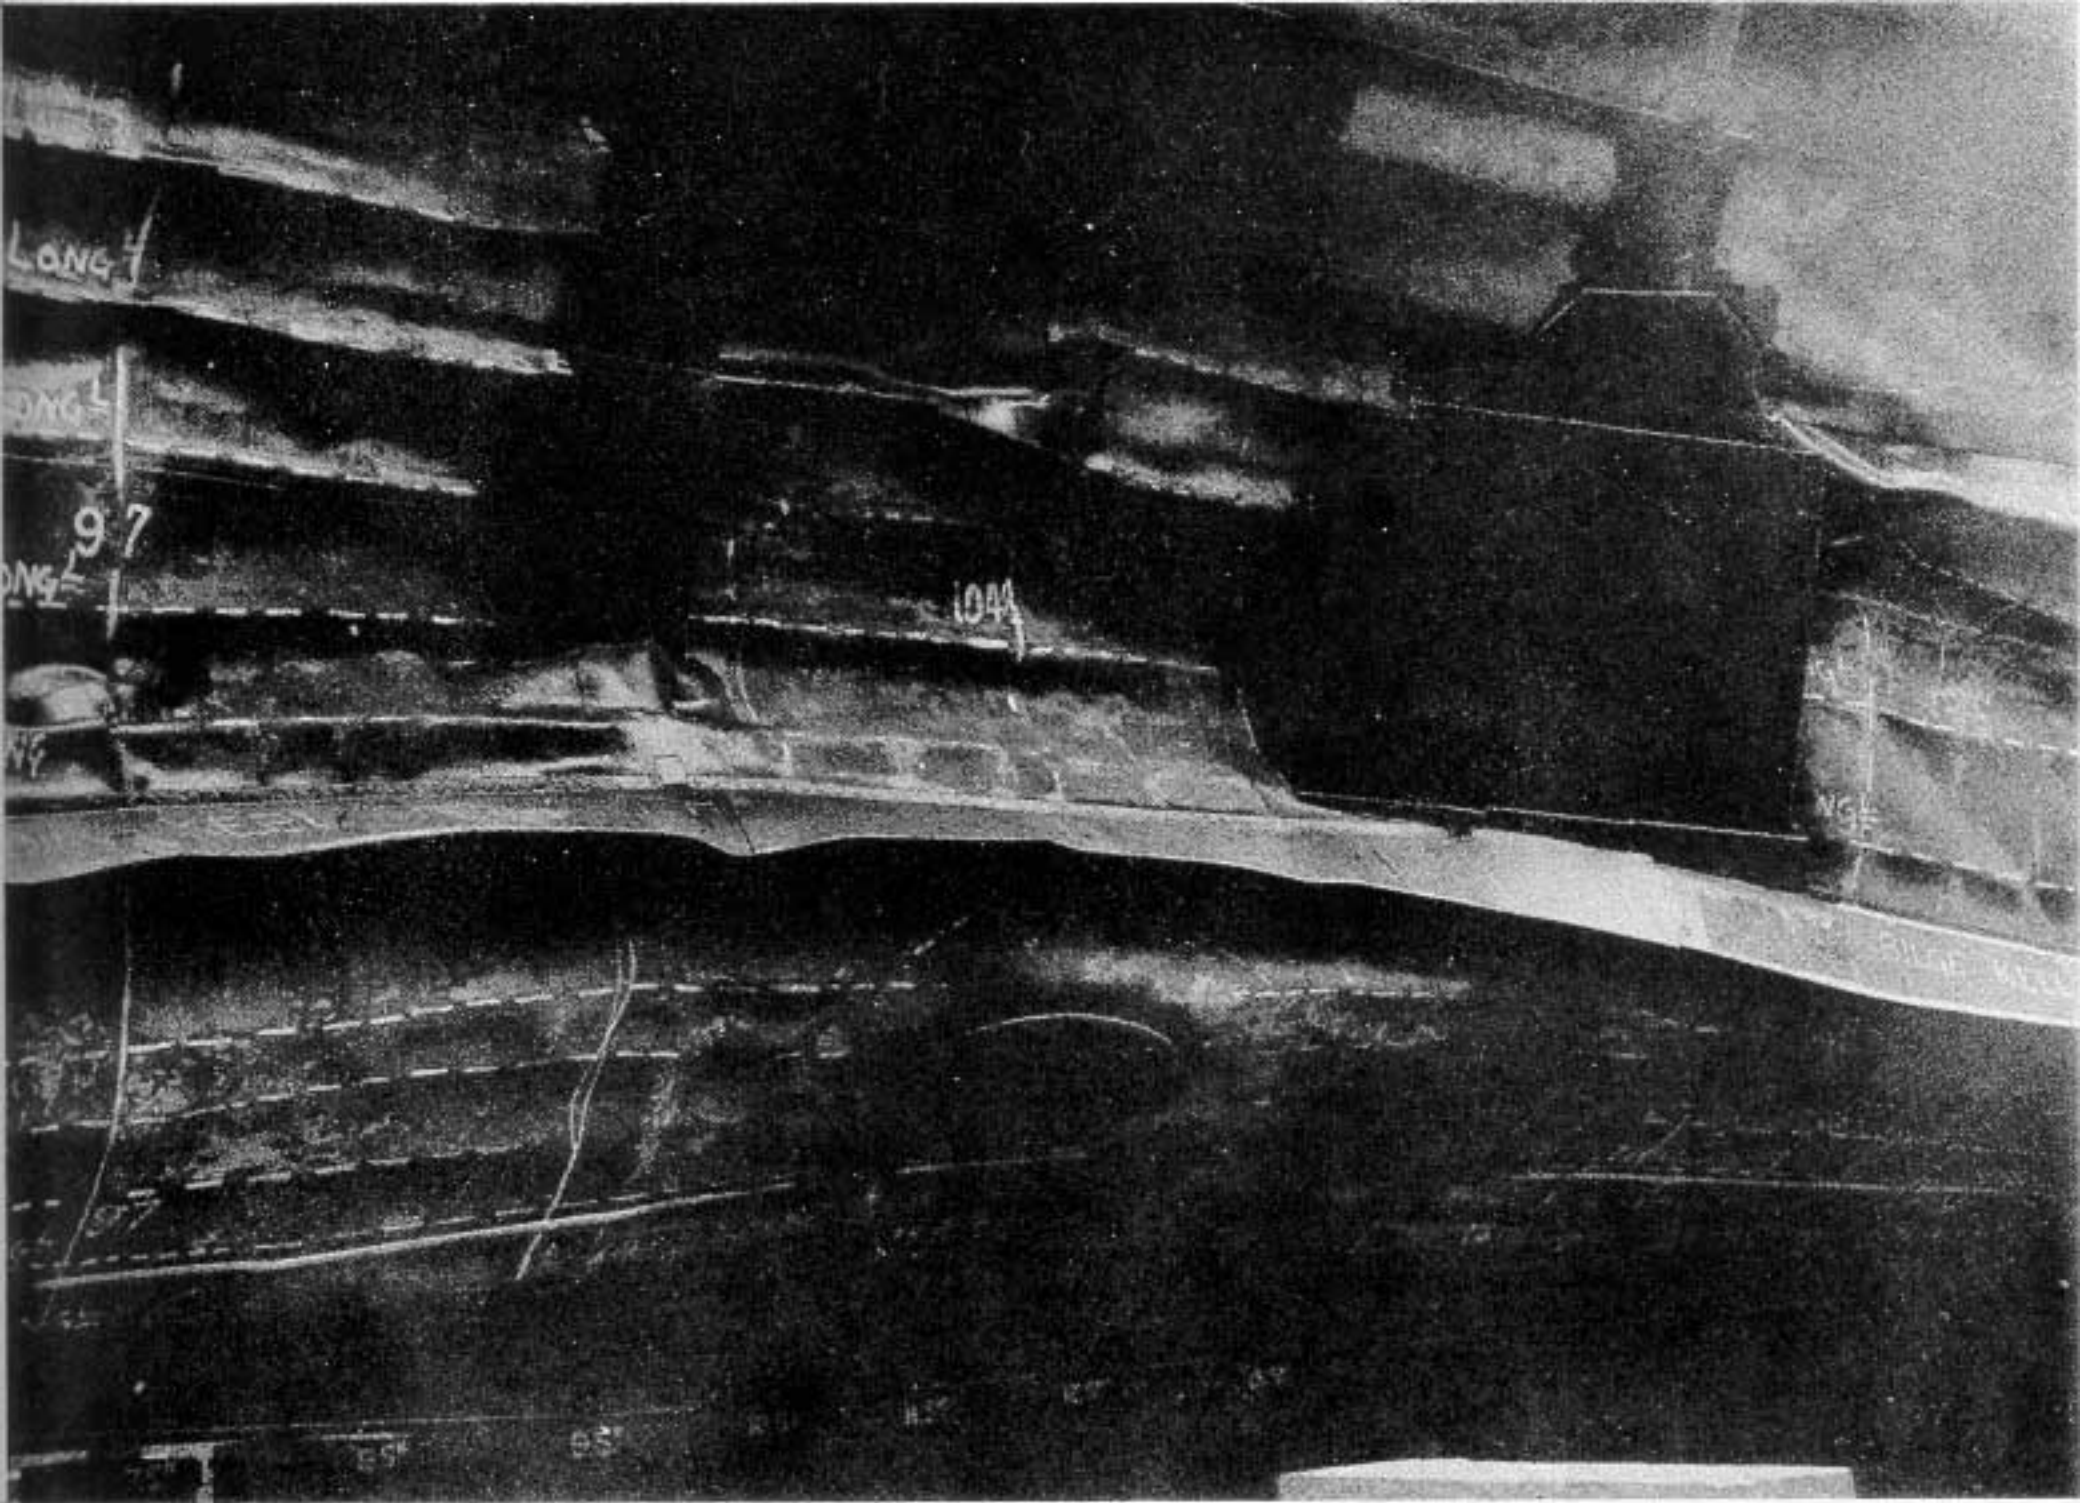
Photo 7-4: MAYRANT (DD402). Preliminary patches fitted to port side during first docking in Malta.

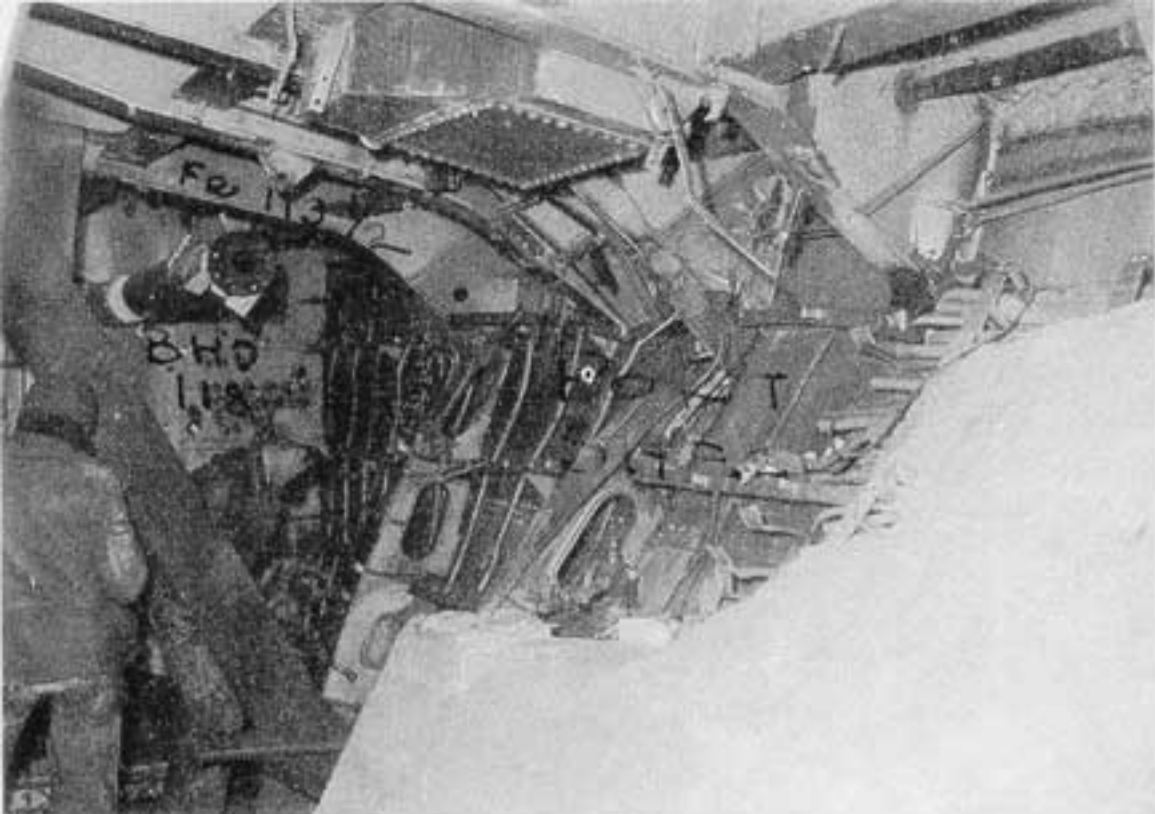
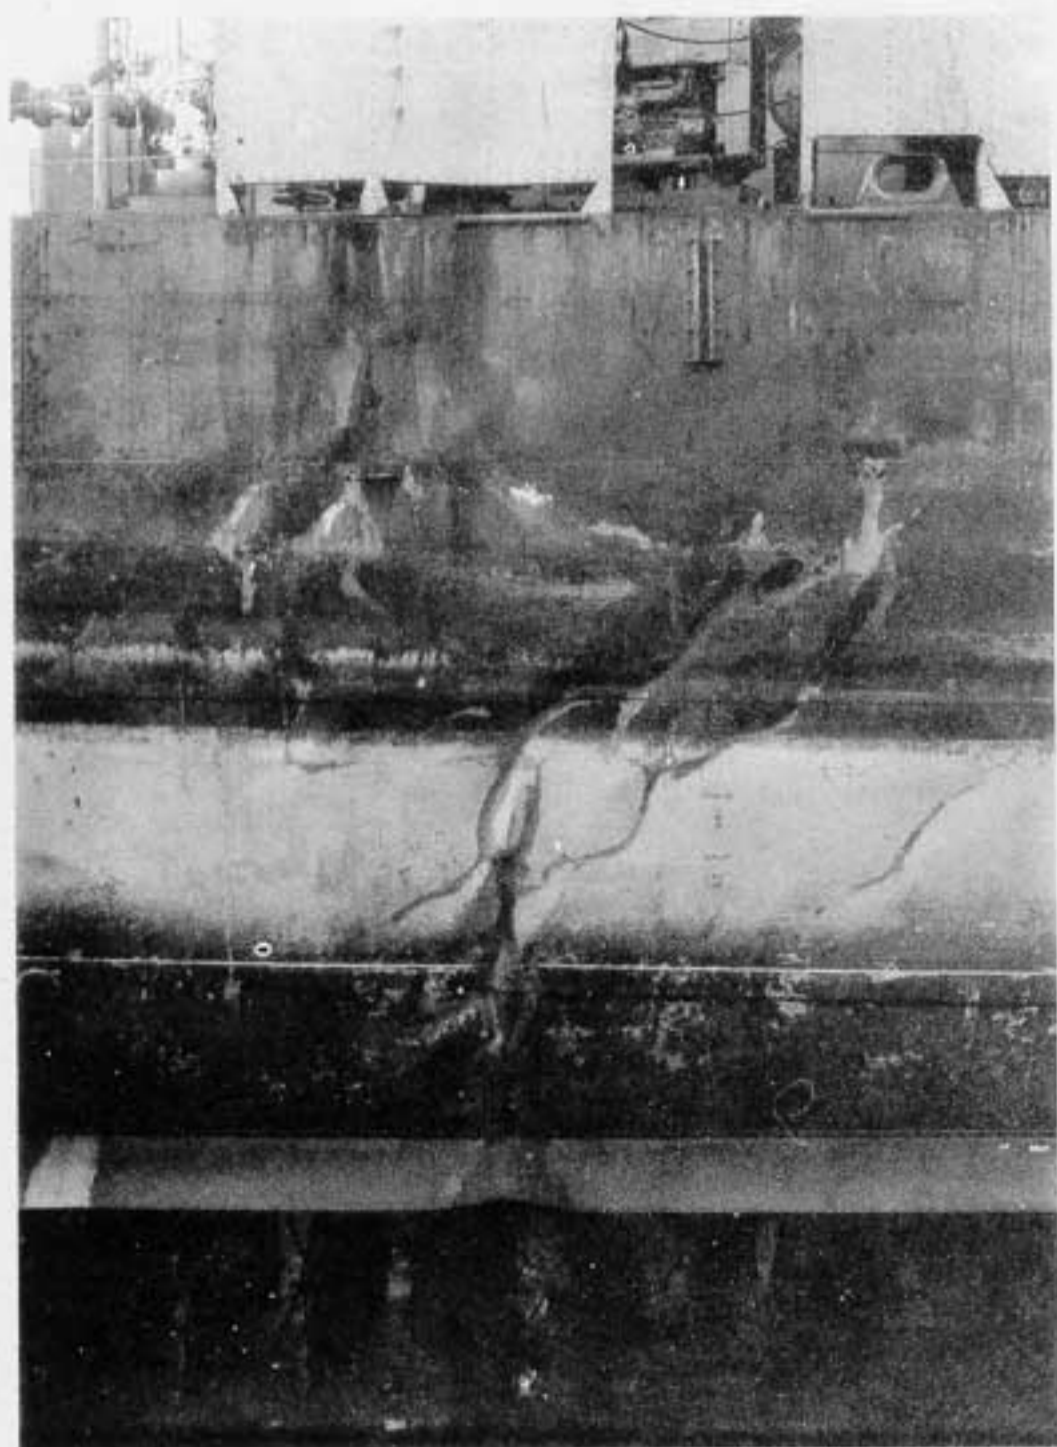
Photo 7-5: MAYRANT (DD402). Forward engine room, upper level, looking aft and to port. The concrete patch was poured at Palermo, and the diagonal stanchion fitted at Malta. Below - Photo 7-6: Buckling in starboard side, frames 95 to 104.

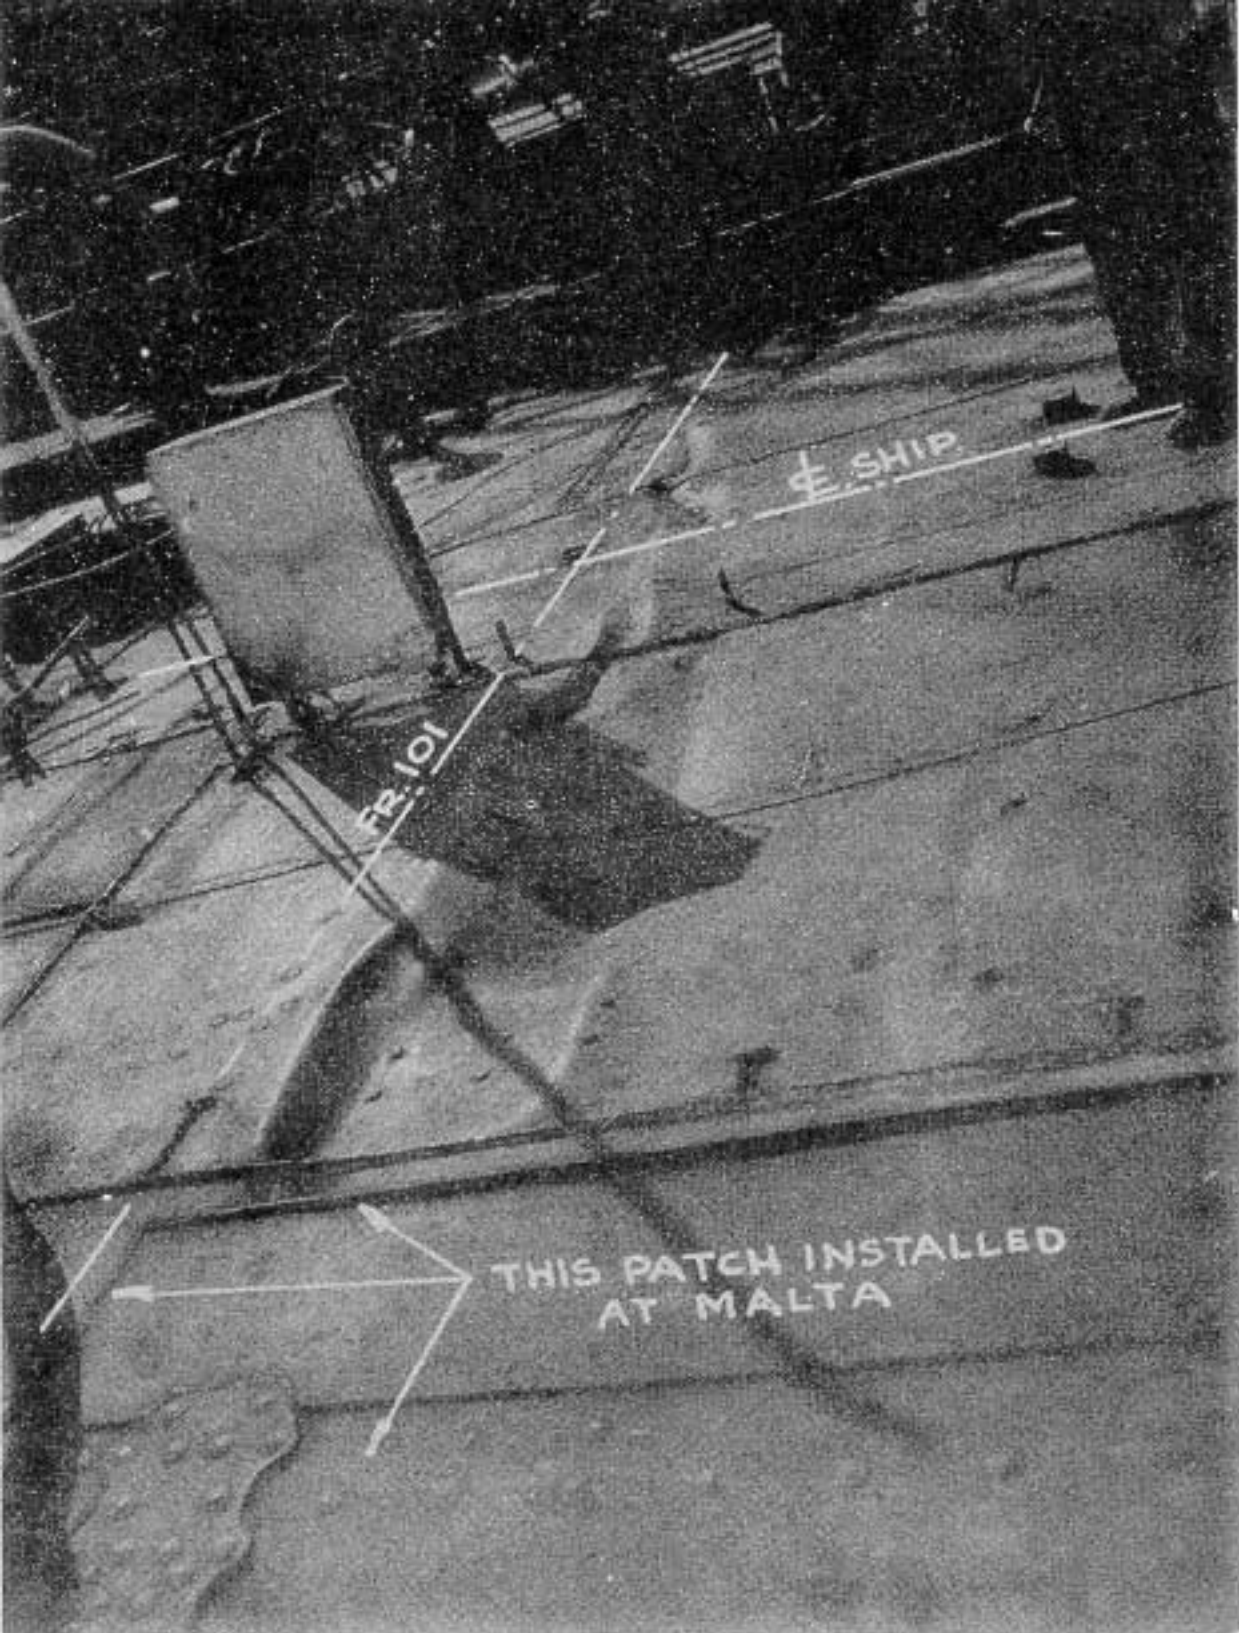
Photo 7-7: MAYRANT (DD402). Main deck looking to port and aft at wrinkled plating (Deckhouse removed at Charleston).

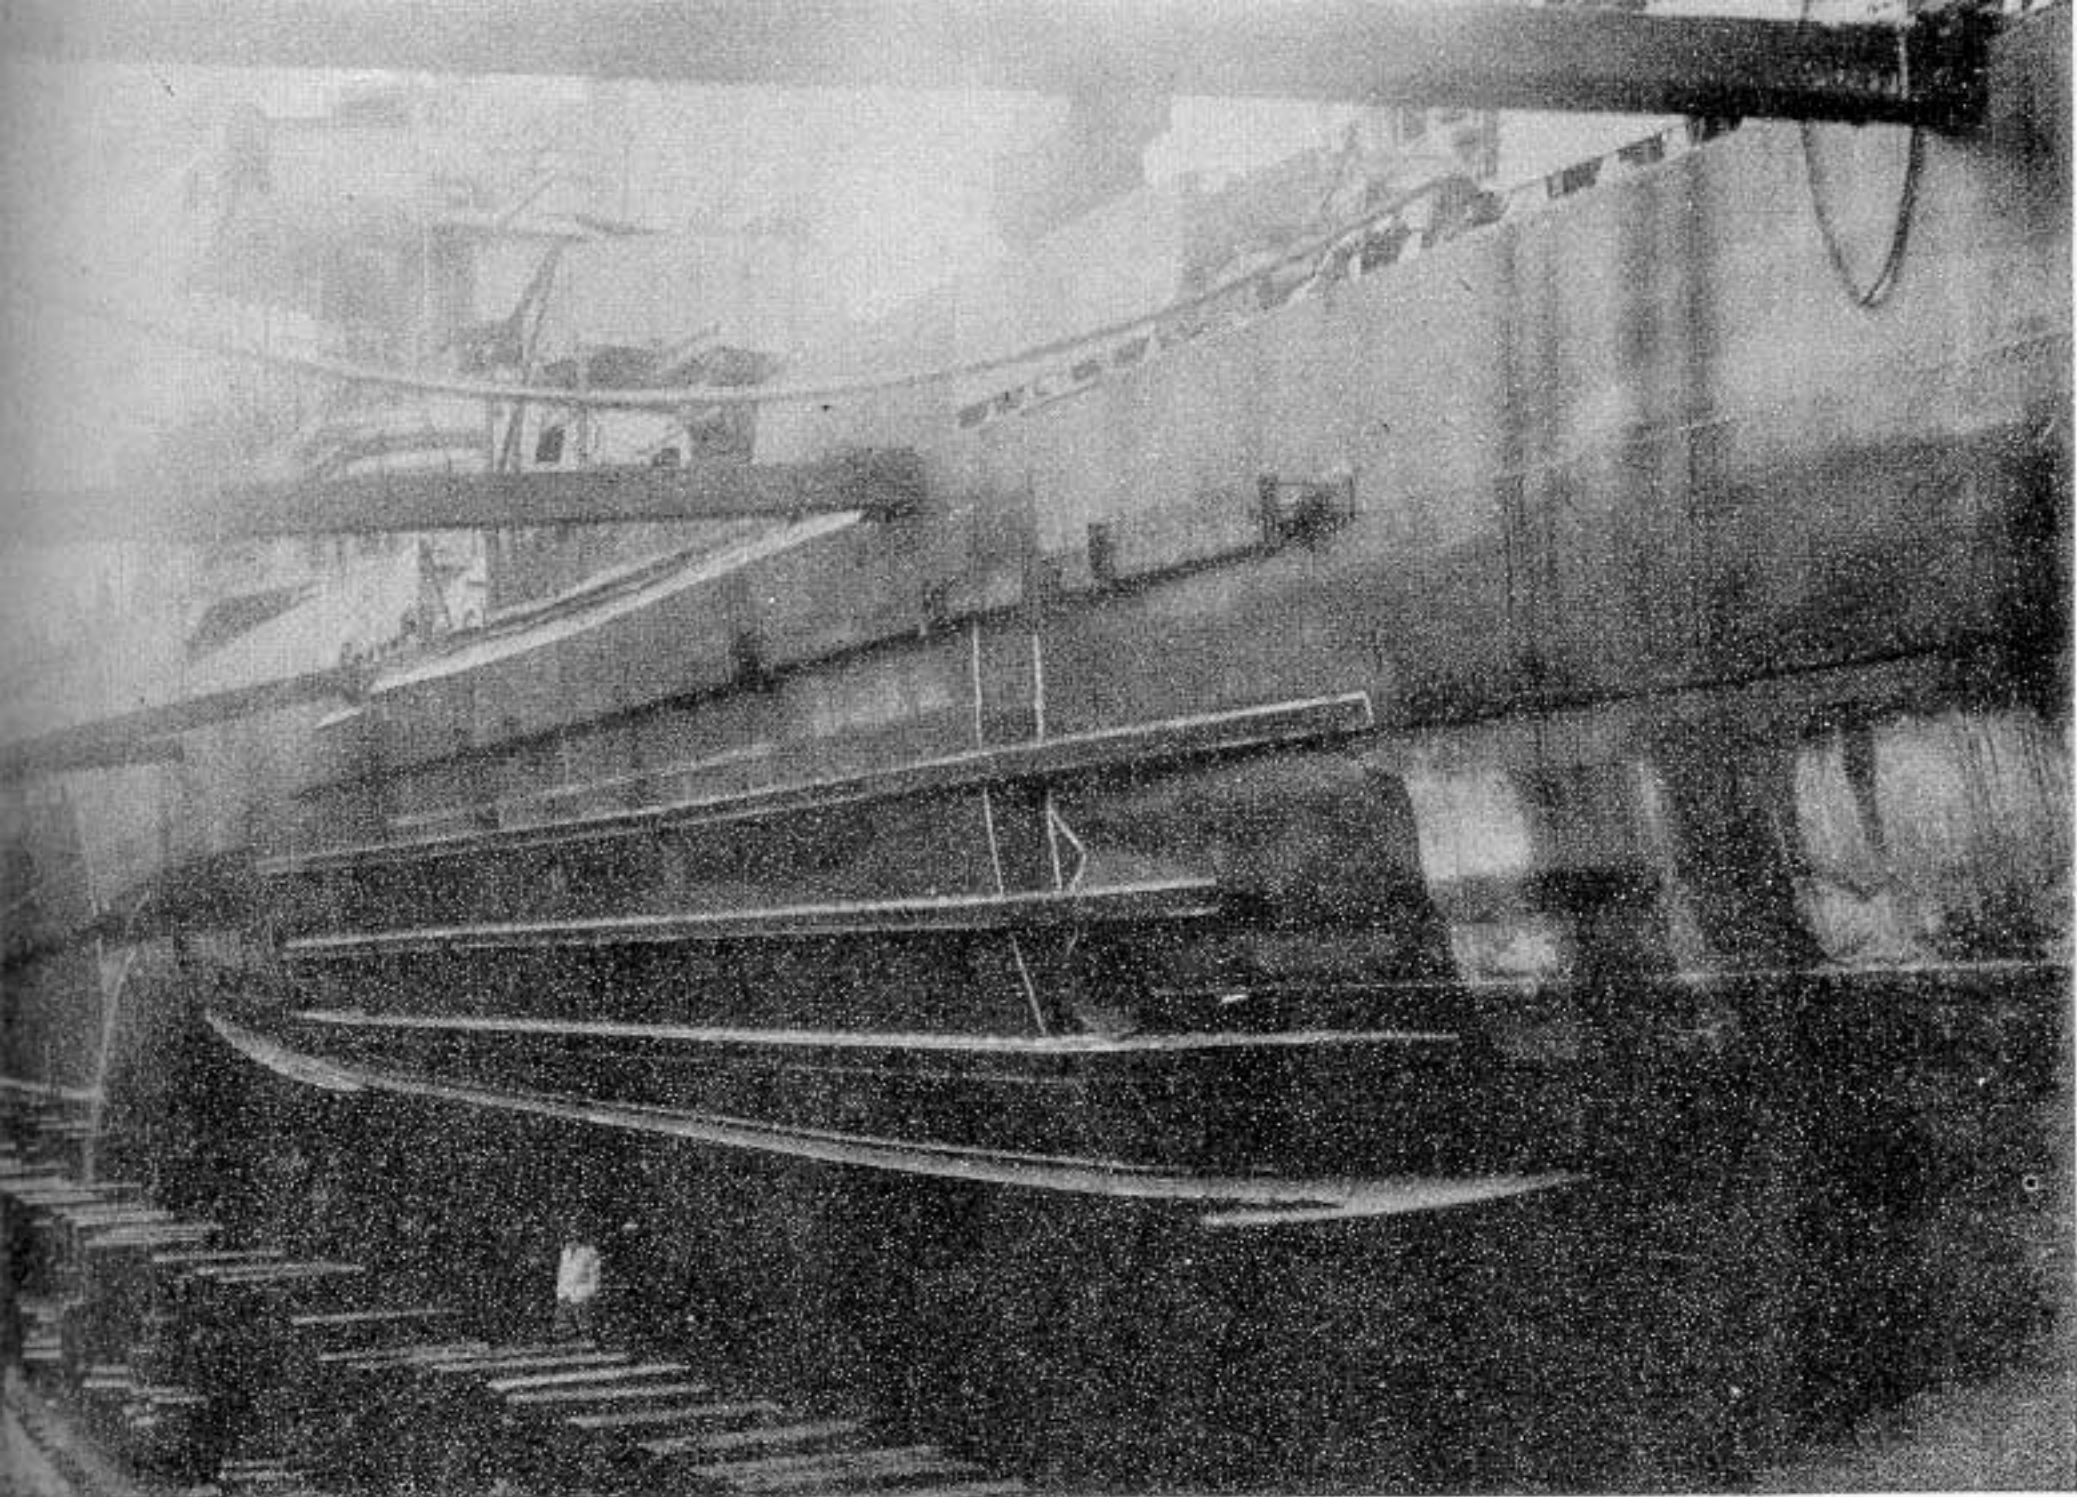
Photo 7-8: MAYRANT (DD402). Port shell amidships after temporary repairs at Malta. Note extent of repairs compared with extent of buckling shown in Photo 7-1.

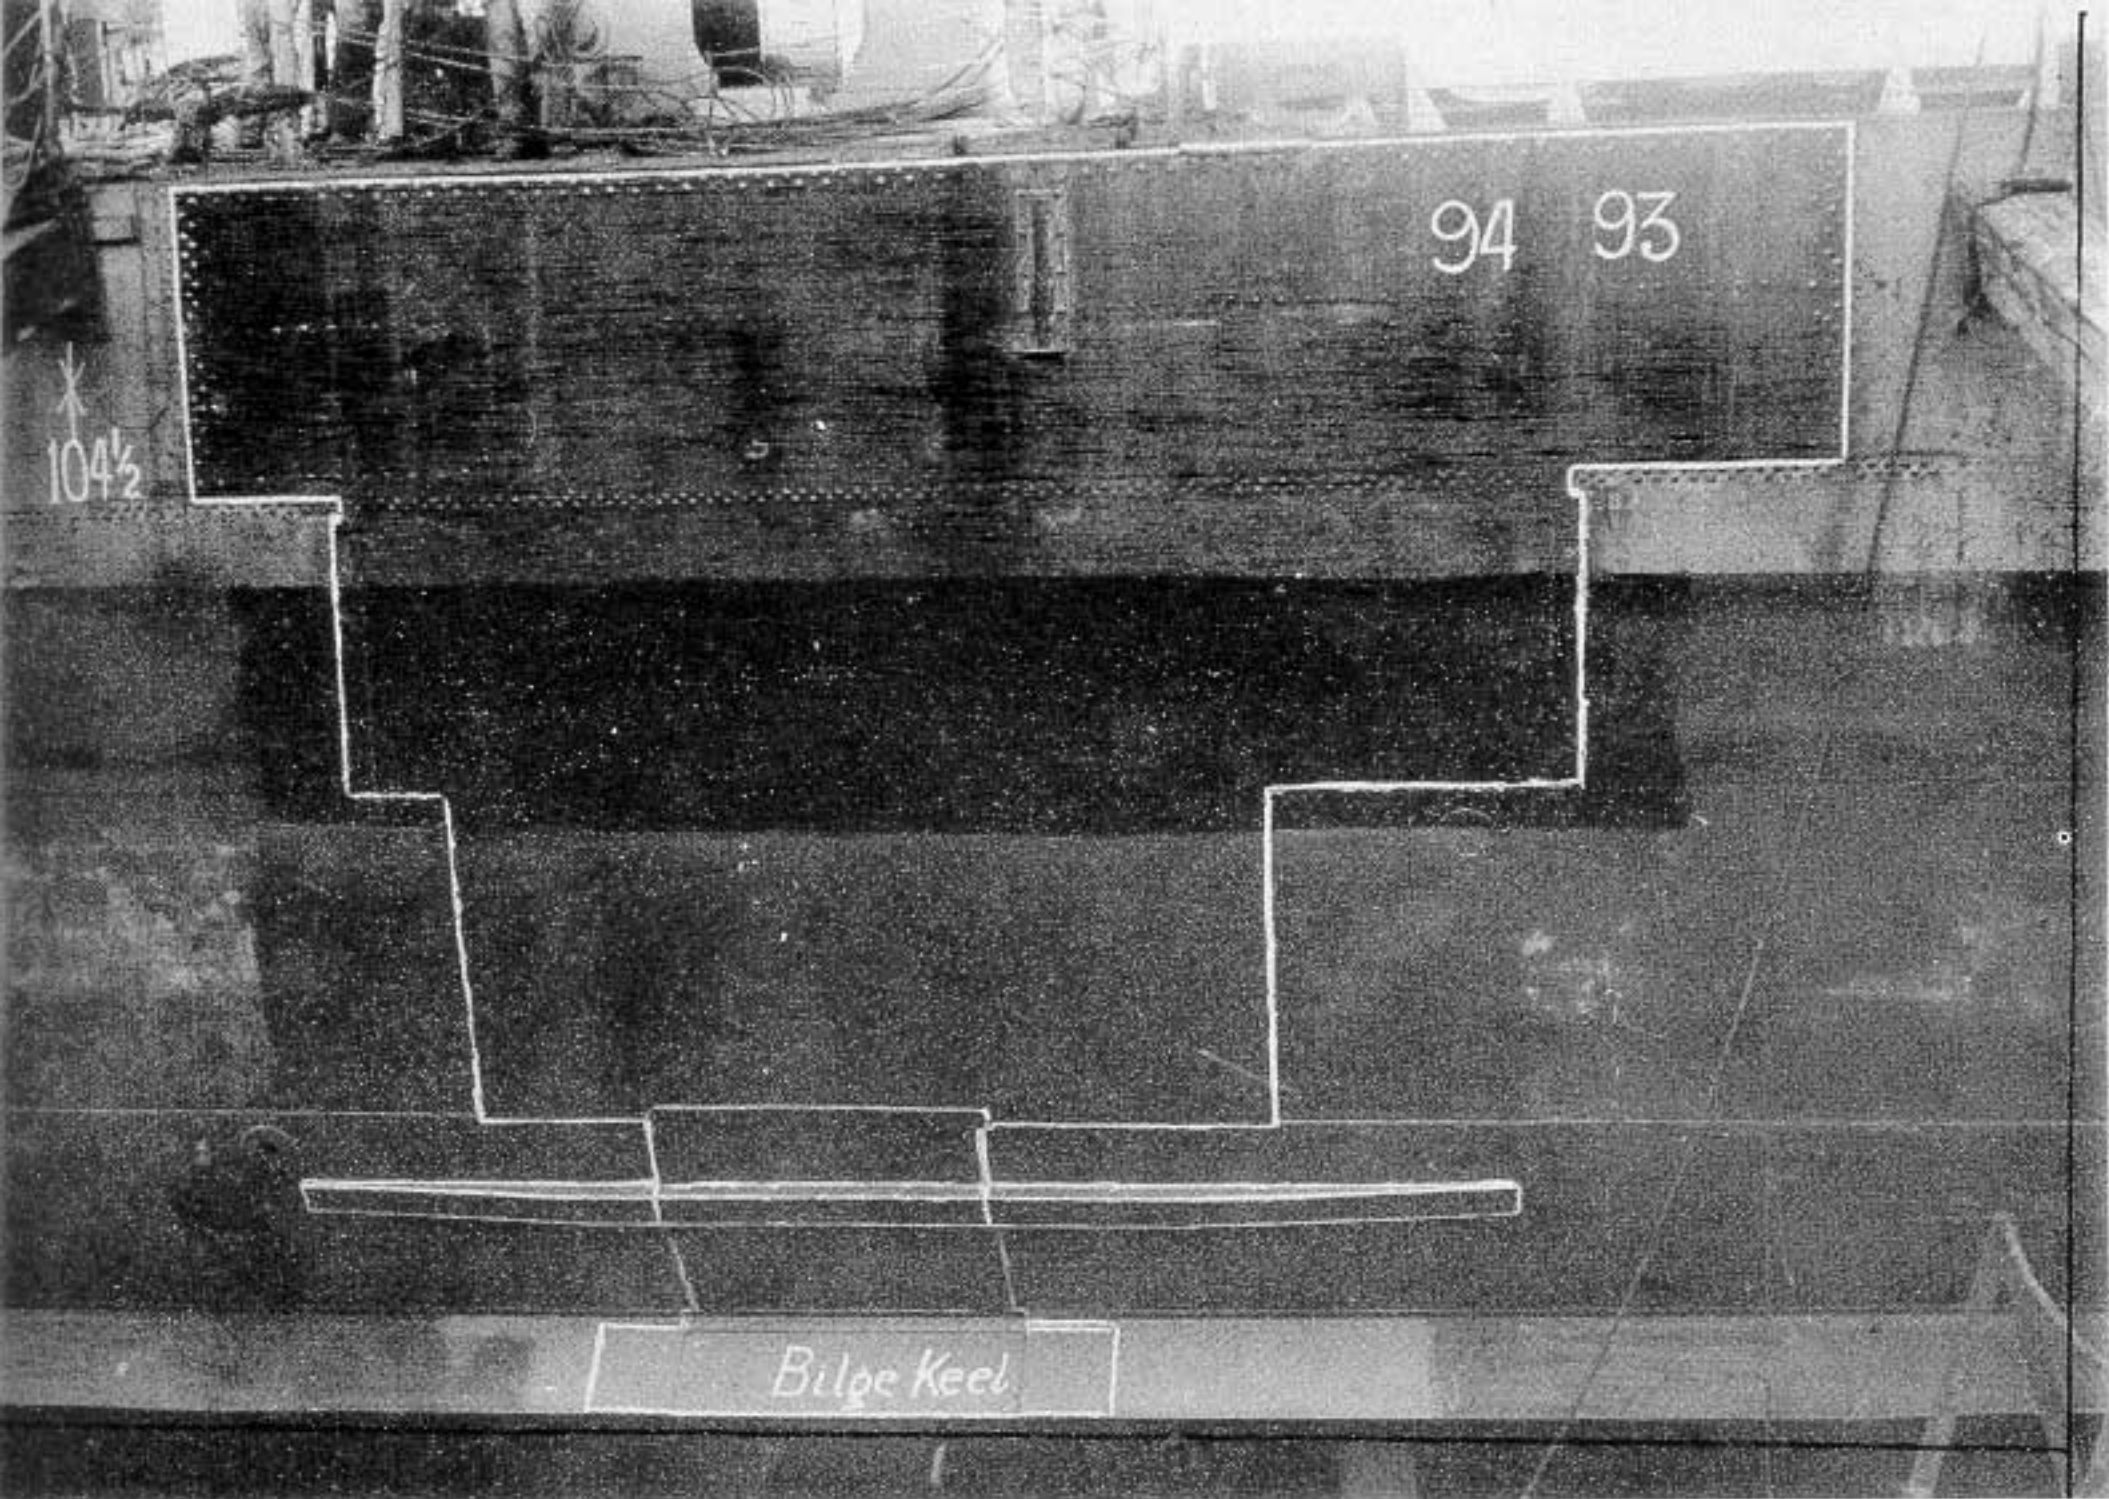
Photo 7-9: MAYRANT (DD402). Starboard shell amidships after temporary repairs at Malta. Note extent of repairs compared with extent of buckling shown in Photo 7-6.
