DESTROYER REPORT

GUNFIRE, BOMB AND KAMIKAZE DAMAGE
INCLUDING LOSSES IN ACTION

17 OCTOBER, 1941 TO 15 AUGUST, 1945

WAR DAMAGE REPORT No. 51

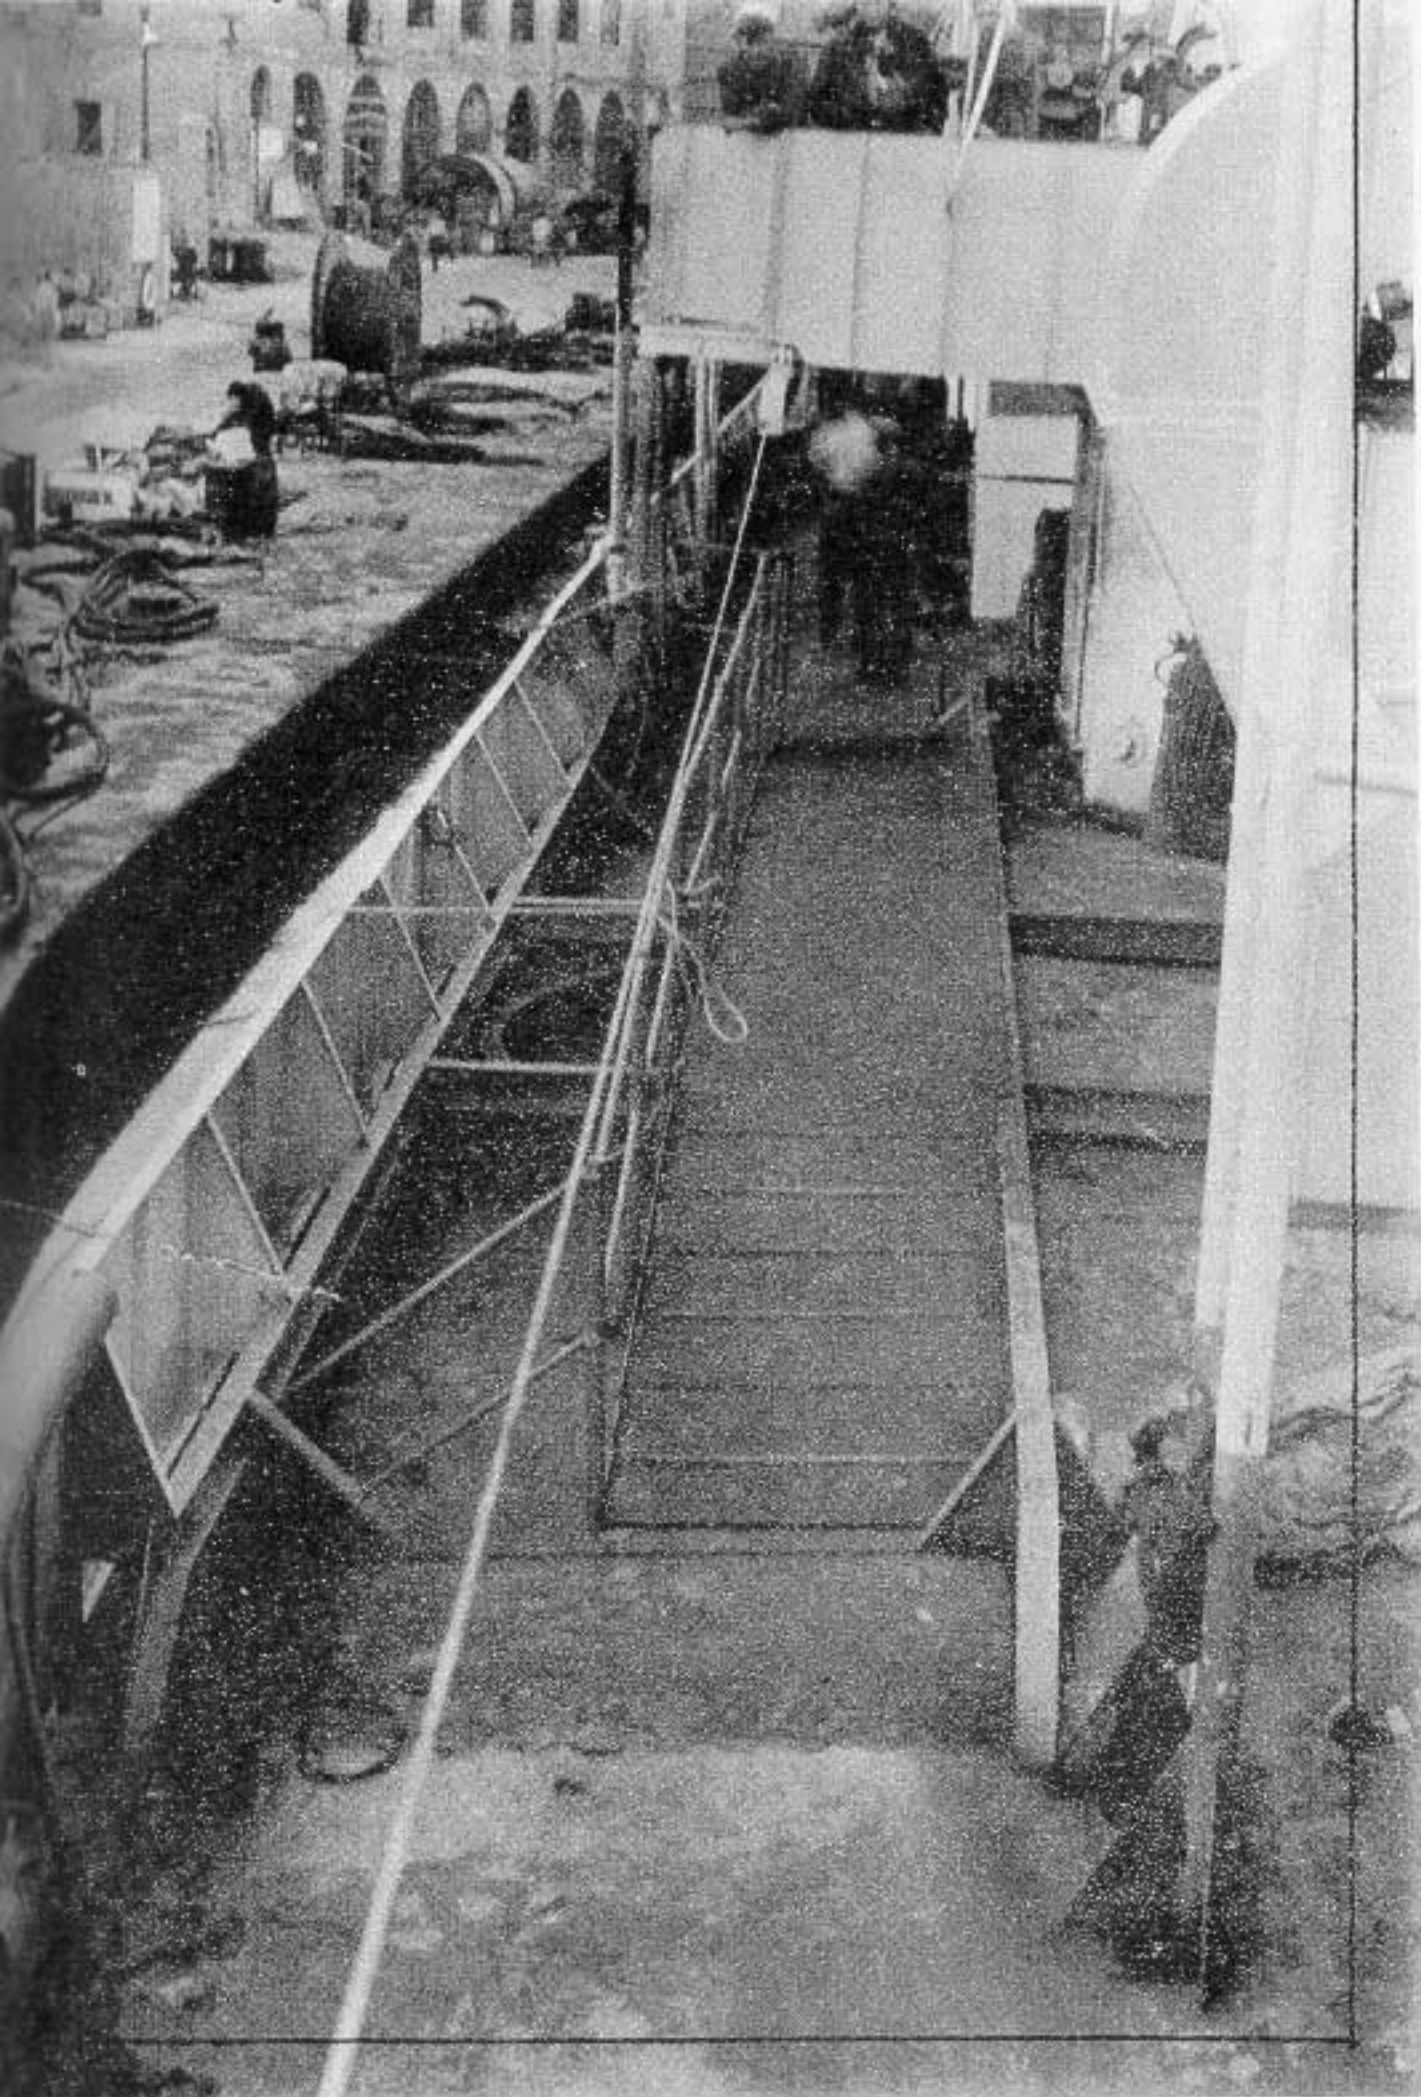
Photo 7-10:
MAYRANT (DD402)
Main deck, port side,
after repairs. Note
depth and length of
longitudinal stiffeners
and walkway over trans-
verse stiffeners.

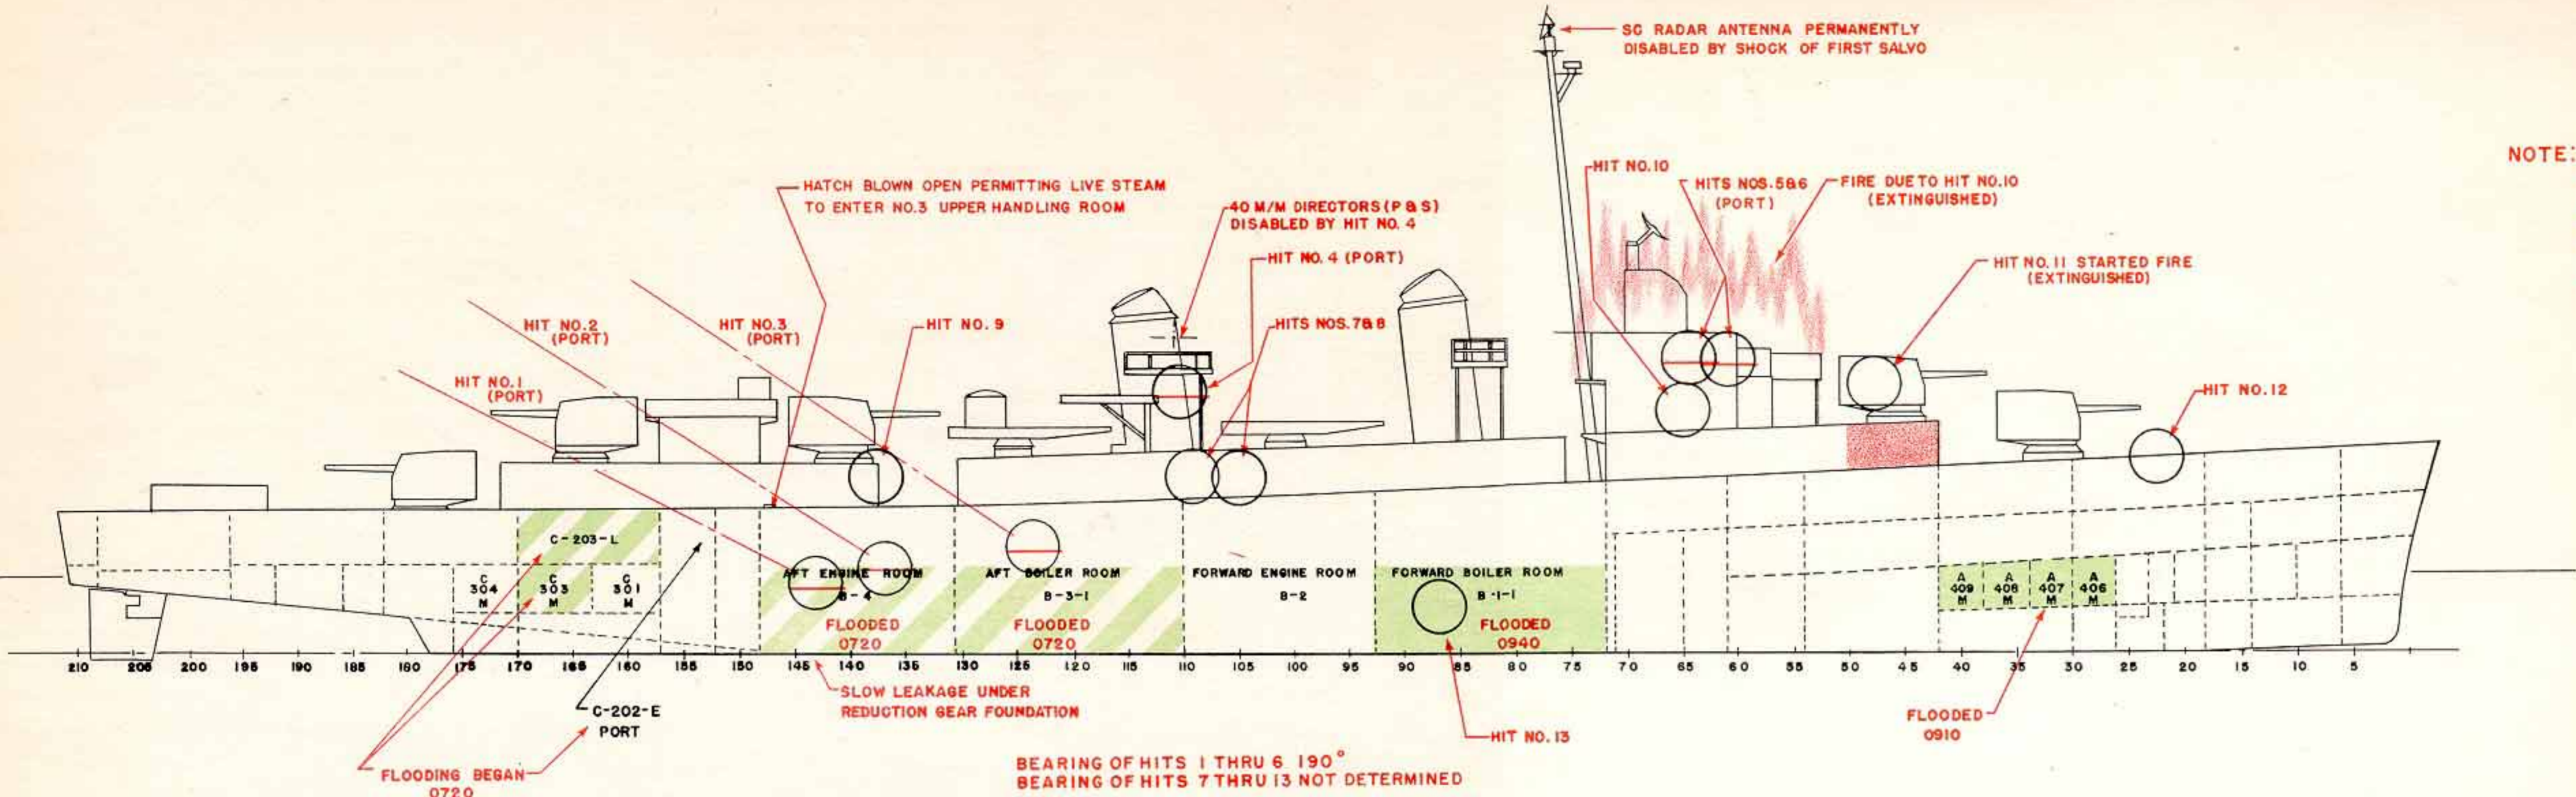
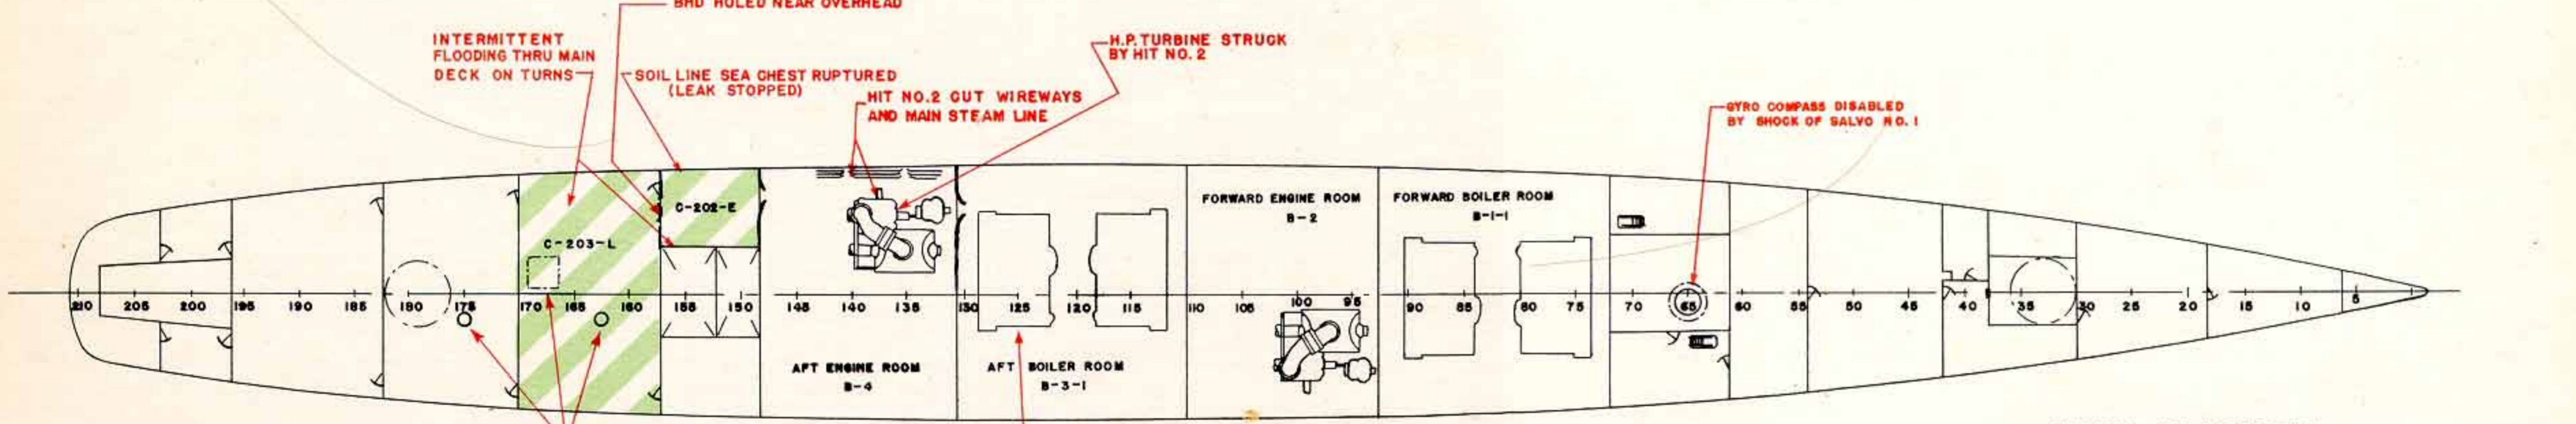
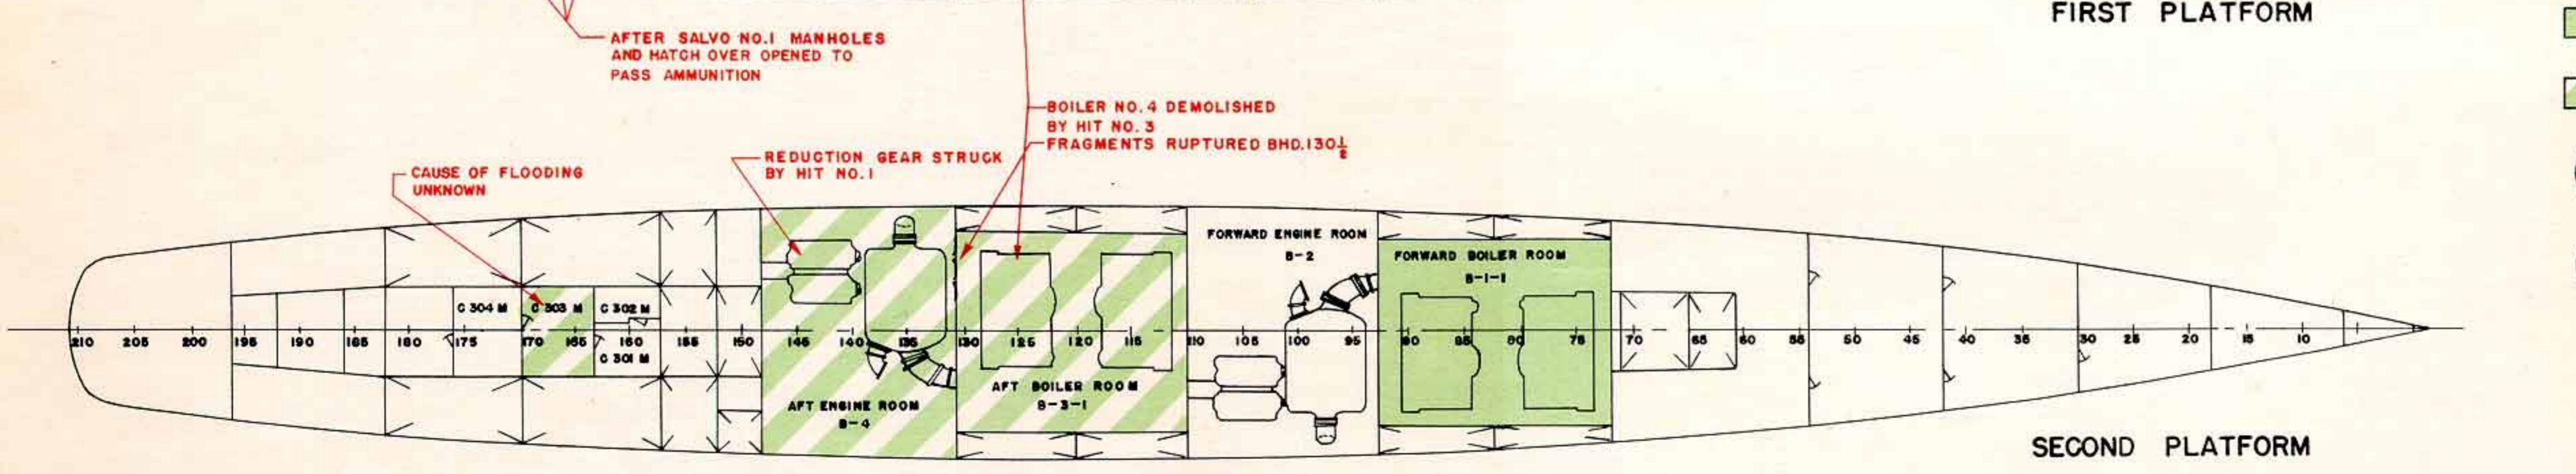
U.S.S. JOHNSTON
SAMAR, P.I. DD-557
25 OCTOBER 1944
GUNFIRE DAMAGE
NAVY DEPT. BUREAU OF SHIPS
J. M. Janin

NOTE: THE INDICATED HITS NUMBERED CHRONOLOGICALLY ALL OCCURRED BEFORE JOHNSTON WAS IMMOBILIZED. AFTER 0945 WHILE THE SHIP LAY DEAD IN THE WATER NUMEROUS ADDITIONAL HITS OCCURRED MOSTLY FORWARD. THE BOW WENT UNDER ABOUT 1010 AND THE SHIP PLUNGED RAPIDLY. GENERAL FLOODING FORWARD OF BHD. 72 WAS REQUIRED TO CAUSE THIS PERFORMANCE BUT HAS NOT BEEN INDICATED ON THIS DRAWING OWING TO ABSENCE OF DETAILED INFORMATION.

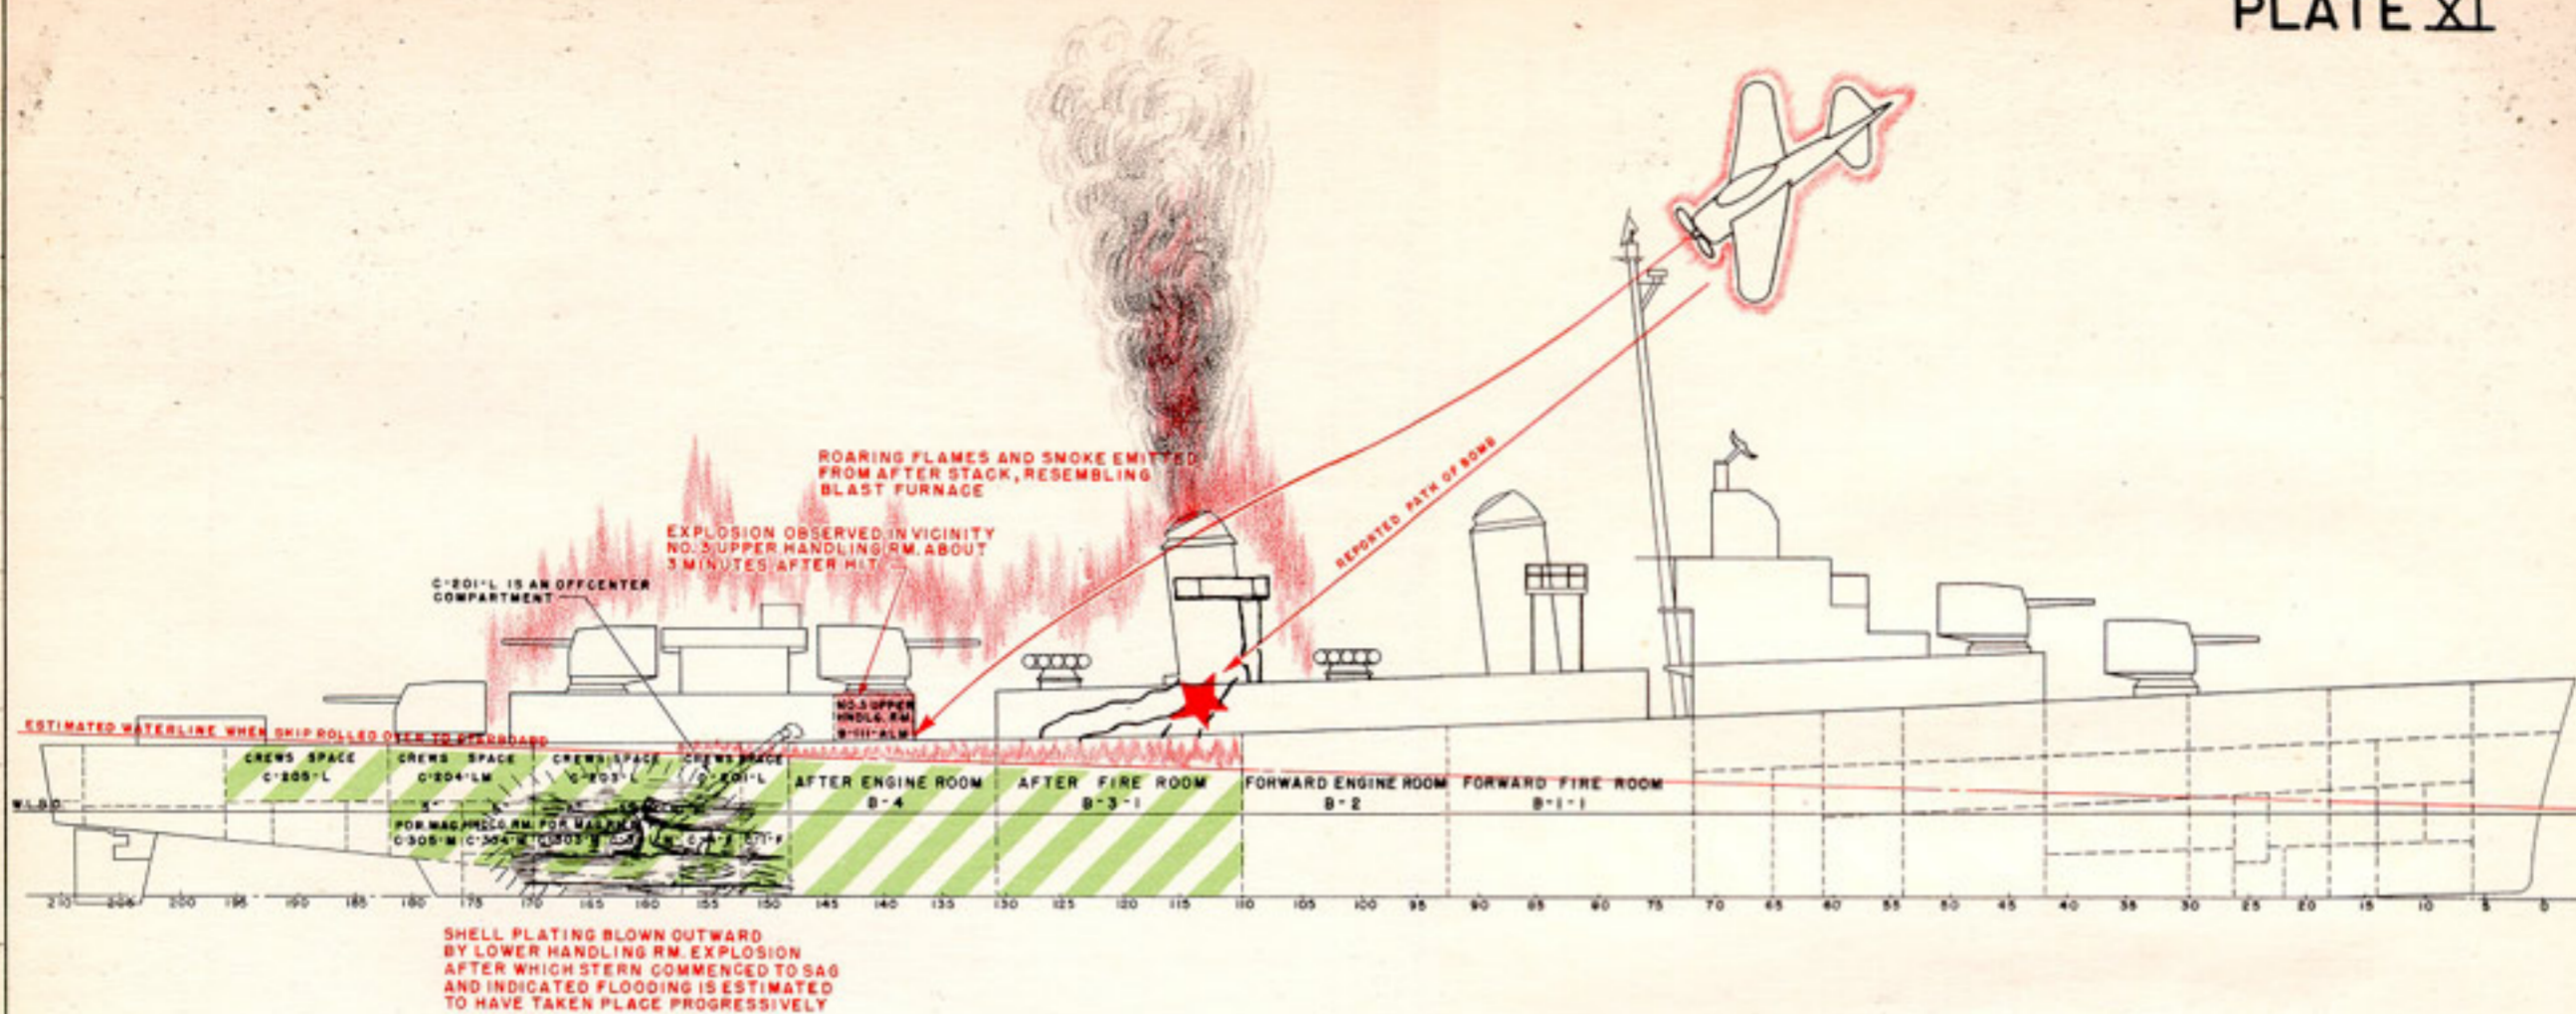
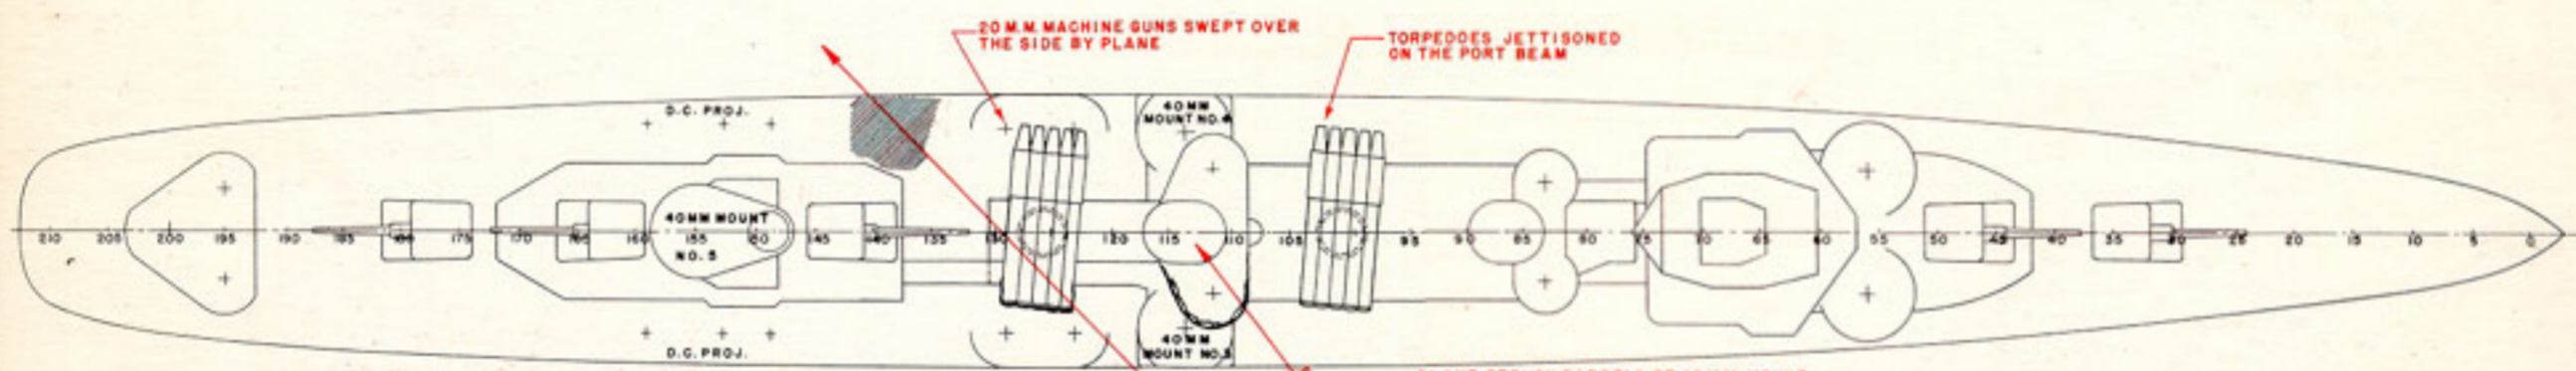
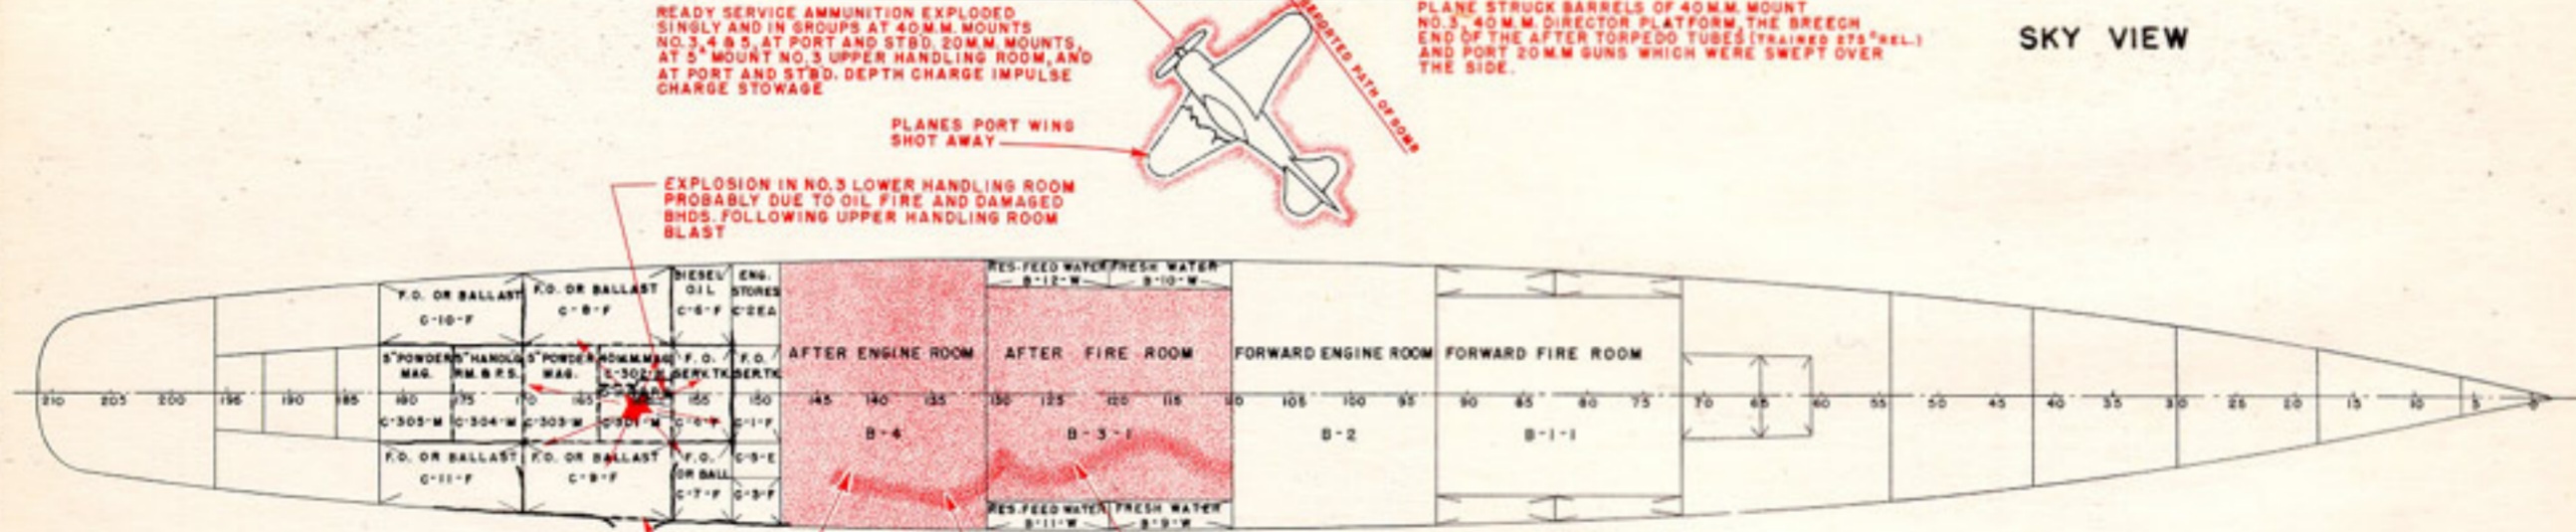
U.S.S. ABNER READ DD-526
LEYTE GULF 1 NOV. 1944

ESTIMATED CONDITION AT 1415, 1 NOV. 1944. OPEN TO THE SEA:

- B-3-1
- B-4
- C-1-F
- C-3-F
- C-5-E
- C-2EA
- C-6-F
- C-4-F
- C-7-F
- C-201-L
- C-202-E
- C-205-L
- C-304-M
- C-305-M
- C-8-F
- C-8-F
- C-301-M
- C-302-M
- C-303-M
- C-10-F
- C-11-F
- C-203-L
- C-204-LM
- C-205-L
- C-304-M
- C-305-M

NET ADDED WEIGHT: 1800 TONS APPROX.
MEAN DRAFT: 18' WITH 10' TRIM BY STERN
DISPLACEMENT: 4525 TONS APPROX.
