WAR DAMAGE REPORT No. 43

USS HELENA (CL50)

Loss in Action

6 July, 1943

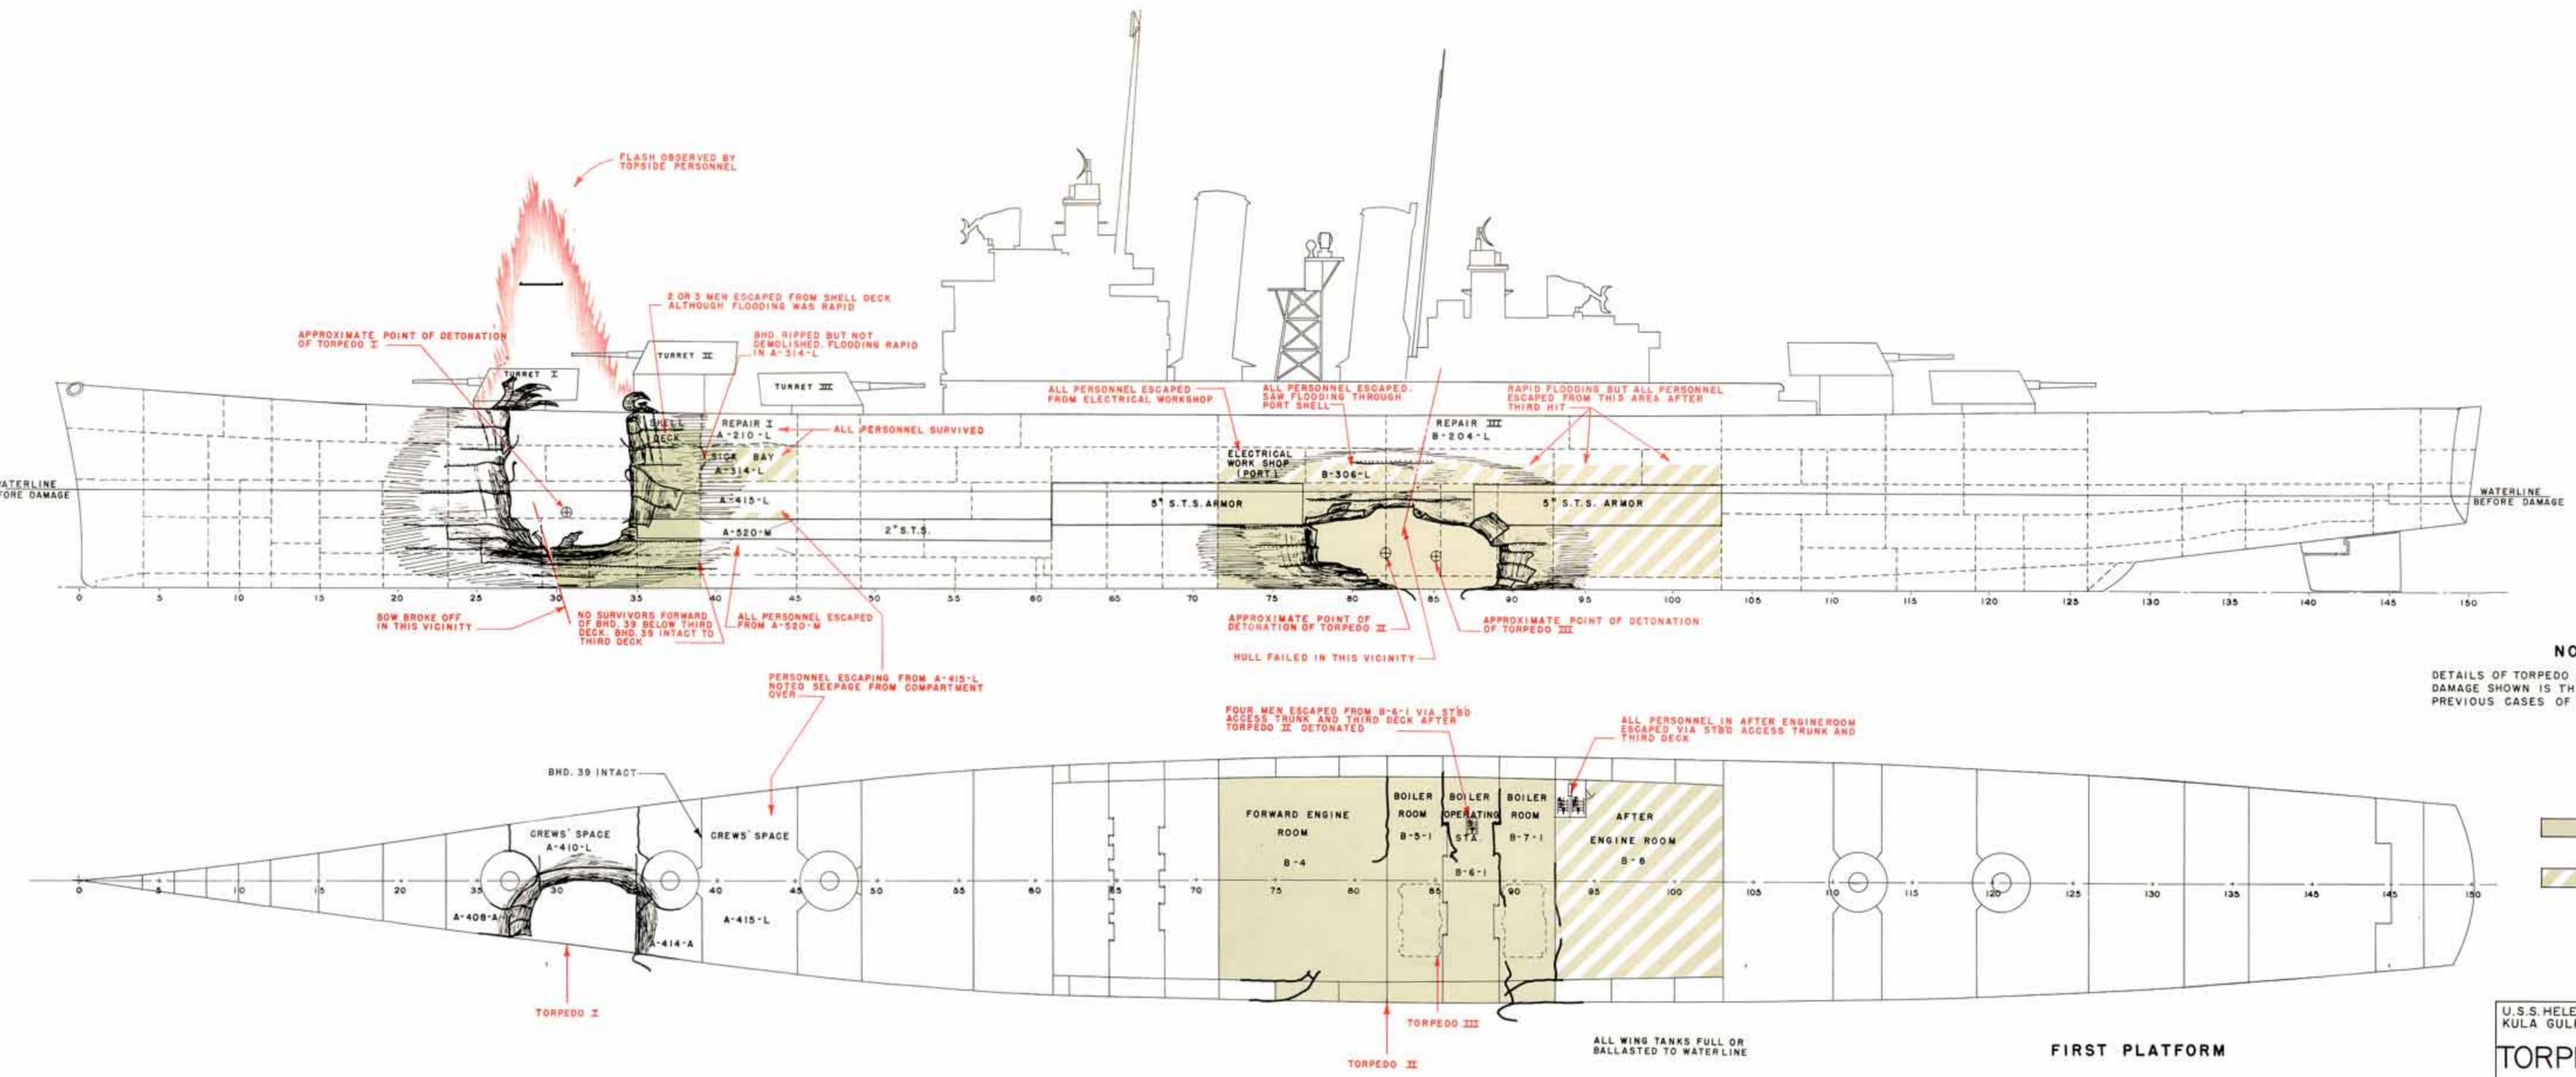
U.S.S. HELENA CL 50
 KULA GULF 6 JULY 1943
TORPEDO DAMAGE
 NAVY DEPT. BUREAU OF SHIPS
L.A. Krueger

Torpedo Hit No. 1 - Frame 32 port, about 15 feet below the water line.

Torpedo Hit No. 2 - Frame 82 port, below armor belt, possibly 10 feet below water line.

Torpedo Hit No. 3 - Frame 89 port, below armor belt, possibly 10 feet below water line.

NOTE
 DETAILS OF TORPEDO DAMAGE NOT REPORTED.
 DAMAGE SHOWN IS THAT ESTIMATED FROM
 PREVIOUS CASES OF SIMILAR NATURE

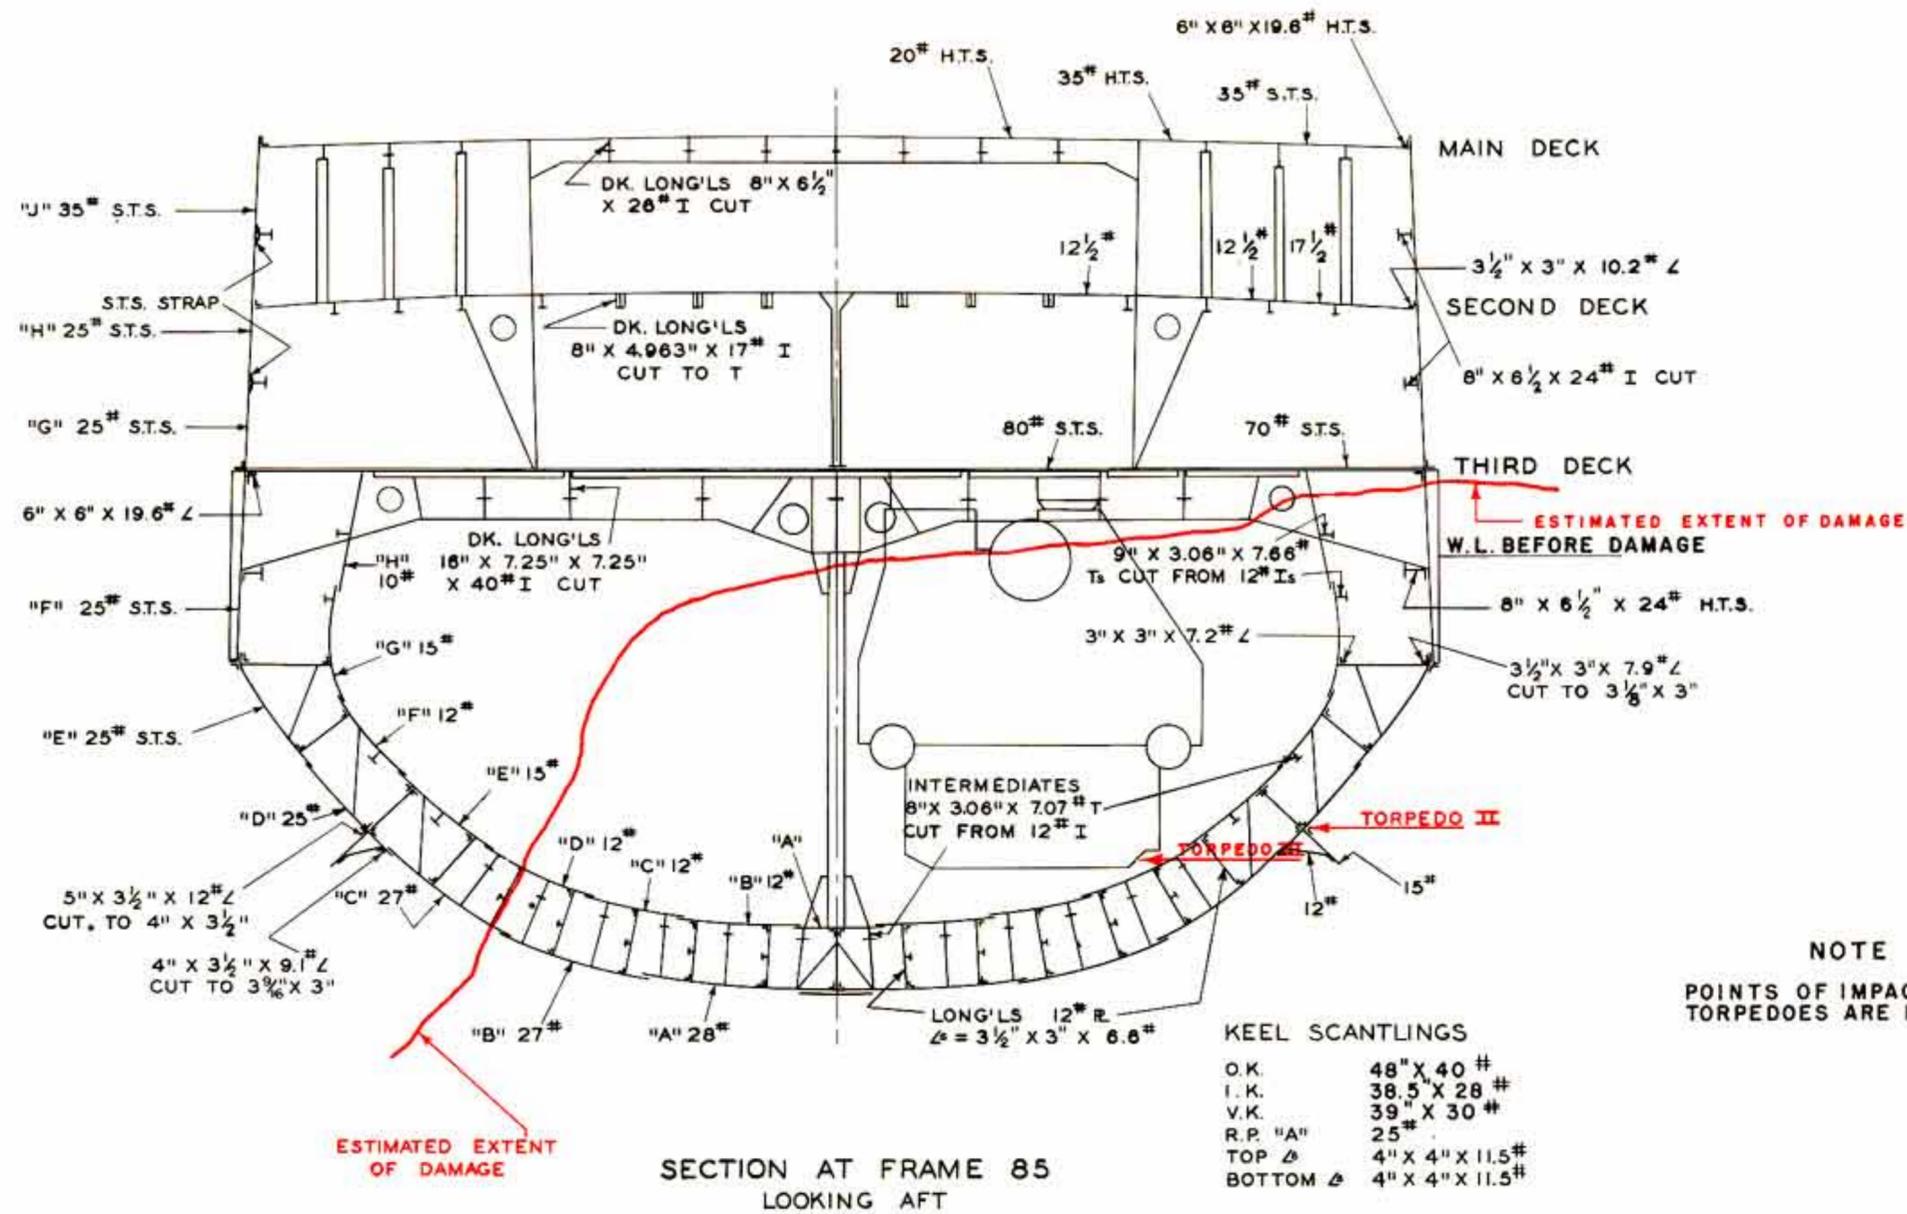
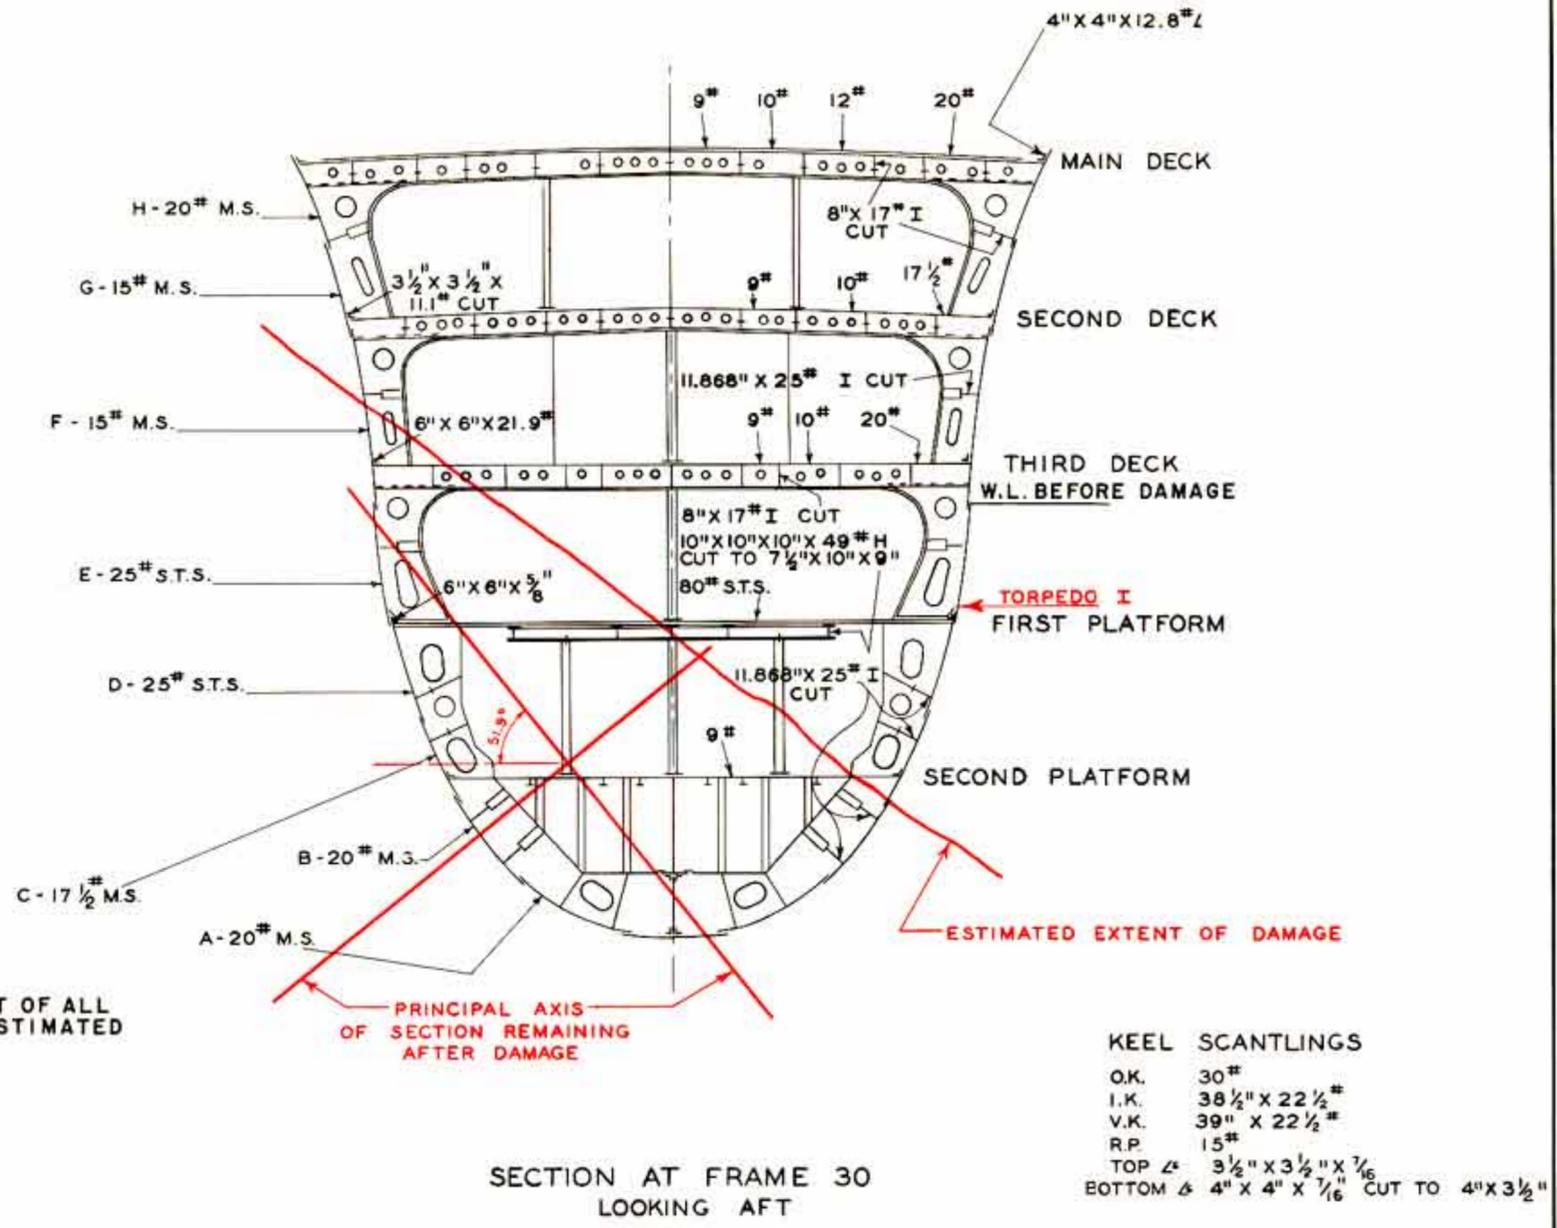
19. Based on the results of the shallow torpedo hits on PORTLAND* and PENSACOLA*, the section at frame 30 in way of the damage, shown on plate II, was prepared. It will be noted that between turrets I and II the hull narrows considerably. For example, at the first platform level at frame 32, the beam is approximately 31 feet. In this vicinity most of the resistance of the ship girder to bending is provided by the upper part of the structure, i.e., the sheer and stringer strakes. If the upper portion (the sheer and stringer strakes) of the ship girder is destroyed and if the major portion of the port shell is missing, the bow structure forward of the damage becomes free to swing about the remaining intact starboard shell plating. If the torpedo detonated above the first platform, damage of the order described above and shown on plate II occurred. Analysis of the bending moments at the damaged section clearly indicates that the remaining members in the lower portion of the starboard shell would be insufficient to prevent failure. Further, if a fracture were started, the magnitude of the forces involved would insure complete failure in a very short time. It is emphasized that the damage shown on plate II is consistent with what can be expected from a 660-pound charge detonating in the vicinity of frame 32 at shallow depth and somewhat above the armored first platform.

23. In analyzing the breaking up of HELENA, the damaged section in way of frame 85, shown on plate II, was developed. The damage to the ship girder shown on this section is based on the Commanding Officer's description as modified by the remarks in paragraphs 21 and 22 above, and also on the damage from a single torpedo hit on MINNEAPOLIS*. The results of this analysis indicate that for the damage shown on plate II and assuming the bending moment occurring in still water, the induced tensile stress in the remaining bottom structure was some 33% above the yield point of the material. Specifically, this stress was calculated to be 16.4 tons per square inch, considerably higher than the yield point of the material involved (13.4 tons per square inch) and almost twice the designed stress of 9.1 tons per square inch tension in the keel. This induced tensile stress in the most strained fiber is of such magnitude as to cause breaking up at a comparatively slow rate, particularly when the assistance given by the side armor and armored third deck is considered. This is consistent with the period of about 20 minutes which was required for HELENA to jackknife in the middle and sink. It thus appears that the damage assumed and shown on plate II is reasonably consistent with that which caused HELENA to break in two.

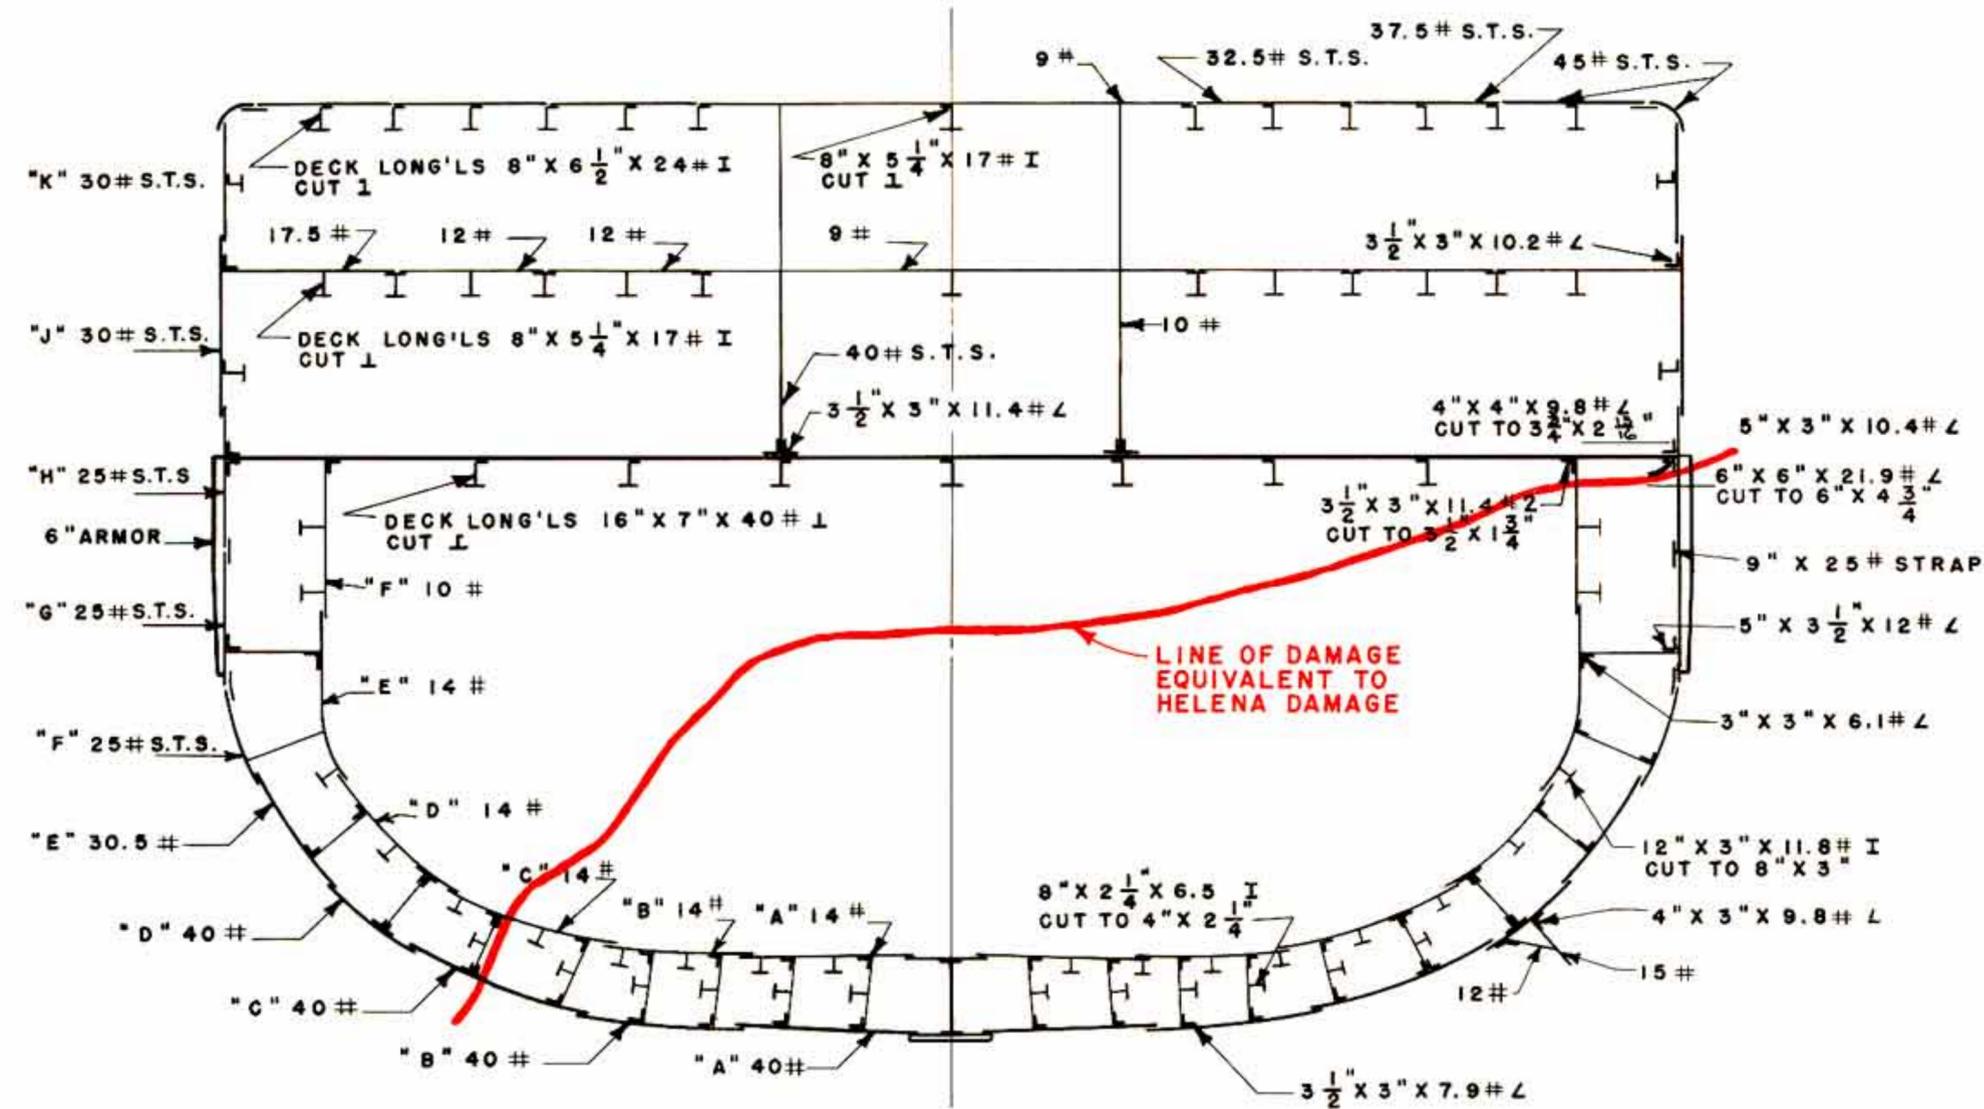
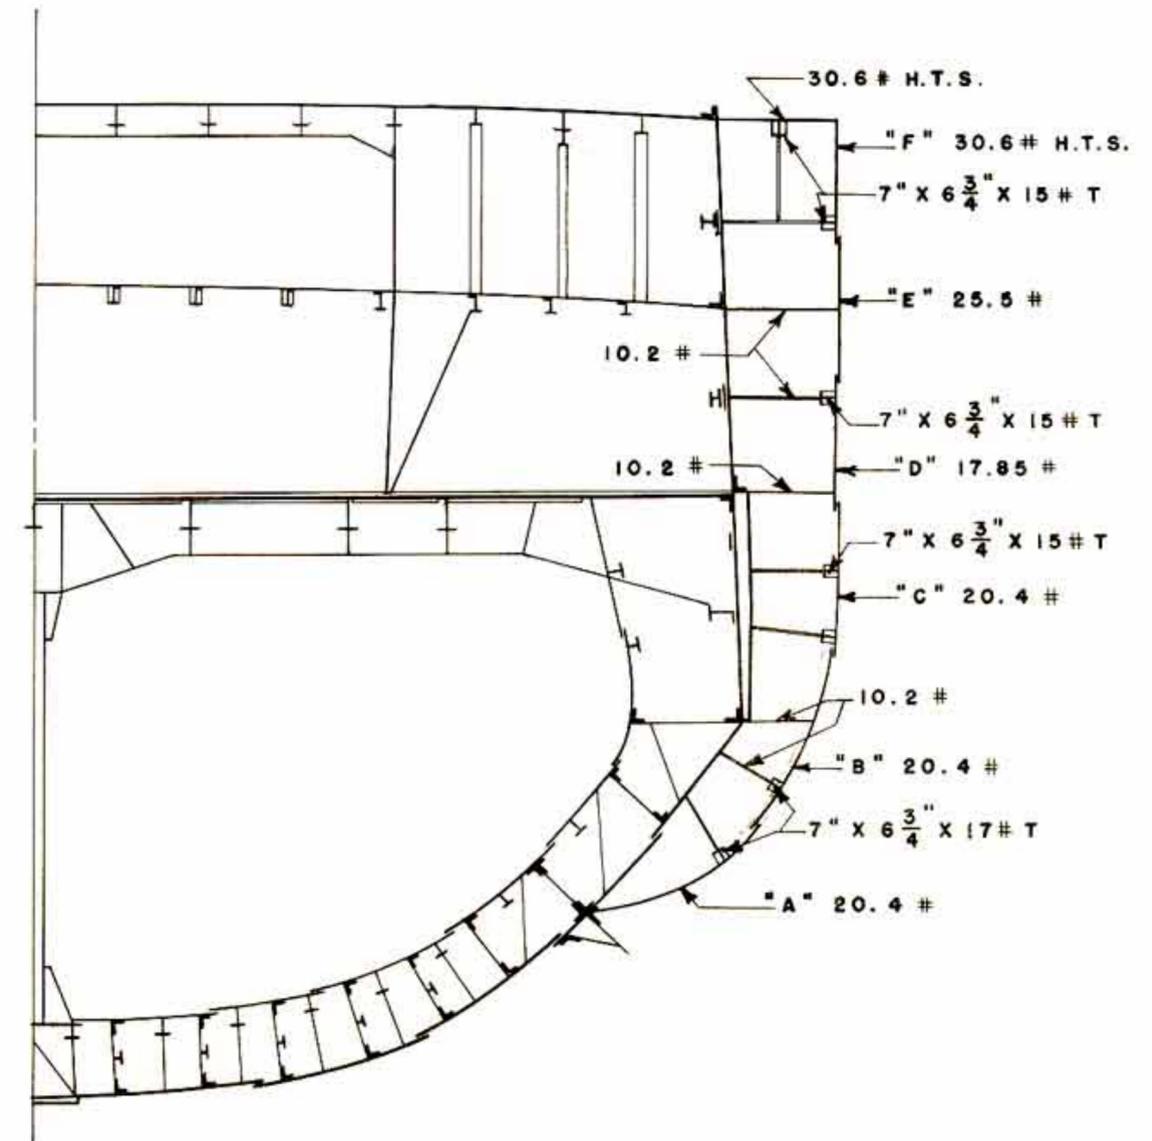
U.S.S. HELENA CL-50
 KULA GULF 6 JULY 1943
 CL 42 BLISTER AND
 CA 68 SECTIONS
 NAVY DEPT. BUREAU OF SHIPS
L. A. Kriskern

24. In paragraph 6(a) of Section III, the Commanding Officer recommended that stiffness be added to the parallel middle body of cruiser hulls. In exploring this suggestion, blisters similar to that provided on the CVL22-30 class were assumed to be added to HELENA's hull, and an analysis was made of the strength after damage of the same order as that assumed for HELENA. The resulting section is shown on plate III. It was found that these blisters added approximately 14% to the longitudinal strength of the ship girder in the intact condition. After damage of the same order as that shown on plate II for HELENA, the starboard blister would have added 32% to the strength of the remaining intact structure. Specifically, the induced tensile stress at the bottom of the ship girder was only 12.4 tons per square inch as compared to the figure of 16.4 tons per square inch for the unblistered hull. The figure of 12.4 tons per square inch is less than the yield point of 13.4 tons per square inch of the material involved. Therefore, if HELENA had been provided with blisters, it is possible that she would not have

25. In general, a given charge will produce a given amount of damage. The end effect on a target with respect to damage to the ship girder thus becomes a function of physical dimensions - beam, depth of girder, length and displacement - as well as the scantlings of the longitudinal strength members. The beneficial effect of the blisters would thus be partly due to the increase of beam from 62 to 70 feet (which removed the detonations farther from the starboard members, thus insuring that more structure remained undamaged) as well as to the increase in sectional modulus. In following this line of reasoning, an analysis was made of the strength of the CA68 hull after damage of the same order as that assumed for HELENA. The damaged section is shown on plate III. The beam of the CA68 hull is 70 feet and this ship, being somewhat larger than HELENA, has correspondingly heavier scantlings.

26. Because of somewhat better subdivision on CA68 (the engineering spaces are not as long) the total length of flooding would only have been 100 feet as compared to 124 feet on HELENA and the sagging bending moment, therefore, would have been somewhat less. The tensile stress in the structure remaining on the starboard side was found to be only 9.3 tons per square inch, considerably less than the 16.4 tons per square inch for HELENA's hull and the 12.4 tons per square inch for HELENA's hull with blisters. The figure of 9.3 tons per square inch is also considerably less than the yield point of 12.4 tons per square inch of the hull material. It thus appears that CA68 would have survived the damage assumed for HELENA, in calm water, and assuming that cracks did not progress through otherwise undamaged structure.

28. The blisters shown on plate III have been installed on SAVANNAH (CL42). In addition to the desirability of providing an increased margin of structural strength after damage to the ship girder, blisters were required to provide the increased buoyancy and the improvement in stability characteristics necessary to permit the replacement of the 5-inch/25 battery with the heavier 5-inch/38 battery. The long period of availability for extensive battle damage repairs permitted the installation of blisters and the replacement of the battery.
