BATTLE DAMAGE TO SURFACE SHIPS DURING WORLD WAR II
(BOEVYE POVREZHDENUA NADOVDNYKH KORABLEI)

I. M. Korotkin
Leningrad, Sudpromgiz, 1960

Translated by U. S. Joint Publications Research Service
for the David Taylor Model Basin

SUMMARY

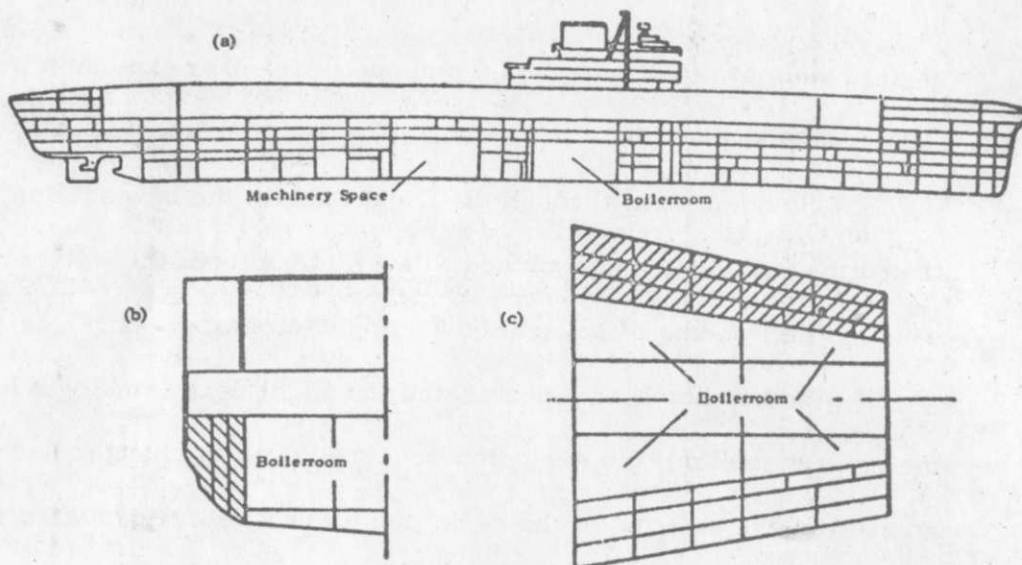
Direct bomb hits led to damage of the decks, aircraft elevators

Figure 16 - ILLUSTRIOUS

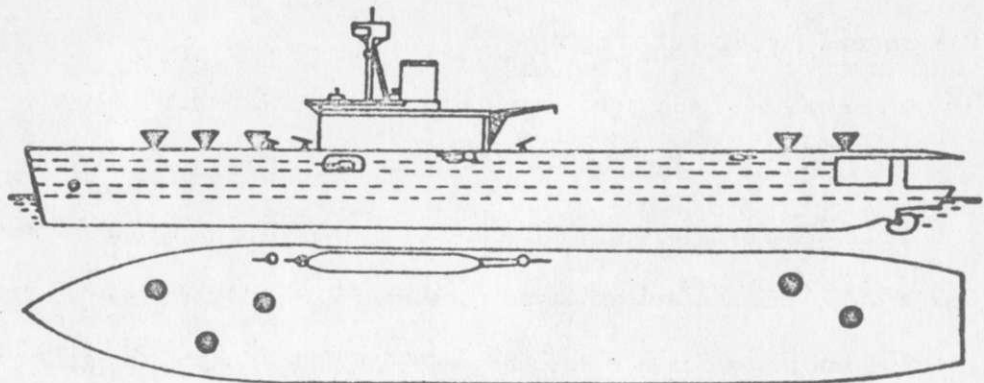
Figure 18 - HERMES. Diagram of Aerial Bomb Hits

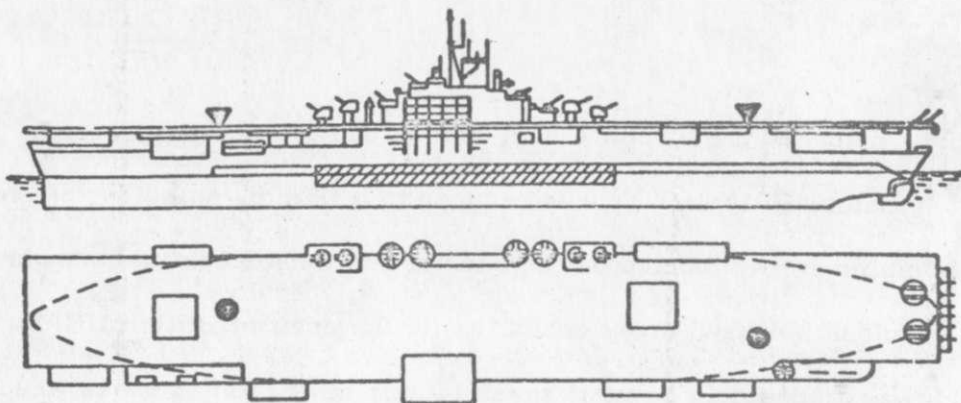
Damage to the Ship and Aftereffects. FRANKLIN, operating in the vicinity of the island of Kyushu, underwent an aerial attack and received two direct hits by aerial bombs launched by Japanese bombers (Figure 20). Internal explosions occurred and fires broke out. Thousands of gallons of aviation gasoline gushed out of ruptured gasoline lines and worsened the fire aboard ship. Aircraft on the flight deck and in the hangars were burned; bombs, rockets, and machine-gun ammunition

Figure 20 - FRANKLIN. Diagram of Aerial Bomb Hits

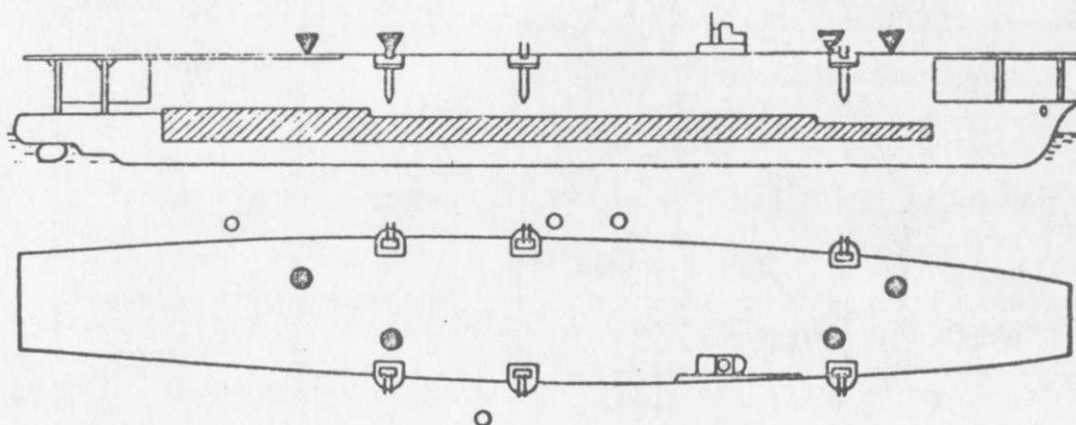
Damage to and Circumstances of the Loss of the Ship. KAGA was attacked in the vicinity of Midway Island on the morning of 5 June 1942 (between 0530 and 0730) by 12 United States bombers and received four direct aerial bomb hits (Figure 21). In addition, seven bombs exploded in the water close aboard at various spots along the length of the ship. Fifty aircraft (by other information, 30) were located aboard the aircraft carrier.

Figure 21 - KAGA. Diagram of Primary Bomb Hits

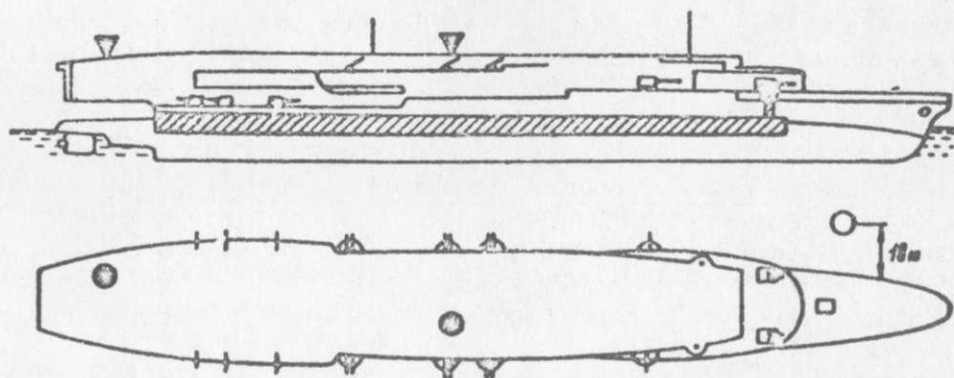
The carrier was heavily damaged; huge fires broke out, and the
ship lost way. Firefighting continued throughout the day, but proper re-
sults were not obtained, and on the morning of 6 June, the crew abandoned

Figure 22 - AKAGI. Diagram of Aerial Bomb Hits

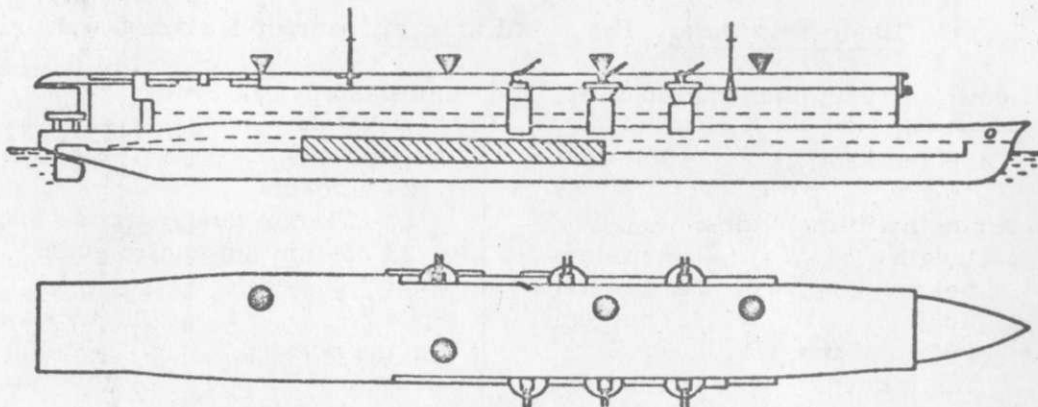
Figure 24 - RYUZYU. Diagram of Aerial Bomb Hits

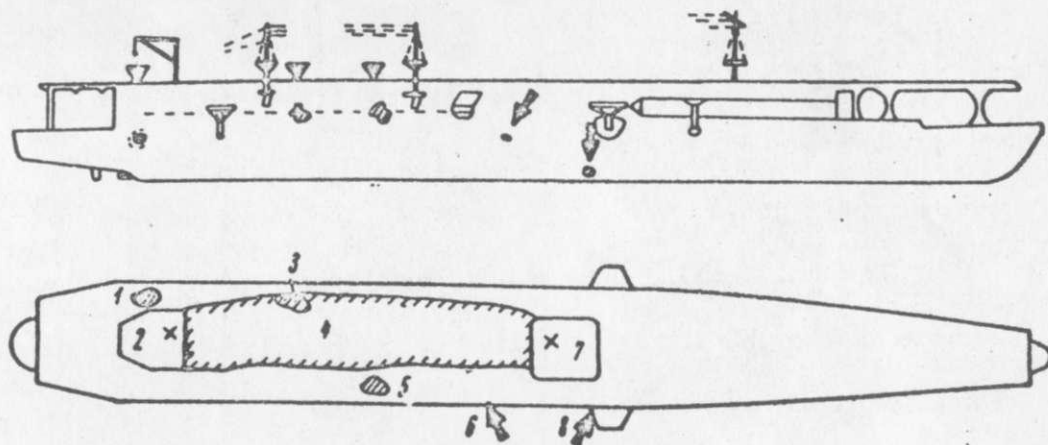
One bomb, which fell in the midsection of the ship, made holes

Figure 25 - RYUHO. Principal Damage to the Ship

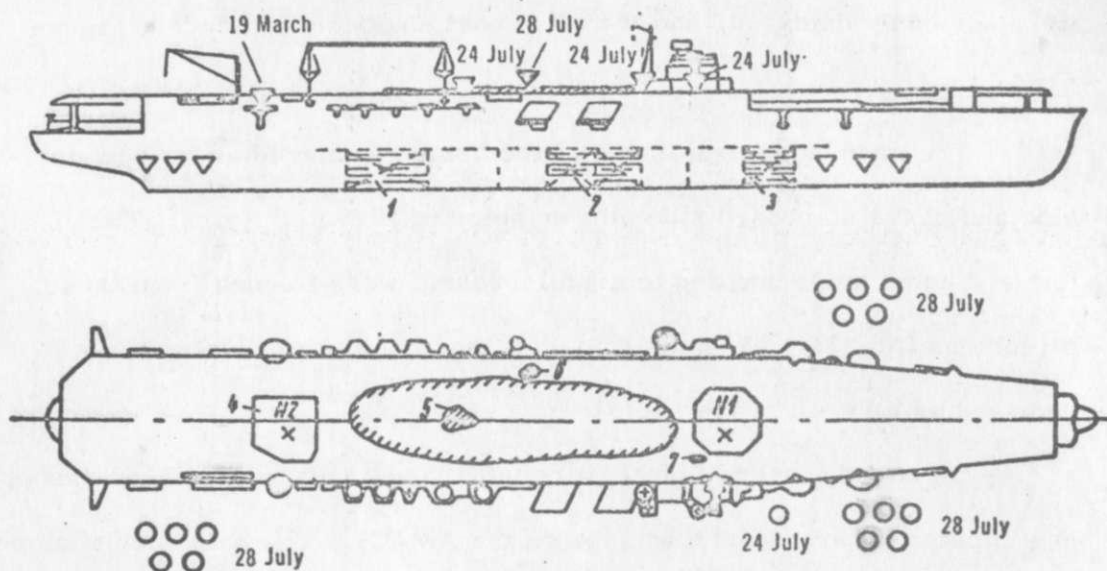
The basic reason for the loss of the ship was the damage to the hull caused by the explosions of aerial bombs which fell close to the ship; having taken on a great quantity of water, the aircraft carrier heeled over and sank.

Figure 26 -- AMAGI. Principal Damage to the Ship

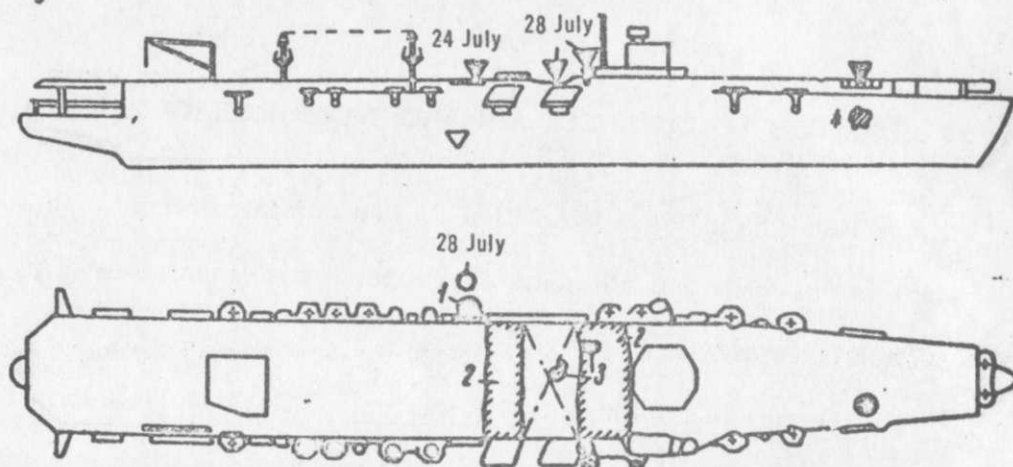
Some days later, on 28 July, 10 to 12 United States aircraft again carried out an attack on the carrier. The ship suffered two more direct hits amidships from bombs weighing 500 kilograms each. Penetrating the flight deck, the bombs exploded on the upper hangar deck. A considerable part of the flight deck (up to 10 meters wide) was carried away to the portside and fell on the ship stacks, and the remaining part of the deck in this vicinity was deformed. The upper hangar deck was blown outward; all elevators were warped (Figures 28 and 29). Insignificant damage was done to the underwater body. Thirteen men were killed and 12 wounded.

Figure 28 - KATSURAGI. Principal Damage to the Ship

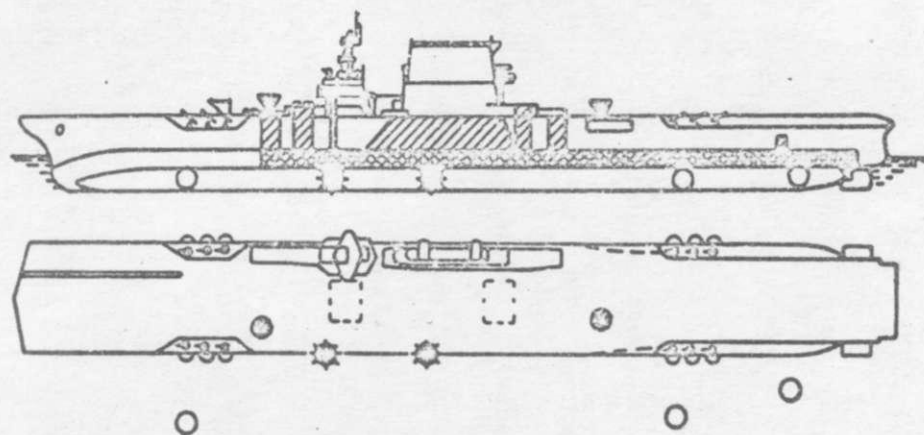
As the heaviest ship of the American formation, LEXINGTON received the main blow of the Japanese aircraft. An attack by 70 aircraft began at 1102 and lasted 9 minutes. First torpedoes launched from torpedo planes passed astern; some torpedoes passed too deep below the keel of the ship and did not explode. Two torpedoes hit (portside), and two aerial bombs landed on the flight deck on the same side (one of the bombs fell in the vicinity of the Admiral's cabin, another in the vicinity of the bridge). Fires broke out from the explosions of the aerial bombs. Three aerial bombs fell into the water and exploded alongside the ship, causing damage to her hull (Figure 30). As a result of the damage, several compartments were flooded, and LEXINGTON took on a list of several degrees. The list was corrected by shifting water ballast. The speed of the ship decreased to 20 knots. Fires enveloped the magazine and fuel bunker areas. Special firefighting details at first tried to fight the fires and succeeded in putting out some of them, but at 1247, i.e., 1 hour and 45 minutes after the beginning of the battle, the ship suffered a strong internal explosion and the flames of fires again appeared in many areas; smoke poured out of the elevators onto the flight deck. The

Figure 30 - LEXINGTON. Diagram of Damage by Torpedoes and Aerial Bombs

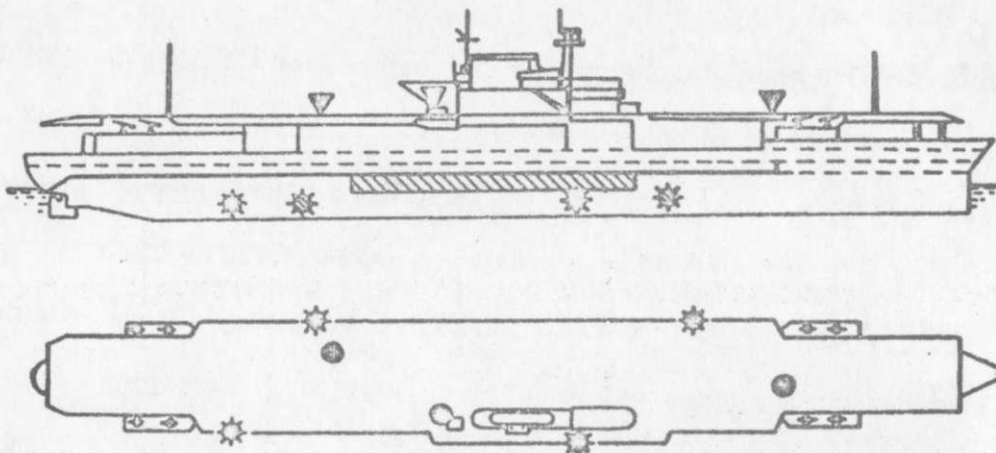
Conclusions. YORKTOWN went out of commission after suffering three bomb and two torpedo hits from aircraft. The explosions of the bombs led to the cessation of flight operations, and the torpedo hits caused the flooding of ship compartments along with the formation of a

Figure 32 - YORKTOWN. Diagram of Damage by Torpedoes and Bombs

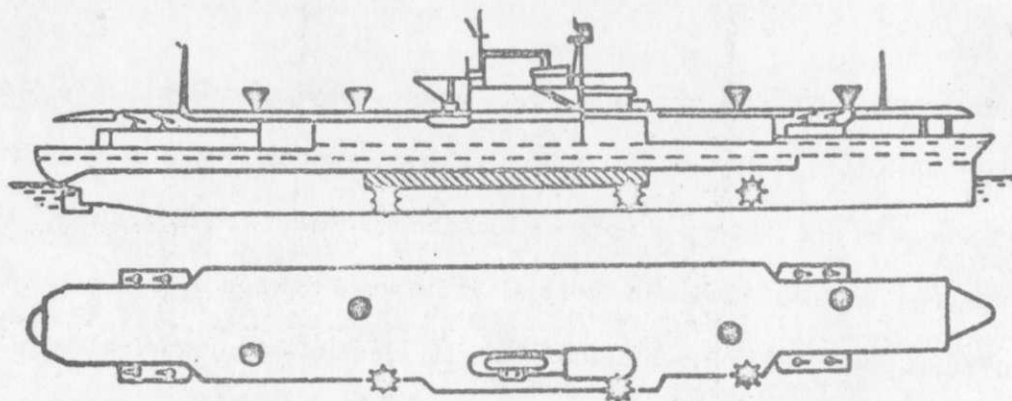
Conclusions. From the action of three contact explosions of torpedoes, four direct hits from aerial bombs, and two kamikaze aircraft

Figure 33 -- HORNET. Diagram of Damage by Torpedoes and Bombs

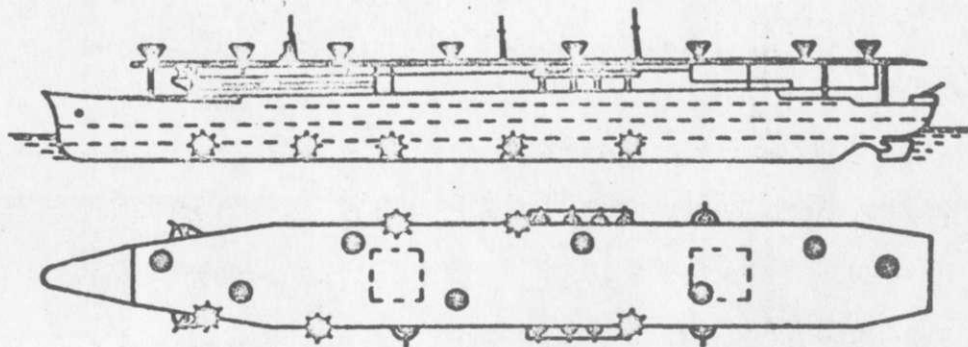
At 0845 on 7 May 1942, the Americans discovered a part of the Japanese force and attacked SHOHU with dive bombers and torpedo planes from LEXINGTON and YORKTOWN. More than 70 aircraft took part in attacking both sides of the ship. Thirteen direct hits from aerial bombs and seven torpedo hits resulted (Figure 34). The damage was so great that the ship rolled over and sank in a period of 15 minutes with the loss of all aboard.

Figure 34 - SHOHU. Diagram of Damage by Torpedoes and Bombs
Principal hits are shown

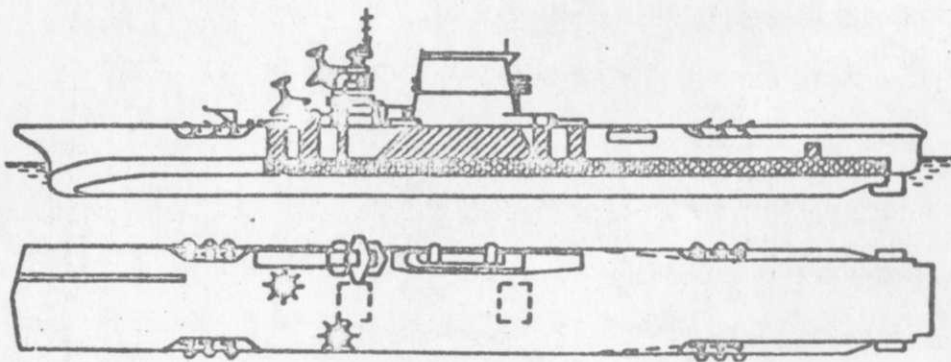
Damage to the Ship and Aftereffects. SARATOGA underwent attack by four Japanese kamikaze aircraft while part of a task group supporting landing operations on Iwo Jima. Two aircraft crashed on the flight deck of the ship forward of the island superstructure: one on the starboard side and the other on the portside (Figure 36). As a result of the explosions that occurred, fires broke out and enveloped the aircraft

Figure 36 - SARATOGA. Diagram of Damage by Kamikaze Aircraft

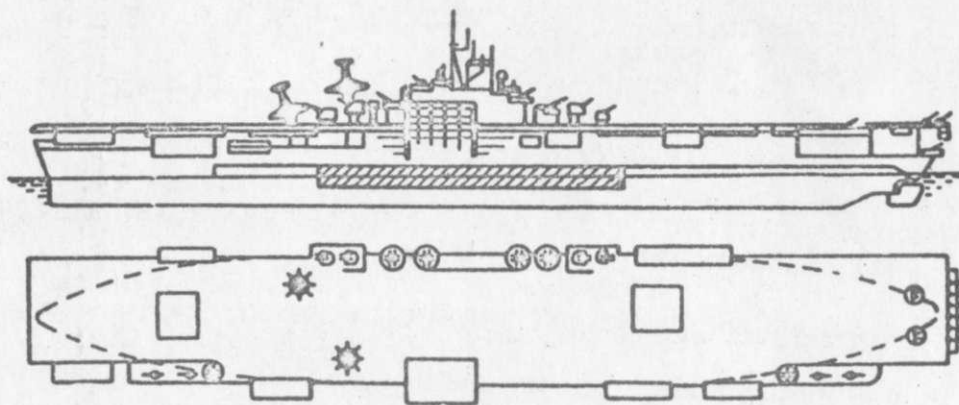
Figure 38 - TICONDEROGA. Diagram of Damage by Kamikaze Aircraft

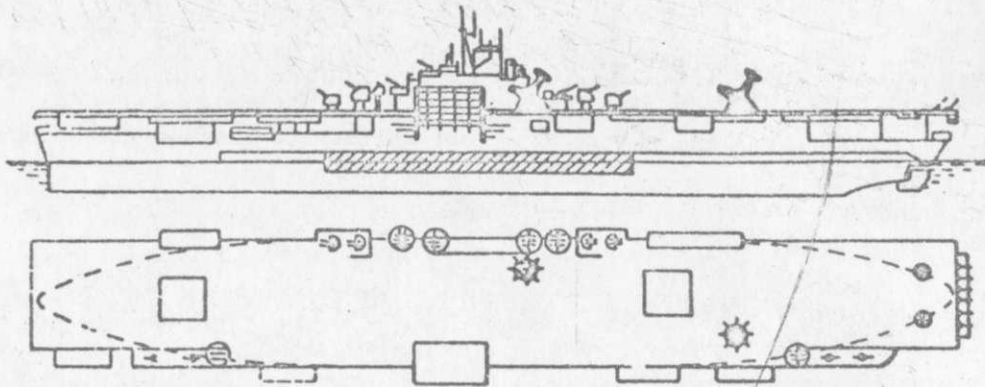
The fire on the flight deck was put out 1 1/2 hours later, but that in the hangar required 3 1/2 hours. Despite serious destruction and bad fires, the carrier was saved as a result of effective measures

Figure 39 - BUNKER HILL. Diagram of Damage by Kamikaze Aircraft

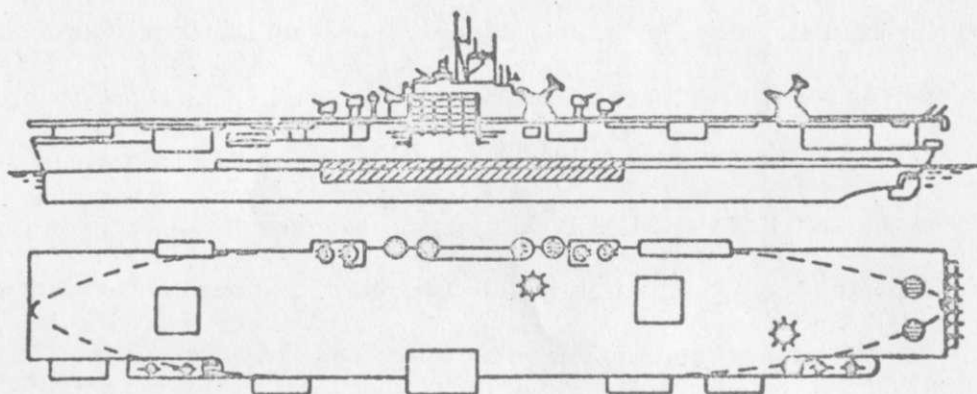
dropped by this plane exploded below the flight deck, burning 19 aircraft which were fueled and armed with ammunition. The second kamikaze crashed before the bomb it was carrying exploded on the after section of the carrier. The bomb entered the hangar and exploded in the vicinity of the fire that was being extinguished (Figure 40). The intensity of the fire in the hangar increased significantly, and the flames enveloped aircraft on the flight deck.

Figure 40 - INTREPID. Diagram of Damage by Kamikaze Aircraft

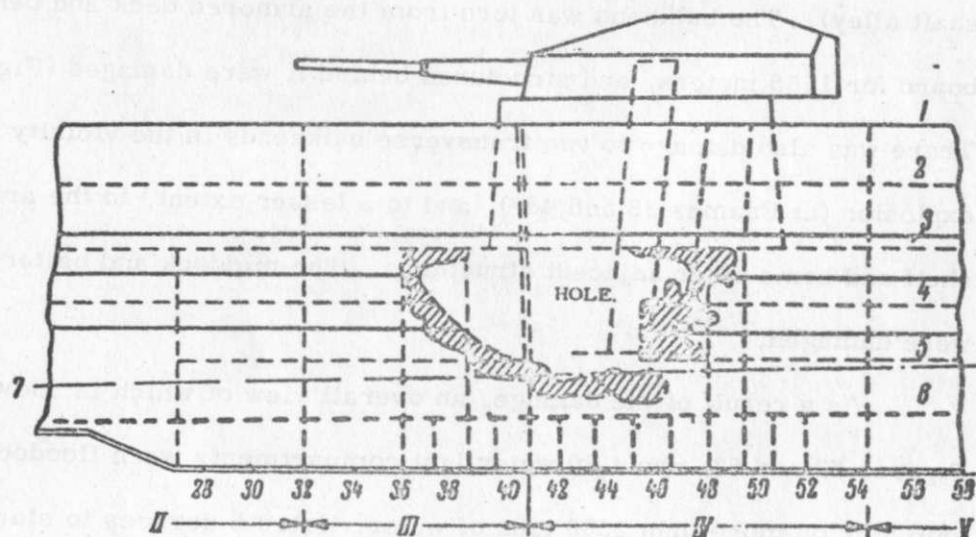
Figure 50 - SCHARNHORST. Diagram of Damage to Plating

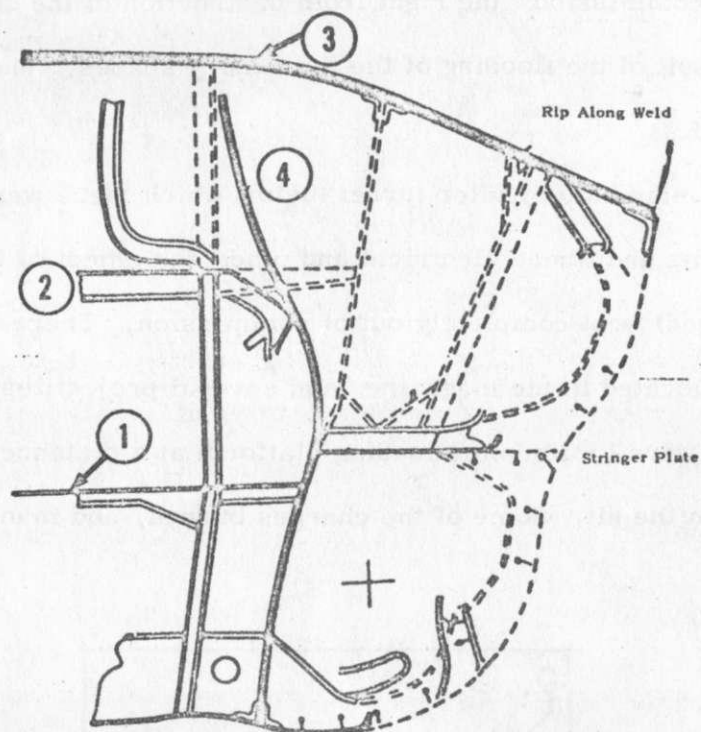
Figure 51 - SCHARNHORST. Diagram of Damage to the Underwater Protection Due to Torpedo Explosion

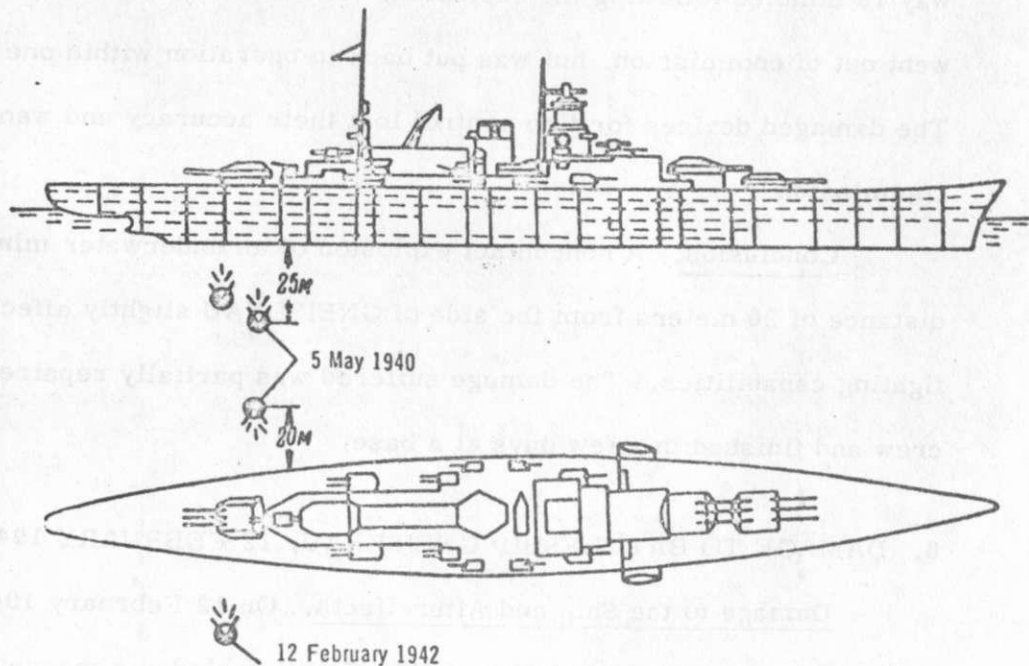
Hull. The ship suffered comparatively minor damage: dents in the vicinity of the cheek belt and individual breaks and cracks in the outer plating to a distance from 0.5 to 2.0 meters. The platform deck in the inboard fore-aft passageway appeared to be deformed. The area of the damage extended 2 to 4 meters below the structural underwater protection, enveloping, along the length of the ship, the II-IV compartments (between Frames 20-50), i.e., about 30 meters. Several compartments were flooded: a shaft tunnel, two storage and empty compartments. The ship took on a list of 0.5 degree to port and a slight settling at the stern.

Figure 63 - GNEISENAU. Approximate Locations of Centers of Mine Explosions
5 May 1940 and 12 February 1942

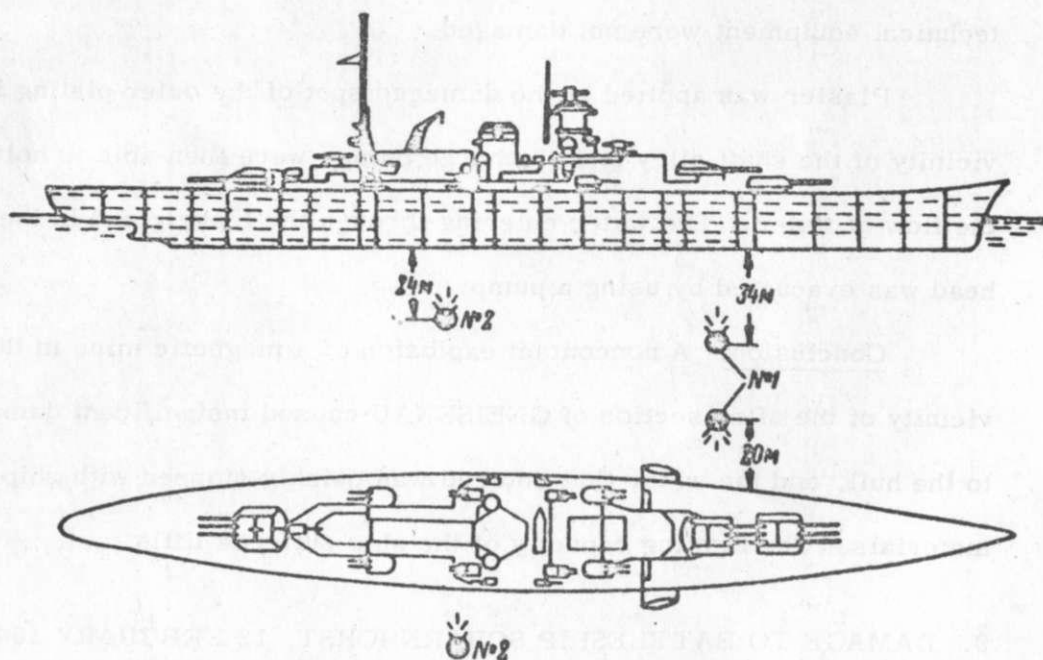
The hull of the ship suffered deep dents and individual rips of the outer plating caused by the impact of the water. About 30 watertight compartments were flooded within the limits of five main compartments (XIV-XVIII) for a distance of about 40 meters. The ship took on more than

Figure 64 - SCHARNHORST. Distribution of Centers of Mine Explosions 12 February 1942

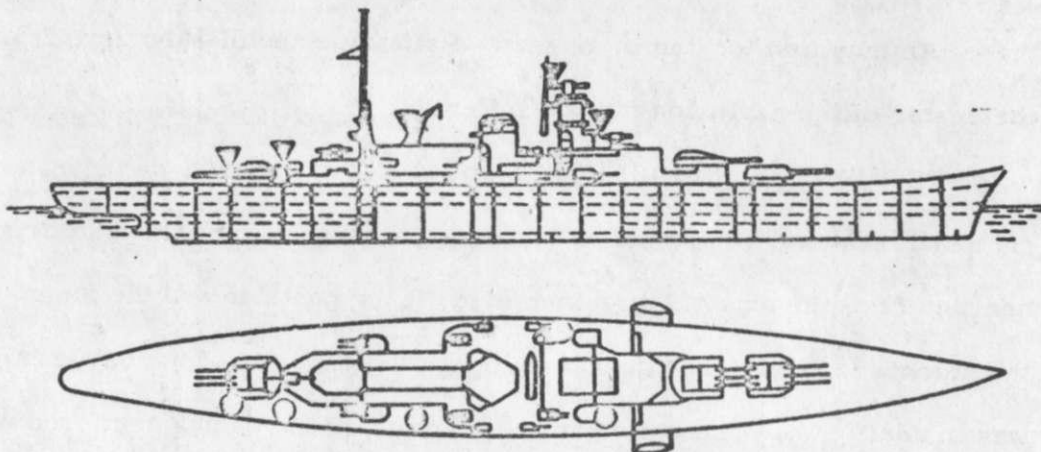
Hit 1. A semi-armor-piercing aerial bomb weighing 100 kilograms fell in the vicinity of the 150-mm installation (Frame 133), passed through the upper and middle decks, exploded on the armored main deck, and damaged the outer plating of the ship over the armored bevel. The side armor plating was slightly deflected (30 mm) from the bomb.

Figure 67 - SCHARNHORST. Diagram of Aerial Bomb Hits 24 July 1941

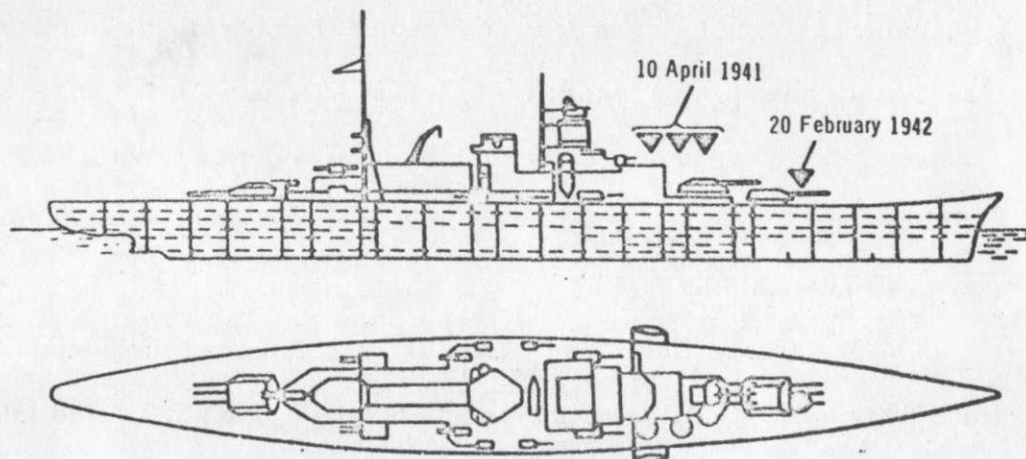
Damage to the Ship and Aftereffects. While at anchor in the port of Brest, GNEISENAU suffered three direct hits from semi-armor-piercing aerial bombs (weighing 250 kilograms each) launched from British aircraft. The bombs fell on the ship (Figure 69) from the starboard side: the first in the upper deck at the No. 2 Main Battery Turret in the vicinity of Frame 158 (Figure 70), the second and third in the deck of the superstructure at Frames 153 and 146, respectively. The bombs penetrated the upper and battery decks and (except for the second bomb which did not explode) exploded on the main armored deck. The main armored deck suffered light damage from the explosions; the outboard longitudinal bulkhead was puffed out and its welded seams were torn (Figure 71). A puff-out appeared in the barbette of the second main battery turret, and the rotating part suffered several splinter hits (Figure 72). The barbette of the second main battery turret warped and the rotating part suffered some splinter damage (Figure 72). Several compartments, including the forward antiaircraft gun station and the central automatic gun control station, were partially flooded. The engine installation of the ship was not damaged; however, the gyrocompasses and the welding

Figure 69 - GNEISENAU. Diagram of Aerial Bomb Hits 10 April 1941

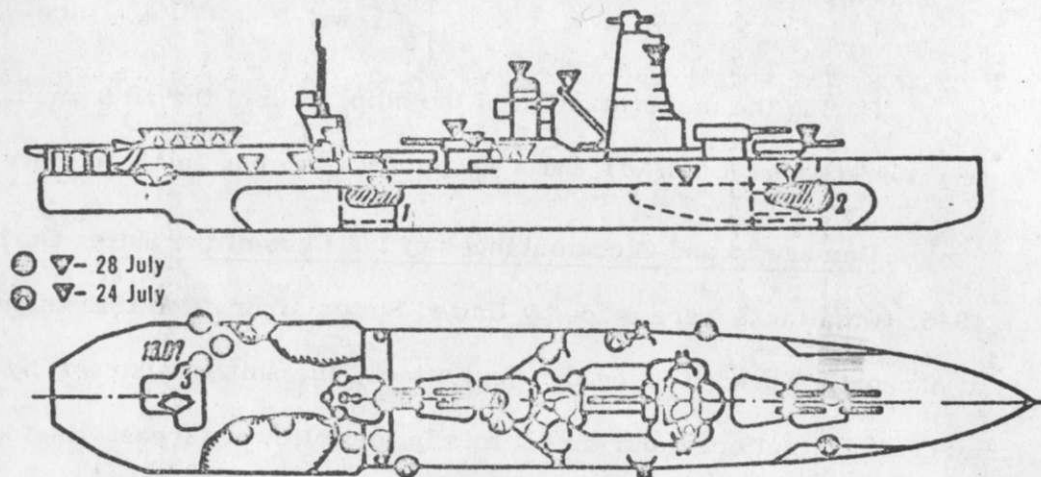
participated, the battleship suffered six direct hits, and about ten bombs fell close to the ship. Then, during a subsequent attack, the ship suffered eight more direct hits, and several more bombs exploded close by her in the water (Figure 73).

Figure 73 - ISE. Diagram of Damage by Aerial Bombs

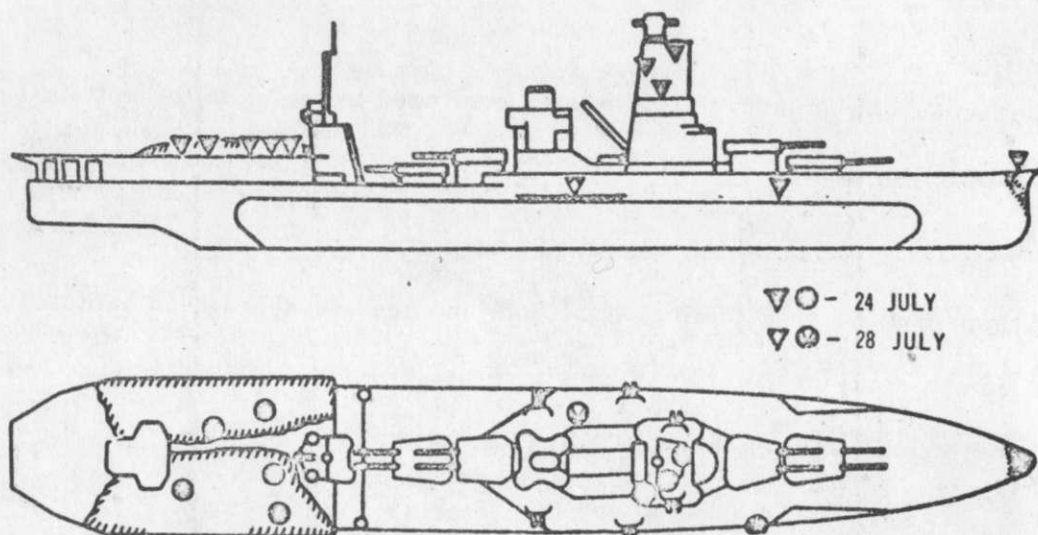
Damage to and Circumstances of the Loss of the Ship. Two attacks by United States carrier aircraft were made on HYUGA, which was at anchor in Kure, on 24 and 28 July 1945. In the first attack on 24 July, up to 60 aircraft participated and launched about 200 aerial bombs at the ship. The battleship suffered 10 direct hits (Figure 74); more than 20 bombs exploded close aboard. The ship was seriously damaged; the entering

Figure 74 - HYUGA. Diagram of Damage by Aerial Bombs

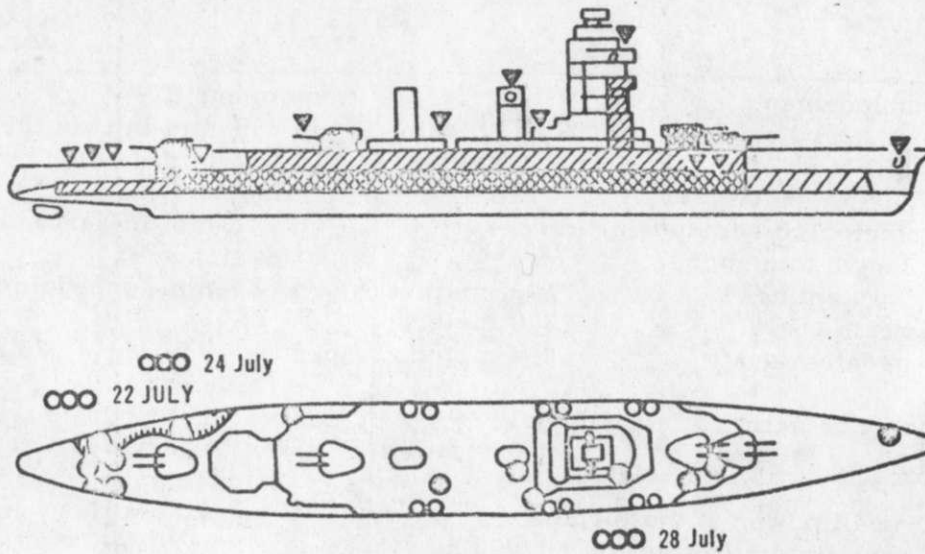
On 28 July, the battleship was attacked several times by carrier-based aircraft and B-24 heavy bombers and suffered a great number of direct hits (Figure 75); several bombs exploded close aboard. As a

Figure 75 - HARUNA. Diagram of Damage by Aerial Bombs

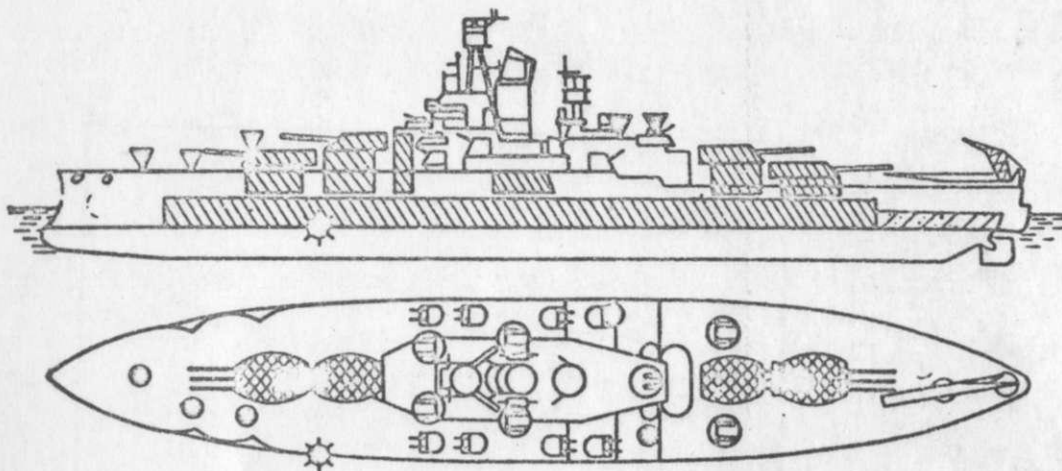
Figure 78 - NEVADA. Diagram of Damage to the Ship by a Torpedo and Aerial Bombs

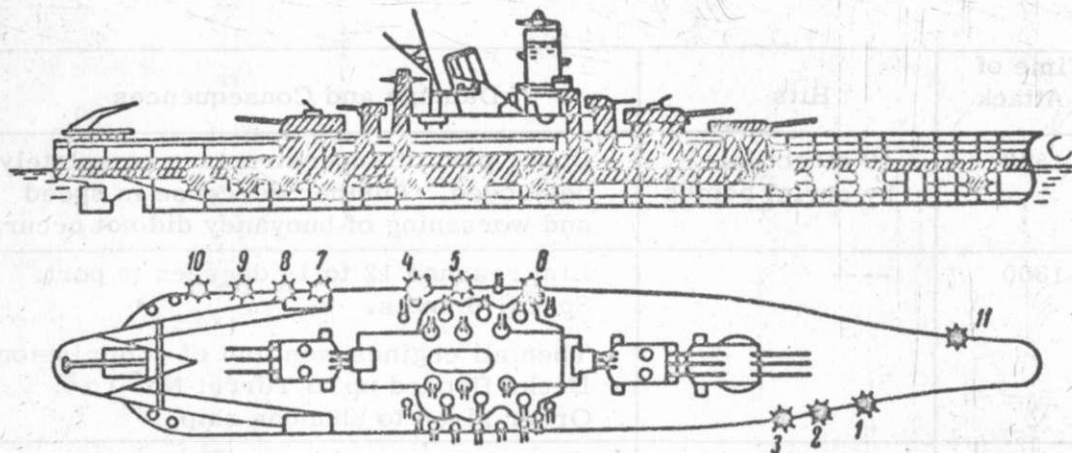
The fate of the battleship was decided by contact explosions from torpedoes, which subsequently decreased the buoyancy and stability of the ship and, in connection with the flooding of compartments and the growth of the damaging list, led to incapacitation of the engineroom and

Figure 87 -- MUSASHI. Diagram of Damage by Torpedoes

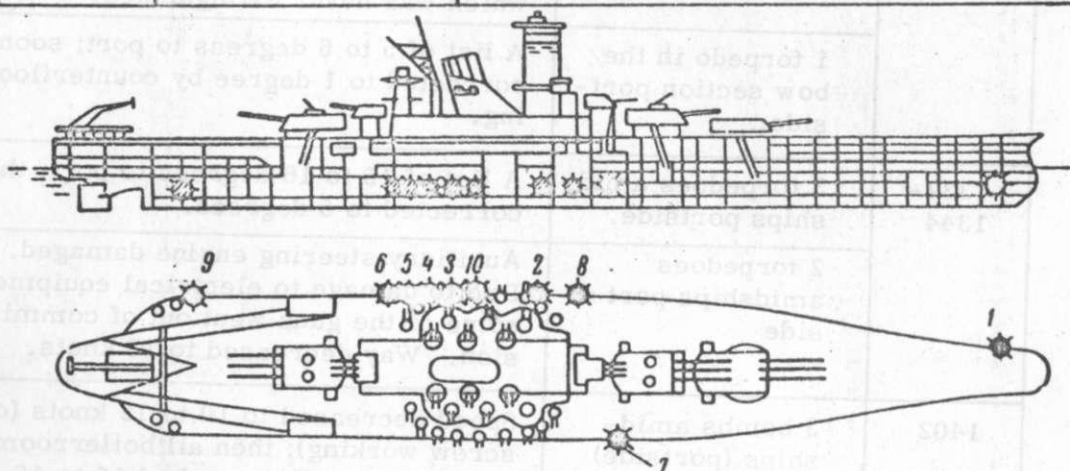
Figure 88 - YAMATO. Diagram of Torpedo Hits

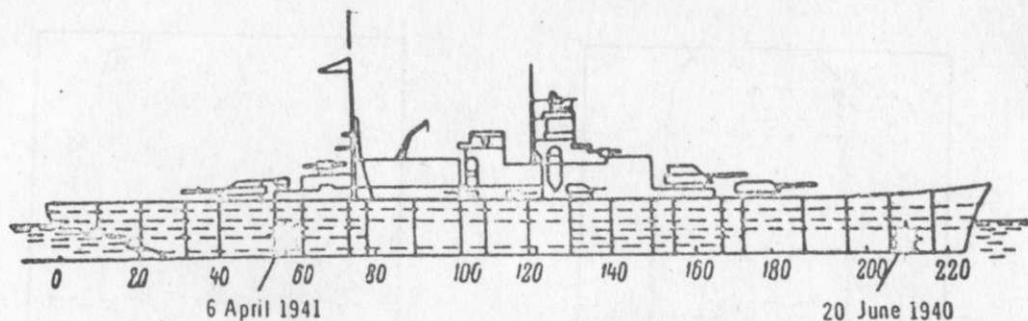
Figure 54 - GNEISENAU. Areas are Shown where Torpedoes Hit
20 June 1940 and 6 April 1941

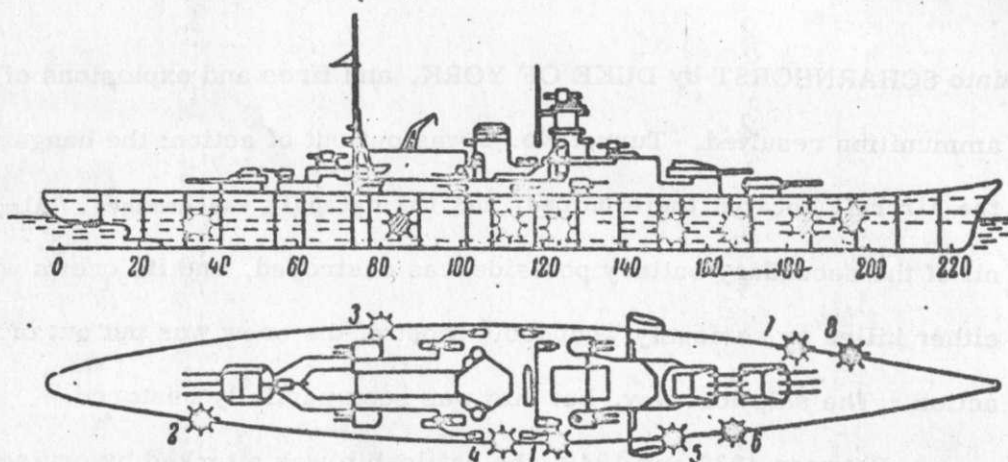
Most of the torpedoes hit the starboard side; this led to significantly damaging lists and complicated the job of preserving watertight integrity.

Figure 91 - SCHARNHORST. Diagram of Torpedo Hits¹

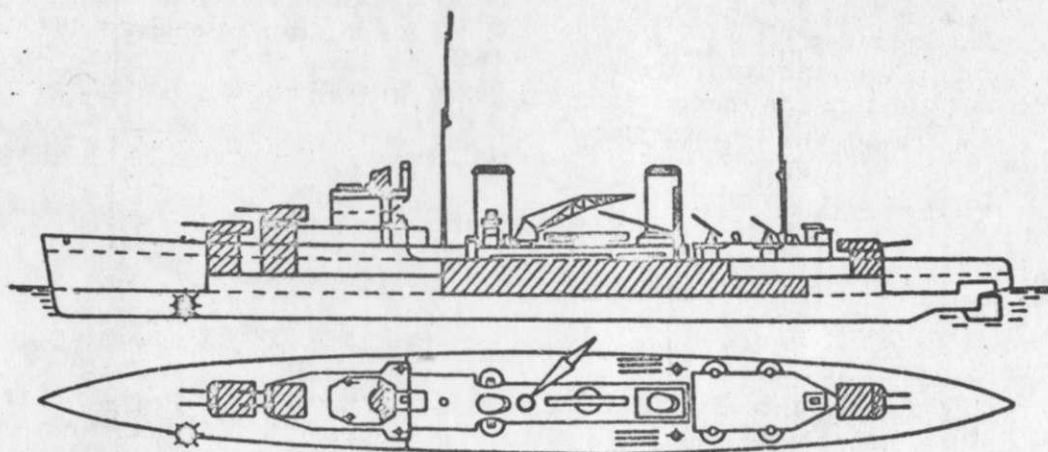
Figure 92 - ARETHUSA. Area Where Torpedo Exploded Shown

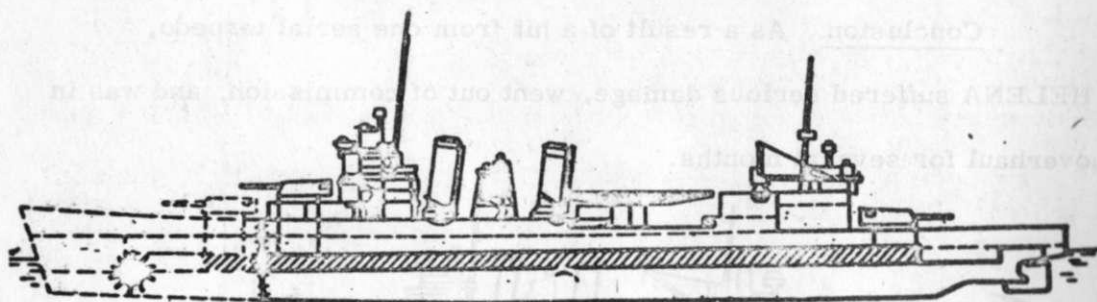
Figure 97 - NEW ORLEANS. Area where Torpedo Exploded
Shown and the Line where the Bow Broke Off

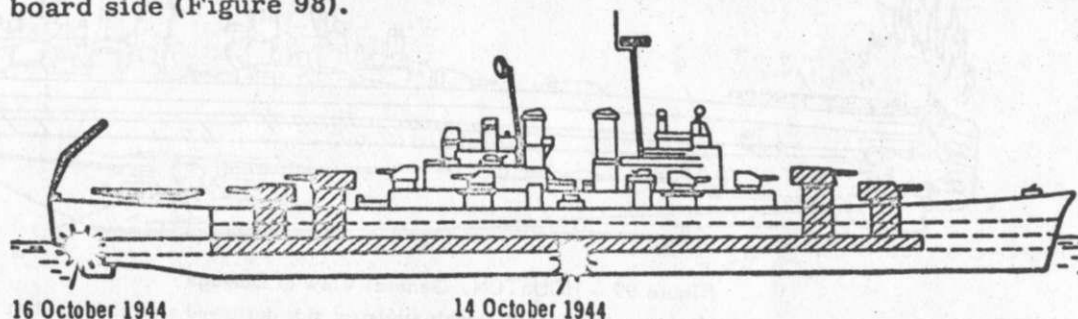
Figure 98 - HOUSTON. Diagram of Torpedo Hits

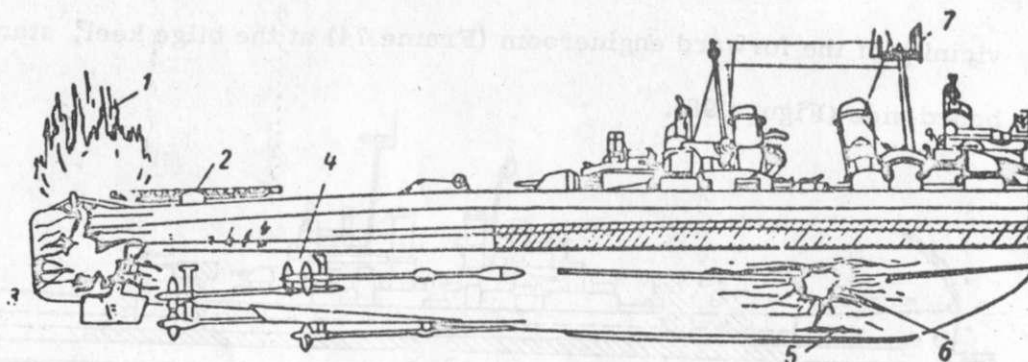
Figure 99 - HOUSTON. General View of Damage

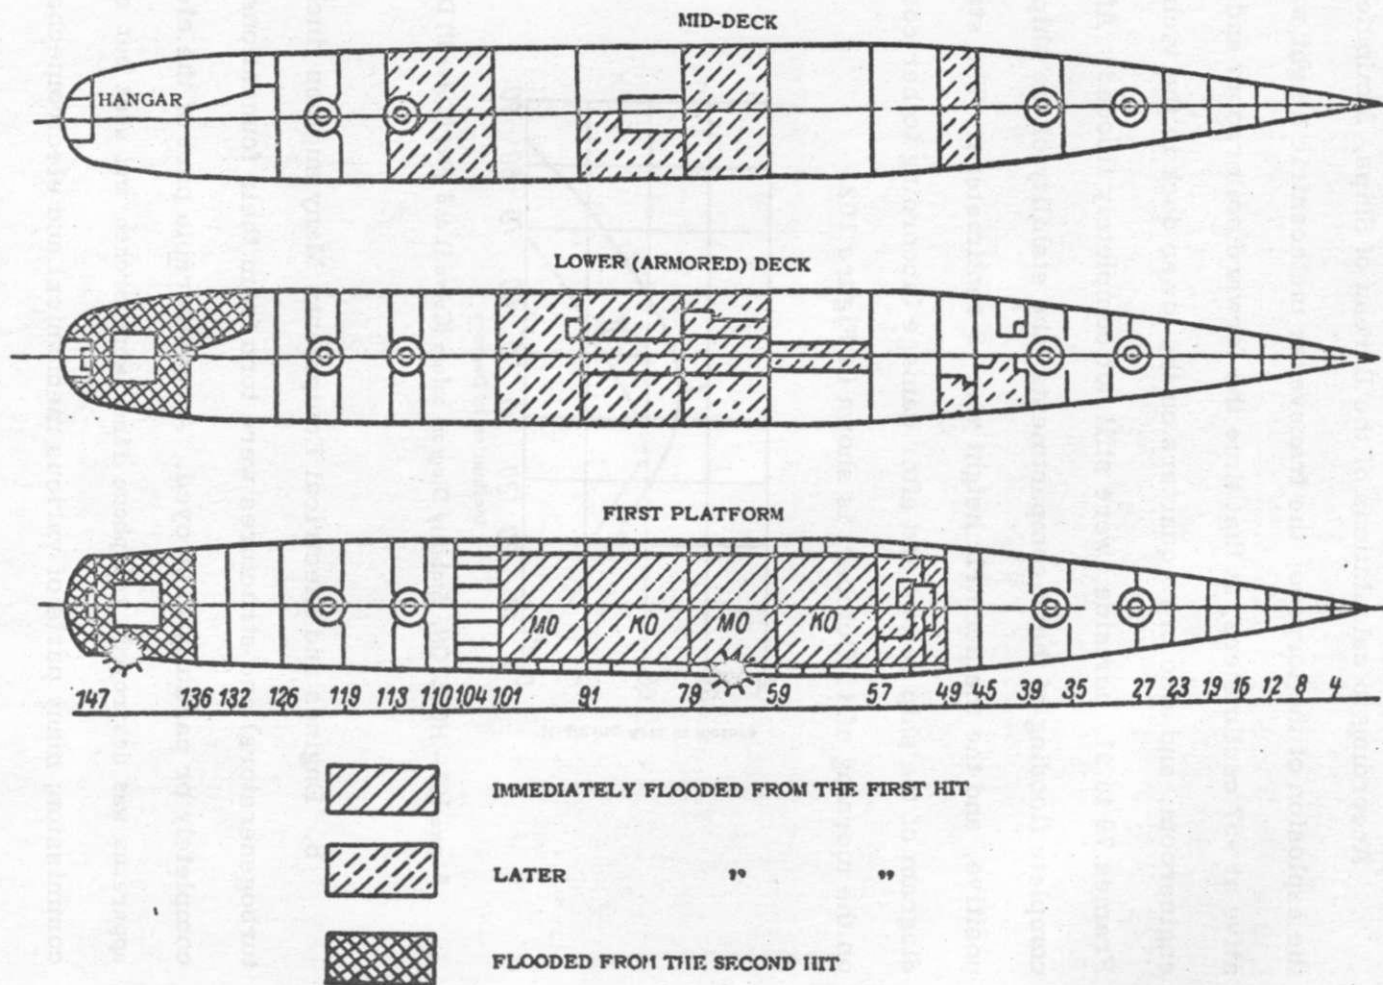
Figure 101 - HOUSTON. Diagram of Flooded Compartment

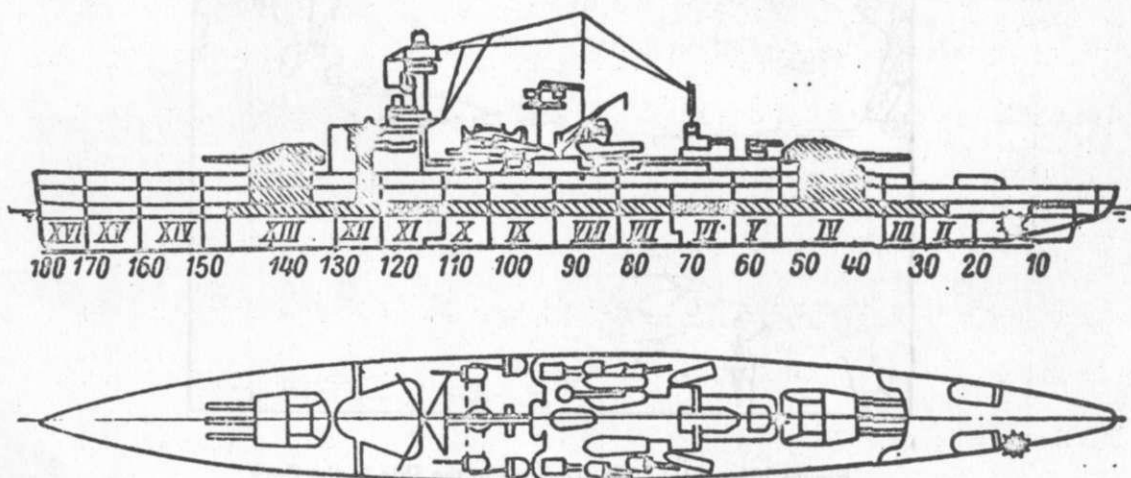
Figure 105 - LUTZOW. Vicinity of Torpedo Explosion Shown

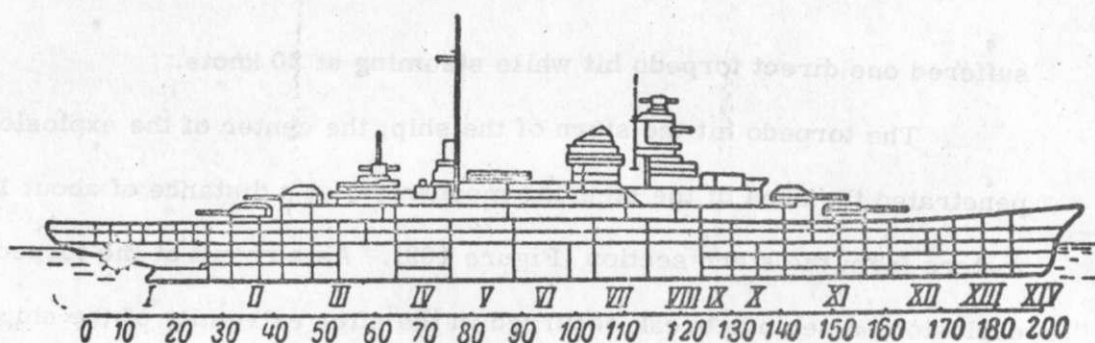
Figure 109 - PRINZ EUGEN. Vicinity of Torpedo Hit Shown

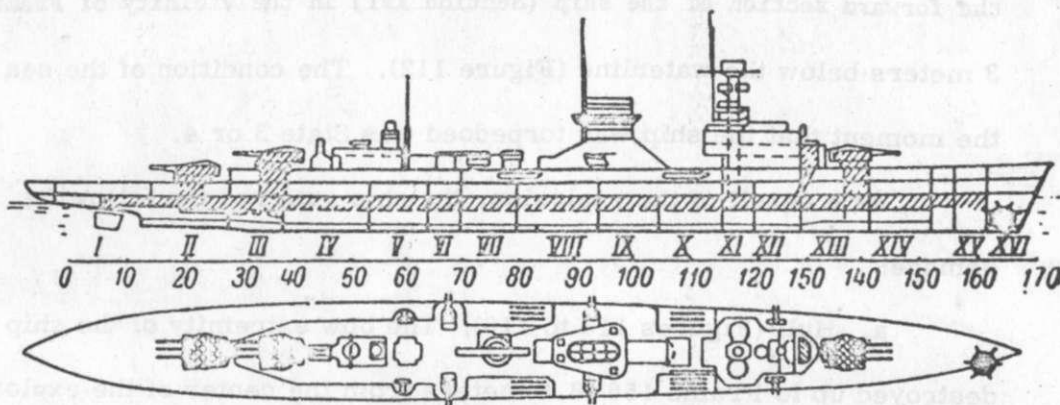
Figure 112 - NURNBERG. Vicinity of Torpedo Hit Shown

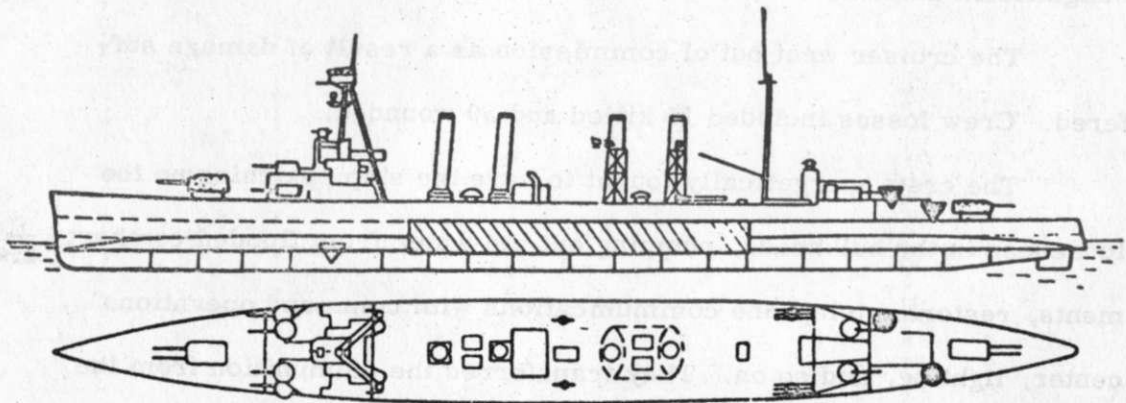
Figure 121 - MARBLEHEAD. Diagram of Damage by Aerial Bombs

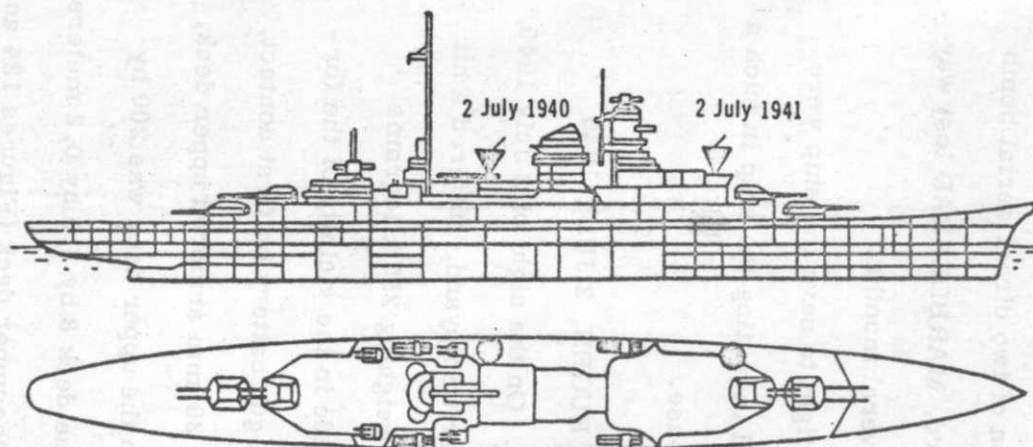
Figure 123 - PRINZ EUGEN. Diagram of Damage from Aerial Bombs 2 July 1940 and 2 July 1941
