BATTLE DAMAGE TO SURFACE SHIPS DURING WORLD WAR II
(BOEVYE POVREZHDENUA NADOVDNYKH KORABLEI)

I. M. Korotkin
Leningrad, Sudpromgiz, 1960

Translated by U. S. Joint Publications Research Service
for the David Taylor Model Basin

SUMMARY

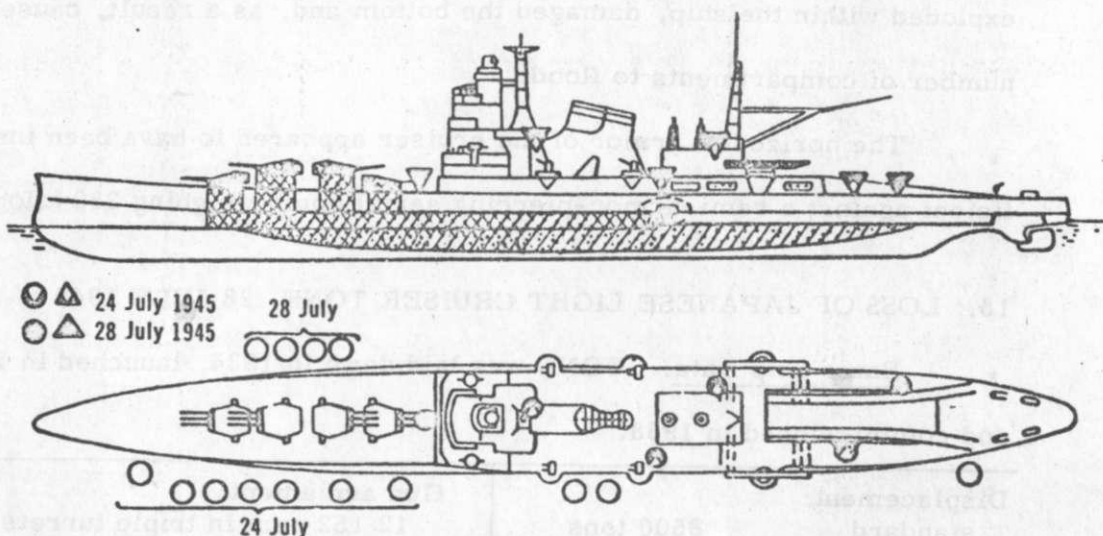
Figure 127 - TONE. Diagram of Damage by Aerial Bombs

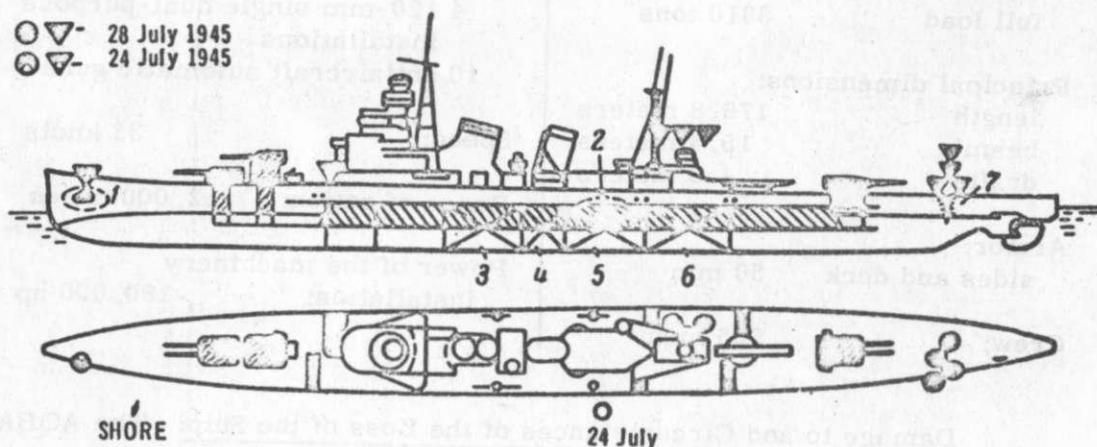
Figure 129 - AOBA. Diagram of Damage by Aerial Bombs, 24 July 1945

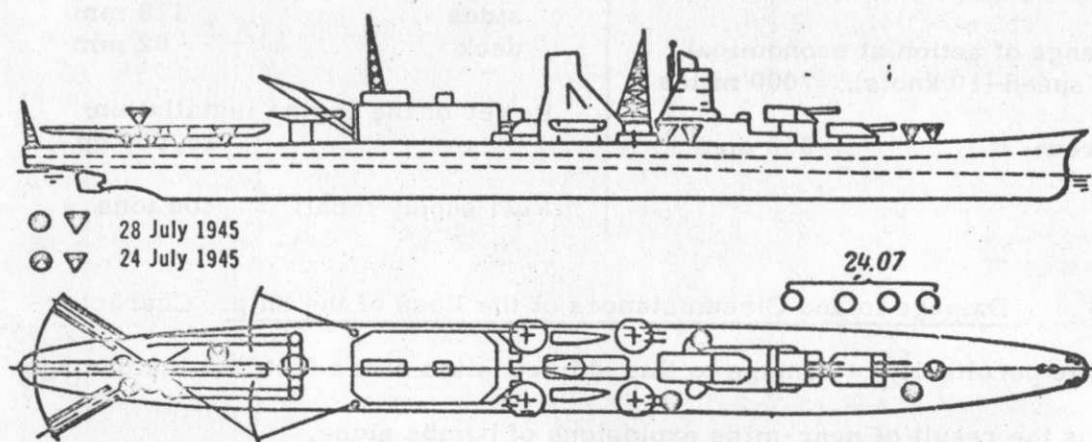
Figure 131 - OYODO. Diagram of Damage by Aerial Bombs

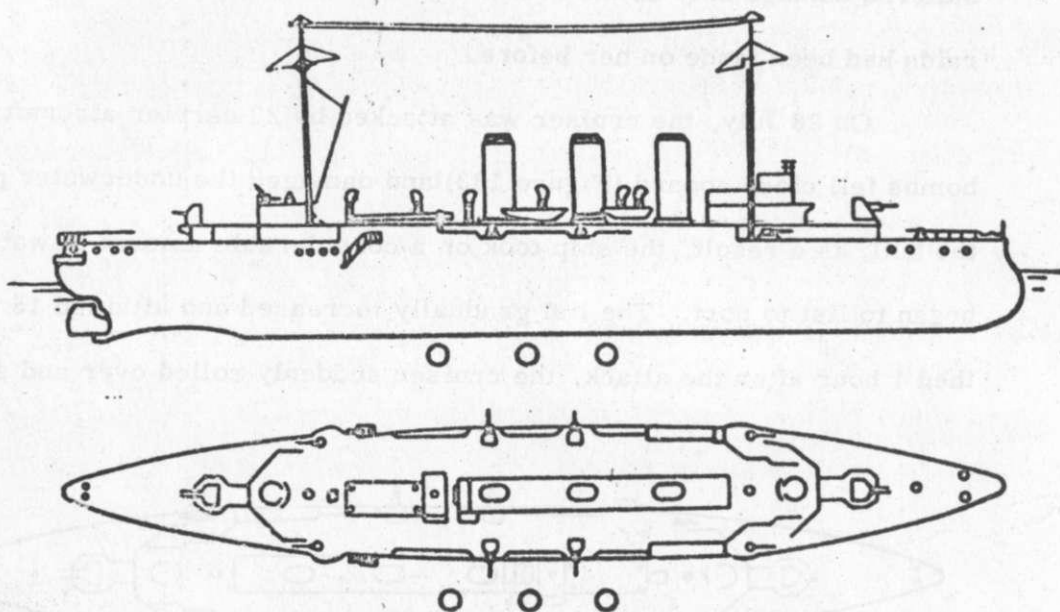
Figure 132 - IWATE. Diagram of Damage by Aerial Bombs 24 July 1945

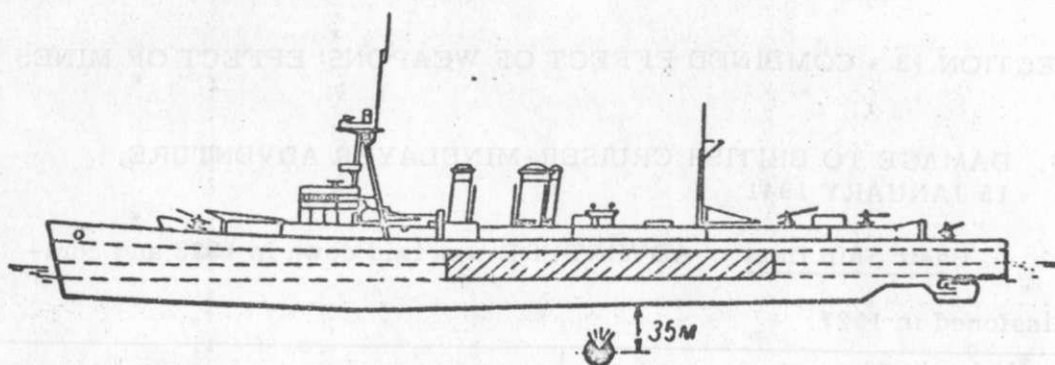
Figure 134 - ADVENTURE. Vicinity of Mine Explosion Shown

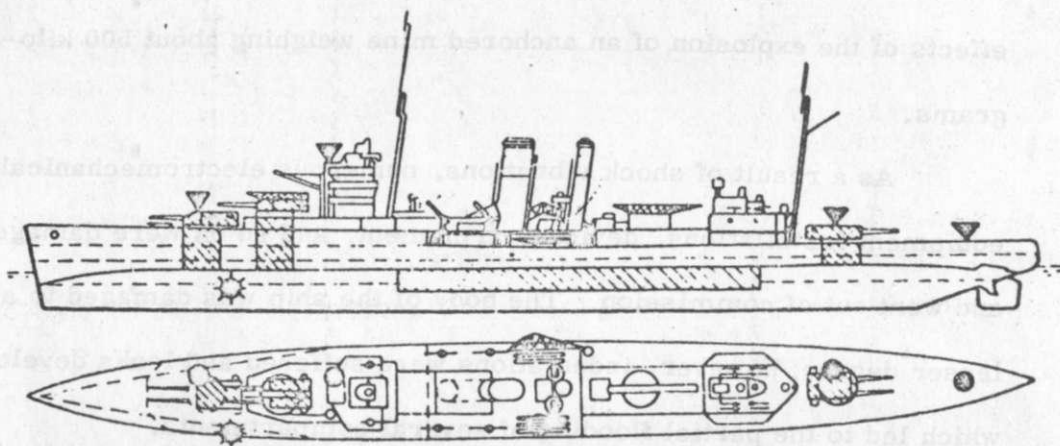
Figure 135 - YORK. Diagram of Damage by Bombs and Torpedo

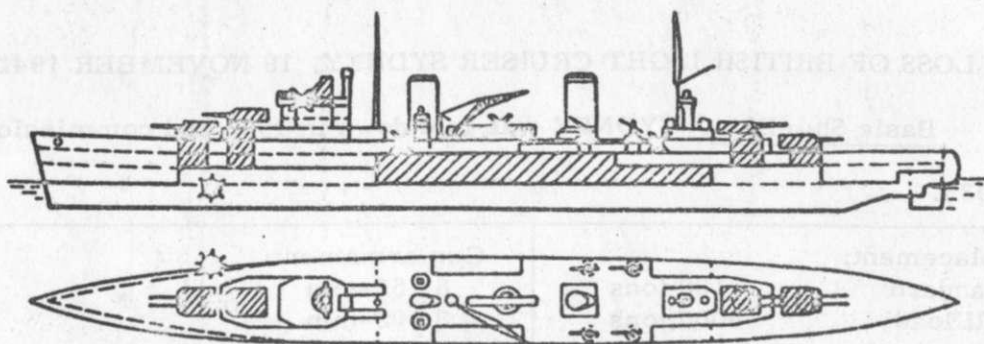
Figure 136 - SYDNEY. The Disposition of the Center of the Torpedo Explosion and the Areas of the Primary Shell Hits are Shown

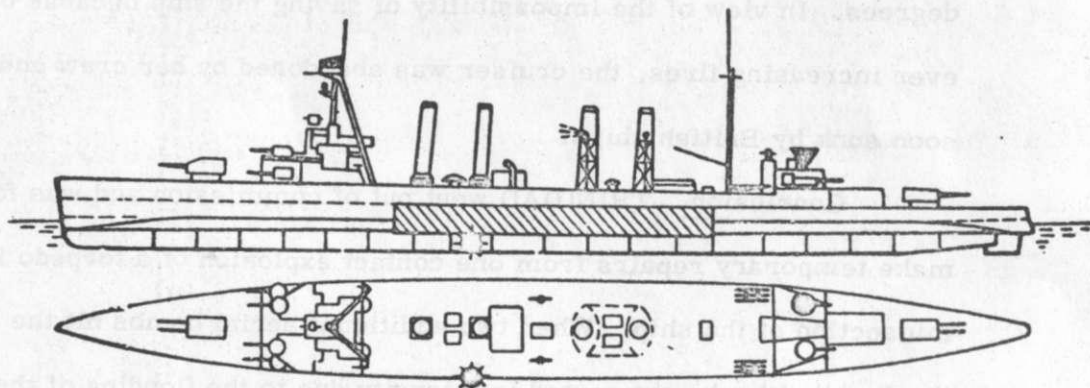
Figure 138 - RALEIGH. Diagram of Damage by Torpedo and Aerial Bomb

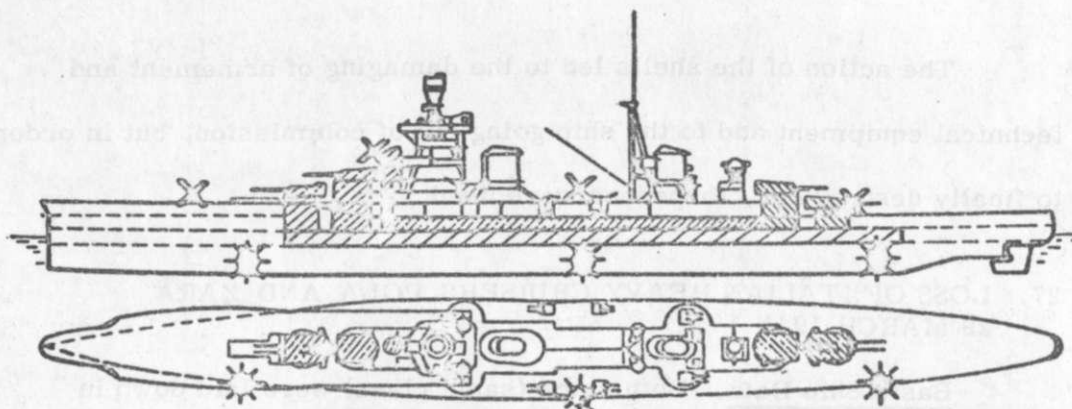
Figure 140 - POLA. Areas of Primary Torpedo and Shell Hits Are Shown

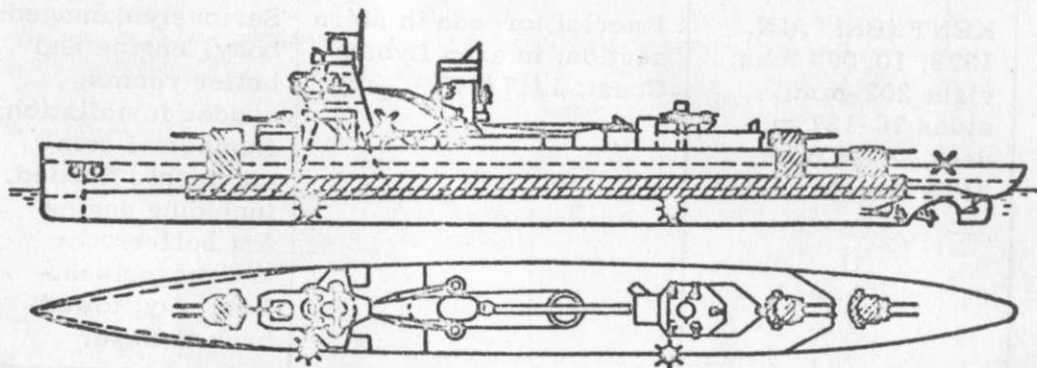
Figure 141 - DE RUYTER. Areas of Primary Torpedo and Shell Hits Are Shown

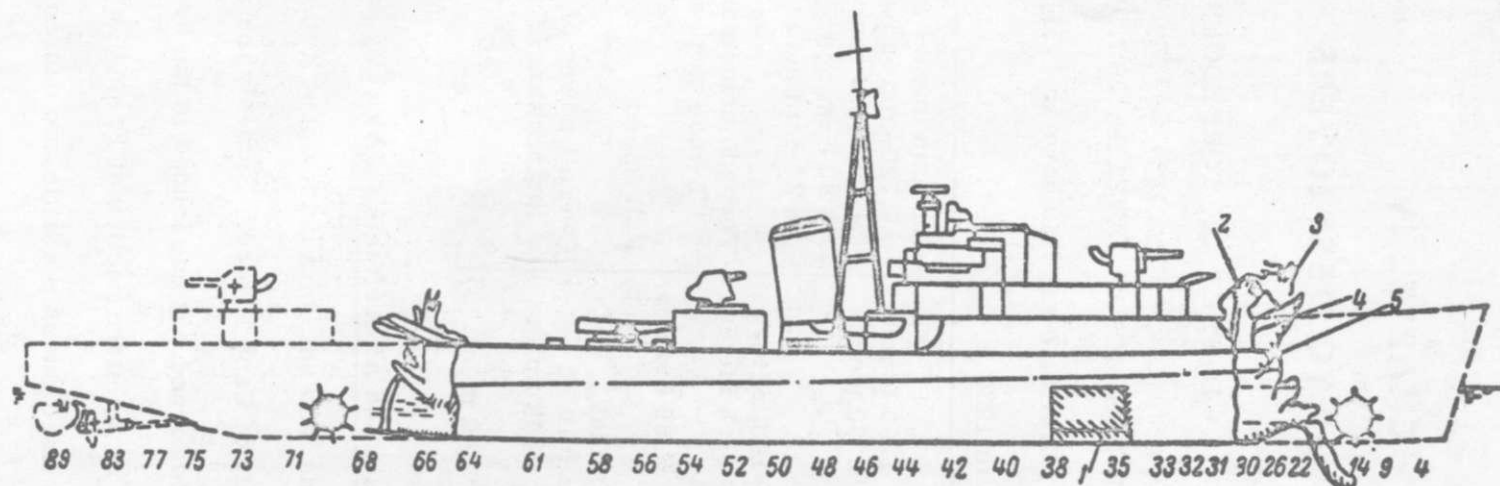
Figure 142 - JAVELIN. Diagram of Damage

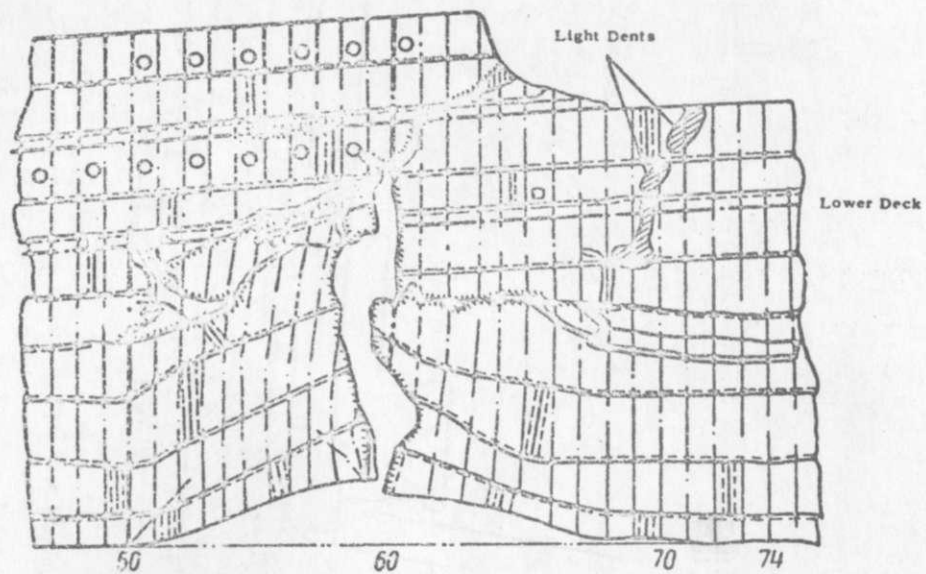
Figure 150 - HUNTER. Damage to Port Side

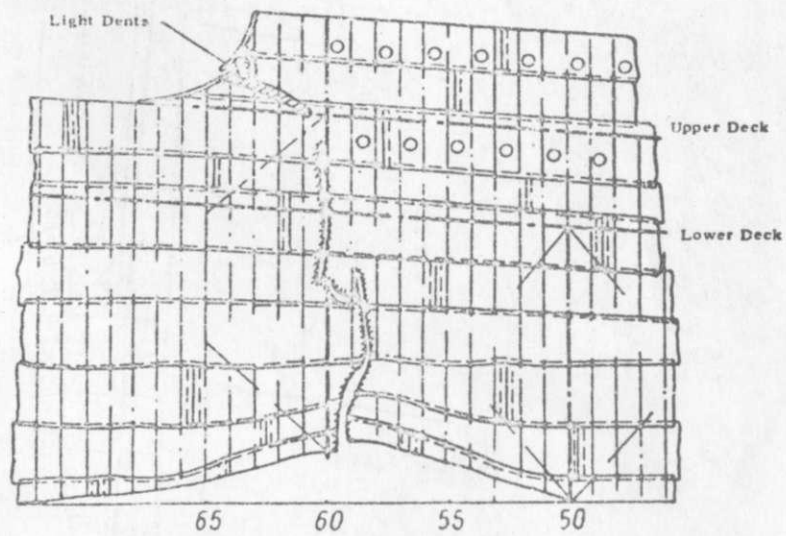
Figure 151 - HUNTER. Damage to Starboard Side

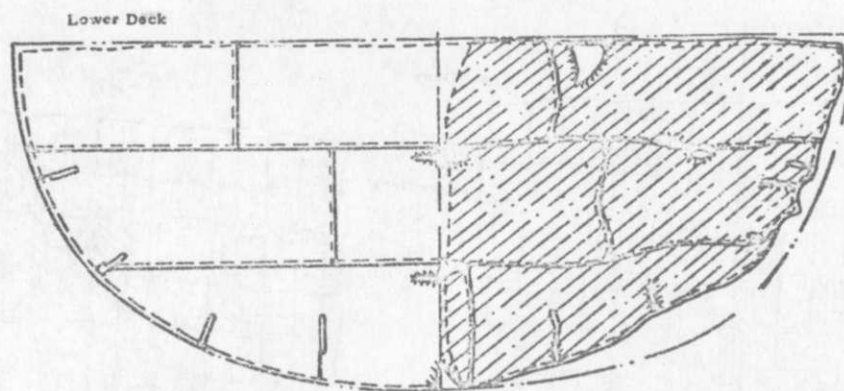
Figure 155 -- HUNTER. Welded Bulkhead at Frame 50. Seriously Deformed Section Cross-Hatched (Seen from Aft)

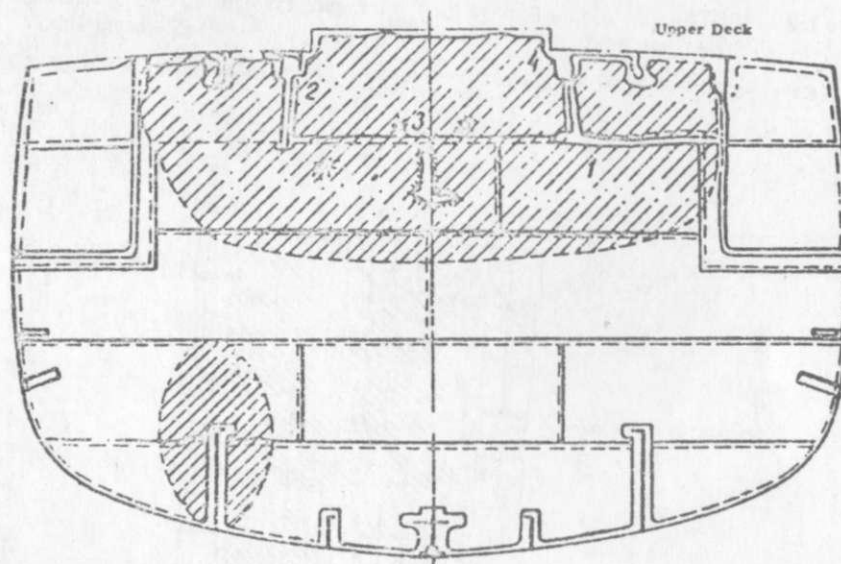
Figure 156 -- HUNTER. Welded Bulkhead at Frame 74. Seriously Deformed Section Cross Hatched (Seen from Bow)

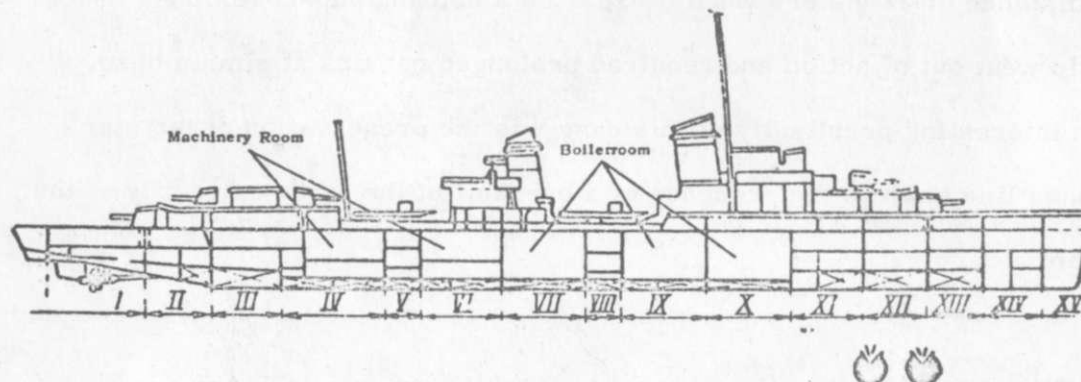
Figure 160 - BRUNO HEINEMANN. Location of Mine Explosions Shown
