Figure 1. Correct cup washer direction, installation of

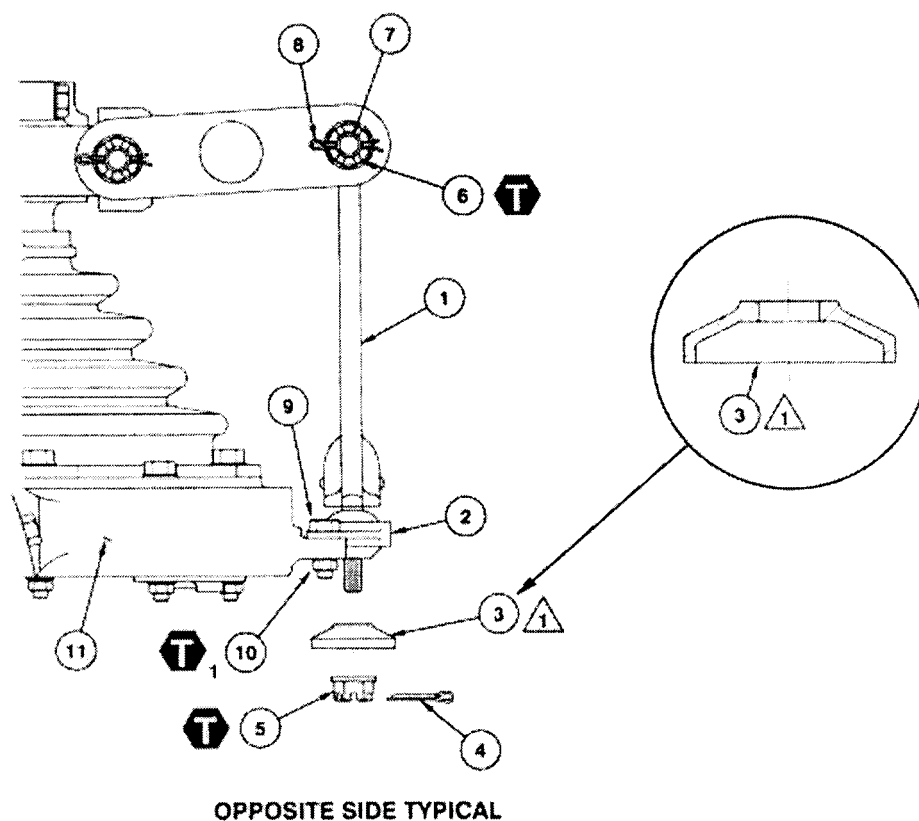
1. Washer shown is correctly installed.
2. Washers under bolt head (9) and nut (10) are not shown for clarity.

(b) If a cup washer is installed incorrectly, remove and replace the swashplate outer ring, each cup washer, bearing and liner, and drive link where the cup washer was installed incorrectly. Replace these parts in accordance with Part II of the Accomplishment Instructions in Bell Helicopter Textron Alert Service Bulletin No. 407-02-55, dated October 29, 2002.

Note 2: In Part II, step 3.a. of the alert service bulletin, the swashplate is incorrectly referenced as item 10 of Figure 1. The reference should state item 11.
