2003-12-13 Agusta S.p.A.: Amendment 39-13198. Docket No. 2003-SW-26-AD.

Applicability: Model A109K2 helicopters with tail rotor blades (blades), part number (P/N) 109-8132-01-107, having 1,500 or more hours time-in-service (TIS), installed, certificated in any category.

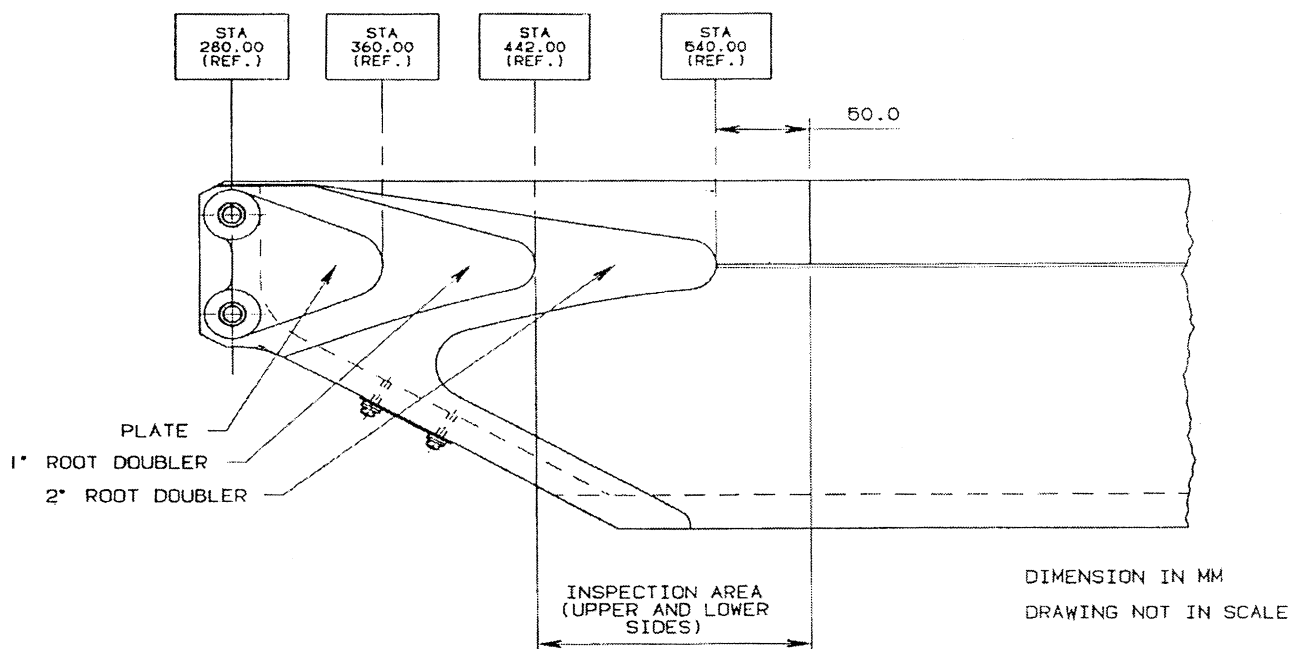
FIGURE 1

(a) Before each start of the helicopter engines, visually check the upper and lower surfaces of each blade for a crack in the area depicted in Figure 1 of this AD. An owner/operator (pilot) holding at least a private pilot certificate may perform this check, but must enter compliance with this paragraph into the aircraft records in accordance with 14 CFR sections 43.11 and 91.417(a)(2)(v). See Figure 1:

Note 1: Paint irregularities on the blade may be due to a crack.

(b) Before the first flight of each day, and thereafter at intervals not to exceed 5 hours TIS, and anytime an increase in vibration levels occurs, inspect each blade for a crack using a 5x or higher magnifying glass in accordance with Part II of the Compliance Instructions of Alert Bollettino Tecnico No.

109K-35, dated May 13, 2003 (ABT) and Figure 1 of this AD.

(c) After each visual inspection using a 5x or higher magnifying glass and before further flight, if you are unable to determine by the visual inspection whether there is a crack, inspect each blade for a crack using a dye-penetrant method in accordance with Part II of the Compliance Instructions of the ABT and Figure 1 of this AD.

(d) If a crack is found, replace each cracked blade with an airworthy blade before further flight.
