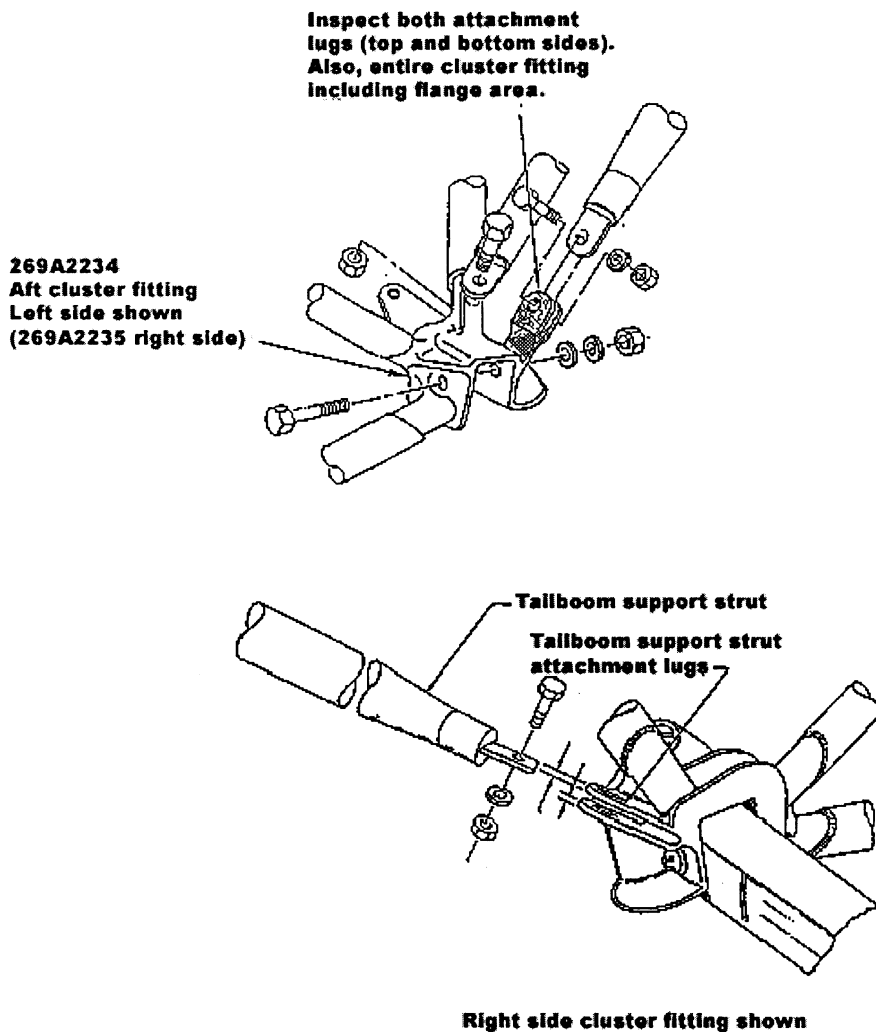
Figure 1

To prevent failure of a tailboom support strut or lug on a cluster fitting, which could cause rotation of a tailboom into the main rotor blades, and subsequent loss of control of the helicopter, accomplish the following:

(2) Dye-penetrant inspect the lugs on each cluster fitting. See the following Figure 1:

(3) If a crack is found, before further flight, replace the cracked cluster fitting with an airworthy cluster fitting.

fitting, P/N 269A2234 and P/N 269A2235, with an airworthy cluster fitting or modify each cluster fitting, P/N 269A2234 and P/N 269A2235, with Kit, P/N SA-269K-106-1. Installing the kit is terminating action for the 50-hour TIS repetitive dye-penetrant inspection for these cluster fittings. Broken or cracked cluster fittings are not eligible for the kit modification.
