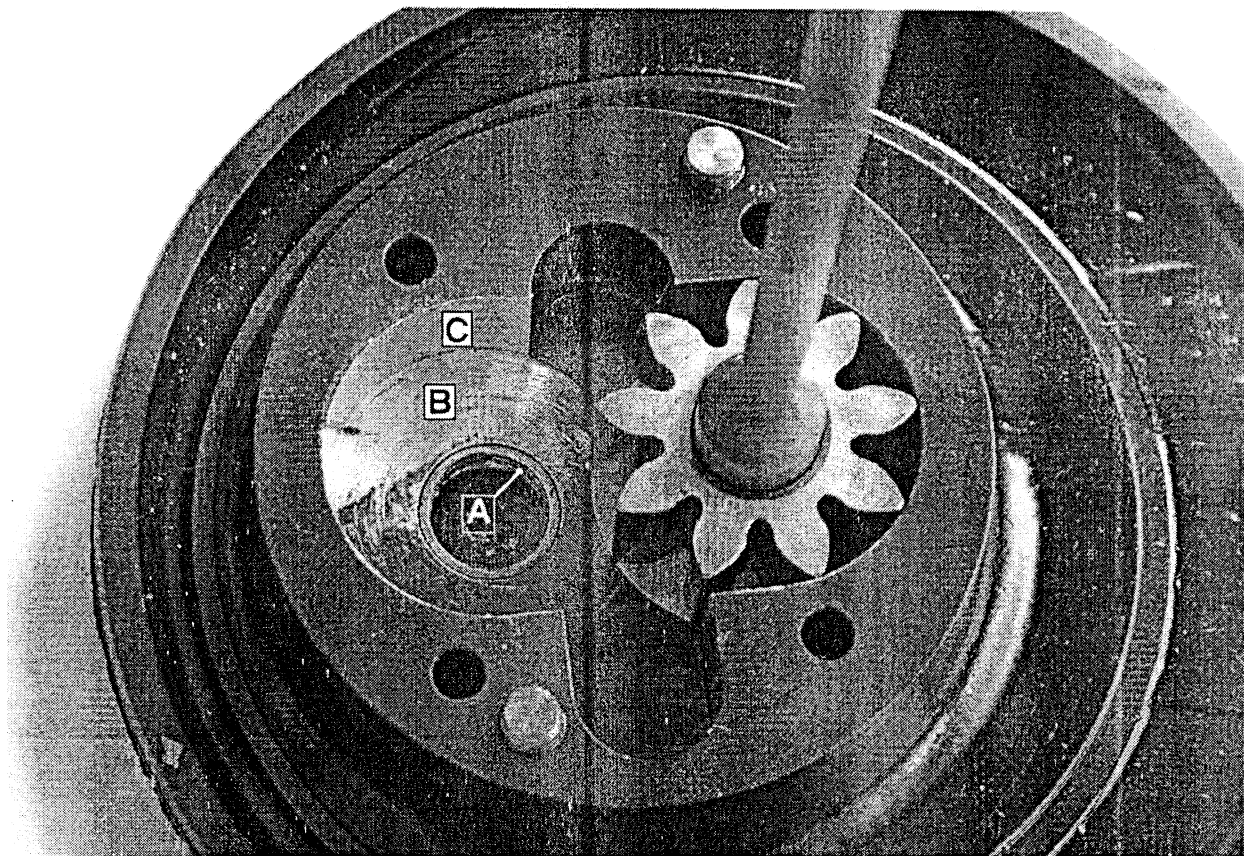
Figure 1

- (1) Crank pin play,
- (2) Out of round bronze bushing (A of Figure 1),

- (3) Offset of the driven gear pinion,
 - (4) Metal chips, or
 - (5) Wear (C of Figure 1).
- See the following Figure 1:

Note 2: If wear is present in the B area only as depicted in Figure 1, replacing the MGB and the pump is not required.

(d) While inspecting the pump, if you find any of the following, replace the MGB and the pump with an airworthy MGB and pump before further flight:
