**BILLING CODE 4910-13-C****Repetitive Inspections**

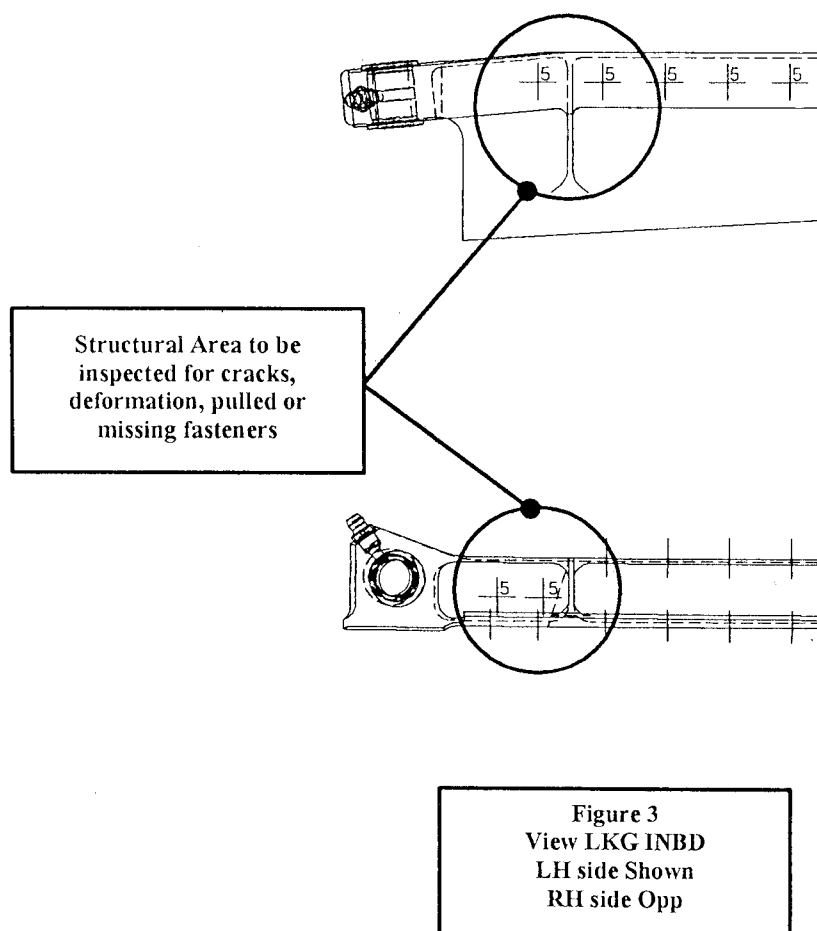
(c) If no cracking or deformation, or pulled or missing fastener, as applicable, is found during any inspection required by paragraph (b) or (c) of this AD, repeat the inspections thereafter at intervals not to exceed 100 flight cycles.

(d) If any cracking or deformation, or pulled or missing fastener, as applicable, is found during any inspection in accordance with paragraph (b) or (c) of this AD: Before further flight, accomplish paragraph (d)(1), (d)(2), or (d)(3) of this AD.

(1) Repair the damage in accordance with a method approved by either the Manager, New York Aircraft Certification Office (ACO), FAA; or Transport Canada Civil Aviation (or its delegated agent); and accomplish repetitive inspections in accordance with a method and at a repetitive interval approved by same.

(2) Replace the lower panel assembly, P/N CC670-10520, of the affected MLG door with a new or serviceable lower panel assembly having the same P/N, in accordance with Task Cards 32-12-01-000-801-A01 and 32-12-01-400-801-A01 of the CRJ 700/900 Series Regional Jet Aircraft Maintenance Manual; and repeat the inspections specified in paragraph (b) of this AD at intervals not to exceed 100 flight cycles.

(3) Remove the lower panel assembly, P/N CC670-10520, of the affected MLG door, and accomplish paragraph (d)(3)(i) or (d)(3)(ii), as applicable.
