Visual Inspection of Gearbox Pressure Tube and No. 4 Bearing Front Pressure Manifold

Gearbox Pressure Tube, No. 4 Bearing Front Pressure Manifold, and Clamp Assembly Positioning

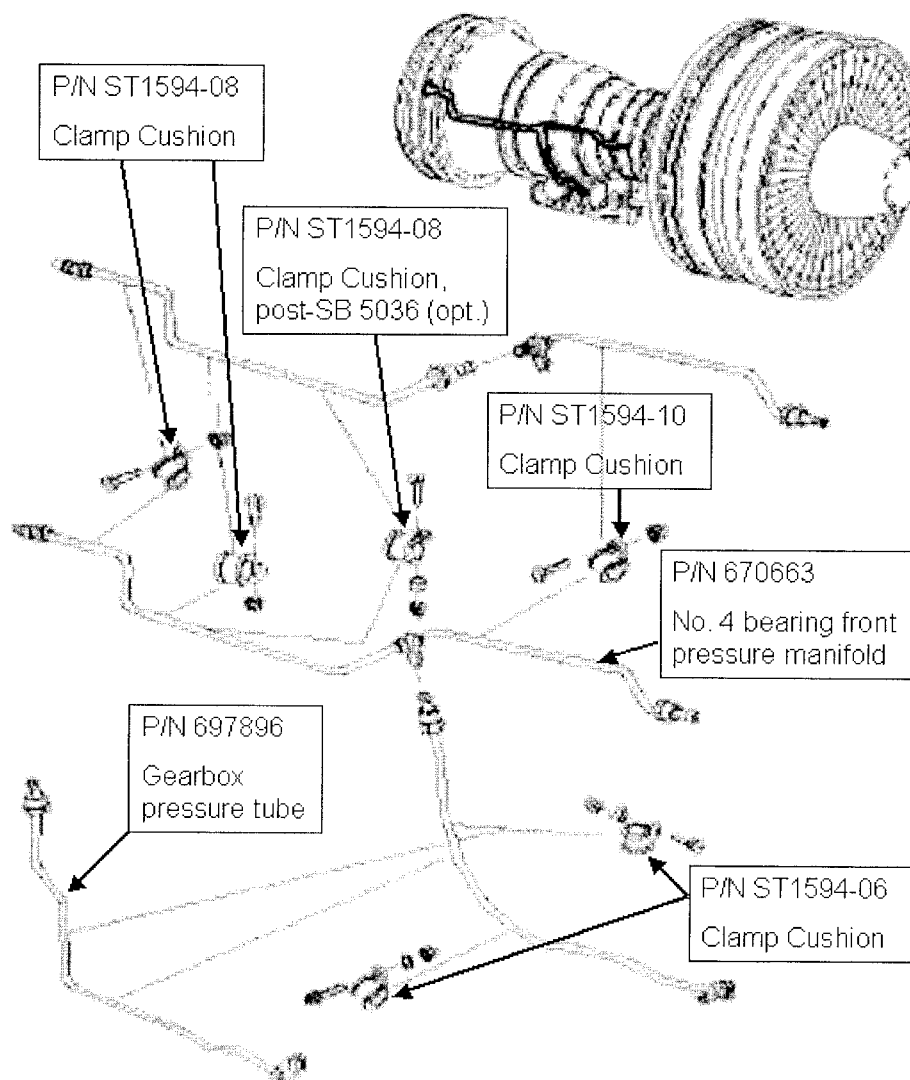
(g) If one or more clamp assemblies are rejected as described in paragraph (f) of this AD, or out of position or missing (see Figure 1 of this AD), clean any debris and oil from the outer surface of the gearbox pressure tube and No. 4 bearing front pressure manifold and visually inspect the tube and manifold. Repair or replace the affected tube or manifold before further flight if it is rejected by any of the following rejection criteria:

- (1) Nicks, chafing, scratches, and or pitting 0.003 inch or greater in depth.
- (2) Dents within 0.25 inch of the ferrules or will not permit free passage of a ball having a minimum diameter of 80% of the tubing inner diameter.
- (3) Corrosion that is unable to be removed by a light polishing.
- (4) Tube or manifold is leaking oil.

- (i) Dents in the gearbox pressure tube, P/N 697896, greater than 0.055-inch depth.
- (ii) Dents in the No. 4 bearing front pressure manifold, P/N 670663, forward of the tee fitting, greater than 0.100-inch depth.
- (iii) Dents in the No. 4 bearing front pressure manifold, PN 670663, aft of the tee fitting, greater than 0.080-inch depth.

(h) Ensure that the gearbox pressure tube, No. 4 bearing front pressure manifold, and clamp assemblies are properly positioned, before further flight, as shown in Figure 1 of this AD.
