**RBD INSPECTION LIMITS  
FIGURE 1.**

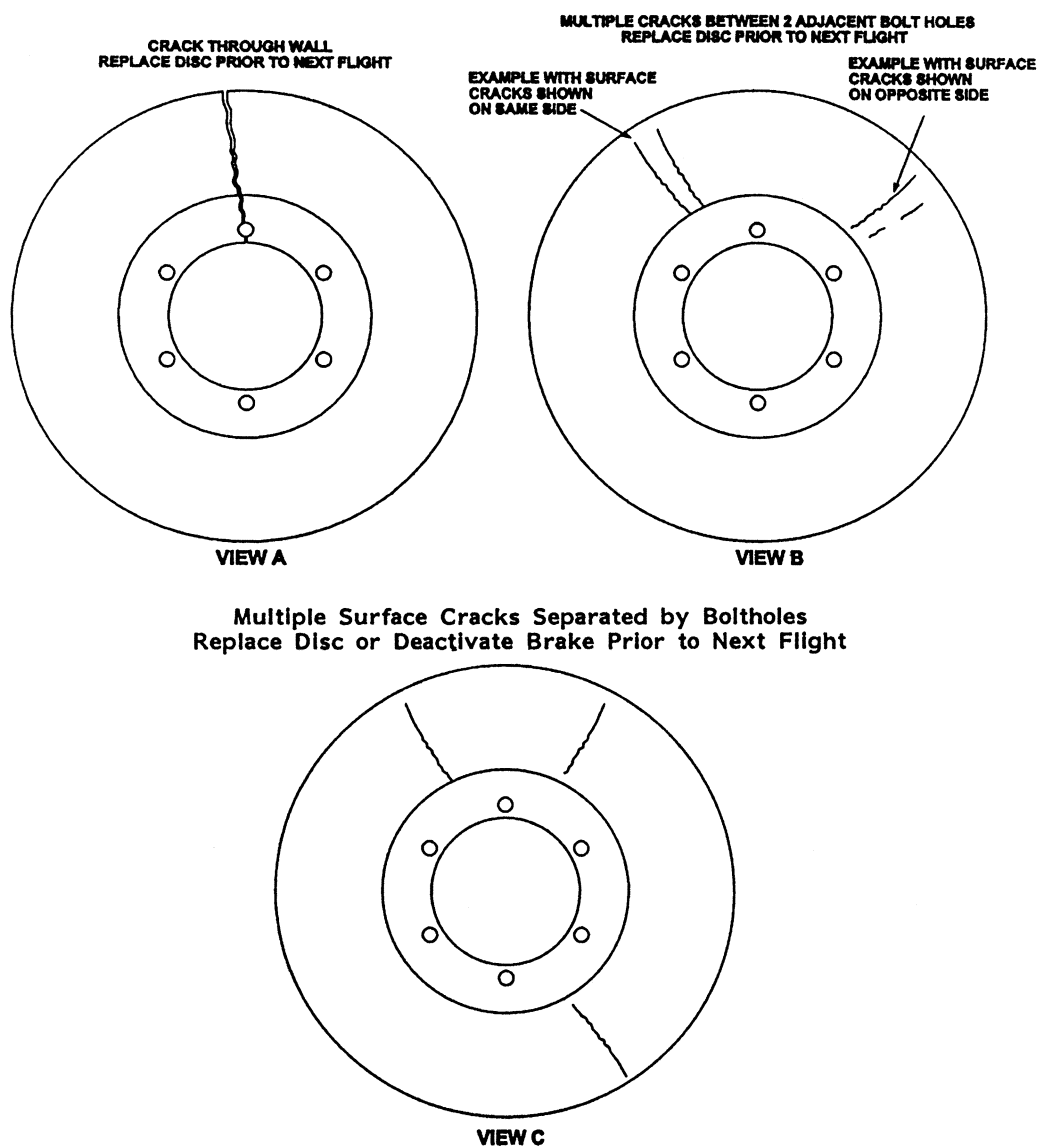
(1) If you find a crack through the entire RBD thickness as shown in Figure 1, View A, replace the RBD with an airworthy RBD, other than P/N 76363-09103-104, before further flight.

(2) If you find two or more surface cracks between adjacent boltholes as shown in Figure 1, View B, replace the RBD with an airworthy RBD, other than P/N 76363-09103-104, before further flight.

(3) If you find a surface crack or surface cracks separated by the boltholes as shown in Figure 1, View C, replace the RBD with an airworthy RBD, other than P/N 76363-09103-104, or deactivate the RBD before further flight.

**Note 3:** Short "glazing" cracks are not a cause for rejection.

(c) Replace PHC RBD, P/N 76363-09103-104, with an airworthy RBD on or before May 31, 2003, or within 60 days after the effective date of this AD, whichever occurs later. Any replacement RBD, P/N 76363-09103-104, is not airworthy.
