**Part Number 109-8132-01-111 Tail Rotor Blade**

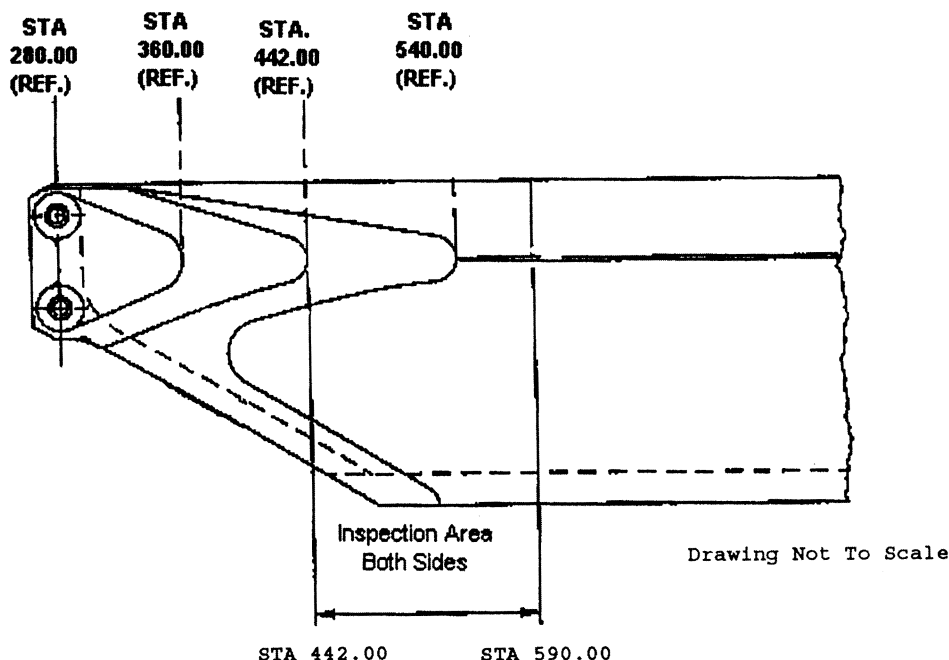
**FIGURE 1**

(h) Before each start of the helicopter engines, visually check both sides of each tail

rotor blade for a crack in the area depicted in Figure 1 of this AD. An owner/operator (pilot) holding at least a private pilot certificate may perform this visual check and must enter compliance with this paragraph into the aircraft maintenance records in accordance with 14 CFR 43.11 and 91.417(a)(2)(v). See Figure 1.

(d) Before further flight, replace any unairworthy T/R blade with an airworthy blade.

(j) Before further flight, replace any unairworthy T/R blade with an airworthy blade.
