Map of Marcellus formation natural gas drilling sites identified during 8/27/09 field trip to Bradford County, PA.

George Frantz  
Natural gas Drilling Reconnaissance Trip to Bradford County, PA  
August 27, 2009

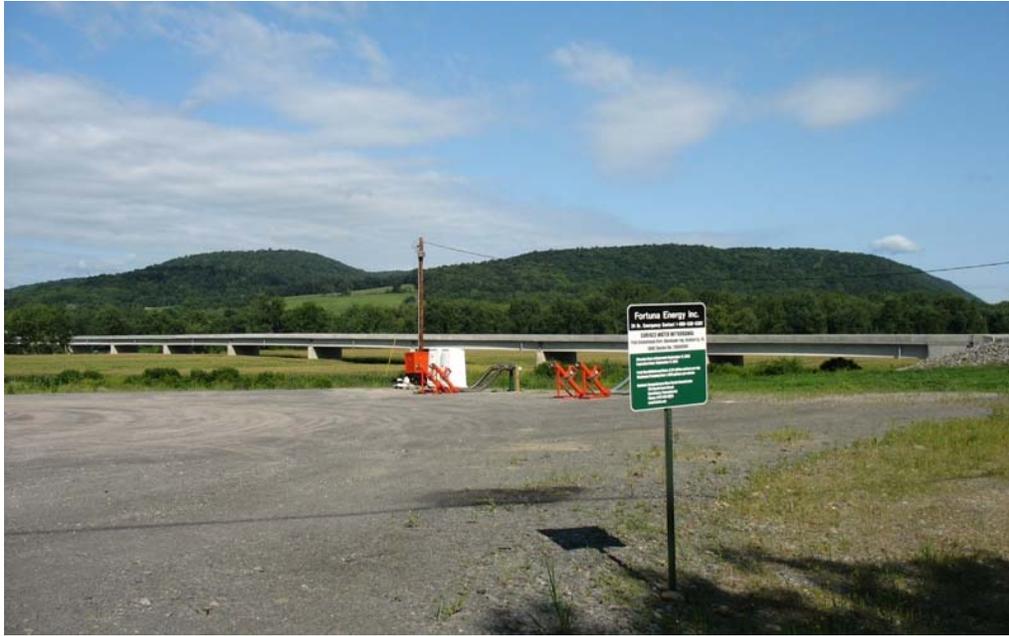
Water withdrawal site at Sheshequin, PA. Site consists of a gravel pad approximately 1 acre in area with four hydrants hookups, generator and pump. The actual intake in the river is approximately 1,000 feet to the left of the photo and is connected to the pad by an underground main. These water withdrawal pads are subject to local zoning regulations and some townships and boroughs require site plan approval or special permit review.

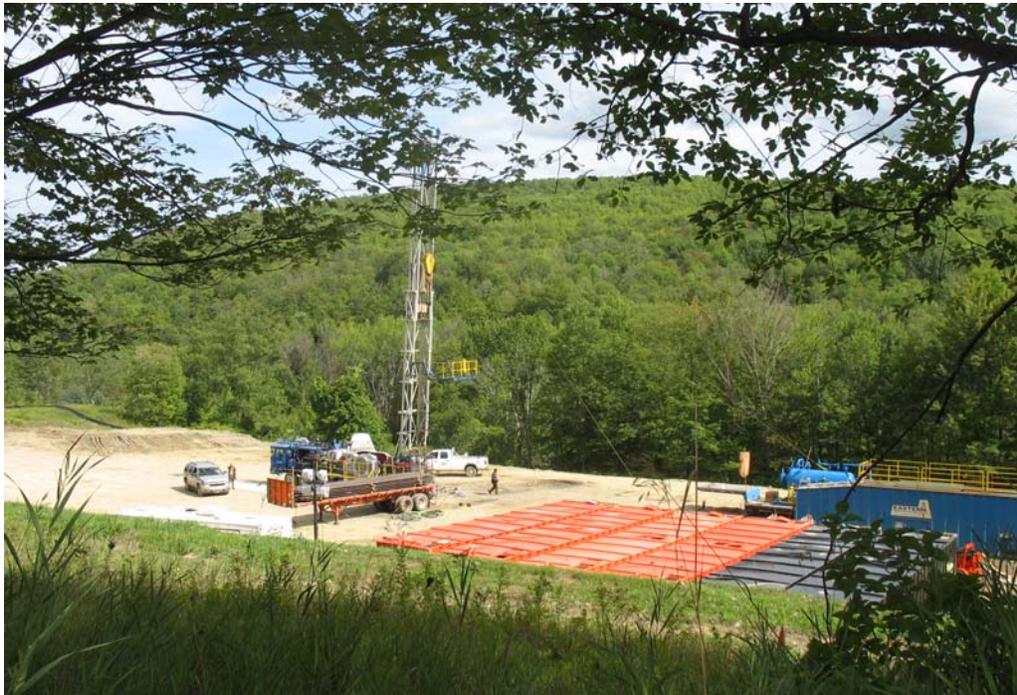
New drilling pad being developed in Smithfield Township. The pad is located on abandoned pasture land.

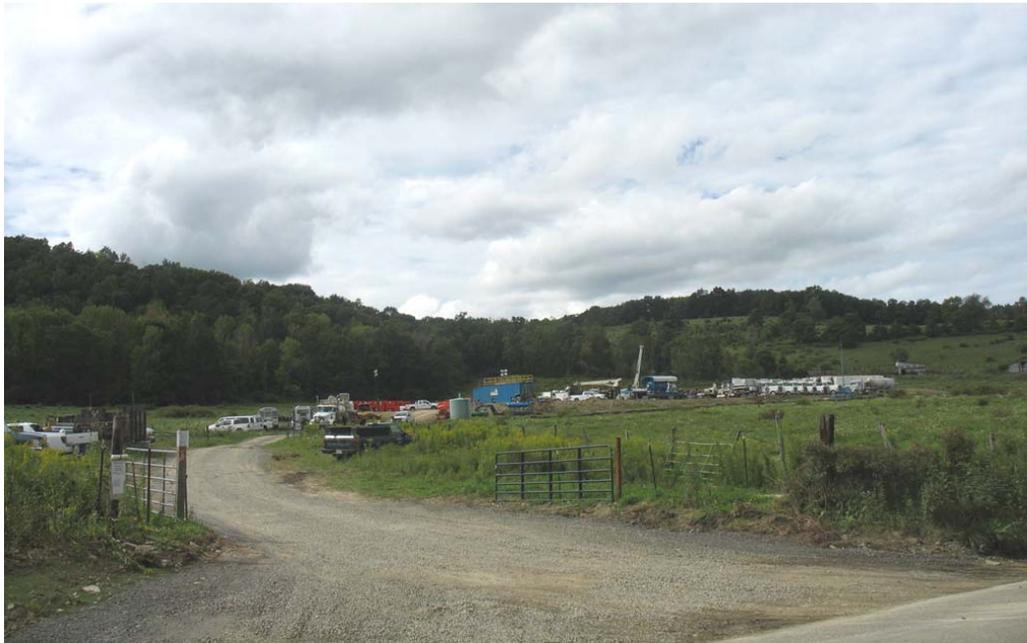
New drilling pad being developed off Mile Lane, Athens Township, on abandoned farmland.

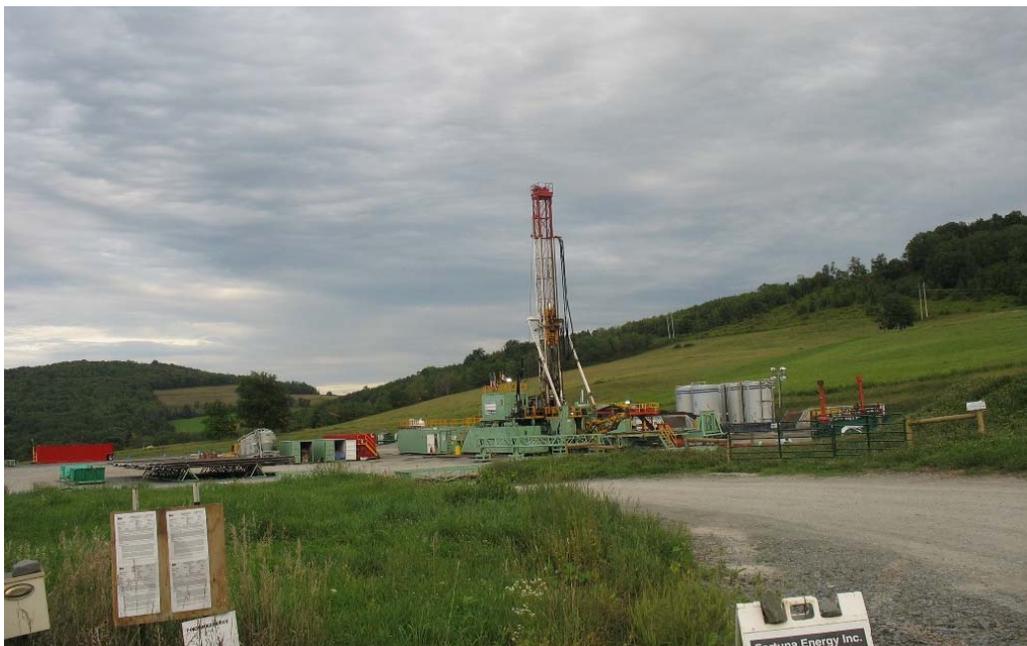
The Bense Pad, located just west of Troy, PA. The pad covers about one acre and is located on what was actively farmed land, probably hay field. (The neighbors gave me access across their land to photograph.)

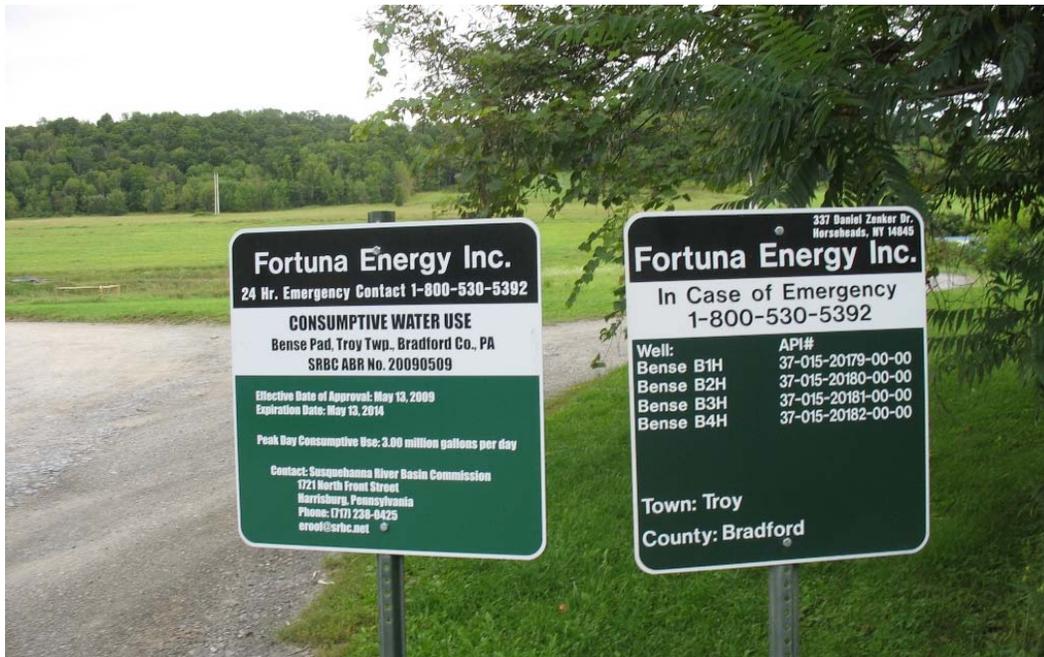
Signs posted at the entrance to the Bense Pad. Sign on left is required by the SRBC and indicates a maximum water usage of 3 MGD; sign on right indicates that four wells are being drilled from the pad.

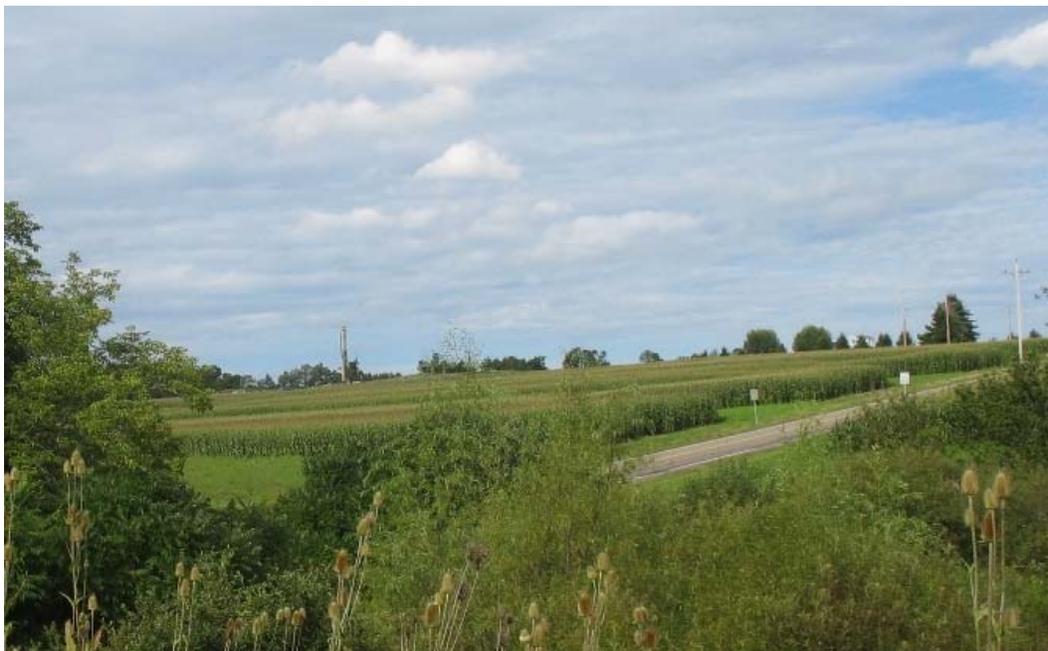
Natural gas drilling operation off Springfield Road, Springfield Township, located on area of active cropland.

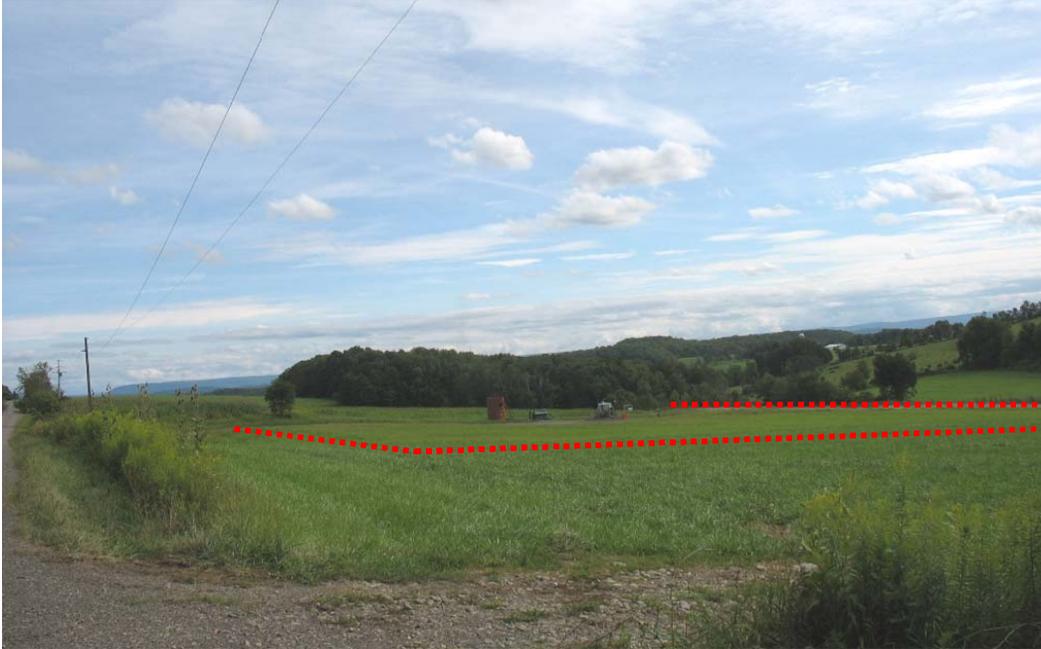
Completed natural gas well on cropland off Ballantine Road in Smithfield Township. The lighter green vegetation within red dashed lines indicates size of area of disturbance from former drilling pad. Site appears to be restored to former condition.

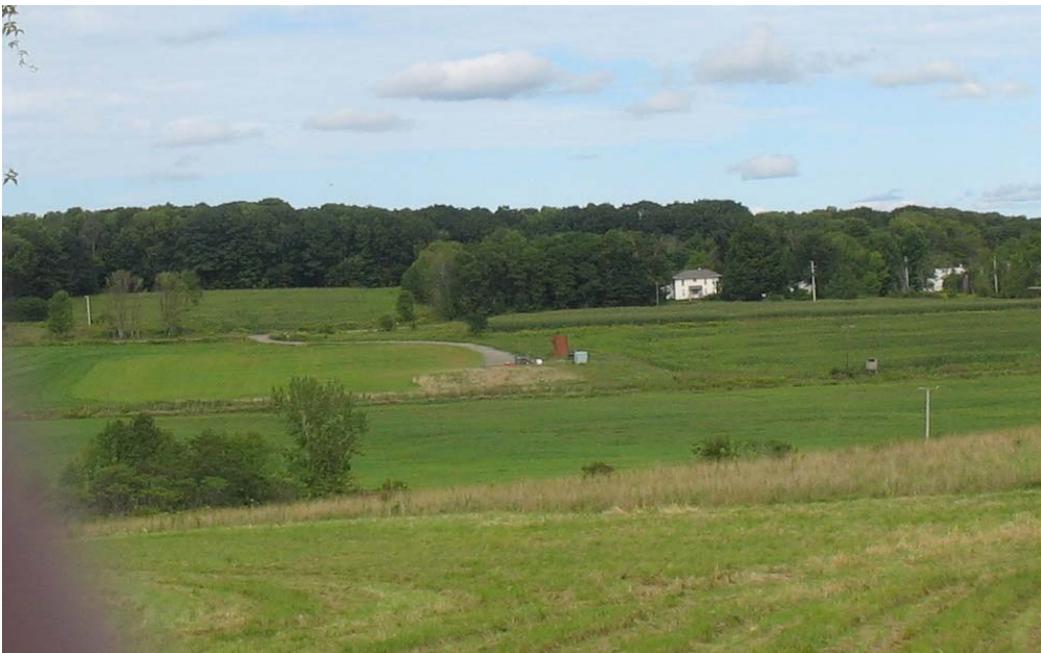
Ballantine Road well from approximately 0.4 miles away. Lighter area of vegetation to the left of well and tank indicates area of drilling pad disturbance.

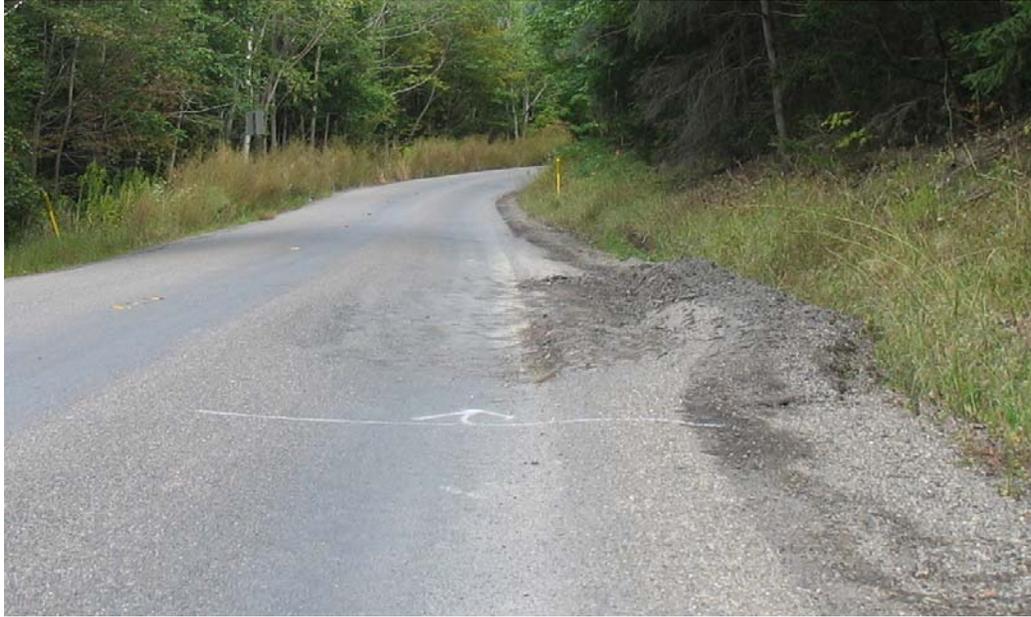
Typical area of failure along Fallbrook Road (SR 3032) on Armenia Mountain. It appears that area of sub-base has failed, causing the road sub-base and surface to sink and displace to the right and upward. In numerous places the road exhibits such damage from heavily loaded truck traffic. A ruling road gradient of 10% or more exacerbates the impact of heavy trucks on the pavement due to the additional horizontal forces exerted by the driving wheels of a truck. Fallbrook road is a state owned and maintained road.

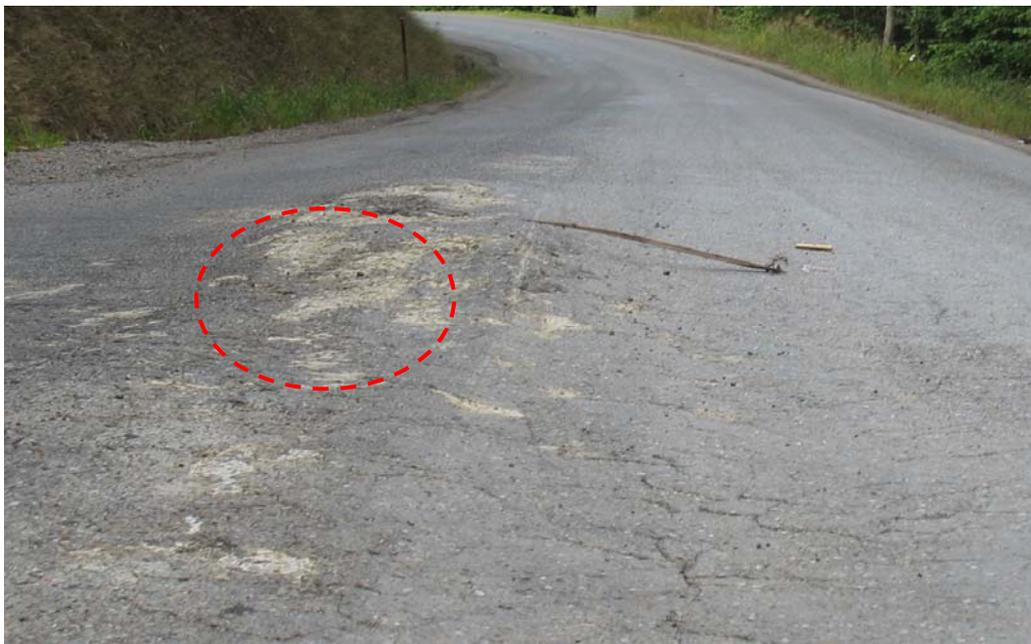
Another damaged section of Fallbrook Road. Lighter areas within oval indicate where cars and light trucks have scraped the area of pavement where the road has been displaced upwards 6 inches or by heavy trucks.

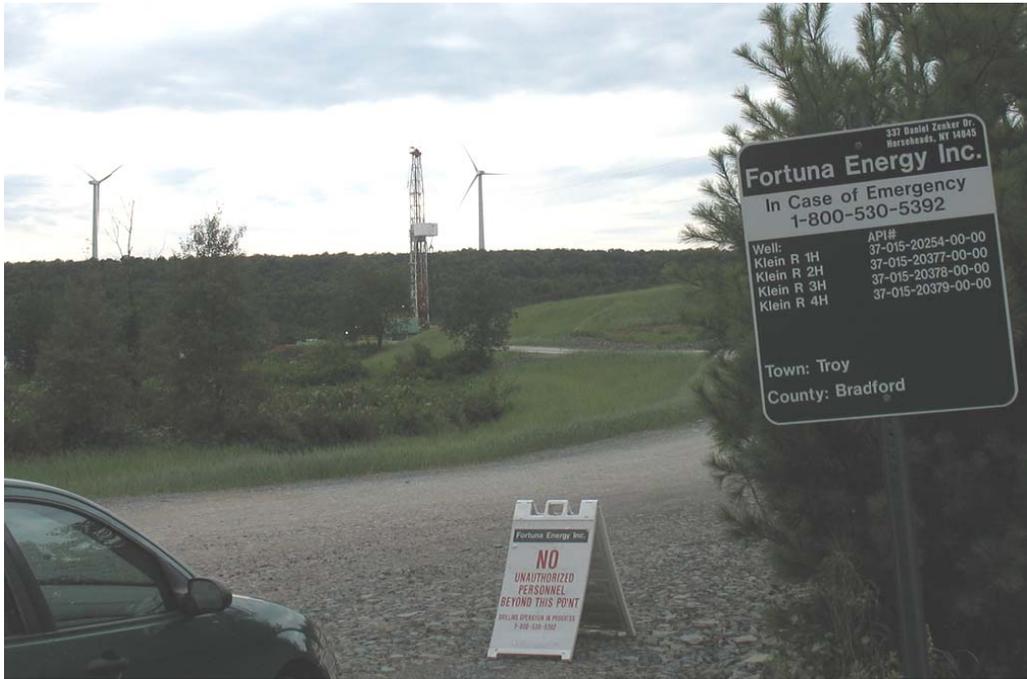
Drilling rig and new wind turbines, Armenia Mountain.

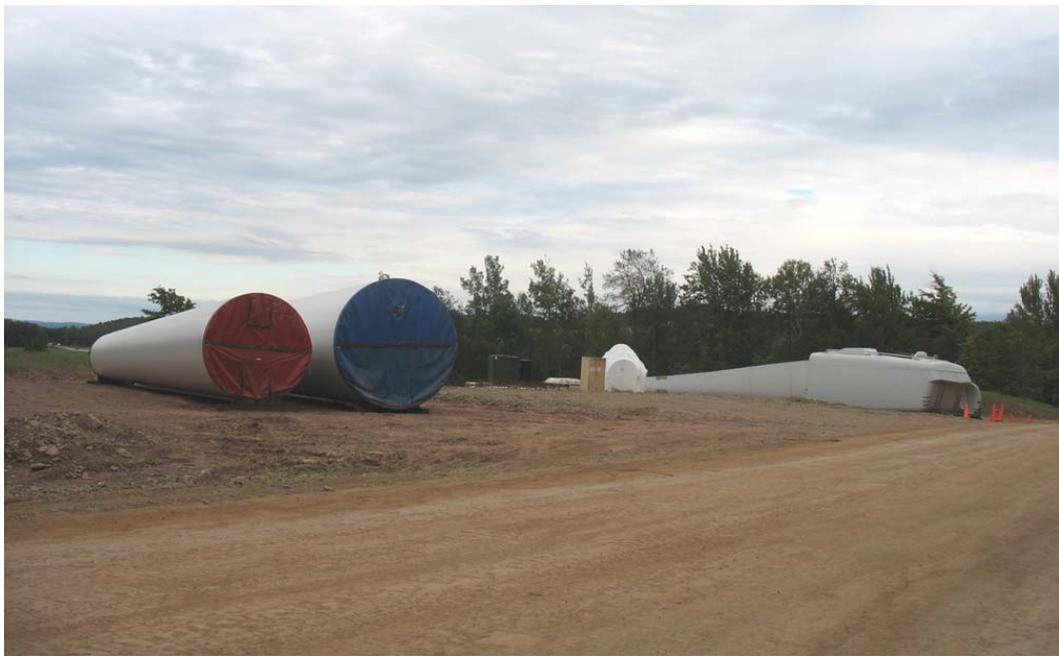
Wind Turbine pad and turbine components, AES Armenia Mountain Wind Farm currently under construction.
