NATIONAL AERONAUTICS AND SPACE ADMINISTRATION

APOLLO 13 MISSION REPORT

MANNED SPACECRAFT CENTER

SEPTEMBER 1970

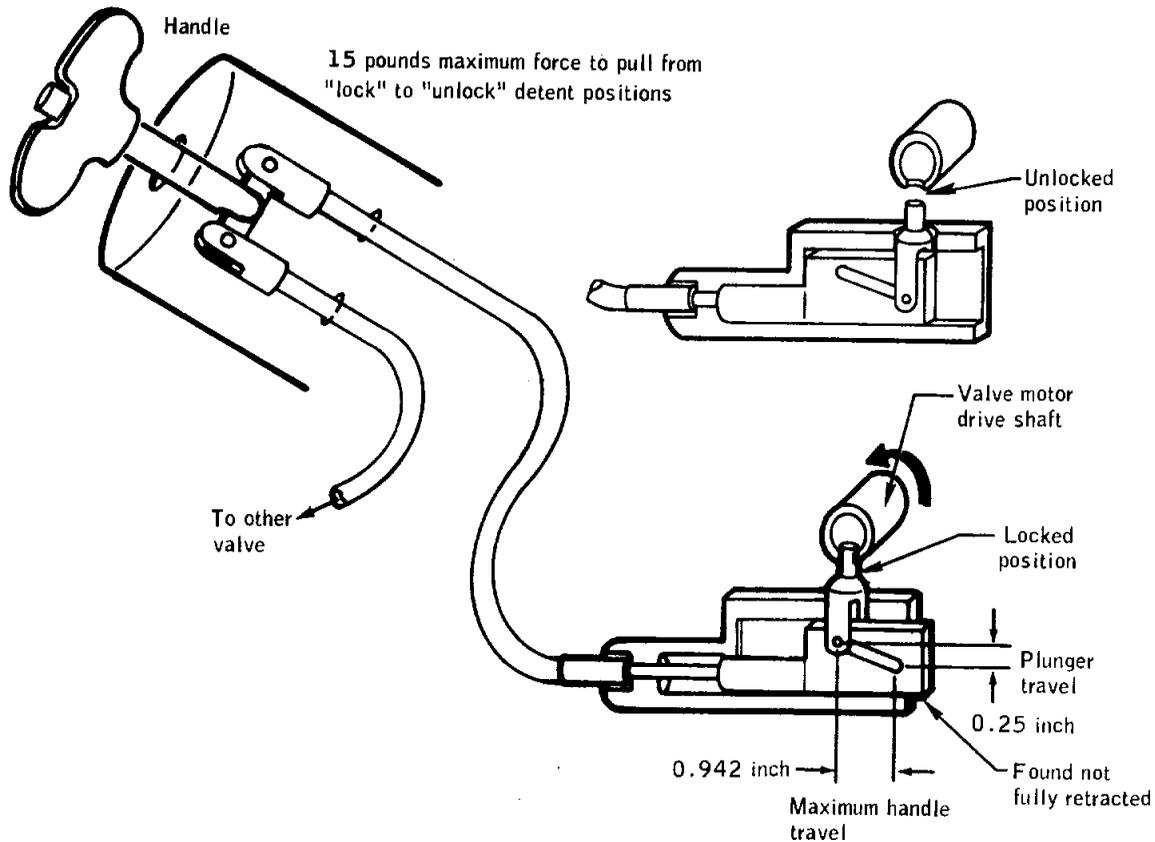
Figure 14-1.- Post-landing vent valve lock.

The valve-lock mechanism rigging tolerances were found to be within specifications. When reassembled in the spacecraft, the malfunction was duplicated with only partial travel of the handle.

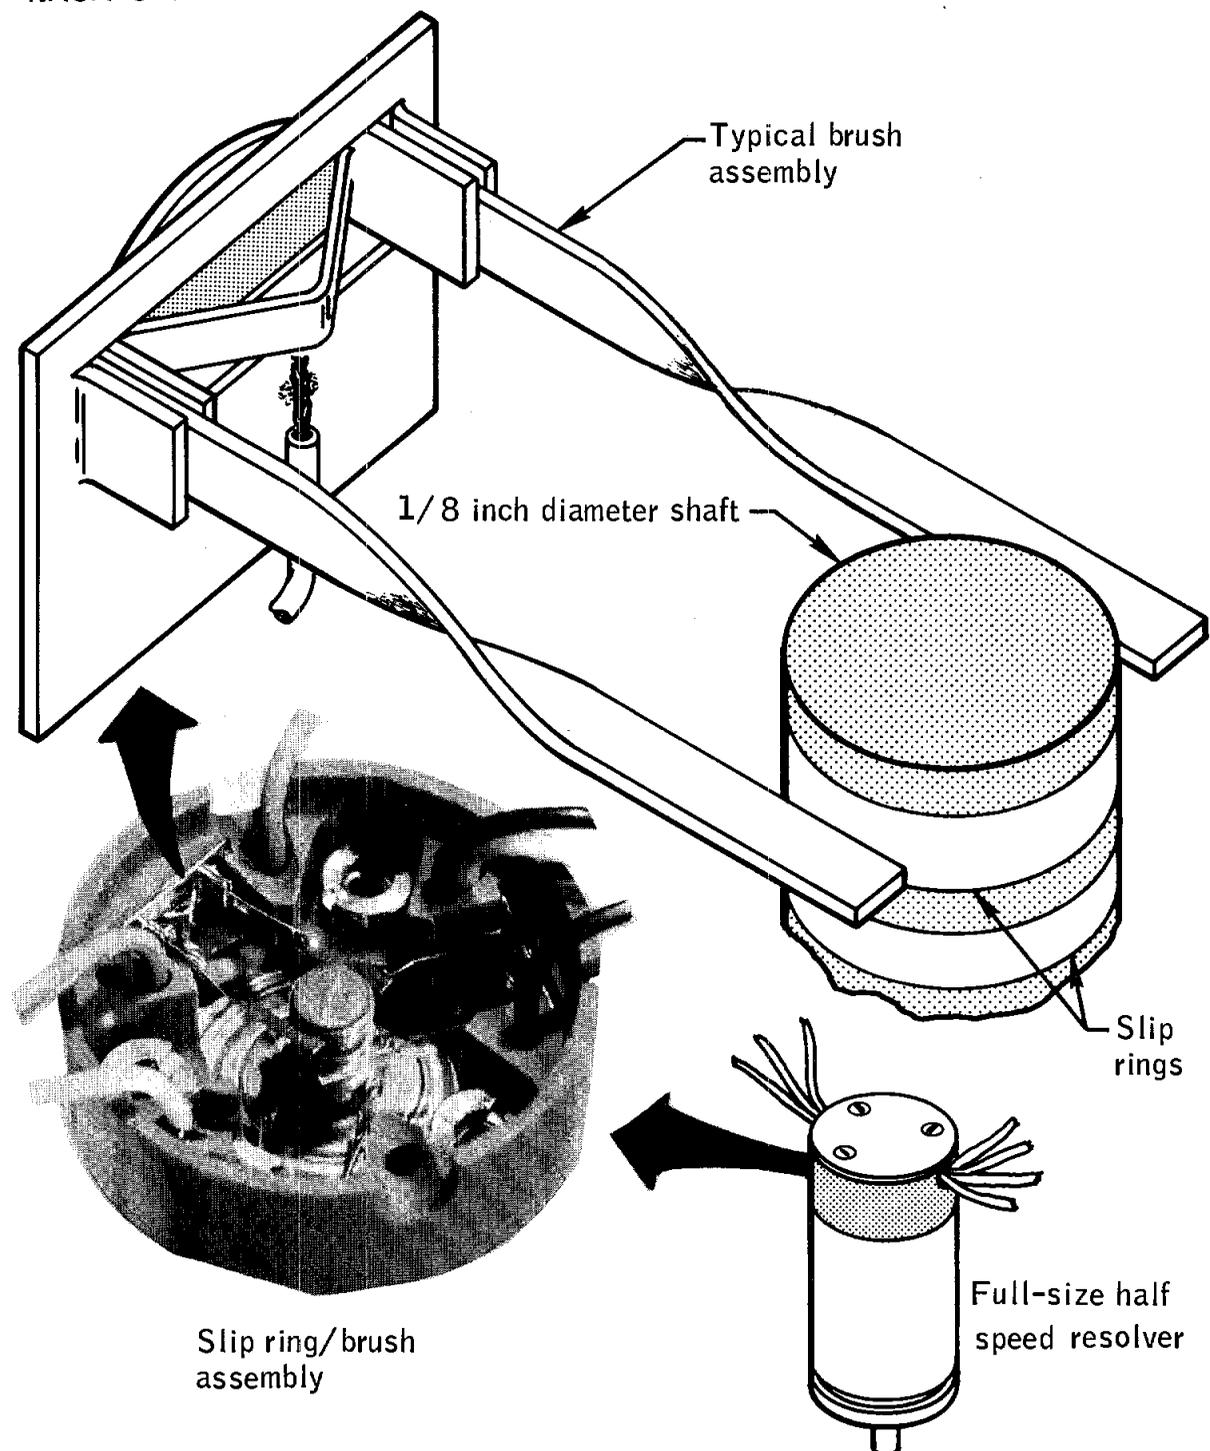
Figure 14-3.- Details of half speed resolver.

vacuum testing. The tests were run with the units rotating at 1 rpm, however, and the momentary resistance changes disappeared with the wiping action.

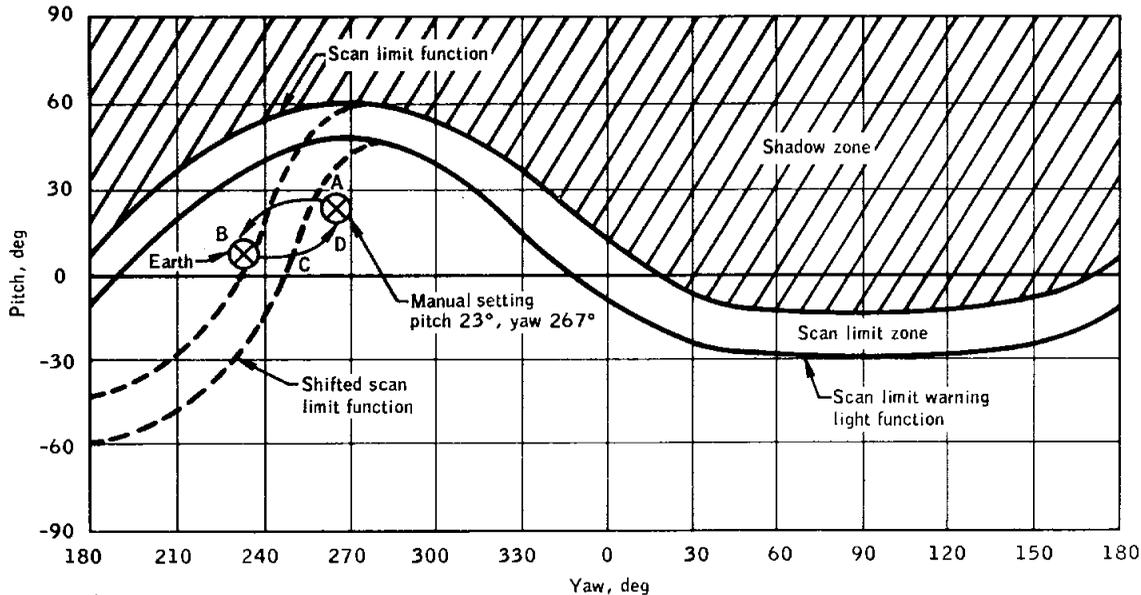
Figure 14-5.- Shift in scan-limit, scan-limit-warning illustrated.

mode and drive back toward the manual settings until the scan limit warning function line at point C was reached, thereby maintaining wide-beam operation. When the antenna reaches the scan limit warning function line, the system would automatically switch to the medium-beam mode and continue to drive in the manual mode until the manual setting error was nulled out at point A. The antenna would then switch to the auto-track mode and repeat the cycle. The most important feature of this cycle is that the antenna moves at the manual scan rate between points B and D, which is confirmed by the rapid changes in the downlink signal strength.

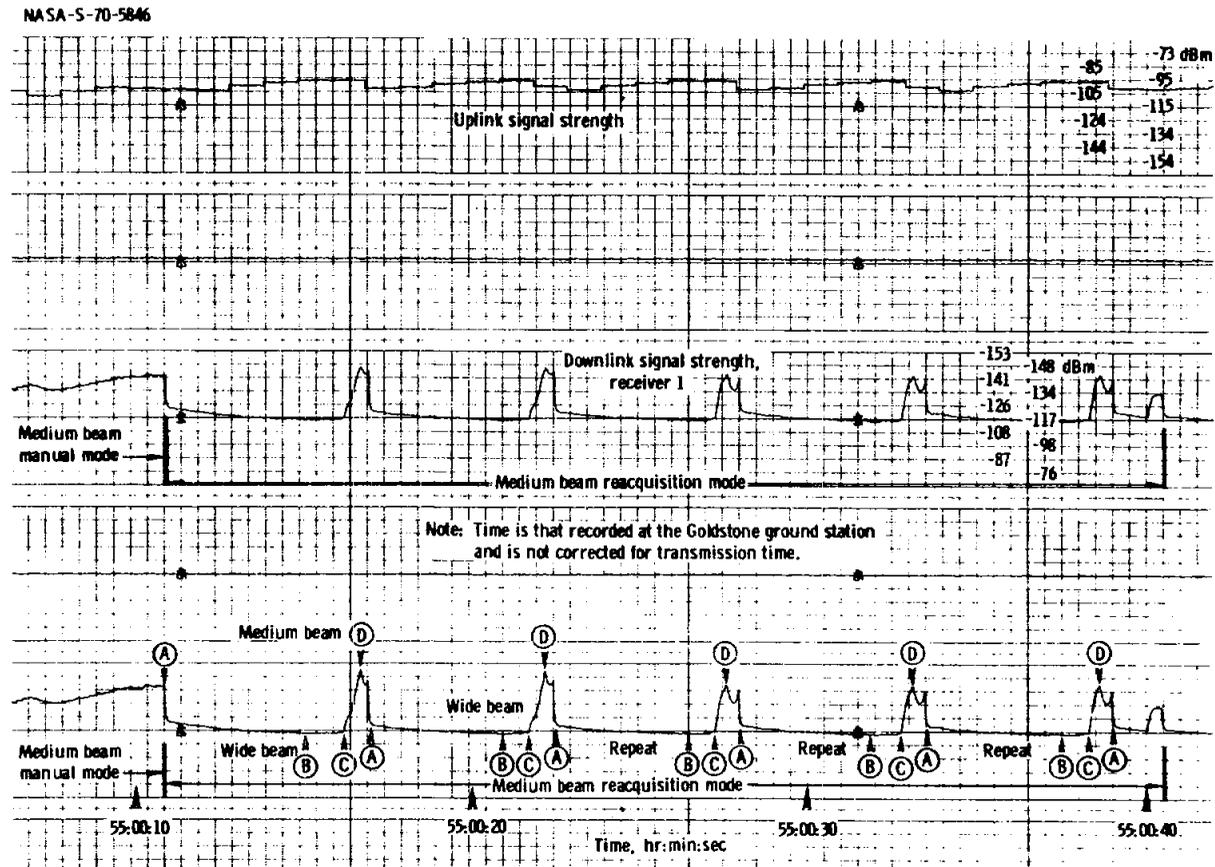
Figure 14-6.- Recorded signal strengths during high-gain antenna operation.

results of this test shifted the scan-limit functions but did not produce the necessary change in the scan-limit slope. Consequently, a failure in the electronic box is ruled out.

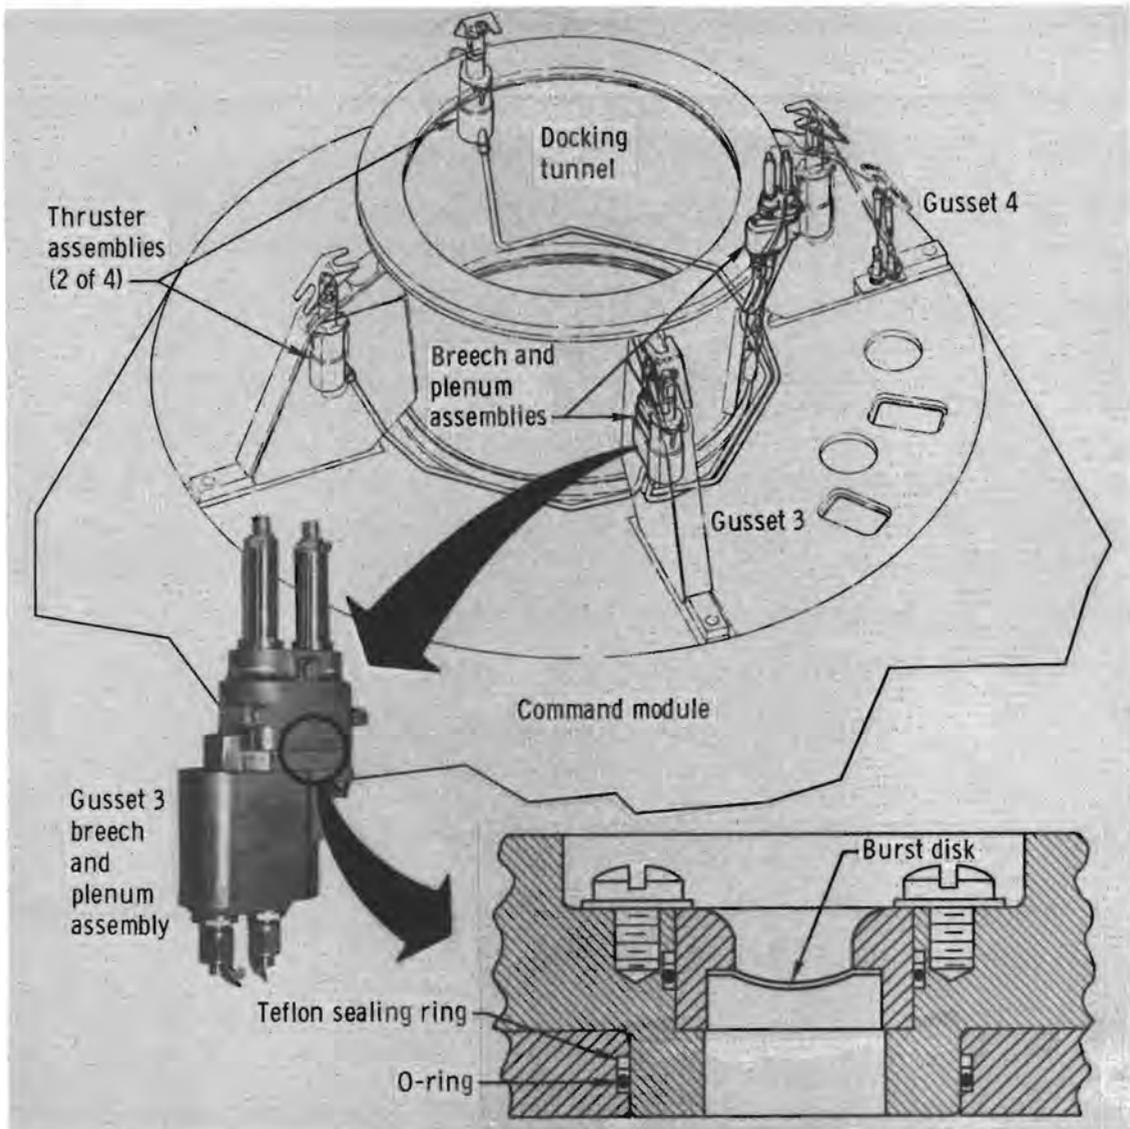
Figure 14-7.- Apex cover jettison system.

- a. Out of tolerance parts - Measurement of the failed parts indicate acceptable dimensions of the metal parts.
- b. Damaged O-rings - The 21 000-psi static proof-pressure test was successful.
- c. Gap in backup ring - The installation procedure specifies the backup ring may be trimmed on assembly to meet installation requirements,

but does not specify any dimensional control over the scarf joint. Since the gap portion was burned away, a gap in the backup ring could have caused the problem.

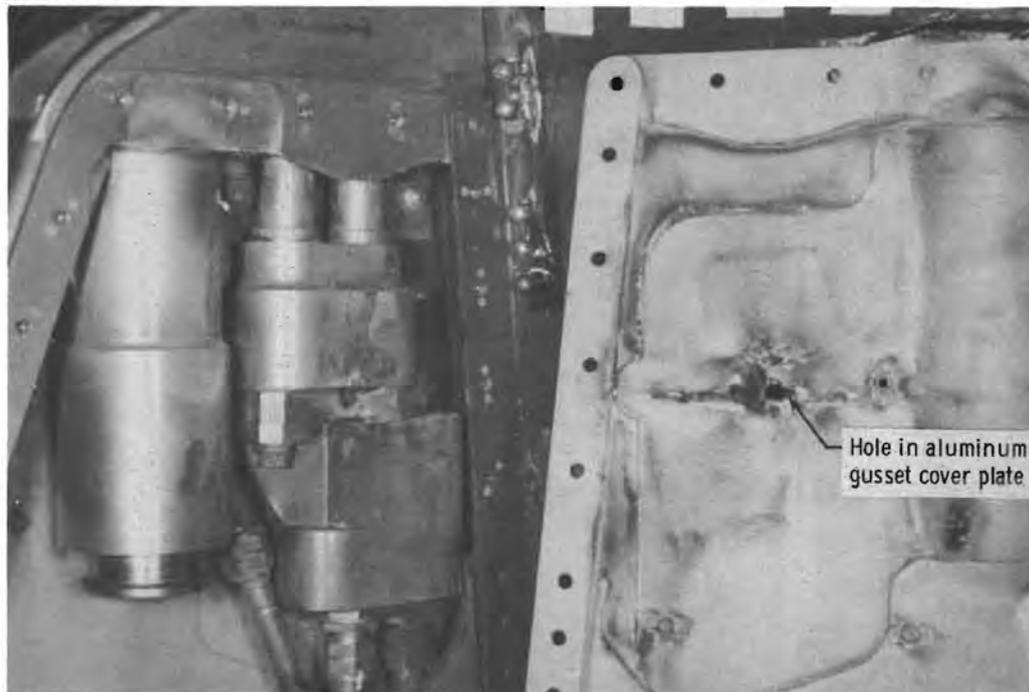
Figure 14-8.- Damage from apex jettison thruster.

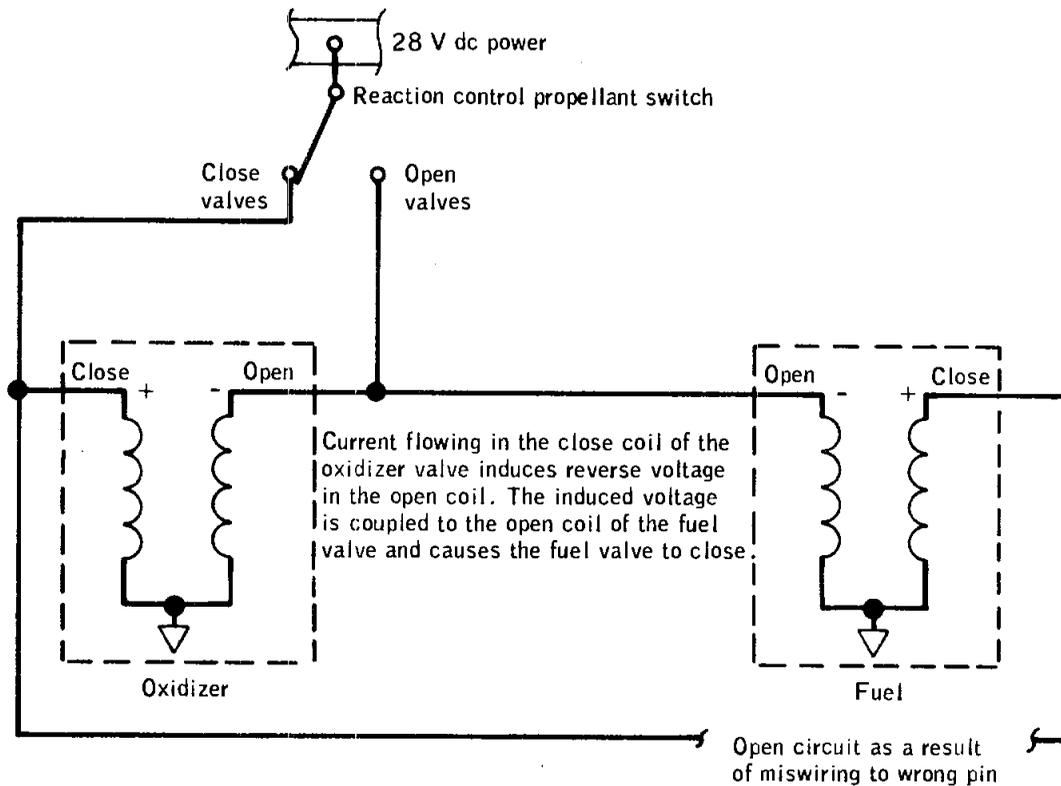
Figure 14-11.- Isolation valve circuit.

action. This voltage is applied to the fuel valve opening coil where it induces a magnetic field flux that closes the fuel valve. With 28 volts or more on the spacecraft bus, this phenomenon was consistently repeatable. With 24 to 28 volts on the bus, the valve would occasionally close, and with less than 24 volts, the valve would not close. Since preflight testing is accomplished at 28 volts, the functional tests did not disclose the miswiring. During the mission, the voltage was such that the valve did not close when commanded and therefore was found open after the flight.

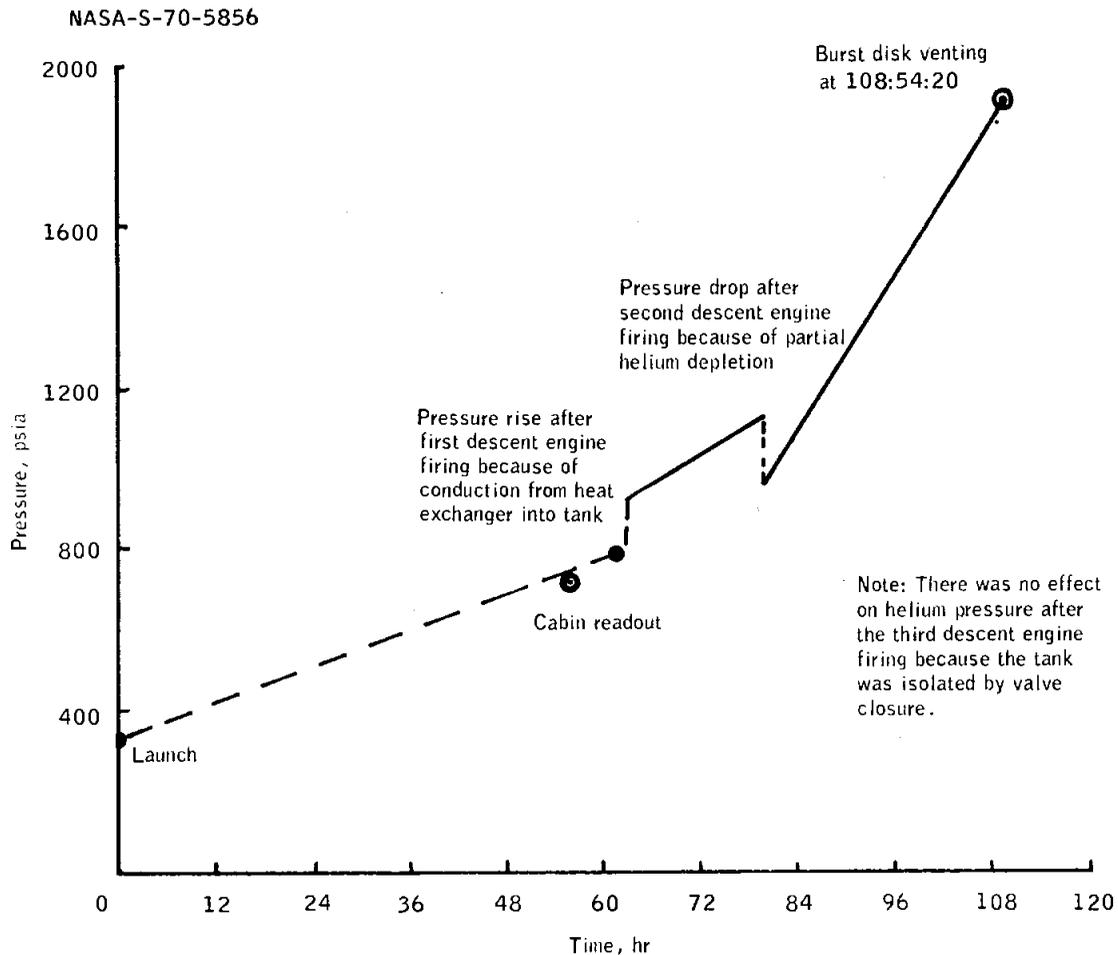
Figure 14-14.- Inflight profile of supercritical helium tank pressure.

The most likely cause of the anomaly is a tank-insulation degradation which would result in increased heat conduction to the helium. The insulating characteristics of the annular vacuum in tank was most likely degraded by the introduction of a contaminant (probably hydrogen) in extremely small concentrations (approximately 10^{-6} pounds). These contaminants when vaporized can exponentially increase the thermal conductivity in proportion to their vapor pressure, as indicated by special tests. While loading helium into the tank, the contaminants would freeze upon the inner shell. In the frozen state, the pressure of the contaminant is too low to significantly affect the thermal conductivity. However, the flow check which preceded the cold-soak operation would vaporize the contaminants in the vicinity of the heat exchanger lines which pass through the annulus. The subsequent increase in thermal conductivity could cause the abnormally high pressure-rise rate observed during the cold soak. These vapors would slowly condense on the cold (10° R) inner wall, resulting in the pressure rise rate dropping to the nominal level, as was observed. The rise rate would remain normal until the helium temperature increased above the vaporization temperature of the contaminant.

A screening test was devised for all future flight tanks to supplement normal helium tank testing. The purpose of this test is to determine the pressure rise rate for a wide range of helium temperatures from approximately 9° to 123° R. For a perfect tank, the steady-state rise rate should remain at approximately 8 psi/hour over the entire range of temperatures. The Apollo 14, 15, and 16 tanks have been subjected to the screening test, and each exhibit the same phenomena observed during Apollo 13, but to a lesser degree. For new tanks, the manufacturer will periodically analyze the gases removed from the vacuum jacket during pump down for possible contaminants. The pressure in the jacket will be measured 2 or 3 weeks after pumpdown to verify vacuum integrity.

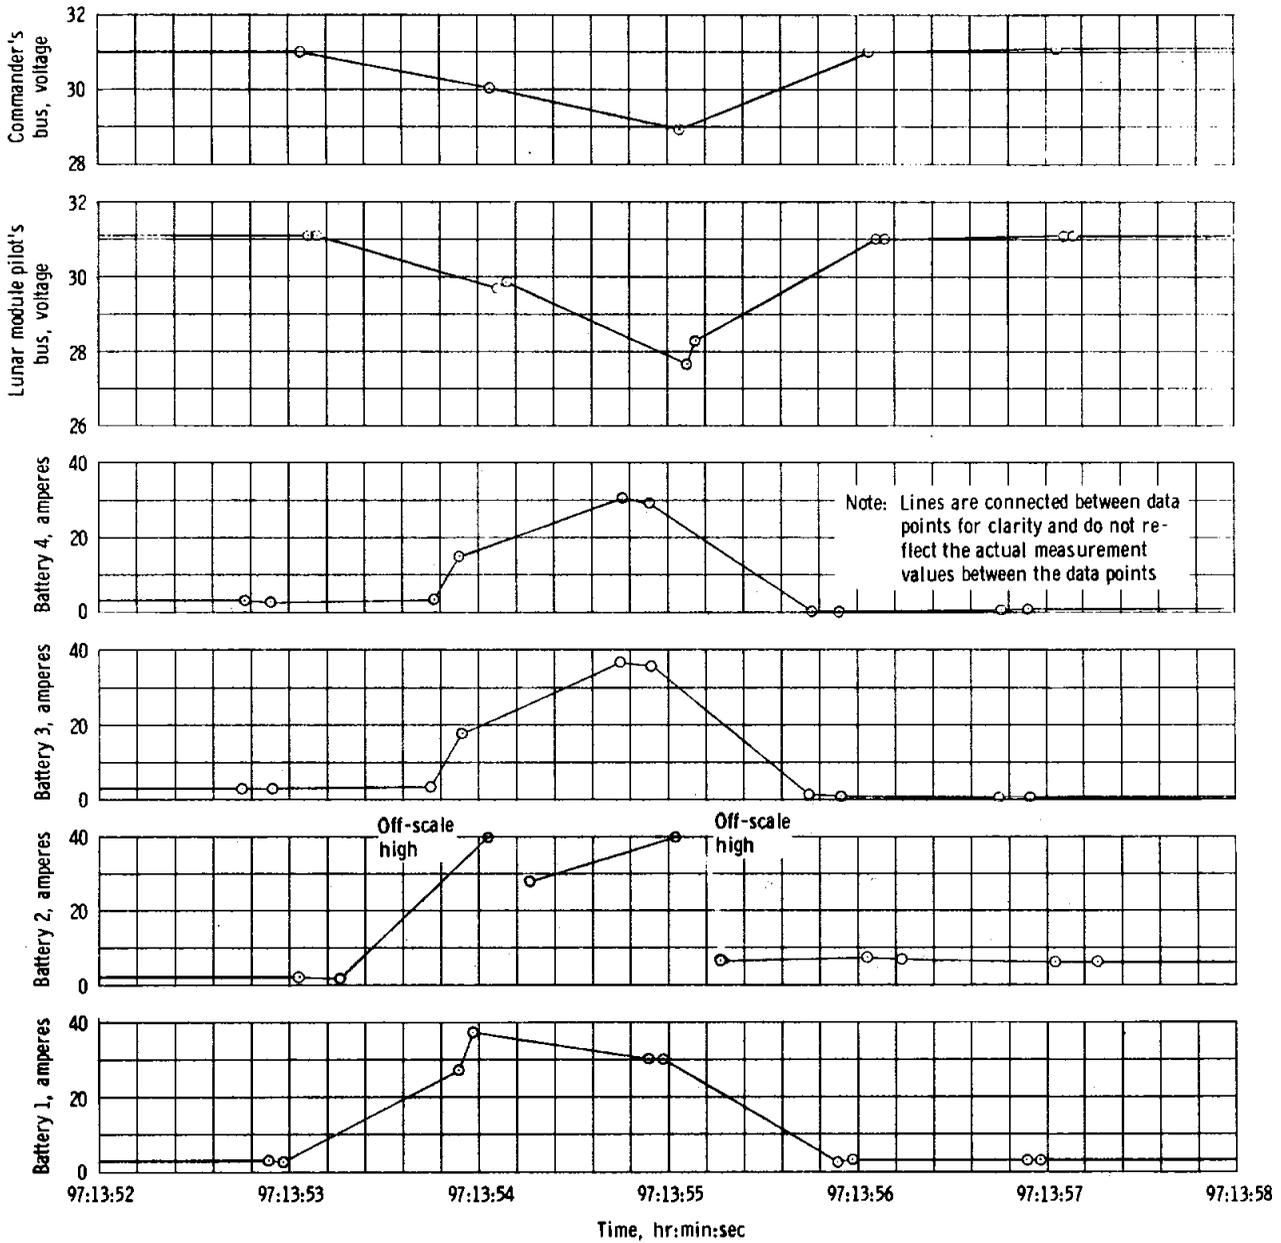
Figure 14-16.- Battery electrical transients.

The thumping noise occurred at about the same time as the current spikes. The current spikes show that a momentary short circuit existed in the Lunar-Module-Pilot side of the dc electrical system, which includes descent batteries 1 and 2 (fig. 14-16). The current surge was not of sufficient duration either to open the balance-load cross-tie circuit breakers, to display a reverse current indication, or to trip a battery-off relay as a result of an overcurrent condition.

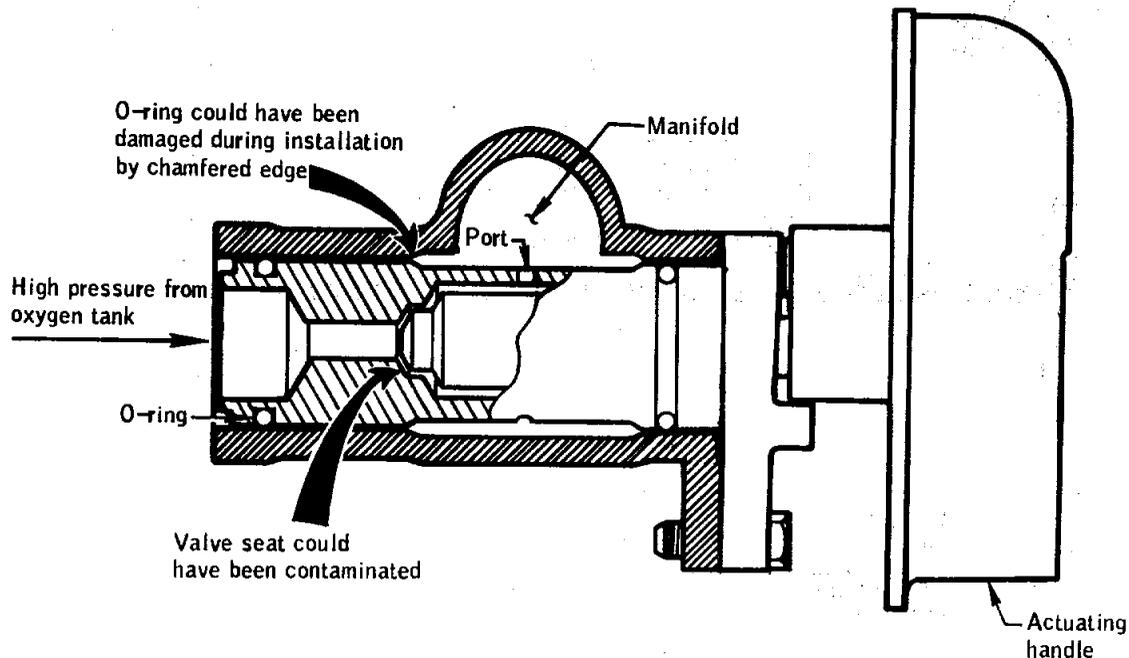
Figure 14-20.- Ascent stage tank shutoff valve.

The internal portion of three valves of this type had been replaced previously on the spacecraft because of excessive leakage through the ascent oxygen tank 1 shutoff valve. In one valve, a rolled O-ring

(fig. 14-20) caused the leakage. When the valve is installed, the forward O-ring can be rolled and damaged when it passes the manifold port. In the other two valves, the cause was not identified and was assumed to be contamination.

compression allowed in the valve design would aggravate the tendency for the O-ring to roll during valve assembly.

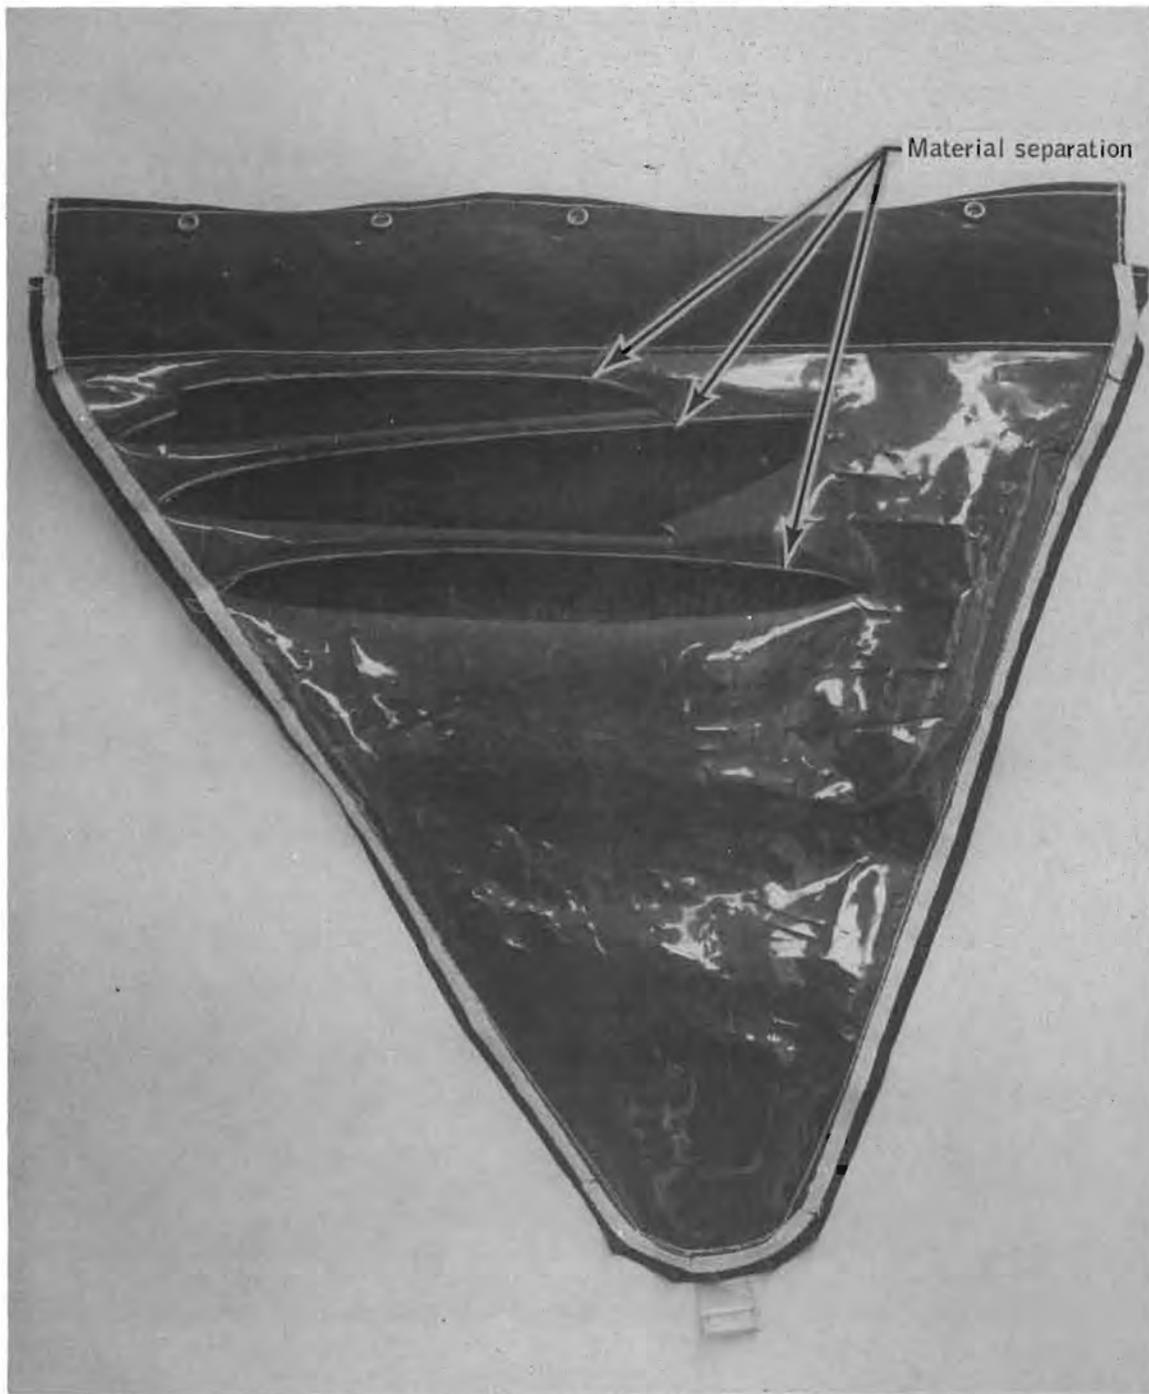
Figure 14-21.- Cracked left-hand window shade.

Cracking as a result of Aclar embrittlement has occurred before, therefore, the Apollo 13 shades were examined prior to flight. Since no cracks were found, the shades were approved for flight.
