I. Salvage of the USS GUITARRO (SSN 665)I.1. Brief

USS GUITARRO (SSN 665) was in an advanced state of construction at the San Francisco Bay Naval Shipyard (Mare Island Division). On the evening of 15 May 1969 uncontrolled flooding caused the GUITARRO to sink. Salvage operations were conducted by the Supervisor of Salvage.

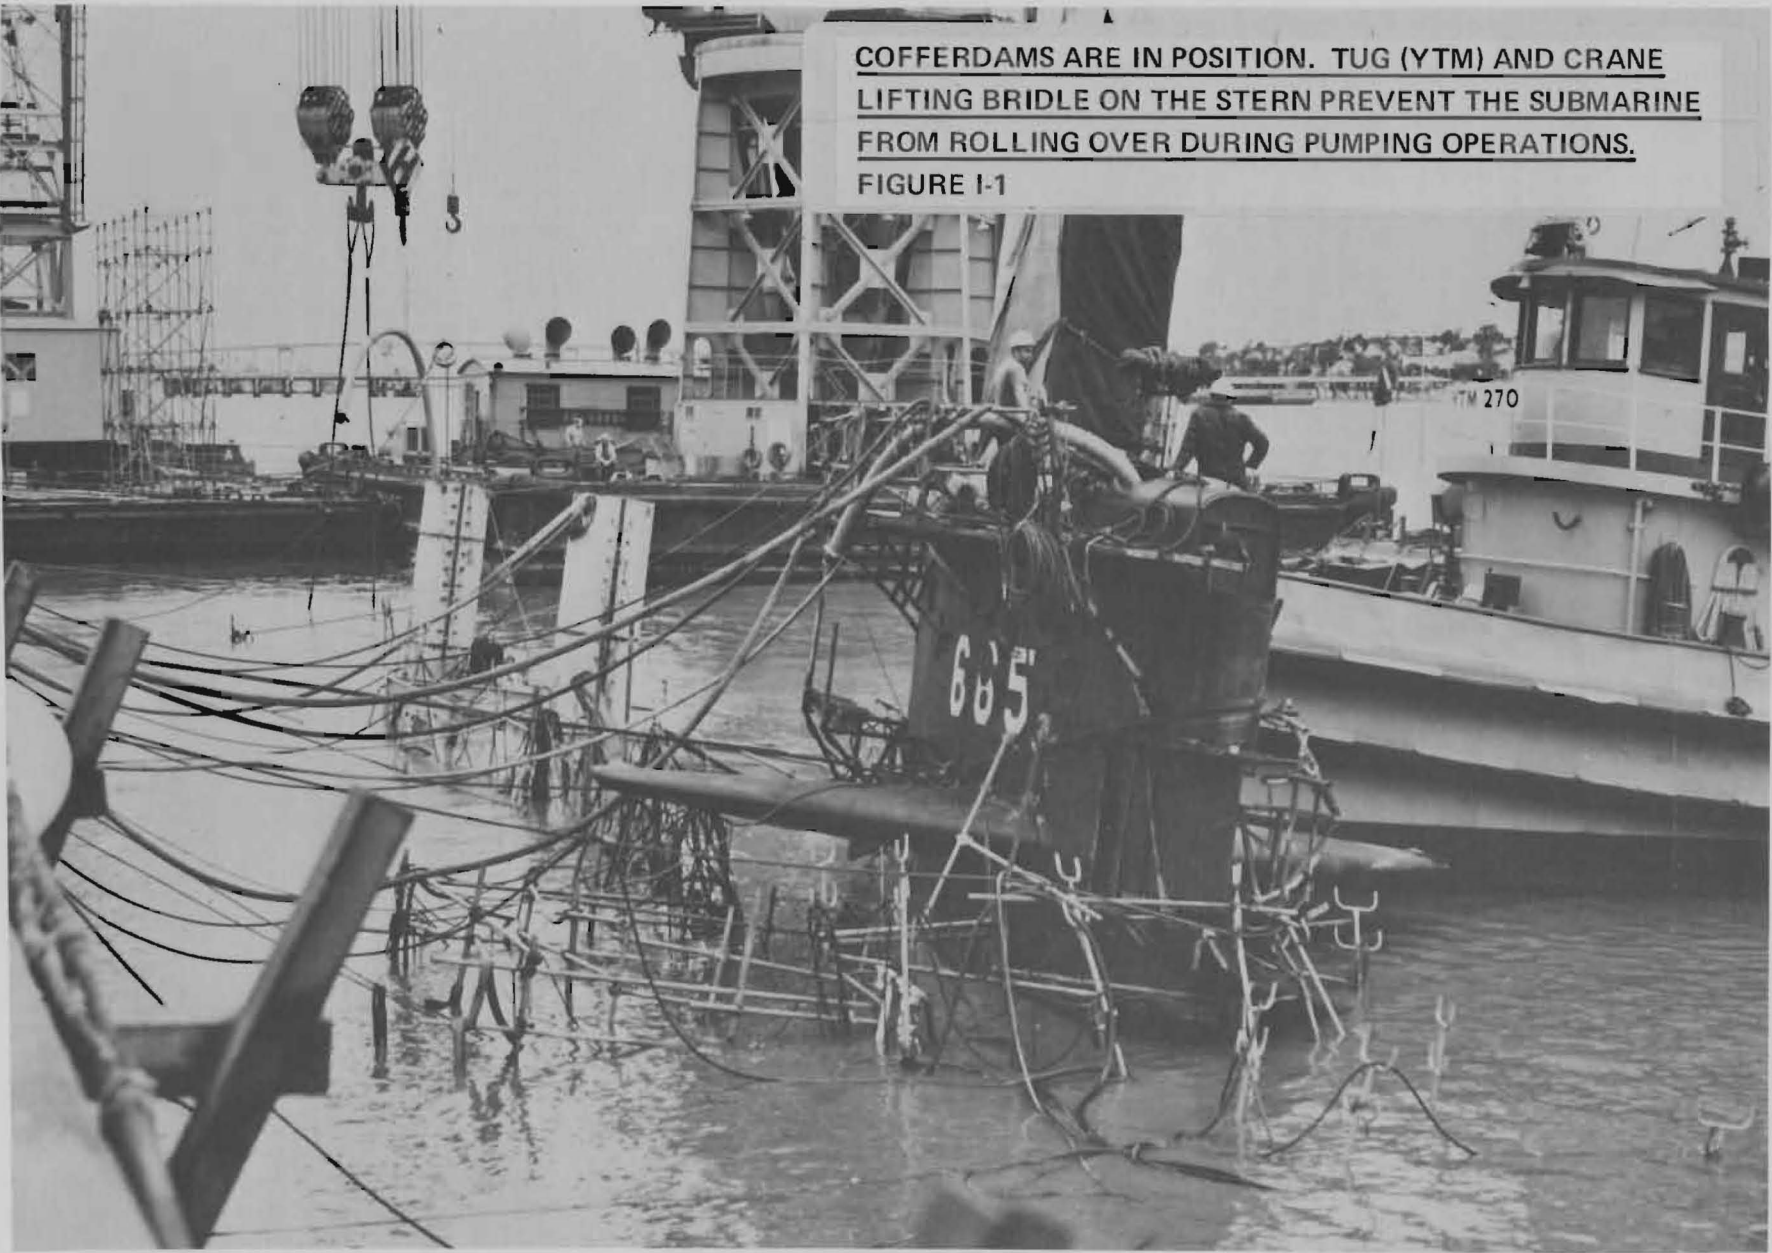
FIGURE I-1

COFFERDAMS ARE IN POSITION. TUG (YTM) AND CRANE  
LIFTING BRIDLE ON THE STERN PREVENT THE SUBMARINE  
FROM ROLLING OVER DURING PUMPING OPERATIONS.

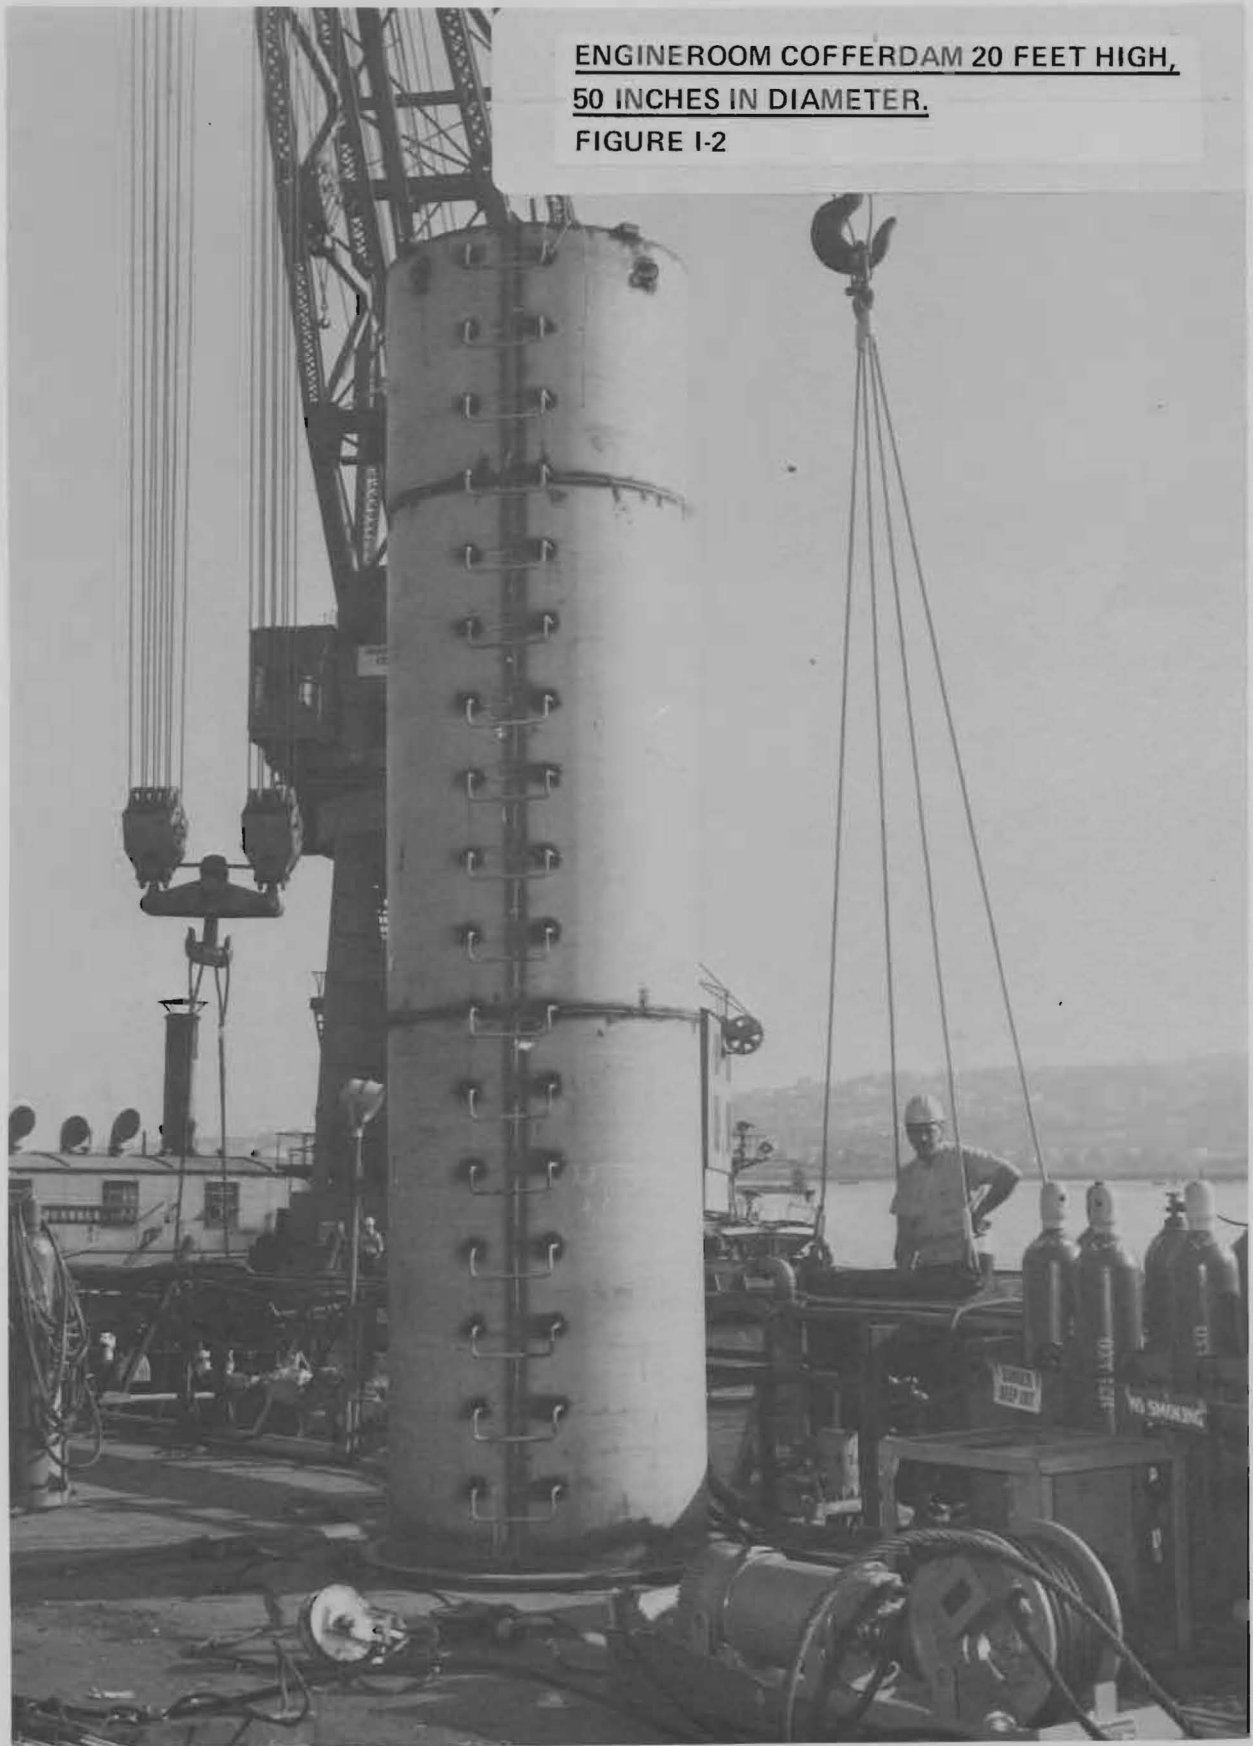
ENGINE ROOM COFFERDAM 20 FEET HIGH,  
50 INCHES IN DIAMETER.  
FIGURE I-2

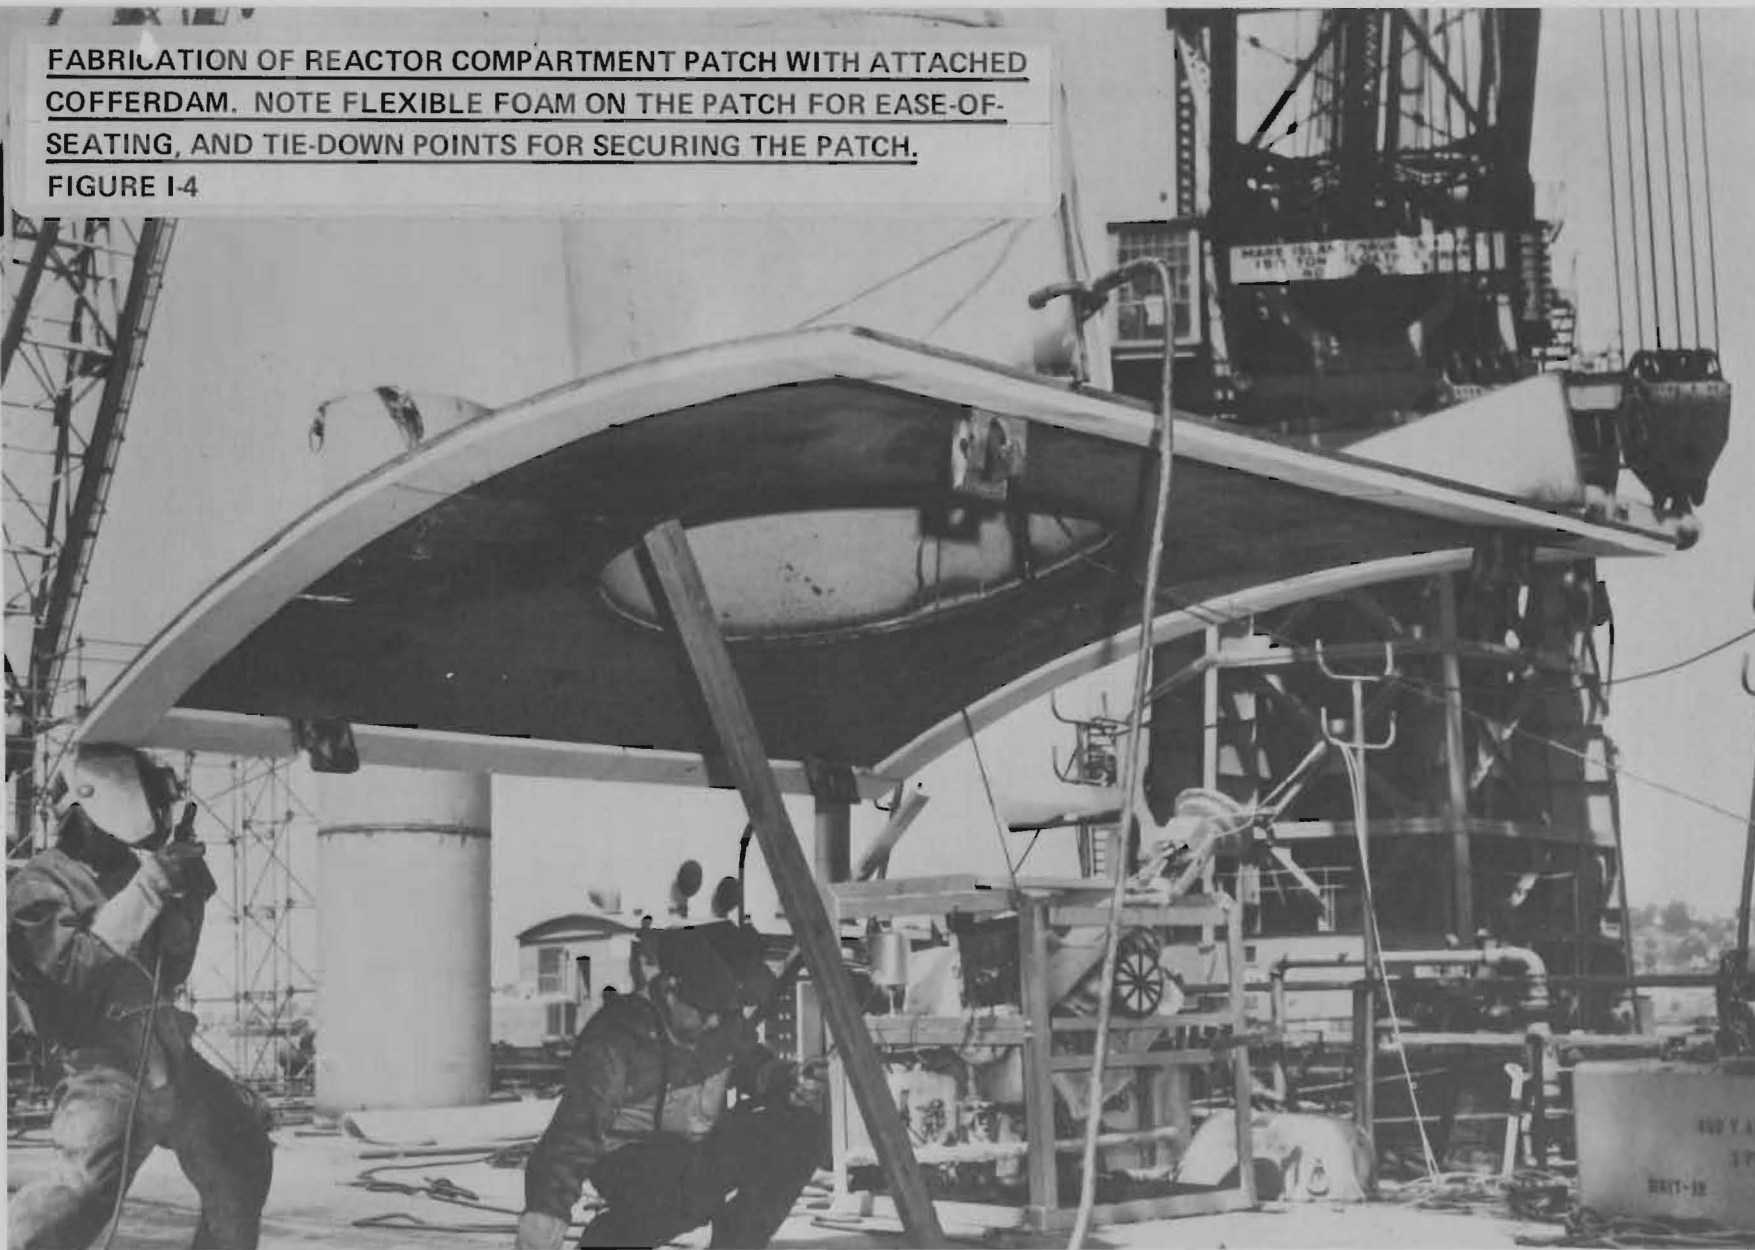
FIGURE I-4

FABRICATION OF REACTOR COMPARTMENT PATCH WITH ATTACHED  
COFFERDAM. NOTE FLEXIBLE FOAM ON THE PATCH FOR EASE-OF-  
SEATING, AND TIE-DOWN POINTS FOR SECURING THE PATCH.

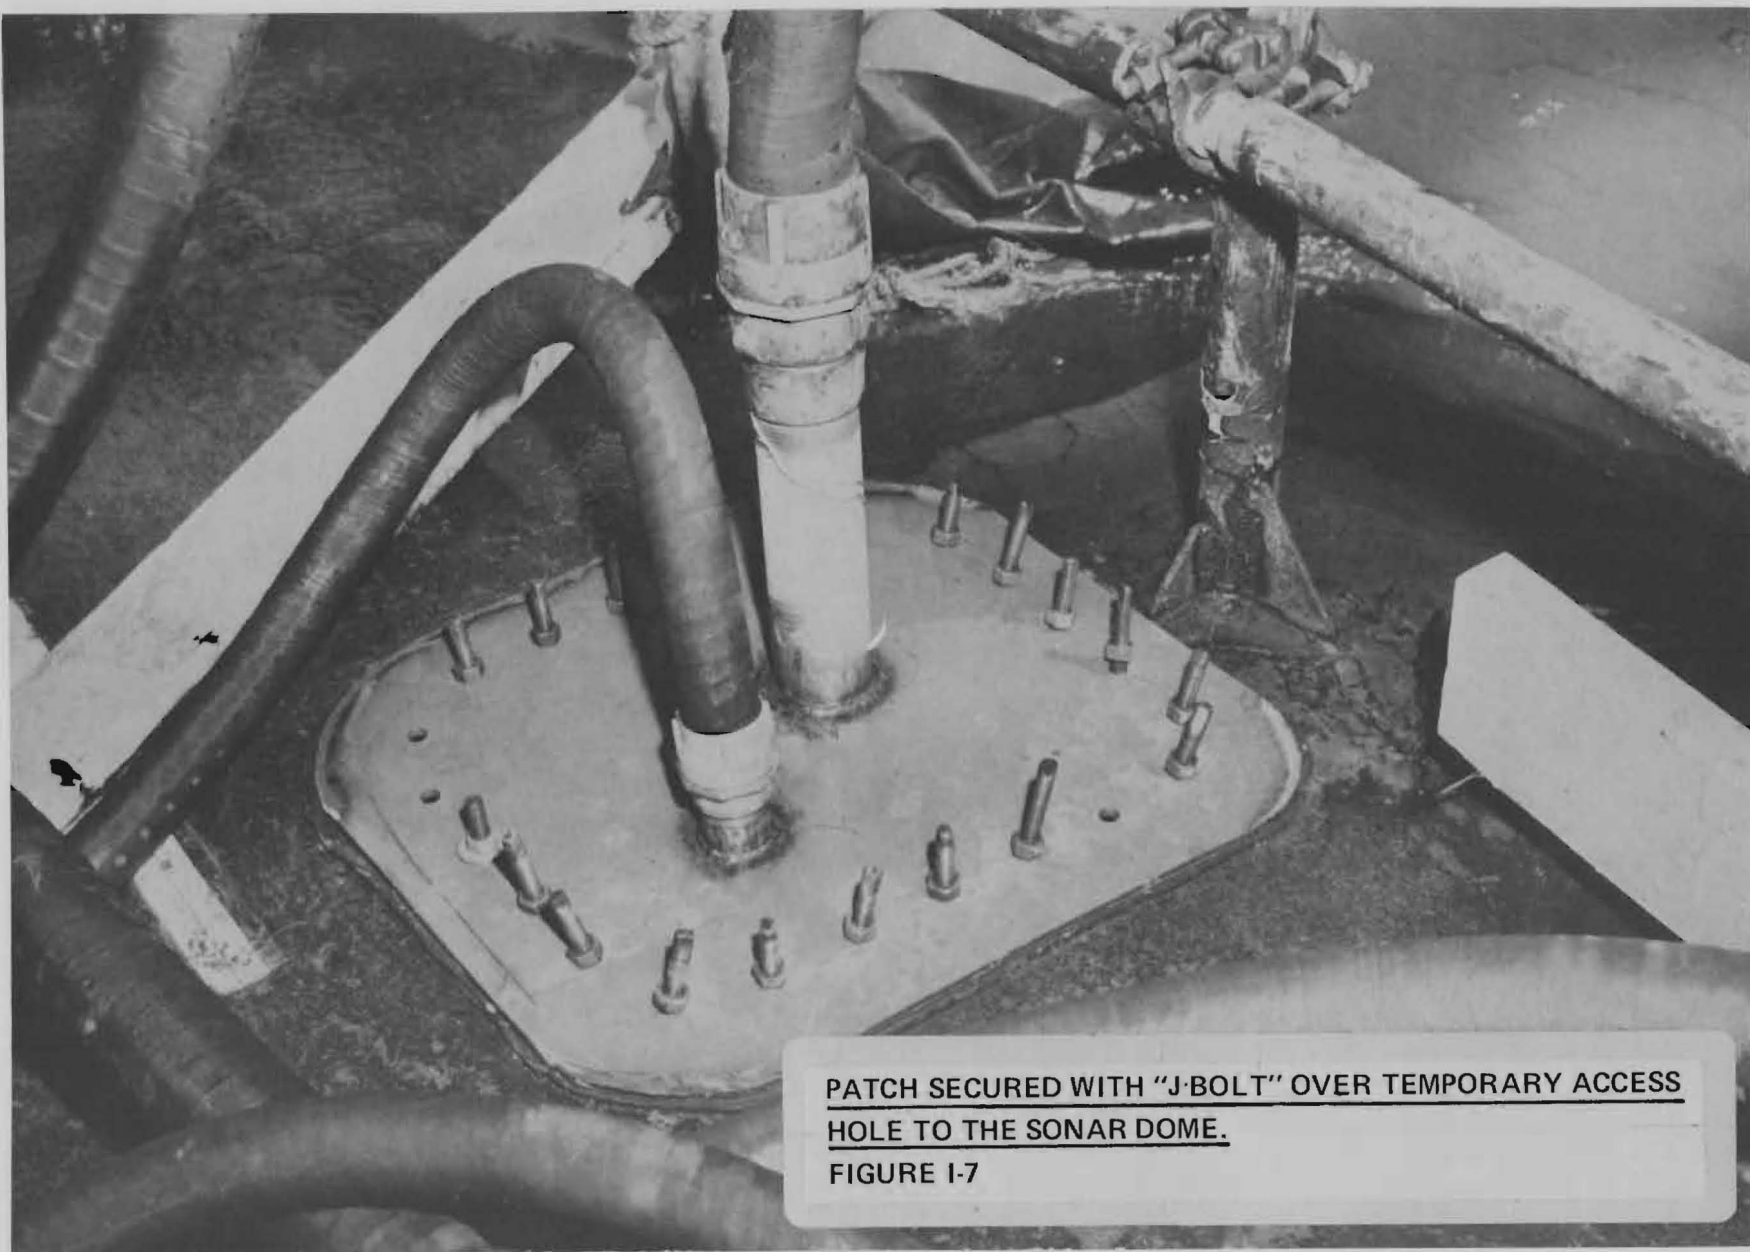
PATCH SECURED WITH "J-BOLT" OVER TEMPORARY ACCESS  
HOLE TO THE SONAR DOME.  
FIGURE I-7

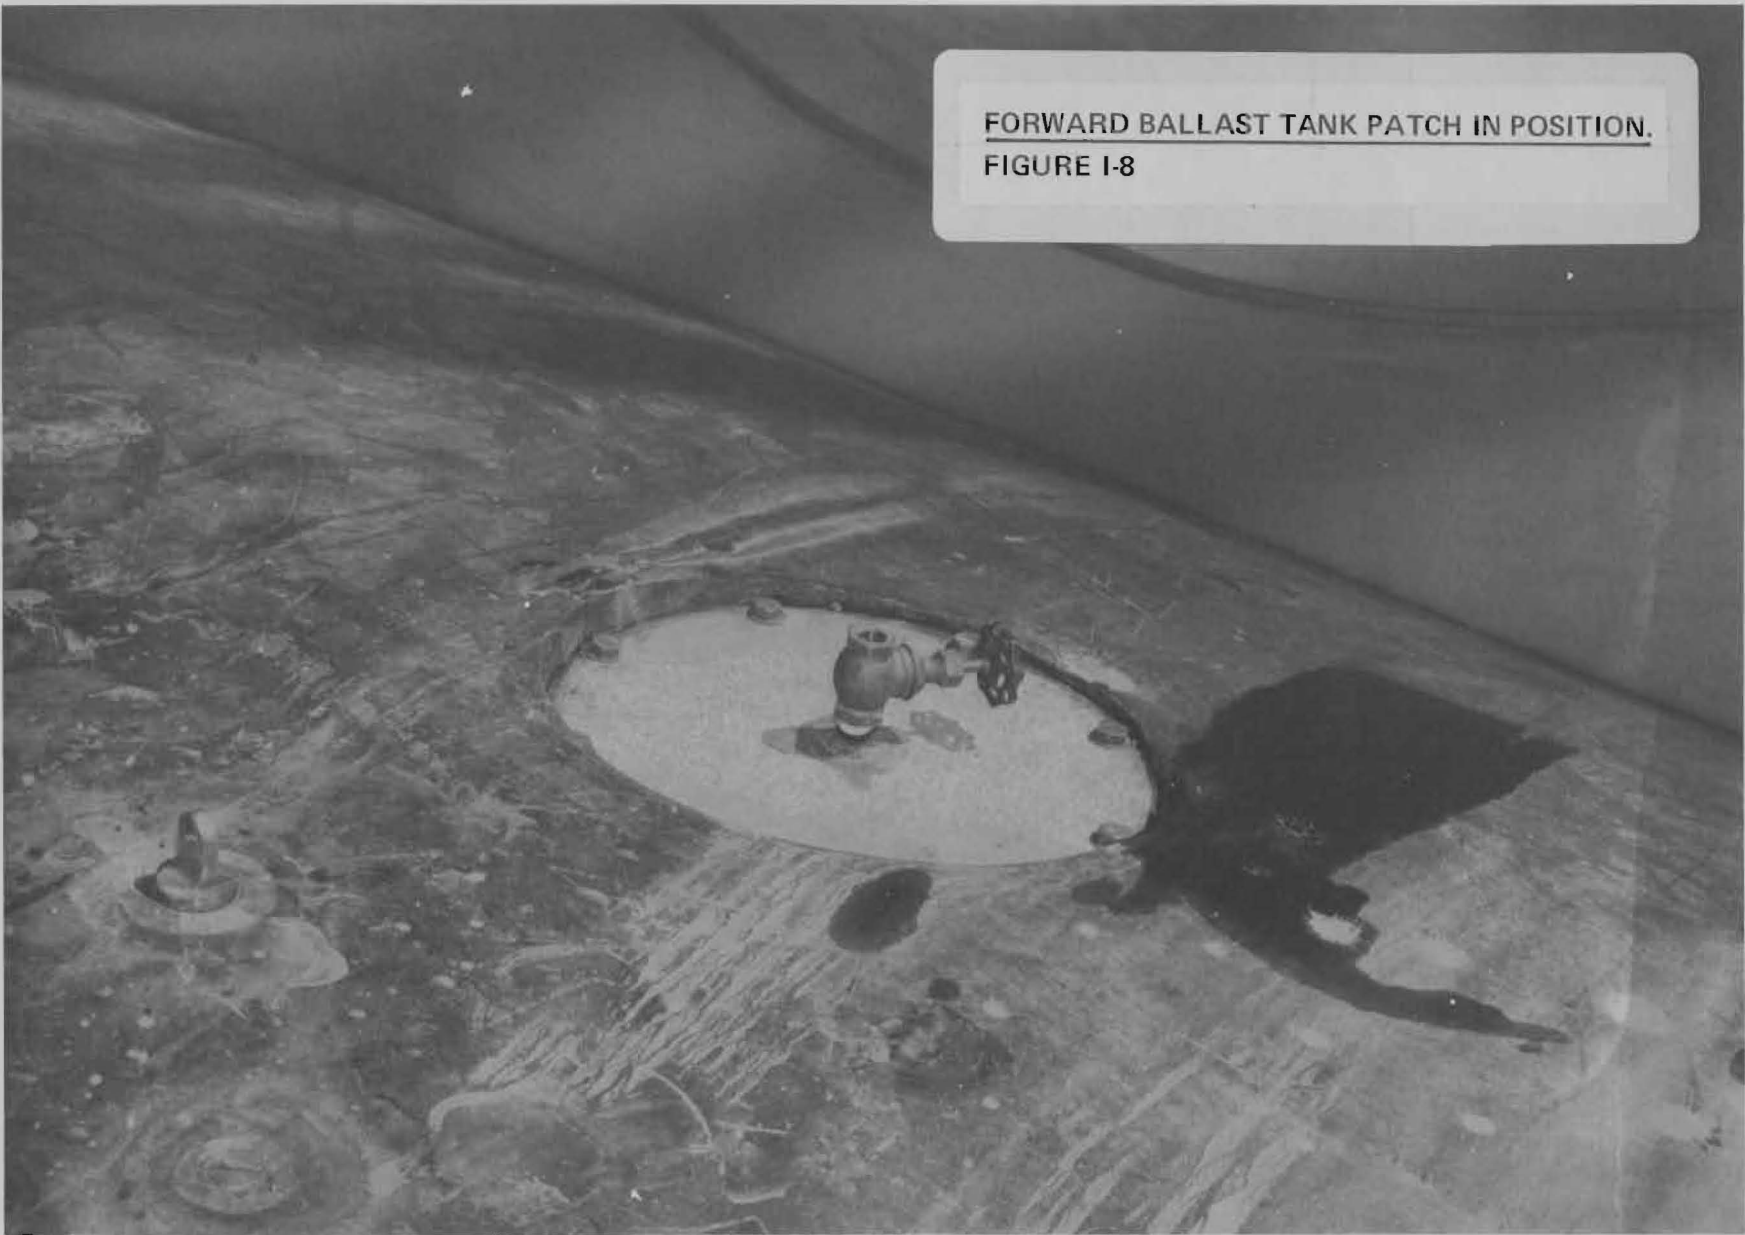
FORWARD BALLAST TANK PATCH IN POSITION.  
FIGURE I-8

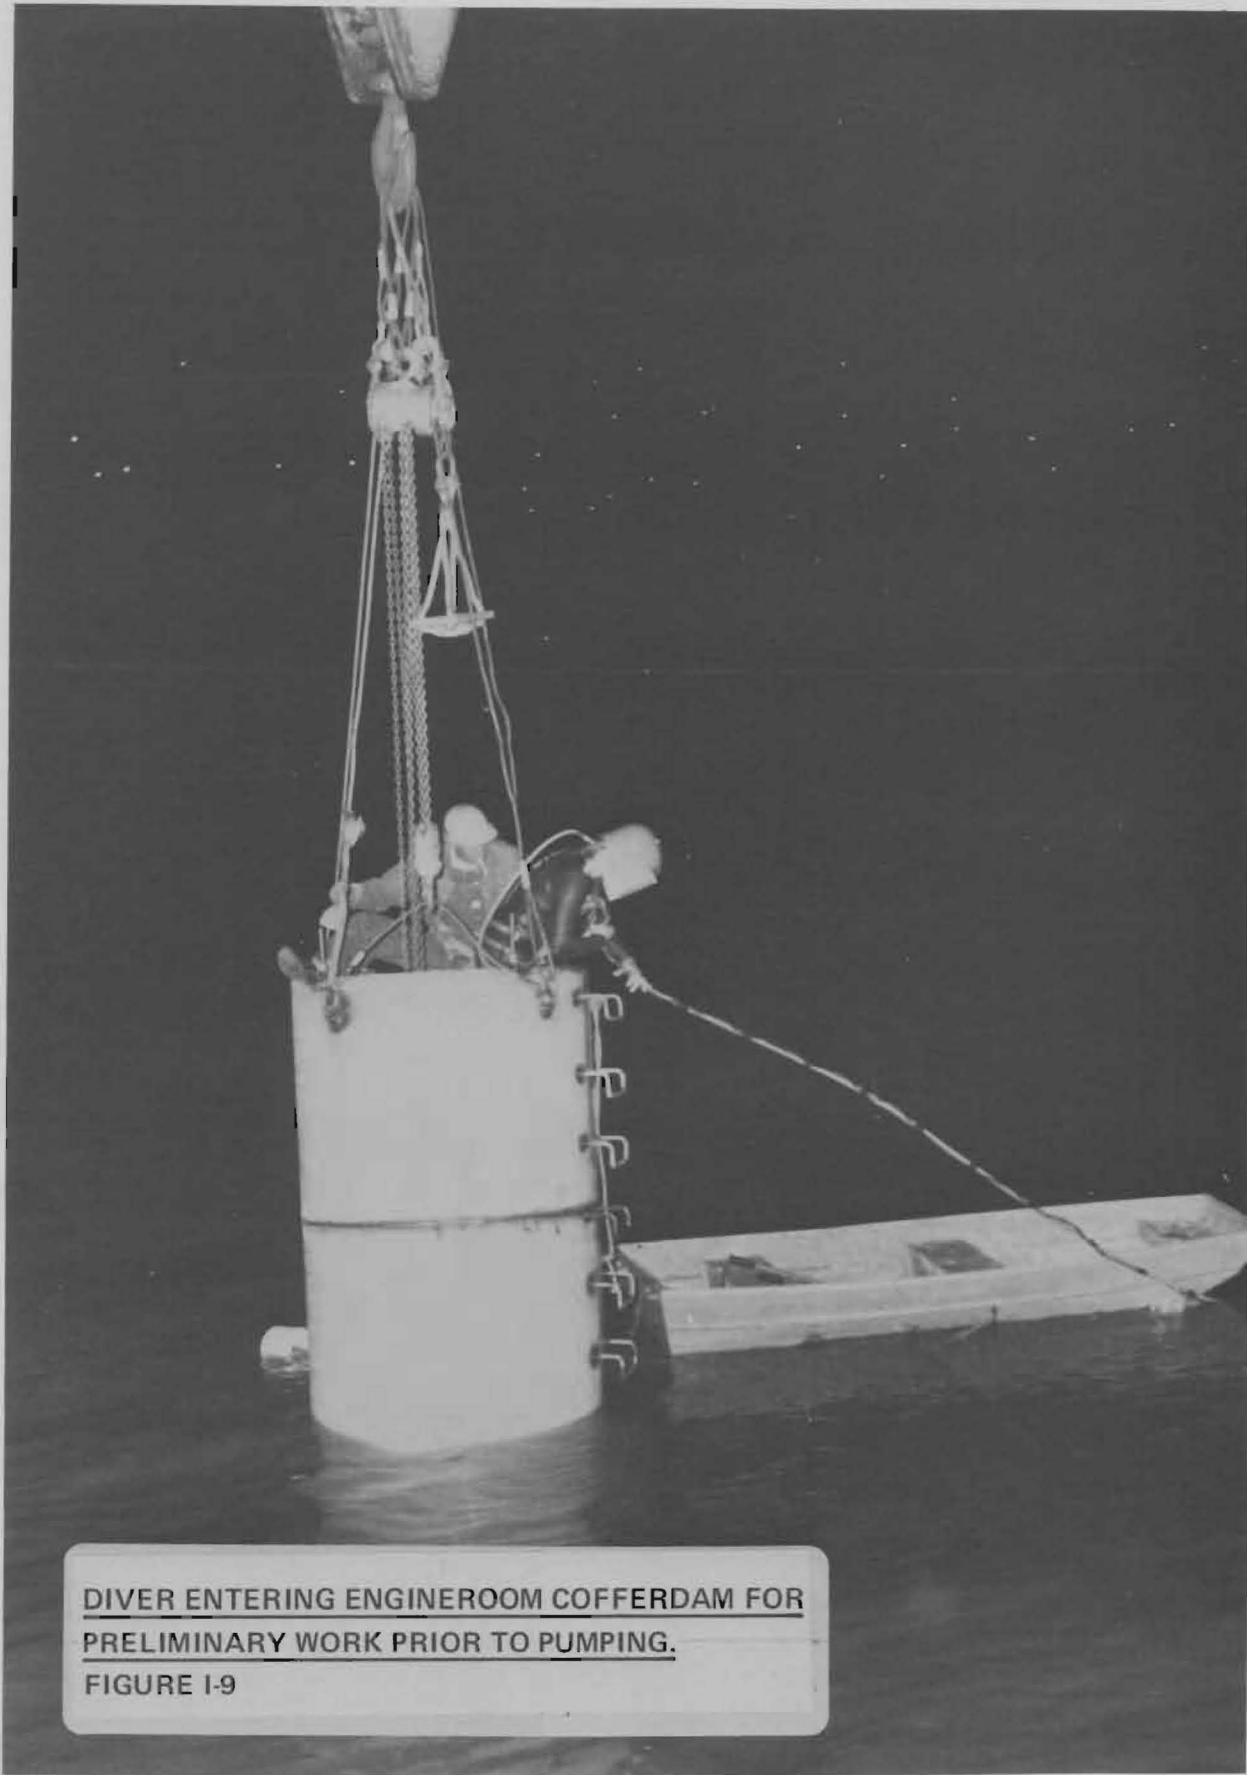
DIVER ENTERING ENGINE ROOM COFFERDAM FOR  
PRELIMINARY WORK PRIOR TO PUMPING.  
FIGURE I-9

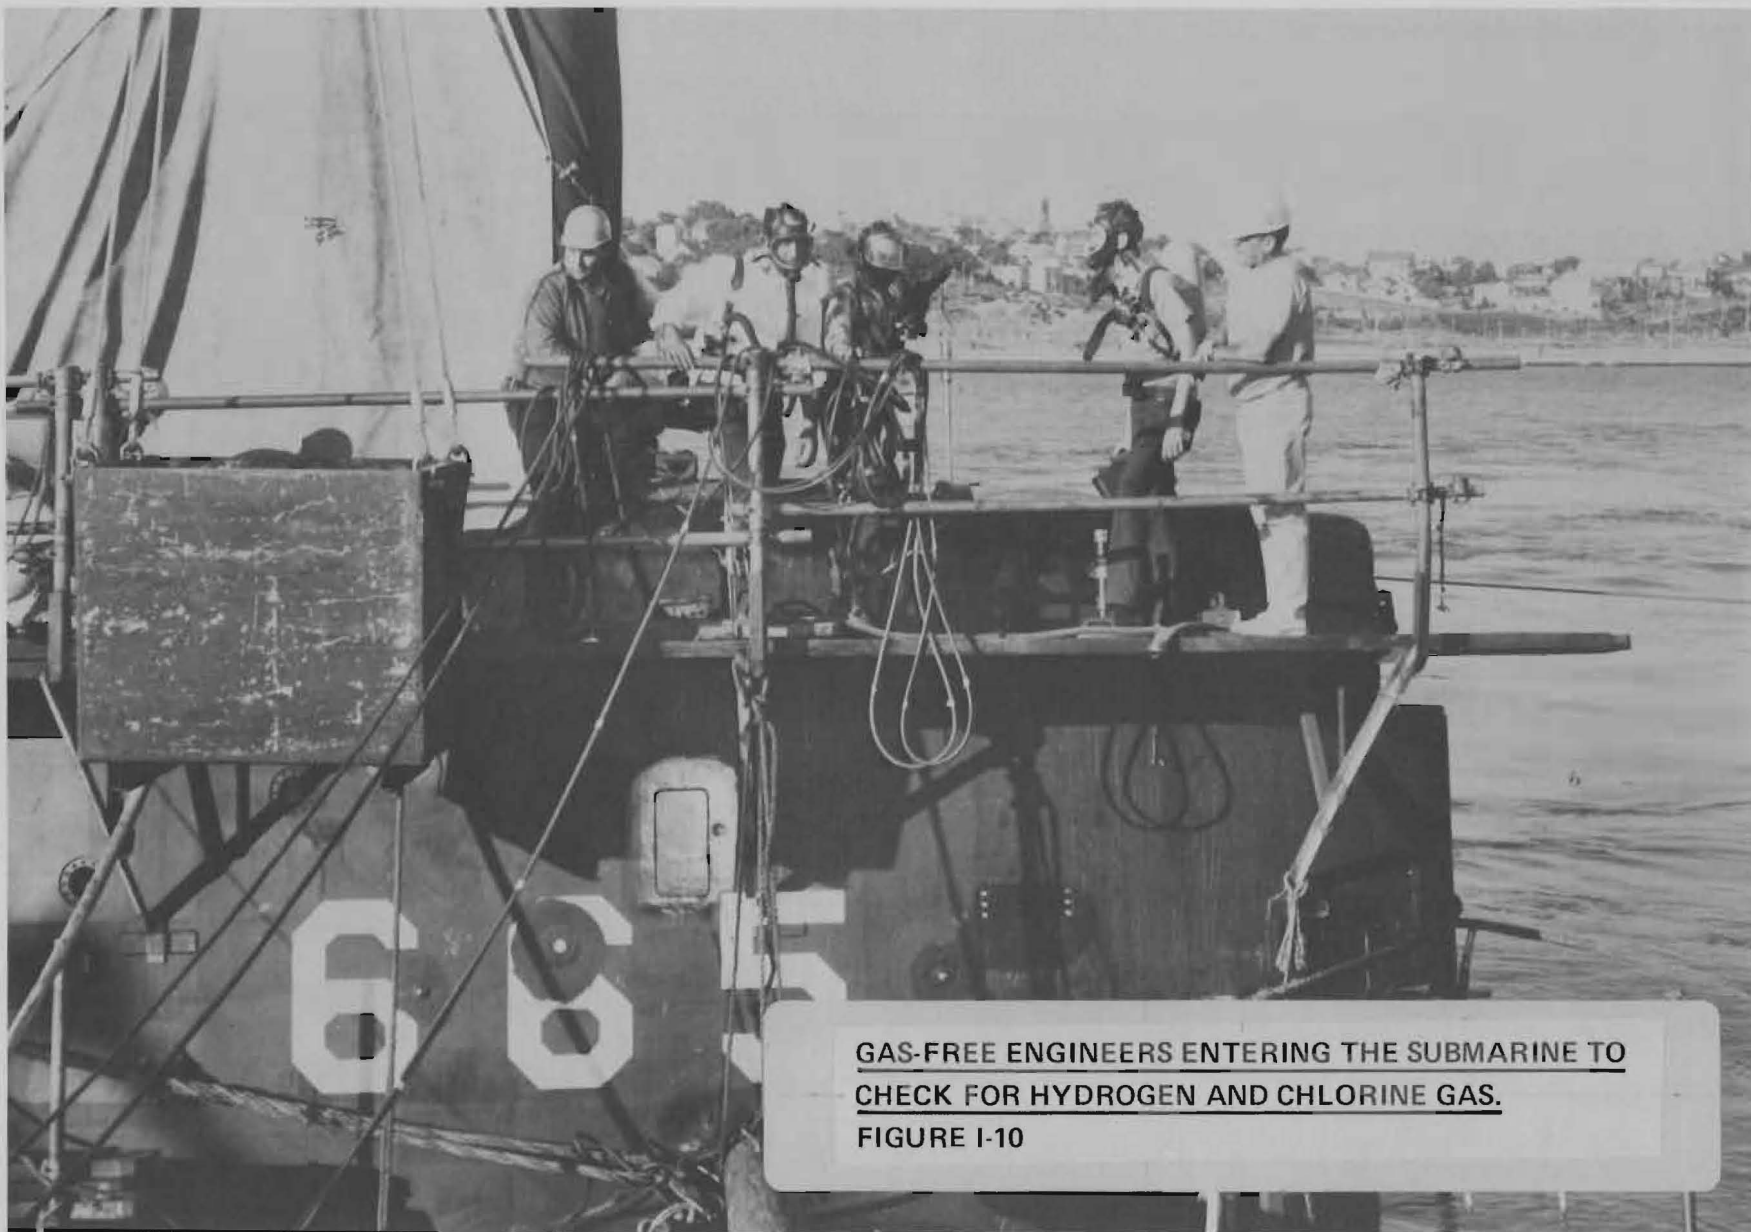
GAS-FREE ENGINEERS ENTERING THE SUBMARINE TO  
CHECK FOR HYDROGEN AND CHLORINE GAS.  
FIGURE I-10

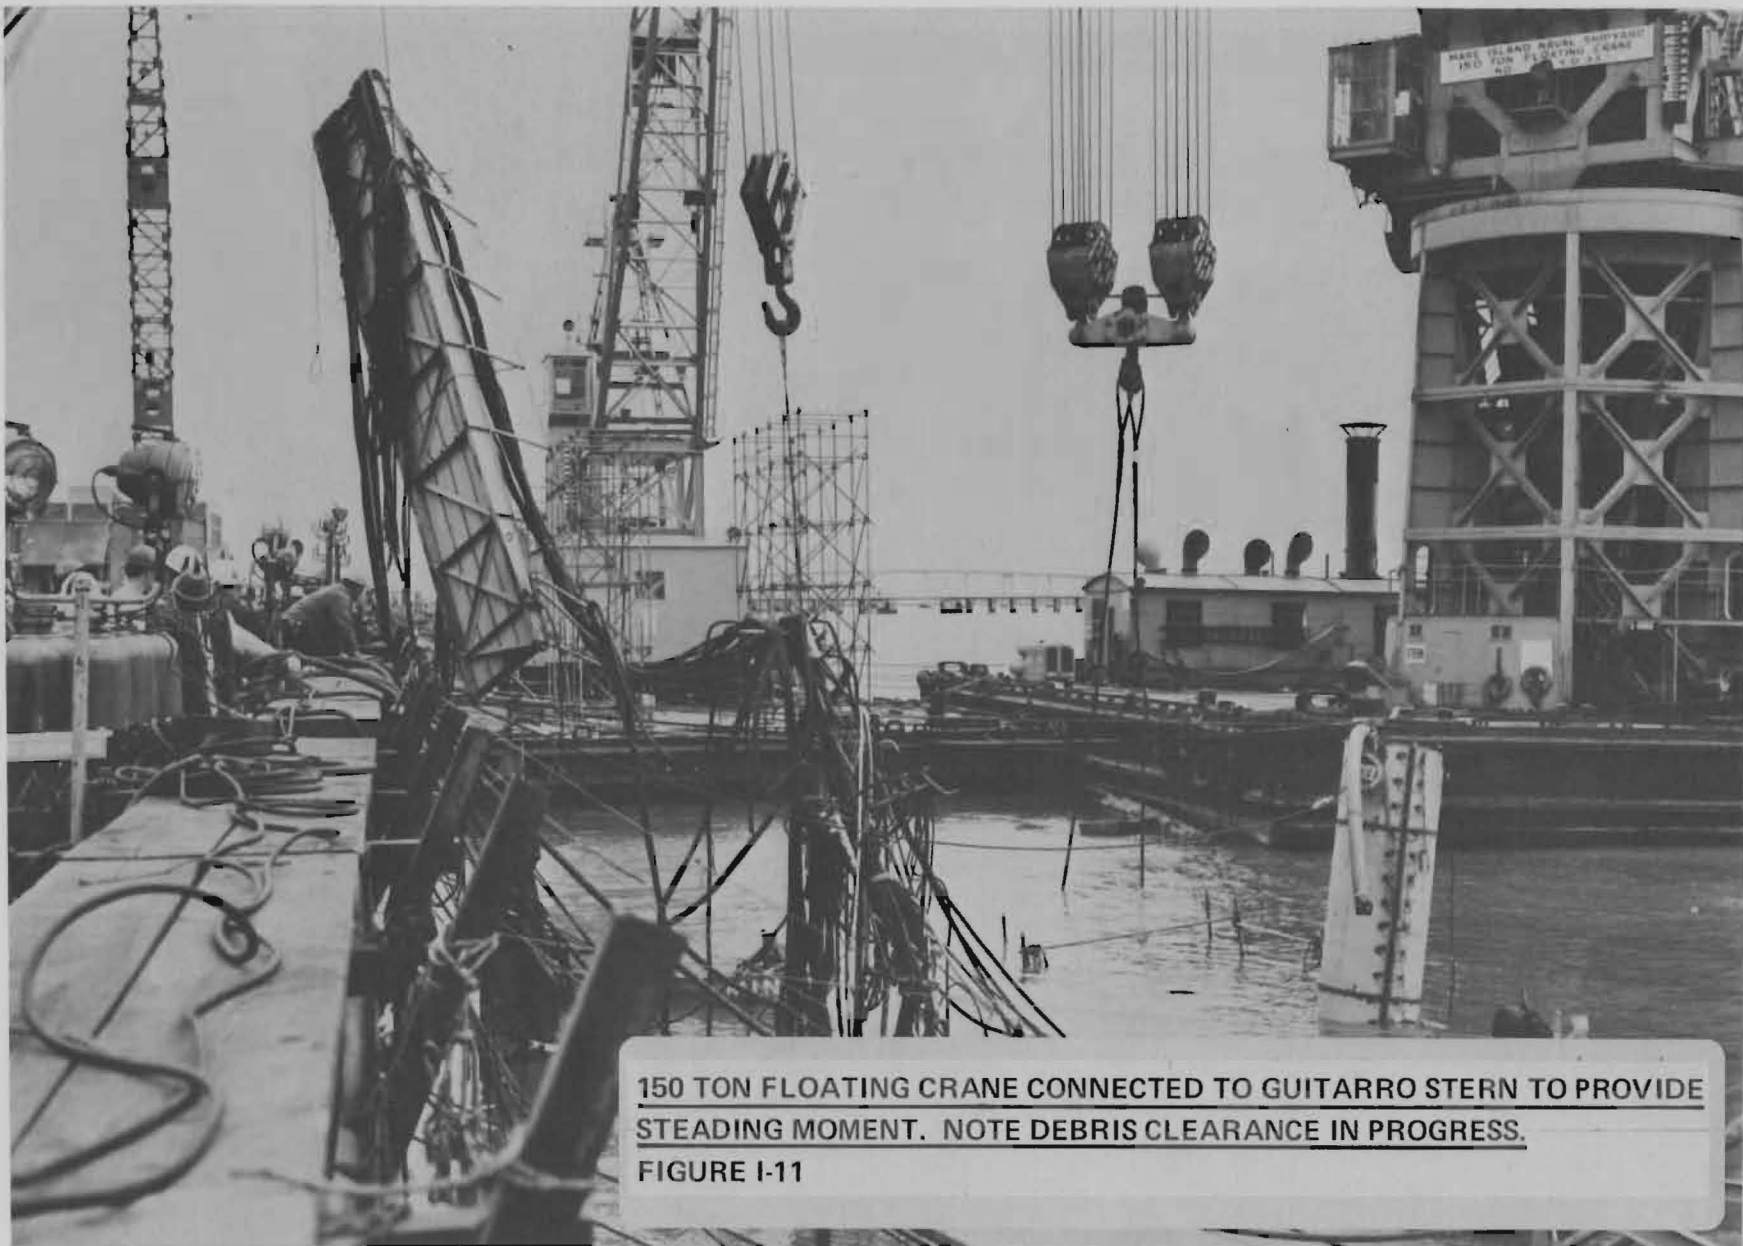
FIGURE I-11

150 TON FLOATING CRANE CONNECTED TO GUITARRO STERN TO PROVIDE  
STEADYING MOMENT. NOTE DEBRIS CLEARANCE IN PROGRESS.

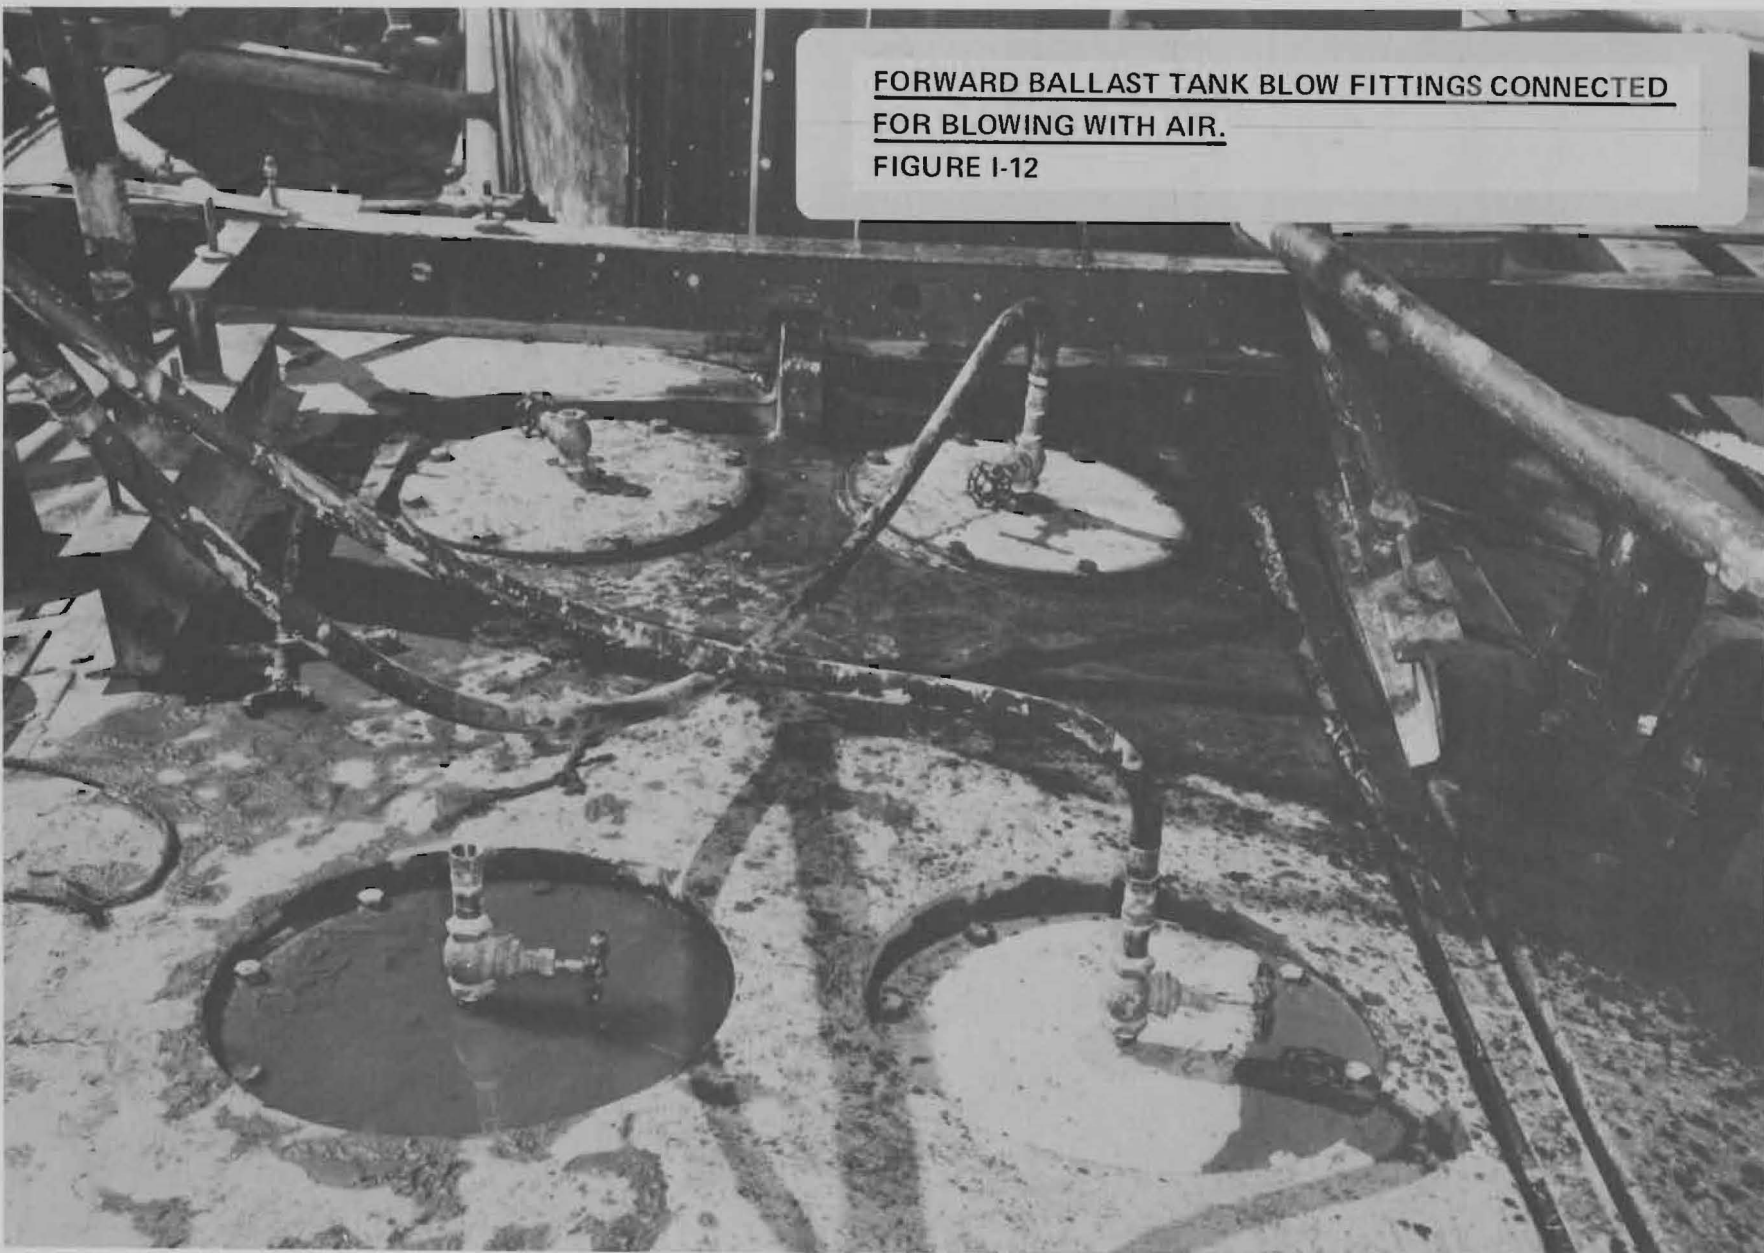
FORWARD BALLAST TANK BLOW FITTINGS CONNECTED  
FOR BLOWING WITH AIR.  
FIGURE I-12
