# U. S. S. SARATOGA (CV3)

## TORPEDO DAMAGE

JANUARY 11, 1942

WAR DAMAGE REPORT No. 19

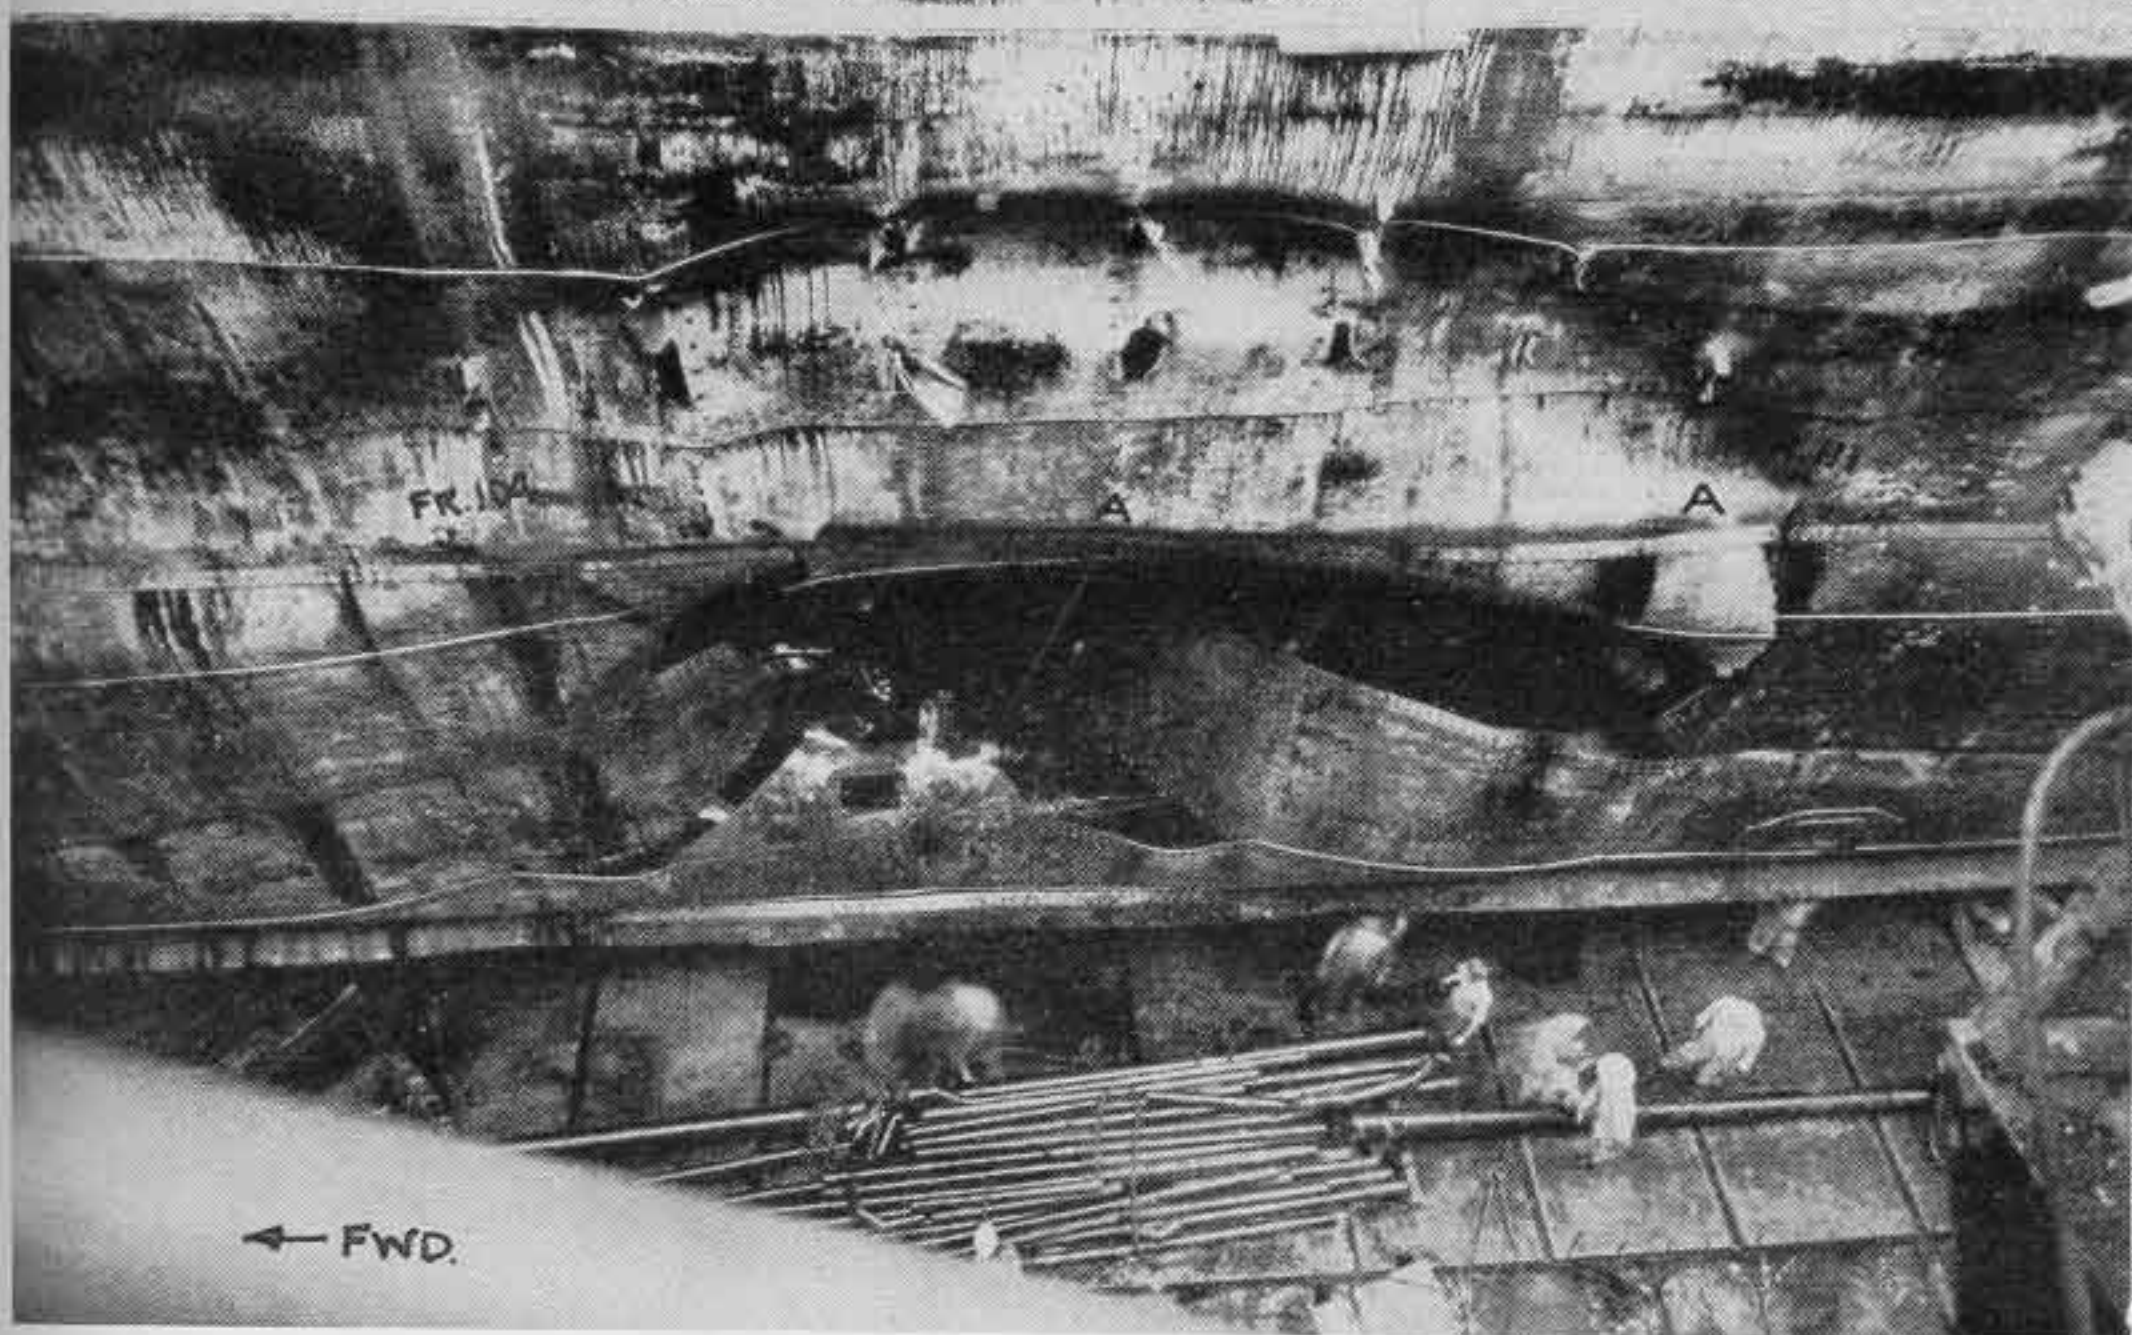
Photo 1: View from side of dock. Ridge A-A is at the junction of the upper and lower blisters where the inaccessible outboard corner is filled with cement.

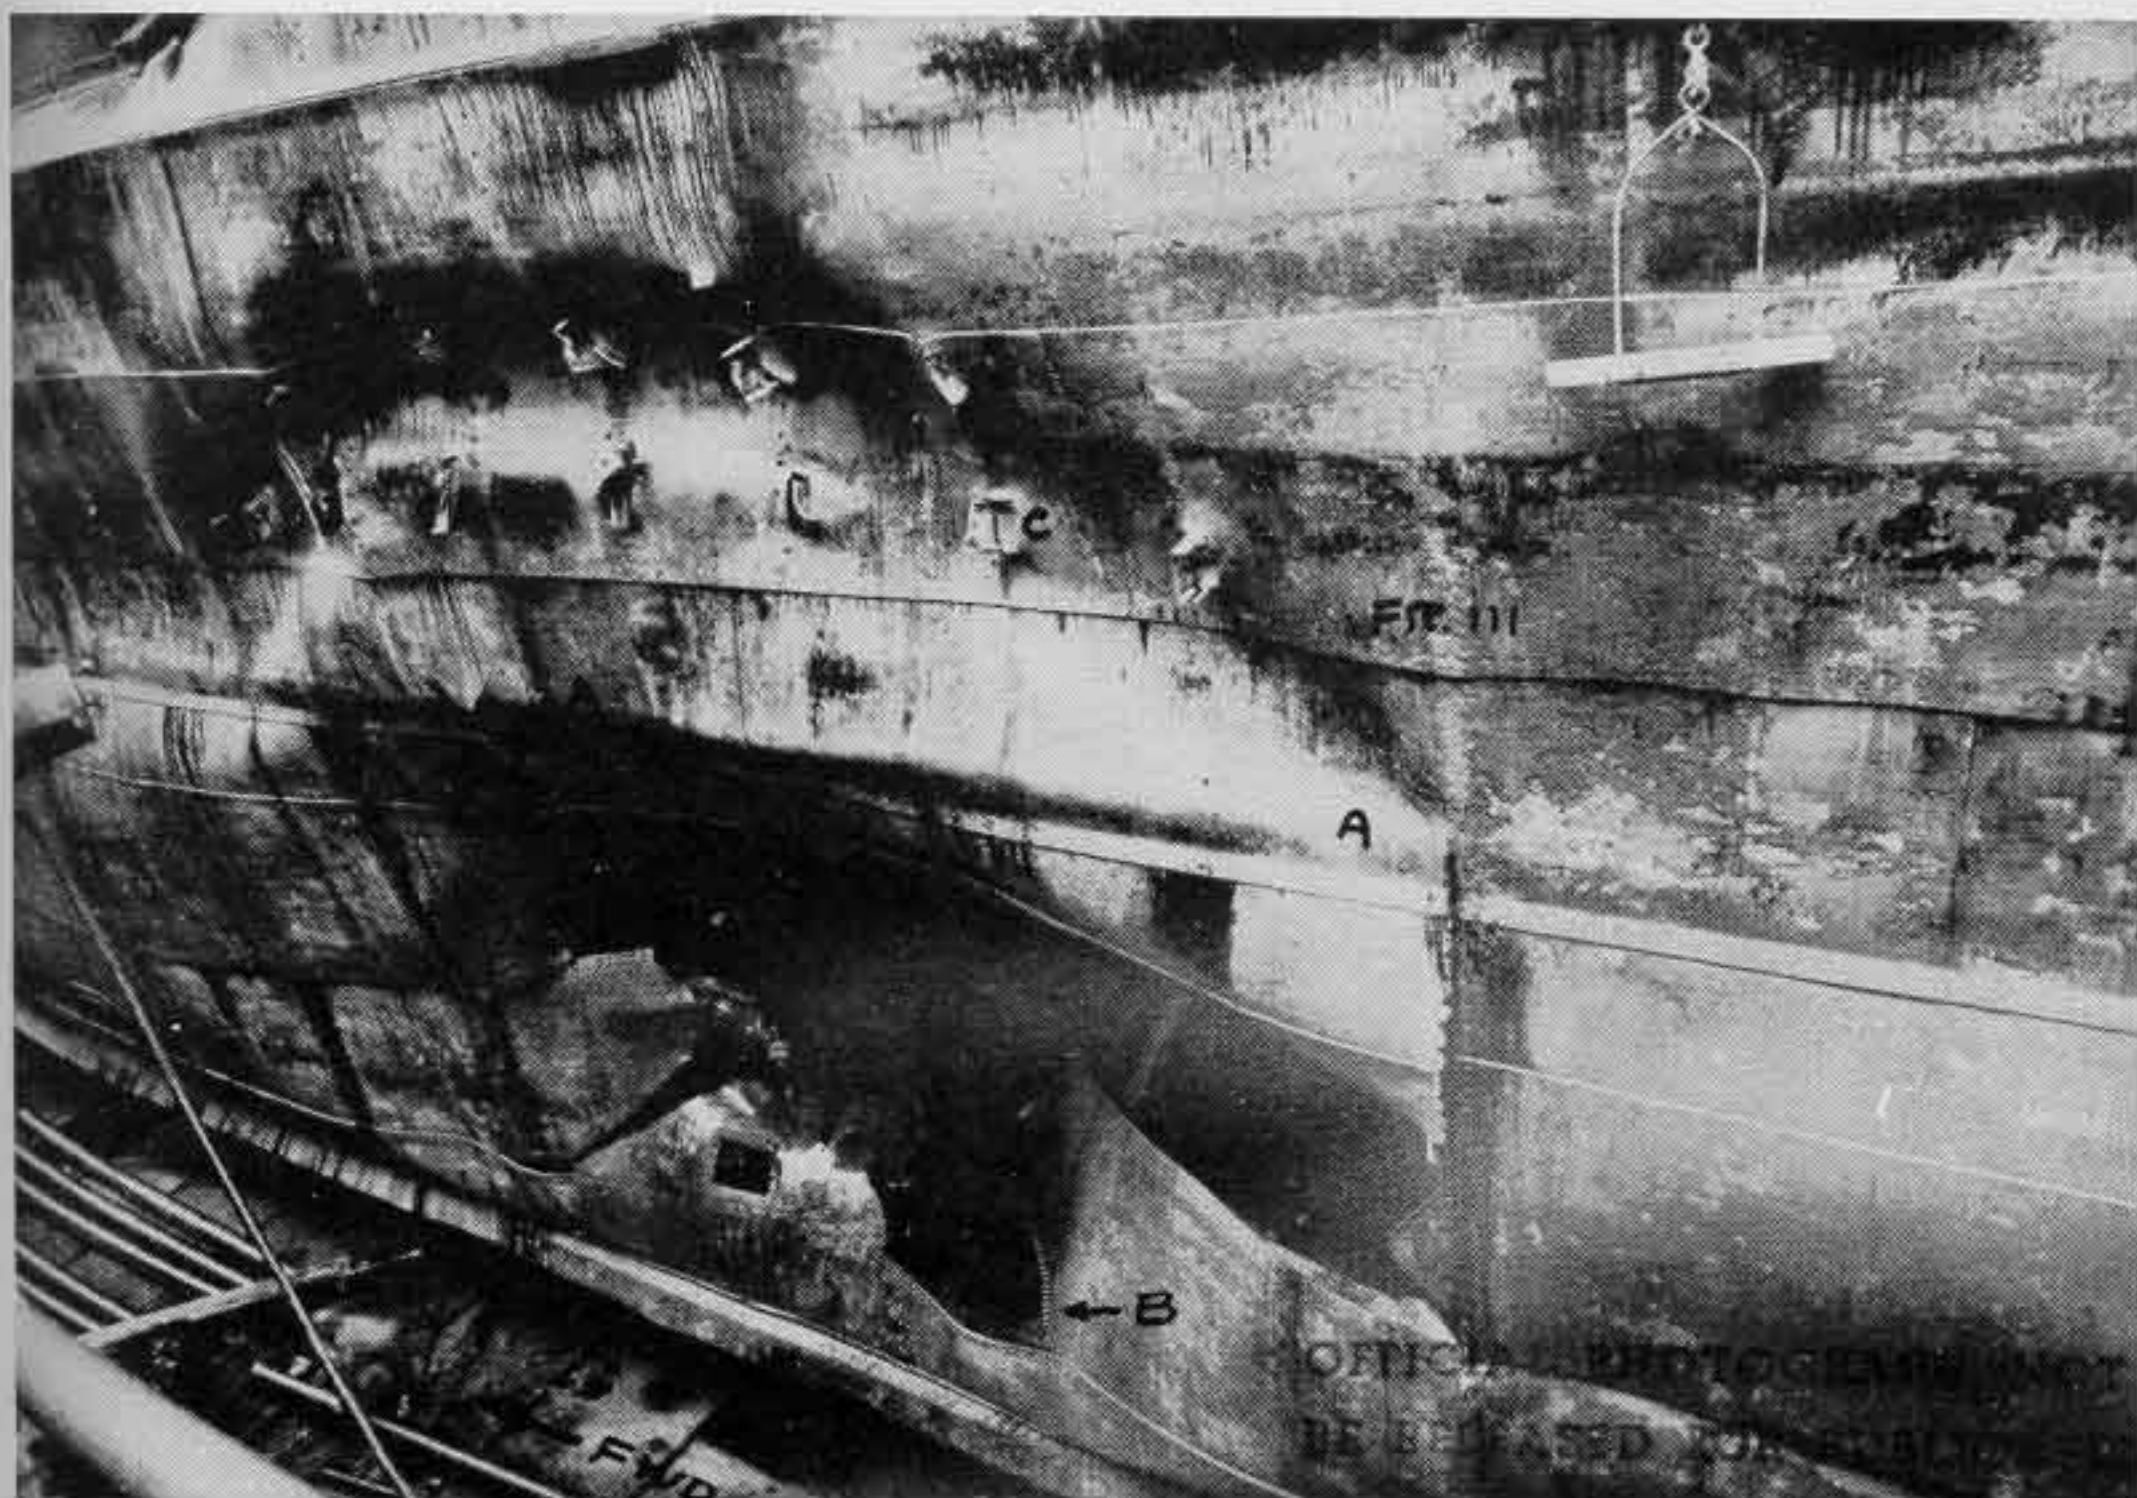
Photo 2: View from half-way down the dock, looking forward. Countersunk rivets pulled out at B. Channel struts in upper blister pierced the plating as at C.

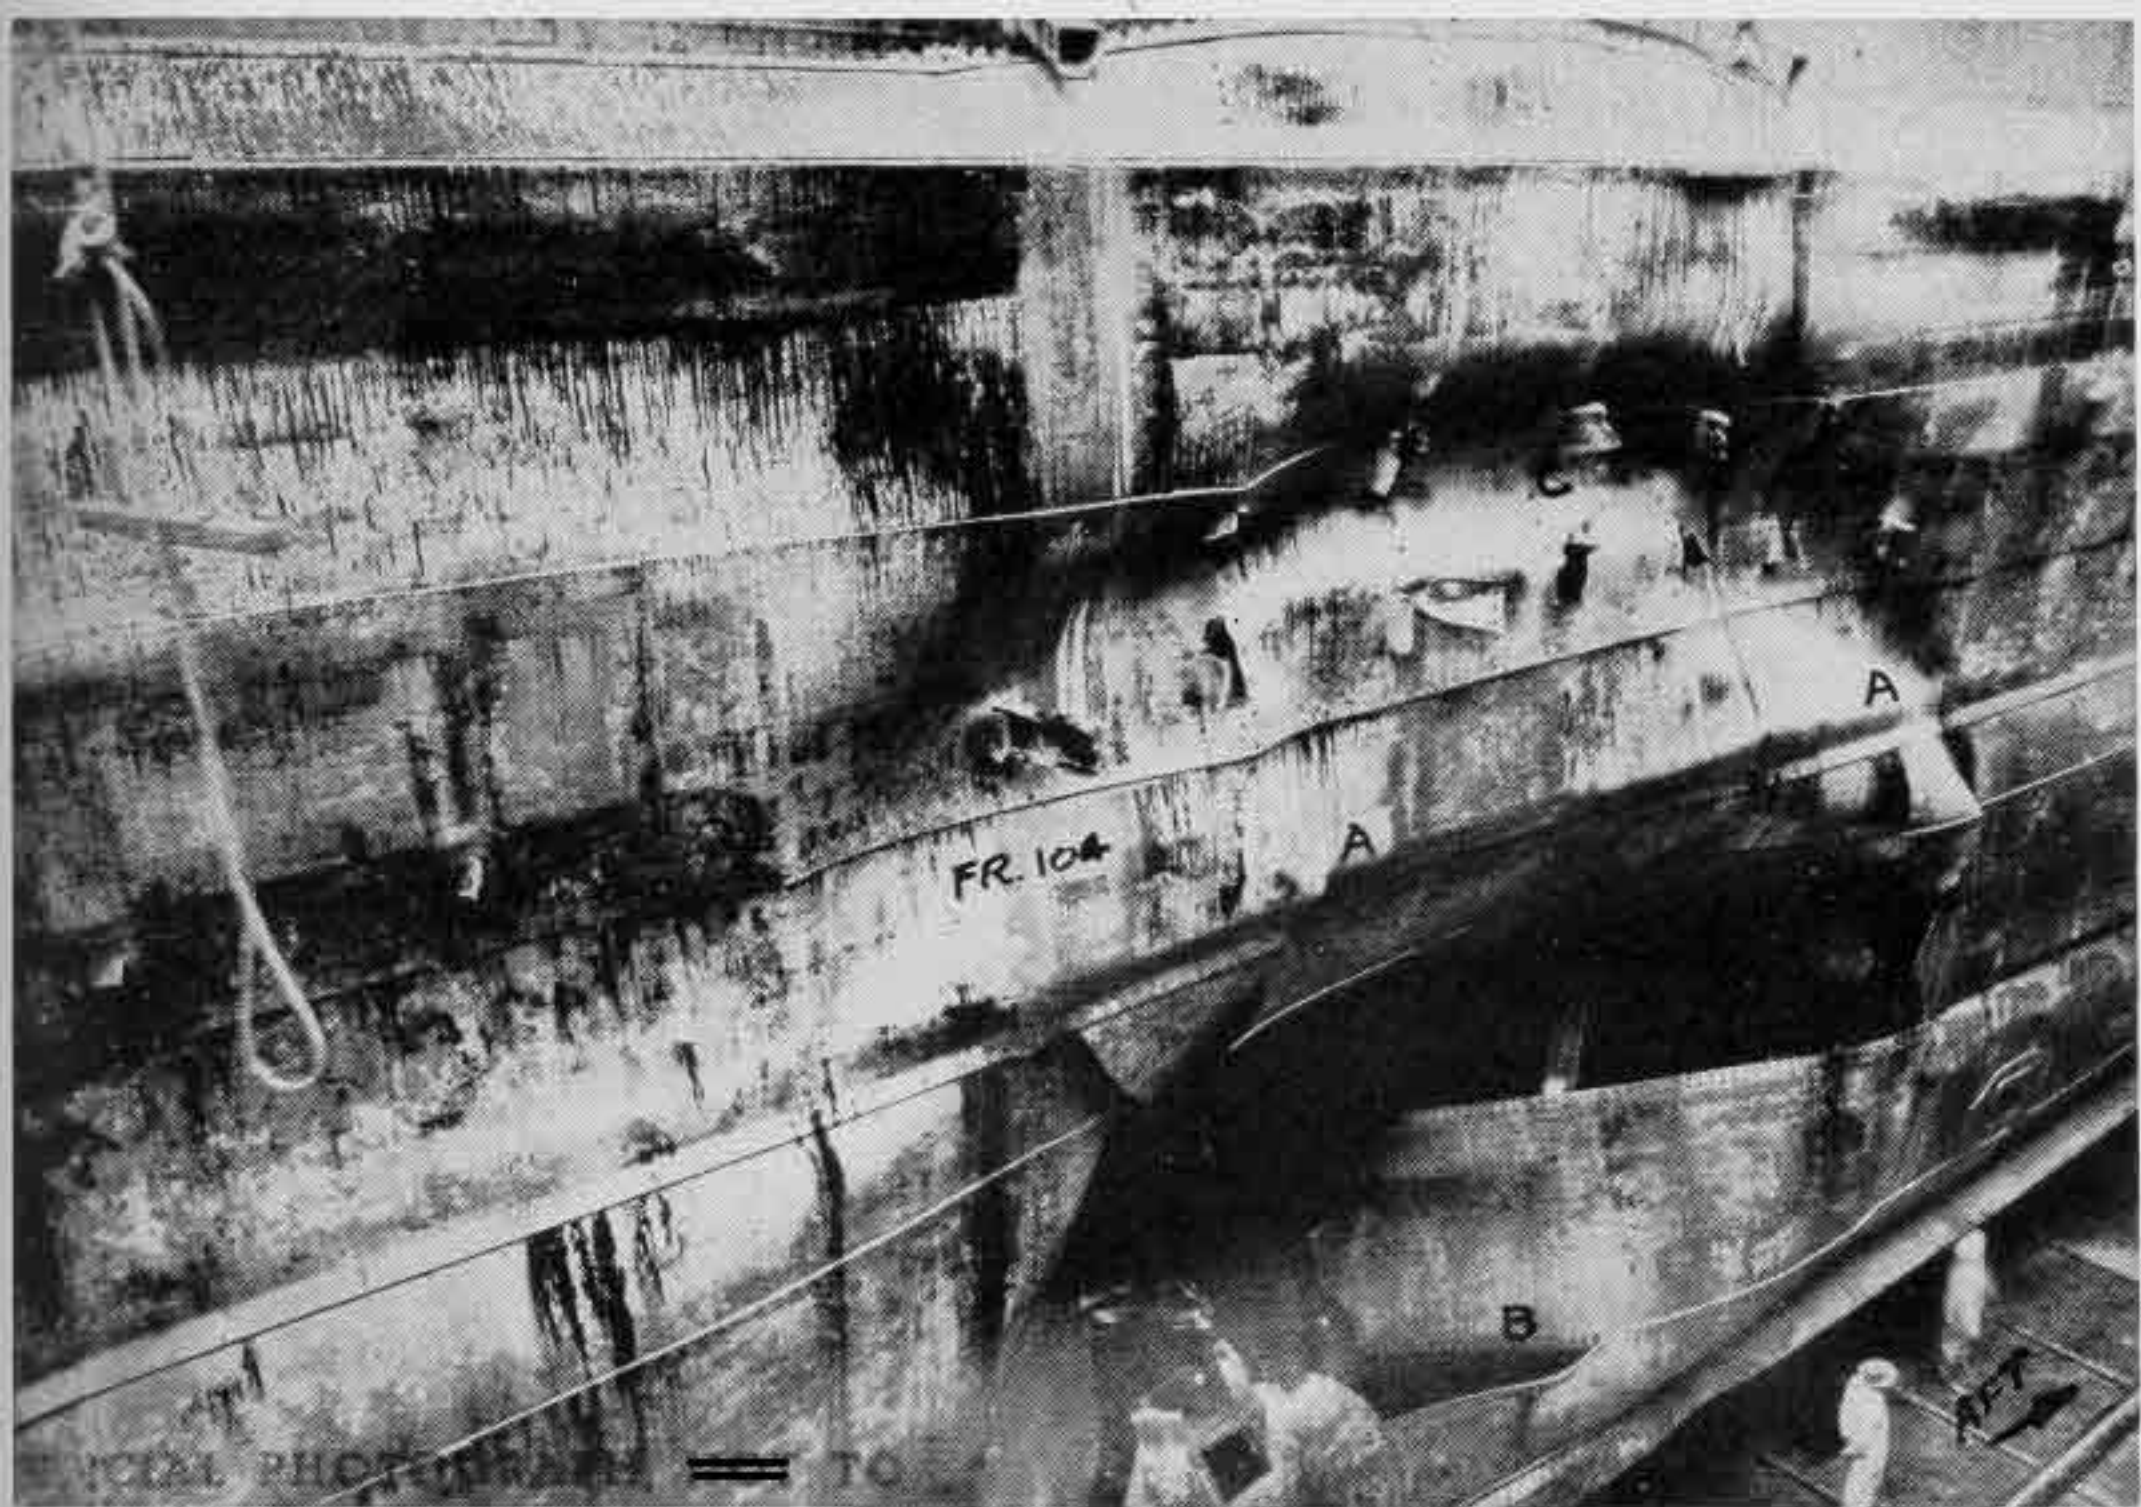
Photo 3: View from half-way down the dock looking aft.

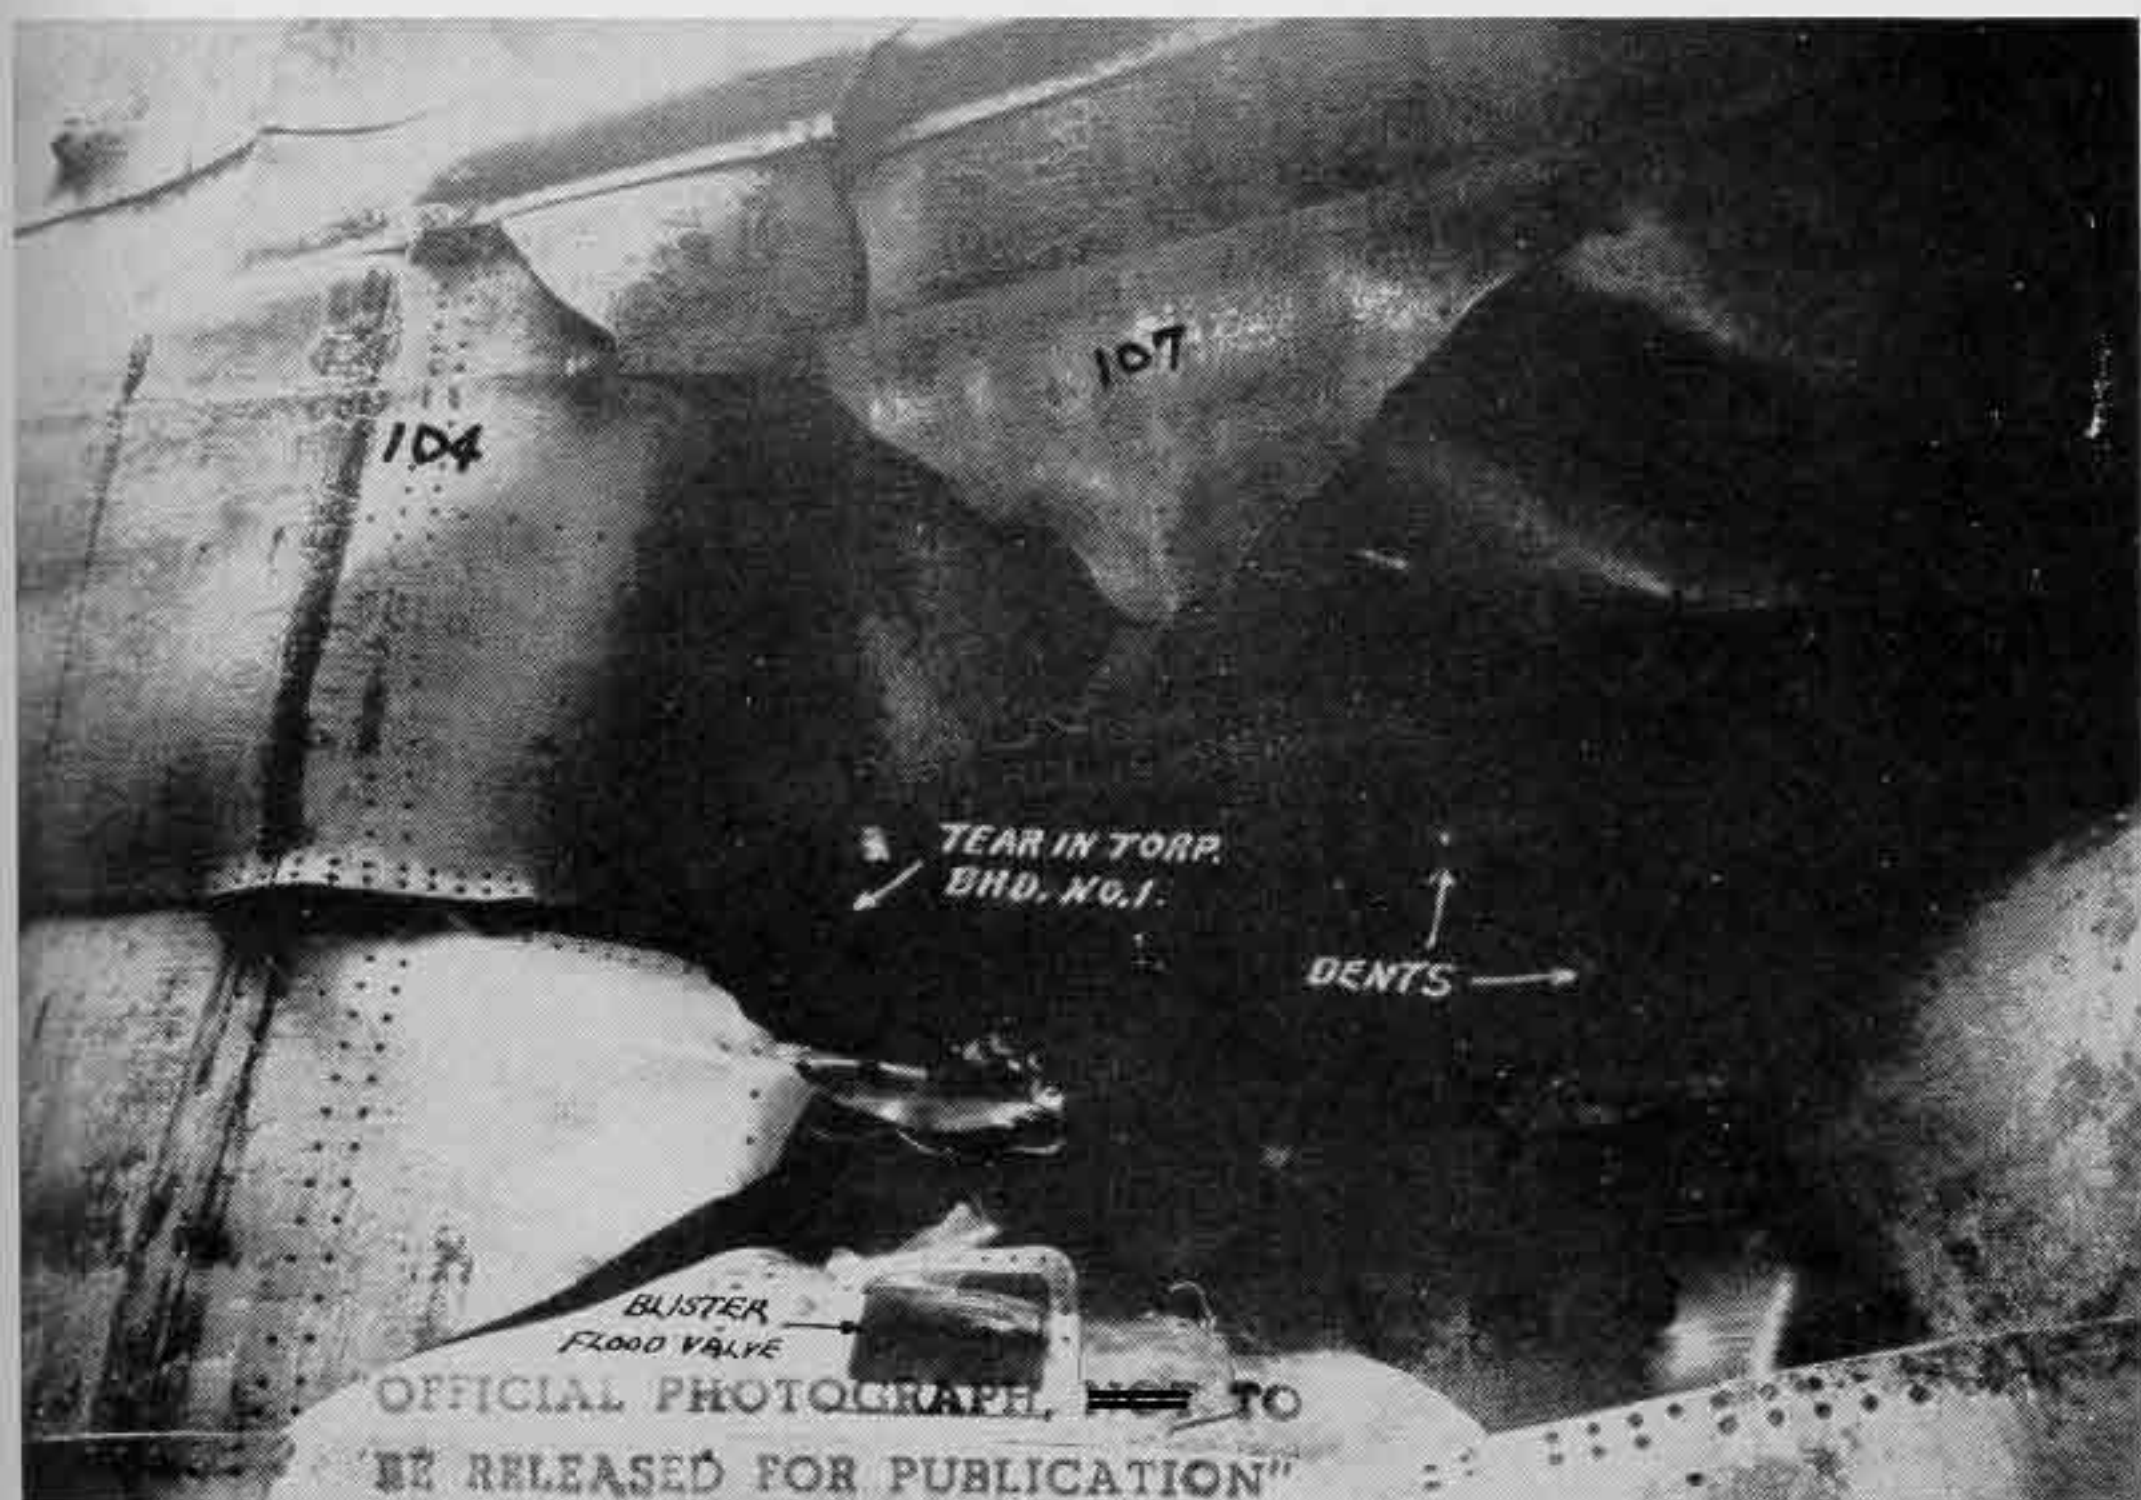
Photo 4: View from directly opposite the damage showing torpedo bulkhead No. 1 and the forward edge of the hole.

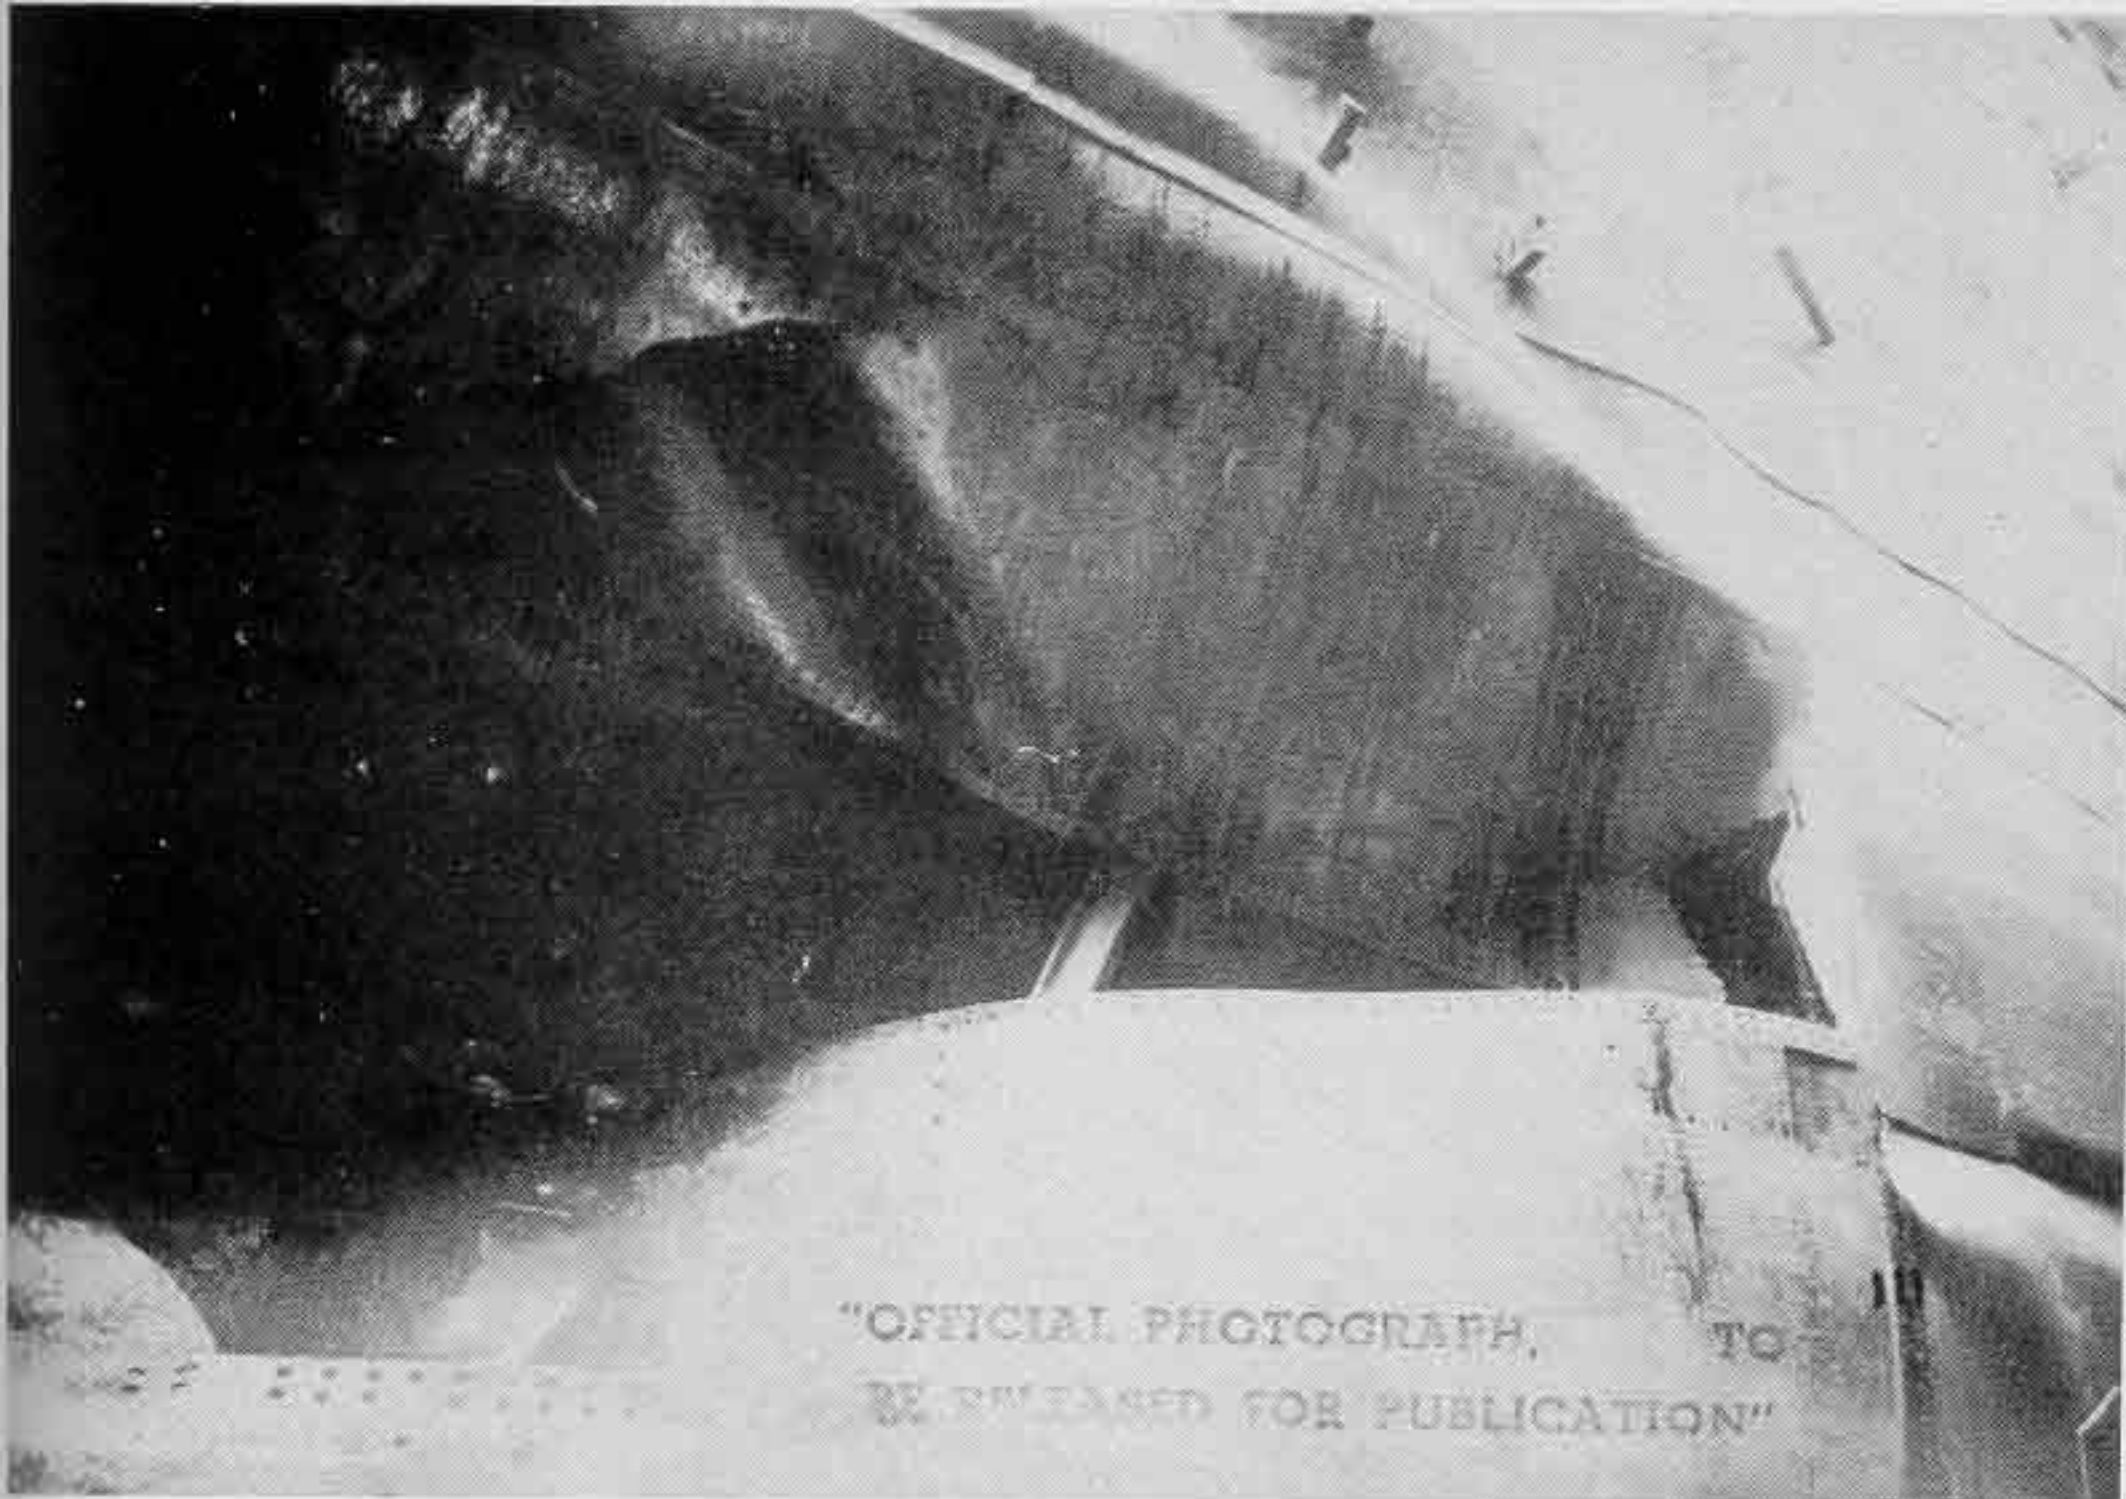
Photo 5: After edge of the hole.

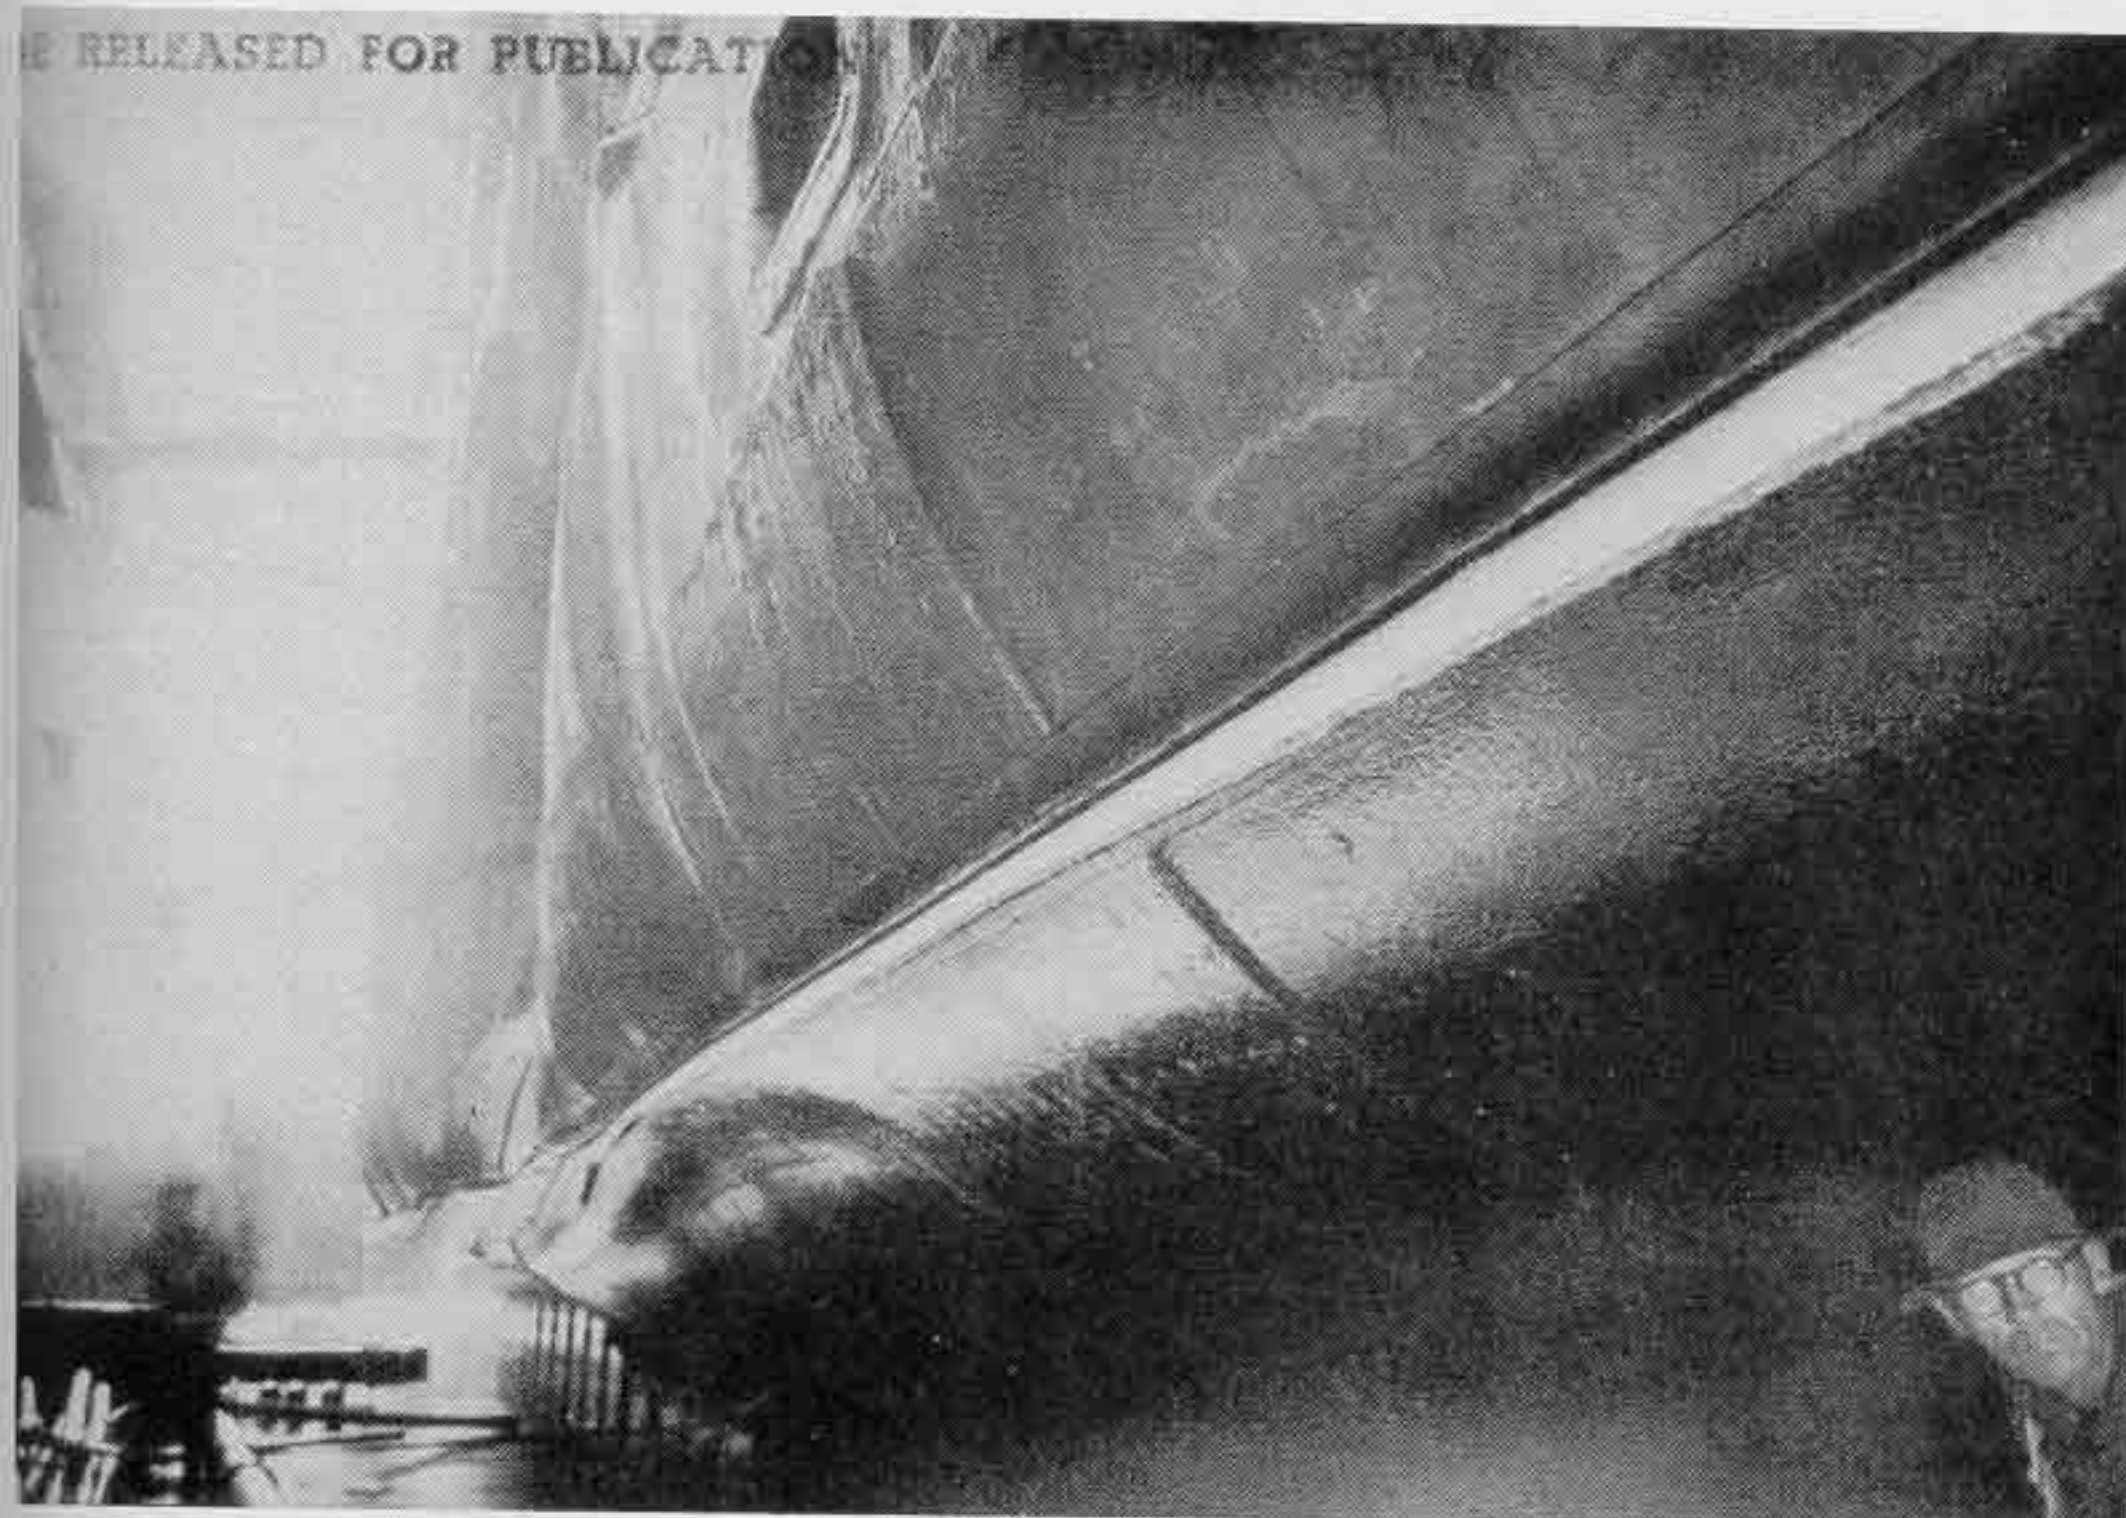
Photo 6: View looking forward along the port bilge keel. Note how the bottom plating inboard of the bilge keel was blown down by the explosion.

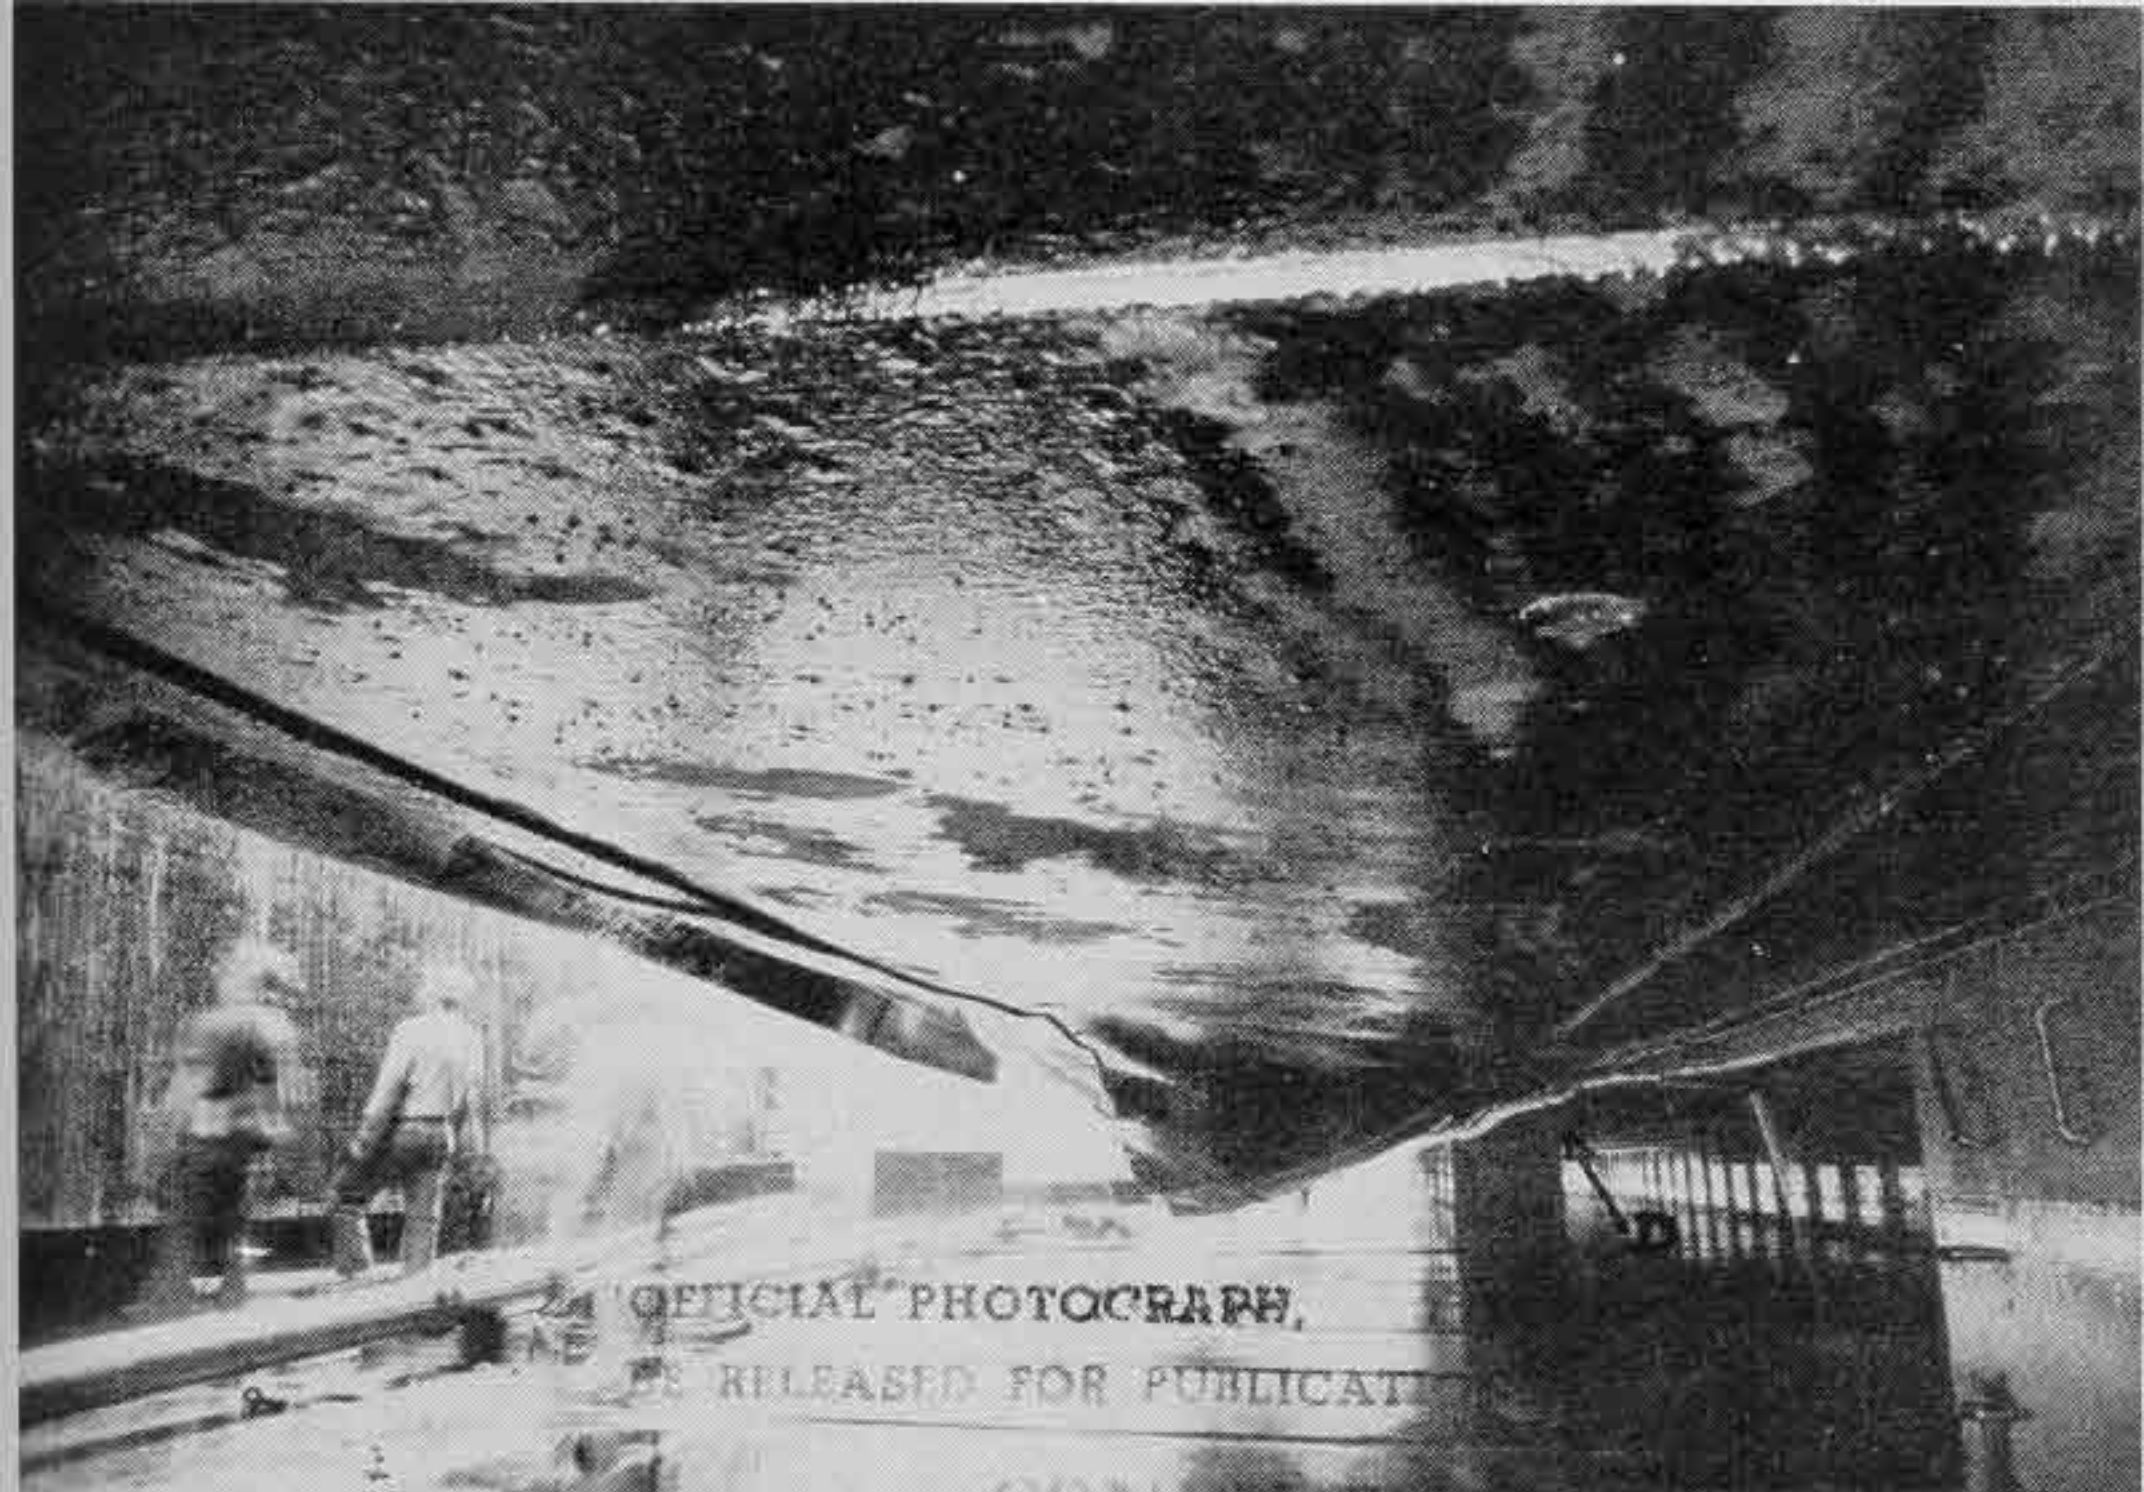
Photo 7: View forward along the outer row of keel blocks. Note that the docking keel is bowed up (D). The maximum lift is about 6 inches.
