# U. S. S. SARATOGA (CV3)

## TORPEDO DAMAGE

JANUARY 11, 1942

WAR DAMAGE REPORT No. 19

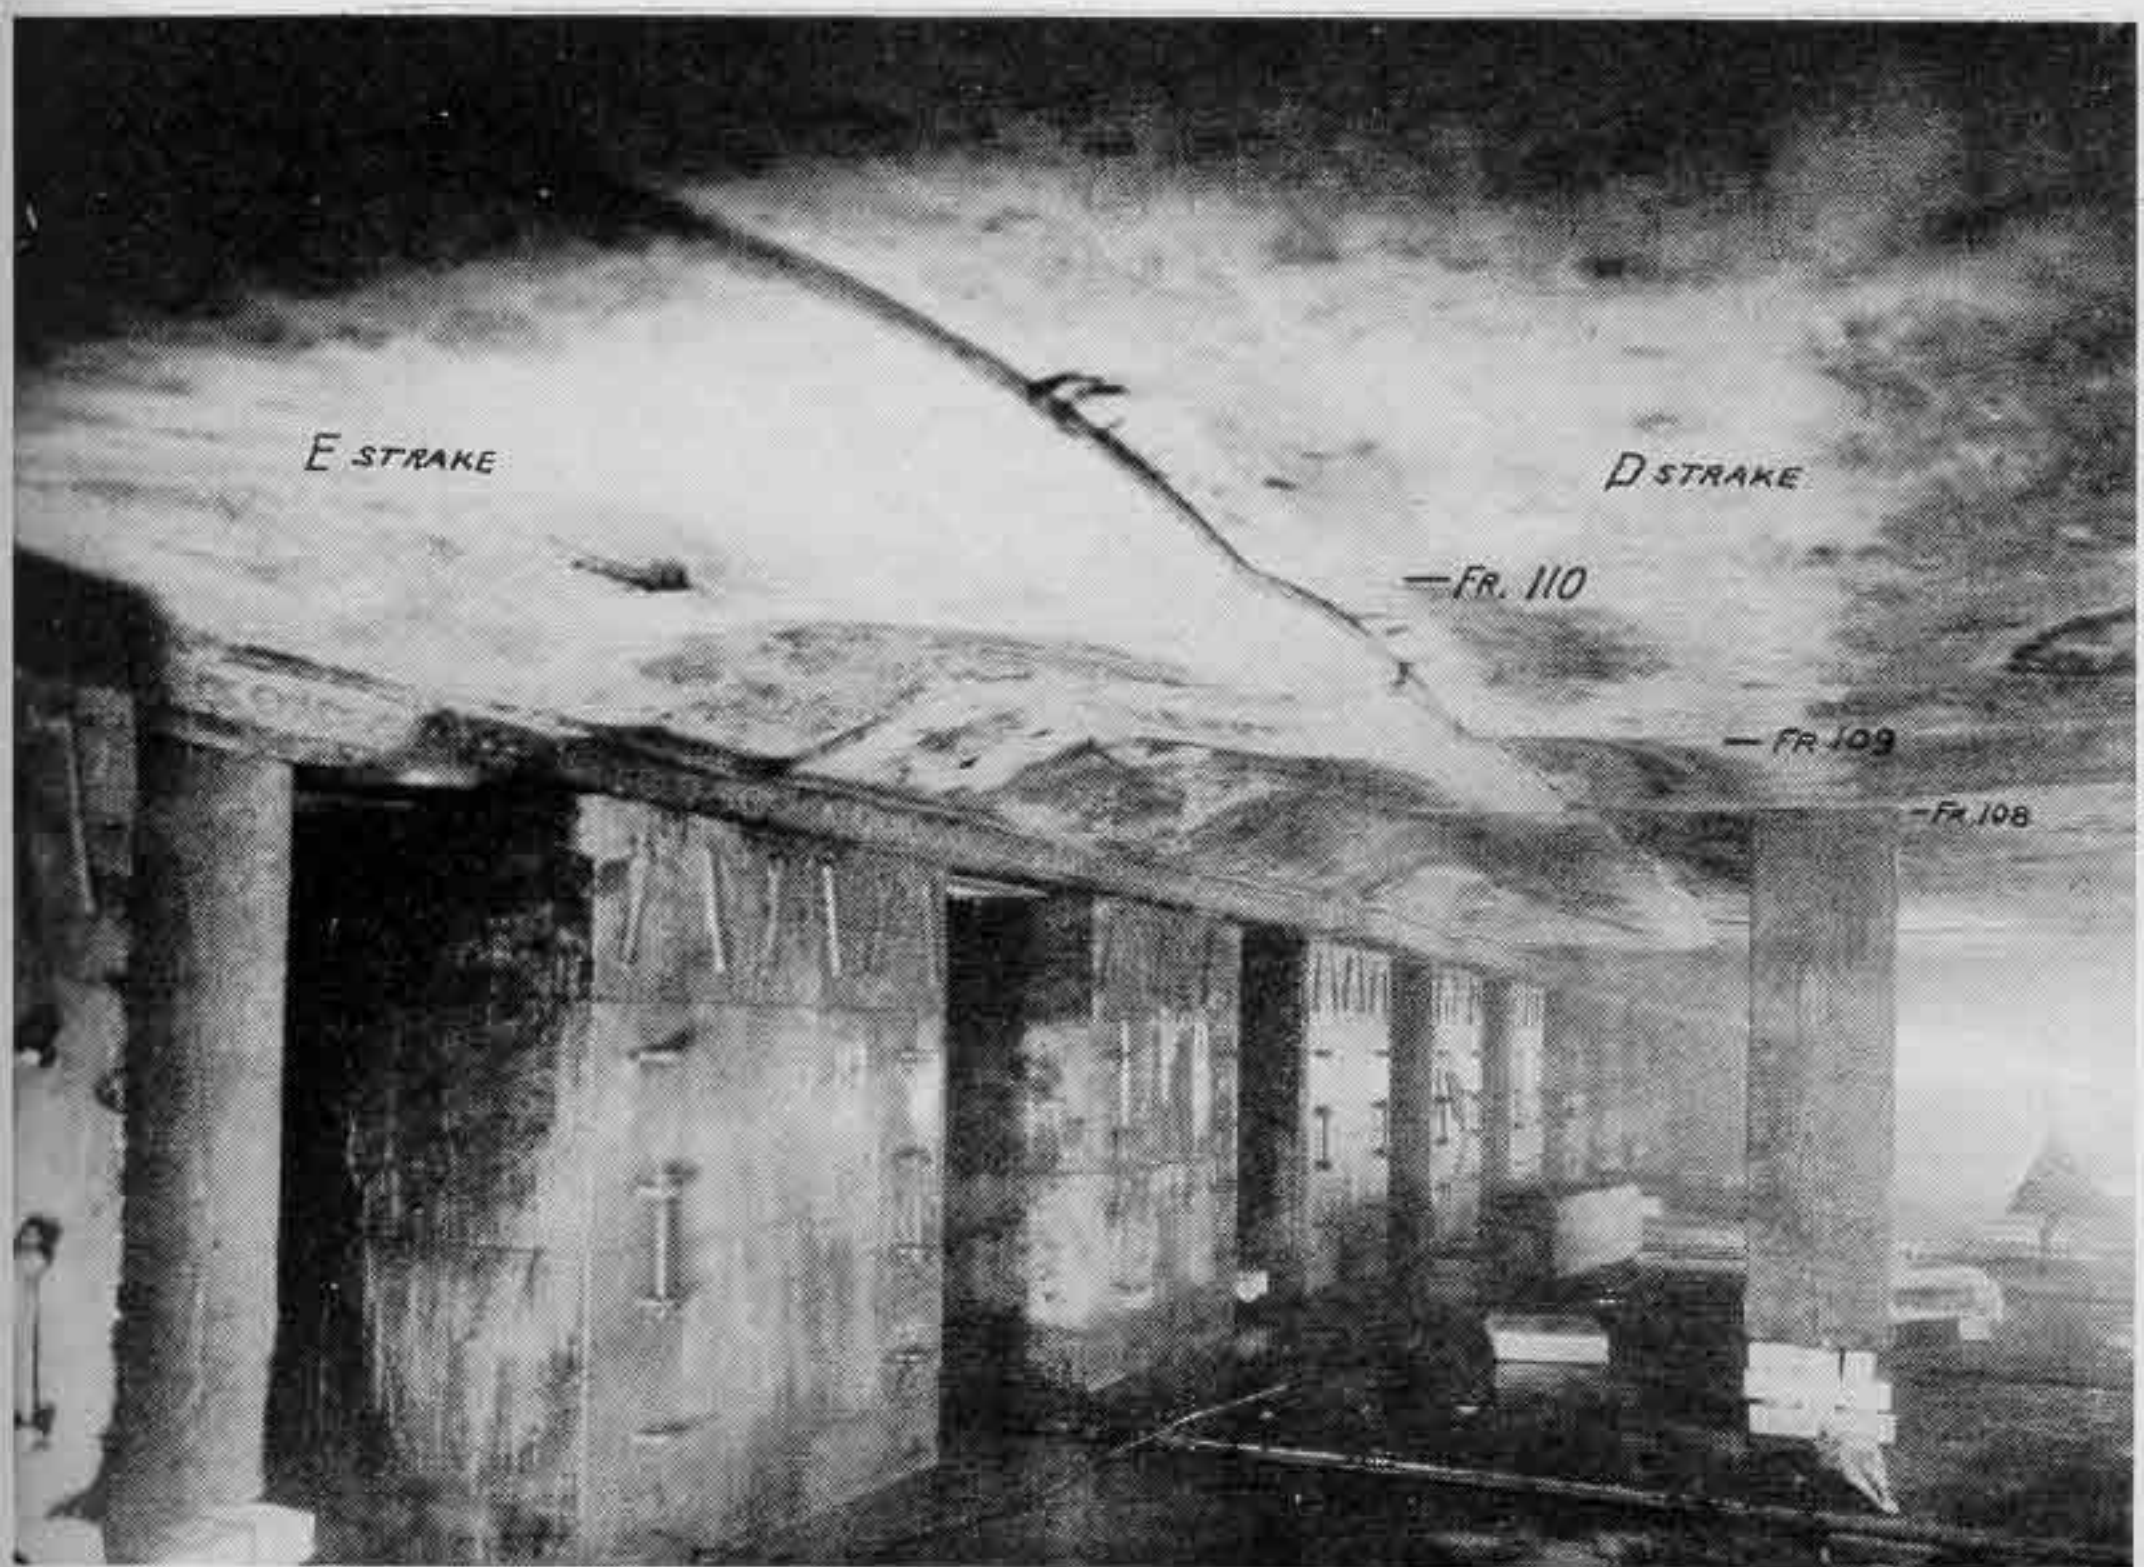
Photo 8: View inboard of the outboard docking keel looking forward and showing shell indentations. (See plate III).

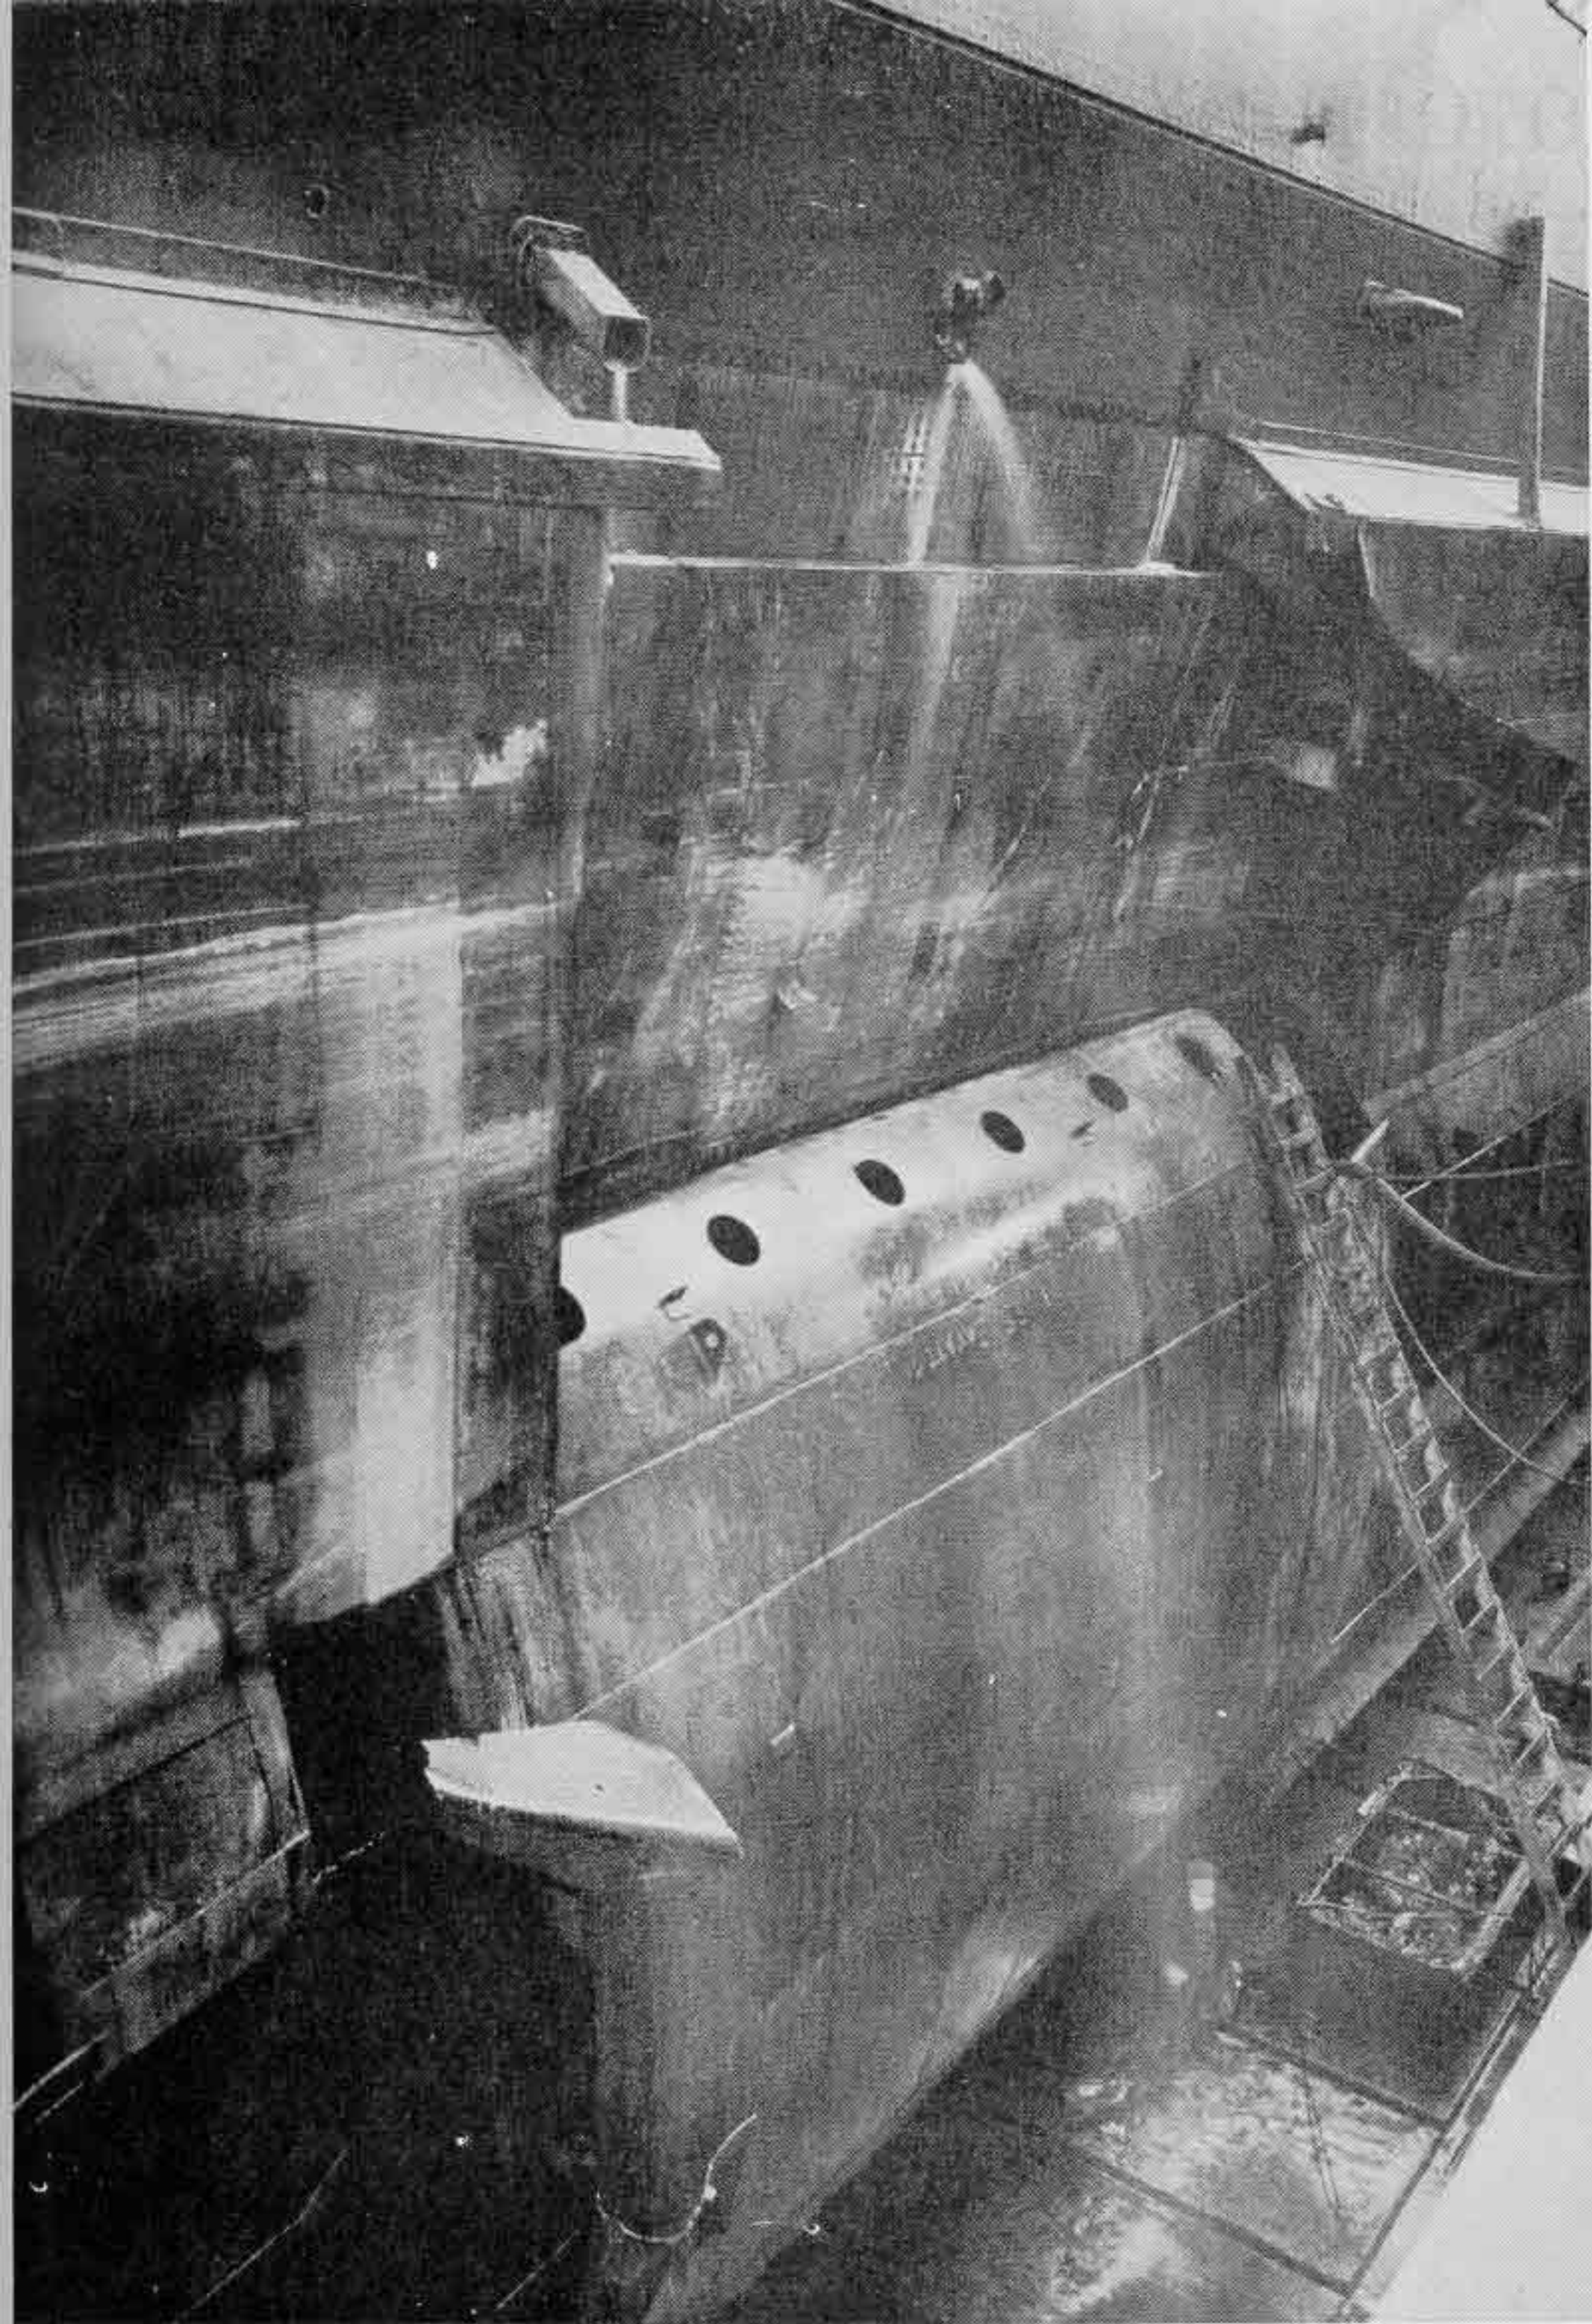
Photo 9: General view of temporary patch on arrival at Puget Sound looking aft and showing plating peeled back by action of the sea.

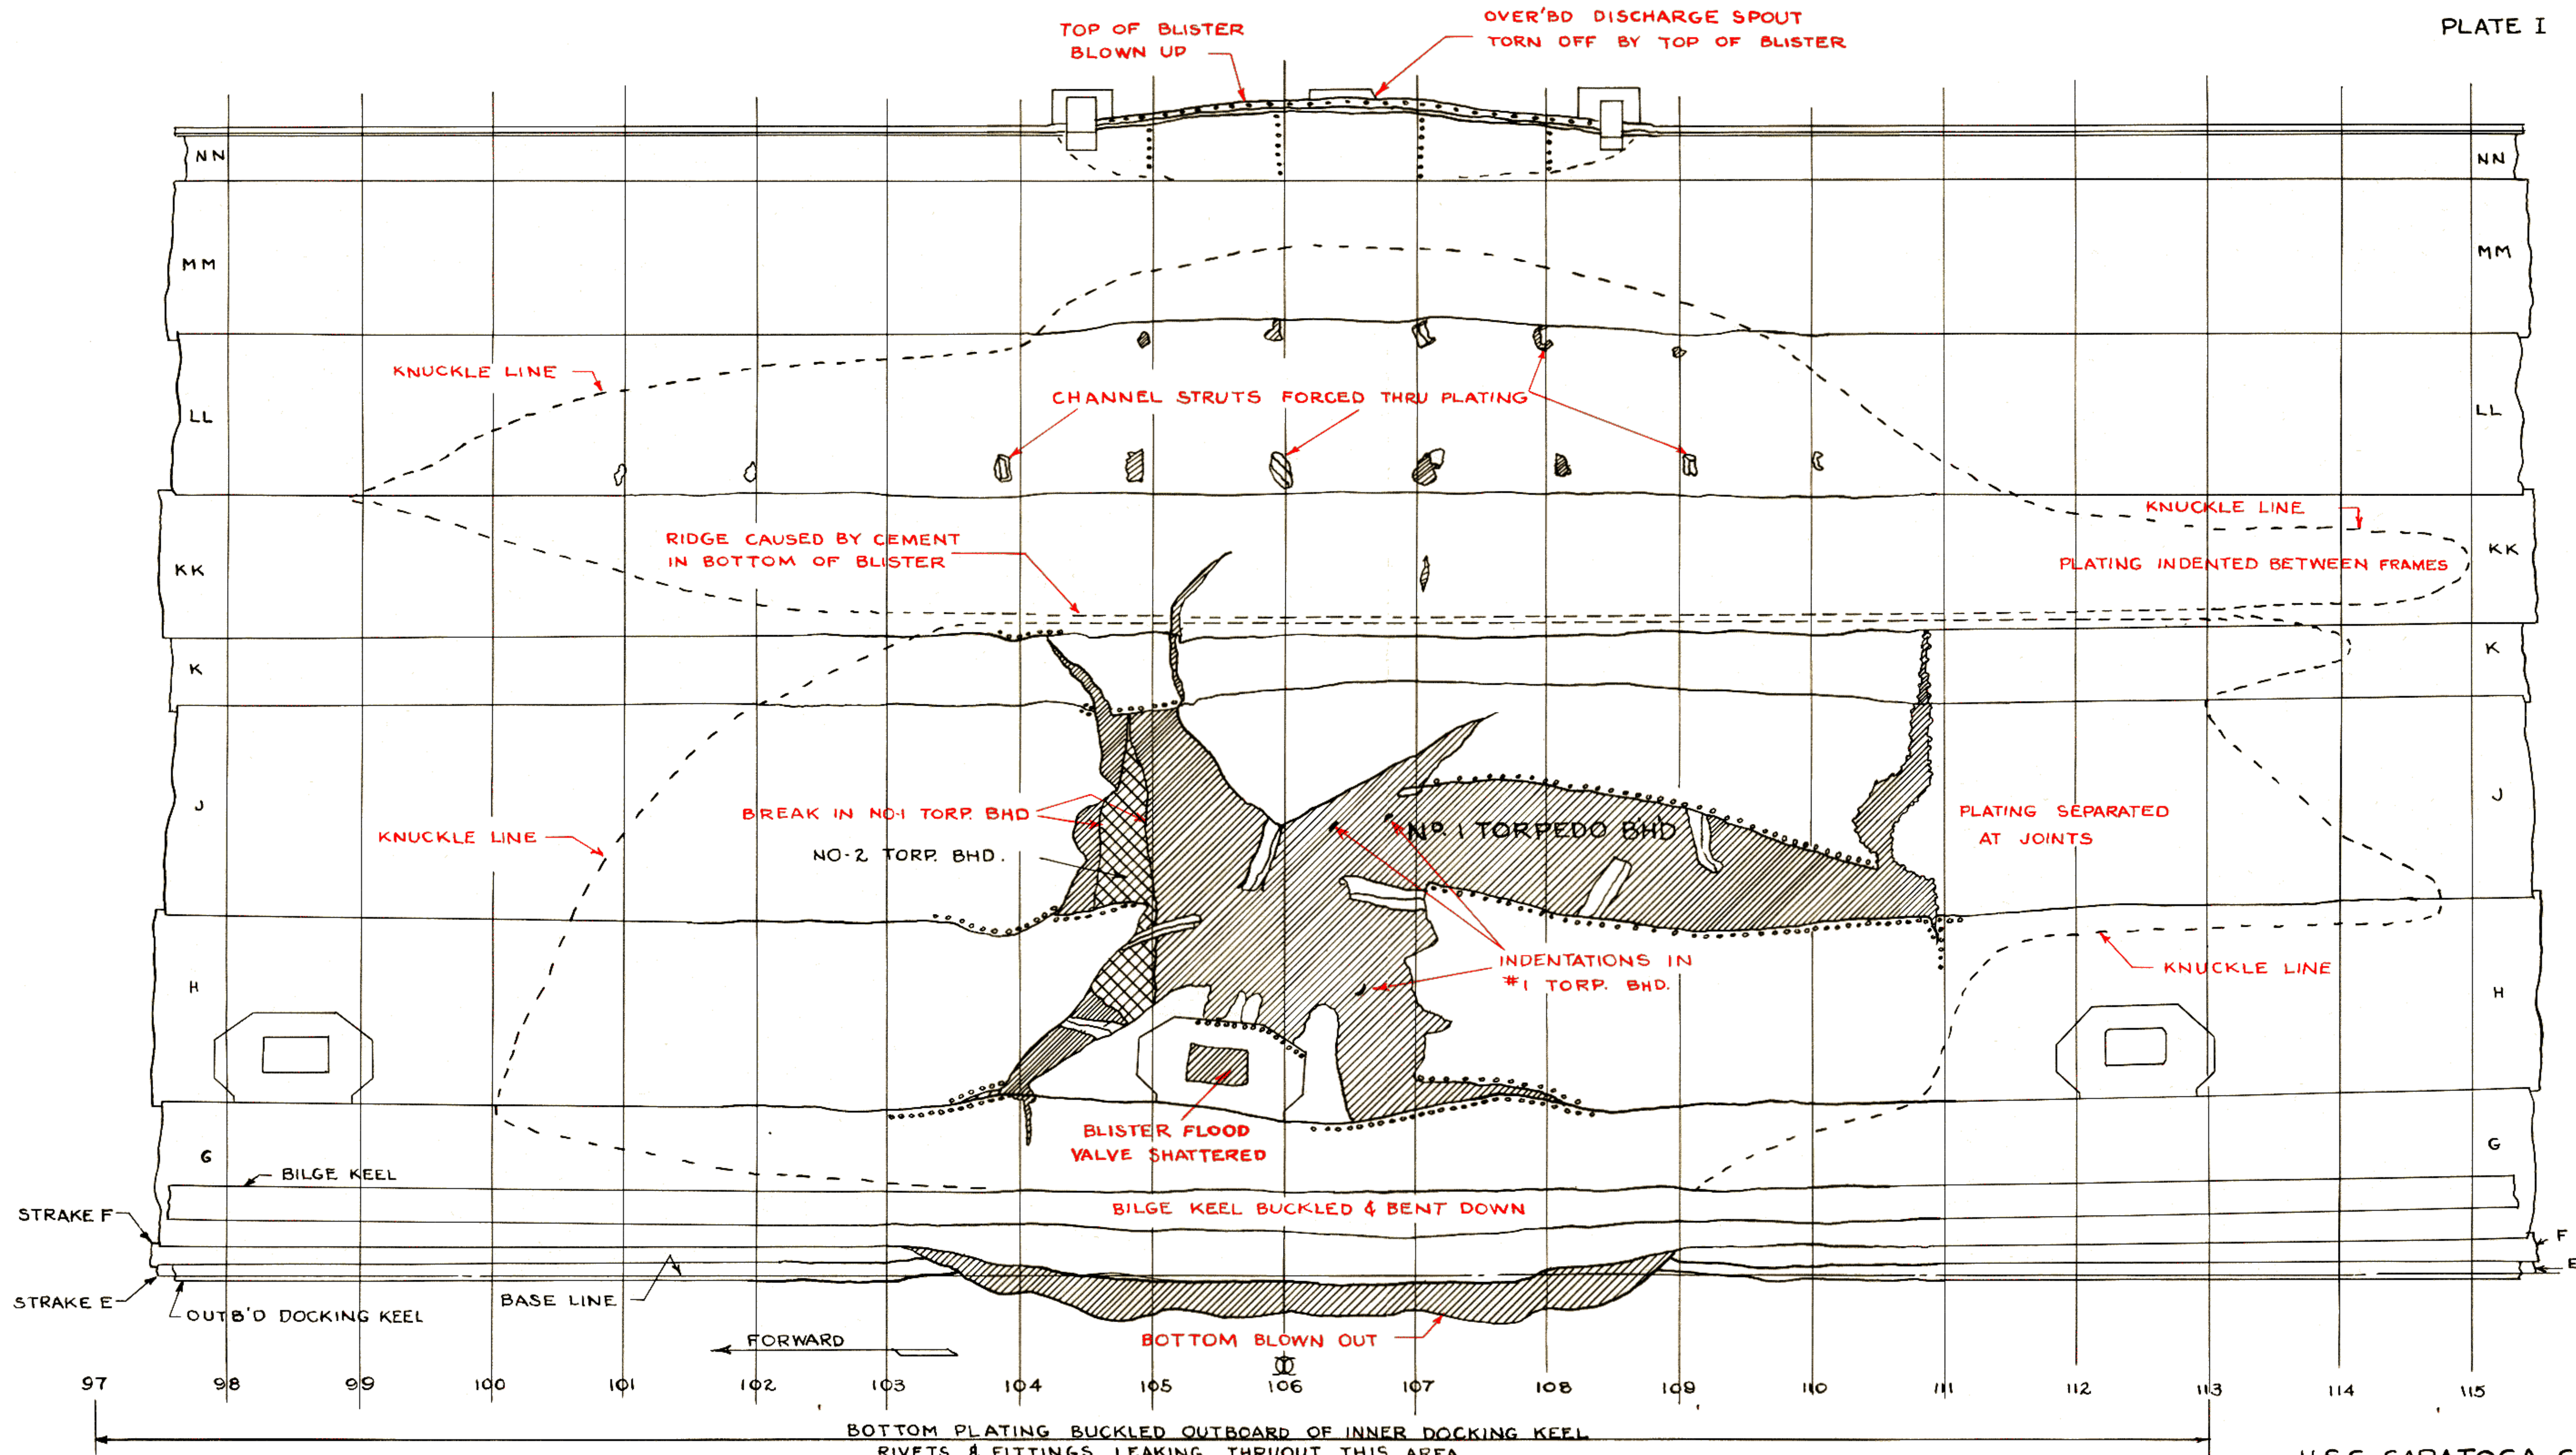
# ELEVATION OF TORPEDO DAMAGE - PORT SIDE

BOTTOM PLATING BUCKLED OUTBOARD OF INNER DOCKING KEEL  
RIVETS & FITTINGS LEAKING THRUOUT THIS AREA
