# U. S. S. YORKTOWN (CV5)

## BOMB DAMAGE

CORAL SEA

WAR DAMAGE REPORT No. 23

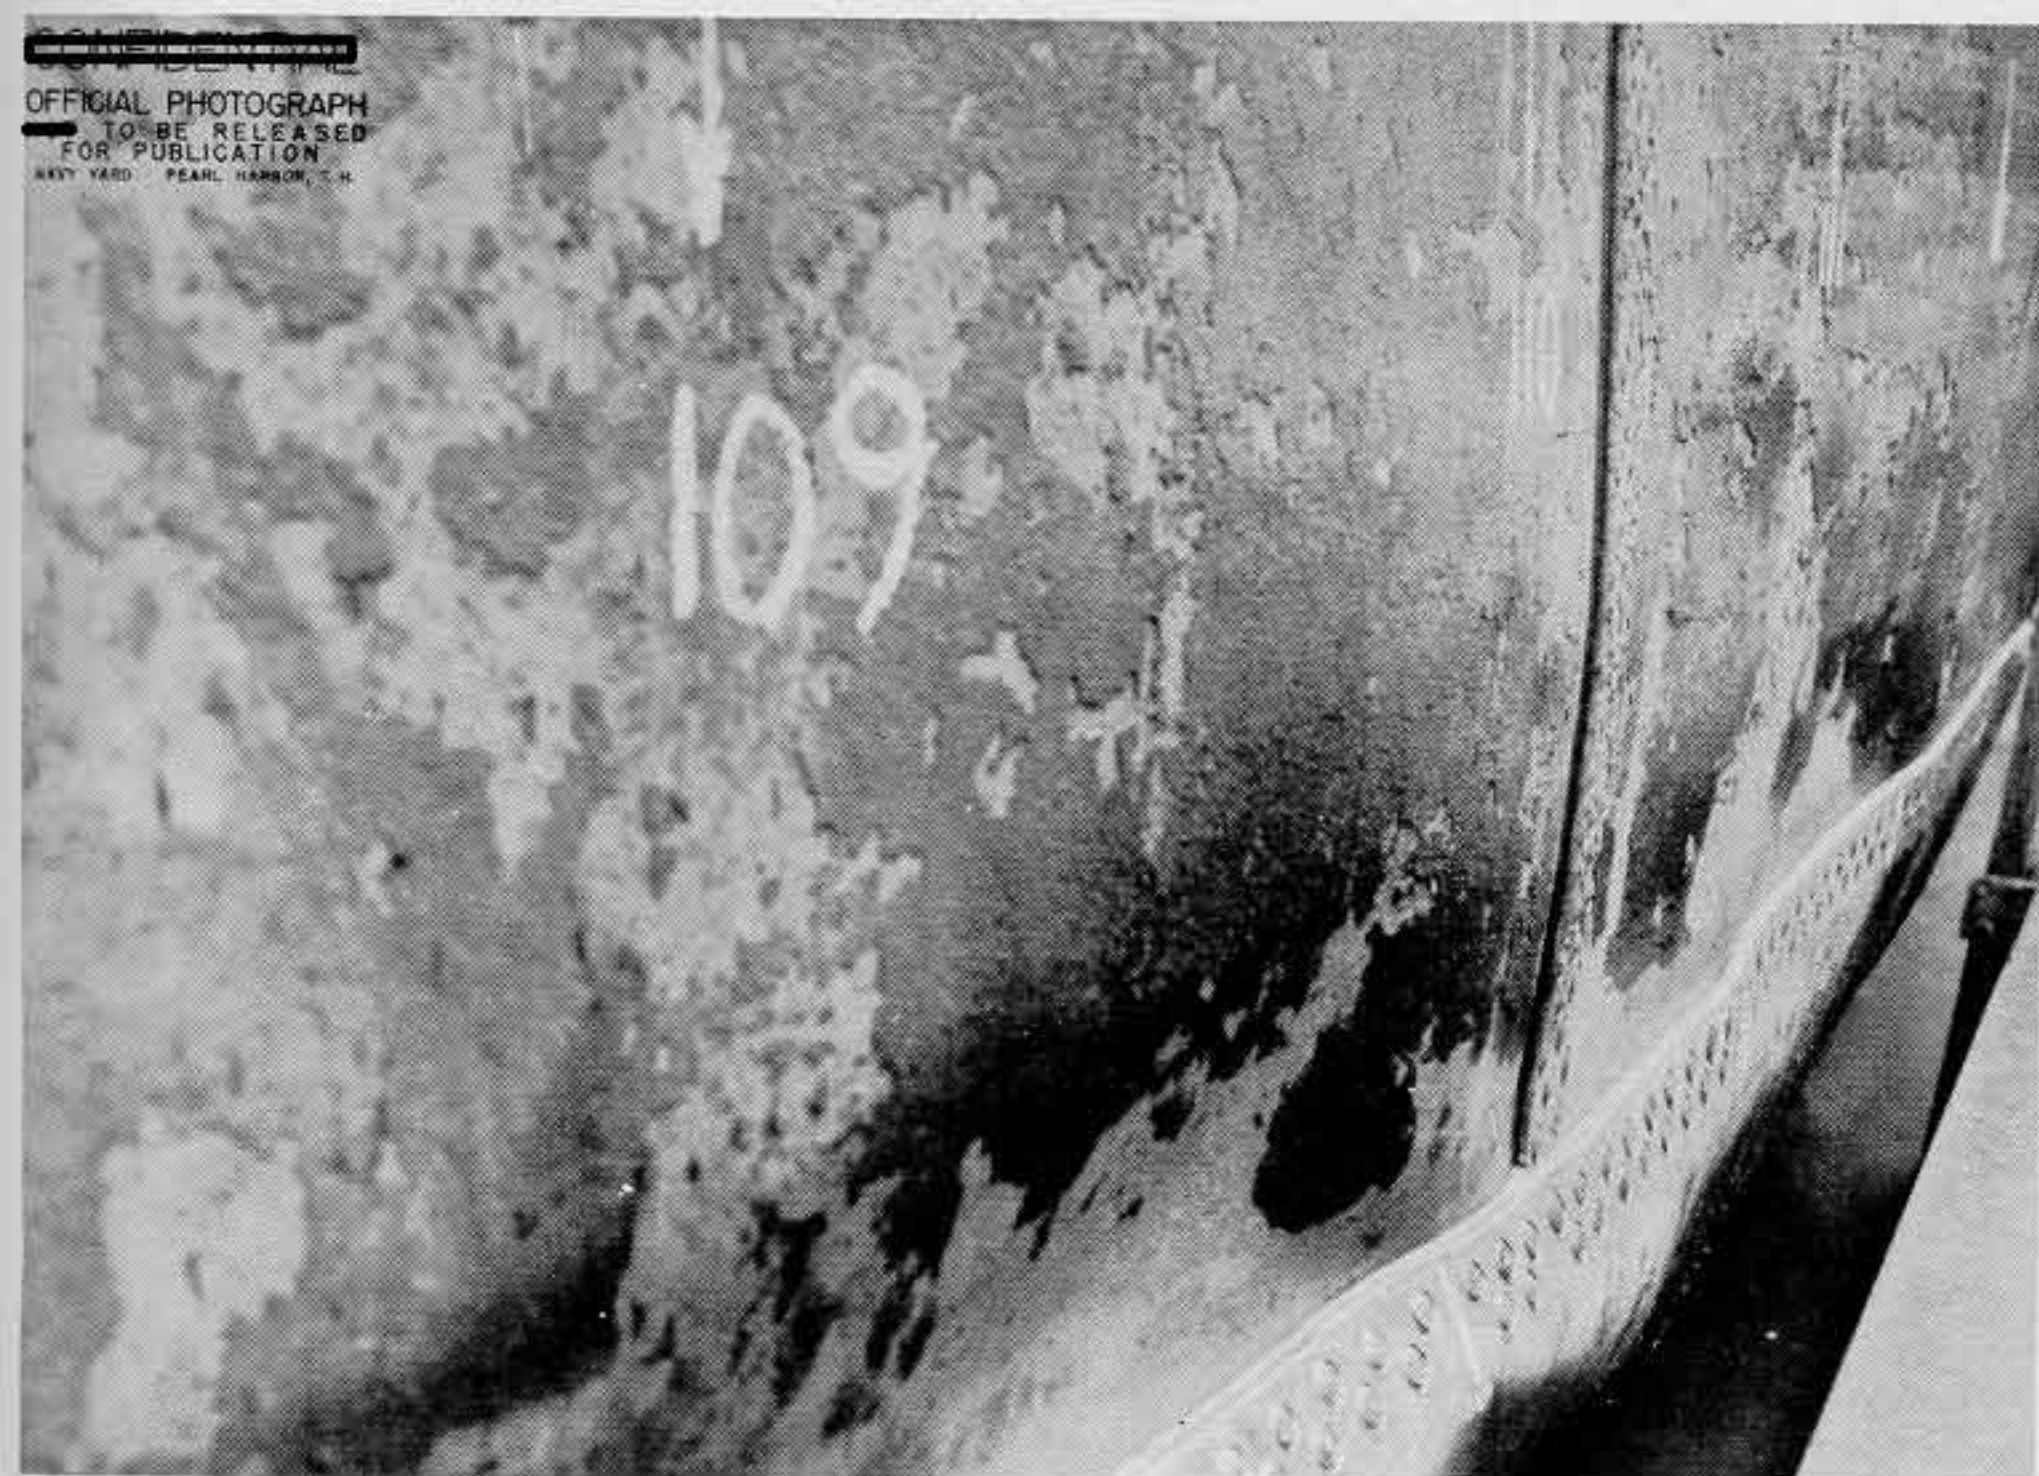
Photo 1: Bomb Damage to Port Shell, looking aft, FRS108-112.

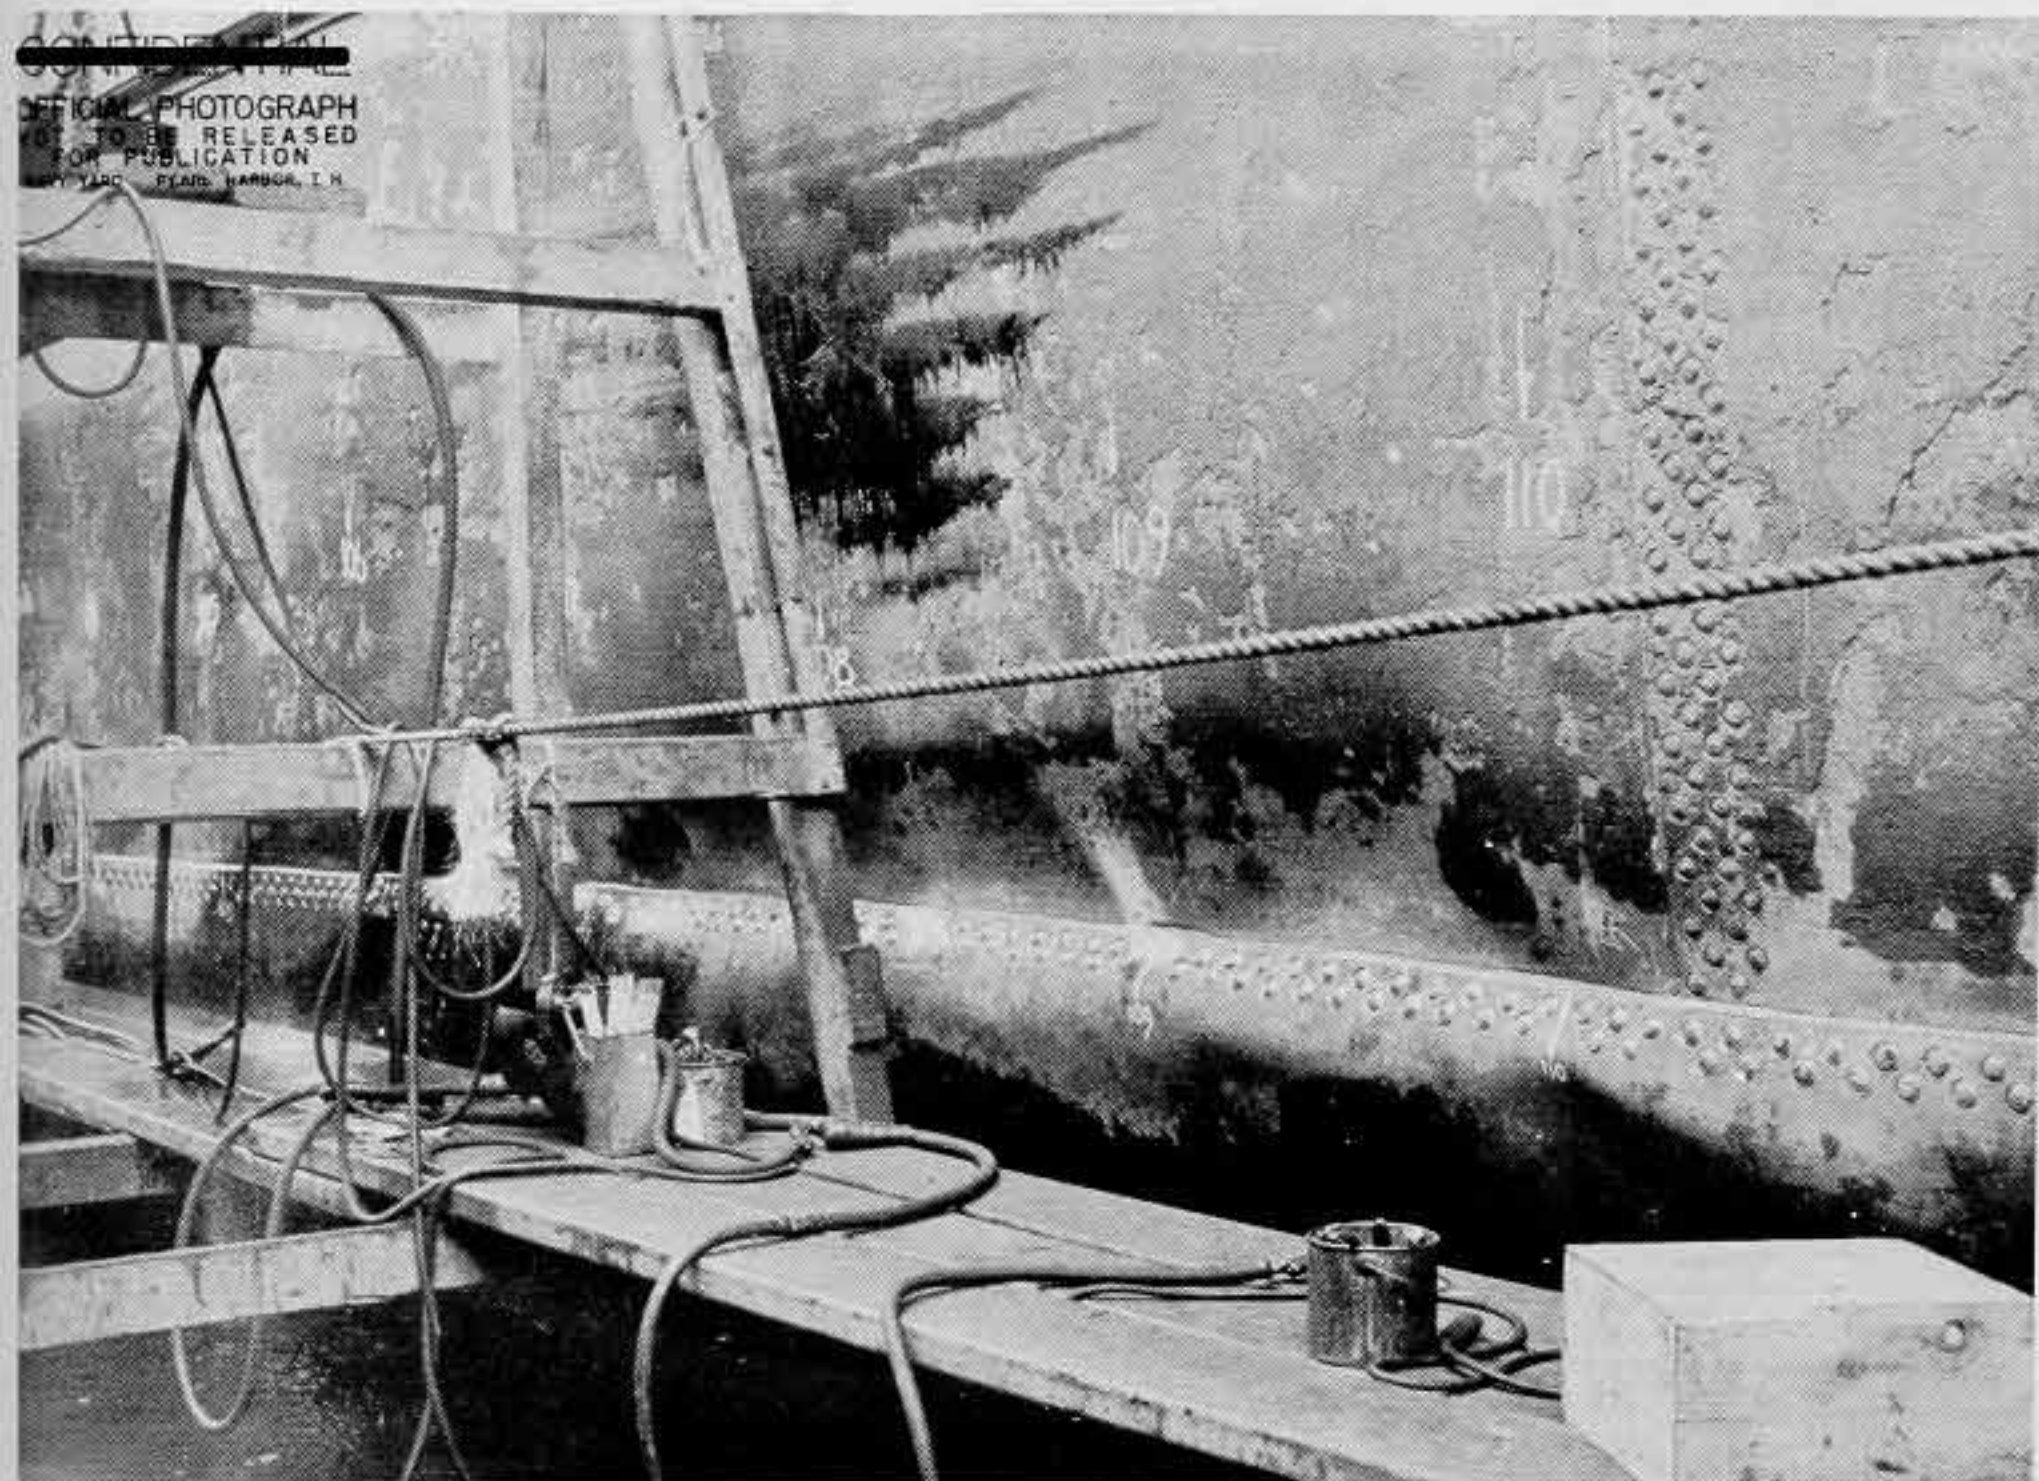
Photo 2: Bomb Damage to Port Shell, FRS 104-11, temporary repairs complete.

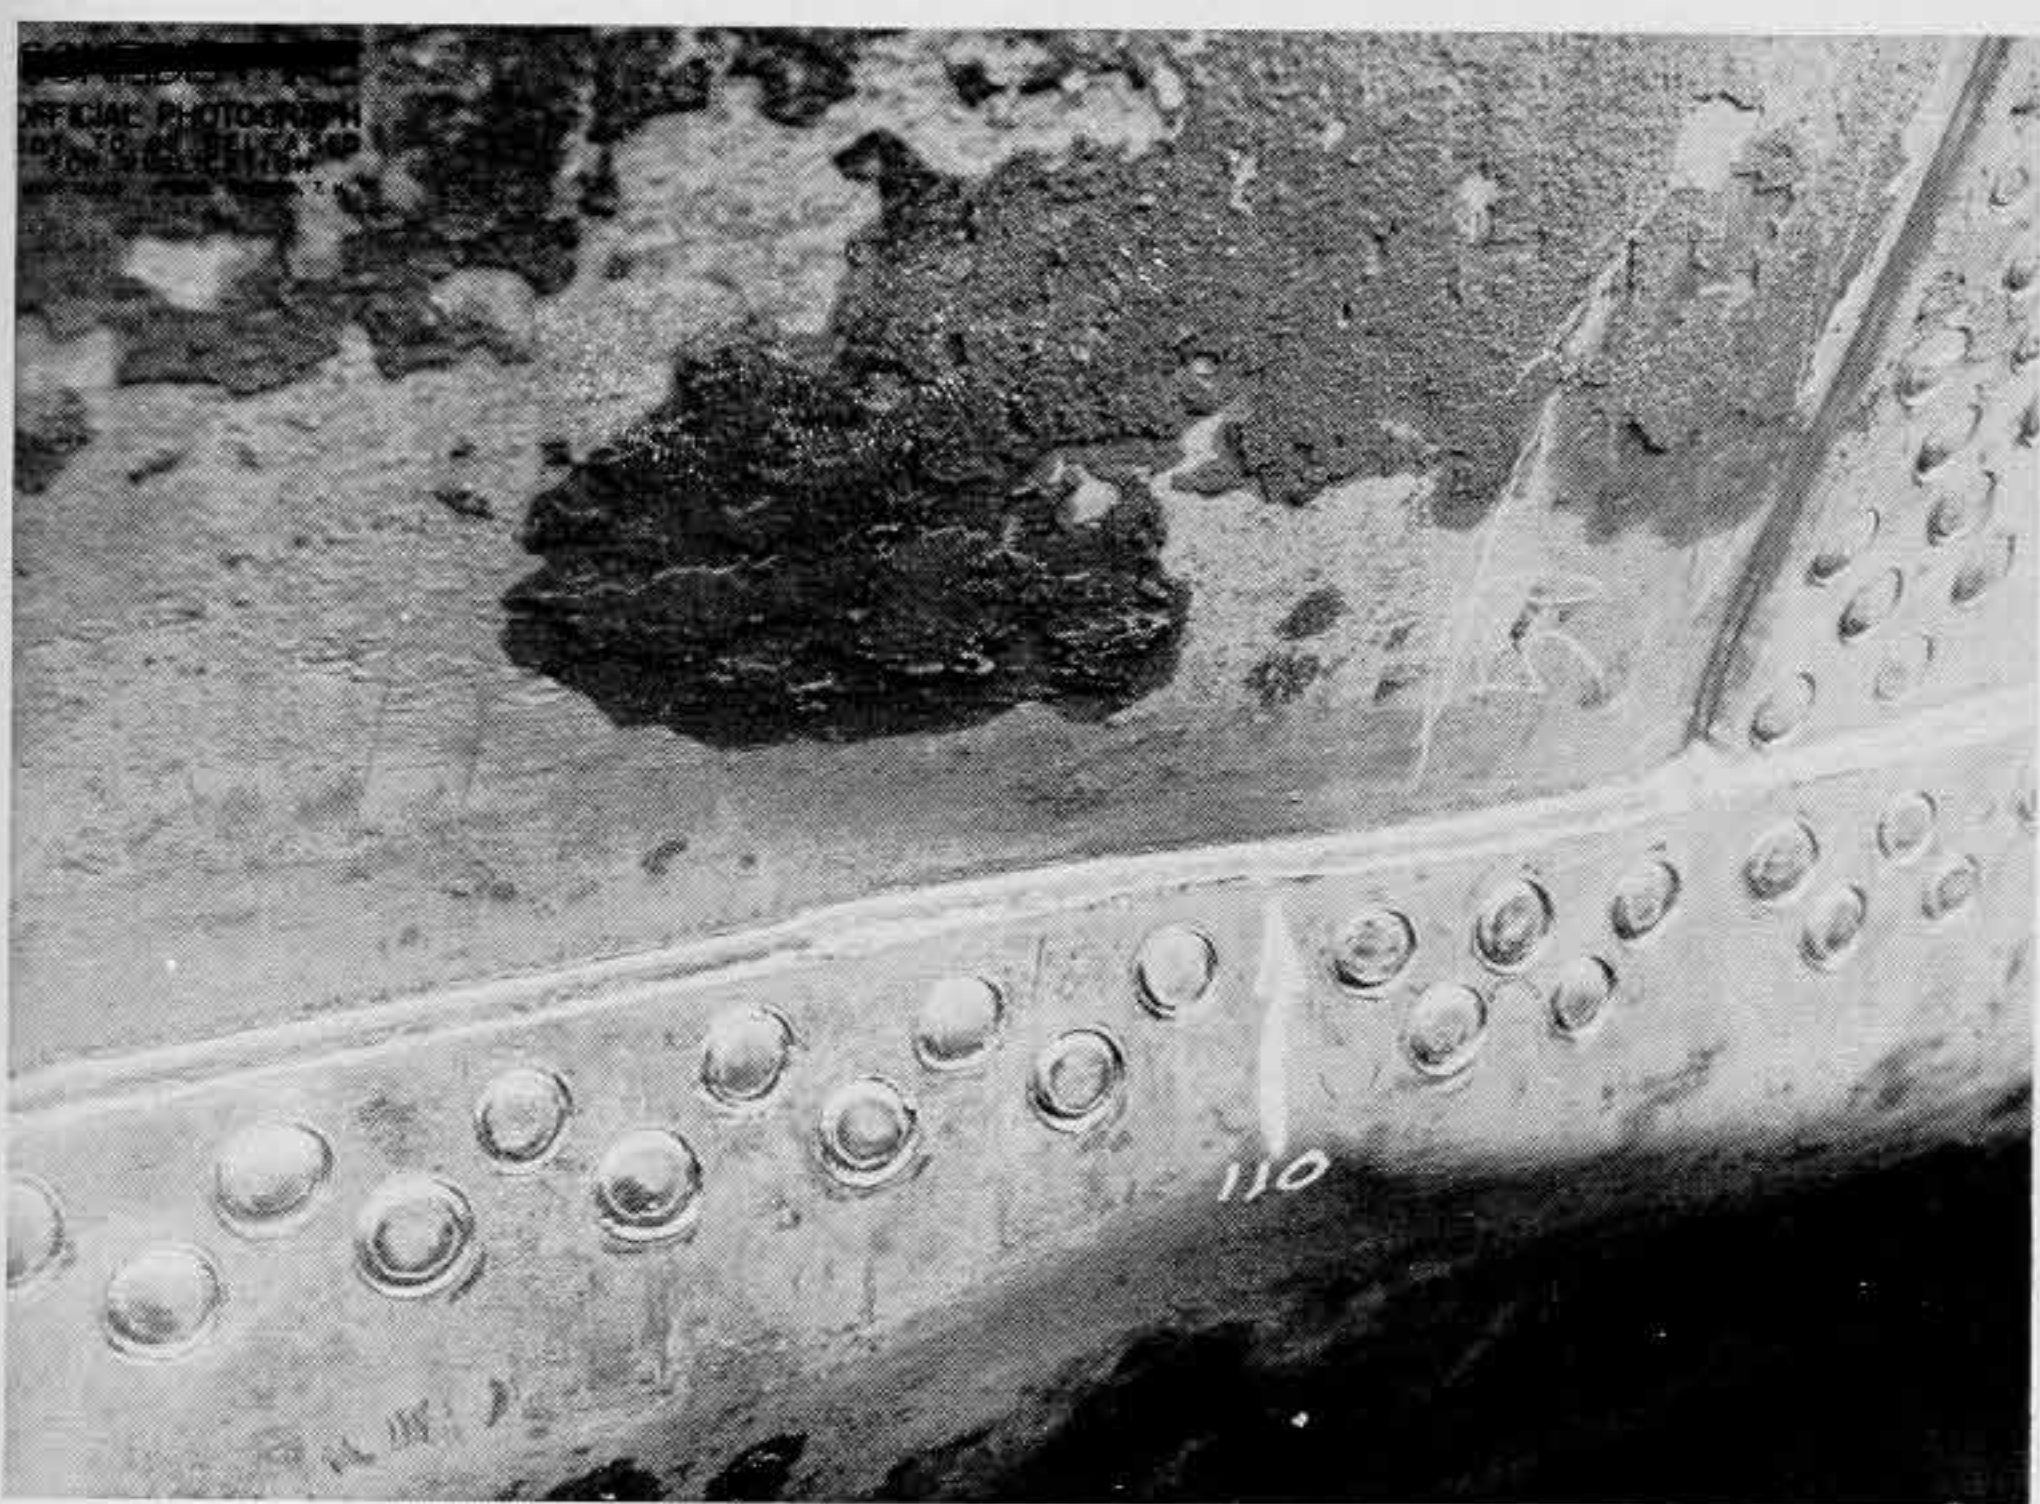
Photo 3: Bomb Damage to Port Shell, FR 110, details of temporary repairs.

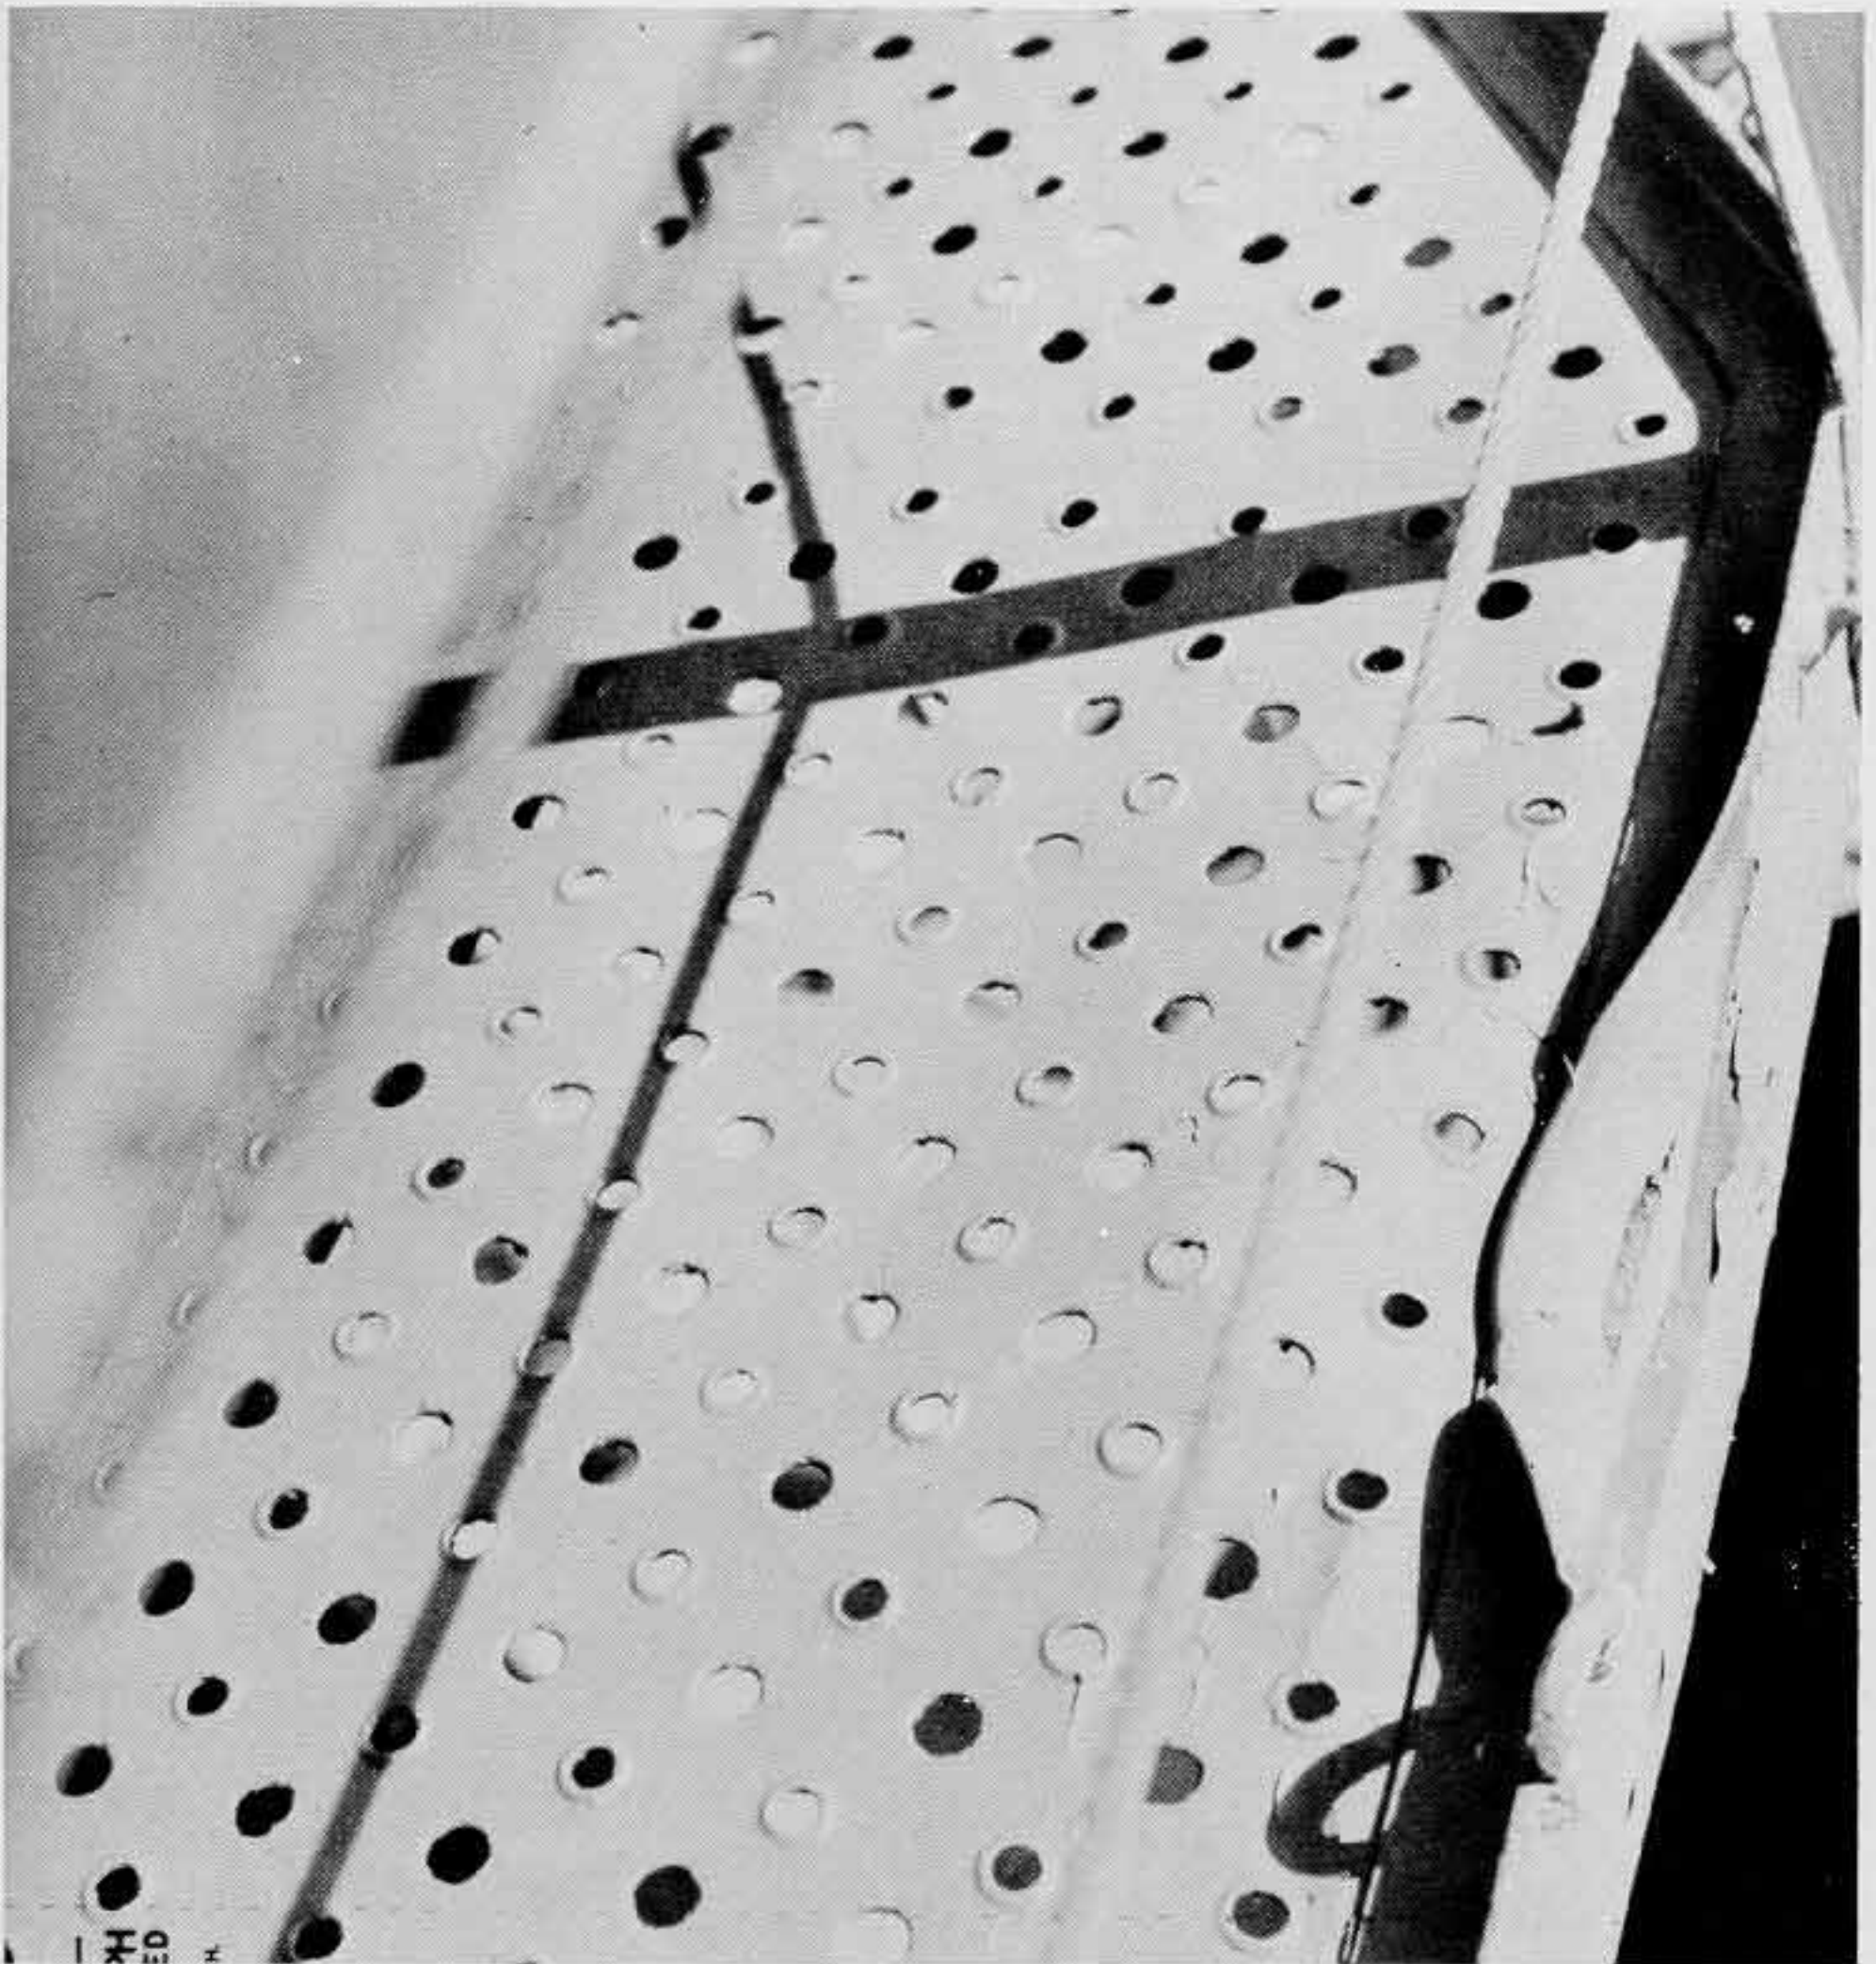
Photo 4: Damage to Coaming of Starboard Gallery Walkway, 15" aft. FR 42. Bomb glanced off and exploded some distance away.

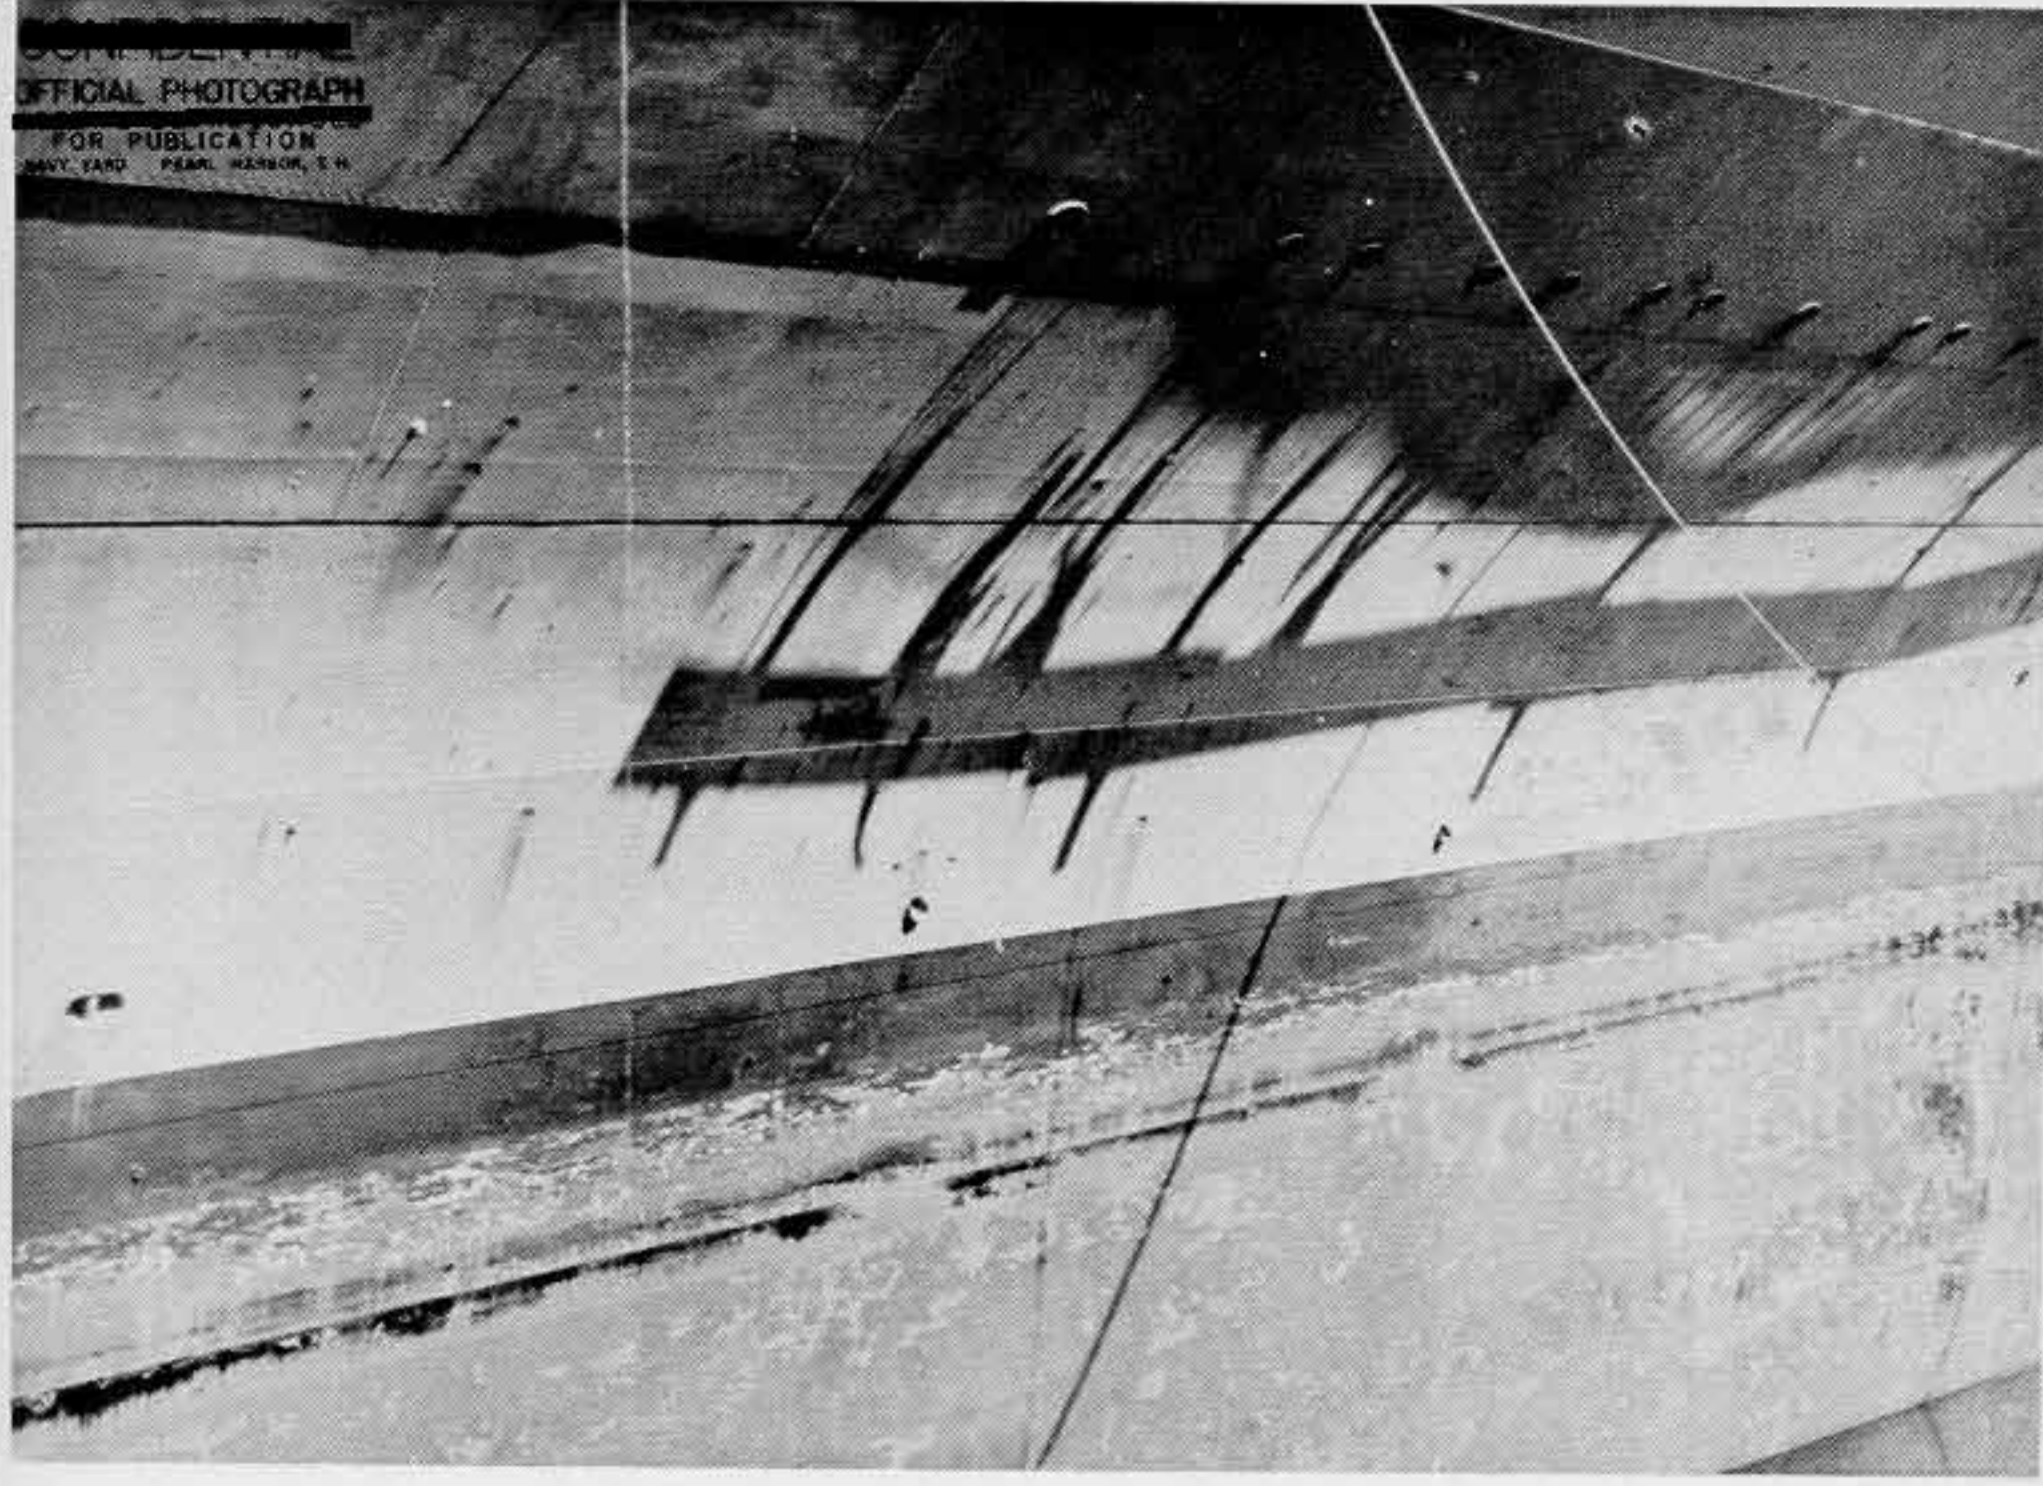
Photo 5: Bomb Fragment Damage, starboard shell, FRS 13-23.

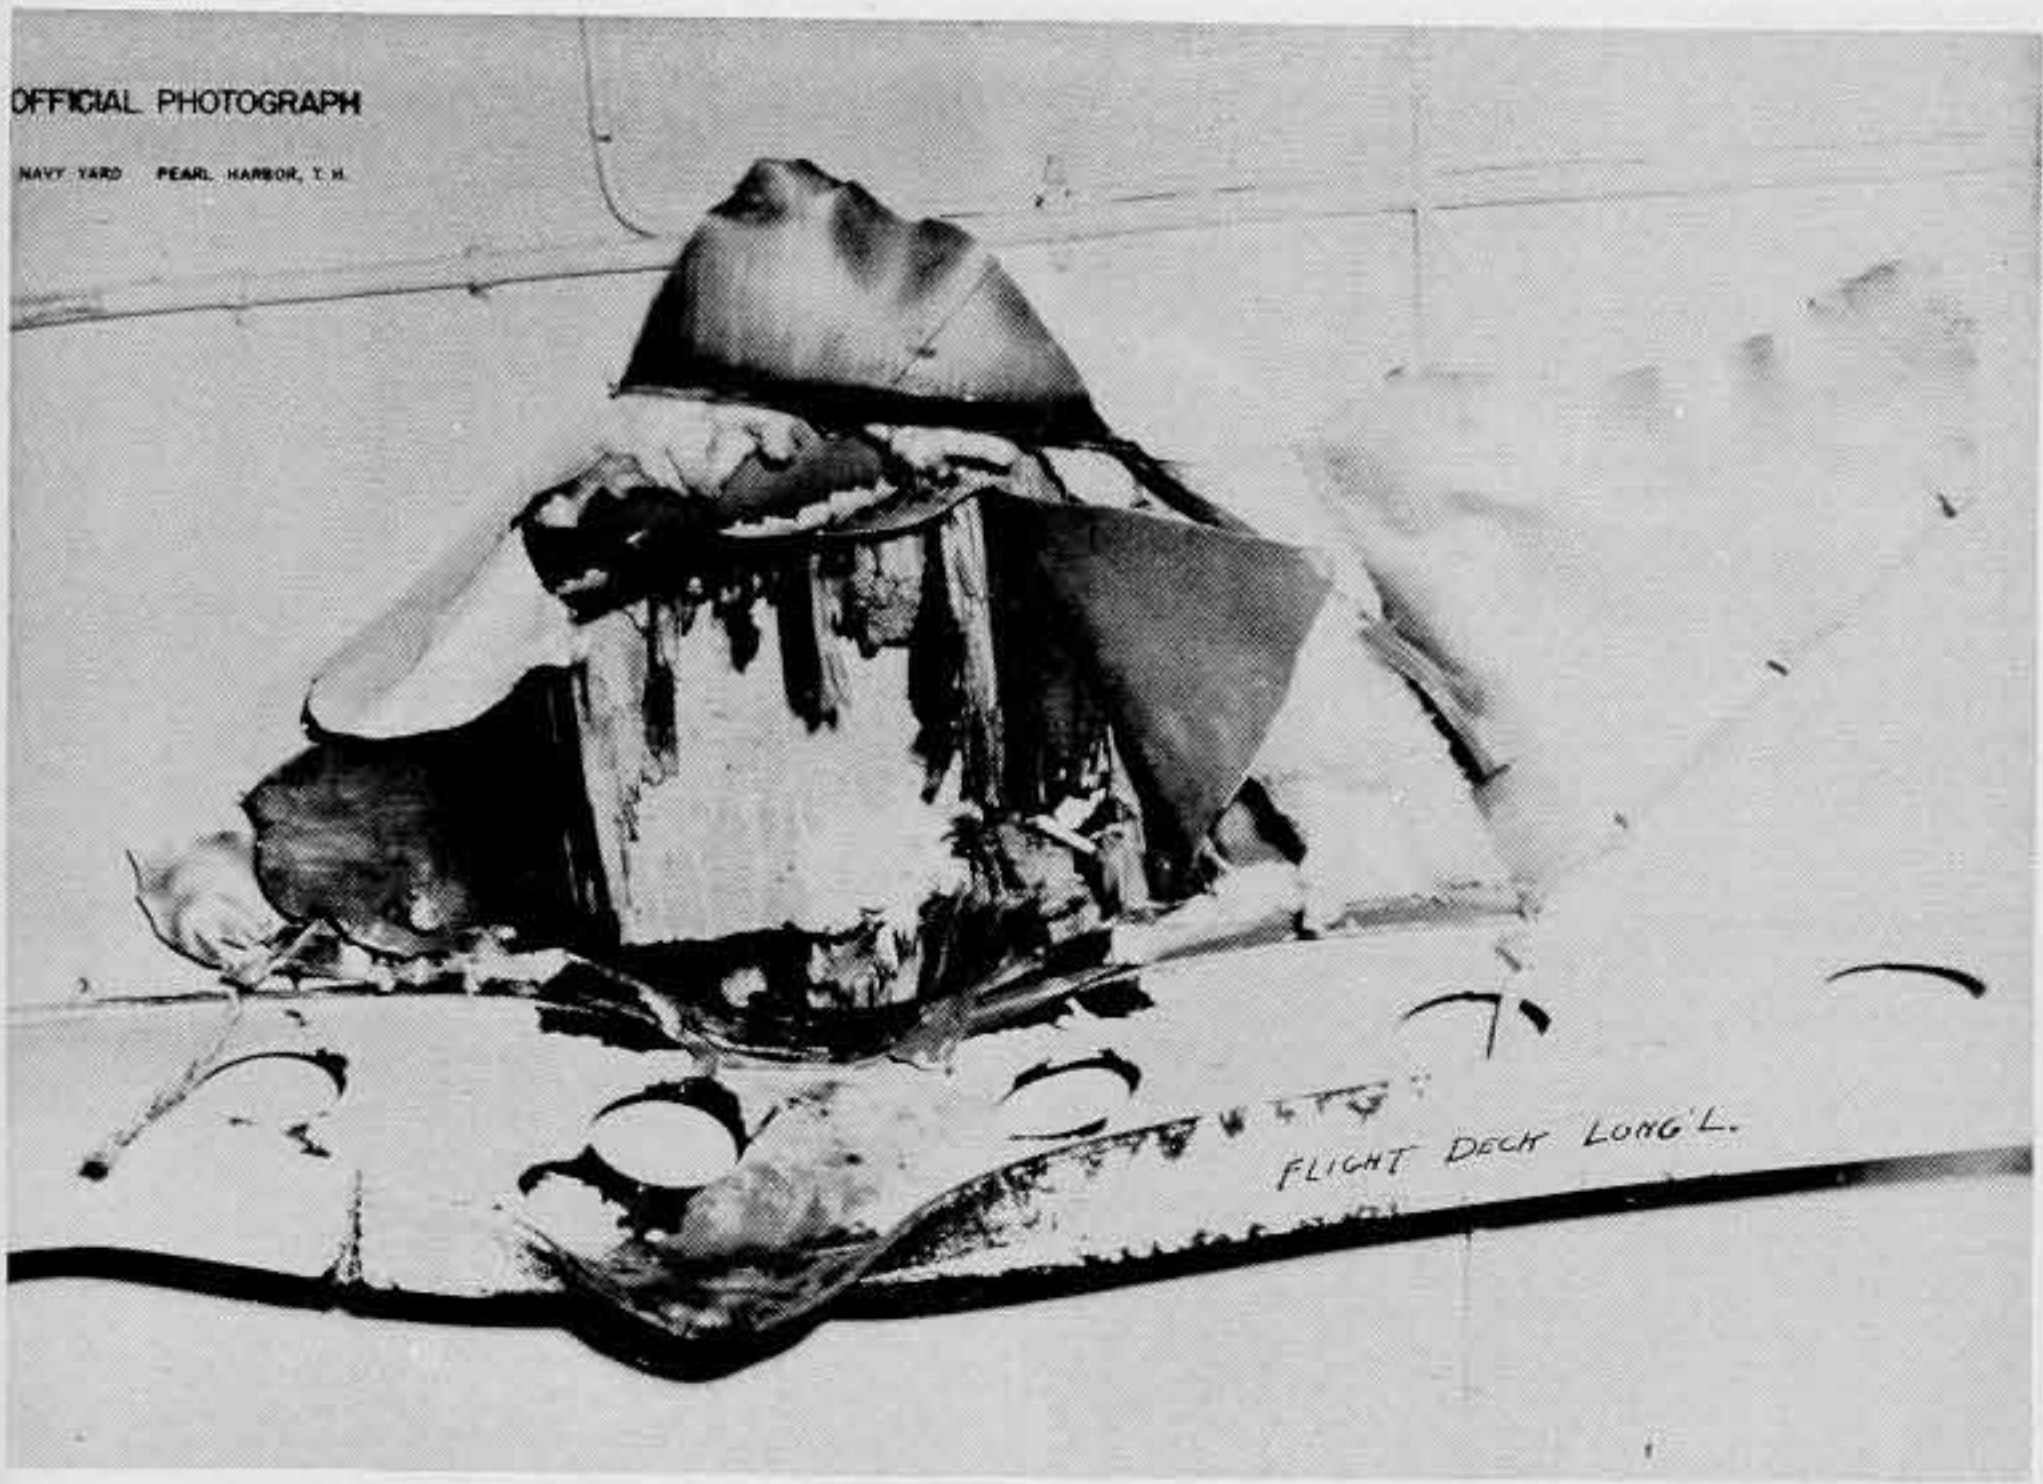
Photo 6: Bomb Entry Hole, Flight Deck, looking up. Note failure of butt weld in face plate.

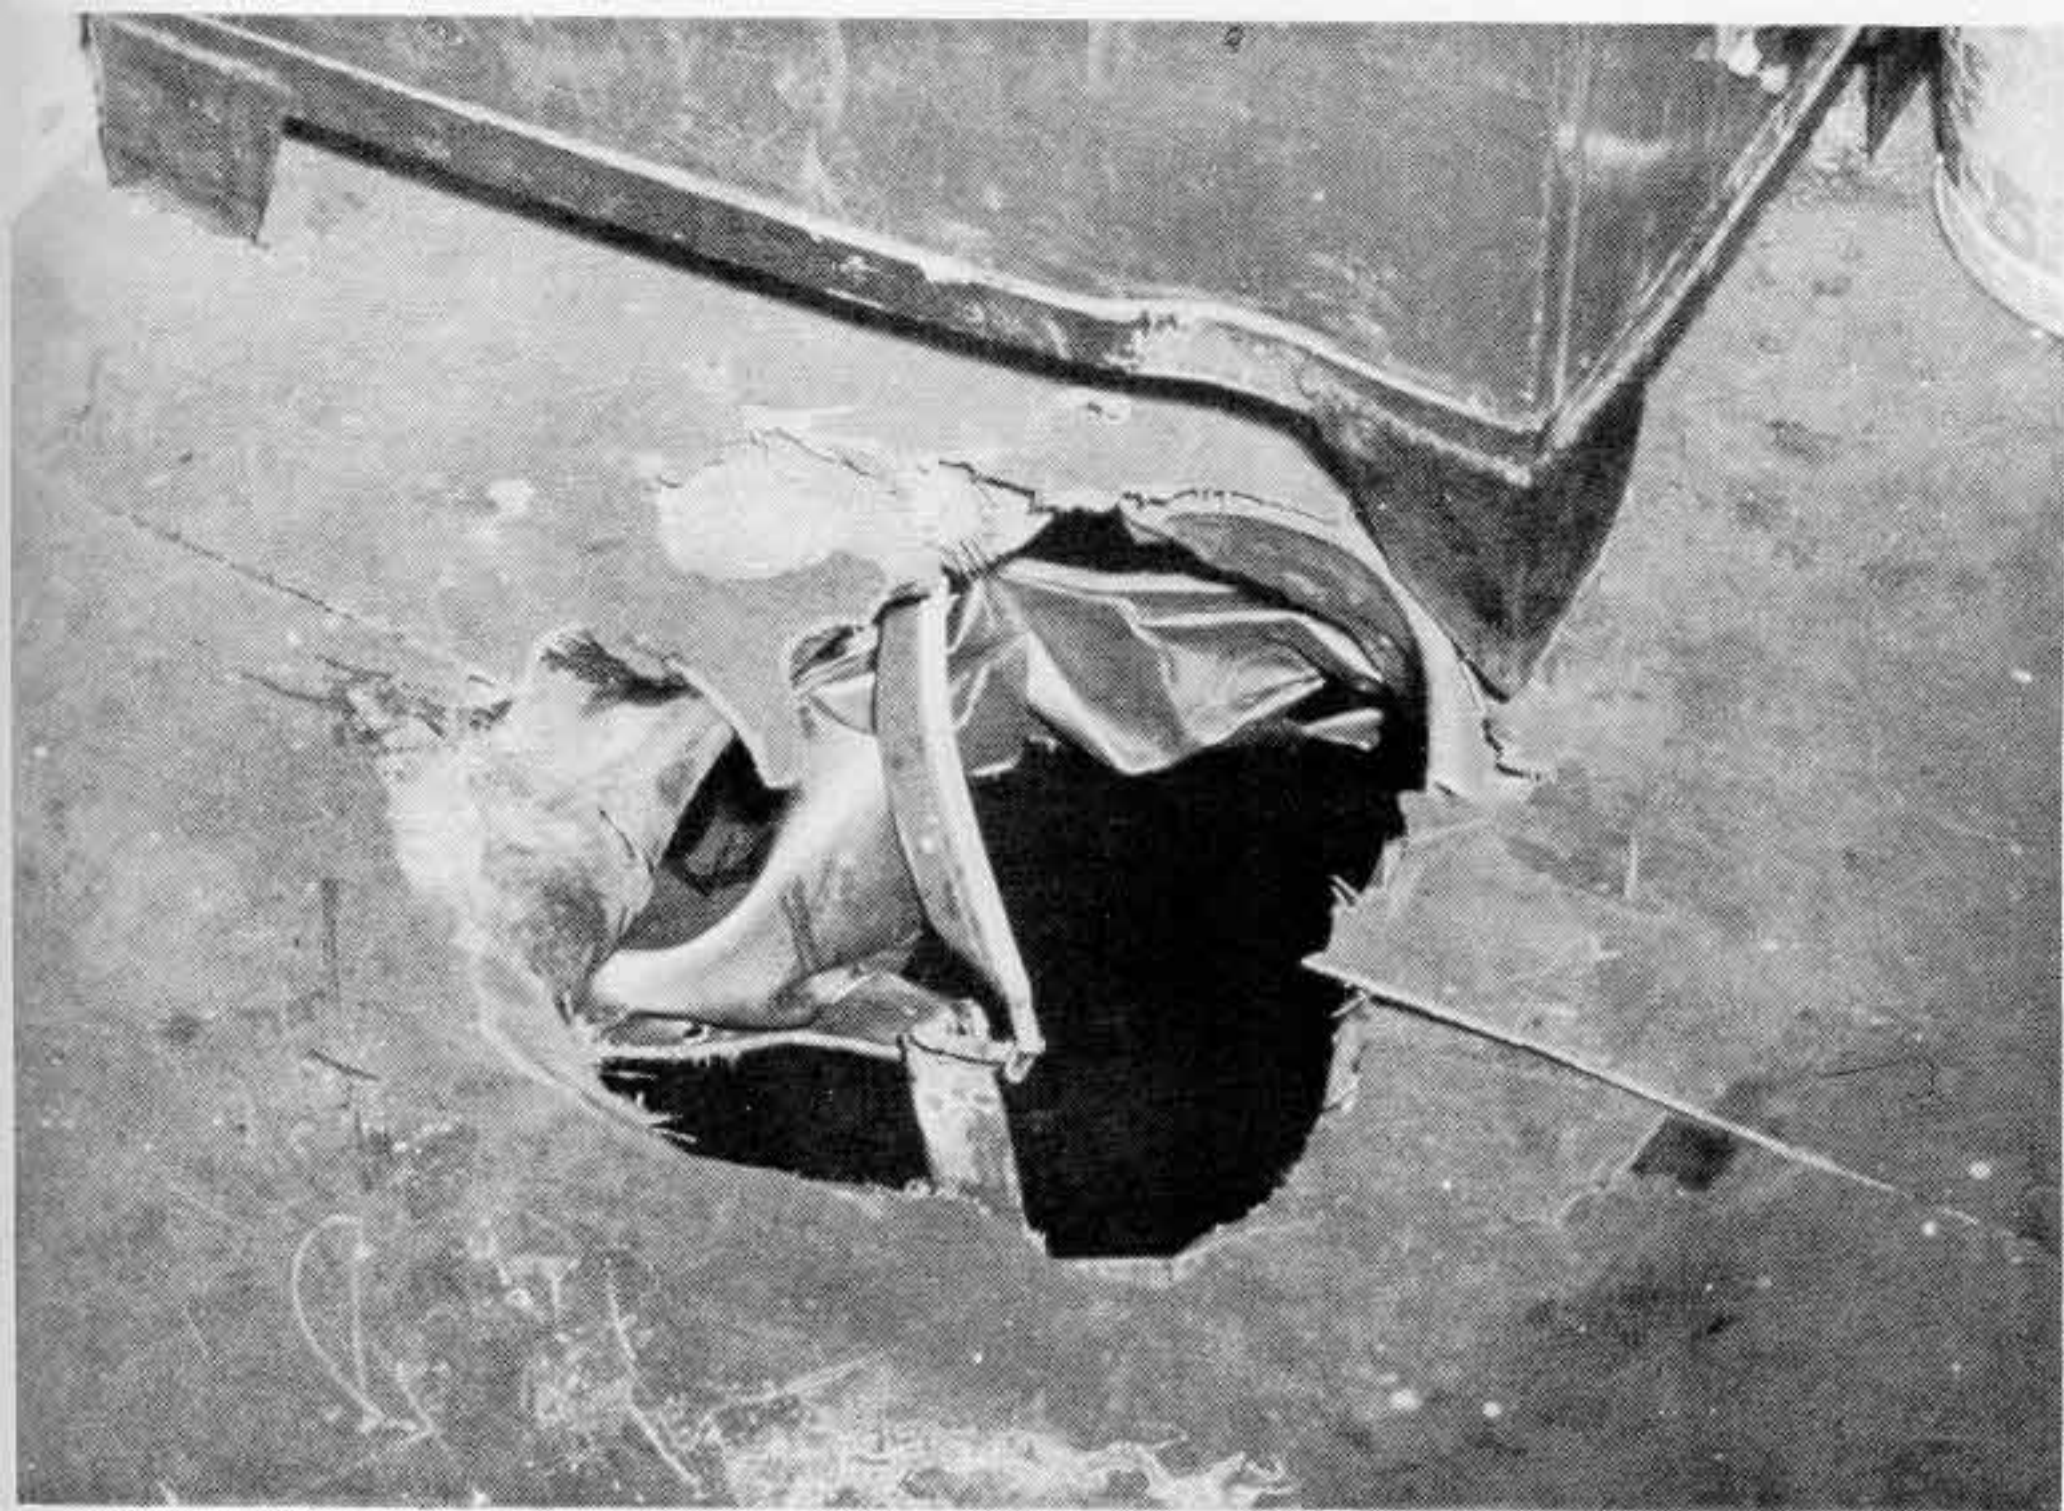
Photo 7: Bomb Hole, Gallery Deck, FR 108, looking down.
