# U. S. S. YORKTOWN (CV5)

## BOMB DAMAGE

CORAL SEA

WAR DAMAGE REPORT No. 23

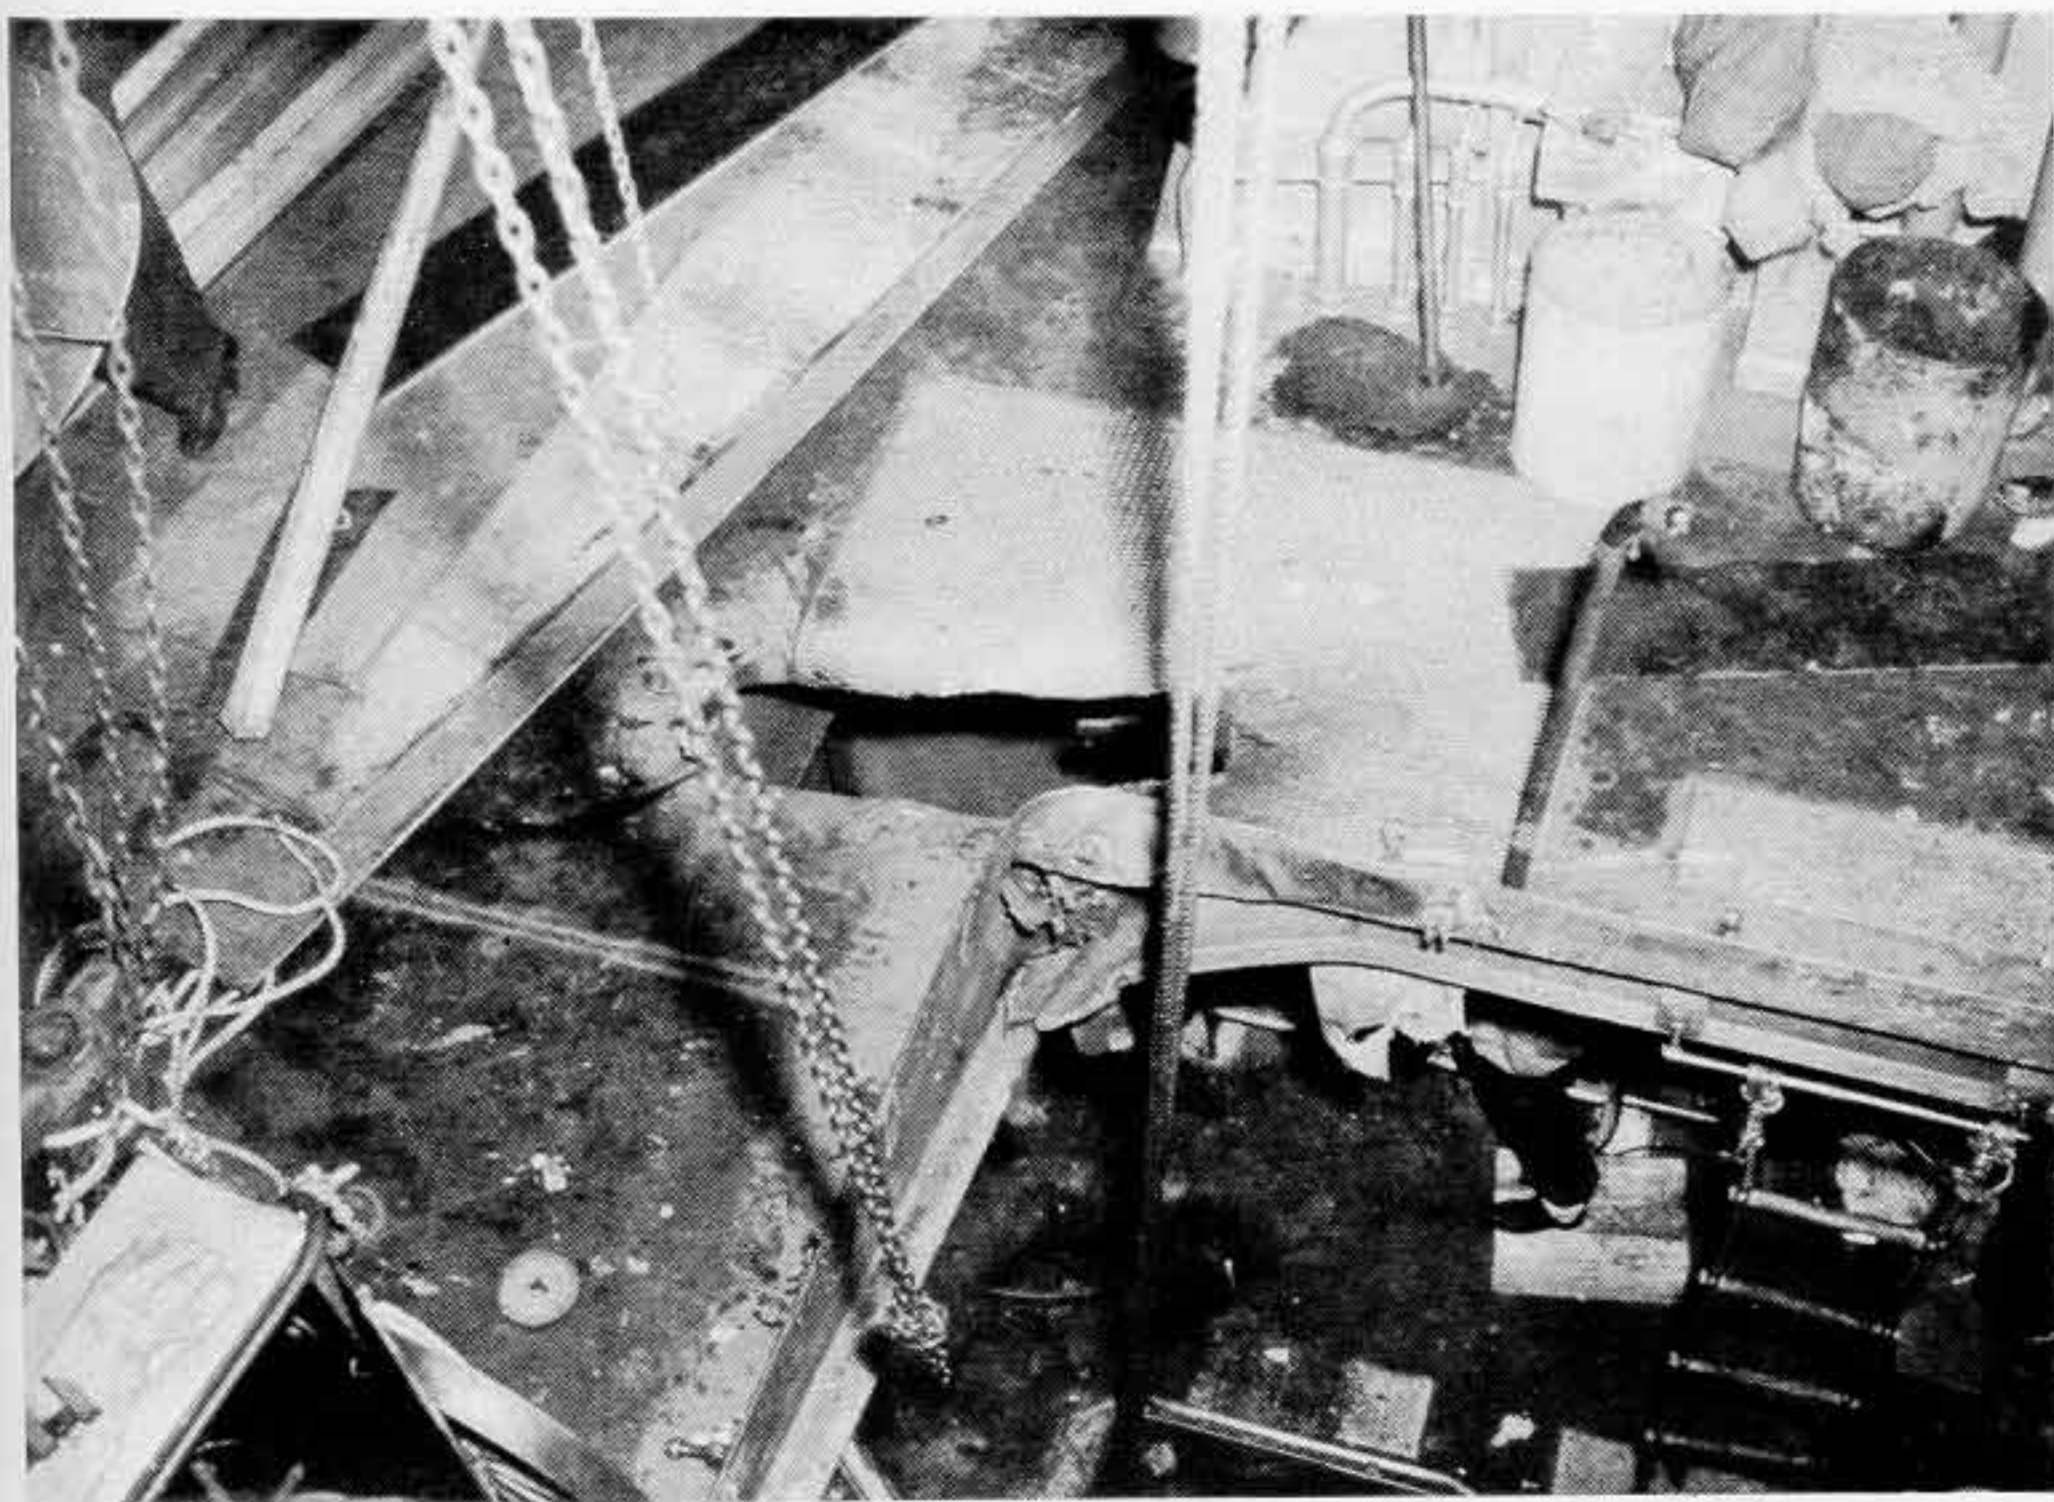
Photo 8: Bomb Hole, Main Deck, FR 107 1/2 looking down.

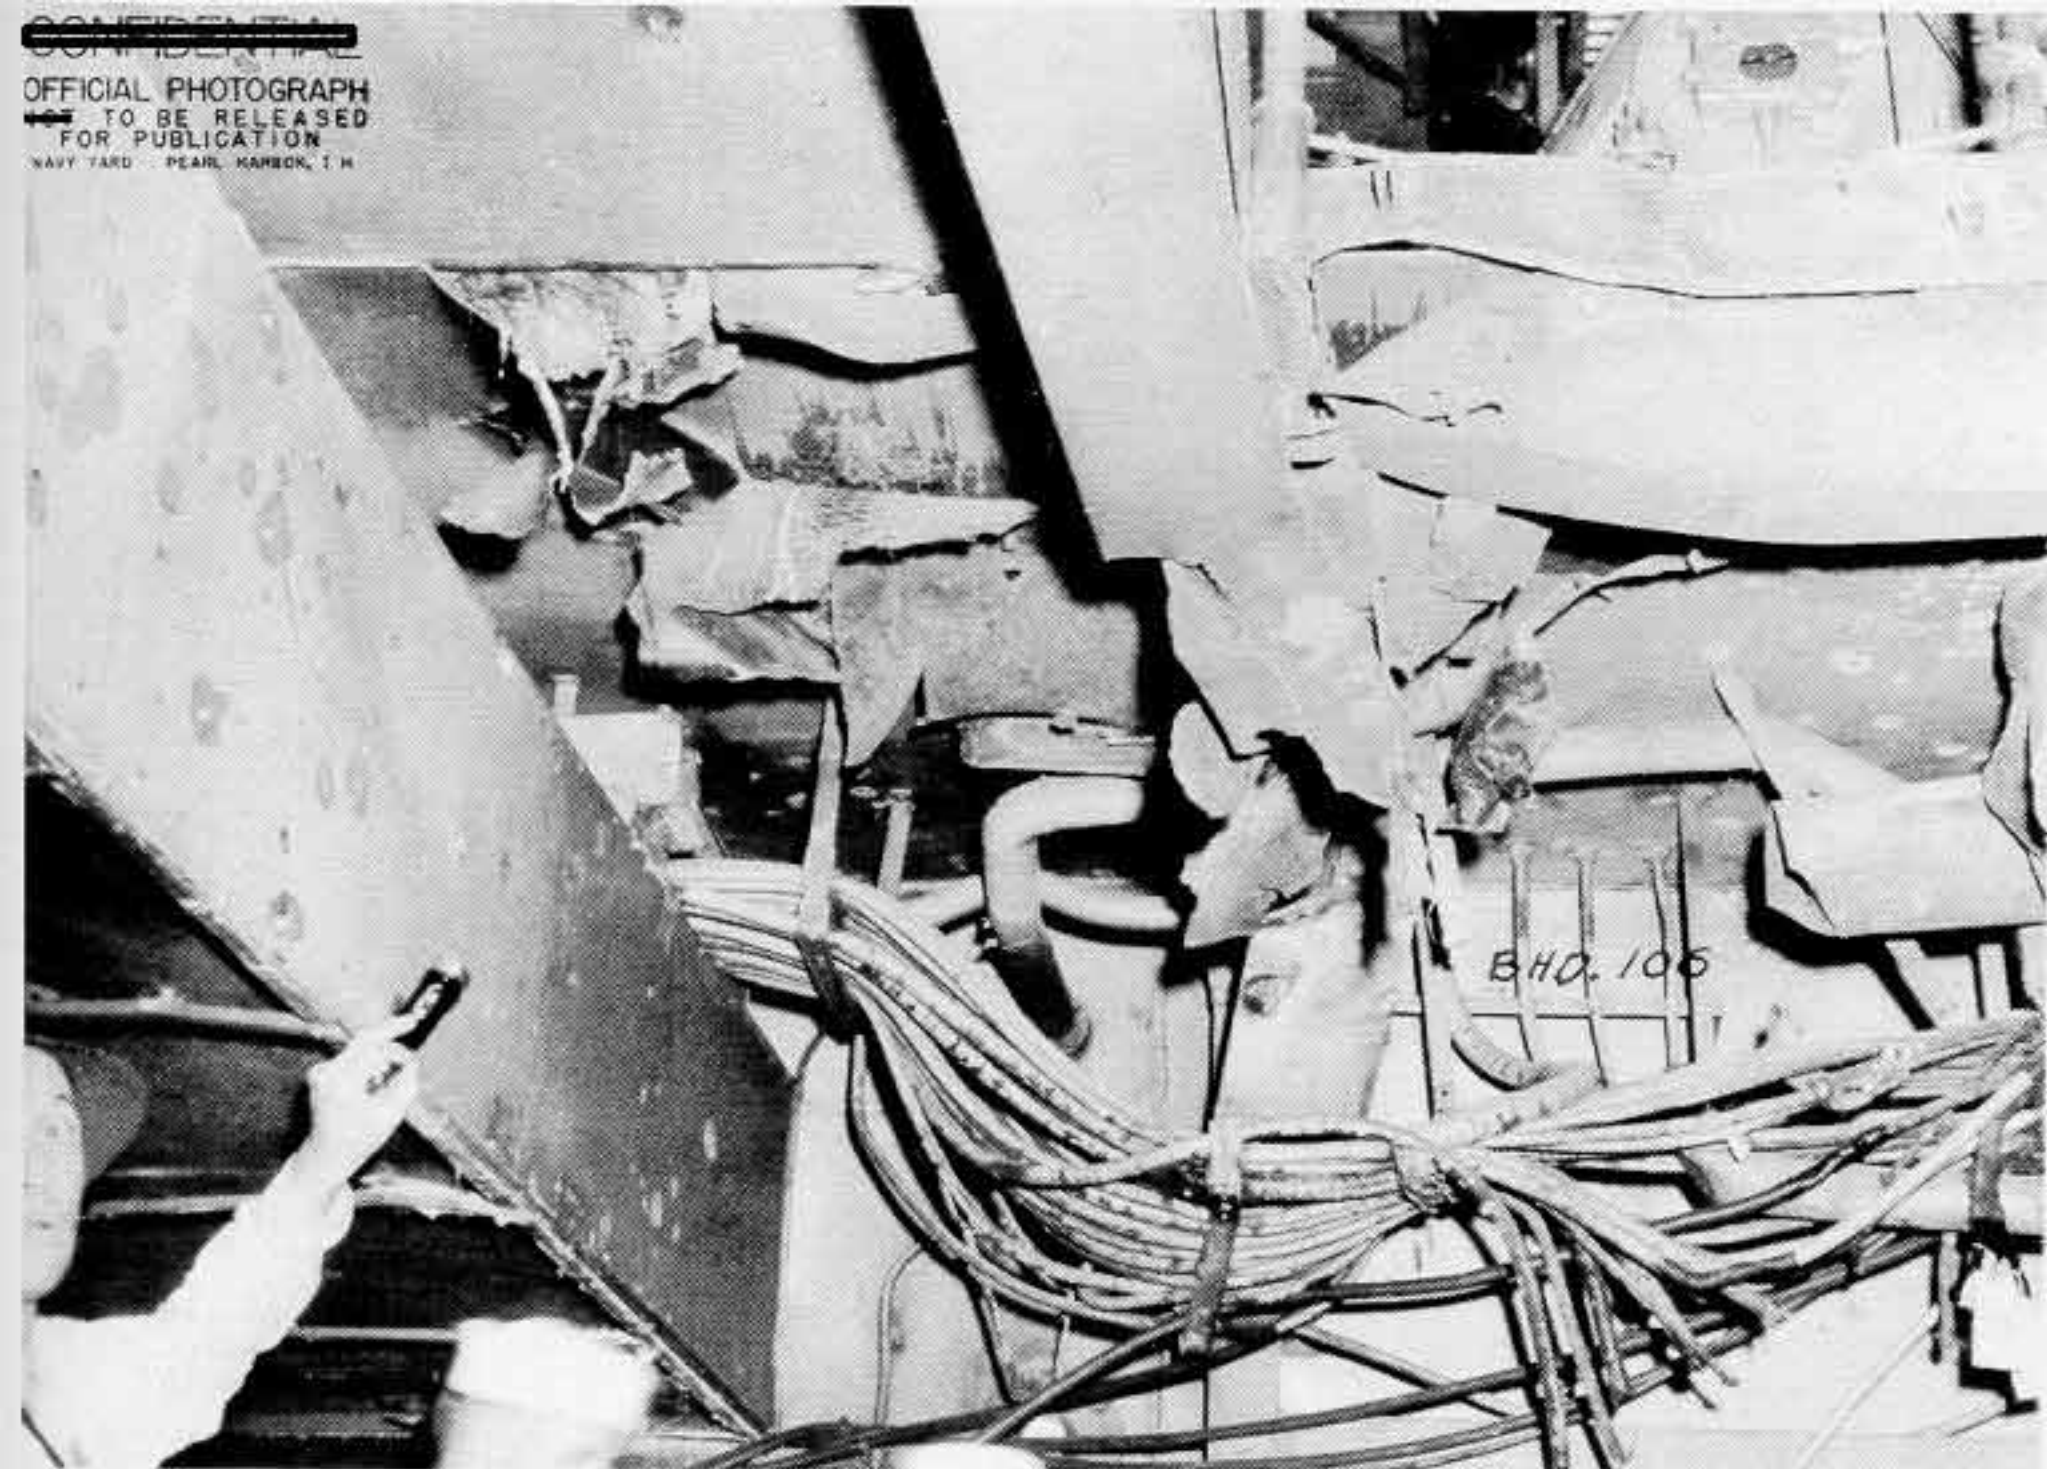
Photo 9: Bomb Hole, Main Deck, FR 107 1/2, looking forward and up. Note severed deck longitudinal.

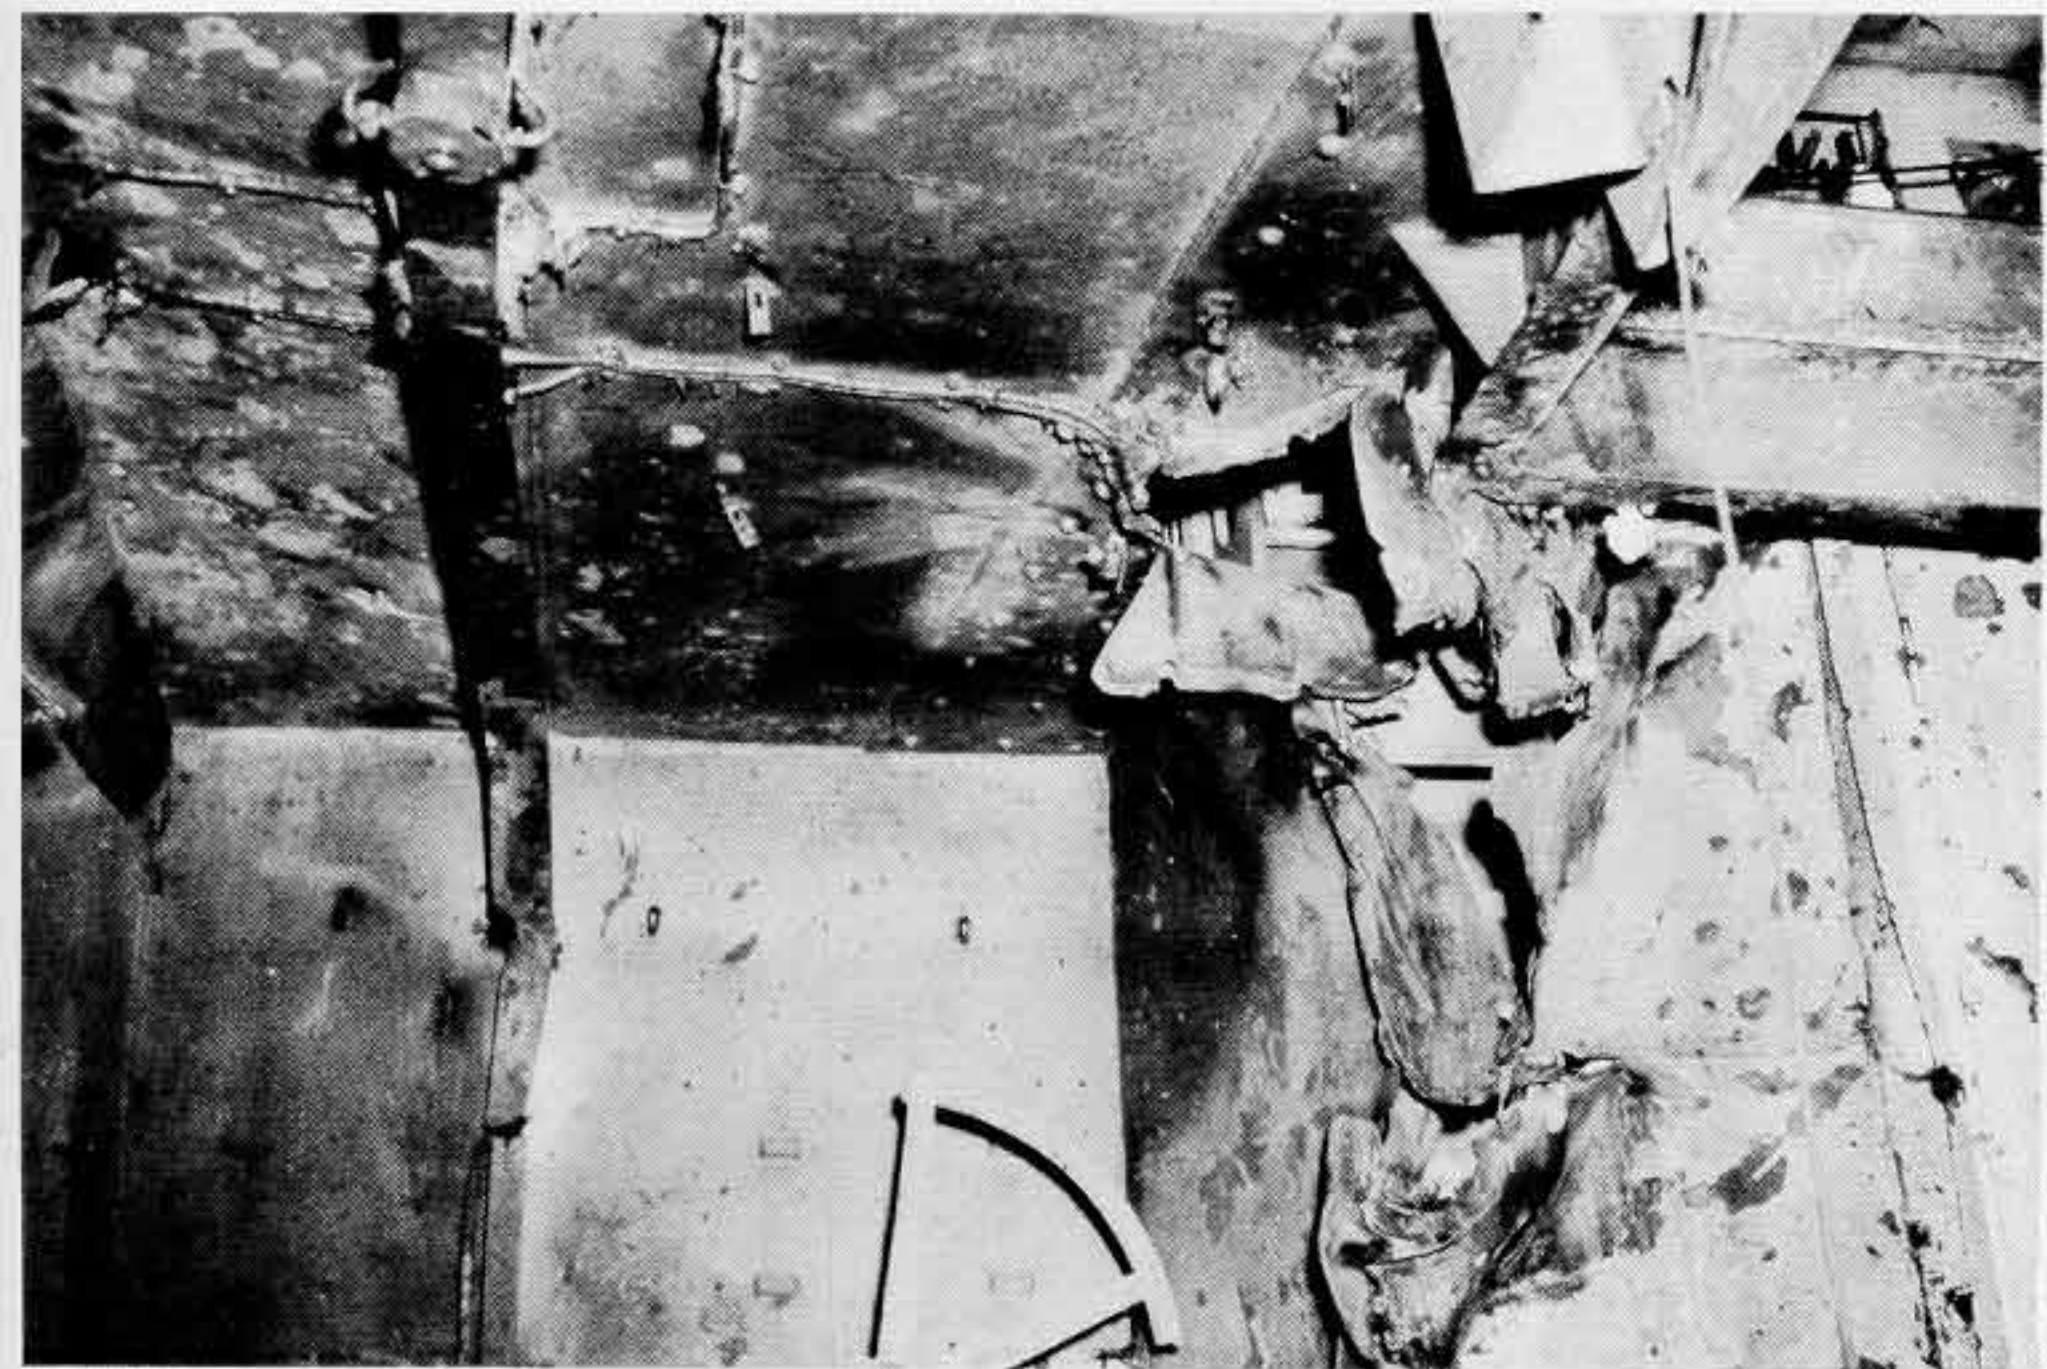
Photo 10: Bomb Hole, Second Deck, FR 107, looking forward and up. Note after inboard corner of transverse access trunk C-501-3T which deflected bomb inboard.

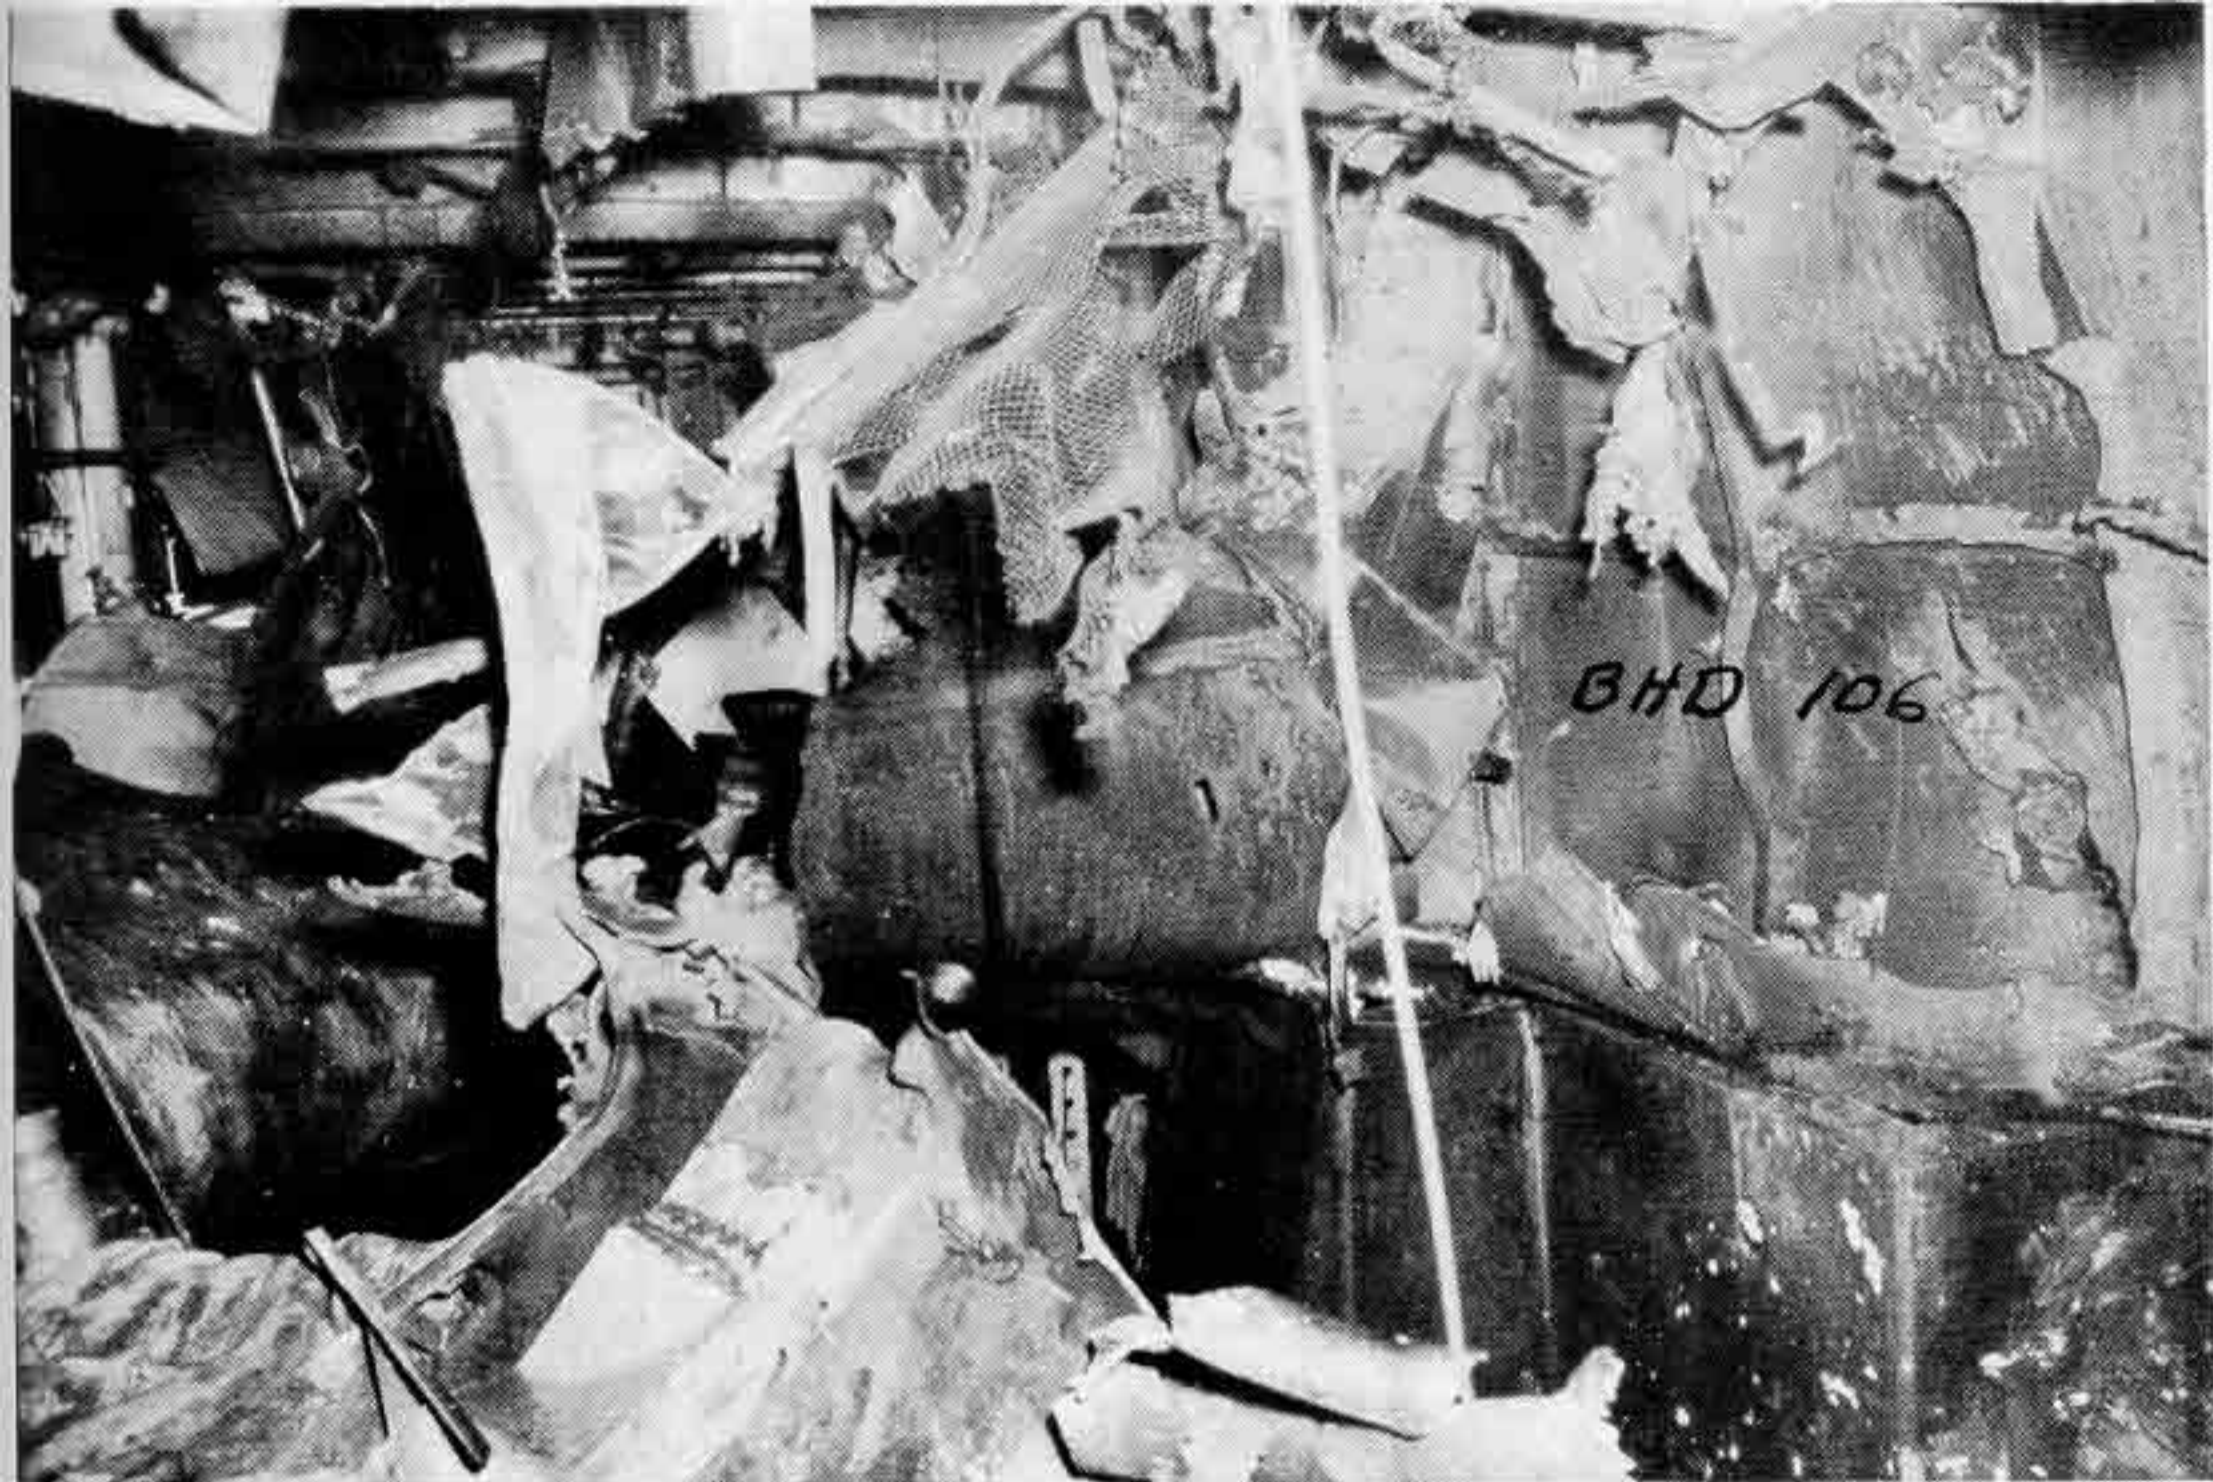
Photo 11: Blast Hole in Third Deck and Damage to Bulkhead 106. Looking forward and to port. Explosion occurred just below third deck in this area.

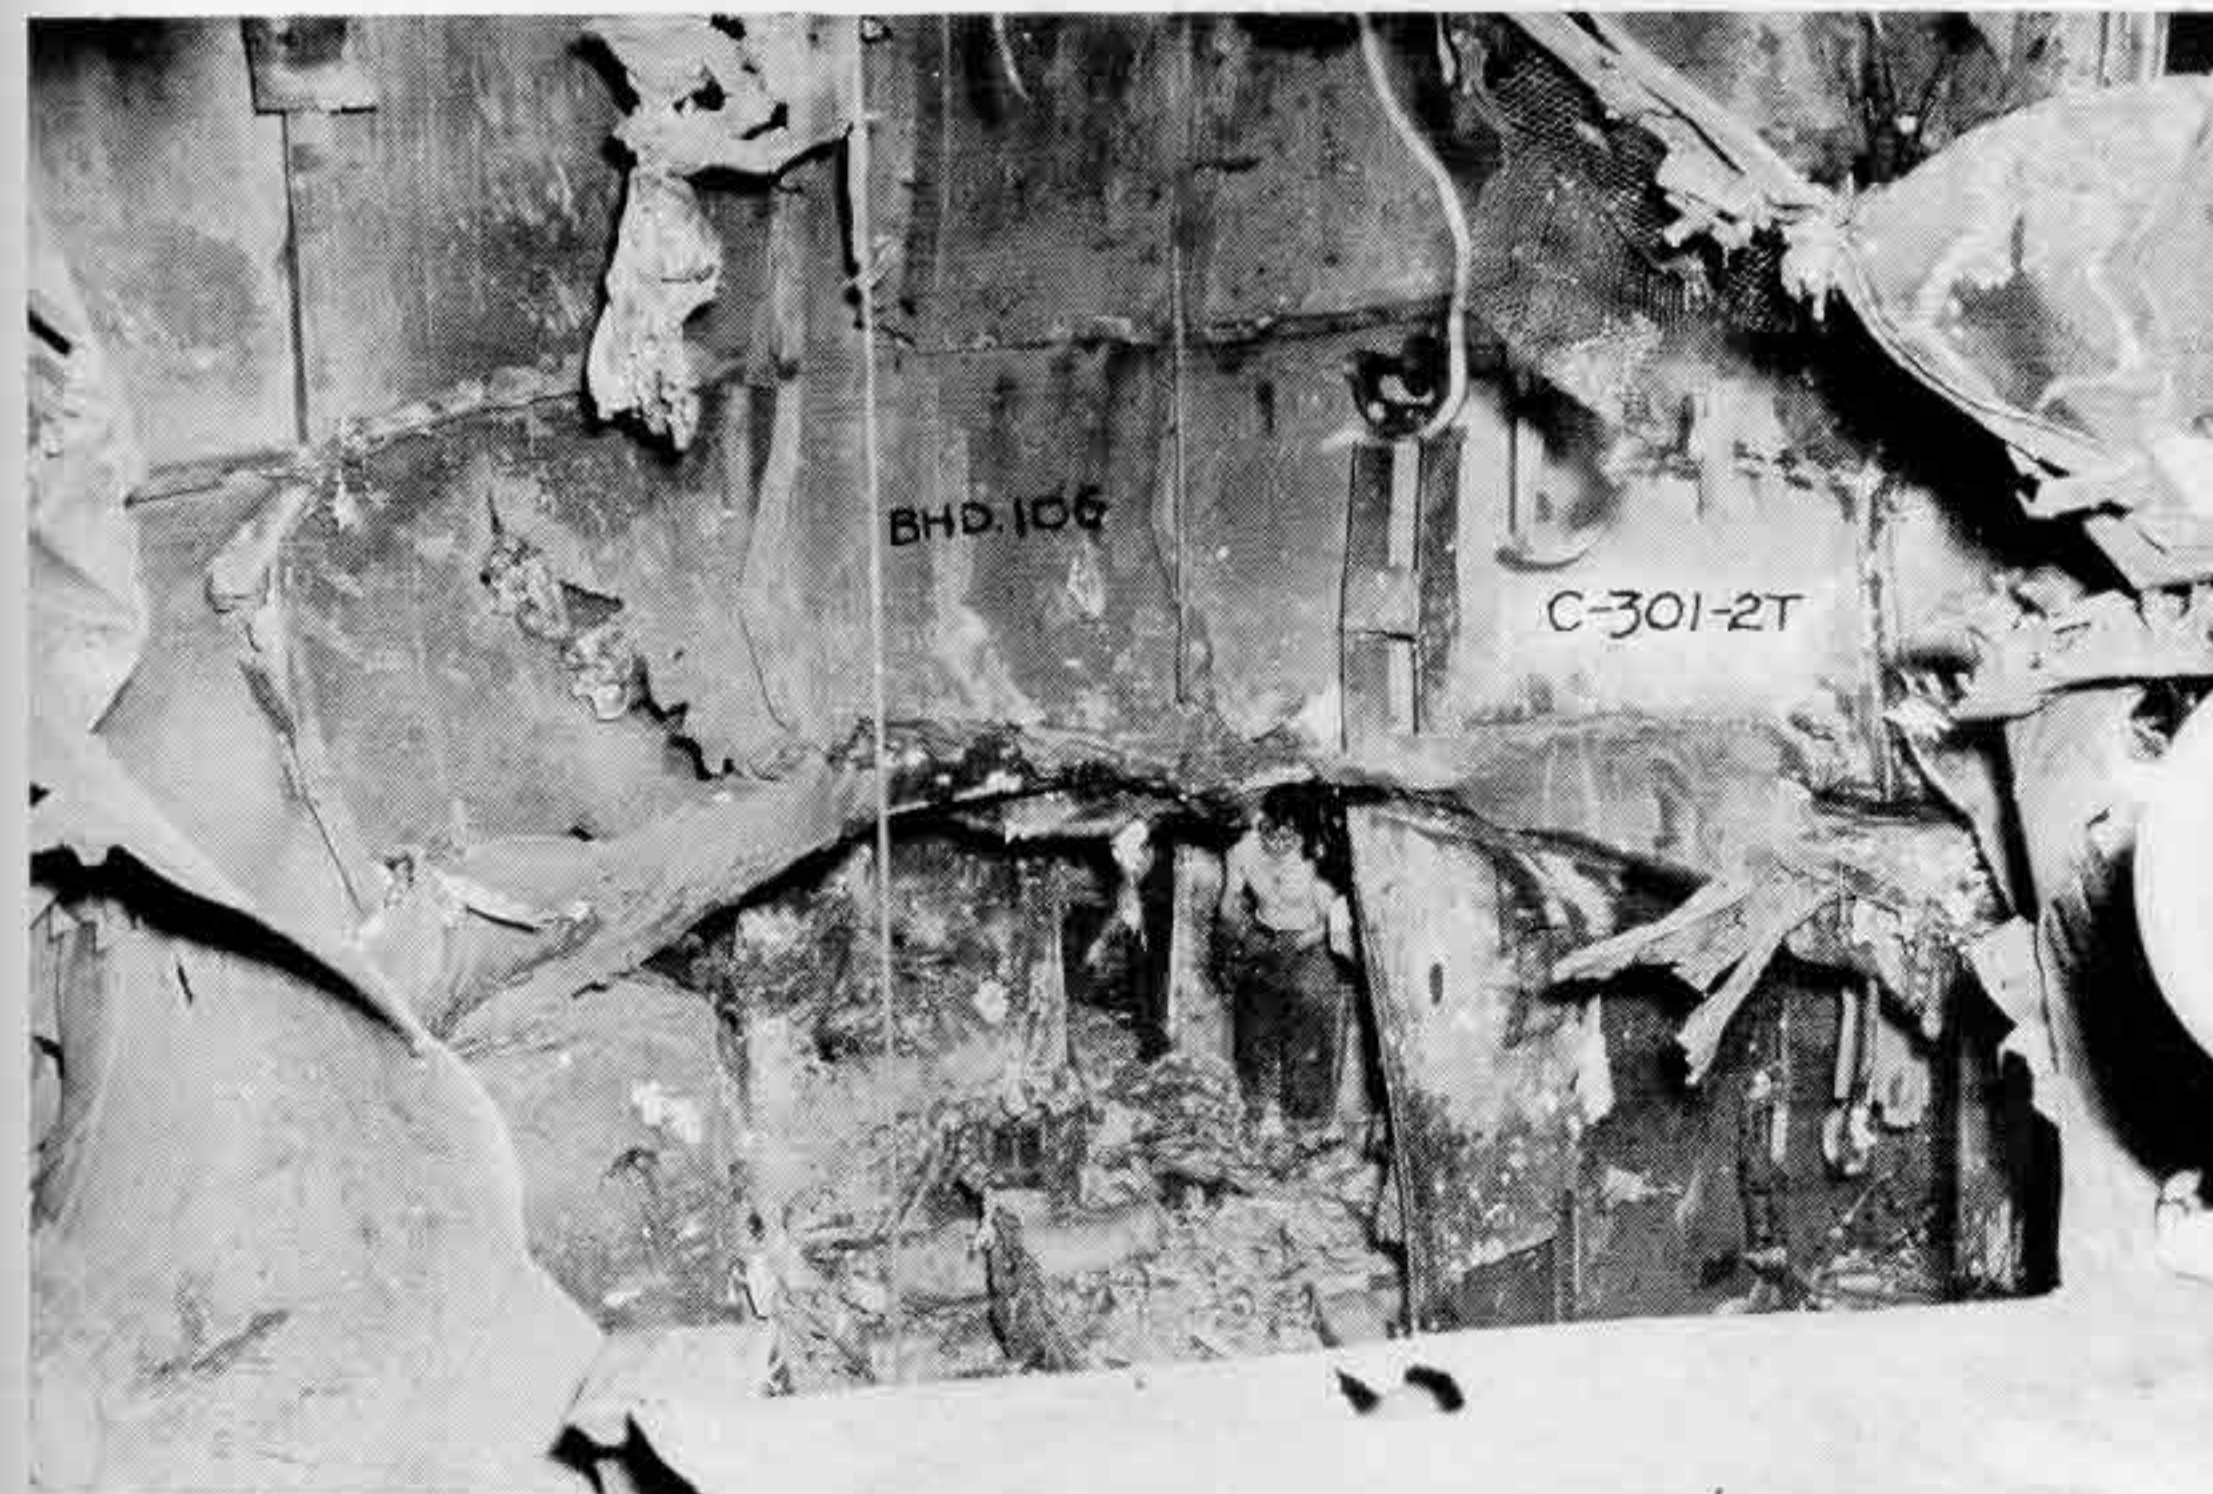
Photo 12: Blast Hole in Third Deck. Some wreckage cleared away. Looking forward and down.

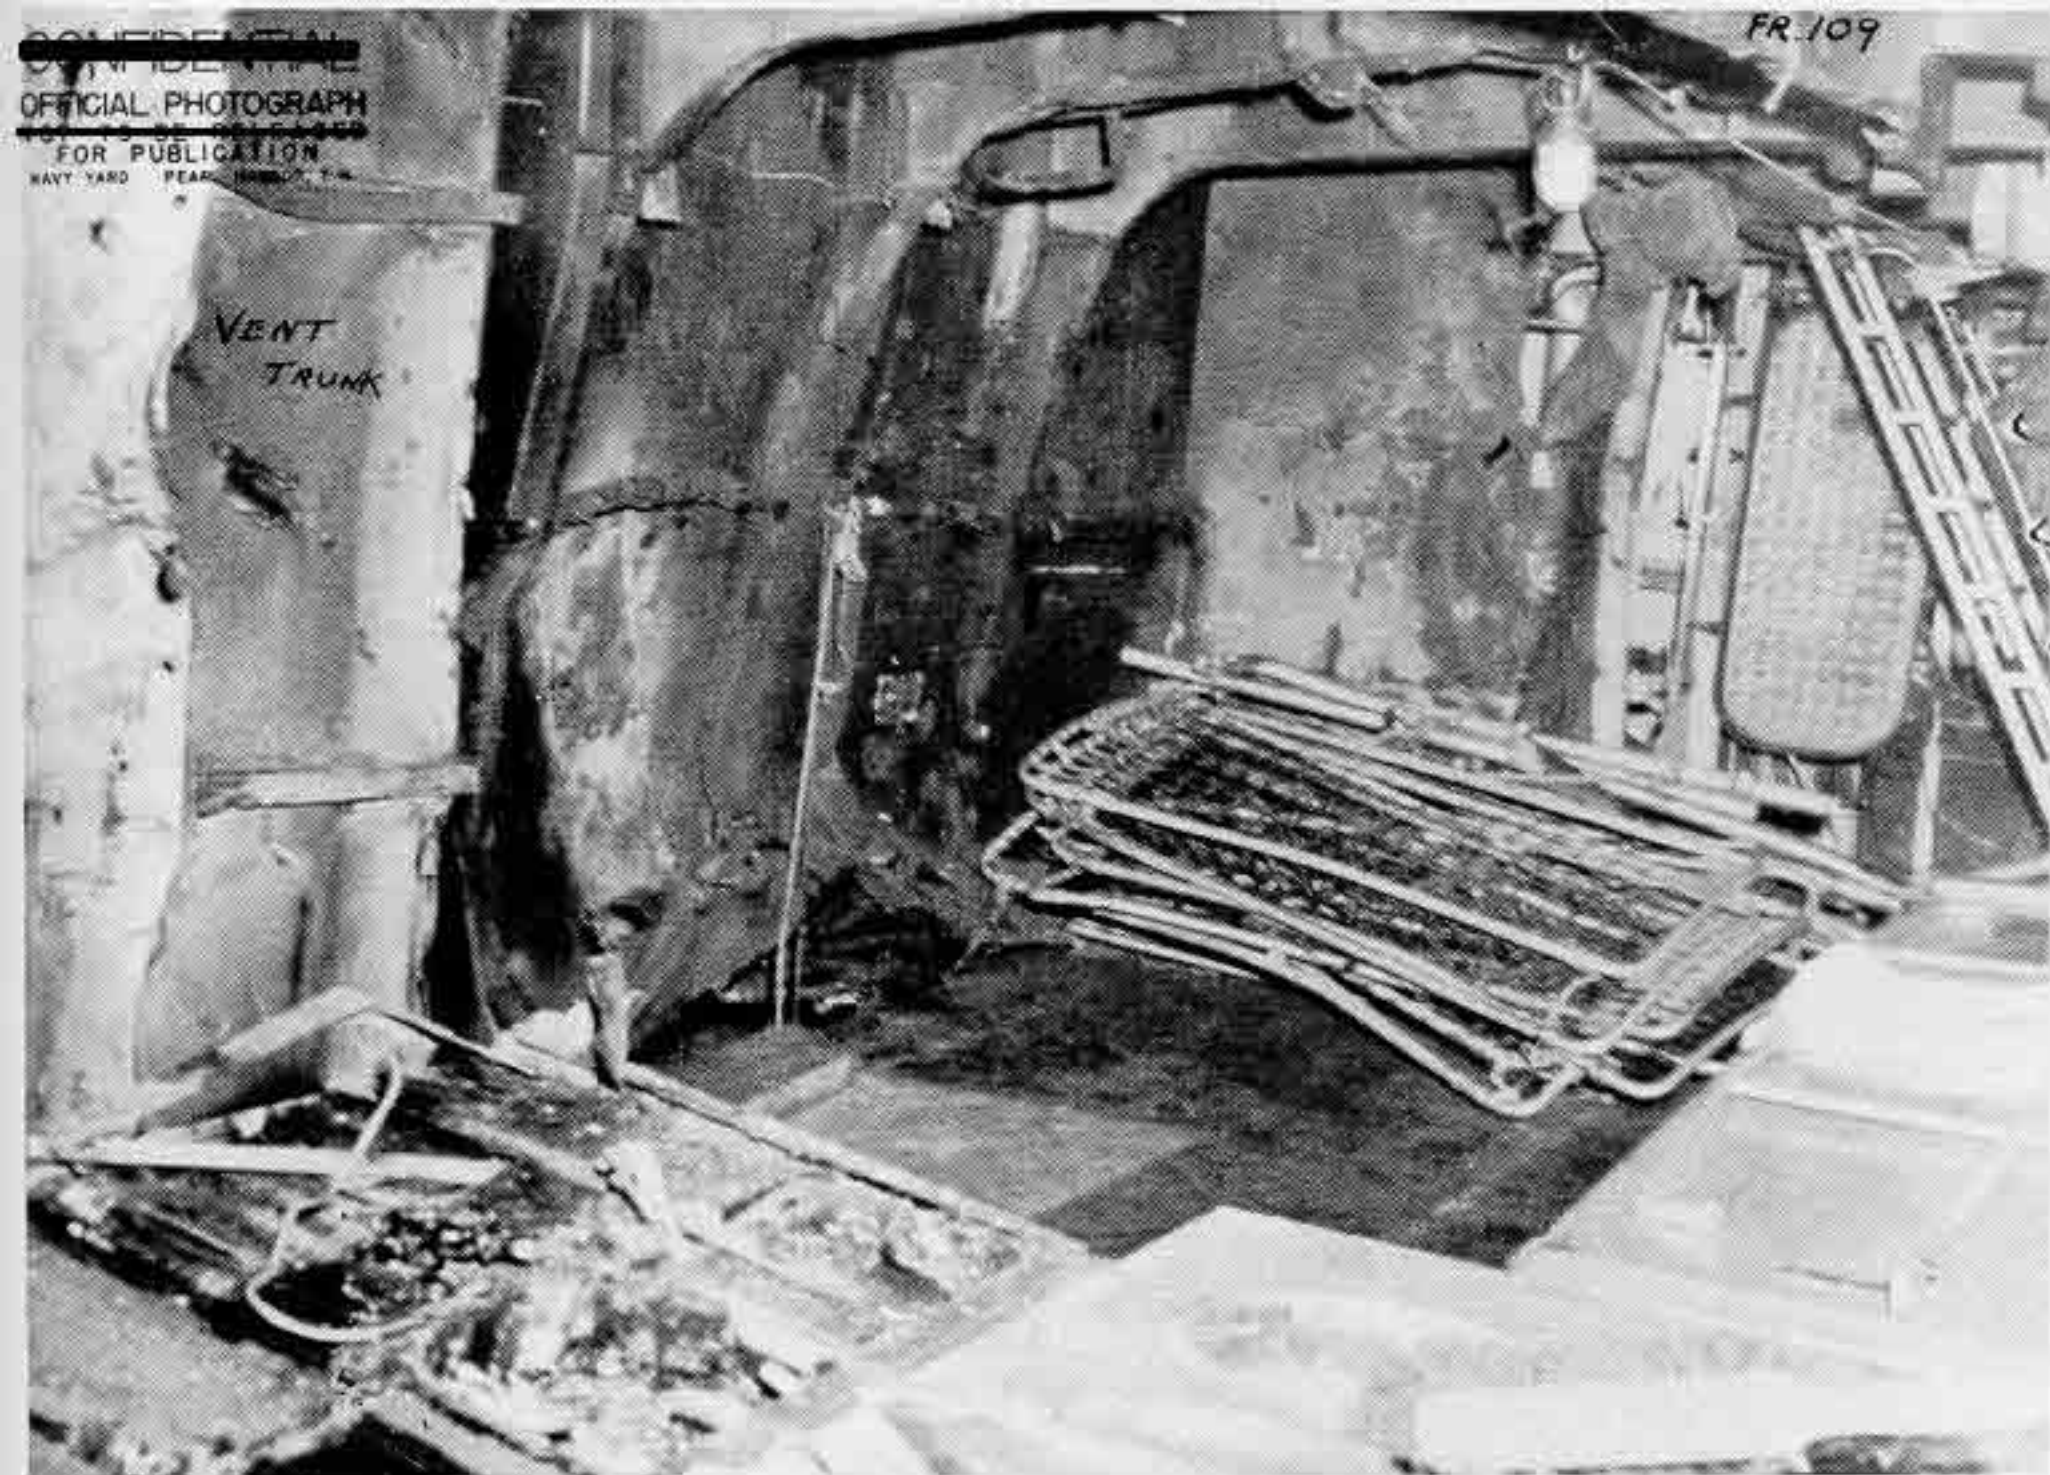
Photo 13: Damage to Bulkhead 106, between 3rd and 2nd decks, looking forward and outboard. Note partially collapsed ventilation trunk at left and distortion of web frame 109, upper right.

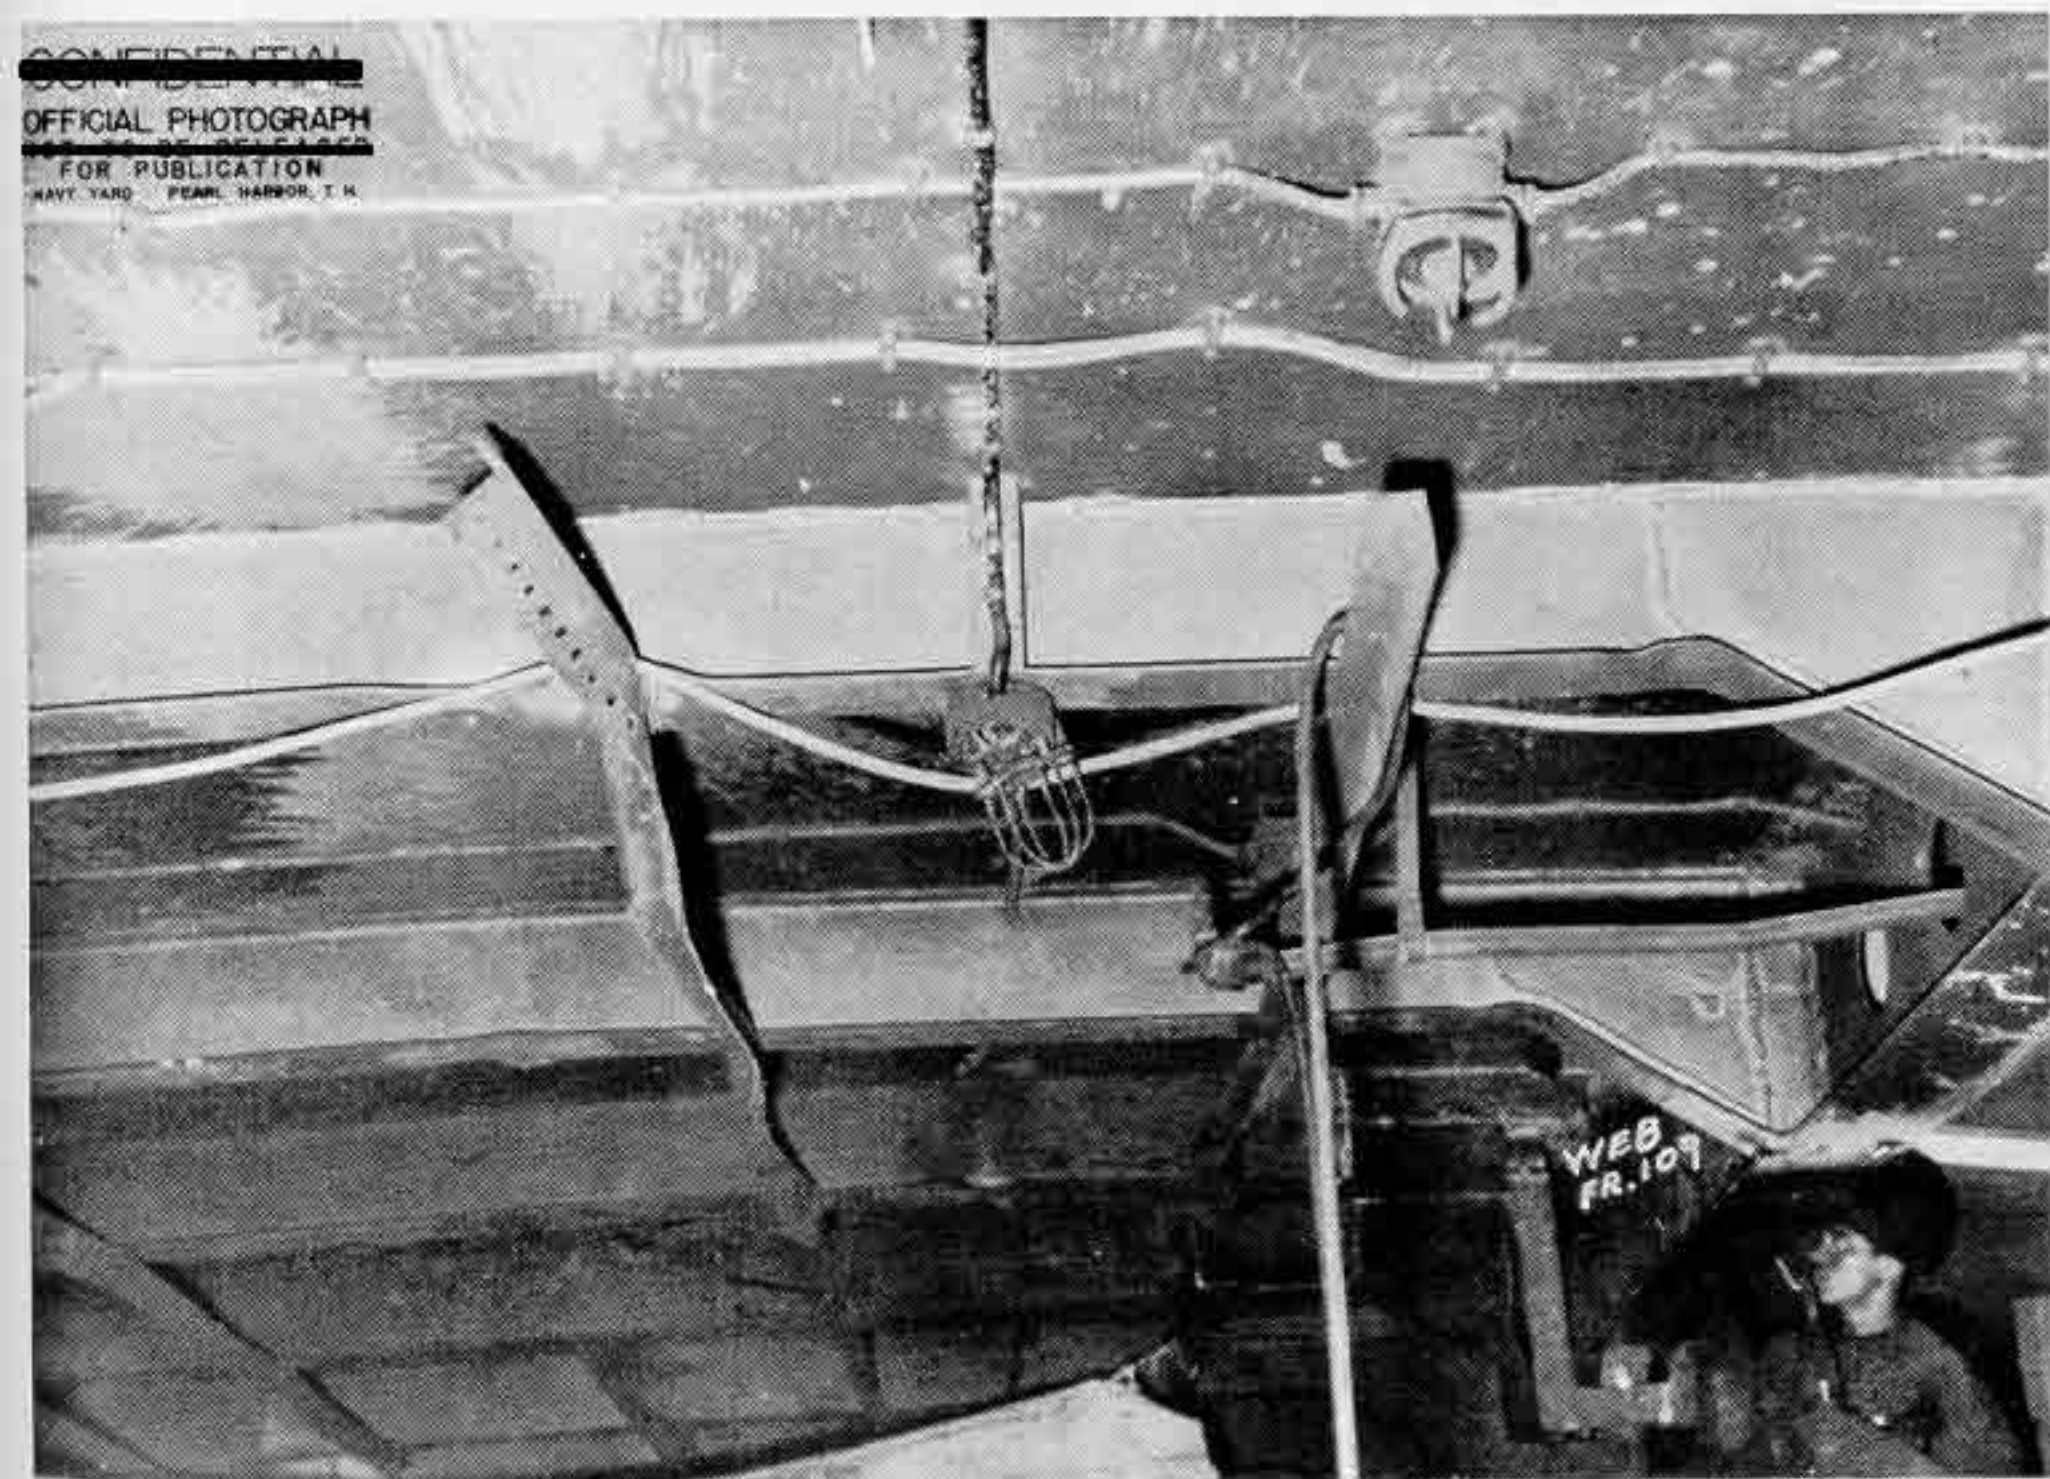
Photo 14: Underside of 3rd deck, looking inboard and to port. Note upward deflection of deck and longitudinals.
