# U. S. S. YORKTOWN (CV5)

## BOMB DAMAGE

CORAL SEA

WAR DAMAGE REPORT No. 23

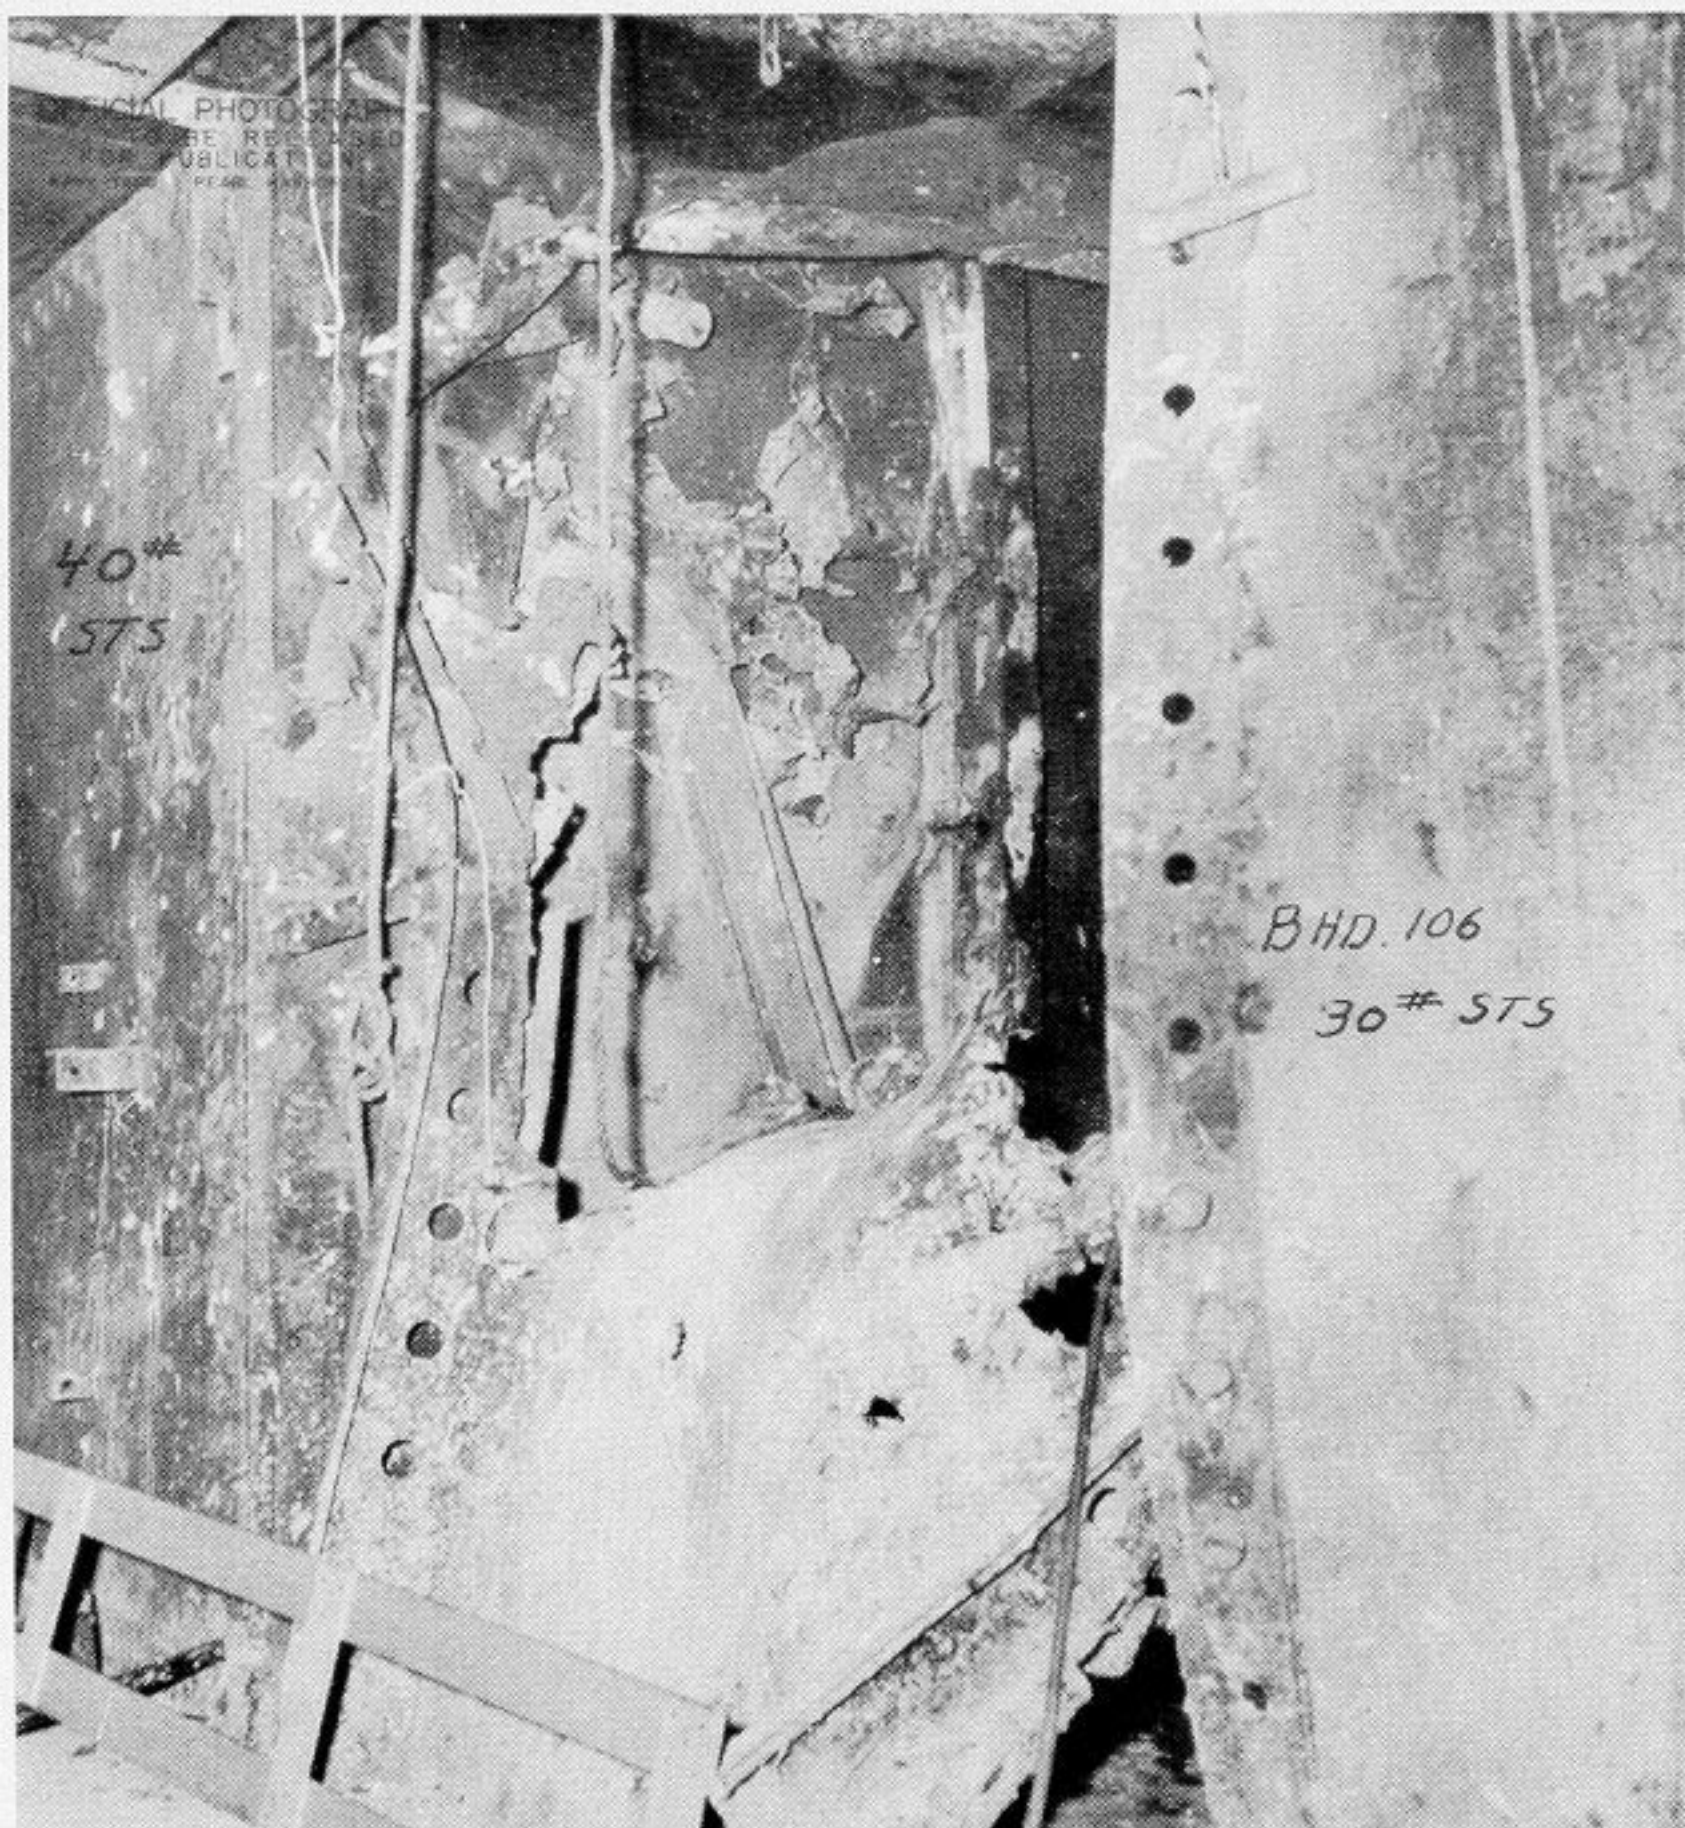
Photo 15: Damage to Bulkhead 106, between 4th and 3rd decks, looking forward and inboard.

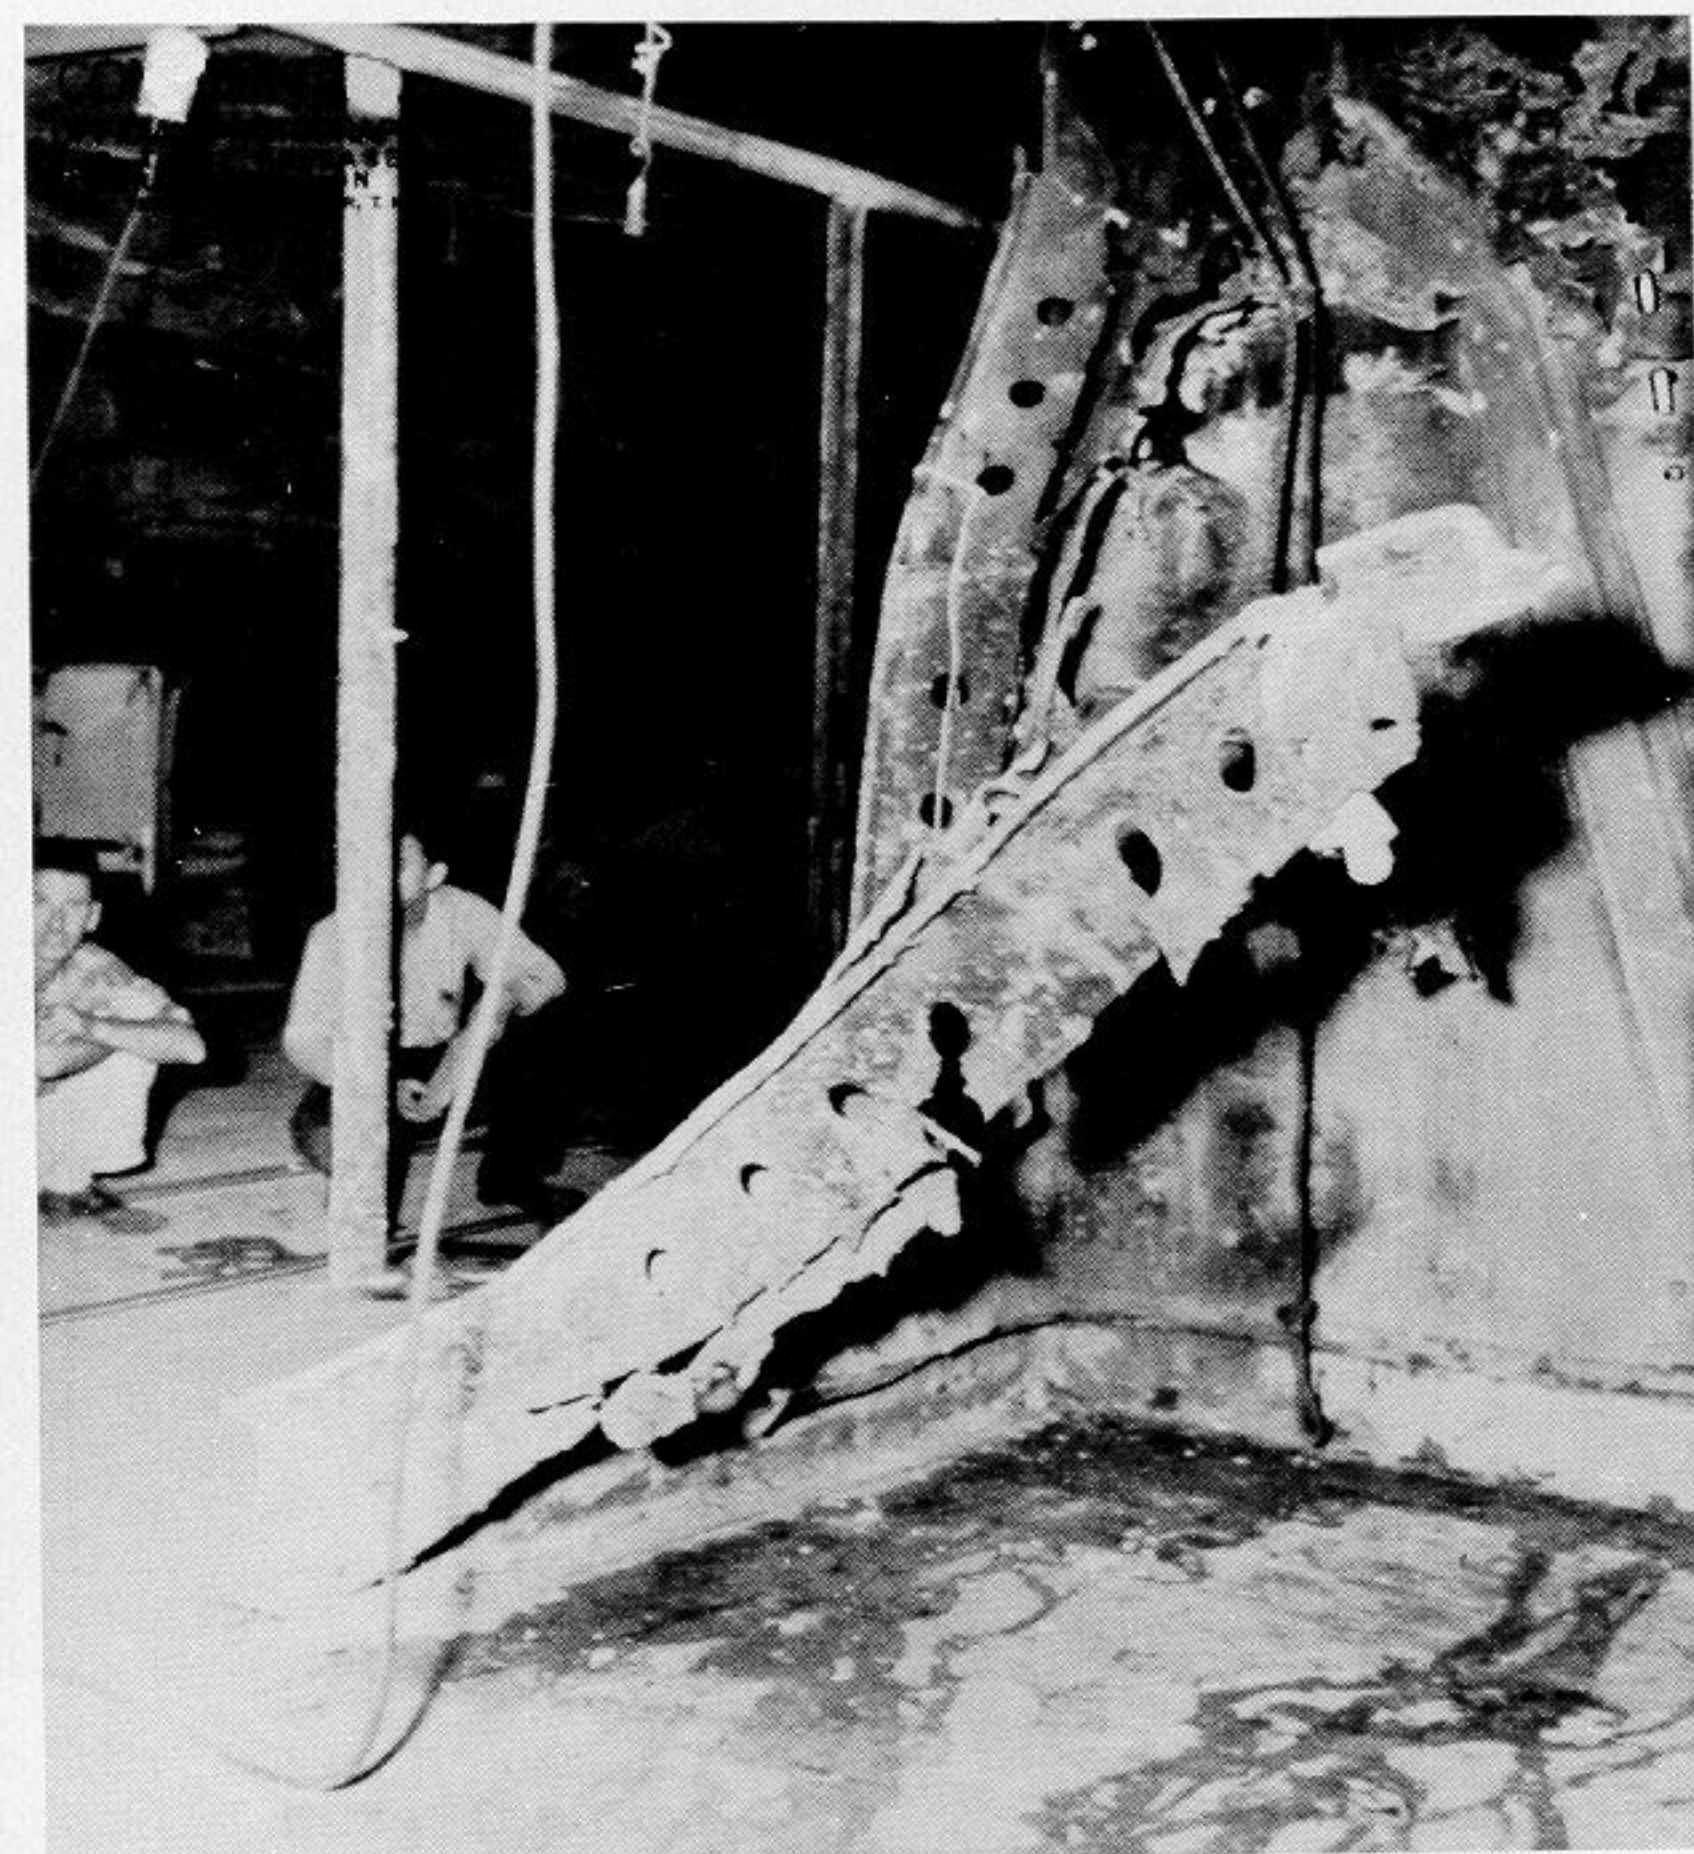
Photo 16: Damage to Bulkhead 106, between 4th and 3rd decks, looking aft.

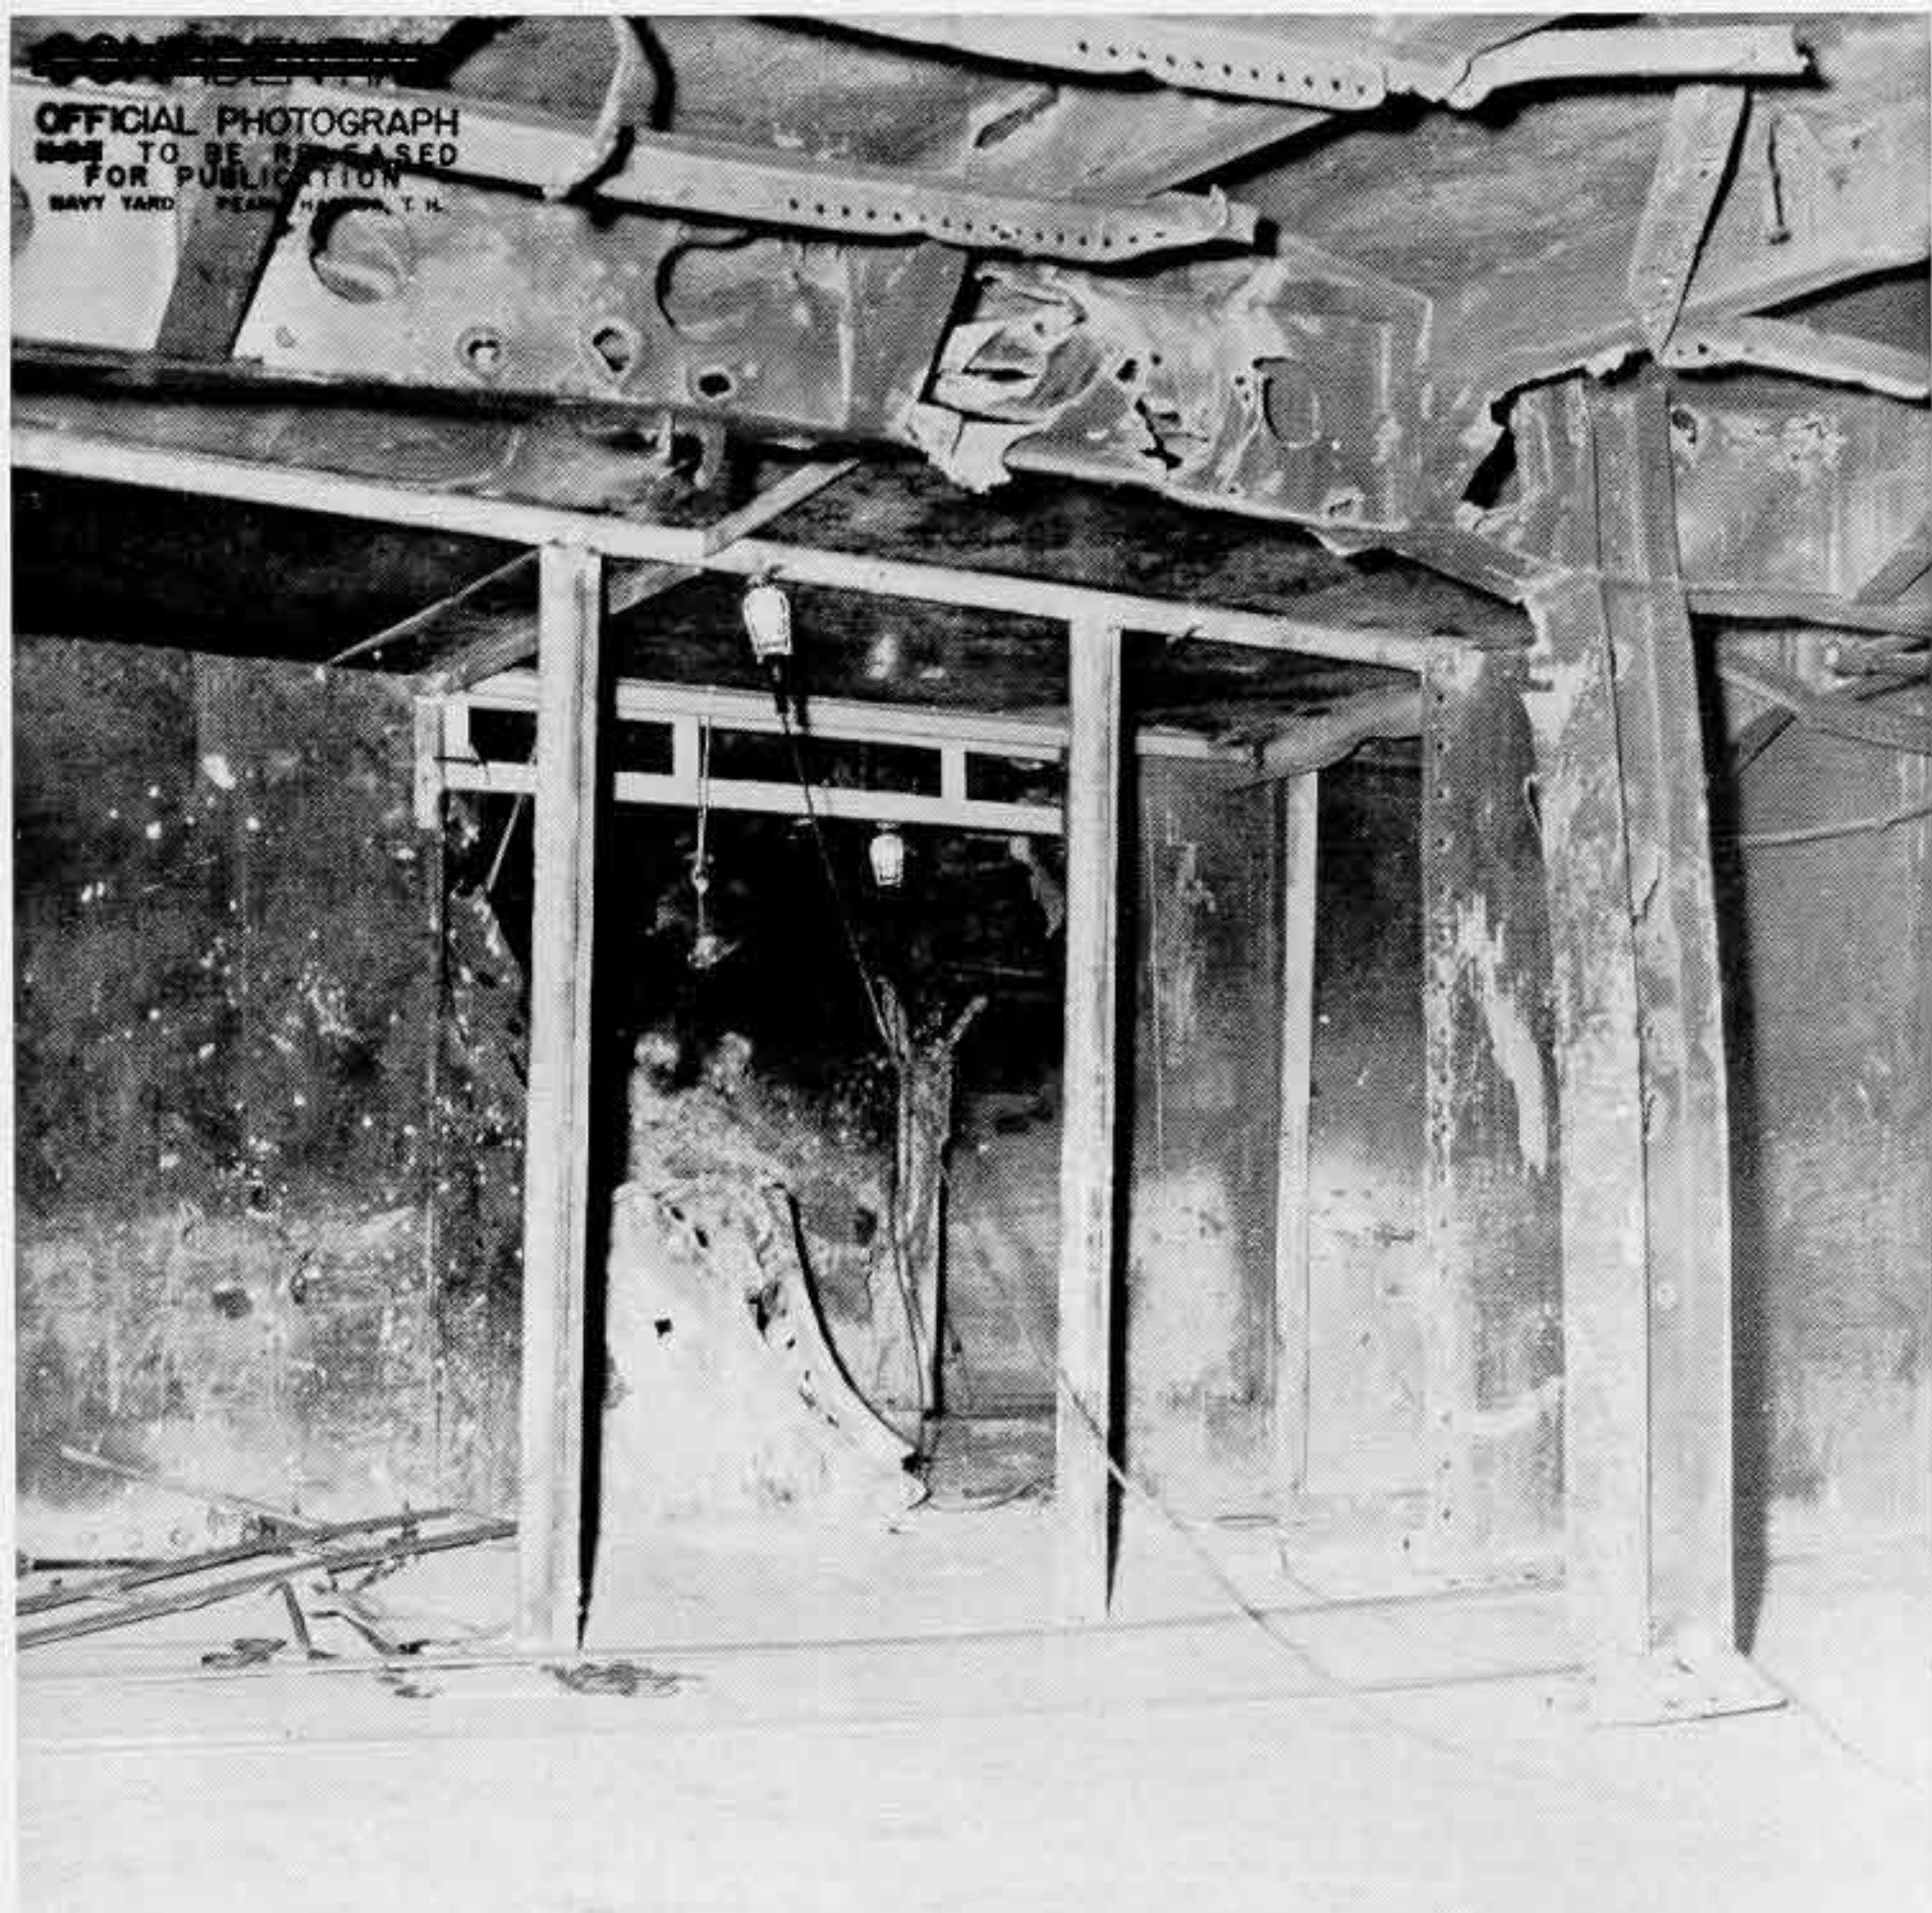
Photo 17: Between 4th and 3rd decks, looking forward and to starboard. Note that 4th (armored) deck is undamaged and that web frame 109 is virtually cut in two.

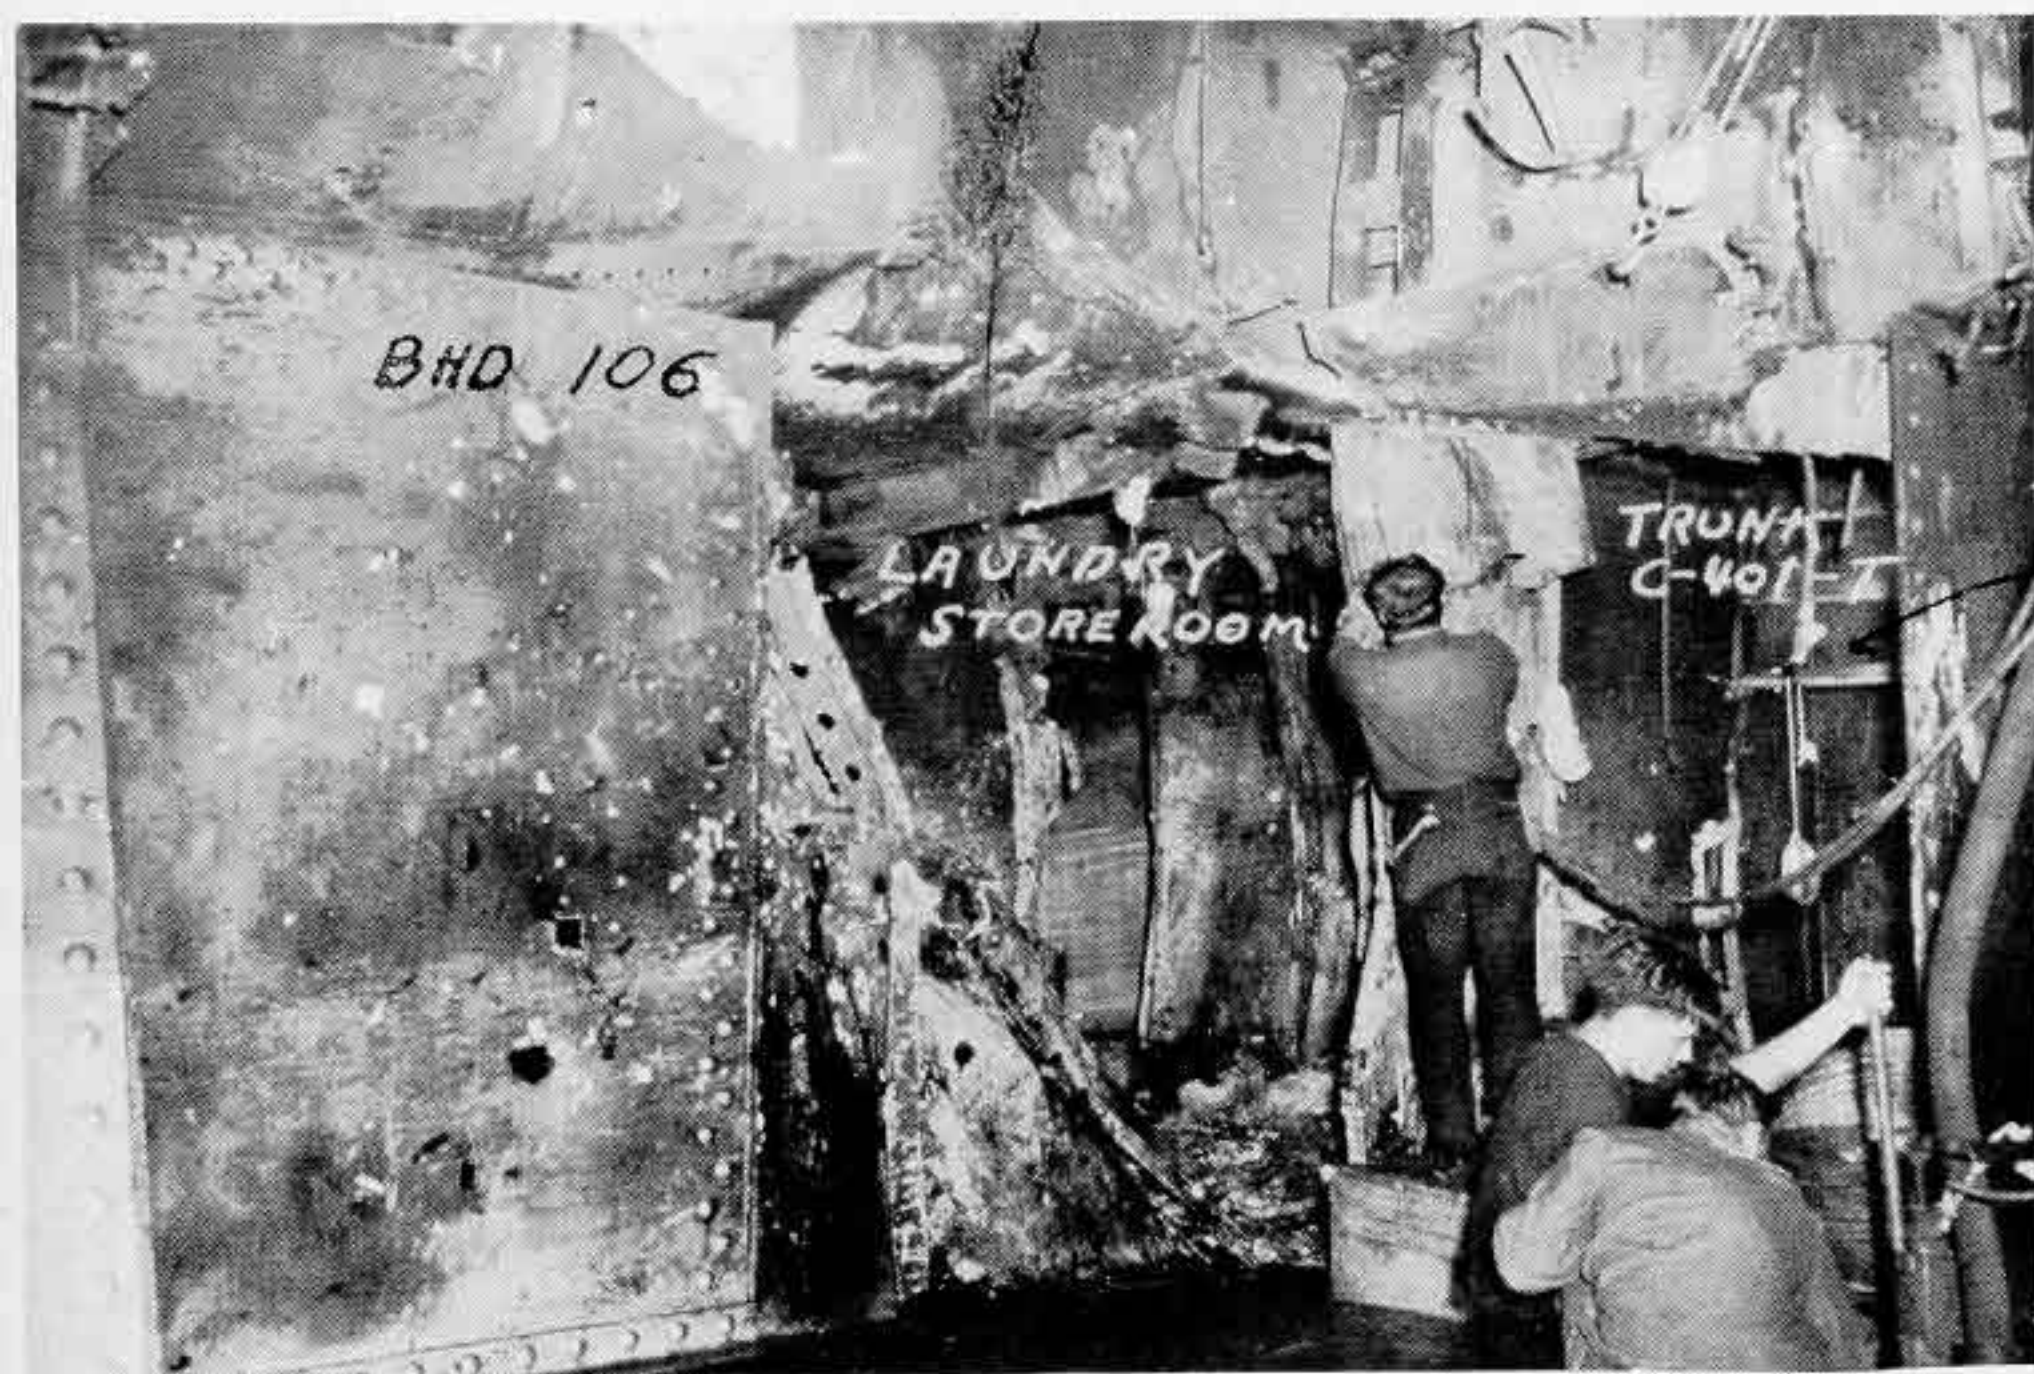
Photo 18: Damage on 4th deck, looking forward and to starboard. Note inboard longitudinal bulkhead of trunk C-401-T has been blown out. Laundry storeroom is forward of hole in bulkhead 106.

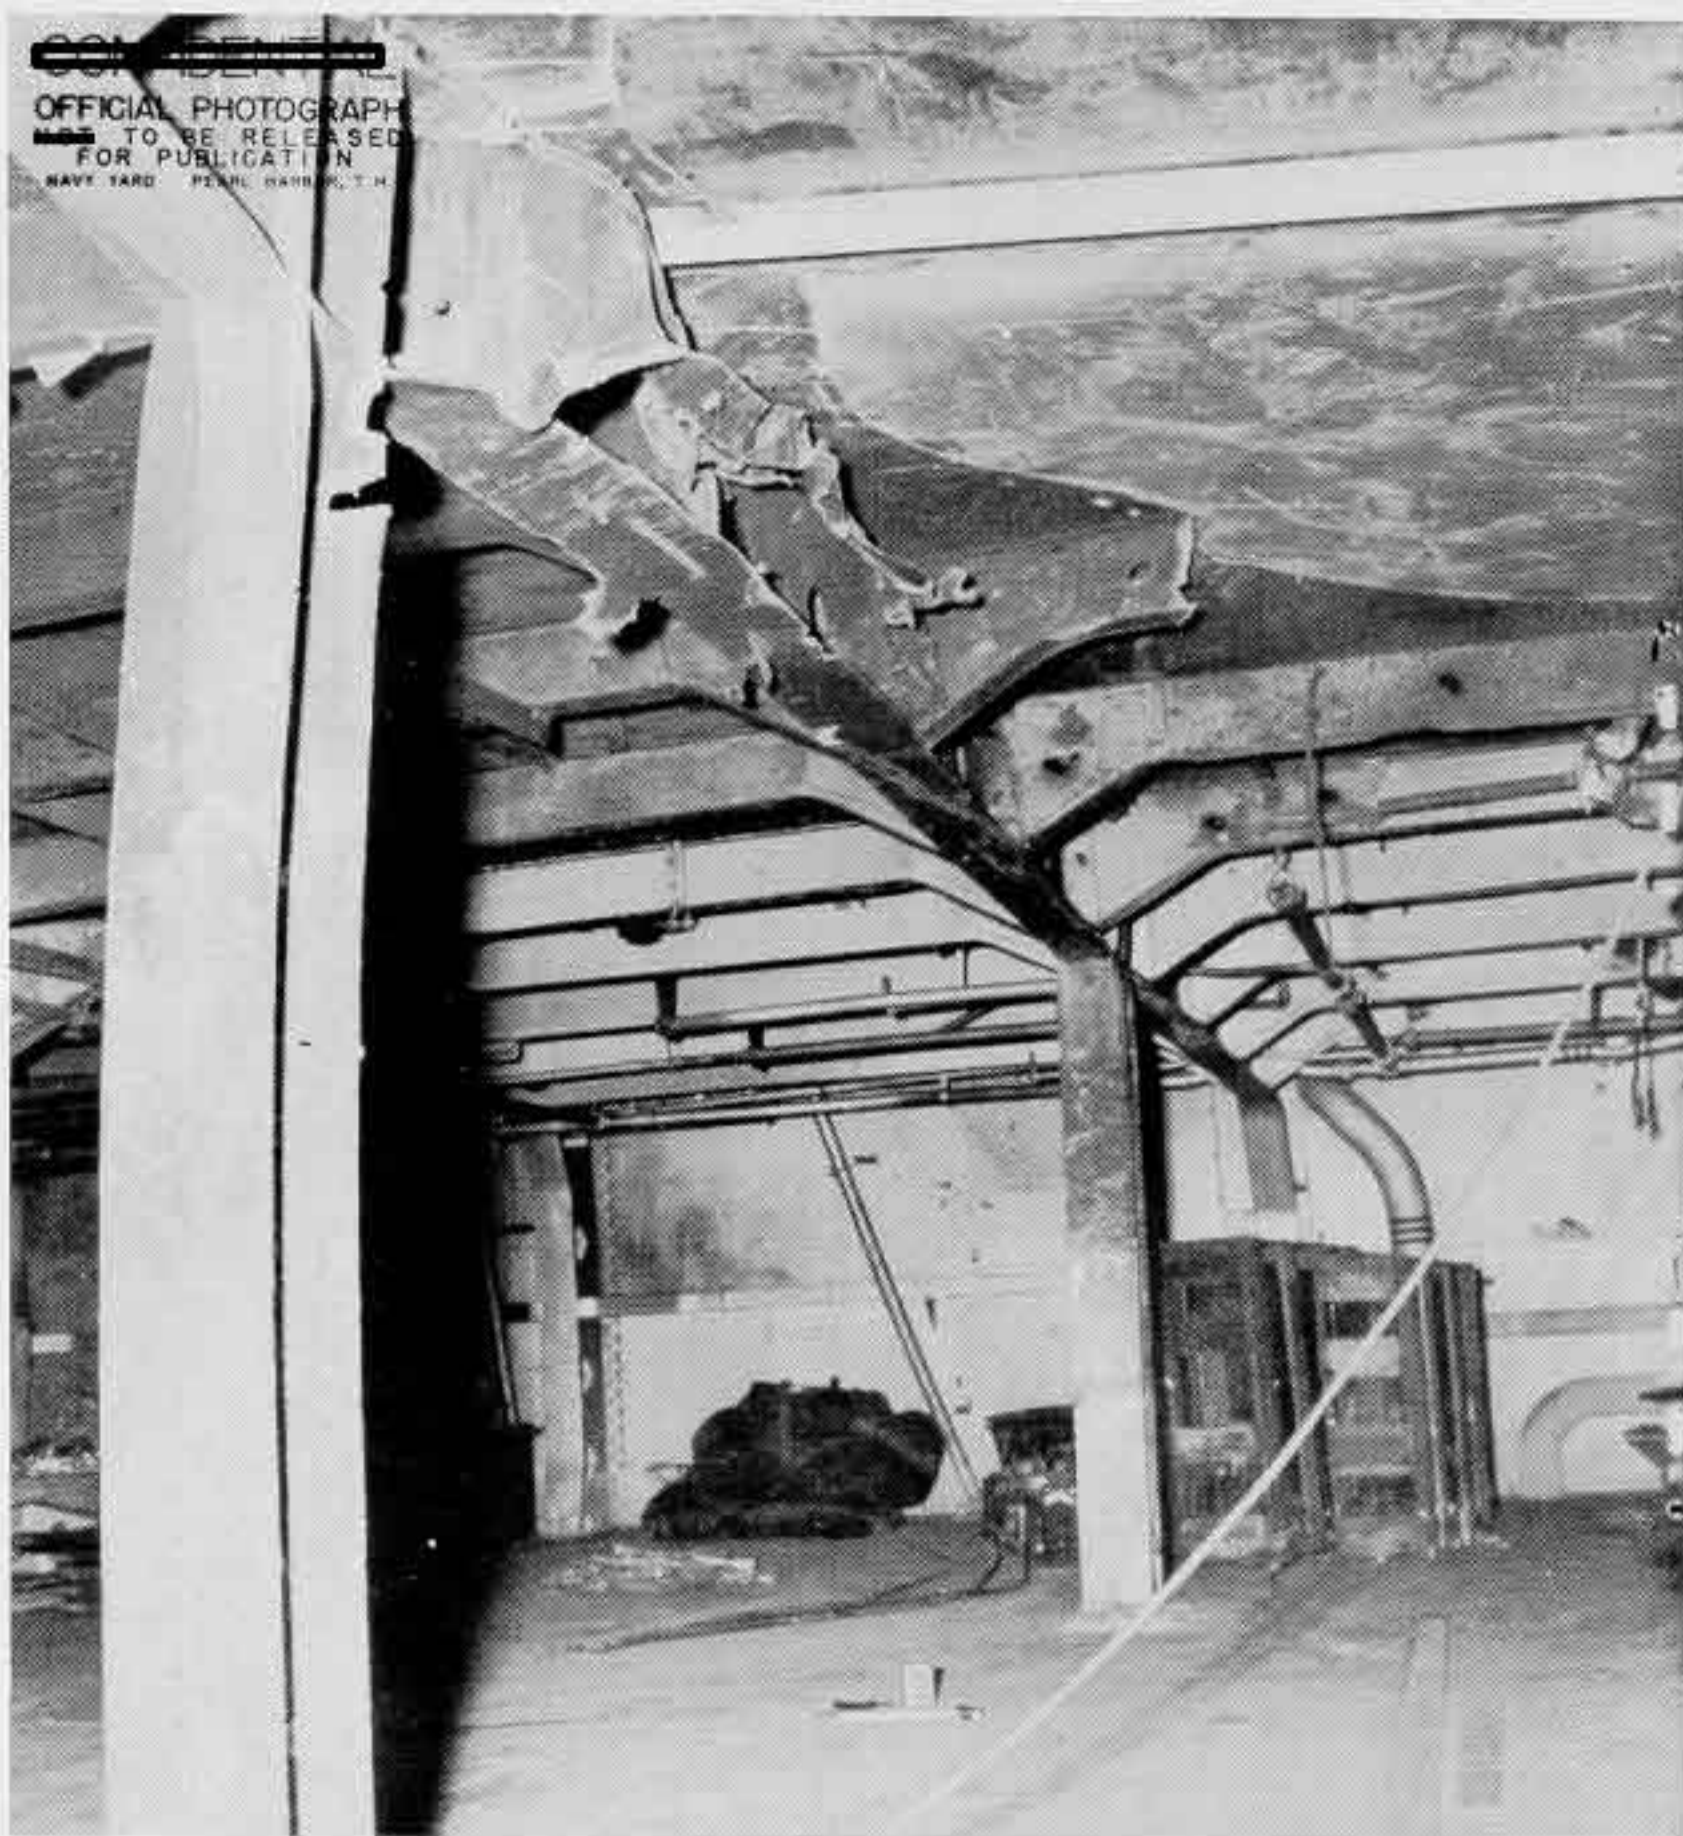
Photo 19: Web FR 109, underneath 3rd deck, looking to port.

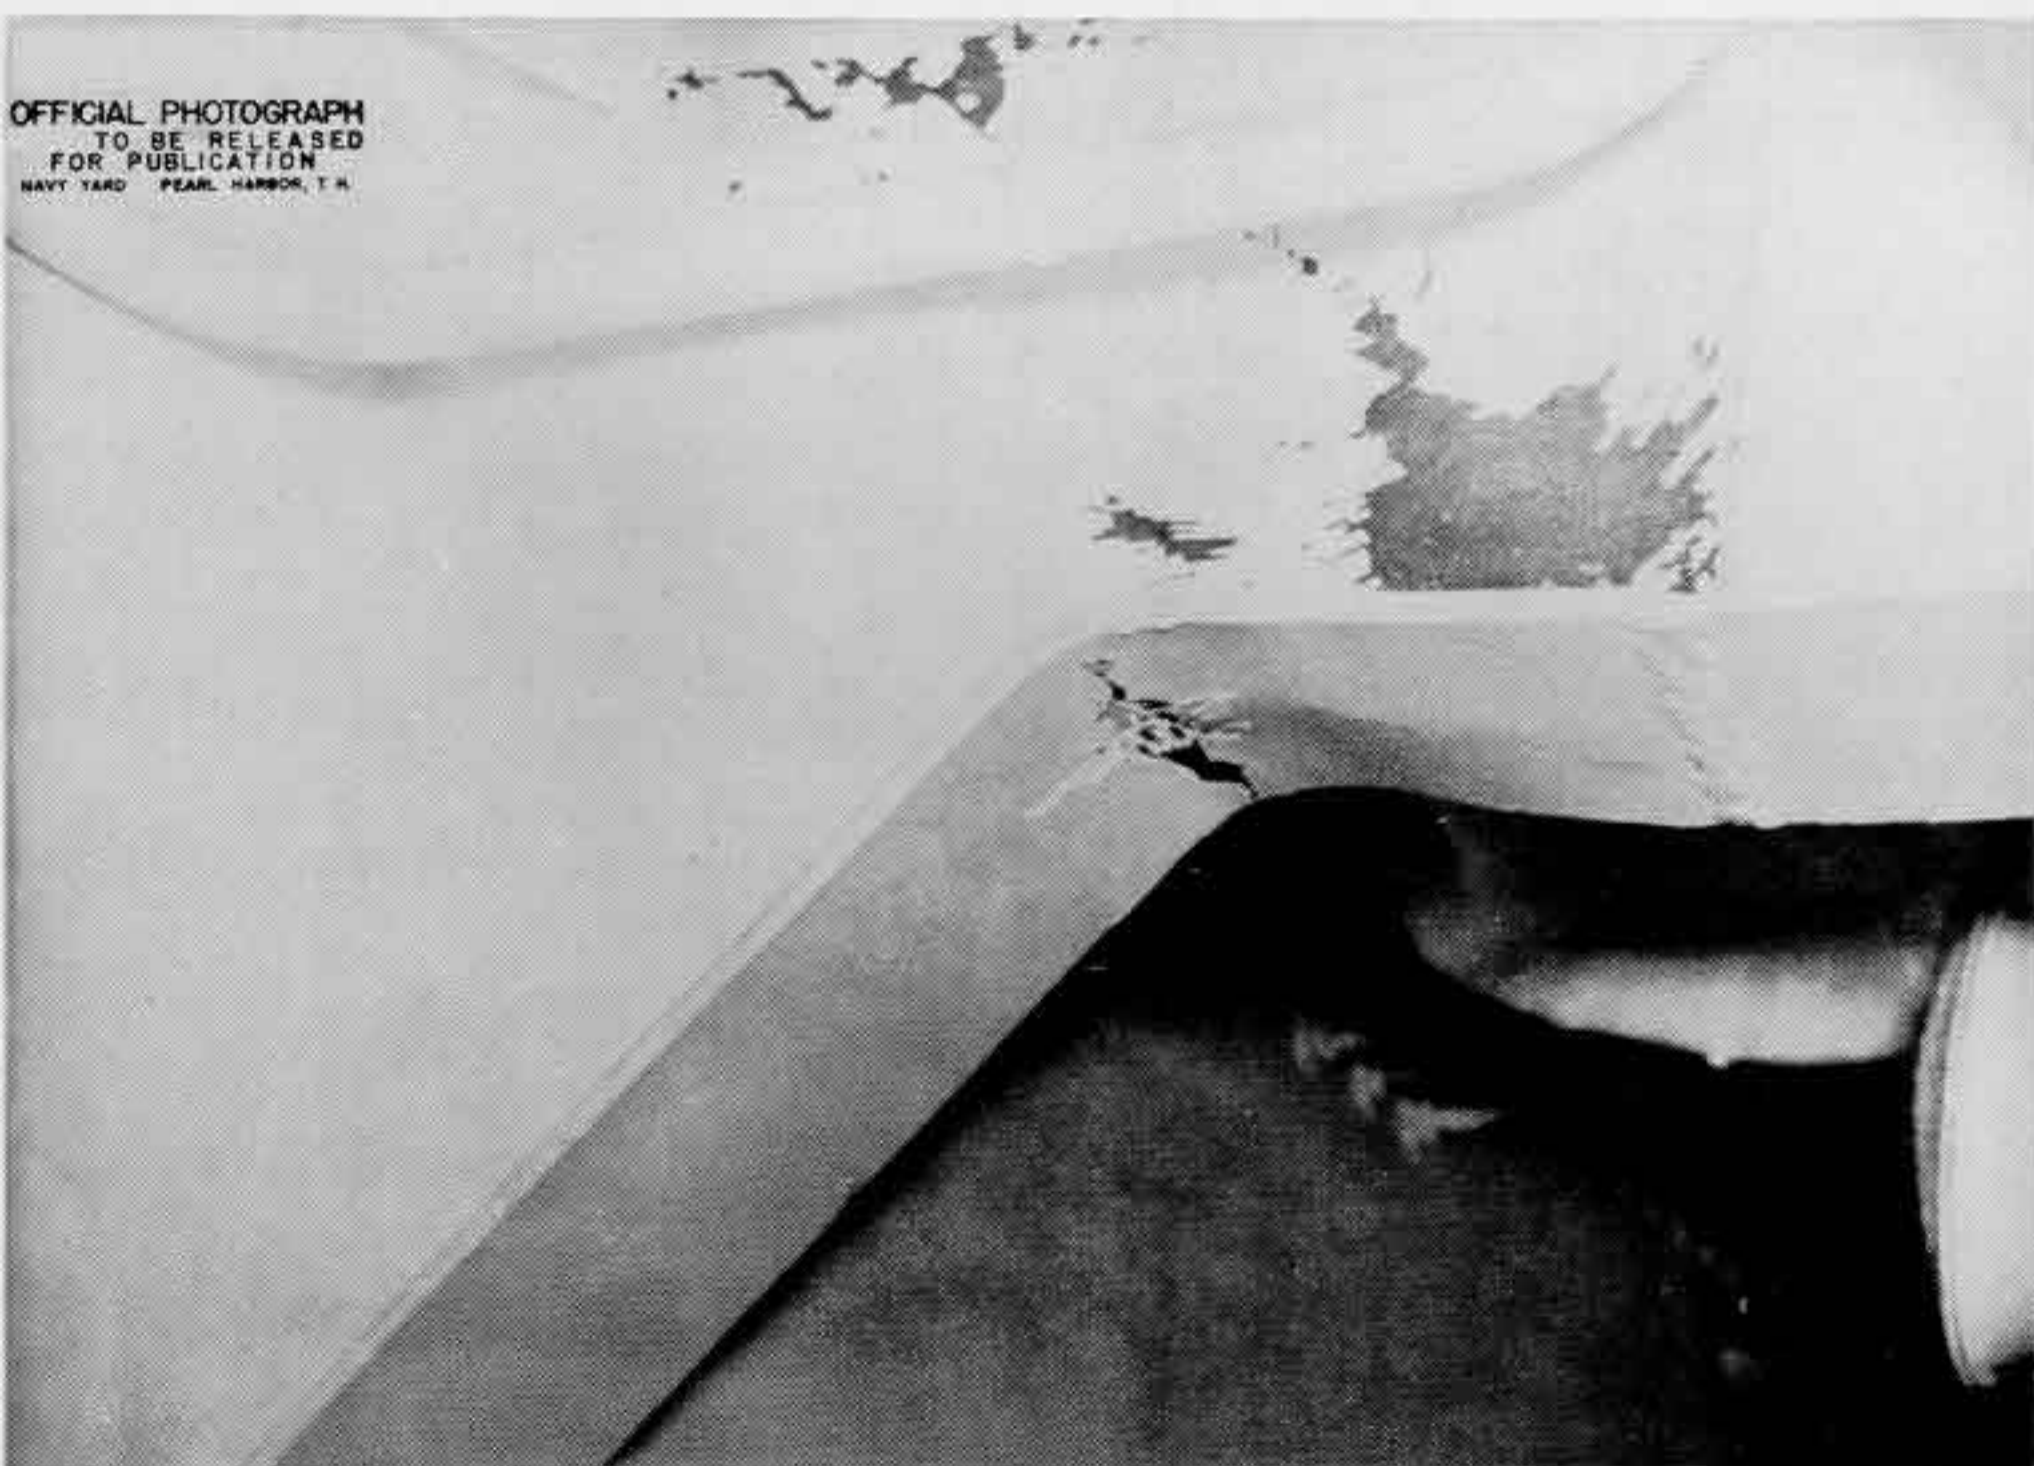
Photo 20: Web FR 109, underneath 3rd deck, outboard bracket to starboard longitudinal bulkhead, looking forward.

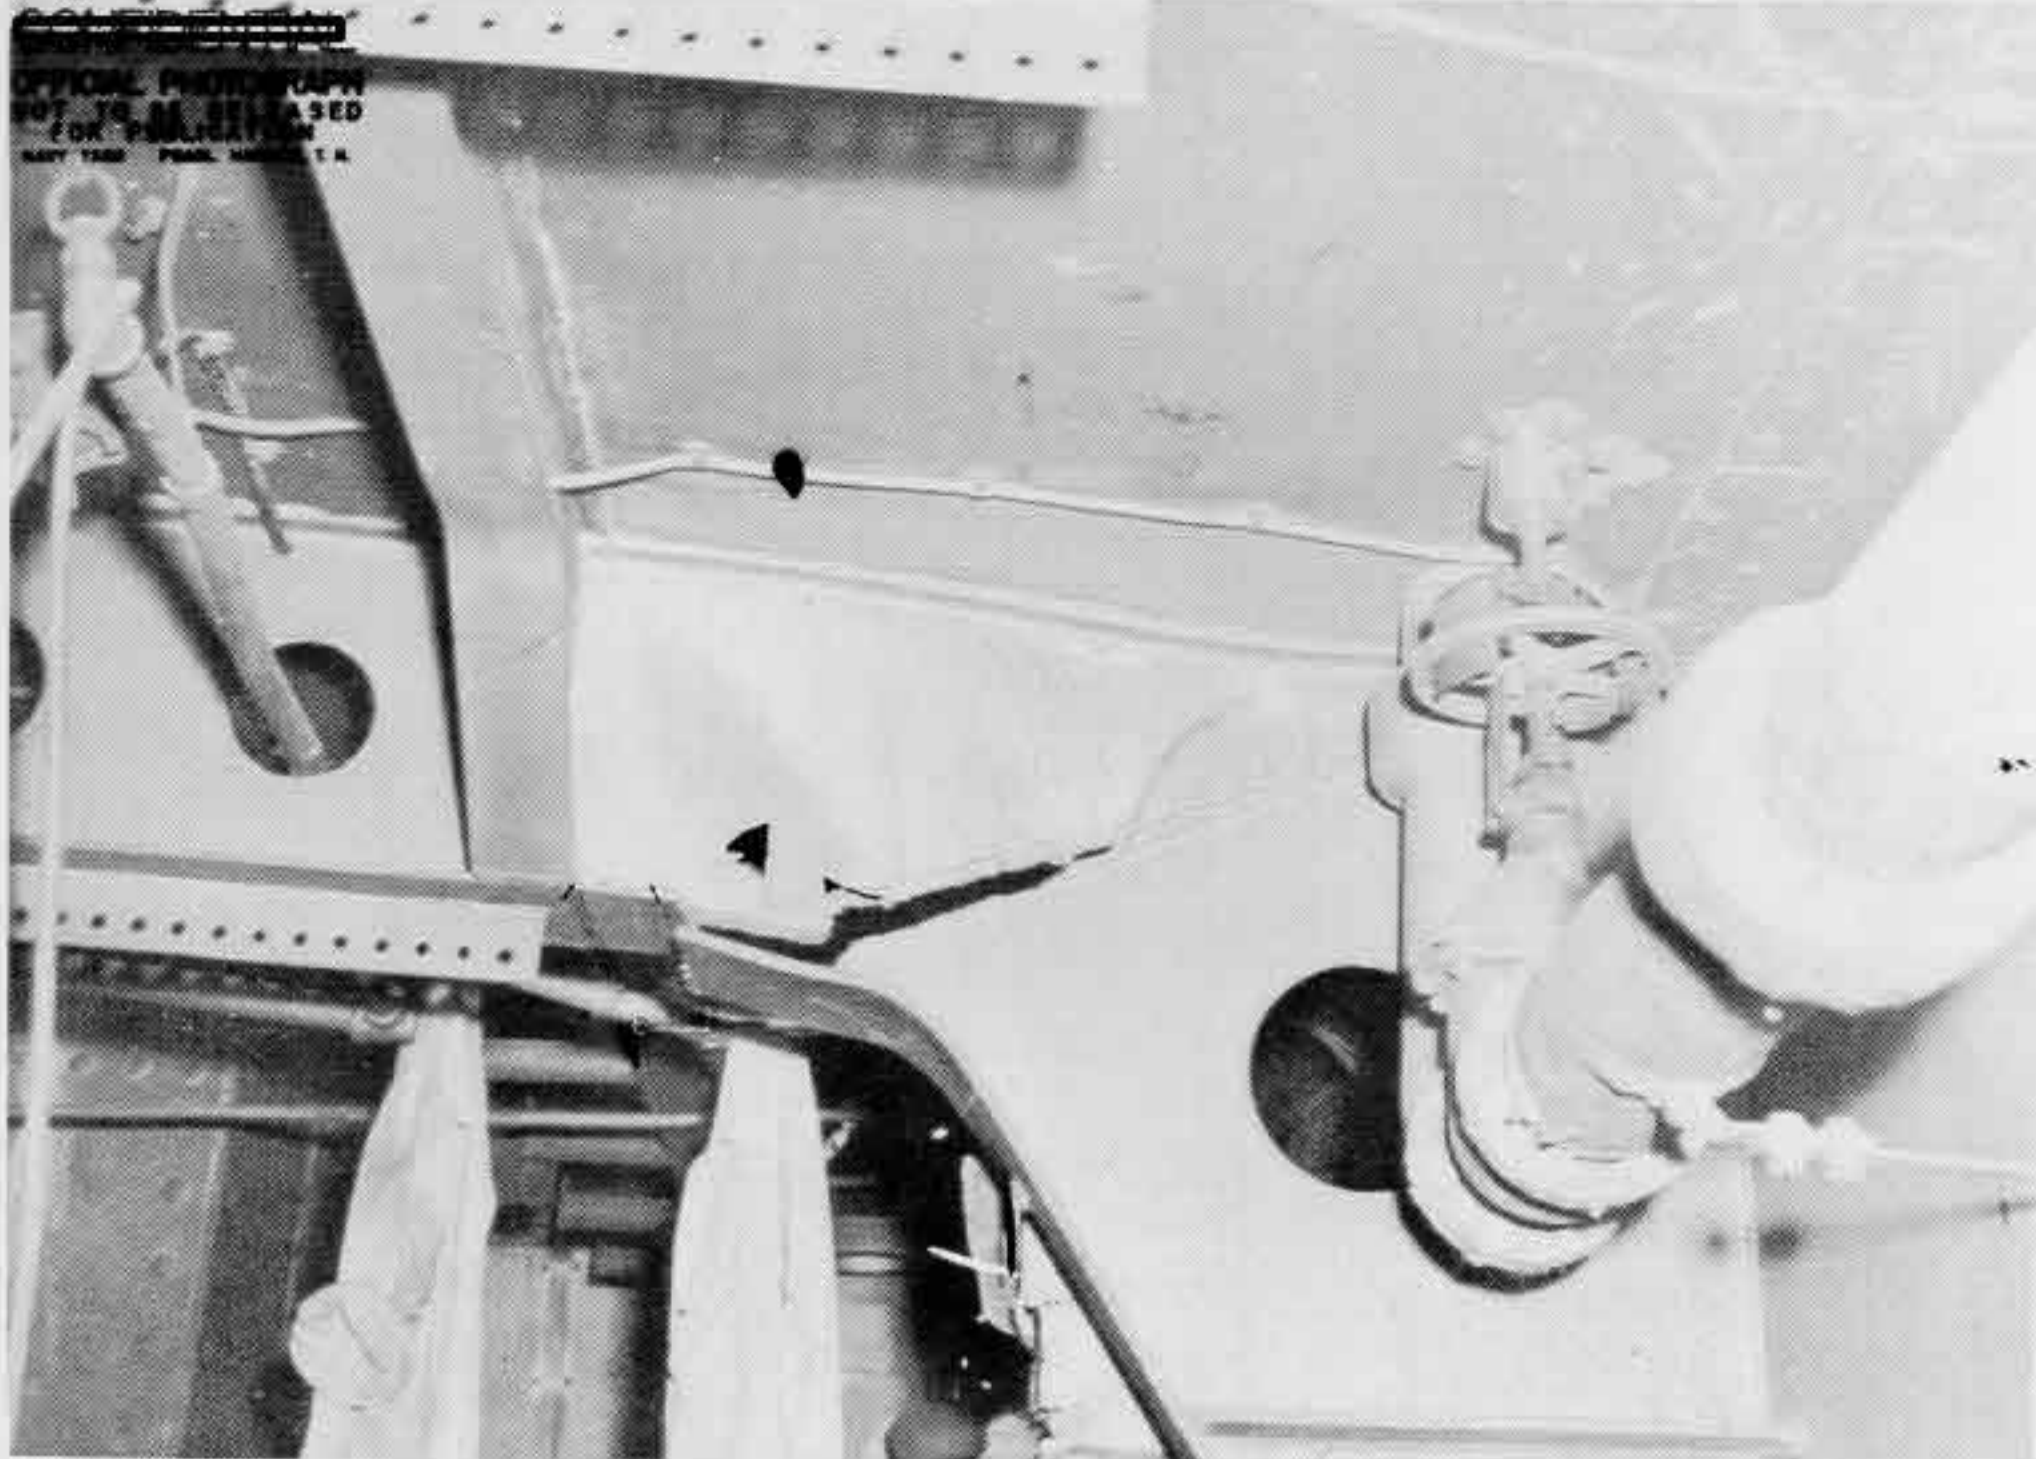
Photo 21: Web FR 109, underneath 3rd deck, inboard bracket to starboard longitudinal bulkhead, looking forward. Note rupture of weld and tear in flange.
