# U. S. S. YORKTOWN (CV5)

## BOMB DAMAGE

CORAL SEA

WAR DAMAGE REPORT No. 23

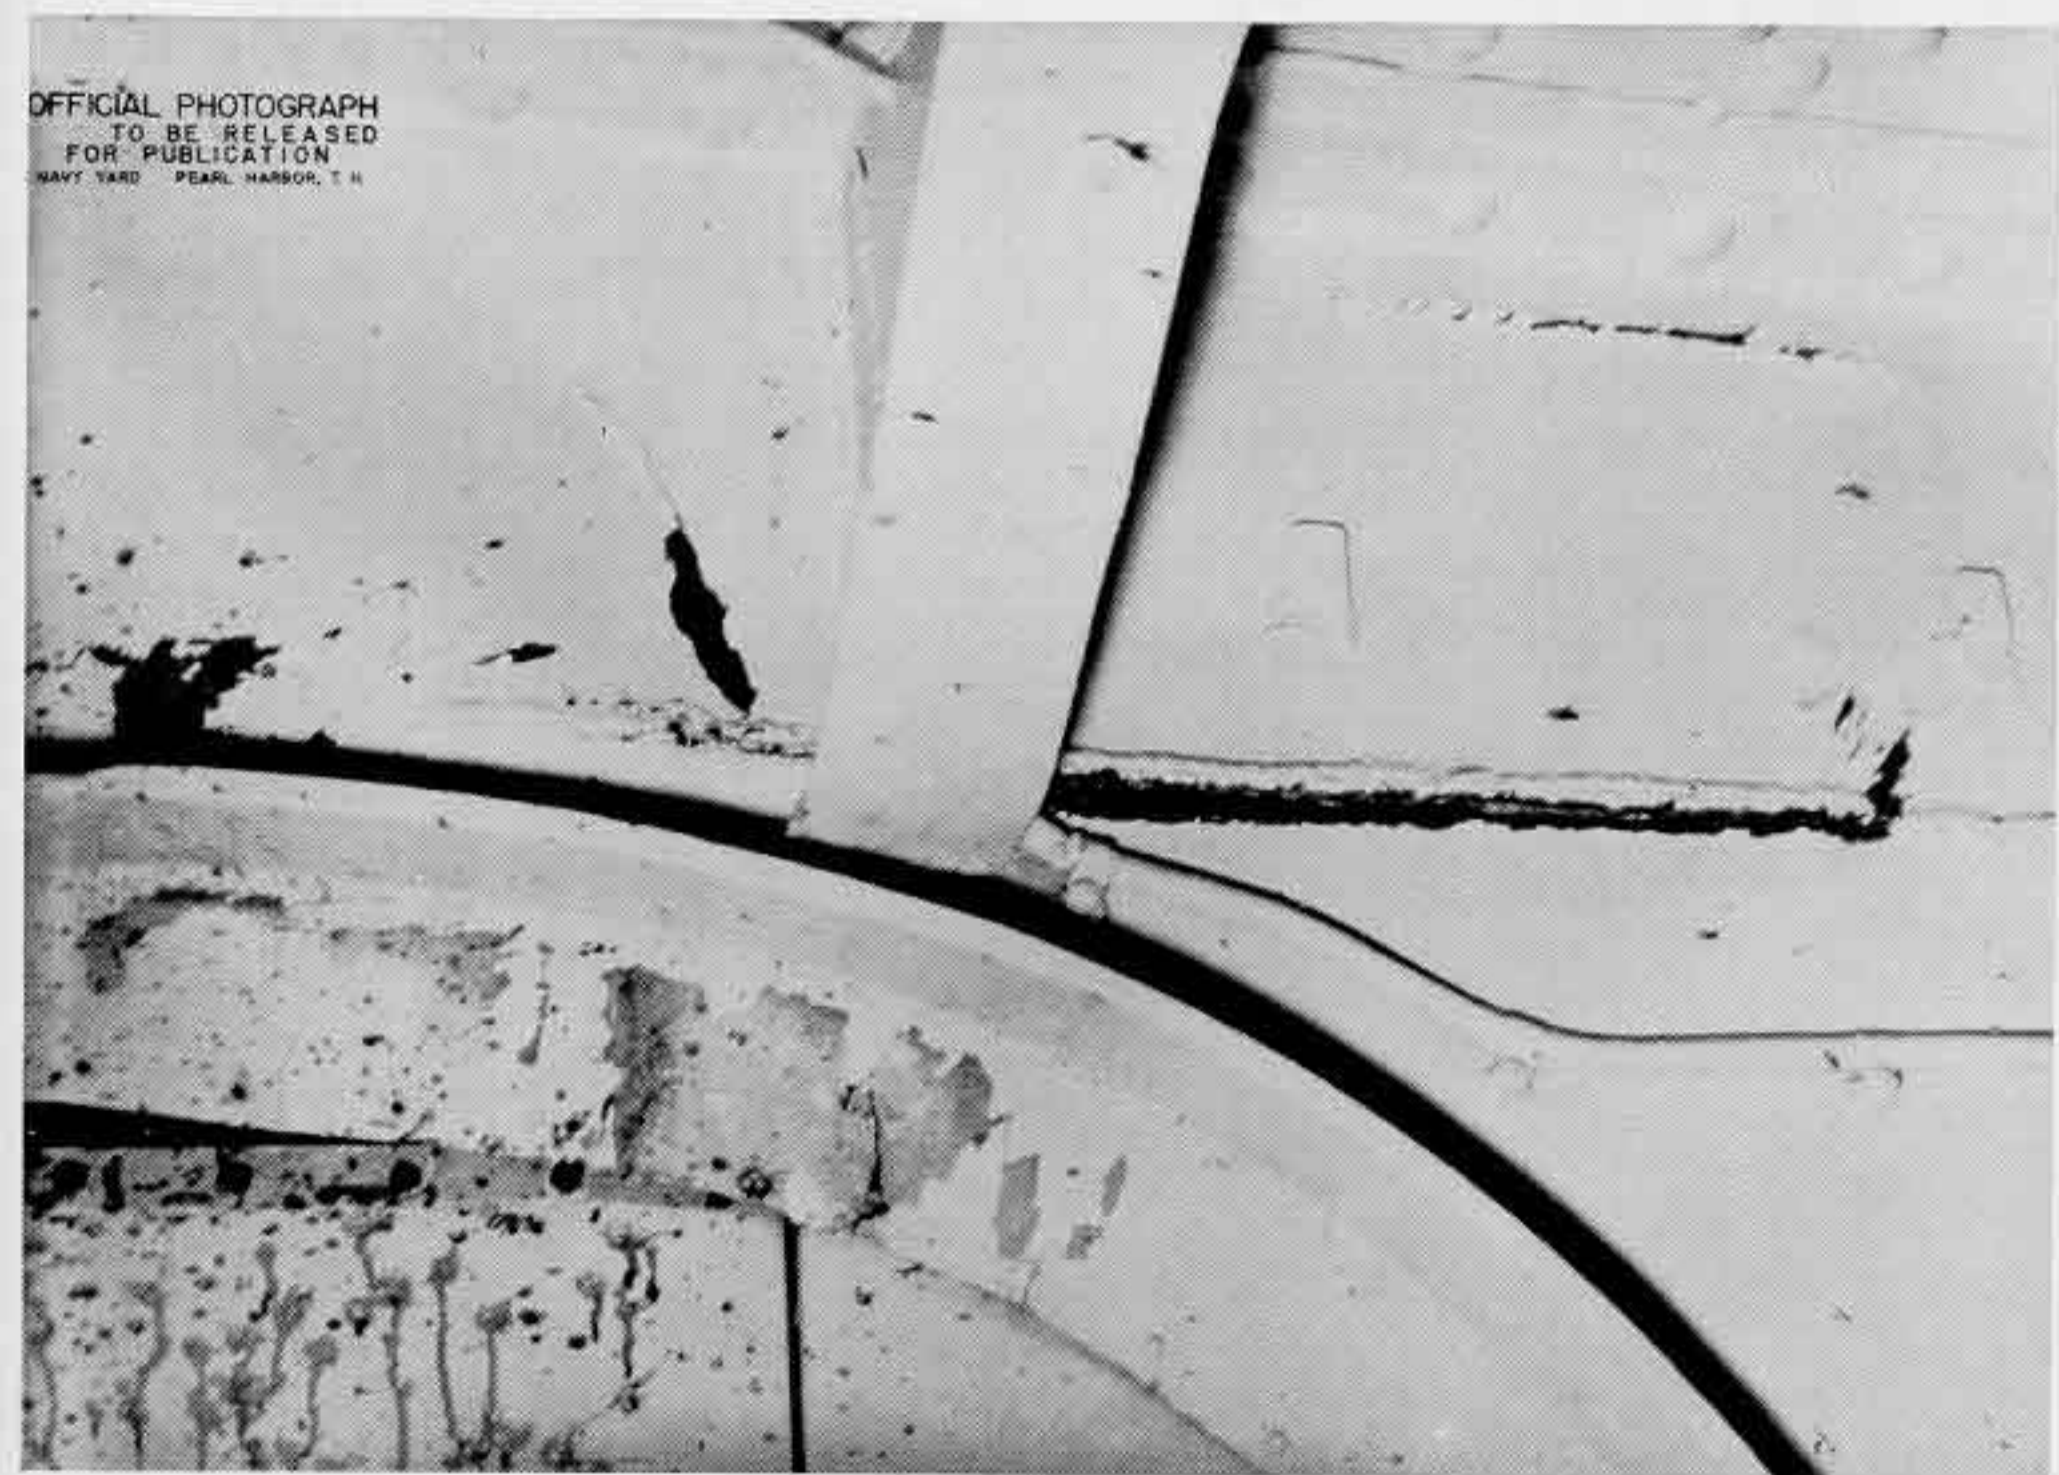
Photo 22: Web FR 109, underneath 2nd deck, bracket to starboard shell, looking forward. Note rupture at weld.

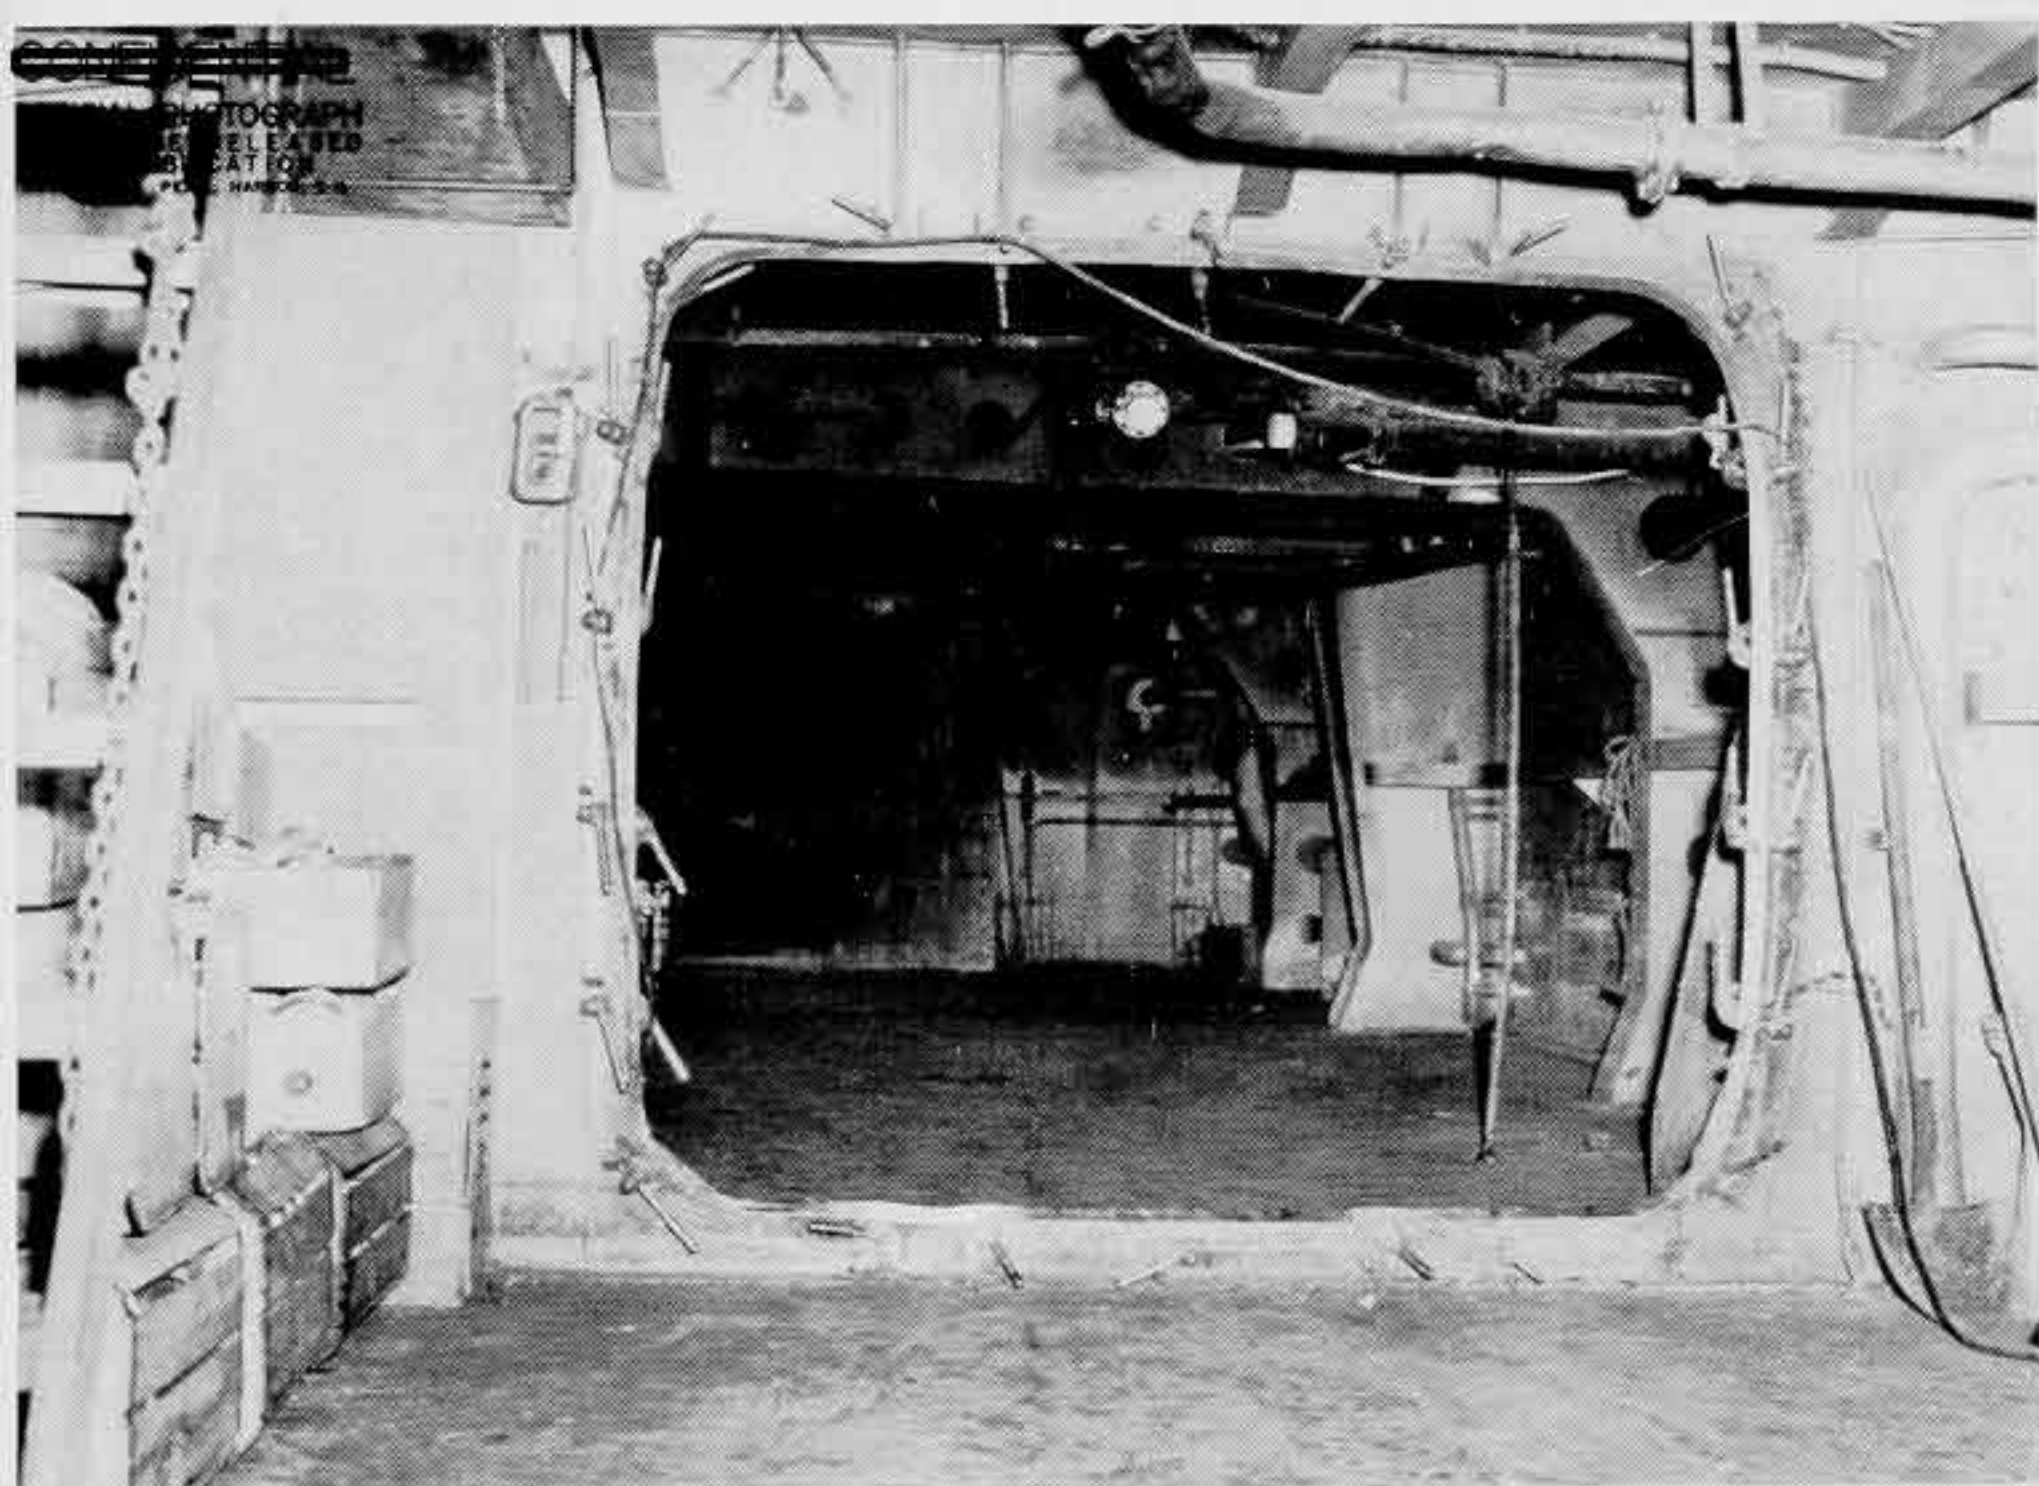
Photo 23: Frame for double size door in bulkhead 118, 4th deck, starboard, looking forward. This door opened forward. Note frame around entire periphery is bent aft. Explosion occurred in space just forward of door.

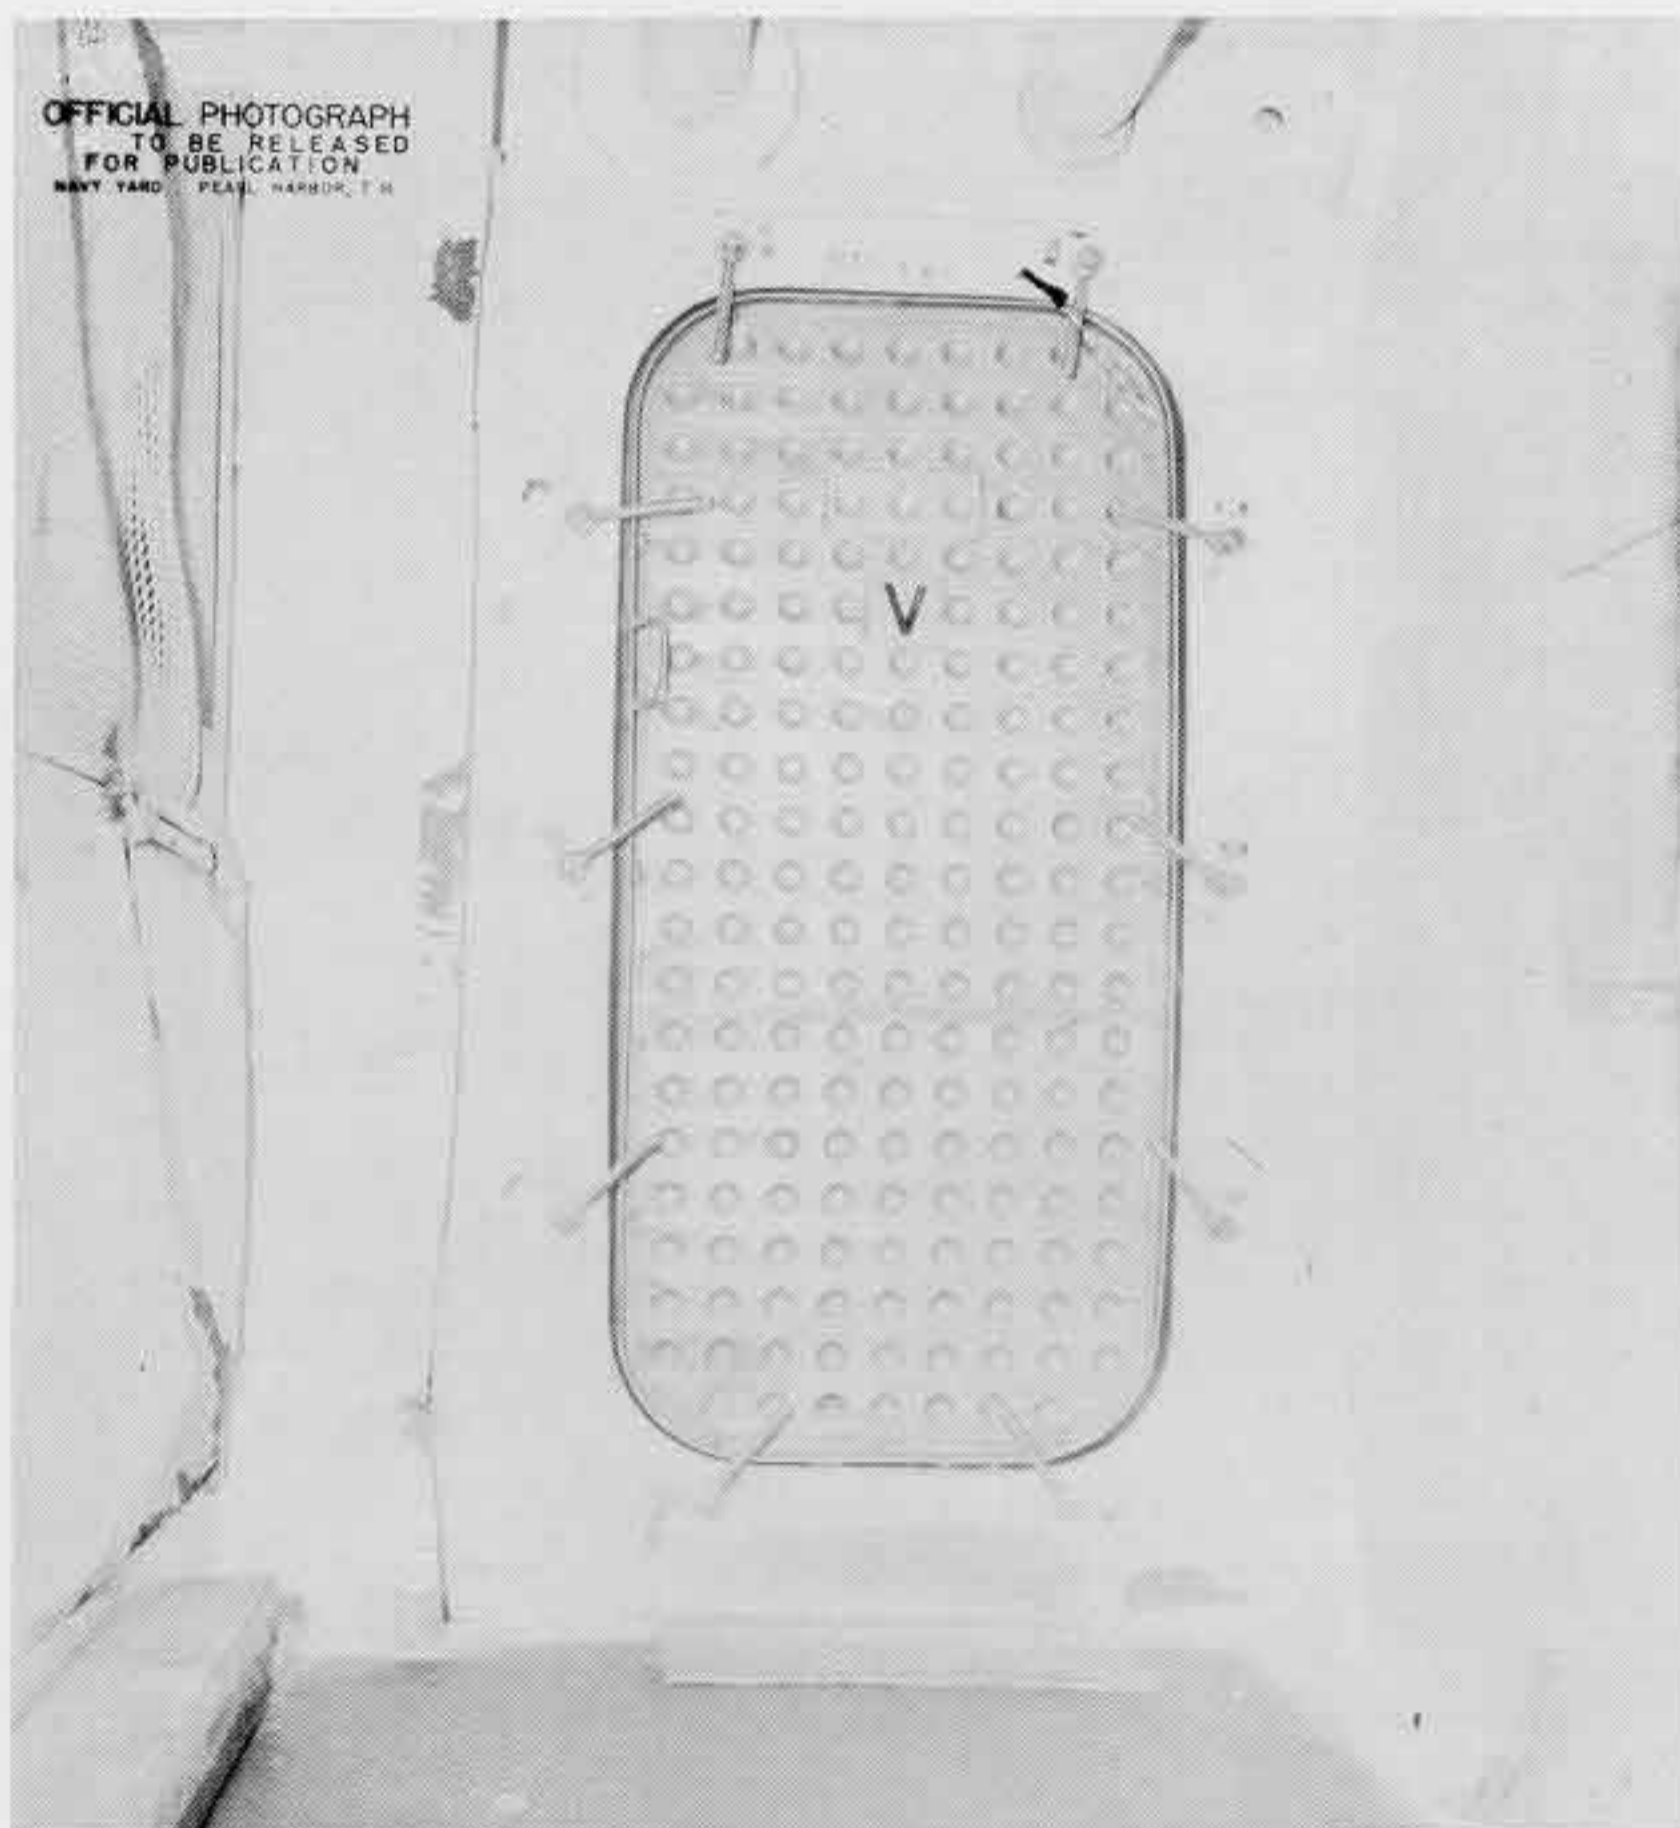
Photo 24: Watertight door, bulkhead 112, starboard side, 3rd deck. Note door and bulkhead are dished aft, but not ruptured. Note crumpling of sheet and expanded metal bulkhead at left.

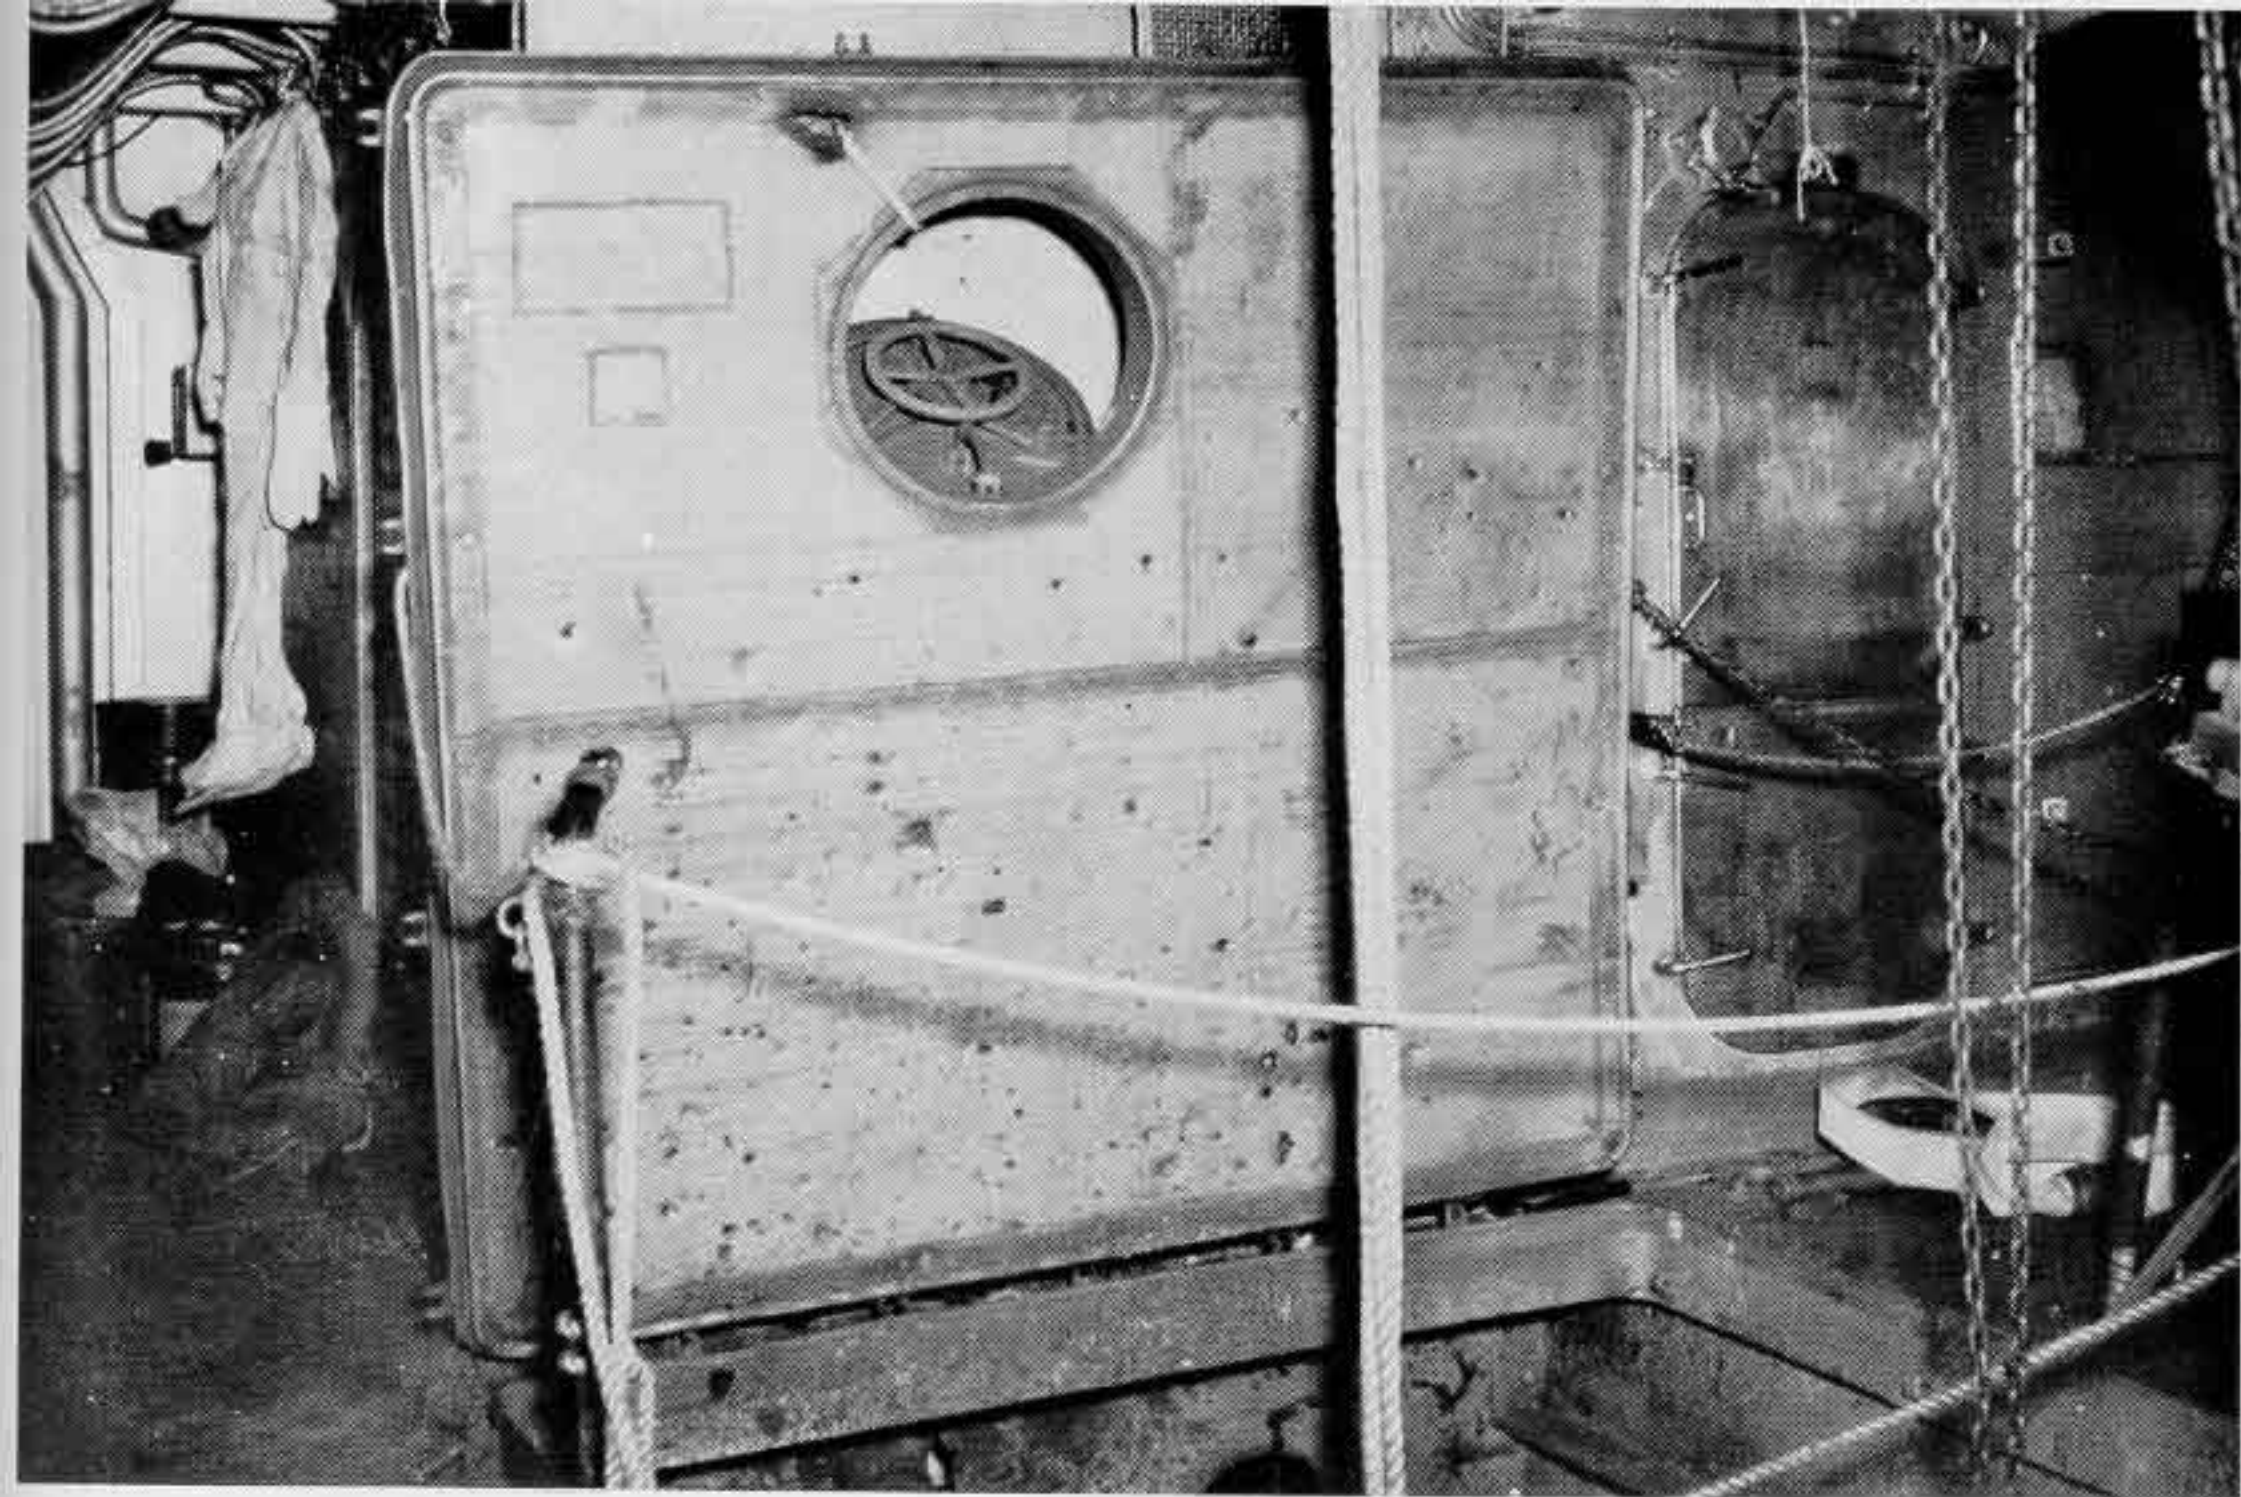
Photo 25: Fragment damage to main deck hatch, FRS 107-109, starboard, immediately above explosion.

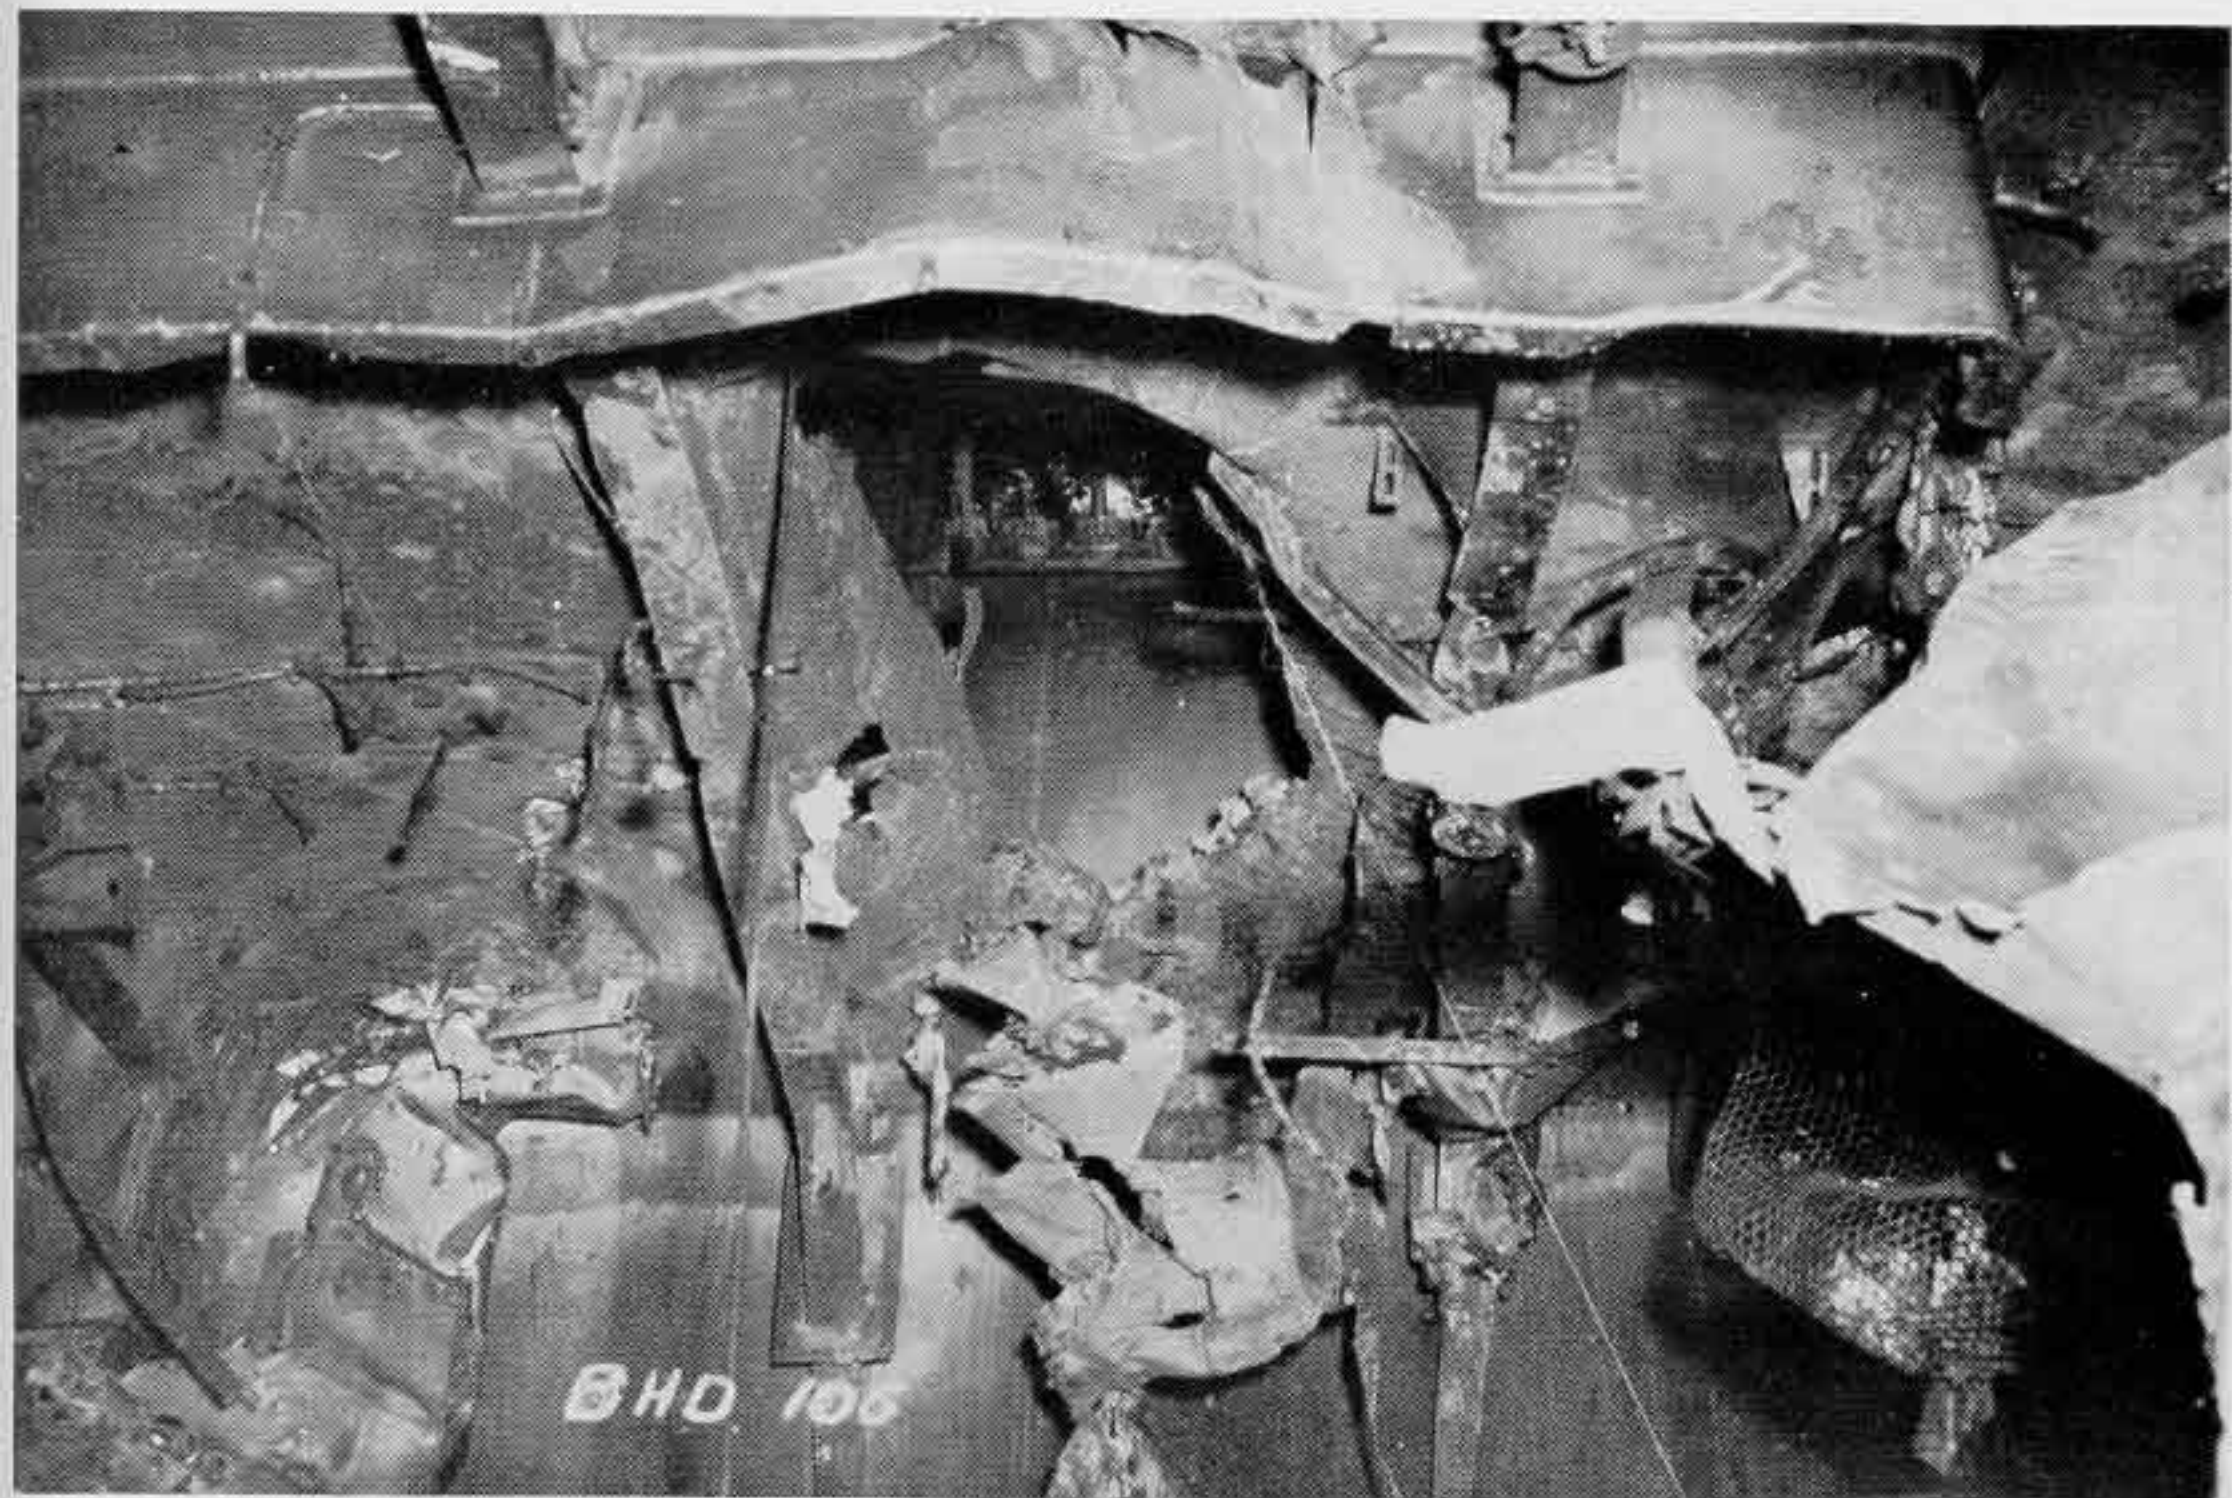
Photo 26: Bomb blast hole, second deck, FRS 106-107, starboard.

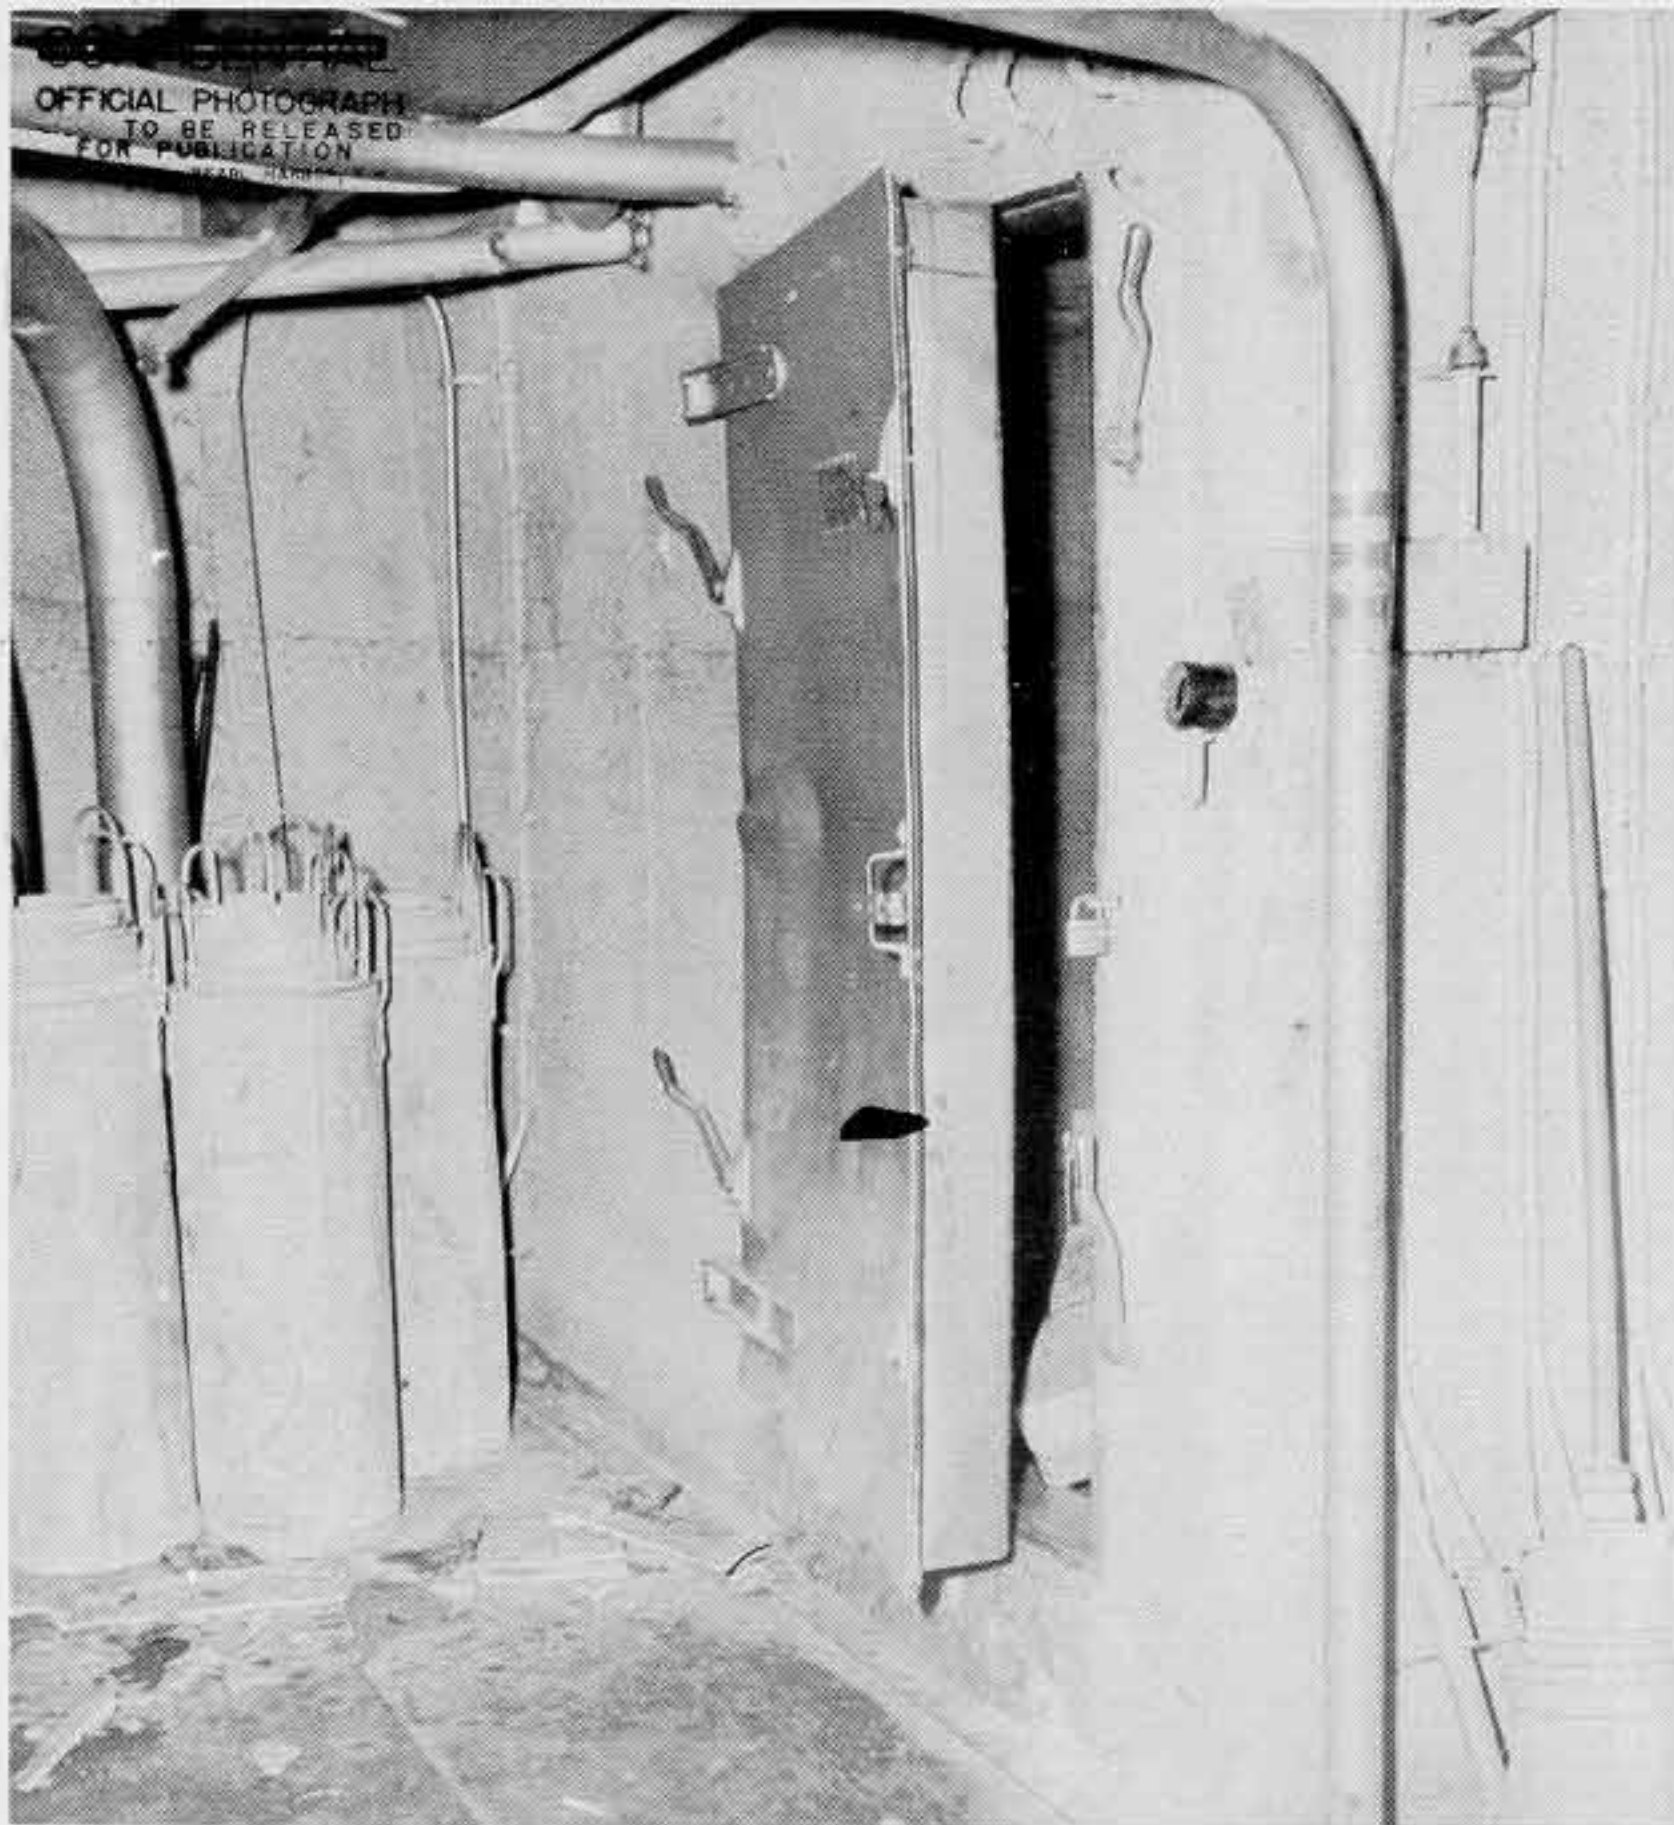
Photo 27: Refrigerator door, 4th deck, 13'-0" to starboard of centerline, FRS 127-129. Note deflection. This was 80' aft of explosion.

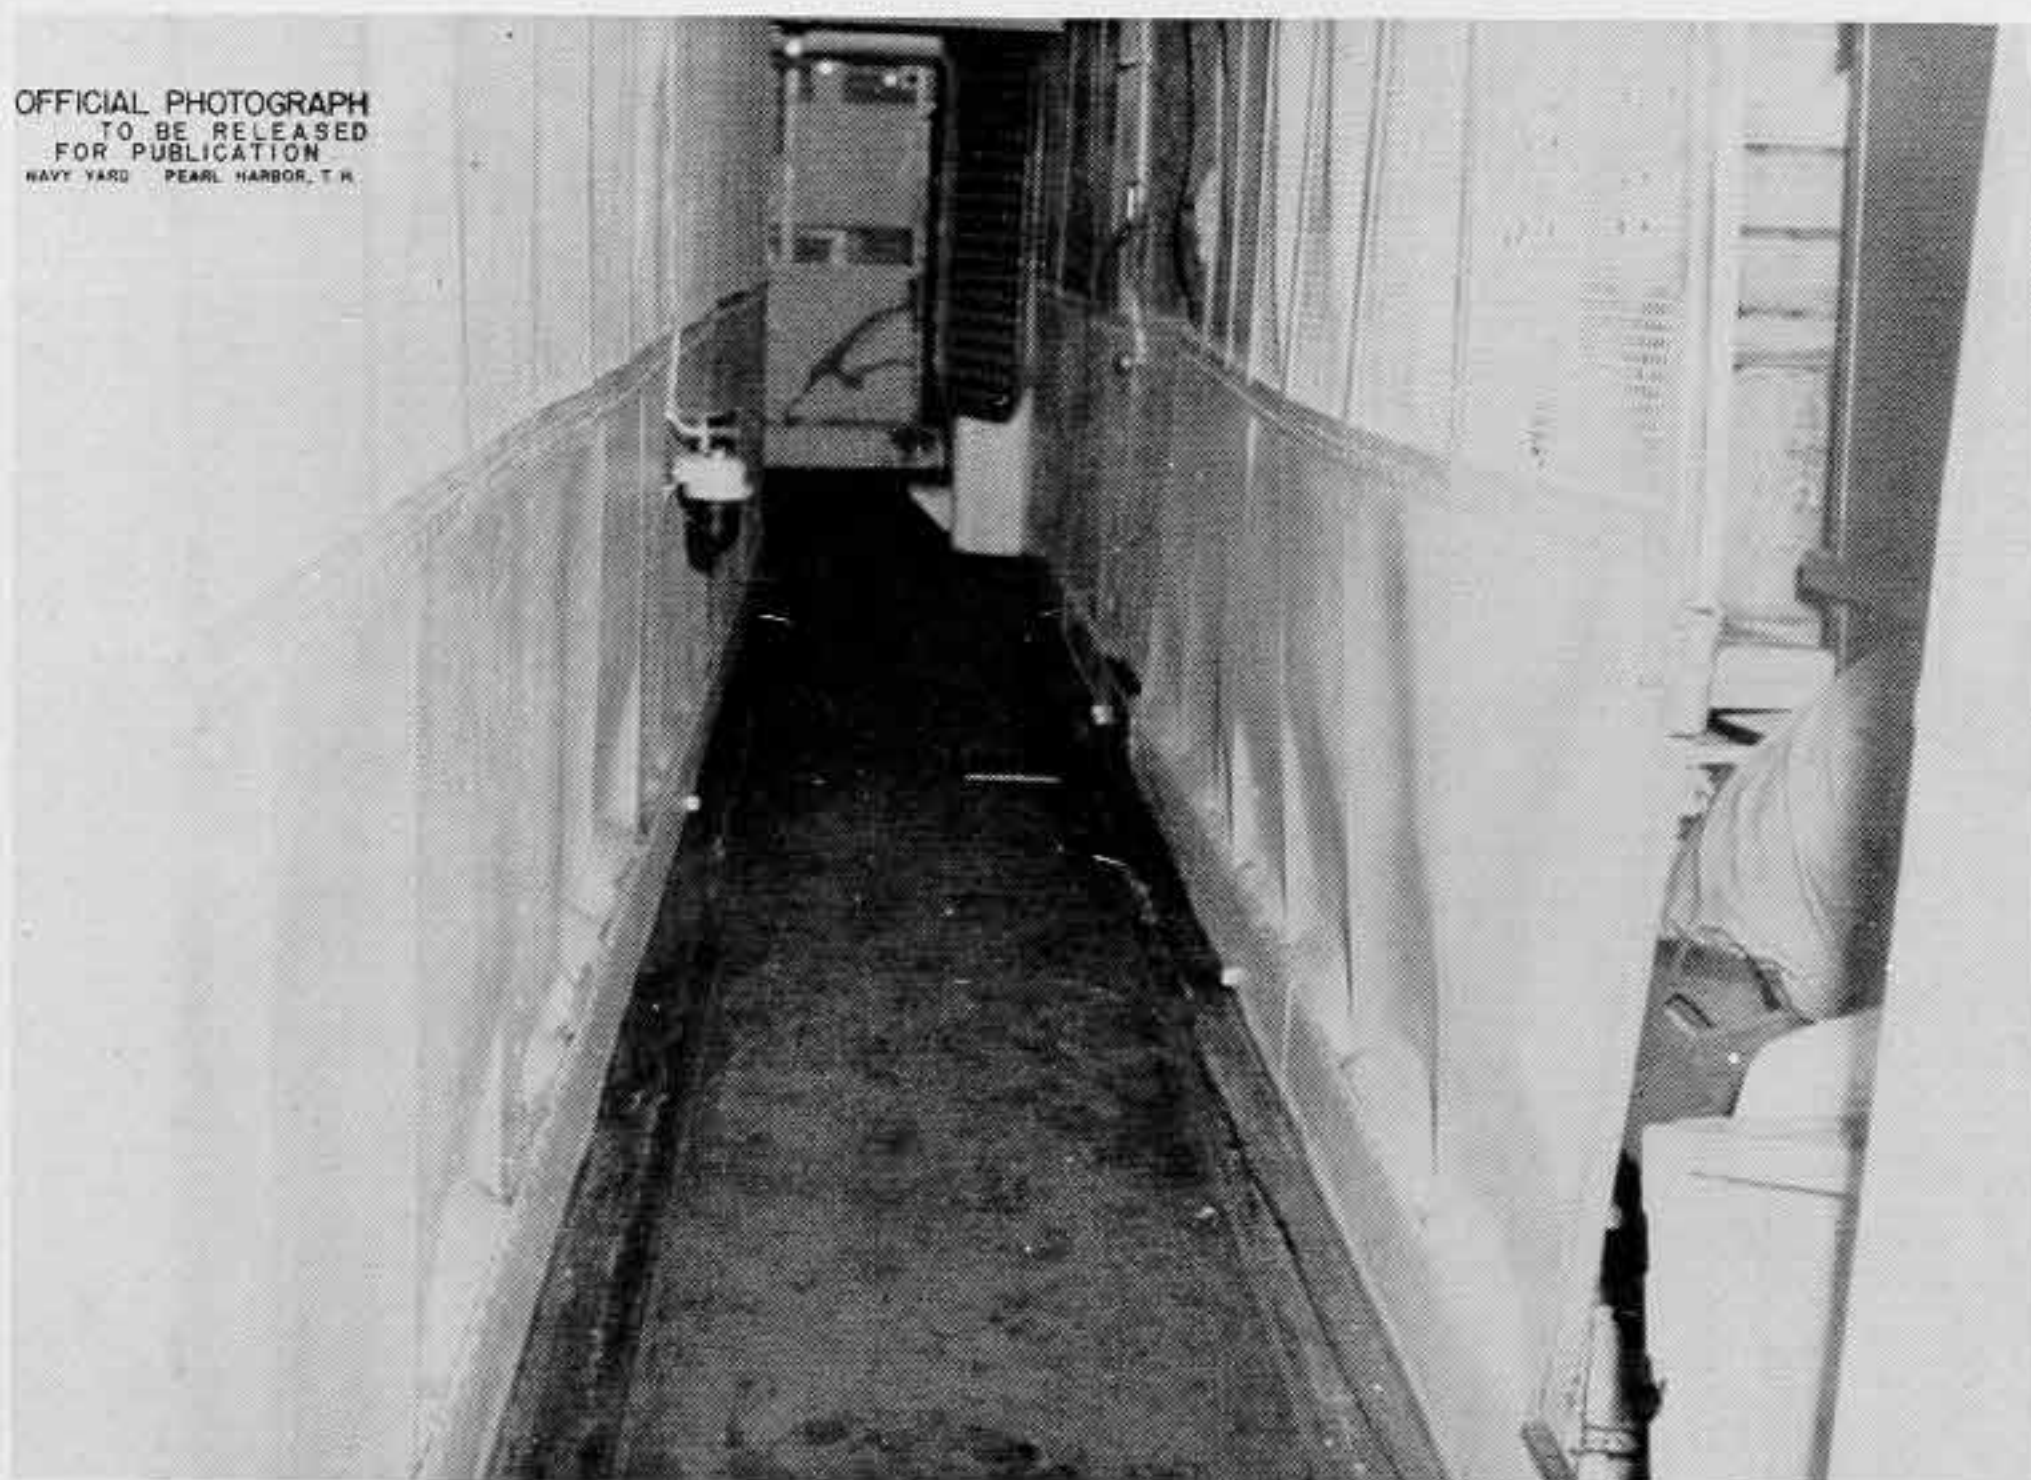
Photo 28: Athwartships passage, 3rd deck, FRS 115 1/2-116 1/2, looking to starboard. Damaged sheet and expanded metal bulkheads are aft of W.T. bulkhead 112 which remained tight.
