# U. S. S. YORKTOWN (CV5)

## BOMB DAMAGE

CORAL SEA

WAR DAMAGE REPORT No. 23

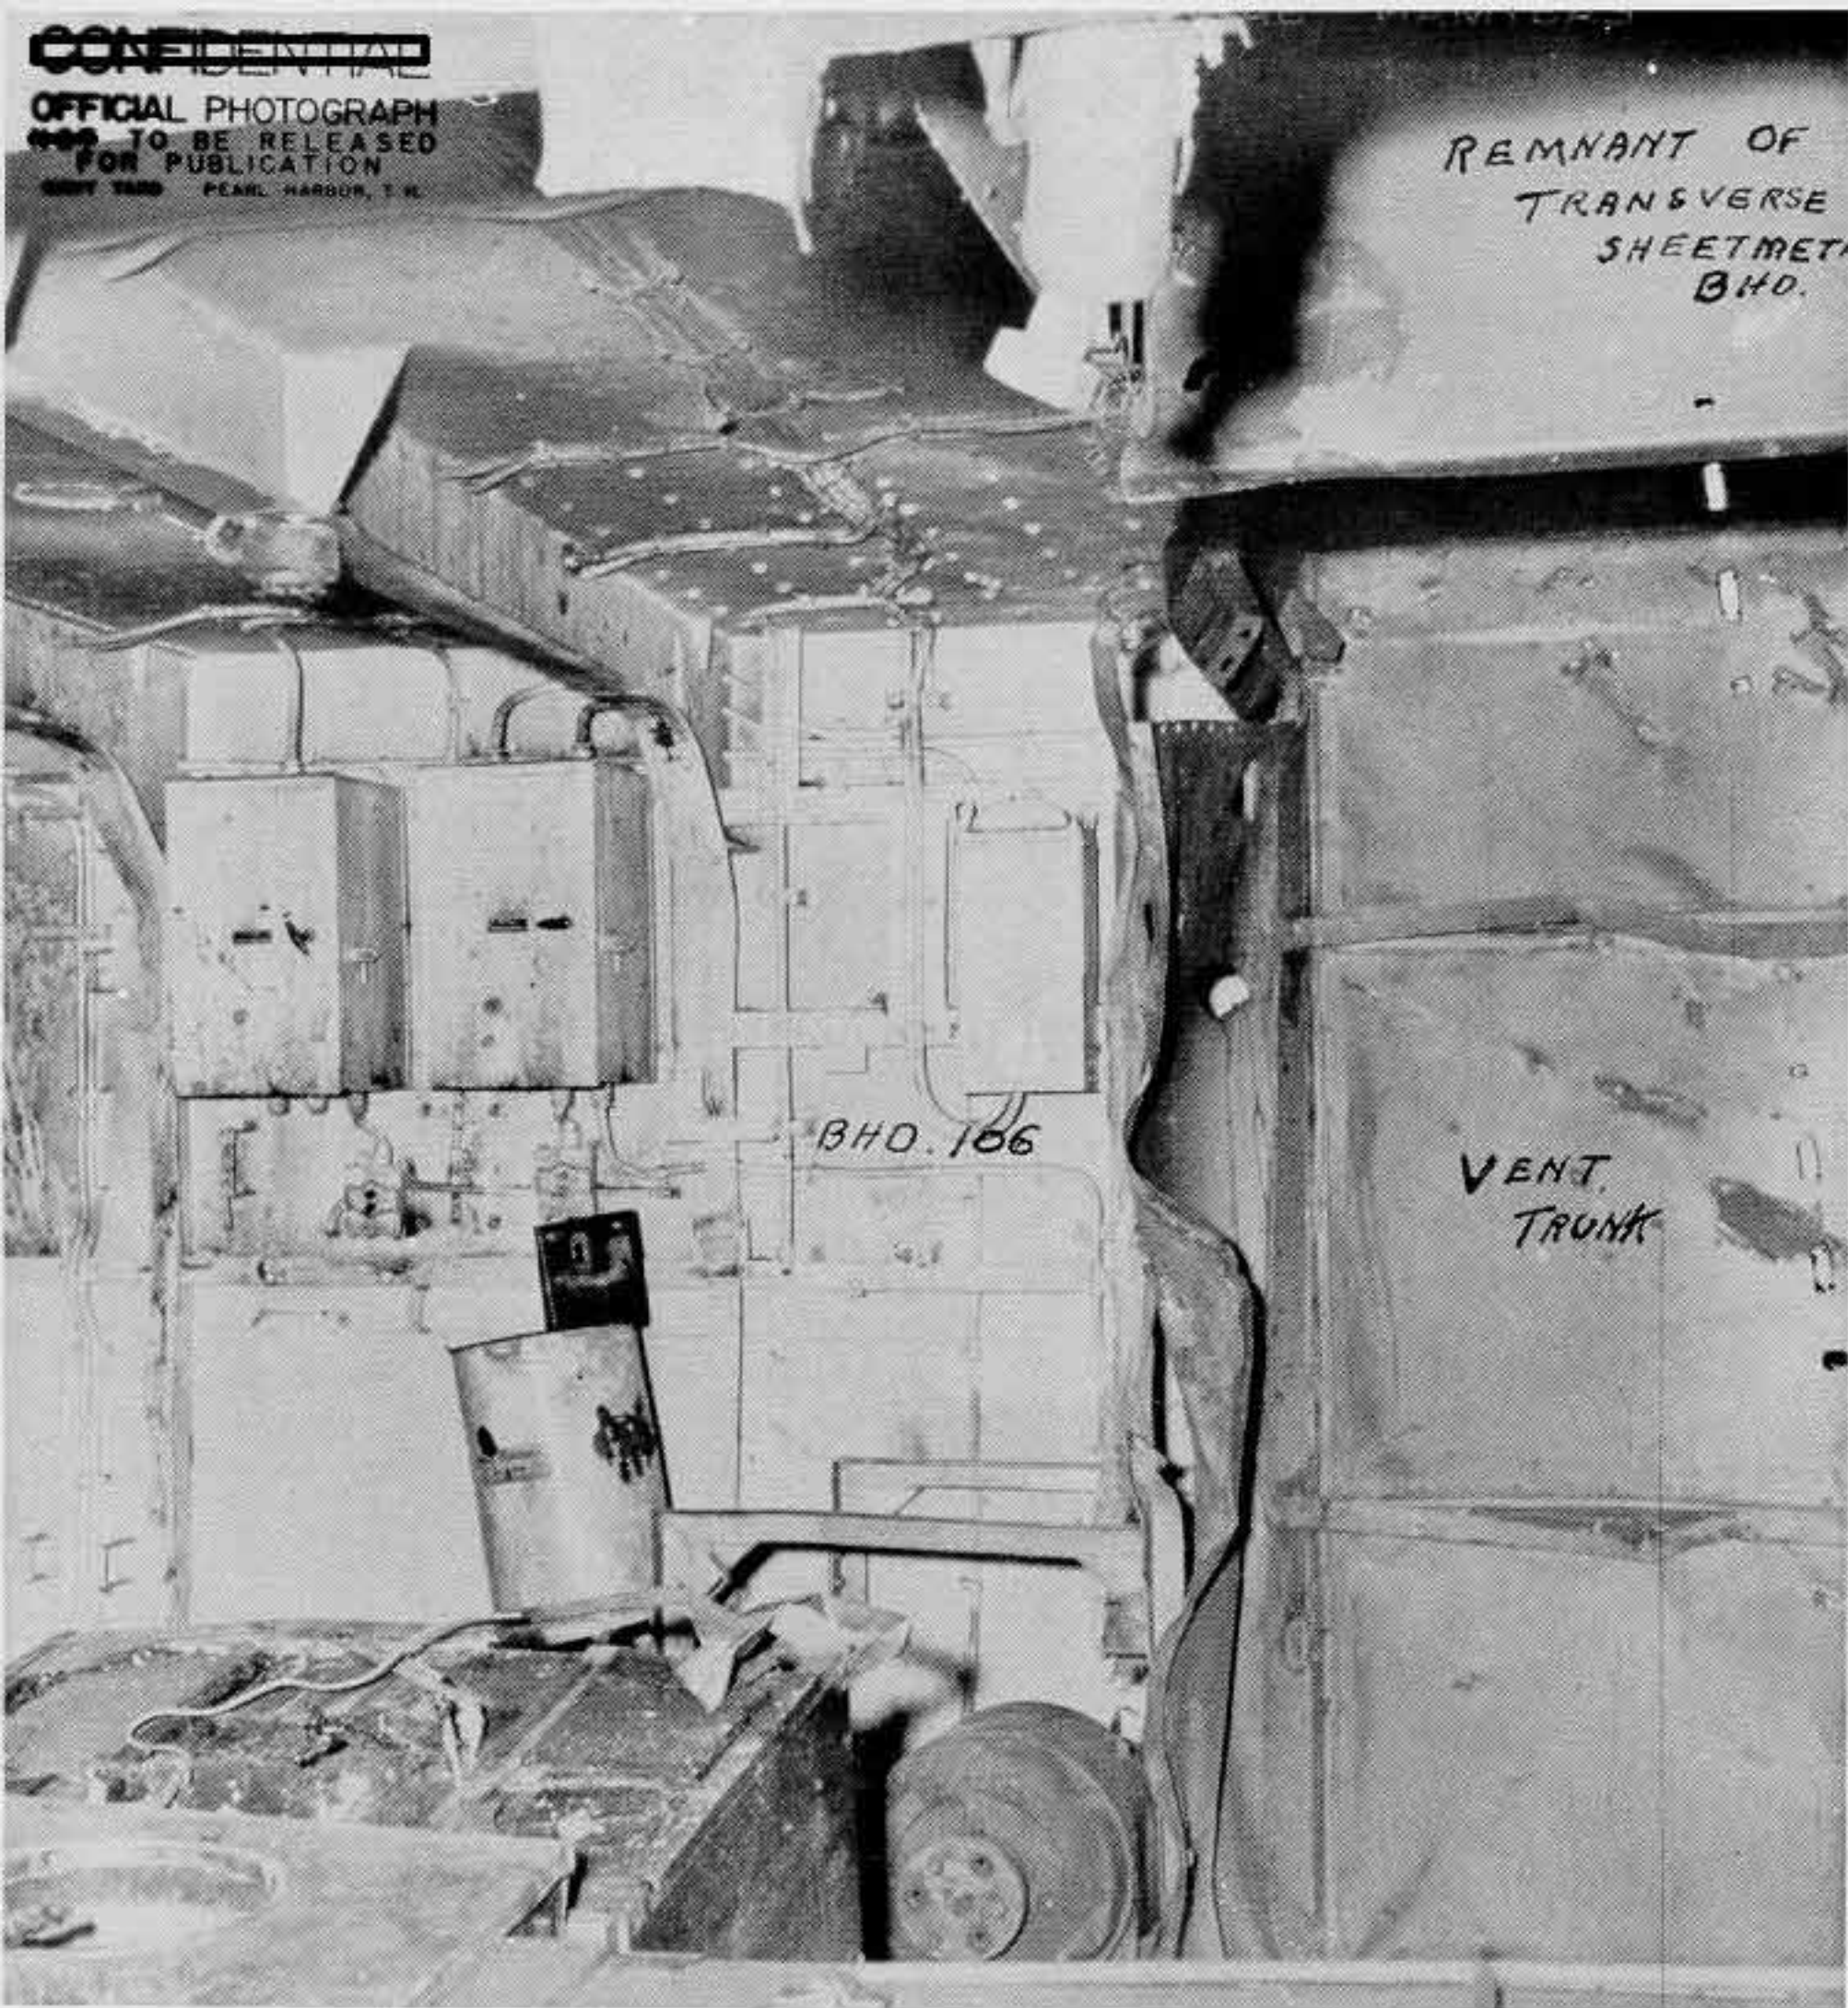
Photo 29: Bulkhead 106, between 3rd and 2nd decks, looking forward.

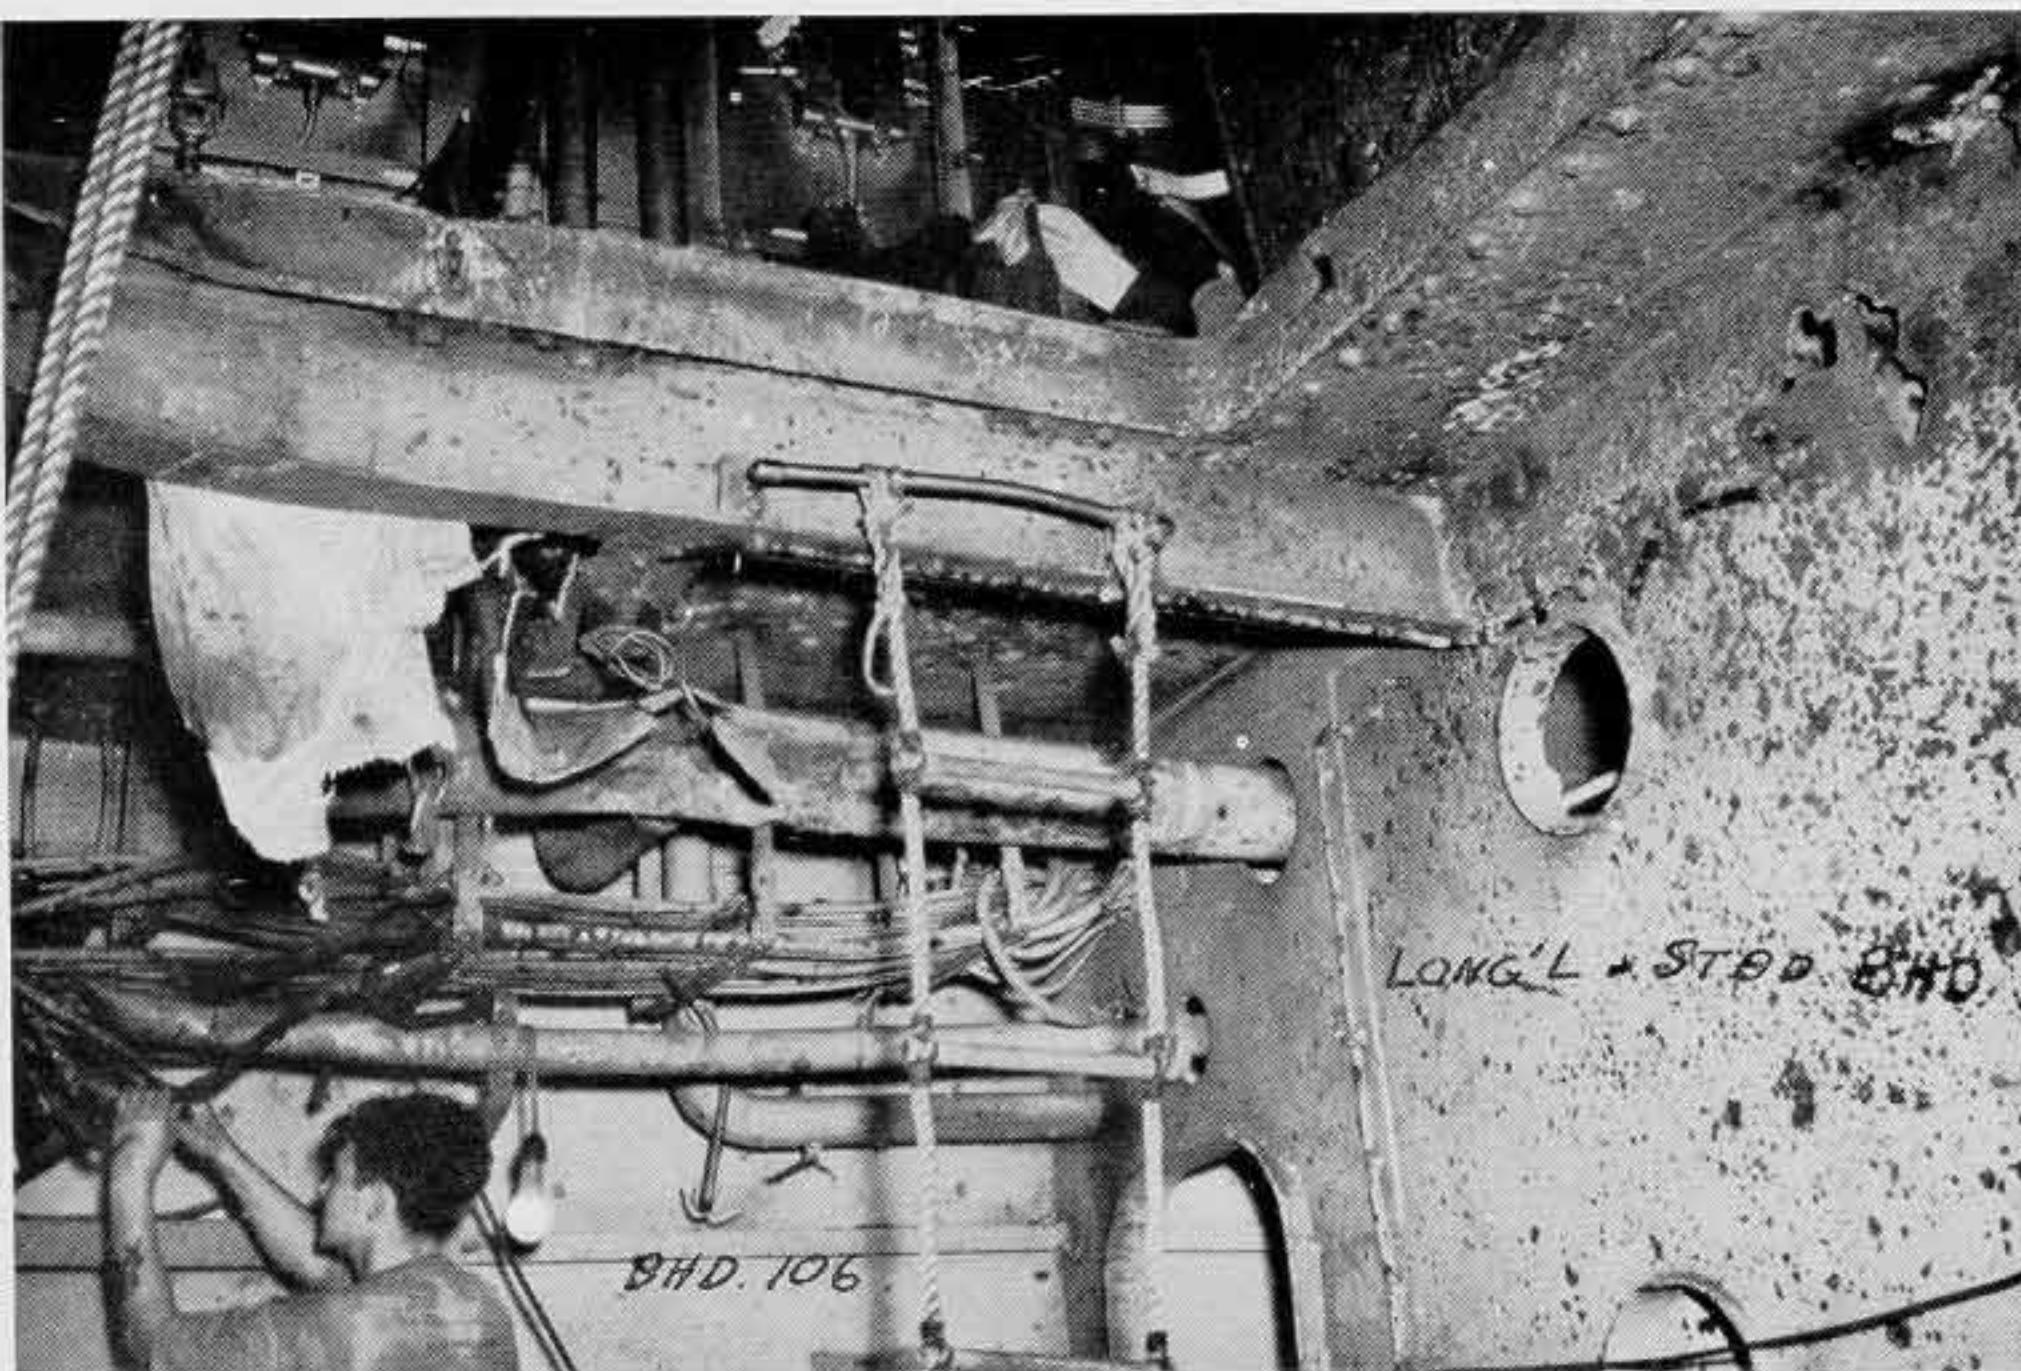
Photo 30: Fragment damage, starboard longitudinal bulkhead, second deck, FRS 106-109, looking forward.
