U. S. S. MARBLEHEAD (CL12)

BOMB DAMAGE

4 FEBRUARY 1942

710205-1048
 WAR DAMAGE REPORT No. 34

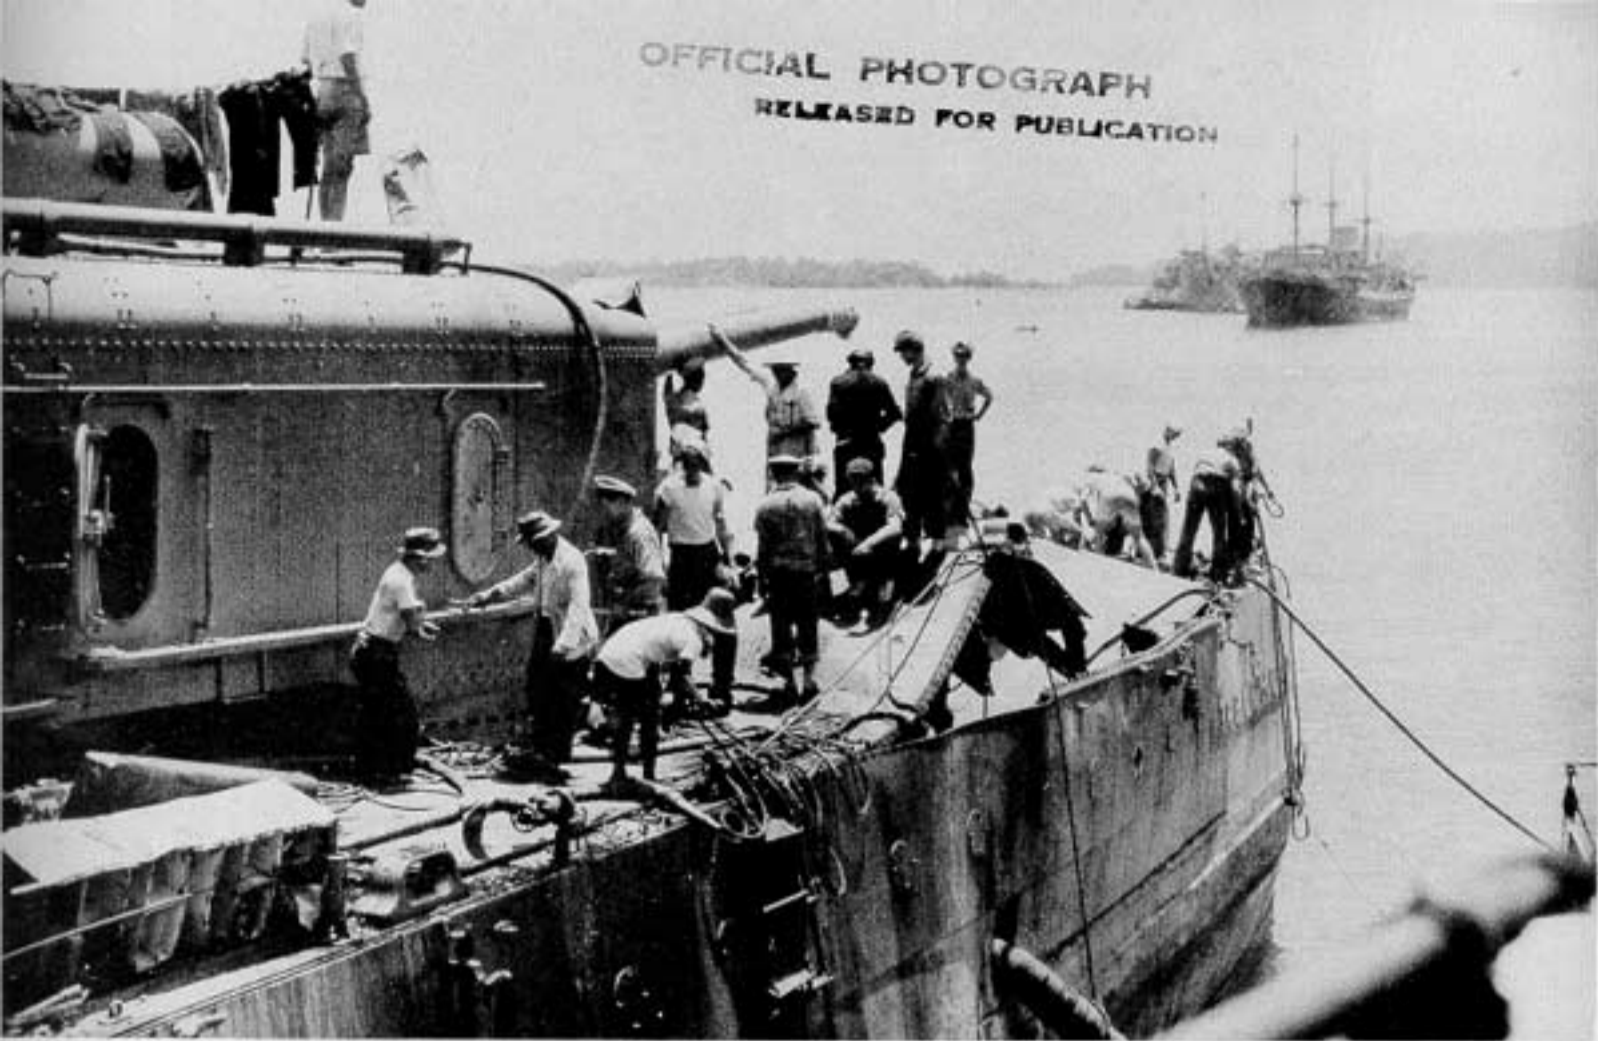
Photo 1: View of damage to main deck at fantail.

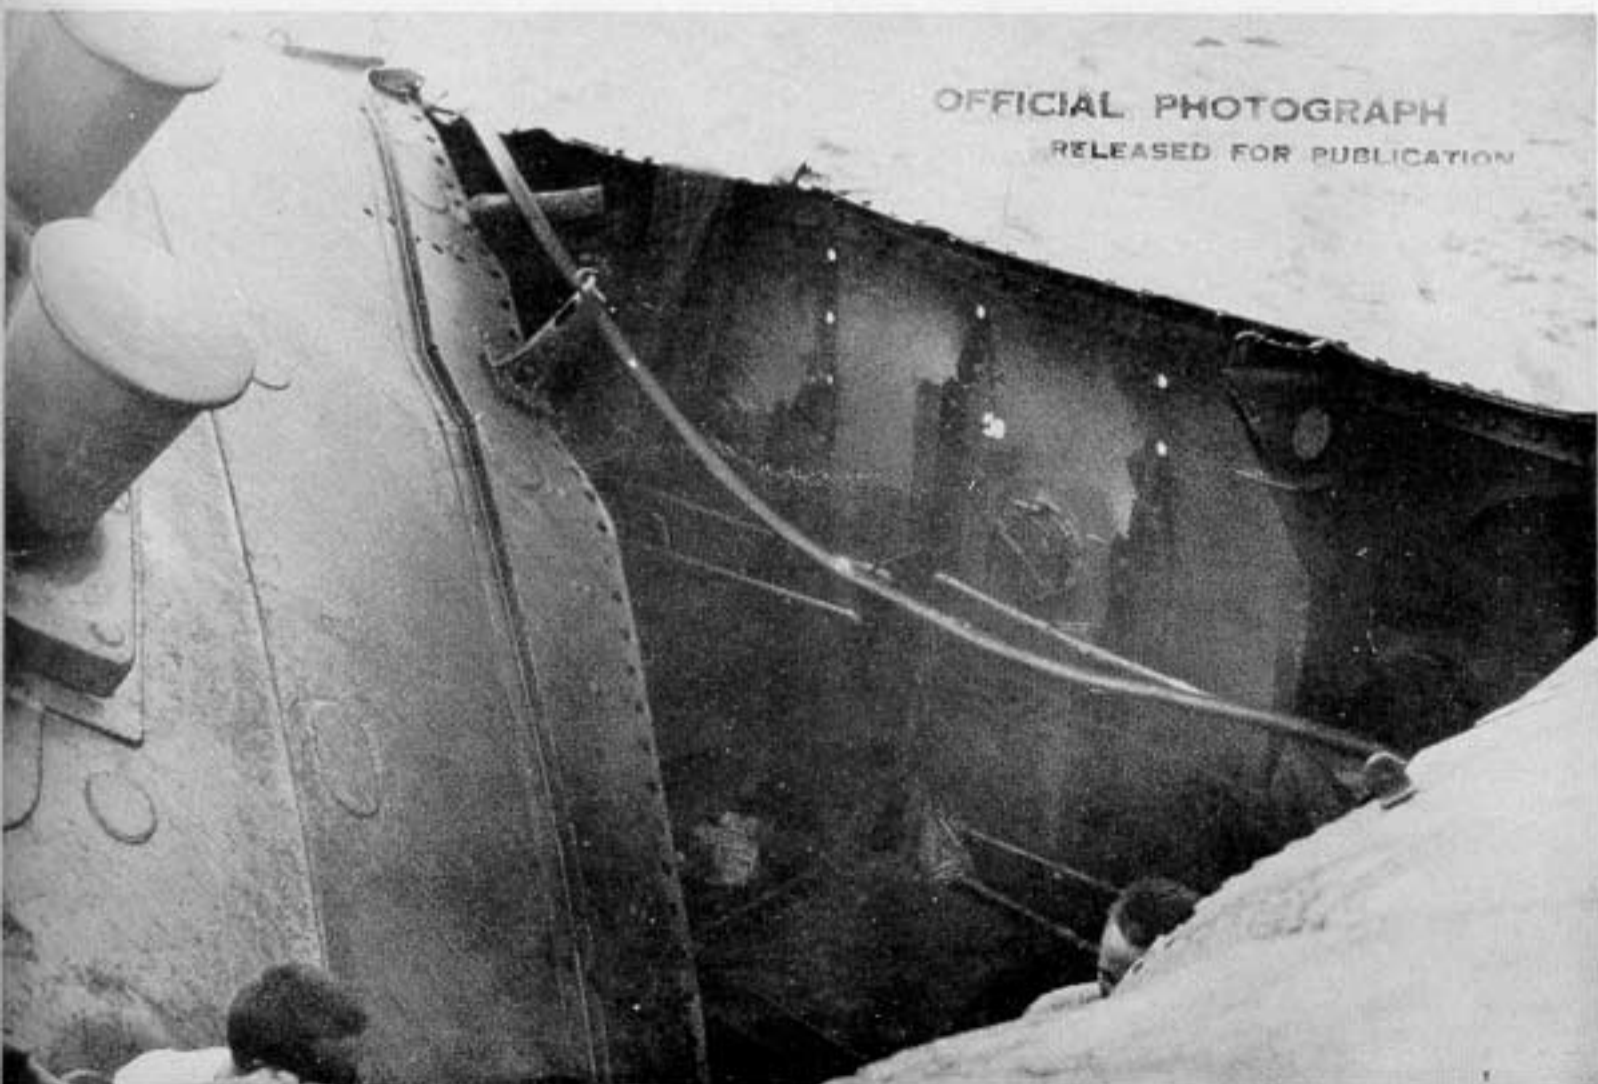
Photo 2: Port side looking aft into C.P.O. quarters.

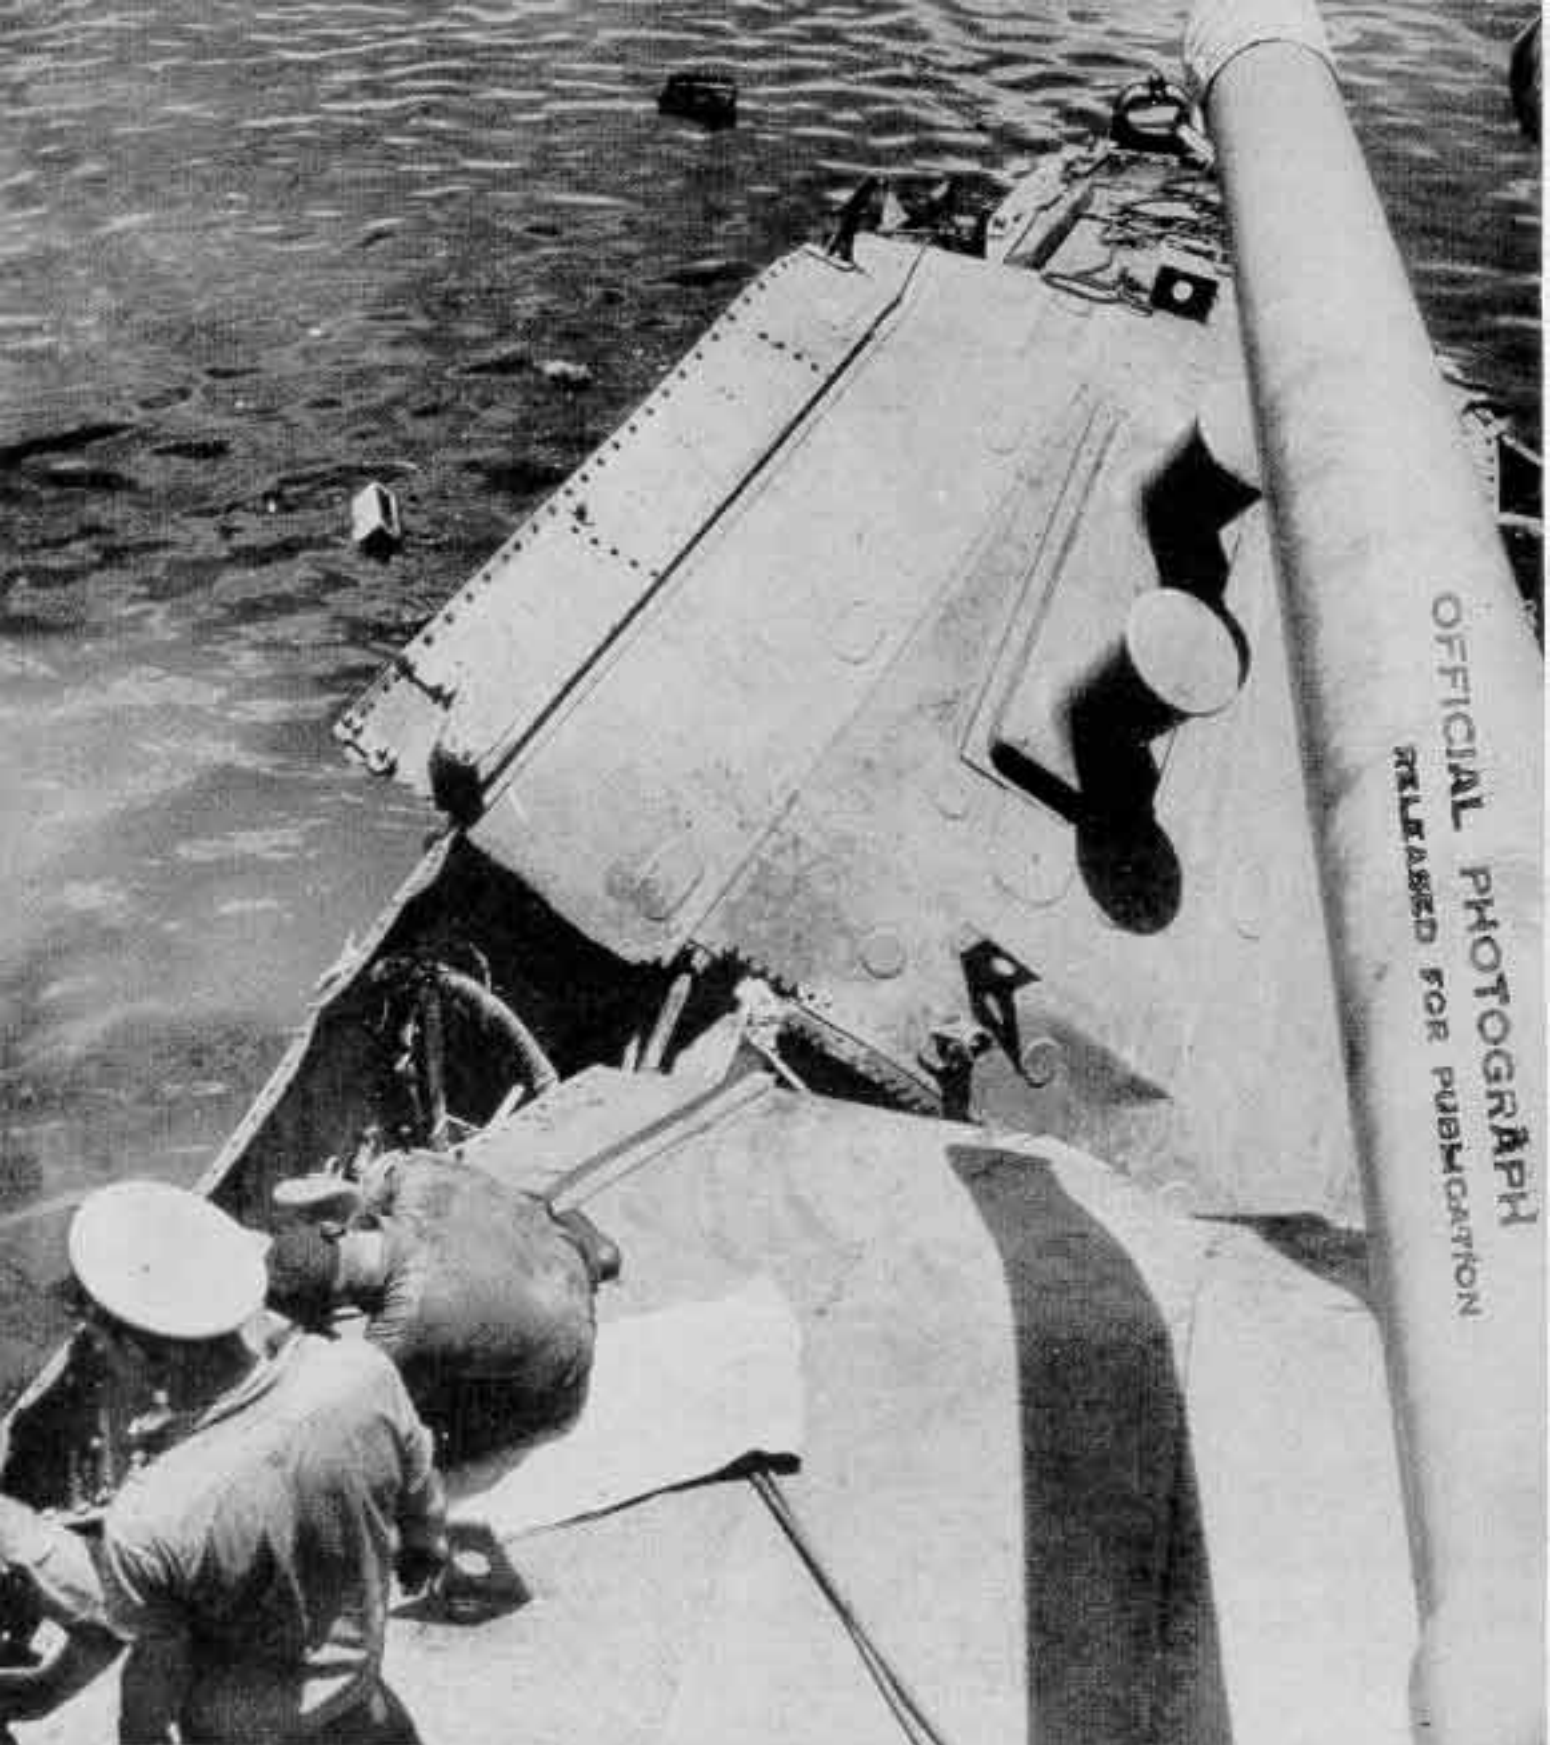
Photo 3: Starboard side of fantail looking aft.

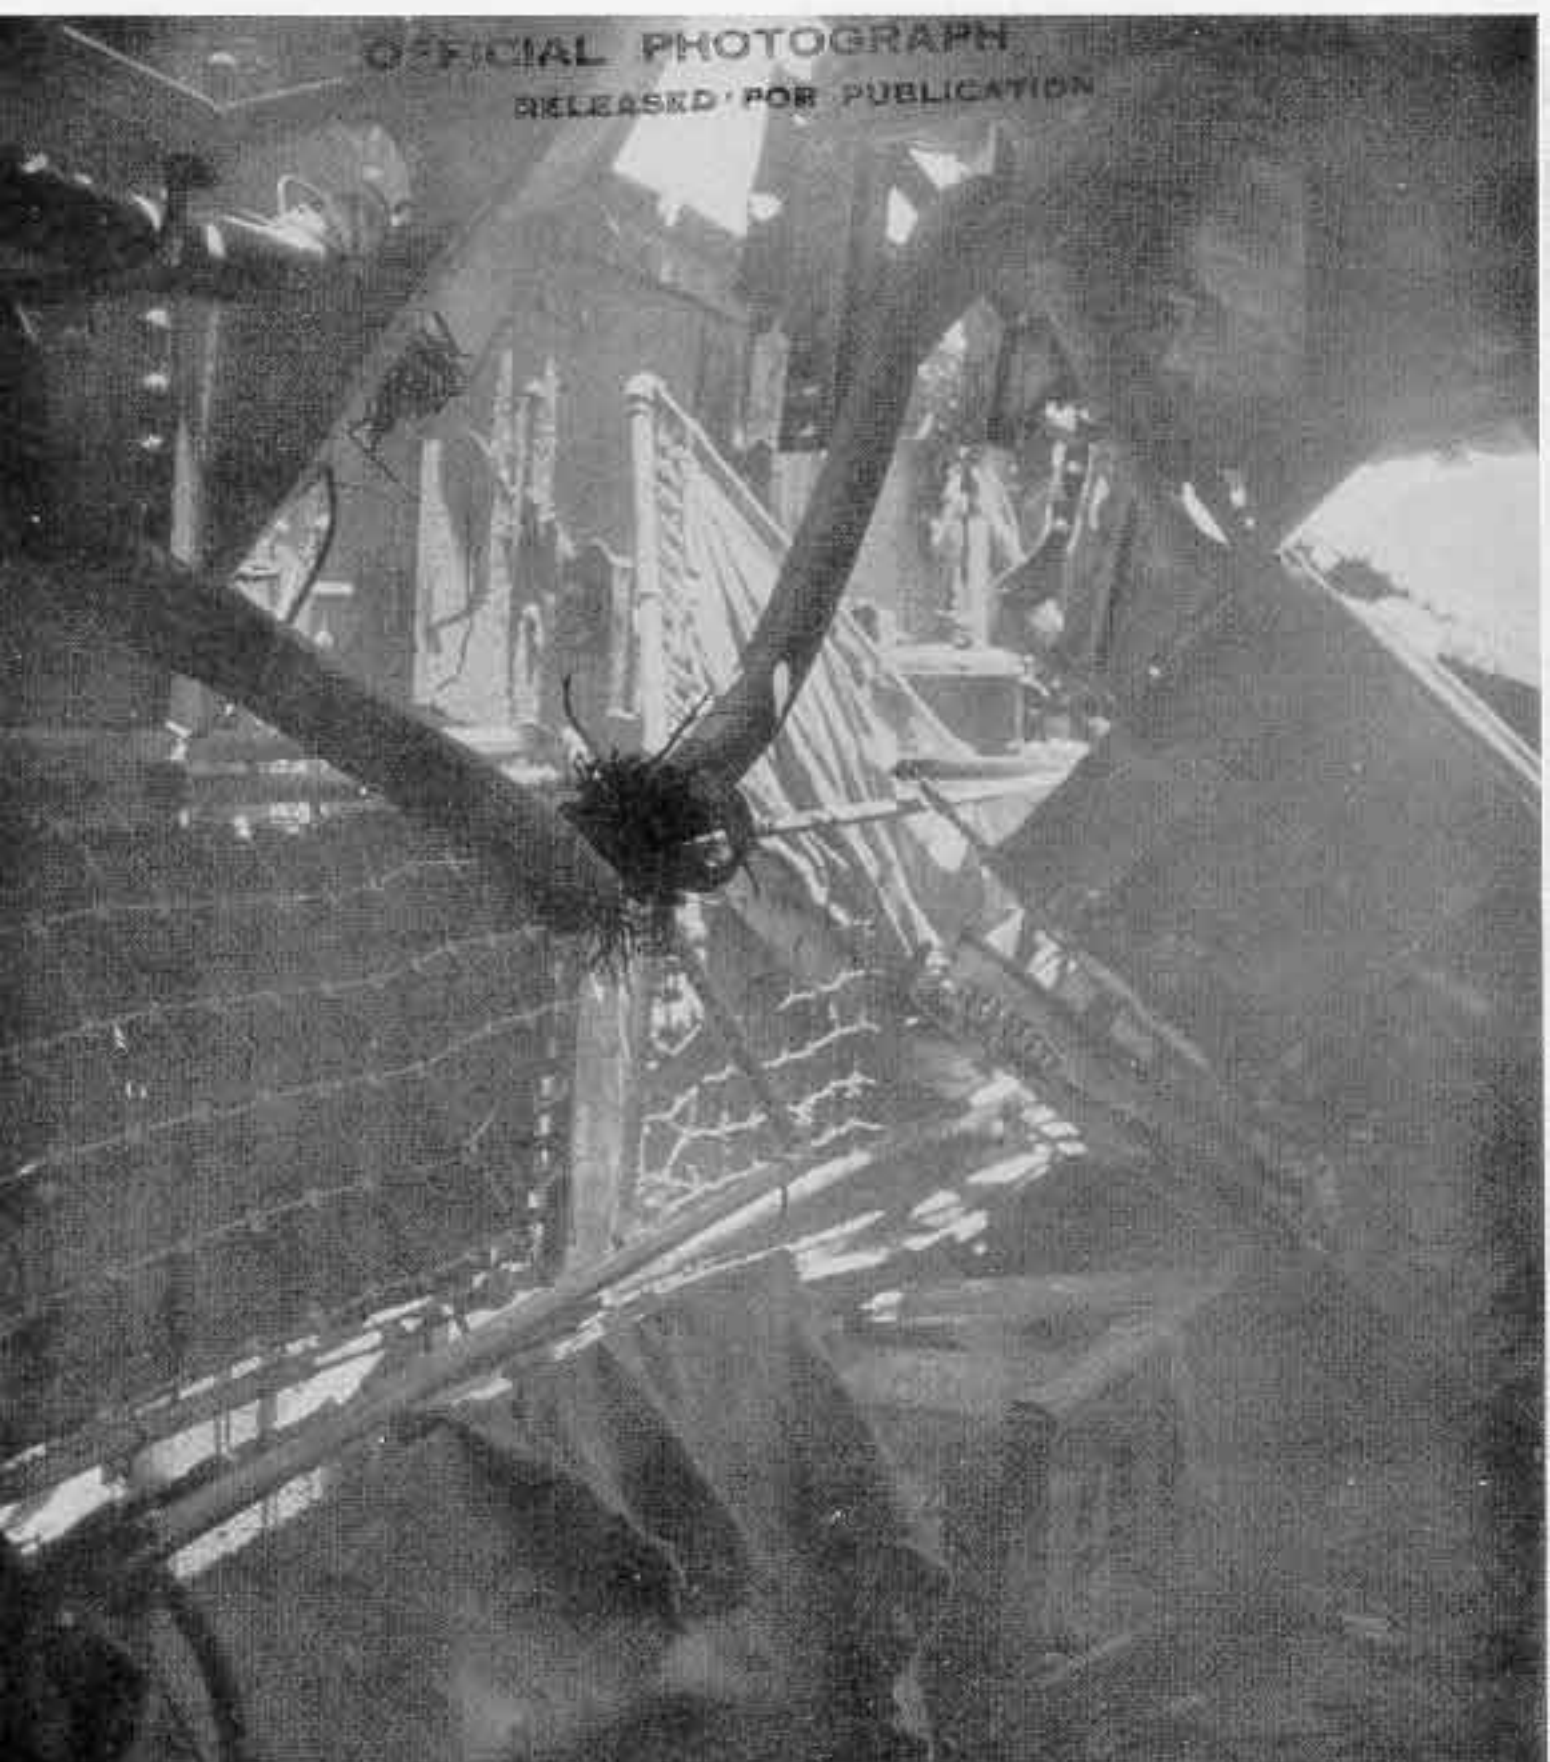
Photo 4: C.P.O. quarters D-304 port side.

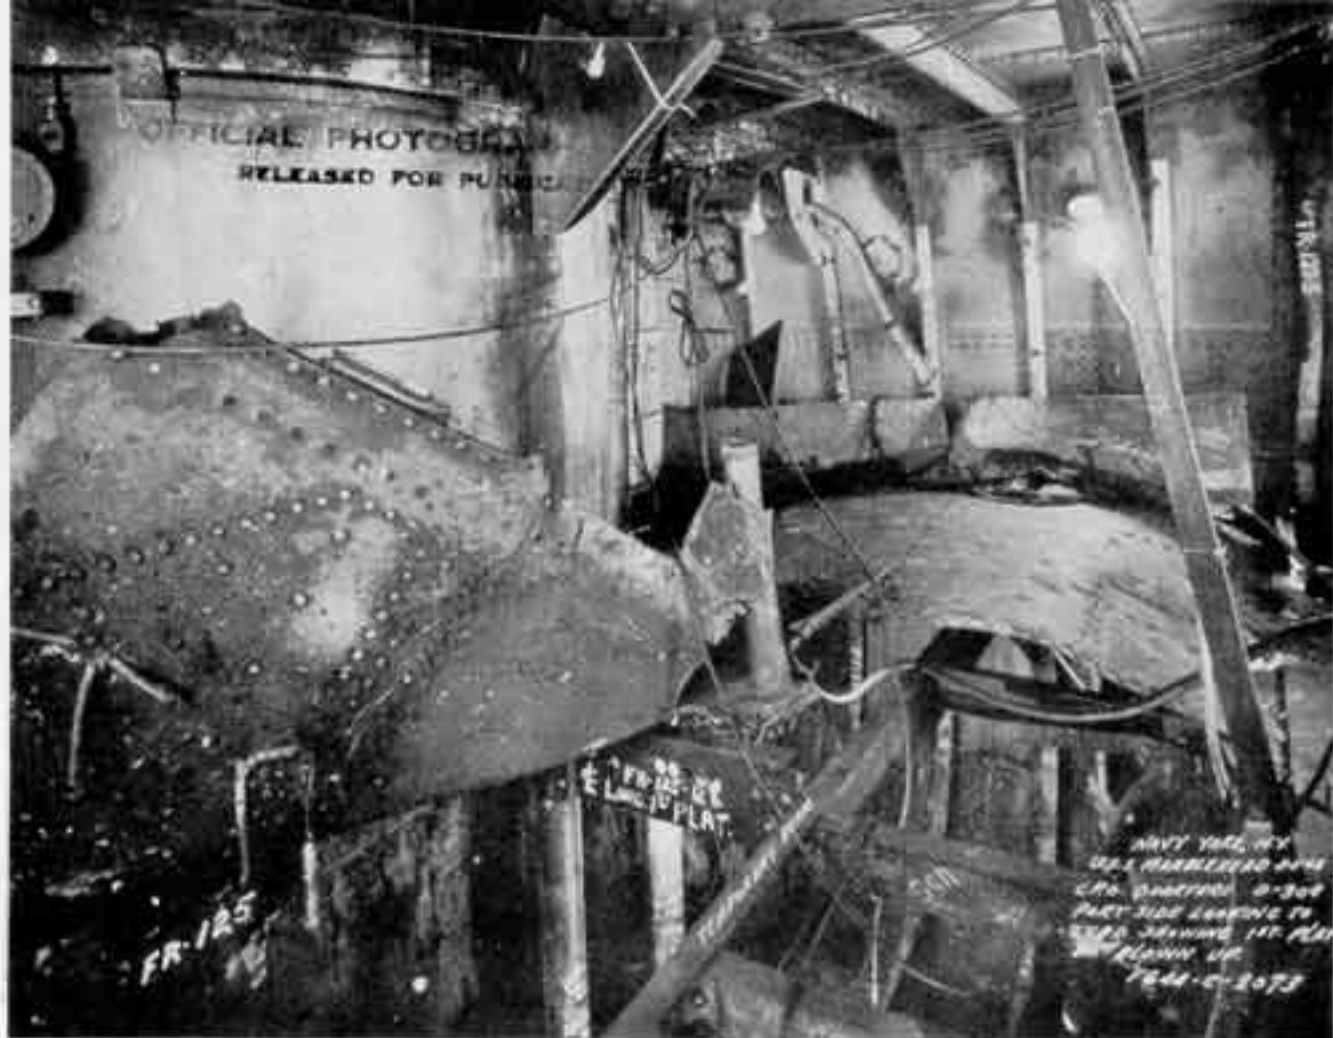
Photo 5: C.P.O. quarters D-304 port side looking to starboard showing first platform deck blown up.

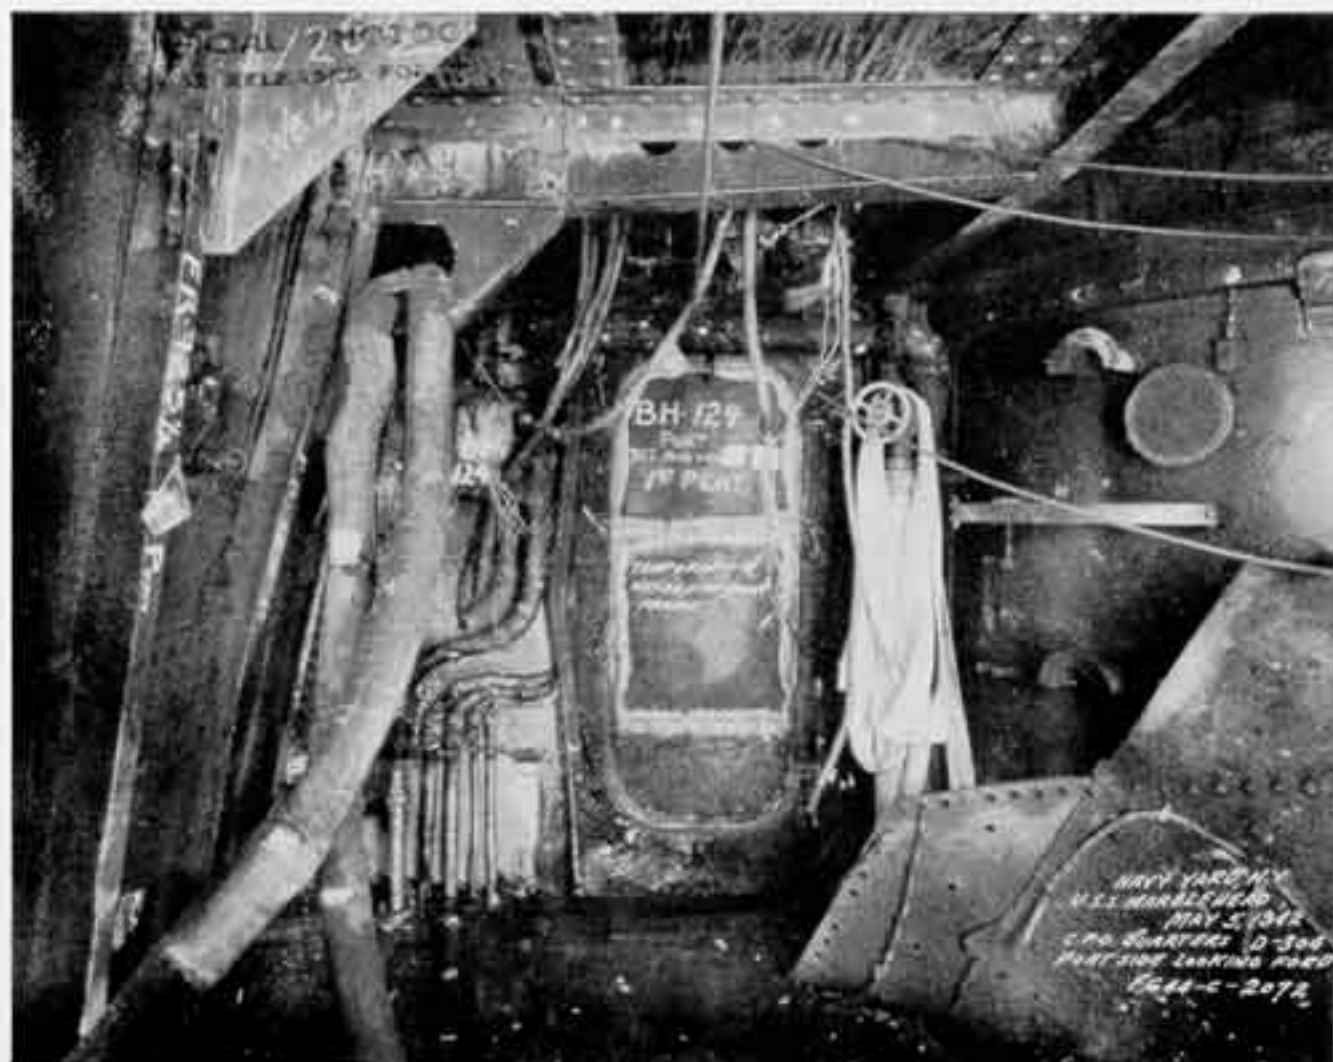
Photo 6: C.P.O. quarters D-304 port side looking forward.

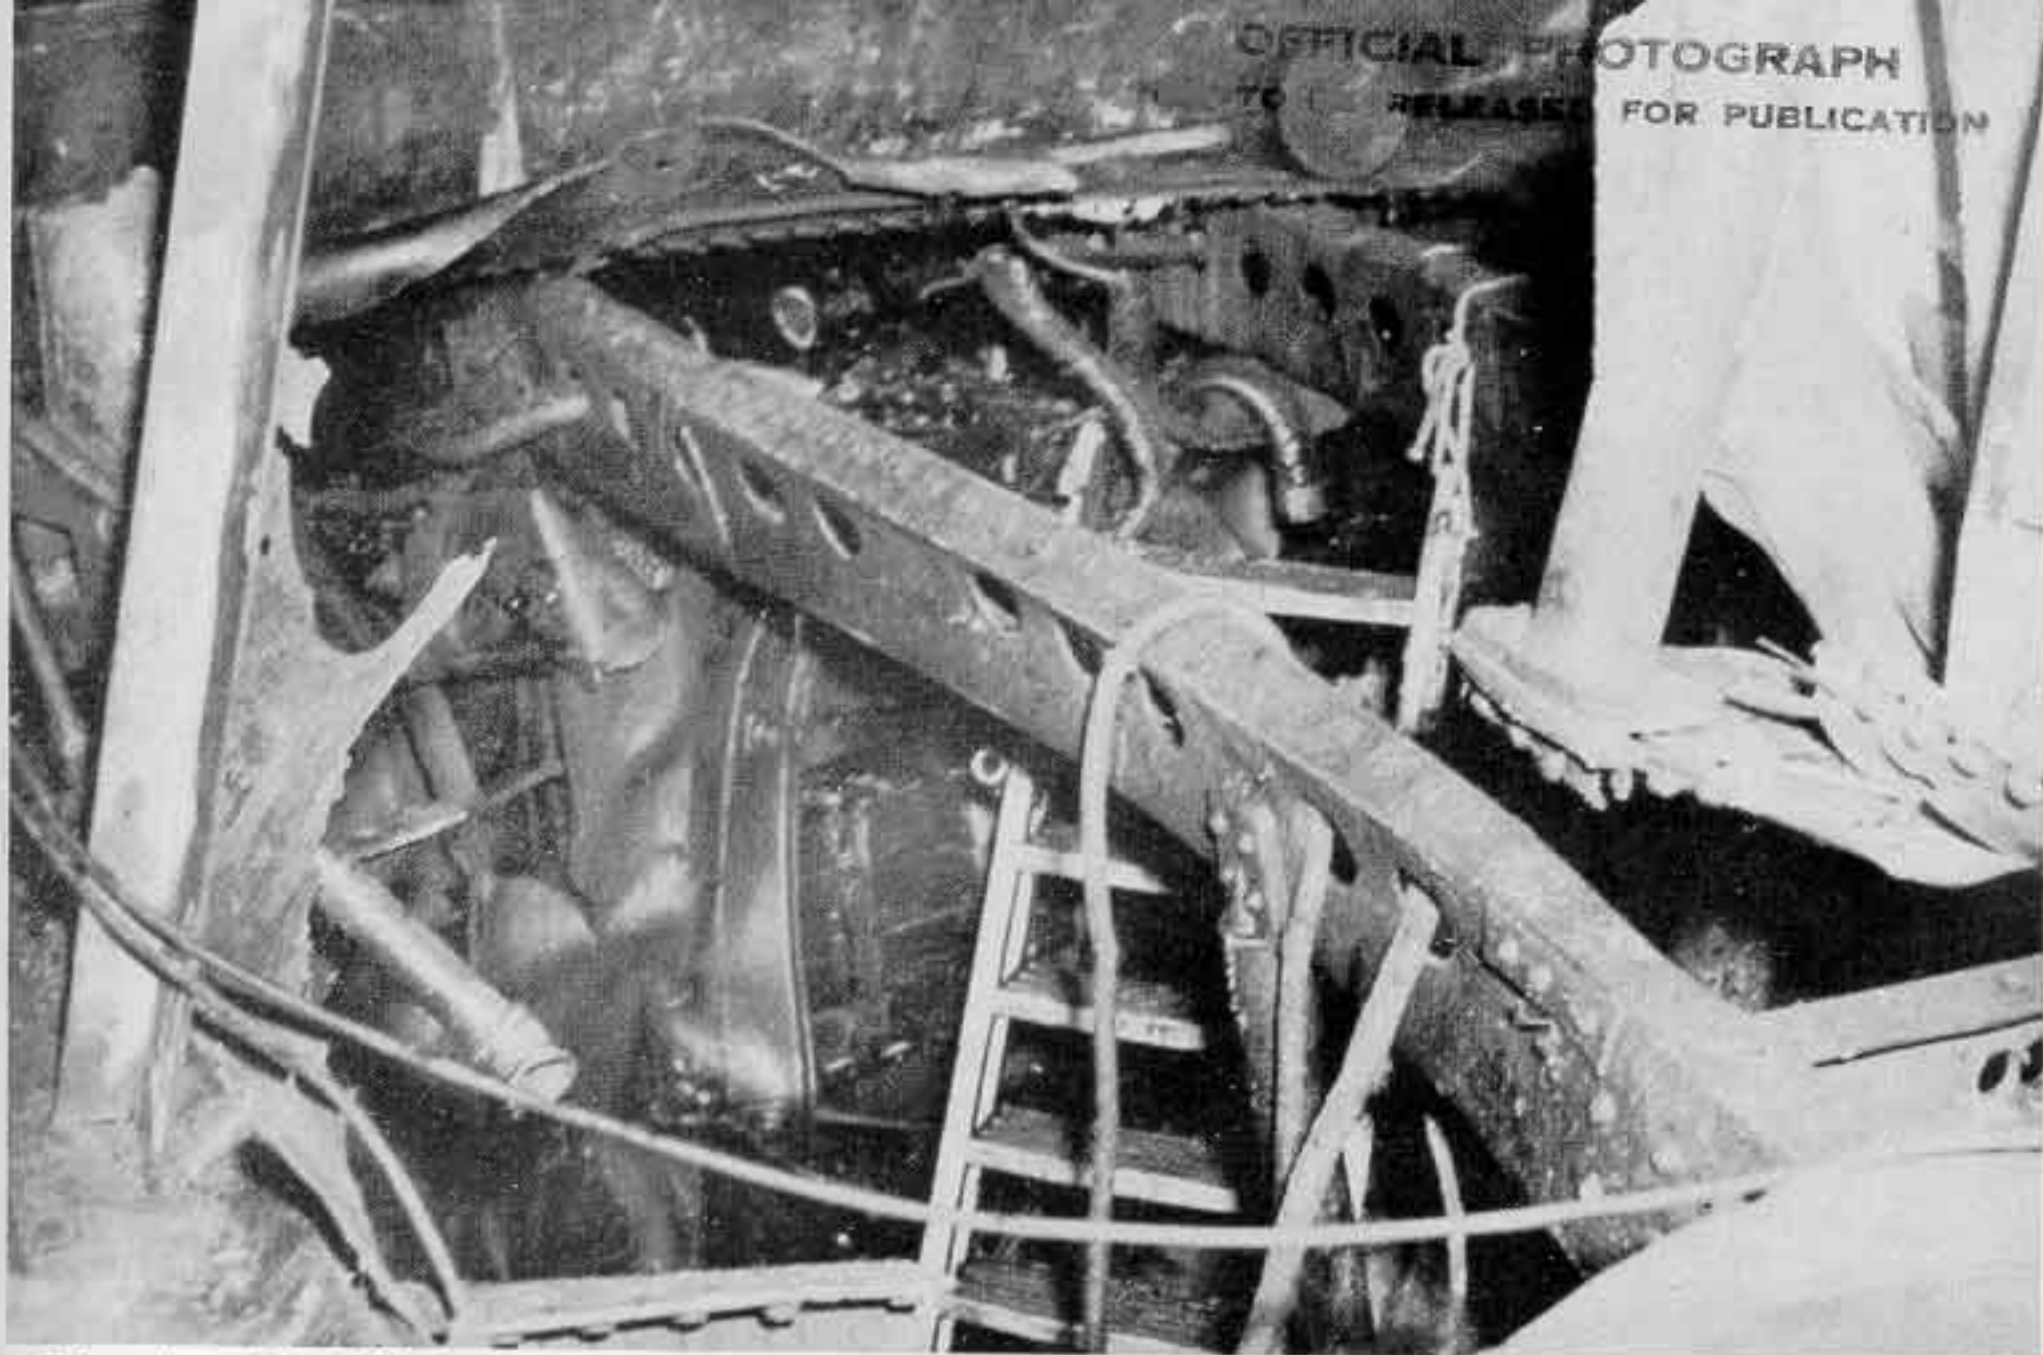
Photo 7: Hole in first platform deck frames 125 to 127 portside.

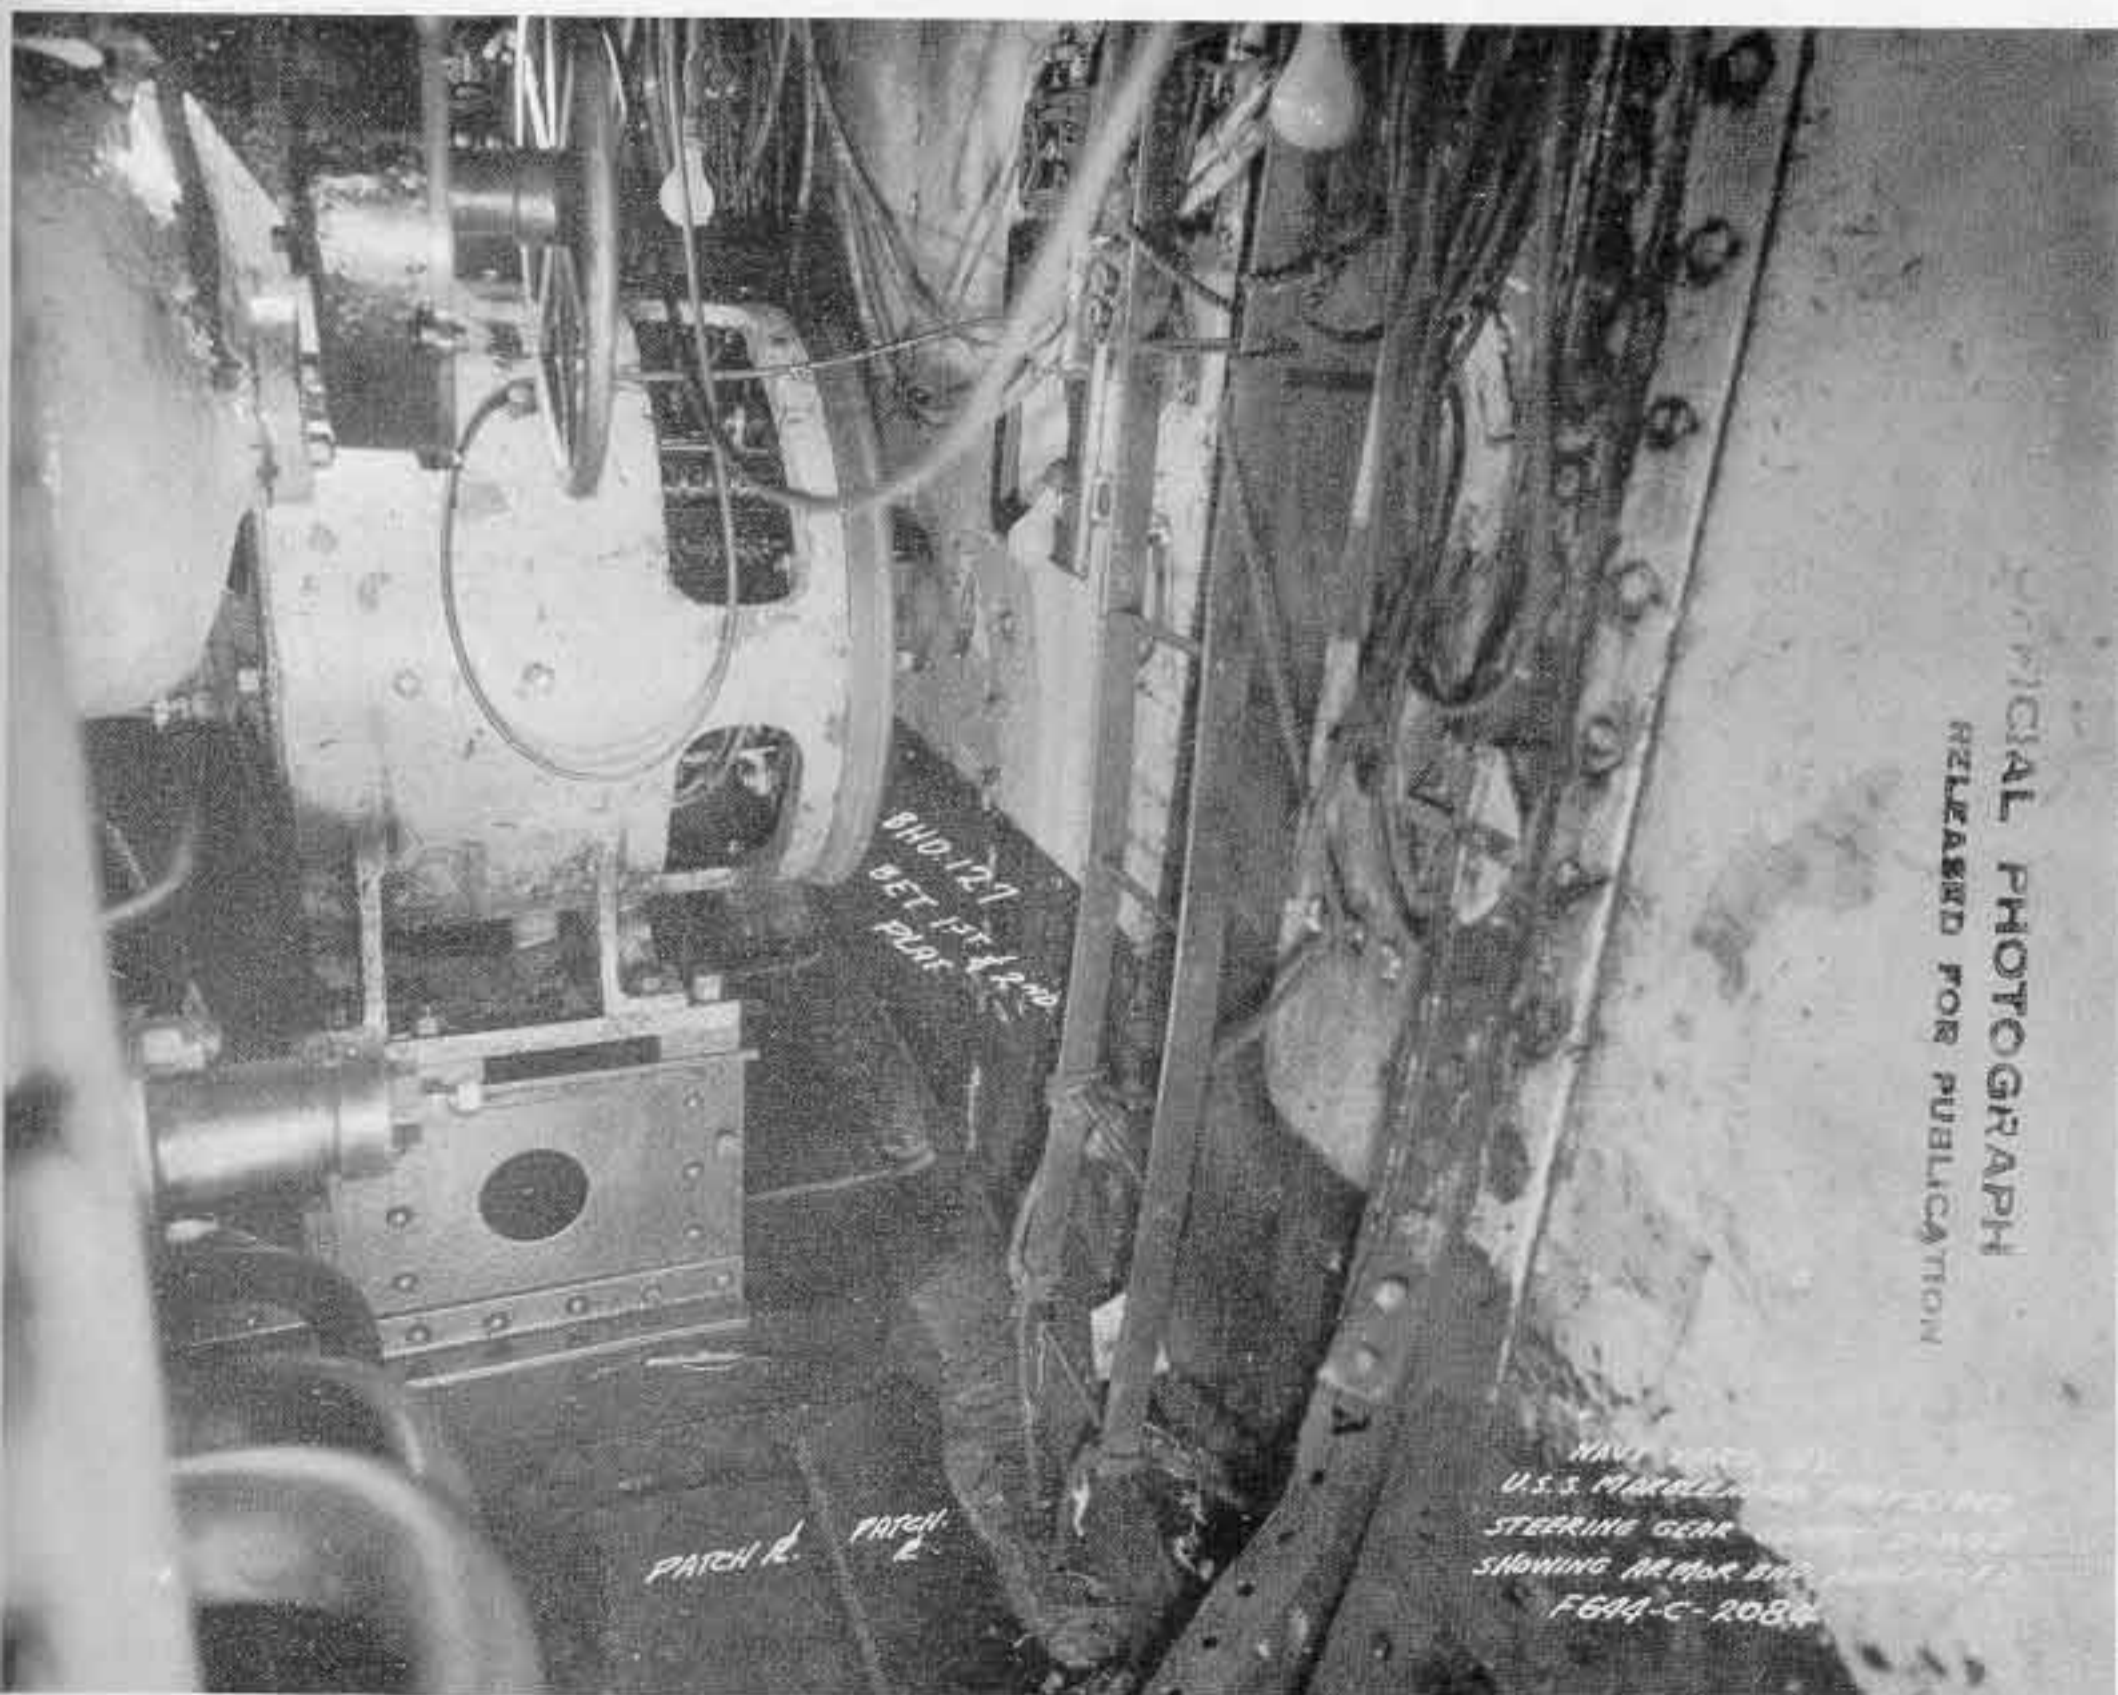
Photo 8: Steering gear compartment D-205 showing temporary repairs to armored bulkhead 127.

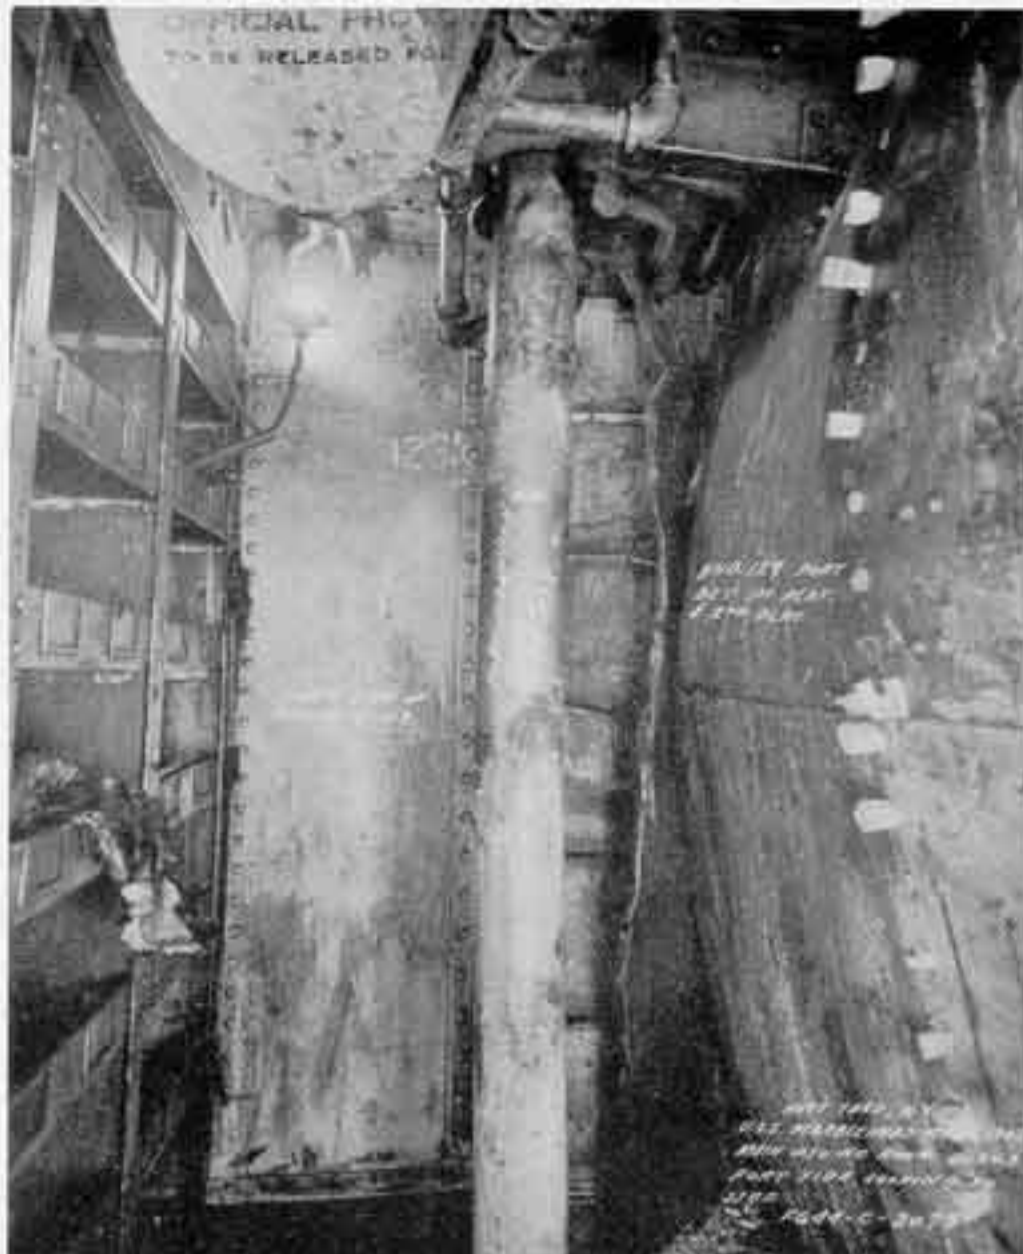
Photo 9: Compartment D-203, port side, looking to starboard.

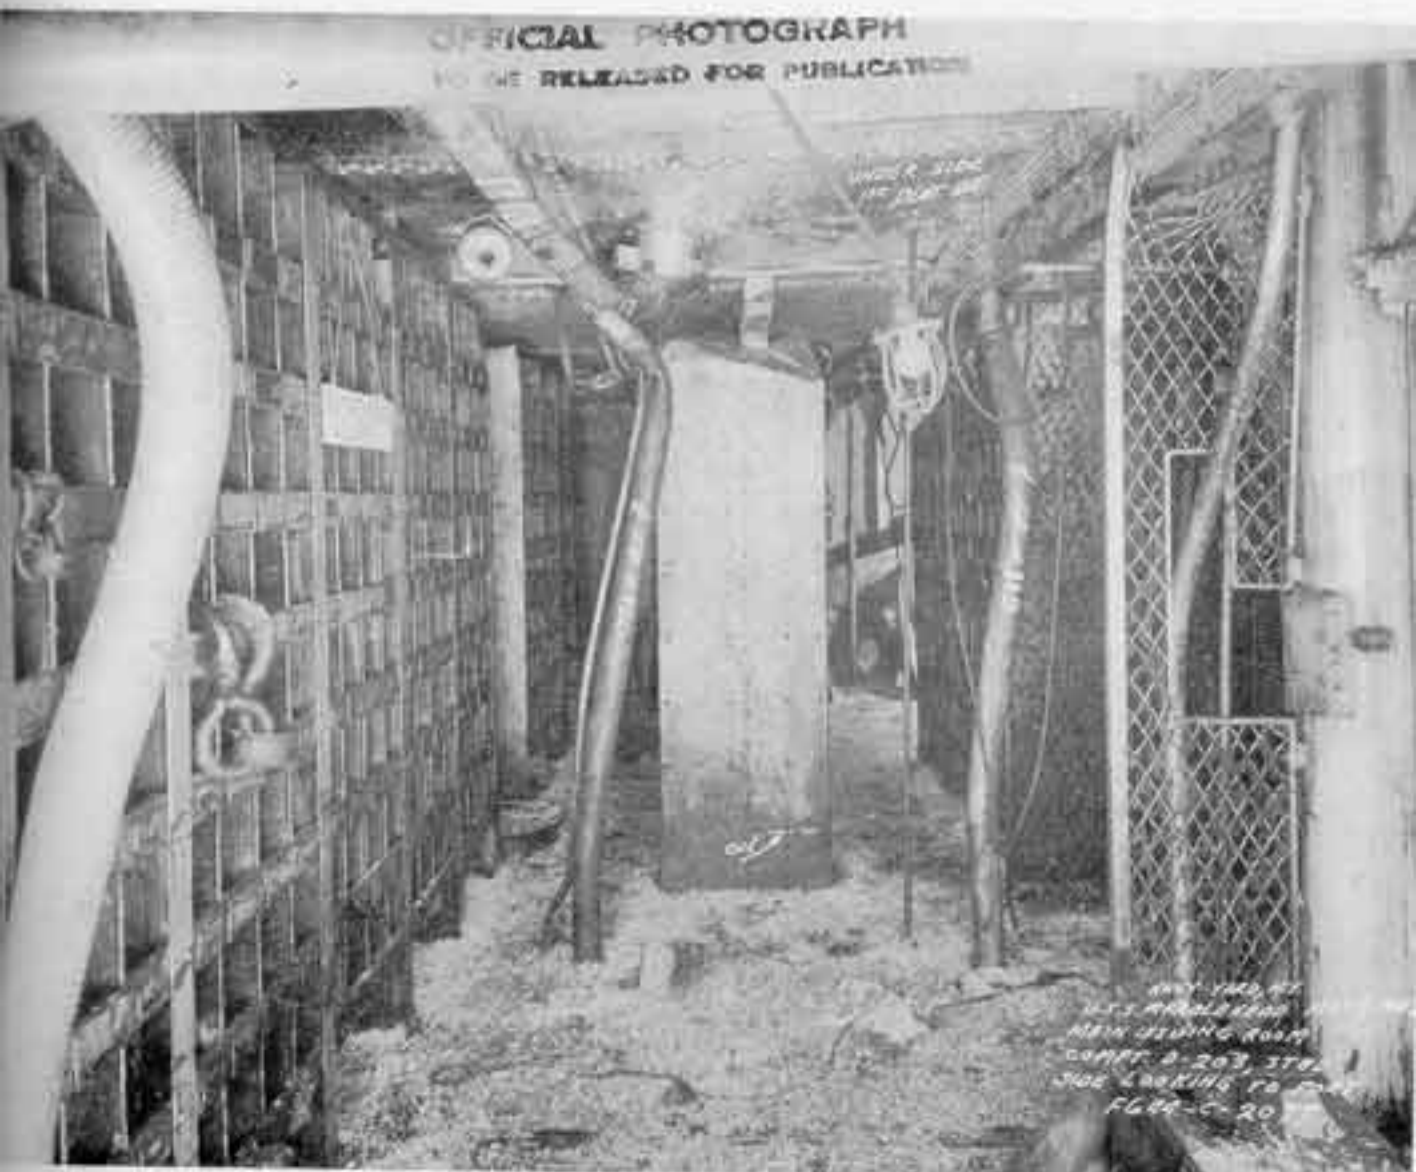
Photo 10: Compartment D-203, starboard, looking to port.

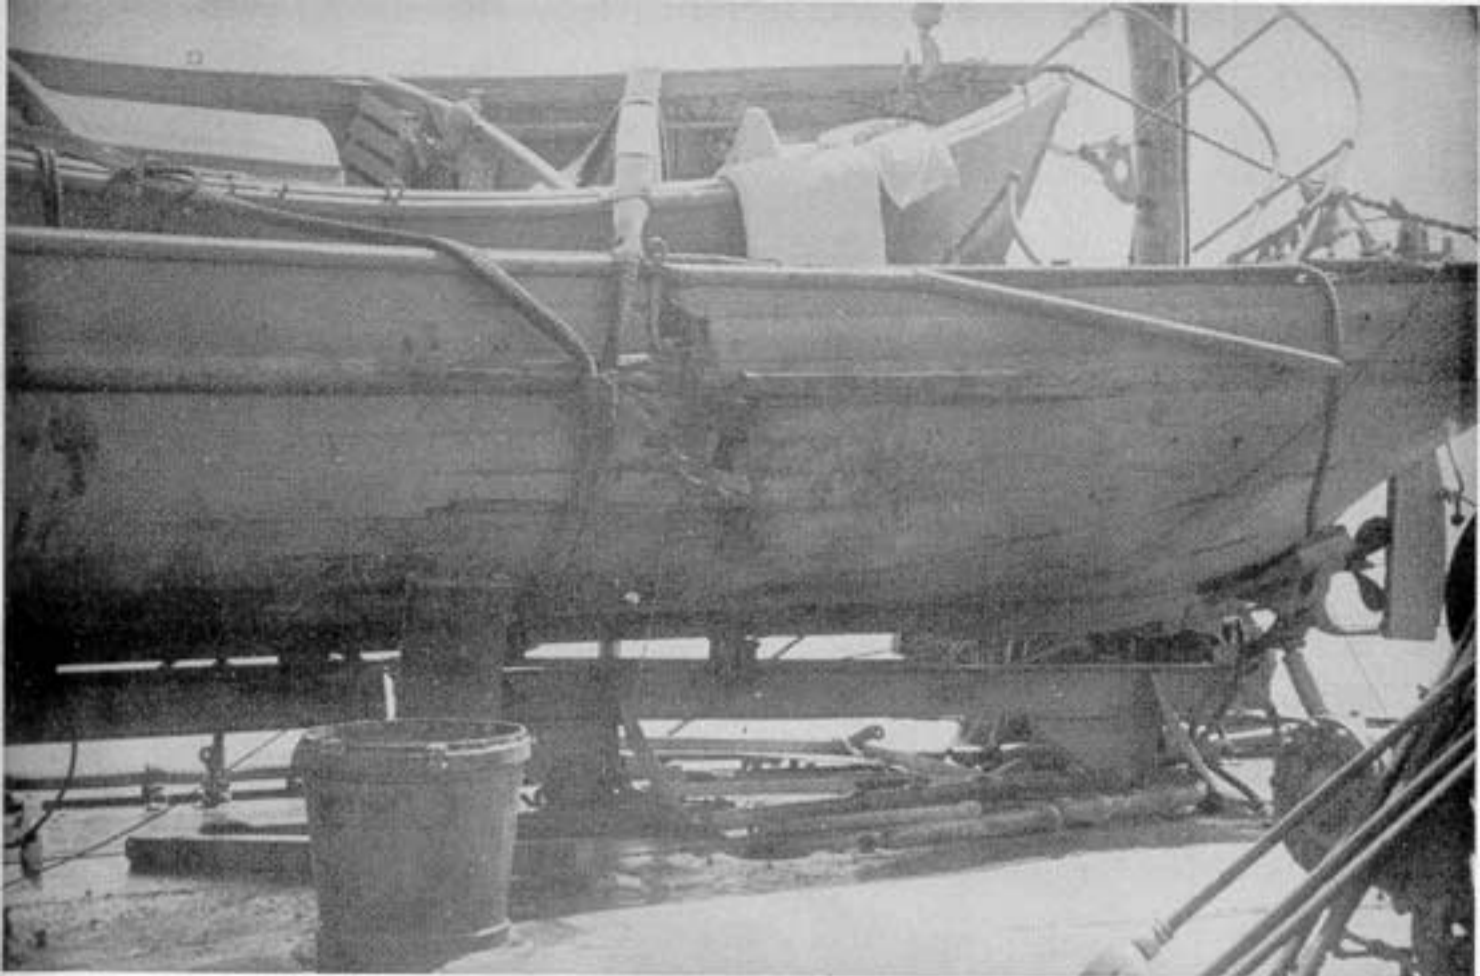
Photo 11: Motor launch amidships showing path of bomb.
