U. S. S. MARBLEHEAD (CL12)

BOMB DAMAGE

4 FEBRUARY 1942

710205-1048
 WAR DAMAGE REPORT No. 34

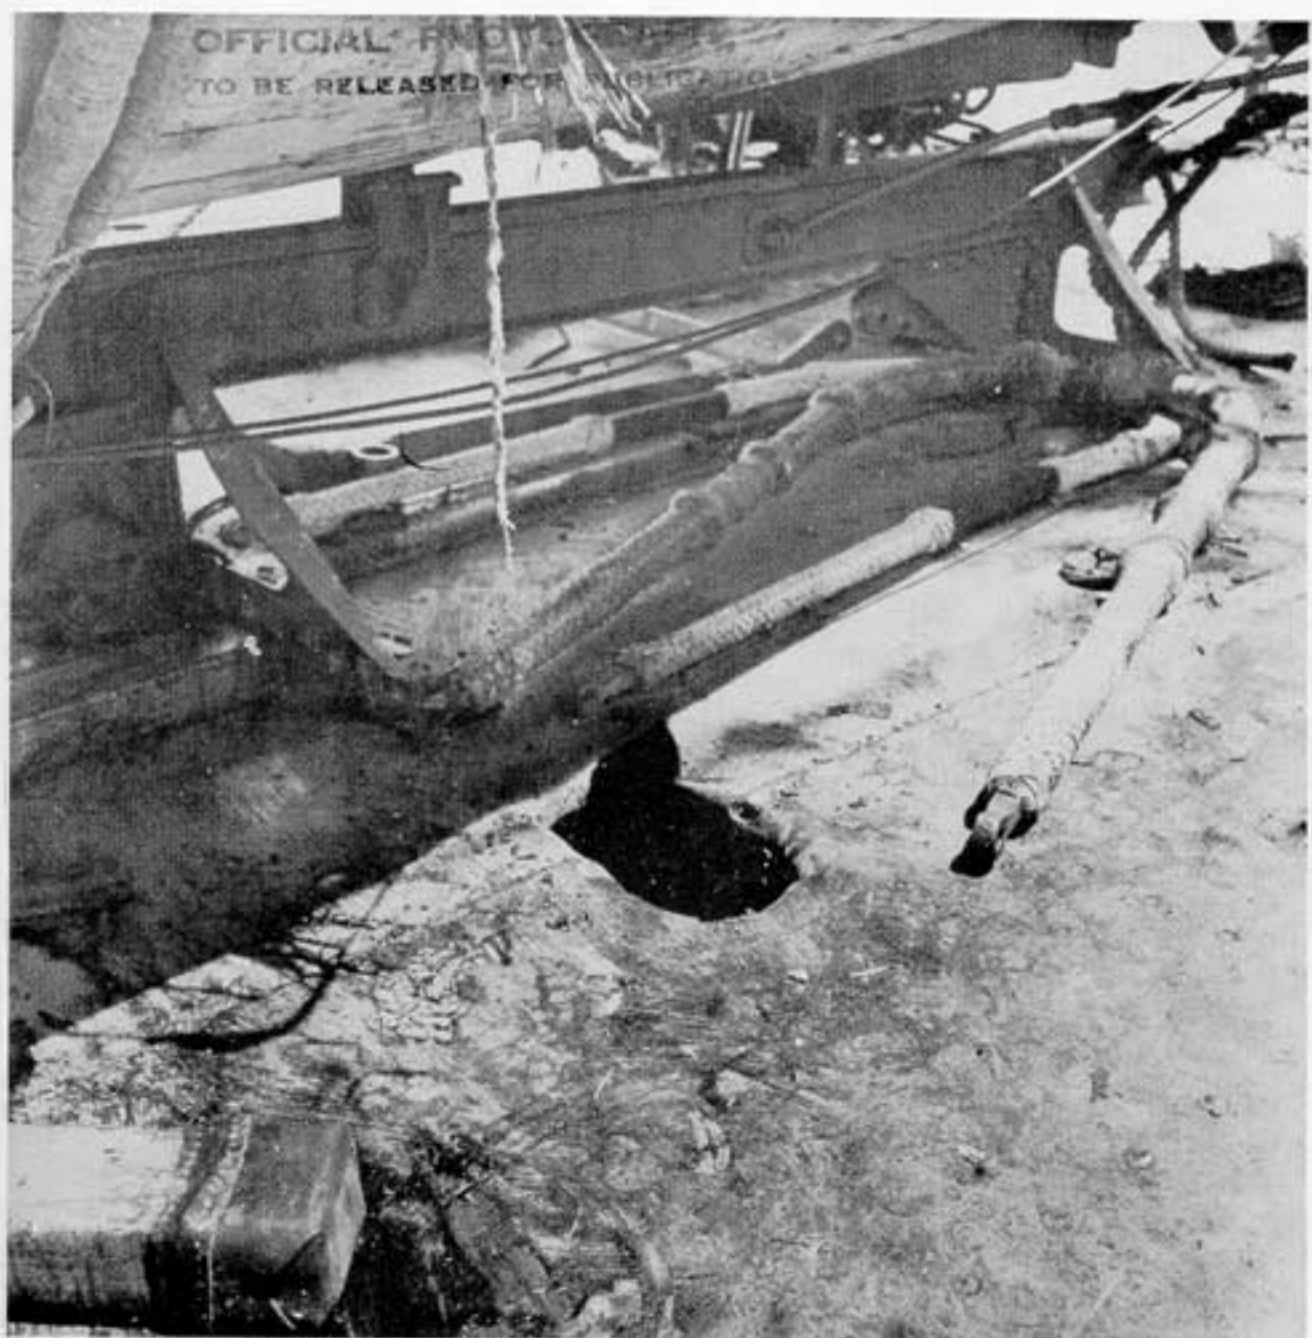
Photo 12: Bomb hole upper deck under motor launch.

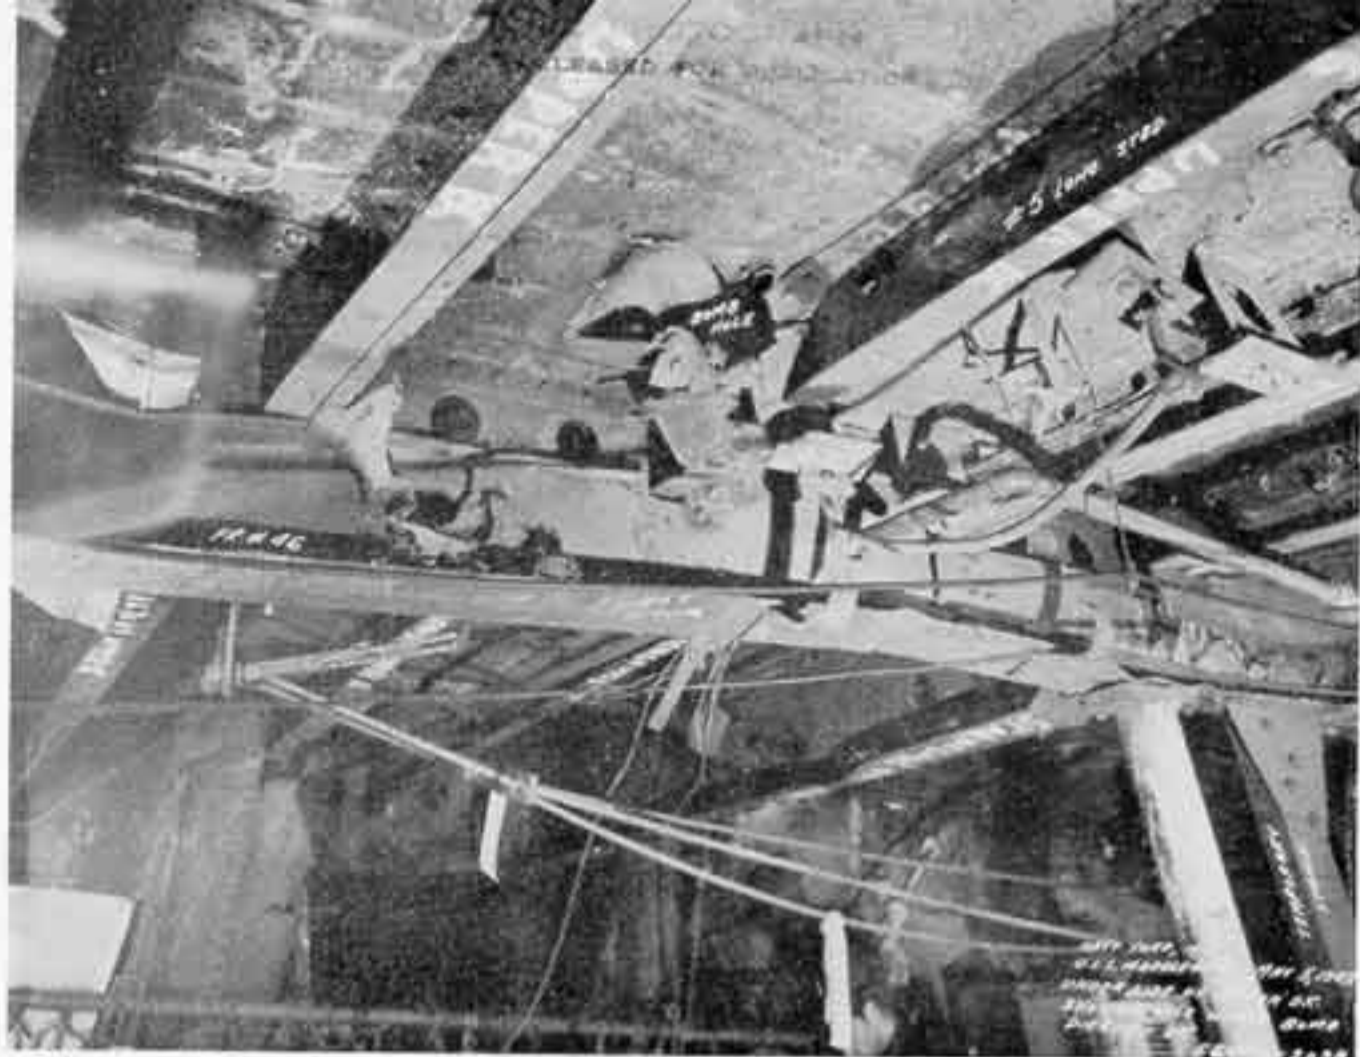
Photo 13: Under side of upper deck showing hole where bomb pierced deck.

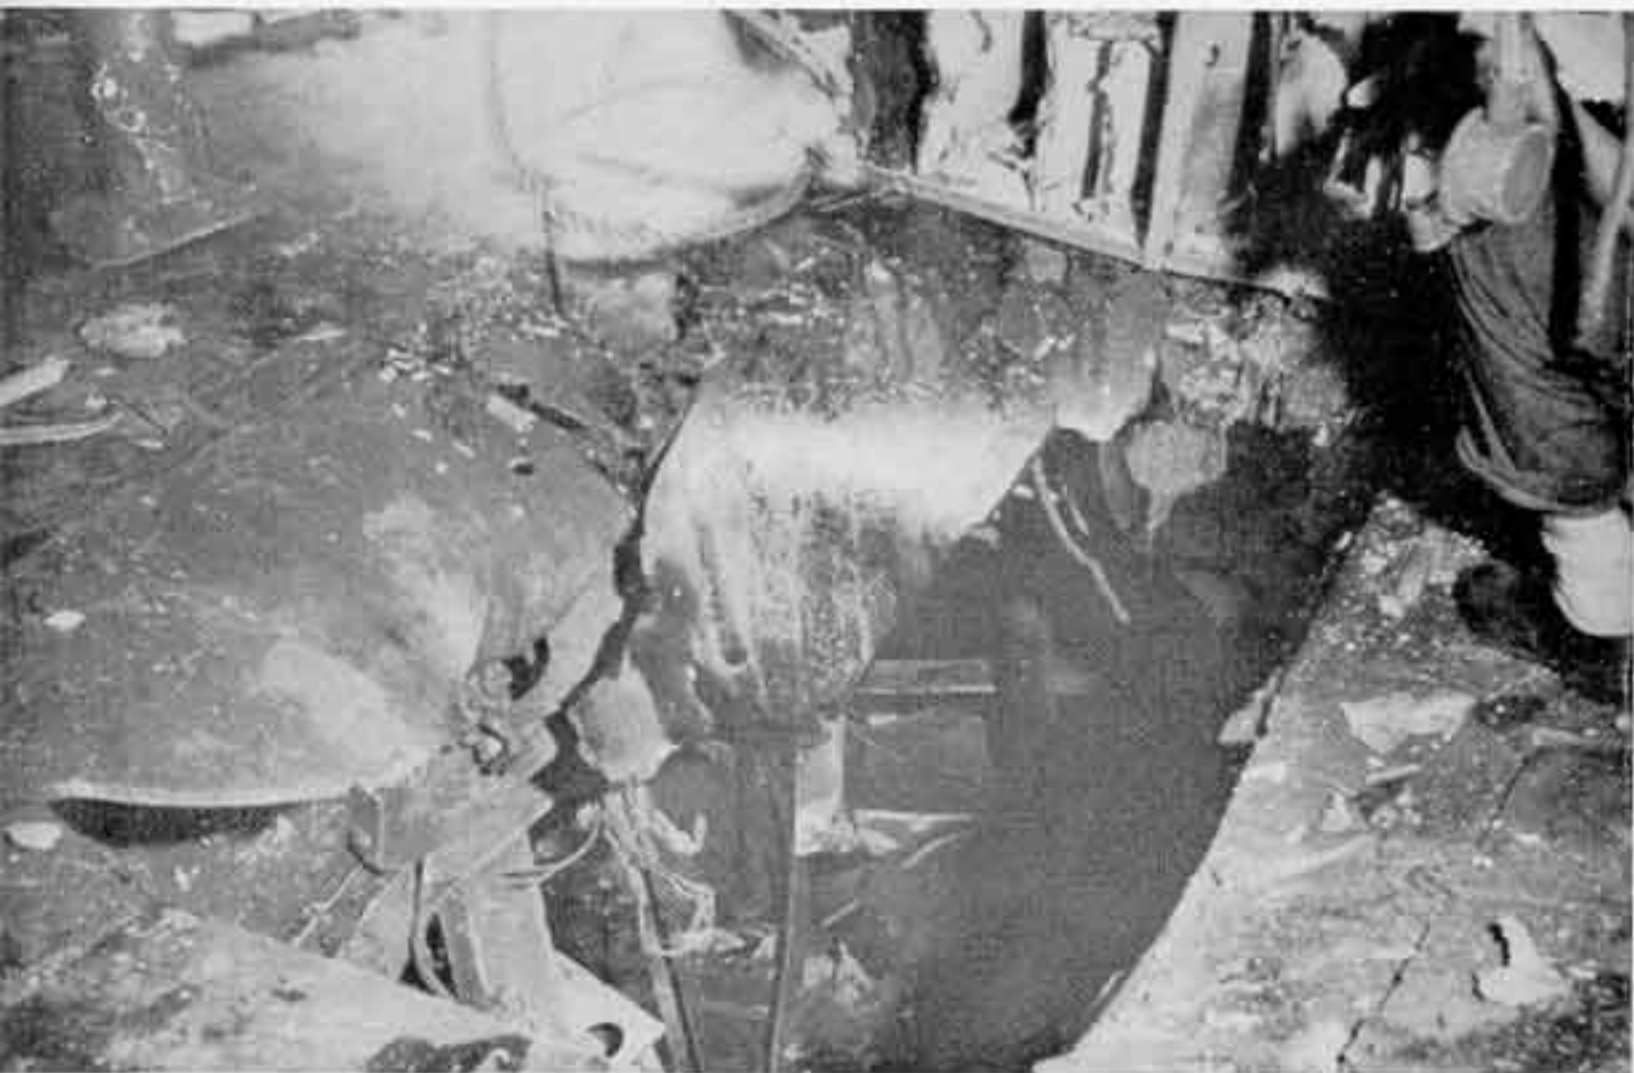
Photo 14: Hole made by bomb in main deck, frame 47.

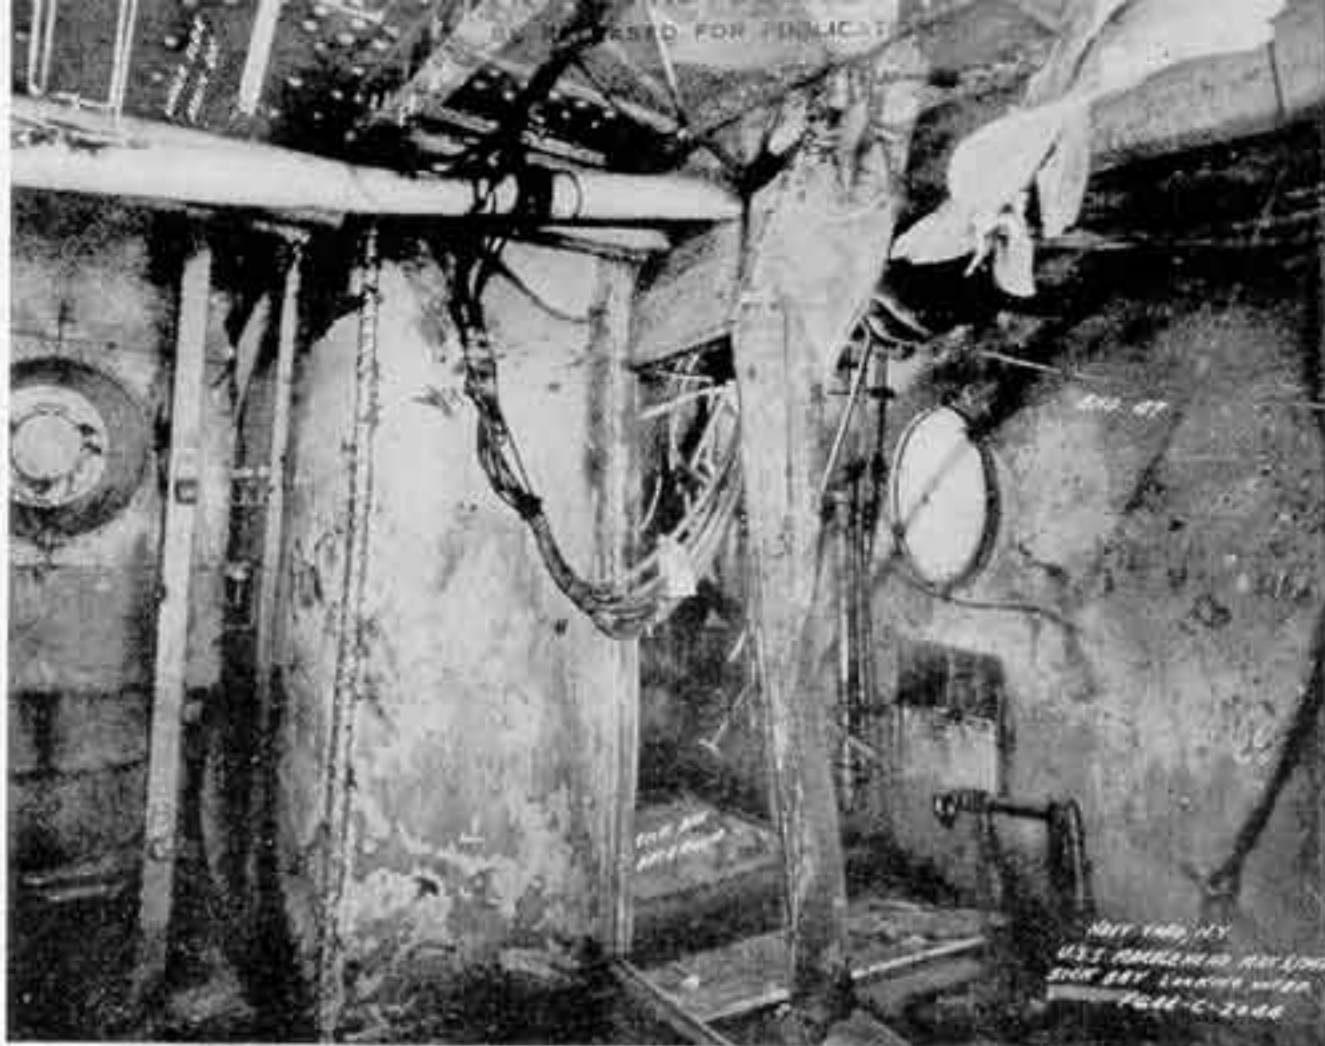
Photo 15: Sick bay first platform deck looking outboard.

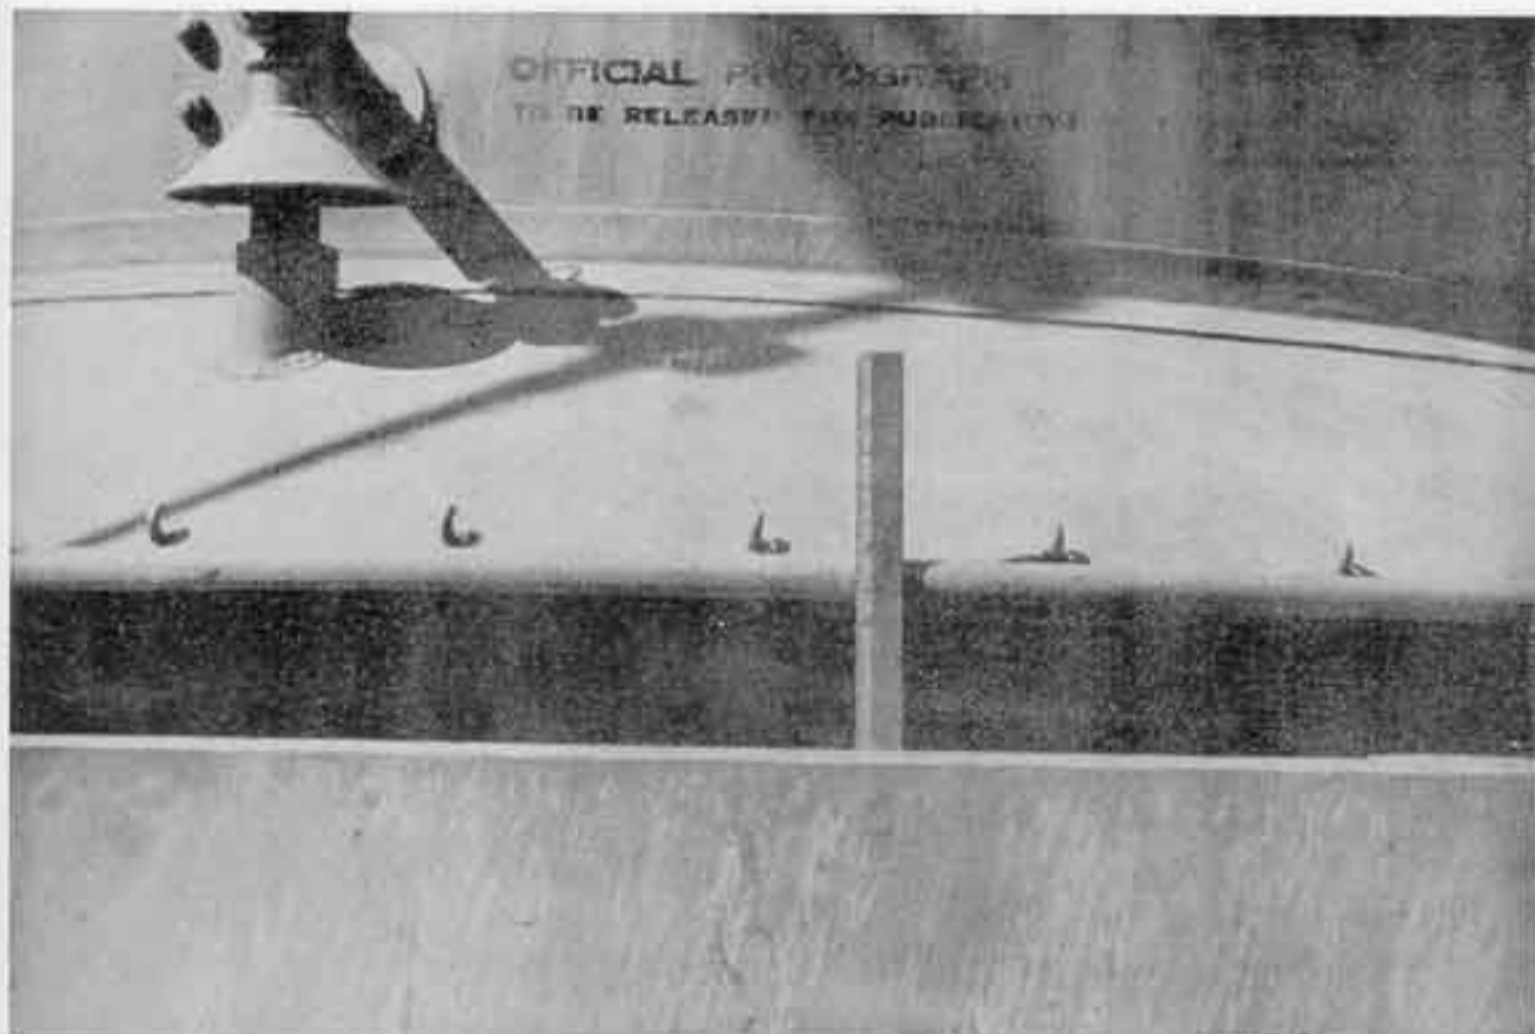
Photo 16: Flare of shield of No. 1 stack, showing deflection. Normal space between shield and deck is 12 inches.

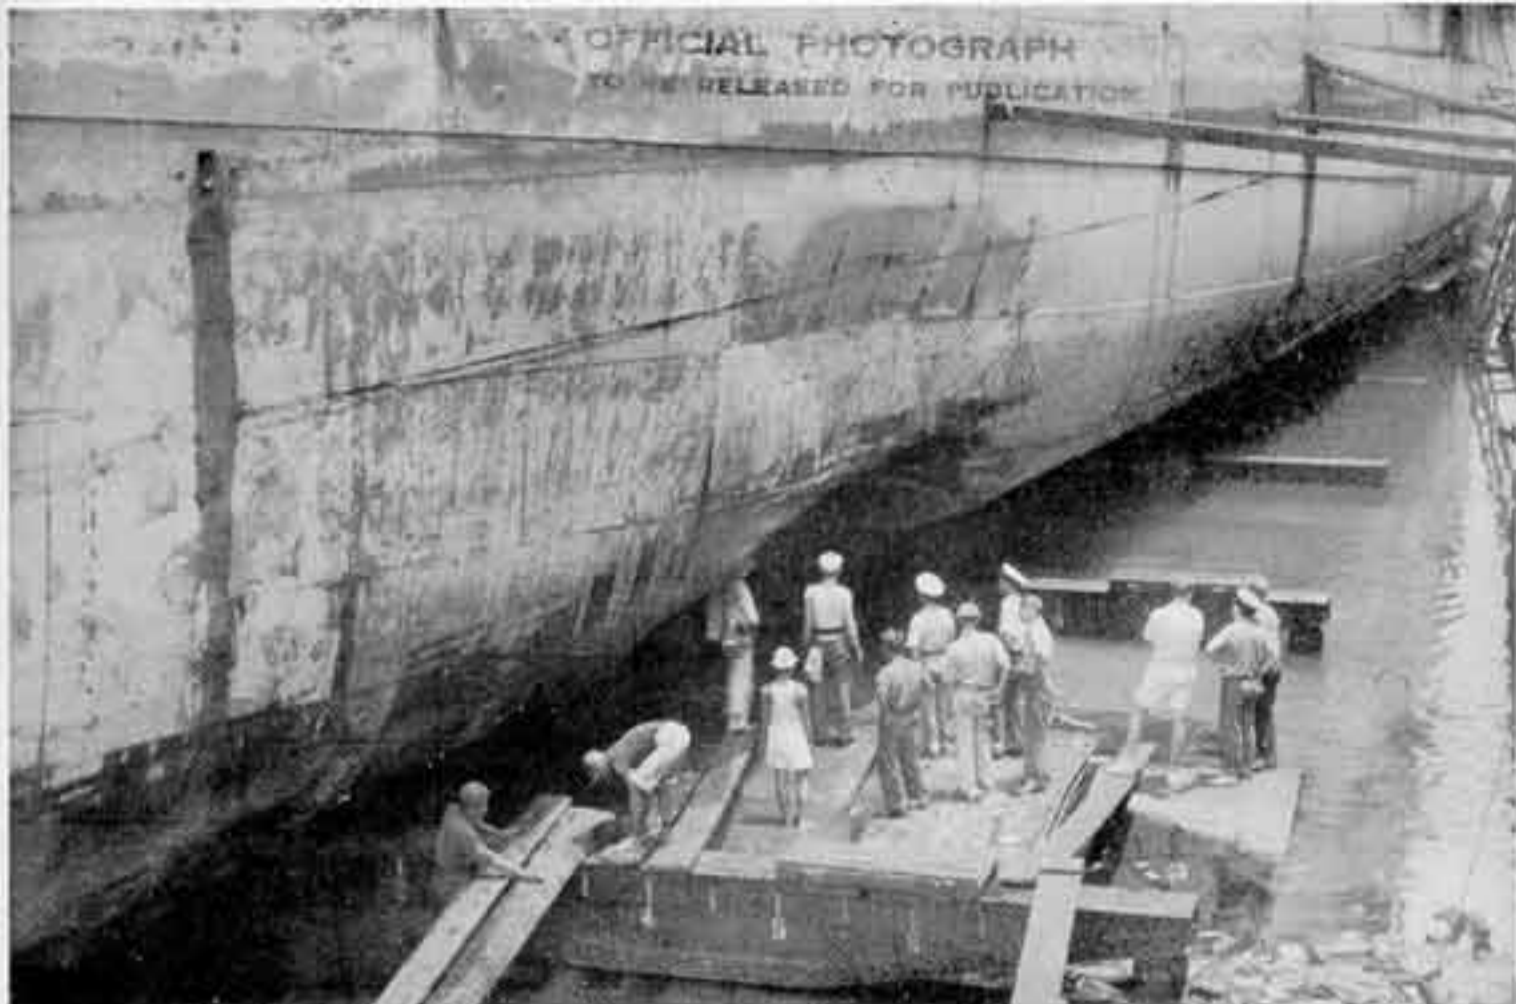
Photo 17: Near miss showing bulge port side.

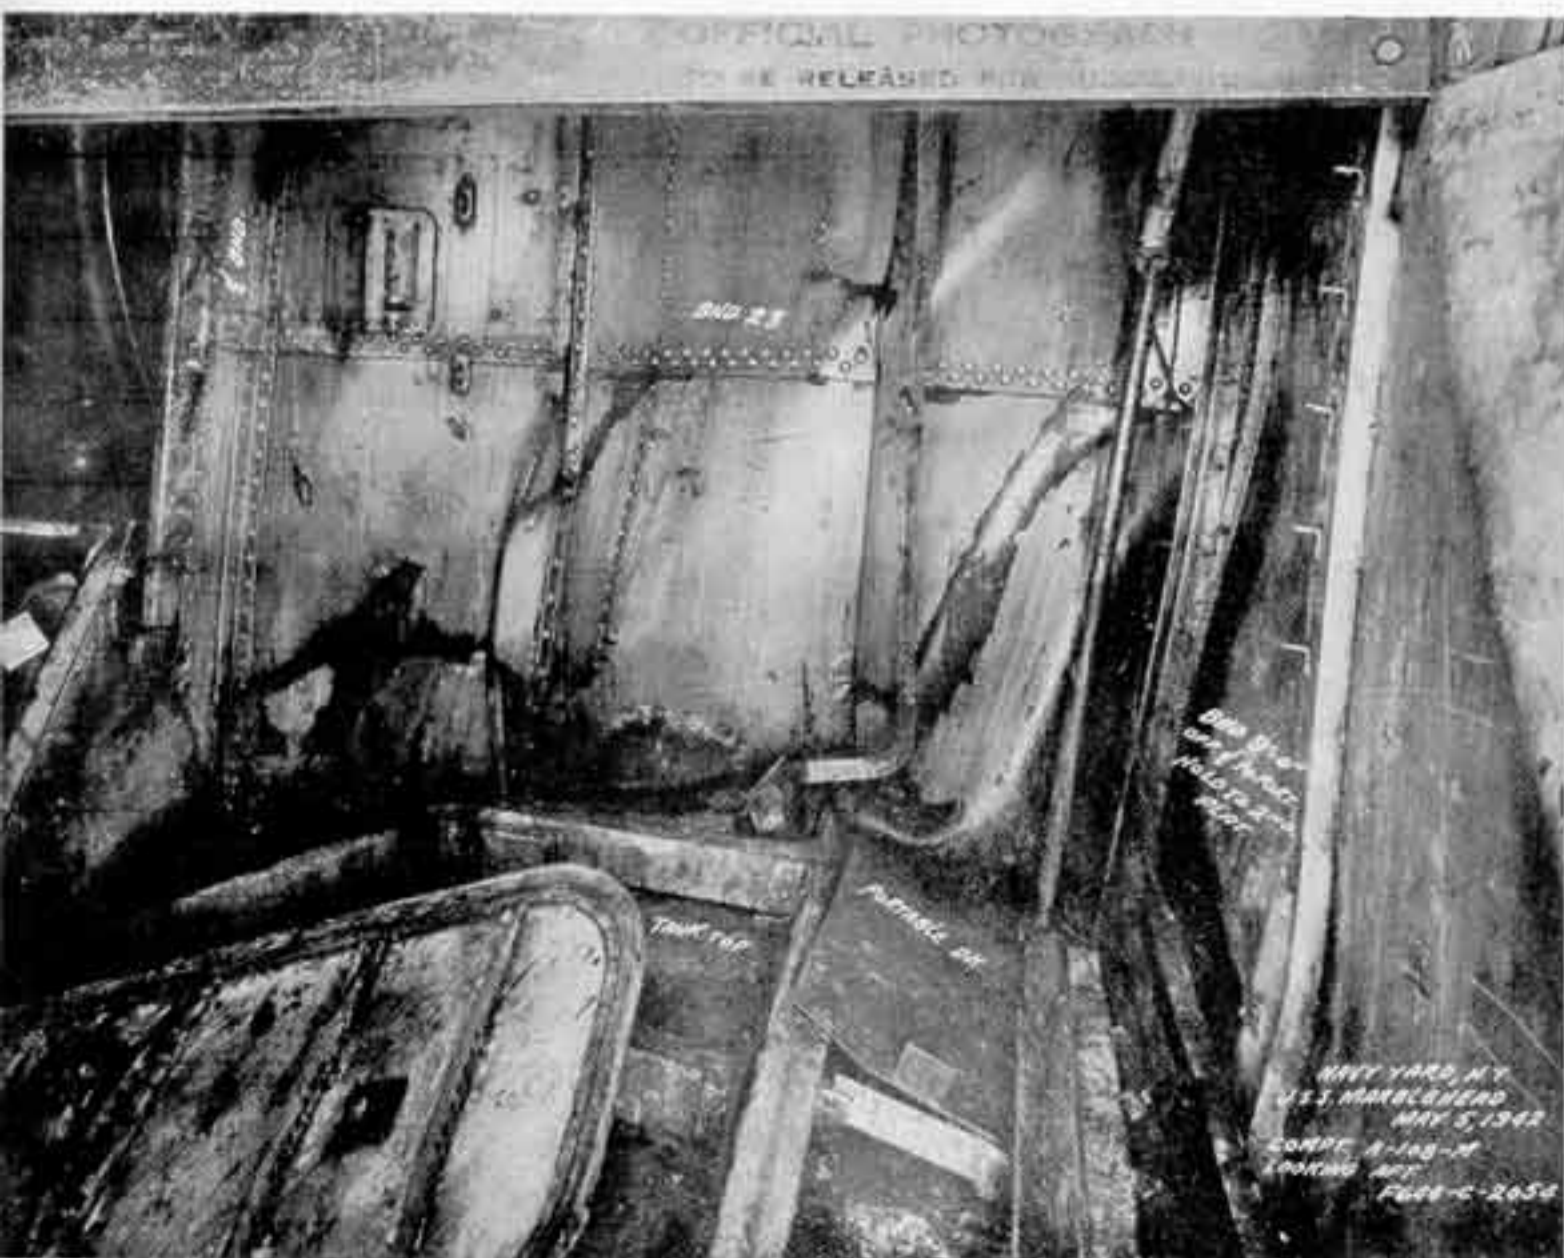
Photo 18: Six-inch powder magazine A-108-M, looking aft.

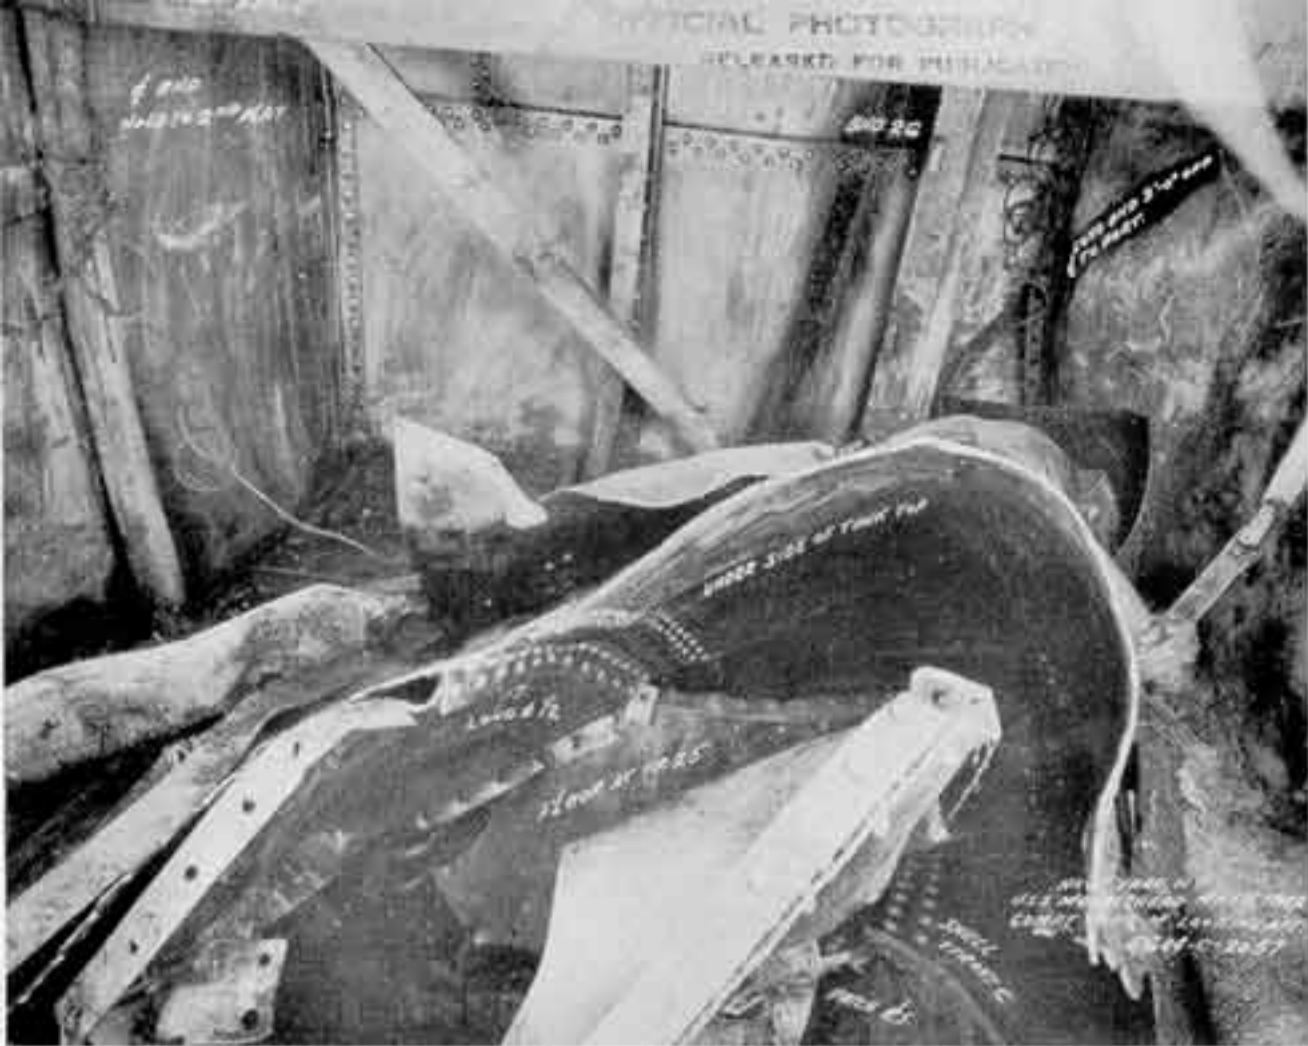
Photo 19: Magazine A-110-M looking aft.

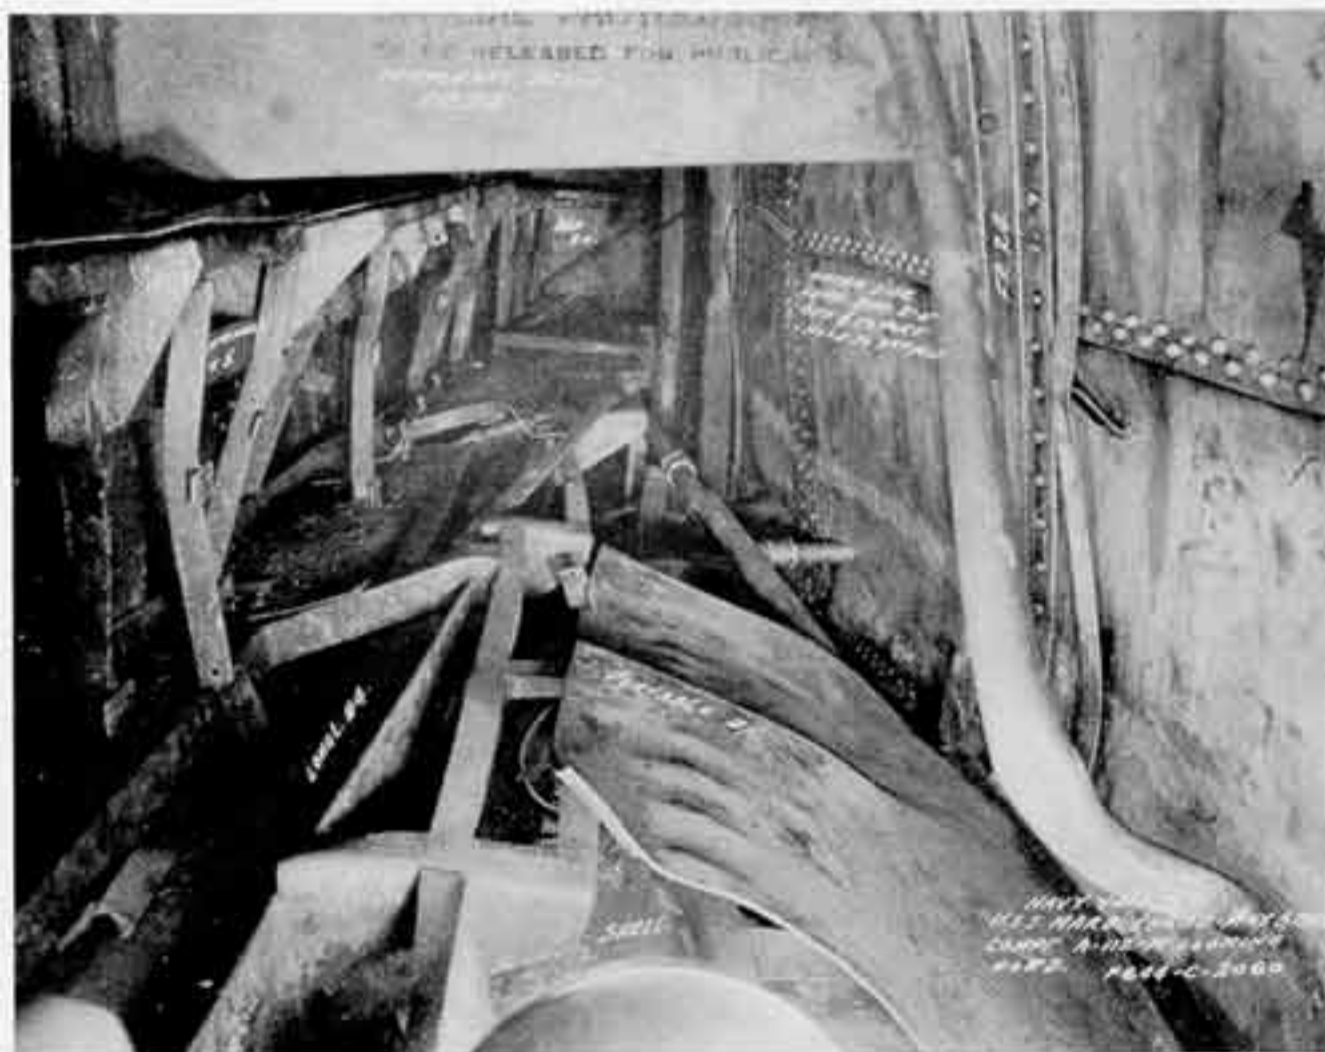
Photo 20: .50 caliber magazine A-112-M looking forward.

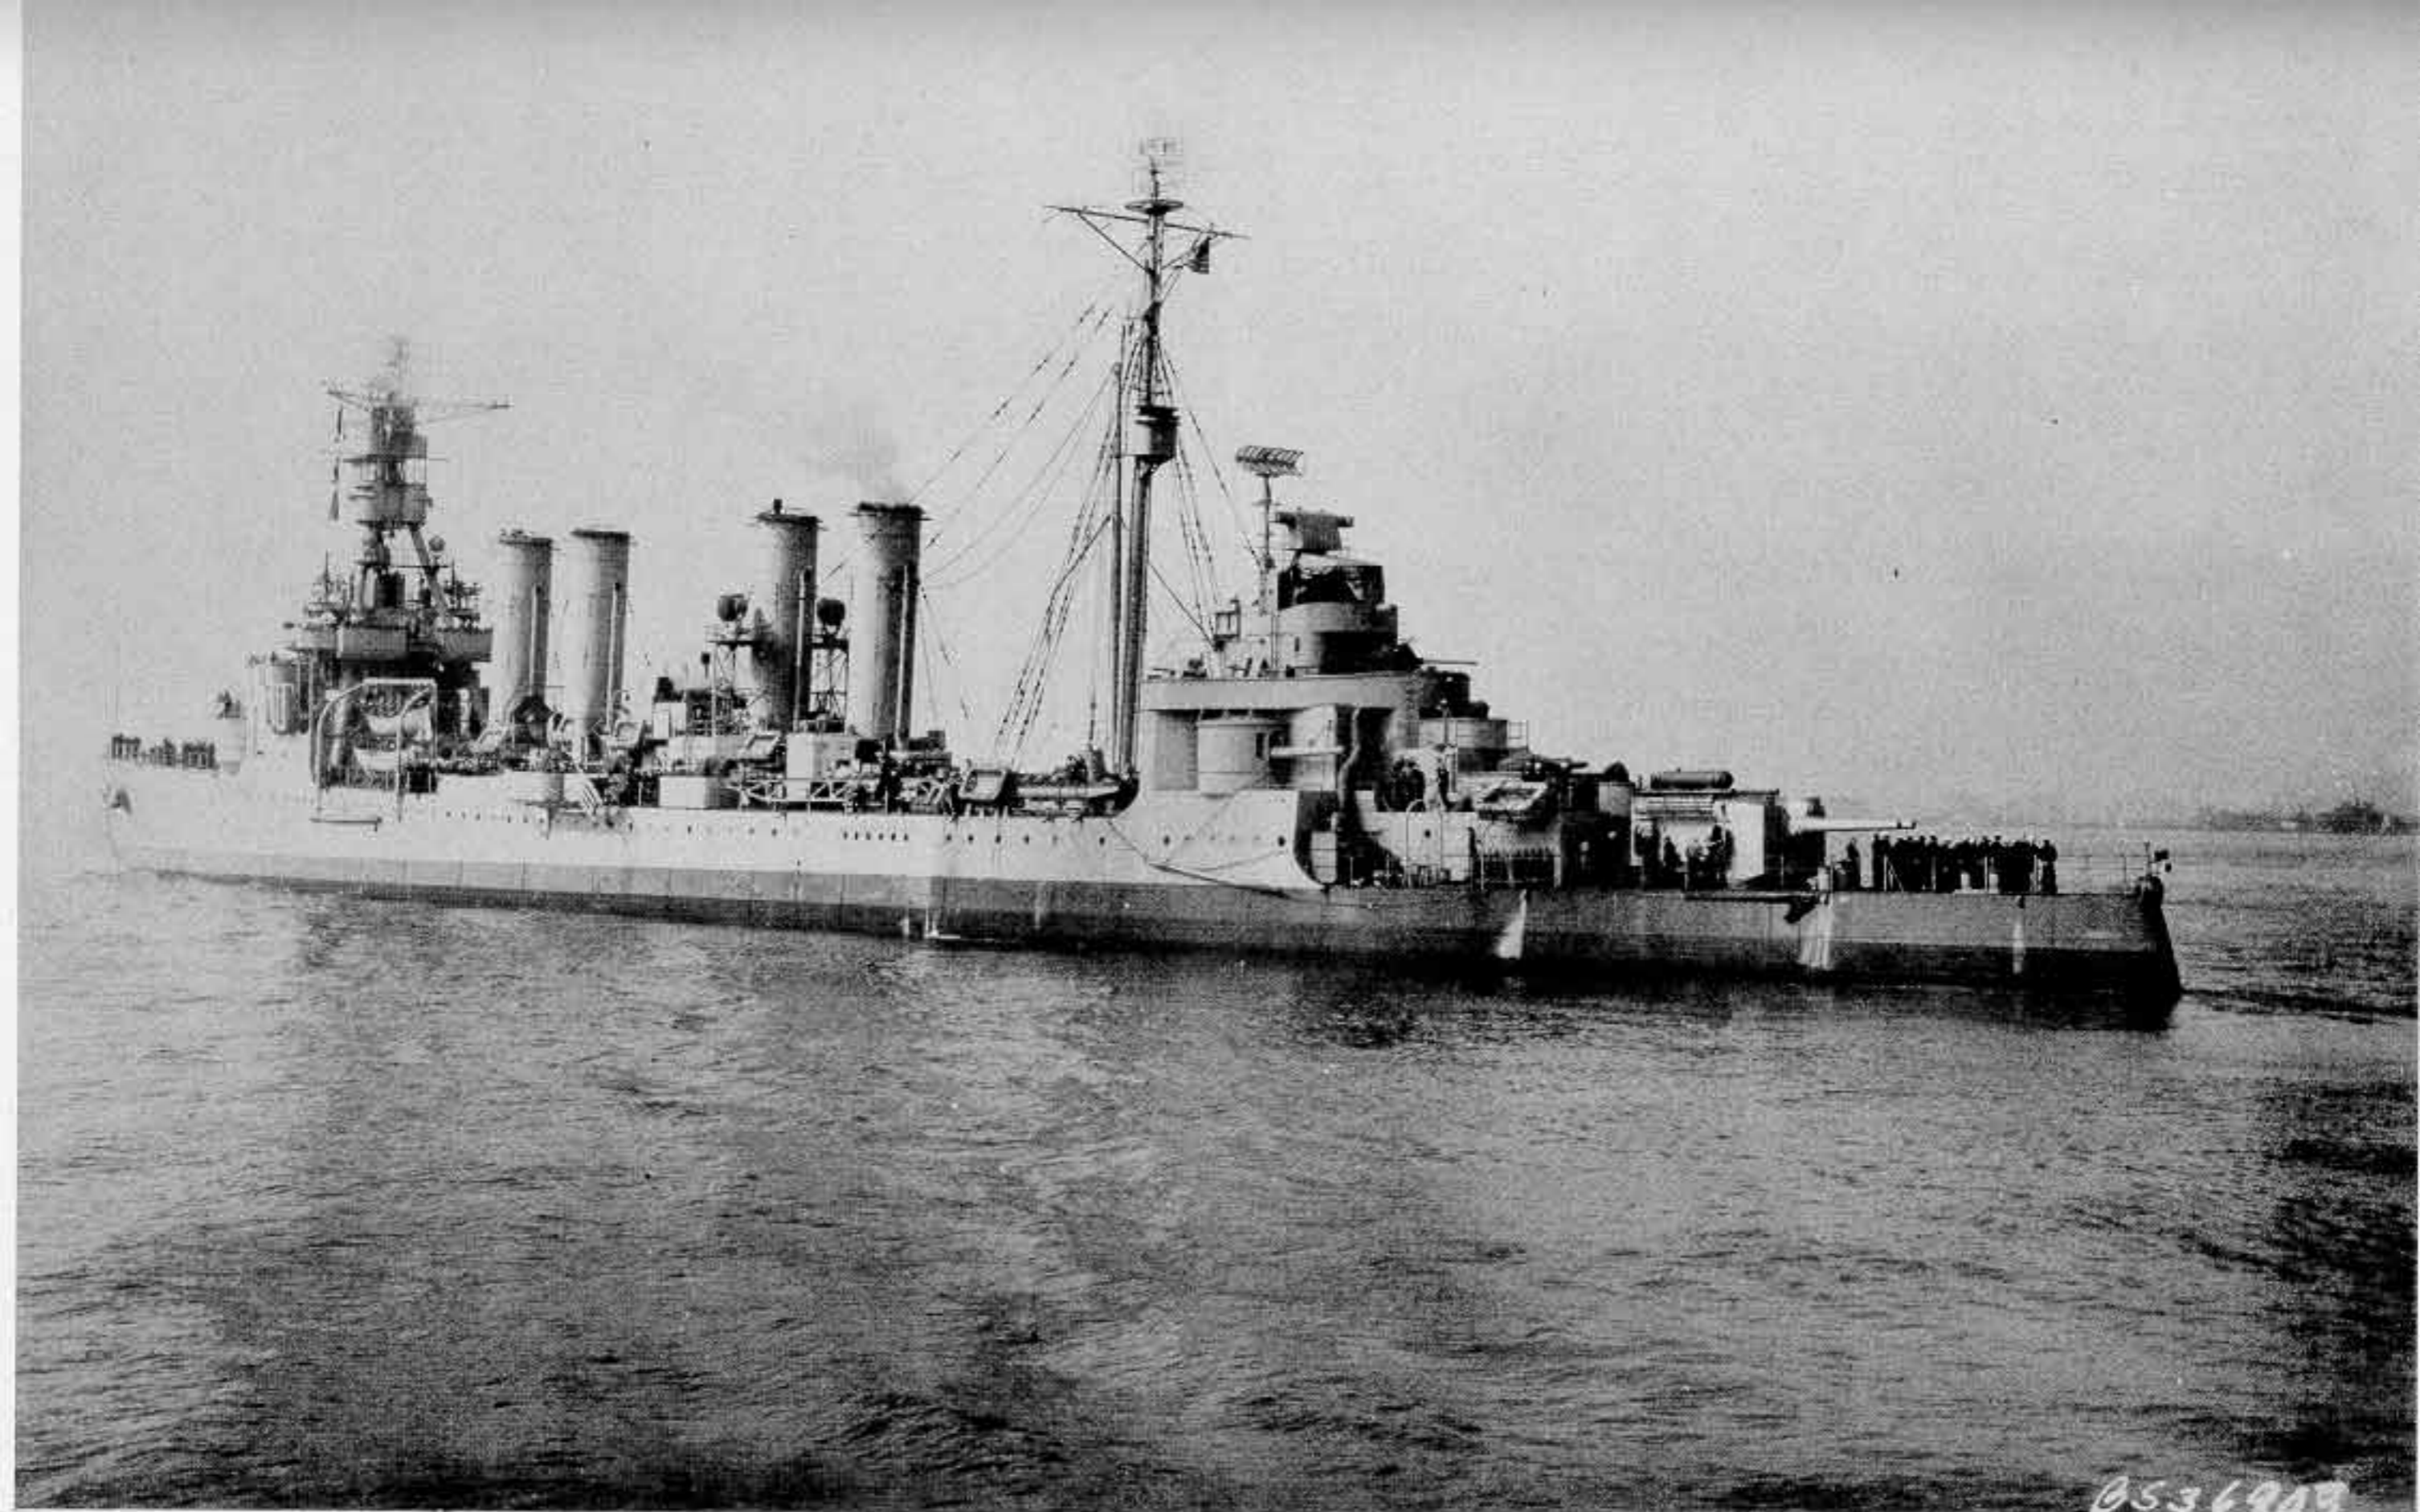
Photo 21: MARBLEHEAD after completion of permanent repairs and alterations.

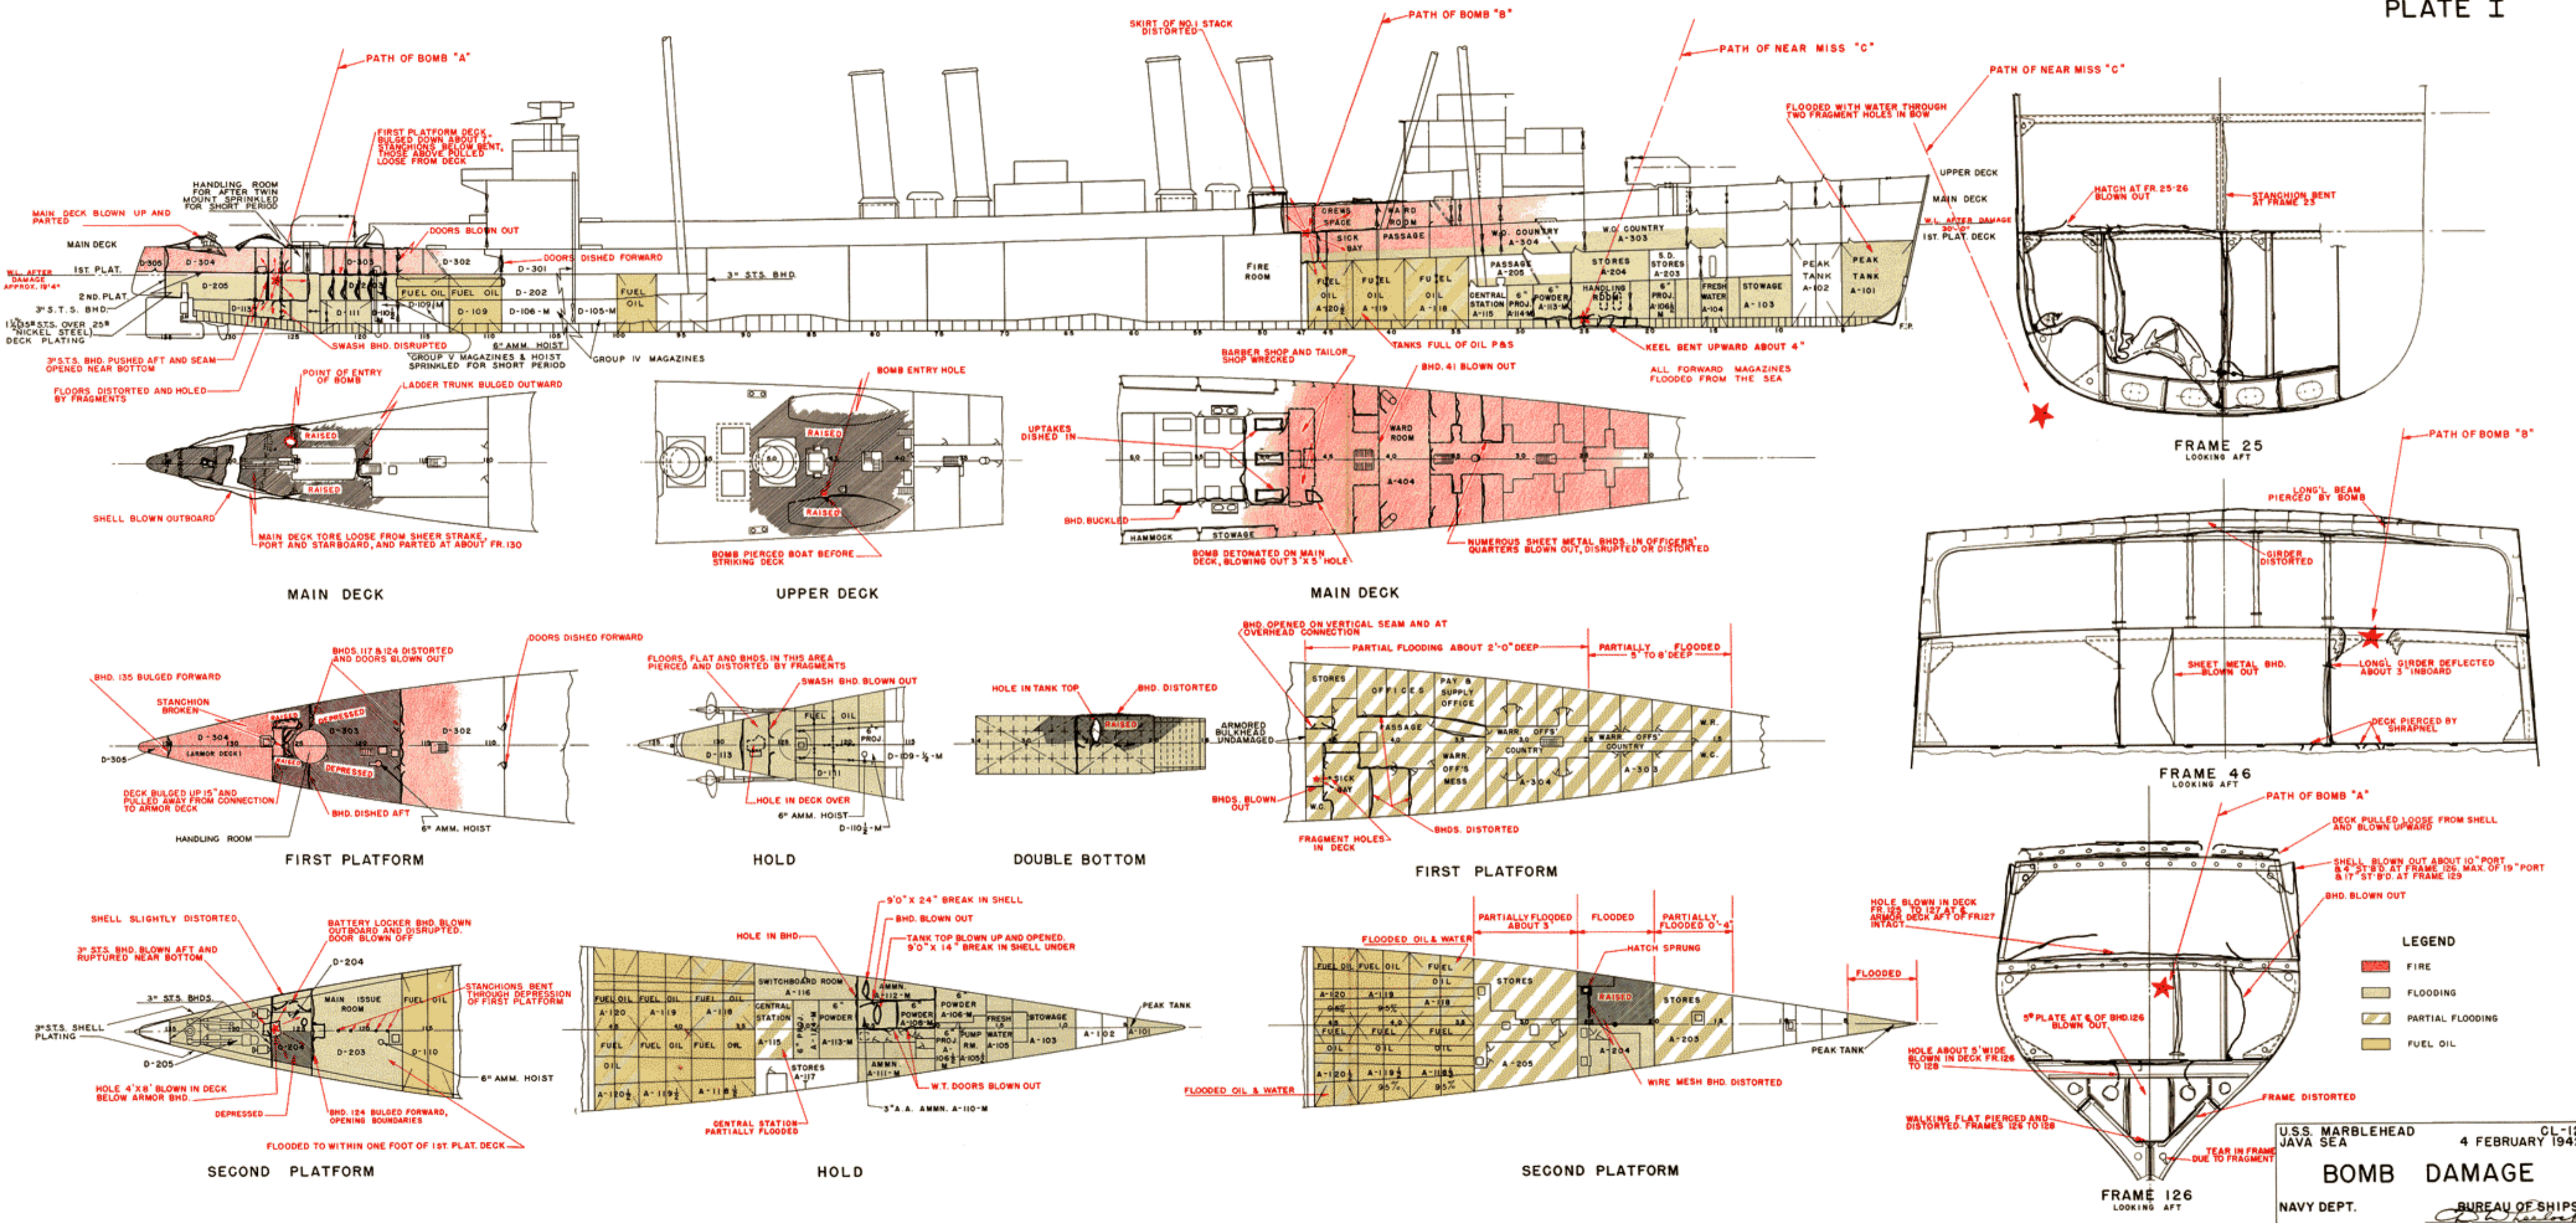
BOMB DAMAGE
