PRELIMINARY REPORT  
**U.S.S. SARATOGA**  
TORPEDO DAMAGE  
JANUARY 11, 1942.

### DAMAGE CONTROL AND CHEMICAL DEFENSE

Feb. 14, 1942

Bureau of Ships  
Navy Department

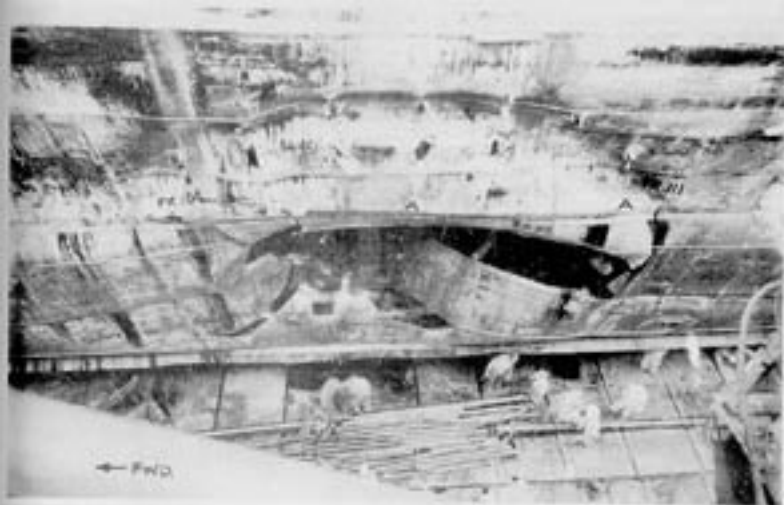
Photo No. 1: View from side of dock. Ridge A-A is at junction of upper and lower blisters, where the inaccessible outboard corner is filled with cement.

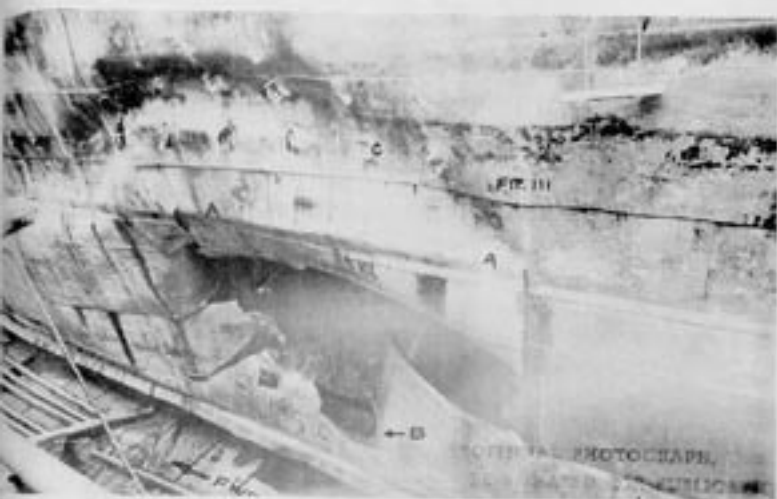
Photo No. 2: View from half-way down the dock, looking forward. Countersunk rivets pulled out at B. Channel struts in upper blister pierced the plating, as at C.

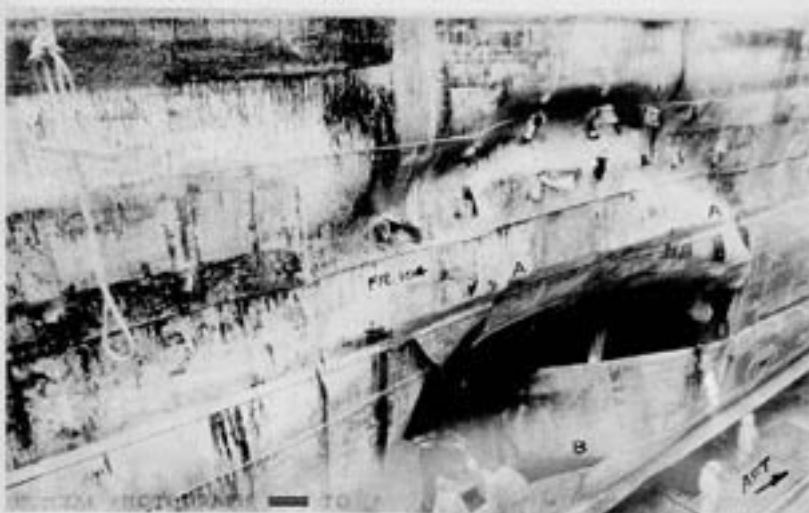
Photo No. 3: View from same level as No. 2, looking aft.

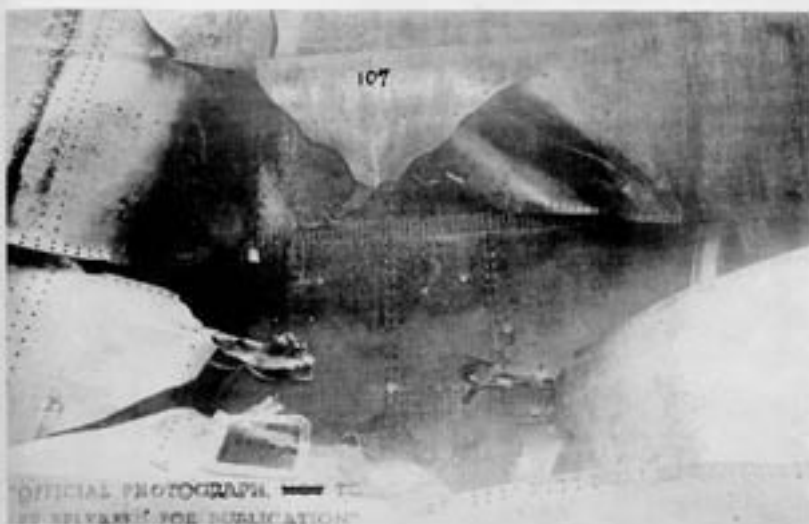
Photo No. 4: View from directly opposite damage, showing torpedo bulkhead No. 1.

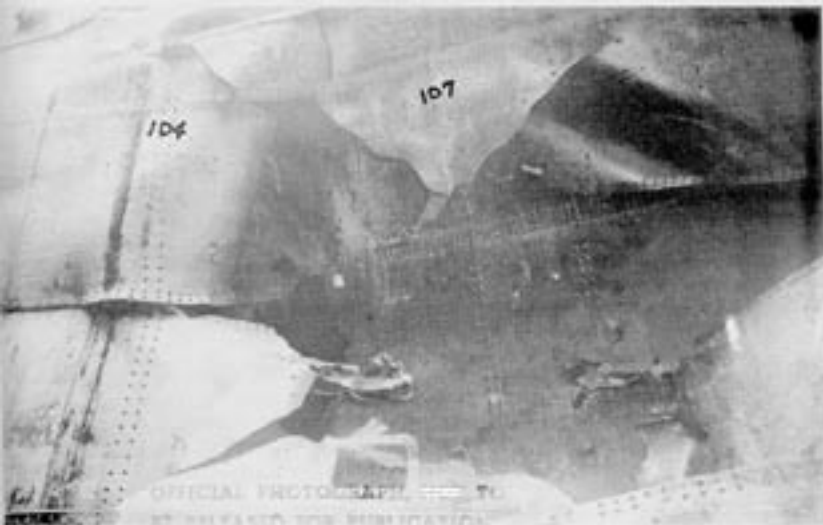
Photo No. 5: Forward edge of hole.

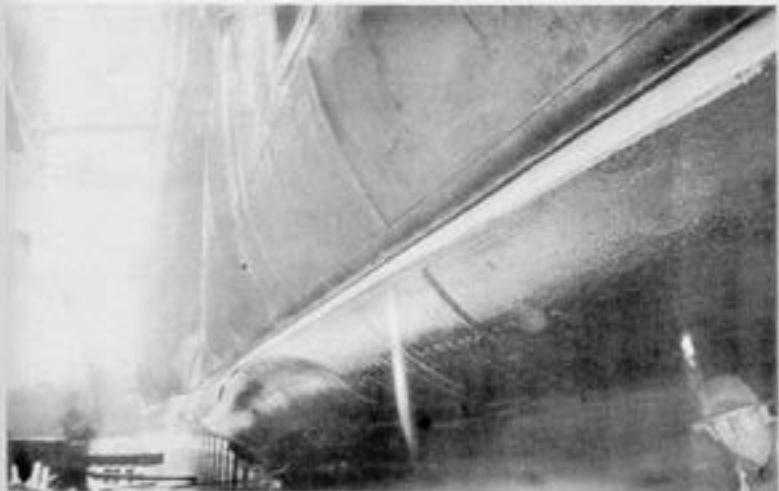
Photo No. 7: View looking forward along port bilge keel. Note how the bottom plating inboard of the bilge keel was blown down by the explosion.

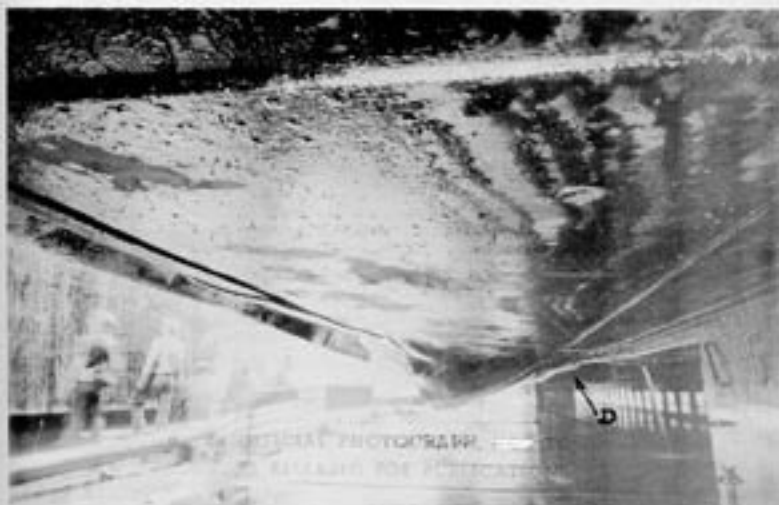
Photo No. 8: View looking forward along outer row of keel blocks. Note that docking keel is bowed up (D): the maximum lift is about 6 inches.

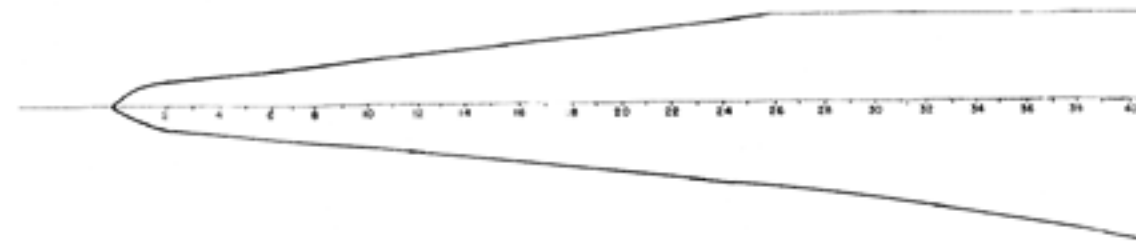
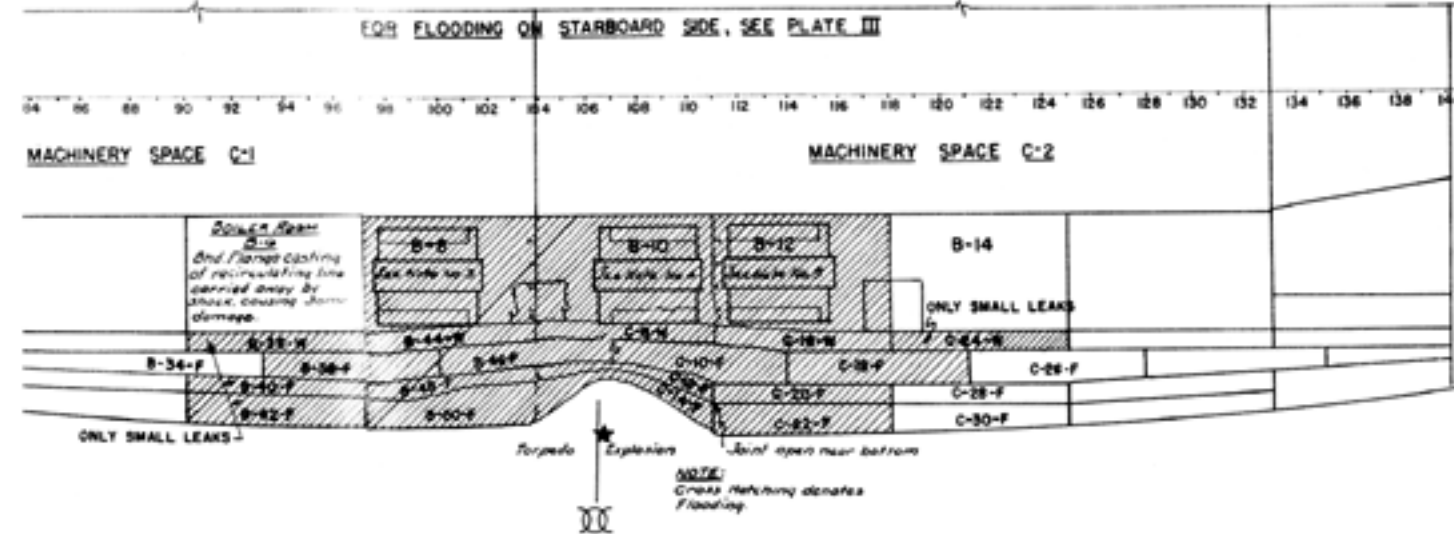
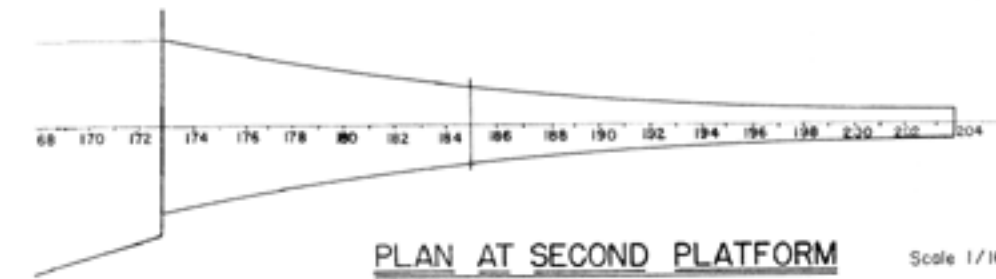
PLAN AT SECOND PLATFORM

Damage to Boiler Rooms:  
No. 8: Outboard bulkhead deflected about 22" at Fr. 104, causing a 15" wrinkle in Bulkhead 104, extending from the third deck to the inner bottom. Bulkhead 104 remained tight. Air lock crushed. Port side of boiler crushed; tubes bent.  
No. 12: Outboard bulkhead deflected about 13" at Fr. 111, causing a 12" wrinkle in Bulkhead 111, extending from the third deck to the inner bottom. Bulkhead 111 remained tight.  
All these boiler rooms flooded completely, chiefly through broken piping.

Bulged between frames opposite B-8, B-10, B-12

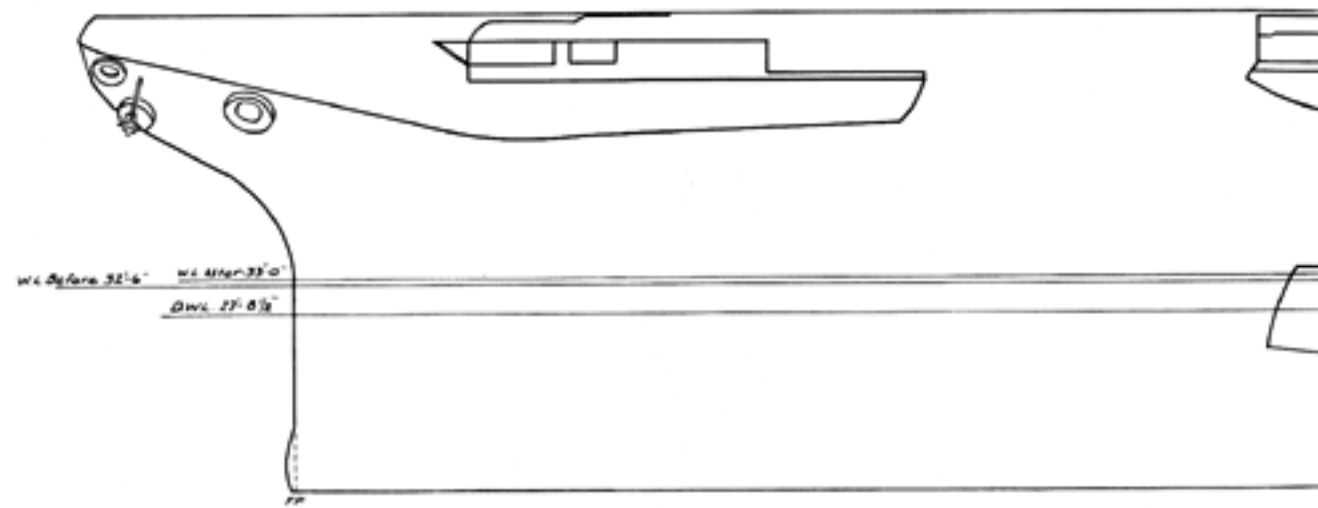
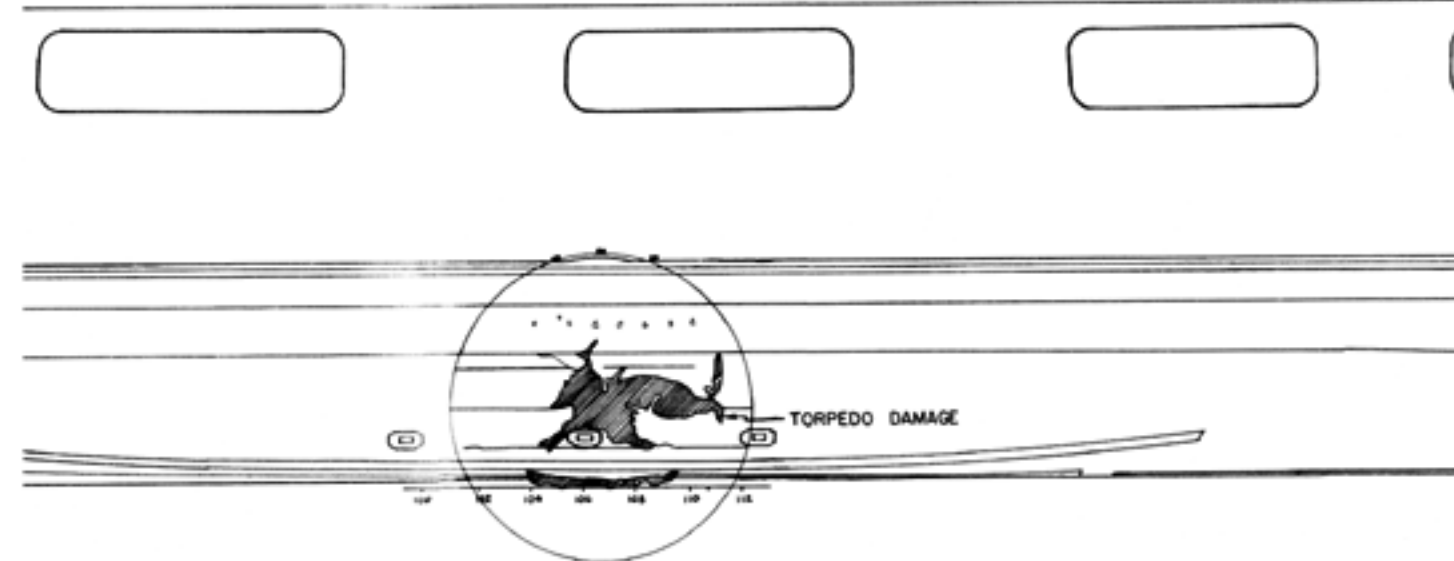
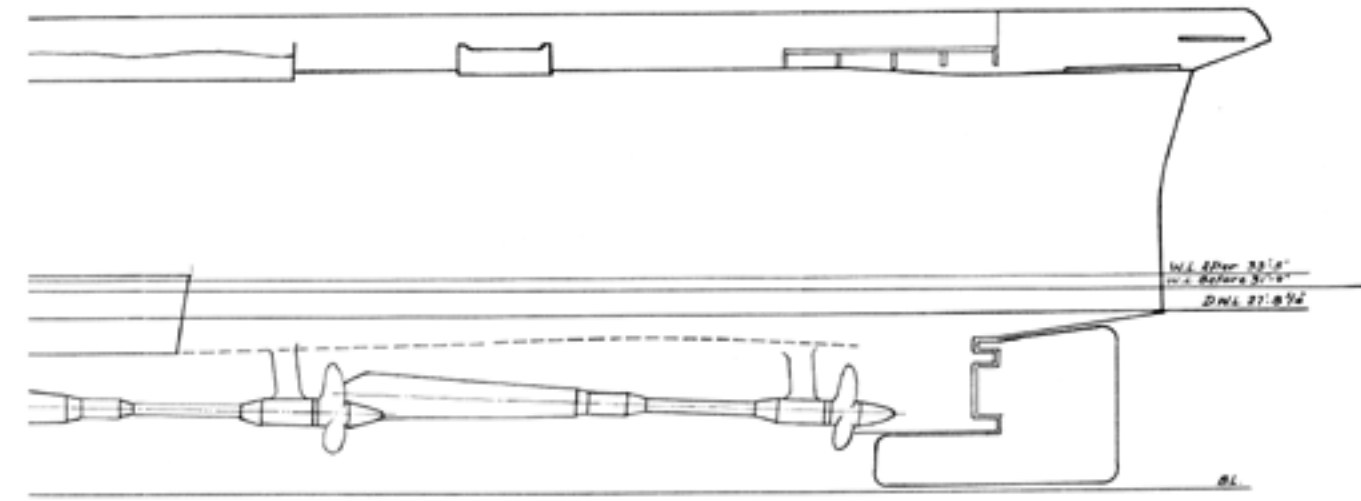
OUTBOARD PROFILE - PORTSIDE

Top of blister blown up (Partially flooded)  
Bracket virtually intact  
Approx. W.L. after damage 31'-2 1/2"  
Approx. W.L. prior to damage 32'-1 1/2"

Some channel struts sheared rivets  
In others, angle clips came off armor  
Armor belt and backing apparently intact

Strip of armor-shelf P.L.T. and "K" strake butt strap sheared off on corner of armor, Fr. 105 1/2 to 108; and for'd and aft of this portion, bent up tight against face of armor.

Top of "K" strake blown up

Torpedo evidently exploded at shell plating

Shell plating blown in

Locking keel lifted ast. 6" and moved slightly inboard

Large buckle in bottom from Fr. 104 to 111

Bottom plating blown out, separated at joint of "F" and "G" strakes

Bilge keel buckled and bent down
