MSC-04112

APOLLO 14 MISSION REPORT

MANNED SPACECRAFT CENTER HOUSTON.TEXAS MAY 1971

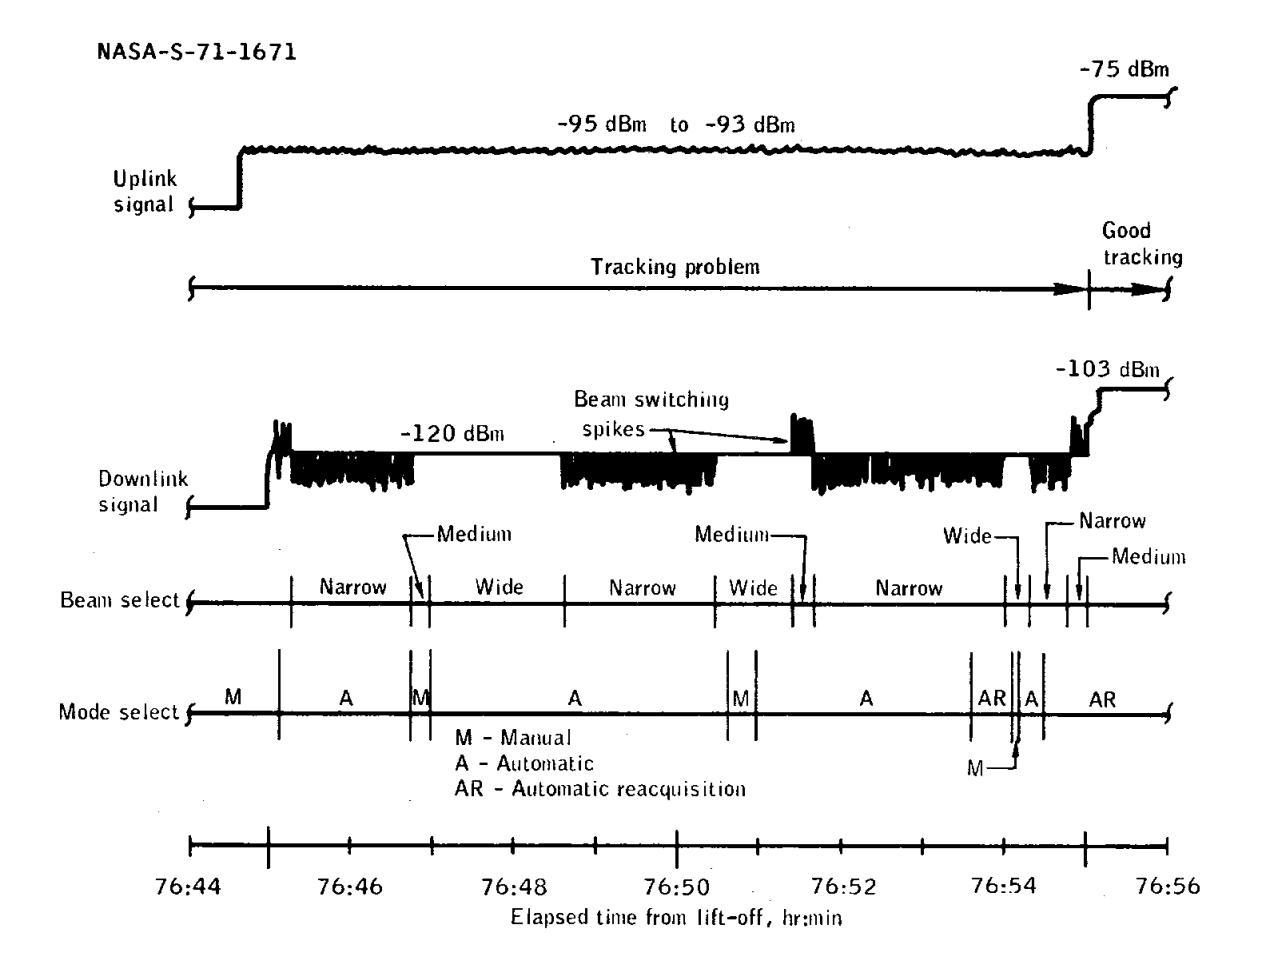
Figure 14-3.- Data from first period of anomalous operation.

The ground data signatures which show the first acquisition and tracking problems are illustrated in figure 14-3. The antenna started tracking a point approximately 5 to 8 degrees off the earth pointing angle at 76:45:00 elapsed time and continued tracking with low uplink and downlink signal levels for 10 minutes at which time a good narrow beam lock-up was achieved.

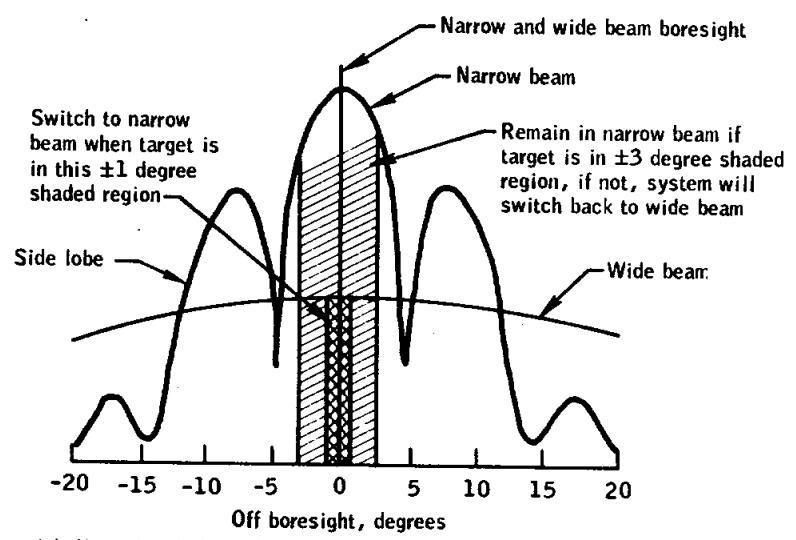
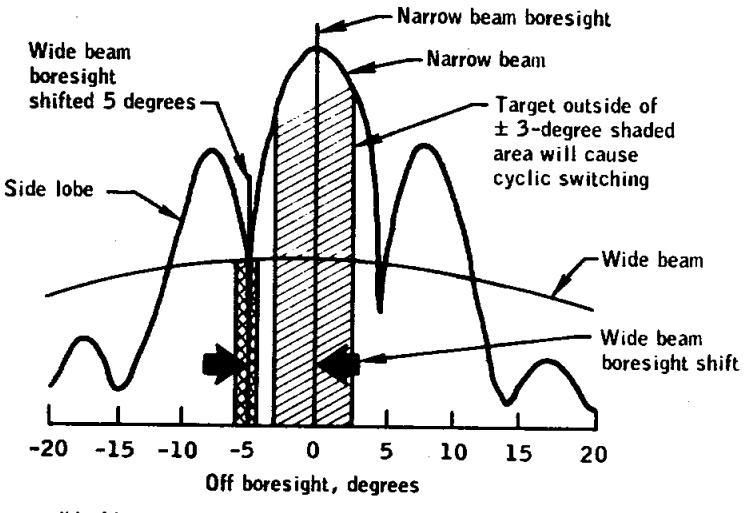
The low signals correlate with antenna pattern and gain data for a 5- to 8-degree boresight shift in the wide-beam mode. The direction of the spikes observed on the downlink data in figure 14-3 are consistent with switching between the wide and narrow beams. Conditions for a normal alignment and a misalignment of the wide and narrow beams are shown in figure 14-4. A 5- to 8-degree shift in the wide-beam mode boresight NASA-S-71-1672

(a) Normal wide beam/narrow beam antenna alignment patterns.

(b) Alignment conditions indicated by Apollo 14 data.

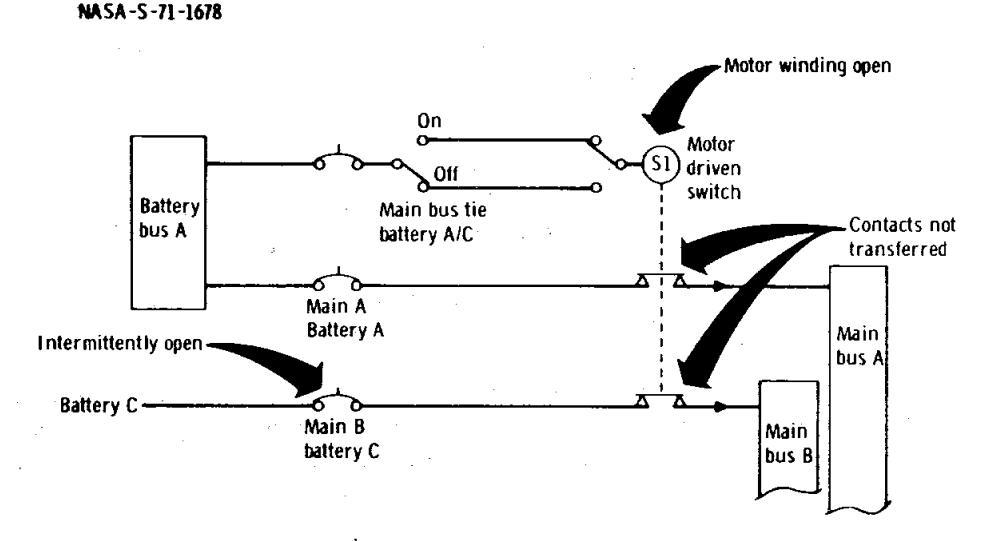
Figure 14-10.- Bus-tie circuitry.

During entry, when the main bus tie switches (motor-driven switches) were placed in the off position at 800 feet, main bus A should have deenergized; however, the bus remained on until after landing when the battery bus-tie circuit breakers were opened. Postflight testing showed that the main motor switch contacts were closed (fig. 14-10). Also, the

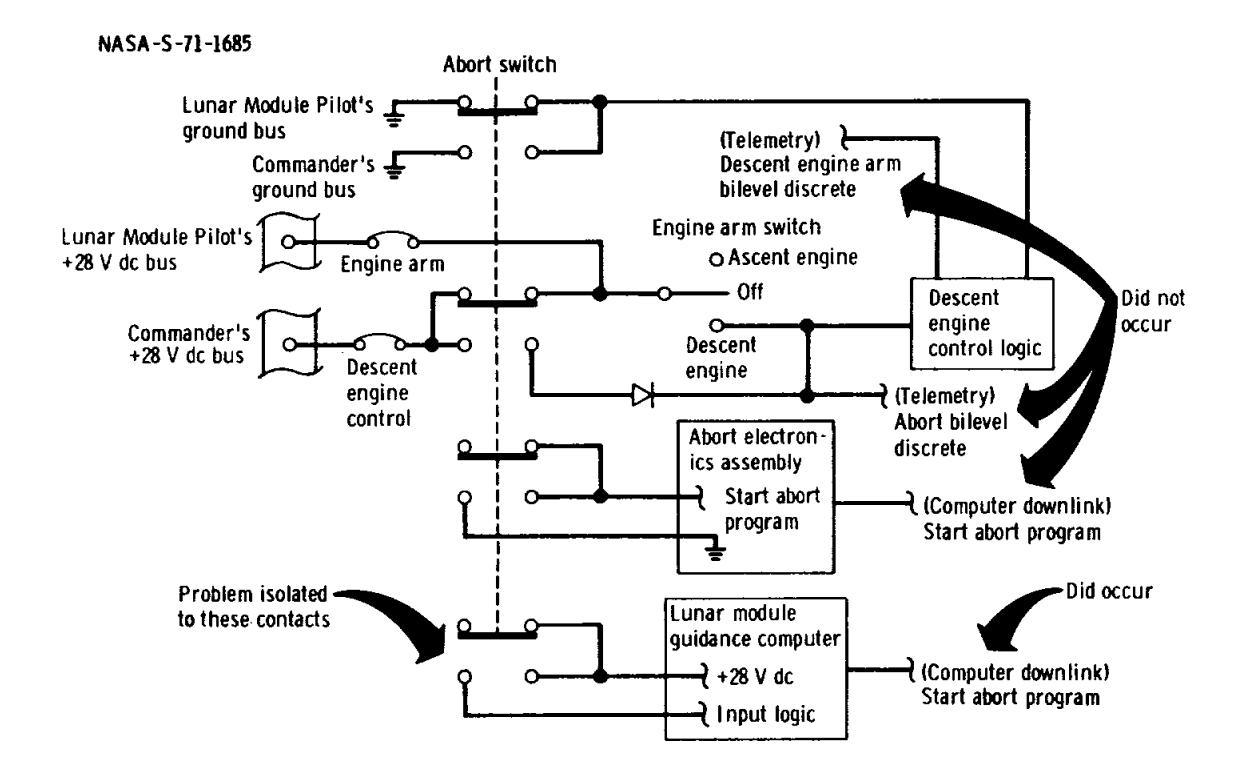
Figure 14-17.- Abort switch logic.

Prior to descent, the primary guidance computer received an abort command four different times. The computer would have reacted if the descent program had been initiated. The failure was isolated to one

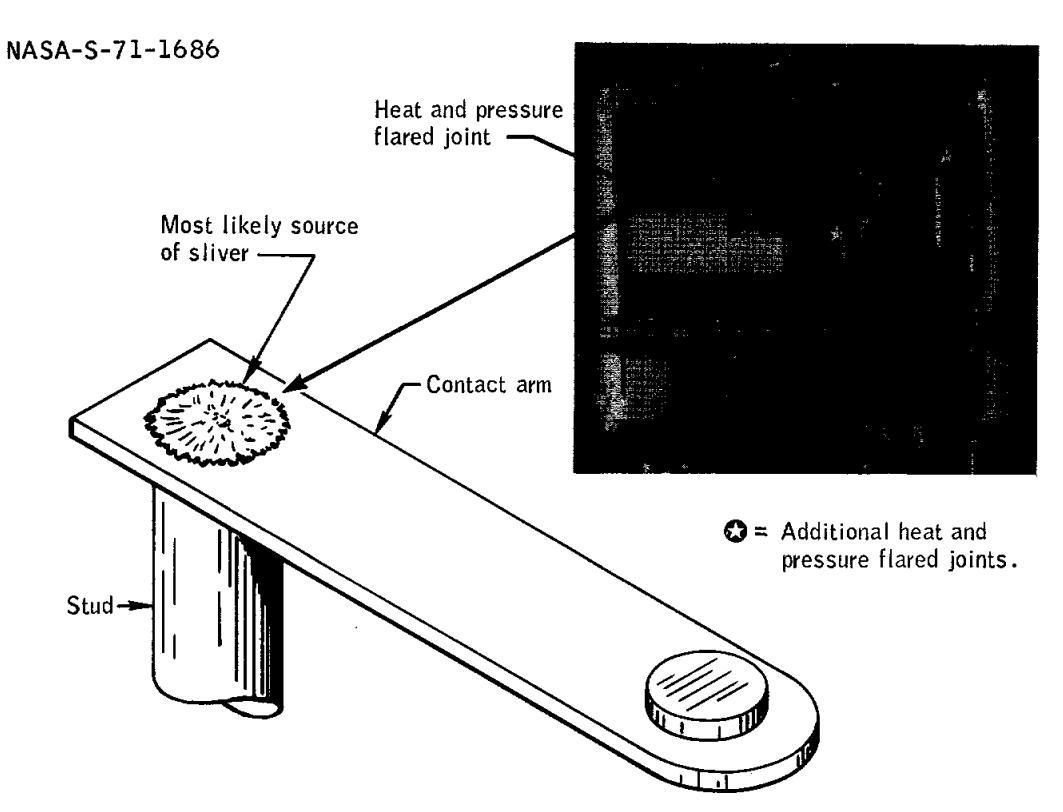
Metal contamination up to 0.030-inch long slivers found in several switches (a) Simplified sketch of internal switch parts.

(b) X-rays of switch showing metallic contamination.

b. Each of the two engine stop switches were rewired so that two series contacts are required to close in order to stop the engine. Formerly, the two sets of contacts in each stop switch were connected in parallel so that closure of either would shut down the engine.

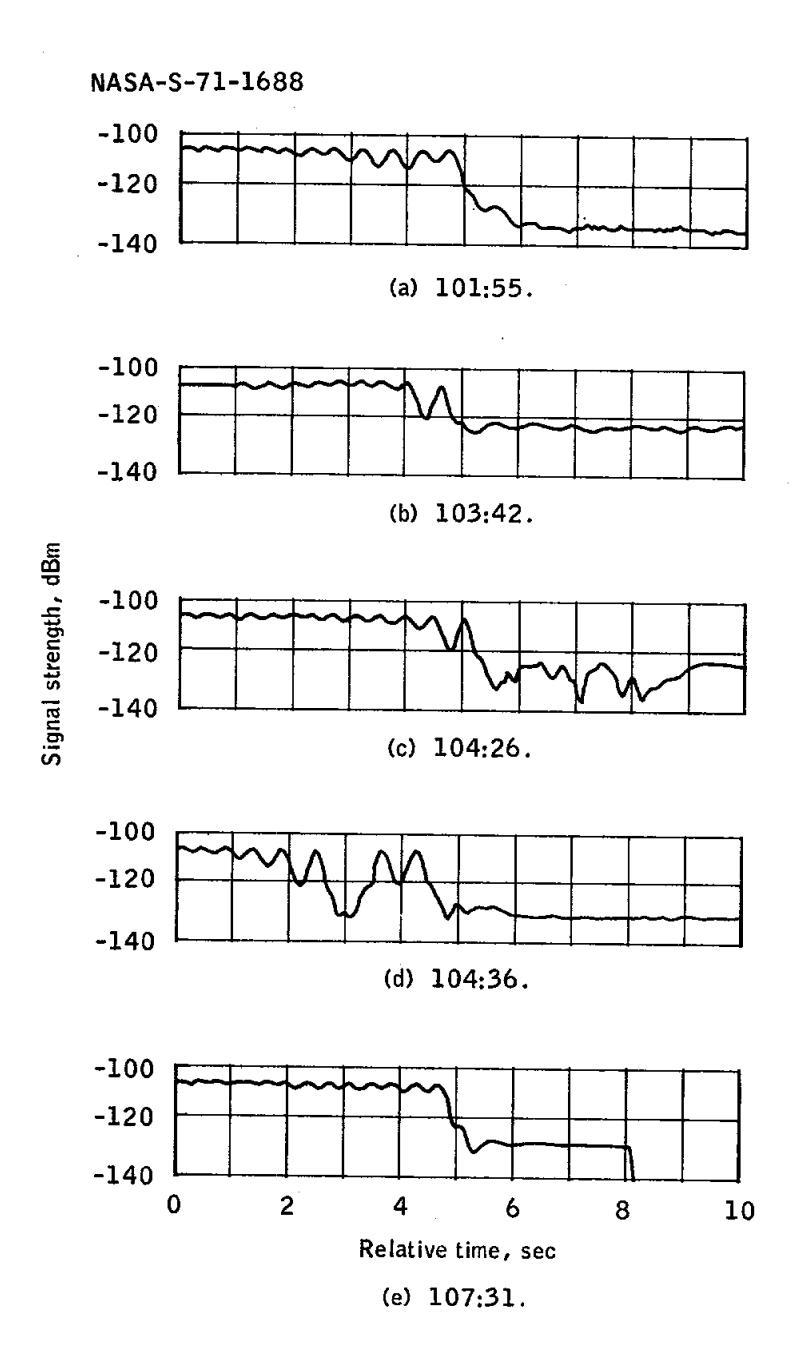
Figure 14-20.- Signal strength oscillations associated with five unexplained losses of lock.

Look-angle data indicate that the antenna was not pointed at or near the vehicle structure during the time periods when antenna lock was lost.

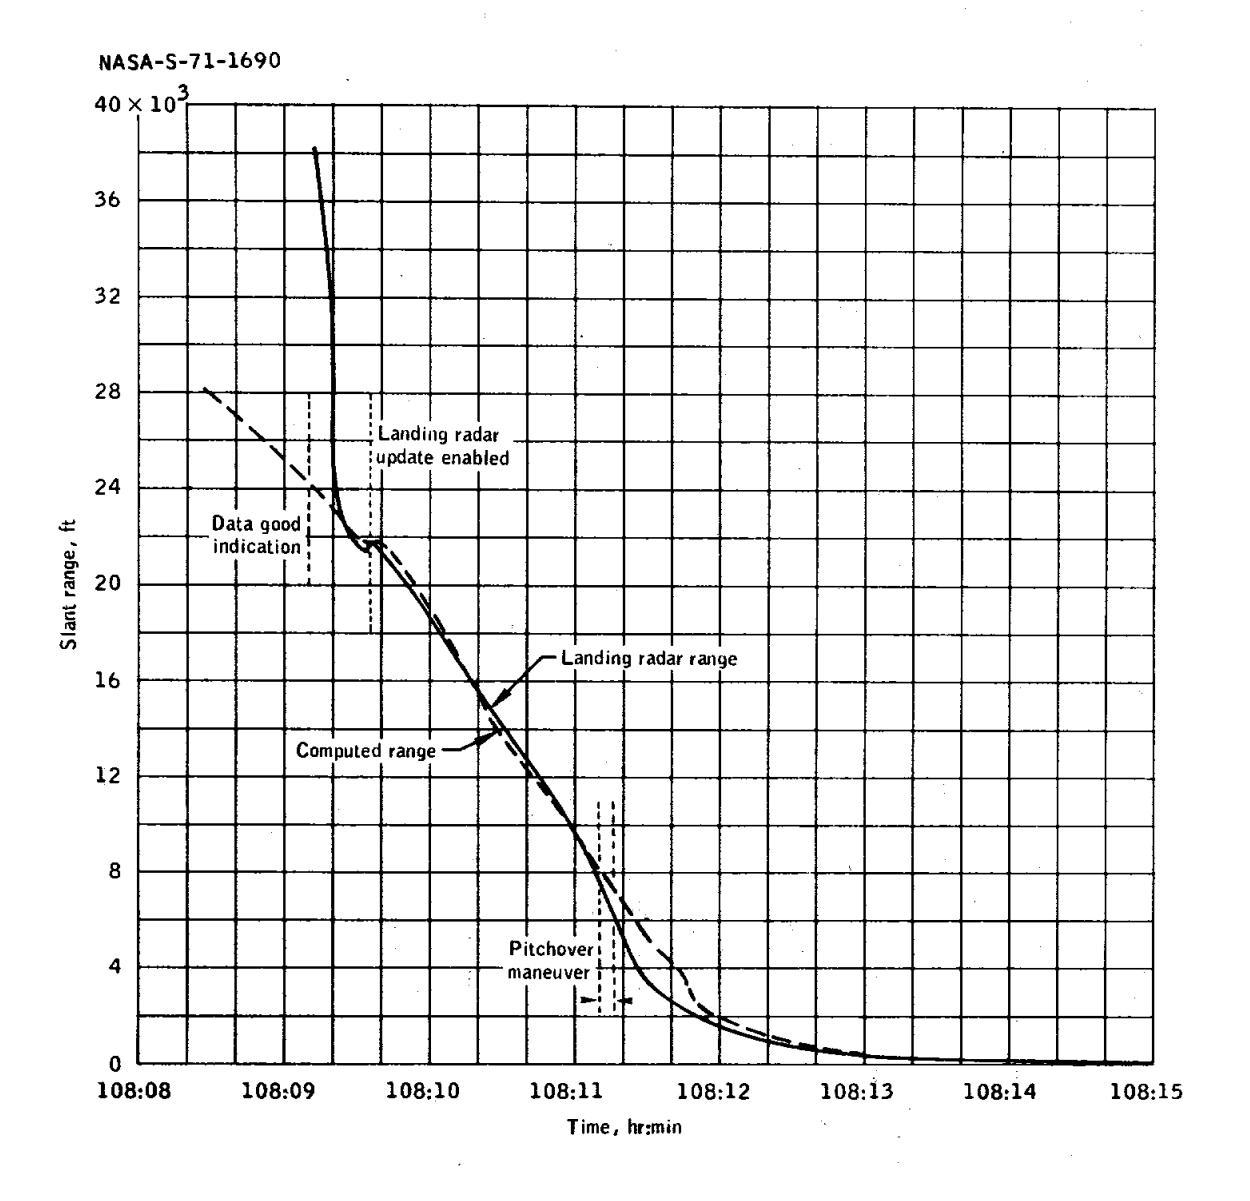
Figure 14-22.- Comparison of measured and computed slant range during powered descent.

The second condition which was not expected occurred after the circuit breaker was recycled. At this time the initial slant range reading was approximately 13 000 feet greater than that calculated from the operational trajectory. Several seconds later, the indicated slant range jumped from 32 000 to 25 000 feet. Subsequently, the landing radar readings compared favorably with the operational trajectory (fig. 14-22).

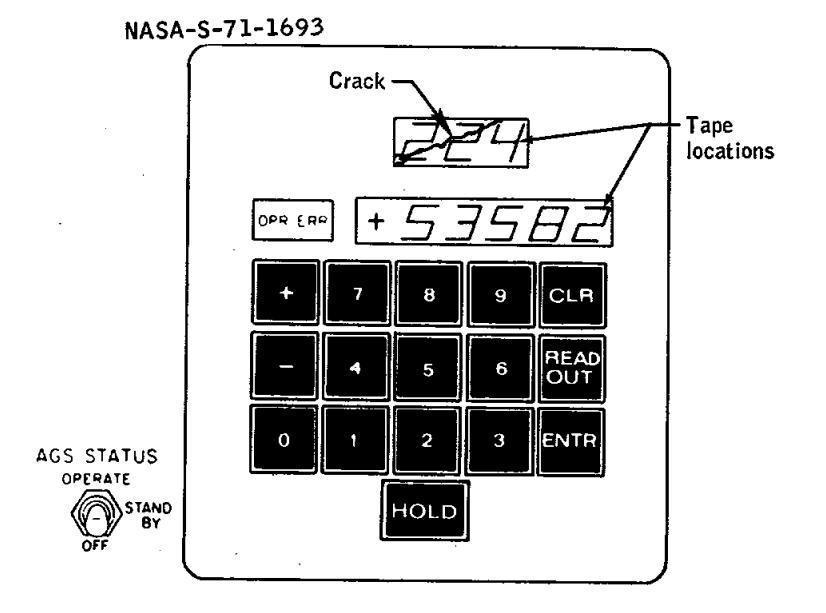
Figure 14-25.- Locations of crack and tape on data entry and display assembly.

The crew reported a crack in the glass across the address register of the data entry and display assembly. Figure 14-25 shows the assembly and the location of the crack. Figure 14-26 is an enlarged drawing of the glass and associated electroluminescent segments.

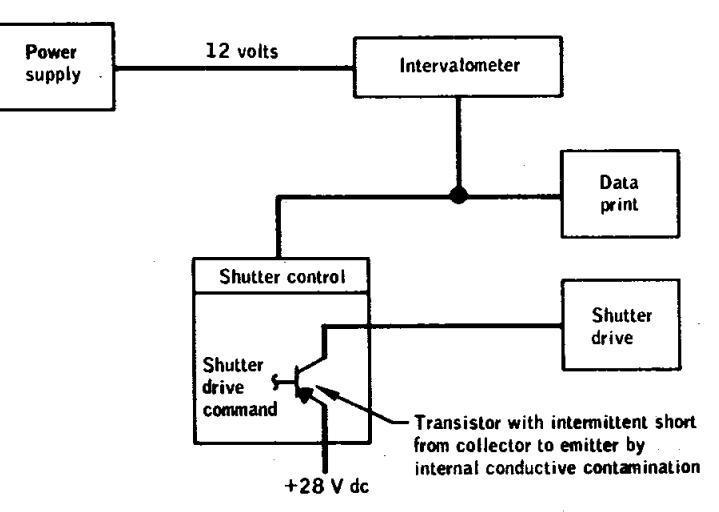
Postflight tests with the flight camera showed satisfactory operation in all simulated environments (pressure, thermal, and vibration) at one-g. An intermittent failure was found in a transistor in the shutter control circuit (fig. 14-27). The transistor was contaminated with a

loose piece of aluminum 0.130 inch by 0.008 inch, which was foreign to the transistor material. With a shorted transistor, 28 volts is applied continuously to the shutter drive circuit, causing continuous shutter operation, independent of the intervalometer and independent of the single, auto, or standby mode selections. The sprocket holes in the 1/200 slot in the shutter curtain were torn as a result of the prolonged, continuous, high-speed shutter operation (fig. 14-28).

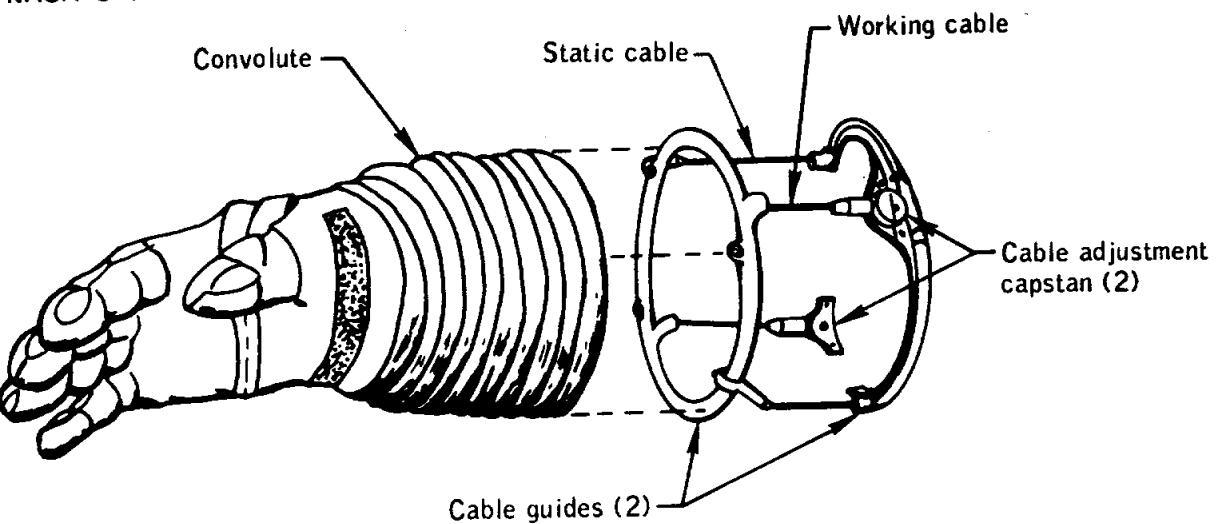
After suit pressurization for the second extravehicular activity, the Lunar Module Pilot reported that his right glove had pulled his hand to the left and down and that he had not had this trouble during the first extravehicular activity period. The condition was a nuisance throughout the second extravehicular activity period. Initial indications from the Lunar Module Pilot were that a cable had broken in the glove (fig. 14-29).
