**MPR-SAT-FE-73-5**

**OCTOBER 8, 1973**

## SATURN 1B LAUNCH VEHICLE FLIGHT EVALUATION REPORT-SA-207 SKYLAB-3

The Saturn IB, SA-207 Launch Vehicle was launched on July 28, 1973, from Kennedy Space Center and placed the Command Service Module containing three crew members into an 149.87 x 226.29 km altitude earth orbit. No anomalies occurred that seriously affected the mission.

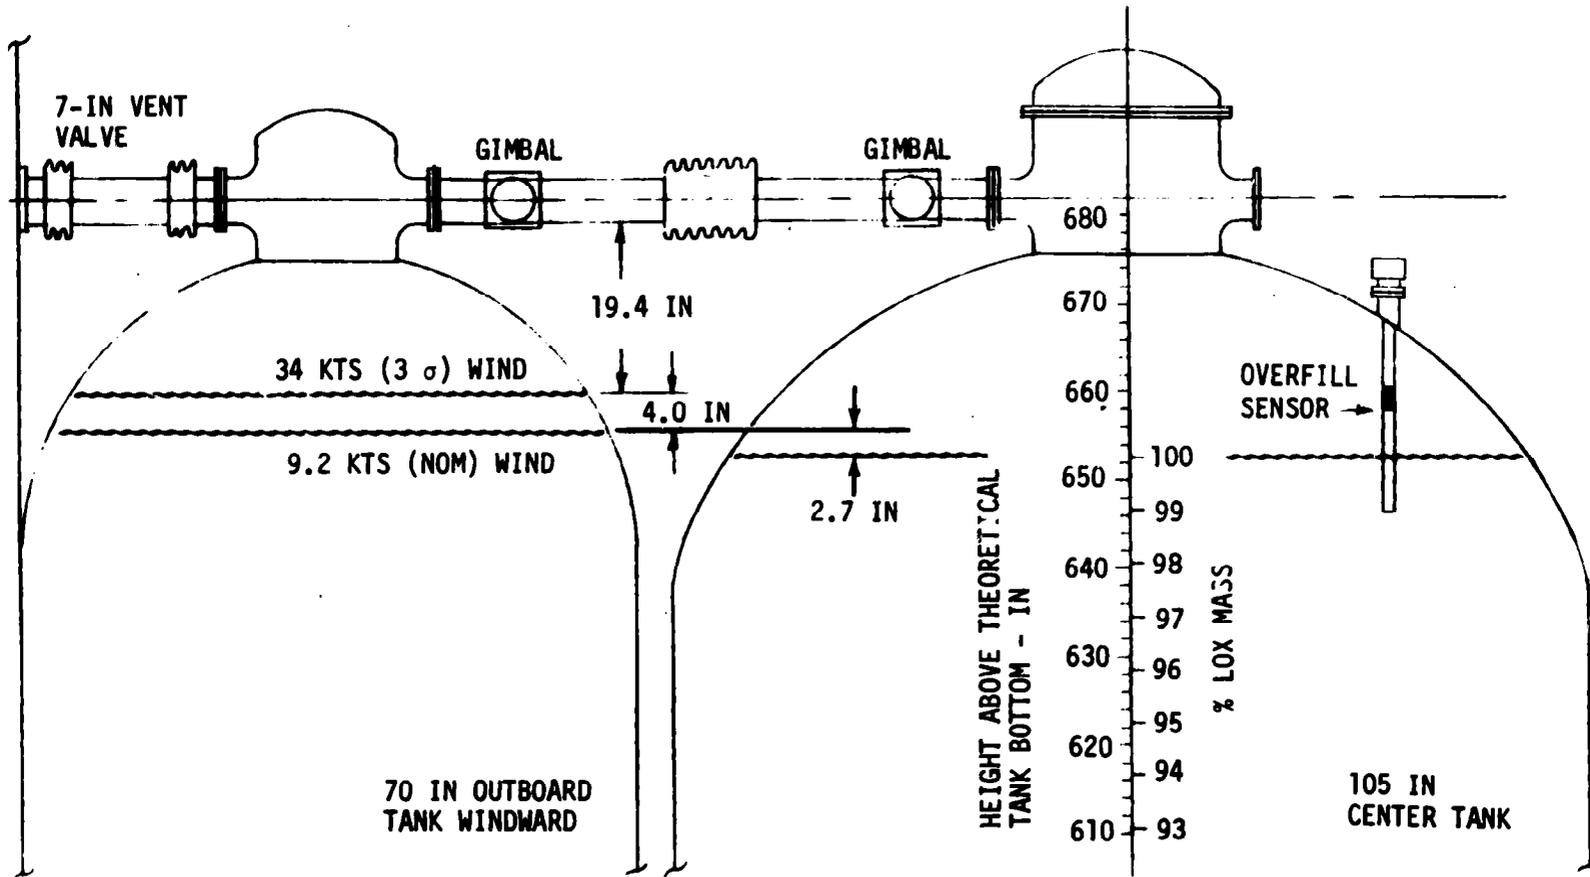
Figure 3-2. Center LOX Tank - Outboard LOX Tank Relationship

NOTE: CENTER TANK 4-IN VENT NOT SHOWN.  
TANKS INTERCONNECTED AT BASE.

LOX pump inlet temperatures (one per engine) were reviewed together with the Engine No. 1 LOX pump inlet pressure for the 8-hour period prior to launch. This period covered start of LOX loading until liftoff. Additionally, center LOX tank ullage pressure was scrutinized for any unusual fluctuations which could be related to the discharges seen on the film. None were noted during the 8-hour period. The overflow sensor, located 21 inches below the vent duct, did not indicate liquid presence during LOX loading. None of these measurements indicated any unusual conditions which would explain the apparent LOX venting.

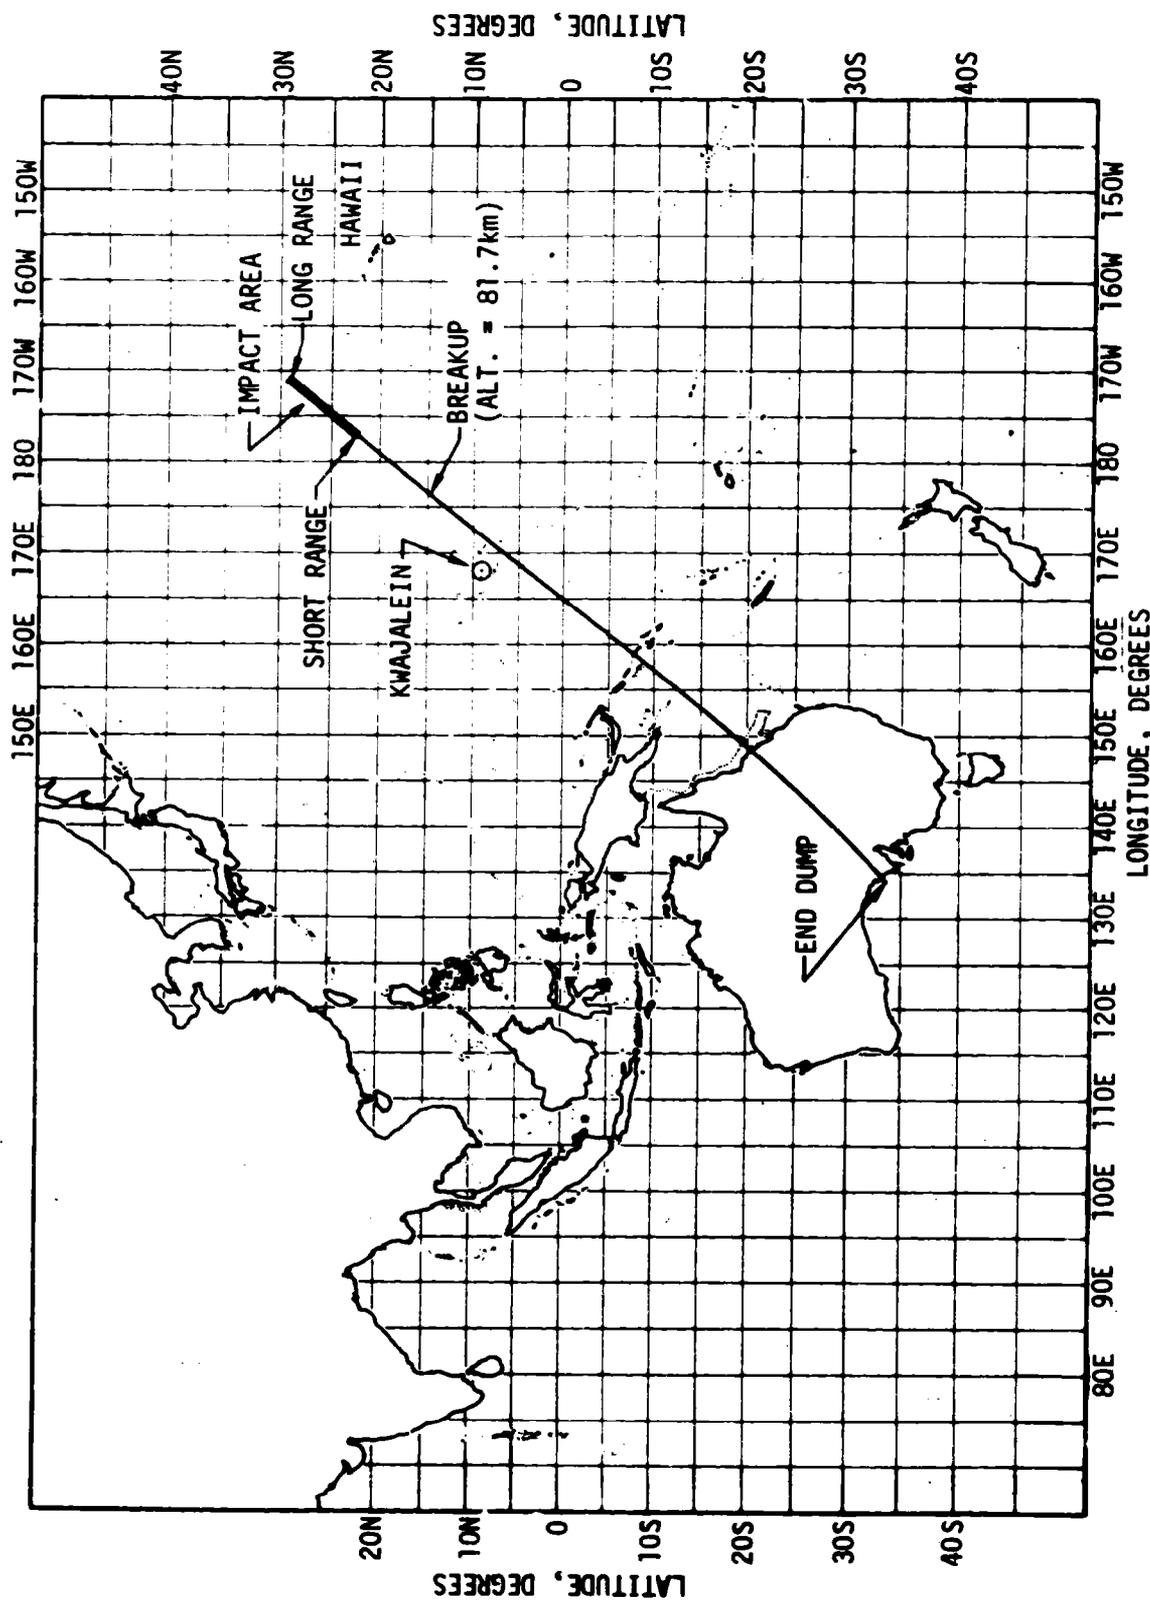
Figure 5-4. S-IVB/IU Ground Track - Dump to Impact

SHORT RANGE	NOMINAL	LONG RANGE
Range Time (sec)	21,756.	21,650.	21,593.
Latitude (deg, North)	21.73	23.75	27.51
Longitude (deg, West)	177.43	175.50	171.60

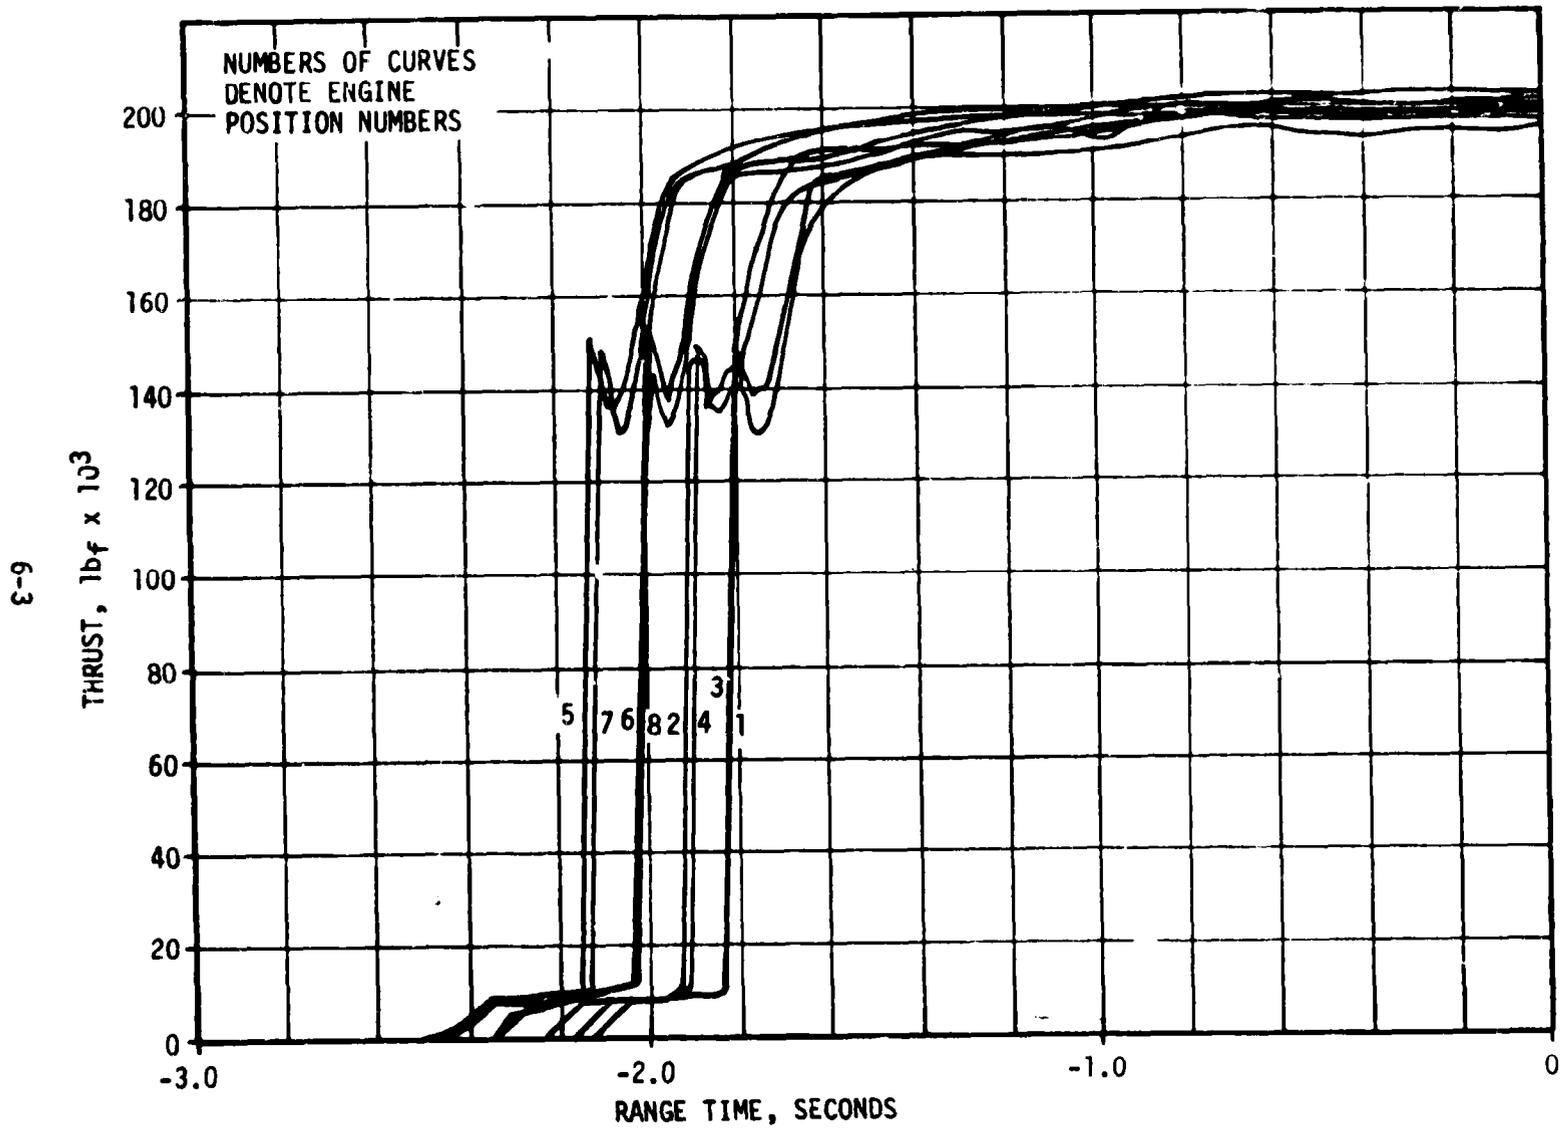
Figure 6-1. S-IB Engines Thrust Buildup

Postflight evaluation of Saturn IB vehicles SA-201 through SA-205 showed the flight thrust and flowrates to be significantly higher than thrust and flowrates experienced during ground tests, when reduced to standard sea level conditions. Consequently, the flight predictions, based on ground test levels, were biased upwards to compensate for this phenomenon and thus more accurate flight predictions were achieved through vehicle SA-205. SA-206 flight exhibited a contrary trend as the thrust was lower than the levels experienced during ground tests. SA-206 postflight analysis was inconclusive as to the cause of the contrary flight thrust trend which could have been (1) the unique flight performance of the uprated engine (205 klbf) first used on SA-206 or (2) the known inconsistencies in the various SA-206 engine and stage ground tests. Since the thrust levels of SA-207, which also utilize uprated engines, were in agreement with the earlier flights

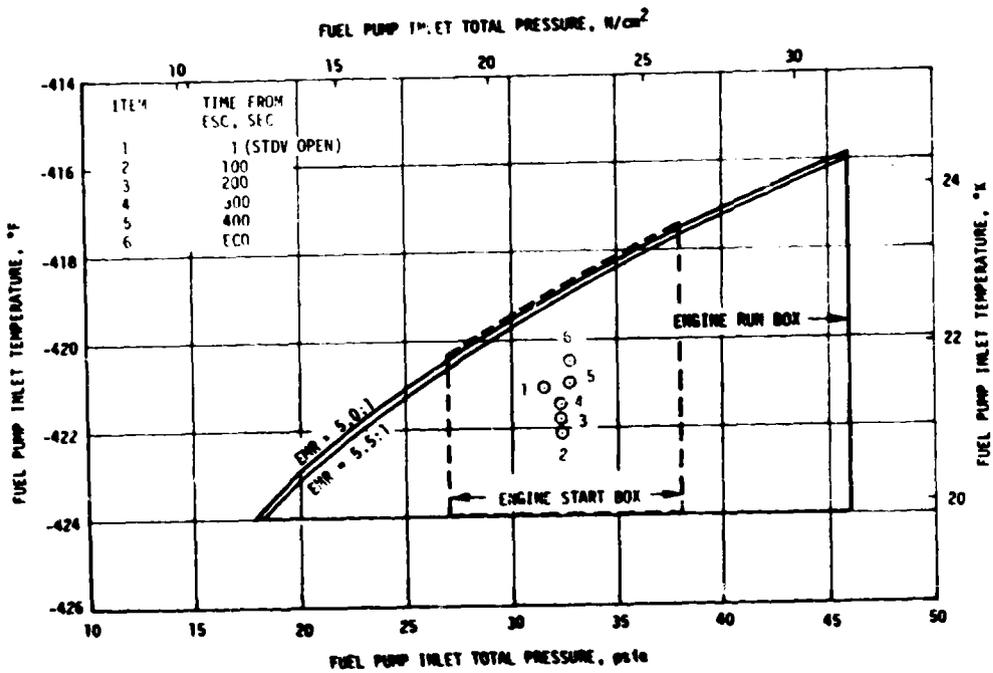
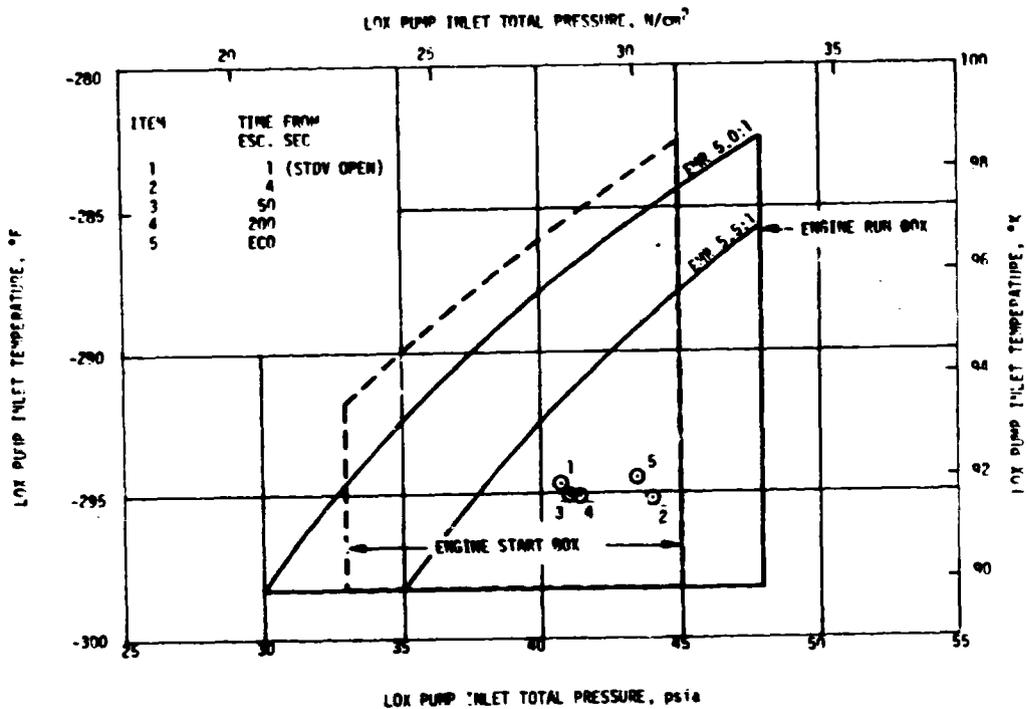
Figure 7-1. S-IVB Start Box and Run Requirements

The propulsion reconstruction analysis verified that the stage performance during mainstage operation was satisfactory. A comparison of predicted and actual performance of thrust, specific impulse, total flowrate, and EMR versus time is shown in Figure 7-2. Table 7-1 shows the thrust, specific impulse, flowrate, and EMR deviations from predicted at the STDV open +60 second time slice at standard altitude conditions.

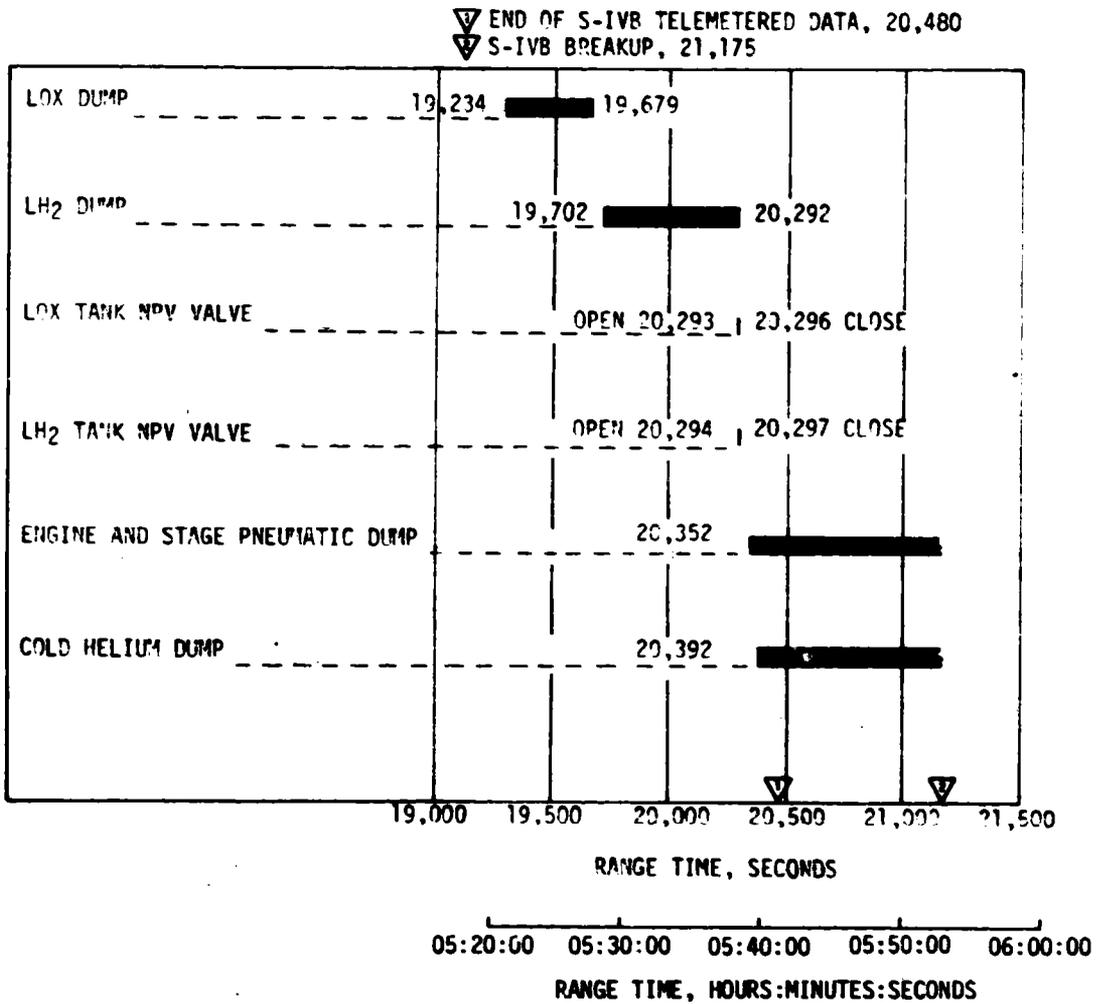
Figure 7-9. S-IVB Deorbit Propellant Dump and Safing Sequence

The reconstructed total impulse before MOV closure was 72,200 lbf-sec, as compared to real time predicted total impulse of 72,000 lbf-sec. The close agreement between the real time predicted and reconstructed total impulse is attributed to the compensating effects of higher than

predicted nominal specific impulse and lower than predicted LOX mass at end of thrust decay. The reconstructed specific impulse during the liquid portion of the dump was 7% higher than predicted, but within the predicted limits. LVDC accelerometer data indicates an S-IVB stage velocity change of 71.46 ft/sec from LOX dump.

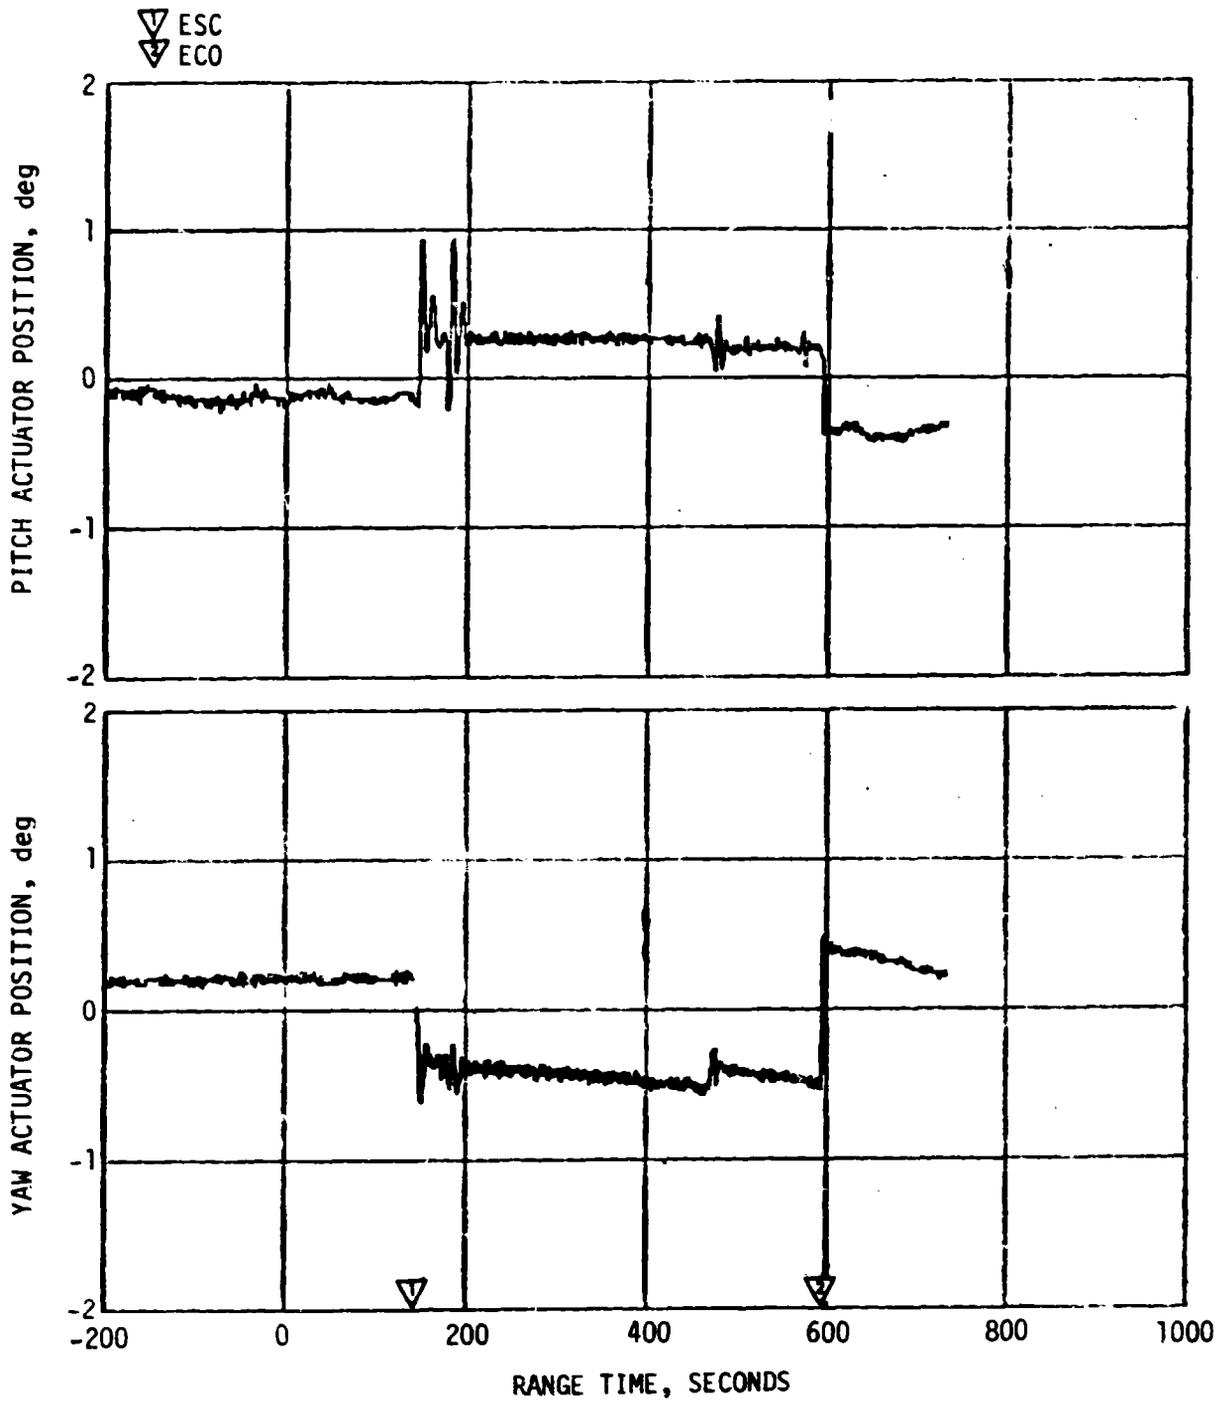
Figure 7-14. S-IVB Hydraulic System - Boost

Following J-2 engine cutoff and prior to the auxiliary hydraulic pump off, the actuators extended beyond the null position indicated prior to J-2 engine start (Figure 7-14). Data review indicated that a valve current bias of .75 to 1.0 milliamps corresponded to the shift in actuator position from the original null positions.

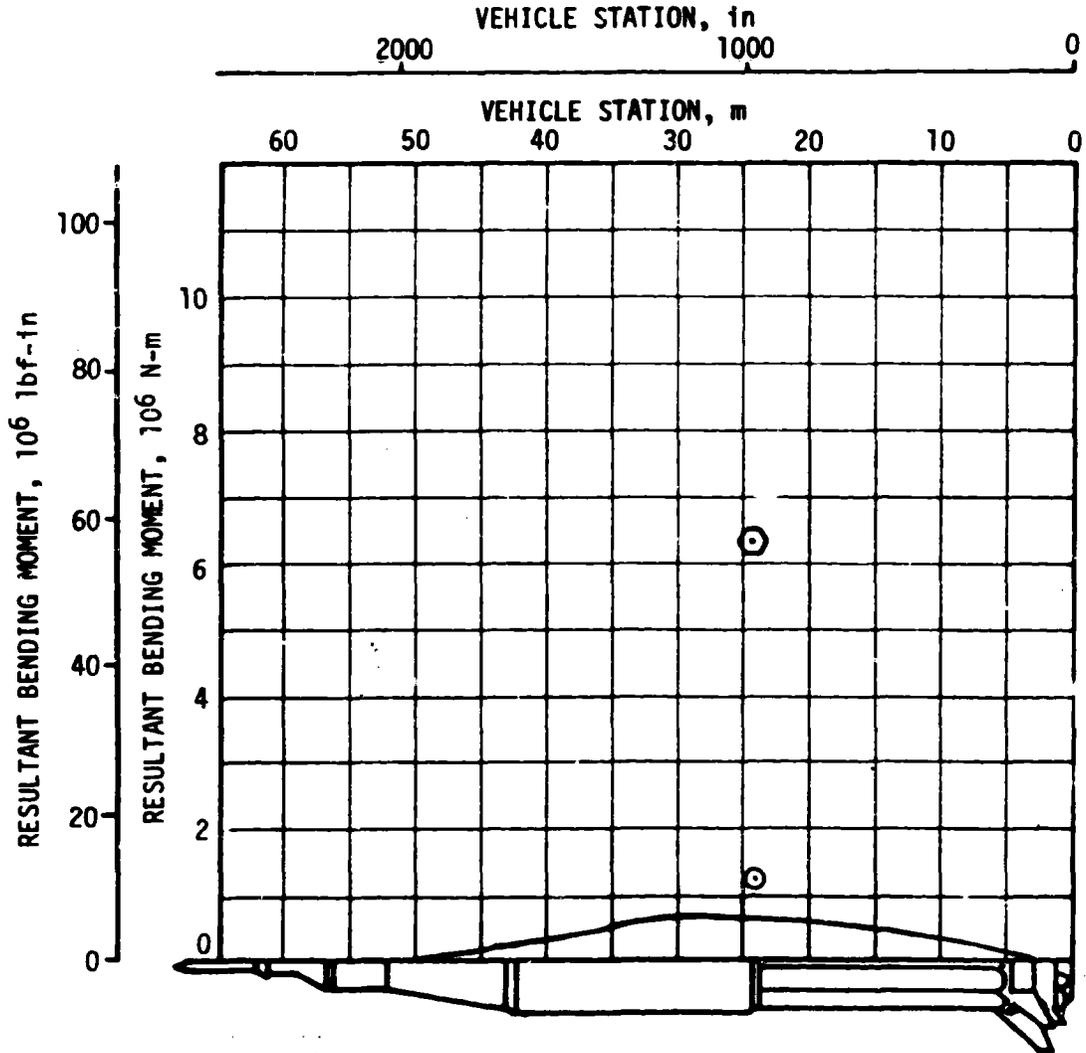
Figure 8-5. SA-207 Resultant Bending Moment Distribution at Time of Maximum Resultant Moment

⊙ BENDING MOMENT  
 DERIVED FROM  
 STRAIN DATA  
 ⬡ DESIGN CRITERION  
 BENDING MOMENT

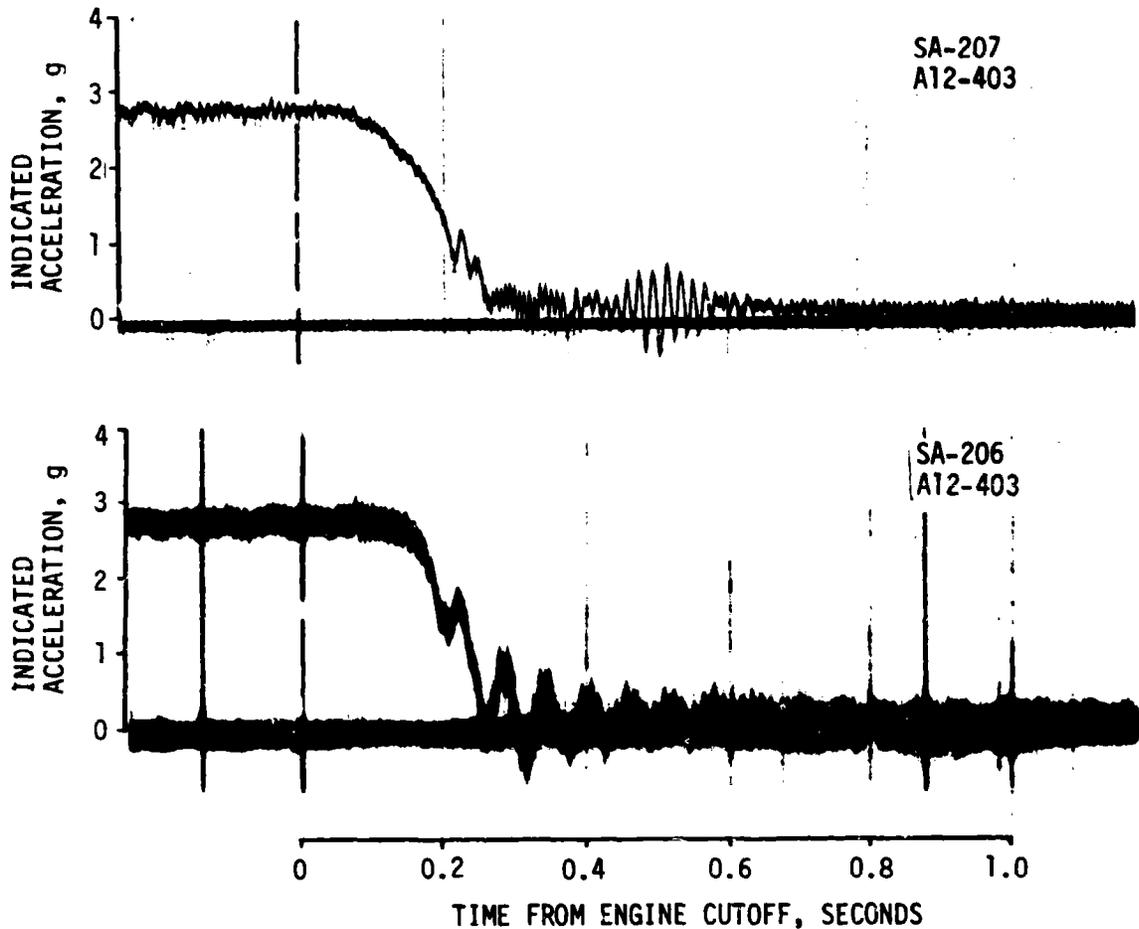
Figure 8-15. S-IVB Cutoff Transients on J-2 Engine Gimbal Block, SA-207 and SA-206

The S-IVB engine cutoff transient produced 55 Hz oscillations on the gimbal block of  $\pm 4.25$  g. Both the frequency and the amplitudes are within the envelope observed during S-IVB cutoff on previous Saturn flights. This cutoff transient caused unusually large vibrations on the IU ST-124 stabilized platform (Figure 9-5) for this time of flight. Attention was originally focused on this phenomenon because the amplitude of the SA-207 transient measured in the IU was greater than that measured on previous flights.

The 55 Hz structural resonance did not degrade the platform performance since it coincides with neither the accelerometer servo loop resonance (35 Hz) nor the platform gimbal system resonance (100-150 Hz). Furthermore, more severe vibration environments have been encountered at liftoff, max q and Mach 1 on this and previous flights.

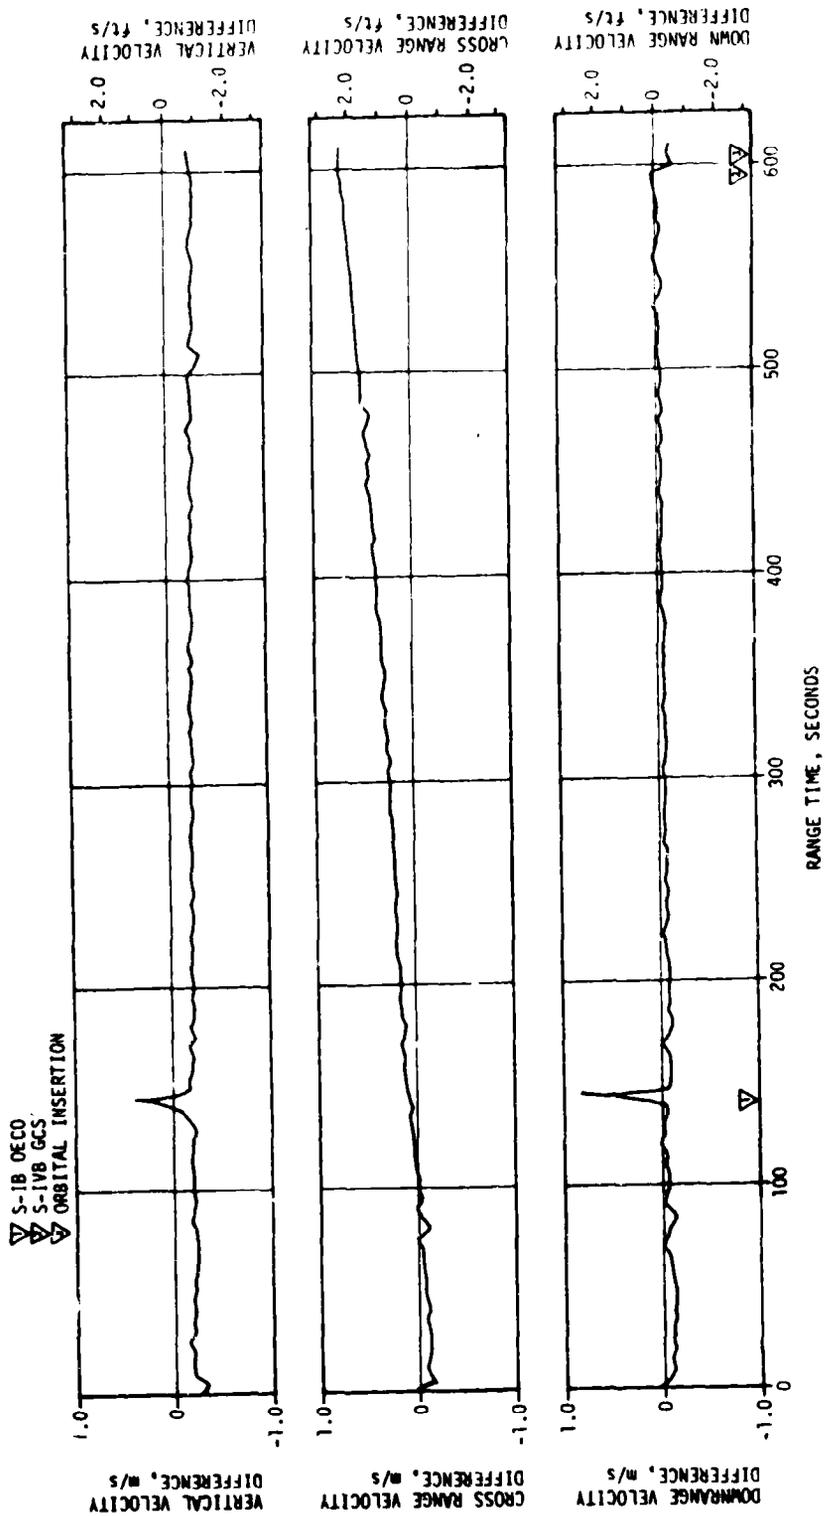
Figure 9-1. SA-207 Trajectory and ST-124M Platform Velocity Comparisons (OMPT Minus LVDC)

Velocity gain due to thrust decay after GCS was 7.37 m/s (24.18 ft/s) compared to 6.72 m/s (22.05 ft/s) predicted by the Operational Trajectory (OT). The oscillations in the accelerometer outputs caused by thrust decay vibration (see paragraph 9.3.2) had no accumulative effect.

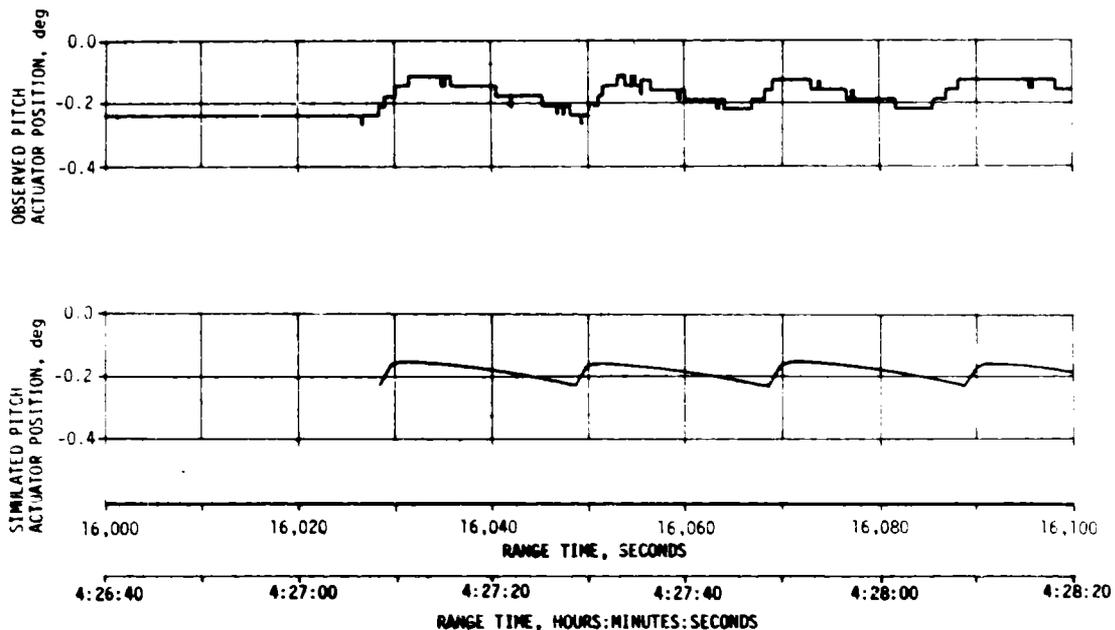
Figure 10-10. Comparison of Measured S-IVB Pitch Actuator Motion with Simulation Incorporating Effects of Stiction

An analog computer simulation of the valve actuator dynamics was implemented to investigate the low amplitude oscillation characteristics of the system with non-linear characteristics in the valve. Stiction (static friction) in the valve spool (due to minute contaminants in the valve), suspected to be the cause of low amplitude oscillations, was included in the simulation. Figure 10-10 presents a comparison of a simulation generated engine position and the actual engine position during auxiliary pump cycle number 6. A small amount of spool stiction (equivalent to 0.01 inch-pounds of torque-motor torque) is all that was required to produce the oscillations. A slight asymmetry in the stiction characteristic was included to achieve the asymmetric engine position trace. These simulation results substantiate the conclusion that spool stiction caused the low amplitude oscillations observed and that the level of this stiction was quite low, having a negligible effect on system performance at higher amplitudes such as during powered flight or during deorbit dump.

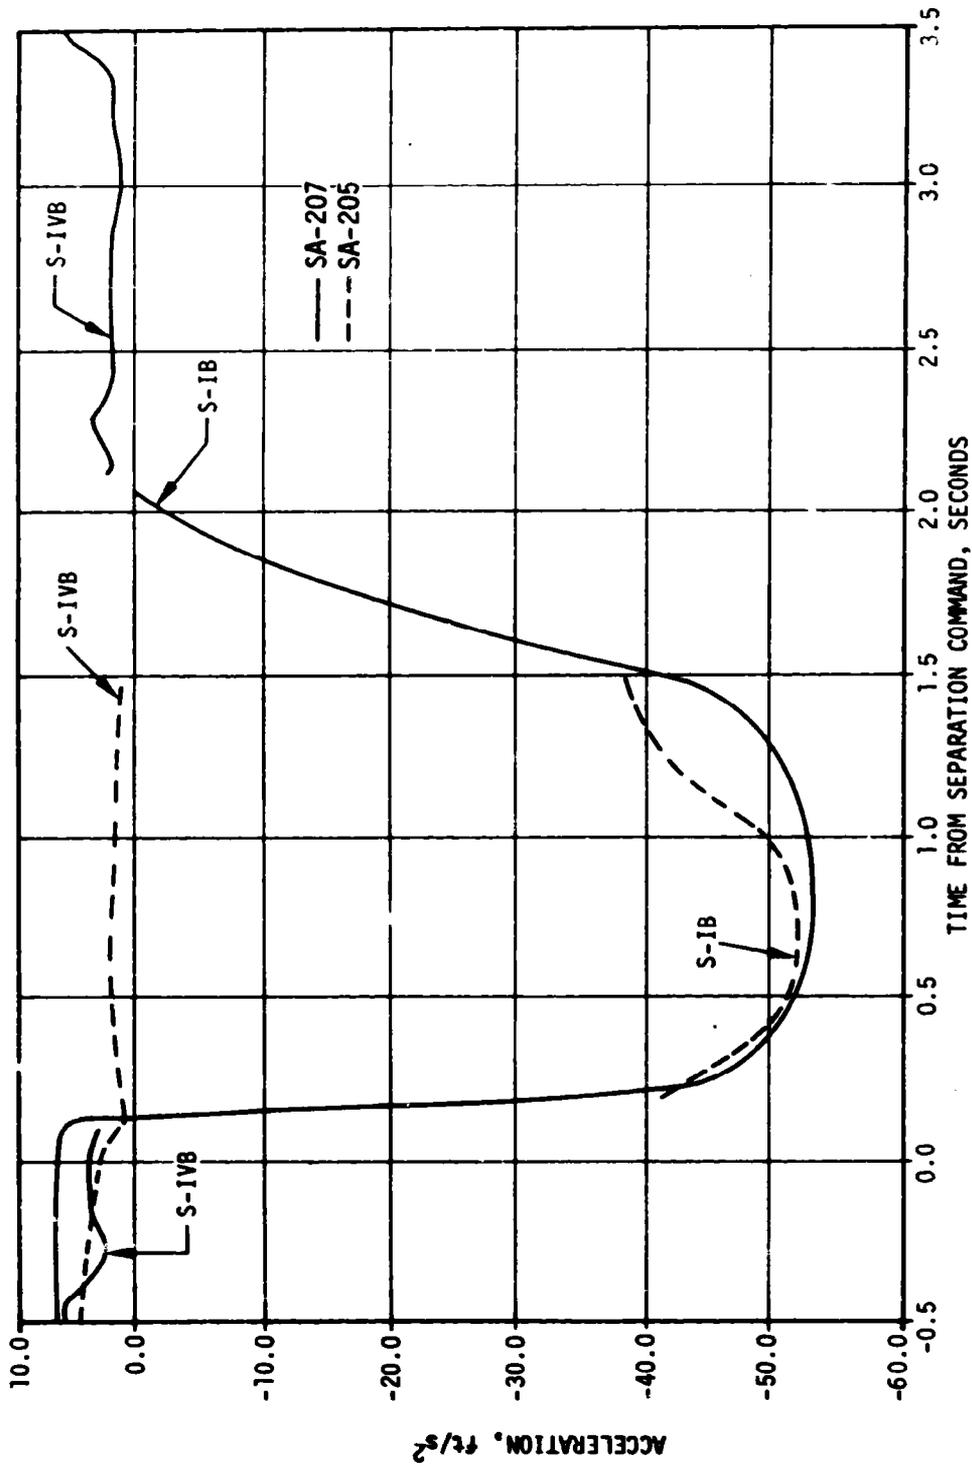
Figure 10-12. S-IB/S-IVB Longitudinal Acceleration During Separation

S-IVB/CSM separation was accomplished on SA-207 with the vehicle in the in-plane local horizontal attitude with an orbital pitch rate of approximately  $-0.068$  degrees/second. S-IVB disturbances due to spacecraft separation were first observed at 1080.6 seconds (00:18:00.6) on APS engine firing data. However, disturbances may have occurred earlier, but were not evidenced due to data dropout during separation. The S-150 experiment deployment sequence which is referenced to S-IVB/CSM separation indicates that S-IVB/CSM separation occurred at approximately 1080.4 seconds (00:18:00.4). Maximum vehicle rates following separation were 0.09 degrees/second pitch,  $-0.09$  degrees/second yaw, and 0.0 degrees/second roll. APS firings occurred for approximately 30 seconds following separation in response to separation-induced disturbances.

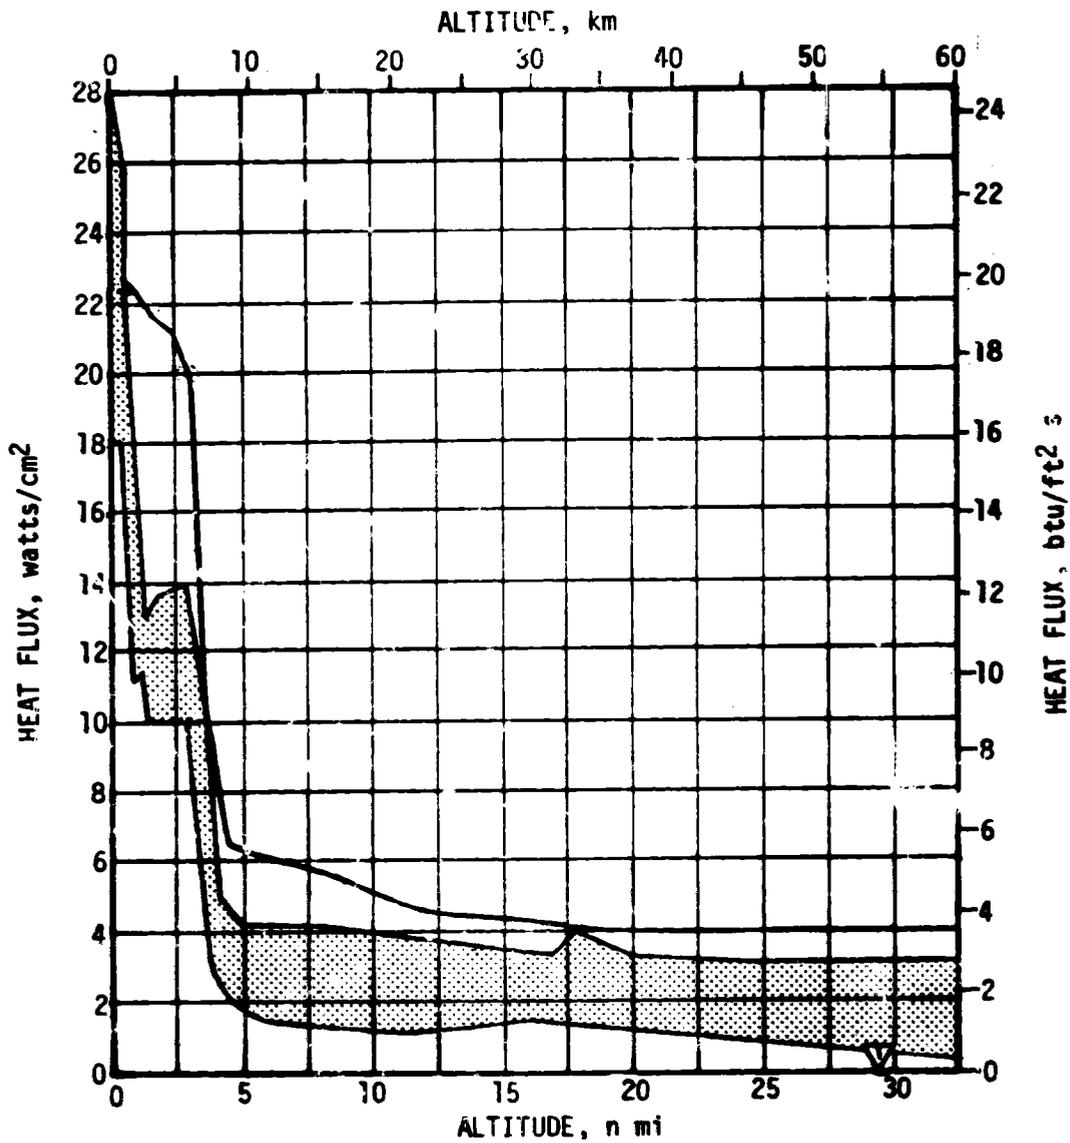
Figure 13-7. S-IB Stage Flame Shield Radiation Heating Rate

SA-203 THRU SA-206 DATA BAND  
 SA-207 DATA  
 IECG

The thermal environment measured in the SA-207 S-IB base region has been compared with corresponding data from flights SA-203 through SA-206. With the exception of the flame shield radiation heating data (measurement C0603-006), these comparisons show excellent agreement. Two possible causes which would allow more radiation from the engine exhaust plume to reach the flame shield radiometer are, reduction in opacity of the turbine exhaust gas or sustained local burning of the turbine exhaust gases. Neither of these provide a completely satisfactory explanation, but reduced local opacity is the most probable. In all areas the measured thermal environments in the base region of SA-207 were well below the S-IB stage design level.

- a. A reduction in opaqueness of the turbine exhaust gas would allow more radiation to be detected. However, because a comparable deviation was not detected by the total calorimeter, it would be necessary for such a reduction to have been localized; producing a much greater effect in the vicinity of the radiation calorimeter.

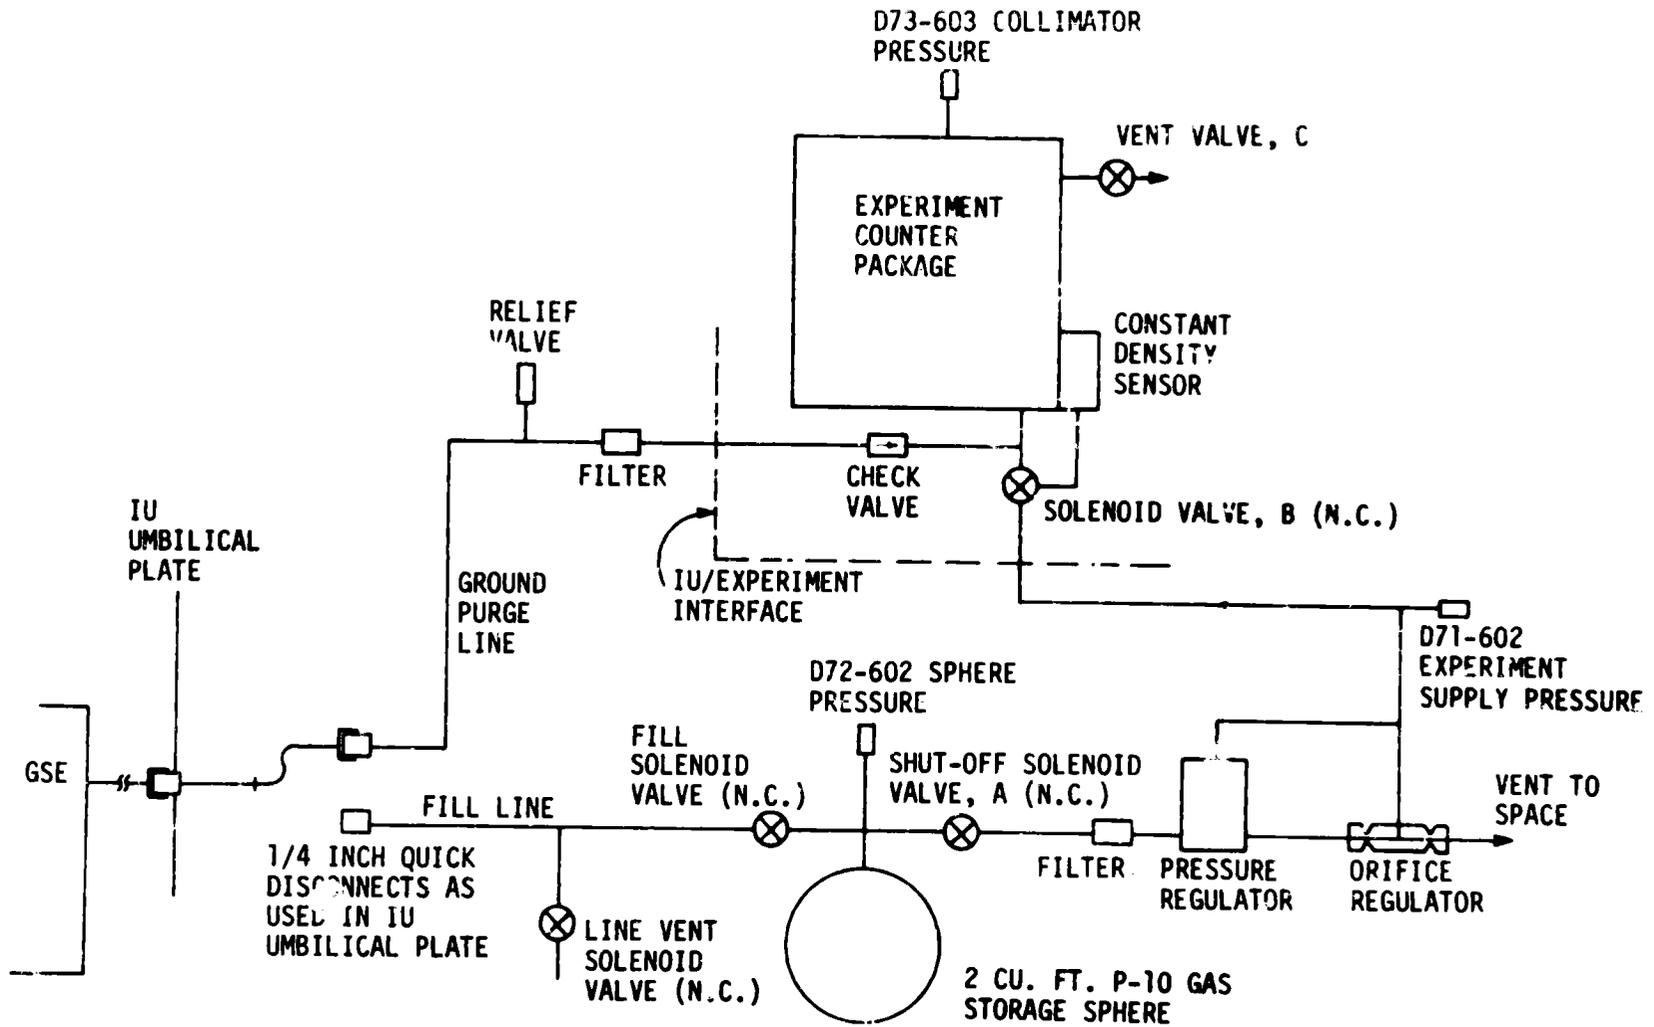
Figure 18-1. P-10 Gas Supply System Schematic

System operation was initiated at 0:23:35 when programmed switch selector commands opened the high pressure supply solenoid valve A and powered on the S-150 sensor. The S-150 control valve B opened fully at this time and the counter package began filling with gas. Deployment of the experiment sensor was initiated with firing of the pyrotechnic devices at approximately 0:24:14. At approximately 0:24:22, the sensor was fully deployed against its mechanical stop. Filling of the control package continued at the predicted rate, and at approximately 0:29:44, the experiment counter collimator pressure D73-603 approached the desired operating pressure, and the S-150 control valve B went from full open to cyclic mode of operation. By 0:31:30 the supply pressure at the S-150 interface (measurement D71-602) had reached operating pressure.
