Morgan and Little Creeks Local Watershed Planning Initiative

Meeting Announcement & Summary

January 15, 2003 meeting at the Totten Center, NC Botanical Garden

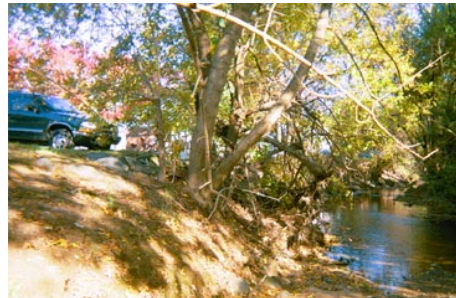
Bolin Creek at University Mall

- Stripped of vegetation, sewer crossing present, riprap, mowing to the creek, sediment is obvious
- Chapel Hill Golf Course: instream pollution, algae, evidence of nutrient inputs
- Severe bank erosion in Bolinwood

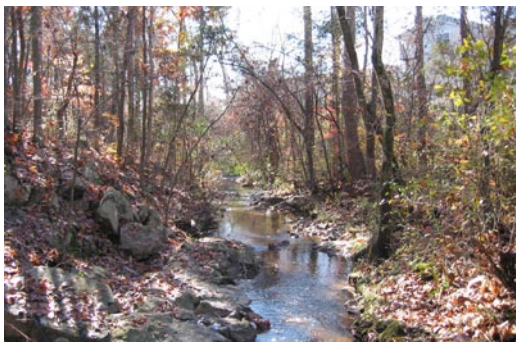
Tom's Creek

- Morgan Creek: Kings Mill, good-looking floodplain is forested
- Tom's Creek: behind the shopping center portions look good and stable, bedrock is visible

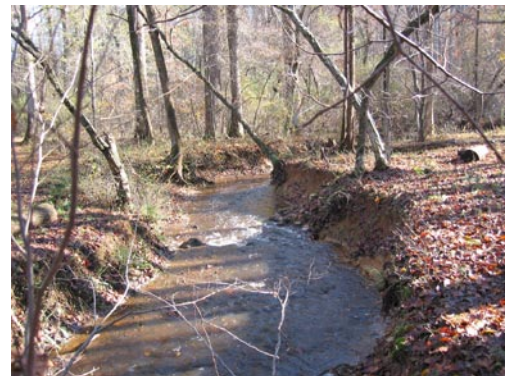
Morgan Creek Tributary

- Unnamed tributary to Morgan Creek: incised banks although it's forested, stream is entrenched
- Dairy Farm: cattle in the stream, banks eroded.
