WAR DEPARTMENT
OFFICE OF CHIEF OF ENGINEERS
MILITARY ENGINEERING DIVISION
TECHNICAL INTELLIGENCE BRANCH

RHINE RIVER CROSSINGS

FIRST UNITED STATES ARMY

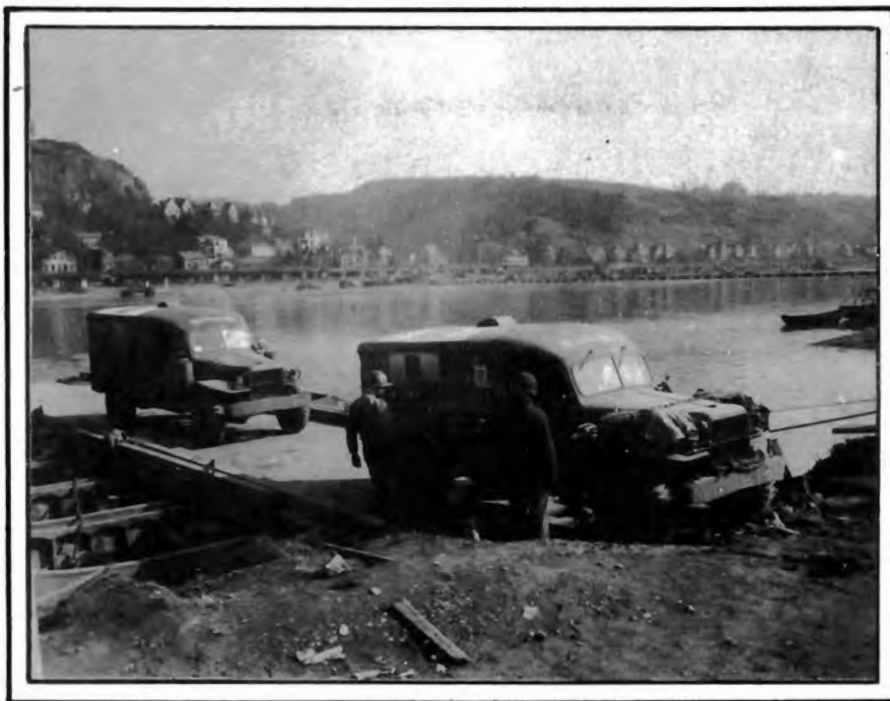
6 PONTON FERRY RAFT

Unloading ambulances on West bank of RHINE
River at KRIPP, GERMANY on 12 March 1945.

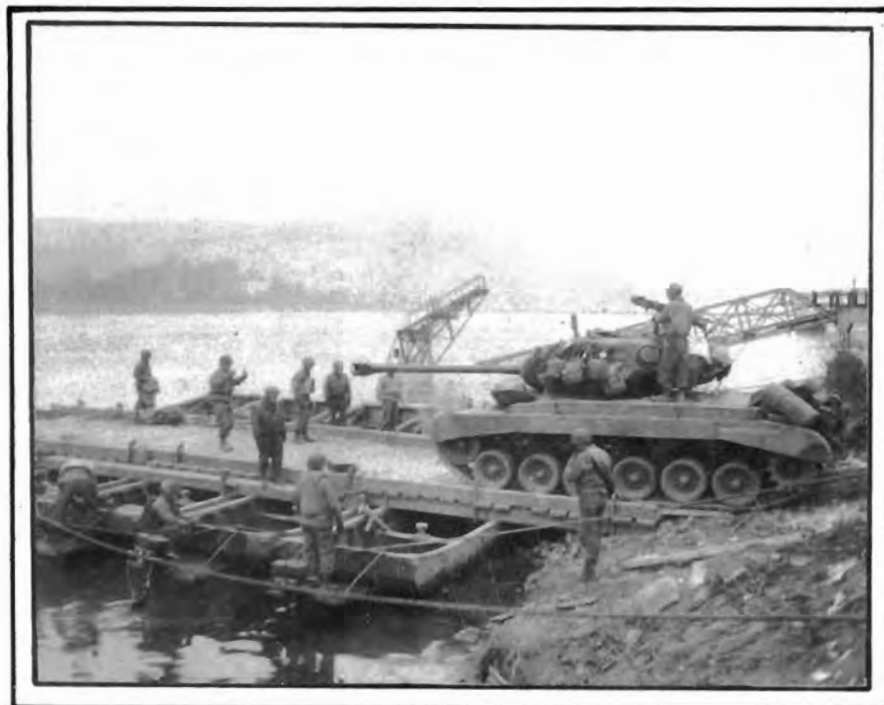
REINFORCED 5 PONTON FERRY RAFT

Loading M-26 tank on West bank of RHINE
River at REMAGEN, GERMANY on 12 March 1945.

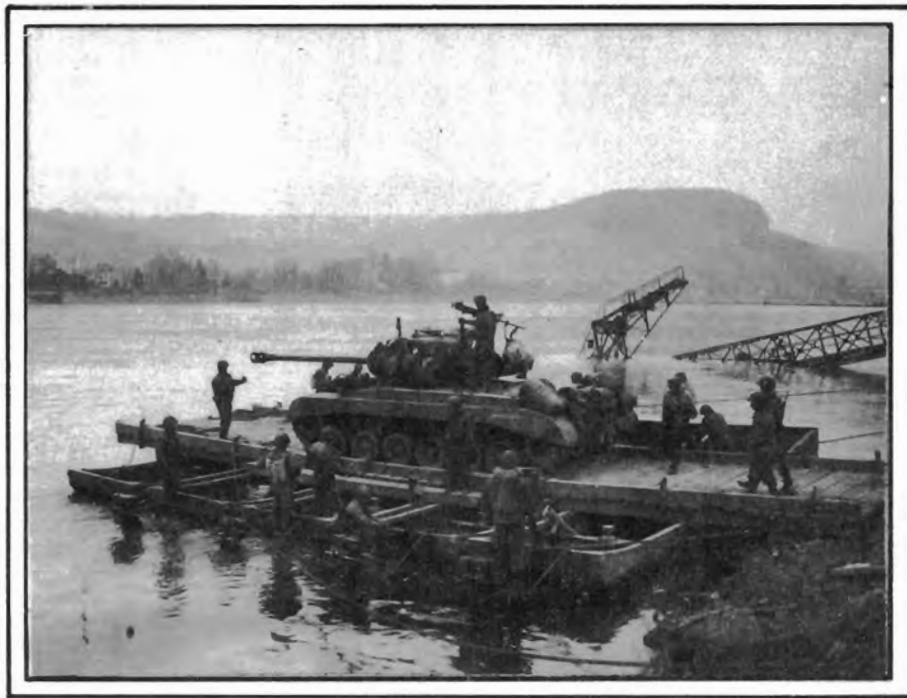
REINFORCED 5 PONTON FERRY RAFT

Loading M-26 tank on West bank of RHINE River at REMAGEN, GERMANY on 12 March 1945. Note 4 22 HP outboard motors and landing deck.

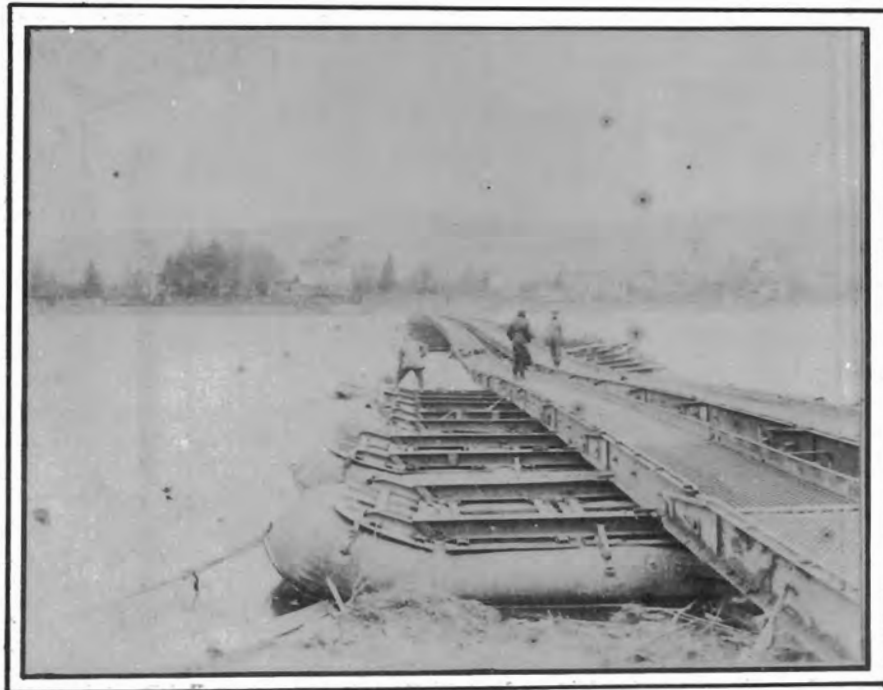
M-2 STEEL TREADWAY BRIDGE

Looking EAST from REMAGEN, Germany.
Photo shows 5 damaged floats.

Very little maintenance was needed on the completed bridge, other than that necessary to replace floats damaged by artillery fire. Four (4) partially inflated floats were kept in the water on the west bank as reserve at all times. Floats were partially inflated in order to permit their placement under the treadways of the constructed bridge.

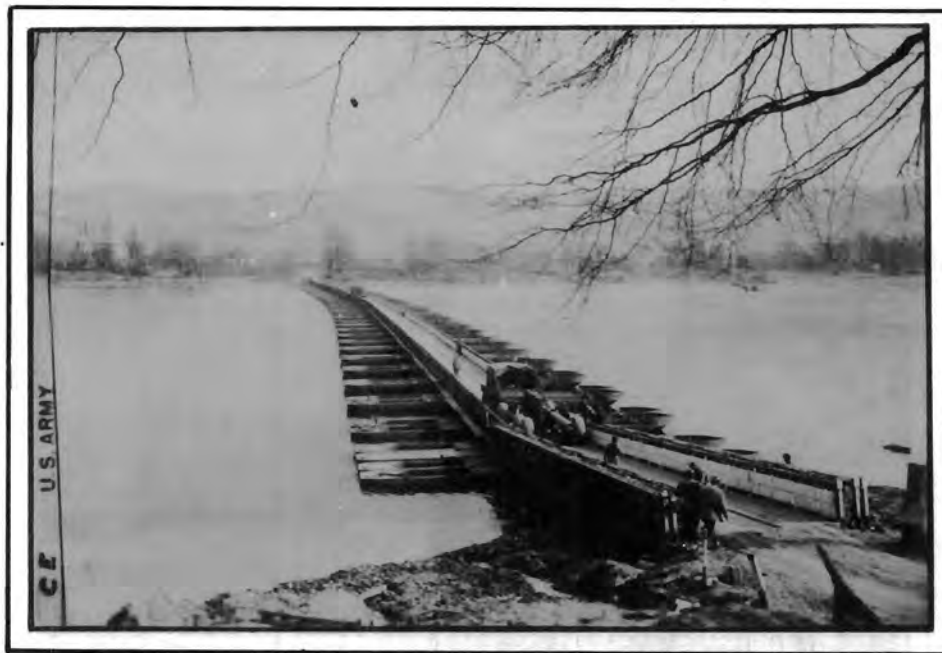
CLASS 40 BAILEY BRIDGE

RETAGEN, Germany. Completed bridge showing WEST bank approach. NOTE hub guards on panels and absence of standard ribbands.

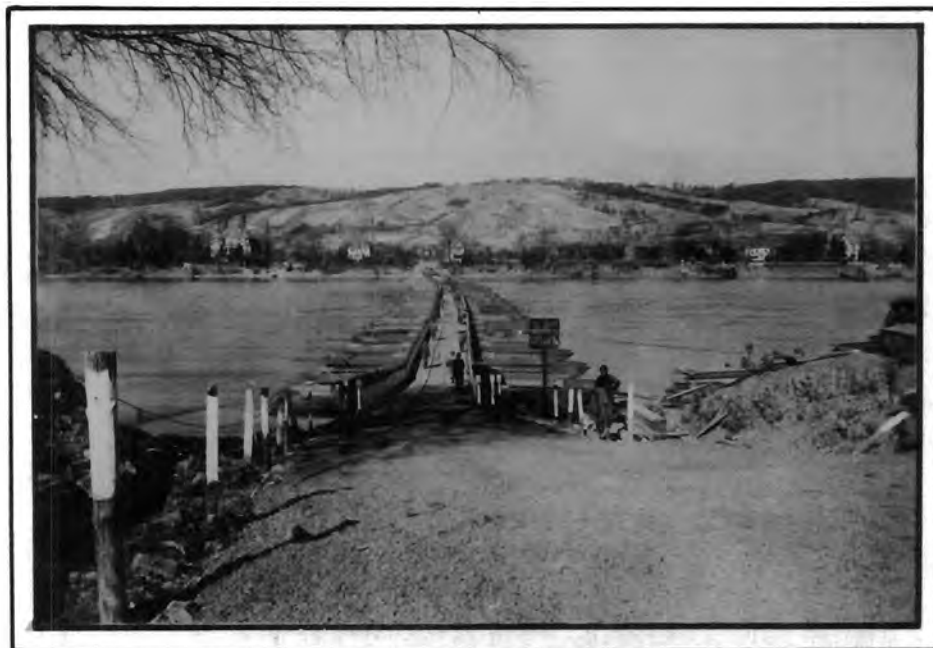
CLASS 40 BAILEY BRIDGE

RETAGEN, Germany. Completed bridge showing WEST bank approach road. NOTE slight upstream bow of bridge.

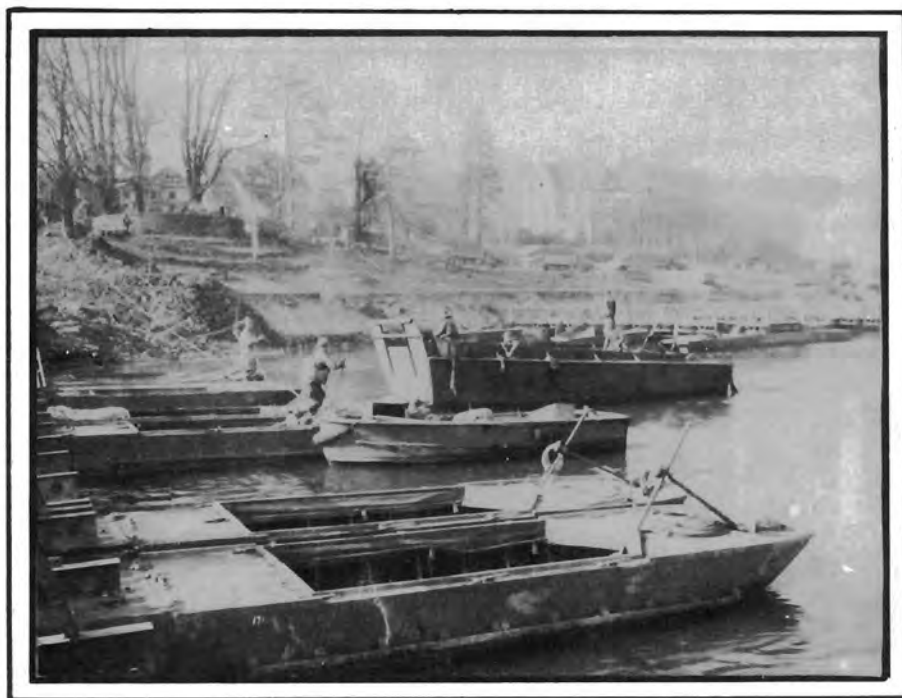
CLASS 40 BAILEY BRIDGE

REMAGEN, Germany. LVP preparing to tow 30 ft.
floating section into position. LVP were ex-
cellent work boats in the swift current.

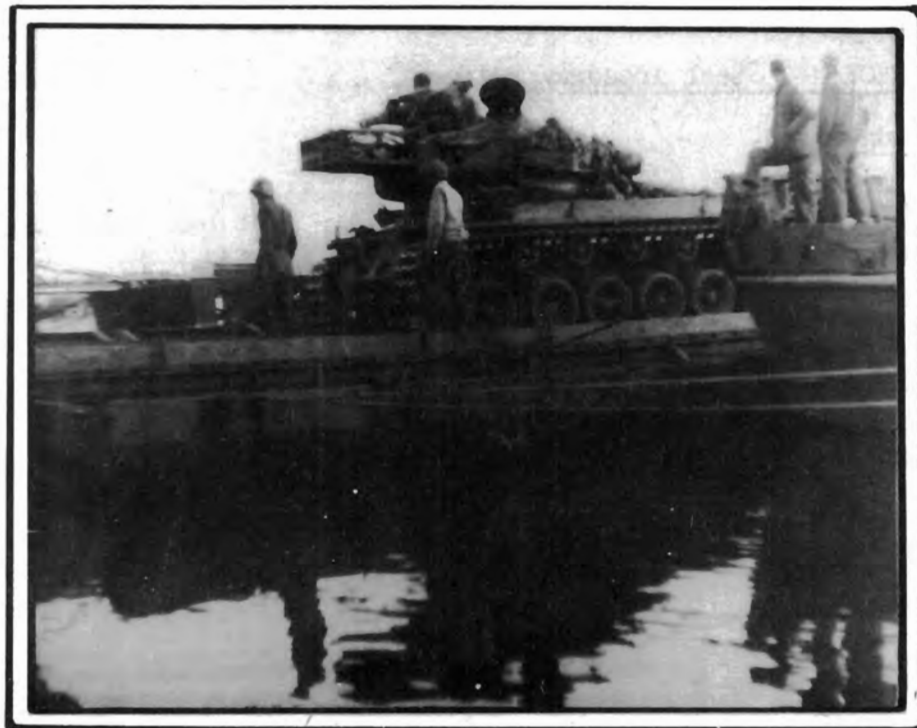
REINFORCED 6 PONTON RAFT

Ferrying M-26 tank. Ferry is propelled by one LCVP.

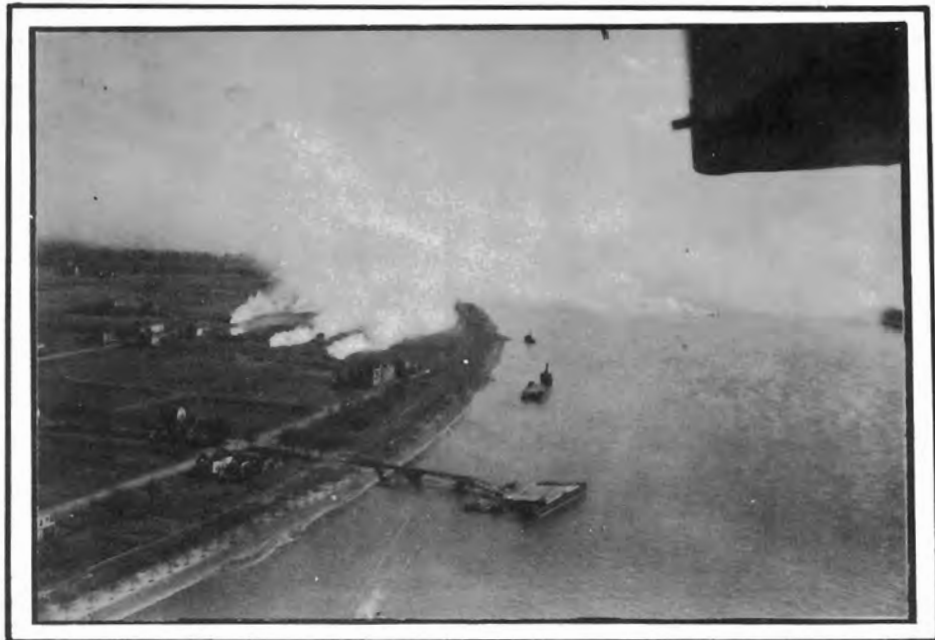
M-2 STEEL TREADWAY BRIDGE

BONN, Germany. Air view showing screening effect of fixed and floating smoke generators. Floating smoke generators were mounted in storm boats.

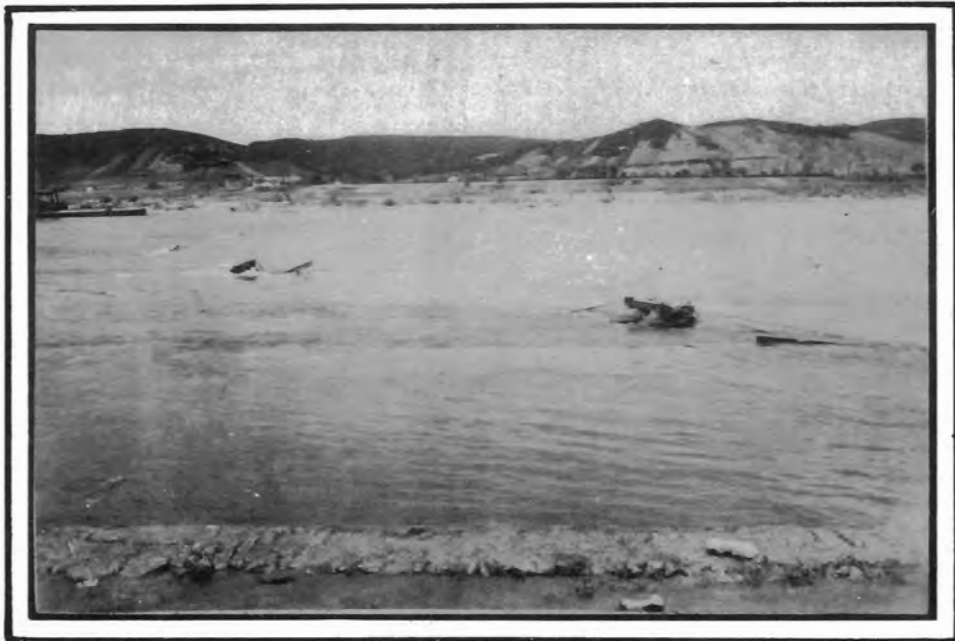
Impact boom with center sections partially submerged.

b. Impact Boom. This boom was constructed and launched as described in paragraph 5 b. At this site, however, the nature of the gravel riverbed, caused all standard anchors to creep and shift. This anchorage problem was solved by the use of the Bailey rubble box anchors described in paragraph 4.

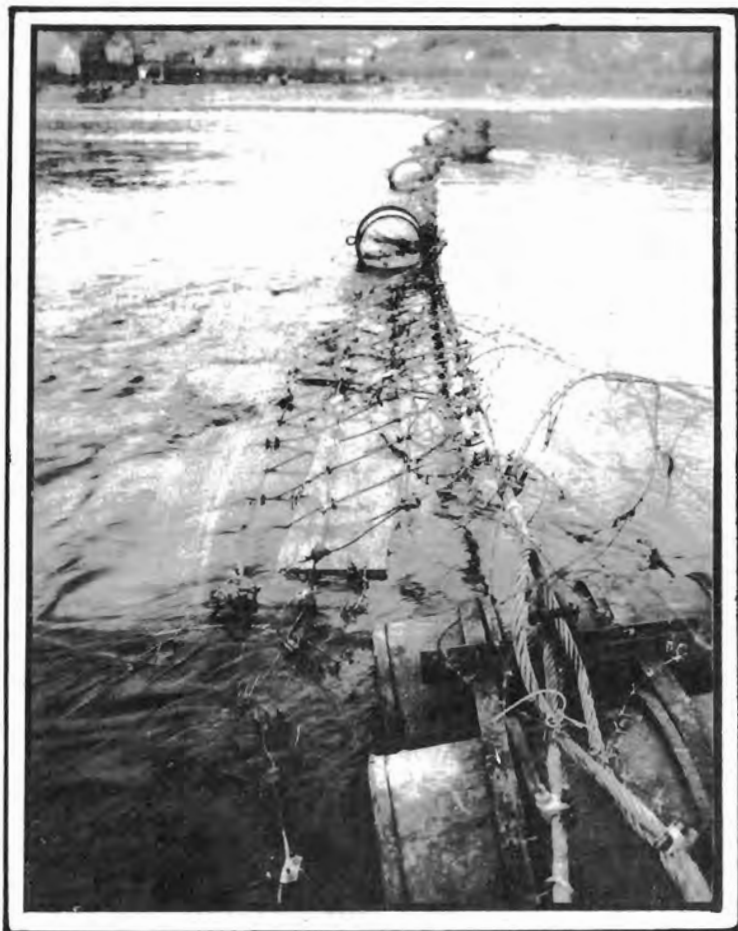
Debris gathered in 12 hours showing tendency to float net up. Note concertina beaten down by debris.

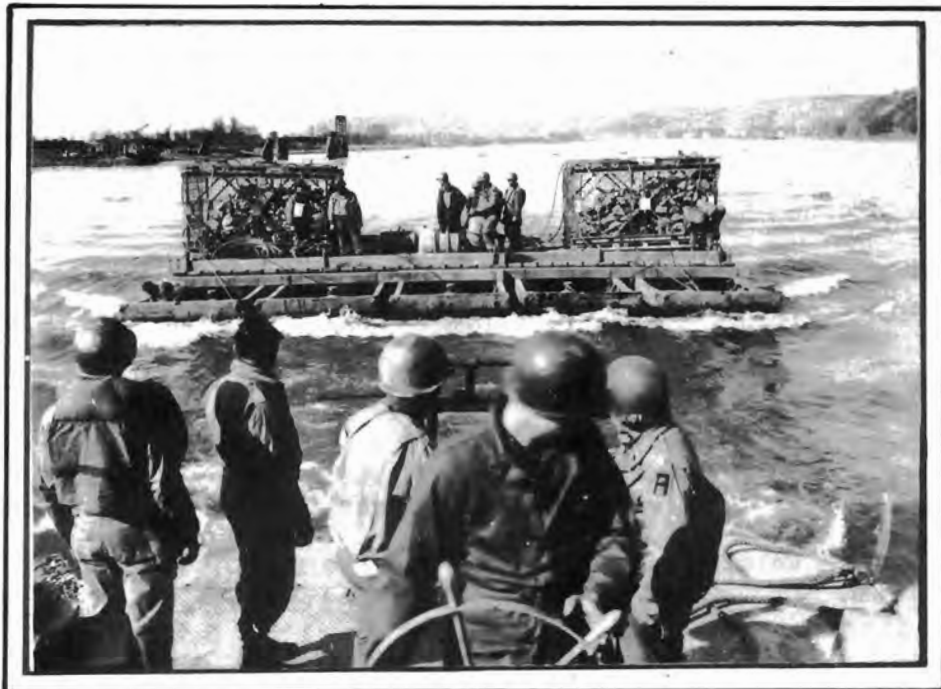
Sea mule towing ponton raft loaded with two Rubble Box anchors. Note high bow wave set up and small amount of free board left.

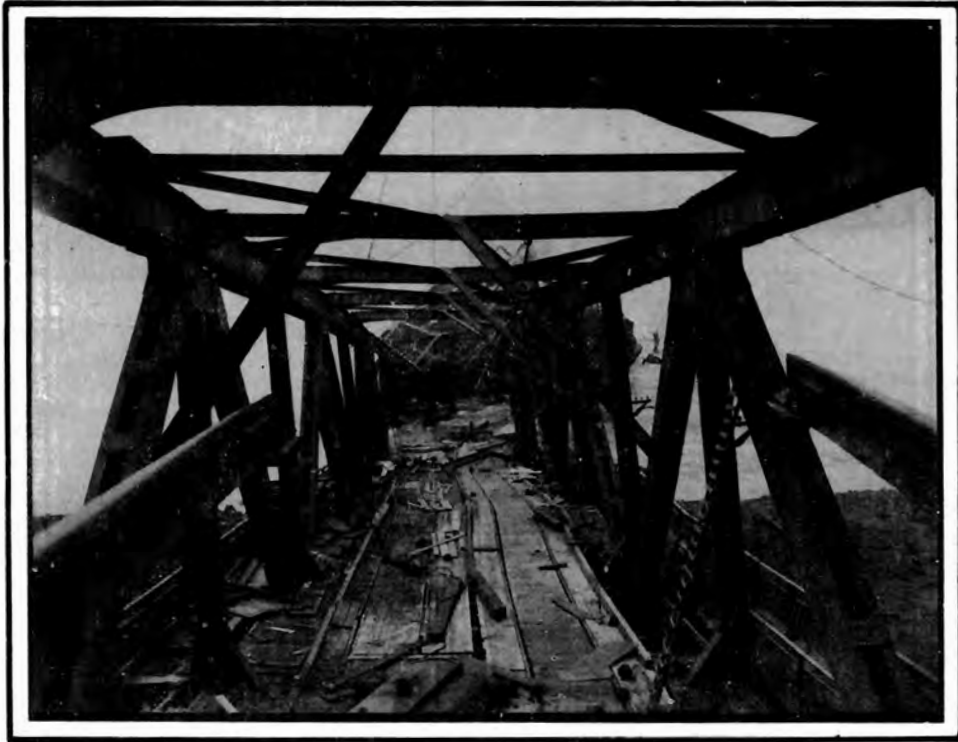
View of collapsed north span with north pier in the distance.
