U.S. NAVY SHIP SALVAGE MANUAL

VOLUME II

SUBMARINE SALVAGE

**OFFICE OF THE SUPERVISOR OF SALVAGE, U. S. NAVY
NAVAL SHIP SYSTEMS COMMAND
WASHINGTON, D. C.
1970**

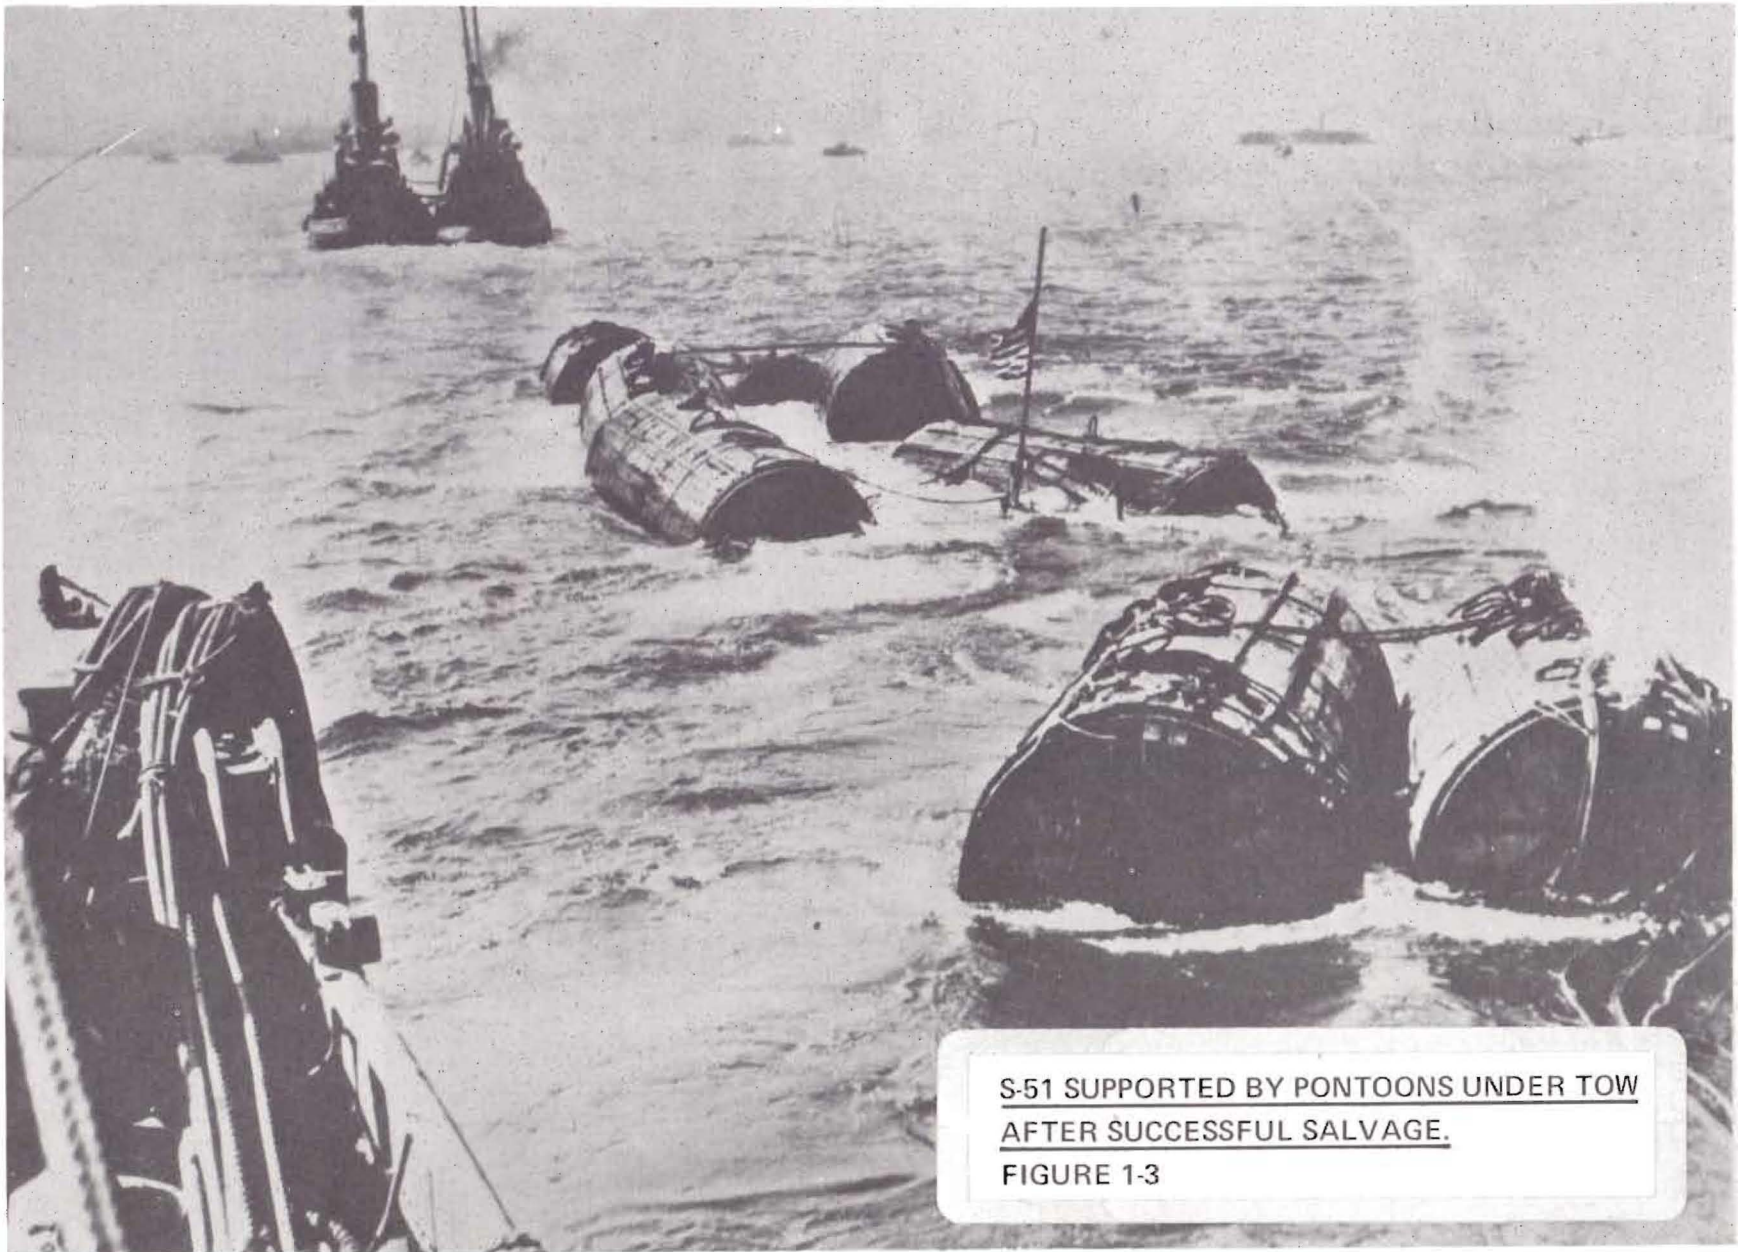
FIGURE 1-3

S-51 SUPPORTED BY PONTOONS UNDER TOW
AFTER SUCCESSFUL SALVAGE.

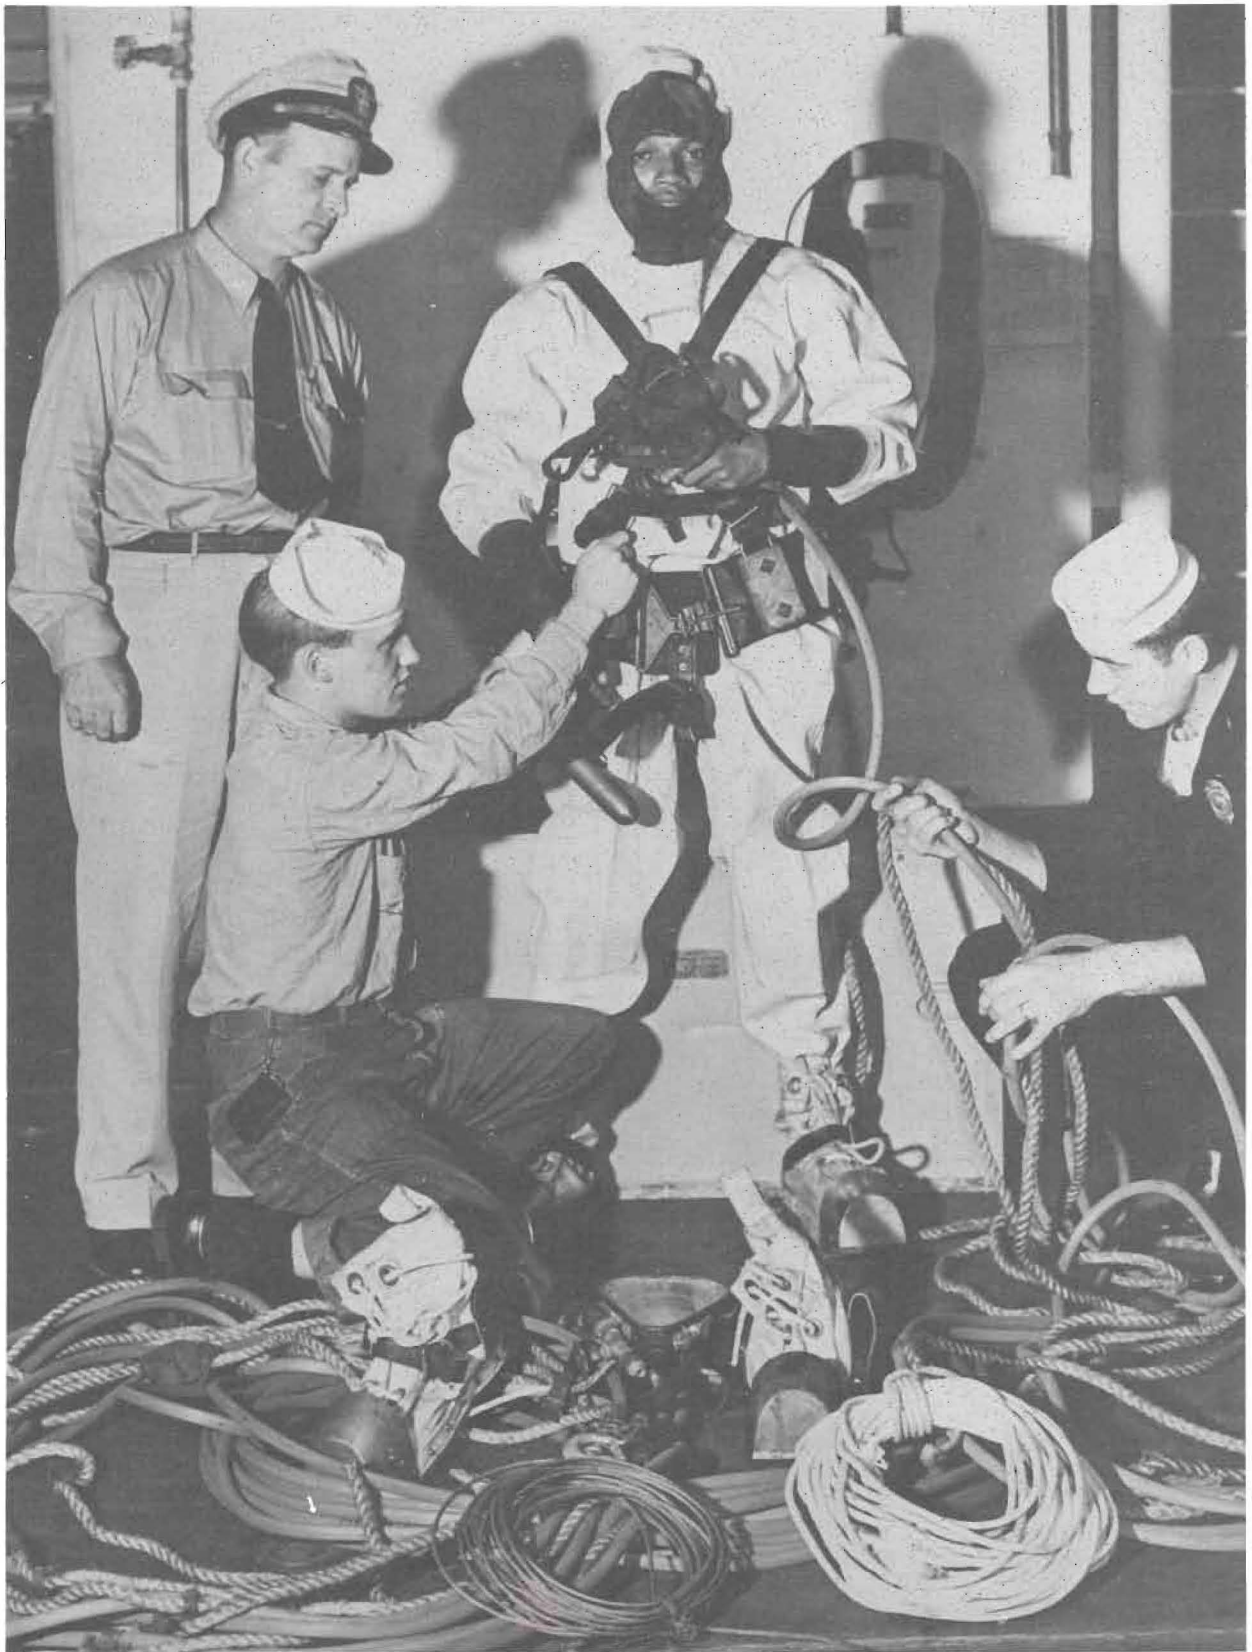
LIGHTWEIGHT AIR DIVING RIG.
FIGURE 2-4

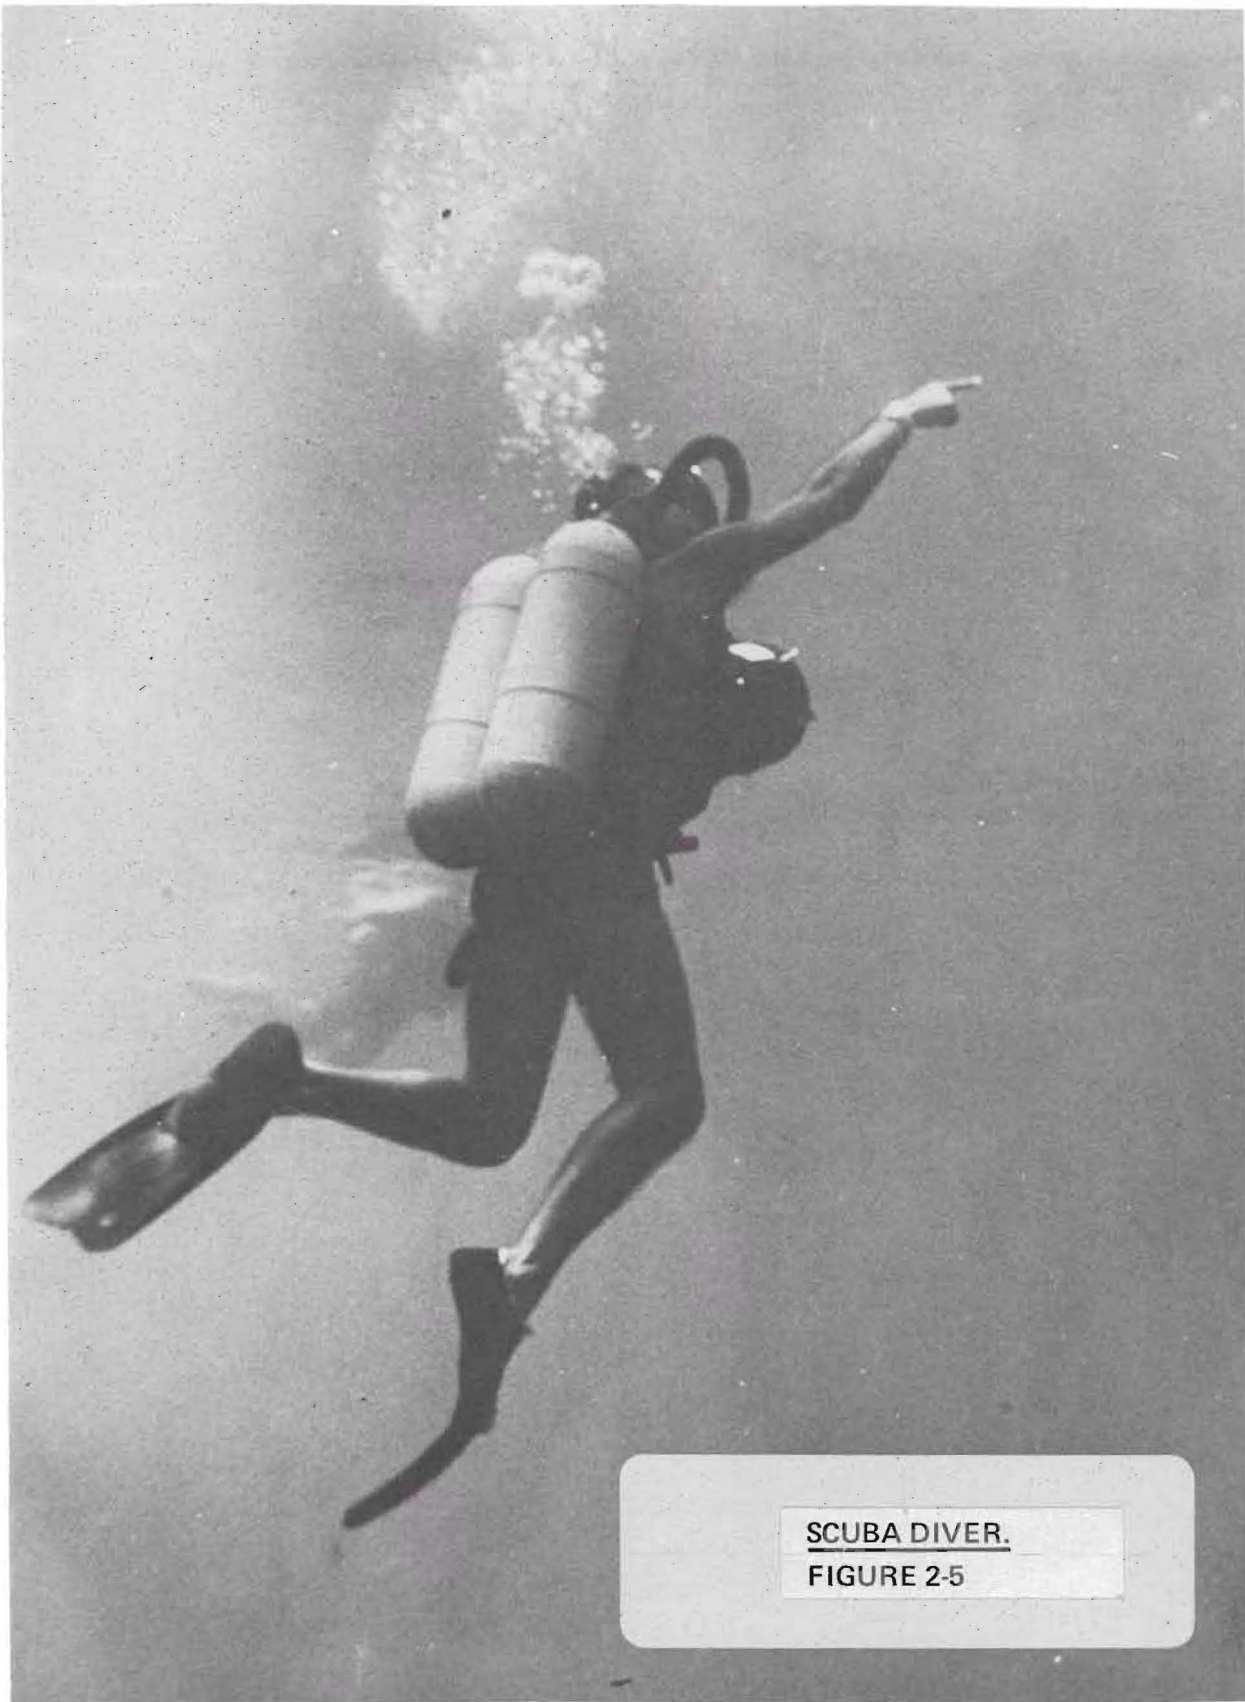
SCUBA DIVER.
FIGURE 2-5

The demand type (open circuit) breathing apparatus is the simplest type and the one most frequently used. The diver carries large cylinders of compressed air on his back and breathes through a mouthpiece (Figures 2-5 and 2-6).

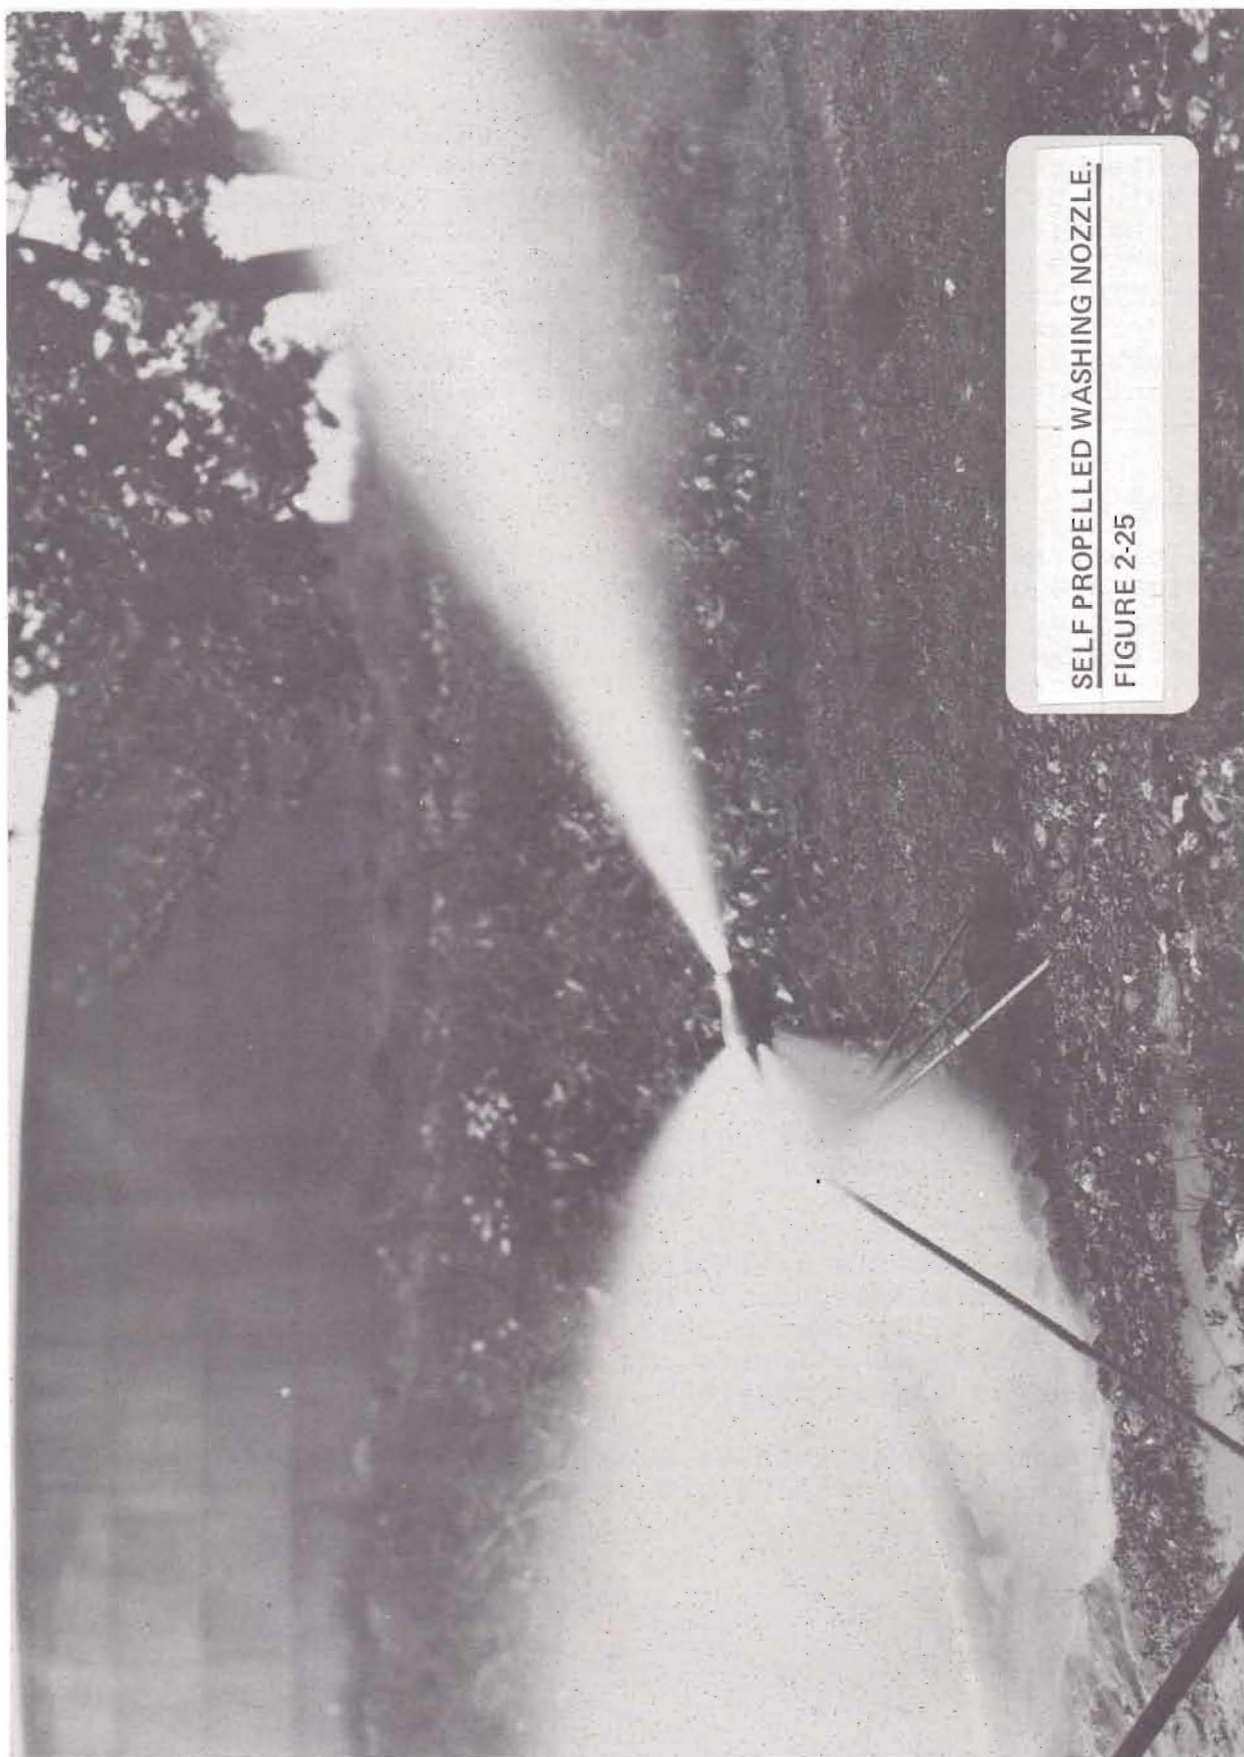
SELF PROPELLED WASHING NOZZLE.
FIGURE 2-25

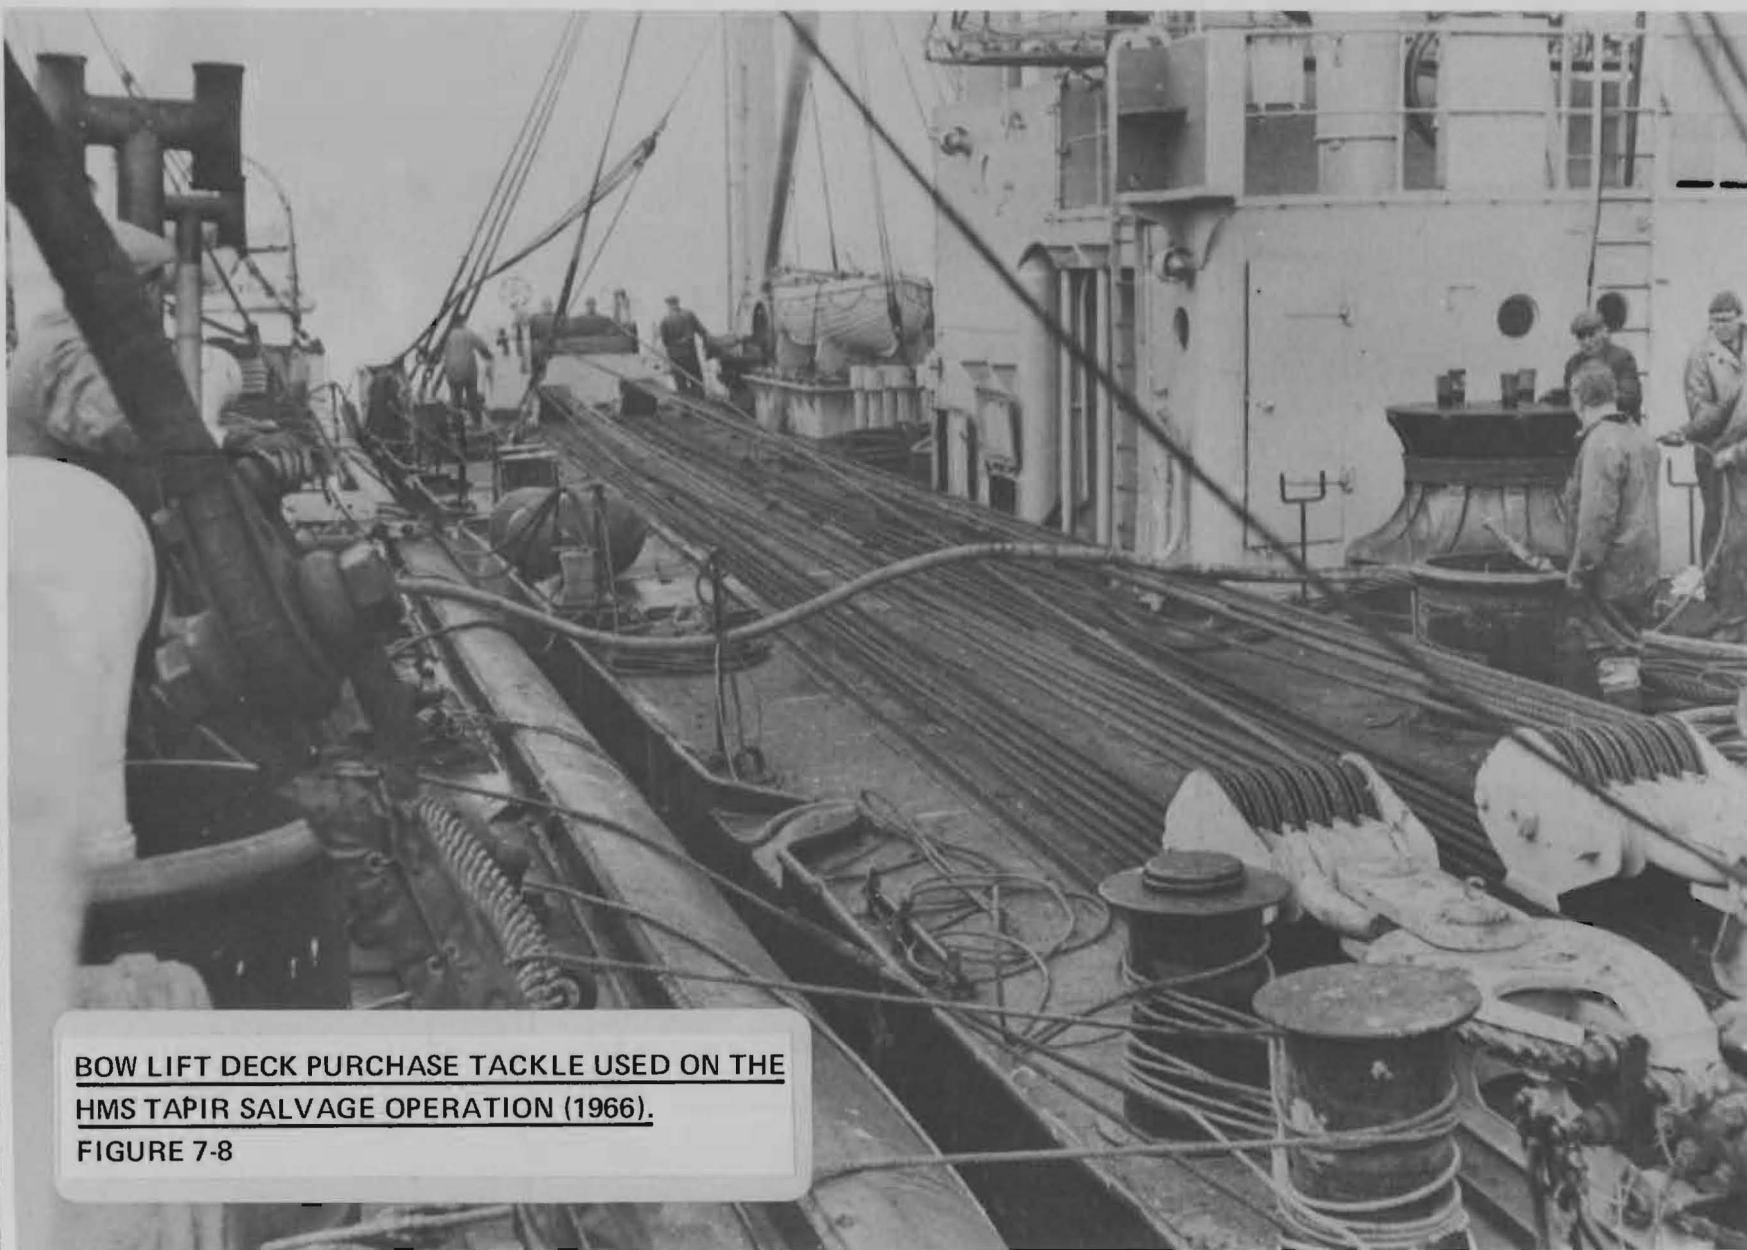
BOW LIFT DECK PURCHASE TACKLE USED ON THE
HMS TAPIR SALVAGE OPERATION (1966).

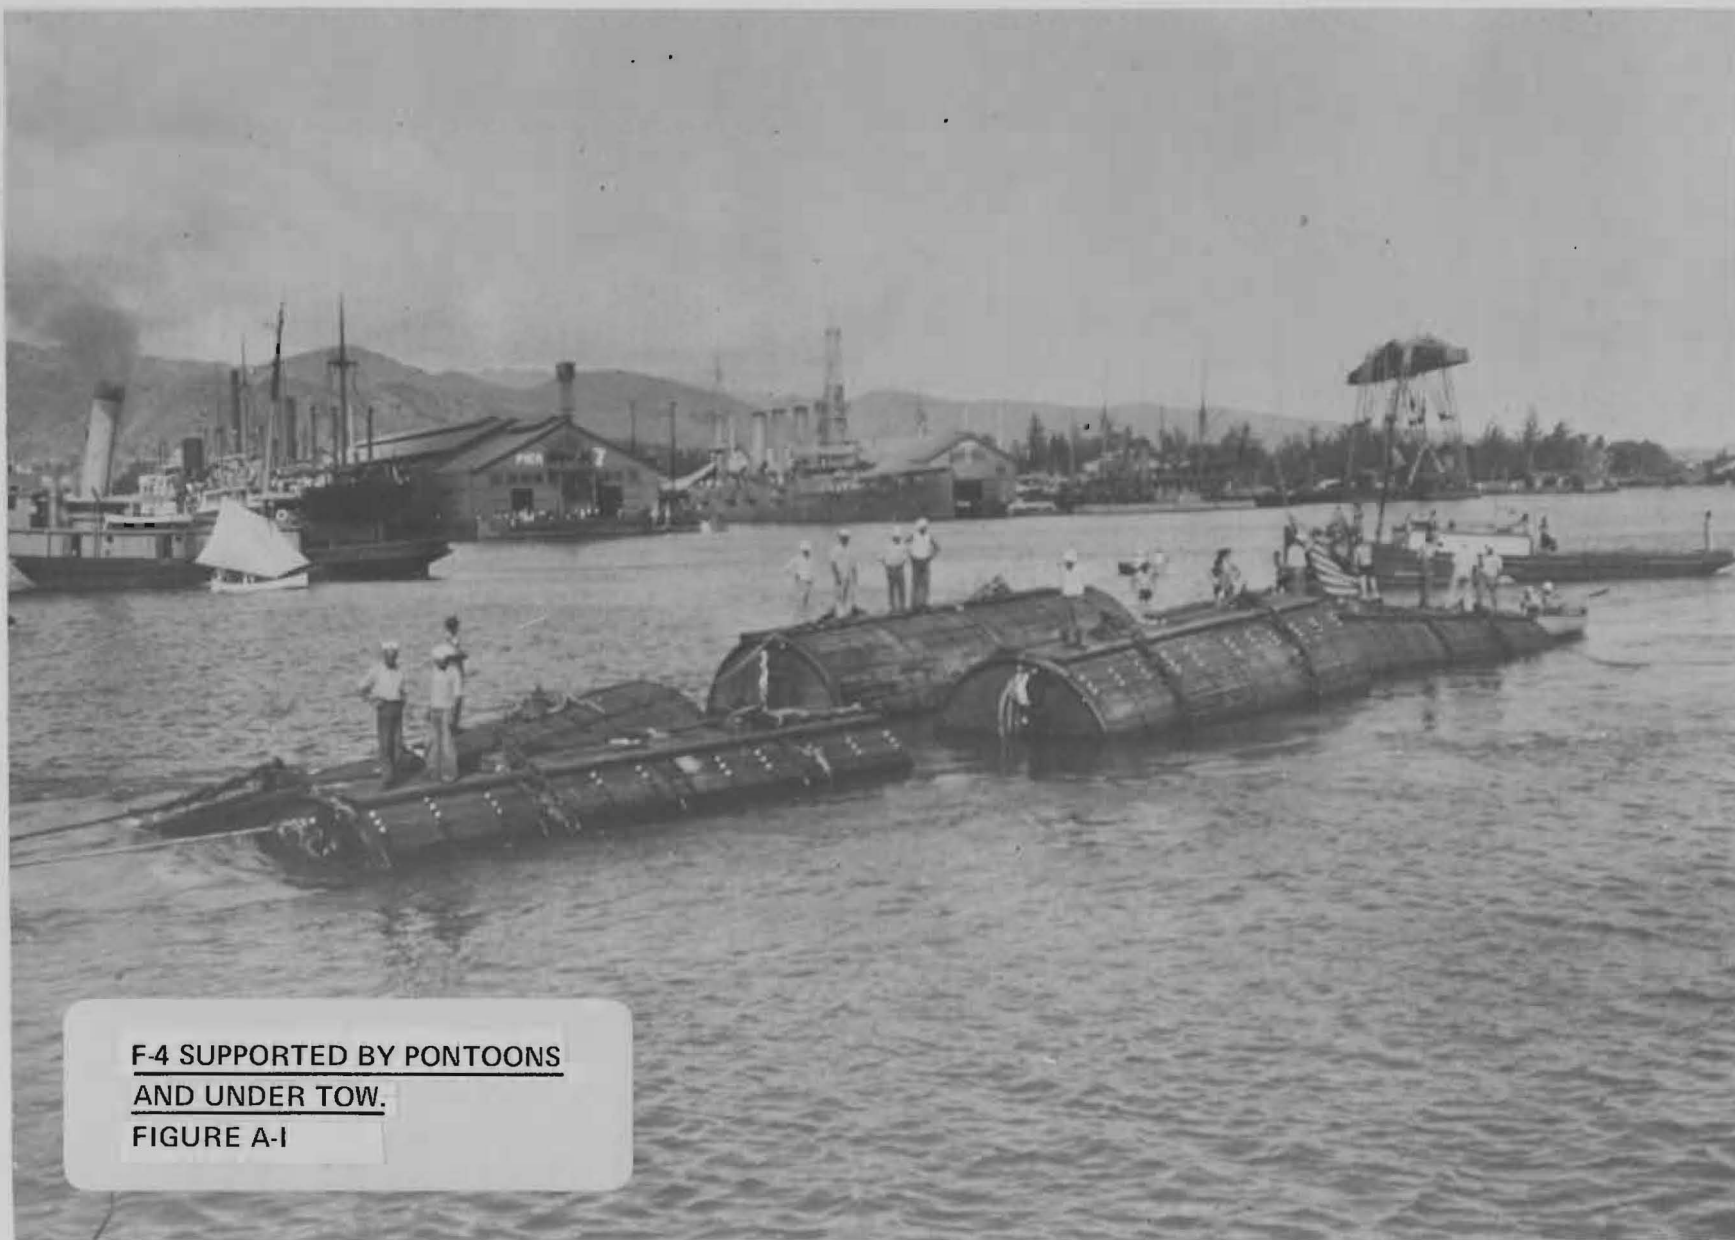
F-4 SUPPORTED BY PONTOONS
AND UNDER TOW.
FIGURE A-1

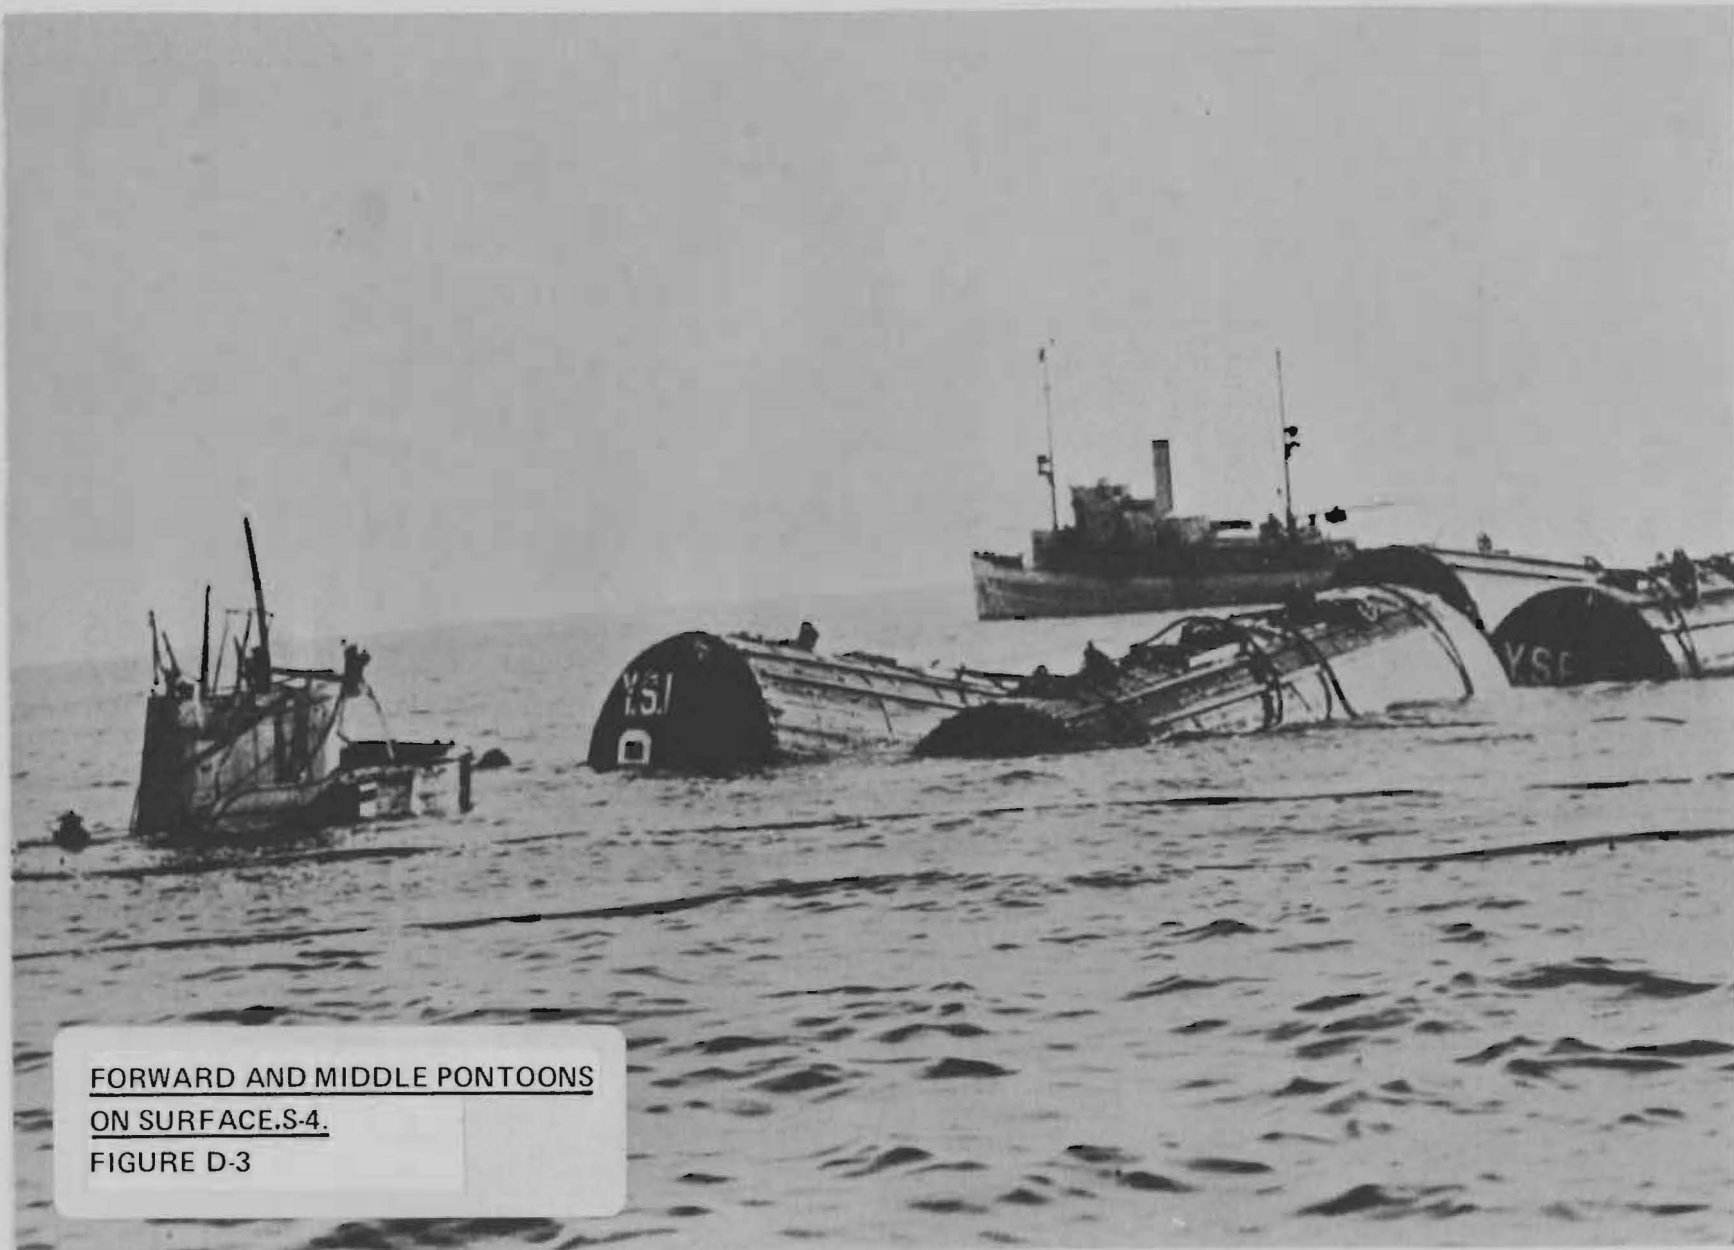
FORWARD AND MIDDLE PONTOONS
ON SURFACE.S-4.
FIGURE D-3

The bow buoyancy tank was blown by placing a hook pipe on the end of a blowing hose in one of the flooding holes and blowing it. A hole was cut in the bottom of the forward trim tank and it was blown by putting the hooked pipe in this hole also.

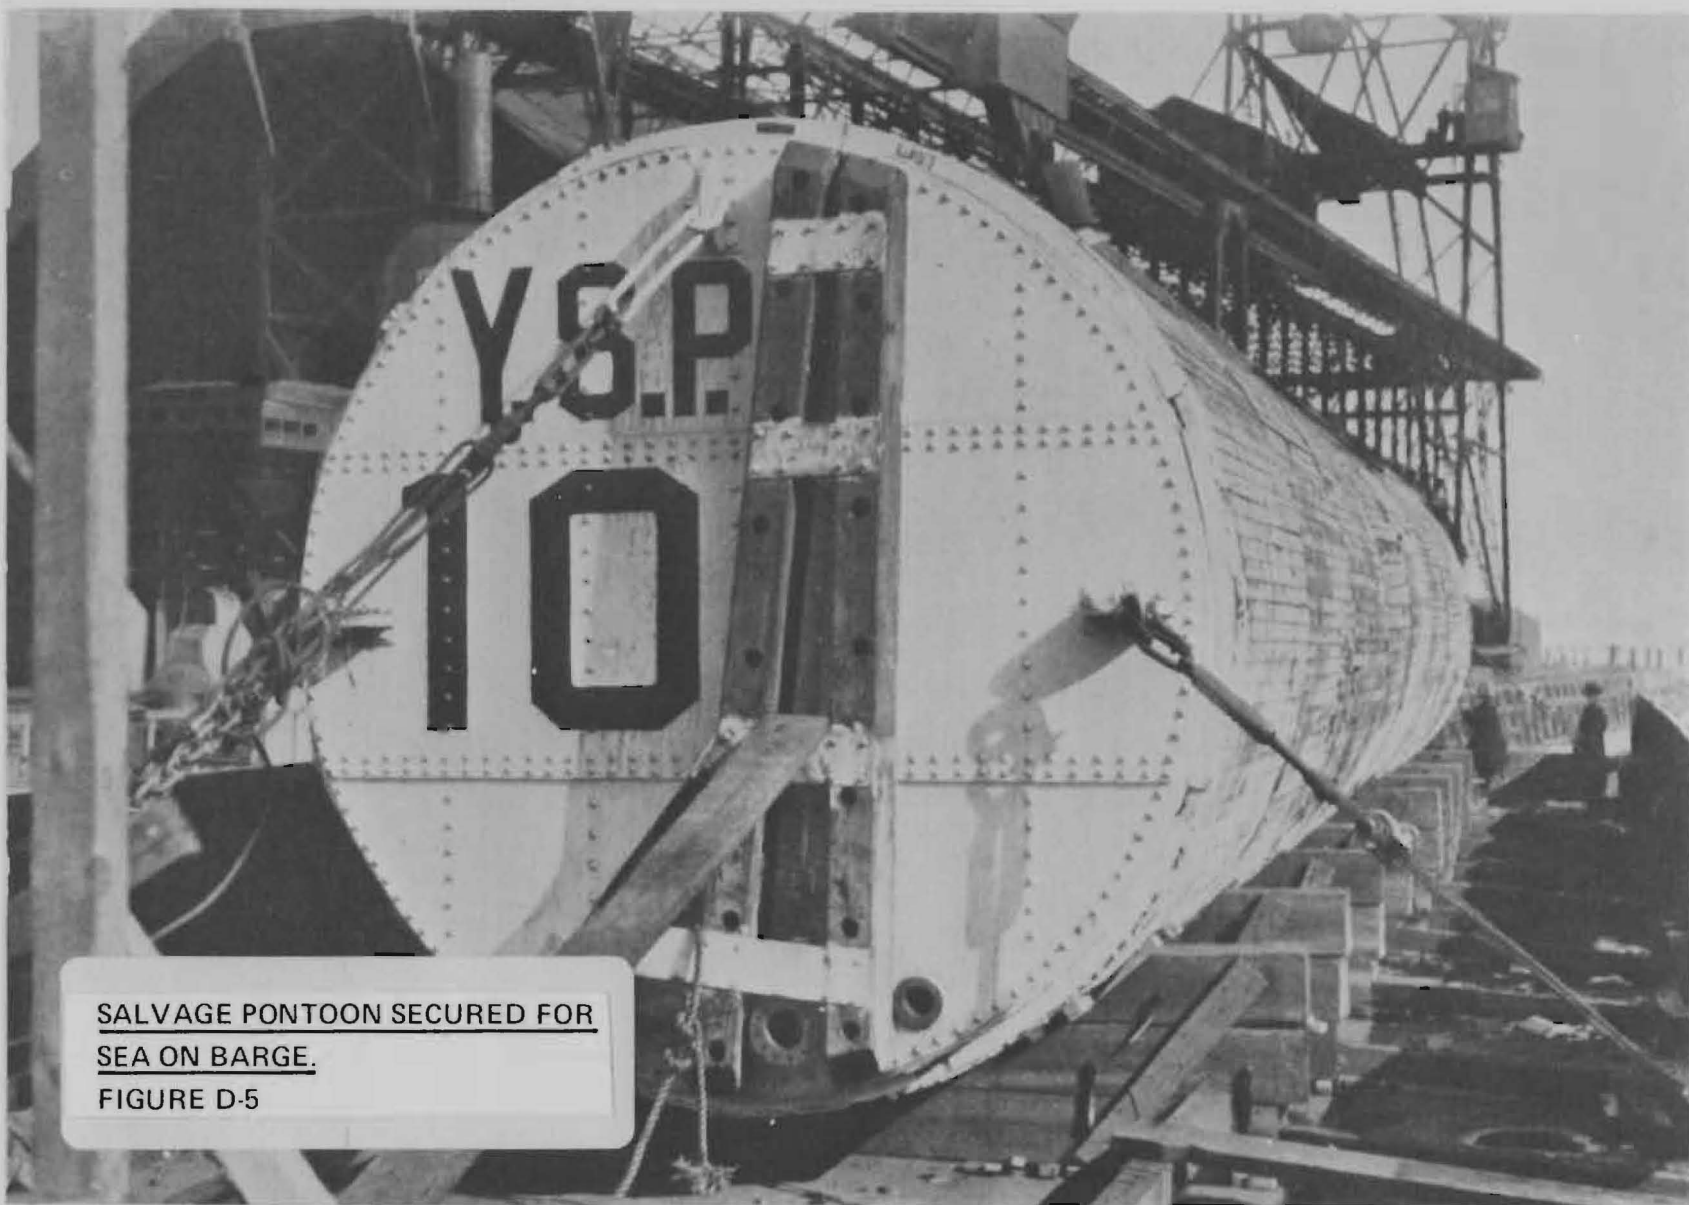
SALVAGE PONTOON SECURED FOR
SEA ON BARGE.
FIGURE D-5

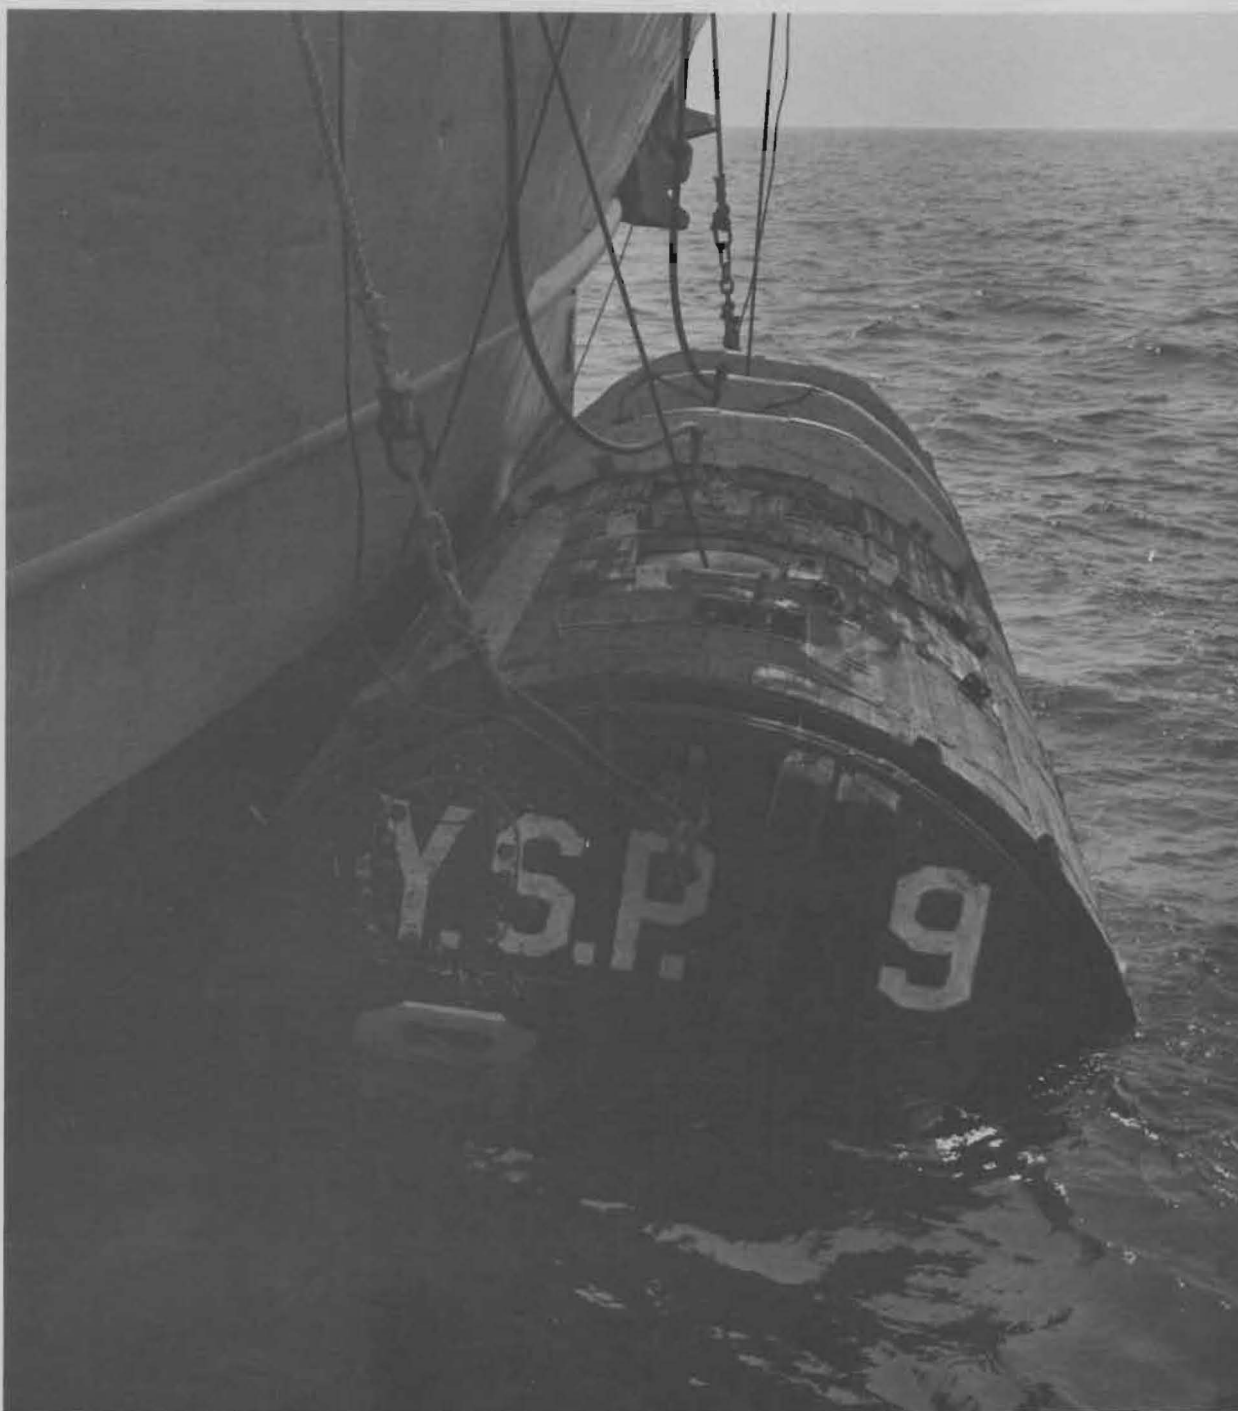
SALVAGE PONTOON ALONGSIDE TO STARBOARD OF
ARS READY FOR POSITIONING ON HAKE.
FIGURE H-7

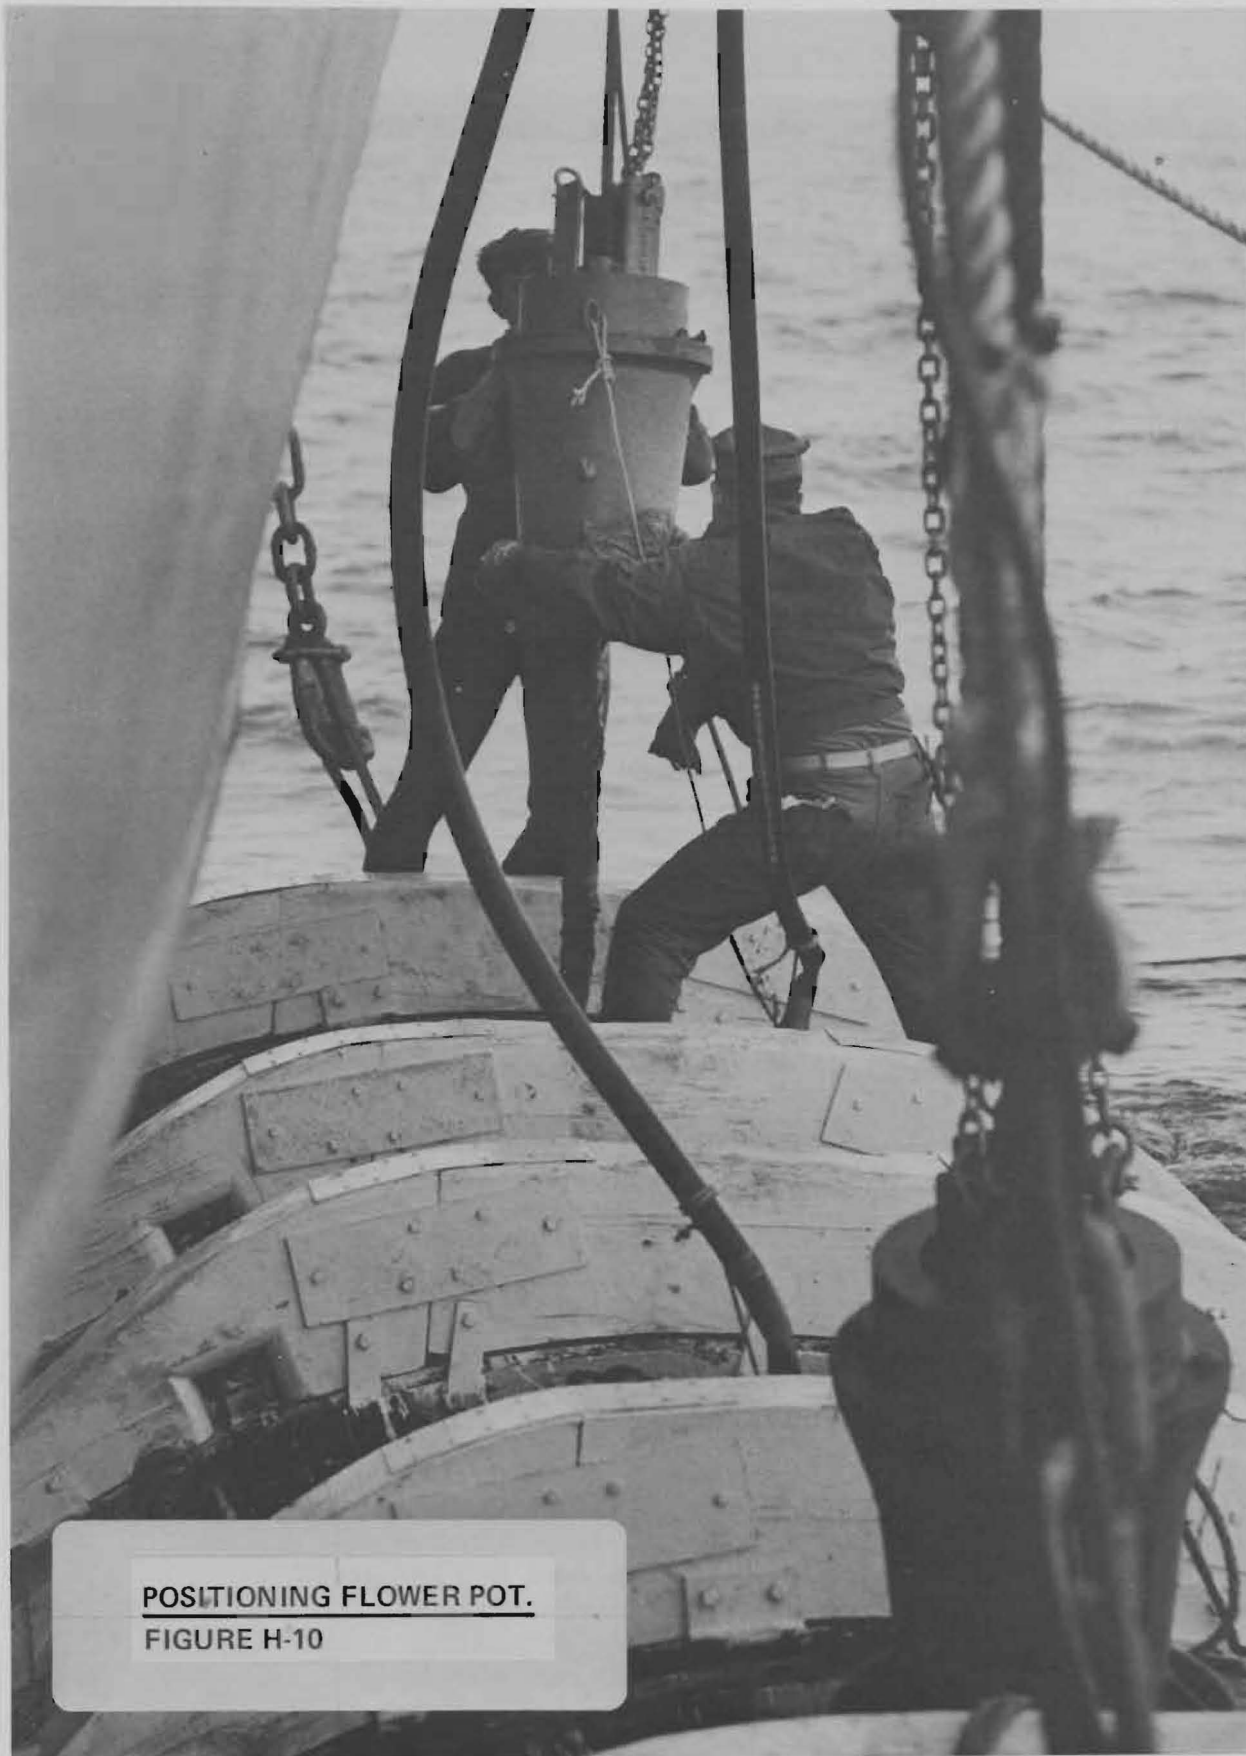
POSITIONING FLOWER POT.
FIGURE H-10

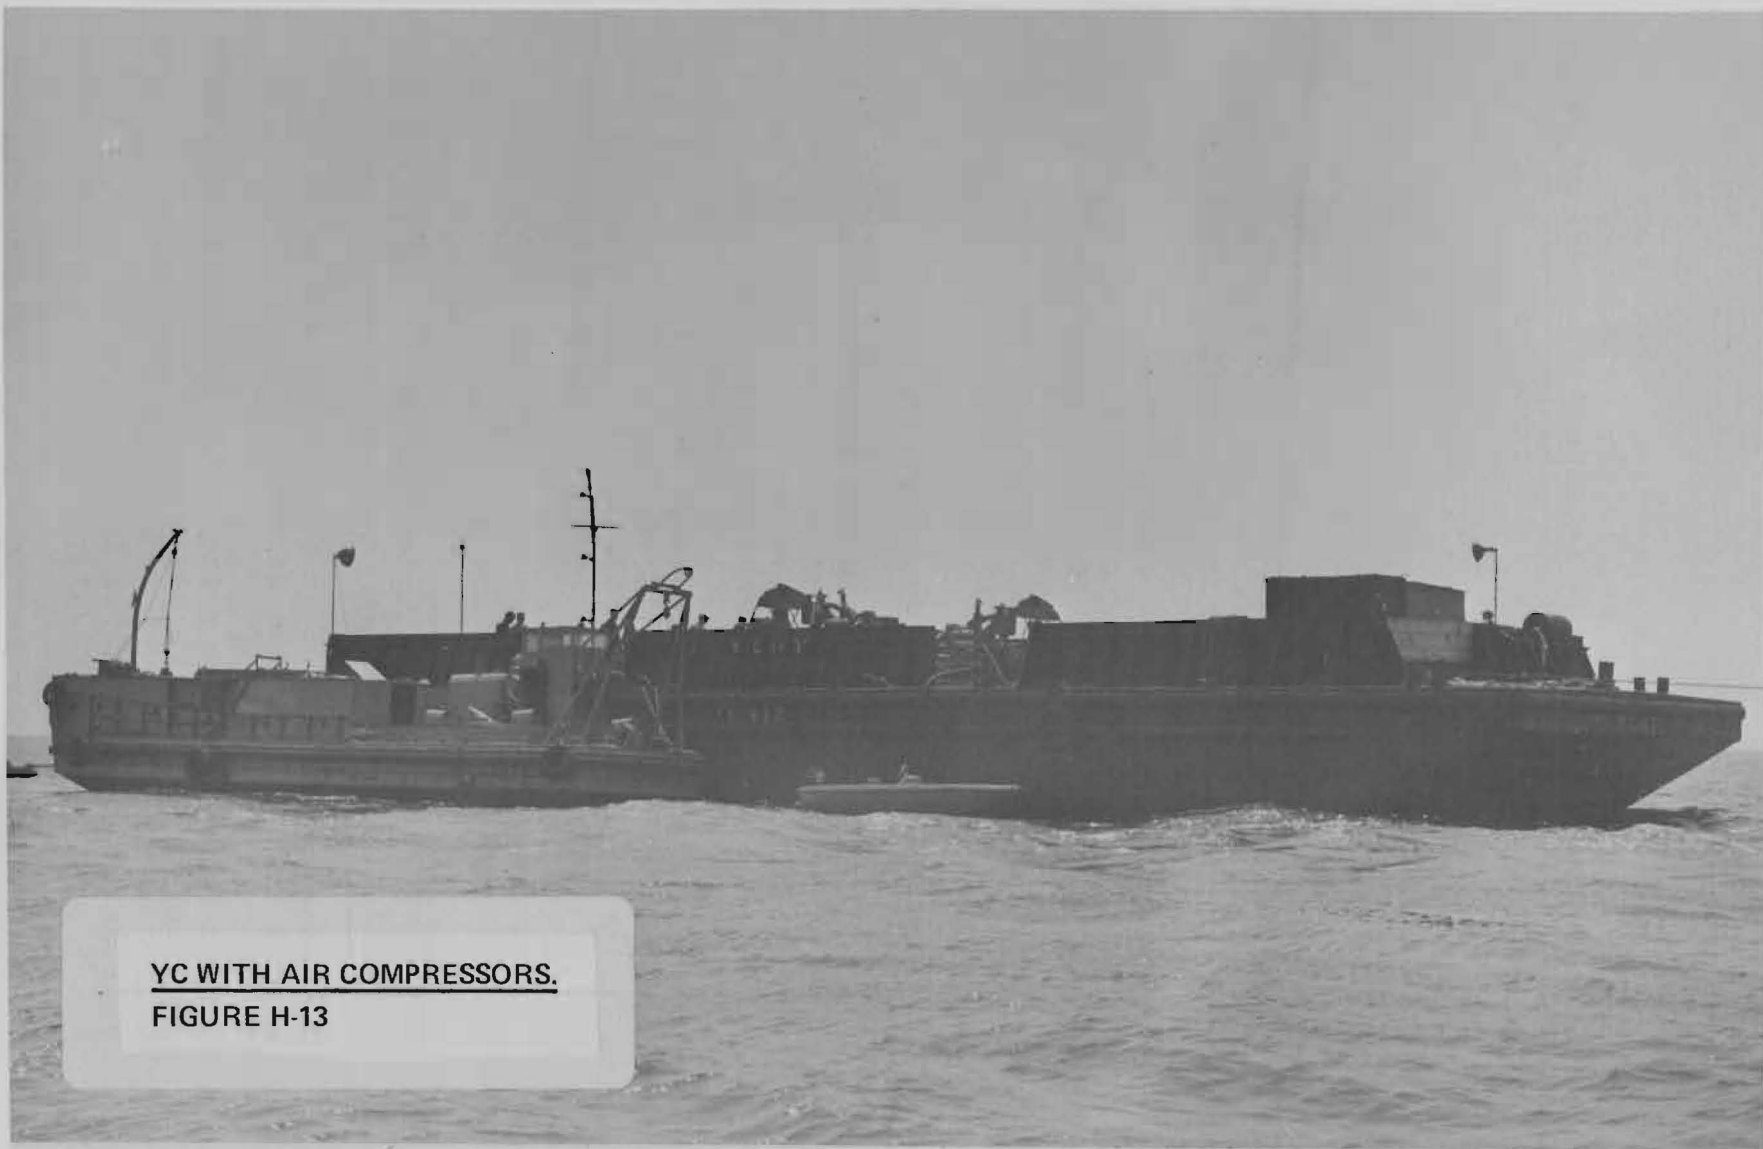
YC WITH AIR COMPRESSORS.
FIGURE H-13
