U.S. NAVY SHIP SALVAGE MANUAL

VOLUME II

SUBMARINE SALVAGE

**OFFICE OF THE SUPERVISOR OF SALVAGE, U. S. NAVY
NAVAL SHIP SYSTEMS COMMAND
WASHINGTON, D. C.
1970**

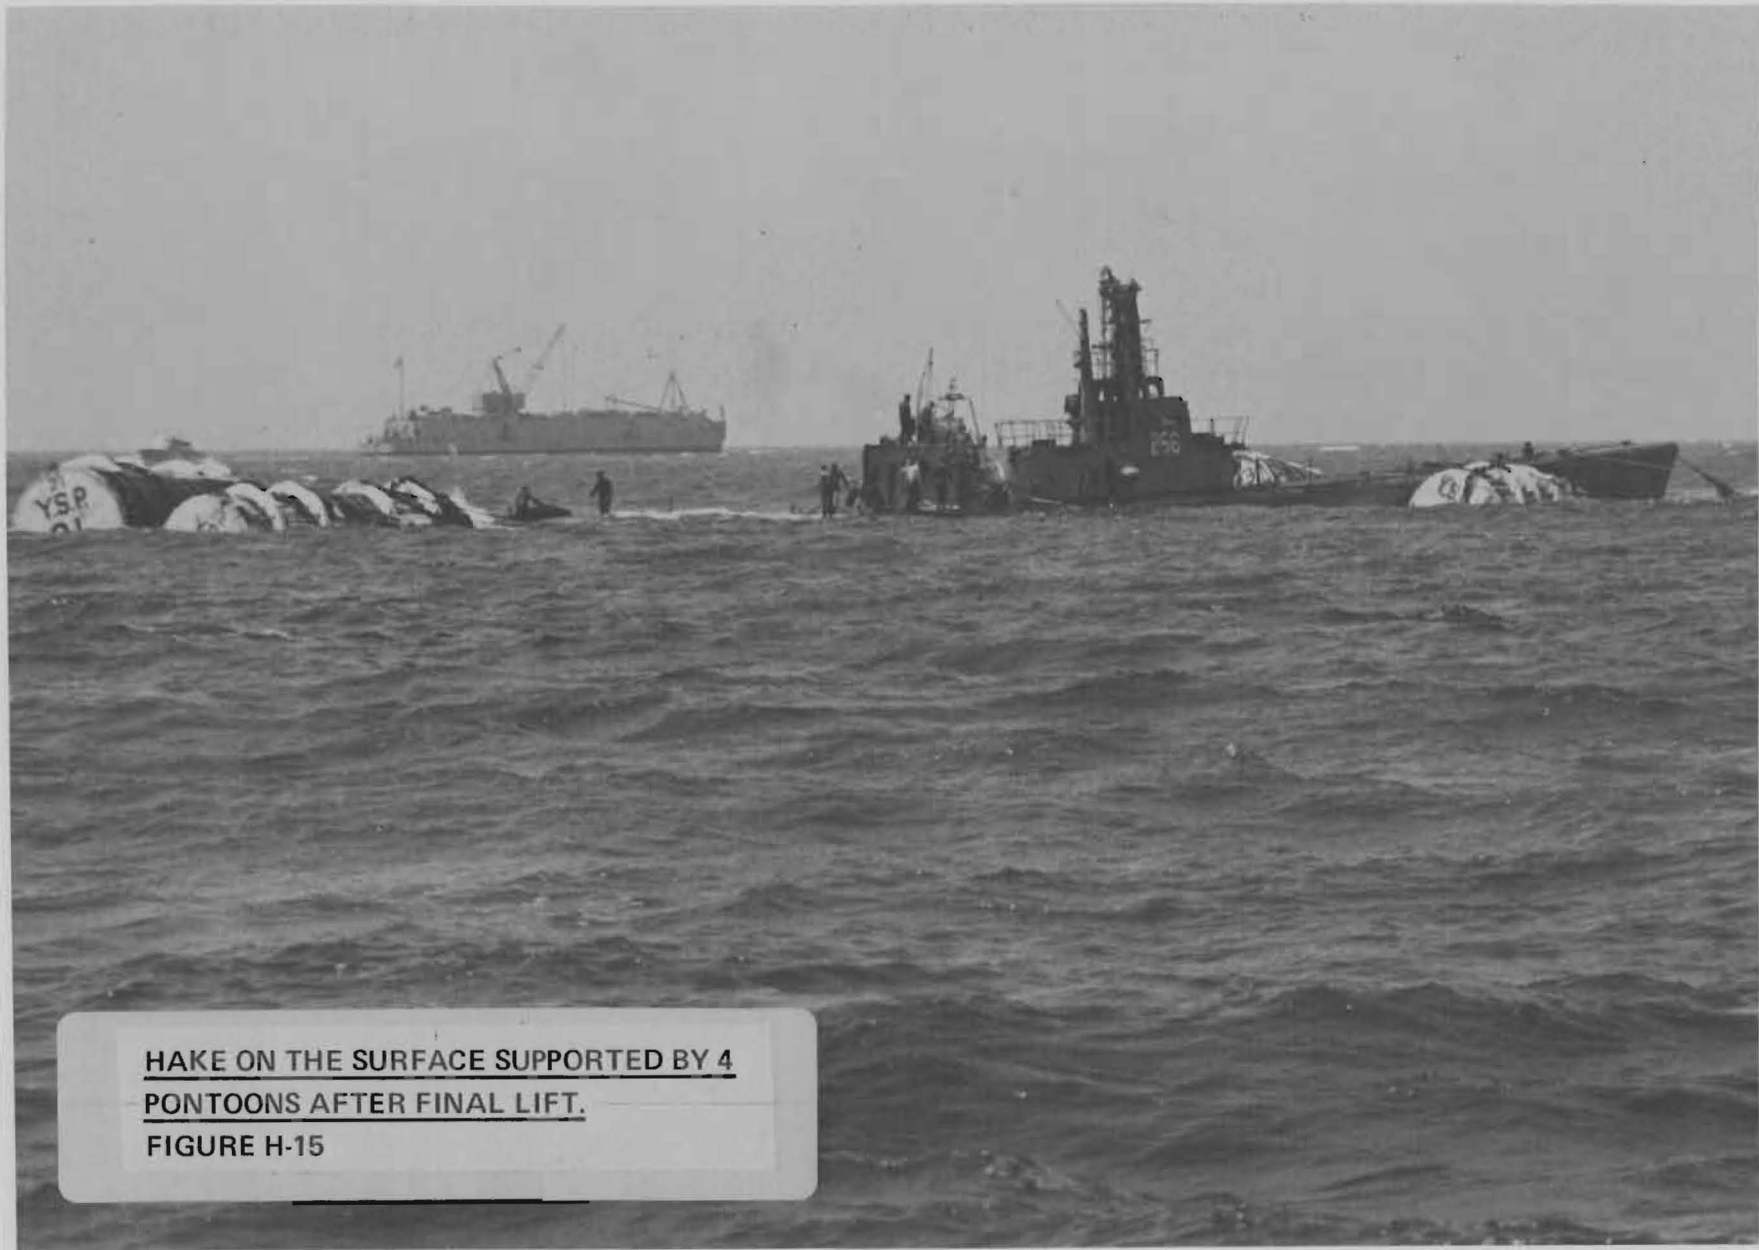
HAKE ON THE SURFACE SUPPORTED BY 4
PONTOONS AFTER FINAL LIFT.
FIGURE H-15

NOTE: The submarine's main ballast tanks, Numbers 1 and 7 were blown for the final lift; a comment on that is appropriate. The mud suction force was greater than originally estimated. Because of the predicted lift angle of 13.7 degrees it was important to lift the bow first. If the stern had lifted first it is almost certain that the bow pontoons' slings would have slid aft along the submarine's hull until they came up against the bilge keel or a greater hull diameter; it was important to avoid this sling movement. In retrospect, it seems apparent that all the estimated mud suction force must be provided by excess lifting force at the end to be lifted first. For this reason MBT #1 with a capacity of 47.66 tons and MBT #7 with a capacity of 43.11 tons were blown dry prior to the lift; the additional buoyancy provided a safety margin against the mud suction on the hull.

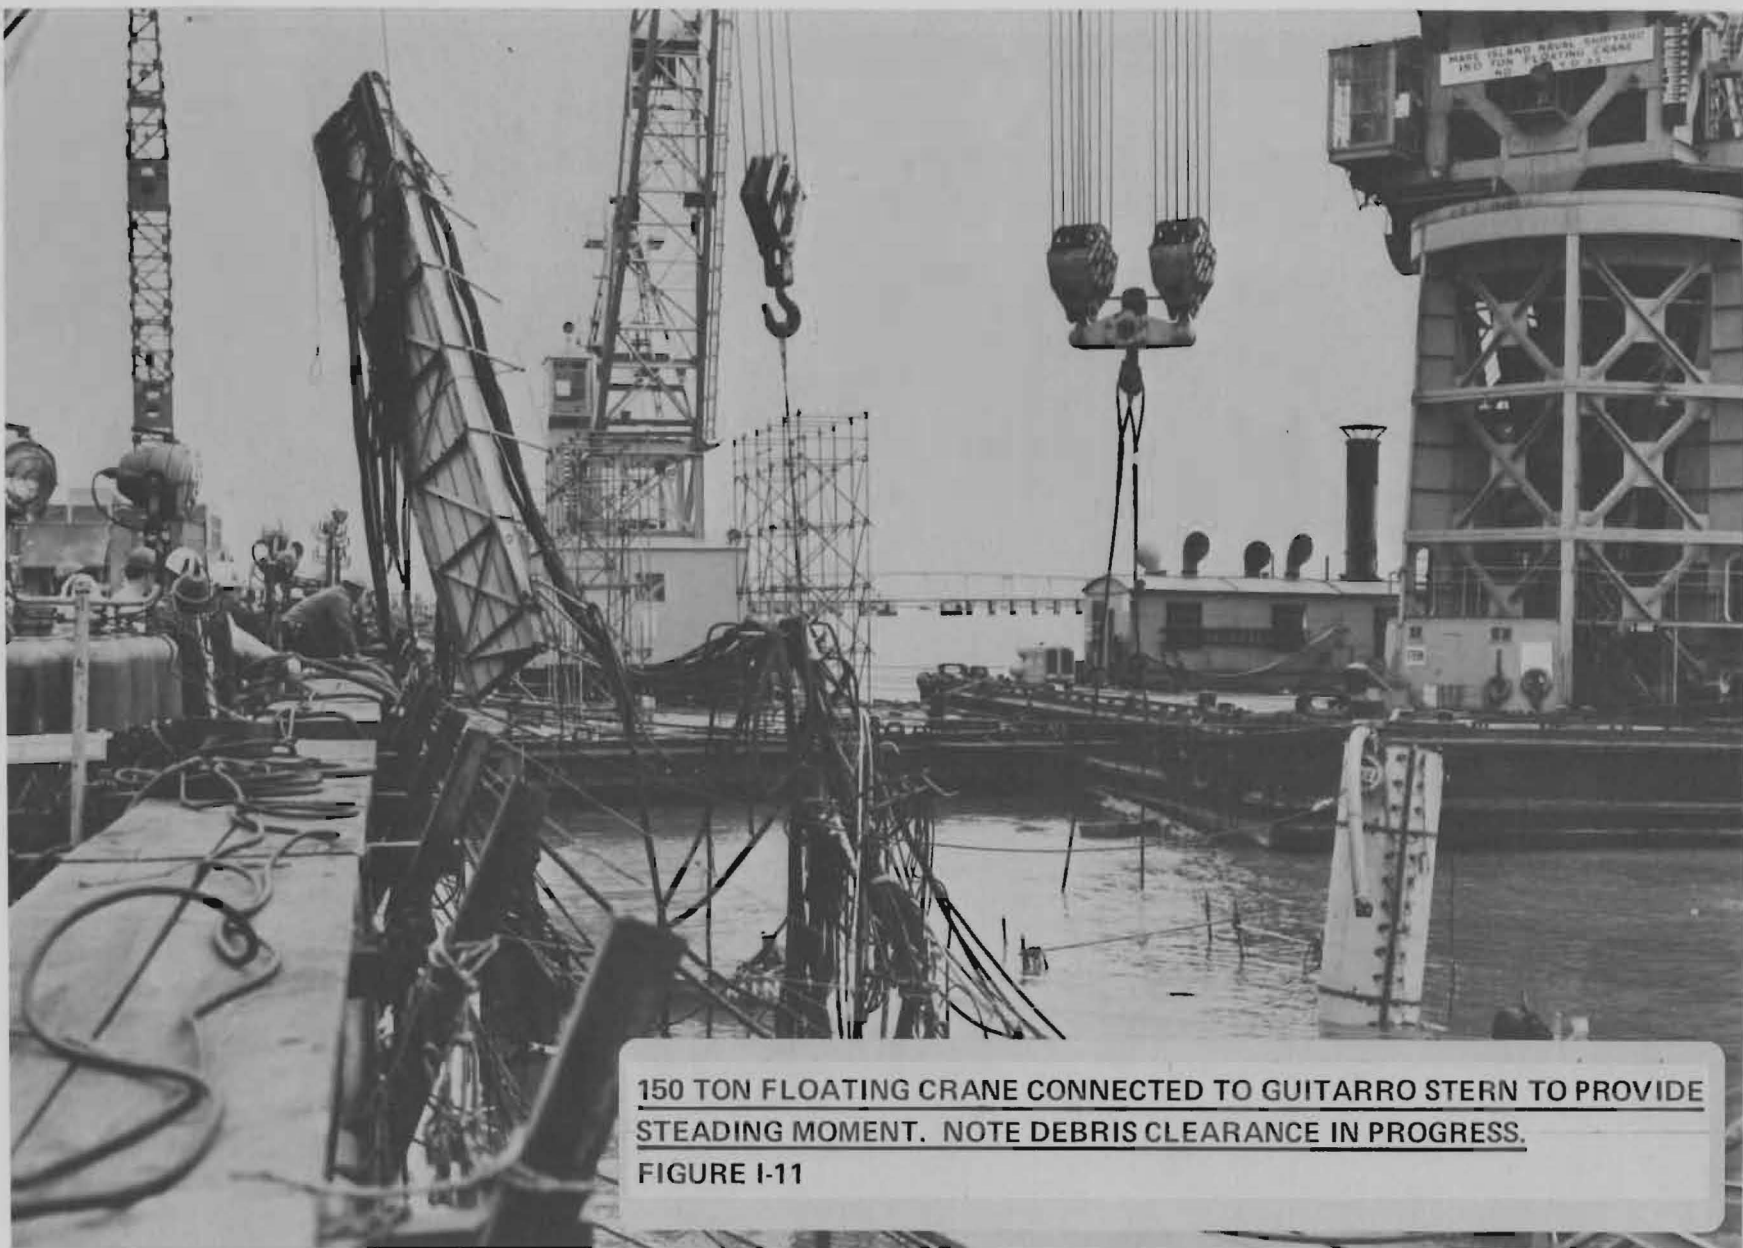
150 TON FLOATING CRANE CONNECTED TO GUITARRO STERN TO PROVIDE
STEADYING MOMENT. NOTE DEBRIS CLEARANCE IN PROGRESS.

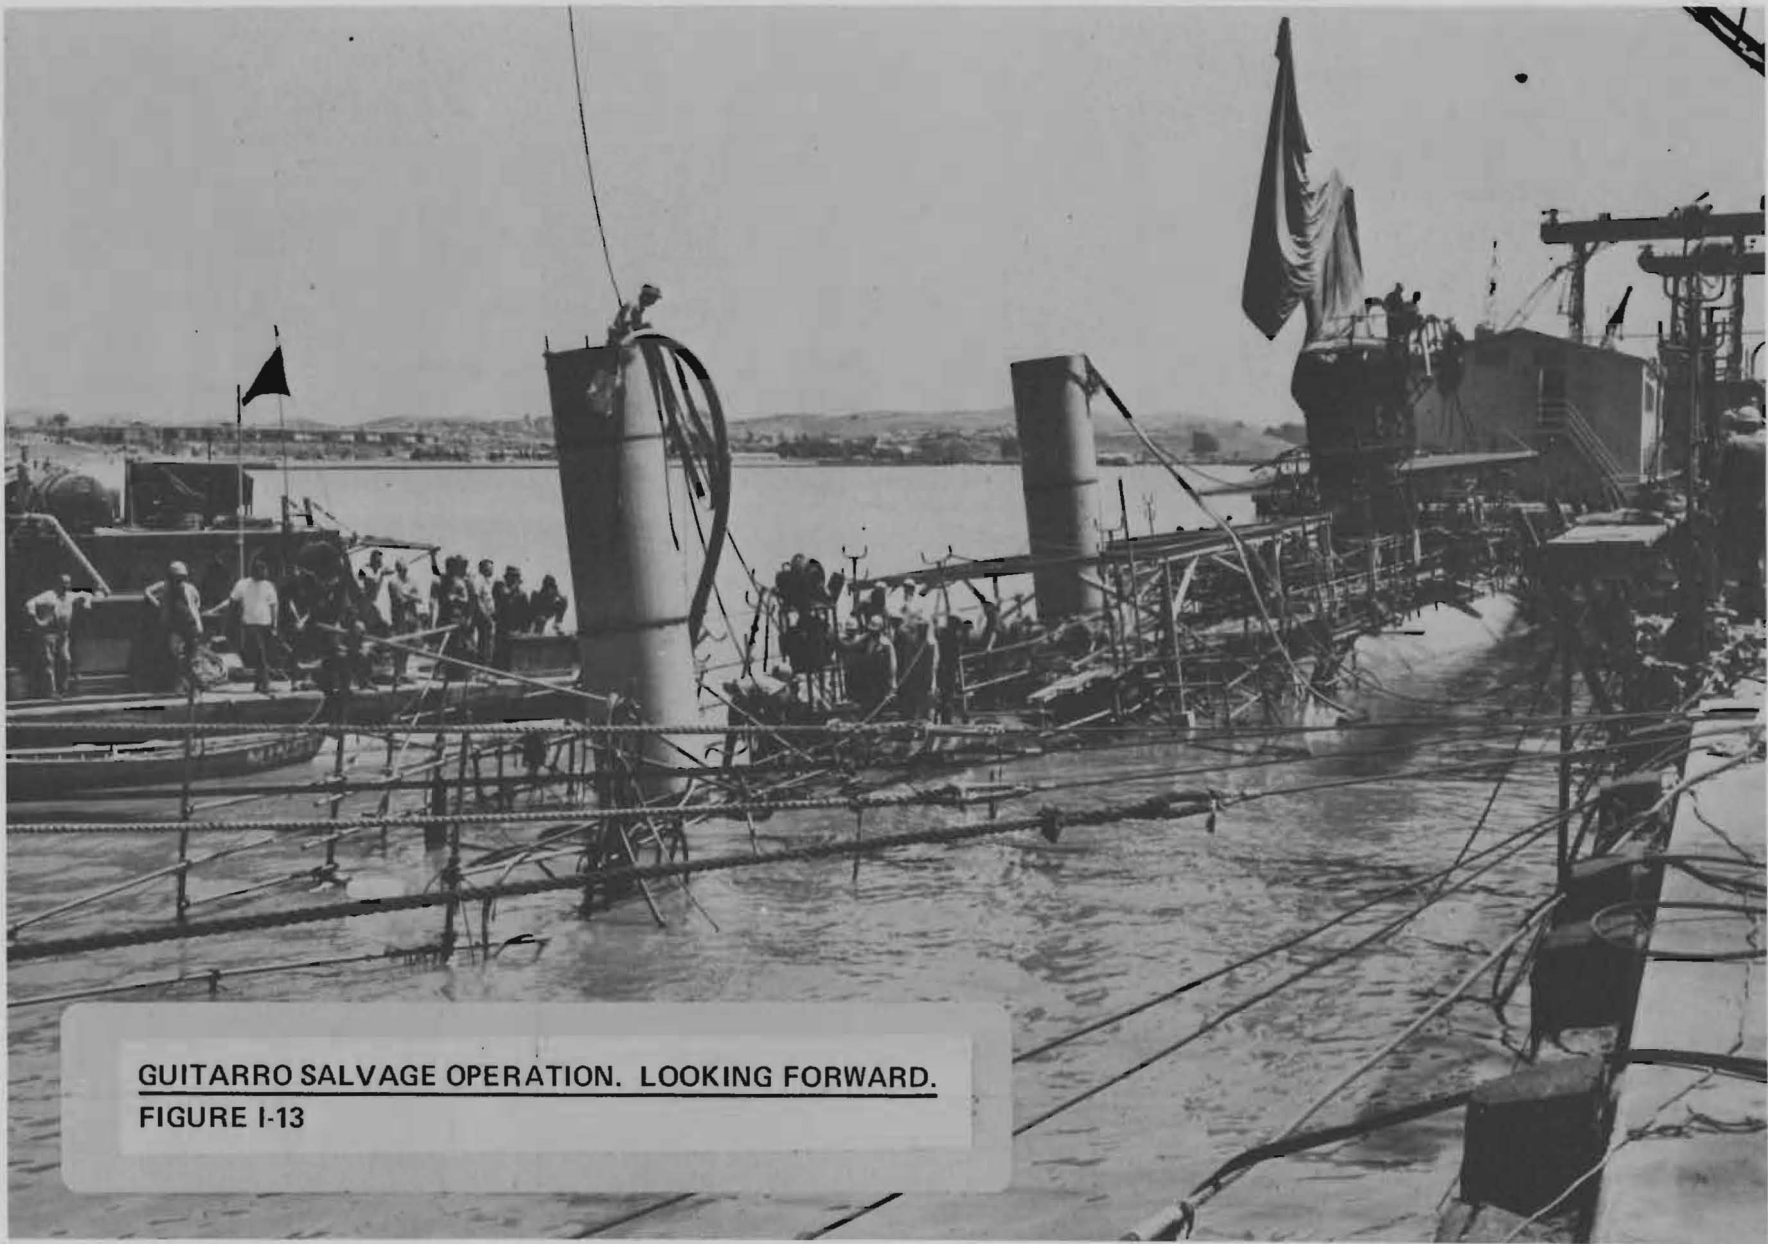
GUIRARRO SALVAGE OPERATION. LOOKING FORWARD.
FIGURE I-13
