Report on Post Tsunami Survey along the Myanmar Coast for the December 2004 Sumatra-Andaman Earthquake

June 2005

The content of this report, with reduced number of photographs, was submitted to special issue on the Sumatra-Andaman earthquakes of 2004 and 2005 of *Earth, Planet and Space*. A proper citation would be as follows.

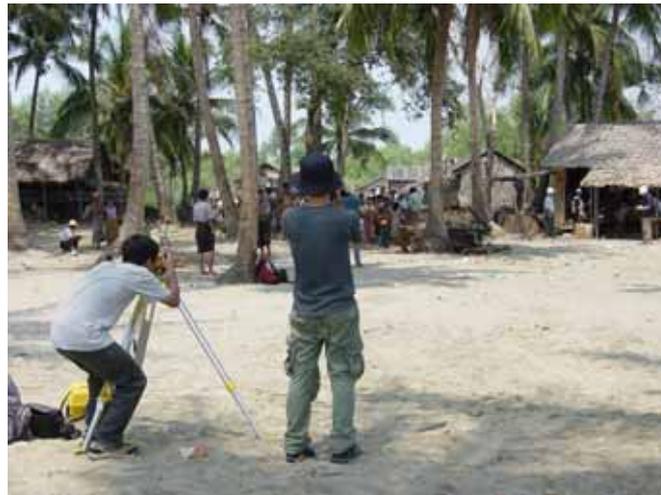
In order to measure the tsunami heights, we used a handheld laser ranging instrument (Impulse 200LR; Laser Technology Inc.) and an auto-level equipment (Photo 1). In general, auto-level with the tripod provides more accurate heights than the laser instrument without the tripod, while the laser instrument provides quicker results for a long distance (>100 m). For measurements of a short distance, we used both instruments. The vertical difference between them is at most 20 cm. For measurements of longer distance, we used only laser instrument.

Photo.1 Two kinds of measurements, using auto-level (left) and laser (right) instruments

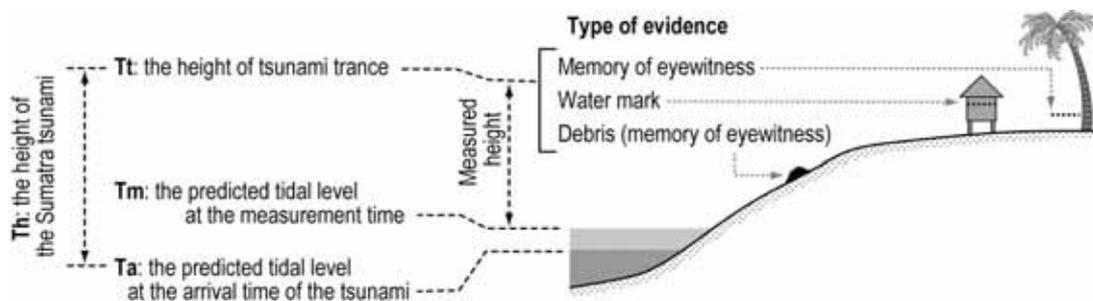
Figure 3. Measurement of tsunami heights and corrections

$$Th = (Tt - Tm) + (Tm - Ta)$$

where Th is the estimated tsunami height, Tt is the height of tsunami trace, Tm the tidal level at the time of measurement, and Ta the computed tide at the time of Sumatra heights on December 26, 2004 (Figure 3).

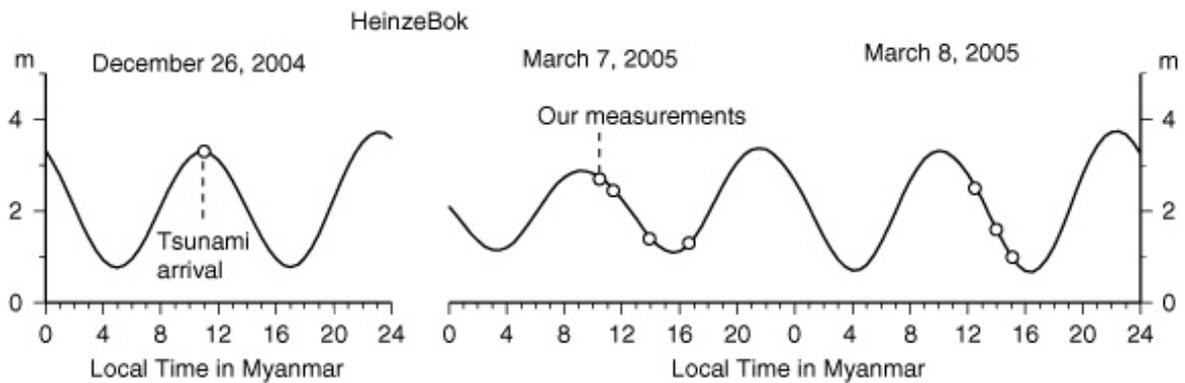
on the basis of astronomical tides, by using computer program WXTide 32 release 4. The maximum differences of the predicted tides with a tide table (Hydrographic office, 2004) are within 70 minutes and 50 cm at ebb/flood times. For Ayeyarwaddy delta coast, tide was calculated based on predicted tides at Bassein River, Diamond Island (15° 52.0' N, 94° 17.0' E). For Dawei coast, the tide was calculated at Heinze Bok, Long Island (14° 24.0' N, 97° 47.0' E). For Myeik measurements, the tide was calculated at Mergui (12° 26.0' N, 98° 35.9' E). For the measurements around Kawthaung, tide was calculated at Pulo Basin (9° 59.0' N, 98° 29.0' E) (Figures 4 and 5).

Figure 4. Predicted astronomical tidal changes at Heinze Bok (Long Island), near Dawei. (a) Tidal change on December 26, 2004. An open circle on the curve shows the time of the tsunami arrival. (b) Tidal change on March 7-8, 2005. Circles on the curve show time of our measurements.

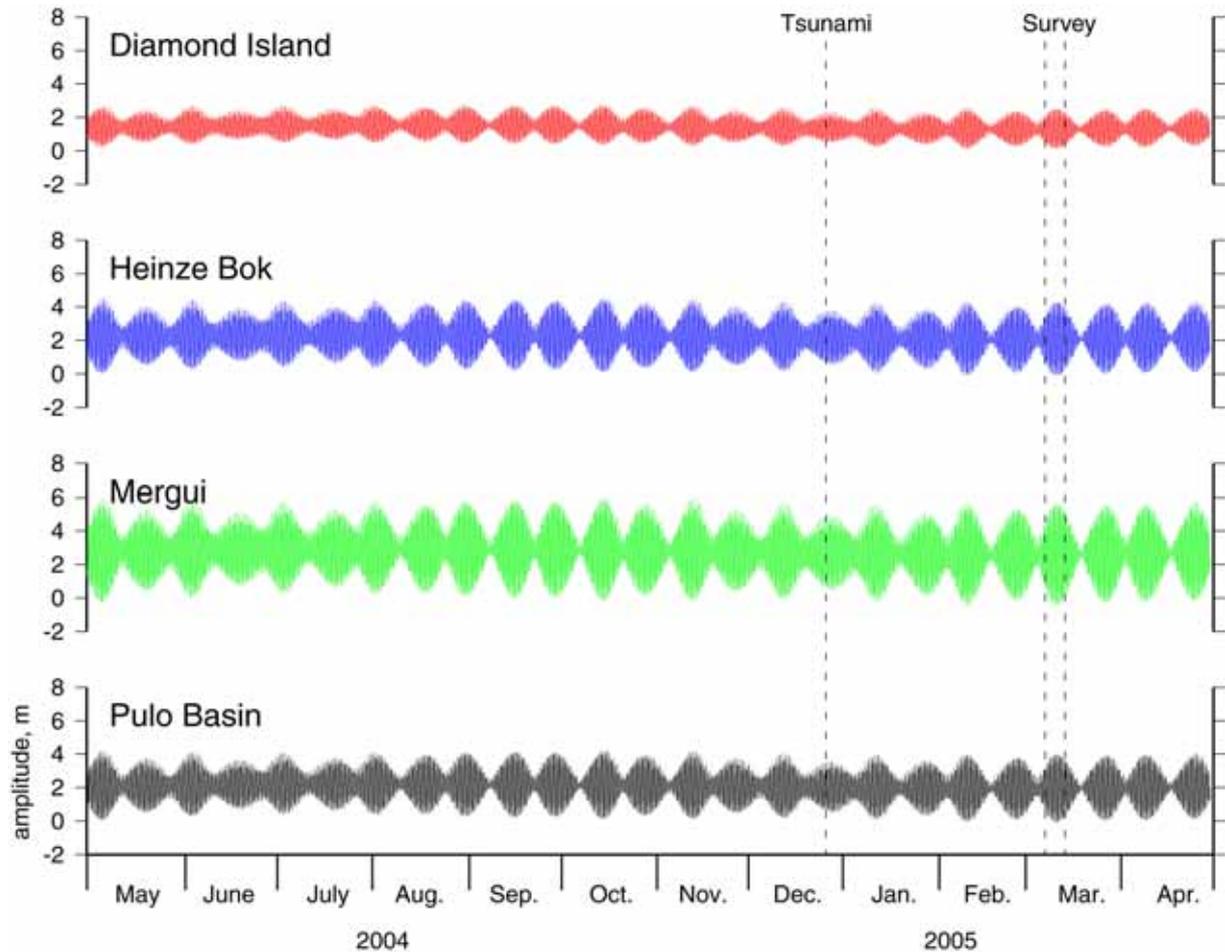
Figure 5 indicates the tidal levels for one year, from May 2004 through April 2005, including both dry and rainy seasons. As reported in more detail in each locality, many coastal residents compared the tsunami heights with the “rainy season high tide level”. From the interviews, we had impressions that high tide levels are different from dry and rainy seasons. However, astronomical high tide levels are more or less similar throughout the year. The seasonal changes of high tide levels may be affected by meteorological reasons such as flooding.

Figure 5. Computed astronomical tidal changes at Diamond Island, Heinze Bok, Mergui and Pulo Basin for one year, starting May 2004. Note that tidal range is similar throughout the year, both dry and rainy seasons.

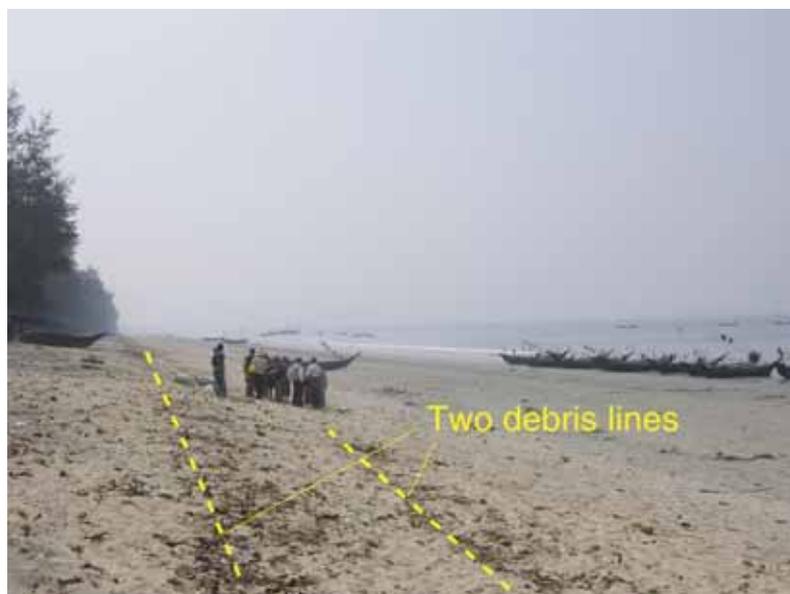
On this beach, two parallel lines of debris were observed (Photo 2). A local fisherman (36 years old male) told us that the lower debris line was formed by the December tsunami. He did not feel the earthquake but observed that the tsunami arrived at around 2 pm, in a total of four successive waves with 3 to 4 m height. The tsunami arrived at low tide and did not exceed the high tide level of the rainy season (the higher debris line). Another eyewitness indicated the tsunami arrival times to be at 10 am and 12 noon.

Our measurement at 10:27 am on March 7, 2005 indicates that the lower and higher debris lines are 2.4 m and 2.9 m above the sea level at the time of measurement (Photo 2). The dune, to which the tsunami did not reach, was 4.0 m high. The corrected tsunami height, assuming that the tsunami arrived at 11:00 am, becomes 1.8 m.

Photo 2. Photograph showing group interviewed to local people who had observed tsunamis at Maungmagan Beach, MM-01 (looking south).

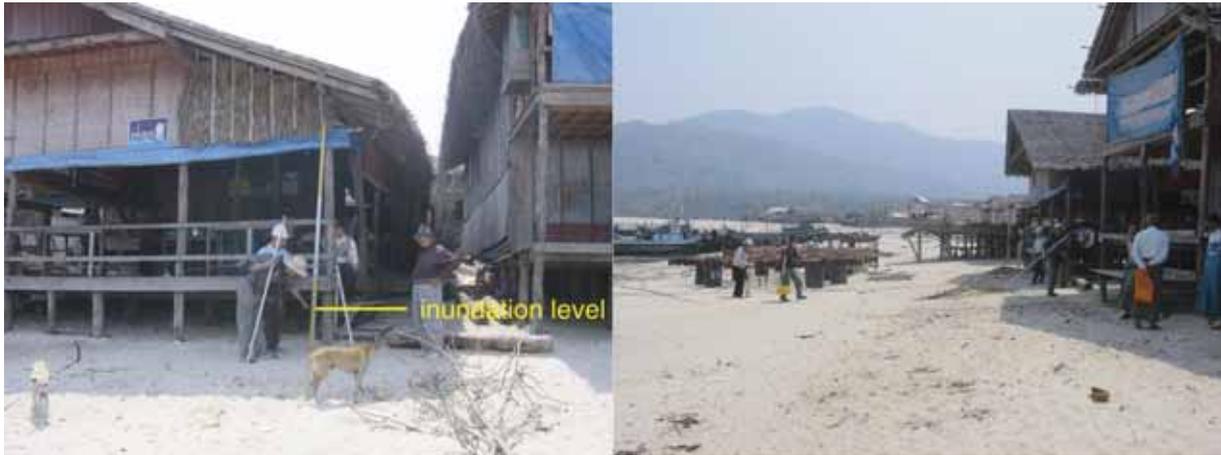
Thabawseik-Kyauksent Village is a coastal village of about 200 houses which builds up very close to the shore line. The peoples' stable earning is mainly fishery. The interview with the local person (51 year old male) confirmed that the tsunami reached up to 55 cm above the ground (Photo 3) and arrived between about noon and 1 pm in three successive waves of 20 minute intervals but caused no severe damage. The tsunami height was lower than the rainy season high-tide level. The measurement at 11:25 am on March 7 indicates that the tsunami height was 2.4 m above the sea level, while rainy season high tide level was 3.0 m. The corrected tsunami height becomes 1.6 m.

Photo 3. Photographs show survey measurement at Thabawseik-Kyauksent Village. Arrow indicates the height of tsunami (pointed by Interviewee).

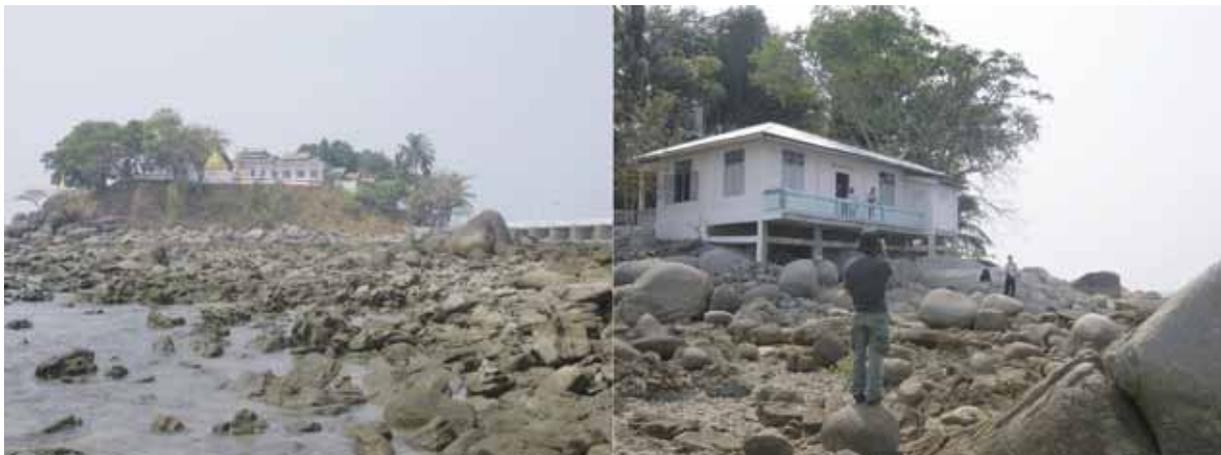
Myaw Yit Gyi Pagoda is situated on a small isolated granite body and connected to the opposite bank by a concrete bridge (Photo 4). A Buddhist monk from the Pagoda told us that he did not feel the earthquake shaking. Between 9:30 and 11:30 am, he observed that three waves coming from the different directions reached at the base of the bridge. The height of tsunami was larger than the high tide of the rainy season. When receded, the seafloor was exposed about 200 m from shore line.

The measurement at 13:56 pm on March 7, 2005 indicated that the tsunami height was 3.3 m above the sea level. The corrected tsunami height becomes 1.4 m.

Photo 4. Interview with a Buddhist monk at Myaw Yit Gyi Pagoda (left) and view of Myaw Yit Gyi pagoda in seaward (westward) direction (right).

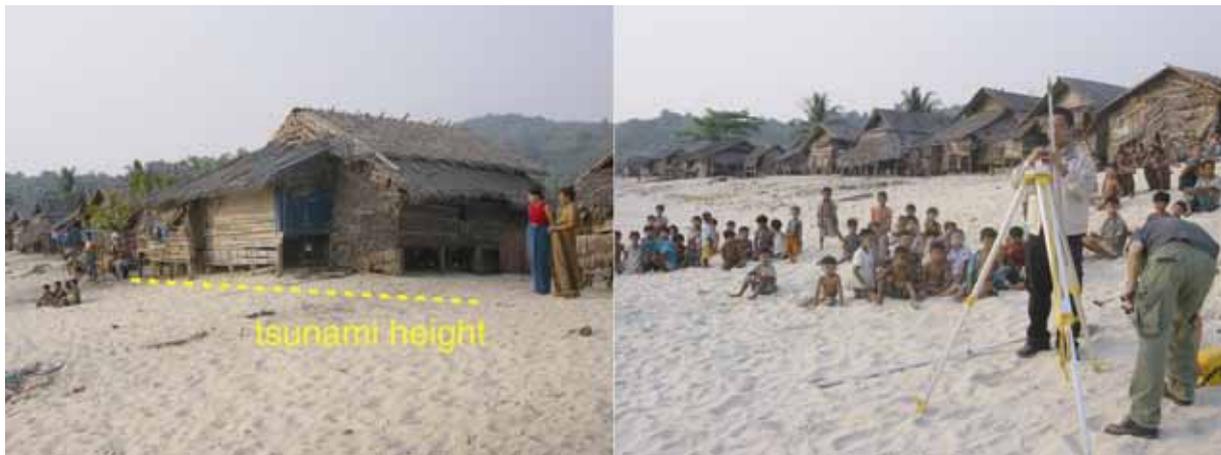
Sann Lan Village is also situated on the same shore line, and constituted of almost wooden houses. The major earning is fishery. A fisherman told that the tsunami arrived at 11:00 am in four times with 15-minute interval and it was coincidence with low tide,.

Measurement at 16:40 pm on March 7, 2005 indicates that the tsunami height was 4.9 m above the sea level, while the high tide of the day was between 1.9 and 2.3 m. The corrected tsunami height becomes 2.9 m.

Photo 5. Survey at Sann Lan Village. Yellow dotted line is tsunami height (left). Measurement at Sann Lan Village (right)

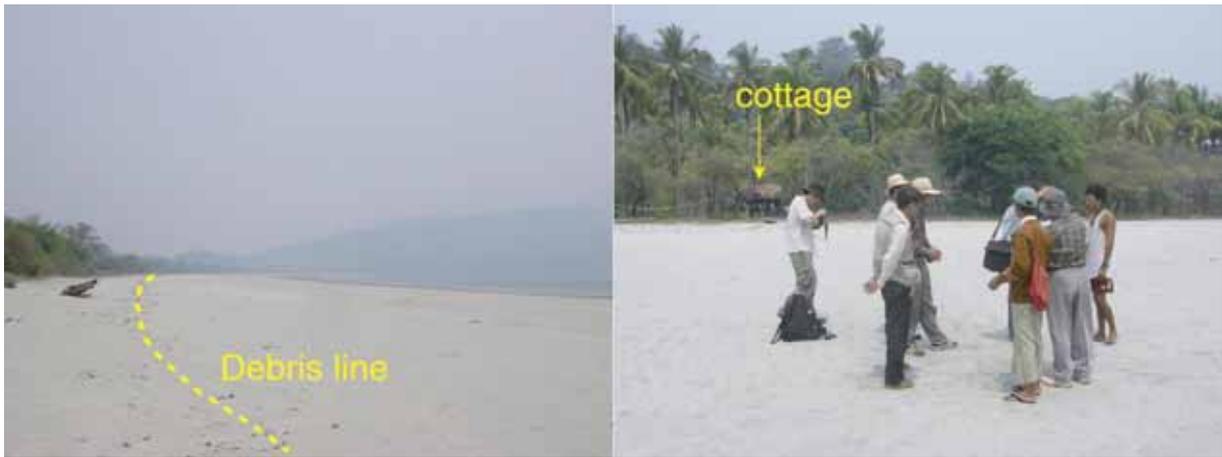
Kyet Lut beach is situated on the southern tip of the peninsula, 60 km from the Dawei. Two parallel debris lines were observed on the beach. A 19-years old male who live in a cottage where a group of farmers living seasonally reported that the tsunami entered after lunch (normally, local people take lunch about 10 am), and observed three times with 3 to 5 minute intervals (Photo 6). In addition, the lower debris was brought by the tsunami, while the upper one was by rainy season high tide.

Measurement at 12:30 on March 8, 2005 indicated that the lower debris line was 2.7 m above the sea level, while the upper line was 3.2 m. The corrected tsunami height becomes 1.9 m.

Photo 6. Survey at Kyet Lut Beach. Debris line indicates the maximum reach of tsunami (left) and a small seasonal hut where the interviewee lives.

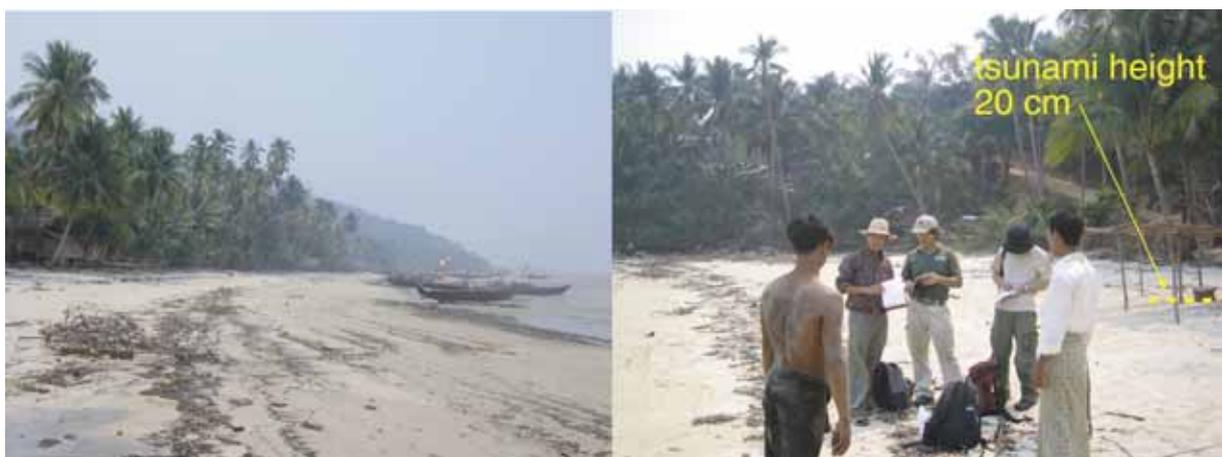
Kyaukmattat Village is situated on the west bank of the Dawei River and the major earnings of the people are farming and fishery. A fisherman mentioned that a receding wave firstly came around 1 pm and then another high tide appeared at 8 pm (Photo 7). He indicated that the tsunami height was about 20 cm above ground on the wooden structure (right photograph).

Measurement at 14:00 pm on March 8, 2005 indicates that the tsunami height was 2.6 m above the sea level. The indicated high tide levels of the day and rainy season were 2.3 m and 3.8 m, respectively. The corrected tsunami height becomes 0.9 m.

Photo 7 Survey at Kyaukmattat Village on the west bank of the Dawei River

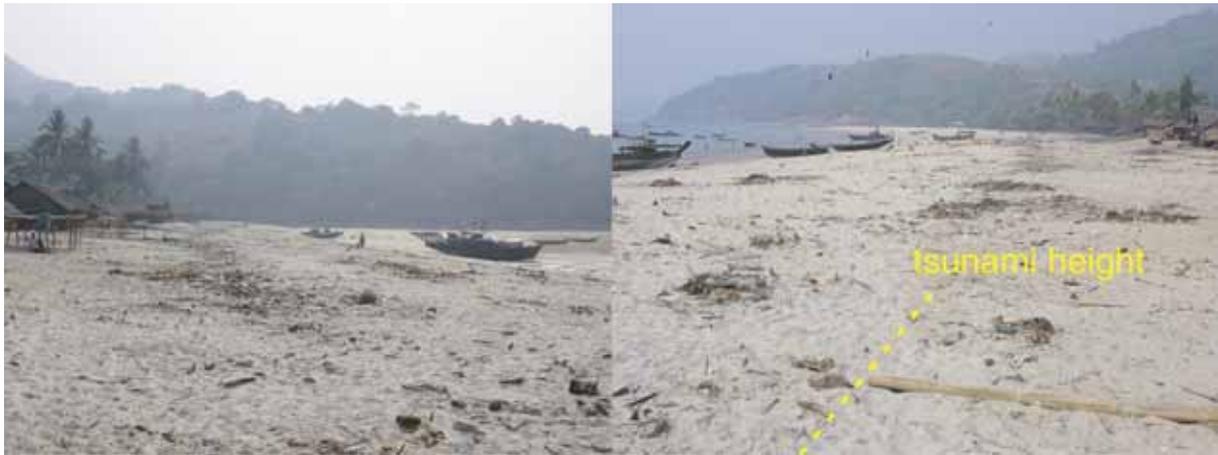
Nyawbyin Village is situated on the western coast of the peninsula in Longlon Township and its curve shape beach profile is surrounded by two ridges. Most people did not feel the earthquake but noticed that the tsunami arrived there around noon.

The measurement at 15:07 on March 8 indicates that the tsunami height was 4.3 m above the sea level. The indicated high tide levels of the day and rainy season were 4.8 m and 3.2 m, respectively. The corrected tsunami height becomes 2.0 m.

Photo 8. Survey at Nyawbyin Village in Longlon Township

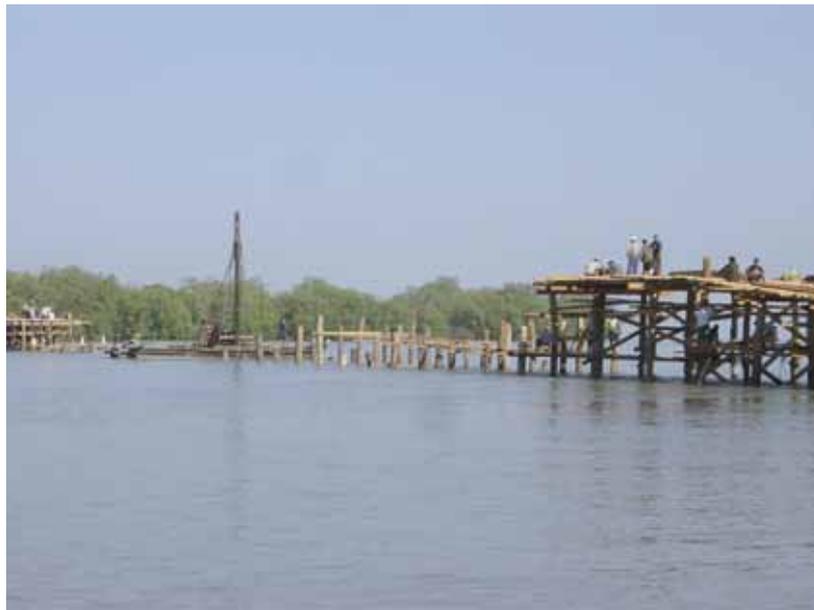
Plautonton Island is a small island close to west coast of the Kawthaung City, connected by a 600 meter long wooden bridge. The central part of the bridge was destroyed

by the tsunami (Photo 9). Field survey was taken at Plautonton Village on the island. Most houses of the village are built on a mudflat, raising floor level up to one or two meters above the sea surface. Water marker was observed at the interviewee's house (Photo 10). A 37 year old housewife told that the tsunami arrived at 10: 30 am in three waves with 15 minute intervals. A 62 year old male, owner of a grocery store, said that two waves with 10-15 minute intervals arrived. Because the tsunami arrived during low tide, there was no severe damage to buildings, but some household wares (rice, bags, cloths and TV sets, etc) were flooded. One person died in this village.

Photo 9. Destruction of wooden bridge to Plautonton by the tsunami

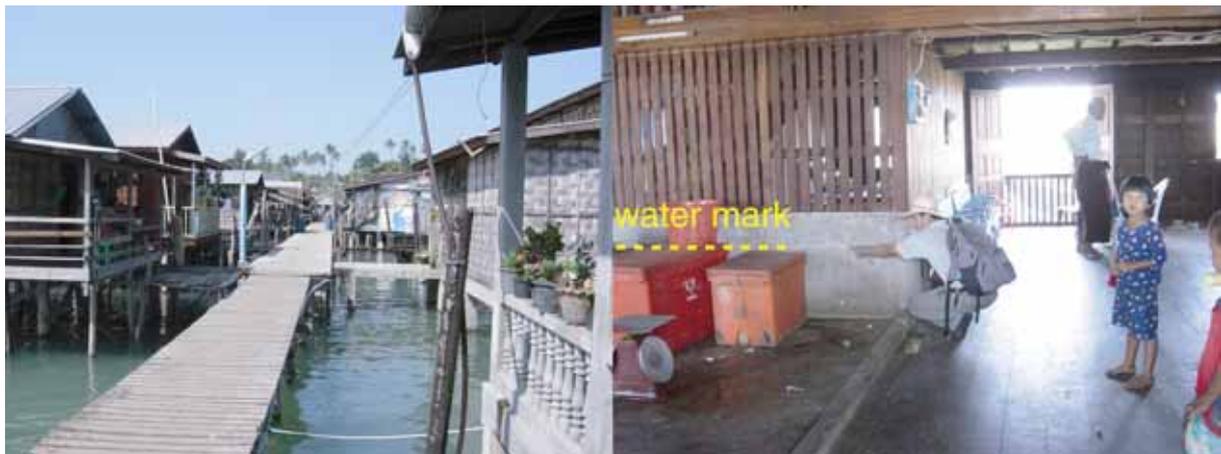
Photo 10. Houses above water (left) and the watermark on the wall of a house (right)

Measurement at 9:30 on March 10, 2005 indicates that the tsunami height was 1.8 m above sea level, while that of the rainy season high tide was 0.7 m. By assuming that the time arrived at 11:00 am, the corrected height becomes 2.5 m.

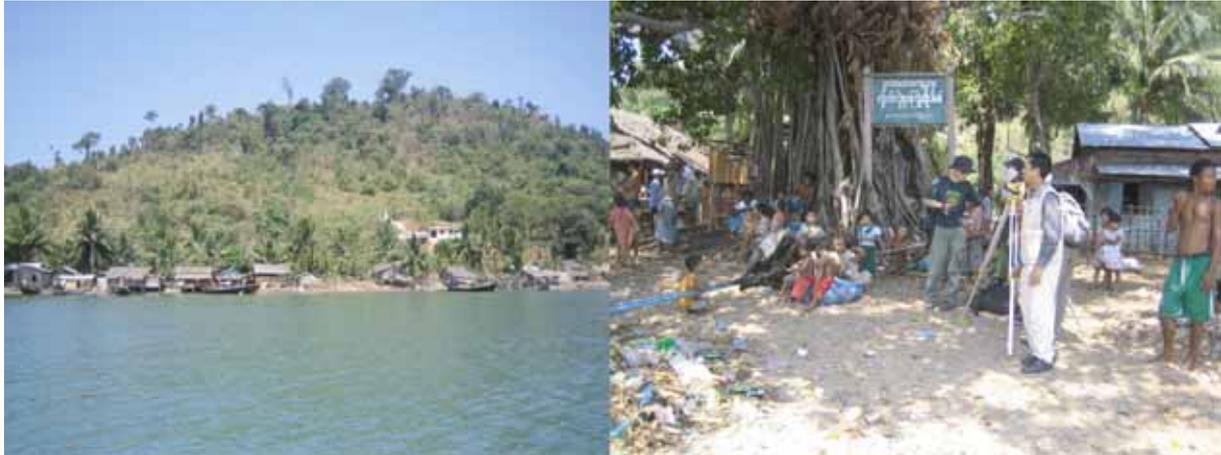
Photo 11. Field survey at Ywarthaya Village, Salonlay Island

At the Ywarthaya Village of Salonlay Island, situated at the west of the Plautonton Island, there was no damage at all by the tsunami (Photo 11). A 23 year old male told us that the tsunami arrived at 11:15 am. Three to four waves arrived with 5 minute intervals. Measurement (at 10:50 March 10) indicates that the tsunami height was 1.0 m above the sea level, while the rainy season high tide level was 0.6 m. The corrected height is 1.8 m.

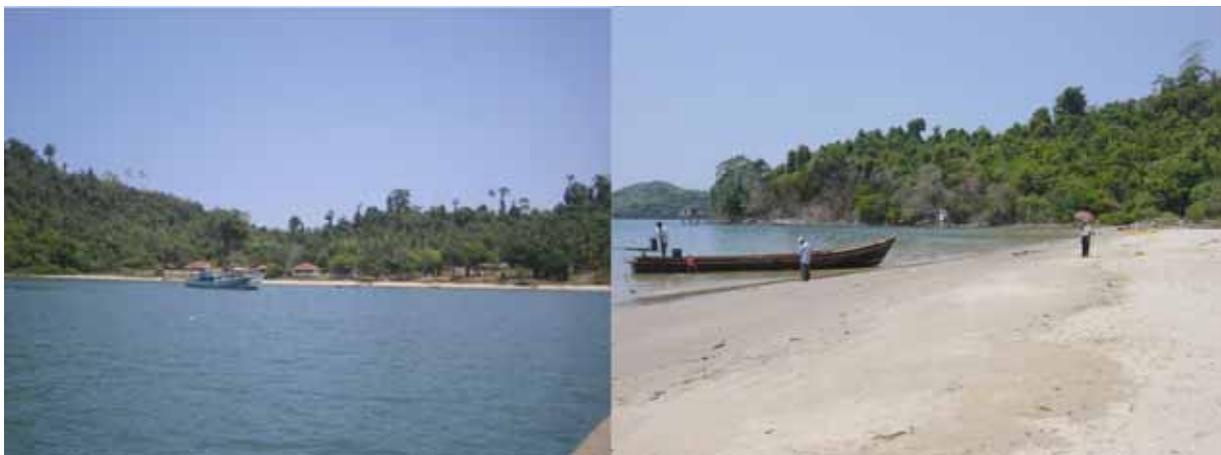
Photo 12. Survey at the Dolphin Club, Salon Island

The Dolphin Club of Salon Island, a few kilometers south of Salonlay Island, has a flat shore line. An interview was made to an eyewitness from the Dolphin Club. A 27 year old male told us that tsunami arrived at 11:45, in four waves with 5 minute intervals, and the height of sea level was the same as that of sea level at the time of our visit at 11:40 on March 10. The high tide level in rainy season is 1.1 m above the sea level. The corrected height is 0.4 m (Photo 12).

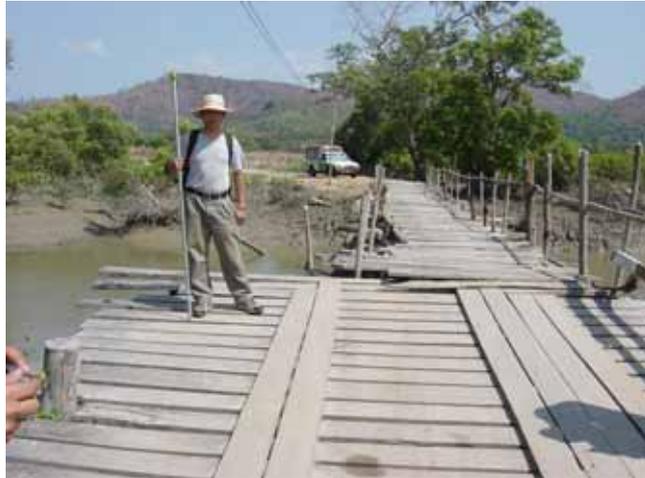
Konnamaing Chaungwa is a small village located on the western coast, northwest of the Kawthaung city. A bridge over a stream connected to the village is partly damaged during the incoming tsunami (Photo 13).

Photo 13 Destruction of bridge to Konnamaing Chaungwa Village by tsunami (narrow flat portion in the right far site of photo)

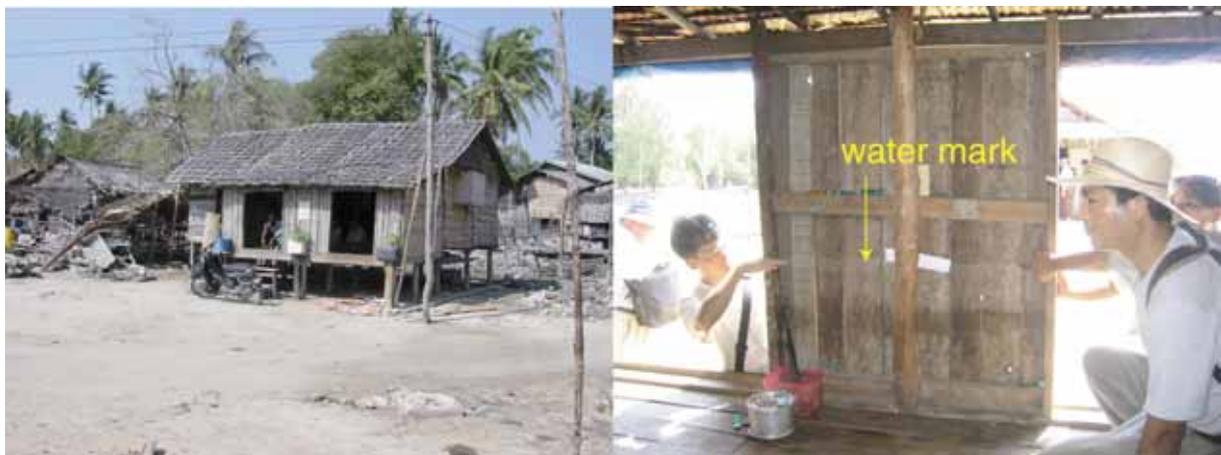
There were some damages by the tsunami: one death and destruction of eight houses. There is a clear watermark on a wall of a house indicating the tsunami height (Photo 14). Furthermore, the tsunami brought up some fishing boats along the stream course and then onto the paddy field (Photo 15 left). Some traces of marine mud on telephone post indicated the height of splash from the tsunami (Photo 15 right). According to eyewitness account, the tsunami arrived at 10:45 am.

Systematic measurement at 14:40 pm on March 10, 2005 indicates that the two water marks were 1.4 and 1.2 m above ground level, and 3.9 m and 4.0 m above the sea level. The corrected tsunami height is 1.9 m.

Photo 14. Water mark (right) at the wall of the interviewee's house (left)

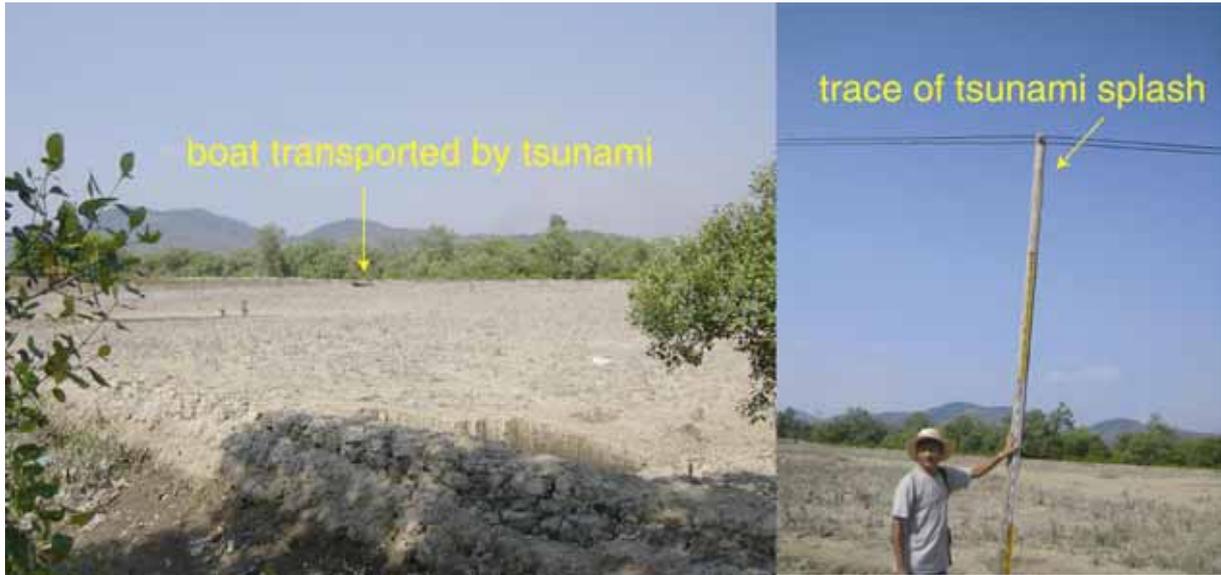
Photo 15. Traces of mud brought by tsunami at the top of the telephone post (right photo) and a boat and tsunami deposit in a paddy field (left photo).

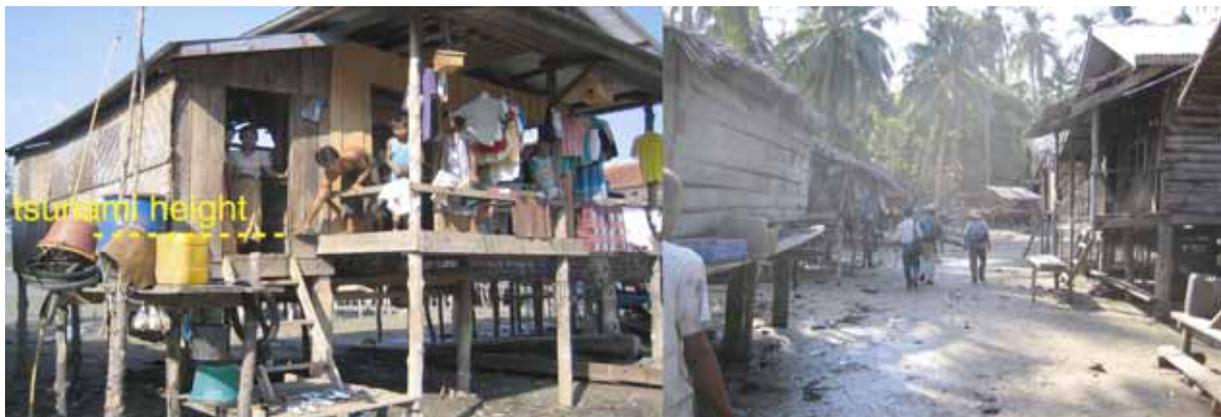
Photo 16. Field survey at Tannyopada

Tannyopada is a small village of 40 houses located along the shore line northwest of Kawthaung city. A 40 year old man told that the tsunami arrived between 10:30 and 11:00 am, in three times with 10 minute intervals (Photo 16).

The measurement at 15:50 on March 10 indicates that the tsunami height was 4.4 m above the sea level. The sea level was very low at the time of measurement and the current water front was more than 200 m offshore, hence the height measurement was less reliable. The corrected tsunami height becomes 1.7 m.

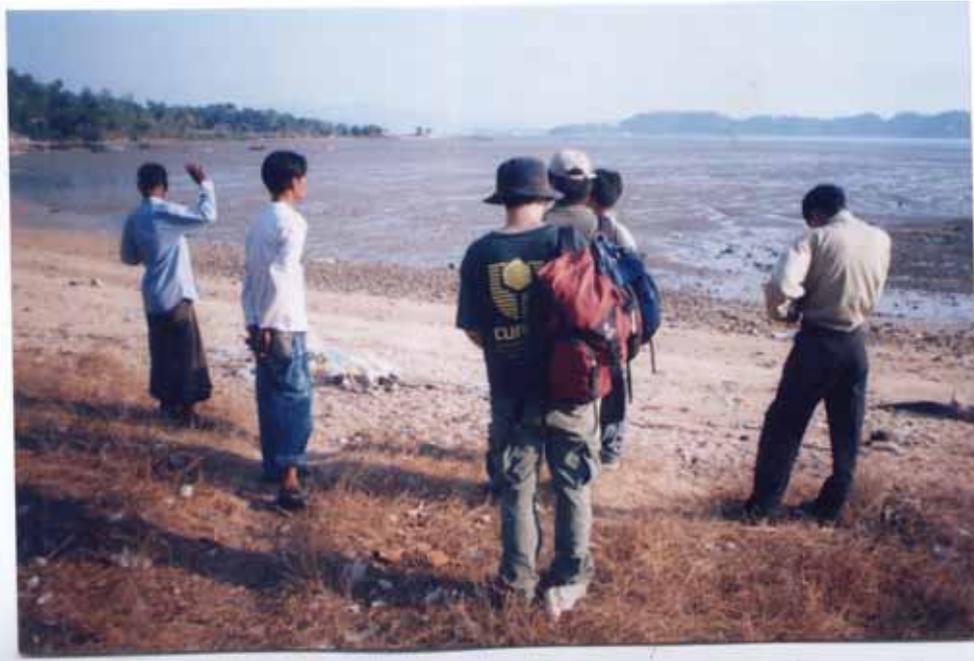
The locality is the west part of Kawthaung city with coast line facing to west. Survey measurement and tsunami information were taken by interviewing with local people. A 25 year old female told us that the tsunami arrived at 10:30 am, in five times with 5 minute intervals (Photo17).

Photo 17. Field measurement was carried out in Thirimyaing Quarter of Kawthaung. A large coverage of mud flat in connection with low tide and a barrier of Island in the seafront lead to less tsunami effect on the shore.

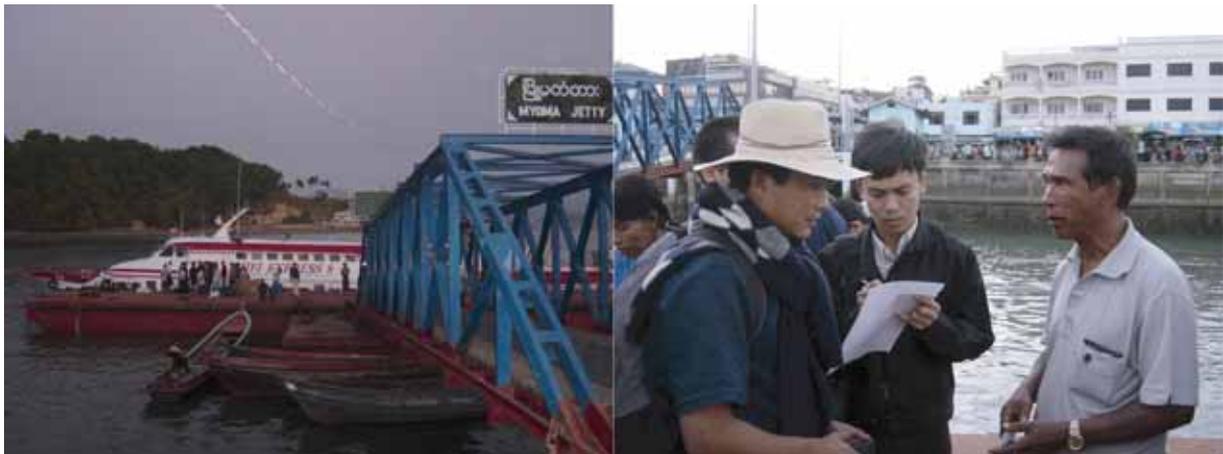
Photo 18. Survey at Kawthaung Myoma Jetty

Myoma Jetty of Kawthaung is a harbor for domestic transportation near the center of Kawthaung City. Many people noticed the abnormal rise of sea level and reported that the highest tsunami level was about 30 cm below the top of the quay wall (Photo 18).

Measurement at 17:30 pm March 10 indicates that the tsunami height was 4.1 m above the sea level. The estimated tsunami height becomes 1.6 m.

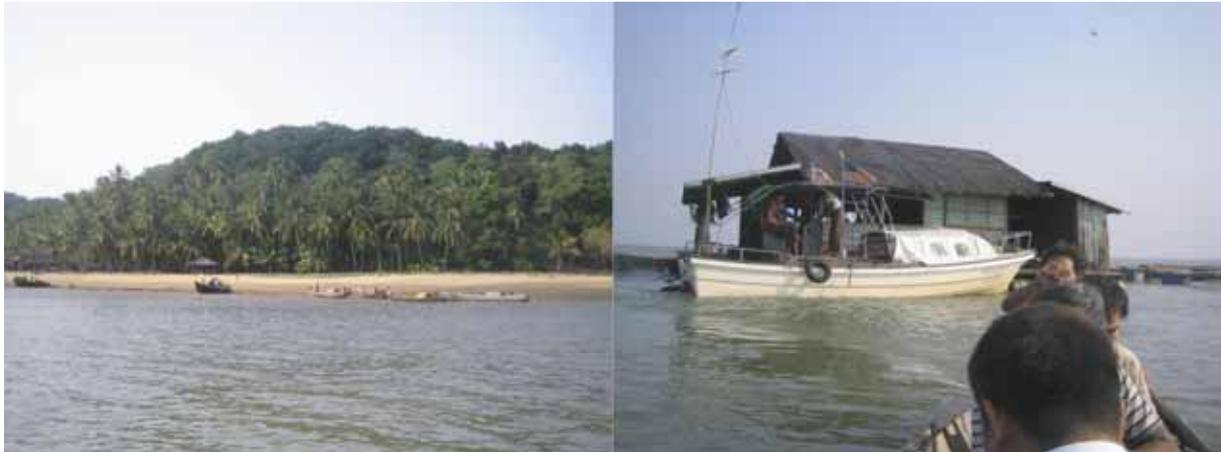
Photo 19. Field survey at Thandar Kyun Village

Survey was taken at Thandar Kyun Village about 10 km west of Myeik city (Photo 19). A 27 year old male told that the tsunami arrived at 11 am, in two waves with a 20 minute

interval.

Our measurement (at 16:10 March 11) of the tsunami levels of two accounts were 2.2 m and 4.4 m, while the high tide level of the rainy season is 5.1 m. Assuming that the tsunami arrival time as 11:00 am, the corrected maximum tsunami height is 0.7 m.

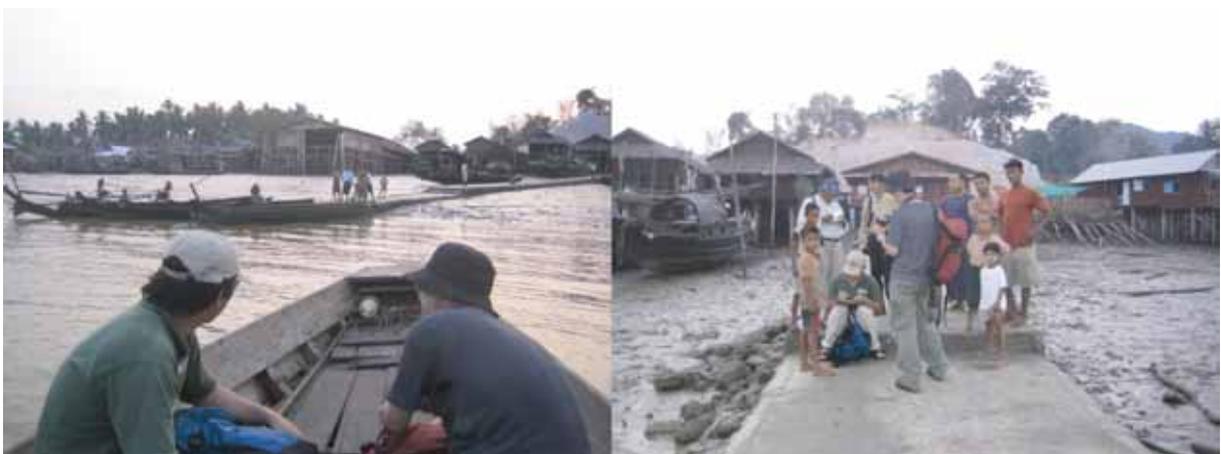
Photo 20 Field survey at Pahtaw Village, Myeik area.

Pahtaw Village is located on a small island, a few kilometers west of Myeik city. An eyewitness reported that the tsunami arrived at 12 noon in three waves (Photo 20).

Measurement (at 18:00 March 11) indicates that the tsunami height was 6.7 m above the sea level, while the high tide in the rainy season was 6.3 m. Assuming the tsunami arrival time was 11:00 am, the corrected tsunami height becomes 2.2 m. An eyewitness indicated that the tide level just before the tsunami arrival was 4.6 m, making the tsunami height 2.1 m, very similar to the corrected height.

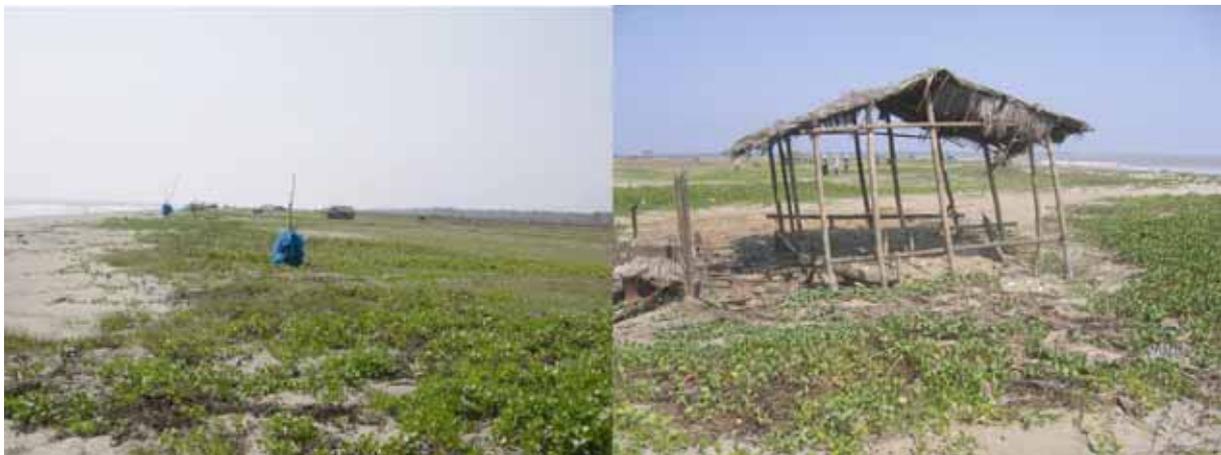
Photo 21. Field survey at Layyin Kwin (Airfield) Village a, Pyinsalu

At Layyin Kwin Village, 16 huts out of 20 were washed away and one person was perished by the tsunami. According to an eyewitness, the tsunami arrived at 11:45, when the tide was low, in four waves. The inundation depth was about 20 cm.

Measurement at 14:46 pm on March 13, 2005 indicates that the tsunami level was 0.6 m above the sea level. Assuming that the tsunami arrived at 11:30 am, the corrected tsunami height is 0.7 m.

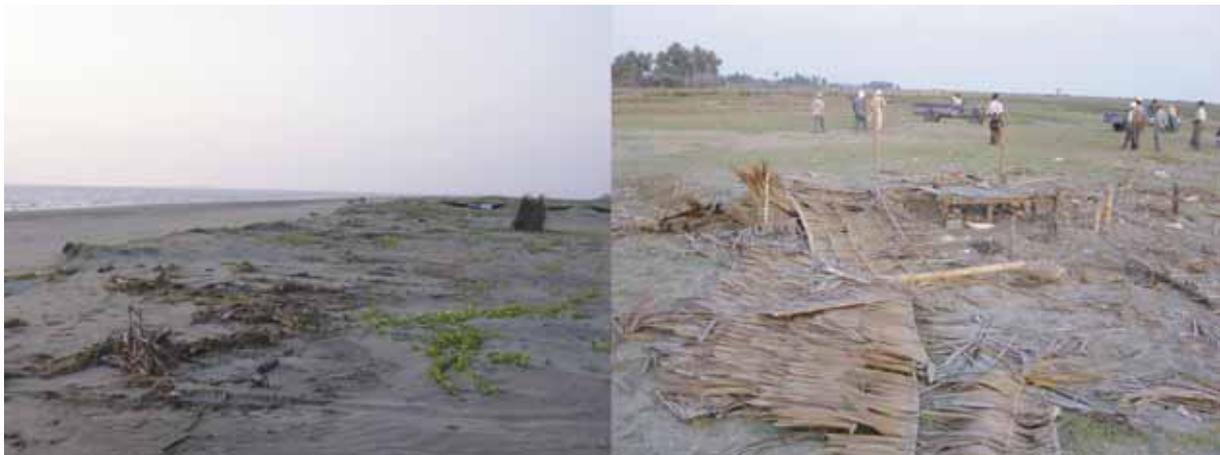
Kapyet Thaung Village is highly affected by the tsunami. Almost all of 130 huts were washed away and 17 casualties were reported (Photo 22). Some ships were dragged over inland. According to an eyewitness account, the tsunami arrived at 11 am in three waves with 15 minute intervals. Measurement at 17:51 pm on March 13 indicates that the tsunami height was 3.5 m above the sea level. Assuming that the tsunami arrived at 11:30 am, the corrected height is 2.0 m.

Photo 22. Field survey at Kapyet Thaung Village, Pyinsalu. Small huts were damaged by the tsunami (left photo) and the situation of ocean at the time of measurement (right)

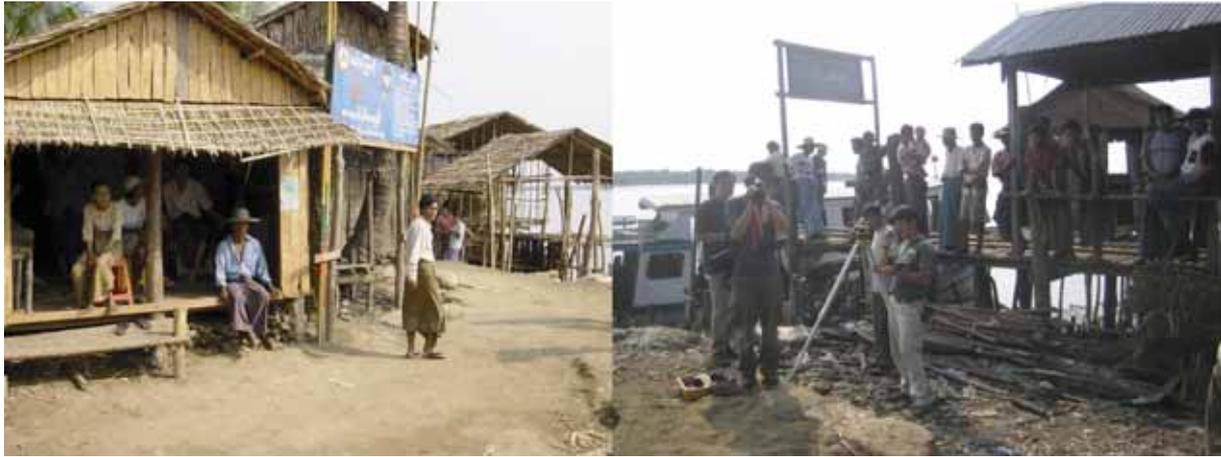
Photo 23. Field survey at Thit Poke Village

Thit Poke Village is a small one with 332 houses and located at about 20 km from Pyinsalu. Two houses were damaged, but the tsunami caused no injuries or casualties. Interview with local people indicated that the tsunami inundated about 50 cm above ground at 11:40 am. Measurement at 8:57 on March 14 indicates that the tsunami height was 2.9 m above the sea level. Assuming that the tsunami arrived at 11:30 am, the corrected height is 1.7 m.

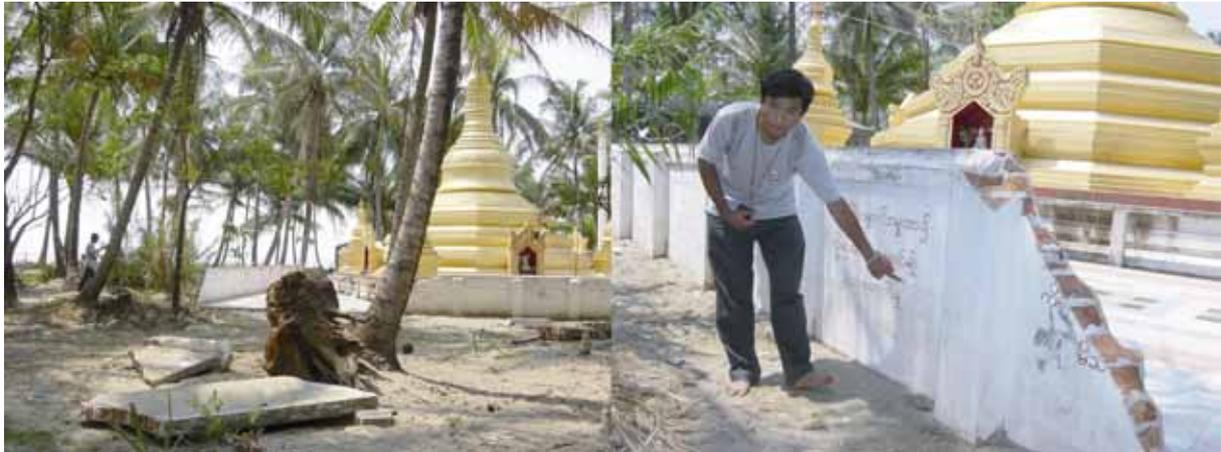
In Kaing Thaung Village, a pagoda built near the shore line was damaged by the tsunami. Part of the outer wall was knocked down (Photo 24, left) and watermark was clearly observed at 50 cm above the ground level (Photo 24, right). A Buddhist monk told us that the tsunami arrived at 11:30 am. Our measurement at 11:46 am on March 14 indicates that the tsunami height was 1.8 m above the sea level. Assuming that the tsunami arrived at 11:30, the corrected height is 1.9 m.

Photo 24 Field survey at Kaing Thaung Island Pagoda. Walls of Pagoda are destroyed by Tsunami (left photo) and Water marker at the wall (right photo)

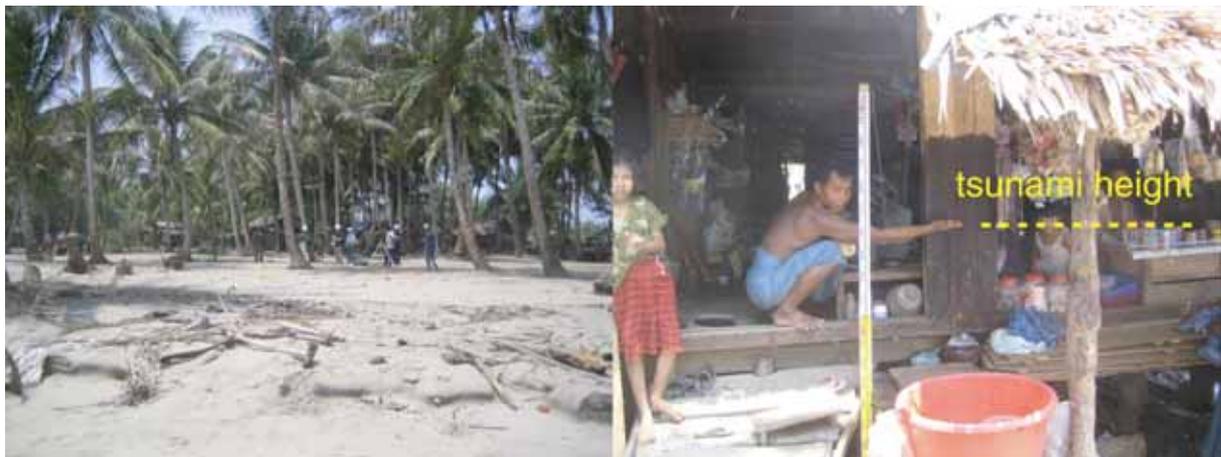
In the village, 8 casualties and 16 damaged houses are reported by Department of Meteorology and Hydrology. An eyewitness account indicated that the tsunami height was 1.35 m above the ground (Photo 25). Measurement at 12:05 on March 14 indicates that the tsunami height was 2.0 m above the sea level, and the corrected tsunami height is 2.3 m.

Photo 25. Field survey at Kaing Thaung Island Village. Local people showed the inundation height of tsunami wave (right photo).

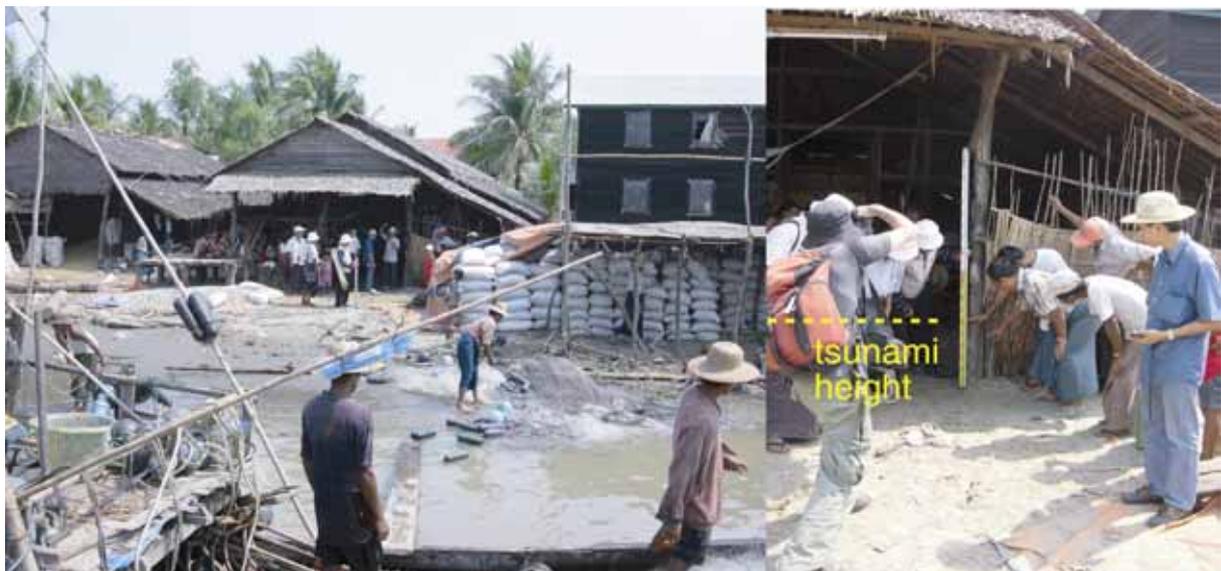
In Aung Hlaing Village, an eyewitness account indicated that the tsunami arrived at 11:45 in two waves. The tsunami inundated about 60 cm above the ground (Photo 26, right). The second wave caused damage to 55 houses without any fatalities. Measurement at 14:06 on March 14 indicates that the tsunami height was 1.2 m above the sea level. Assuming that the tsunami arrived at 11:30, the corrected height is 1.5 m.

Photo 26 Survey at Aung Hlaing Village

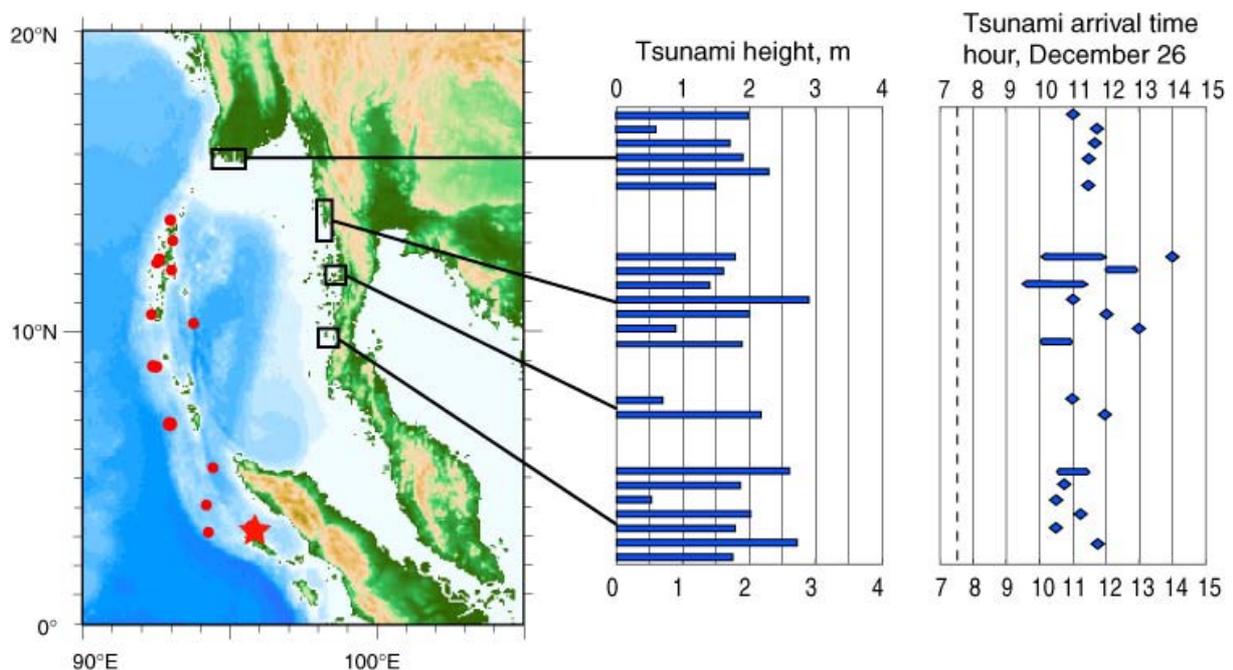
Survey data of the 22 localities (MM-01 to MM-22) from Myeik Archipalegos, Taninthayi Division and Ayeyarwaddy Delta reveal that tsunami heights along the Myanmar coast were not more than 3 m and the affected time was mostly between 9:30 and 13:00, that is 2 to 5.5 hours after the main earthquake event off the coast of Sumatra (Figure 10). The arrival times are very variable at each locality in the same area, indicating that the reported times depend on the interviewees. Among the eyewitness we interviewed, nobody felt the earthquake shaking, making the time estimate between the earthquake and tsunami more difficult. About the tsunami heights, eyewitness often compared the December tsunami height with the 'rainy season high tide'; at most locations, the tsunami was similar or smaller than the 'rainy season high tide'. As shown in Figure 8 (page 11), the calculated high tides are more or less similar throughout the year. Hence the 'rainy season high tide' must be the results of meteorological effects such as floods rather than astronomical tides.

Figure 10 Summary of tsunami survey
