Report on Post Tsunami Survey along the Myanmar Coast for the December 2004 Sumatra-Andaman Earthquake

June 2005

The content of this report, with reduced number of photographs, was submitted to special issue on the Sumatra-Andaman earthquakes of 2004 and 2005 of *Earth, Planet and Space*. A proper citation would be as follows.

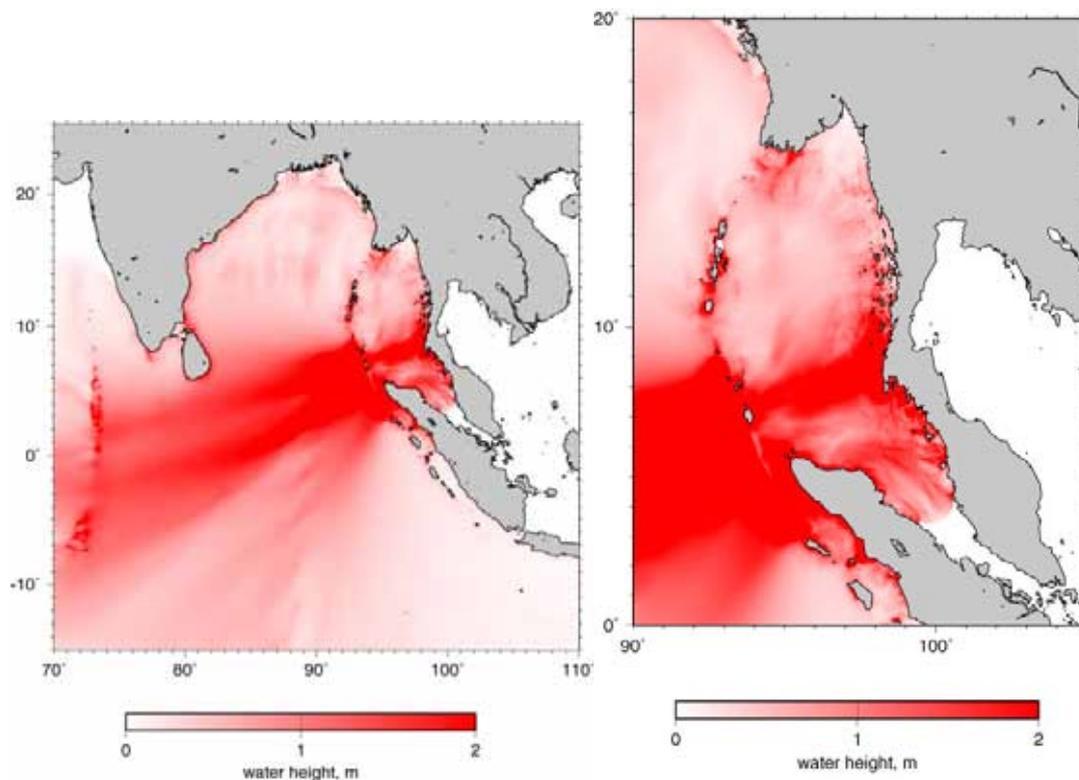
Figure 12 Computed maximum tsunami heights

tsunami amplitudes are larger in the NE (toward Phuket) direction and SW (toward Maldives) direction. The computed tsunami amplitudes are relatively smaller along the Myanmar coast. The amplitudes are slightly large off Ayeyarwaddy delta, because the shallow delta extends offshore to cause concentration of tsunami energy.
