JSC-10607

APOLLO SOYUZ
MISSION EVALUATION REPORT

National Aeronautics and Space Administration
LYNDON B. JOHNSON SPACE CENTER

Houston, Texas
December 1975

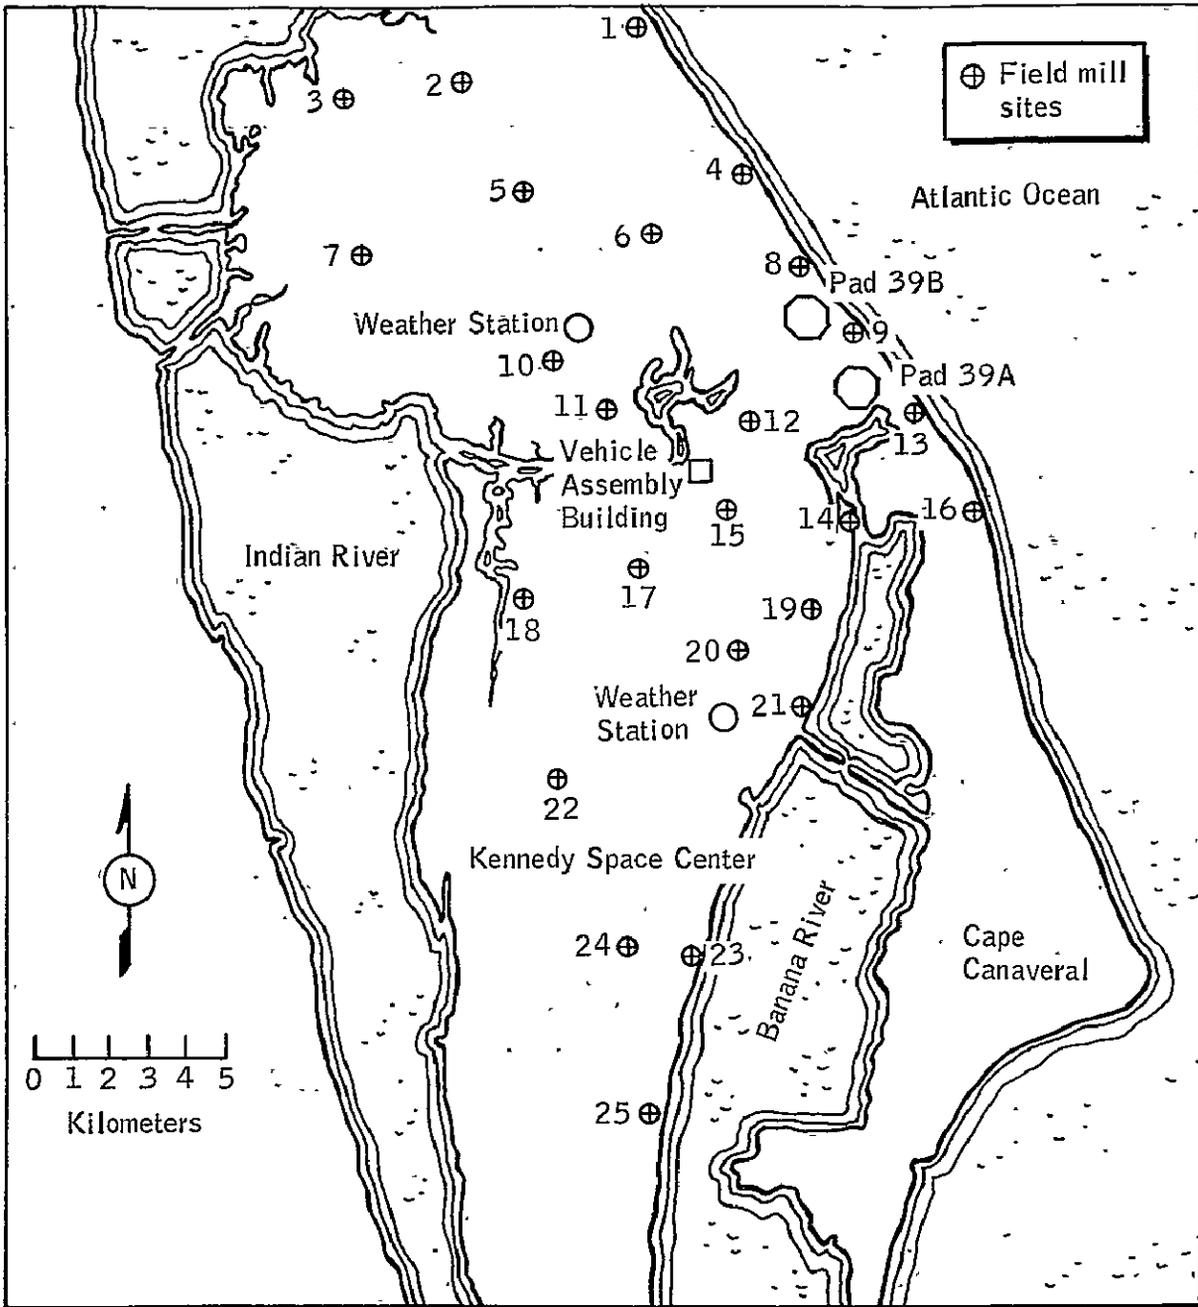
Figure 13-1.- Field mill network at Kennedy Space Center.

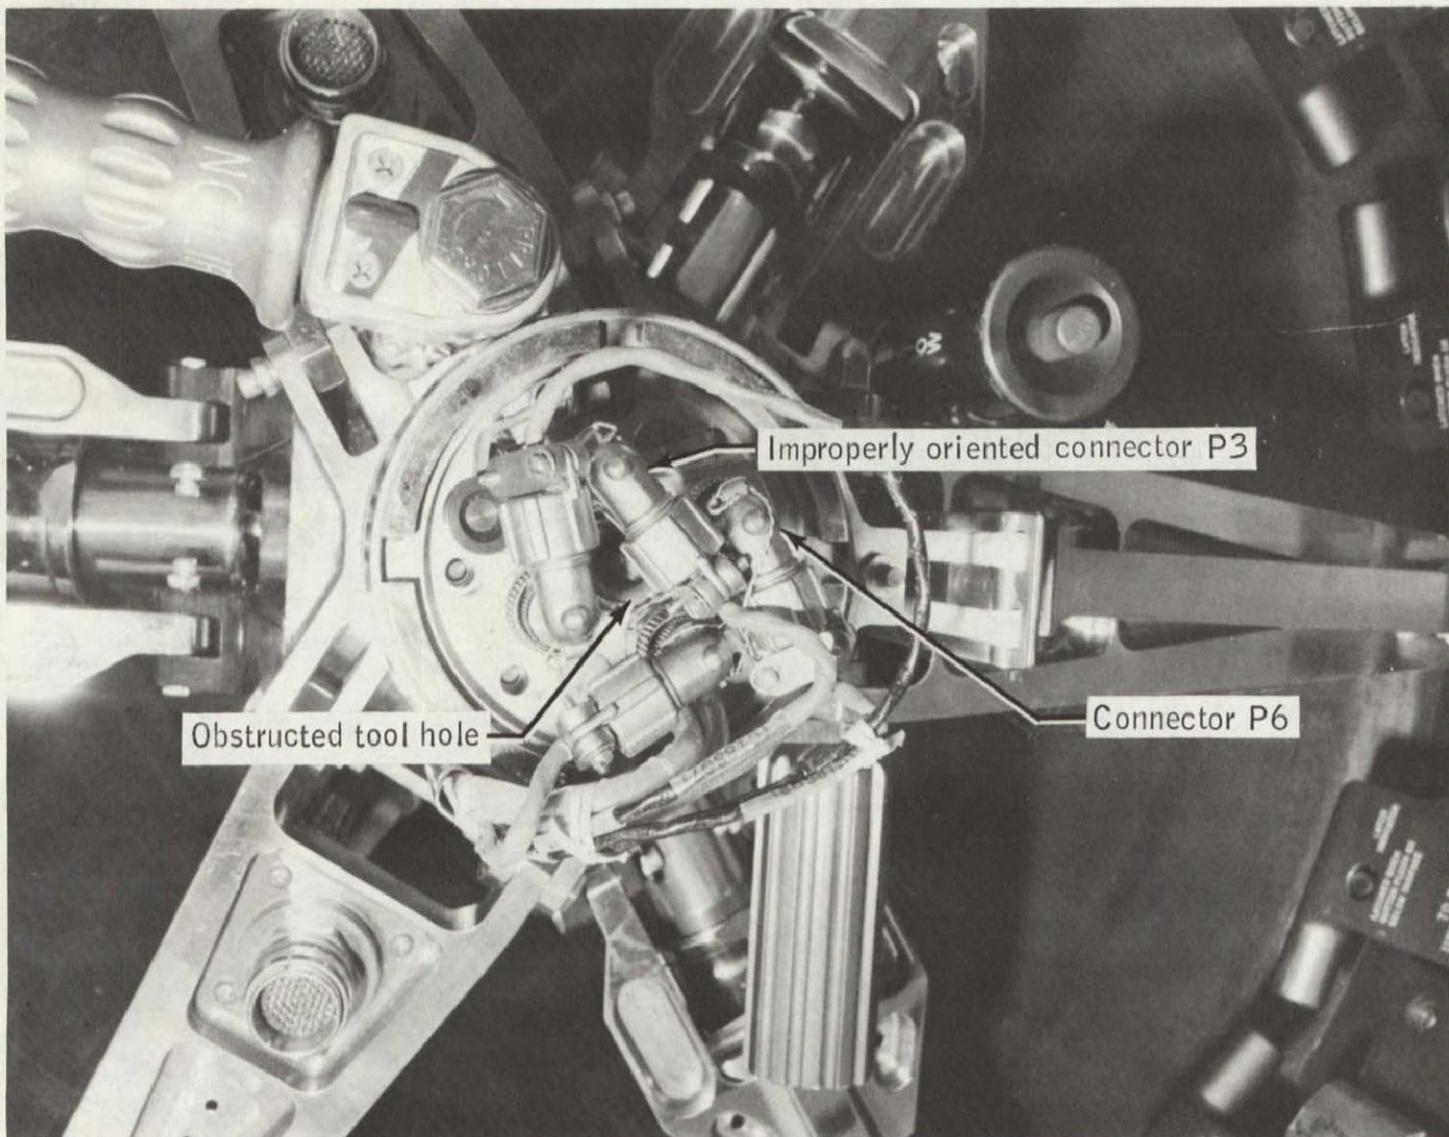
As shown in figure 14-1, the adjacent pyrotechnic connector (P6) was mated and safety-wired prior to installation of P3. This sequence of installation caused the wire from P3 to ride over instead of under connector P6 as shown in figure 14-2. As a result, the wire to P3 was so short that that proper connector backshell orientation could be achieved only by pulling on the wire, contrary to good wiring practice. The connector installation team decided to reclock the P3 connector backshell to the position shown in figure 14-1 to prevent overstressing the wire. The reclocked connector backshell obstructed the capture latch release tool access hole.

Figure 14-1.- Closeout photograph of improperly installed docking probe pyrotechnic connector.

All command and service module mechanisms functioned properly except that the crew had difficulty removing the docking probe from the command module tunnel after docking with the docking module. When the crew attempted to remove the docking probe, a special tool for releasing the probe capture latches from the drogue could not be installed in the aft end of the probe. The Command Module Pilot observed that one of the pyrotechnic electrical connectors was obstructing the tool entrance hole. The interfering connector was for the expended pyrotechnic initiator that had been used for probe retraction. Procedures were sent to the crew for removing the connector cover plate and the interfering connector. The connector was disengaged, the cover replaced, the loose connector taped to the cover, and the probe successfully removed in accordance with the checklist. The docking probe problem is discussed further in section 14.1.1.

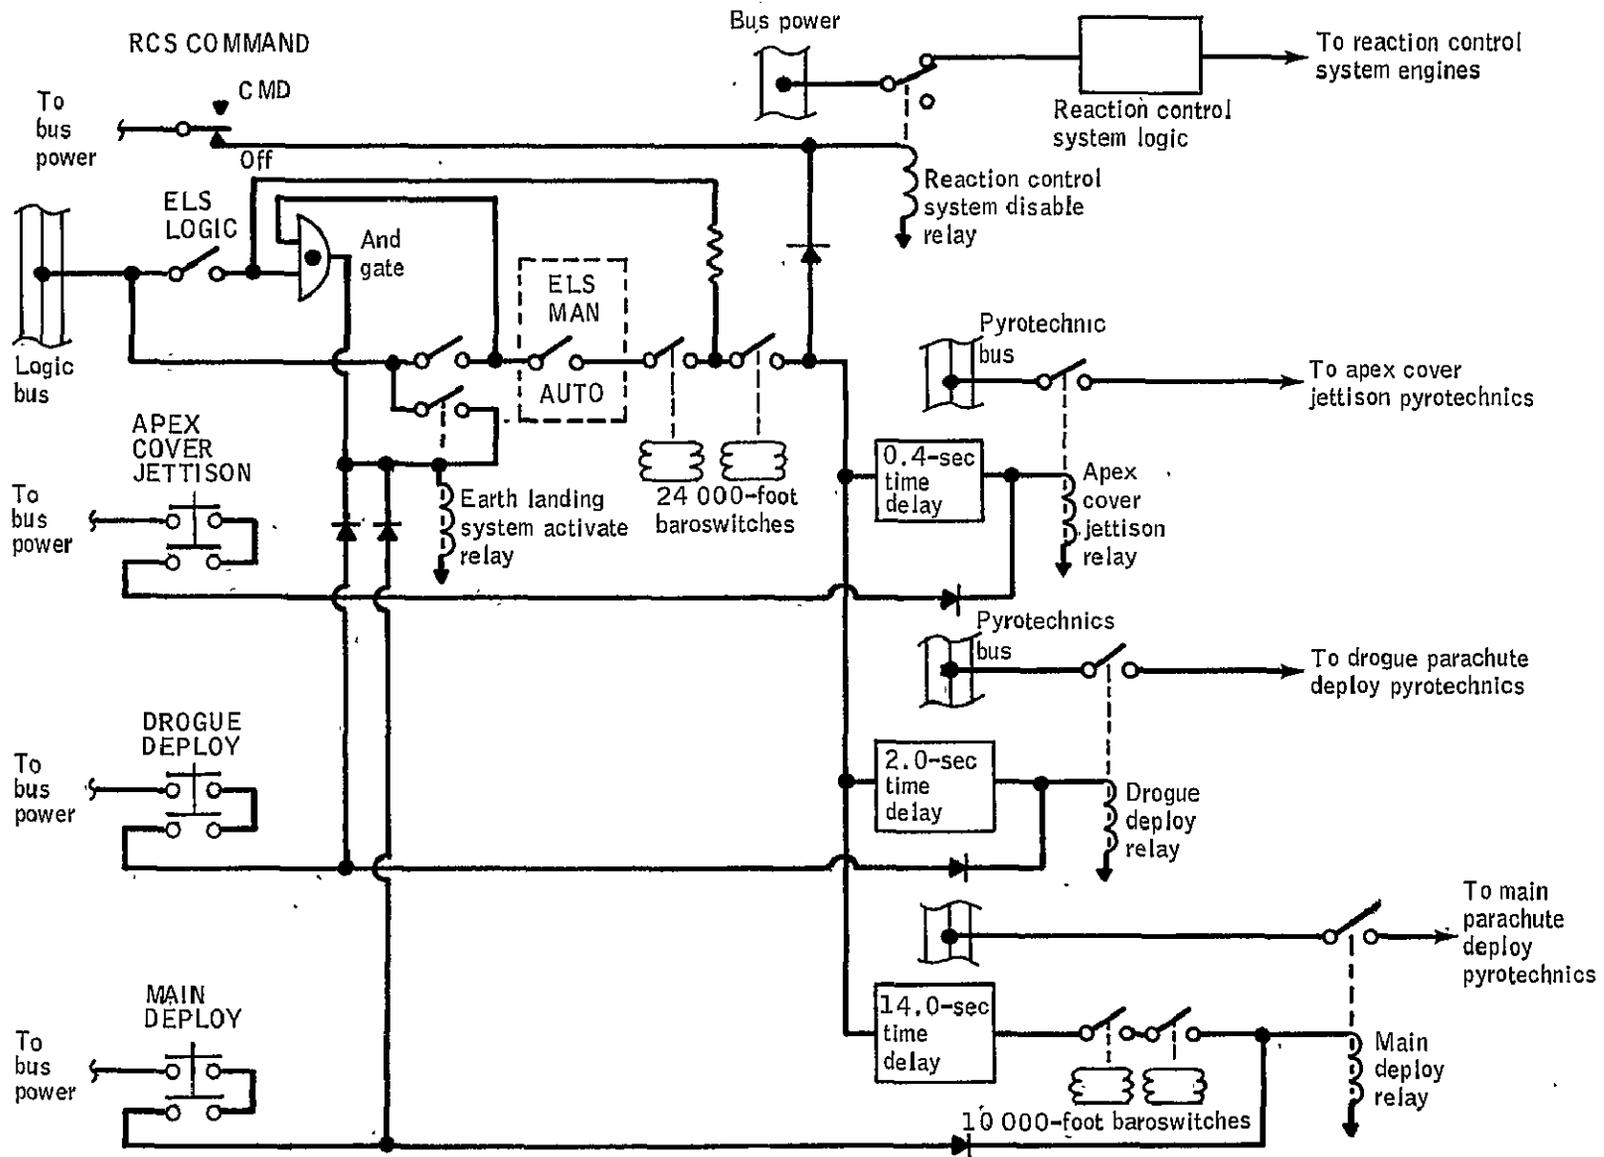
When the crew realized that the drogue parachutes had not been deployed automatically, the forward heat shield and drogue parachutes were deployed manually. The spacecraft motions that were induced by the drogue parachute deployment caused the reaction control system thrusters to respond vigorously. The thruster activity was terminated when the crew armed the automatic earth landing system 30 seconds after drogue parachute deployment, disabling the reaction control system (fig. 14-4).

Figure 14-3.- Simplified manual and automatic circuits of earth landing system (system A).

During the landing phase, an abnormal sequence of events involving manual and automatic control of the earth landing system caused reaction control system combustion products and, primarily, a mixture of nitrogen tetroxide vapors and air to be drawn into the cabin for about 30 seconds commencing at an altitude of about 5650 meters. This sequence is discussed in detail in section 14.1.2. Functioning of the automatic and manual landing systems and associated hardware was normal.

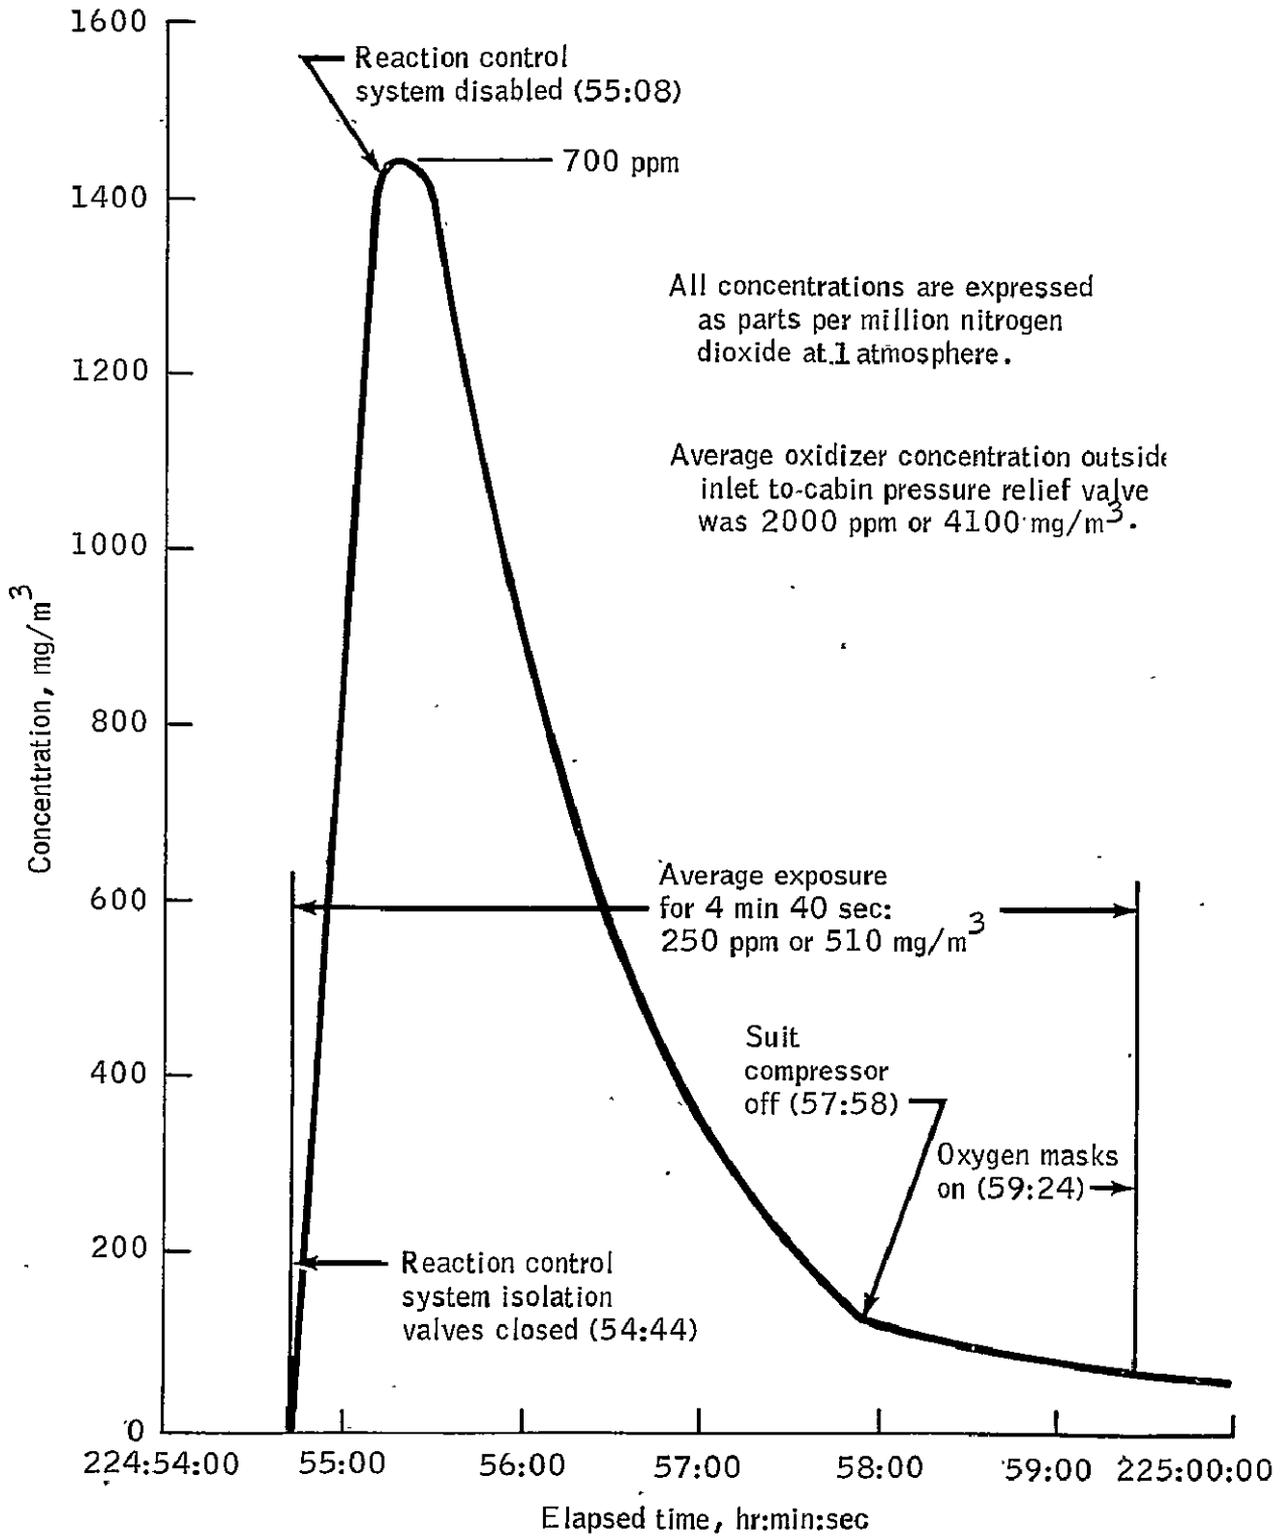
Figure 14-7.- Oxidizer concentration in cabin

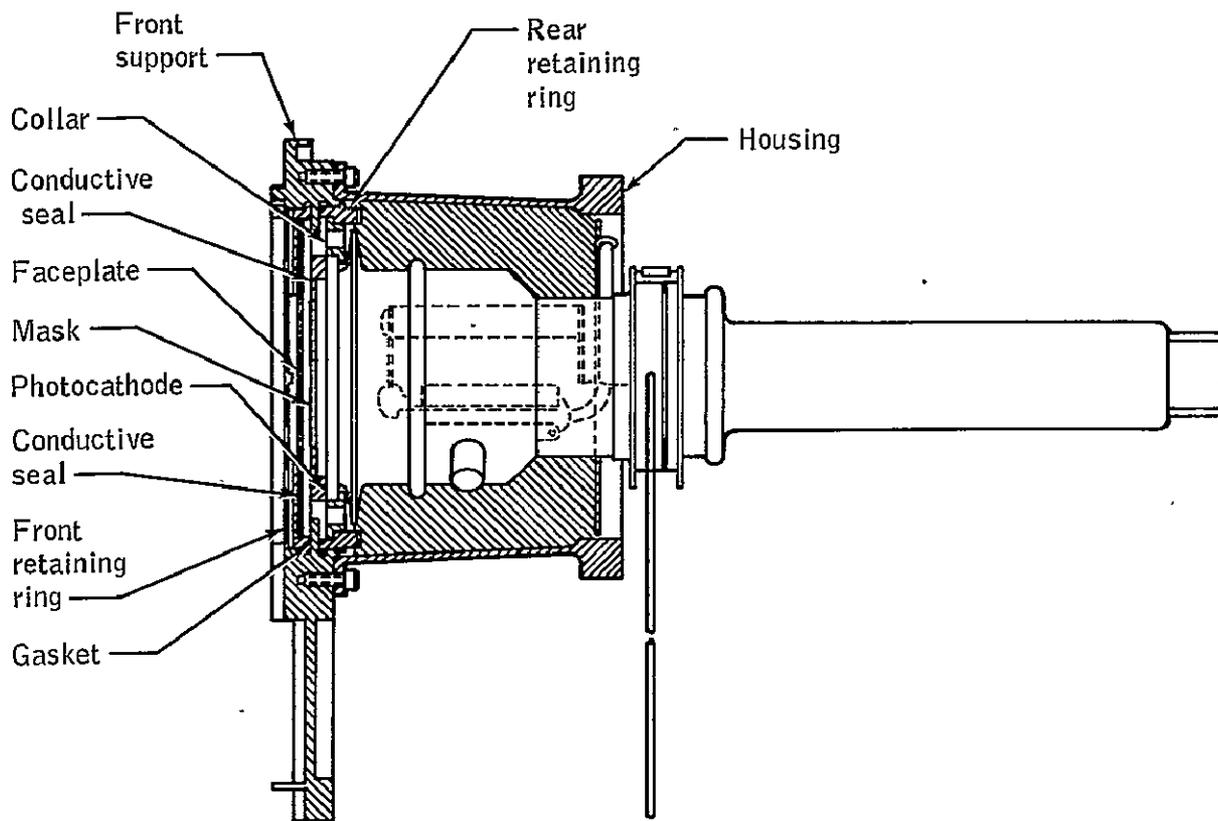
Figure 14-9.- Image tube.

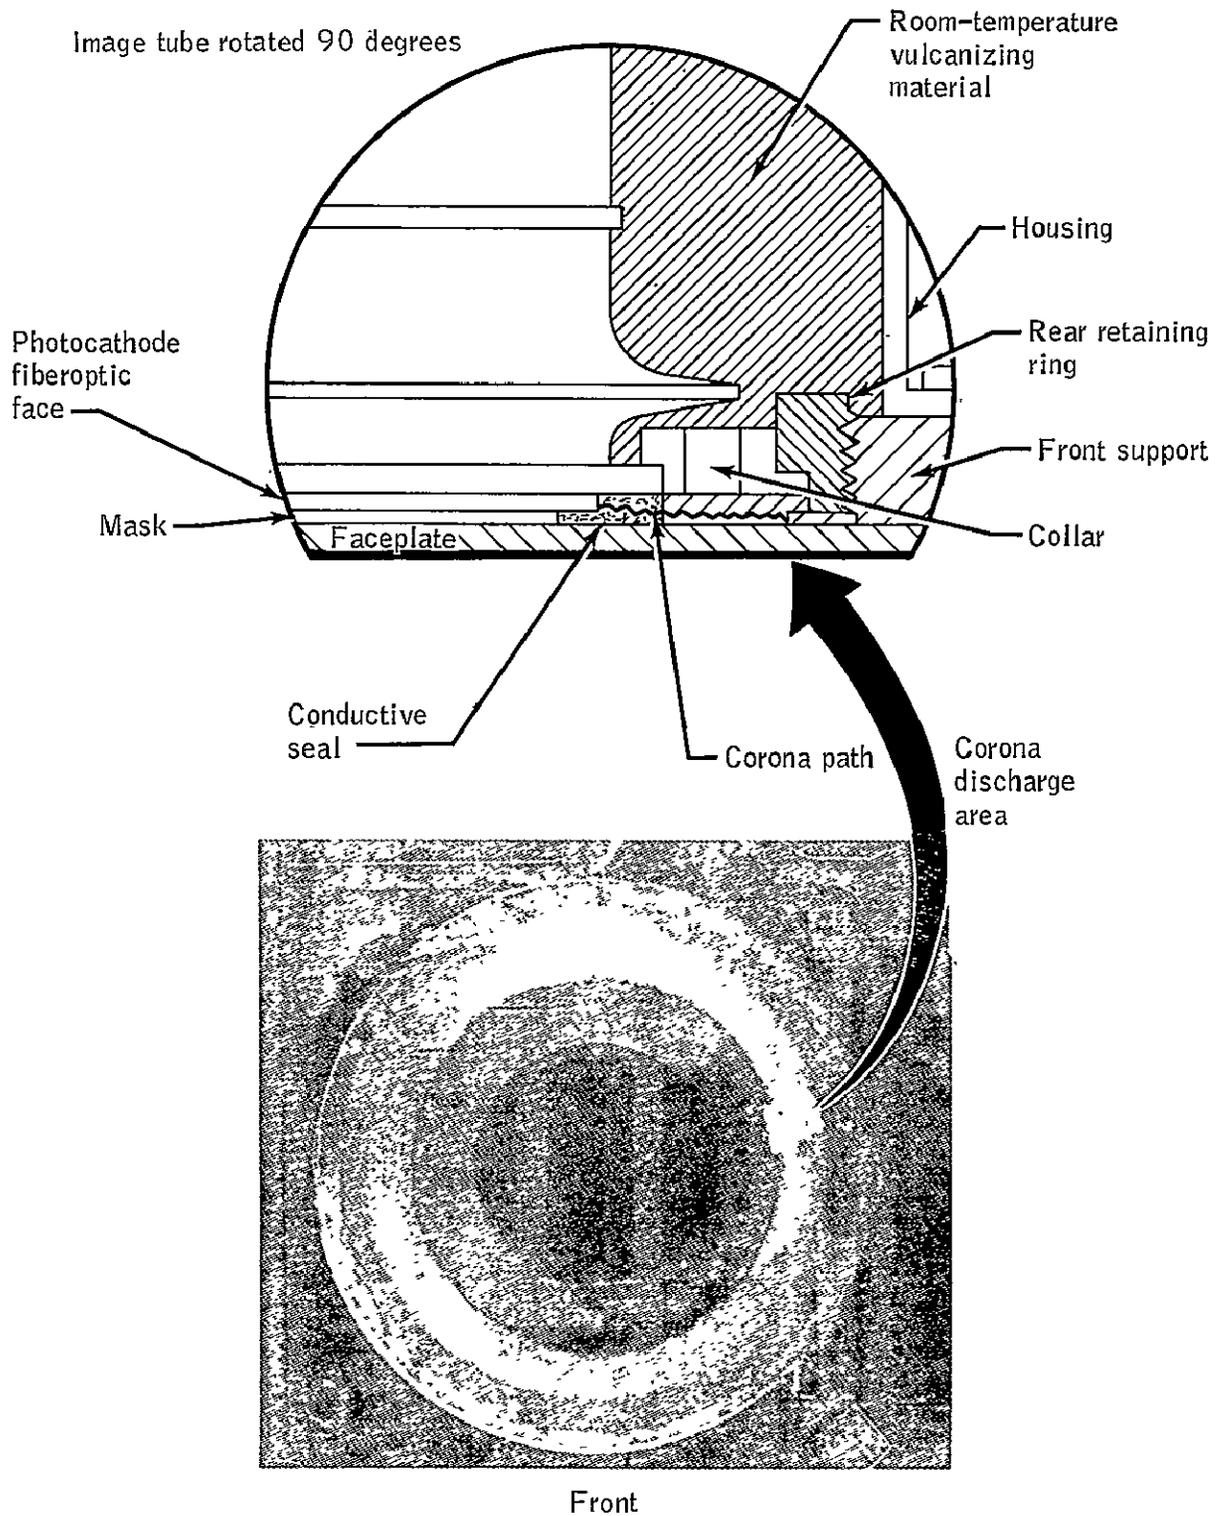
Postflight testing at a sustained lowered pressure produced corona which was observed through the glass faceplate going from the lip of the photocathode fiberoptic face across the inner surface of the faceplate to the front support. Figure 14-10 shows an enlarged section of the region where the corona occurred and includes a photograph of the corona taken in a darkened room, viewing from the front of the image tube.

Figure 14-10.- Corona discharge observed during postflight testing.

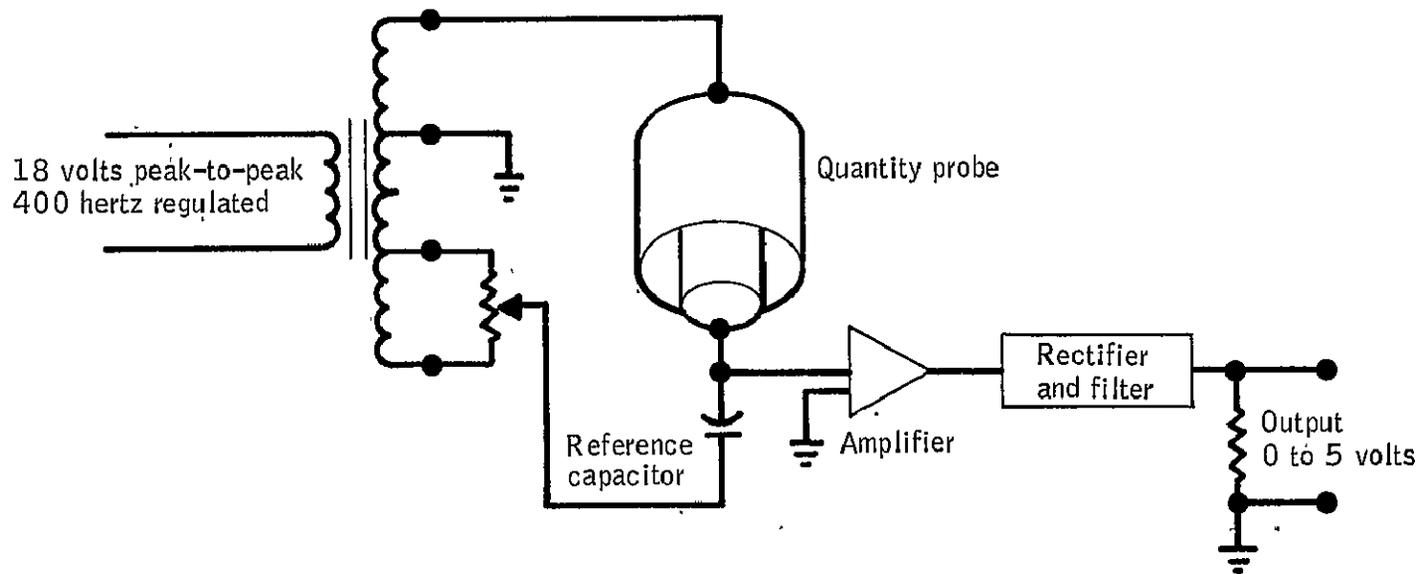
The reactive voltage developed across the probe capacitance will change as rapidly as capacitance changes. The rectifier filter on the output of the signal conditioner introduces a time constant of about 0.022 second in the instrument response.

Figure 14-11.- Cryogenic oxygen tank quantity measurement schematic.

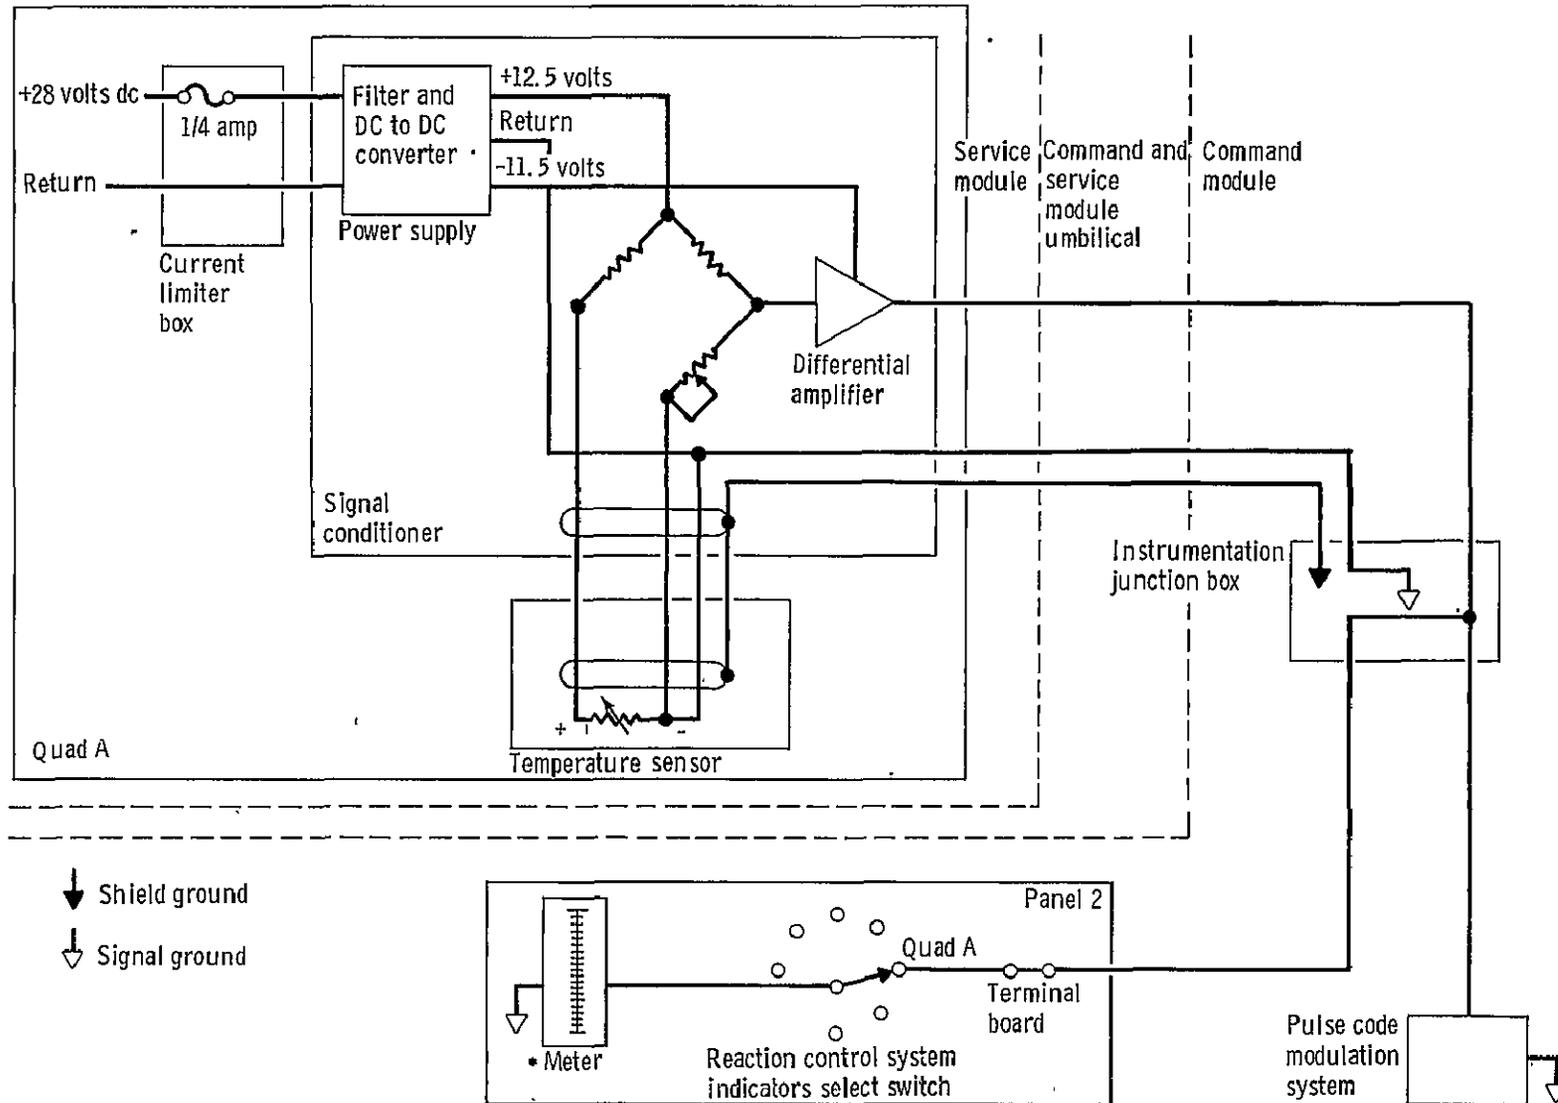
Figure 14-12. - Service module reaction control system quad A helium tank temperature measurement schematic.

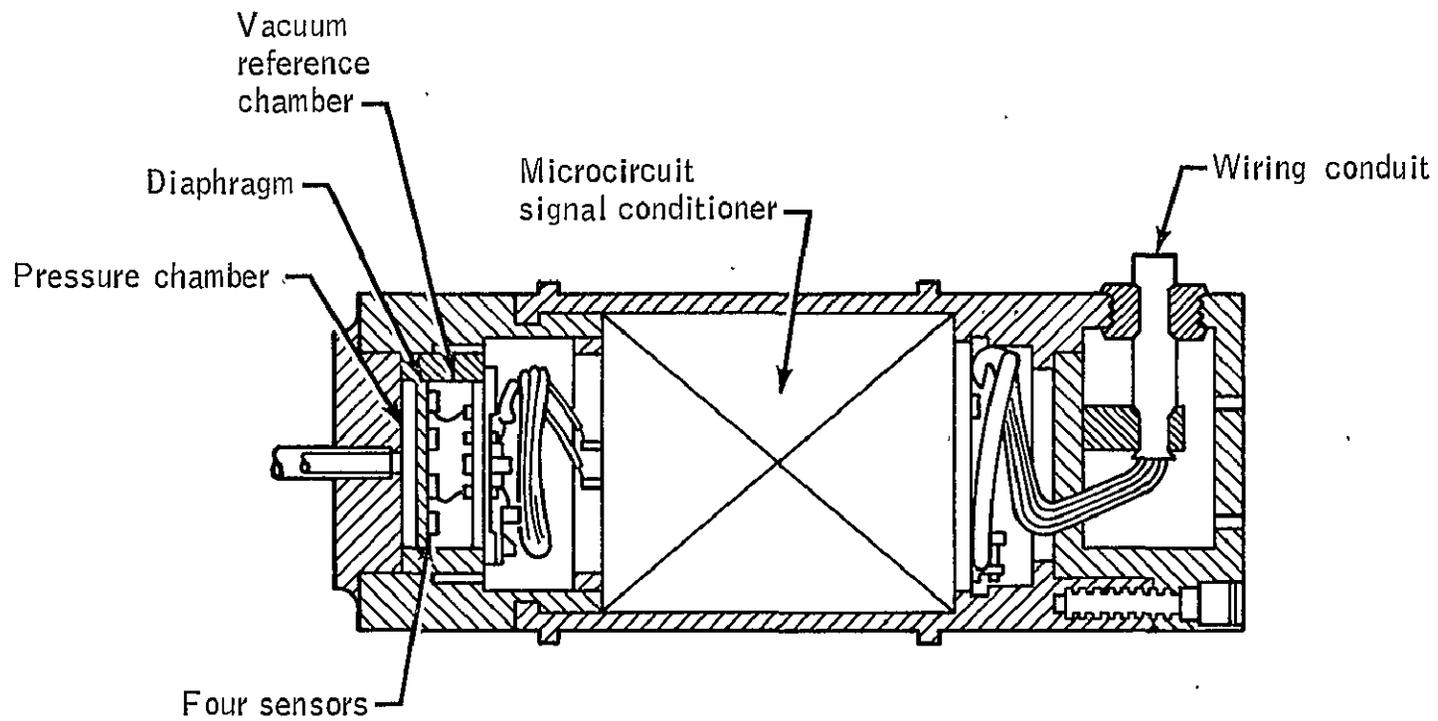
Figure 14-13.- Oxygen pressure transducer.

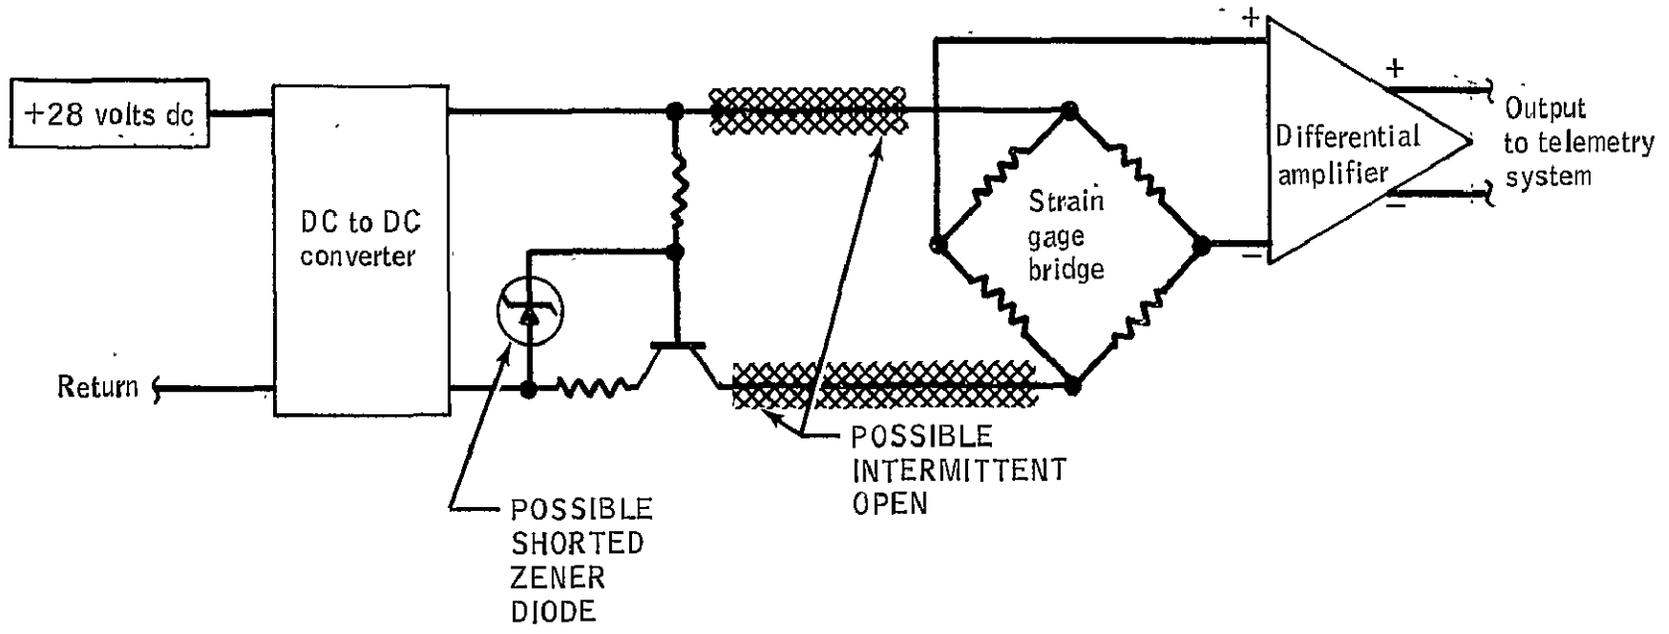
Analysis of the transducer circuit (fig. 14-14) indicates that the likely cause of the failure was an intermittent open at a joint in the pressure gage bridge excitation circuit. This conclusion is supported

Figure 14-14.- Oxygen tank pressure transducer schematic.

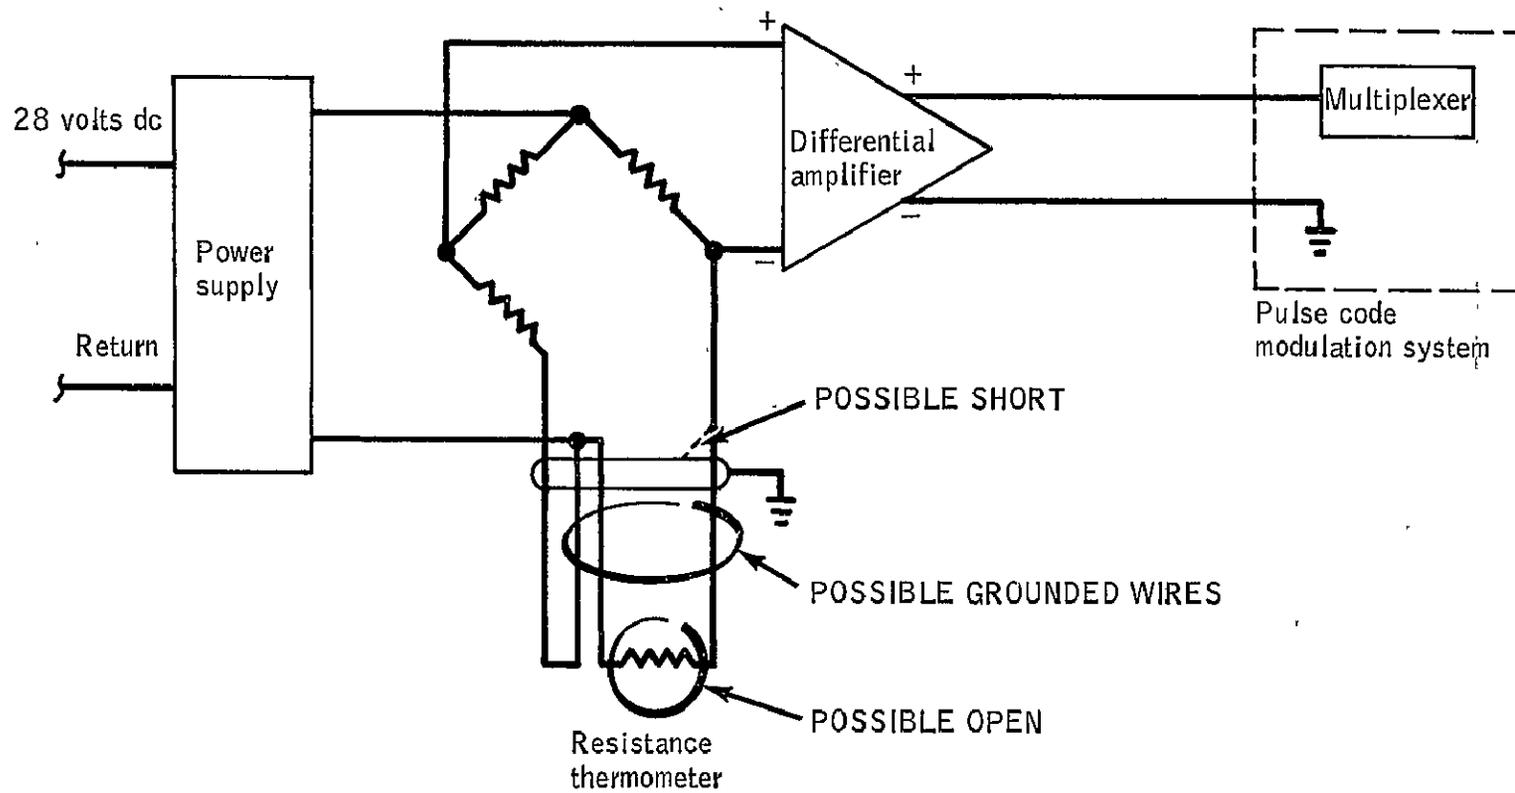
A second possible failure mechanism is a short to ground in any one of three of the four wires in the twisted shielded quad cable. Such a short would tie the differential amplifier negative output to the negative input through the ground path and drive the amplifier to maximum output, giving the off-scale-high indication. The transducer cable shield is connected to ground at the signal conditioner. The shield connection

Figure 14-15.- Primary evaporator inlet temperature measurement schematic.

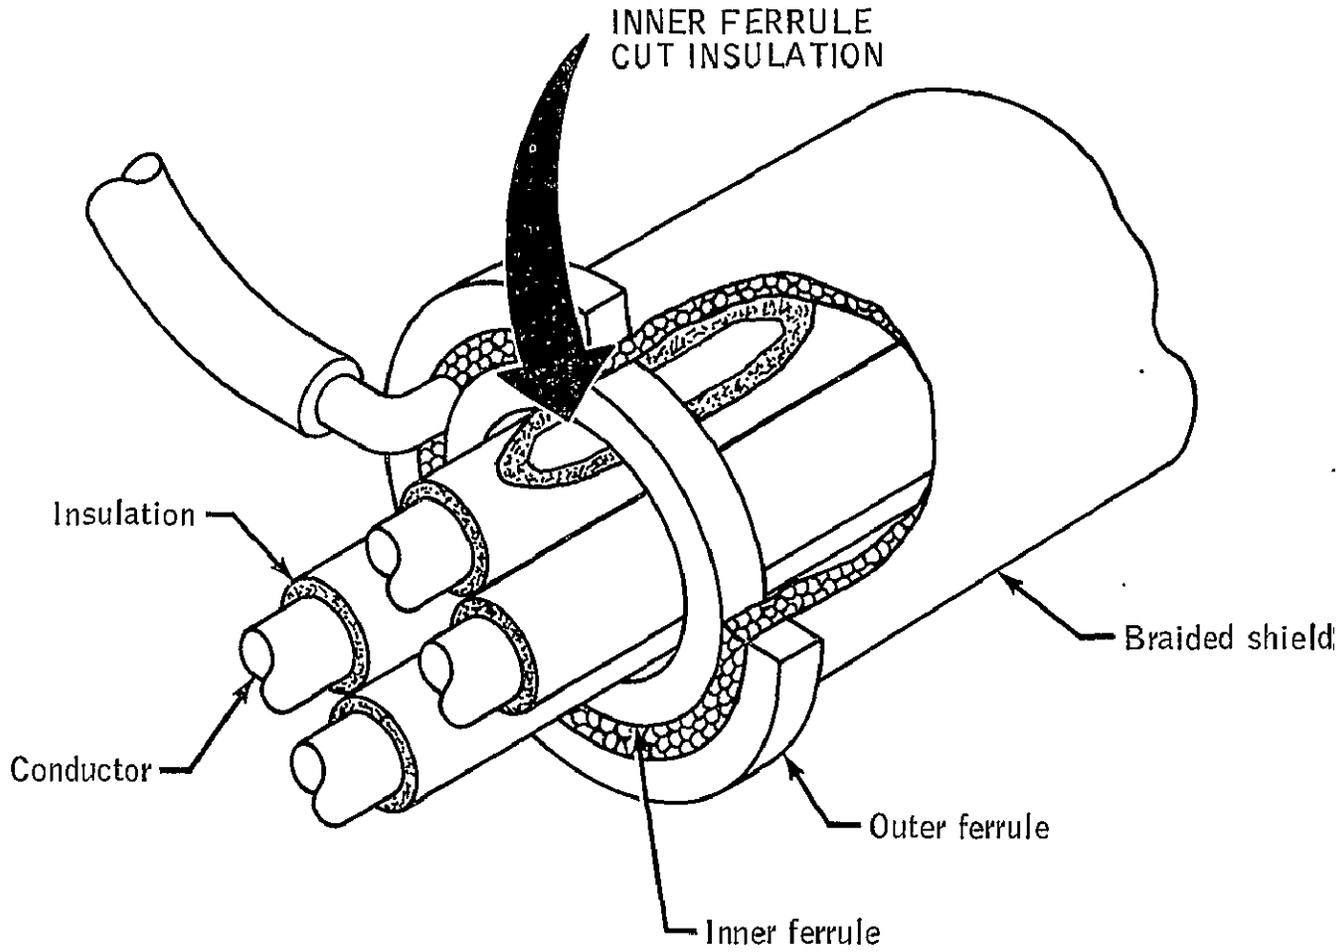
Figure 14-16.- Short in wire bundle from conductor to inner ferrule to braided shield.

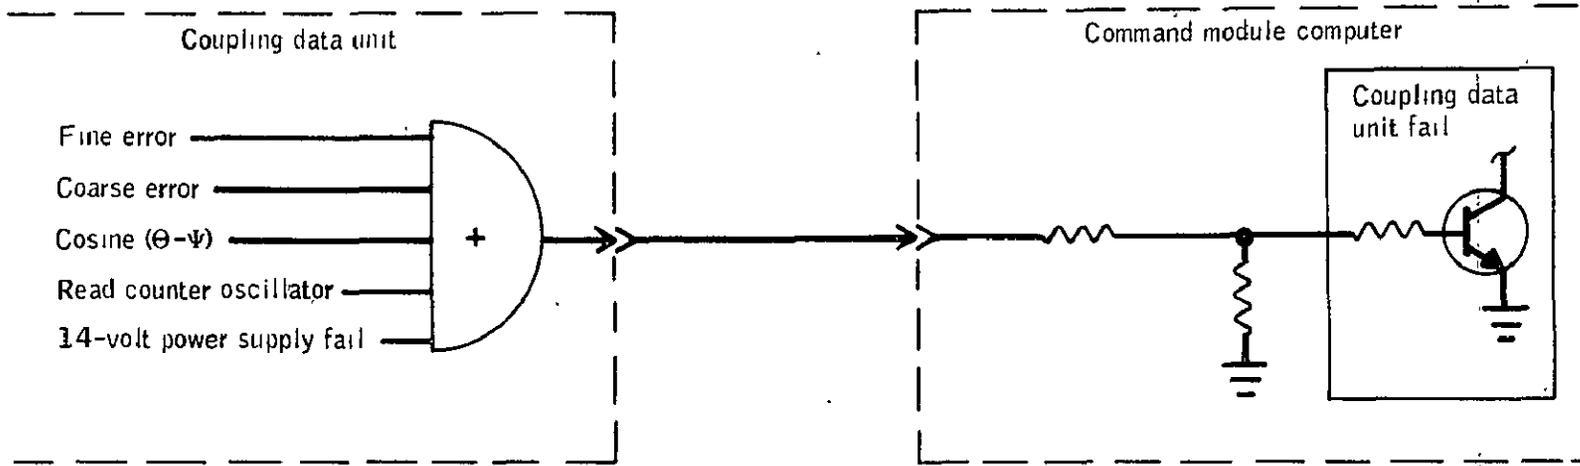
An evaluation of the inertial subsystem was performed in an effort to determine the possible failure source. The units isolated by this evaluation are the electronic coupling data unit, the A-harness, and the computer.

Figure 14-17.- Coupling data unit fail indication.

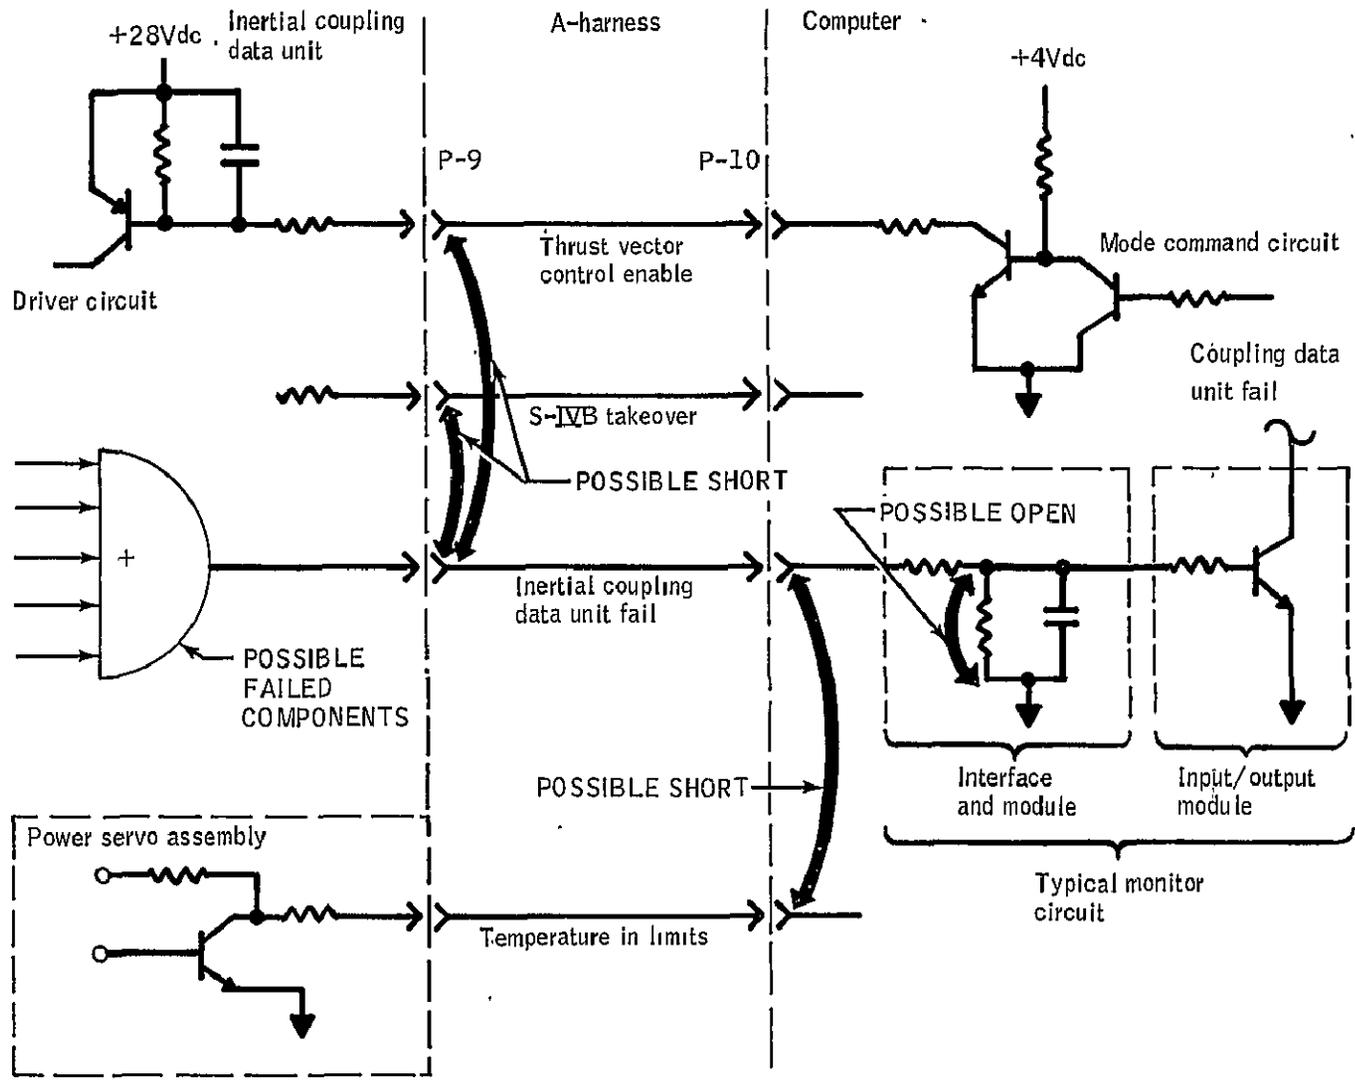
Figure 14-18.- Inertial coupling data unit fail - interconnect diagram.

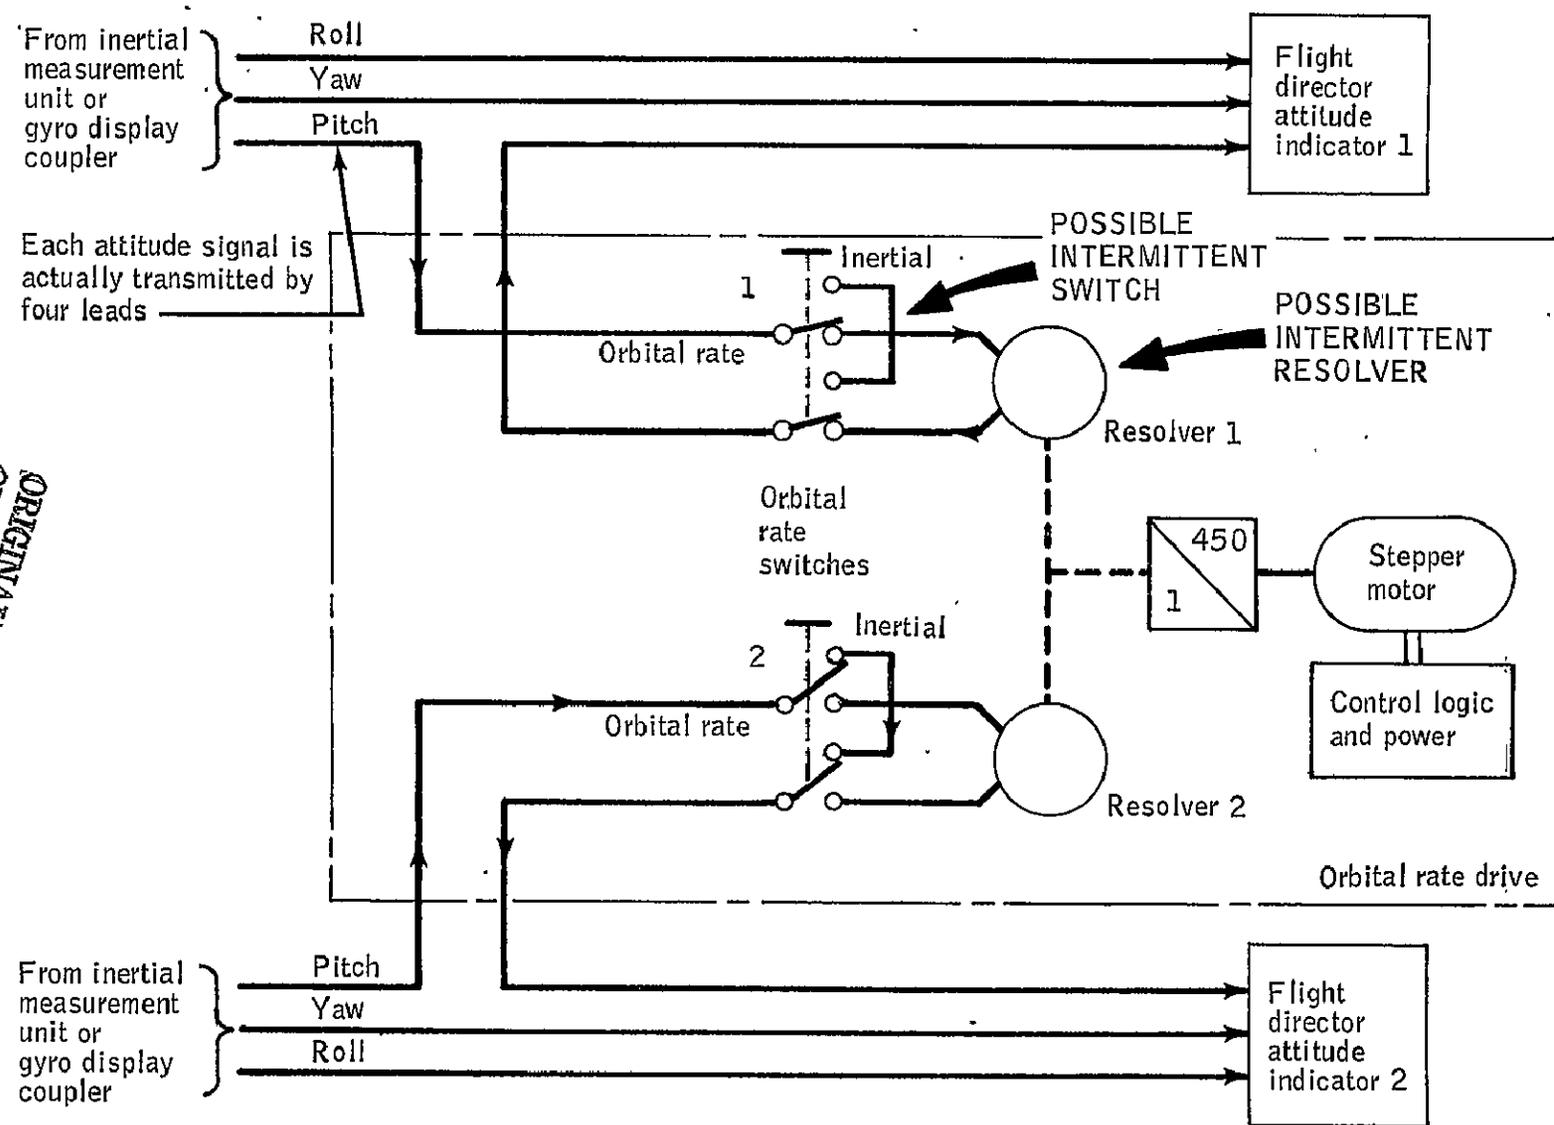
The Docking Module Pilot reported prior to docking module jettison that the attitude ball on flight director attitude indicator 1 did not always flip to orbital attitude when the "orbital rate 1" switch was set from "inertial" to "orbital rate." The attitude ball did not always indicate the correct orbital attitude when it did flip.

Figure 14-19.- Orbital rate display/flight director attitude indicator interface.
