JSC-10607

APOLLO SOYUZ
MISSION EVALUATION REPORT

National Aeronautics and Space Administration
LYNDON B. JOHNSON SPACE CENTER

Houston, Texas
December 1975

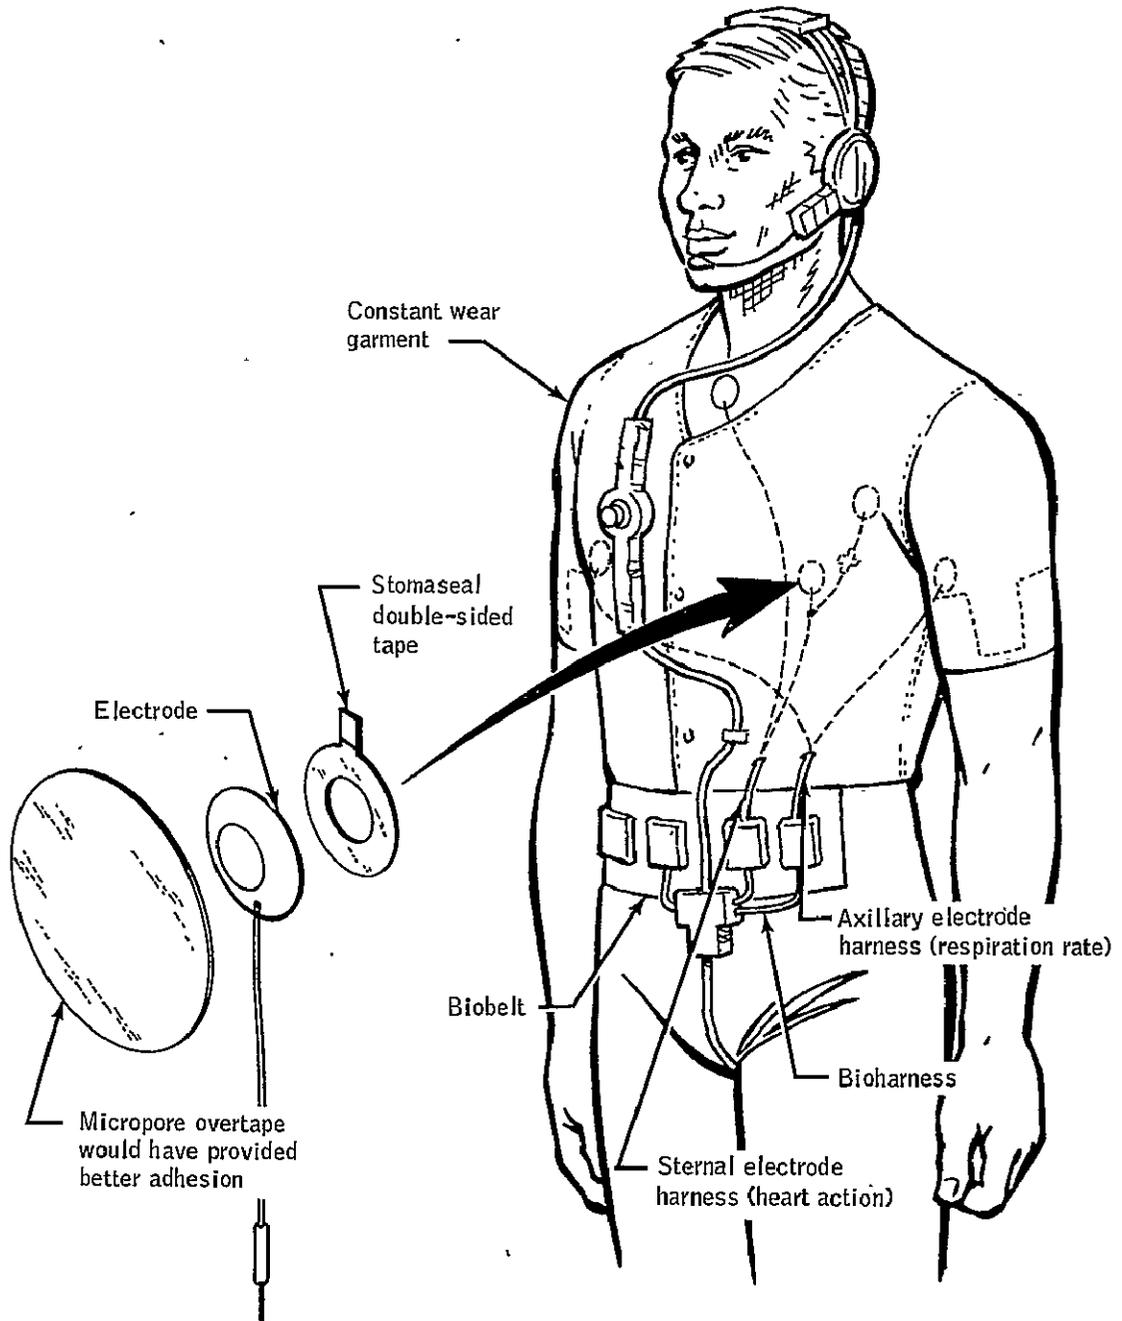
Figure 14-20,- Electrode installation.

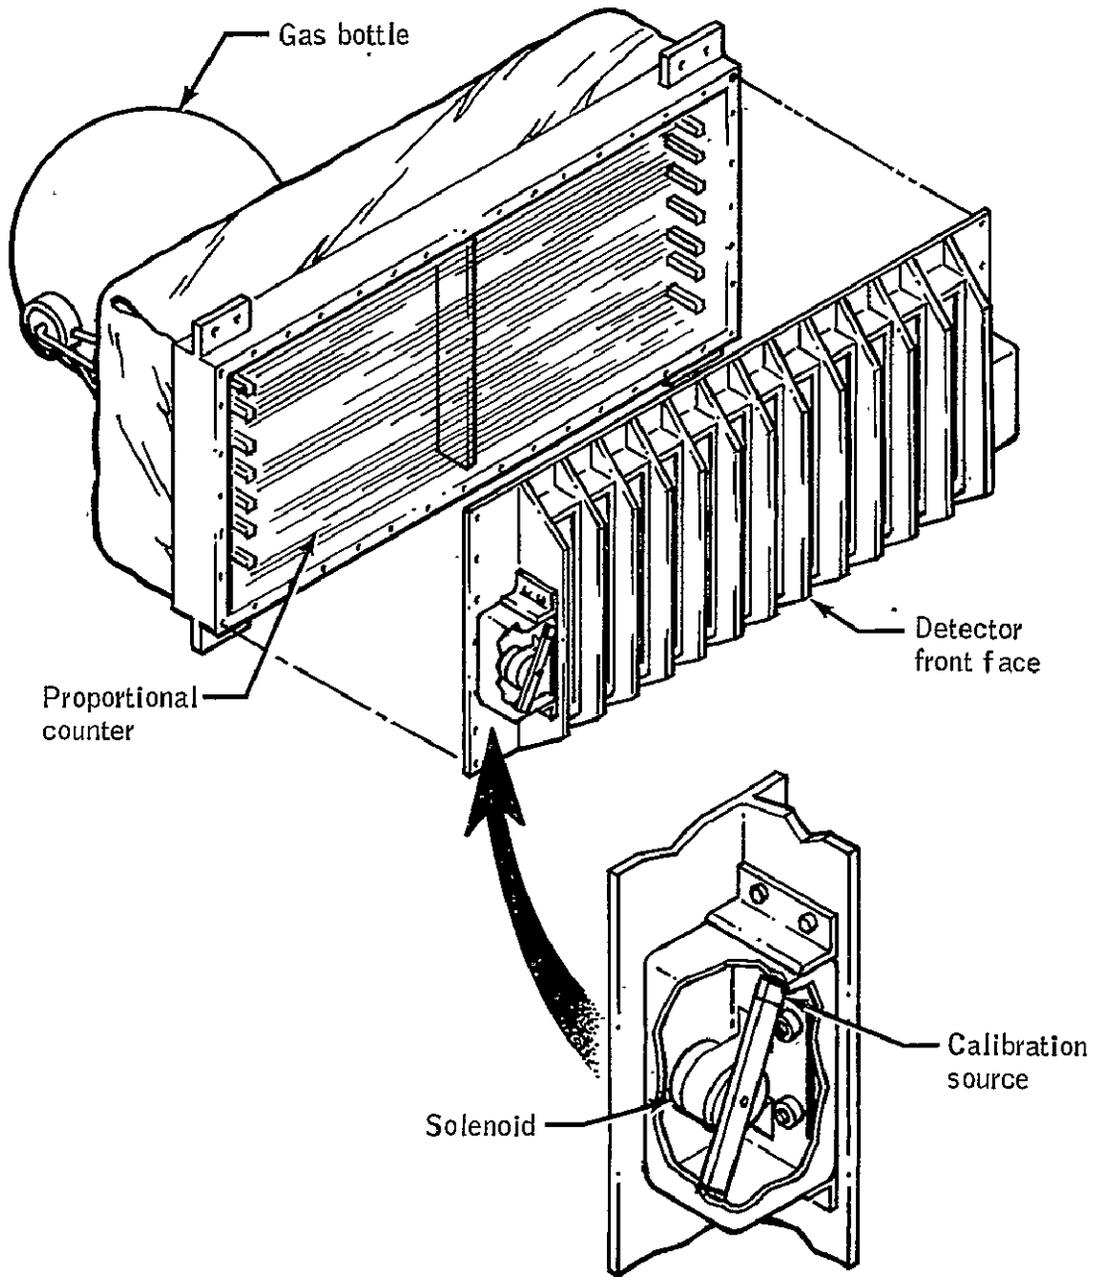
High-voltage discharge.- High-voltage breakdown in proportional counters is a common problem. The gas gain region of the detector amplifies any discharge or breakdown due to sharp points, metal chips, or inadequate spacing of elements. The soft X-ray instrument exhibited an intermittent breakdown problem. It operated correctly for periods ranging

Figure 14-21.- Detector assembly.

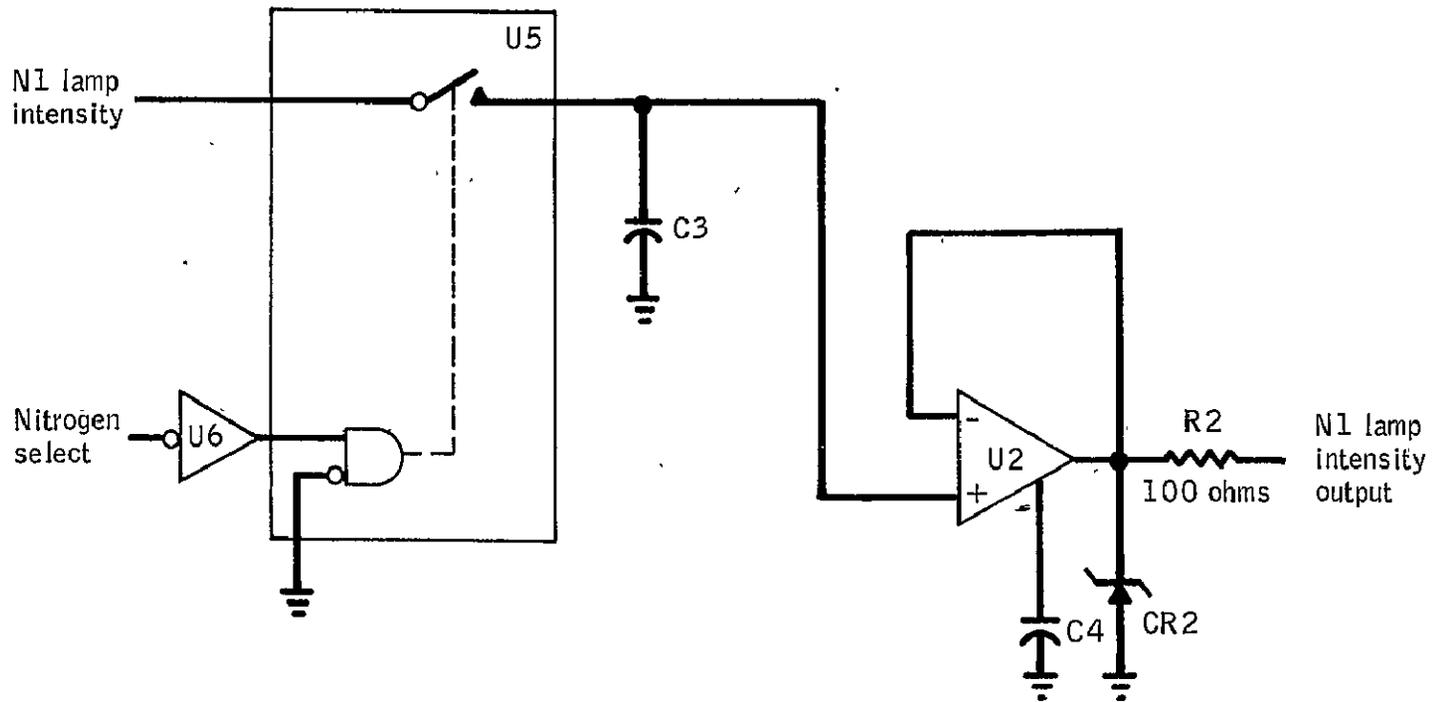
Figure 14-23.- Nitrogen lamp intensity monitor circuit schematic.

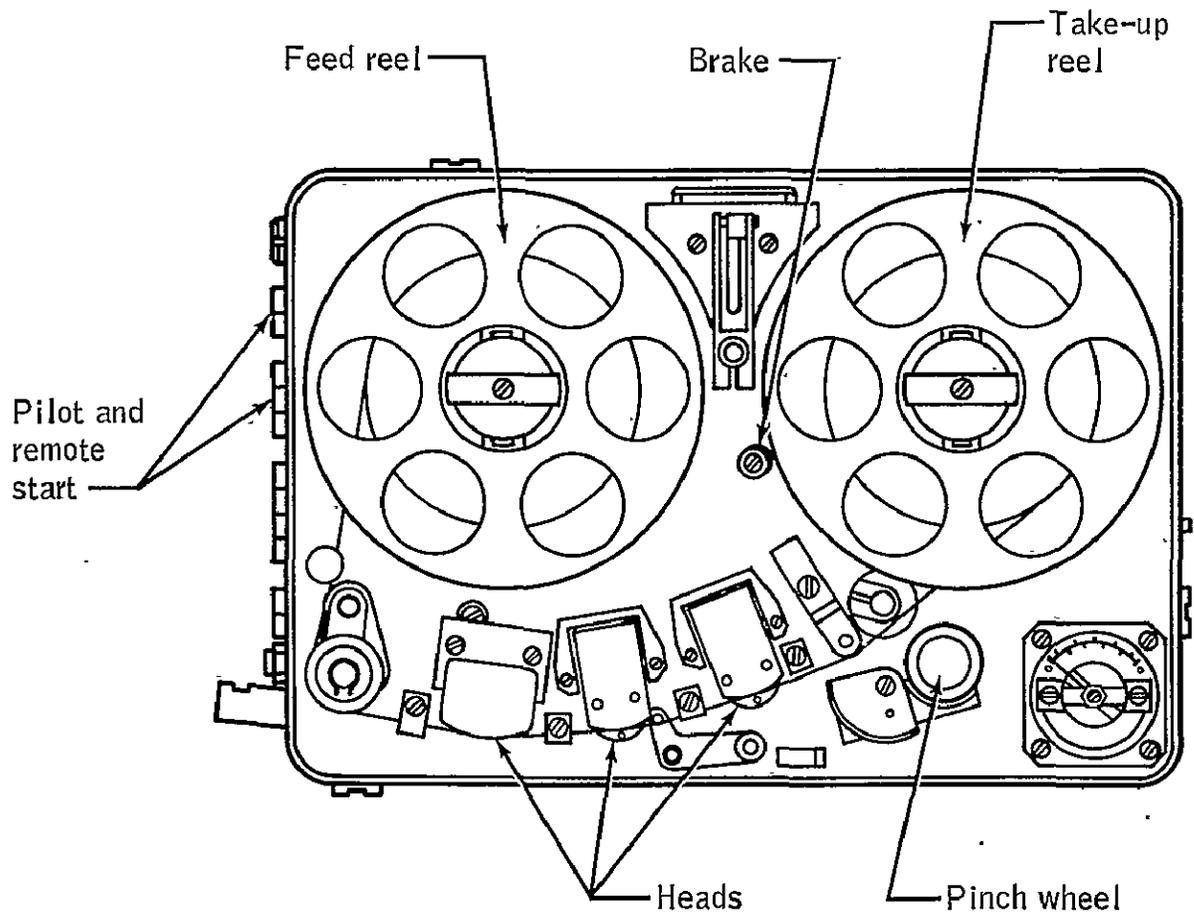
Figure 14-24 shows the arrangement of the recorder components with the tape threaded through the transport mechanism traveling across the erase, record, and playback heads. It is important to note that the tape is always resting against the heads, even when it is not being transported.

Figure 14-24.- Doppler tape recorder.

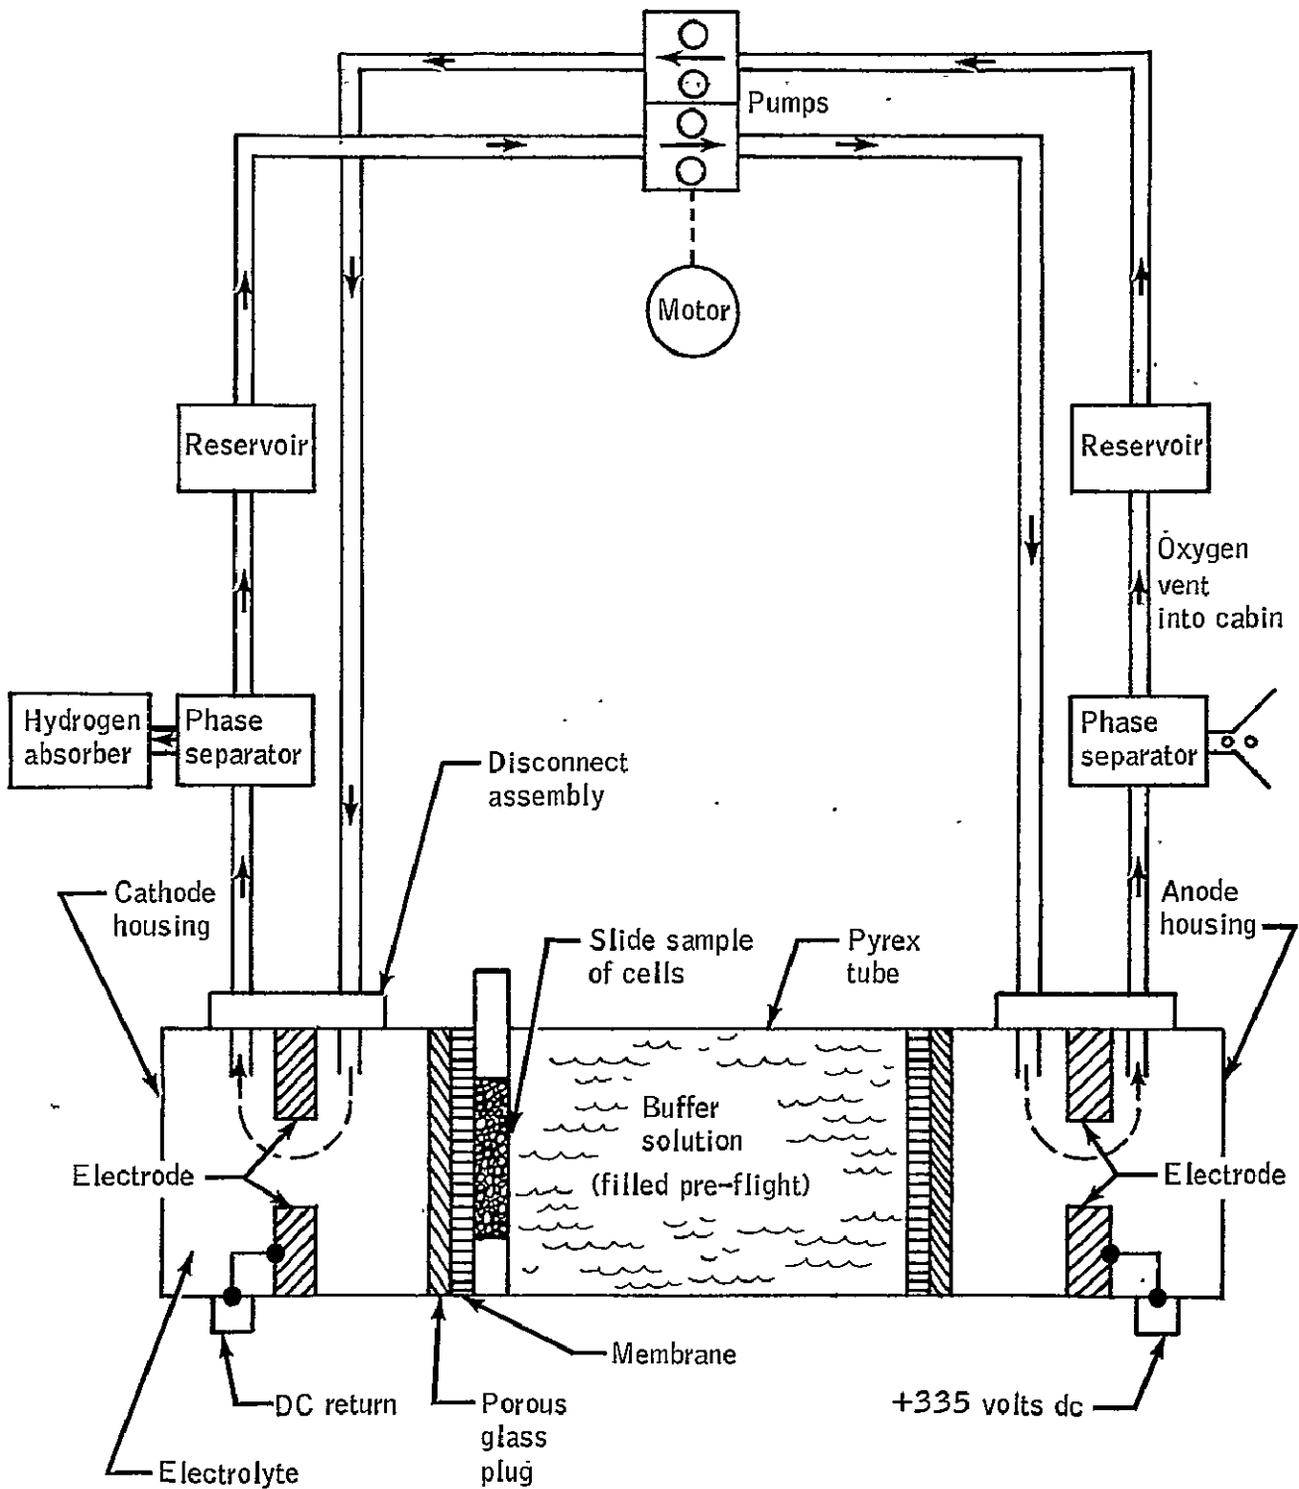
Figure 14-25.- Electrophoresis technology unit fluid system functional schematic.

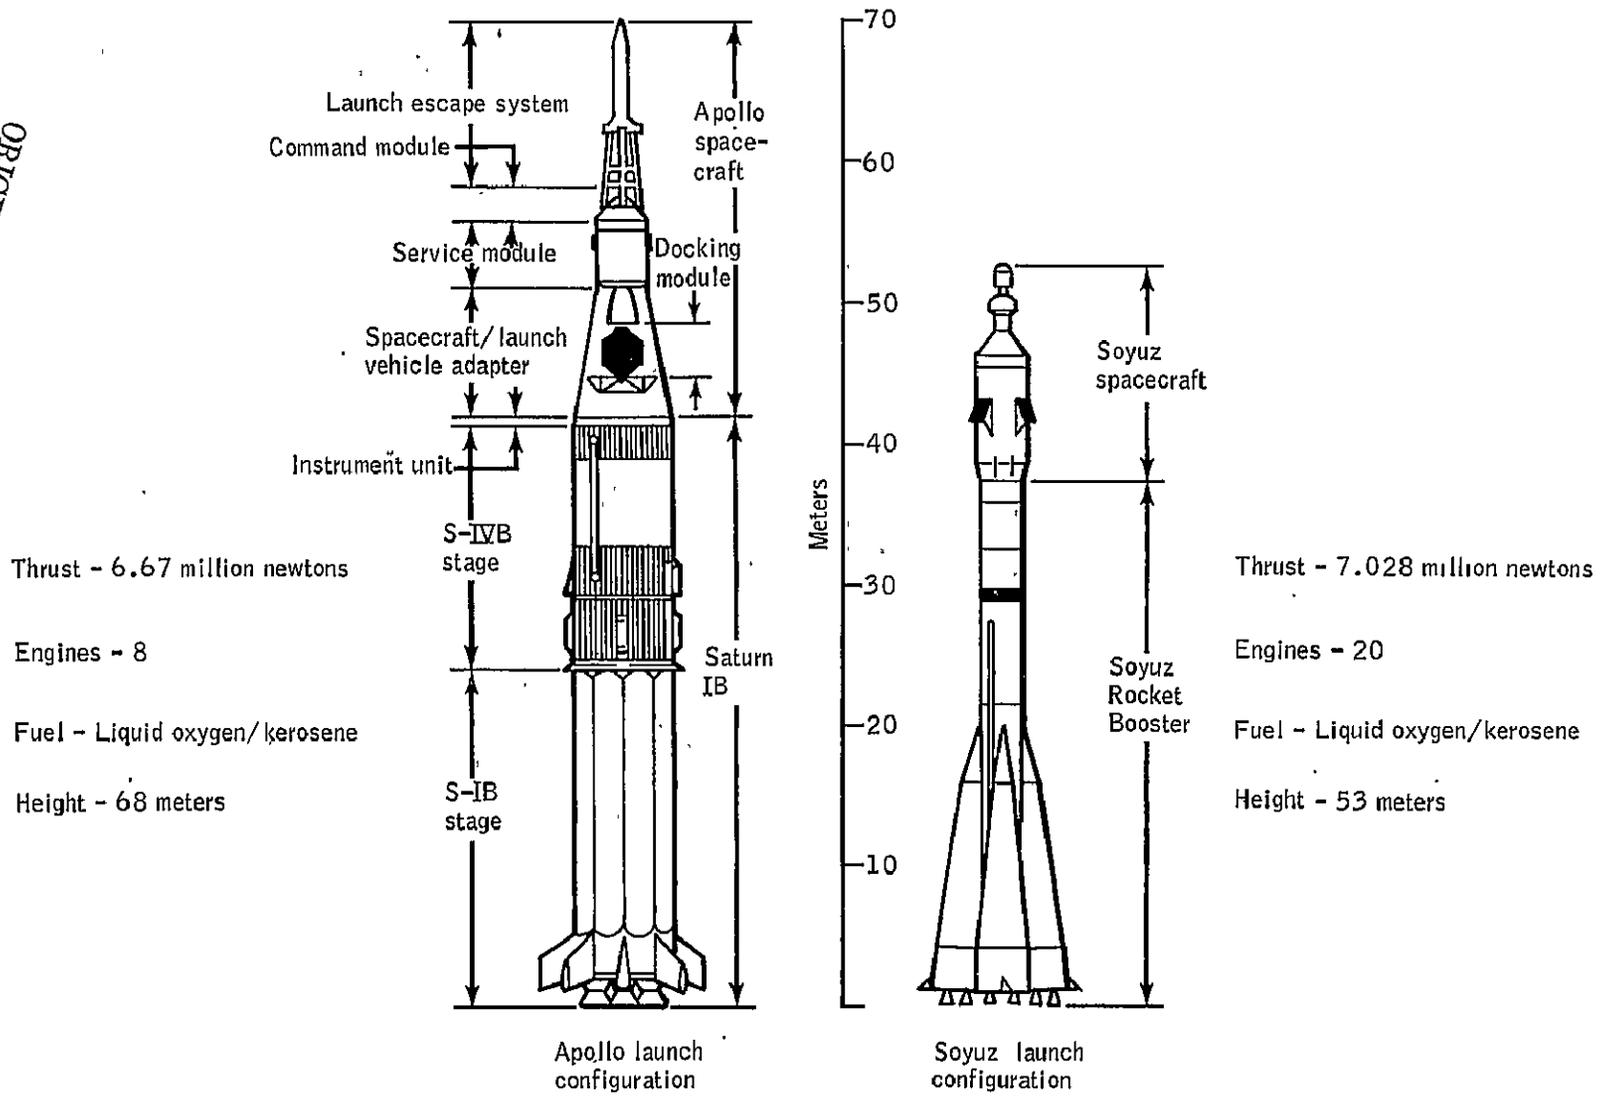
Figure A-1.- Apollo and Soyuz space vehicles.

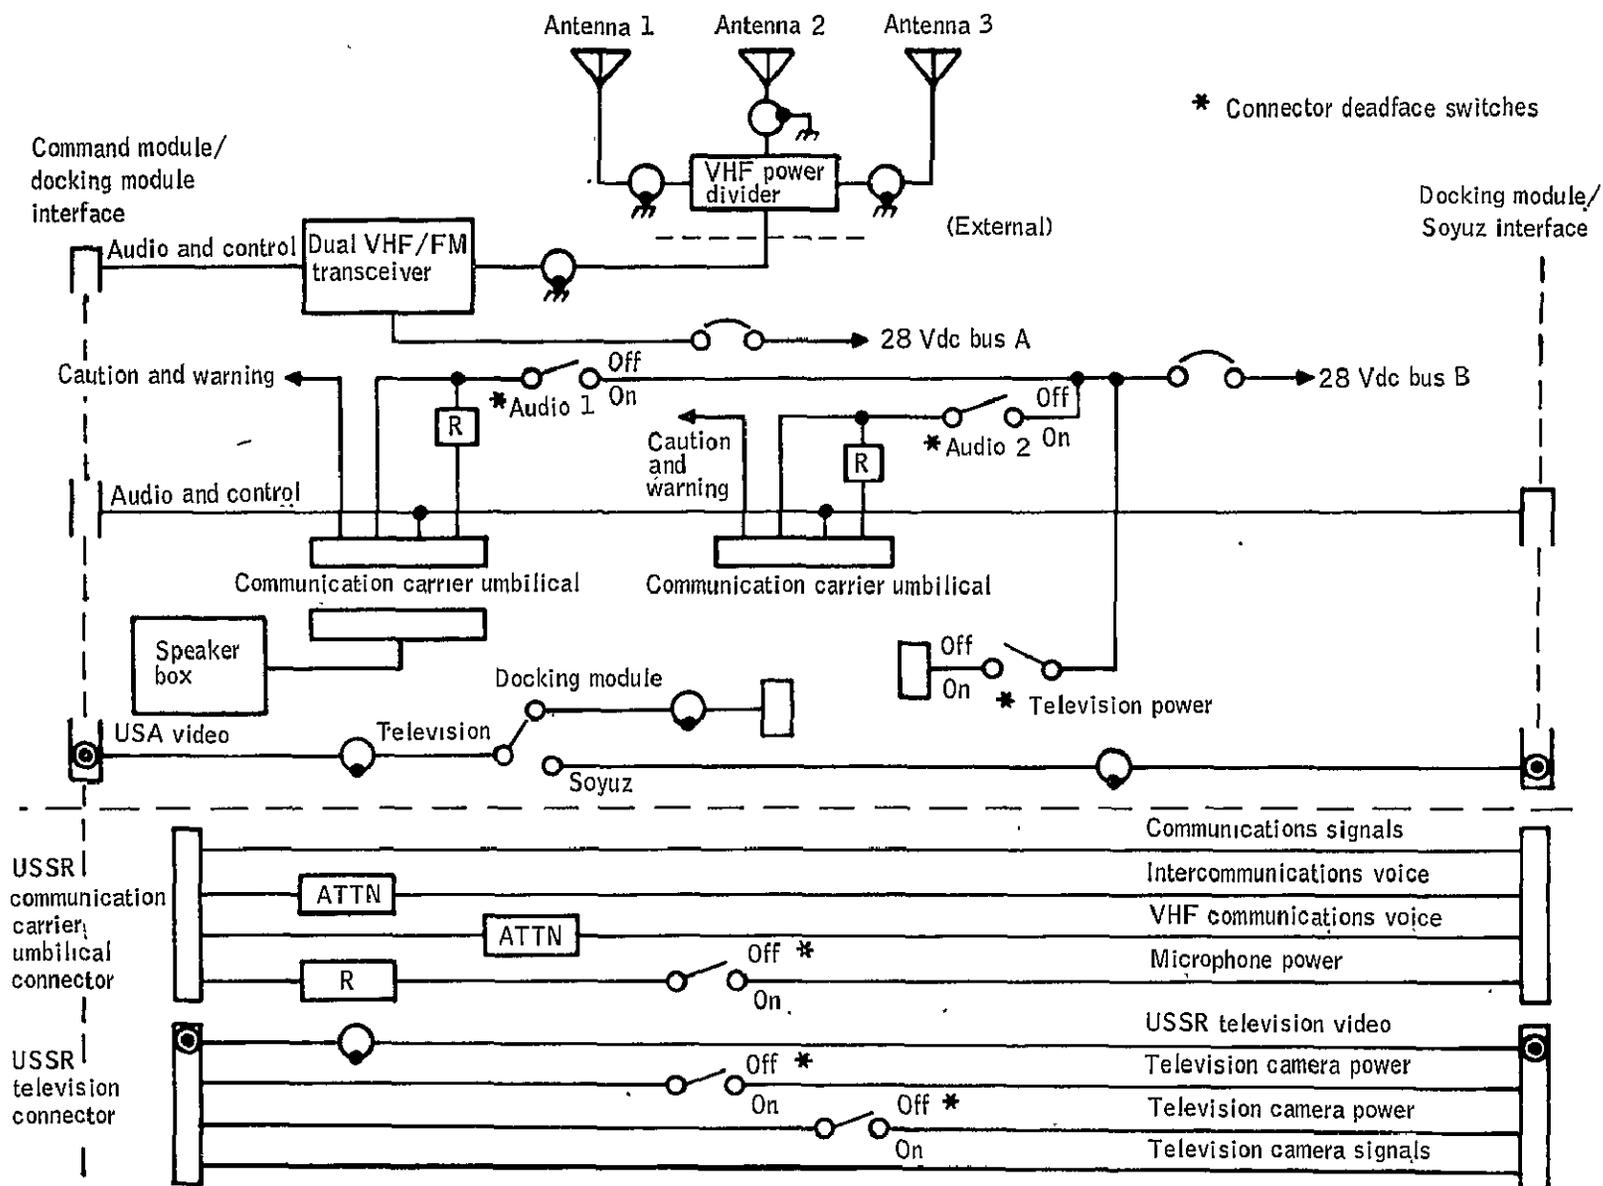
Figure A-7.- Simplified schematic of the docking module telecommunications system.

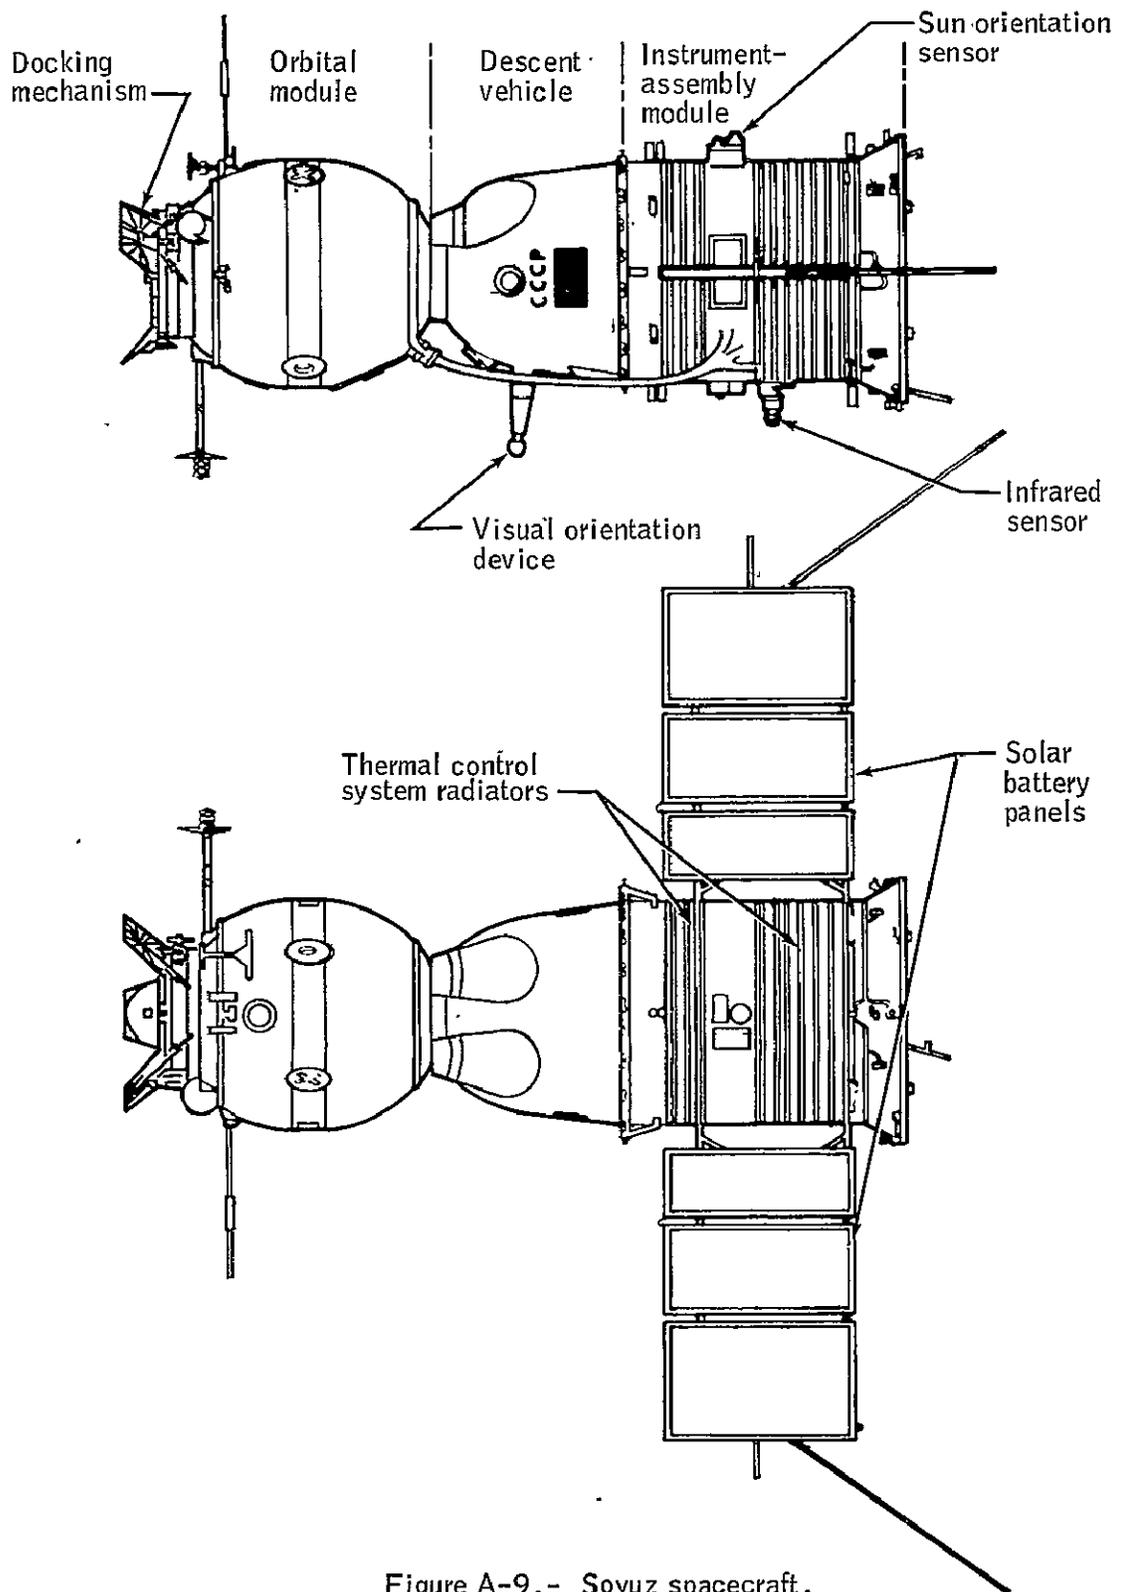
Two sets of wing-like solar battery panels were mounted on opposite sides of the instrument-assembly module. Figure A-9 illustrates the panels and other external equipment.

Figure A-9.- Soyuz spacecraft.

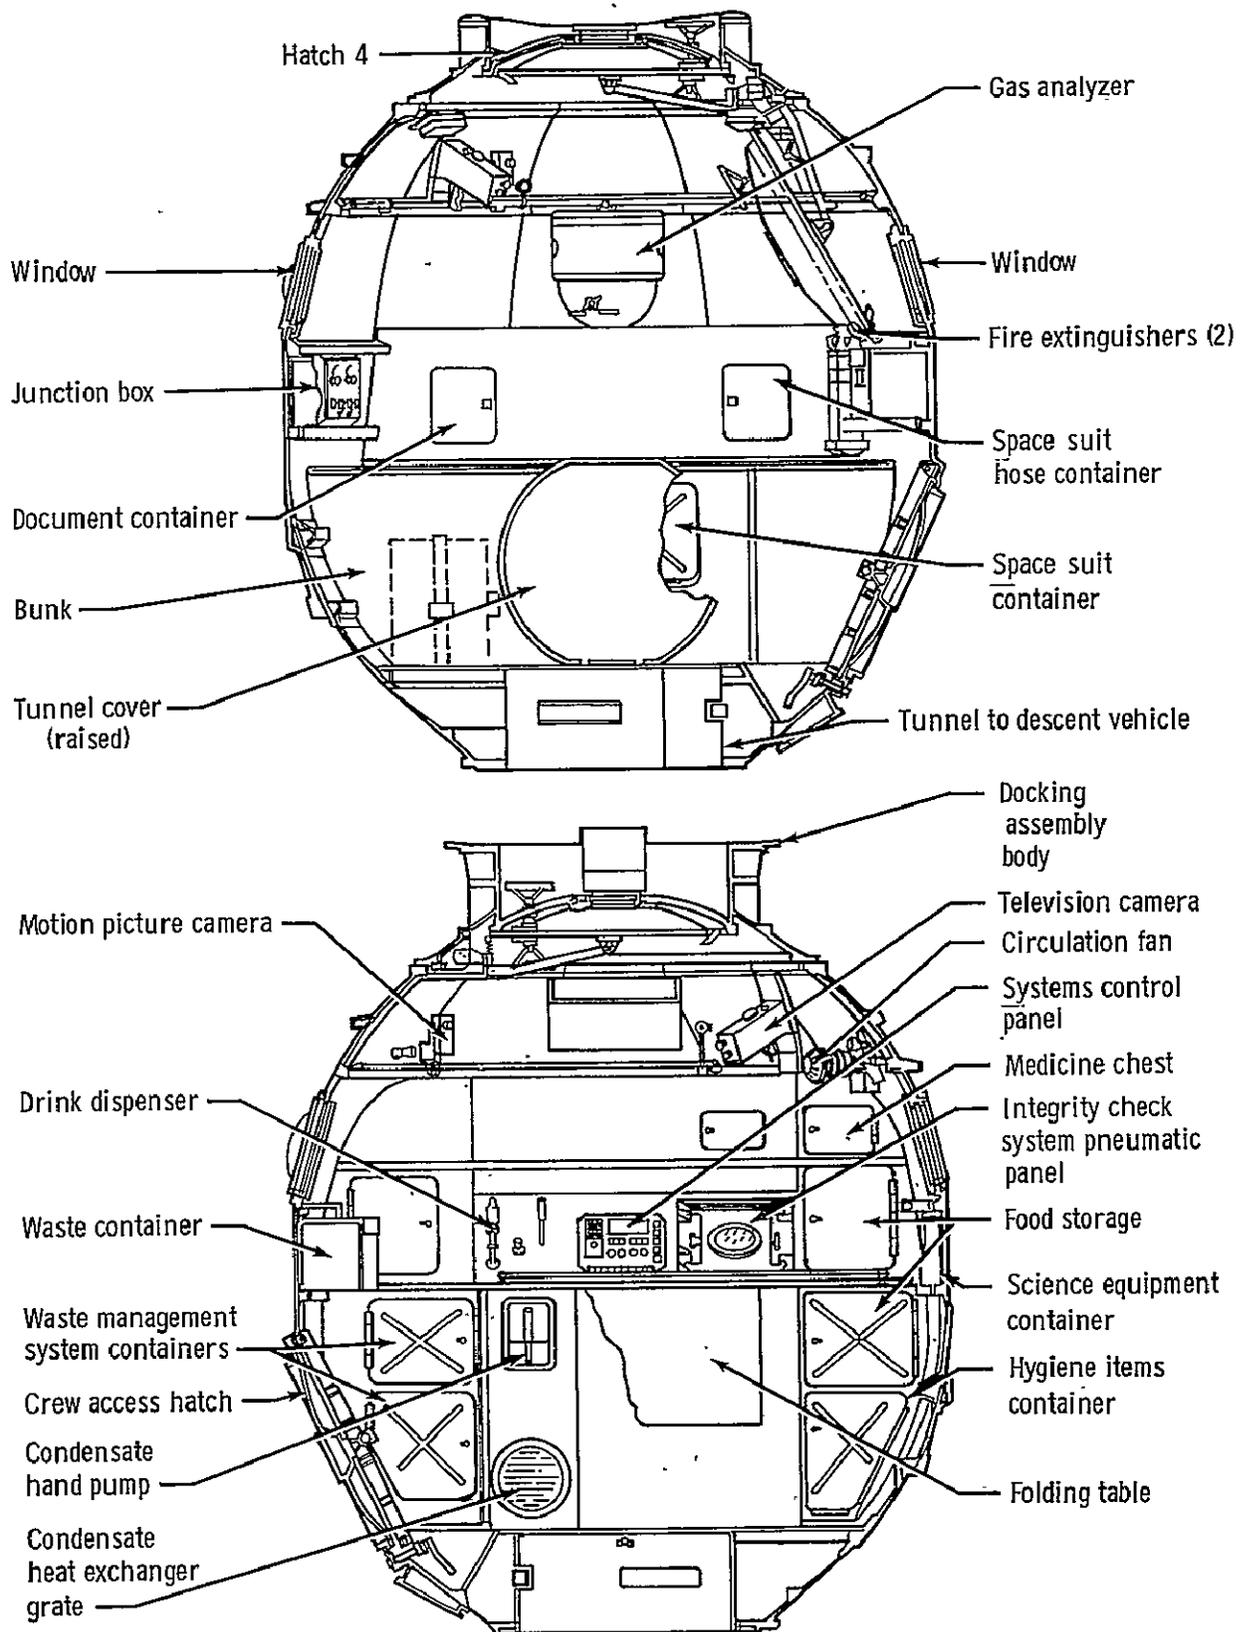
Figure A-11. - Orbital module interior.

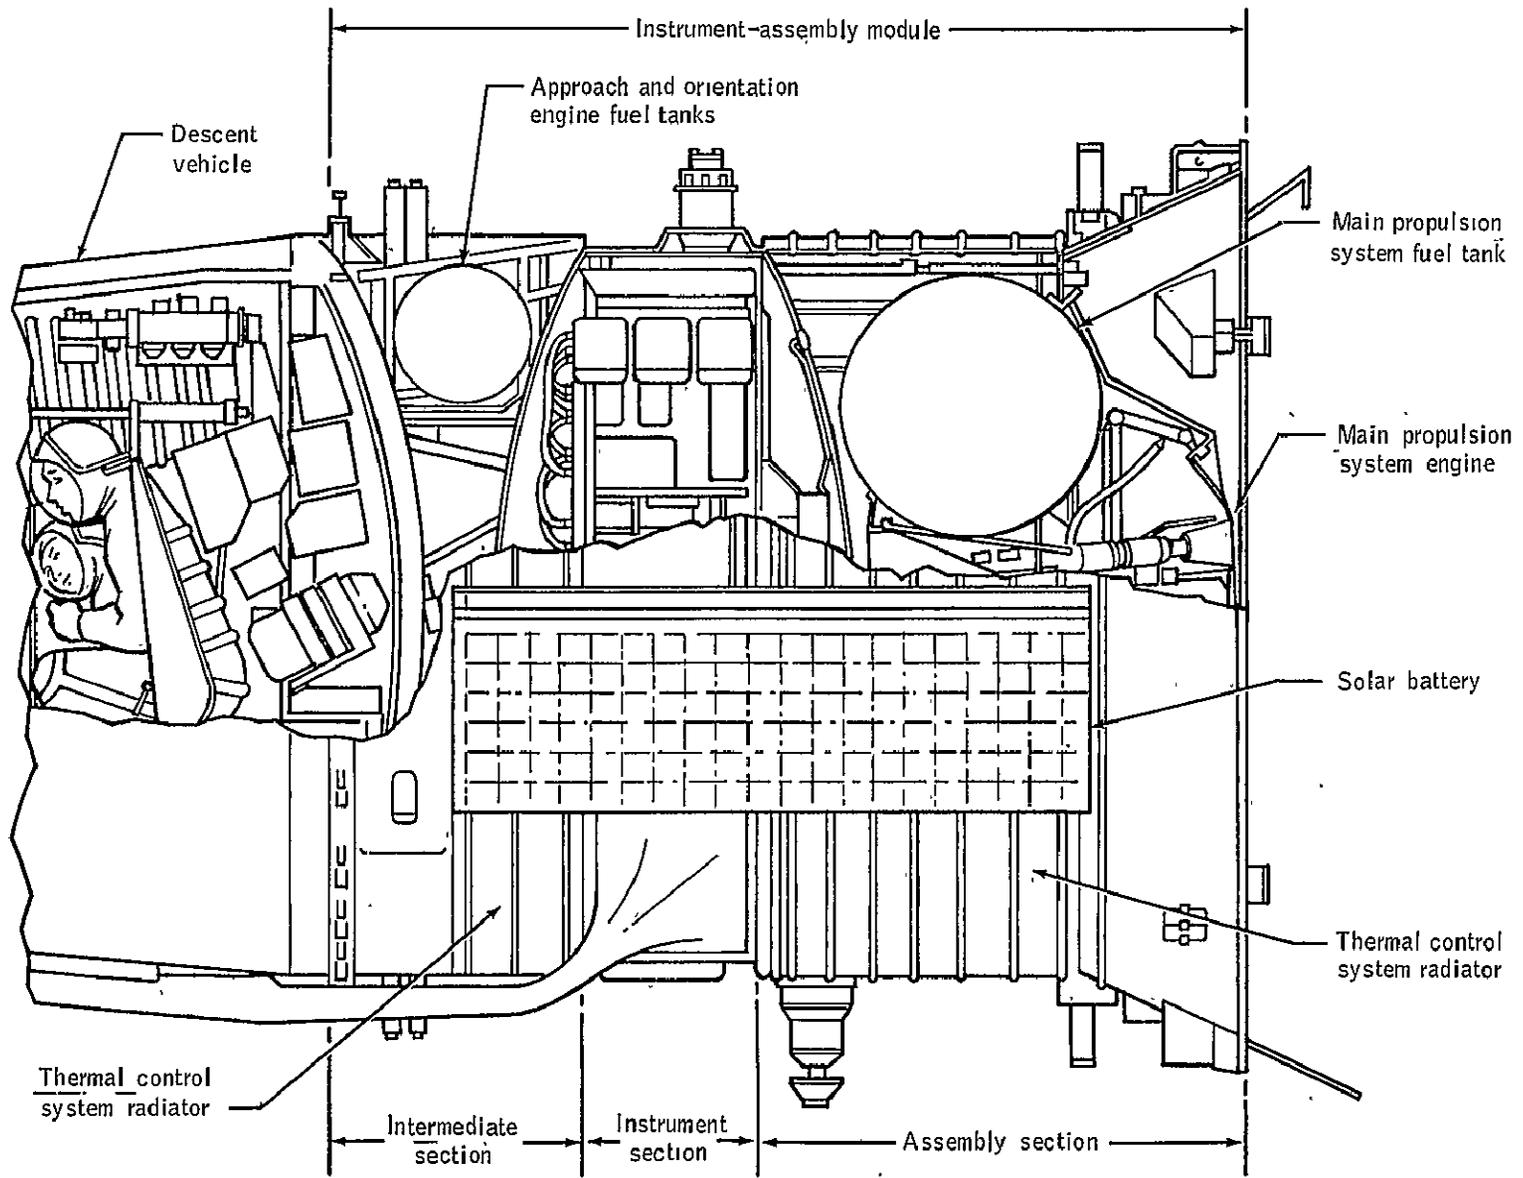
Figure A-13.- Instrument-assembly module.

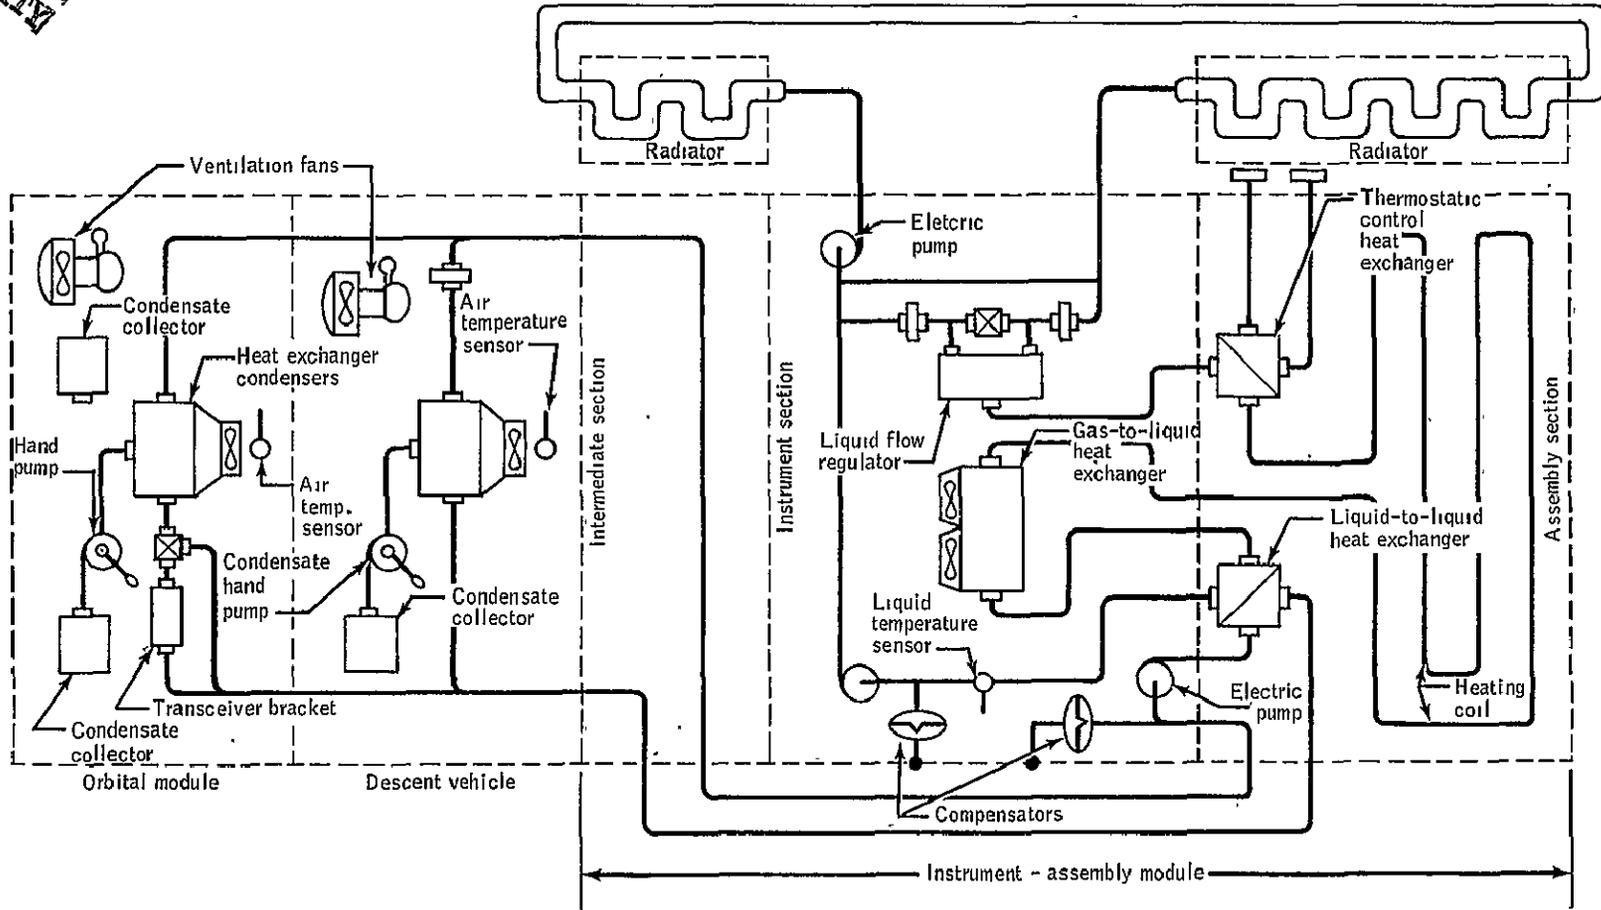
Figure A-14.- Thermal control system schematic.

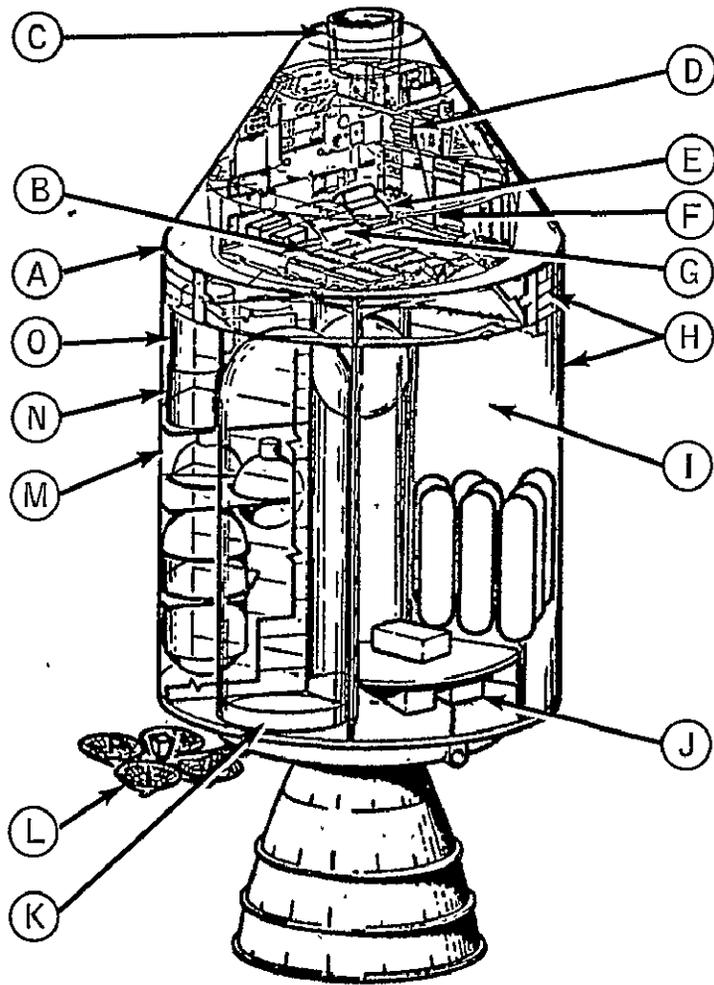
- A Provisions for experiments added.
- B Stowage provisions modified.
- C Docking module umbilicals replaced Skylab tunnel umbilical.
- D Displays and controls added for compatible docking system, docking module, experiments, and ATS-6 communications.
- E Modified unified S-band equipment and premodulation processor added for ATS-6 communications.
- F Extravehicular activity station deleted.
- G Video tape recorder added.
- H Receiver and antenna added for doppler tracking experiment.
- I Descent battery pack deleted.
- J Experiments and remotely controlled covers added (service module bay 1).
- K Power amplifiers added for ATS-6 communications.
- L High-gain antenna added for ATS-6 communications.
- M Water storage tank deleted.
- N Insulation added adjacent to RCS thrusters.
- O Three fuel cells installed instead of two.

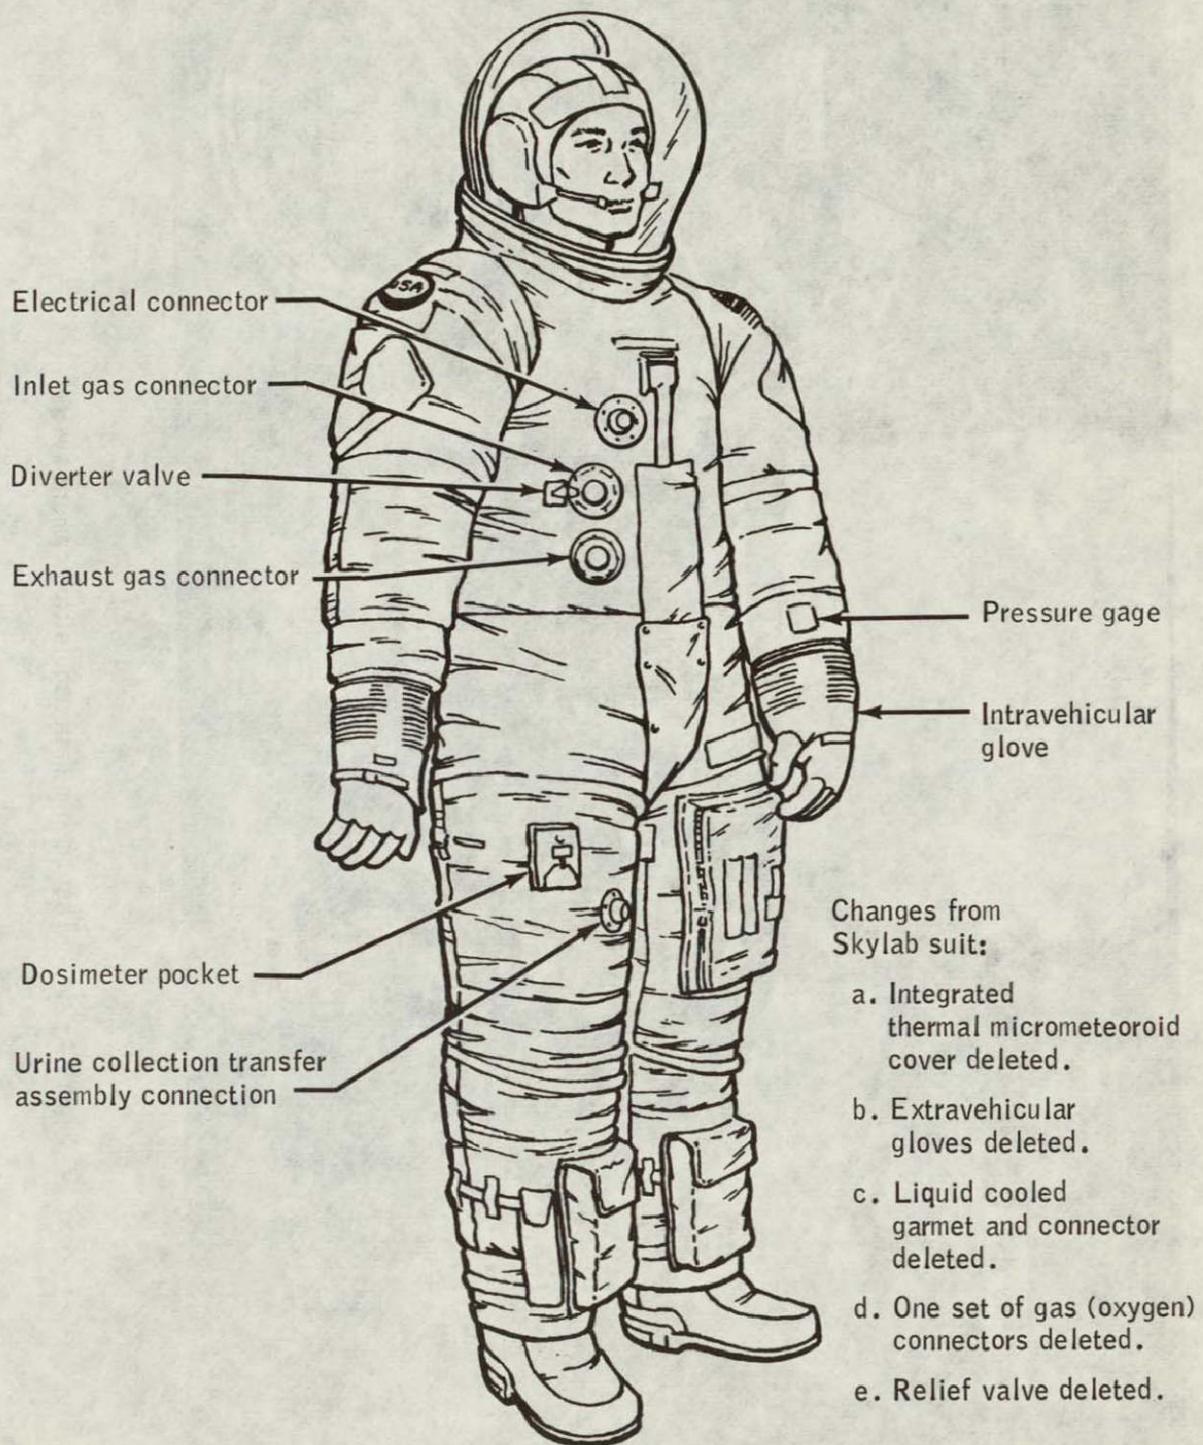
Figure A-21.- Space suit configuration.

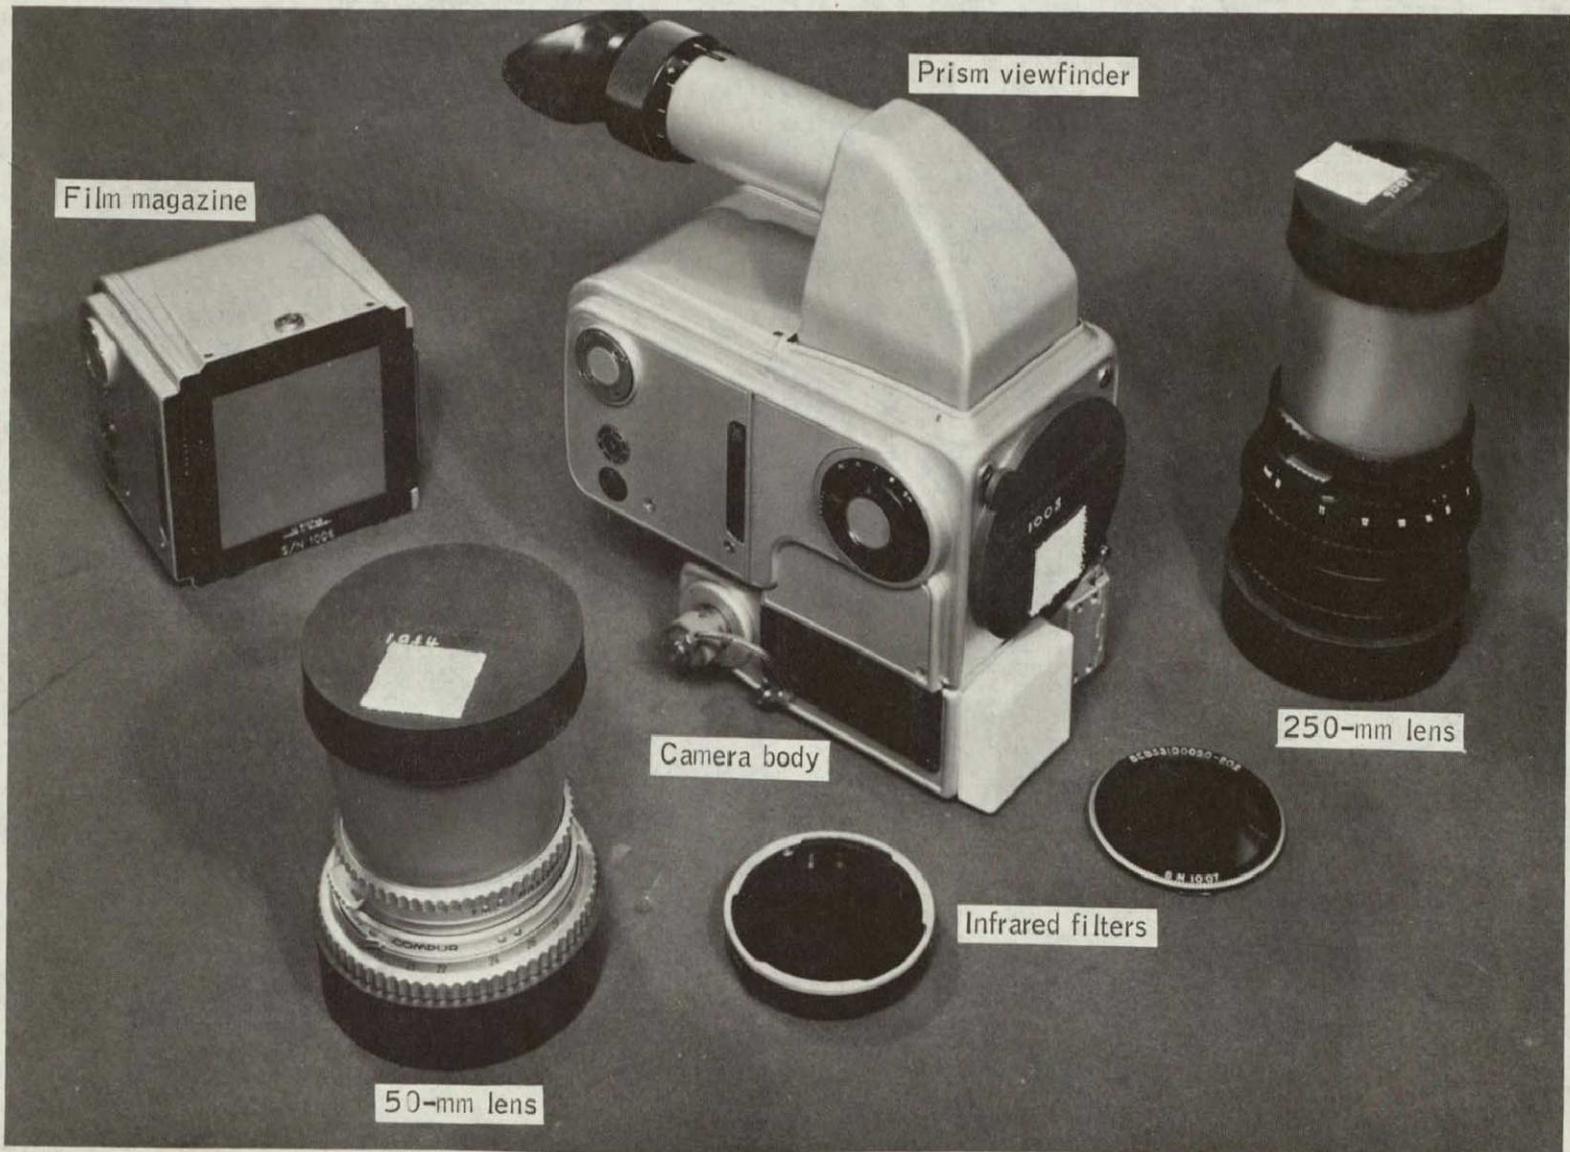
Figure A-25.- The 70-mm reflex camera system.
