JSC-10607

APOLLO SOYUZ
MISSION EVALUATION REPORT

National Aeronautics and Space Administration
LYNDON B. JOHNSON SPACE CENTER

Houston, Texas
December 1975

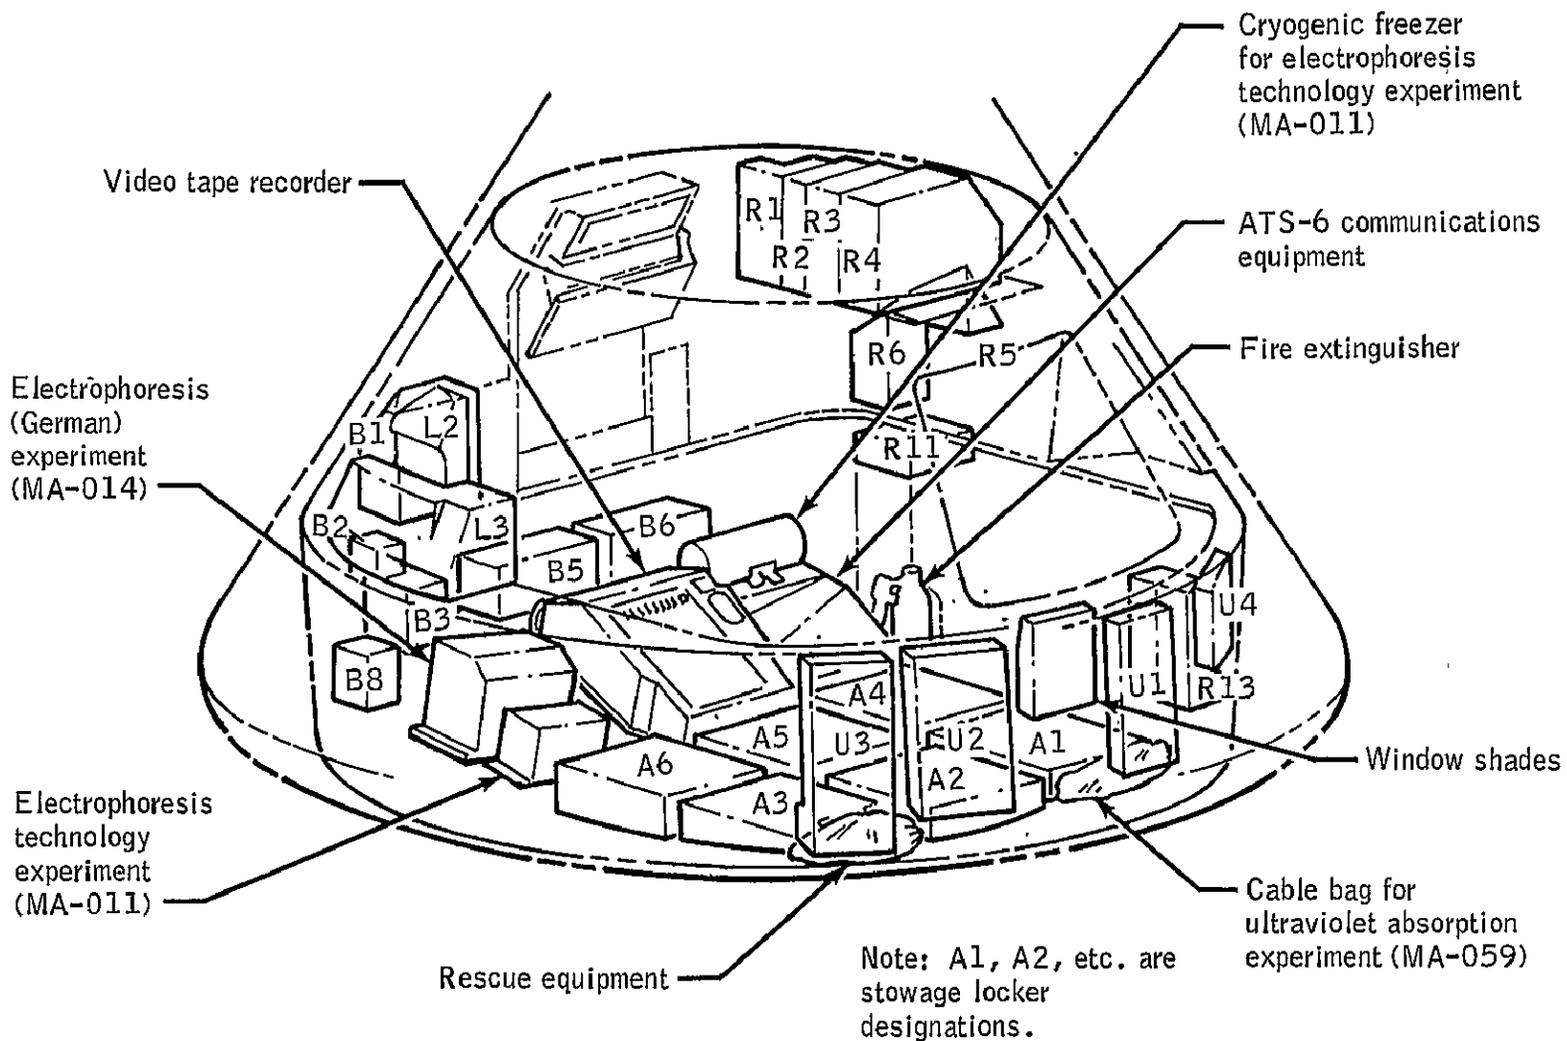
Figure A-26.- Command module launch stowage arrangement.

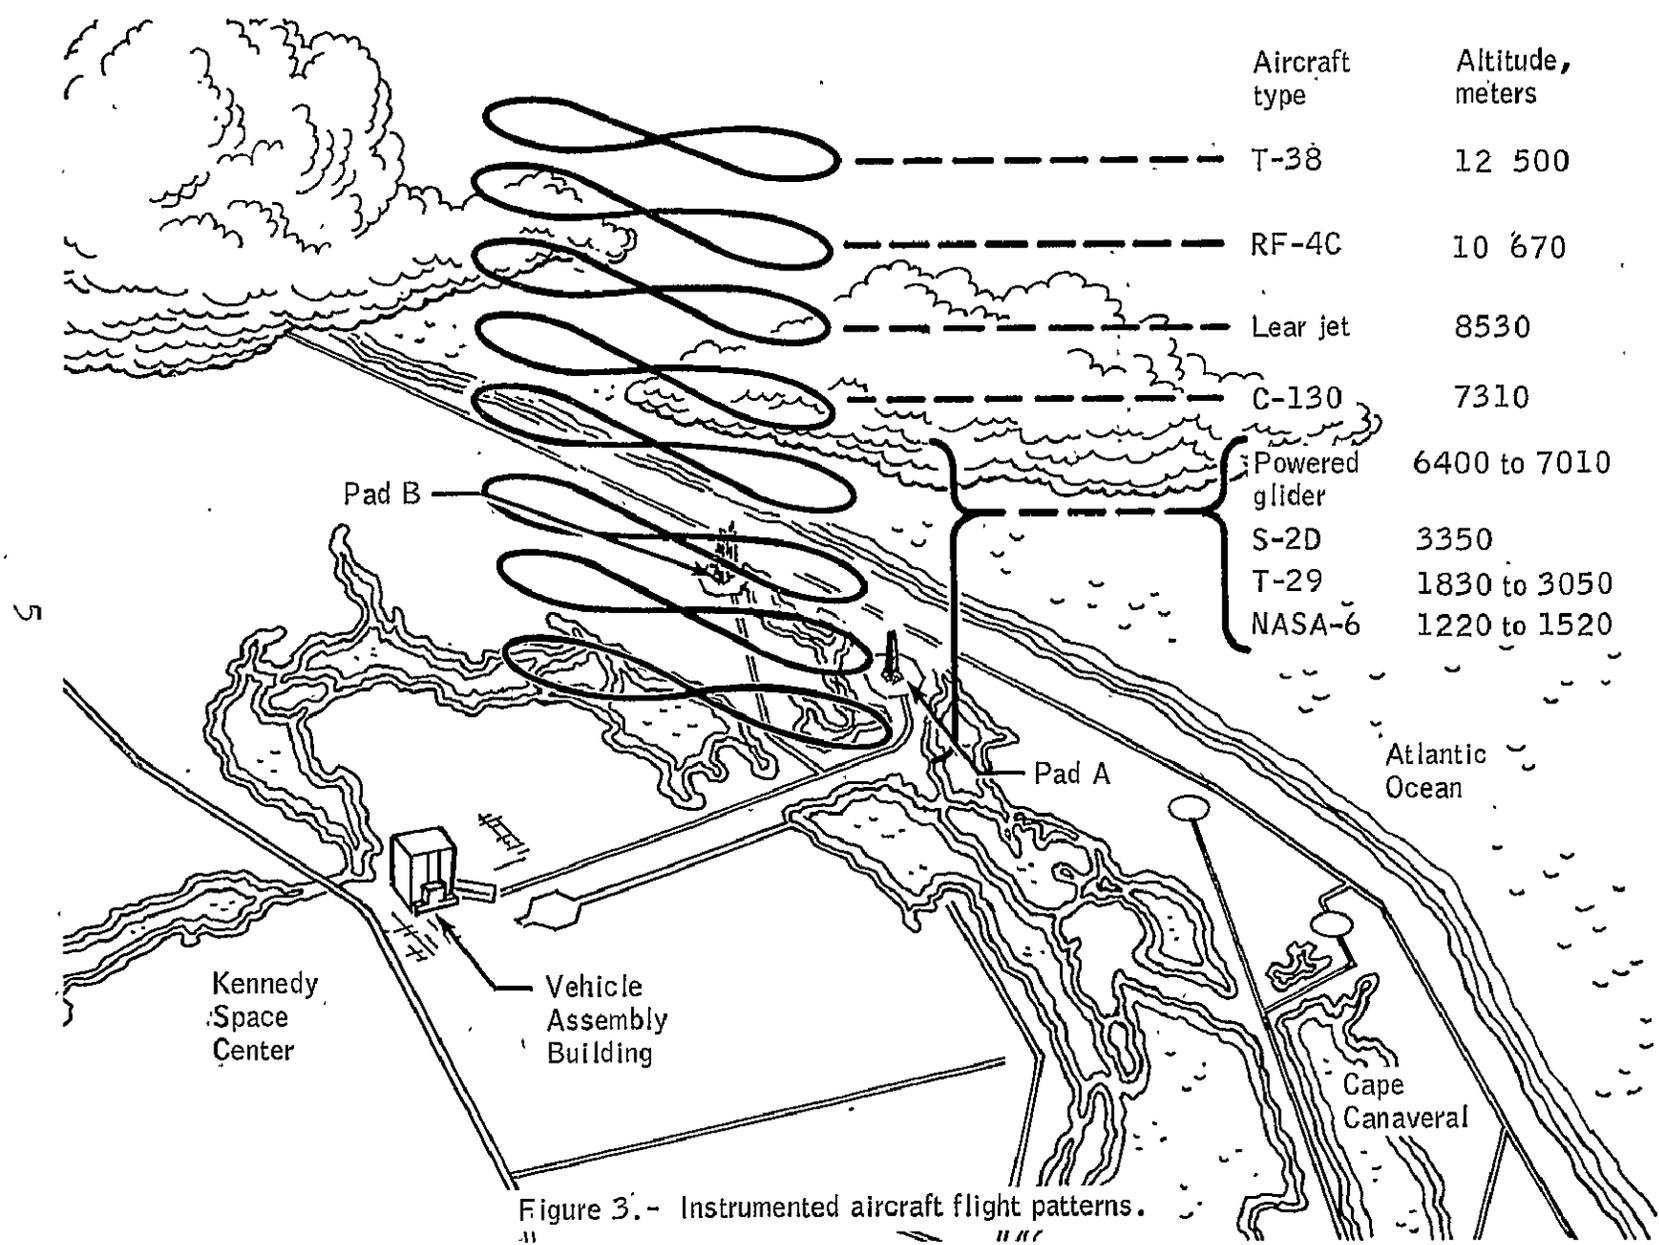
Figure 3.- Instrumented aircraft flight patterns.

The aircraft flown on launch day, the altitudes at which they were flown, and the flight patterns are shown in figure 13-4. Field mill readings were communicated from the aircraft to the Kennedy Space Center weather office from T minus 35 minutes to T minus 5 minutes. All measurements were very near 0 kilovolts per meter.

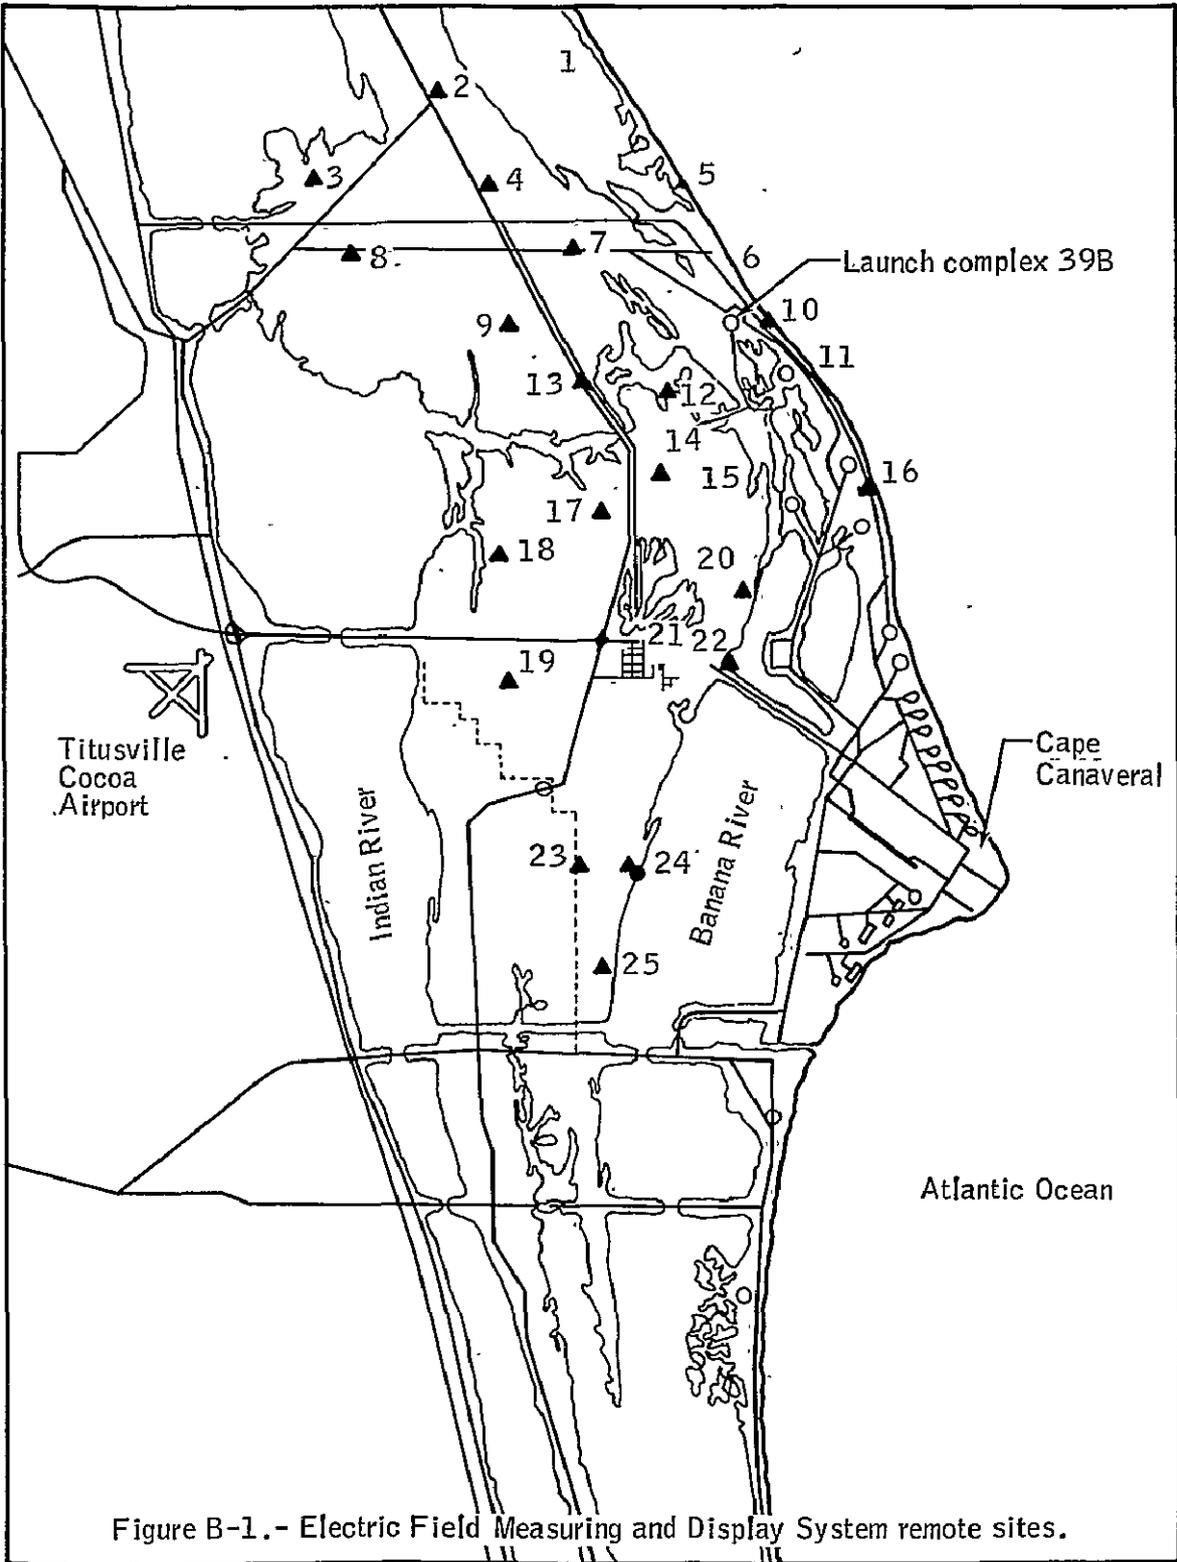
Figure B-1.- Electric Field Measuring and Display System remote sites.

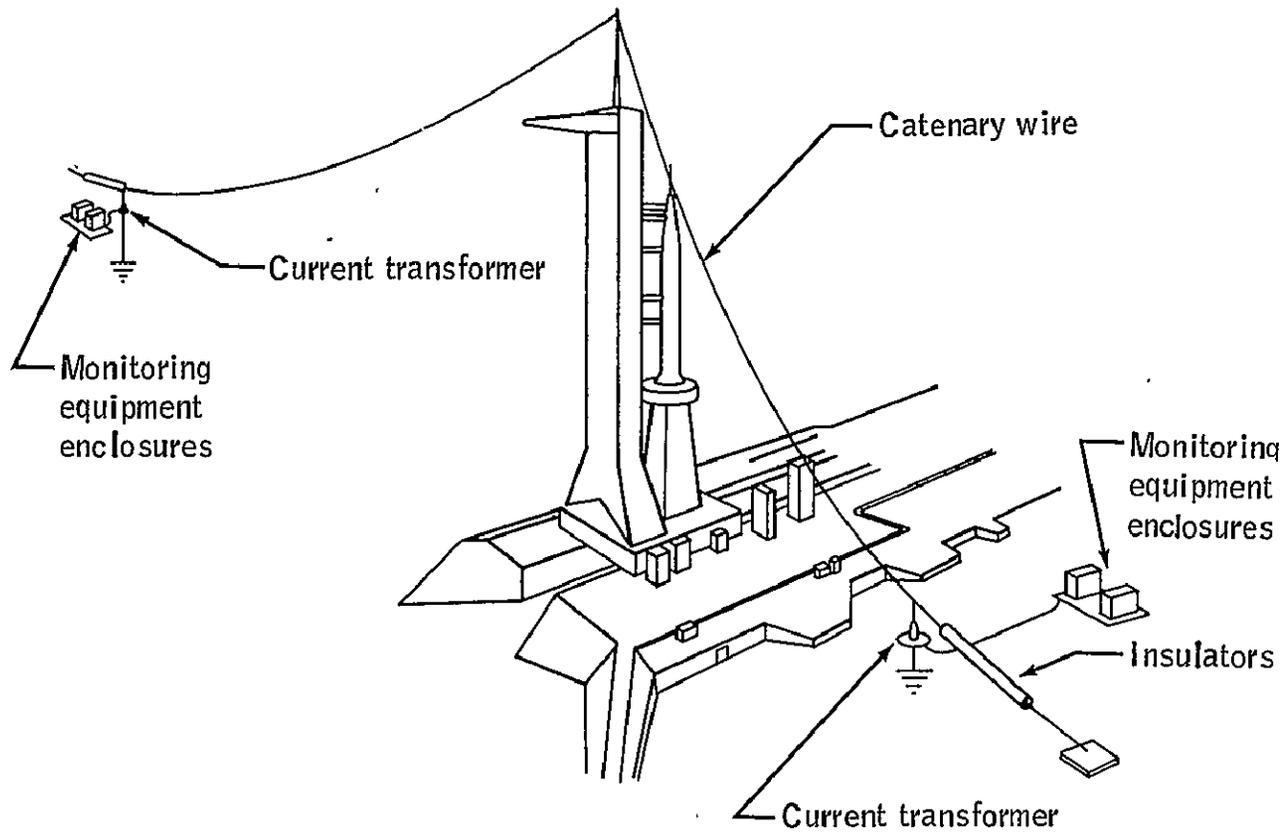
The lightning data acquisition systems for Apollo, Skylab and the Apollo Soyuz Test Project were closely associated with the lightning protection systems of the launch pad structure. There was a lightning mast atop the mobile service structure and, for the Apollo Soyuz Test Project, a special launch tower lightning protection system was installed to protect the mobile launcher. This system consisted of a catenary steel cable that was supported above the mobile launcher by a 25-meter fiberglass tower (fig. B-3). The cable was anchored to earth at two places 275 meters from the structure base. The lightning peak current and the current waveform was measured at the anchor points. The output of a current transformer around the cable grounding wire was fed to a transient recorder which obtained the digital equivalent of electrical waveforms. Currents surging through current transformers located on the ground down wires were transformed into voltages and fed to individual memory voltmeters and recorded on strip charts.

Figure B-3.- Launch Complex Lighting Protection Systems for the Apollo Soyuz Test Project.

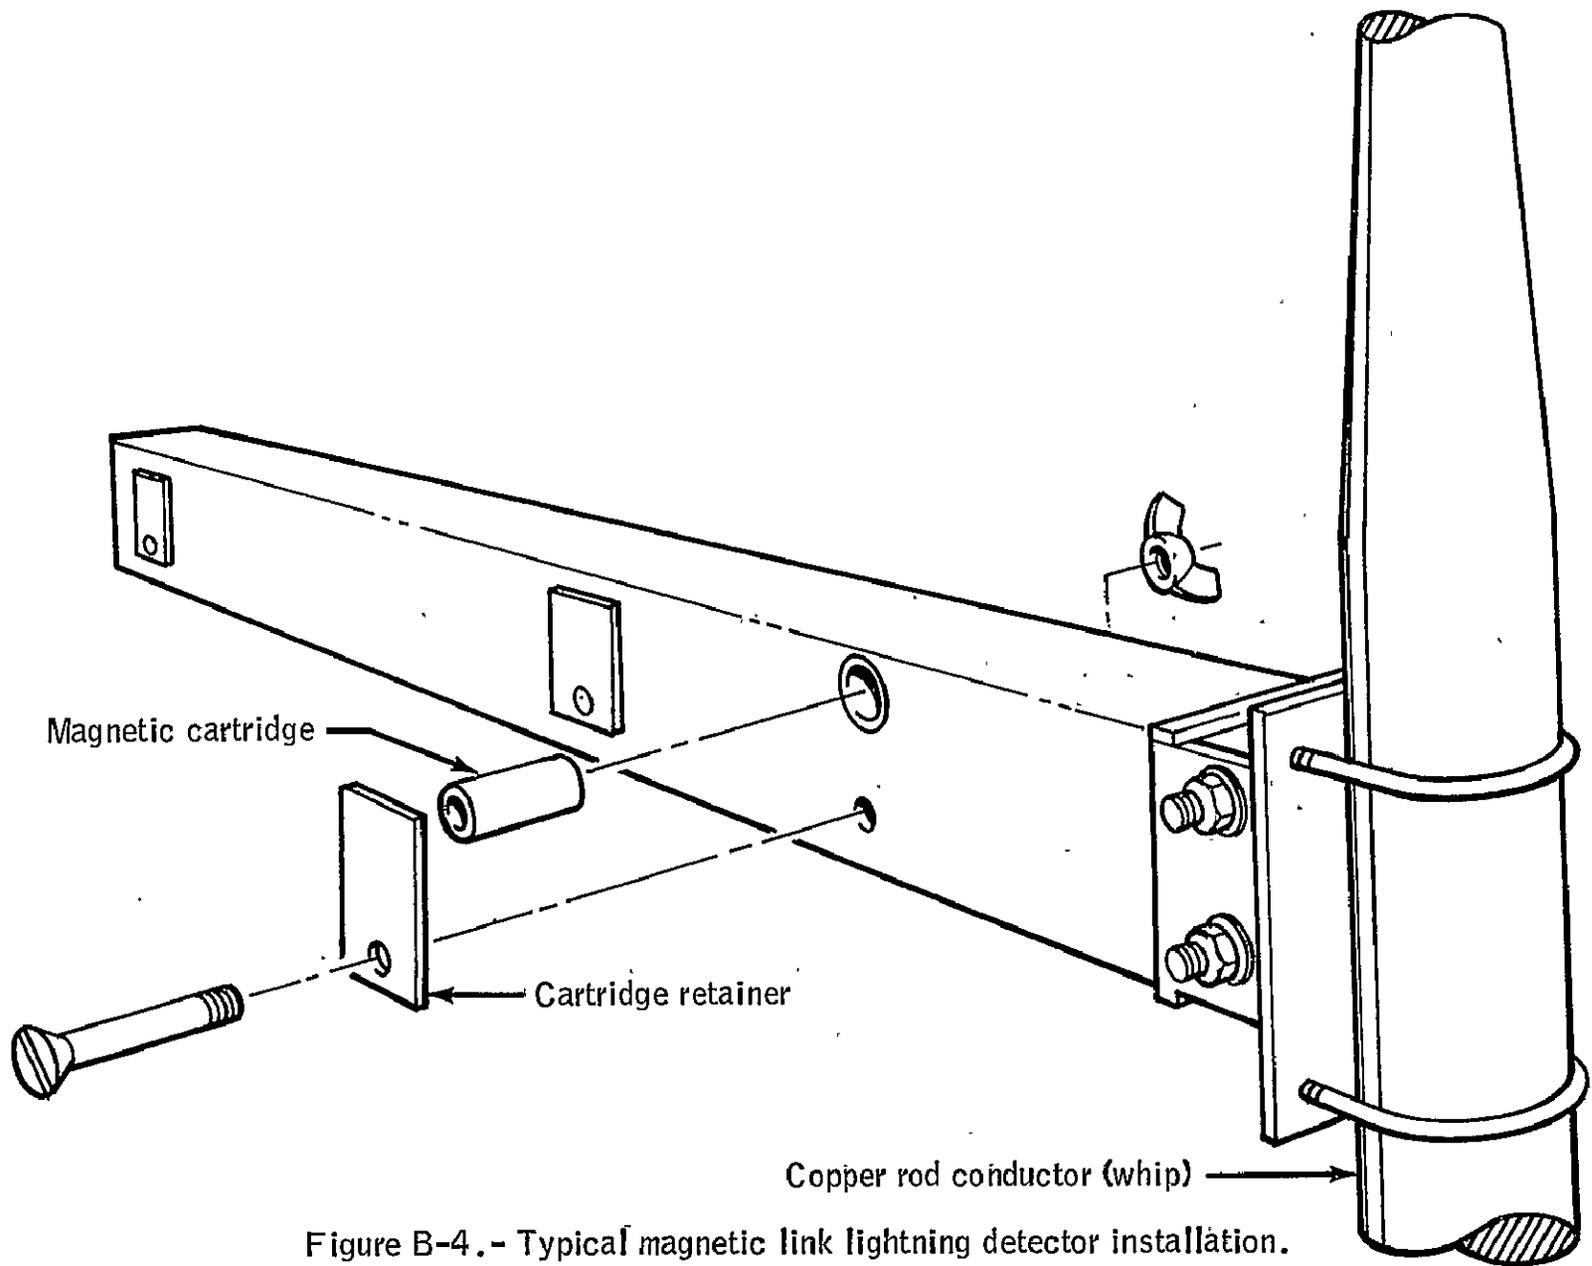
Figure B-4.- Typical magnetic link lightning detector installation.

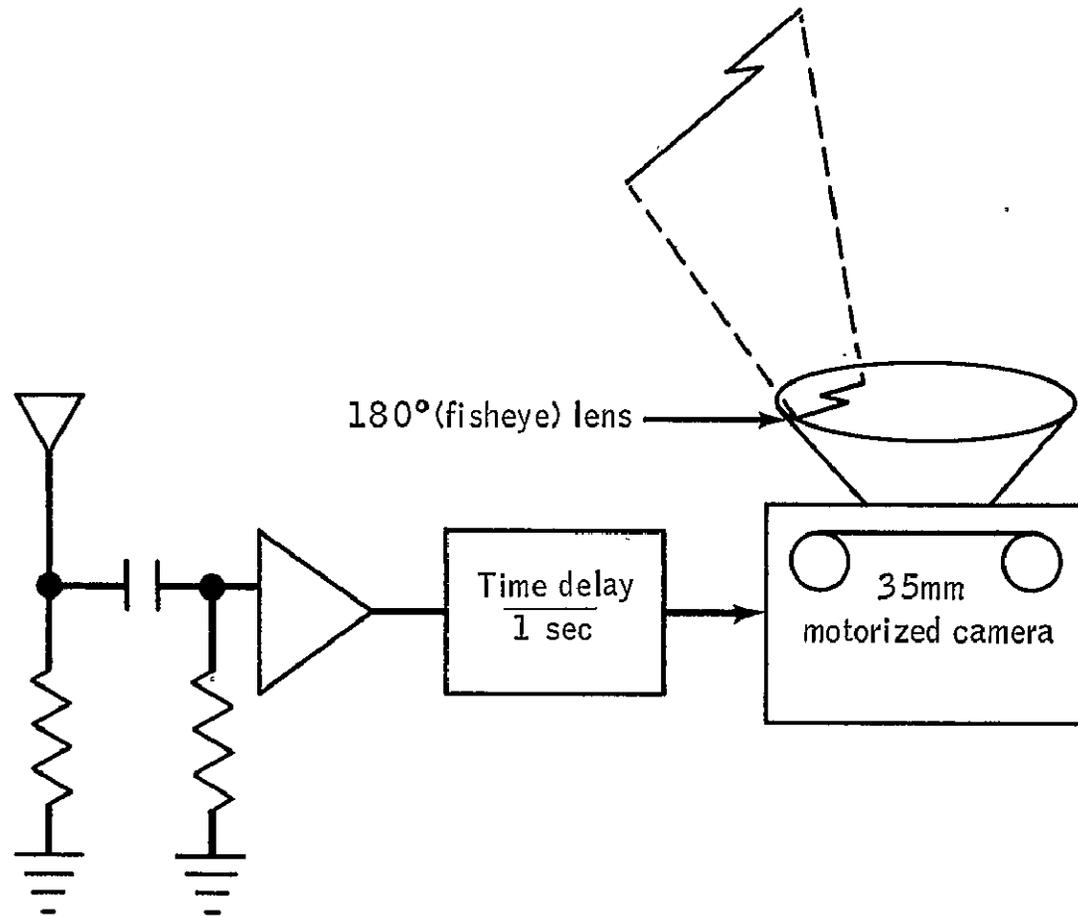
An automatic lightning photography system augments the measurement system. Three cameras around the periphery of the launch area (Complex 39) photograph lightning strikes. Each camera station of the system consists of a motorized Nikon camera with a 180° (fisheye) lens and a triggering circuit as shown in figure B-5. The lens is aimed such that a horizon-to-horizon picture in all directions is obtained. The camera systems are self-contained giving complete freedom of placement. The cameras are routinely serviced once a week with a film load of 250 frames. Camera performance figures include a shutter opening of 40 milliseconds, exposure time of 0.5 second, and a reset interval of 1 second. The electric field pulse from a lightning strike triggers the electronic circuitry, which trips the camera shutter and photographs the lightning. The film then automatically advances and the camera is automatically reset for the next lightning strike. Although the leader lightning strike is not photographed, succeeding strikes which immediately follow the leader's path were photographed. This method permits photographing 90 percent of the cloud-to-ground flashes. The photographs are used to locate the lightning impact point, either by showing actual location or by triangulation.

Figure B-5.- Automatic motorized camera.

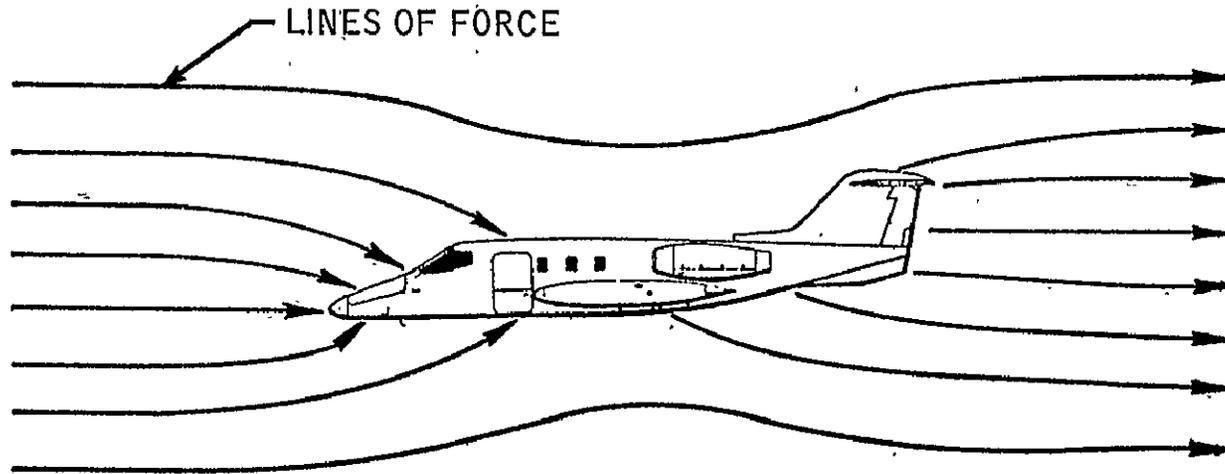
Figure C-1.- Distortion of uniform electric field caused by an aircraft.

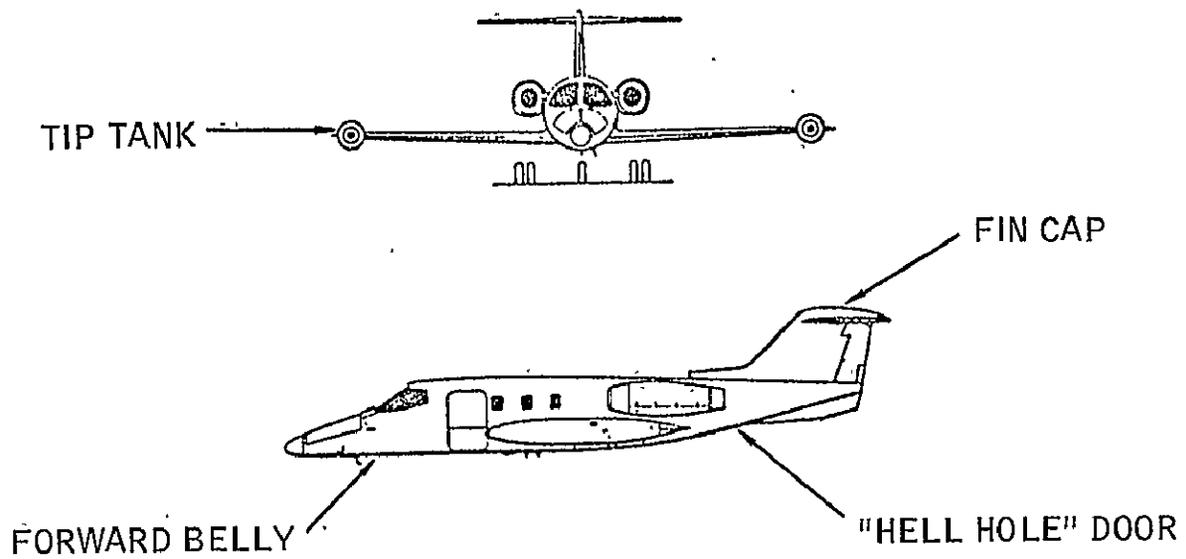
Figure C-2.- Location of field meter sensors on test aircraft.

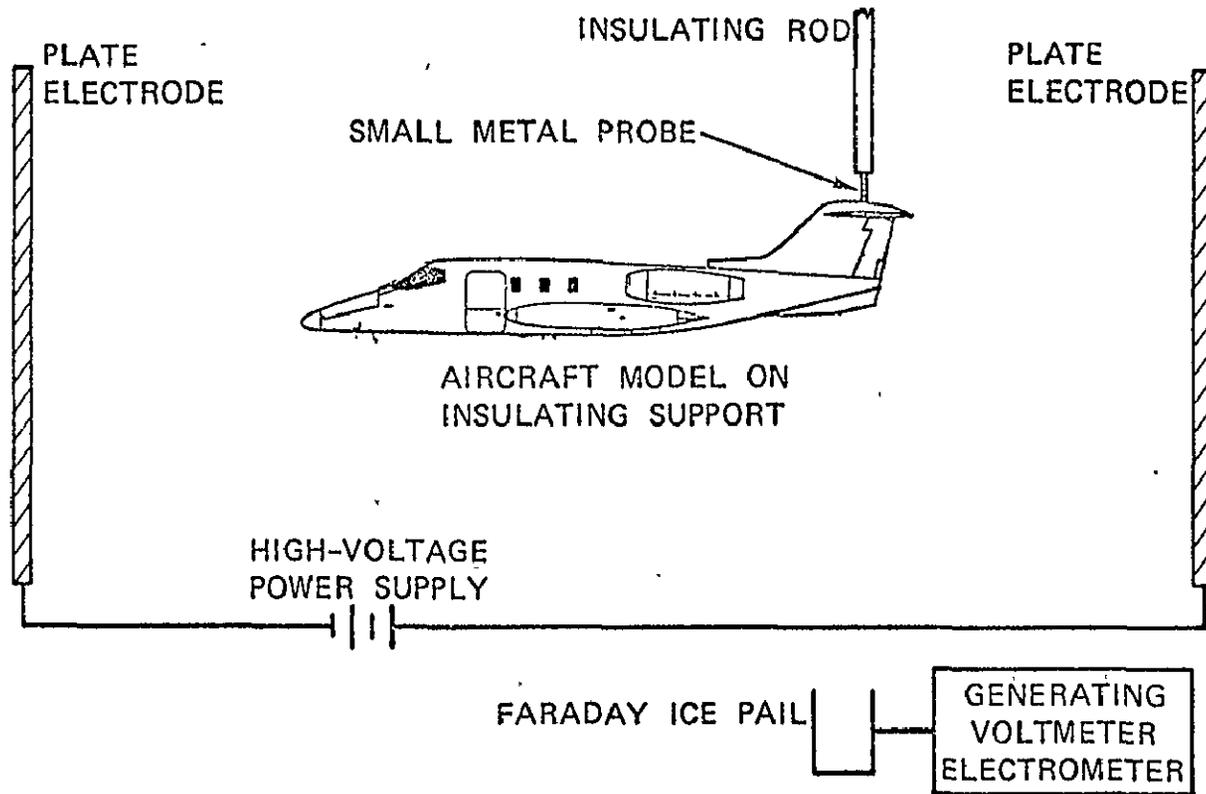
Figure C-4.- Electrostatic cage used for aircraft calibration.
