BATTLE DAMAGE TO SURFACE SHIPS DURING WORLD WAR II

I. M. Korotkin

Leningrad, Sudpromgiz, 1960

Translated by U. S. Joint Publications Research Service
for the David Taylor Model Basin

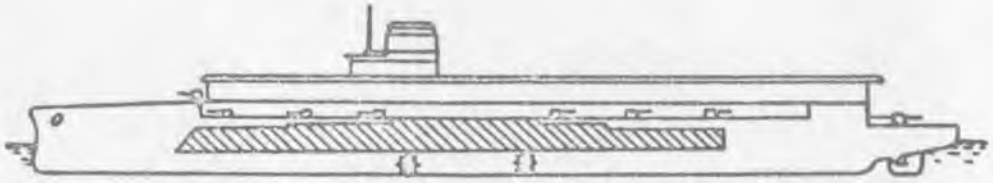
Figure 1 – COURAGEOUS. Diagram of Torpedo Hits

at 15 knots off the southwest coast of Ireland. Attacked by a German submarine at the instant she had completed a maneuver to retrieve aircraft, the ship received two torpedo hits in the midsection (in the machinery spaces and boiler room) portside; see Figure 1. Twenty minutes after the explosions, the carrier sank. Only about 700 of her crew were saved by destroyers and nearby British submarines.

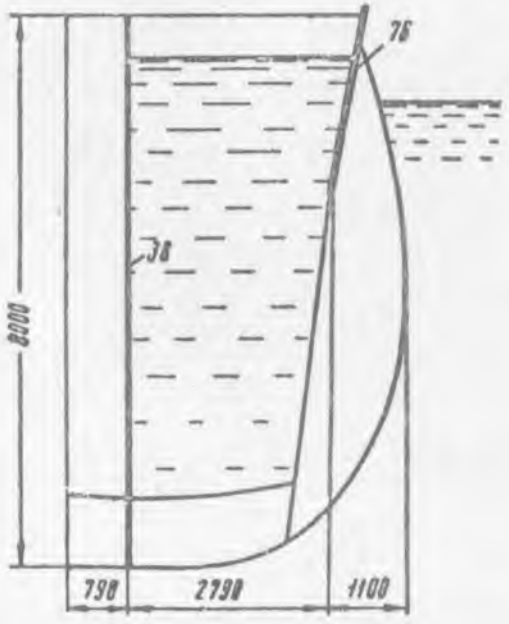
Figure 2 – COURAGEOUS. Diagram of Underwater Protection

Conclusion. Weak underwater protection (Figure 2) did not ensure the watertight integrity of the ship, and as a consequence, the carrier sank in a short time from two torpedo hits.

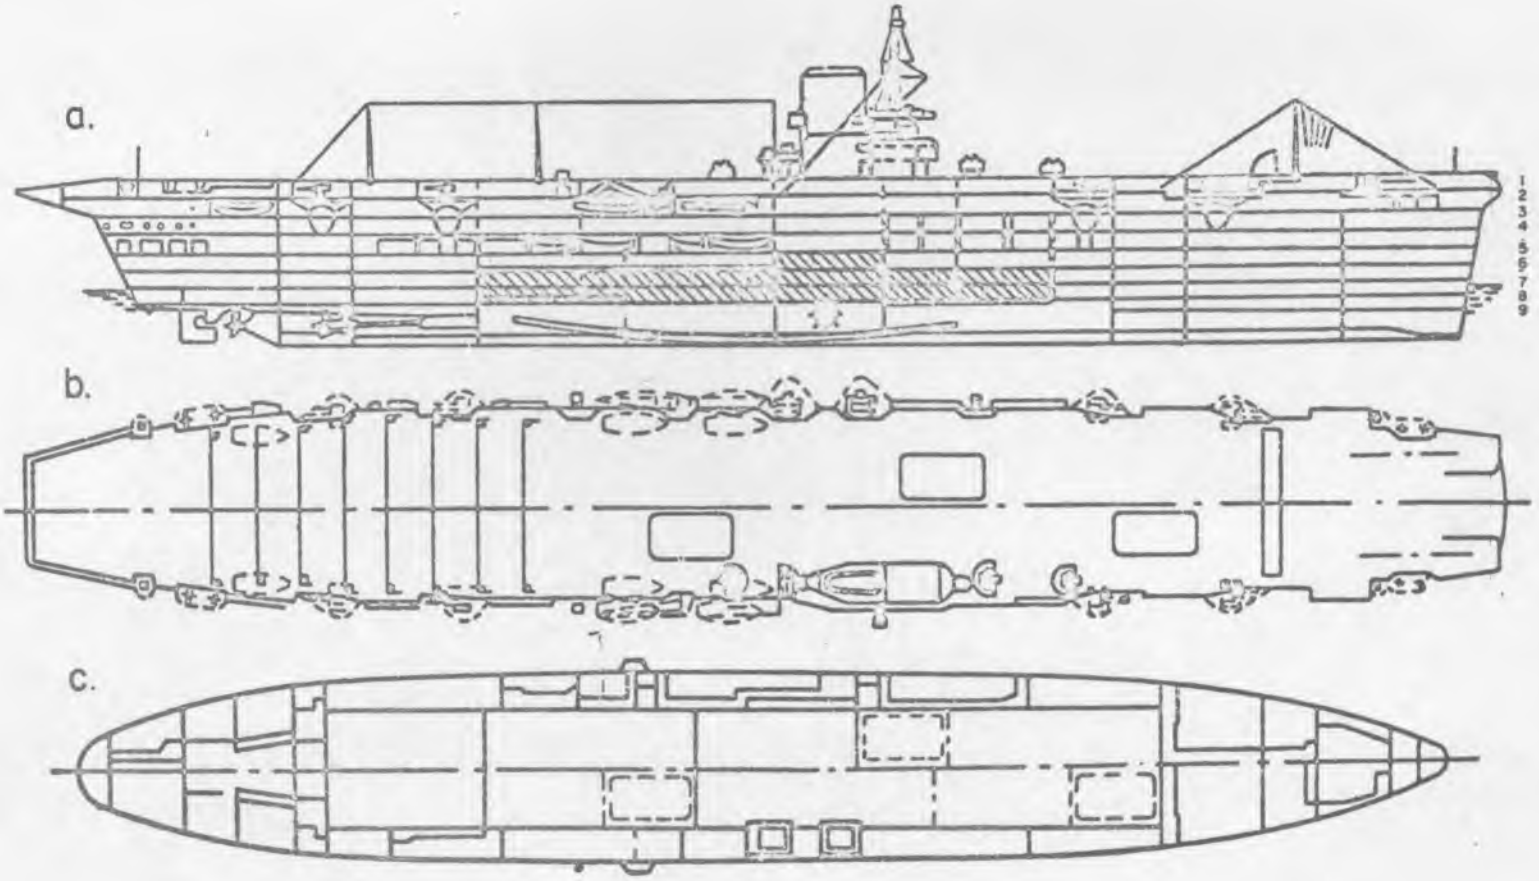
Figure 3 – ARK ROYAL

Damage to and Circumstances of the Loss of the Ship. The carrier, having completed an operating mission in the Gibraltar area, was torpedoed by a German submarine. As a result of a torpedo hit on the starboard side (Figure 3), the starboard boilerroom was immediately flooded, the ship quickly began to heel, and water began to enter the adjacent port boilerrooms through the flues.

Conclusions. The newly built British aircraft carrier took on a significant list from a hit in the midsection of the hull by one torpedo and, remaining afloat a little more than 14 hours, rolled over and sank. This attests to the following structural deficiencies in the ship:

mate ratio 1:1.5)*. Therefore, the fundamental protective bulkheads were ruptured as a result of the explosion, and the water then immediately entered into the vitally important compartments of the ship. The low position of the platform over the underwater protective belt (characteristic of the British system of ship construction for hulls of similar ships) also led to the flooding of topside compartments.

b. Inadequate integrity and watertightness of bulkheads (especially transverse) which were not in the immediate zone of destruction of the explosion appeared to be the obvious reason for the spread of flooding (even though slowly) throughout the entire ship and for the growing list.

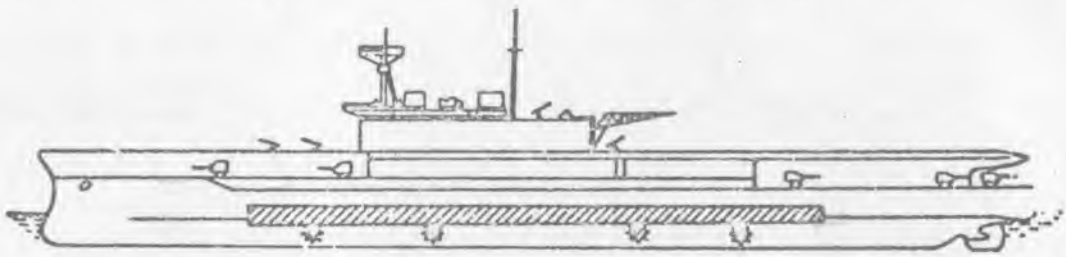
Figure 5 – EAGLE. Oriented Diagram of Torpedo Hits

marine which launched a spread of several torpedoes from her forward torpedo tubes. The carrier received three or four torpedo hits on the portside; these were distributed almost evenly along the length of the ship (Figure 5). After remaining afloat for some time, the ship sank. Since the details of the loss of the carrier have not been published, it is not possible to draw any conclusion on the nature of the damage.

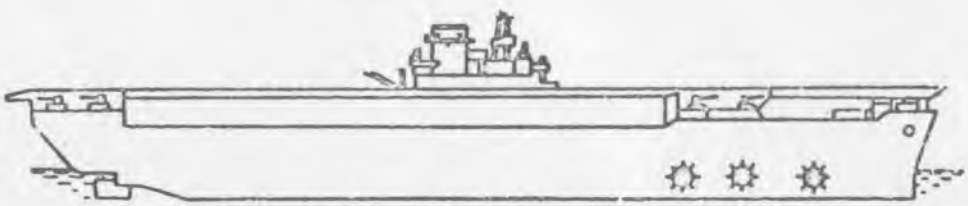
Figure 6 – WASP. Diagram of Torpedo Hits

On 15 September 1942, WASP and HORNET appeared in the vicinity of the island of Santa Cruz. That afternoon WASP was attacked by a Japanese submarine from a distance of 500 meters and received three torpedo hits in the bow, starboard side (Figure 6). At the instant of the torpedo attack, WASP was refueling aircraft and, consequently, all of the gasoline lines were full of gasoline.

As a result of the torpedo explosions (533-mm caliber), fires broke out, and the burning along with the damage to the gasoline lines increased the blaze, which quickly spread throughout the ship. The hull of the ship was shaken by internal explosions. The carrier took on a great quantity of water and listed heavily. It was not possible to put out the fires, and the crew abandoned the blazing and listing ship (Figure 7), after which United States destroyers fired more torpedoes into her to hasten sinking.

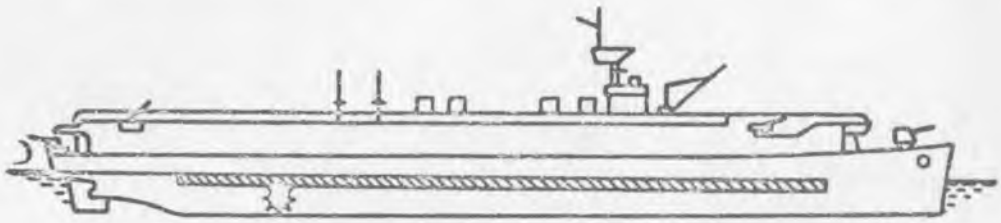
Figure 8 – INDEPENDENCE. Area of Torpedo Hit Shown

Damage to the Ship and Aftereffects. Toward the end of the day on 20 November 1943, a task force of high-speed aircraft carriers, with INDEPENDENCE in company, underwent an air attack by Japanese aircraft in the vicinity of the Gilbert Islands. During a left turn at high speed, INDEPENDENCE received a hit from an aerial torpedo (Figure 8) which exploded 4 meters from the after bulkhead of the after machinery spaces on the starboard side. All of the hull structure in the area of the explosion was destroyed, including the first platform and the lower armored deck; a large hole was formed in the side (Figure 9). Within 2 or 3 minutes after the explosion, the after machinery spaces were flooded

Conclusions. INDEPENDENCE received severe damage to the hull and engines from the explosion of one aerial torpedo in the stern section and went out of commission.

Open piping and leaky electric cable packing glands in the bulkheads caused the spread of water to compartments adjacent to those which were flooded as a result of damage by the explosion.

At the auxiliary base, toward which the ship headed under its own power, the hole was temporarily fixed and a preliminary repair was made to enable transfer to a main base for major repairs.

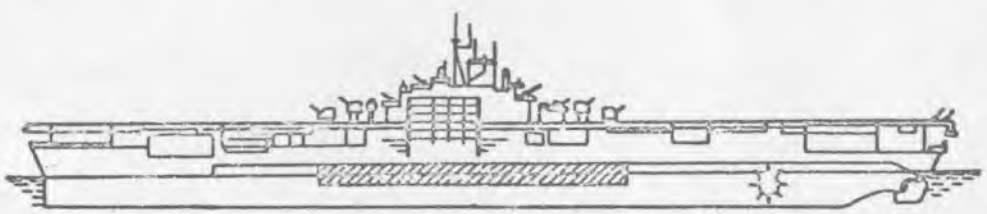
Figure 10 – INTREPID. Area of Torpedo Hit Shown

Damage to the Ship and Aftereffects. In February 1944, INTREPID was a part of a task force which participated in the battles for the Gilbert and Marshall Islands. During the time that she was completing one operation, INTREPID received a torpedo hit in the stern section of the ship (Figure 10). As a result of the explosion, the steering mechanism was seriously damaged, and part of the after compartments were flooded. The carrier was forced to return to base at Pearl Harbor for major repairs.

Conclusion. INTREPID went out of commission and was returned to base for repairs as the result of one torpedo hit.

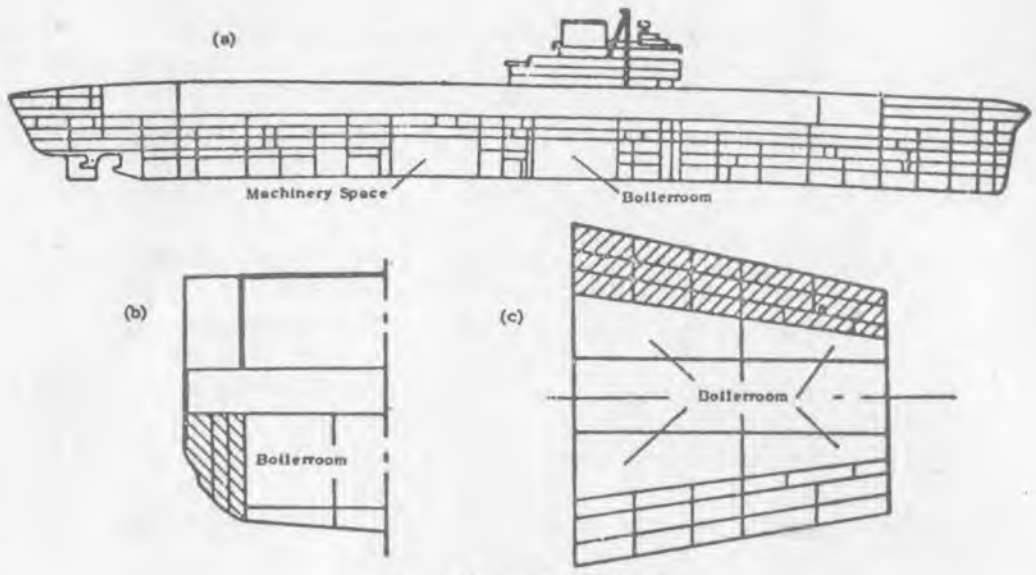
Direct bomb hits led to damage of the decks, aircraft elevators

Figure 16 – ILLUSTRIOUS

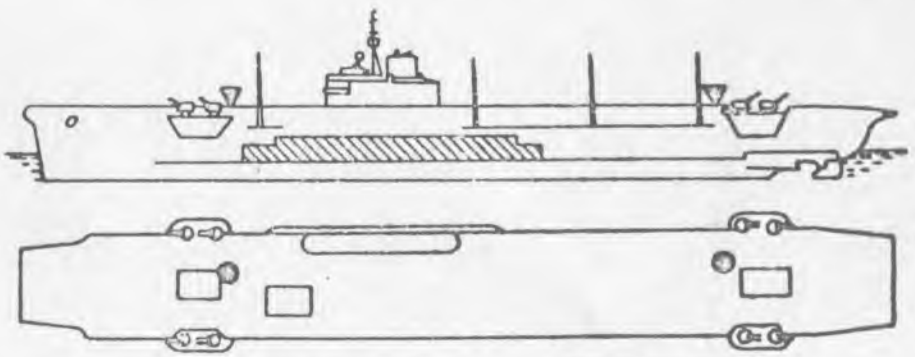
Figure 17 – FORMIDABLE. Diagram of Aerial Bomb Hits

Damage to the Ship and Aftereffects. The ship was attacked by German aircraft and received two aerial hits (bombs weighing 500 kilograms each) in the unarmored region of the hull (one at the bow and the other at the extreme stern; see Figure 17). As a result of the explosion of the bomb at the bow of the ship, the forward aircraft elevator went out of commission, and the gunfire-control equipment of the forward group

suffered severely. Some forward compartments of the hull were flooded.

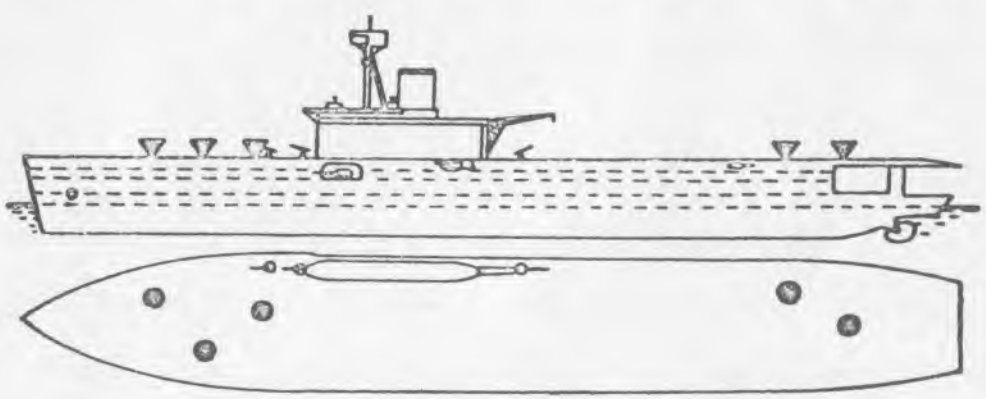
Figure 18 – HERMES. Diagram of Aerial Bomb Hits

direct bomb hits, some in the vicinity of the forward aircraft elevator and at the stern (Figure 18). The damage suffered was so great that the carrier sank in 10 to 15 minutes.

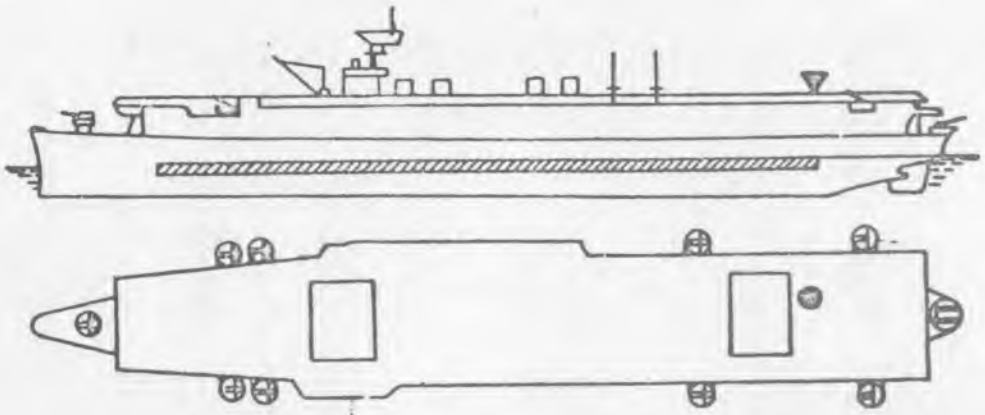
Figure 19 – PRINCETON. Area of Aerial Bomb Hit Shown

October, 1944, the ship suffered an attack by Japanese land-based bombers. One 250-kilogram aerial bomb (according to other information, 500-kilogram) hit the after section of the flight deck. The bomb penetrated through the flight deck and hangar, and exploded on the second deck over the after machinery spaces. A big fire broke out in the hangar where the aircraft were located; these planes were filled to capacity with fuel and some of them were armed with torpedoes. The first series of internal explosions began in 20 minutes and lasted 20 to 30 minutes. The fire spread throughout the ship.

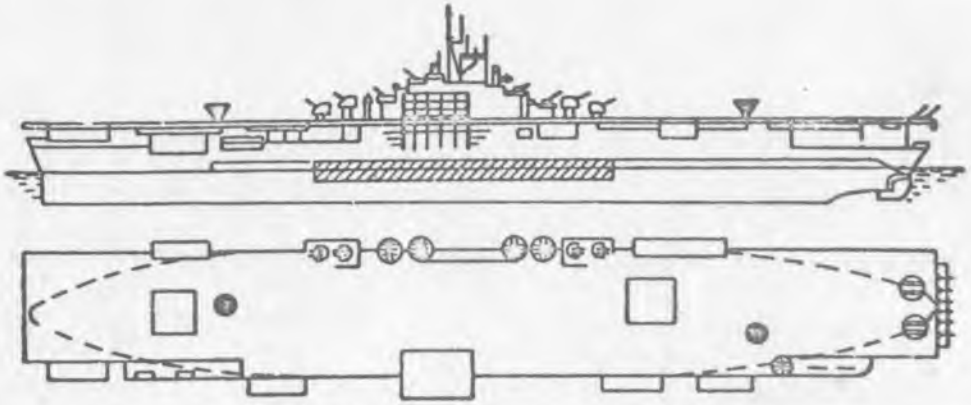
Damage to the Ship and Aftereffects. FRANKLIN, operating in the vicinity of the island of Kyushu, underwent an aerial attack and received two direct hits by aerial bombs launched by Japanese bombers (Figure 20). Internal explosions occurred and fires broke out. Thousands of gallons of aviation gasoline gushed out of ruptured gasoline lines and worsened the fire aboard ship. Aircraft on the flight deck and in the hangars were burned; bombs, rockets, and machine-gun ammunition

Figure 20 – FRANKLIN. Diagram of Aerial Bomb Hits

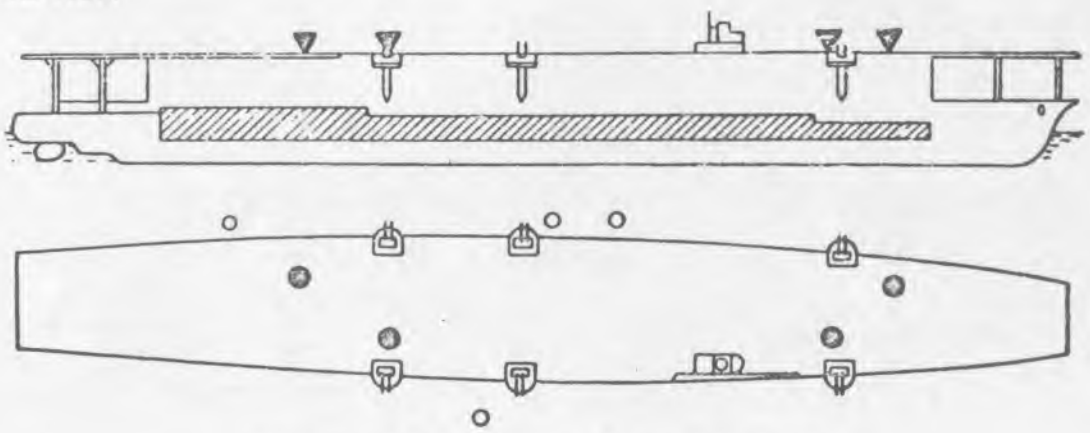
Damage to and Circumstances of the Loss of the Ship. KAGA was attacked in the vicinity of Midway Island on the morning of 5 June 1942 (between 0530 and 0730) by 12 United States bombers and received four direct aerial bomb hits (Figure 21). In addition, seven bombs exploded in the water close aboard at various spots along the length of the ship. Fifty aircraft (by other information, 30) were located aboard the aircraft carrier.

Figure 21 – KAGA. Diagram of Primary Bomb Hits

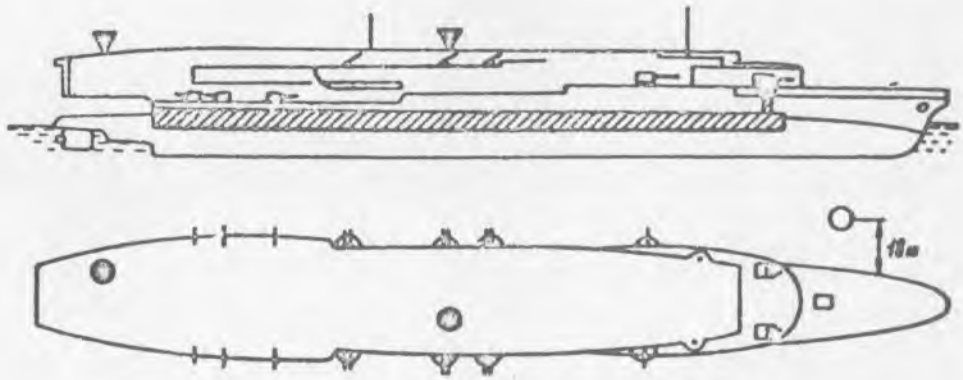
The carrier was heavily damaged; huge fires broke out, and the ship lost way. Firefighting continued throughout the day, but proper results were not obtained, and on the morning of 6 June, the crew abandoned

Figure 22 – AKAGI. Diagram of Aerial Bomb Hits

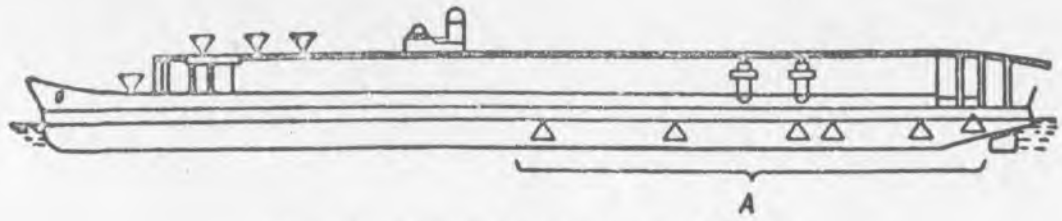
Figure 23 – HIRYU. Diagram of Aerial Bomb Hits

Damage to and Circumstances of the Loss of the Ship. During the action off Midway Island on the morning of 5 June 1942 (at 0456), HIRYU was attacked by 60 American aircraft which launched about 30 aerial bombs and 20 torpedoes in the space of 16 minutes. The ship suffered four direct hits from aerial bombs on the bow (Figure 23), and six bombs

A. Indicates area affected by near-miss explosions

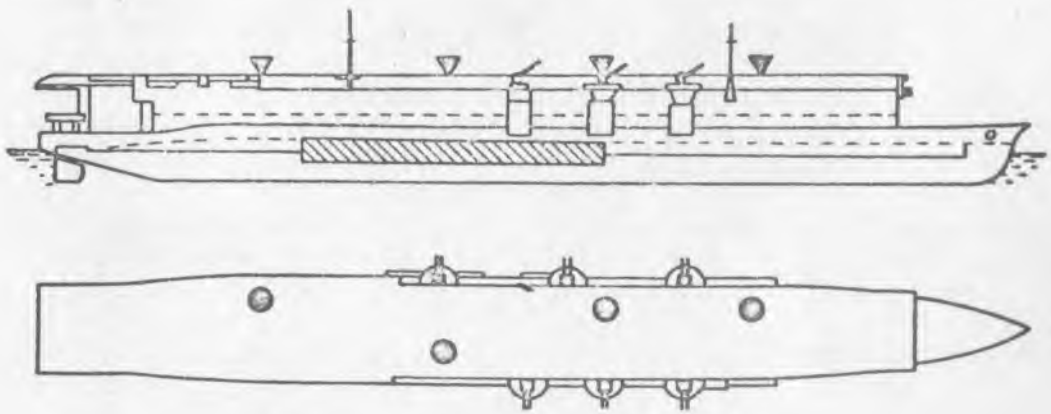
Figure 24 – RYUZYO. Diagram of Aerial Bomb Hits

The ship was hit by about eight aerial bombs, each weighing 500 kilograms, which were launched by dive bombers from SARATOGA (Figure 24). The serious fires which broke out were impossible to extinguish and RYUZYO sank less than an hour after the attack.

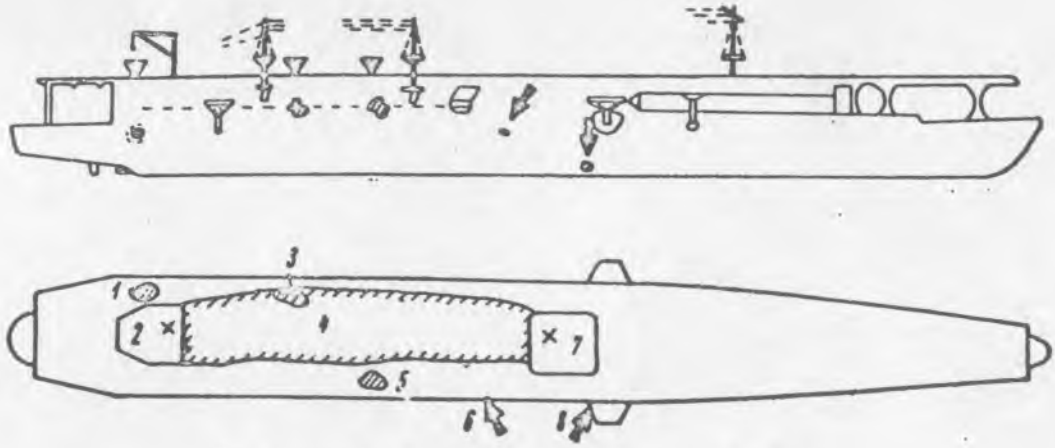
One bomb, which fell in the midsection of the ship, made holes

Figure 25 – RYUHO. Principal Damage to the Ship

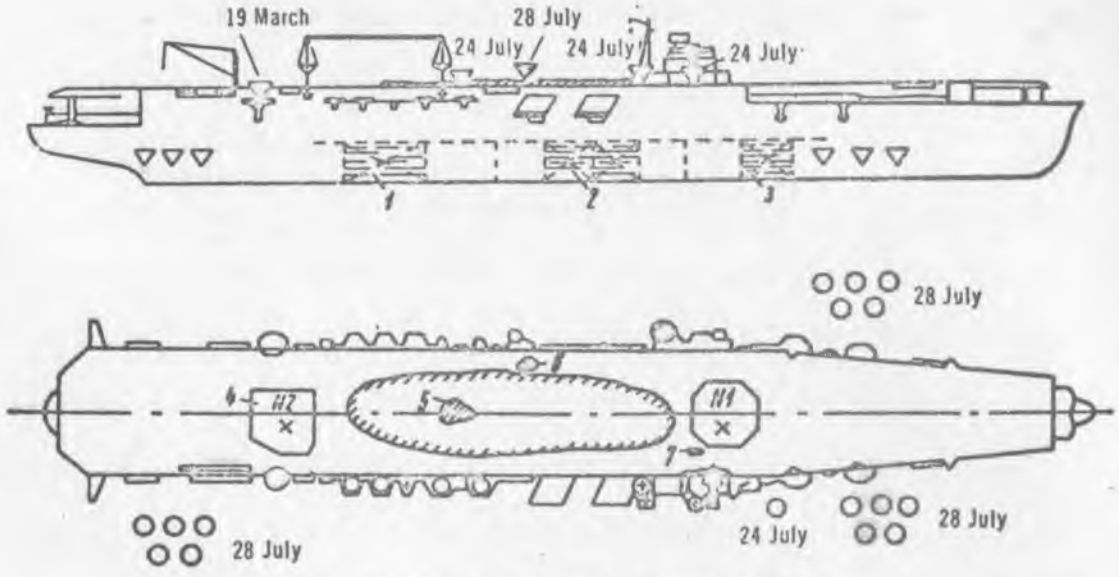
The basic reason for the loss of the ship was the damage to the hull caused by the explosions of aerial bombs which fell close to the ship; having taken on a great quantity of water, the aircraft carrier heeled over and sank.

Figure 26 – AMAGI. Principal Damage to the Ship

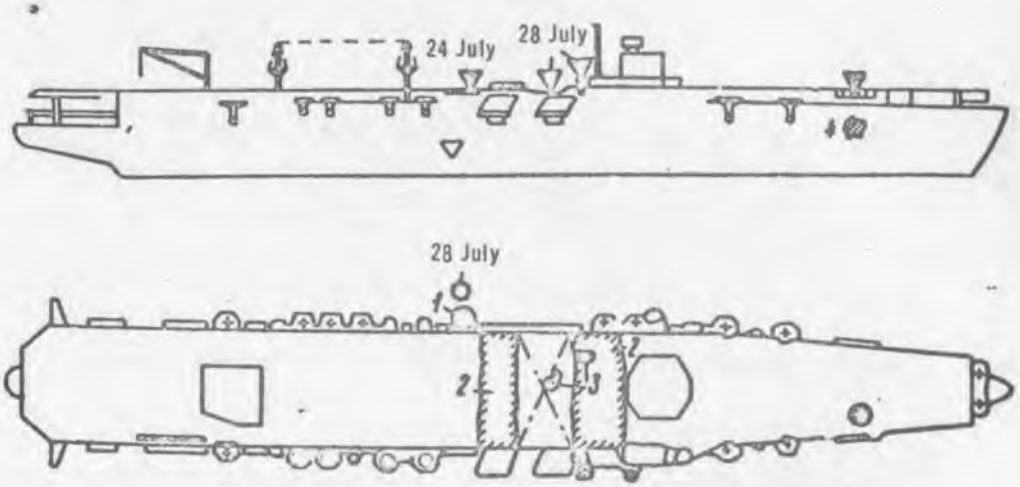
Some days later, on 28 July, 10 to 12 United States aircraft again carried out an attack on the carrier. The ship suffered two more direct hits amidships from bombs weighing 500 kilograms each. Penetrating the flight deck, the bombs exploded on the upper hangar deck. A considerable part of the flight deck (up to 10 meters wide) was carried away to the portside and fell on the ship stacks, and the remaining part of the deck in this vicinity was deformed. The upper hangar deck was blown outward; all elevators were warped (Figures 28 and 29). Insignificant damage was done to the underwater body. Thirteen men were killed and 12 wounded.

Figure 28 – KATSURAGI. Principal Damage to the Ship

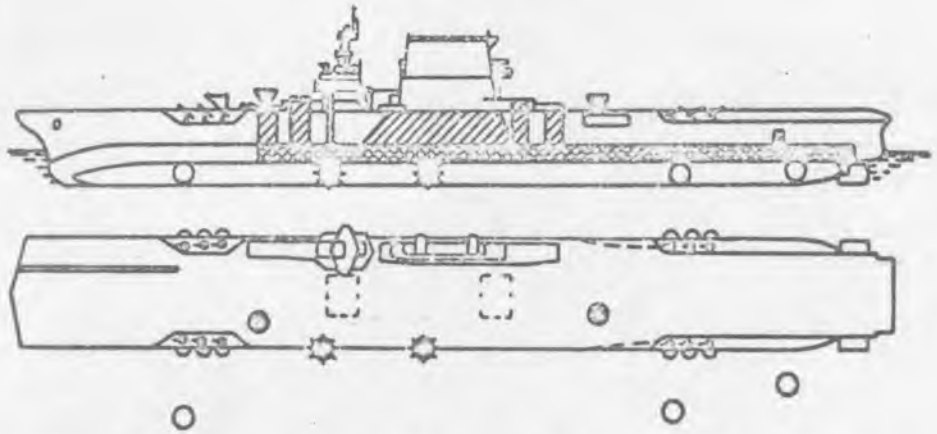
As the heaviest ship of the American formation, LEXINGTON received the main blow of the Japanese aircraft. An attack by 70 aircraft began at 1102 and lasted 9 minutes. First torpedoes launched from torpedo planes passed astern; some torpedoes passed too deep below the keel of the ship and did not explode. Two torpedoes hit (portside), and two aerial bombs landed on the flight deck on the same side (one of the bombs fell in the vicinity of the Admiral's cabin, another in the vicinity of the bridge). Fires broke out from the explosions of the aerial bombs. Three aerial bombs fell into the water and exploded alongside the ship, causing damage to her hull (Figure 30). As a result of the damage, several compartments were flooded, and LEXINGTON took on a list of several degrees. The list was corrected by shifting water ballast. The speed of the ship decreased to 20 knots. Fires enveloped the magazine and fuel bunker areas. Special firefighting details at first tried to fight the fires and succeeded in putting out some of them, but at 1247, i.e., 1 hour and 45 minutes after the beginning of the battle, the ship suffered a strong internal explosion and the flames of fires again appeared in many areas; smoke poured out of the elevators onto the flight deck. The

Figure 30 – LEXINGTON. Diagram of Damage by Torpedoes and Aerial Bombs

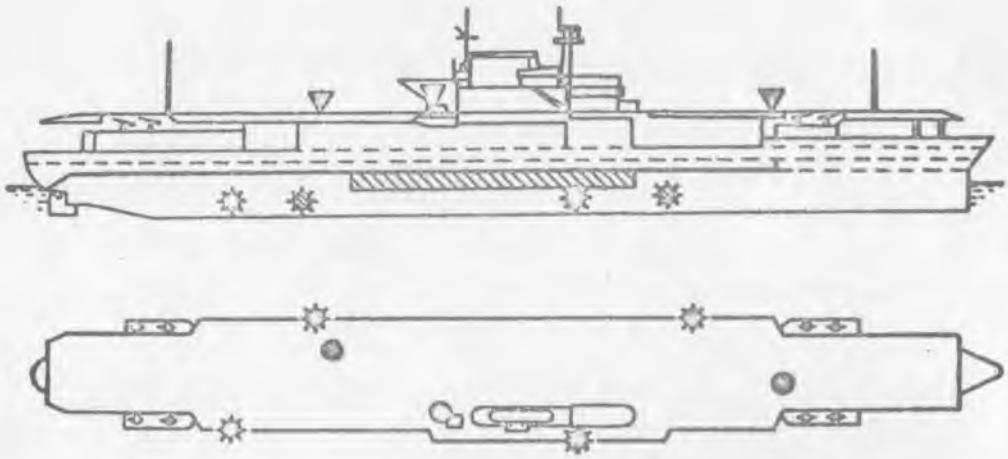
Conclusions. YORKTOWN went out of commission after suffering three bomb and two torpedo hits from aircraft. The explosions of the bombs led to the cessation of flight operations, and the torpedo hits caused the flooding of ship compartments along with the formation of a

Figure 32 – YORKTOWN. Diagram of Damage by Torpedoes and Bombs

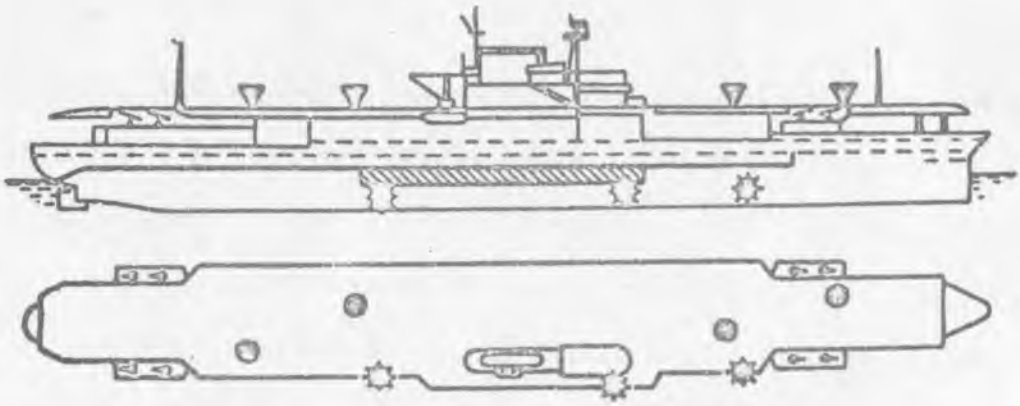
Conclusions. From the action of three contact explosions of torpedoes, four direct hits from aerial bombs, and two kamikaze aircraft

Figure 33 – HORNET. Diagram of Damage by Torpedoes and Bombs

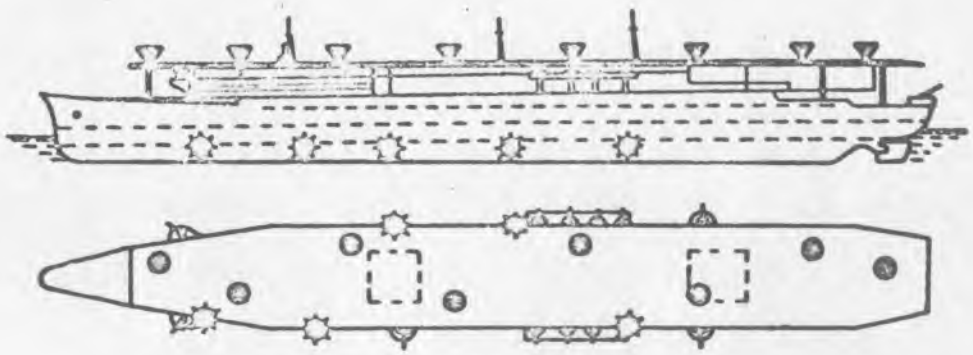
At 0845 on 7 May 1942, the Americans discovered a part of the Japanese force and attacked SHOHO with dive bombers and torpedo planes from LEXINGTON and YORKTOWN. More than 70 aircraft took part in attacking both sides of the ship. Thirteen direct hits from aerial bombs and seven torpedo hits resulted (Figure 34). The damage was so great that the ship rolled over and sank in a period of 15 minutes with the loss of all aboard.

Figure 34 – SHOHO. Diagram of Damage by Torpedoes and Bombs
Principal hits are shown

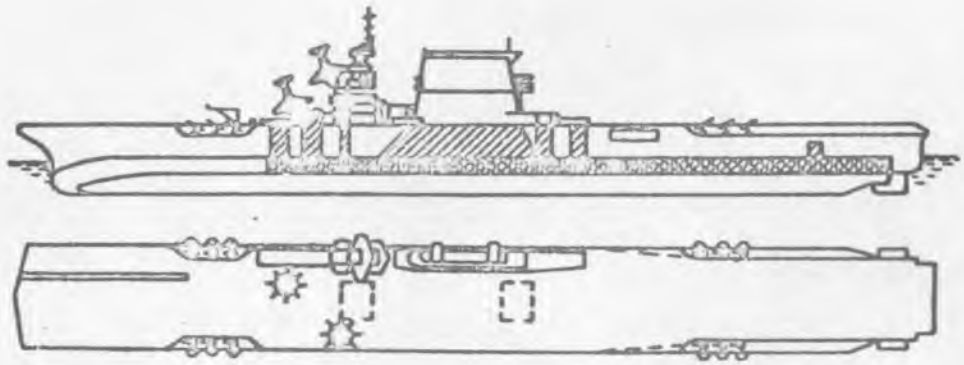
Damage to the Ship and Aftereffects. SARATOGA underwent attack by four Japanese kamikaze aircraft while part of a task group supporting landing operations on Iwo Jima. Two aircraft crashed on the flight deck of the ship forward of the island superstructure: one on the starboard side and the other on the portside (Figure 36). As a result of the explosions that occurred, fires broke out and enveloped the aircraft

Figure 36 – SARATOGA. Diagram of Damage by Kamikaze Aircraft

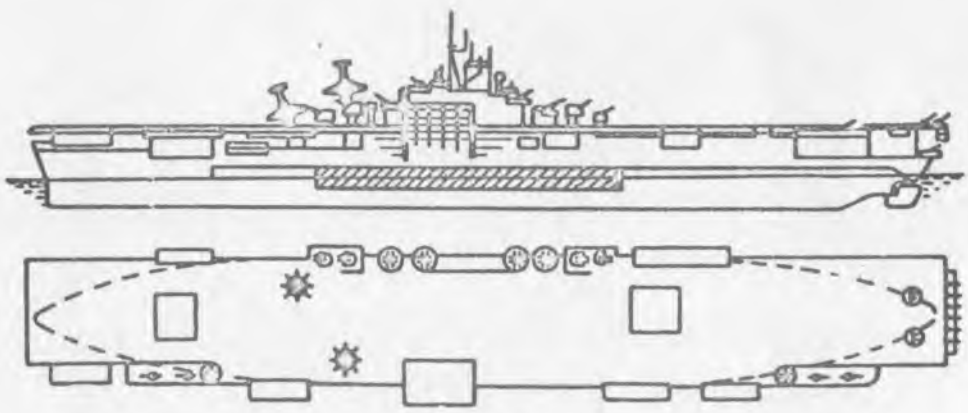
Figure 38 – TICONDEROGA. Diagram of Damage by Kamikaze Aircraft

After having been docked for a short while, TICONDEROGA was sent to a major base for final repairs.

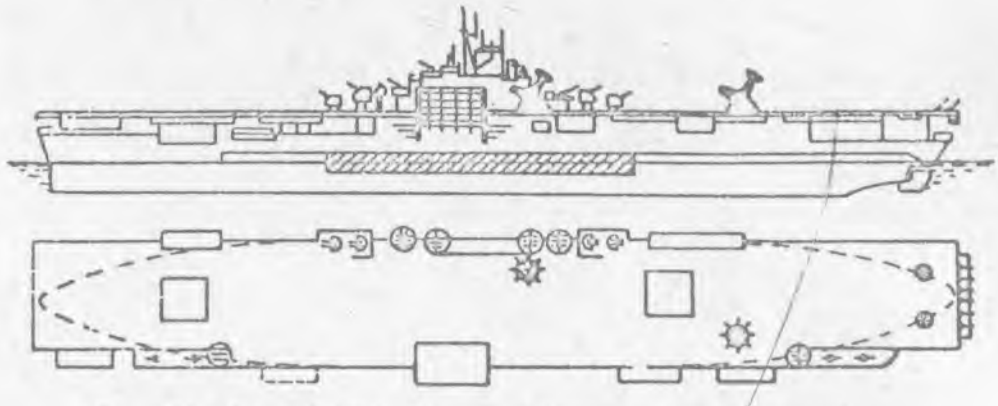
The fire on the flight deck was put out 1 1/2 hours later, but that in the hangar required 3 1/2 hours. Despite serious destruction and bad fires, the carrier was saved as a result of effective measures

Figure 39 – BUNKER HILL. Diagram of Damage by Kamikaze Aircraft

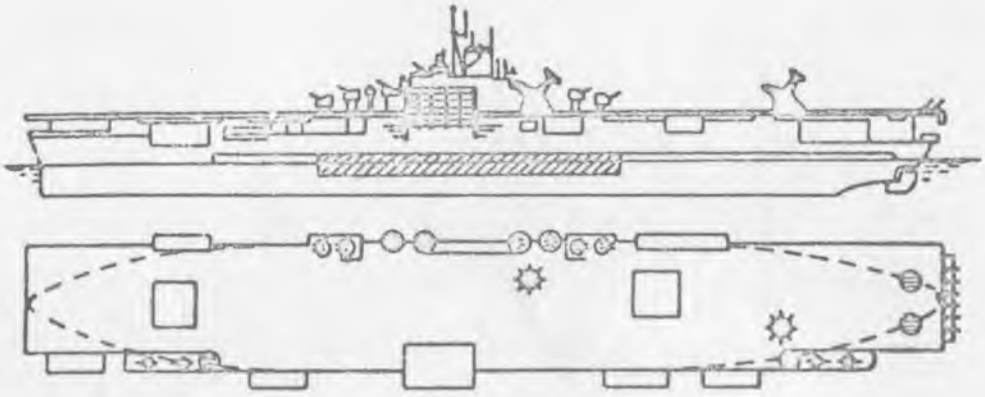
dropped by this plane exploded below the flight deck, burning 19 aircraft which were fueled and armed with ammunition. The second kamikaze crashed before the bomb it was carrying exploded on the after section of the carrier. The bomb entered the hangar and exploded in the vicinity of the fire that was being extinguished (Figure 40). The intensity of the fire in the hangar increased significantly, and the flames enveloped aircraft on the flight deck.

Figure 40 – INTREPID. Diagram of Damage by Kamikaze Aircraft

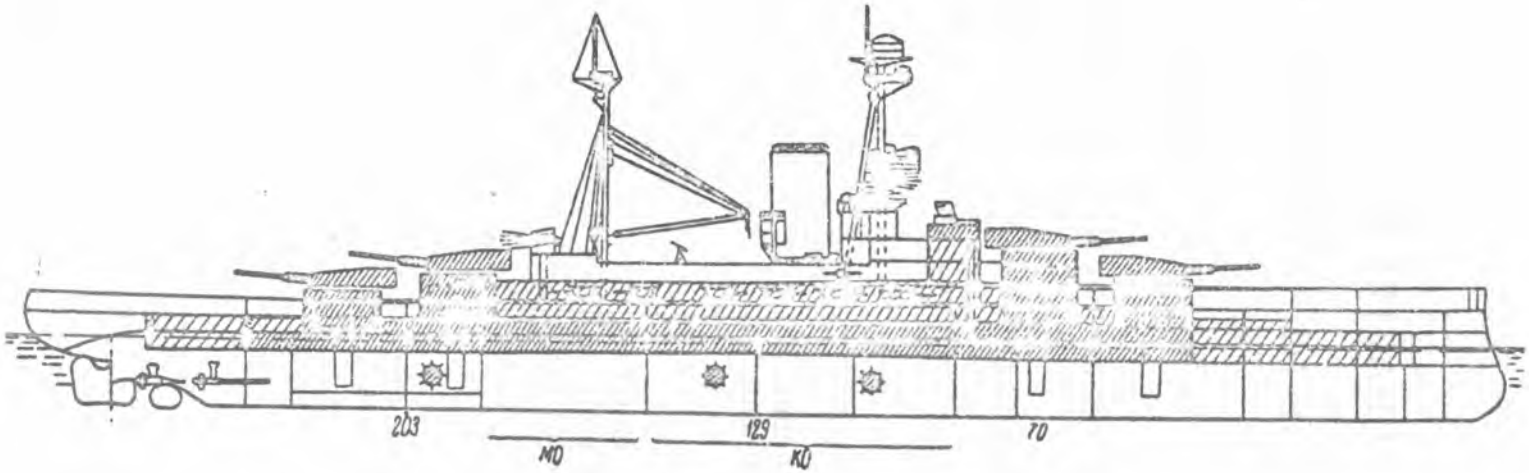
Figure 42 – ROYAL OAK. Longitudinal Section Areas of Torpedo Hits are Shown

OAK was torpedoed by the German submarine U-47.* The ship suffered two or three torpedo hits in the portside approximately amidships and in the after section (Figure 42). The panic-striken crew took no measures to save the battleship, and did not keep her afloat for more than 23 minutes. ROYAL OAK then rolled over and sank.

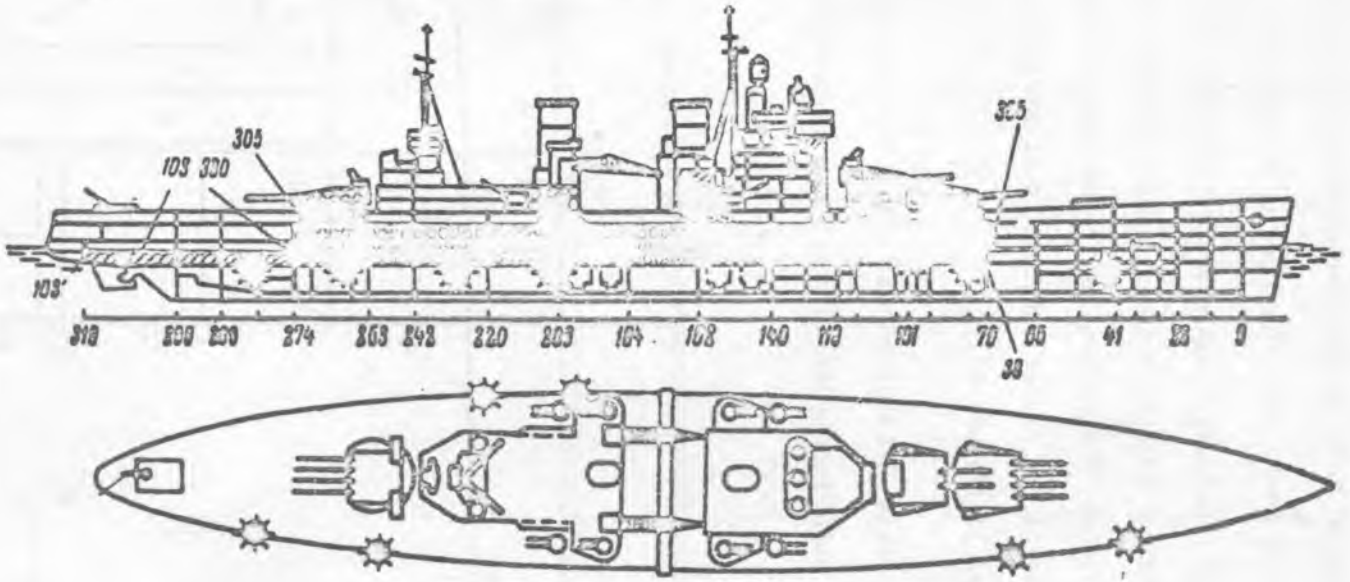
Figure 45 – PRINCE OF WALES. Areas of Torpedo Hits are Shown

Damage to and Loss of Battleship PRINCE OF WALES. At 1144 on 10 December 1941, the ship suffered two torpedo hits in the portside in an area abaft the after bridge. One engineroom and one boilerroom were flooded. The ship took on a list of 11.5 degrees to port and was down at the stern. Five of the 127-mm turrets were put out of commission. Two screws were damaged as well as the steering gear. Main

At 1222, the battleship suffered three or four more torpedo hits in the starboard side, one or two in the bow, and two in the stern of the ship (Figure 45). The list to port decreased, but insignificantly. Speed dropped to 8 knots.

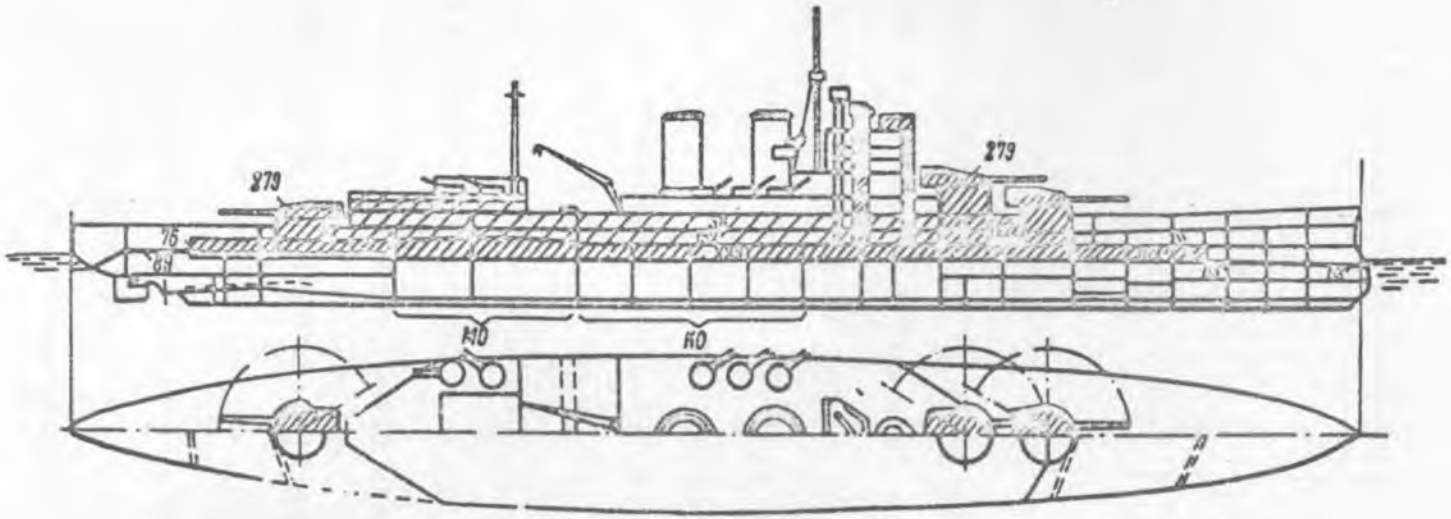
Figure 46 – REPULSE. Thickness of Armor Plating Shown

Damage to and Loss of Battle Cruiser REPULSE. (Figures 46 and 47). At 1222 on 10 December 1941, the ship suffered one torpedo hit in the portside amidships; speed dropped to 25 knots. Within a few minutes, the cruiser suffered four more torpedo hits on the same side. The ship began to list heavily to port and at 1233, after the list had reached 60-70 degrees, she rolled over and sank. In all, she had remained afloat 15 minutes from the instant of the first torpedo attack. A part of the crew was saved by accompanying destroyers.

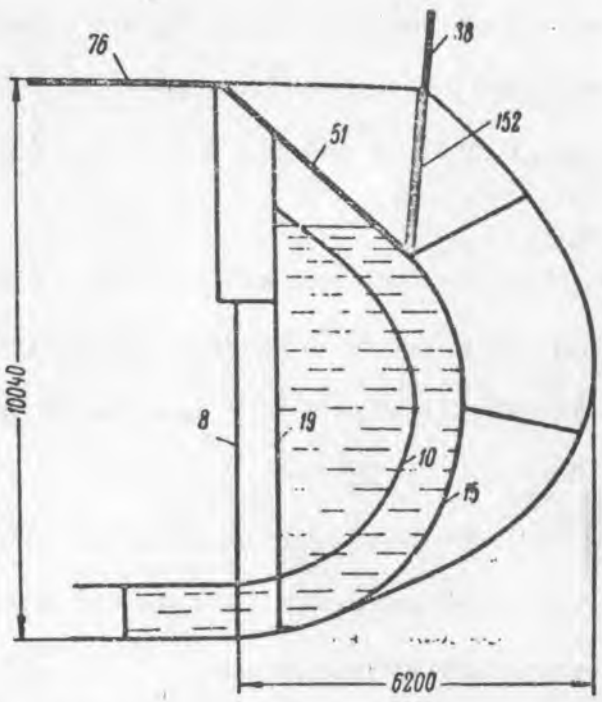
Figure 47 – REPULSE. Diagram of Underwater Protection

Conclusions. The new British battleship PRINCE OF WALES and modernized battle cruiser REPULSE rolled over and sank from several (up to five) contact explosions of Japanese torpedoes.

After reviewing the deficiencies in protection of the vital parts of RESULUTION and ROYAL OAK, which are peculiar to all British battleships built during World War I, the rapid sinking of REPULSE from several torpedo hits becomes understandable, the more so if one takes into account the fact that the underwater protection for battle cruisers of this type was still weaker than that of the indicated battleships. Further-

more, the condition of REPULSE was worsened by the fact that all the torpedo hits were suffered on one side.

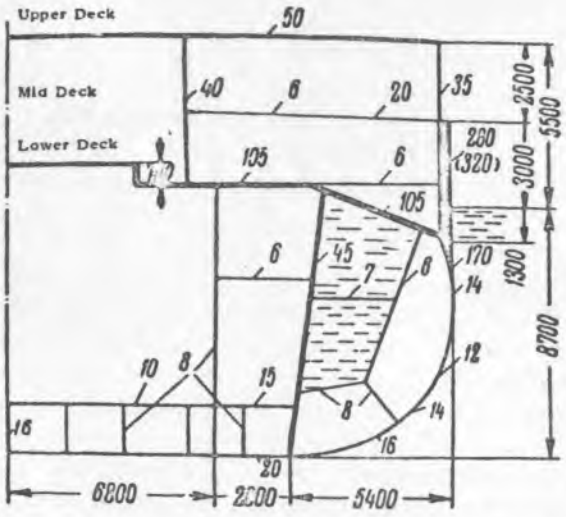
Figure 48 – SCHARNHORST. Torpedo Protection System and Armor are Sketched

The hull of the ship was smooth-decked and divided by transverse bulkheads into 24 watertight sections; the main transverse bulkheads extended to the upper deck. In German designs, two after sections are joined and two bow sections are joined, and therefore it is considered that the ship was divided into 22 sections. Watertightness was counted on to maintain ship fighting capacity during the flooding of any two adjacent compartments. The torpedo protection system and armor are indicated in Figure 48.

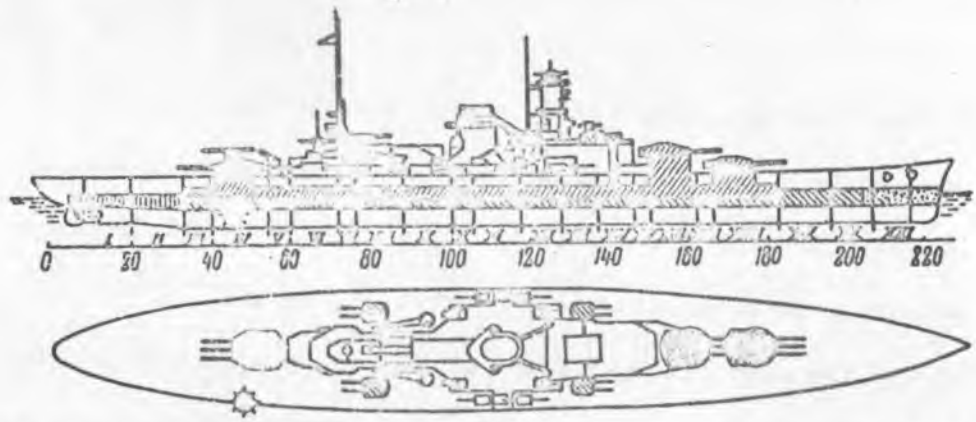
Figure 49 – SCHARNHORST. General View with an indication of the Area where Torpedoes Hit 8 June 1940

Damage to the Ship and Aftereffects. On 8 June 1940 in the North Sea, SCHARNHORST was steaming in company with her sister ship GNEISENAU when she was torpedoed by a British destroyer. The torpedo (caliber 533-mm, weight of the charge about 340 kilograms) was launched at an angle of 15 degrees to the transverse plane of the battleship. It hit the starboard side 2.5 meters below the edge of the side armor in the vicinity of the main battery after turret (Figure 49).

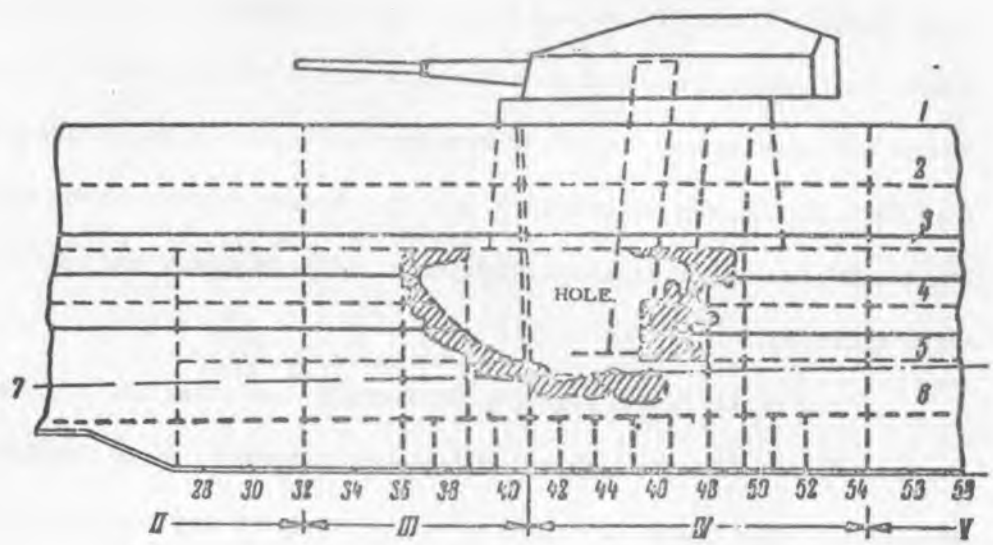
Figure 50 – SCHARNHORST. Diagram of Damage to Plating

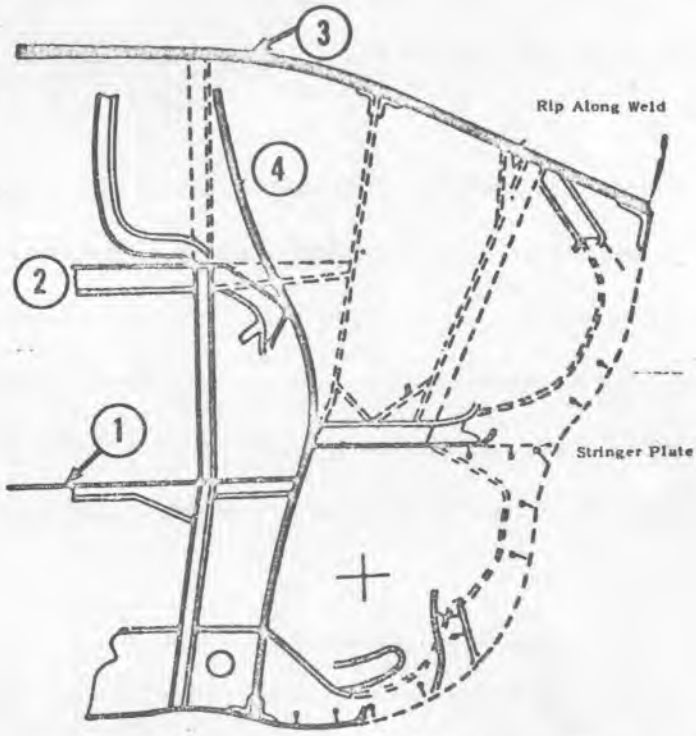
Figure 51 – SCHARNHORST. Diagram of Damage to the Underwater Protection Due to Torpedo Explosion

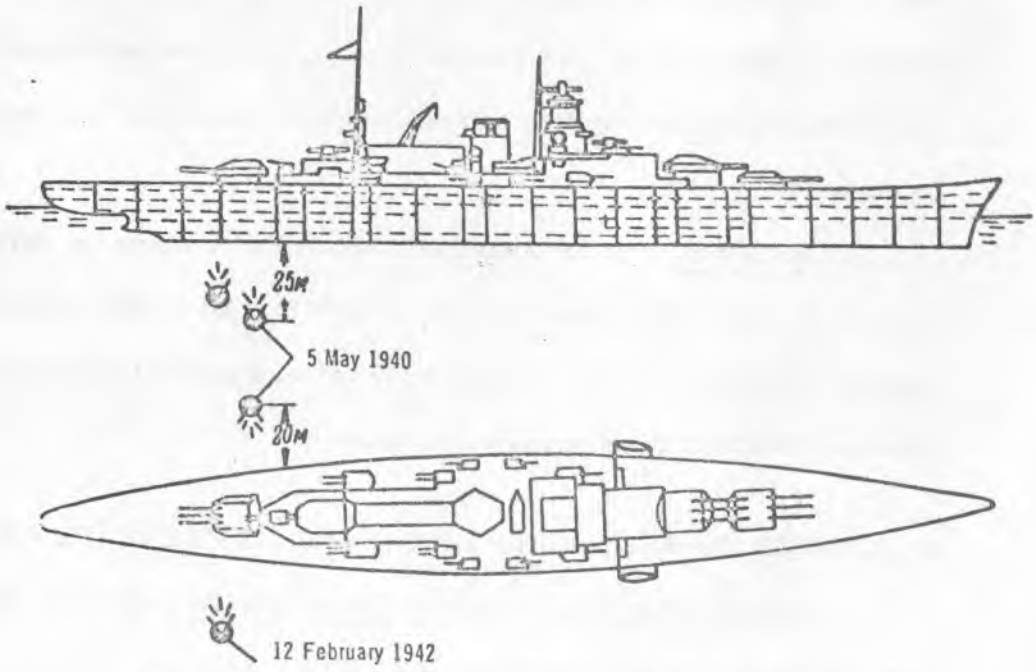
Hull. The ship suffered comparatively minor damage: dents in the vicinity of the cheek belt and individual breaks and cracks in the outer plating to a distance from 0.5 to 2.0 meters. The platform deck in the inboard fore-aft passageway appeared to be deformed. The area of the damage extended 2 to 4 meters below the structural underwater protection, enveloping, along the length of the ship, the II-IV compartments (between Frames 20-50), i.e., about 30 meters. Several compartments were flooded: a shaft tunnel, two storage and empty compartments. The ship took on a list of 0.5 degree to port and a slight settling at the stern.

Figure 63 – GNEISENAU. Approximate Locations of Centers of Mine Explosions 5 May 1940 and 12 February 1942

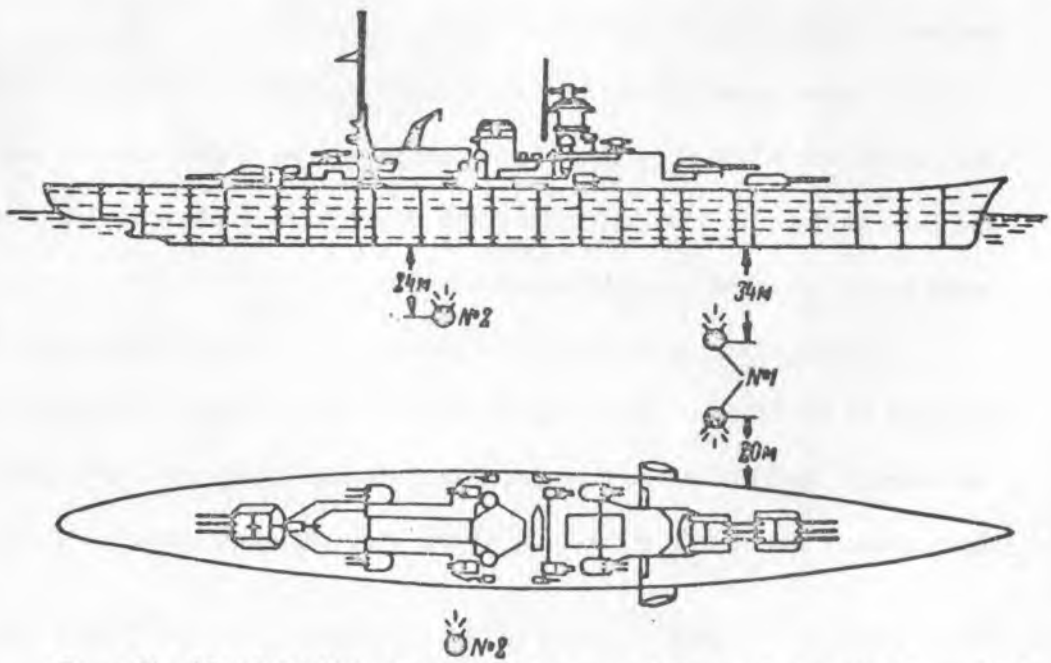
The hull of the ship suffered deep dents and individual rips of the outer plating caused by the impact of the water. About 30 watertight compartments were flooded within the limits of five main compartments (XIV-XVIII) for a distance of about 40 meters. The ship took on more than

Figure 64 – SCHARNHORST. Distribution of Centers of Mine Explosions 12 February 1942
