BATTLE DAMAGE TO SURFACE SHIPS DURING WORLD WAR II

I. M. Korotkin

Leningrad, Sudpromgiz, 1960

Translated by U. S. Joint Publications Research Service
for the David Taylor Model Basin

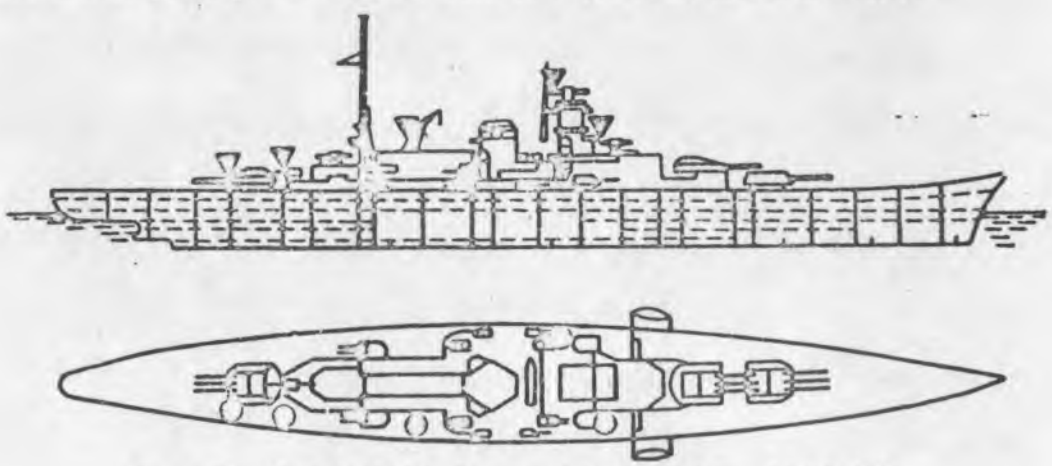
Hit 1. A semi-armor-piercing aerial bomb weighing 100 kilograms fell in the vicinity of the 150-mm installation (Frame 133), passed through the upper and middle decks, exploded on the armored main deck, and damaged the outer plating of the ship over the armored bevel. The side armor plating was slightly deflected (30 mm) from the bomb

Figure 67 – SCHARNHORST. Diagram of Aerial Bomb Hits 24 July 1941

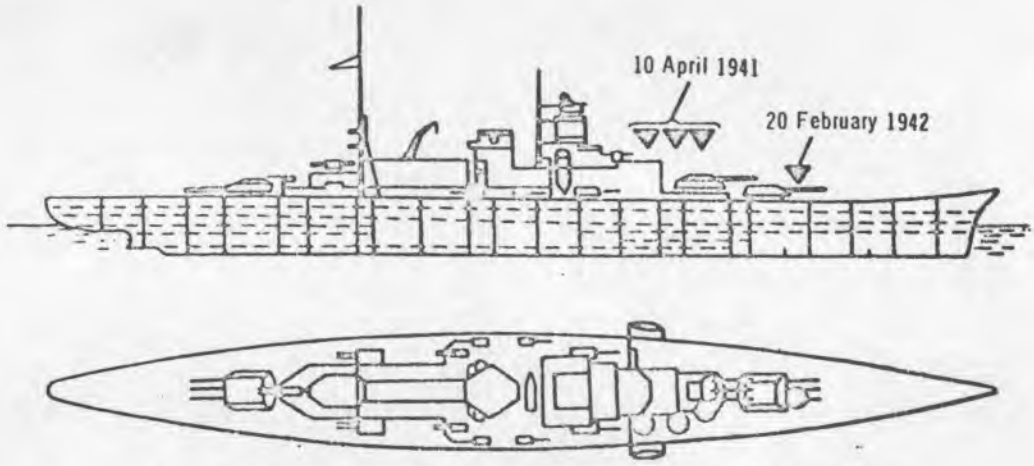
Damage to the Ship and Aftereffects. While at anchor in the port of Brest, GNEISENAU suffered three direct hits from semi-armor-piercing aerial bombs (weighing 250 kilograms each) launched from British aircraft. The bombs fell on the ship (Figure 69) from the starboard side: the first in the upper deck at the No. 2 Main Battery Turret in the vicinity of Frame 158 (Figure 70), the second and third in the deck of the superstructure at Frames 153 and 146, respectively. The bombs penetrated the upper and battery decks and (except for the second bomb which did not explode) exploded on the main armored deck. The main armored deck suffered light damage from the explosions; the outboard longitudinal bulkhead was puffed out and its welded seams were torn (Figure 71). A puff-out appeared in the barbette of the second main battery turret, and the rotating part suffered several splinter hits (Figure 72). The barbette of the second main battery turret warped and the rotating part suffered some splinter damage (Figure 72). Several compartments, including the forward antiaircraft gun station and the central automatic gun control station, were partially flooded. The engine installation of the ship was not damaged; however, the gyrocompasses and the welding

Figure 69 – GNEISENAU. Diagram of Aerial Bomb Hits 10 April 1941

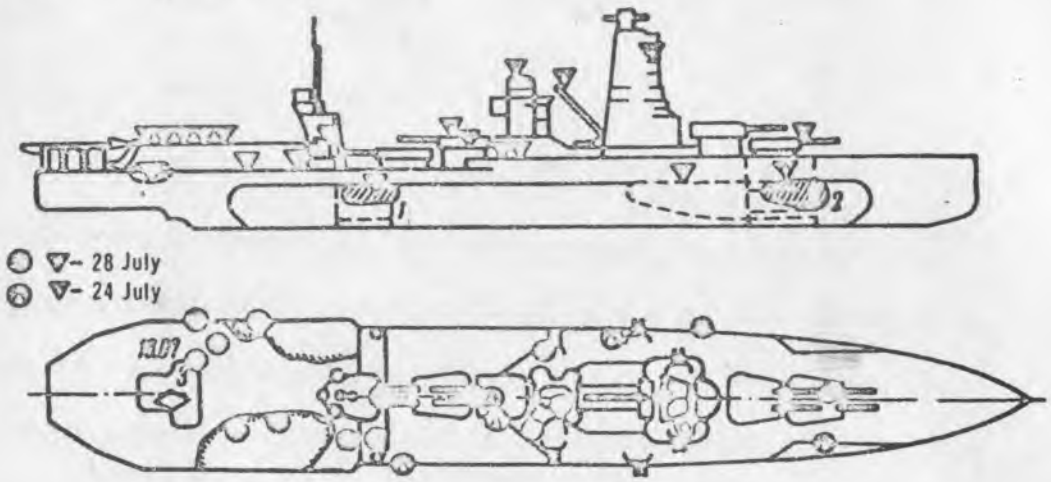
participated, the battleship suffered six direct hits, and about ten bombs fell close to the ship. Then, during a subsequent attack, the ship suffered eight more direct hits, and several more bombs exploded close by her in the water (Figure 73).

Figure 73 – ISE. Diagram of D nage by Aerial Bombs

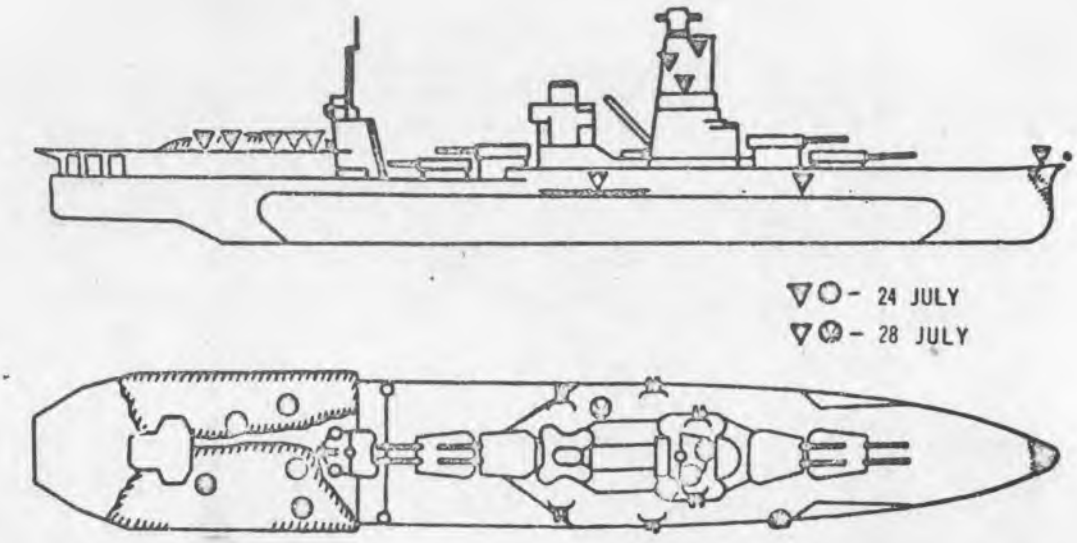
Damage to and Circumstances of the Loss of the Ship. Two attacks by United States carrier aircraft were made on HYUGA, which was at anchor in Kure, on 24 and 28 July 1945. In the first attack on 24 July, up to 60 aircraft participated and launched about 200 aerial bombs at the ship. The battleship suffered 10 direct hits (Figure 74); more than 20 bombs exploded close aboard. The ship was seriously damaged; the entering

Figure 74 – HYUGA. Diagram of Damage by Aerial Bombs

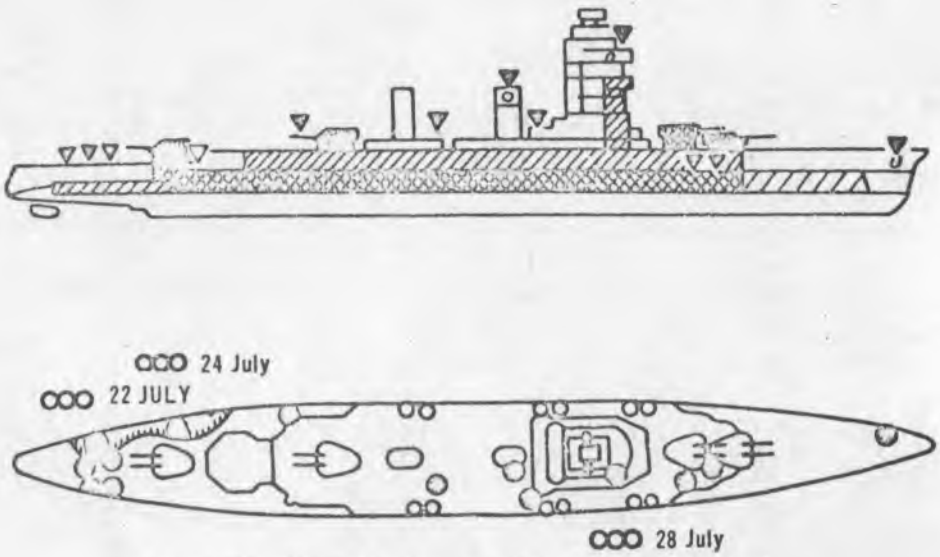
On 28 July, the battleship was attacked several times by carrier-based aircraft and B-24 heavy bombers and suffered a great number of direct hits (Figure 75); several bombs exploded close aboard. As a

Figure 75 – HARUNA. Diagram of Damage by Aerial Bombs

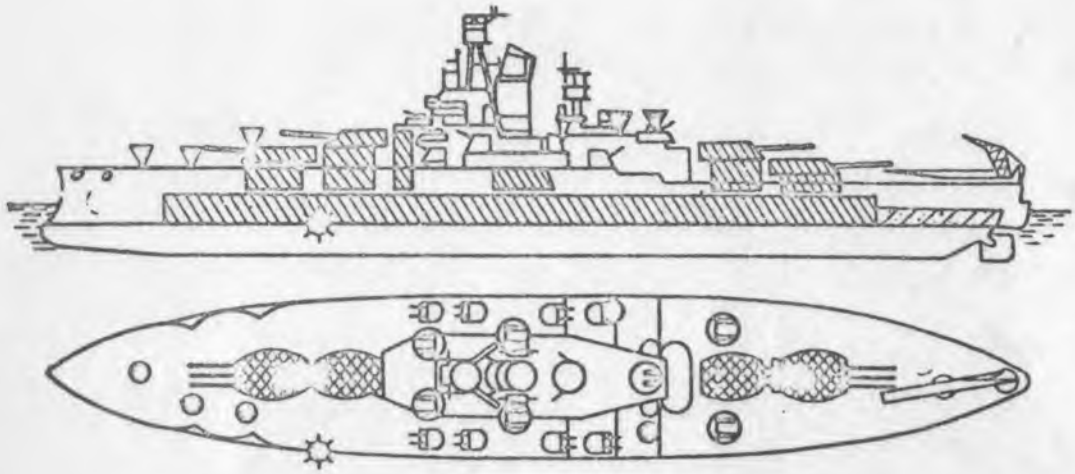
Figure 78 – NEVADA. Diagram of Damage to the Ship by a Torpedo and Aerial Bombs

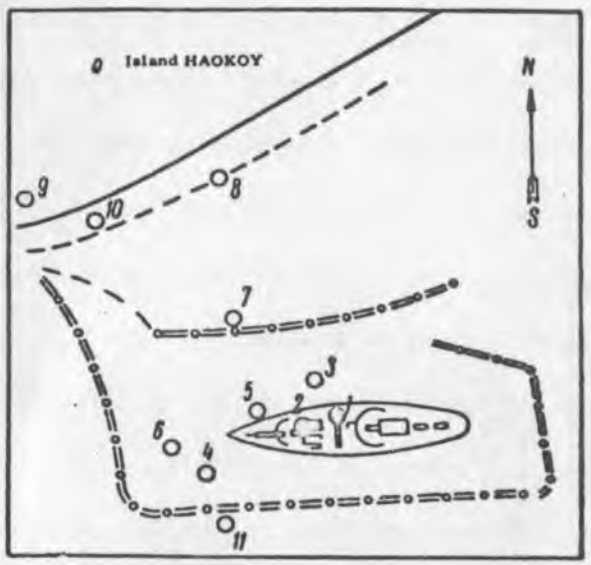
Figure 83 – Diagram of Aerial Bomb Hits During the Attack on TIRPITZ 12 November 1944

Fifth Step. The subsequent attacks on the battleship were made while TIRPITZ was at anchor in this harbor. From 1030 to 1210 on 12 November 1944, a formation consisting of 32 Lancaster aircraft made three consecutive attacks on the ship. The battleship suffered two direct hits from aerial bombs; in addition, four bombs exploded in close proximity to her hull (Figure 83). All of the bombs were high-explosive and each weighed 5.5 tons.

Fifteen minutes after the first attack, the ship caught fire and began to list, and a huge oil slick grew and spread around the ship. However, bombs did not fall in the ammunition magazine, and therefore internal explosions did not occur.

The third and last air attack decided the fate of the ship. A few minutes after the end of the third attack (i.e., at 1215), the battleship rolled over on her portside and lay on the bottom at a distance of 200 meters from the shore. About 700 men went down with their ship. The right half of the bottom, from the knuckle to the keel, stuck out above the water for a distance of more than 200 meters, and the starboard and

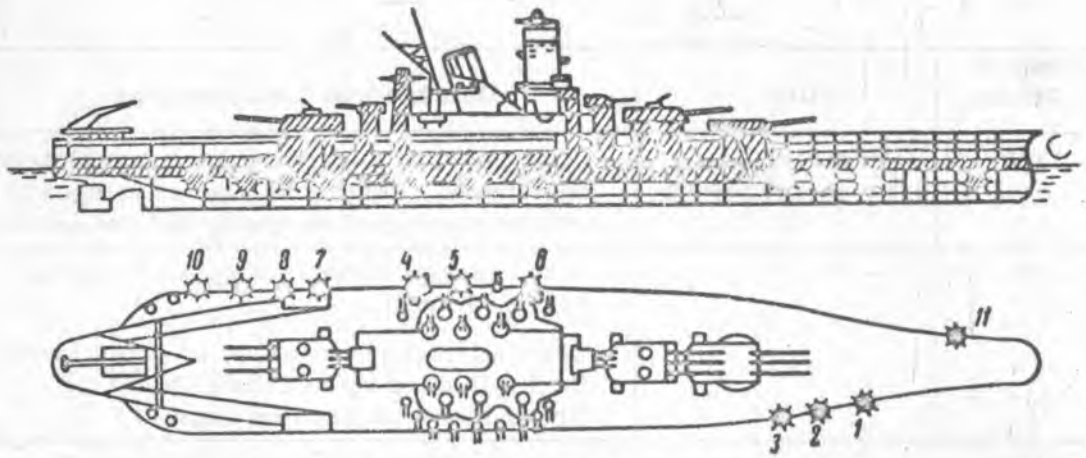
The fate of the battleship was decided by contact explosions from torpedoes, which subsequently decreased the buoyancy and stability of the ship and, in connection with the flooding of compartments and the growth of the damaging list, led to incapacitation of the engineroom and

Figure 87 – MUSASHI. Diagram of Damage by Torpedoes

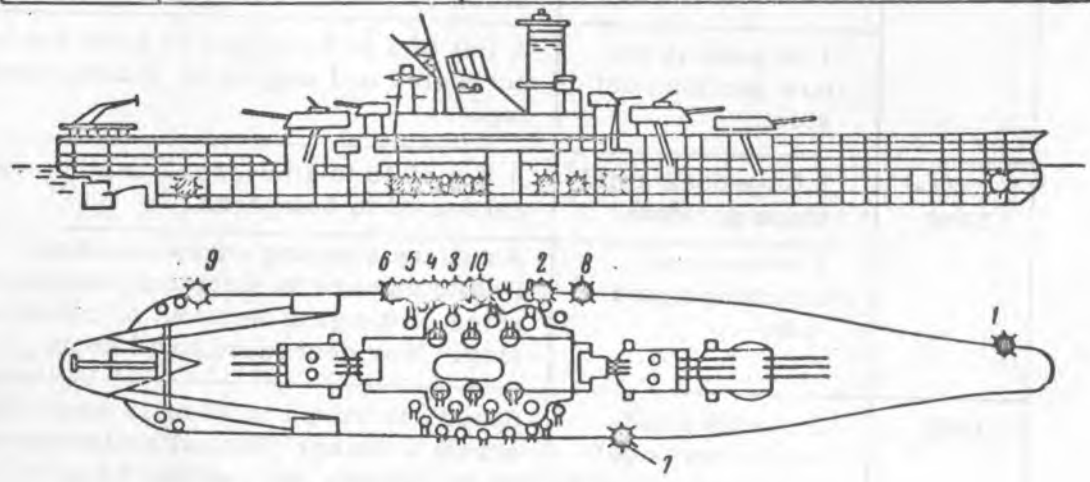
Time of Attack	Hits	Damage and Consequences
1402 (cont'd)	1 torpedo amidships, starboard side 2 torpedoes - - one amidships and one at the stern portside. 1 torpedo amidships portside	crew and loss of the central control station deprived the crew the possibility of continuing to fight to preserve watertight integrity. The commanding officer's order to flood the starboard compartments of the machinery and boilerroom spaces which had a very great effect (according to volume and center of gravity of the water pouring in) for correcting the list still could not be accomplished. List reached 20 degrees. Out of commission went: all guns, internal and external communications, and steering installation. Superstructure was riddled by machine-gun fire from aircraft. A further increase in list occurred. The signal was given to flee; the crew was ordered topside to abandon ship.
1418-1423		The list increased to 80 degrees to port. Internal explosions of ammunition from fires and shell hits detected. After taking on a list of 90 degrees, the ship quickly rolled over. Almost all of the crew was lost.

Figure 88 – YAMATO. Diagram of Torpedo Hits

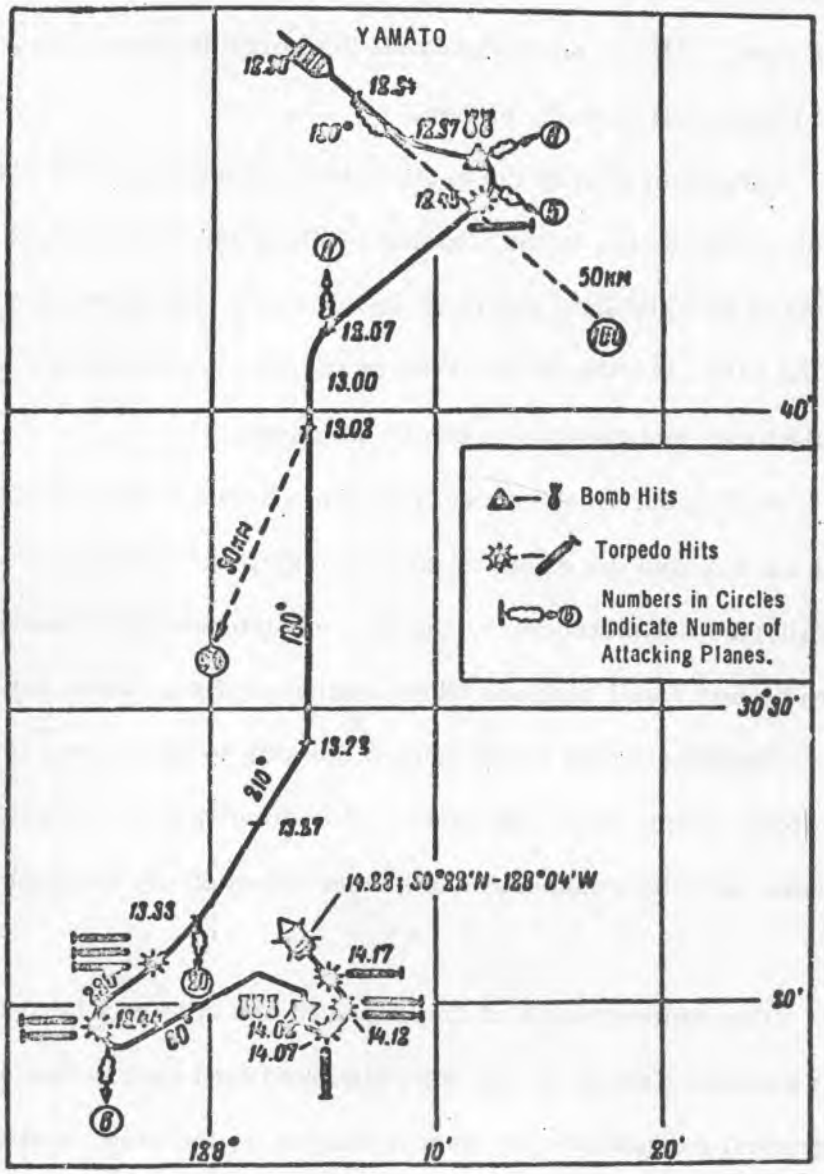
Figure 89 – YAMATO. Diagram of Movements 7 April 1945

Conclusions. YAMATO was sunk as a result of the action of 10 United States aerial torpedoes with 270 kilograms of explosive substance (350-400 kilograms of TNT) and about 13 aerial bombs weighing 250 kilograms each. All but one torpedo hit the portside of the ship, and five aerial bombs fell directly on her.

Thus, YAMATO was lost within the space of 2 hours along with almost all of her crew (2500 men). The steps in the attack on YAMATO are successively reviewed in Table 9. Diagram of the damage by torpedoes and a diagram of movements of the battleship are shown in Figures 88 and 89.

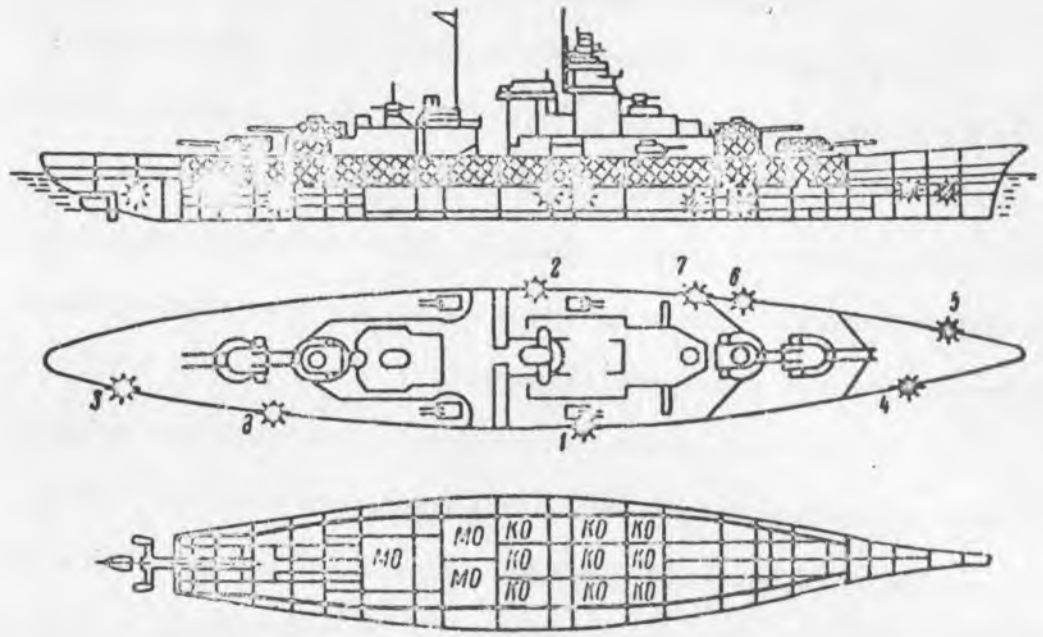
Figure 90 – BISMARCK. Diagram of Torpedo Hits

In all, more than 90 torpedoes were launched at the ship (35 were ship-type and more than 55 were aerial). A diagram of torpedo hits is shown in Figure 90.

Conclusions. BISMARCK was sunk as a result of the combined effects of eight contact torpedo explosions and a great number of shells.

Three of the torpedoes that hit were aviation-type (210 kilograms of explosive substance) and five were ship-type (340 kilograms of

explosive substance). The aerial torpedoes hit the midsection and the after section of the ship; the ship-type hit the bow and midsection. On the whole, the ship suffered the effects of about 3500 kilograms of explosive substance (in TNT equivalent) from torpedo hits alone.

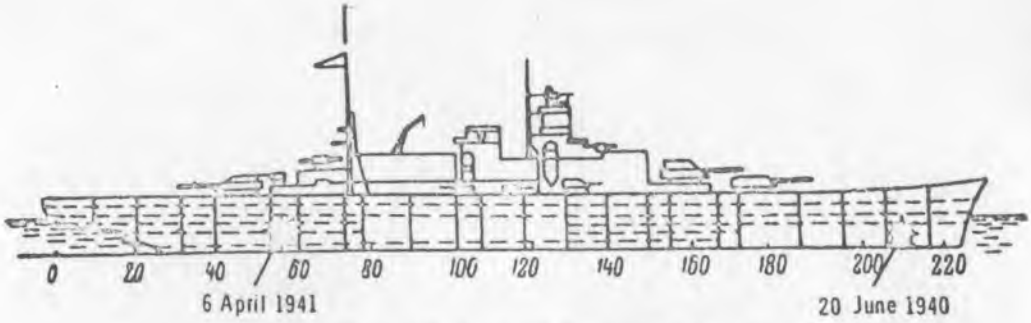
Figure 54 – GNEISENAU. Areas are Shown where Torpedoes Hit 20 June 1940 and 6 April 1941

While at anchor in Brest, GNEISENAU suffered hits from torpedoes launched by British torpedo planes from an altitude of 200 meters. A torpedo (weight of explosive substance TNT/RDX/AL 200-250 kilograms) exploded in the vicinity of the after main battery turret on the starboard side of the ship (Figure 54).

Damage to the Ship, Aftereffects, and the Fight to Save the Ship. On 20 June 1940, GNEISENAU suffered torpedo hits in the bow section in the vicinity of Frame 212. The center of the explosion was on the starboard side about 15 meters from the stern (Figure 54) and 4 to 5 meters from the end of the armor belt (which had a thickness of 75 mm at the bow). In height, the center of the explosion was located 3.0 meters below the designed waterline, i.e., approximately at the level of the lower ledge of the armor belt.

As a result of the explosion an open hole was formed in the region of the hit (Figures 55 and 56). The outer plating with its supports was destroyed over an area 15 meters long and 8 to 10 meters high. Furthermore, in the vicinity of Frame 207 (6 to 7 meters from the center of the

explosion), a crack appeared in the outer plating over almost the entire perimeter of the hull.

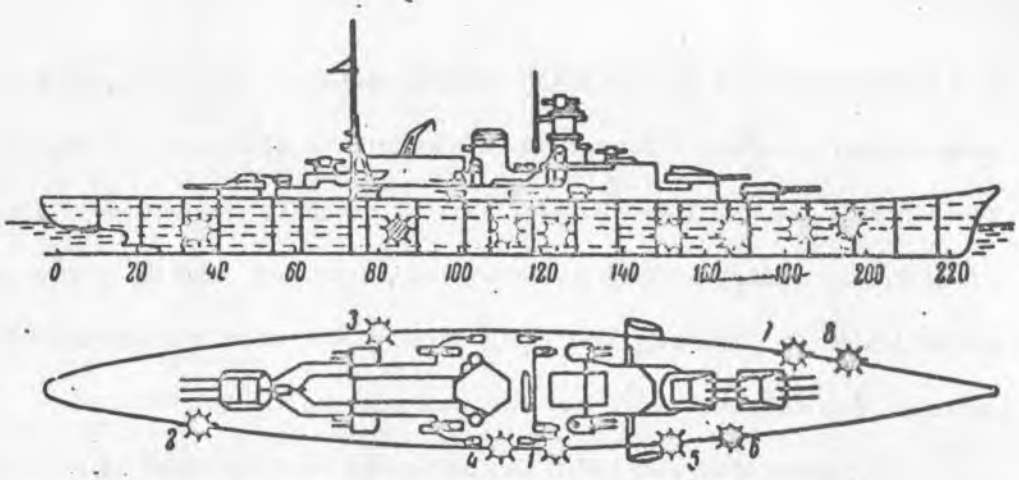
Figure 91 – SCHARNHORST. Diagram of Torpedo Hits[1]

At that time, the battle ship was attacked from the portside by destroyers which launched two torpedoes (according to other information, four) and hastened her sinking. A diagram of torpedo hits in SCHARNHORST is shown in Figure 91.

Along with destruction from torpedoes, SCHARNHORST suffered simultaneous damage from enemy guns which exceeded hers in caliber (DUKE OF YORK); the fact that all of the damage was suffered over a comparatively short period of time complicated the fight to save the ship. A considerable part of the crew was quickly put out of action, and the remaining part of the command was burdened with the difficult problem of trying to save the ship.

Most of the torpedoes hit the starboard side; this led to significantly damaging lists and complicated the job of preserving watertight integrity.

Conclusions. The fighting capacity of SCHARNHORST was significantly lowered when she suffered more than 15 shell hits (8- and 14-inch shells), but the decisive role in sinking her was played by the explosions of eight torpedoes launched from cruisers and destroyers. After the first three torpedo hits, the ship still continued to operate, but after the second three hits, she was soon put out of action. In assessing the difficult circumstances of the battle, this gives a basis for asserting that the six torpedo hits (each torpedo contained 350 kilograms TNT/RDX/AL-type explosive substance) sank the battleship.

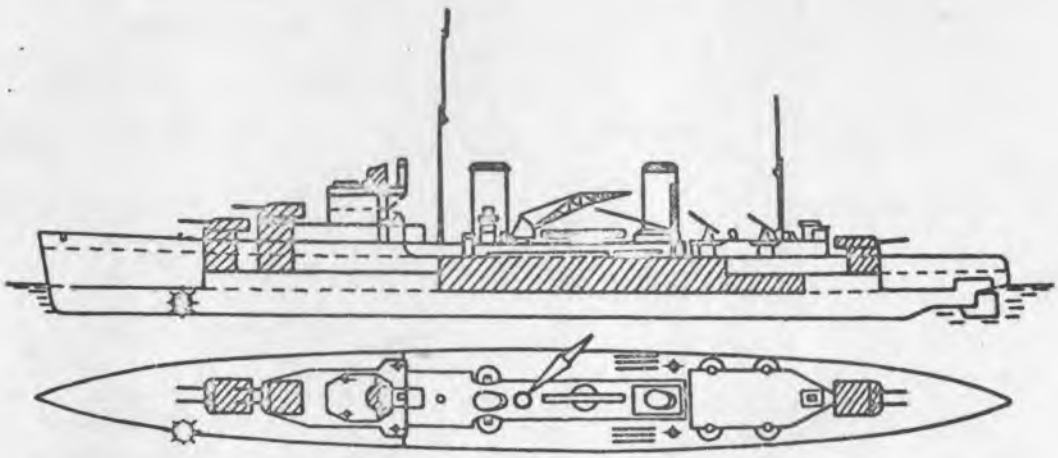
Figure 92 – ARETHUSA. Area Where Torpedo Exploded Shown

Damage to the Ship and Aftereffects. In 1942, ARETHUSA suffered a torpedo hit in the bow section portside (Figure 92). As a result of significant damage to the hull, several main compartments were flooded and the ship settled by the bow and took a list of about 15 degrees to port. A fire broke out in the vicinity of the forward athwartships fuel tanks and enveloped the greatest part of the bow superstructure. The fire was accompanied by separate internal explosions and flashes. The wooden parts, equipment, fuel oil, and so on, burned aboard the ship.

Three pumps were started to put out the fire and foam generators were used. Two pumps quickly went out of action due to the failure of the electrical equipment, but they were started again within 30 minutes.

The torpedo explosion occurred at 1800, and the fire was put out only toward morning, i.e., almost 12 hours later. The ship was out of action for several months and put in overhaul.

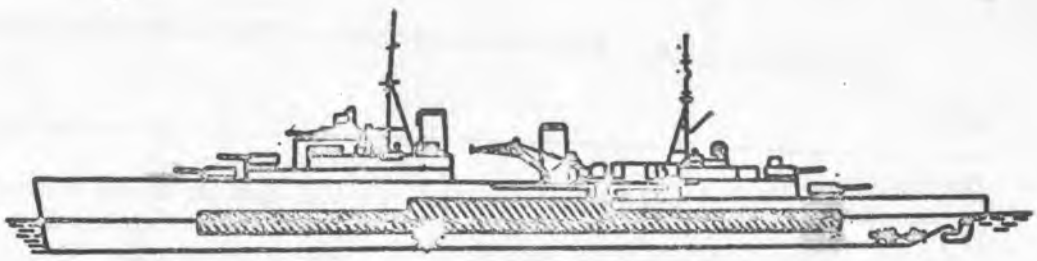
Figure 93 – FIJI. Area where Torpedo Exploded Shown

Conclusion. As a result of hull damage from the explosion of one aerial torpedo, FIJI developed a list along with settling at the bow; the ship decreased speed and was forced out of action.

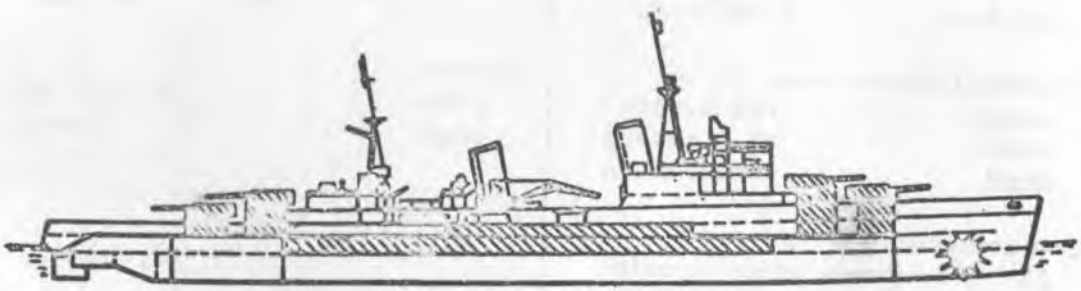
Figure 95 – LIVERPOOL. Area where Torpedo Exploded Shown

Damage to the Ship and Aftereffects. Returning from operations in the vicinity of Alexandria in October 1940, LIVERPOOL suffered a hit from a German submarine torpedo in her forward extremity, starboard side, in the vicinity of gasoline storage (Figure 95). The torpedo explosion caused considerable damage and an internal explosion; the forward part of the ship appeared to have been flooded and broken; fires broke out.

Conclusion. The ship suffered serious damage in the vicinity of the bow section, as a result of which she lost the bow section and was put out of action for several months.

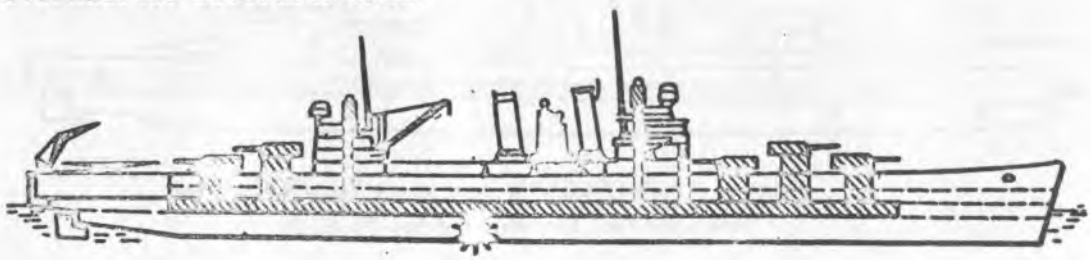
Figure 96 – HELENA. Area where Torpedo Exploded Shown

Damage to the Ship and Aftereffects: While moored to a dock in Pearl Harbor on 7 December 1941, HELENA suffered a hit from a Japanese aerial torpedo. The torpedo exploded in the portside in the vicinity of the forward engineroom (Figure 96) and caused considerable damage to the hull; almost all of the equipment in the No. 1 Main Engineroom, portside, went out of commission. The following were damaged by the explosion: No. 1 Shaft, reduction gear, forward main distribution switchboard, and other equipment. The main engine installation portside remained undamaged, but a part of the equipment ceased operating as a consequence of the flooding of compartments.

Cruiser HELENA went out of commission and was forced into drydock overhaul.

Conclusion. As a result of a hit from one aerial torpedo, HELENA suffered serious damage, went out of commission, and was in overhaul for several months.

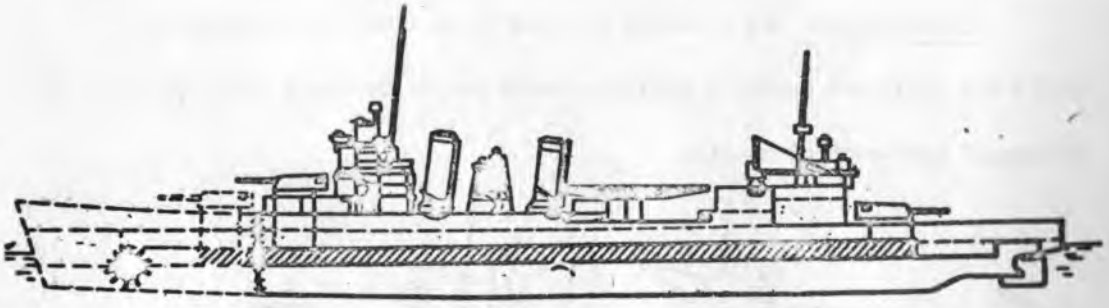
Figure 97 – NEW ORLEANS. Area where Torpedo Exploded Shown and the Line where the Bow Broke Off

Damage to the Ship and Aftereffects. During the action off Tassafaranga (vicinity of the Solomon Islands), NEW ORLEANS suffered a torpedo hit in the bow section (Figure 97). The explosion of the magazines of the forward main battery turrets and gasoline supply tore off the bow extremity

(up to Turret No. 2). Before the bow extremity sank, it drifted along the port side of the cruiser, damaging the side and the port screw. Thus, it has been asserted that NEW ORLEANS was the only ship in the world which rammed herself.

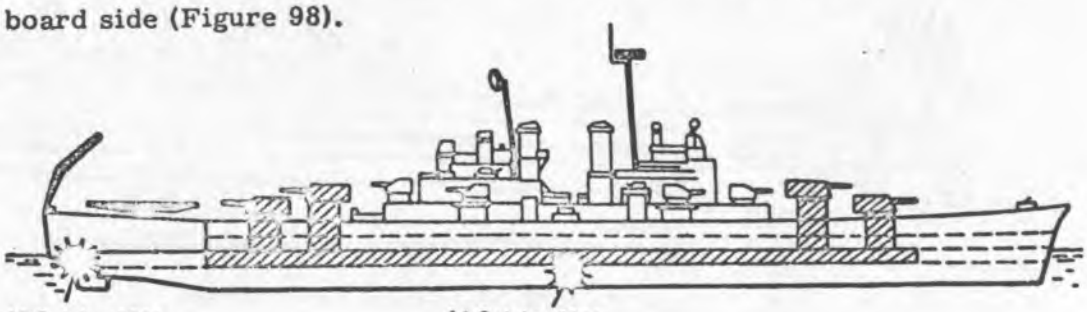
Figure 98 – HOUSTON. Diagram of Torpedo Hits

vicinity of the forward engineroom (Frame 74) at the bilge keel, starboard side (Figure 98).

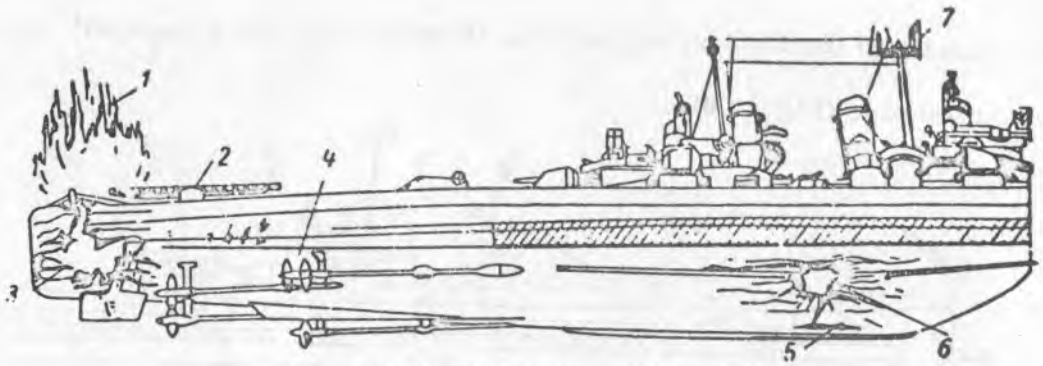
Figure 99 – HOUSTON. General View of Damage

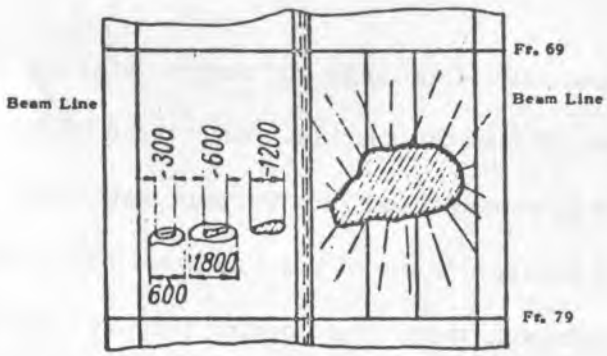
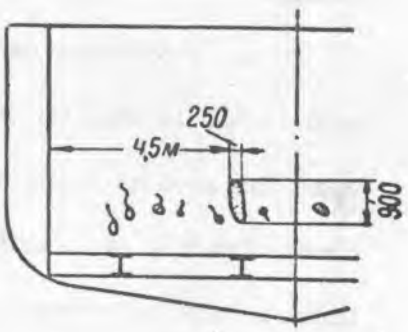
a. Hull (Figures 99 and 100): One large and several smaller holes were formed in the skin of the ship at the knuckle. Watertight bulkheads were damaged by splinters at Frames 69 and 79. Various watertight covers (doors, etc.) suffered damage; some of the doors were torn off. Immediately following the explosion, there was flooding (Figure 101) of the forward boilerroom (flooded in 5 to 6 minutes; boilers were exposed due to the action of the deck), the after boilerroom, the forward engineroom (flooded in 30 minutes through damage to the gland of the propeller shaft and from the after boilerroom), and machine workshop.

1. Fire from blazing gasoline; 2. Catapult starboard side destroyed after the first hit; 3. Damage in the vicinity of the second hit; 4. Shaft No. 1 swept into the hull to 1.8 meters together with the propeller; 5. Tears, cracks and cave-ins in the bottom; 6. Damage in the vicinity of the first hit; 7. Damage to the radar installation

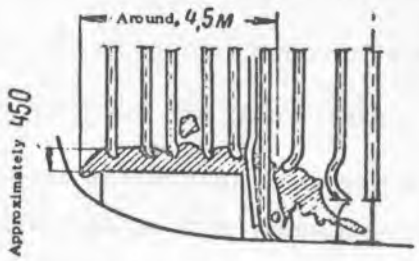
Figure 100 – HOUSTON. Damage

a. Plating

c. Bulkheads at Frame 79

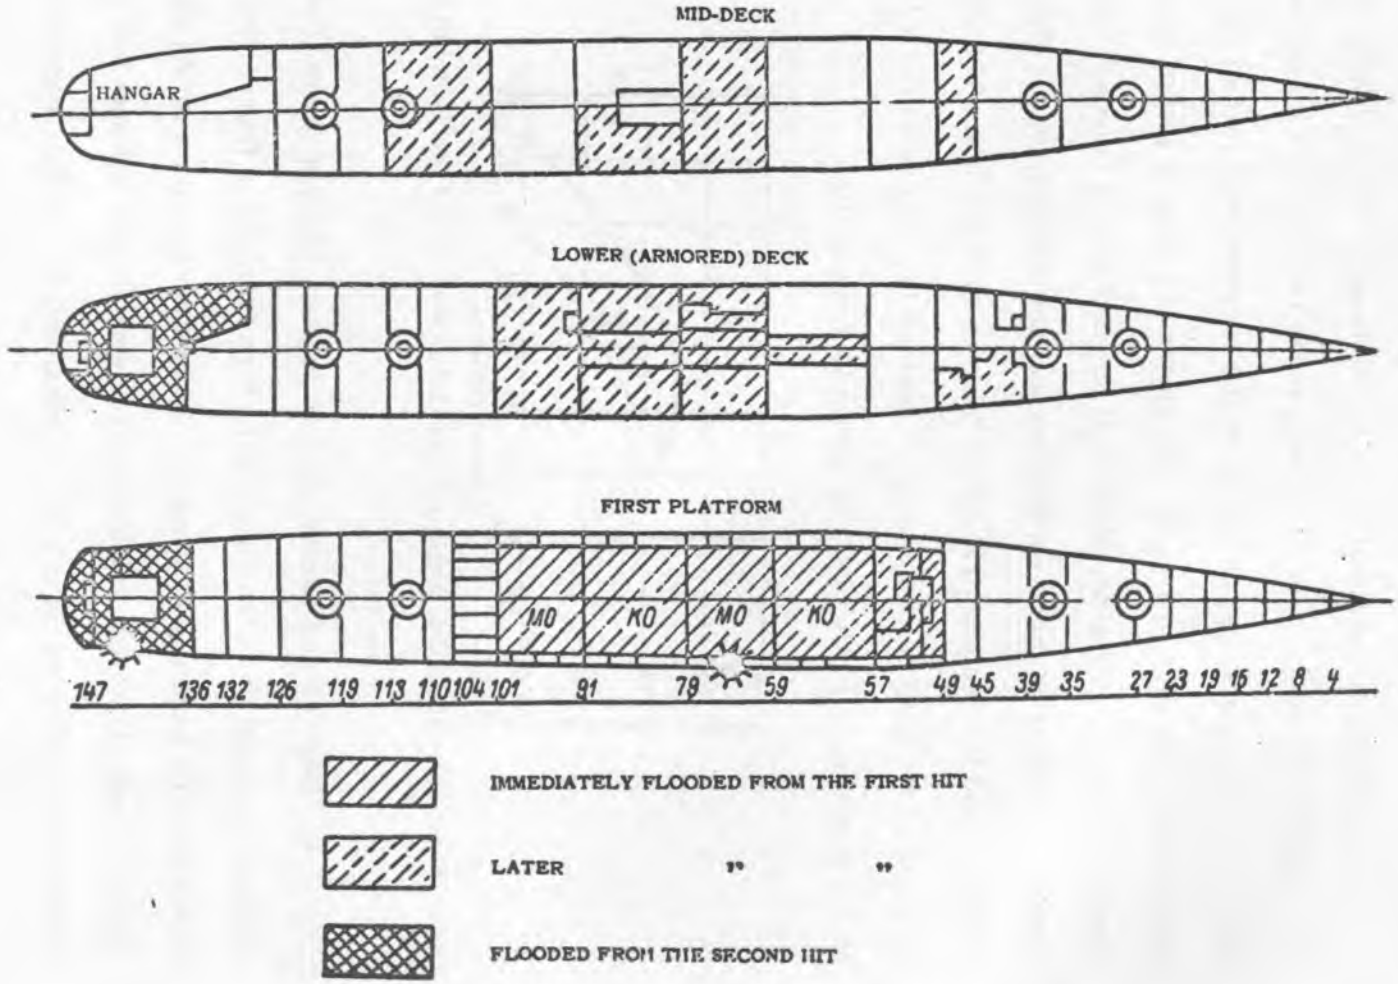
Figure 101 – HOUSTON. Diagram of Flooded Compartment

Further flooding of compartments occurred through open hatches, electric cable stuffing glands, air ventilation ducts and from below, through damaged decks or platforms. In all, 36 compartments were flooded for a distance of one-third of the length of the ship. In 30 minutes, the cruiser took on 6400 tons of water (which was one-half of

her displacement), and as a result, developed a list of 16 degrees to starboard.

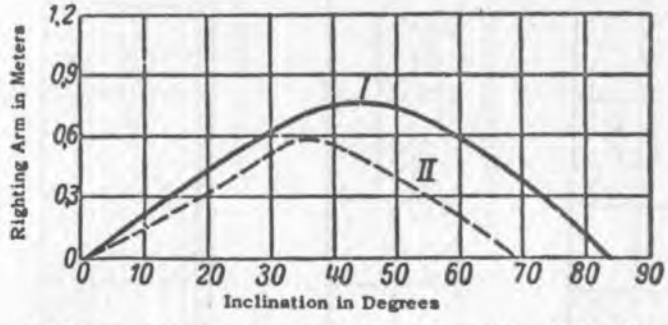
Figure 102 – HOUSTON. Stability Diagram before (Curve I) and after (Curve II) Damage

According to calculations of the Bureau of Ships, 5 minutes after the explosion of the torpedo, the transverse metacentric height was negative at -57 centimeters; at that time the forward boilerroom and forward engineroom, and also crew quarters on the lower deck in the vicinity of Frames 79 to 91, portside, were still not completely flooded. After the complete flooding of these compartments, the stability of the ship became positive, and the metacentric height was +6 centimeters. The stability diagram of the ship before and after damage (according to her condition on the morning of 15 October) is shown in Figure 102.

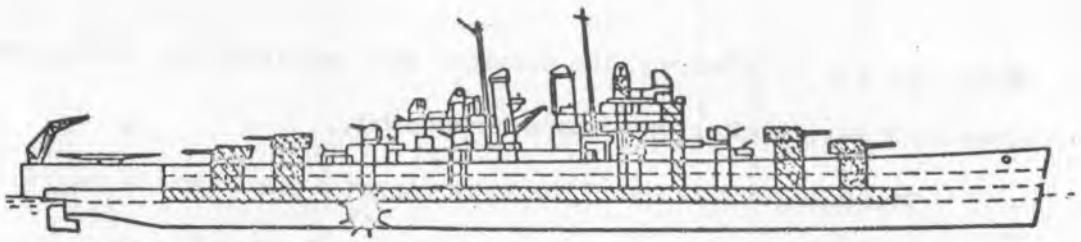
On the evening of 13 November 1943, DENVER suffered an aerial torpedo hit. The torpedo exploded on the lower edge of the main armored belt, starboard side, at a distance of 1.0 meter from the after bulkhead of the after engineroom (Figure 103), which was immediately flooded. The

Figure 103 – DENVER. Area of Torpedo Explosion Shown

after boilerroom slowly flooded with water through ducts, wooden bearings, and electric cable stuffing glands.

Damage was caused principally to the hull and partially to engines which went out of commission due to the sudden action of an explosion (shock) and flooding of compartments. Inasmuch as the explosion occurred beneath the lower aft side armor, the joints of the side armor were ruptured in places as was the lower armor deck; this led to the collapse of two armored plates and the flooding of compartments. The armored plating was not destroyed in all places.*

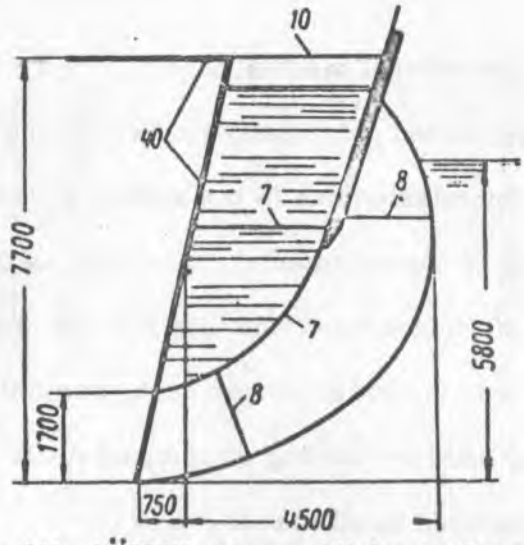
Figure 104 – LÜTZOW. Diagram of Underwater Protection

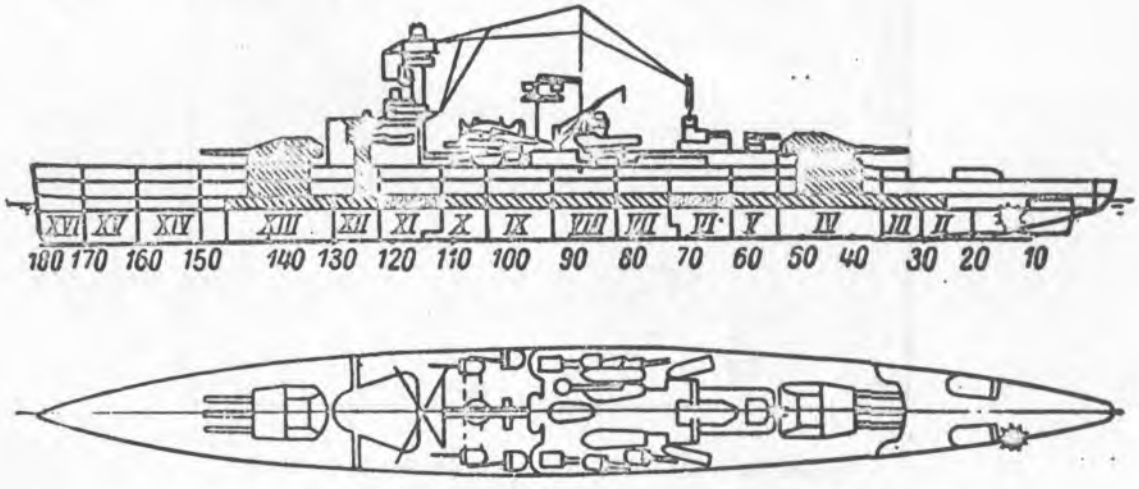
The torpedo hit the ship from the portside in the vicinity of Frames 14 - 15 at the beginning of the stern rangefinder (Figure 105). The explosion occurred when the torpedo struck the port shaft strut; the stern section of the ship was broken and sagged downward. The break began at the vertical keel, at Frame 25, portside, proceeded on an angle to the armored belt to Frames 27-28, then continued to the junction of this belt with the side plating and the widened armor belt at Frame 31. Further, the break went along the shear strake, where, from the sagging of the hull, an open crack 400 to 500 mm wide was formed and went along the upper deck on both sides. The portside, for a distance of several meters, had deep indentations without open holes. Sheets of outside plating above the side armor were strongly dented into the ship on both sides and had a great number of breaks.

Figure 105 – LÜTZOW. Vicinity of Torpedo Explosion Shown

Both of the deck stringers and carlings of the upper deck had breaks in the vicinity of Frames 33 and 34. The junction of the intermediate and armored decks at Frame 31 was broken. Significant puff-outs (up to 500 mm) and individual breaks along the weld occurred along the armored and intermediate decks and the lower platform.

The rudder pintle was broken, the rudder head bent, the strut for the shaft torn away, a propeller ripped off (sank), and a shaft warped downward.

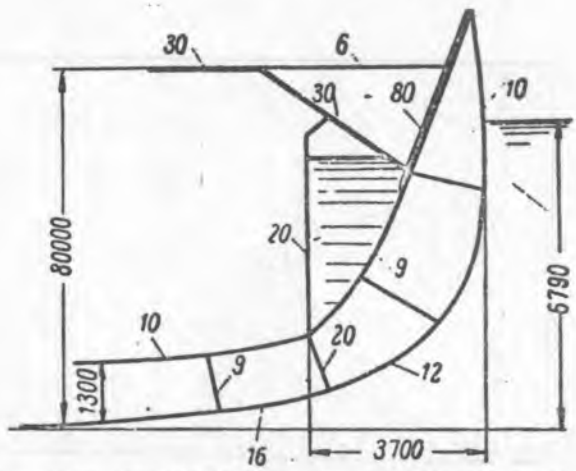
Figure 108 – PRINZ EUGEN. Diagram of Underwater Protection

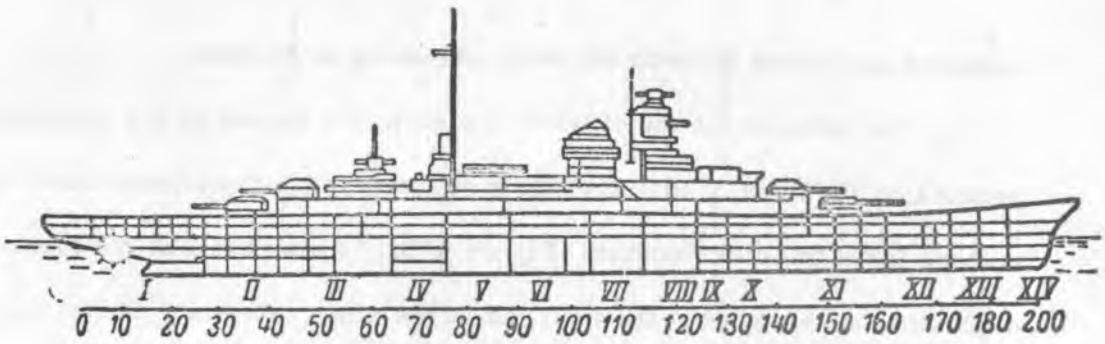
The torpedo hit the stern of the ship; the center of the explosion penetrated the area of the steering mechanism at a distance of about 11 meters from the stern section (Figure 109). As a result of the torpedo explosion, a serious break occurred in the after extremity of the ship (Figures 110 and 111); moreover, individual breaks formed in the hull: horizontally in the stern section at Frames 36 and 37 (in the vicinity of the main battery turret) and vertically in the bow section of the hull at Frame 168 (in the vicinity of Section XII at a distance of 25 meters from the forefoot), in the middle athwartships for a distance of three bottoms (secondary damage).

Figure 109 – PRINZ EUGEN. Vicinity of Torpedo Hit Shown

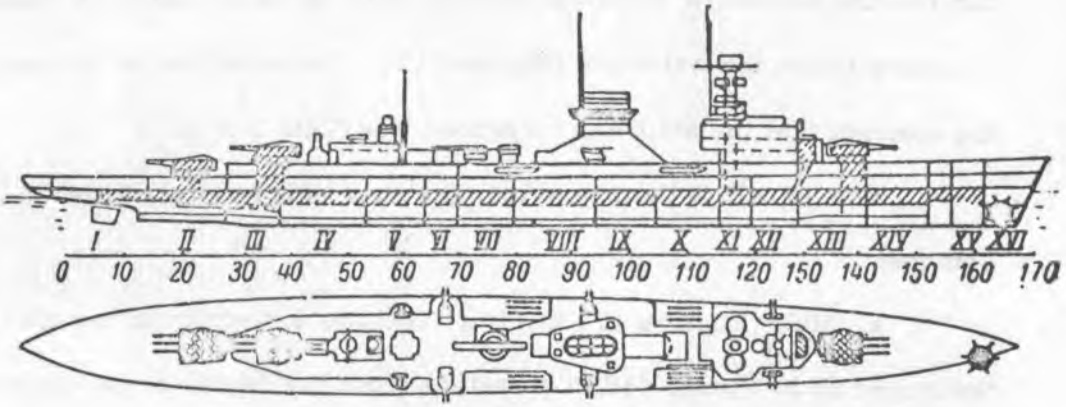
Figure 112 – NURNBERG. Vicinity of Torpedo Hit Shown

the forward section of the ship (Section XVI) in the vicinity of Frame 163, 3 meters below the waterline (Figure 112). The condition of the sea at the moment that the ship was torpedoed was State 3 or 4.

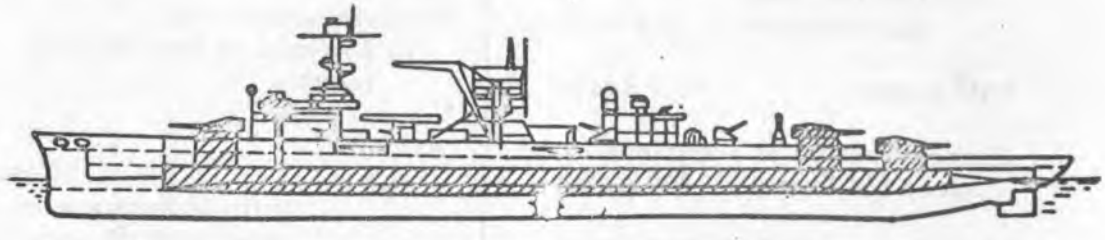
The center of the explosion occurred in the vicinity of Frame 89, portside, 4.0 meters below the waterline in an athwartships bulkhead which divided Boilerroom No. 1 and Boilerroom No. 2. The following damage from the explosion was suffered by the cruiser:

Figure 117 – LEIPZIG. Vicinity of Torpedo Hit Shown

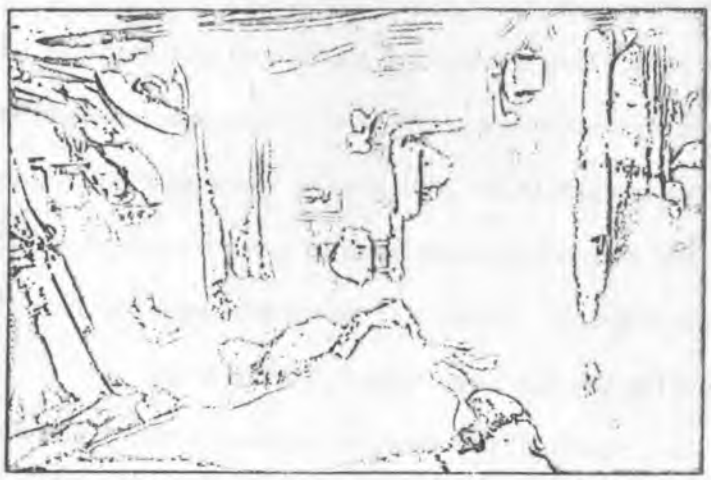
Figure 119 – LEIPZIG. Damage to Intermediate Deck

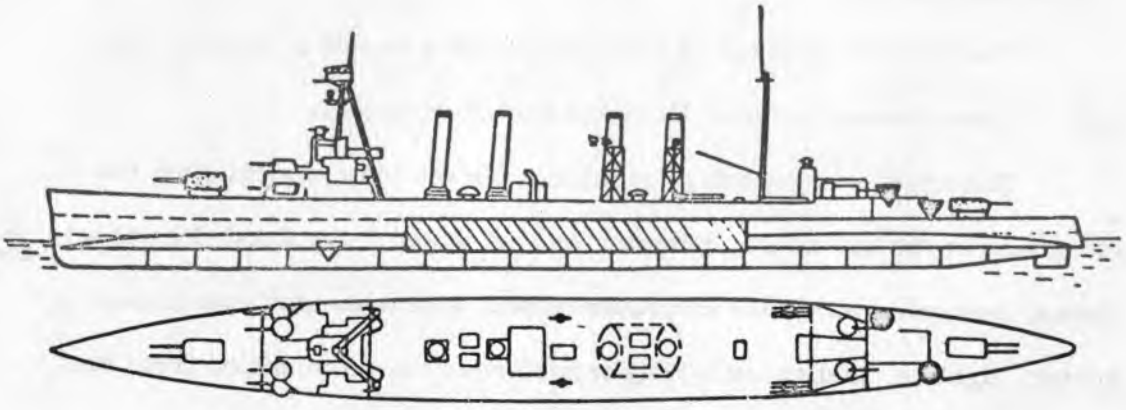
Damage to the Ship and Aftereffects. On 4 February 1942, MARBLEHEAD was attacked by 18 Japanese aircraft in the vicinity of the western part of the Island of Java. She was damaged by three bombs; two fell directly in her stern section and one fell into the water and exploded close aboard at her bow section (Figure 121). One of the bombs which fell on the ship penetrated the thin armored deck and exploded; the other went through a ventilator opening and damaged the rudder gear. The ship lost control and circled until the engines again resumed control. The sick bay and several other service compartments were damaged by the explosion; fires broke out and the lighting and communications went out.

Figure 121 – MARBLEHEAD. Diagram of Damage by Aerial Bombs

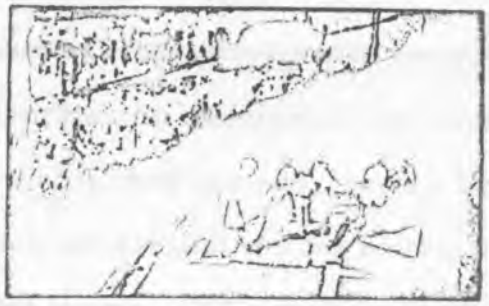
The noncontact explosion of the bomb occurred at the level of the knuckle 30 to 35 meters from the forefoot portside. The plating was considerably caved inward on the hull, and a hole with a diameter of about 3.0 meters (Figure 122) was made in the center of the zone of explosion.

Figure 122 – MARBLEHEAD.
Damage to the Side from A Near-Miss Explosion of An Aerial Bomb

compartments in the forward section of the hull; as a result, the ship suffered a significant list and settling by the bow up to 3.5 meters. The damage from direct bomb hits caused flooding of several after compartments; this partially corrected the settling and decreased the list to an insignificant amount.

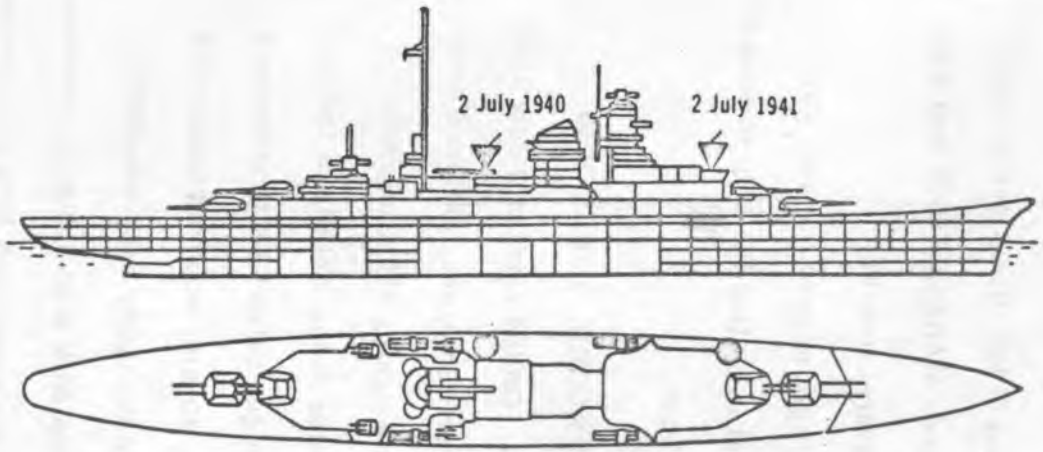
Damage to the Ship and Aftereffects. On the night of 2 July 1940, PRINZ EUGEN, located at the Germania Verft Shipyard, suffered a hit from a British high-explosive aerial bomb weighing 250 kilograms (Figure 123). The bomb hit the deck portside in the vicinity of the forward engineroom. Destroying shields of a gun battery on first contact, the bomb penetrated the weather deck, the 30-mm armored upper deck, and exploded below the latter. The hole in the upper deck was 200 by 300 mm in size; the deformed section of the deck 8 by 3.5 by 0.2 meters. The basic zone of damage was located on the upper deck (Figures 124 and 125) where a part of the hull structure, piping, and galley equipment suffered. The stack was partially caved inward, the catapult damaged, a motorboat torn up and tossed overboard. The battery deck was slightly damaged by blast pressure and splinters from the explosion.

Figure 123 – PRINZ EUGEN. Diagram of Damage from Aerial Bombs 2 July 1940 and 2 July 1941

Damage to the Ship and Aftereffects. A raid was carried out by British aircraft on PRINZ EUGEN located at Brest. A semi-armor-piercing aerial bomb weighing almost 250 kilograms hit the ship. Penetrating the upper open deck at the forward superstructure (see Figure 123) at a distance of 200 mm from the portside and touching the side, the bomb was deflected from its path, penetrated the armored deck

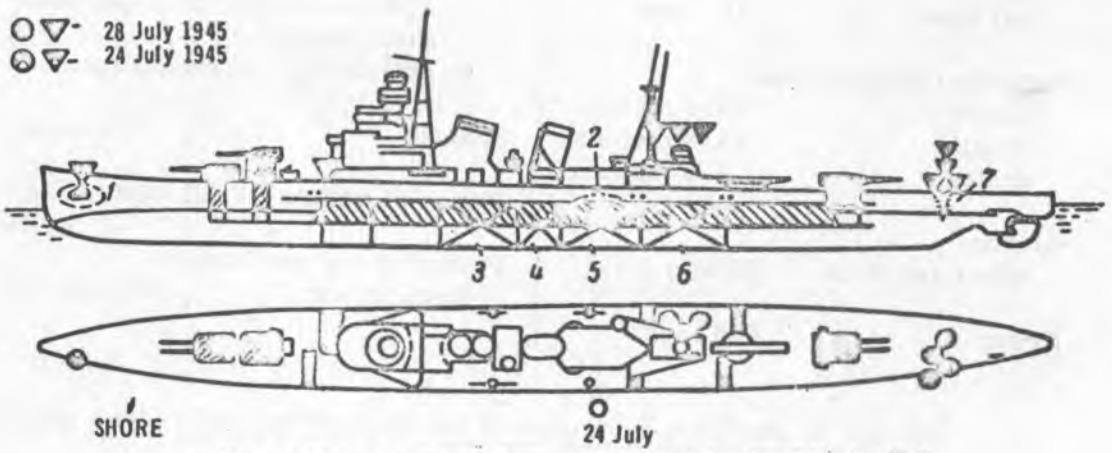
Throughout 28 July, AOBA underwent several attacks. In the first half of the day, the cruiser was attacked by carrier aircraft which succeeded in making four direct hits; many fires broke out aboard the ship. In the second half of the day, B-24 aircraft also made four direct hits on the stern (Figure 129). The explosions tore off the stern section of the cruiser, and the burning ship was abandoned by her crew (Figure 130).

Figure 129 – AOBA. Diagram of Damage by Aerial Bombs, 24 July 1945

1 and 2. Hole in outer plating; 3. No. 4 Boilerroom flooded; 4. No. 5 Boilerroom and No. 6 Boilerroom flooded; 5. Forward machinery spaces completely flooded; 6. All machinery portside and on the starboard side flooded; 7. Crack in the side.

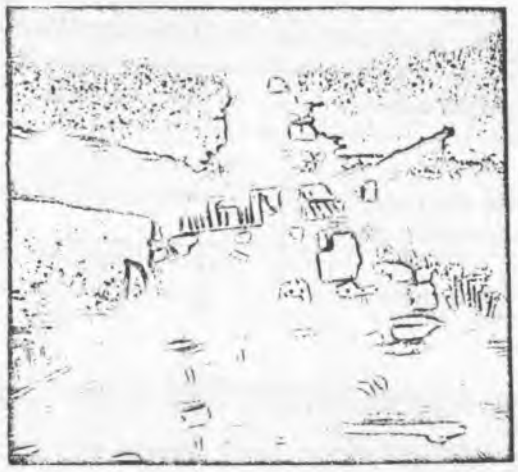
Figure 130 – View of the Damaged Cruiser AOBA

Conclusions. As a result of the action of one direct hit and one near-miss explosion of an aerial bomb close aboard (bomb weighing up to 500 kilograms), the Japanese AOBA suffered considerable damage, lost buoyancy, and settled to the bottom.
