BATTLE DAMAGE TO SURFACE SHIPS DURING WORLD WAR II

I. M. Korotkin

Leningrad, Sudpromgiz, 1960

Translated by U. S. Joint Publications Research Service
for the David Taylor Model Basin

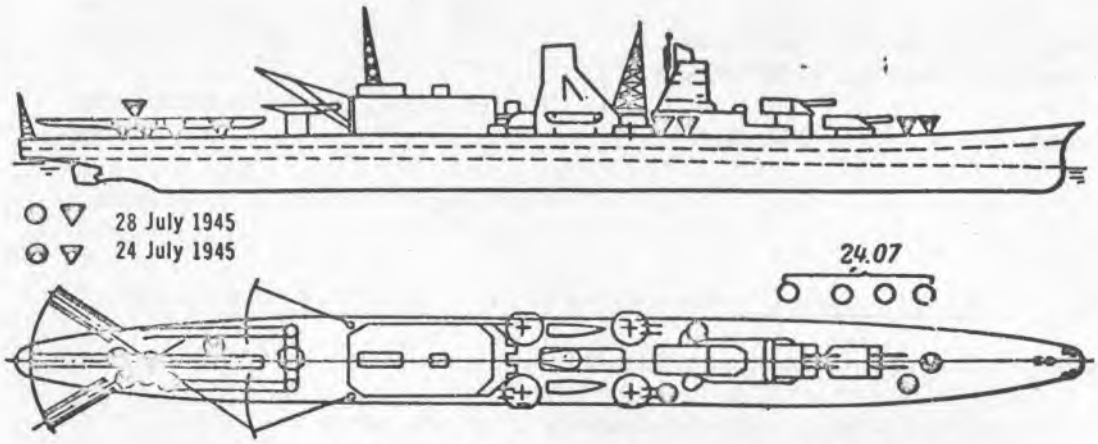
On 28 July, OYODO was attacked by 40 carrier aircraft and suffered four more direct bomb hits; several bombs fell and exploded alongside the ship (Figure 131). As a result of the damage to the hull, the ship listed to starboard, began to sink, and soon rolled over and settled to the bottom.

Figure 131 – OYODO. Diagram of Damage by Aerial Bombs

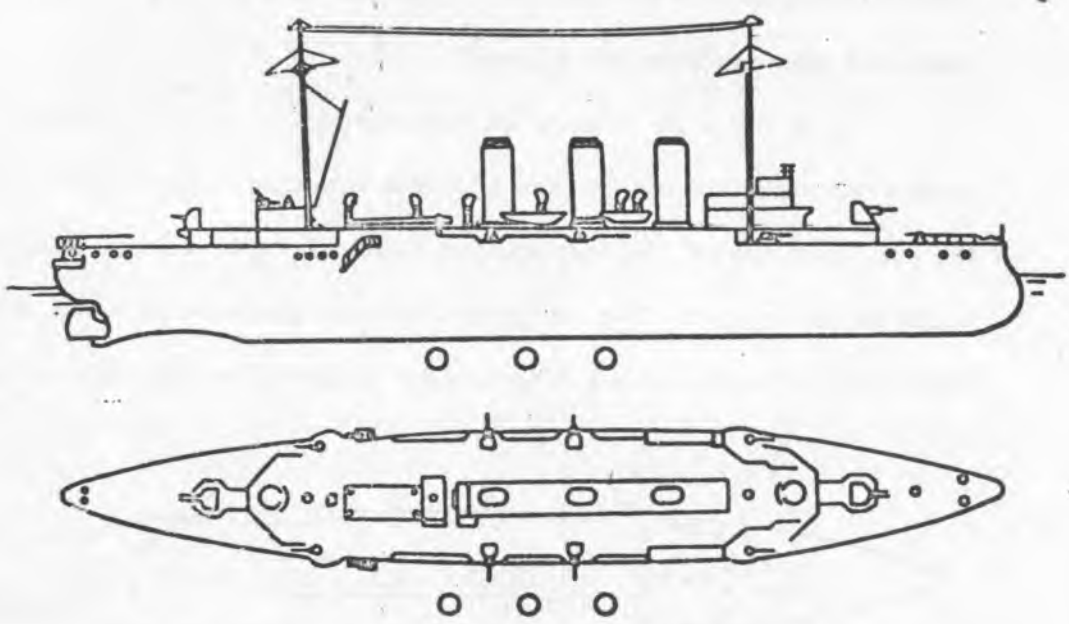
On 24 July 1945 while at anchor at Kure, the cruiser was attacked by four United States aircraft. There were no direct bomb hits, but three of the bombs fell approximately 20 to 30 meters from the starboard side in the vicinity of the midsection of the ship and exploded at a great depth (Figure 132). There were no splashes from the exploding bomb; however, the ship suffered serious shock from the underwater explosions.

No holes were made in the plating, but watertightness was destroyed in a number of places, chiefly due to damage to riveted joints.

The leaking was so considerable that the ship at once took on a great quantity of water, settled by the head and then by the stern. Twenty-four hours after the damage, she rolled over and sank.

Figure 132 – IWATE. Diagram of Damage by Aerial Bombs 24 July 1945

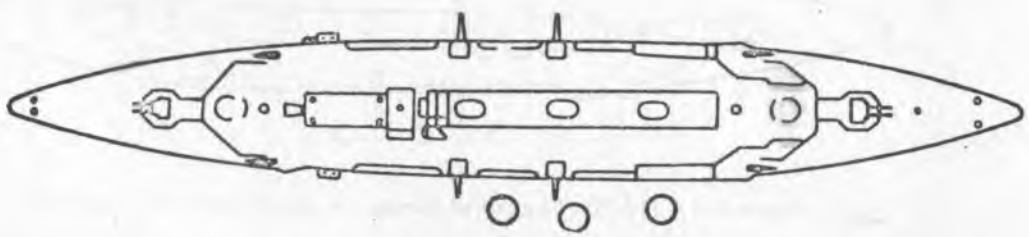
On 28 July, the cruiser was attacked by 20 carrier aircraft; three bombs fell close aboard (Figure 133) and damaged the underwater part of the hull; as a result, the ship took on a considerable amount of water and began to list to port. The list gradually increased and attained 15 degrees; then 1 hour after the attack, the cruiser suddenly rolled over and sank.

Figure 133 – IZUMO. Diagram of Damage by Aerial Bombs 28 July 1945

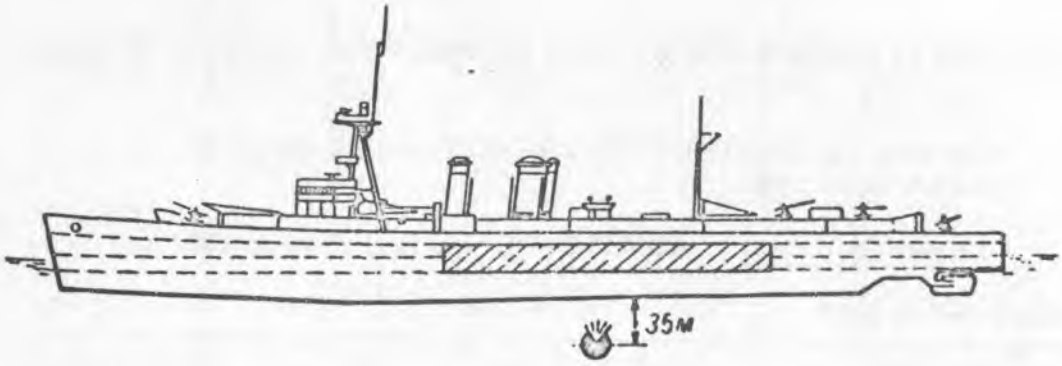
Damage to the Ship and Aftereffects. ADVENTURE was returning to Liverpool after completing a mission. At 0840 a mine explosion occurred under her bottom in the midsection of the ship (Figure 134). Supposedly, it was the explosion of an anchored acoustic mine with a charge weighing about 500 kilograms. The measured depth of the sea was 44 meters.

The ship was tossed upward by the explosion; several deformations and cracks were suffered in the basic hull; the riveted joints were weakened in several places, and watertightness was destroyed. A

Figure 134 – ADVENTURE. Vicinity of Mine Explosion Shown

dripping of fuel oil was noted in the after-gun magazine; sea water entered several compartments, and draft at the stern increased by 0.25 meter. As a result of shock vibrations, cracks formed in the frames (especially cast iron) of a number of engines; the boiler brickwork was seriously damaged; the alignment of a number of installations of ship technical equipment was thrown off; a part of the electrical equipment and armament (gunfire-directing devices) was damaged; and the supply of electrical energy was cut off in a number of battle stations.

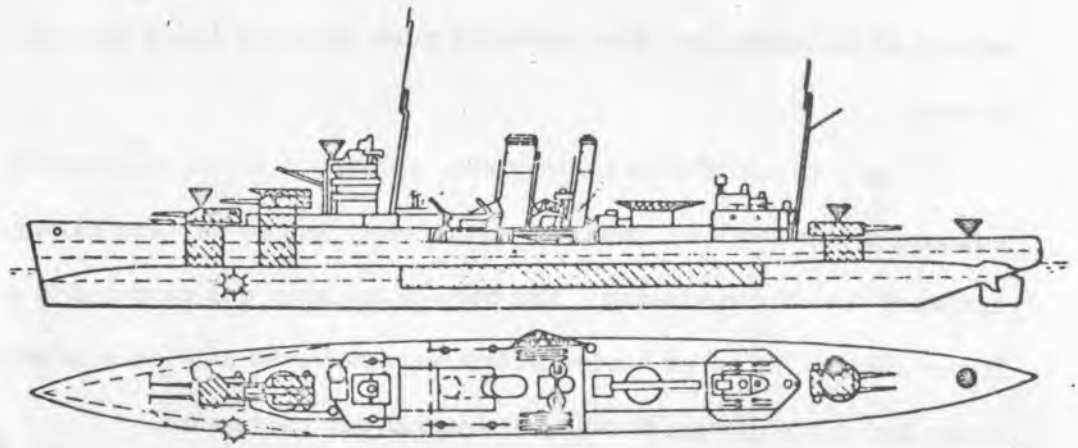
Damage to the Ship and Aftereffects. While operating off the Island of Crete, YORK suffered one torpedo hit and no less than four aerial bomb hits (Figure 135). The torpedo ripped through the ship in

Figure 135 – YORK. Diagram of Damage by Bombs and Torpedo

the bow section (about one-fourth of the length of the ship was damaged). Aerial bombs hit in the vicinity of the forward and after main battery turrets, the forward superstructure, and the stern extremity. As a result of the damage suffered, the ship went down in shallow water. During the evacuation of Crete, the ship was abandoned in a half-sunken condition. According to German data, torpedo hits and one aerial bomb which hit in the vicinity of a main battery turret appeared to have sunk the ship.

Conclusion. YORK was damaged to such a degree that she settled to the bottom and went out of action completely from the effects of one torpedo explosion and four direct aerial bomb hits.

The principal reason for loss of the ship was damage from the action of the underwater explosion of the torpedo and the explosion of an aerial bomb in the vicinity of the forward main battery turret.

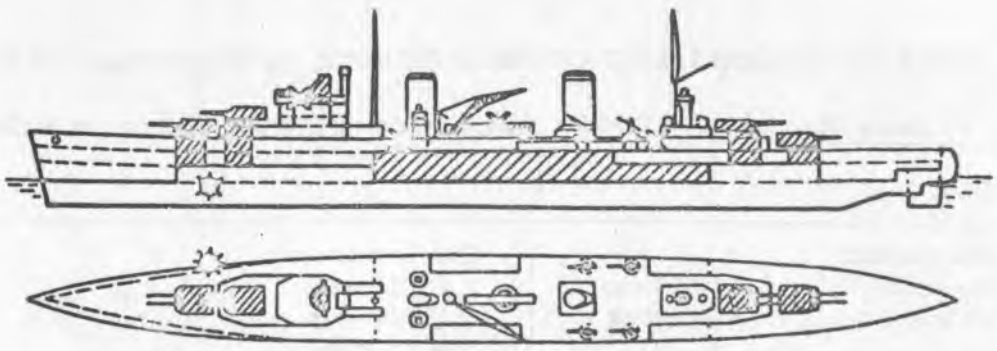
In addition, a torpedo from the raider hit the bow of the cruiser and put the forward turrets out of action (Figure 136). The fire grew in intensity, and the cruiser was enveloped in smoke. Water entered the forward sections, and the draft at the bow increased about 2 meters. In a short time, the ship sank.

Figure 136 – SYDNEY. The Disposition of the Center of the Torpedo Explosion and the Areas of the Primary Shell Hits are Shown

The principal reason for the loss of the ship was the damage from the torpedo explosion in the bow extremity where the gun ammunition magazines were located. The fire which broke out contributed to the loss of the ship.

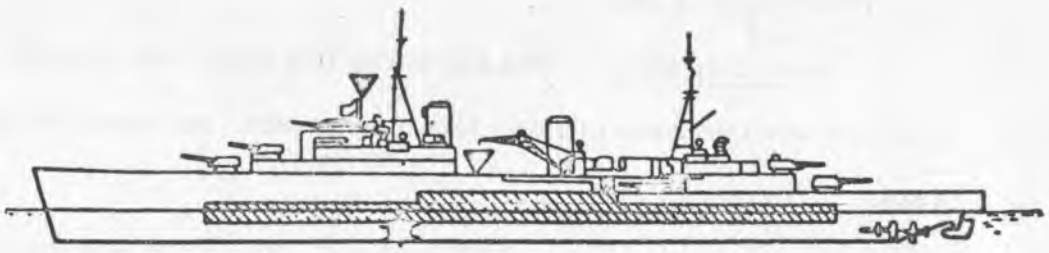
Enroute to the base after temporary repairs had been made, the cruiser suffered two direct aerial bomb hits (Figure 137). The explosions caused a fire to break out aboard, and a part of the crew was put out of action.

Figure 137 – TRINIDAD. Diagram of Damage by Torpedo and Aerial Bombs

splinters and parts of equipment mixed with fuel oil due to the damage suffered in the earlier torpedo hit. When fire broke out aboard after the second attack, all of this refuse burned in various inaccessible spots within the hull, thus feeding the fire.

Conclusion. TRINIDAD went out of commission and was forced to make temporary repairs from one contact explosion of a torpedo in the midsection of the ship. When two additional aerial bombs hit the ship, the fire that broke out gained in intensity due to the flooding of the cruiser from the damage caused and made the fight to save her less effective. The cruiser was abandoned by her crew and was sunk by ships in company.

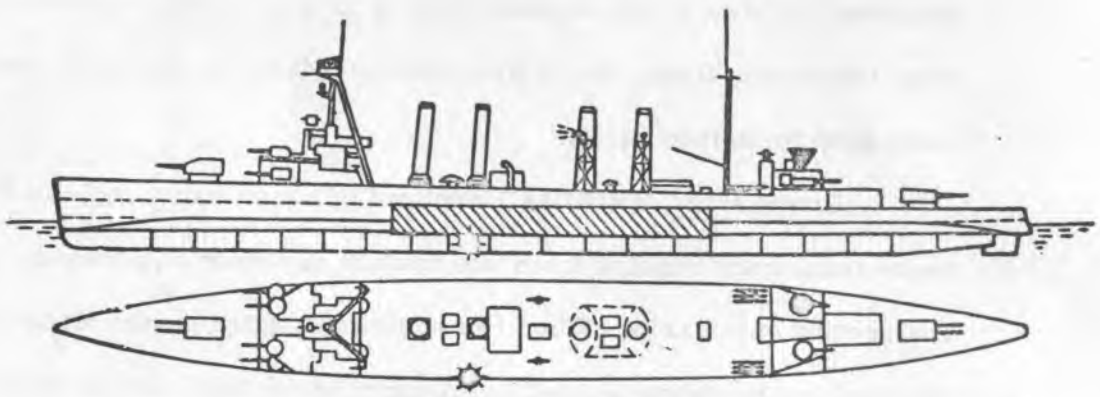
Damage to the Ship and Aftereffects. RALEIGH was attacked by Japanese torpedo planes at Pearl Harbor on 7 December 1941. An aerial torpedo hit the portside of the ship in the vicinity of Boilerroom No. 2 (Figure 138) and, as a result of the damage suffered, the No. 1 and No. 2 Boilerrooms and the forward engineroom were flooded. An hour after the torpedo exploded, another attack was made. An armor-piercing bomb fell on the after superstructure, penetrated clear through the body of the ship, and exploded at a significant distance from her. Several after compartments were immediately flooded.

Figure 138 – RALEIGH. Diagram of Damage by Torpedo and Aerial Bomb

The flooding of compartments continued and tnreatened the condition of the ship for several days. Only the total effort of the energetically fighting crew kept the ship afloat and permitted her transfer to a drydock for overhaul. The hole made in the plating portside was 7.3 meters long and 6.0 meters high. In the vicinity of the torpedo hit, RALEIGH had a double hull of armor, 50 and 25 mm thick. The armor plates on the hull were caved inward from the effect of the explosion; deep indentations formed in the side and consequently rivets were popped and several plates were torn away.

Conclusion. Three main compartments were flooded from the explosion of one aerial torpedo in the midsection of the ship. The ship took on a great amount of water, but remained afloat. With the additional hit of one armor-piercing aerial bomb in the stern section, the cruiser appeared to be in a serious condition, but did not sink, thanks to the energetic action of the crew.

After a partial repair had been made at Pearl Harbor, the ship was taken to another base for a complete overhaul.

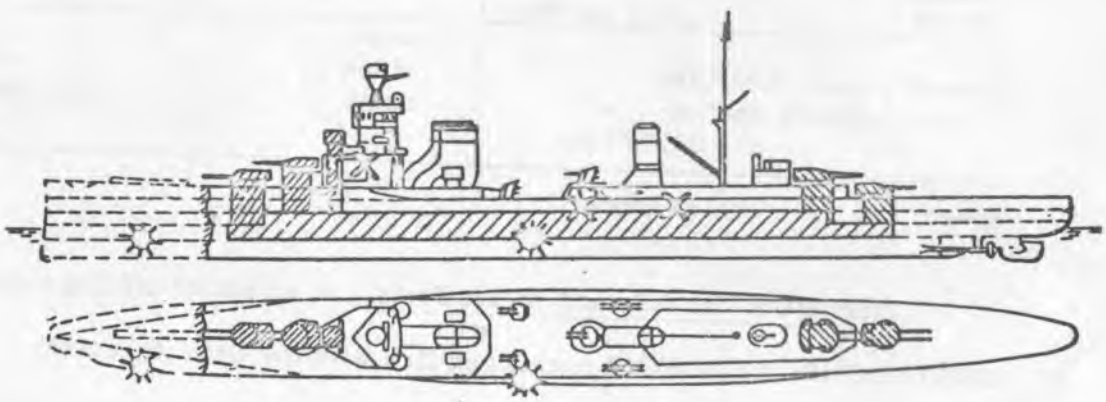
Destroyer torpedoes finally sank the cruiser. One of the torpedoes hit the bow section of the ship and tore off the bow extremity for a distance of 30 meters (Figure 139). Individual internal explosions occurred aboard the ship; one of them blew her forward superstructure apart.

Conclusions. From the combined action of two torpedoes and several shells of medium caliber, the ship rolled over and sank.

Figure 139 – BARTOLOMEO COLLEONI. Areas of Primary Torpedo and Shell Hits, and Break-Off Line of Bow are Shown

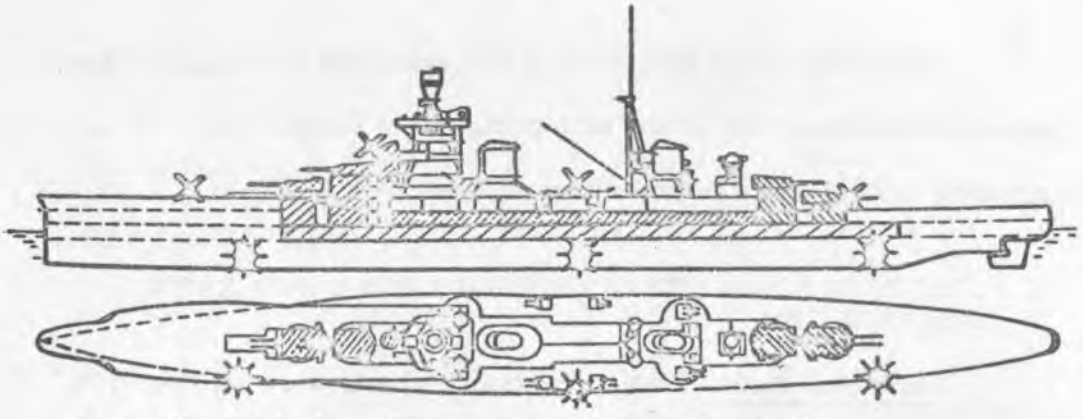
Damage to the Ships and Aftereffects. In a battle off Cape Matapan, POLA suffered a torpedo hit in her side. The main engines and the fire control system were damaged by the explosion. The damaged cruiser, which was discovered by British battleships, was forced to stop under the fire of their after turrets. The crew was taken off and the cruiser was finished by torpedoes from two destroyers (Figure 140).

Figure 140 – POLA. Areas of Primary Torpedo and Shell Hits Are Shown

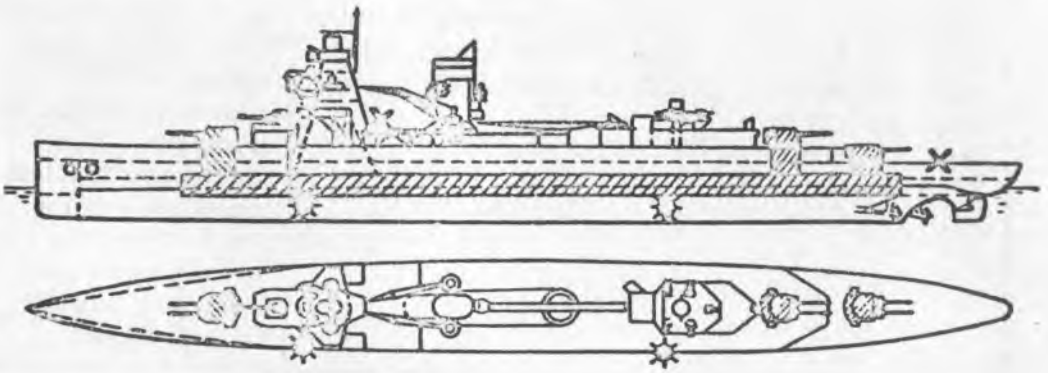
Damage to the Ship and Aftereffects. In a daylight battle during the action in the Java Sea, DE RUYTER suffered a hit from a 203-mm Japanese shell (from a distance of about 10 miles) which went through two decks and exploded within the ship. A fire broke out but was quickly extinguished. Seven hours later, in a night battle with two Japanese cruisers, the ship suffered (from a distance of about 4 miles) hits in the stern and went out of commission. Then the Japanese cruisers attacked DE RUYTER with torpedoes, two of which hit her portside (Figure 141). Fires that started on the ship were impossible to put out. The ship lost way and control, and began to settle.

Figure 141 – DE RUYTER. Areas of Primary Torpedo and Shell Hits Are Shown

Conclusion. DE RUYTER sank as a result of the combined effects of torpedoes and shells; the torpedo explosions not only led to the flooding of compartments in the ship but also to the outbreak of fires which hastened her loss.

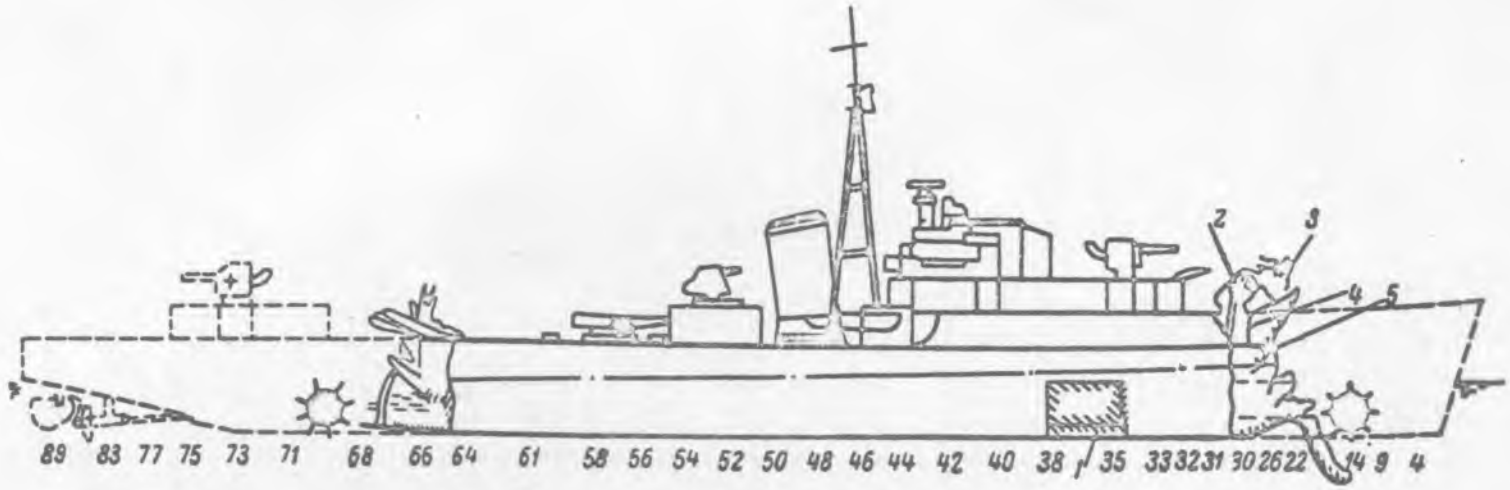
Figure 142 – JAVELIN. Diagram of Damage

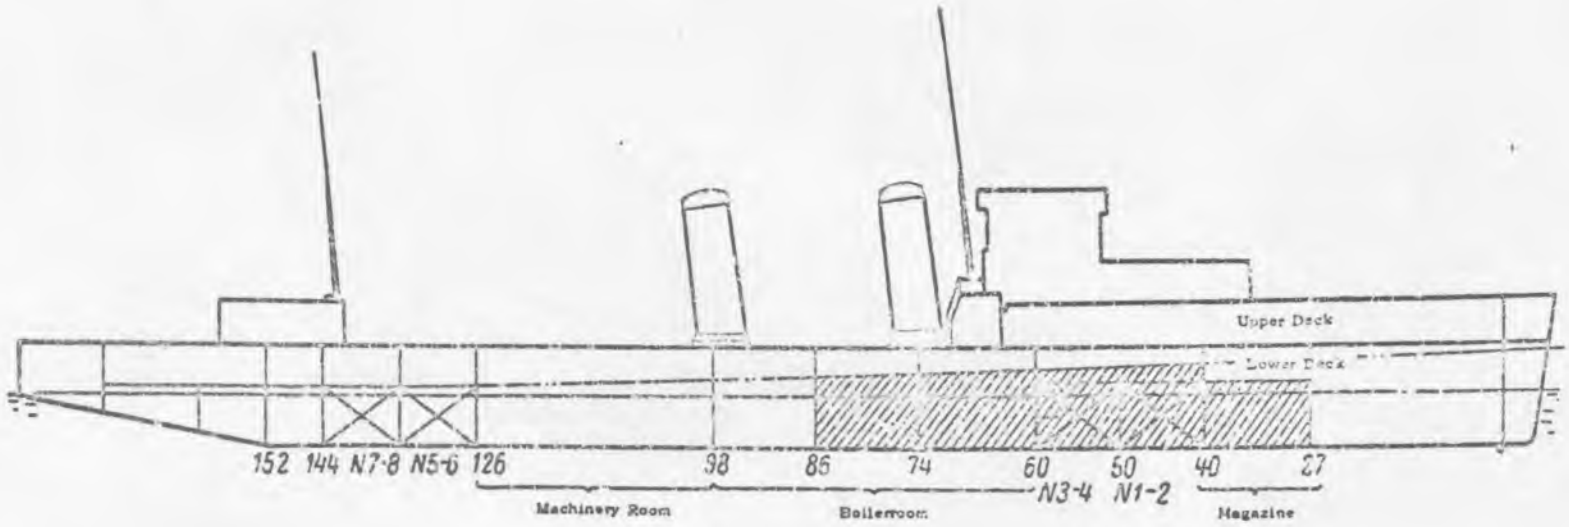
Damage to the Ship and Aftereffects. HUNTER was patrolling 150 miles from Gibraltar. At 1415, while drifting with the engines stopped, the ship exploded a mine on the port side in the vicinity of the bridge between Frames 48 to 73. The hull was seriously damaged, and several

Figure 149 – HUNTER. Schematic Longitudinal Cross-Section

Flooded compartments are cross hatched

compartments were flooded. The ship at first assumed a list of 25 degrees to starboard; she then slowly righted herself and remained afloat with a significant increased draft at the bow (Figure 149).

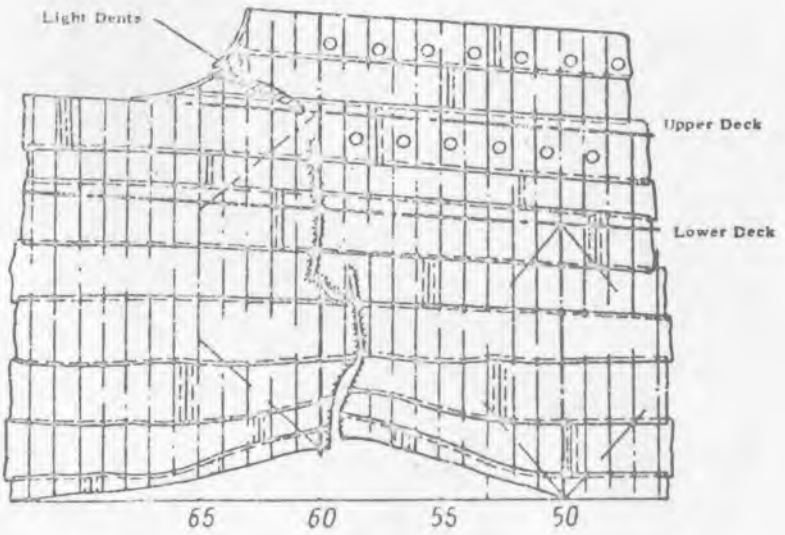
Figure 151 – HUNTER. Damage to Starboard Side

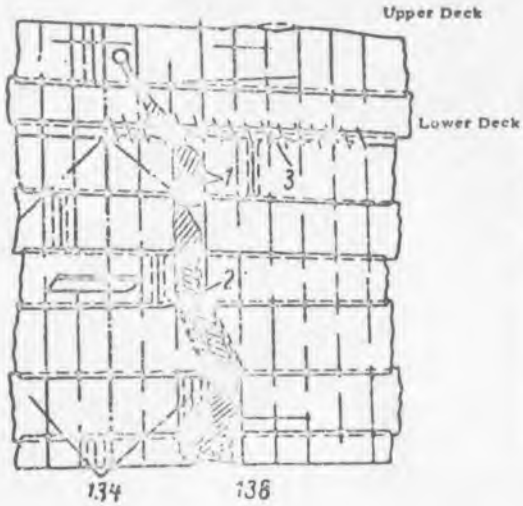
Figure 152 – HUNTER. Secondary Damage to Stern (Port Side)

1. Cave-ins; 2. Puff-outs; 3. Crimps

An area of secondary damage to the hull formed in the stern section approximately 30 meters distant from the center of the explosion. In the vicinity of Frame 137, the outer plating on both sides and the decking of the upper and lower decks appeared to have been crumpled (Figures 152 and 153). Damage was limited to spaces immediately in front of the forward bulkhead of Fuel Tanks No. 7 and 8, which were filled with oil; Tanks No. 5 and 6 in front of them were empty.

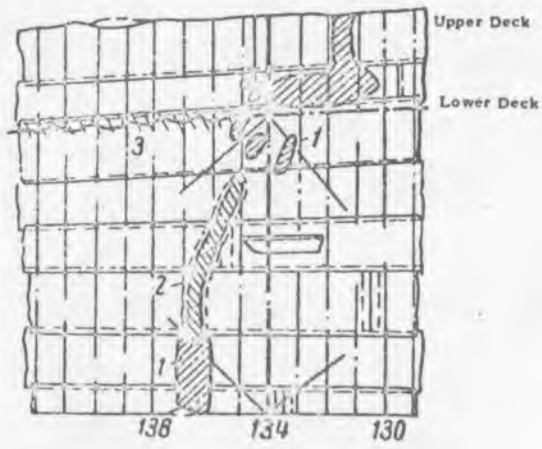
Figure 153 – HUNTER. Secondary Damage to Stern (Starboard Side)

1. Cave-ins; 2. Puff-outs; 3. Crimps

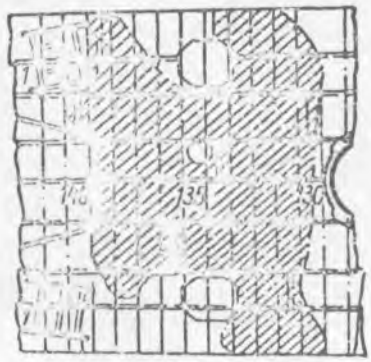
Figure 154 – HUNTER. Damage to the Upper Deck (Deformed Section Cross Hatched)

1. Foundation of a pair of cranes

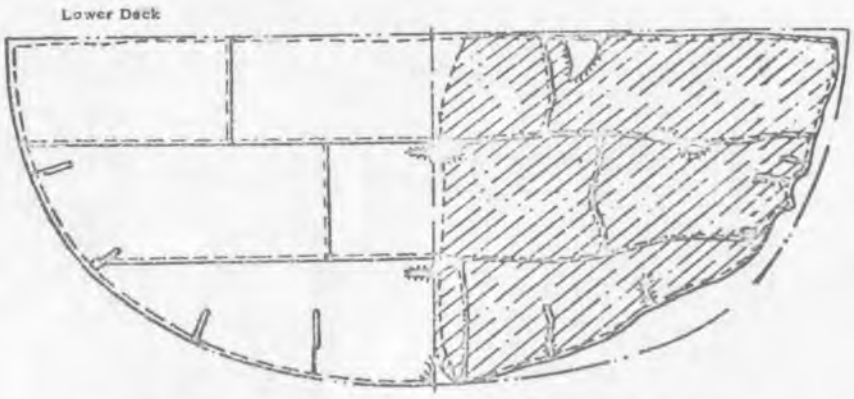
Figure 155 – HUNTER. Welded Bulkhead at Frame 50. Seriously Deformed Section Cross-Hatched (Seen from Aft)

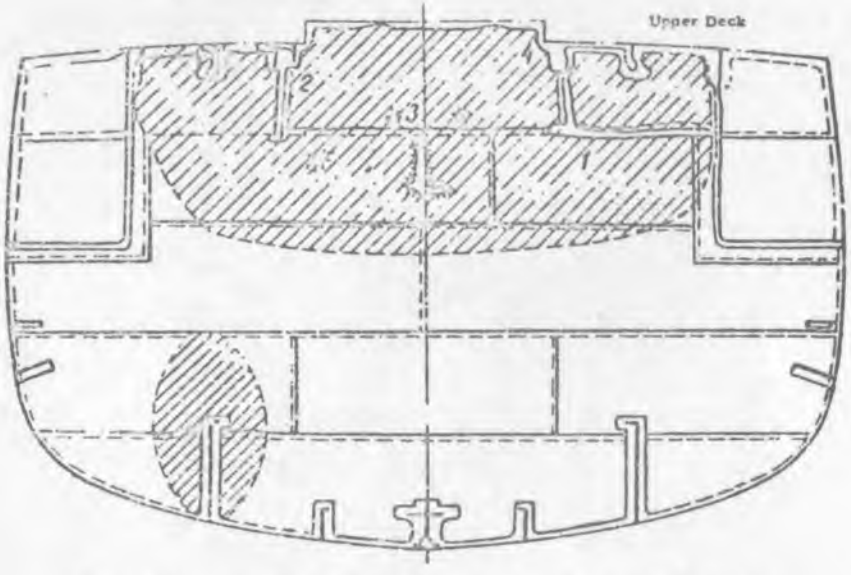
Figure 156 – HUNTER. Welded Bulkhead at Frame 74. Seriously Deformed Section Cross Hatched (Seen from Bow)

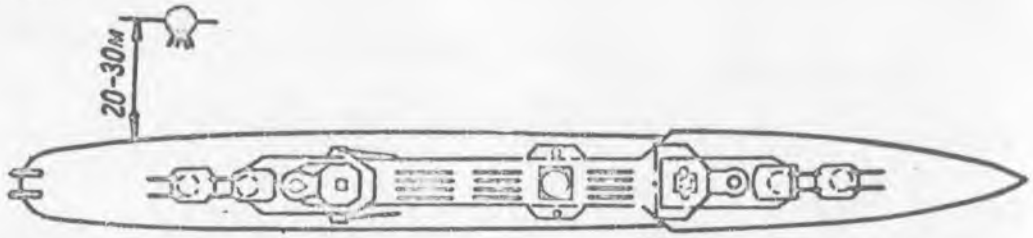
Damage to the Ship and Aftereffects. In July 1944, SOMERS exploded an acoustic mine off the shores of Normandy. The mine detonated in the vicinity of the No. 4 Gun Mount at a distance of 20 to 30 meters from the portside and at a depth of about 20 meters (Figure 157). The ship suffered severe shock; the plating at the stern was caved in to an extent of more than 50 frame spaces; many frames were twisted; several bulkheads appeared to have been deformed. There were no holes in the body.

Figure 157 – SOMERS. Disposition of the Center of the Mine Explosion Shown

The following machinery suffered damage: reduction gears of the main machinery were misaligned, vacuum in the main condensers was lost, and a part of the auxiliary machinery and a great number of pipes were damaged. The following electrical equipment suffered severely: main generators were stopped, circuit breakers on the main distribution boards cut out, and automatic devices on the damaged generators were broken. A searchlight was ripped off and thrown from its foundation. Two radio receivers went out, as did the radar, and so forth.

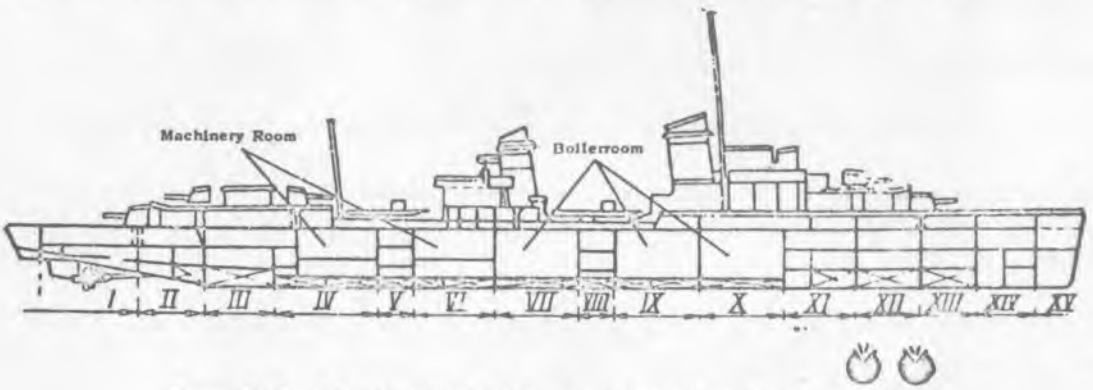
Damage to and Circumstances of the Loss of the Ship. While proceeding at a speed of 25 knots, BRUNO HEINEMANN exploded two mines in the space of 12 minutes. Both explosions occurred off the bow section of the ship in the vicinity of the main battery magazines, one at Frame 97 portside and the other at Frame 91 starboard side (Figure 160).

Figure 160 – BRUNO HEINEMANN. Location of Mine Explosions Shown

Damage to the hull as a result of the first explosion encompassed the vicinity of the magazines and the first two boilerrooms. Several main sections were flooded in the bow section, and the ship assumed a trim by the bow of 1.5 meters. Boilerrooms No. 1 and 2 went out of commission and were abandoned by their crews. The forward guns could not be trained and went out of commission because of damage to foundations. The ship lost way.
