BATTLE DAMAGE TO SURFACE SHIPS DURING WORLD WAR II
(BOEVYE POVREZHDENUA NADOVDNYKH KORABLEI)

I. M. Korotkin
Leningrad, Sudpromgiz, 1960

Translated by U. S. Joint Publications Research Service
for the David Taylor Model Basin

SUMMARY

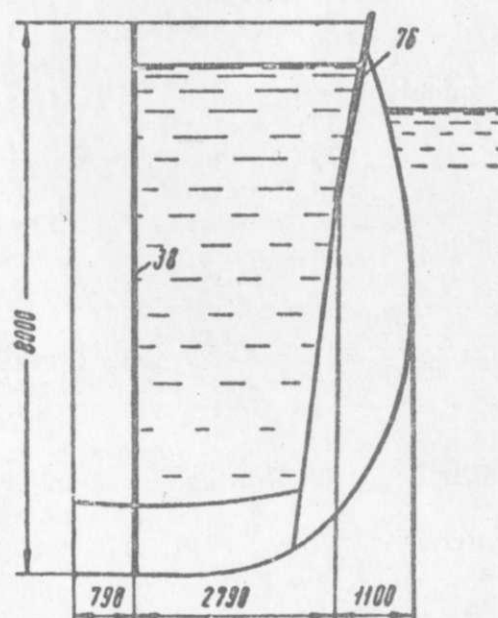
Figure 2 - COURAGEOUS. Diagram of Underwater Protection

Conclusion. Weak underwater protection (Figure 2) did not ensure the watertight integrity of the ship, and as a consequence, the carrier sank in a short time from two torpedo hits.

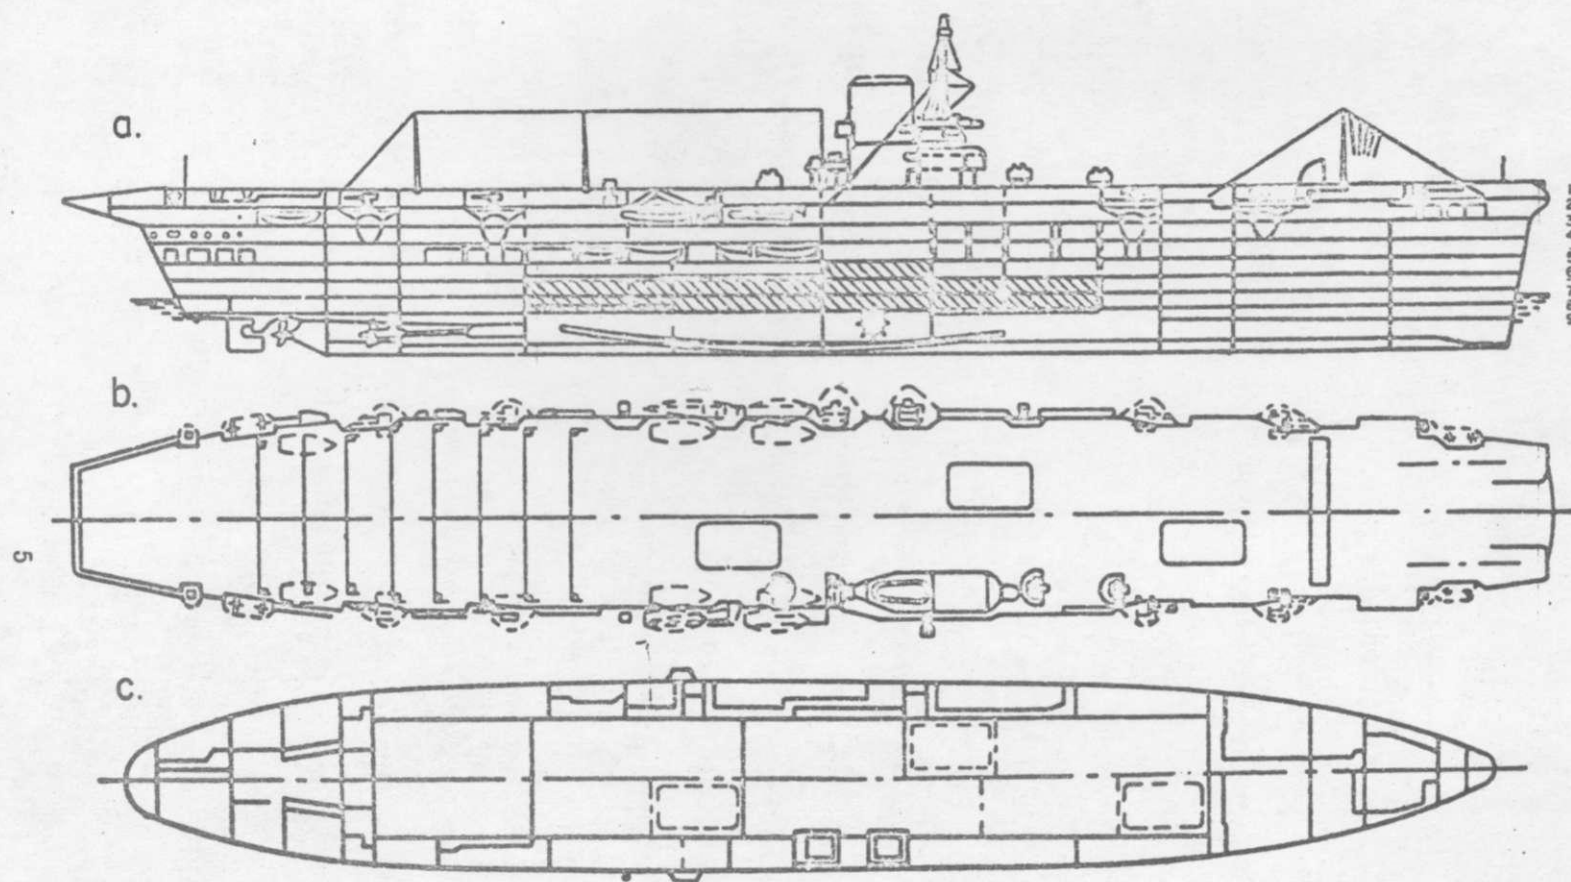
Figure 3 - ARK ROYAL

Damage to and Circumstances of the Loss of the Ship. The carrier, having completed an operating mission in the Gibraltar area, was torpedoed by a German submarine. As a result of a torpedo hit on the starboard side (Figure 3), the starboard boilerroom was immediately flooded, the ship quickly began to heel, and water began to enter the adjacent port boilerrooms through the flues.

Conclusions. The newly built British aircraft carrier took on a significant list from a hit in the midsection of the hull by one torpedo and, remaining afloat a little more than 14 hours, rolled over and sank. This attests to the following structural deficiencies in the ship:

mate ratio 1:1.5)*. Therefore, the fundamental protective bulkheads were ruptured as a result of the explosion, and the water then immediately entered into the vitally important compartments of the ship. The low position of the platform over the underwater protective belt (characteristic of the British system of ship construction for hulls of similar ships) also led to the flooding of topside compartments.

b. Inadequate integrity and watertightness of bulkheads (especially transverse) which were not in the immediate zone of destruction of the explosion appeared to be the obvious reason for the spread of flooding (even though slowly) throughout the entire ship and for the growing list.

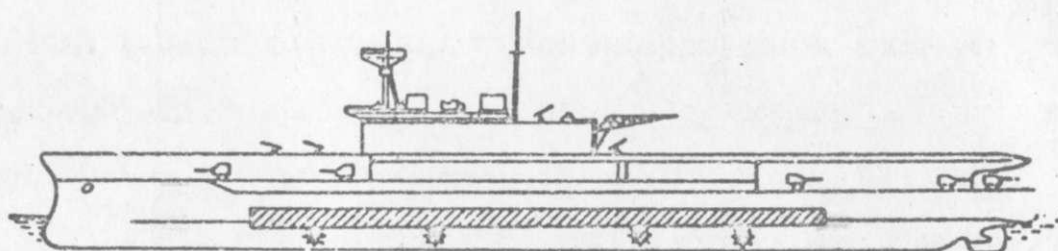
marine which launched a spread of several torpedoes from her forward torpedo tubes. The carrier received three or four torpedo hits on the portside; these were distributed almost evenly along the length of the ship (Figure 5). After remaining afloat for some time, the ship sank. Since the details of the loss of the carrier have not been published, it is not possible to draw any conclusion on the nature of the damage.

Figure 5 - EAGLE. Oriented Diagram of Torpedo Hits

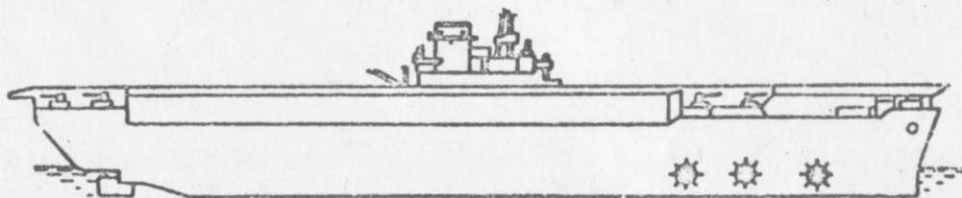
On 15 September 1942, WASP and HORNET appeared in the vicinity of the island of Santa Cruz. That afternoon WASP was attacked by a Japanese submarine from a distance of 500 meters and received three torpedo hits in the bow, starboard side (Figure 6). At the instant of the torpedo attack, WASP was refueling aircraft and, consequently, all of the gasoline lines were full of gasoline.

Figure 6 - WASP. Diagram of Torpedo Hits

As a result of the torpedo explosions (533-mm caliber), fires broke out, and the burning along with the damage to the gasoline lines increased the blaze, which quickly spread throughout the ship. The hull of the ship was shaken by internal explosions. The carrier took on a great quantity of water and listed heavily. It was not possible to put out the fires, and the crew abandoned the blazing and listing ship (Figure 7), after which United States destroyers fired more torpedoes into her to hasten sinking.

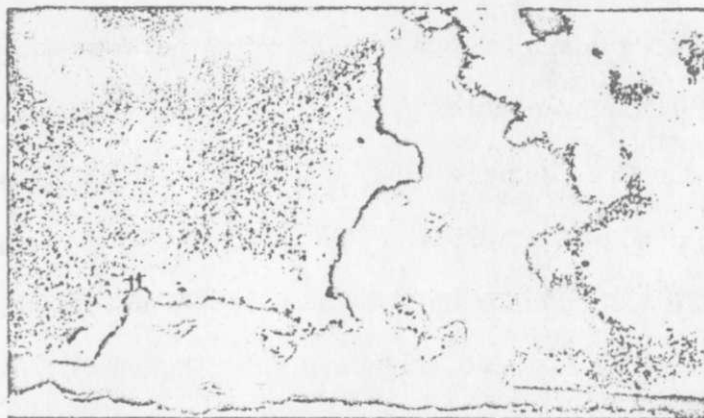
Figure 7 - Loss of WASP

Conclusion. WASP received severe damage as the result of three torpedo hits; huge fires broke out aboard, and the ship appeared to be

beyond recovery and was therefore sunk.

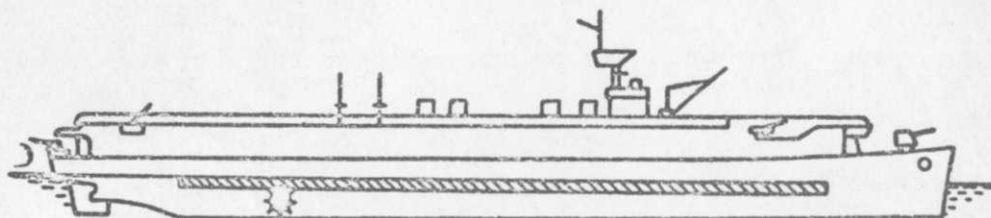
Damage to the Ship and Aftereffects. Toward the end of the day on 20 November 1943, a task force of high-speed aircraft carriers, with INDEPENDENCE in company, underwent an air attack by Japanese aircraft in the vicinity of the Gilbert Islands. During a left turn at high speed, INDEPENDENCE received a hit from an aerial torpedo (Figure 8) which exploded 4 meters from the after bulkhead of the after machinery spaces on the starboard side. All of the hull structure in the area of the explosion was destroyed, including the first platform and the lower armored deck; a large hole was formed in the side (Figure 9). Within 2 or 3 minutes after the explosion, the after machinery spaces were flooded

Figure 8 - INDEPENDENCE. Area of Torpedo Hit Shown

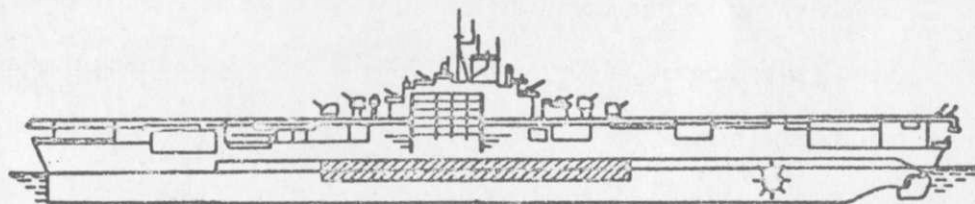
Damage to the Ship and Aftereffects. In February 1944, INTREPID was a part of a task force which participated in the battles for the Gilbert and Marshall Islands. During the time that she was completing one operation, INTREPID received a torpedo hit in the stern section of the ship (Figure 10). As a result of the explosion, the steering mechanism was seriously damaged, and part of the after compartments were flooded. The carrier was forced to return to base at Pearl Harbor for major repairs.

Figure 10 - INTREPID. Area of Torpedo Hit Shown

Conclusion. INTREPID went out of commission and was returned to base for repairs as the result of one torpedo hit.

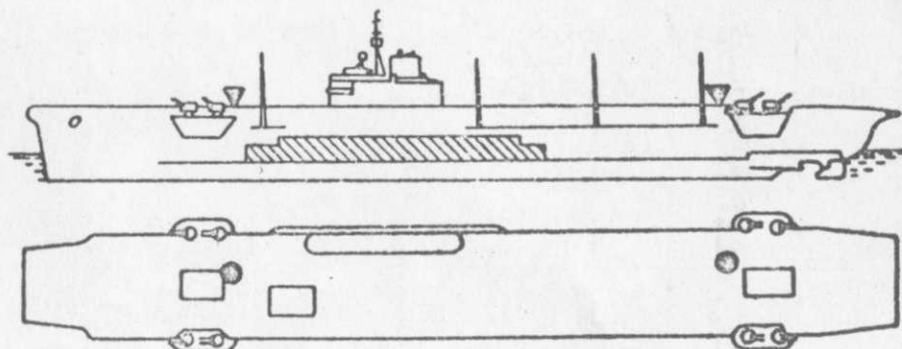
Damage to the Ship and Aftereffects. The ship was attacked by German aircraft and received two aerial hits (bombs weighing 500 kilograms each) in the unarmored region of the hull (one at the bow and the other at the extreme stern; see Figure 17). As a result of the explosion of the bomb at the bow of the ship, the forward aircraft elevator went out of commission, and the gunfire-control equipment of the forward group

Figure 17 - FORMIDABLE. Diagram of Aerial Bomb Hits

suffered severely. Some forward compartments of the hull were flooded.

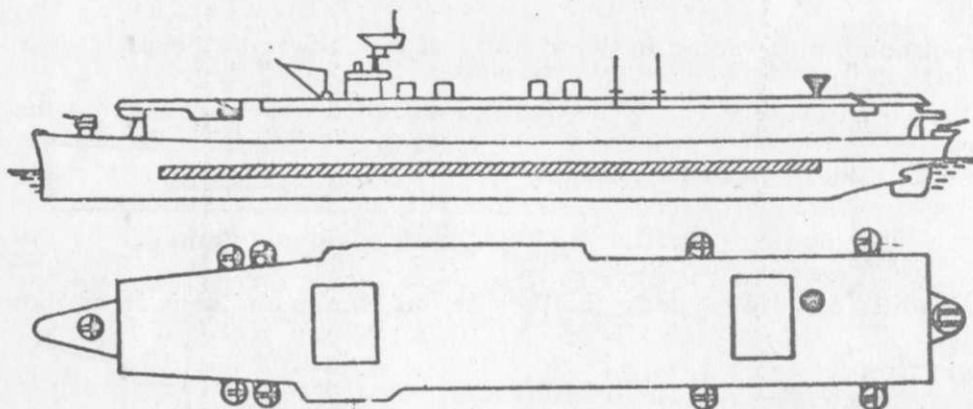
Figure 19 - PRINCETON. Area of Aerial Bomb Hit Shown

October, 1944, the ship suffered an attack by Japanese land-based bombers. One 250-kilogram aerial bomb (according to other information, 500-kilogram) hit the after section of the flight deck. The bomb penetrated through the flight deck and hangar, and exploded on the second deck over the after machinery spaces. A big fire broke out in the hangar where the aircraft were located; these planes were filled to capacity with fuel and some of them were armed with torpedoes. The first series of internal explosions began in 20 minutes and lasted 20 to 30 minutes. The fire spread throughout the ship.

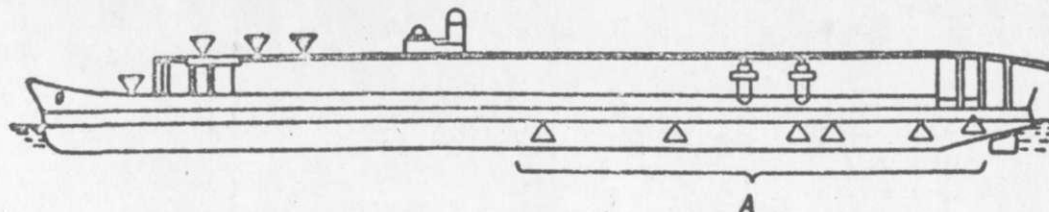
Damage to and Circumstances of the Loss of the Ship. During the action off Midway Island on the morning of 5 June 1942 (at 0456), HIRYU was attacked by 60 American aircraft which launched about 30 aerial bombs and 20 torpedoes in the space of 16 minutes. The ship suffered four direct hits from aerial bombs on the bow (Figure 23), and six bombs

Figure 23 - HIRYU. Diagram of Aerial Bomb Hits

A. Indicates area affected by near-miss explosions

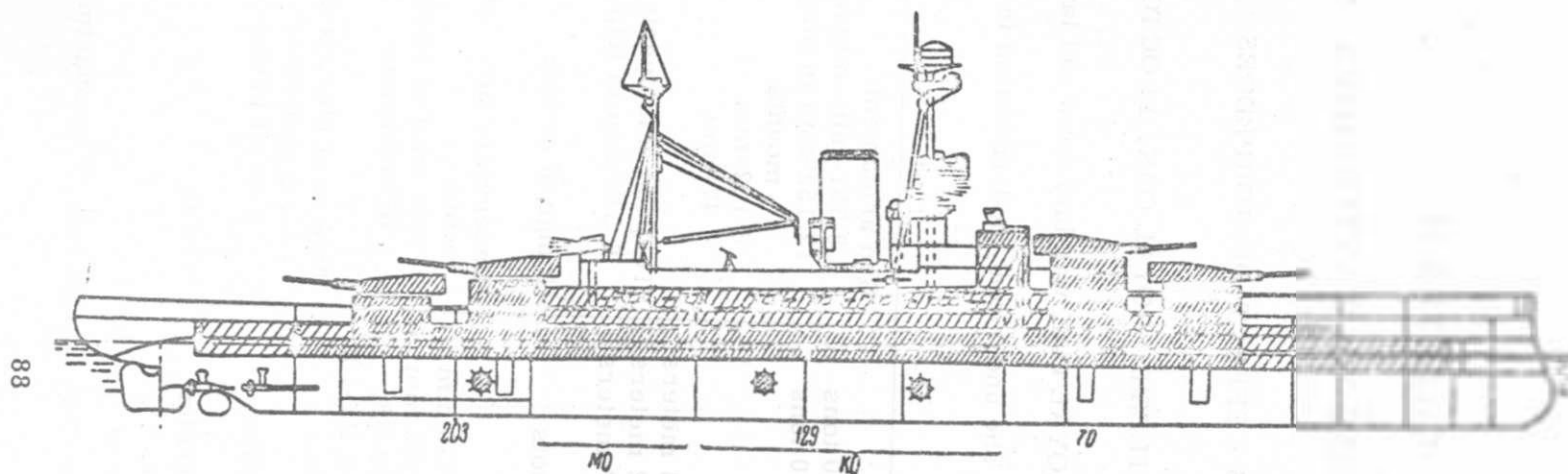
Figure 42 - ROYAL OAK. Longitudinal Section Areas of Torpedo Hits are Shown

OAK was torpedoed by the German submarine U-47.* The ship suffered two or three torpedo hits in the portside approximately amidships and in the after section (Figure 42). The panic-stricken crew took no measures to save the battleship, and did not keep her afloat for more than 23 minutes. ROYAL OAK then rolled over and sank.

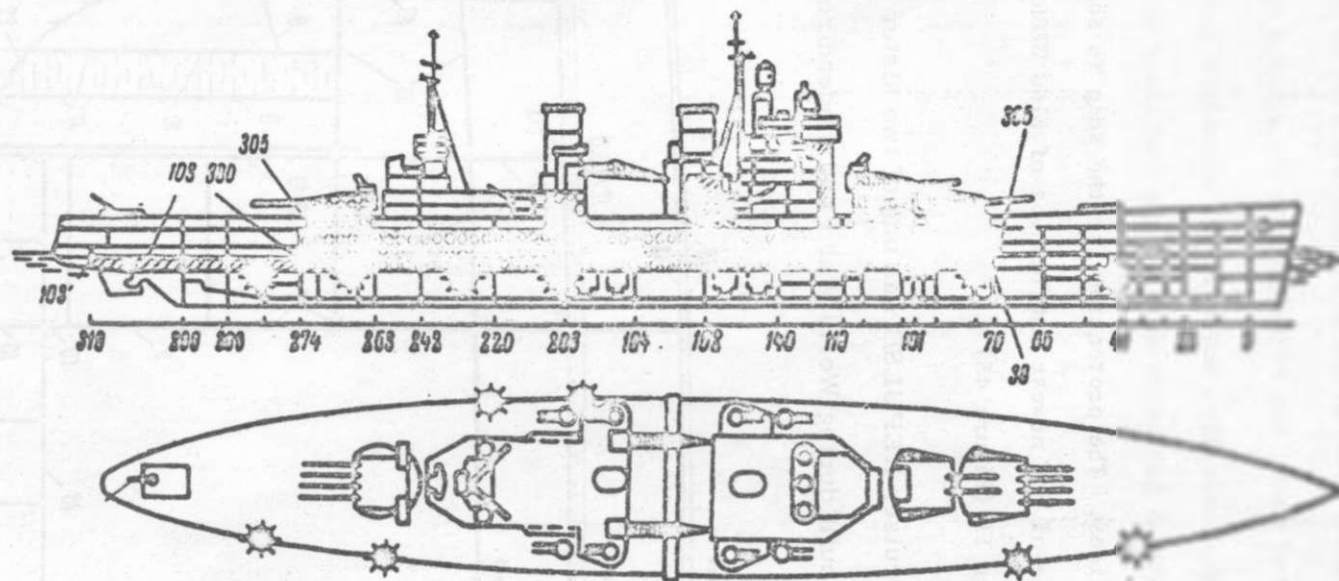
Figure 45 - PRINCE OF WALES. Areas of Torpedo Hits are Shown

Damage to and Loss of Battleship PRINCE OF WALES. At 1144 on 10 December 1941, the ship suffered two torpedo hits in the portside in an area abaft the after bridge. One engineroom and one boilerroom were flooded. The ship took on a list of 11.5 degrees to port and was down at the stern. Five of the 127-mm turrets were put out of commission. Two screws were damaged as well as the steering gear. Main

At 1222, the battleship suffered three or four more torpedo hits in the starboard side, one or two in the bow, and two in the stern of the ship (Figure 45). The list to port decreased, but insignificantly. Speed dropped to 8 knots.

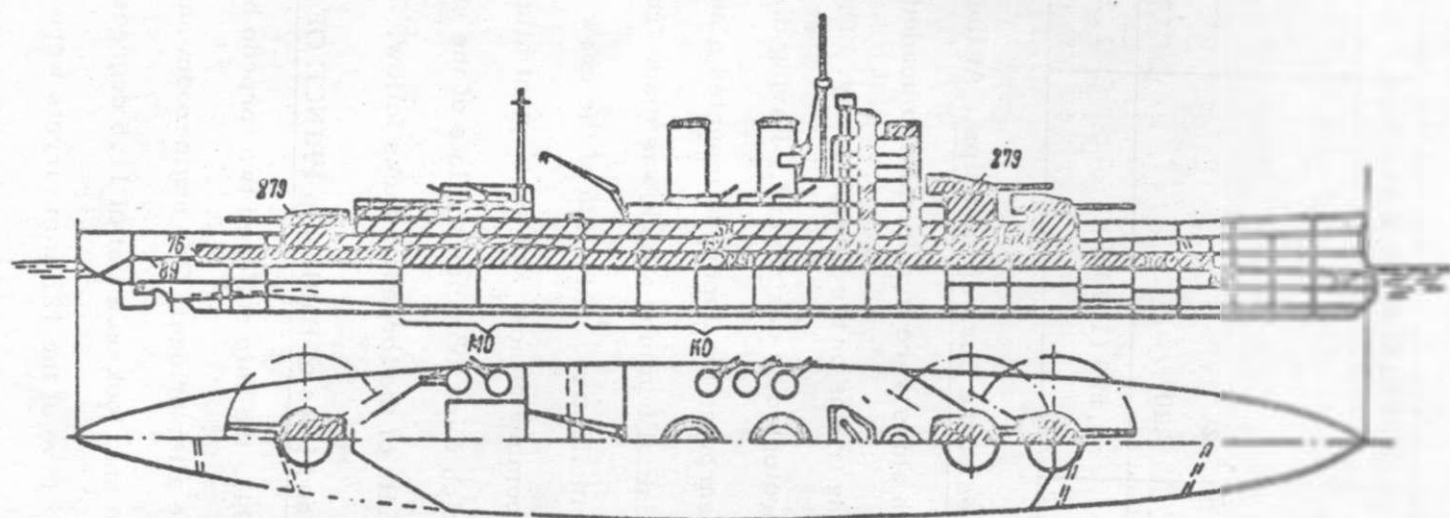
Figure 46 - REPULSE. Thickness of Armor Plating Shown

Damage to and Loss of Battle Cruiser REPULSE. (Figures 46 and 47). At 1222 on 10 December 1941, the ship suffered one torpedo hit in the portside amidships; speed dropped to 25 knots. Within a few minutes, the cruiser suffered four more torpedo hits on the same side. The ship began to list heavily to port and at 1233, after the list had reached 60-70 degrees, she rolled over and sank. In all, she had remained afloat 15 minutes from the instant of the first torpedo attack. A part of the crew was saved by accompanying destroyers.

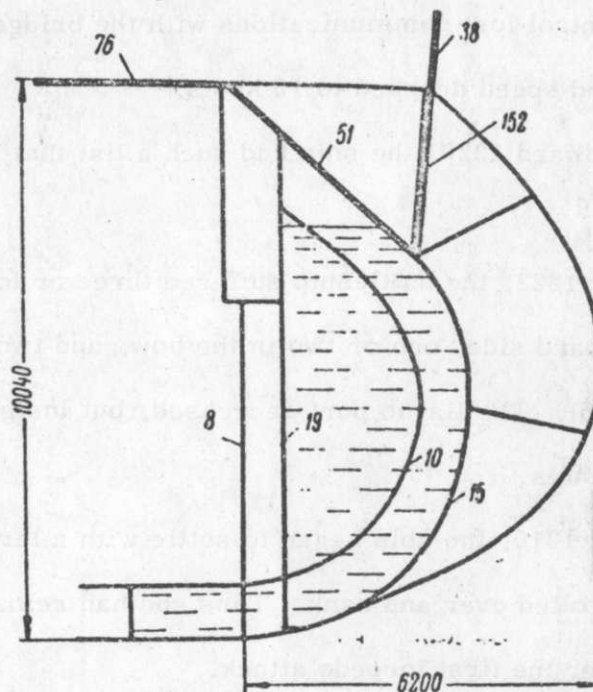
Figure 47 - REPULSE. Diagram of Underwater Protection

After reviewing the deficiencies in protection of the vital parts of RESOLUTION and ROYAL OAK, which are peculiar to all British battleships built during World War I, the rapid sinking of REPULSE from several torpedo hits becomes understandable, the more so if one takes into account the fact that the underwater protection for battle cruisers of this type was still weaker than that of the indicated battleships. Further-

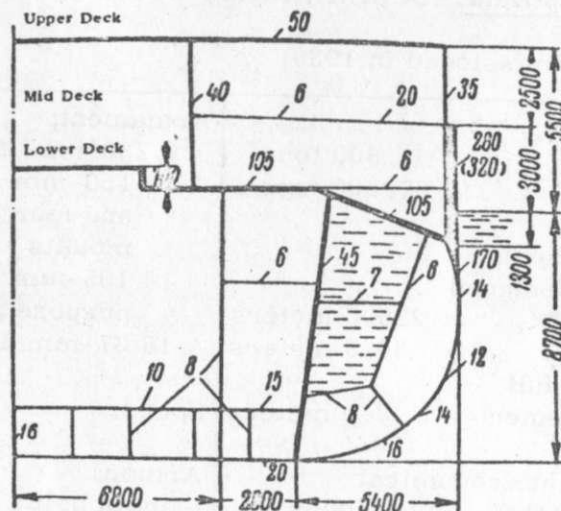
The hull of the ship was smooth-decked and divided by transverse bulkheads into 24 watertight sections; the main transverse bulkheads extended to the upper deck. In German designs, two after sections are joined and two bow sections are joined, and therefore it is considered that the ship was divided into 22 sections. Watertightness was counted on to maintain ship fighting capacity during the flooding of any two adjacent compartments. The torpedo protection system and armor are indicated in Figure 48.

Figure 48 - SCHARNHORST. Torpedo Protection System and Armor are Sketched

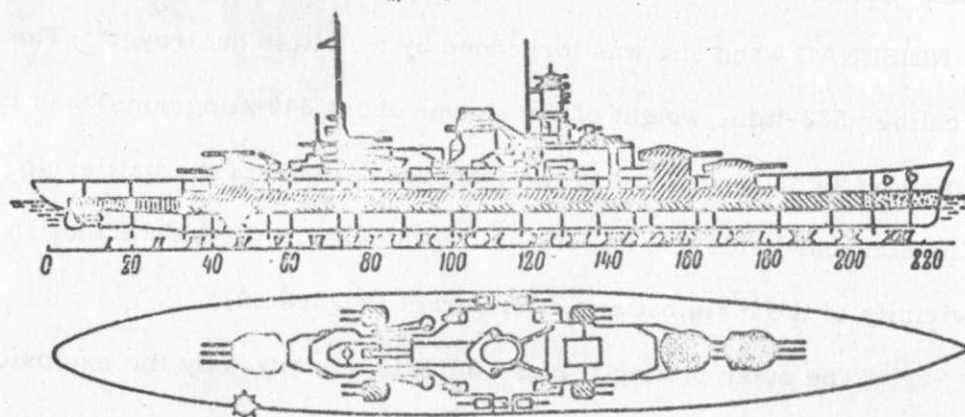
Figure 49 - SCHARNHORST. General View with an indication of the Area where Torpedoes Hit 8 June 1940

Damage to the Ship and Aftereffects. On 8 June 1940 in the North Sea, SCHARNHORST was steaming in company with her sister ship GNEISENAU when she was torpedoed by a British destroyer. The torpedo (caliber 533-mm, weight of the charge about 340 kilograms) was launched at an angle of 15 degrees to the transverse plane of the battleship. It hit the starboard side 2.5 meters below the edge of the side armor in the vicinity of the main battery after turret (Figure 49).

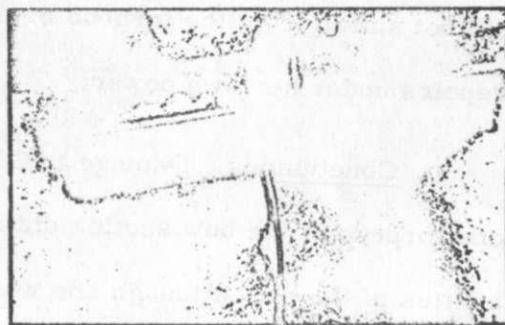
Figure 58 - GNEISENAU.
Welded Bar over the Outer Plating

To avoid letting the bow section break away, the crew placed electrowelded beams across the crack underwater (Figures 57 and 58); the upper (above-water) part of the crack-covering sheets was welded to the hull from both sides.

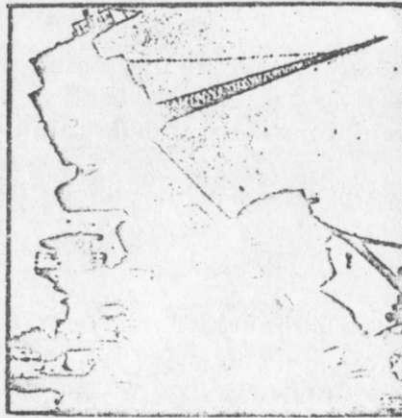
Figure 80 - ARIZONA. After She Sank

principally in the bow section. The aerial bombs went through the armored deck, causing damage and fires. The main boilers and several ammunition magazines exploded. The ship remained afloat several minutes then sank with her crew of 1100 men (Figure 80). The burning fuel oil which had spilled out into the water in the area where she sank threatened nearby ships.

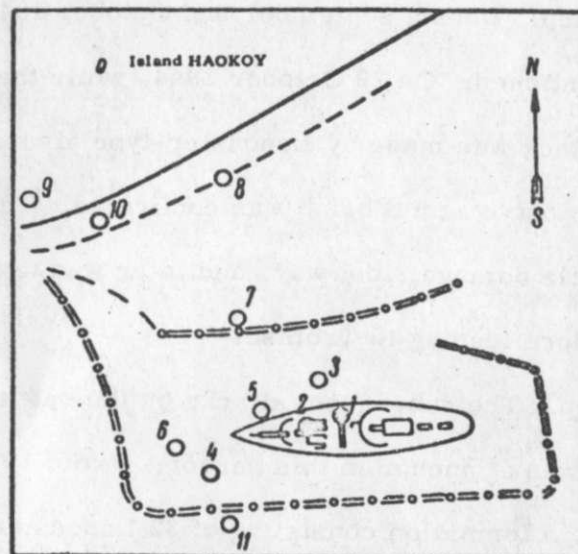
Figure 83 - Diagram of Aerial Bomb Hits During the Attack on TIRPITZ 12 November 1944

Fourth Step. During September and October 1944, the attacks on the battleship continued. On 29 October 1944, while the battleship was underway, an attack was made by Lancaster-type aircraft. The hit of one 5.5-ton high-explosive aerial bomb was confirmed. The battleship suffered considerable damage, lost way, and later was towed to one of the harbors of the fiord leading to Tromse.

Fifteen minutes after the first attack, the ship caught fire and began to list, and a huge oil slick grew and spread around the ship. However, bombs did not fall in the ammunition magazine, and therefore internal explosions did not occur.

The third and last air attack decided the fate of the ship. A few minutes after the end of the third attack (i.e., at 1215), the battleship rolled over on her portside and lay on the bottom at a distance of 200 meters from the shore. About 700 men went down with their ship. The right half of the bottom, from the knuckle to the keel, stuck out above the water for a distance of more than 200 meters, and the starboard and

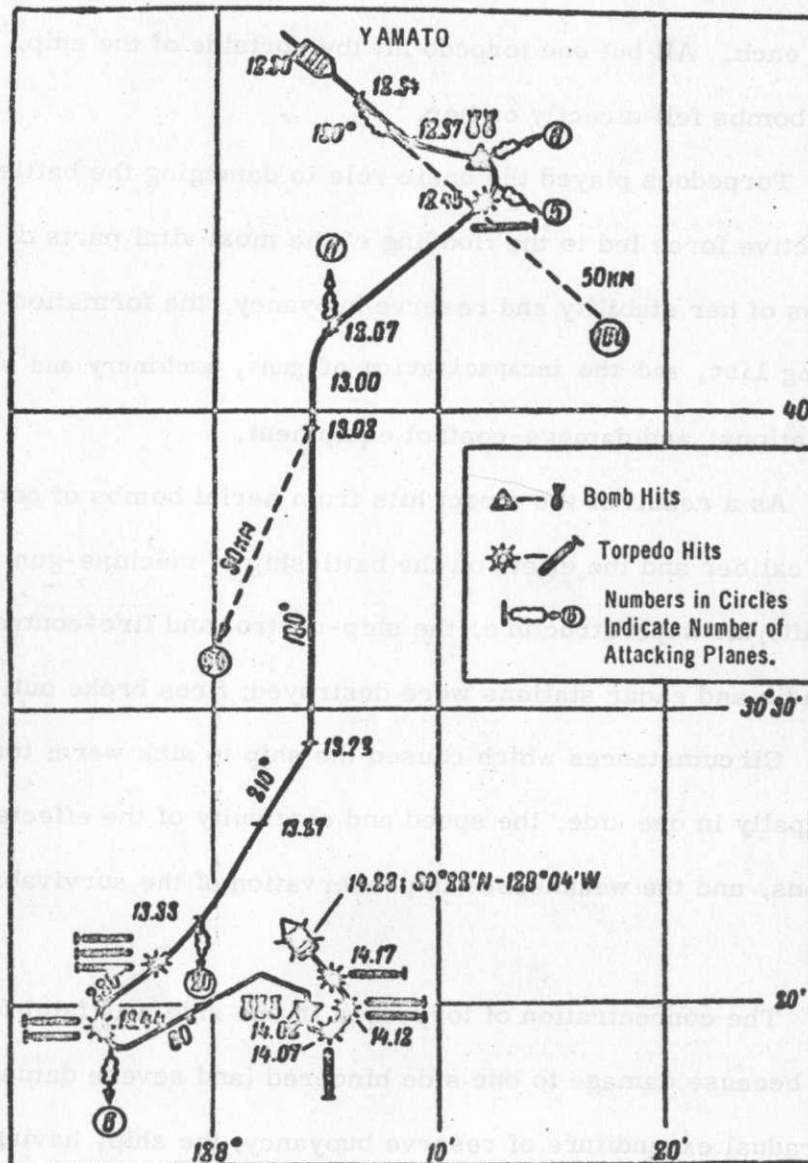
Figure 89 - YAMATO. Diagram of Movements 7 April 1945

Conclusions. YAMATO was sunk as a result of the action of 10 United States aerial torpedoes with 270 kilograms of explosive substance (350-400 kilograms of TNT) and about 13 aerial bombs weighing 250 kilograms each. All but one torpedo hit the portside of the ship, and five aerial bombs fell directly on her.

Thus, YAMATO was lost within the space of 2 hours along with almost all of her crew (2500 men). The steps in the attack on YAMATO are successively reviewed in Table 9. Diagram of the damage by torpedoes and a diagram of movements of the battleship are shown in Figures 88 and 89.

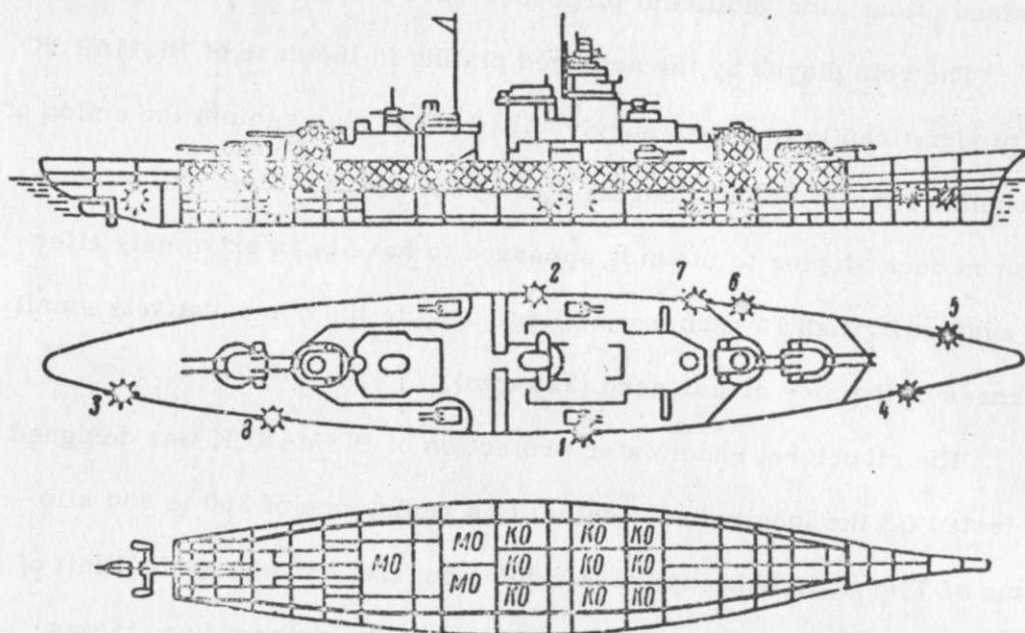
Figure 20 - BISMARCK. Diagram of Torpedo Hits

Conclusions. BISMARCK was sunk as a result of the combined effects of eight contact torpedo explosions and a great number of shells.

Three of the torpedoes that hit were aviation-type (210 kilograms of explosive substance) and five were ship-type (340 kilograms of

explosive substance). The aerial torpedoes hit the midsection and the after section of the ship; the ship-type hit the bow and midsection. On the whole, the ship suffered the effects of about 3500 kilograms of explosive substance (in TNT equivalent) from torpedo hits alone.

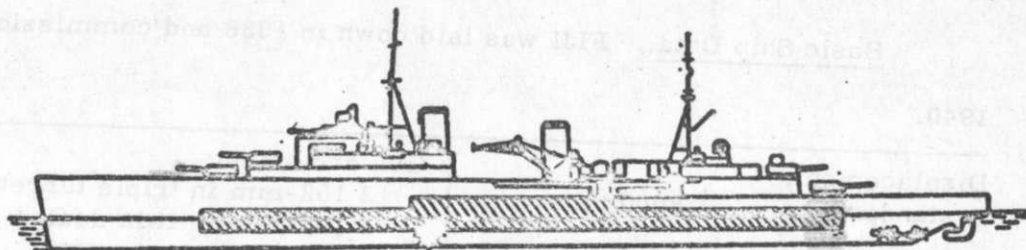
Figure 93 - FIJI. Area where Torpedo Exploded Shown

Damage to the Ship and Aftereffects. The ship suffered hits from aerial torpedoes in the side at 3 to 4 meters below the waterline in the vicinity of the boilerroom portside (Figure 93). The hole formed in the side (Figure 94) was 8 by 6 meters in size. Torn from its position by the explosion, the main boiler destroyed the main transverse bulkhead. Engines, piping, and stacks on the portside were damaged. The ship took on a list of 7 degrees to port and settled by the bow. Speed dropped

Conclusion. As a result of hull damage from the explosion of one aerial torpedo, FIJI developed a list along with settling at the bow; the ship decreased speed and was forced out of action.

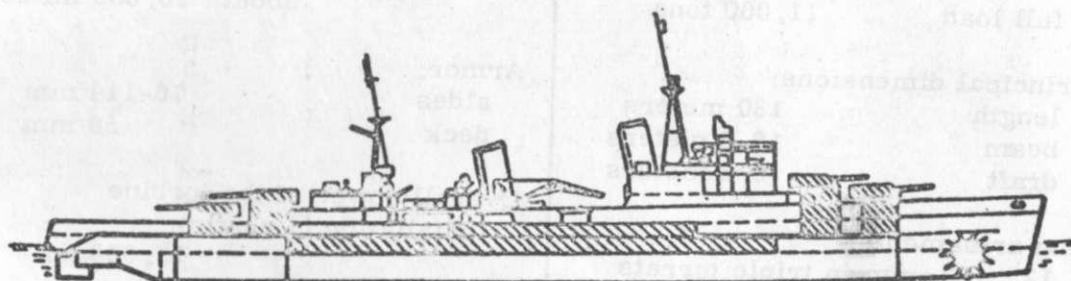
Figure 95 - LIVERPOOL. Area where Torpedo Exploded Shown

Damage to the Ship and Aftereffects. Returning from operations in the vicinity of Alexandria in October 1940, LIVERPOOL suffered a hit from a German submarine torpedo in her forward extremity, starboard side, in the vicinity of gasoline storage (Figure 95). The torpedo explosion caused considerable damage and an internal explosion; the forward part of the ship appeared to have been flooded and broken; fires broke out.

Conclusion. The ship suffered serious damage in the vicinity of the bow section, as a result of which she lost the bow section and was put out of action for several months.

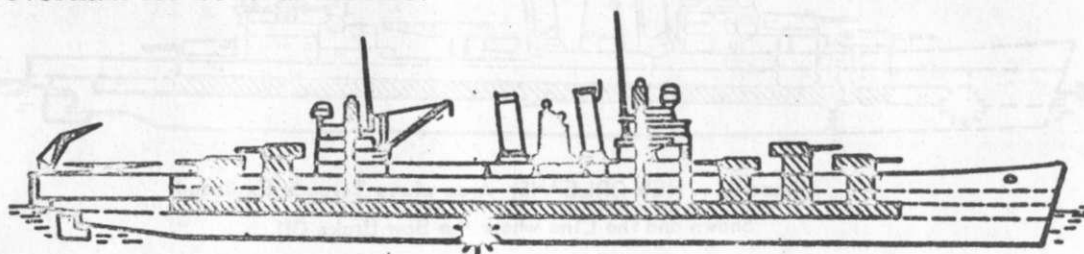
Figure 96 - HELENA. Area where Torpedo Exploded Shown

Damage to the Ship and Aftereffects: While moored to a dock in Pearl Harbor on 7 December 1941, HELENA suffered a hit from a Japanese aerial torpedo. The torpedo exploded in the portside in the vicinity of the forward engine room (Figure 96) and caused considerable damage to the hull; almost all of the equipment in the No. 1 Main Engine room, portside, went out of commission. The following were damaged by the explosion: No. 1 Shaft, reduction gear, forward main distribution switchboard, and other equipment. The main engine installation portside remained undamaged, but a part of the equipment ceased operating as a consequence of the flooding of compartments.

Cruiser HELENA went out of commission and was forced into drydock overhaul.

Conclusion. As a result of a hit from one aerial torpedo, HELENA suffered serious damage, went out of commission, and was in overhaul for several months.

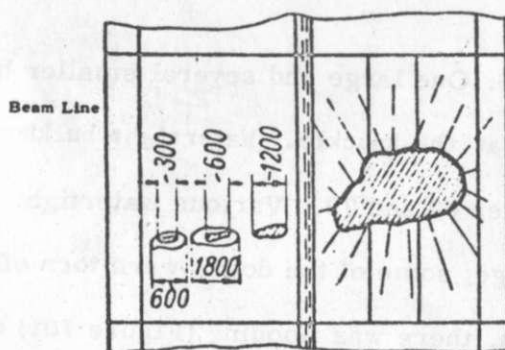
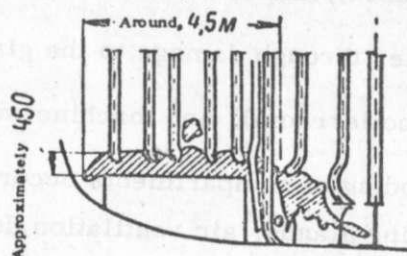
Figure 100 - HOUSTON. Damage

a. Hull (Figures 99 and 100): One large and several smaller holes were formed in the skin of the ship at the knuckle. Watertight bulkheads were damaged by splinters at Frames 69 and 79. Various watertight covers (doors, etc.) suffered damage; some of the doors were torn off. Immediately following the explosion, there was flooding (Figure 101) of the forward boiler room (flooded in 5 to 6 minutes; boilers were exposed due to the action of the deck), the after boiler room, the forward engine room (flooded in 30 minutes through damage to the gland of the propeller shaft and from the after boiler room), and machine workshop.

a. Plating

b. Bulkheads at Frame 69

c. Bulkheads at Frame 79

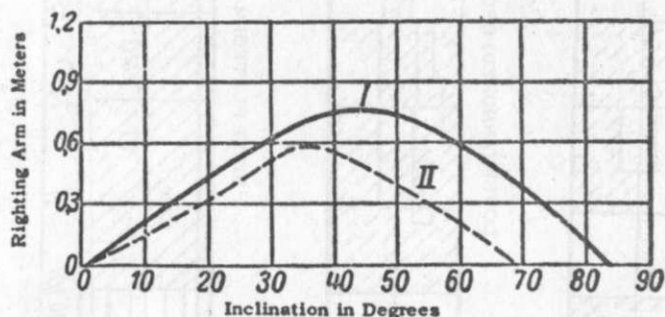
Figure 102 - HOUSTON. Stability Diagram before (Curve I) and after (Curve II) Damage

According to calculations of the Bureau of Ships, 5 minutes after the explosion of the torpedo, the transverse metacentric height was negative at -57 centimeters; at that time the forward boilerroom and forward engine room, and also crew quarters on the lower deck in the vicinity of Frames 79 to 91, portside, were still not completely flooded. After the complete flooding of these compartments, the stability of the ship became positive, and the metacentric height was +6 centimeters. The stability diagram of the ship before and after damage (according to her condition on the morning of 15 October) is shown in Figure 102.

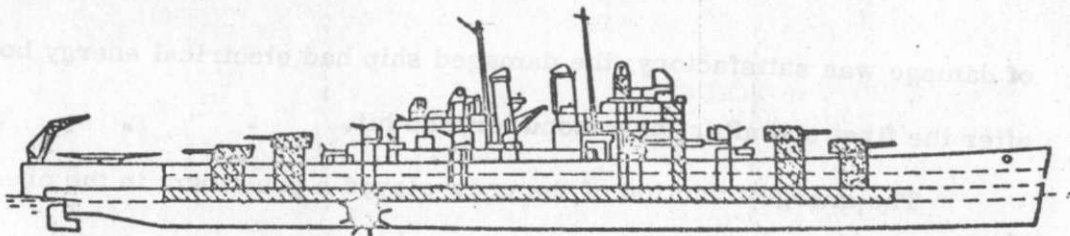
Figure 103 - DENVER. Area of Torpedo Explosion Shown

On the evening of 13 November 1943, DENVER suffered an aerial torpedo hit. The torpedo exploded on the lower edge of the main armored belt, starboard side, at a distance of 1.0 meter from the after bulkhead of the after engineroom (Figure 103), which was immediately flooded. The

after boilerroom slowly flooded with water through ducts, wooden bearings, and electric cable stuffing glands.

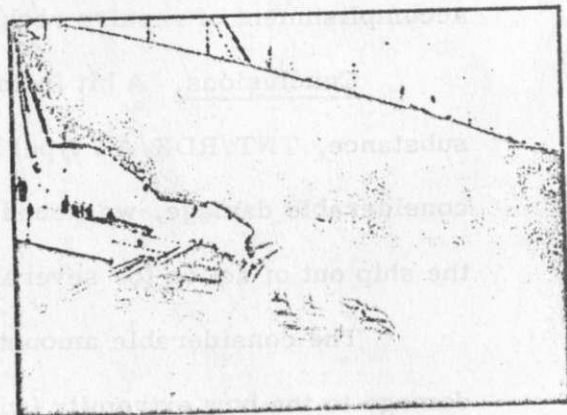
Figure 114 - Damage to NURNBERG.
View from Bow

Figure 115 - Damage to NURNBERG.
View of Starboard Side of Bow

Figure 116 - Damage to NURNBERG.
View of Bow from Port Side

a. Hull (Figures 113 to 116): The bow extremity of the ship was destroyed up to Frame 156 (8.0 meters from the center of the explosion); however, the upper two-thirds of the belt of the side outer plating together with the anchor hawses remained whole. The shear strake extending from Frame 49 to Frame 118 (70 meters) had breaks in nine places along the welded joints and in the metal itself. Such breaks, then, to a great extent were formed in the low-lying belts of the side. Moreover, many breaks were noted along the weld of the bilge keel. The upper deck suffered many breaks that were up to 3 meters in length (principally athwartships) from Frames 49 to 118 (more than 75 meters). Many longitudinal below-deck joints appeared to have been torn. Short breaks were suffered by the second bottom in the vicinity of Sections V and VI (electrical station and diesel-motor compartments). The appearance of a great number of cracks in the superstructure was noted, particularly vertically in the bulkheads. The equipment in the superstructure was damaged and put partially out of action.

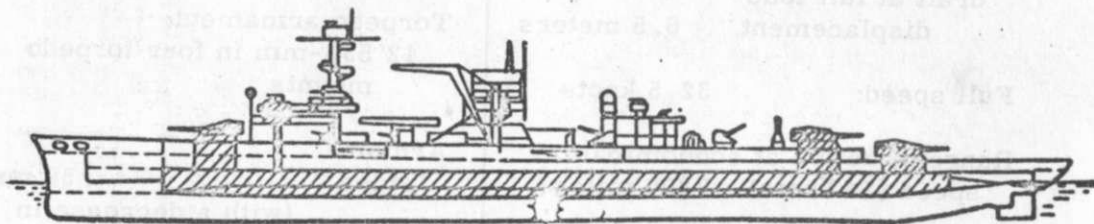
Figure 117 - LEIPZIG. Vicinity of Torpedo Hit Shown

Damage to the Ship and Aftereffects. LEIPZIG, located in the North Sea, suffered a torpedo hit amidships (Figure 117). The torpedo was launched from a British submarine toward the side of the ship from a distance of no more than 600 meters (caliber of the torpedo, 533 mm; weight of explosive substance, 340 kilograms).

The center of the explosion occurred in the vicinity of Frame 89, portside, 4.0 meters below the waterline in an athwartships bulkhead which divided Boilerroom No. 1 and Boilerroom No. 2. The following damage from the explosion was suffered by the cruiser:

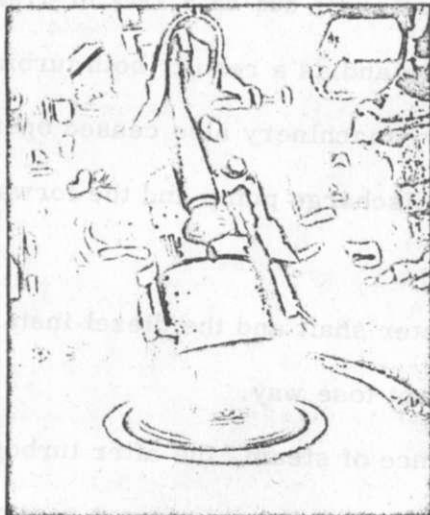
The following went out of commission: the main engine telegraph (temporarily), the electrical control for the rudder, the rangefinder (Figure 120), and the radio station.

Figure 120 - LEIPZIG . Damage to the Rangefinder Atop the Pilot House

The crew energetically fought to save their ship. The operations to control flooding were conducted by patching and draining compartments and by starting overboard discharge pumps that had gone out of commission. Repairs were made to damaged technical equipment including electrical equipment and cables, auxiliary machinery, telephones and so on. Damage was rectified, and guns, torpedo armament, and radio equipment were put into action.

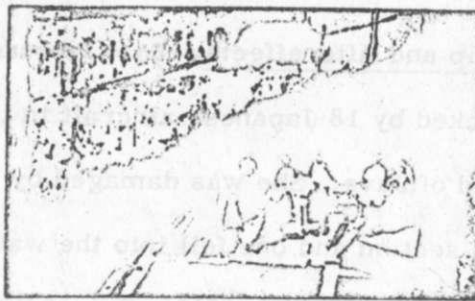
Figure 122 - MARBLEHEAD.

The noncontact explosion of the bomb occurred at the level of the knuckle 30 to 35 meters from the forefoot portside. The plating was considerably caved inward on the hull, and a hole with a diameter of about 3.0 meters (Figure 122) was made in the center of the zone of explosion.

Damage to the Side from A Near-Miss Explosion of An Aerial Bomb

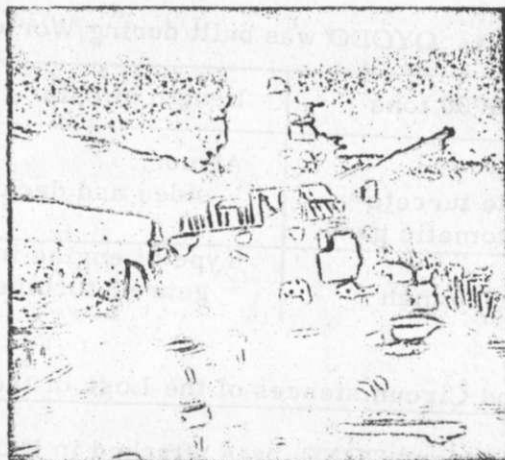
Figure 130 - View of the Damaged Cruiser AOBA

Throughout 28 July, AOBA underwent several attacks. In the first half of the day, the cruiser was attacked by carrier aircraft which succeeded in making four direct hits; many fires broke out aboard the ship. In the second half of the day, B-24 aircraft also made four direct hits on the stern (Figure 129). The explosions tore off the stern section of the cruiser, and the burning ship was abandoned by her crew (Figure 130).

Conclusions. As a result of the action of one direct hit and one near-miss explosion of an aerial bomb close aboard (bomb weighing up to 500 kilograms), the Japanese AOBA suffered considerable damage, lost buoyancy, and settled to the bottom.

The basic reason for the ship being put out of action was the effects of the near-miss explosion of the bomb which led to hull damage and flooding of a number of compartments, including the engineroom and boilerroom spaces.

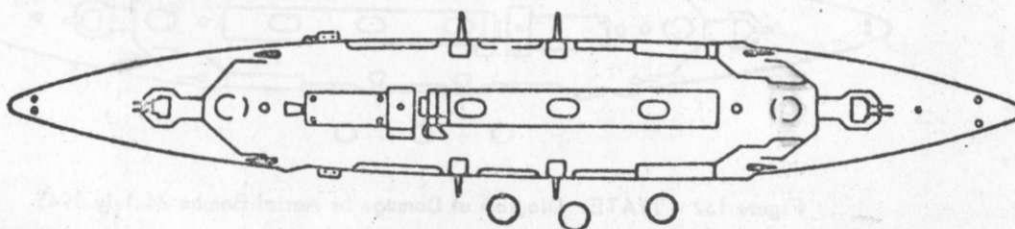
Figure 133 - IZUMO. Diagram of Damage by Aerial Bombs 28 July 1945

On 28 July, the cruiser was attacked by 20 carrier aircraft; three bombs fell close aboard (Figure 133) and damaged the underwater part of the hull; as a result, the ship took on a considerable amount of water and began to list to port. The list gradually increased and attained 15 degrees; then 1 hour after the attack, the cruiser suddenly rolled over and sank.

Conclusions. As a result of serious damage caused by the action of three noncontact explosions of aerial bombs weighing up to 500 kilograms, IZUMO took on a great quantity of water, rolled over, and sank within an hour.

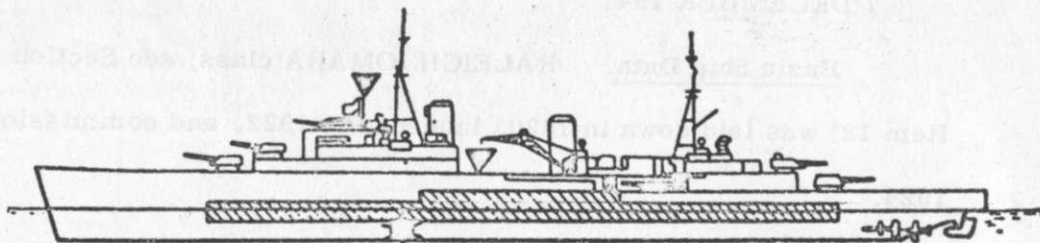
Figure 137 - TRINIDAD. Diagram of Damage by Torpedo and Aerial Bombs

Enroute to the base after temporary repairs had been made, the cruiser suffered two direct aerial bomb hits (Figure 137). The explosions caused a fire to break out aboard, and a part of the crew was put out of action.

splinters and parts of equipment mixed with fuel oil due to the damage suffered in the earlier torpedo hit. When fire broke out aboard after the second attack, all of this refuse burned in various inaccessible spots within the hull, thus feeding the fire.

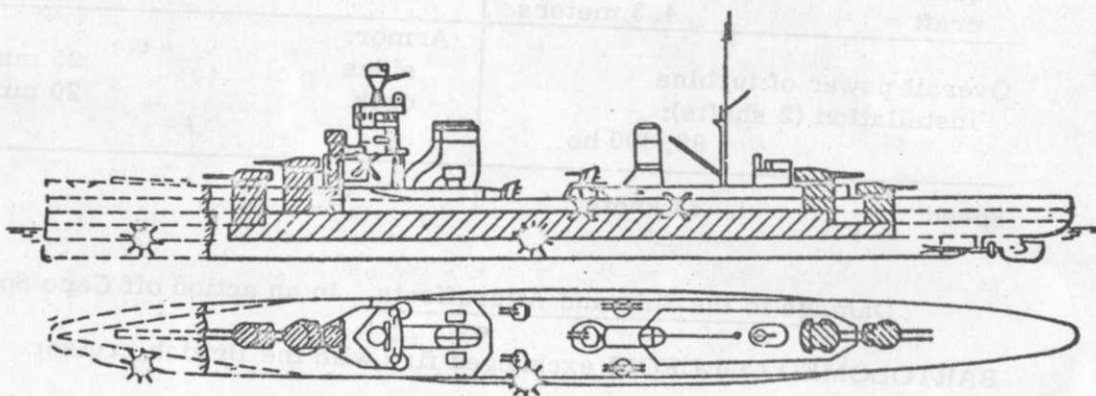
Figure 139 - BARTOLOMEO COLLEONI. Areas of Primary Torpedo and Shell Hits, and Break-Off Line of Bow are Shown

Destroyer torpedoes finally sank the cruiser. One of the torpedoes hit the bow section of the ship and tore off the bow extremity for a distance of 30 meters (Figure 139). Individual internal explosions occurred aboard the ship; one of them blew her forward superstructure apart.

The second torpedo hit the midsection; in a few minutes, the cruiser rolled over and sank with her keel up.

Conclusions. From the combined action of two torpedoes and several shells of medium caliber, the ship rolled over and sank.

The action of the shells led to the damaging of armament and technical equipment and to the ship going out of commission, but in order to finally destroy her, torpedoes were used.

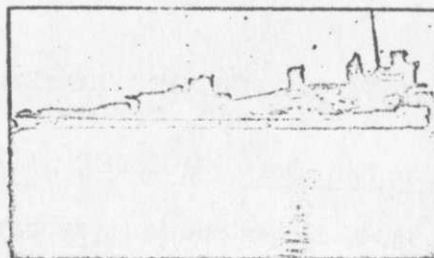
to a distance of 30 meters. Remaining afloat, the section that had been torn off passed along the starboard side, causing damage to the starboard shaft, the foot of the strut, and the propeller (Figures 146, 147, 148). The breakoff of the bow section occurred in the vicinity of the No. 2 Twin-Barrel Mount which was put out of action completely. The destroyer assumed a trim at the bow of 1.2 meters. Flooding of compartments in the stern section as a result of secondary damage was insignificant. Fires did not break out. SELFRIDGE proceeded to the nearest base under her own power with a speed of 10 knots. Both engines continued to operate despite hull vibrations caused by the damaged starboard shaft.

Conclusions. After the bow section of her hull was torn off SELFRIDGE went out of action but remained afloat, and she reached the nearest base under her own power.

Figure 146 - SELFRIDGE. After Torpedo Damage

Figure 148 - SELFRIDGE. General View of Damage
from Port Side

In order for SELFRIDGE to proceed to a main base, a temporary bow section was mounted and preliminary repairs were made on the engines. Major overhaul lasted several months.

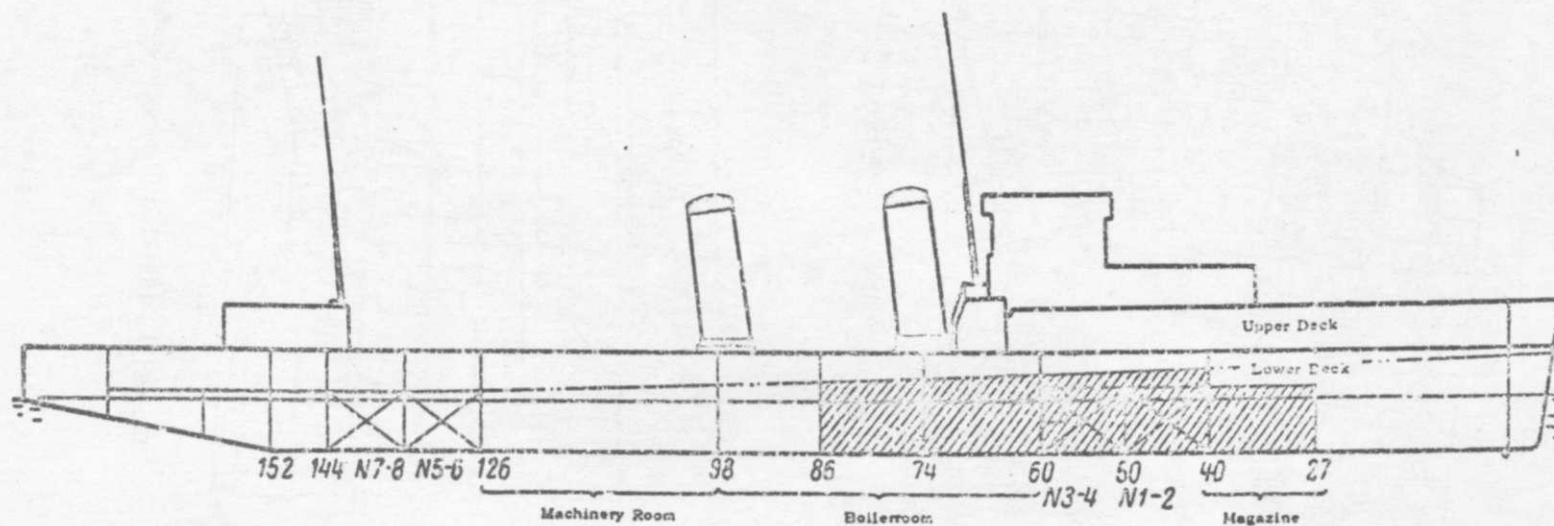
Figure 149 - HUNTER. Schematic Longitudinal Cross-Section

Damage to the Ship and Aftereffects. HUNTER was patrolling 150 miles from Gibraltar. At 1415, while drifting with the engines stopped, the ship exploded a mine on the port side in the vicinity of the bridge between Frames 48 to 73. The hull was seriously damaged, and several

Flooded compartments are cross hatched

compartments were flooded. The ship at first assumed a list of 25 degrees to starboard; she then slowly righted herself and remained afloat with a significant increased draft at the bow (Figure 149).

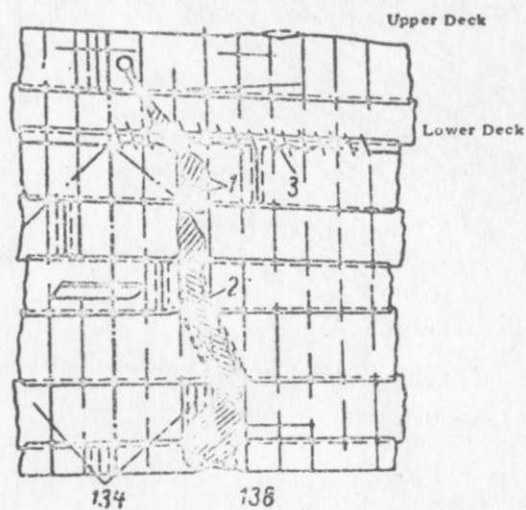
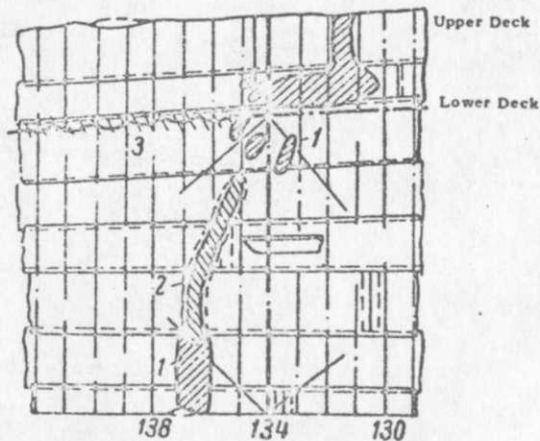
Figure 152 -- HUNTER. Secondary Damage to Stern (Port Side)

1. Cave-ins; 2. Puff-outs; 3. Crimps

Figure 153 -- HUNTER. Secondary Damage to Stern (Starboard Side)

An area of secondary damage to the hull formed in the stern section approximately 30 meters distant from the center of the explosion. In the vicinity of Frame 137, the outer plating on both sides and the decking of the upper and lower decks appeared to have been crumpled (Figures 152 and 153). Damage was limited to spaces immediately in front of the forward bulkhead of Fuel Tanks No. 7 and 8, which were filled with oil; Tanks No. 5 and 6 in front of them were empty.

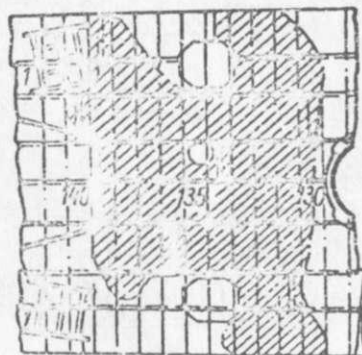
Figure 154 -- HUNTER. Damage to the Upper Deck (Deformed Section Cross Hatched)

1. Foundation of a pair of cranes

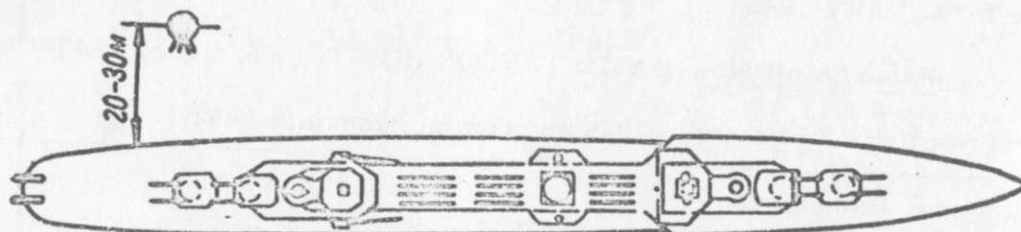
Damage to the Ship and Aftereffects. In July 1944, SOMERS exploded an acoustic mine off the shores of Normandy. The mine detonated in the vicinity of the No. 4 Gun Mount at a distance of 20 to 30 meters from the portside and at a depth of about 20 meters (Figure 157). The ship suffered severe shock; the plating at the stern was caved in to an extent of more than 50 frame spaces; many frames were twisted; several bulkheads appeared to have been deformed. There were no holes in the body.

Figure 157 - SOMERS. Disposition of the Center of the Mine Explosion Shown

The following machinery suffered damage: reduction gears of the main machinery were misaligned, vacuum in the main condensers was lost, and a part of the auxiliary machinery and a great number of pipes were damaged. The following electrical equipment suffered severely: main generators were stopped, circuit breakers on the main distribution boards cut out, and automatic devices on the damaged generators were broken. A searchlight was ripped off and thrown from its foundation. Two radio receivers went out, as did the radar, and so forth.
