NATIONAL AERONAUTICS AND SPACE ADMINISTRATION

APOLLO 13 MISSION REPORT

MANNED SPACECRAFT CENTER

SEPTEMBER 1970

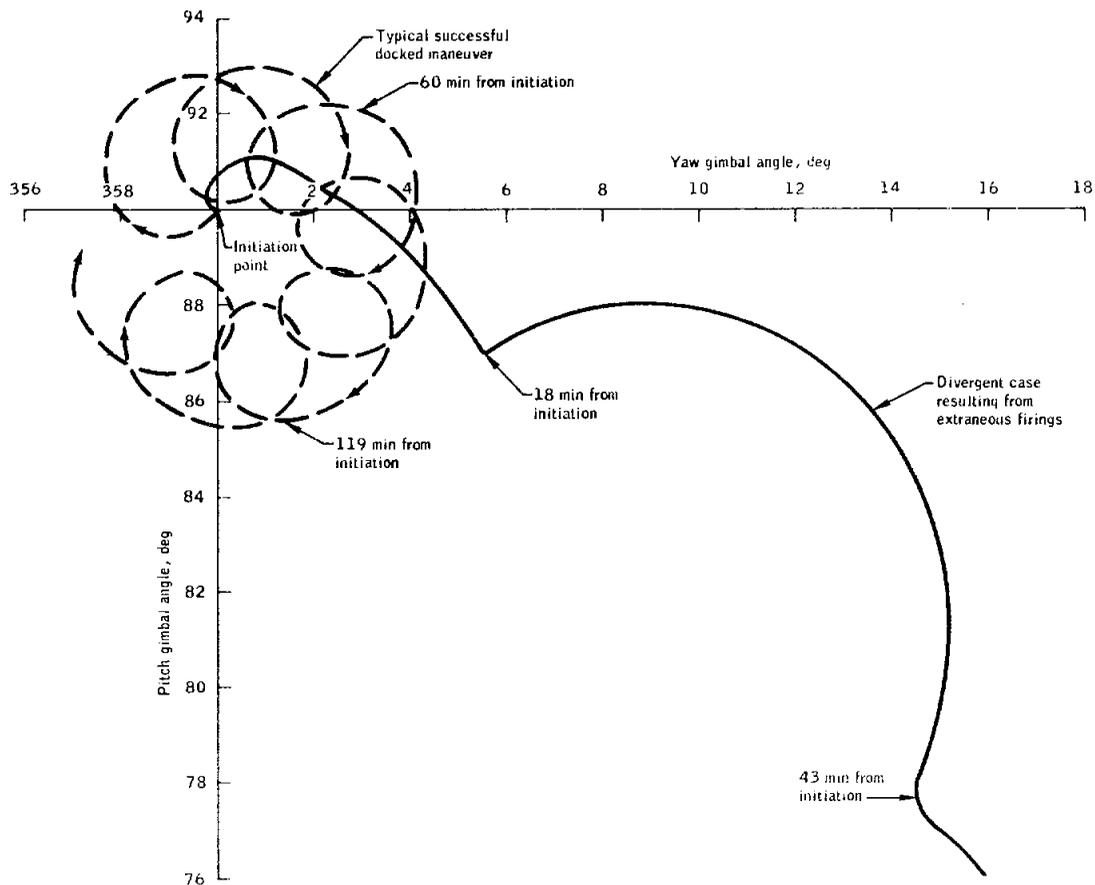
Figure 5.6-1.- Comparison of early translunar maneuver to establish a passive thermal control mode.

firing could have been avoided procedurally by disabling all engines before doing any control system switching. The passive thermal control mode attempted at 32:21:49 is compared with a typical case in figure 5.6-1, which shows the adverse effects of two extraneous firings. All subsequent passive thermal control modes using the command and service module were established normally.

At the time of the oxygen tank incident, three events took place that affected control system performance: the quad C isolation valves closed (as discussed in section 14.1.1), a voltage transient caused a computer restart, and the digital autopilot re-initialized the attitude to which it was referenced. The response of the digital autopilot to these events was as programmed, and rate and attitude errors were reduced to a nulled condition within 75 seconds. Reference 1 contains a more complete discussion of spacecraft dynamics during and after the oxygen tank anomaly.

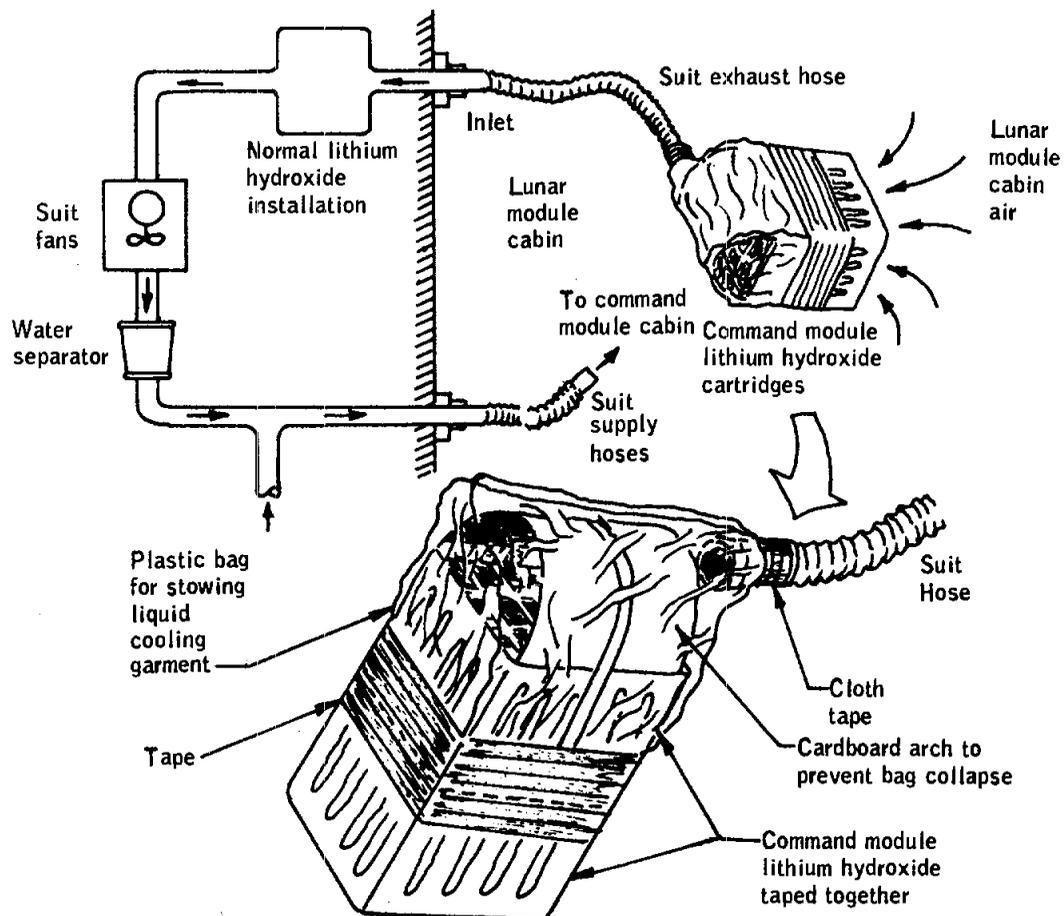
(a) Configuration schematic.

It became apparent that there were insufficient lithium hydroxide cartridges in the lunar module to support the abort mission, even with allowable carbon dioxide levels extended to a partial pressure of 15 mm Hg. With ground instructions, a system was constructed which attached a command module lithium hydroxide cartridge to each of two lunar module suit hoses. The Commander's remaining hose was placed in the tunnel area to provide fresh oxygen to the command module, while the Lunar Module Pilot's remaining hose was positioned in the lunar module environmental control area. At a later time, a second cartridge was added in series to the cartridges initially installed, as shown in figure 6.7-1. In each case, the drop in carbon dioxide levels reported by the ground showed satisfactory operation of this improvised carbon dioxide removal system.

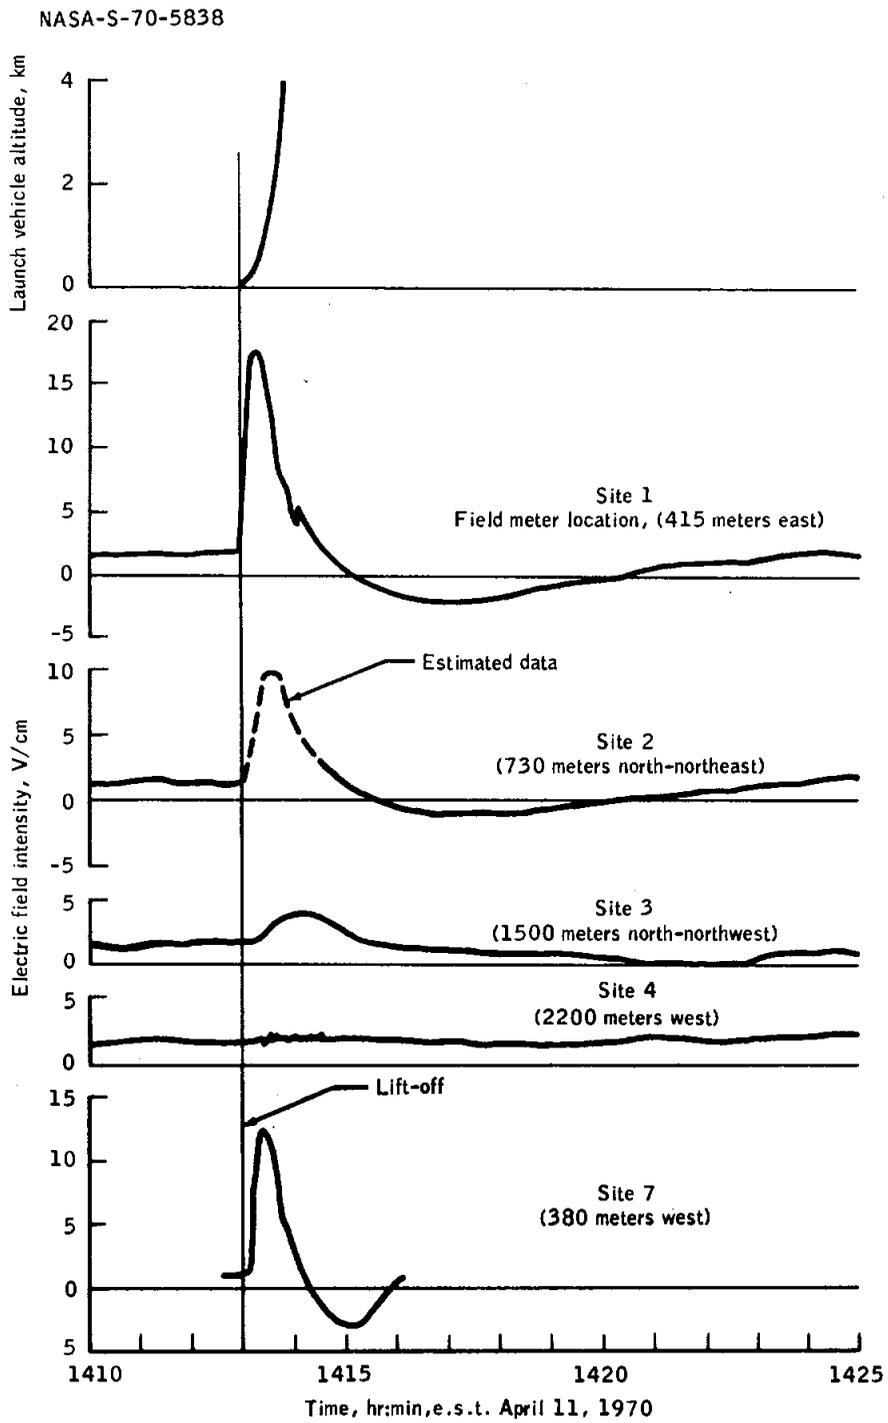
(a) Sites 1 to 4 and 7.

Illustrative data from the field instruments during launch are shown in figure 11.1-3. Very large perturbations of the normal electric field were recorded on meters at sites 1, 2, and 3 located near the launch tower. First, there was a rapid increase in the positive direction, followed by a slower negative decrease. Data taken at site 4, however, did not indicate any significant variations in field intensity. Excellent records at several sensitivity levels were obtained at site 7. The field perturbation immediately following launch rose to a maximum of 1200 volts/meter in about 25 seconds. The direction of field change then reversed, and a negative peak of some 300 volts/meter was reached in about 115 seconds. Thereafter, the field gradually returned to the unperturbed value.

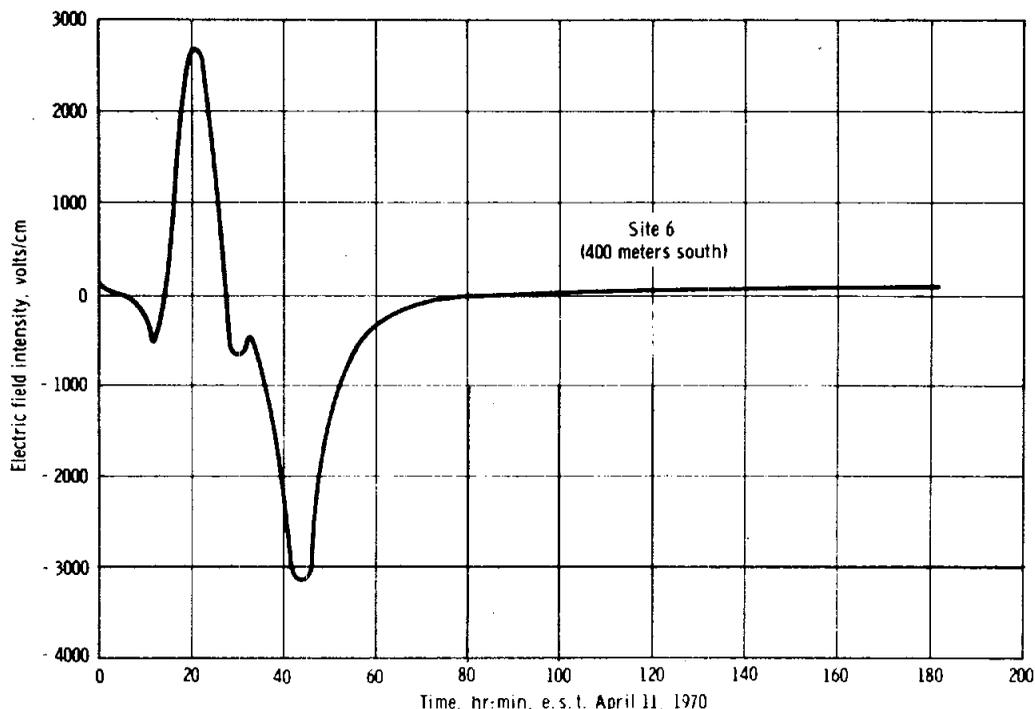
(b) Site 6.

At site 6, the record was similar to that for site 7 with an initial positive excursion followed by a slower negative change. At this station, however, there were large fluctuations superimposed on the record, as shown in figure 11.1-3(b). These fluctuations could have been caused by

gravel and dust stirred up by the exhaust of the launch vehicle engine. After launch, a quantity of such debris was found near the surface of the field meter and its surrounding area. After the oscillations had subsided at T plus 40 seconds, there was a large negative field of approximately minus 3000 volts/meter which probably resulted from the exhaust and steam clouds that tended to remain over site 6.

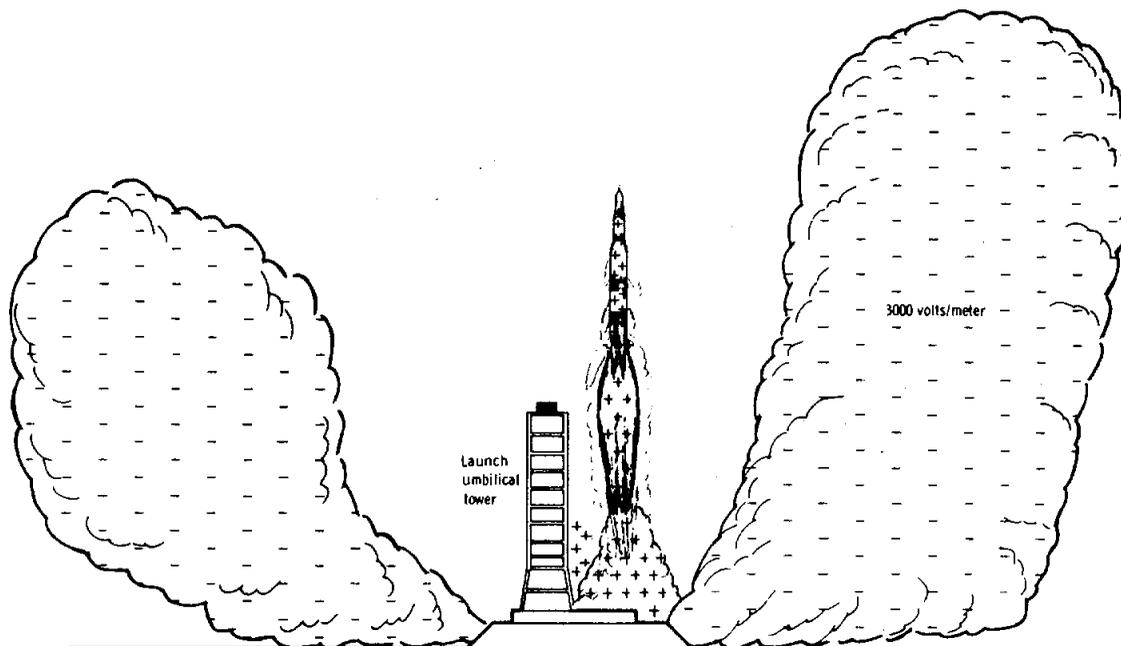
Figure 11.1-4.- Electrical charge characteristics.

Field meter records indicate the Apollo 13 vehicle carried aloft a net positive charge and that the trailing exhaust gases were negatively charged (fig. 11.1-4). Initial analysis indicates the total charge Q carried by the vehicle was about 0.04 coulomb. If the capacitance of the launch vehicle is about 100 picofarads, the vehicle is then at a potential of 4 million volts. A stored charge of 0.04 coulomb at a potential of 4 million volts provides an electrostatic potential energy of 160 000 joules. Although this energy is much less than that dissipated

in a natural lightning discharge, the level is still considerable and could significantly increase the potential hazard in an otherwise marginal weather situation. These numbers are consistent with the electrostatic discharge analysis performed on the Apollo 12 lightning incident. Engines in jet aircraft have been observed to produce similar charging effects.

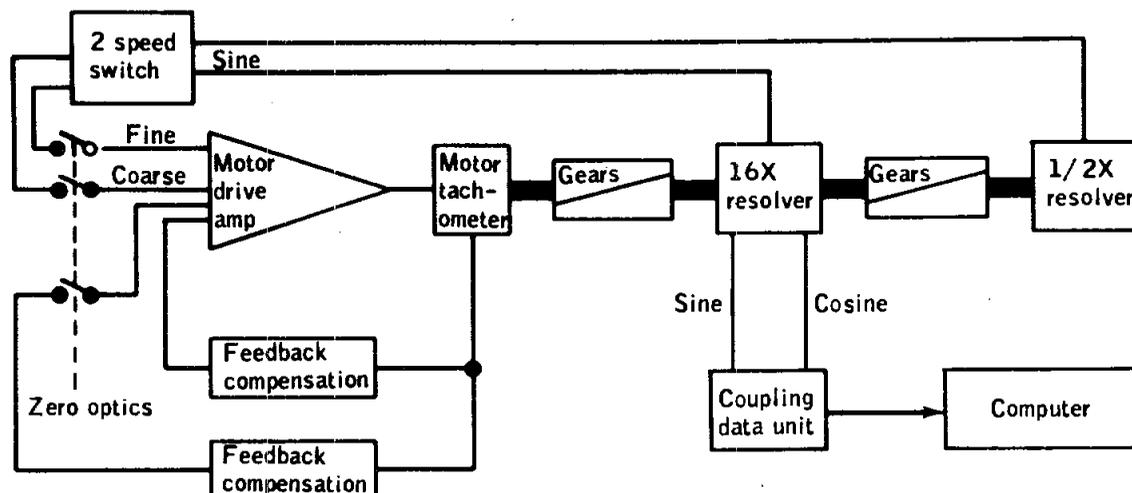
Figure 14-2.- Zero optics mode circuitry.

A simplified schematic of the optics shaft servo loop mechanization is shown in figure 14-2. In the zero optics mode, the sine outputs of

the half-speed and 16-speed resolvers are routed through a coarse/fine switching network to the motor drive amplifier and are used to null the system. Rate feedback from the motor tachometer is routed to the drive amplifier through a compensation network which removes any bias in the signal. When the zero optics mode is selected, the coupling-data-unit counter and the computer register which contains the shaft angle are zeroed for 15 seconds and then released to follow the 16-speed resolver. The half-speed resolver, the fine/coarse switching network, and the tachometer feedback compensation are used only in the zero optics mode.

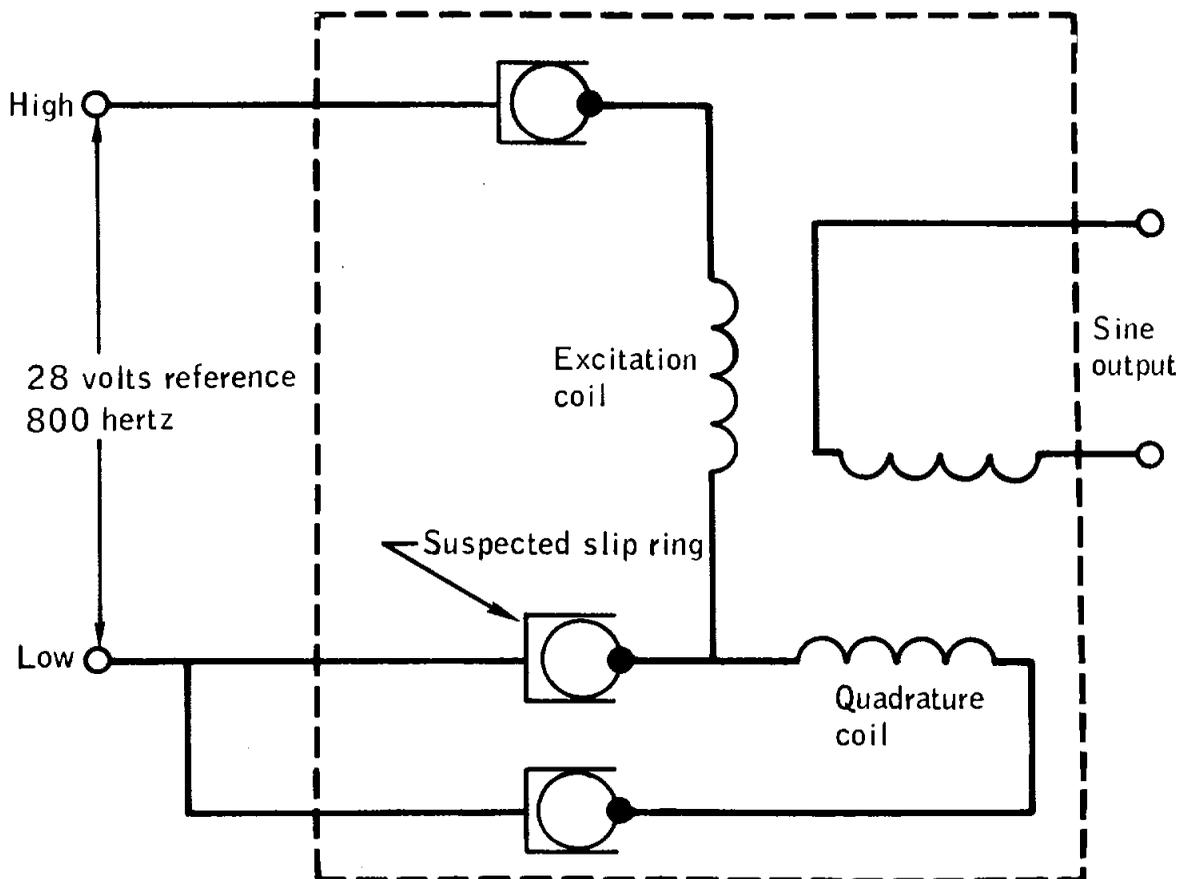
Figure 14-4.- One-half speed resolver.

The most likely candidate is the half-speed resolver, which is used only for the shaft axis and only to provide an unambiguous zero reference. The reference voltage is applied to the rotor through slip rings (fig. 14-3), connected as shown in figure 14-4. If any resistance is present in the common ground path through the slip ring, a portion of the reference voltage will appear across the quadrature winding and induce a finite output (different than zero). Zero output is equivalent to zero degrees in shaft rotation.

Simulated changes in slip ring impedance were made on the half-speed resolver in the shaft loop (fig. 14-4). An impedance of 50 ohms produced an offset of approximately plus 0.5 degree in sextant shaft angle. The trunnion loop does not use this type of resolver or connection.

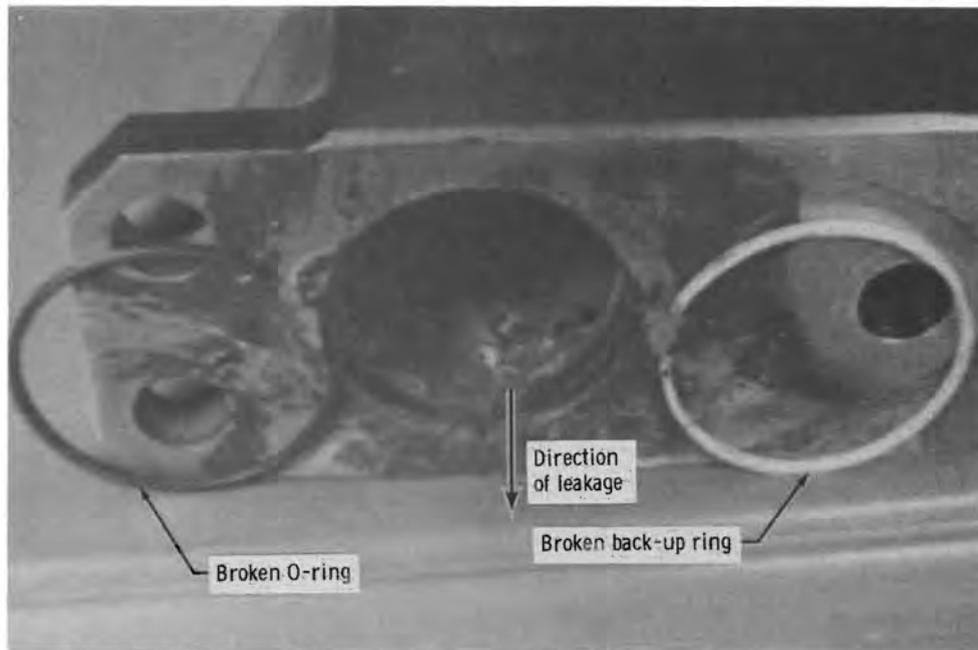
Figure 14-9.- Plenum side of breech-plenum interface.

During postflight inspection, it was discovered that propellant gas had leaked from the gusset-4 breech assembly, which is a part of the apex cover jettison system (fig. 14-7). A hole was burned through the aluminum gusset cover plate (fig. 14-8), and the fiberglass pilot parachute mortar cover on the parachute side of the gusset was charred but not penetrated. The leakage occurred at the breech-plenum interface (fig. 14-9). The breech and plenum are bolted male and female parts which are sealed with a large O-ring backed up with a Teflon ring, as shown in figure 14-7. During operation, the breech pressure reaches approximately 14 000 psi and the gas temperature exceeds 2000° F. The O-ring and backup ring were burned through and the metal parts were eroded by the hot gas at the leak path. The system is completely redundant in that either thruster system will effect apex cover jettison. No evidence of gas leakage existed on the previous firings of 56 units.

sheet (fig. 14-10) will be applied to the interior of the breech plenum area on future spacecraft. The protection provided by the polyimide has been proof-tested by firing the assembly without the O-ring, simulating a worst-case condition.

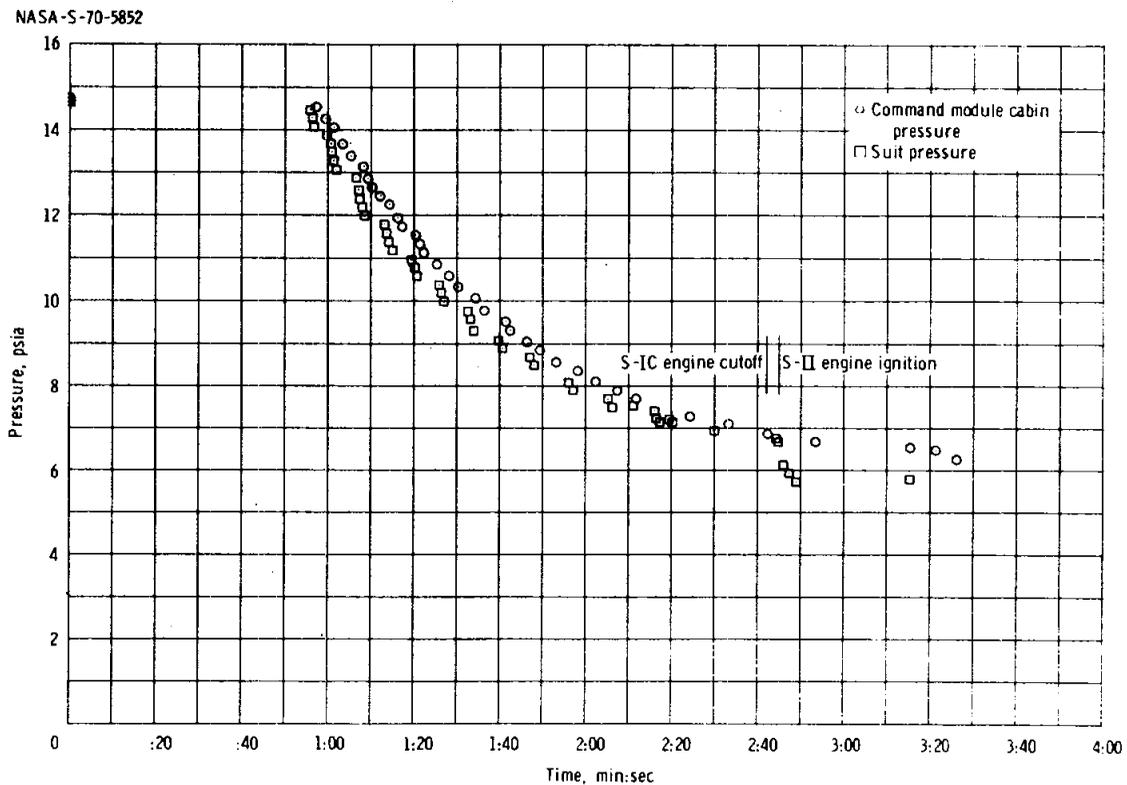
(a) Lift-off through 4 minutes.

During launch the suit pressure transducer reading remained consistent with cabin pressure until 00:02:45, then suddenly dropped from 6.7 to 5.7 psia coincidentally with S-II engine ignition (fig. 14-12). The difference between the two measurements decreased to only 0.2 by 1-1/2 hours, when the cabin reached its nominal regulated pressure of 5.0 psia. For this shirtsleeve mode, the suit and cabin pressure readings should be nearly equal. During normal variations in the command module cabin pressure, the suit pressure measurement responded sluggishly and indicated as much as 1 psi low. Subsequently, the measurement output decayed and remained in the 4.1 to 4.3 psia range for a cabin pressure of 5.0 psia until system deactivation at about 59 hours (fig. 14-12).

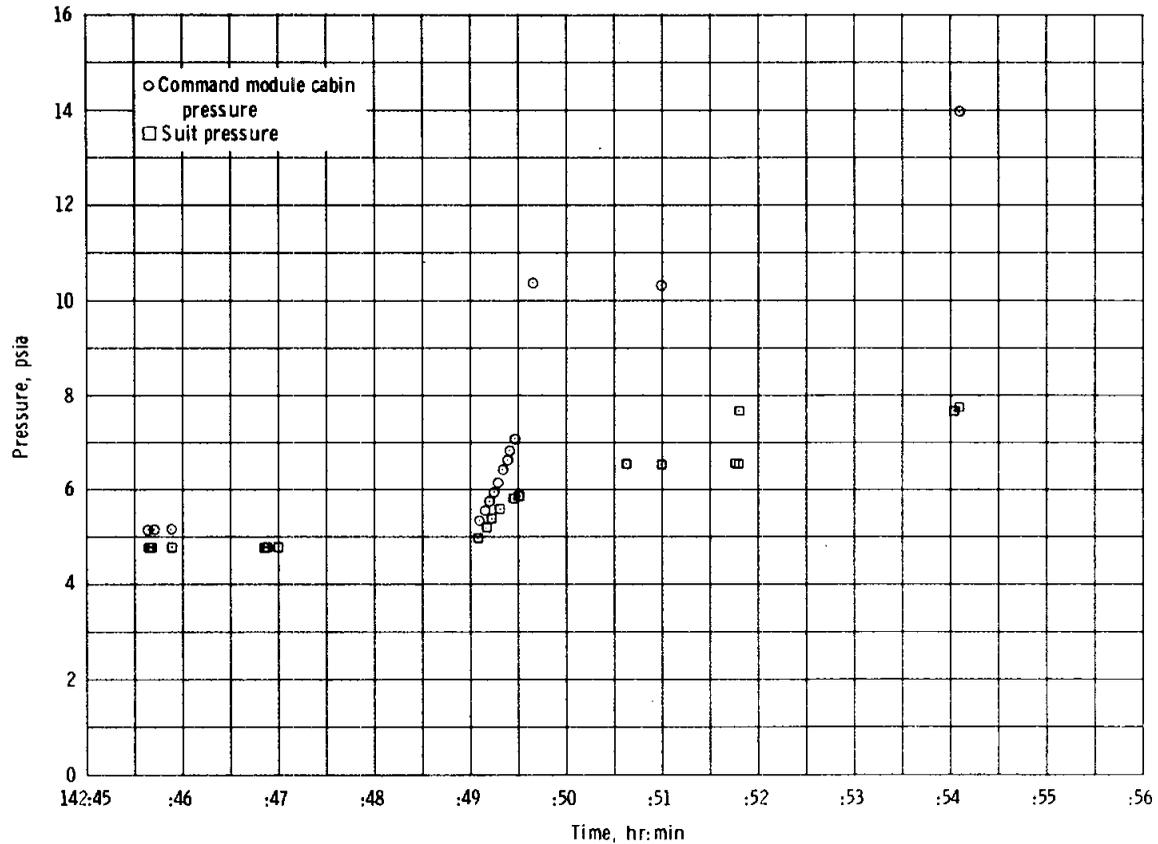
(c) 142:45 through 142:56 hours.

During periods when the lunar module and the command module cabins were interconnected, the lunar module and command module cabin pressure readings were approximately equal, verifying the operation of the command module cabin pressure transducers.

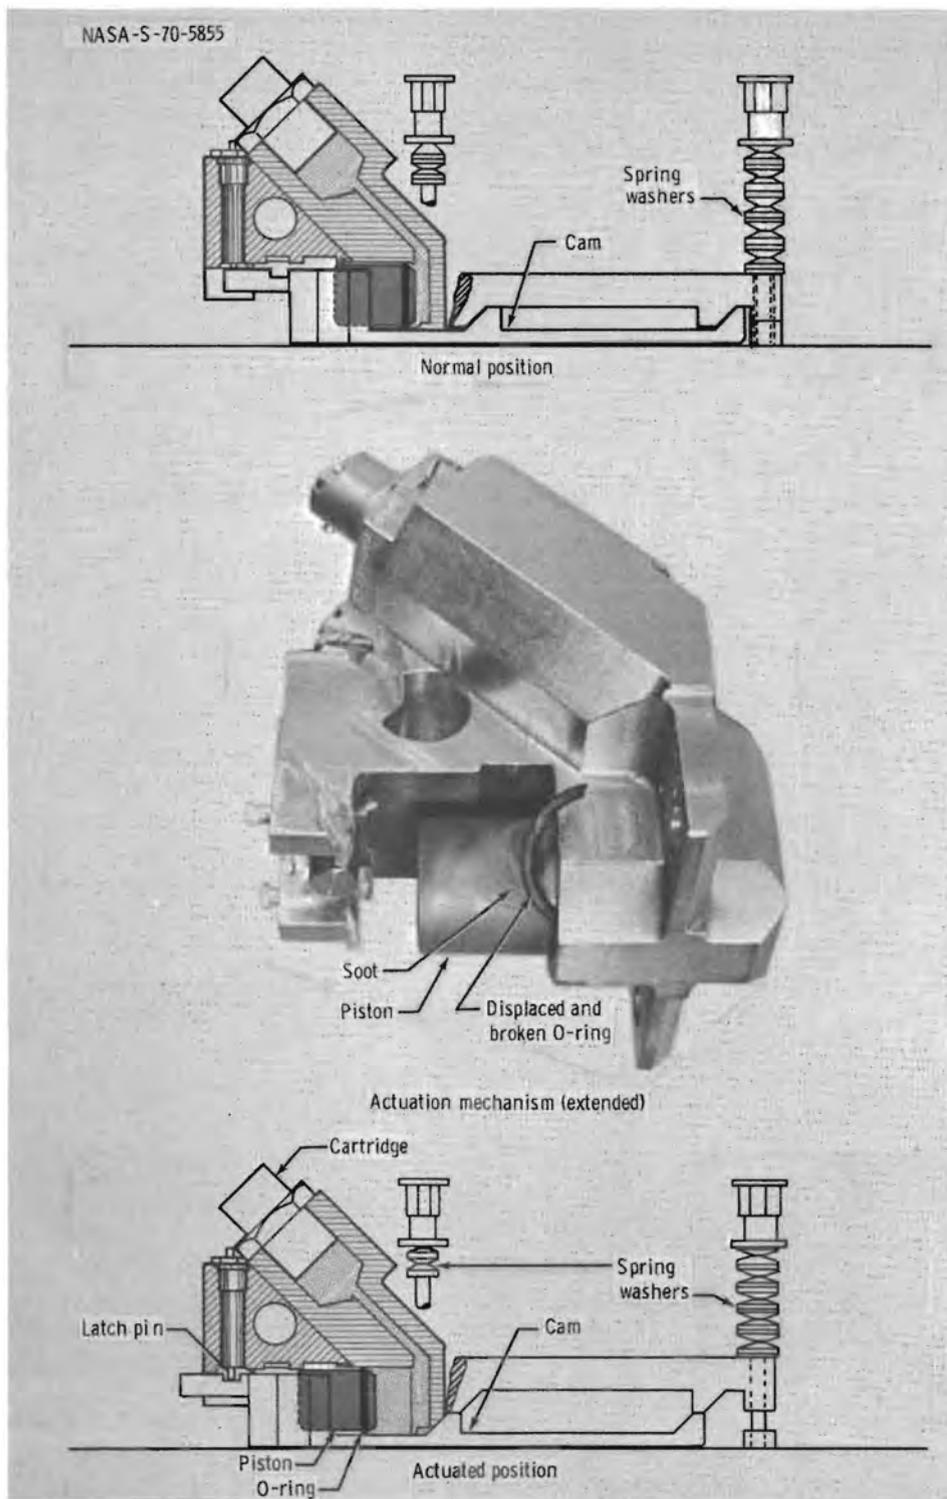
Figure 14-13.- Circuit interrupter.

During postflight inspection of the command module, propellant gas was noted to have escaped from the left-hand electrical circuit interrupter, mounted in the lower equipment bay, and deposited soot on adjacent equipment. The right-hand circuit interrupter showed no evidence of a gas leakage. The removed breech, showing the displaced O-ring and crushed attenuator block, is shown in figure 14-13.

The two interrupters open the electrical circuits about 30 milliseconds before the wires are severed by the command module/service module umbilical guillotine. As illustrated in the figure, a cam fork is moved by a piston, which is operated by propellant gas from redundant cartridges, to function a lift plate. Motion of this plate disconnects the male and female portions of electrical connectors located, respectively, in the lift plate and in the base plate of the interrupter. At the completion of the stroke, the fork is brought to rest by impacting and crushing an aluminum block mounted on the interrupter housing.

The worse-case tolerance buildup is when the fork contacts the attenuator block and the piston O-ring is 0.075 inch from entering the chamfer in the breech assembly. The O-ring enters this chamfer when the block has been crushed about 94 percent, at which point an O-ring displacement and accompanying gas escape could be expected. The factors which affect the degree of attenuator crushing are generally uncontrollable within narrow limits and include:

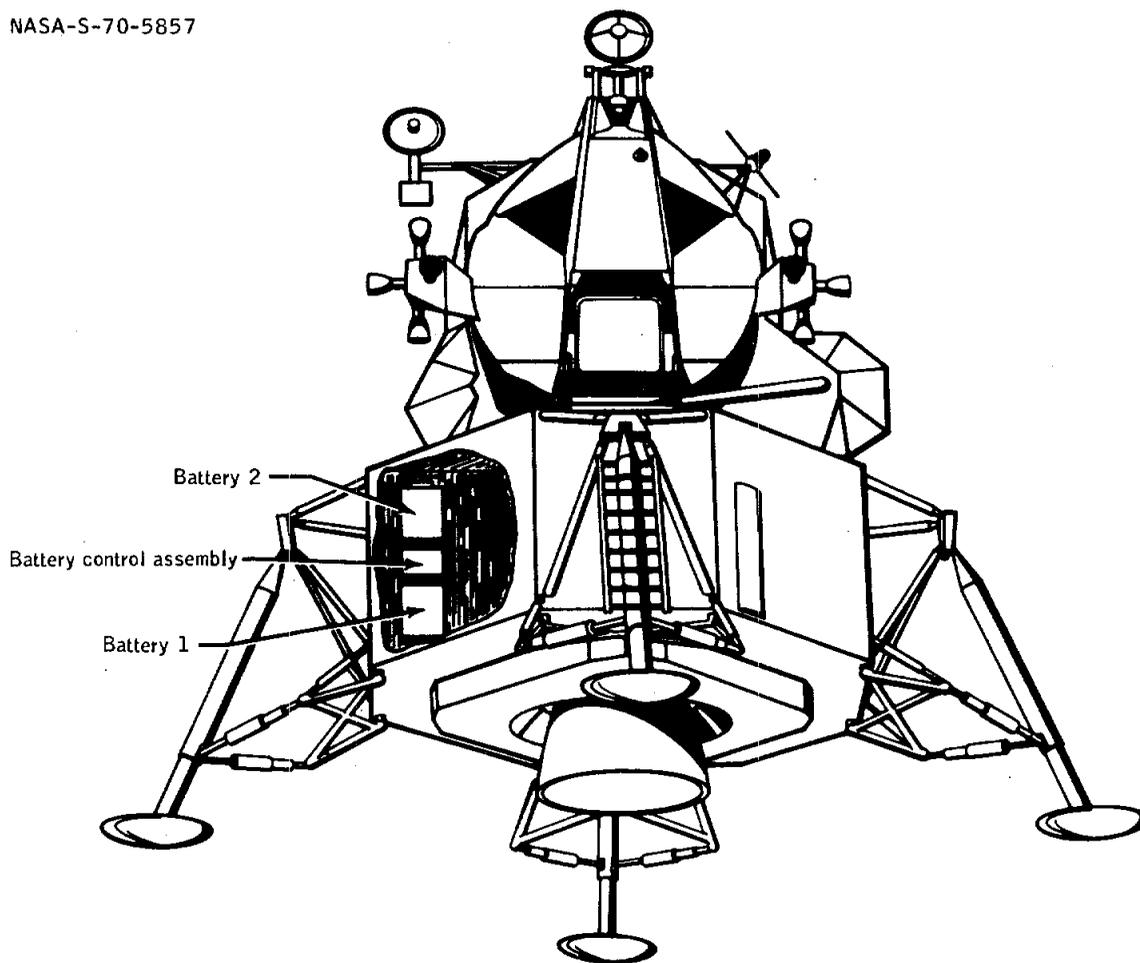
Figure 14-15.- Descent stage battery location.

At 97 hours 14 minutes, the crew reported a thumping noise and snowflakes venting from quadrant 4 of the lunar module descent stage (fig. 14-15). All four descent batteries experienced current transients at 97:13:53 for about 2 seconds, with corresponding drops in dc bus voltage (fig. 14-16). Also, the water glycol pressure differential for the heat transport system decreased momentarily, indicating that the glycol pump momentarily slowed down.

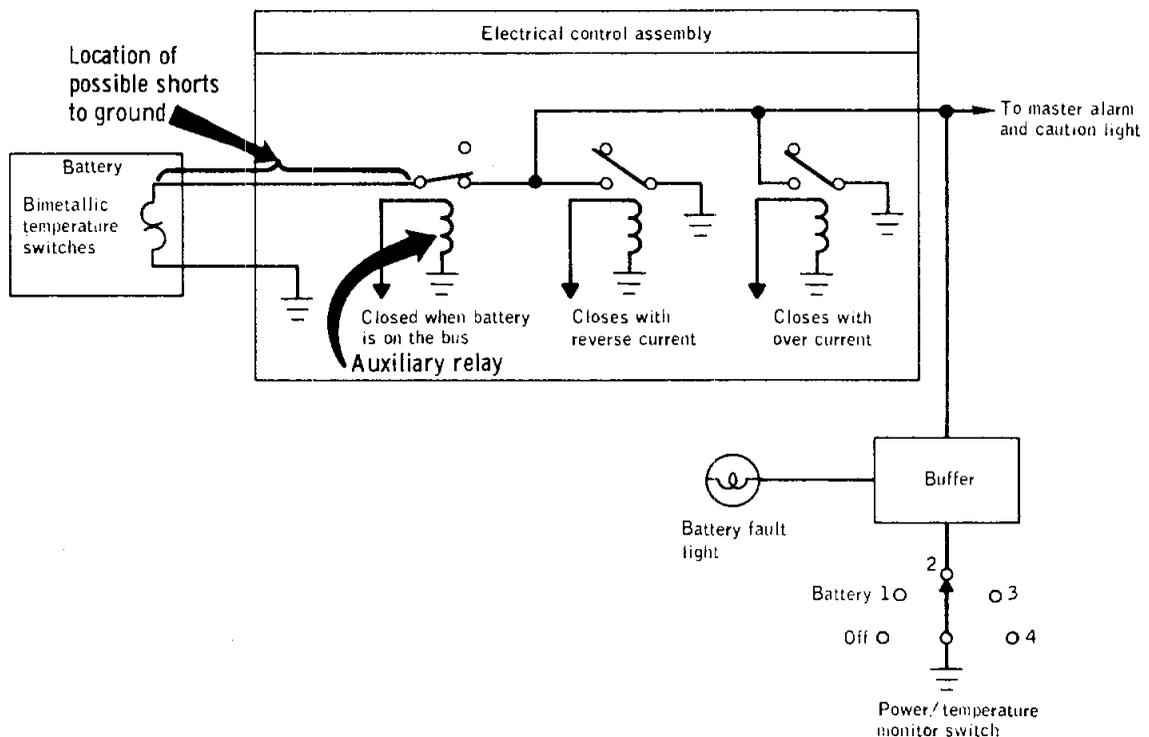
NASA-S-70-5860

The battery malfunction light illuminated at about 100 hours with a corresponding master alarm. The malfunction, isolated to battery 2, could have been caused by an overcurrent, a reverse-current condition, an over-temperature condition, or possibly an erroneous indication. The logic for these malfunction conditions is shown in figure 14-18.

Figure 14-18.- Battery 2 malfunction circuit.

A battery overcurrent can be ruled out because automatic removal of the battery from the bus would have occurred.

A reverse-current condition can be ruled out because, if the battery is removed from and reapplied to the bus, the reverse-current circuit has a built-in delay of about 5 seconds before the reverse-current relay is again activated to illuminate the light. Battery power was removed from and replaced on the bus in flight, and the light immediately illuminated again when the battery was reconnected.

An over-temperature condition can be ruled out because, after the battery was replaced on the bus, the light remained illuminated for a brief period and then began flickering intermittently. A flickering light cannot be caused by the temperature sensing switch because of a temperature hysteresis of approximately 20° F in the switch. The water glycol loop temperature also indicated that the battery temperature was normal.

Either a short between the temperature switch wires to ground or a contamination in the auxiliary relay would actuate the light. The shorted condition could have resulted from electrolyte shorting within the battery case associated with the current surges discussed in the previous section. Contamination of the auxiliary relay has occurred in the past, and relays already packaged were not retrofitted since a false over-temperature indication can be identified as it was here.

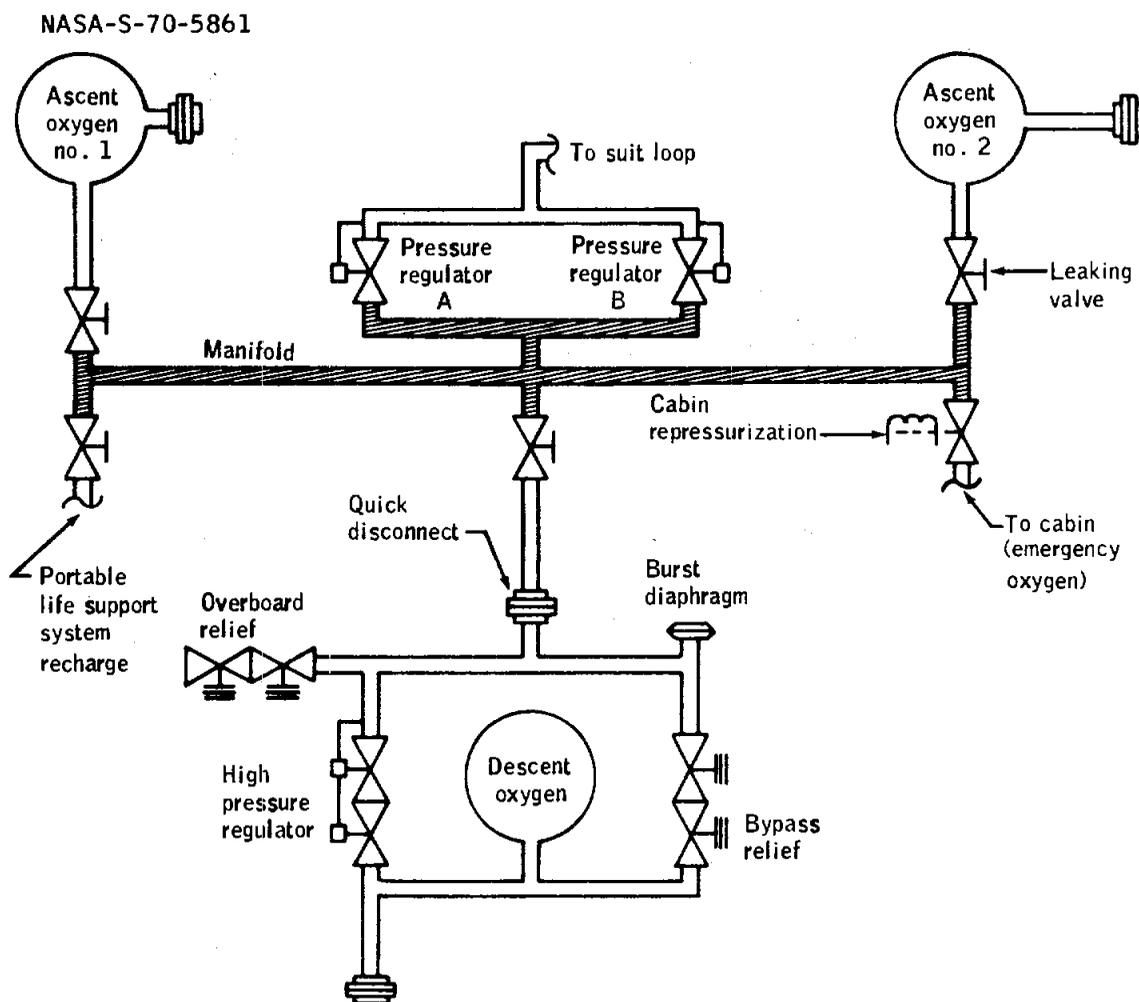
During the flight, the pressure in the ascent stage oxygen tank 2 increased, indicating a reverse leakage through the shutoff valve from the oxygen manifold (fig. 14-19) into the tank. The leak rate, with a maximum differential pressure of 193 psi, varied from about 0.22 lb/hr (70 000 scc/hr) to zero when the tank pressure reached manifold pressure. Allowable leakage for the valve in either direction is 360 scc/hr. Pre-flight test data indicate a reverse leakage of 360 scc/hr and no excessive leaking in the forward direction.

The internal portion of three valves of this type had been replaced previously on the spacecraft because of excessive leakage through the ascent oxygen tank 1 shutoff valve. In one valve, a rolled O-ring

Figure 14-19.- Oxygen-supply system.

(fig. 14-20) caused the leakage. When the valve is installed, the forward O-ring can be rolled and damaged when it passes the manifold port. In the other two valves, the cause was not identified and was assumed to be contamination.

The production tolerances of the valve and bore were examined to determine if a tolerance buildup problem existed. The manufacturer's specification to which the valve was designed requires that the O-ring be subjected to a compression of between 0.0115 and 0.0225 inch, whereas the O-ring supplier recommends between 0.011 and 0.017 inch. The added

Leak tests previously performed on the valve were inadequate, in that only reverse leakage at high pressure was determined. For future vehicles, forward and reverse leakage at both high and low pressures will be measured to detect any defective valves.
