MSC-04112

APOLLO 14 MISSION REPORT

MANNED SPACECRAFT CENTER HOUSTON.TEXAS MAY 1971

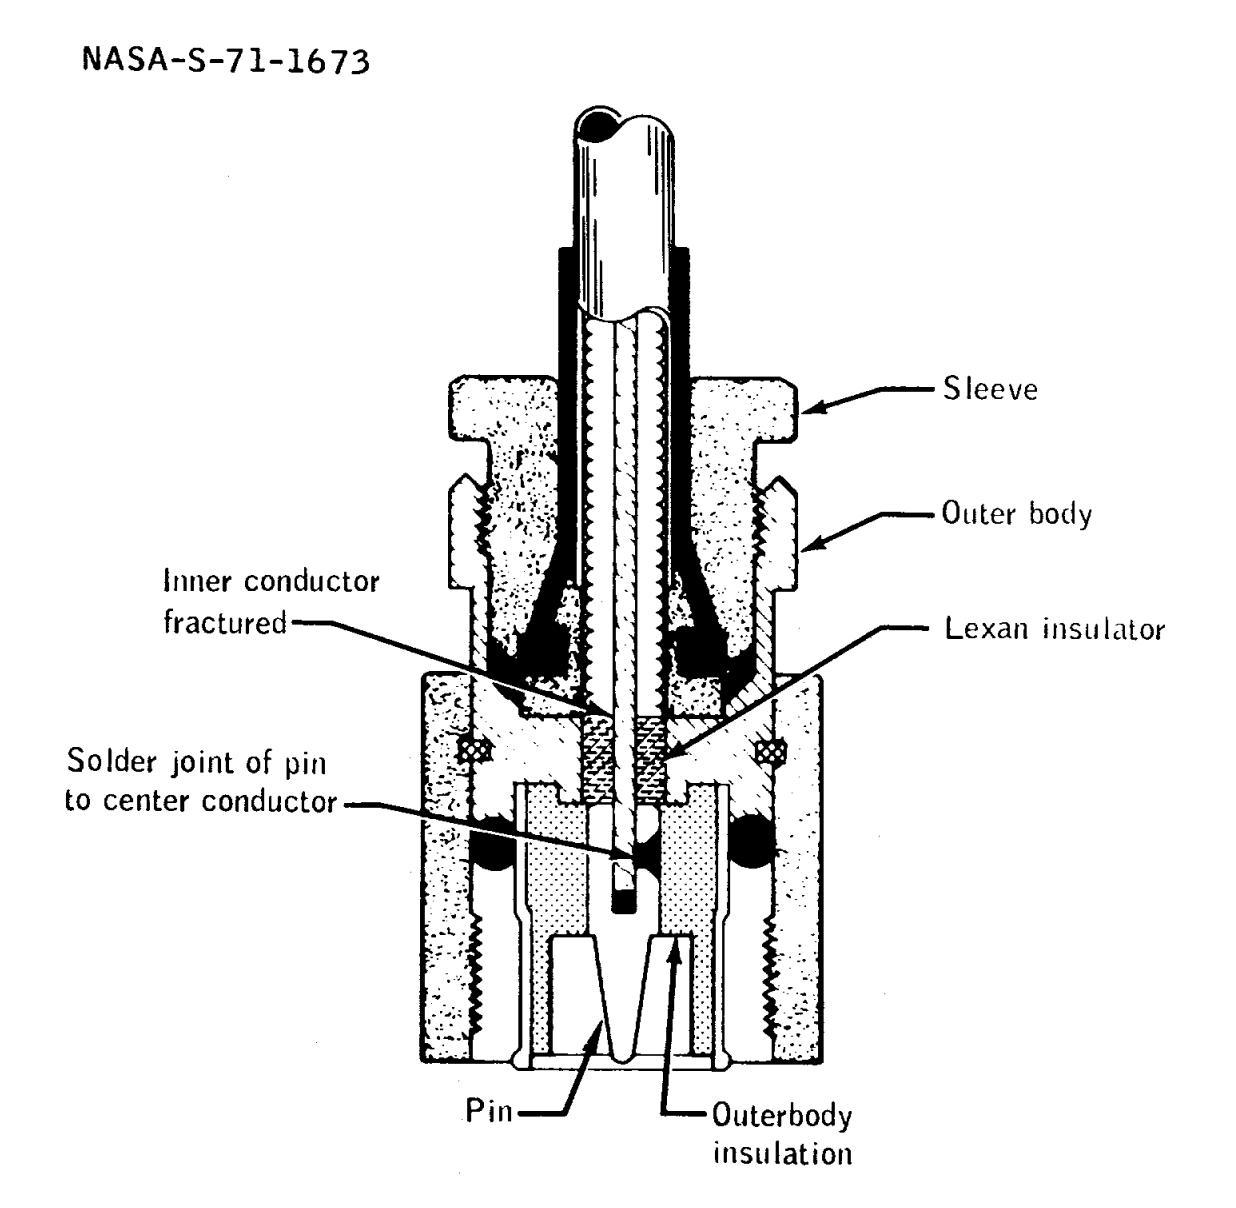
Figure 14-5.- Coaxial cable failures.

In support of this cause, five bad coaxial center conductors have been found. Also, a coaxial connector was disconnected on the antenna and the effect in the beam occurred. There are two causes of the problem with the center conductor, both of which occur during cable-to-connector assembly (fig. 14-5). The sleeve is assembled to the cable, a Lexan insulator is then slipped over the center conductor, and the pin is inserted over the center conductor and soldered. If the wire gets too hot during soldering, the Lexan grows and no longer fits loosely through the hole in the outer body. When this occurs and the outer body is screwed onto the sleeve, the wire can be twisted and the center conductor may fail.

Another possible failure occurs when too much solder is used or the wire is not centered in the pin. These conditions will bind the pin to the outer body insulation and, during assembly, the wire is twisted to failure. These conditions are being corrected by reworking all connectors and applying proper inspection and control procedures during the rework.

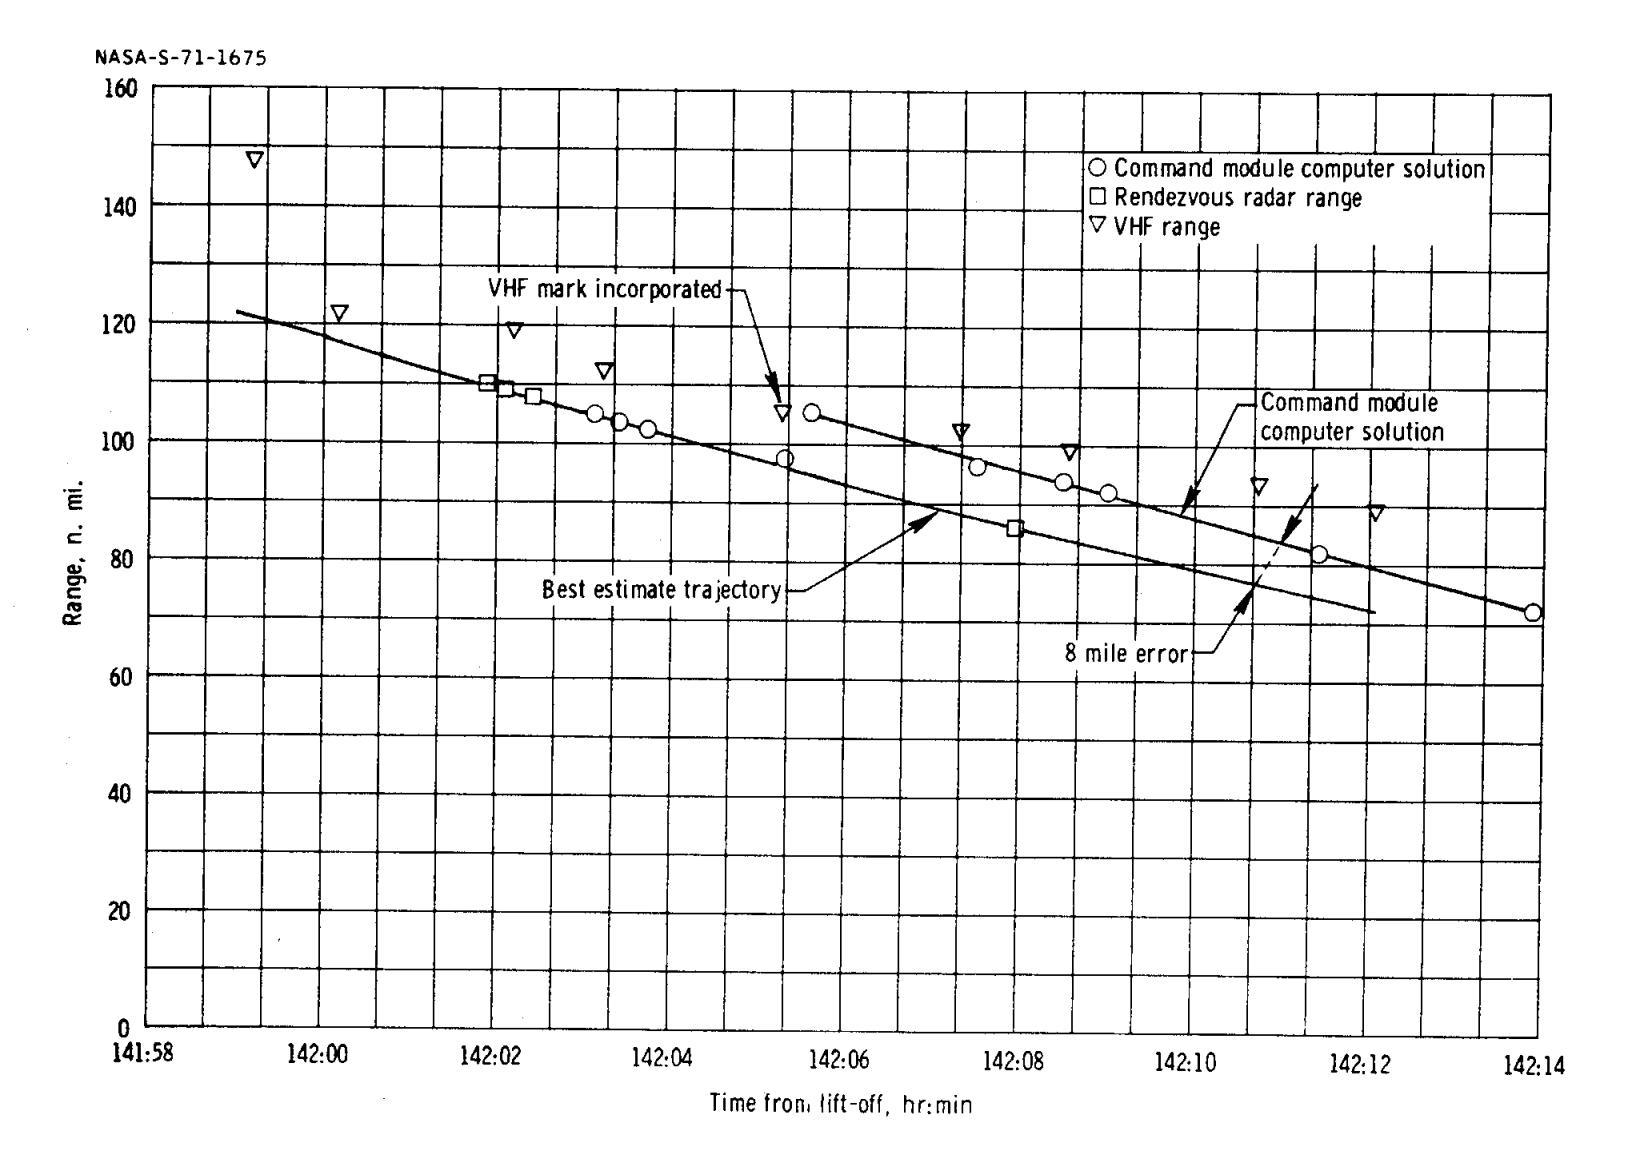
Figure 14-7.- Relative range comparisons during rendezvous.

Prior to lunar descent, the VHF ranging and rendezvous radar range measurements correlated closely. However, during the time period preceding terminal phase initiation, the VHF ranging system indicated erroneous measurements. During this same time period, numerous range tracking dropouts also occurred. The range measurements were in error by 5 to 15 miles when compared with the rendezvous radar range measurements (fig. 14-7). The VHF ranging data presented in the figure results from a number of different acquisitions. After terminal phase initiation, the

signal strength, as indicated by the lunar module receiver automatic gain control voltage measurement, was adequate and VHF ranging operation was normal.

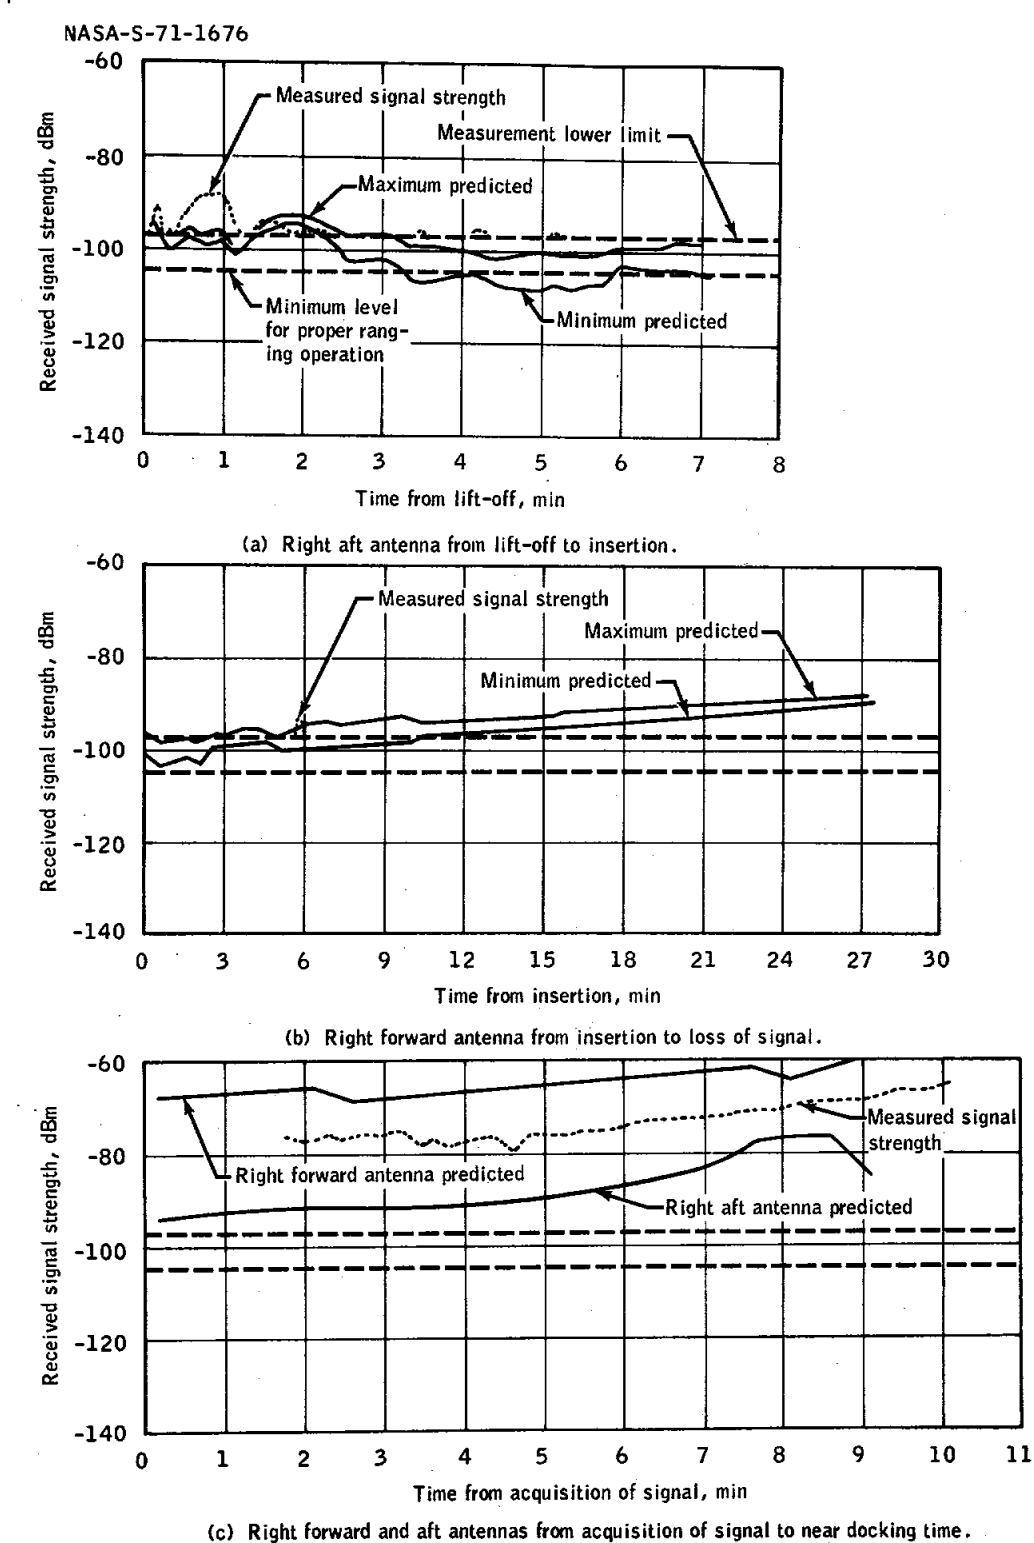
Figure 14-8.- Received signal strength from omnidirectional antennas.

These problems would be expected if the signal strength were low. The signal strength was determined by measuring the automatic gain control voltage in the lunar module VHF receiver. The measurement range was -97.5 to -32 dBm. Figure 14-8 shows the predicted signal strengths and those measured during the mission at the lunar module receiver.

The maximum predicted values assume that direct and multipath signals add. For the minimum predicted, the multipath signal is assumed to subtract from the direct signal. The antenna pattern model used consisted of gain values in 2-degree increments and did not include all the peaks that are known to occur because of antenna polarization differences between the lunar module and command and service module. Line-of-sight to the command module passing through one of these peaks would explain the pulses shown in figure 14-8(a).

Figure 14-8(b) shows that the signal strength should have been on scale subsequent to about 10 minutes after insertion. Figure 14-8(c)shows that the measured signal strength was below that expected for the right-forward antenna, the one which the checklist called out to be used, from insertion to docking and above that predicted for the right-aft antenna for this same time period. This indicates that the proper antenna was selected, but some condition existed which decreased the signal strength to the lunar module receiver.

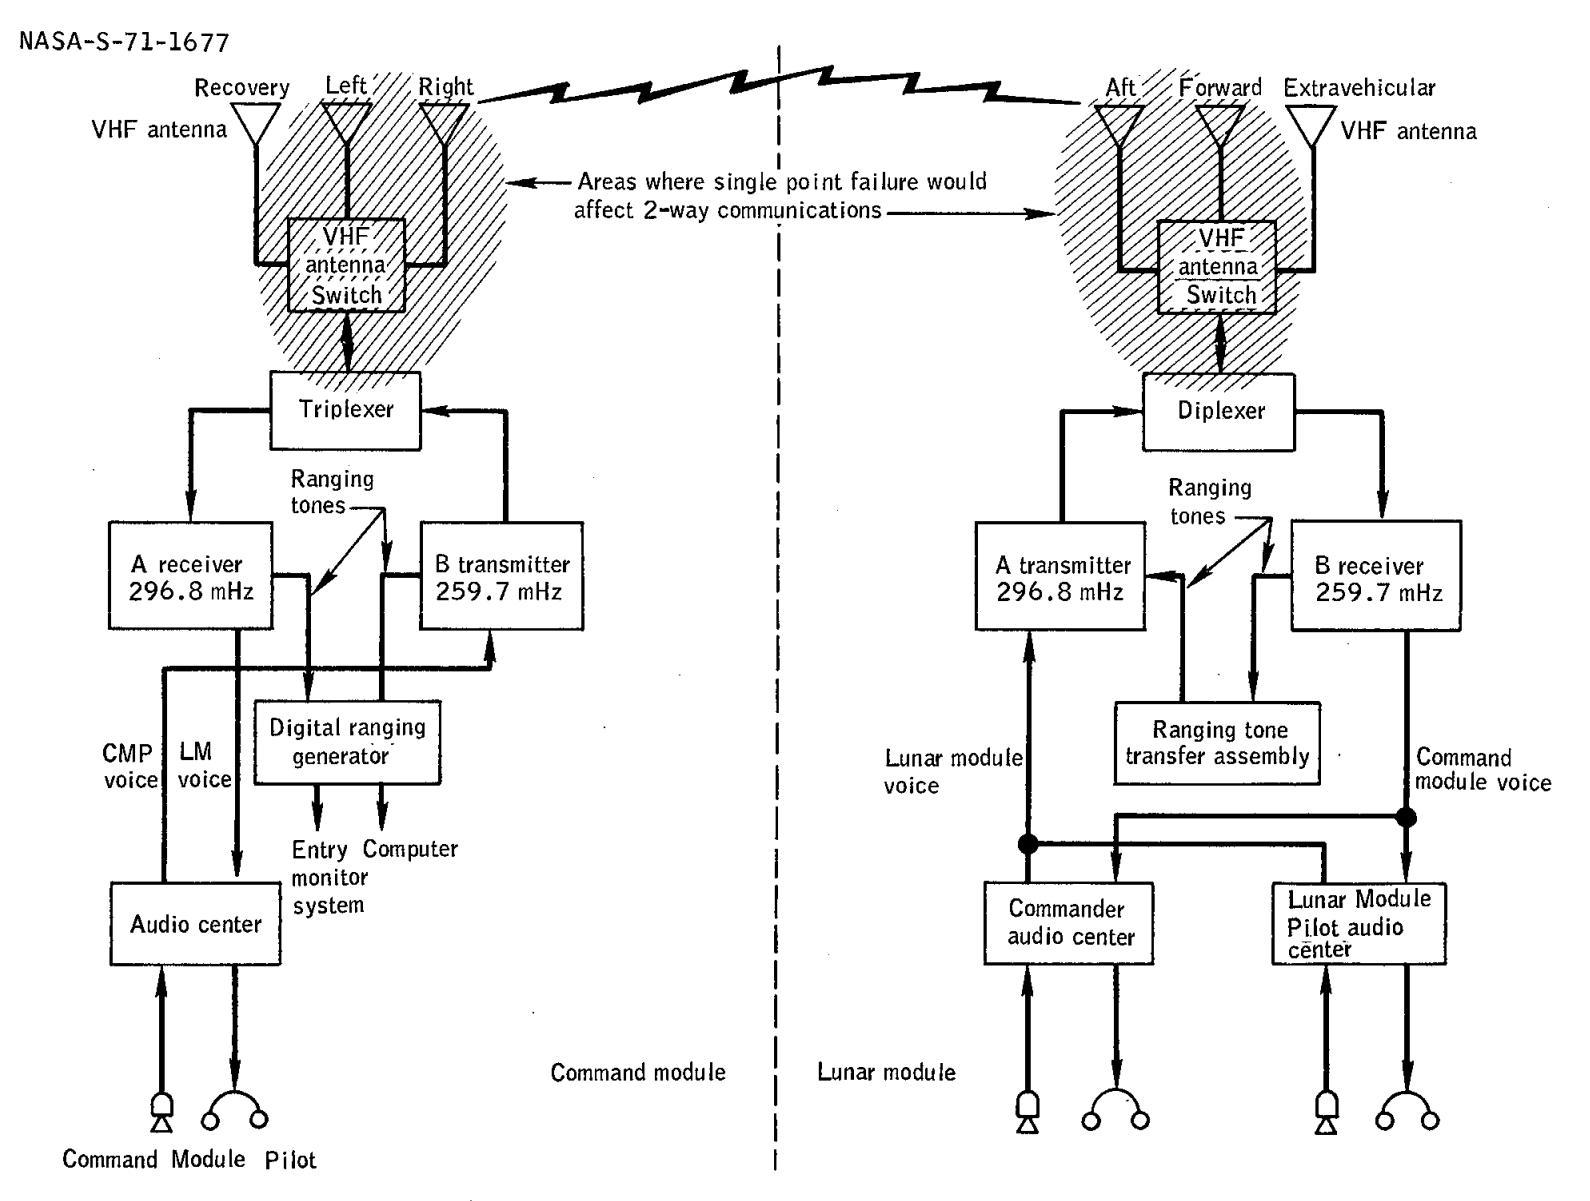
Figure 14-9.- Block diagram of VHF communications systems.

The lower-than-normal RF link performance was a two-way problem (voice was poor in both directions); therefore, certain parts of the VHF system are prime candidates for the cause of the problem. Figure 14-9 is a block diagram of the VHF communications system as configured during the rendezvous phase of the mission. Also shown are those areas in which a malfunction could have affected the two-way RF link performance. A single malfunction in any other area would have affected one-way performance only.

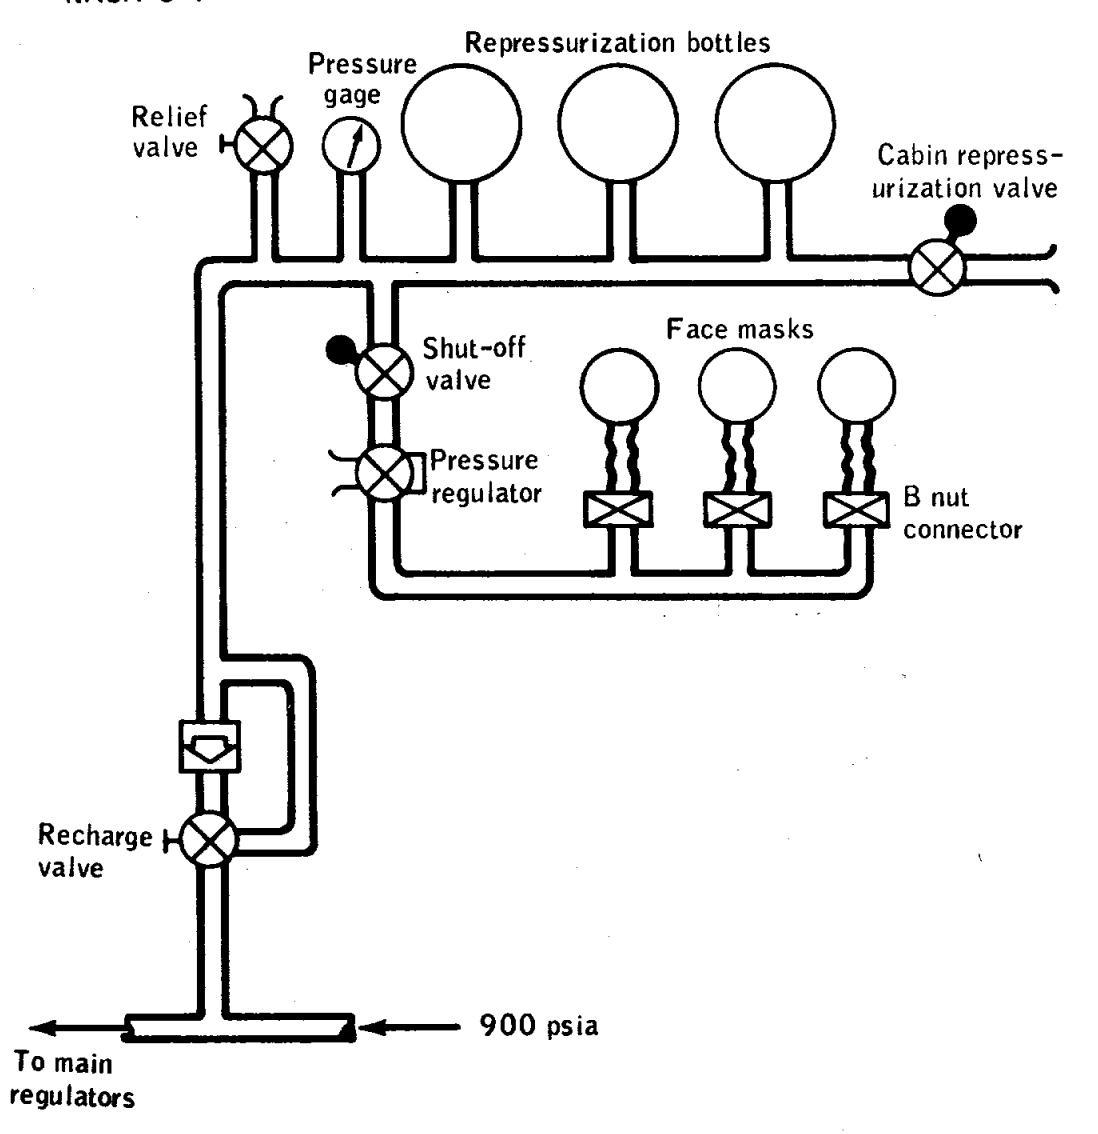
Figure 14-12.- Rapid repressurization system.

Repressurization of the three storage bottles in the rapid repressurization system (fig. 14-12) was required three times in addition to the normal repressurizations during the mission. The system required repressurization once in lunar orbit and twice during the transearth coast phase. Just prior to the first of the transearth coast repressurizations, the system had been used (face mask checks) and refilled (fig. 14-13). In this instance, the fill valve was closed before the system was fully recharged. Calculations from the surge tank pressure data indicate that the repressurization package was at approximately 510 psi at 199 hours 48 minutes and was only recharged to about 715 psi (fig. 14-13). The cabin indication of the repressurization package pressure would have indicated a higher pressure because of the temperature rise of the compressed gas. The crew noted a value of about 700 psi (due to temperature stabilization) at approximately 211 hours and recharged the system again.

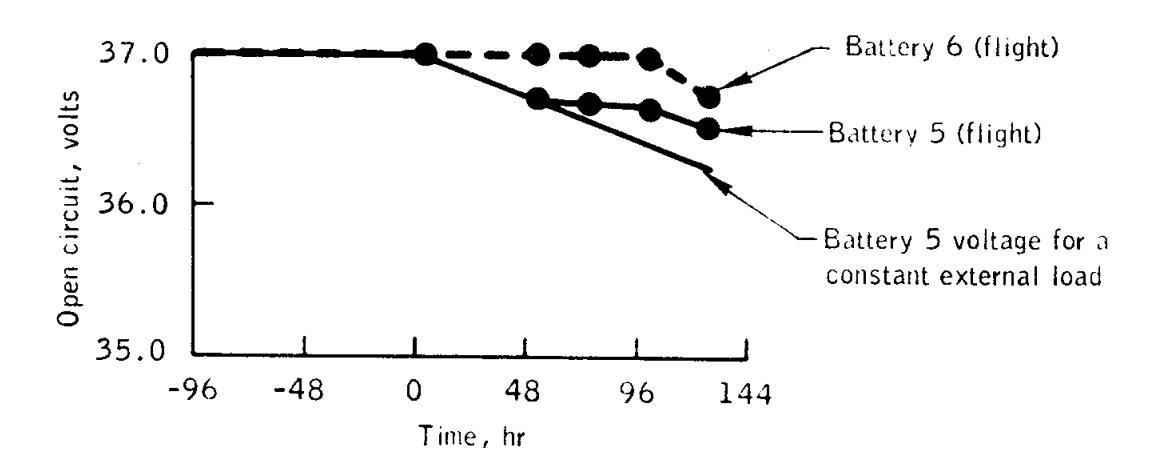
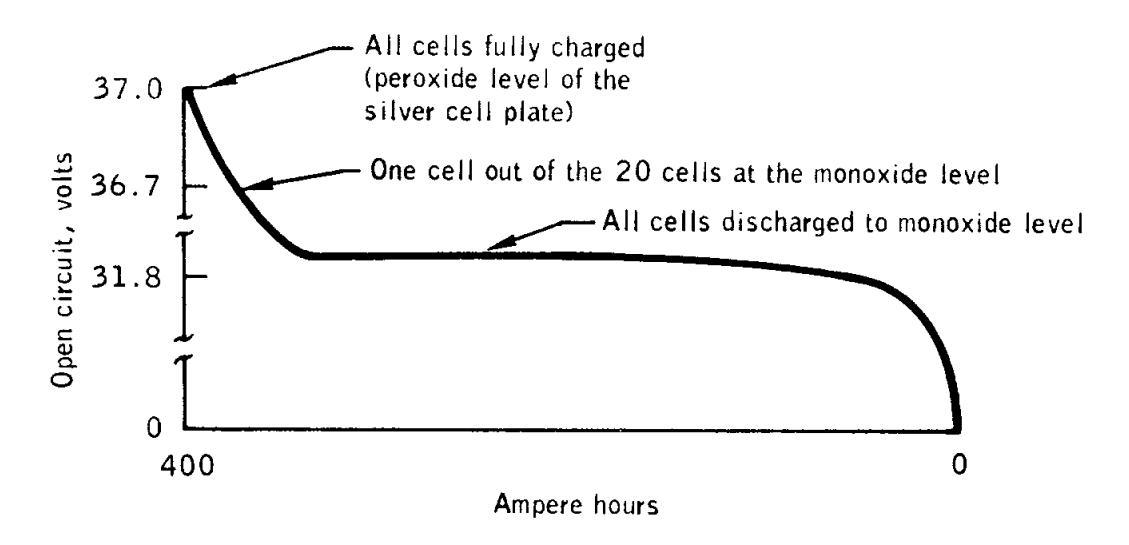
At 62 hours, the ascent battery 5 open-circuit voltage had decreased from a lift-off value of 37.0 volts to 36.7 volts instead of remaining at a constant level (fig. 14-14(a)). Figure 14-14(b) shows characteristic open-circuit voltages for a fully charged battery (peroxide level of all cells) and all cells operating on the monoxide level of the silver plate. Note that one cell at the monoxide level and the remaining 19 at the peroxide level would have caused the observed open-circuit voltage of 36.7 volts. Any one of the following conditions could have caused the voltage drop.

- a. Battery cell short
- b. Cell short-to-case through an electrolyte path
- c. External battery load.

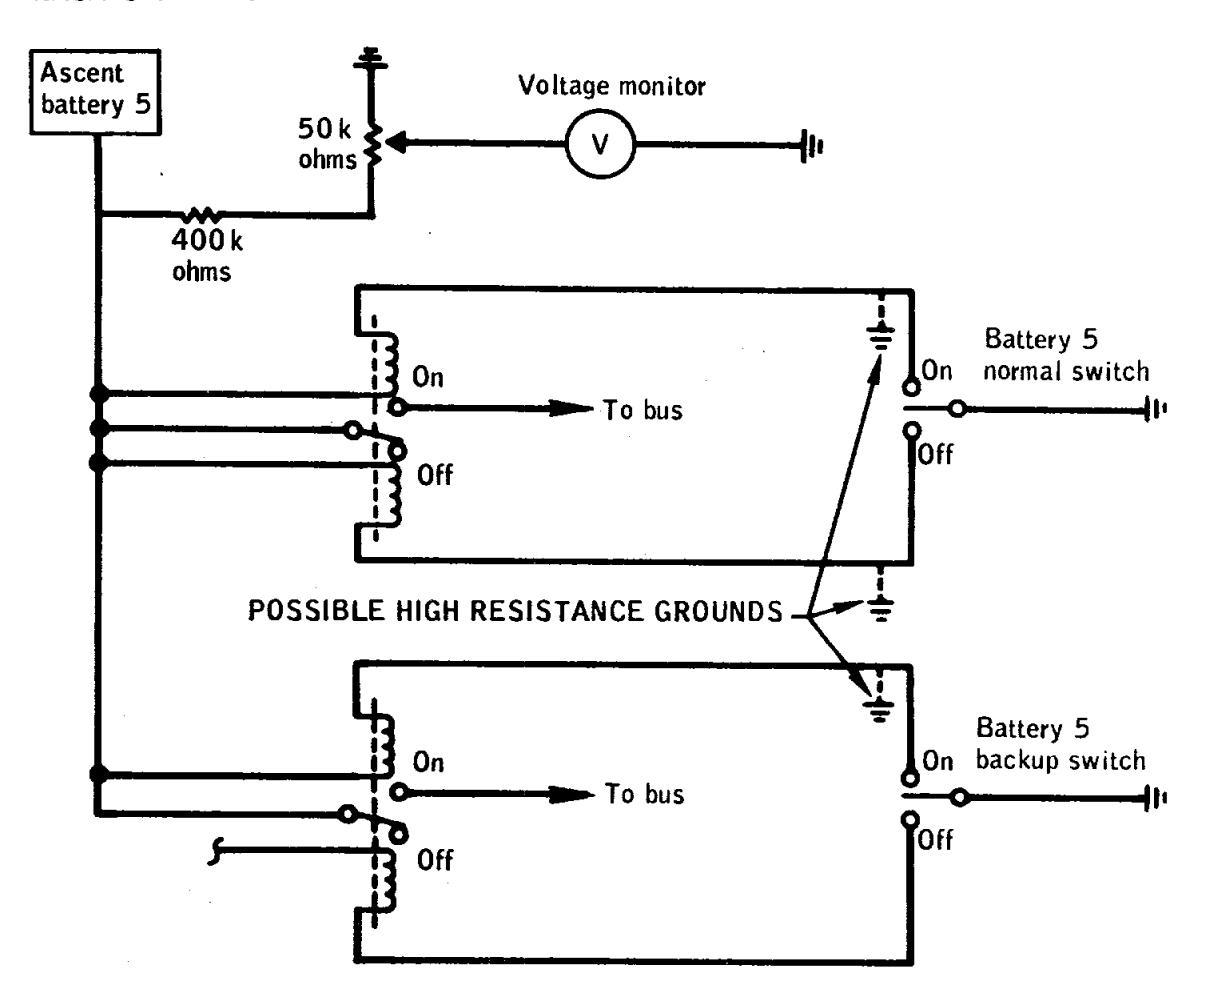
Figure 14-16.- Ascent battery 5 configured for open-circuit loads.

An external battery load could have existed from lift-off to 62 hours on the circuit shown in figure 14-16 in which typical types of high resistance shorts are also shown. For this condition, the current drain would have occurred on all cells. Figure 14-14 shows the time history of the

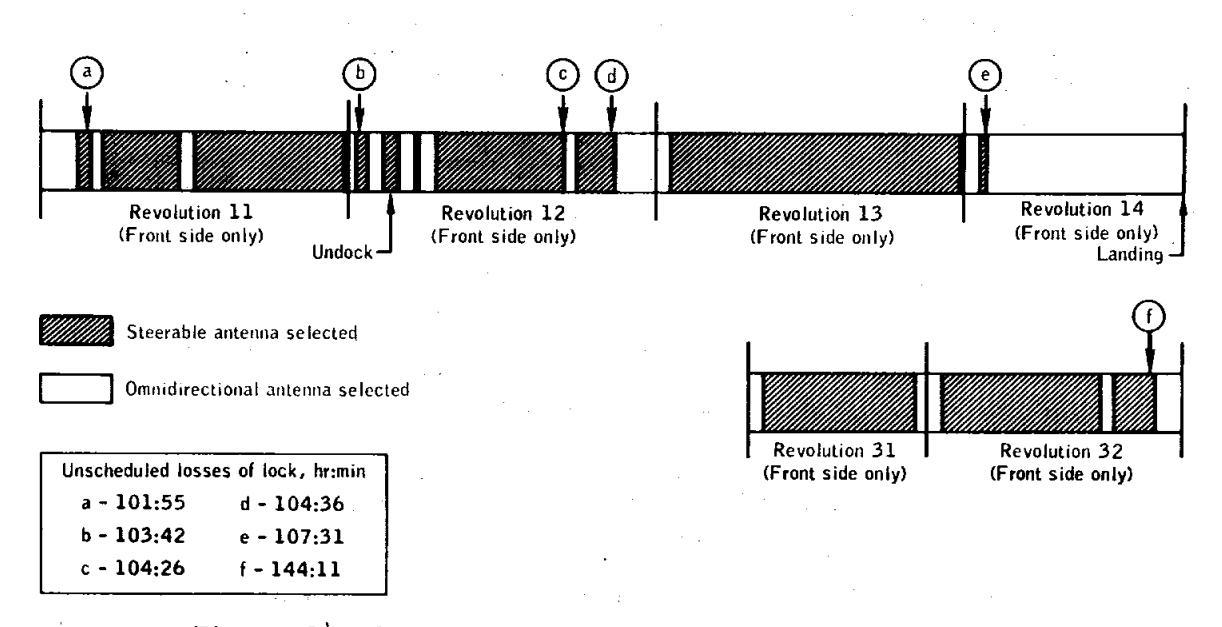
Figure 14-19.- S-band steerable antenna operation.

The remaining unexplained tracking interruptions (fig. 14-19) have similar characteristics. Five tracking interruptions occurred during Goldstone coverage and figure 14-20 is a plot of ground-station-received signal strengths at these times. During the Madrid ground station coverage of revolution 32, another incident was noted with the same type of

antenna response. It indicates that the antenna began to experience a mechanical oscillation of approximately 2 to 3 hertz, which became increasingly larger in amplitude until the antenna lost lock. When antenna oscillations exceed plus or minus 5 degrees, excessive motor drive current causes the 28-volt dc circuit breaker to open and the antenna ceases to track. The crew reset this circuit breaker several times. The antenna was also reported to be noisy, indicating the continual driving that would have occurred during the oscillations. The oscillations occurred randomly at other times during the problem period, but damped out and did not cause tracking interruptions.

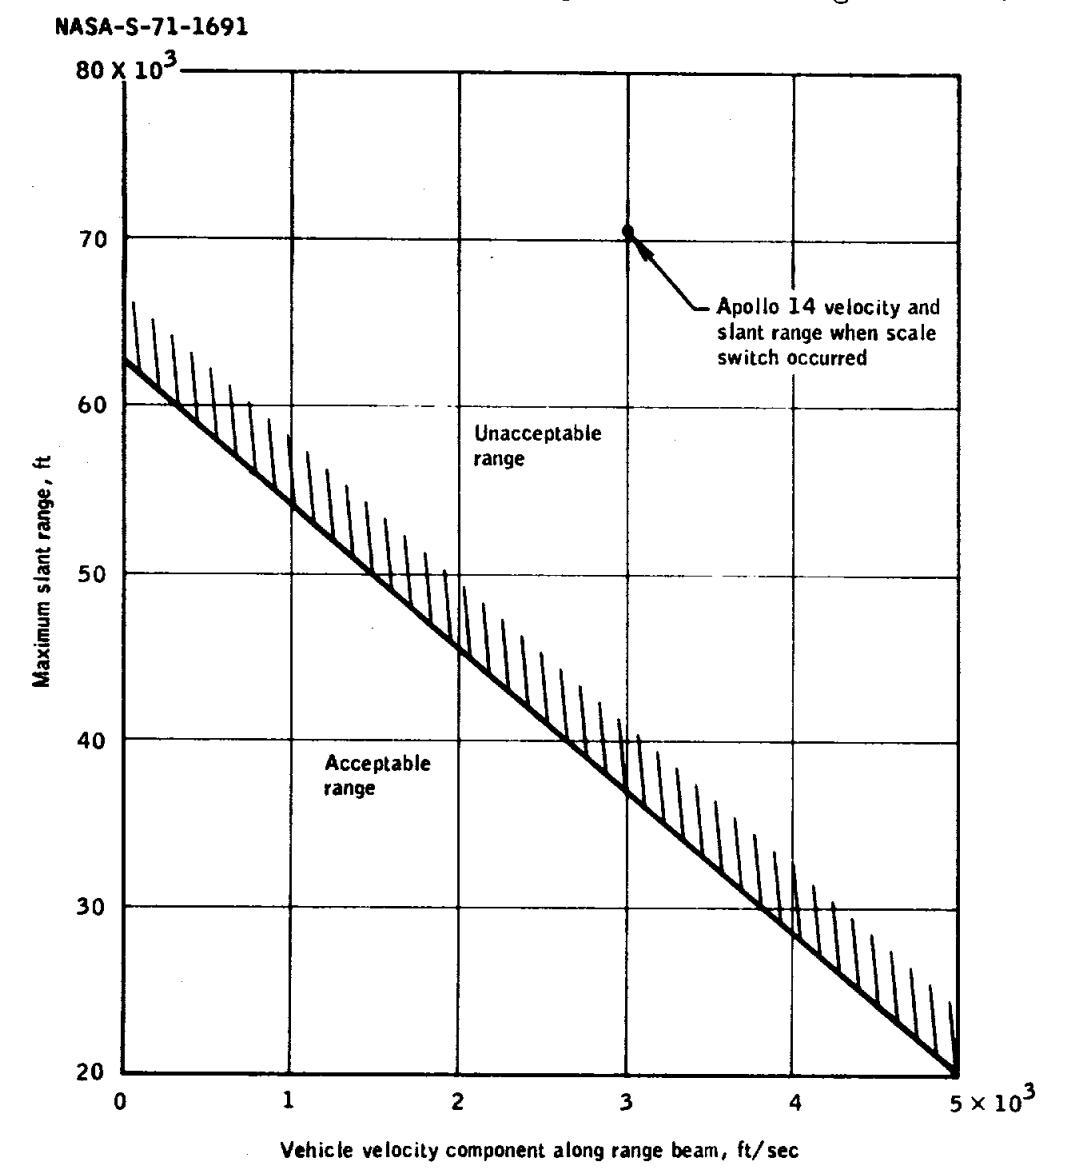
Figure 14-23.- Landing radar range measurement design limitation as a function of vehicle velocity component along range beam.

The scale switching occurred at a slant range of 63 000 feet with a beam 4 velocity of 3000 ft/sec at an incidence angle of 35.4 degrees. Operating the landing radar under these conditions exceeds the maximum range measurement design limit (fig. 14-23). Under these conditions, the receiver is sweeping with maximum gain and the system will be sensitive to any received noise. A test was performed with a radar operating under the Apollo 14 conditions (two range-rate beams locked up and the range beam unlocked). By inserting low-level noise for a fraction of a second into the receiver, range scale switching occurred.

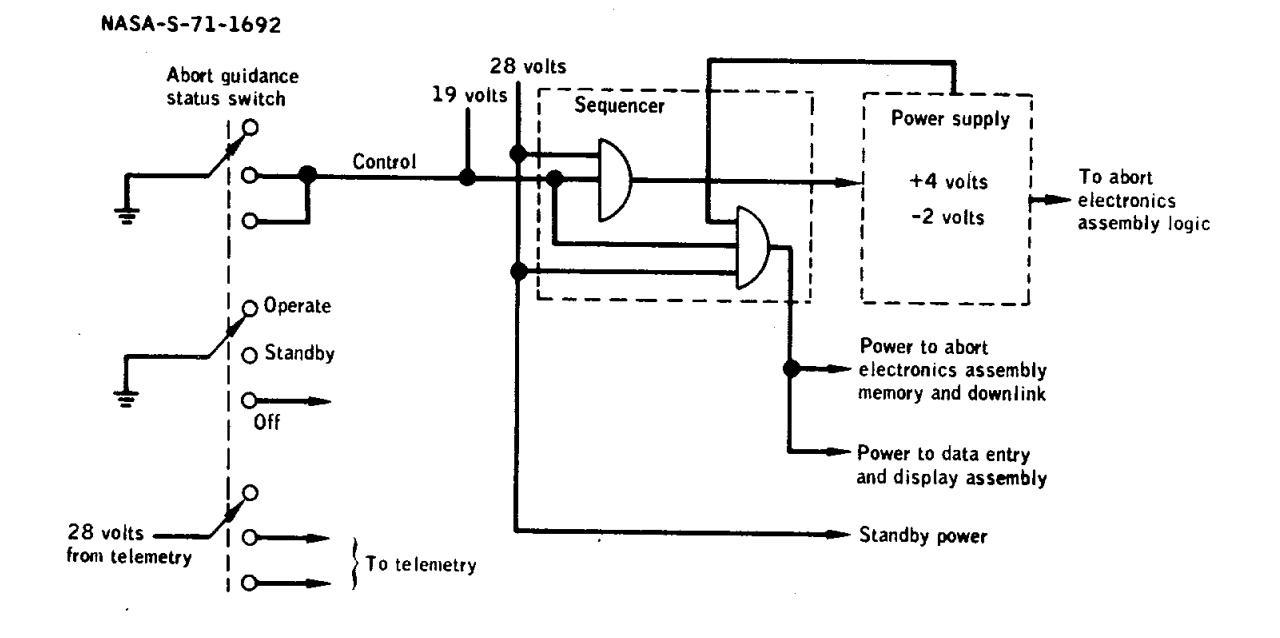
Figure 14-24. - Partial abort guidance system functional diagram.

The abort guidance system failed during the braking phase of rendezvous. Telemetry data were suddenly lost at 143:58:16; however, there was no indication of an abort guidance system warning light or master alarm. The crew was unable to access the data entry and display assembly and depressing any of the pushbuttons had no effect. The status switch was cycled from operate to standby to operate with no effect. Cycling the 28-volt circuit breakers likewise had no effect. The system remained inoperative for the remainder of the mission.

The system was determined to have been in the standby mode after the failure by comparing expected and actual bus current changes that were observed at the time of the failure and the subsequent cycling of the circuit breakers. Further evidence of the system having been in standby was the absence of the warning light and master alarm at the time of the failure. If standby power in the electronics assembly were not maintained, clock pulses to the abort sensor assembly would have been lost and the warning light would have illuminated and the master alarm sounded. A warning light and a master alarm would also have occurred if the failure had been in the abort guidance status switch or the associated external wiring. These conditions isolate the failure to the power supply section or the sequencer of the abort electronics assembly (fig. 14-24).

The failure has been isolated to one of seven modules in the plus 4-volt logic power supply, one module in the sequencer, or one of 27 interconnections between the modules. There are a total of 27 component part types; twelve resistor, two capacitor, four transistor, four diode, four transformer, and one saturable reactor that could have caused the failure.

A component or solder joint failure could have been due to either an abnormal thermal stress or a non-generic deficiency or quality defect that was unable to withstand a normal environment. An abnormal thermal

stress could have been caused by improper installation of the equipment on the cold rails. If this occurred, the first component which should fail is in the particular power supply to which the failure was isolated.

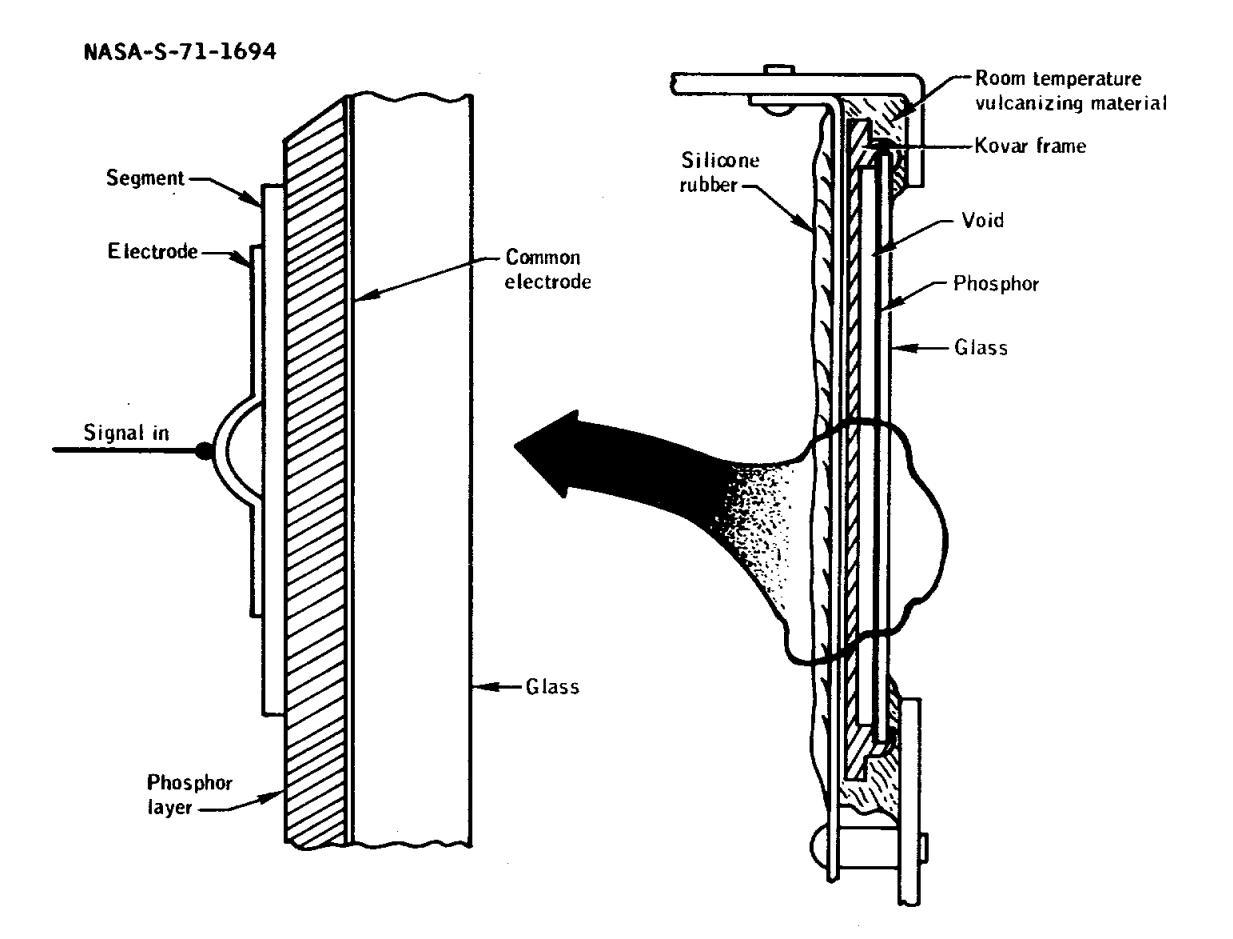
The crew reported a crack in the glass across the address register of the data entry and display assembly. Figure 14-25 shows the assembly and the location of the crack. Figure 14-26 is an enlarged drawing of the glass and associated electroluminescent segments.

The cause of the crack is unknown. Glass cracks have not occurred since a revision was made to the procedure used to mount the glass to the faceplate of the data entry and display assembly. The assembly is qualified for an environment in excess of the flight conditions. Therefore, either excessive internal stresses (under normal conditions) were built into the glass, or the mounting was improper (not as designed), or the glass was inadvertently hit.

Corrective action consists of applying a clear plastic tape prior to flight on the glass of the electroluminescent windows above the keyboard (fig. 14-25), like that previously used on the mission timer windows. The tape is to prevent dislodging of any glass particles if cracks occur in the future, as well as help prevent moisture from penetrating

the electroluminescent segments should a crack occur. The presence of moisture would cause the digit segments to turn dark in about 2 hours if voltage were applied to a cracked unit, making the assembly unreadable.

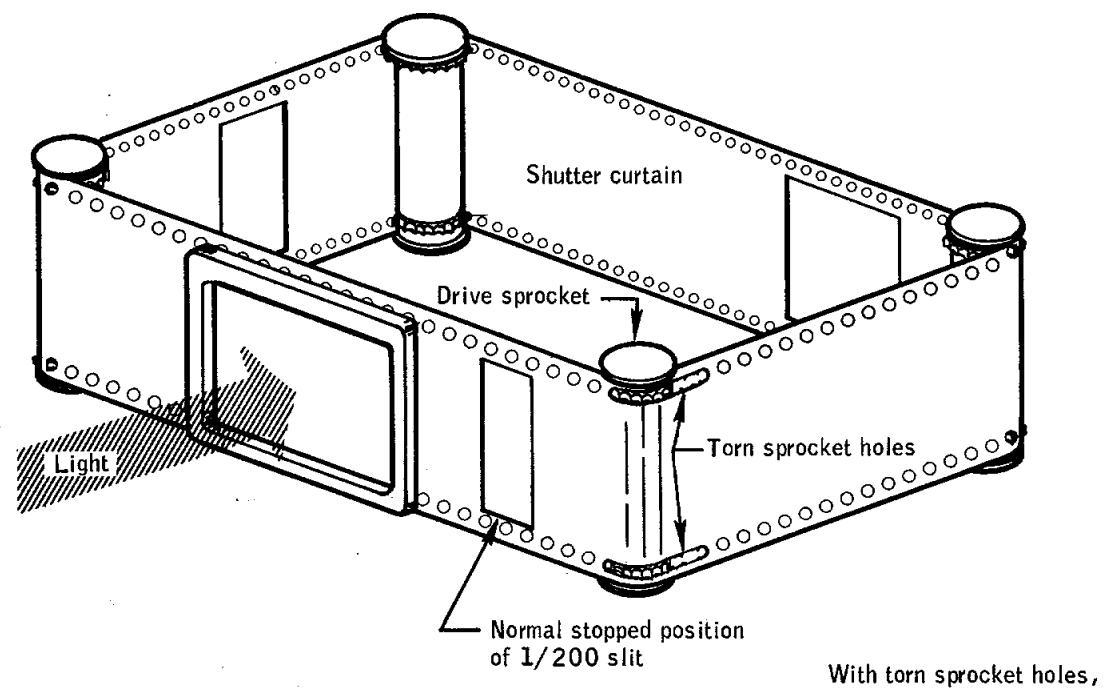
NASA-S-71-1696

loose piece of aluminum 0.130 inch by 0.008 inch, which was foreign to the transistor material. With a shorted transistor, 28 volts is applied continuously to the shutter drive circuit, causing continuous shutter operation, independent of the intervalometer and independent of the single, auto, or standby mode selections. The sprocket holes in the 1/200 slot in the shutter curtain were torn as a result of the prolonged, continuous, high-speed shutter operation (fig. 14-28).

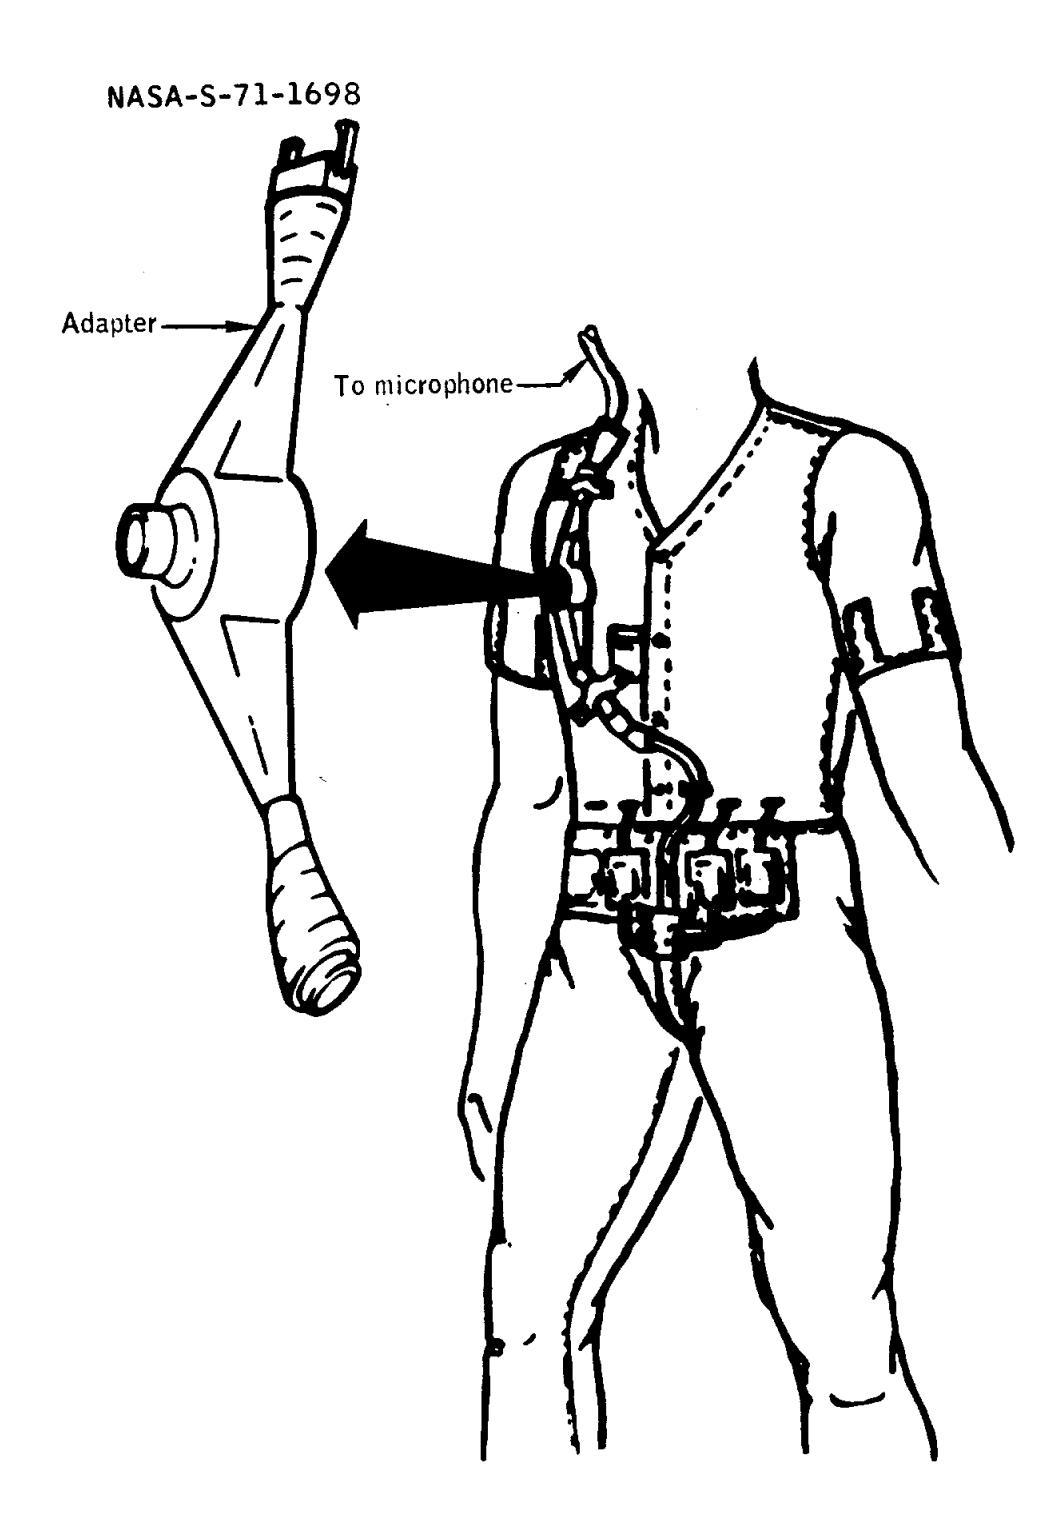
Figure 14-30.- Constant wear garment communications harness.

At approximately 29 hours, Mission Control had difficulty in communicating with the Commander. The Commander replaced his constant wear garment electrical adapter (fig. 14-30) with a spare unit, and satisfactory communications were reestablished.

The most likely cause of the problem was poor contact between connectors because of small contaminants or improper mating of a connector, which was corrected when the spare adapter was installed.

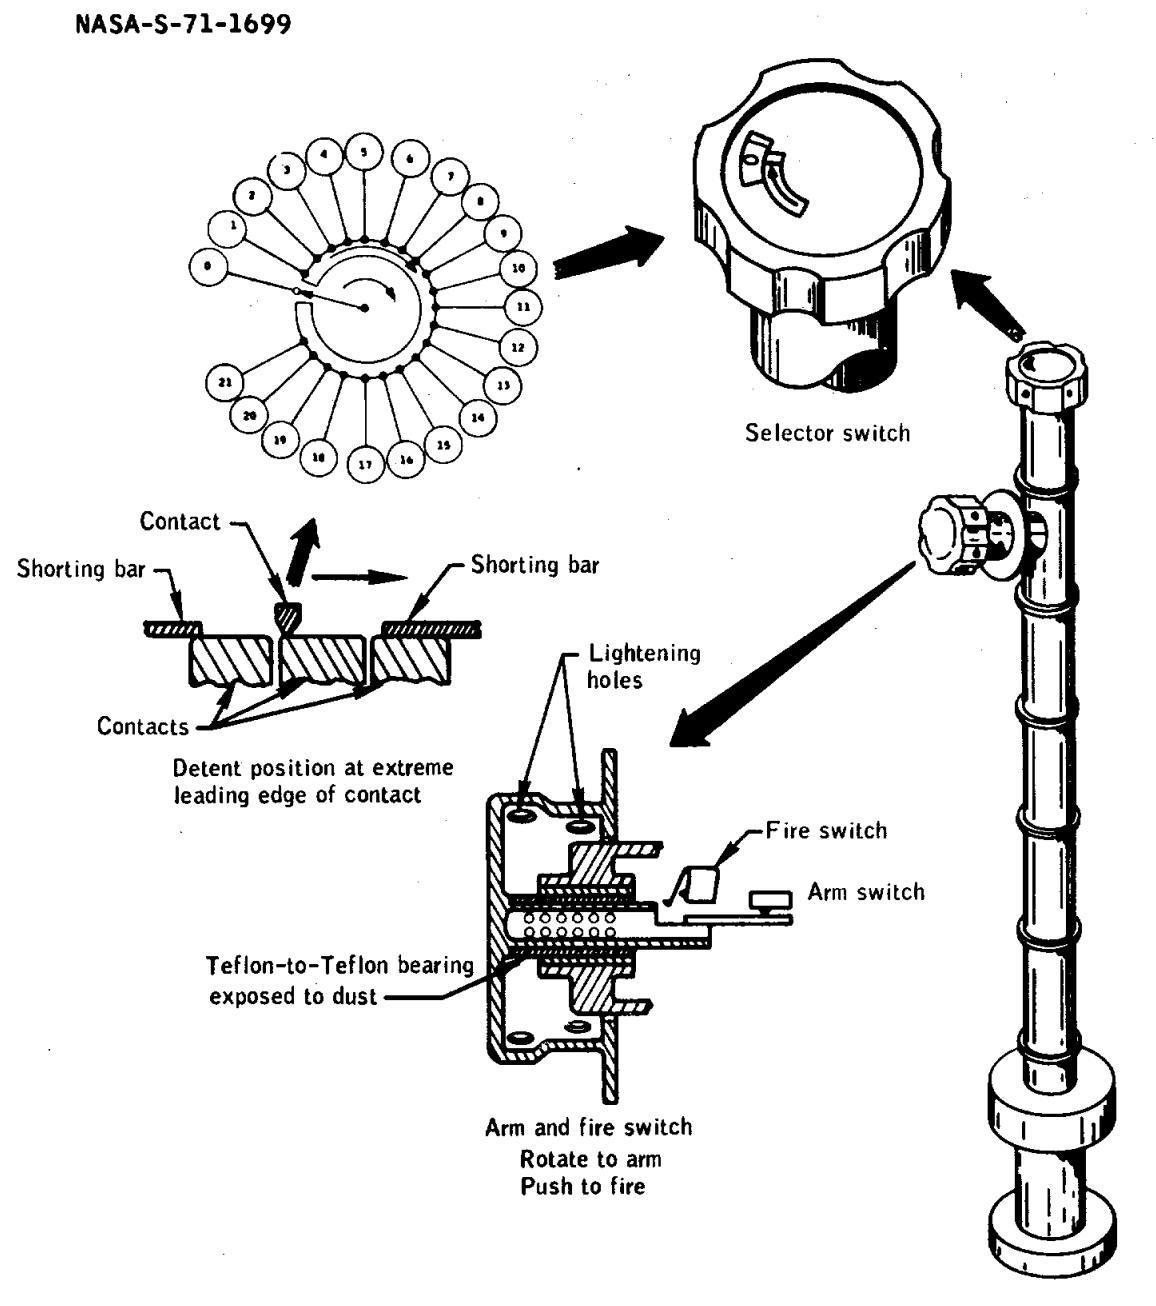
Figure 14-31.- Active seismic experiment.

The most likely causes of the problem are associated with the detent portion of the selector switch (fig. 14-31) and dirt on the firing switch actuator bearing surface. The selector switch dial can reposition out of detent in the course of normal handling because of the lack of positive seating in the detent for each initiator position. For an initiator to be fired, the selector switch must provide contact to the proper unfired initiator position. Examination of the qualification unit has shown that the detent is positioned at the leading edge of the contact surface so that any movement toward the previous position will break the contact. Also, the lightening holes in the firing switch knob make it possible for dirt to get onto the Teflon bearing surfaces, temporarily increasing the force required to close the switch (fig. 14-31).
