MSC-04112

APOLLO 14 MISSION REPORT

MANNED SPACECRAFT CENTER HOUSTON.TEXAS MAY 1971

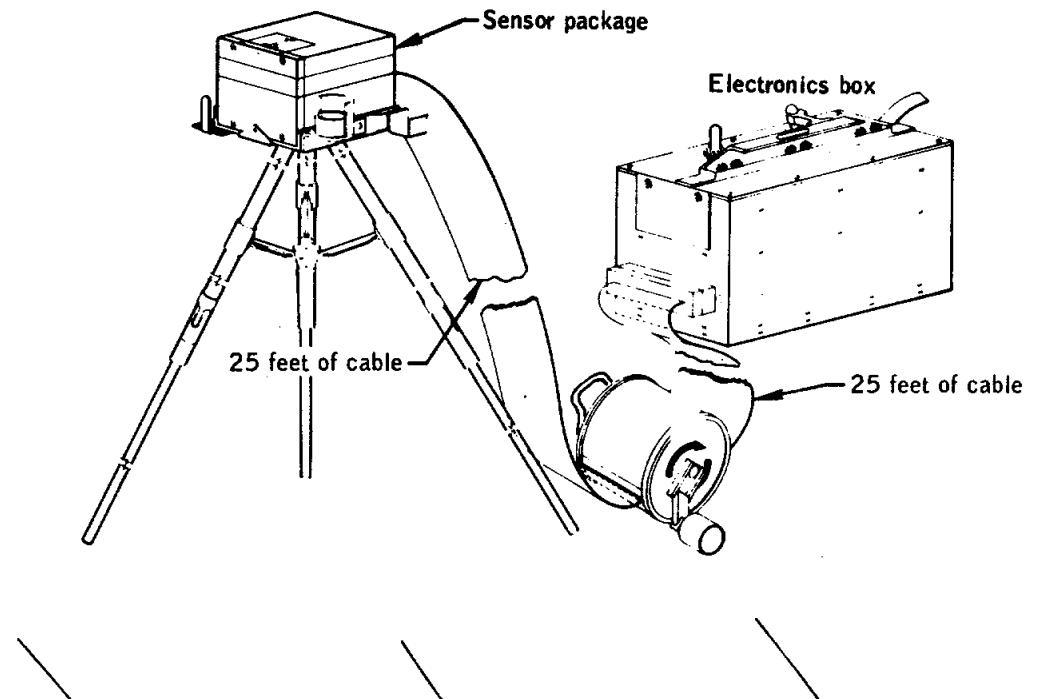
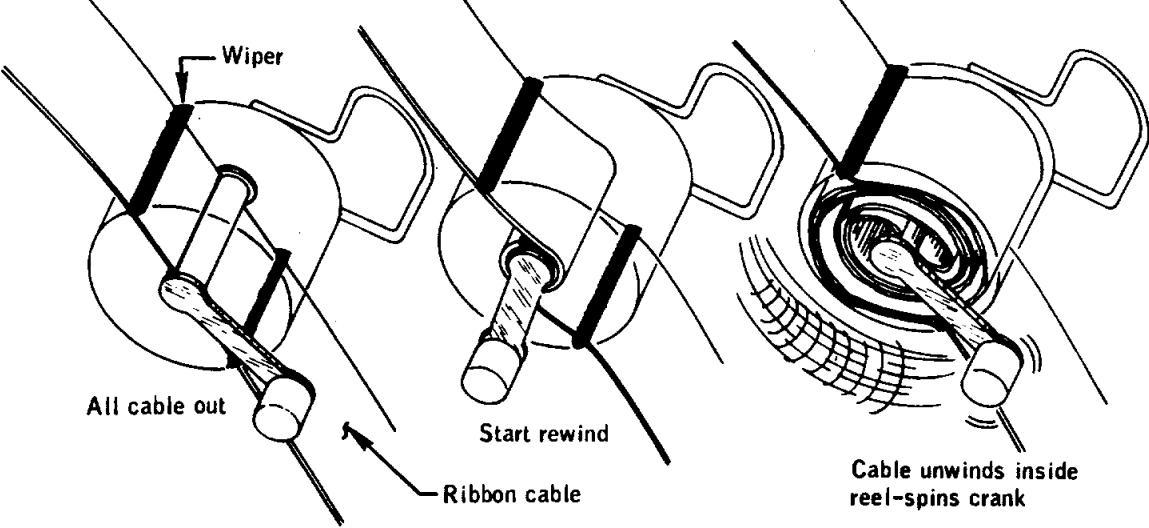
Figure 14-32.- Lunar portable magnetometer cable reel.

The crew reported that it was difficult to rewind the lunar portable magnetometer cable. The cable is deployed and rewound at each location where the lunar portable magnetometer is used (fig. 14-32).

The lunar portable magnetometer ribbon cable snarls easily at 1/6g and is difficult and tedious to unsnarl. If it is necessary to remove the hand from the crank to unsnarl the cable during the first part of rewinding the cable, the cable will unwind within the reel and spin the reel handle (fig. 14-32). Free unwinding of the reel is required during deployment; however, it is desirable to be able to lock the reel against rotation at times during rewind of the cable. Rewinding was difficult because there was no provision to lock the reel during rewind, and gripping the reel and crank was difficult with the gloved hand.

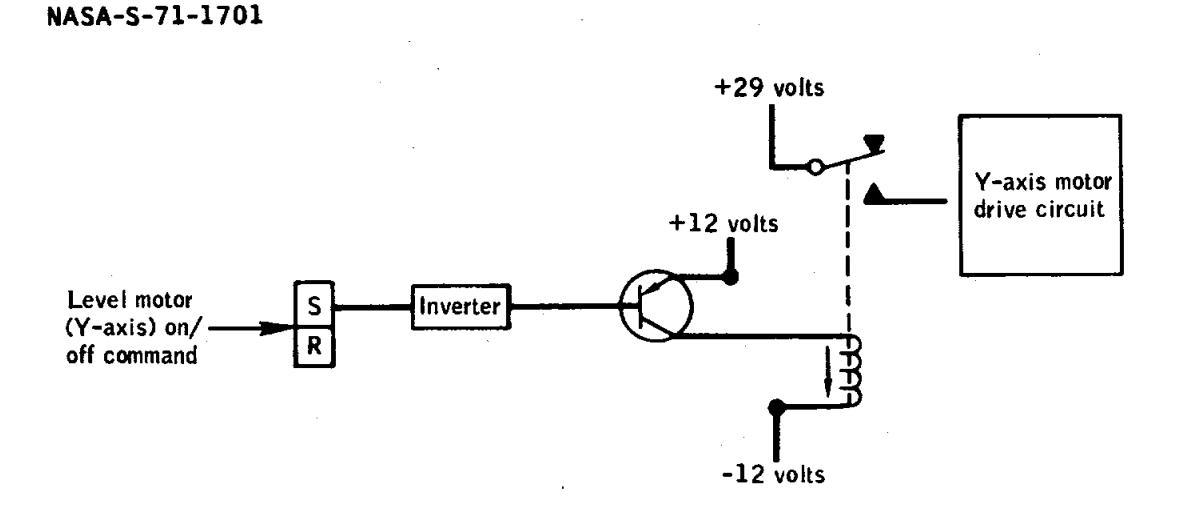
Figure 14-33.- Y-axis leveling motor circuitry.

The horizontal Y-axis leveling motor of the gimbal leveling system operates intermittently (fig. 14-33). Although a command verification is received when commands are sent, power is not necessarily received by the motor. When there is an indication of power to the motor, the motor does operate. As a result, during the first lunar day, response to ground commands was normal except for 6 of the 22 commands when there was no response.

Although no scientific data have been lost to date, intermittent problems have been encountered when leveling the Y-axis of the gimbal platform upon which are mounted the three orthogonal long-period seismometers. Occasionally, either there is no electro-mechanical response, or the response is delayed when the Y-axis motor is commanded on. Delay times vary. Thus far, leveling has been achieved by cycling on/off commands at varying time intervals.

The problem is caused by an intermittent component in the motor control circuit (fig. 14-33). There is no correlation between the occurrence of the problem and the temperature of the lunar surface, the central station electronics, or the experiment. Whenever there is an indication of power to the motor, the motor operates. When the motor operates, it operates properly and pulls the normal current.

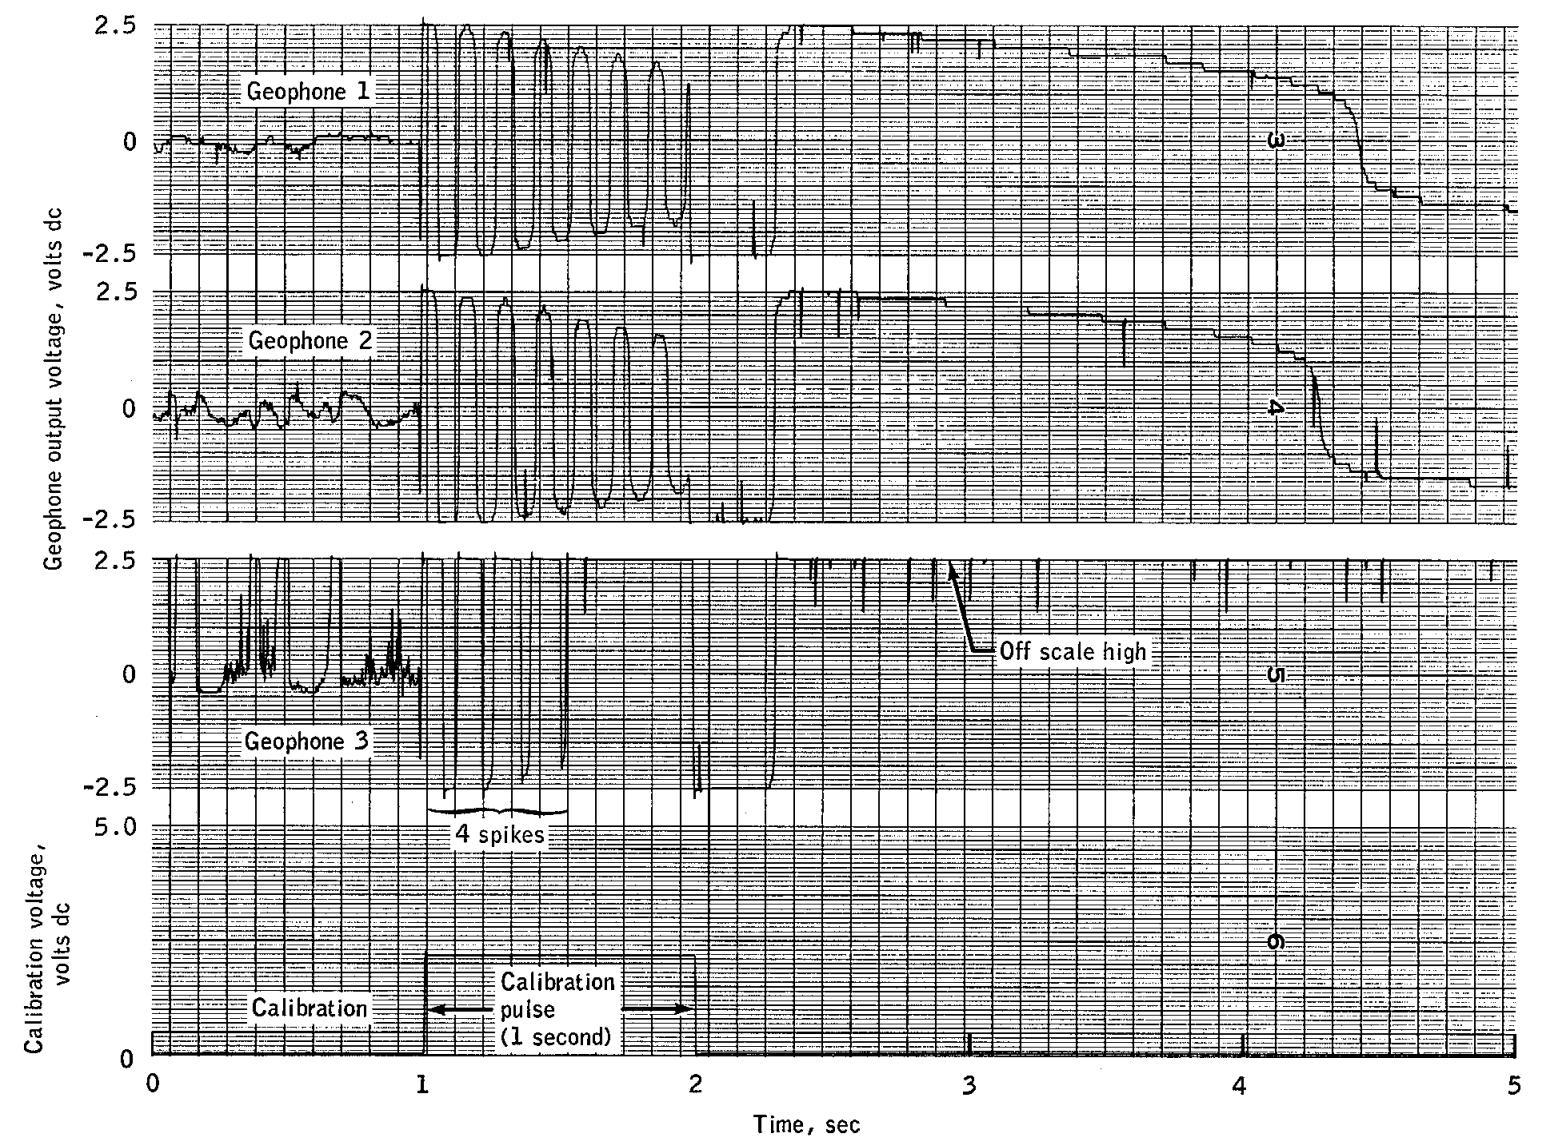
Figure 14-34.- Geophone calibration data.

The experiment was turned on in the listening mode on March 26, 1971, and geophone 3 data were spiking off-scale high (fig. 14-34). When the geophone channels were calibrated, the geophone 3 channel went off-scale high simultaneously with the start of the calibration pulse and stayed off-scale high for the remainder of the listening period. During the 1-second period when the calibration pulse was present, data from geophones 1 and 2 showed the normal 7-hertz ringing caused by the calibration pulse. However, geophone 3 data showed four negative-going spikes coincident with the first four negative half cycles of the ringing on the other two channels. The spikes decreased in duration from the first to the last, the last having an amplitude of 90 percent of

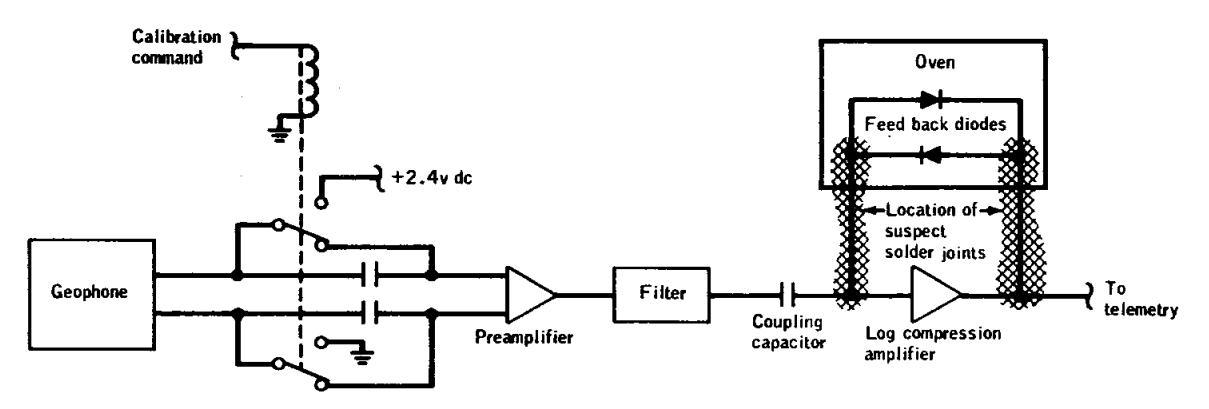
Figure 14-35.- Typical geophone channel.

As shown in figure 14-35, each geophone channel consists of a geophone, an input preamplifier, a low-pass filter, and a logarithmic compressor amplifier. The output of the logarithmic compressor feeds the instrumentation system. The logarithmic compressor is basically an inverting amplifier with exponential negative feedback. Two diode-connected transistors between the output and input of the amplifier supply the feedback. The first diode is used for positive-going and the second for negative-going input signals. The diodes for all three geophone channels (two per channel) are physically located in an oven which controls their temperature at 105° C.

It is believed that the failure is in the logarithmic compression amplifier because signals are coupled into it through an input coupling capacitor. This capacitor would block any offset voltages from the preceding stages which would be required to drive the output off-scale high. Analysis indicates that the most probable cause of the problem is an intermittent open circuit in the diode feedback path. This would allow the amplifier input transistor to saturate, driving the output off-scale high. When signals large enough to drive the input stage out of saturation were present, the output would then respond and the output signal would not be compressed. The experiment electronics uses "cordwood" construction of the type which has caused solder cracks in other equipment. Two copper paths conduct the feedback diodes to the logarithmic compressor amplifier. A solder crack in either path would then result in the data characteristics.

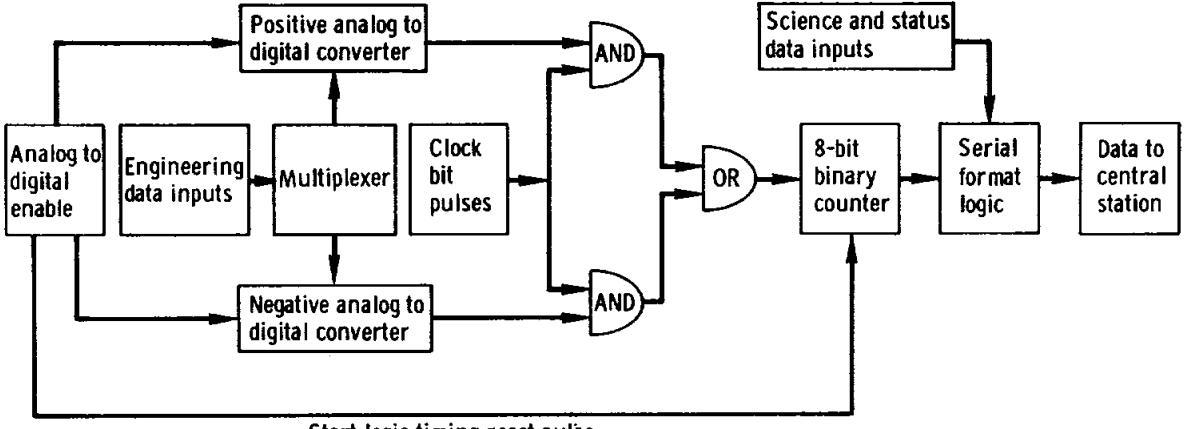
Figure 14-37.- Simplified data logic control.

An intermittent failure of the start reset pulse for the positive log analog-to-digital converter control logic (fig. 14-37) could cause the problem. Although the failure permits the positive converter initial output to fill the eight-bit binary counter and produce a full-scale reading; thereafter, when a start pulse for the positive converter should reset the eight-bit counter, it fails to do so, and the negative word which is still in the counter is read out as a positive word. The cause appears to be an intermittent component or wire connection in one of the associated modules. However, it does not appear to be a function of the temperature. The components have been passed by normal high reliability screening, and systems tests have included operational pressure, temperature, vibration, humidity, and accelerated lunar environment cycles. No failure of this
