# U. S. S. SARATOGA (CV3)

## TORPEDO DAMAGE

JANUARY 11, 1942

WAR DAMAGE REPORT No. 19

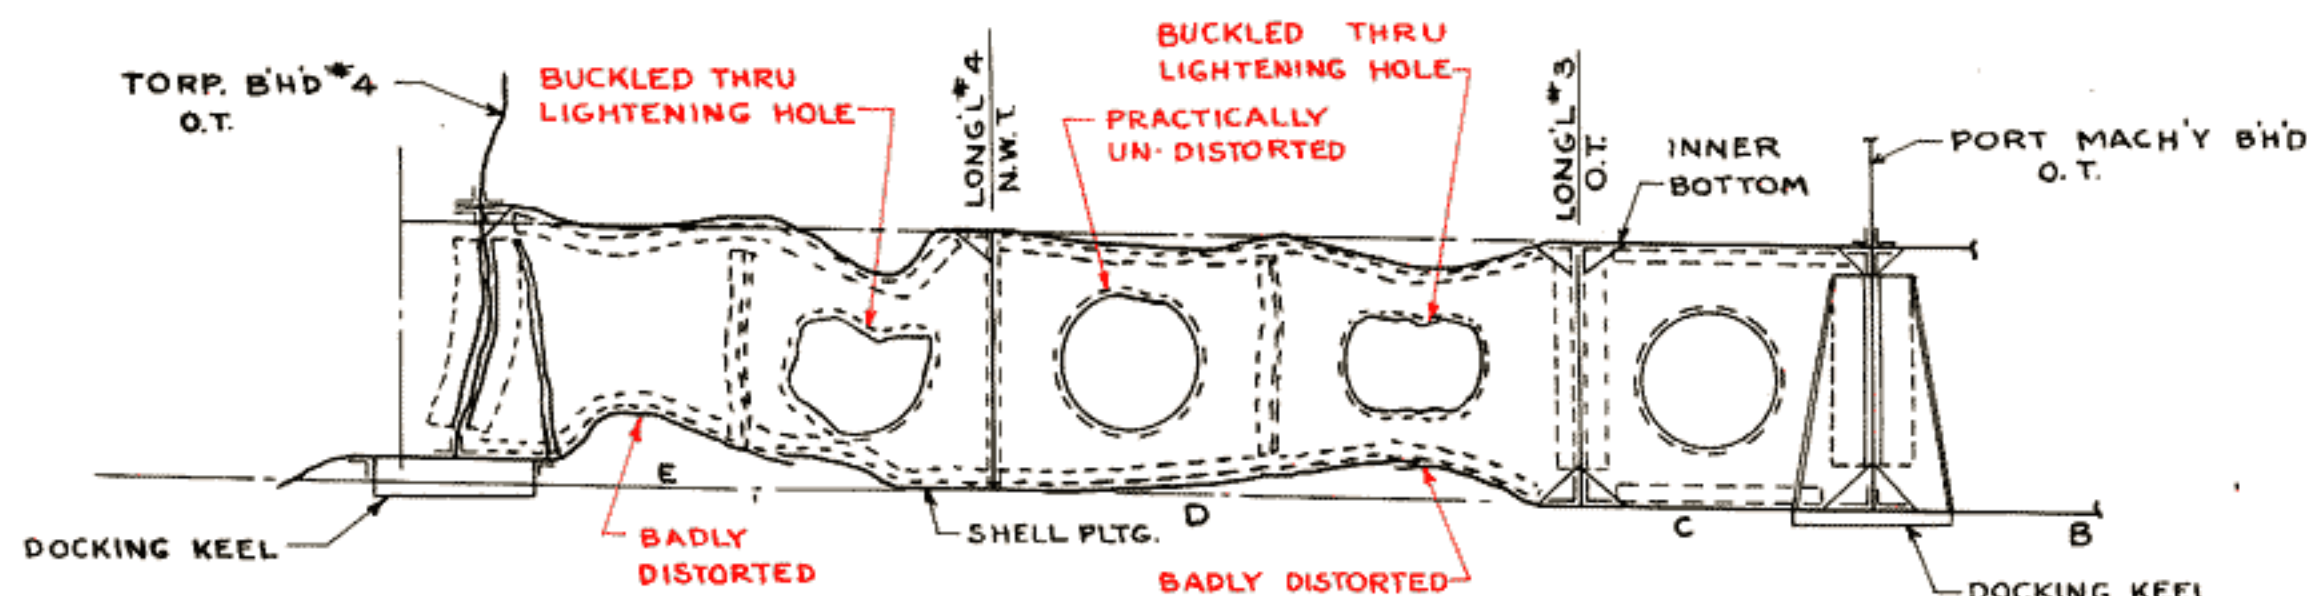
TYPICAL BUCKLING OF FLOORS  
FRAME #107 SHOWN-LOOKING F'W'D  
SCALE  $\frac{3}{8}" = 1'-0"$

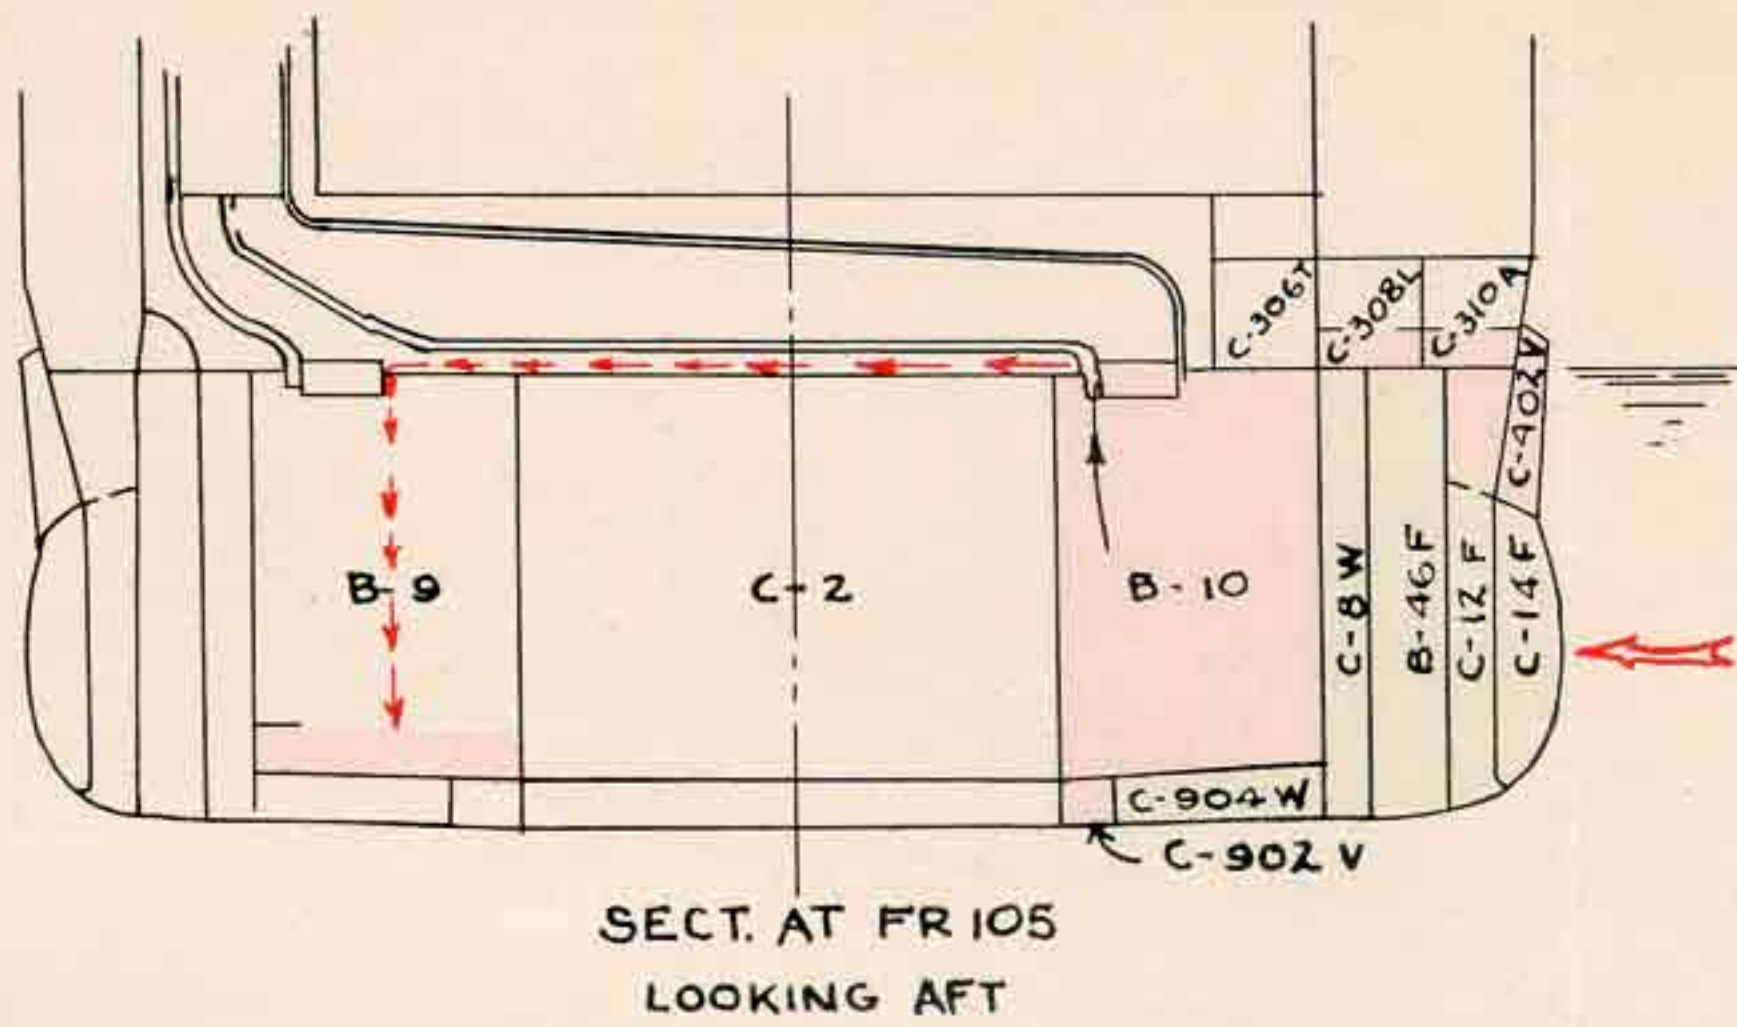
U. S. S. SARATOGA - CV3  
FLOODING DIAGRAM  
TORPEDO DAMAGE  
11 JAN. 1942  
NAVY DEPT. BUREAU OF SHIPS

☐ FILLED BEFORE DAMAGE

☐ FLOODED BY DAMAGE

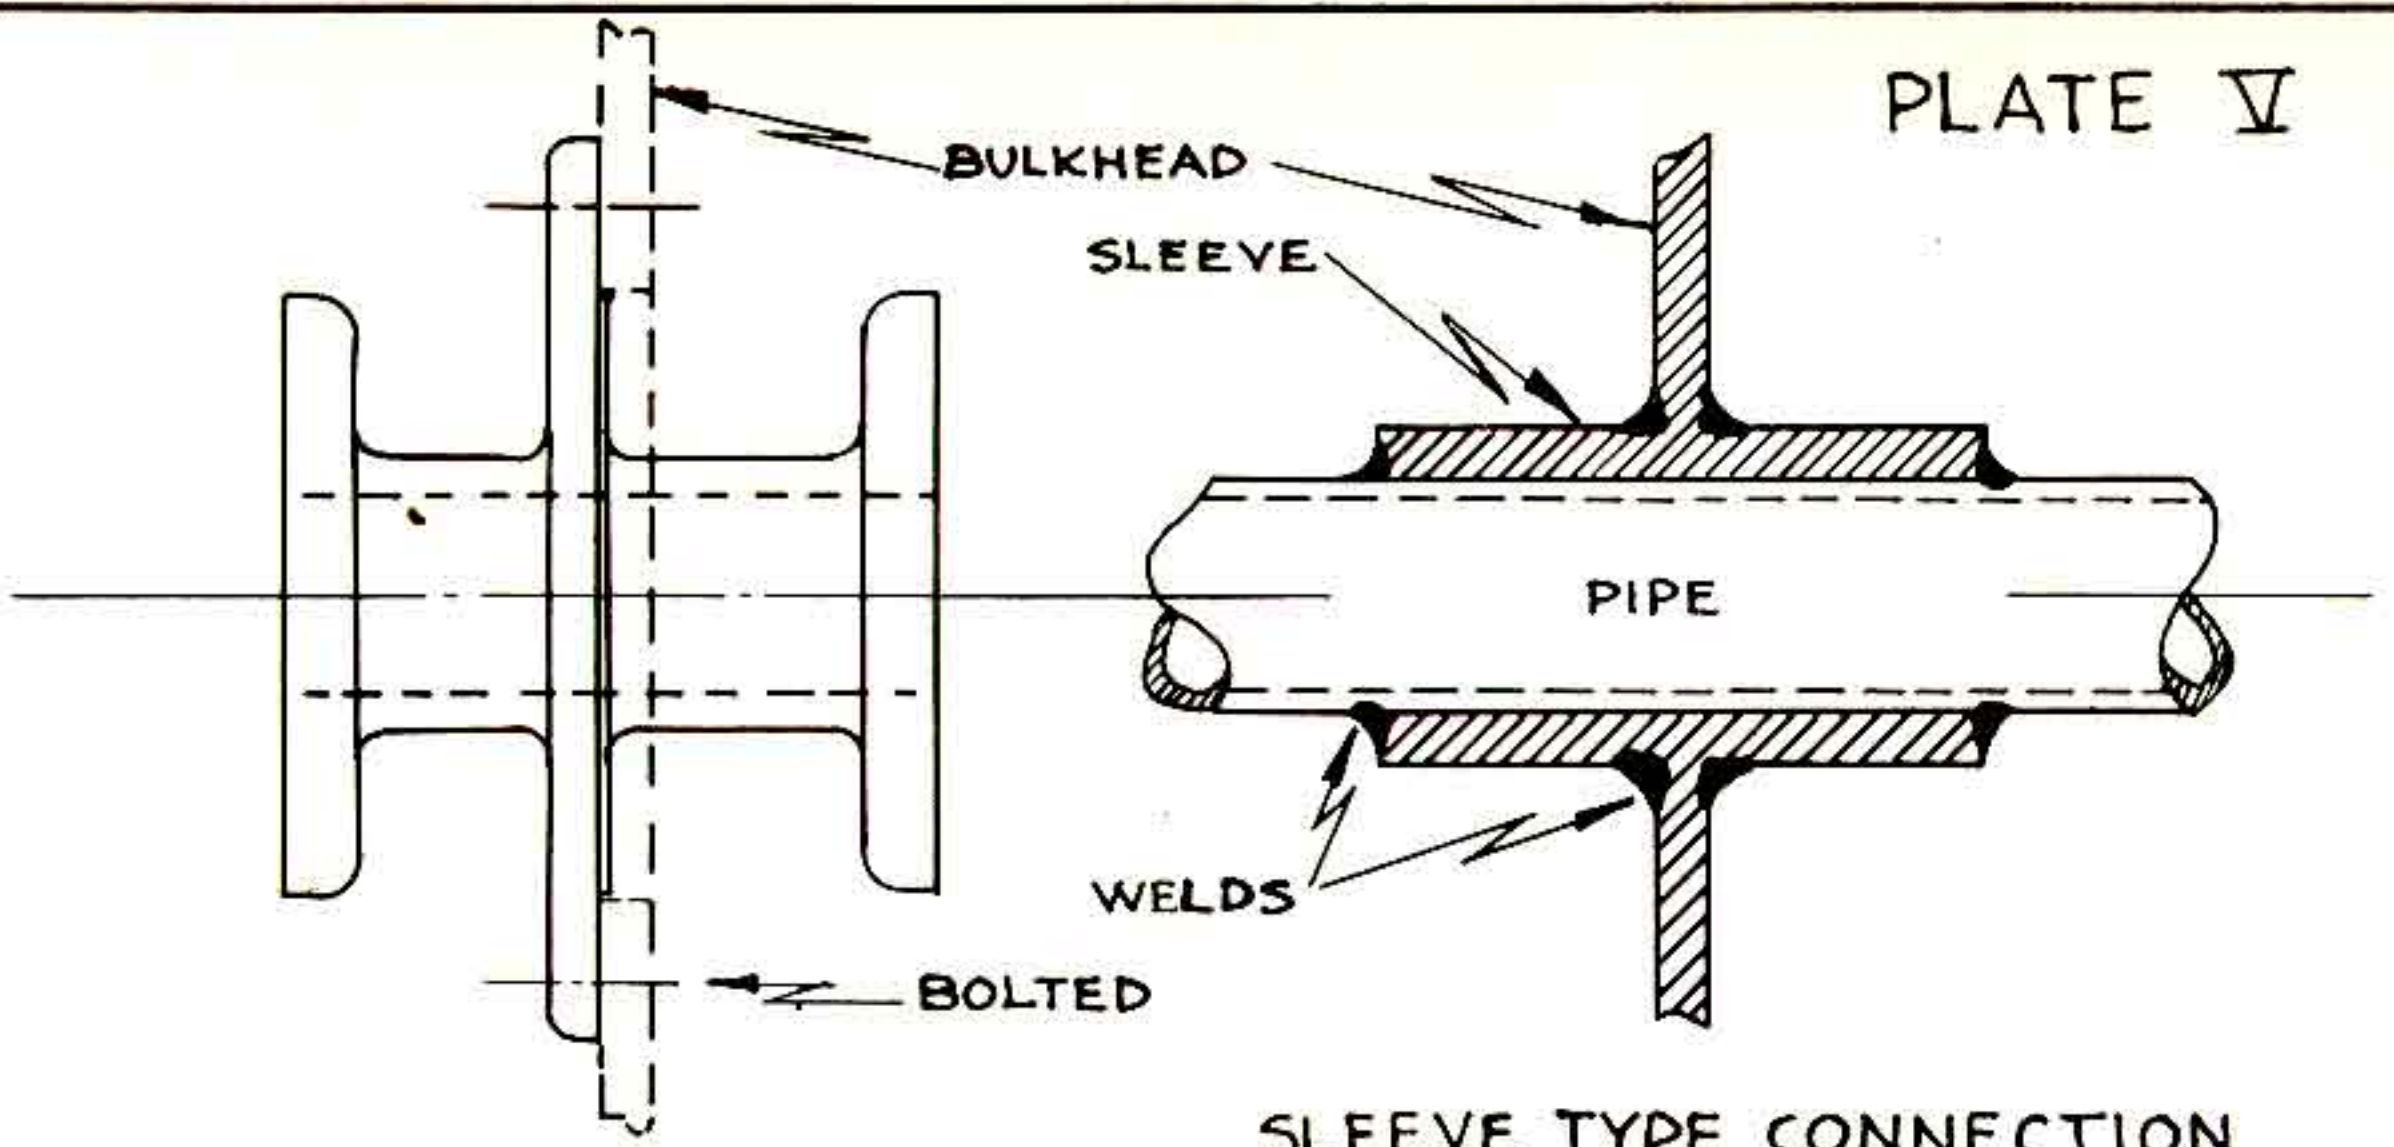
CAST BULKHEAD FITTING

USED ON CV3

SLEEVE TYPE CONNECTION

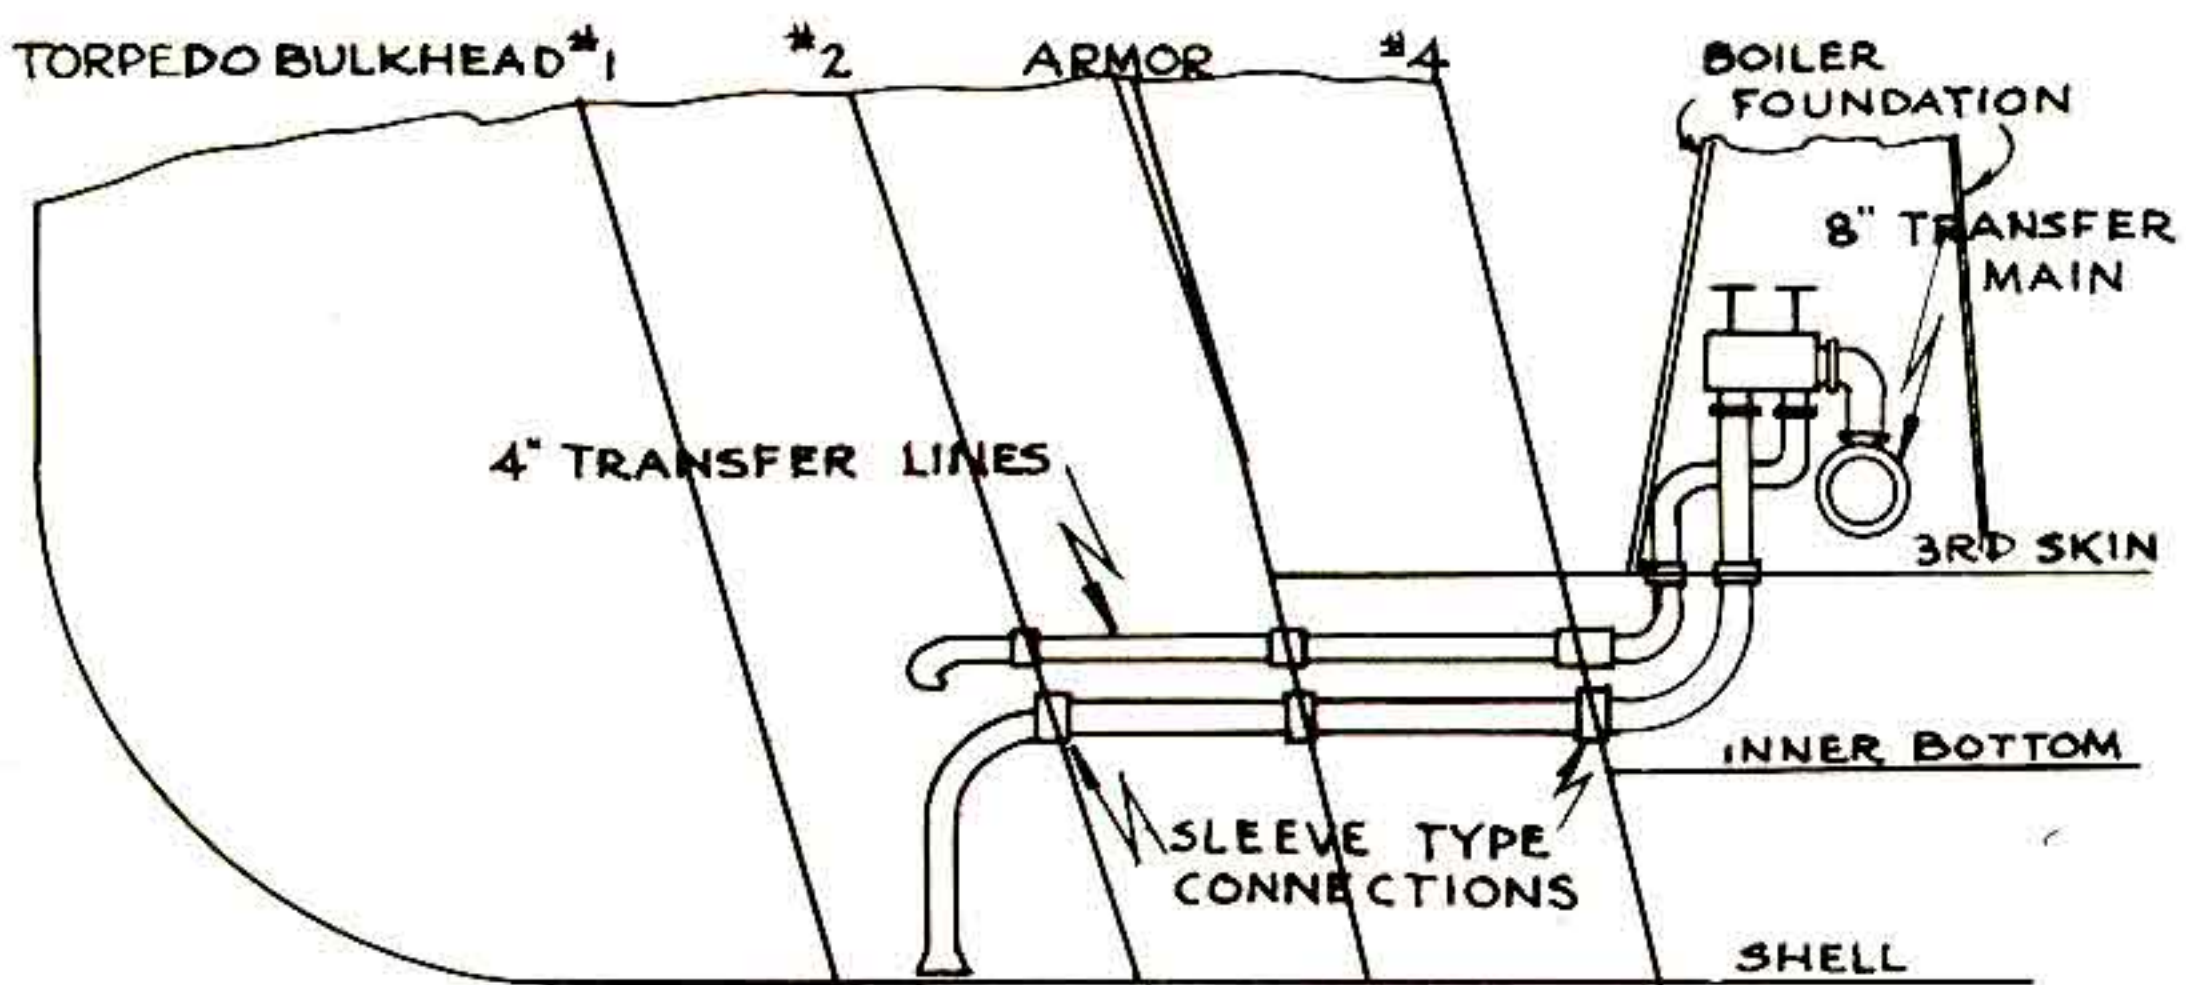
ARRANGEMENT OF FUEL OIL TRANSFER PIPING  
BB-57

(ARRANGEMENT OF 5" SERVICE  
PIPING AND 2 1/2" DRAIN PIPING  
GENERALLY SIMILAR.)
